Building Inspection Report

Inspection Date: Wed, 4 Mar 2026

Property Address: 1 Arabella Pl, Bella Vista NSW 2153,
Australia

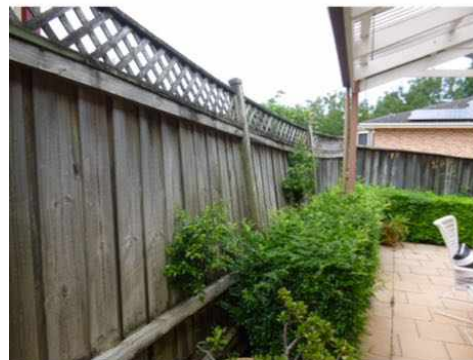
Defects 3.01

Building: Main Building
 Location: Fencing
 Finding: Fencing - Deteriorated
 Information: It was noted at the time of inspection that sections of the fencing of the property have deteriorated. Typically fencing deteriorates due to age and or wear, rot and or rust which is generally expected for a structure of this age, due to prolonged exposure to weather conditions. Sometimes inadequate installation or maintenance can be to blame.

If left unattended, it is likely that further damage will occur. It is suspected that repair of several elements of the fencing may be required however replacement may be a consideration of the client also.

A licensed fencing contractor should be appointed to provide further advice and perform rectification works as necessary.

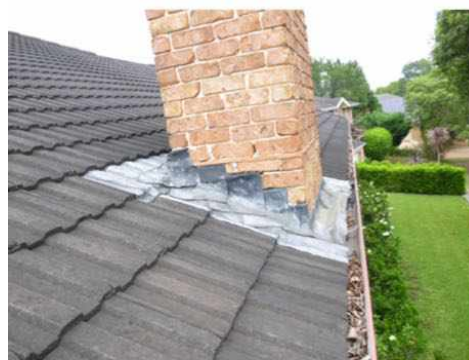
Defects 3.02

Building: Main Building
 Location: Gutters- Front

Blocked gutters are likely to lead to high levels of moisture in the affected areas. Such moisture will not only cause rust and decay of the associated building materials, but can also provide conditions that are conducive to termite and timber pest activity. Blockages in gutters should therefore be removed immediately to ensure dry conditions are maintained.

Consult a Licensed Plumber for further specific advice on remedial works that may be required. In the interim, it is highly advised that blocked gutters be removed by the homeowner or a general handyperson as a matter of urgency.

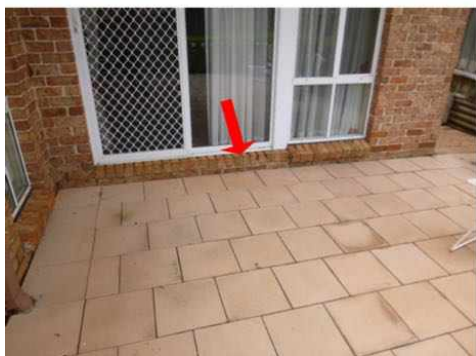
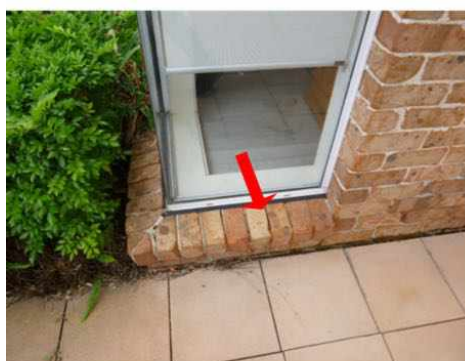
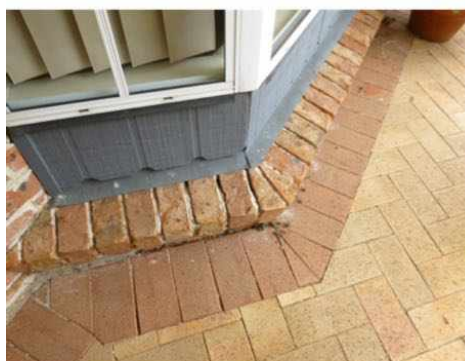
Defects 3.03

Finding: Brickwork - Deteriorated mortar

Information: Mortar, or 'bedding', is the material which fills joins and intersections between bricks in masonry walls and structures. Sections of mortar in this brickwork were identified as having deteriorated, which is generally expected for a property of this age and condition.

Mortar may deteriorate as a result of age of building materials, minor movement of bricks, or frequent exposure to weathering. Mortar should be replaced to ensure that bricks remain in their intended location and to prevent gaps, which would allow water or moisture ingress and secondary damage as a result.

Mortar deterioration can be addressed by a bricklayer where areas of deterioration are

localised and easily accessible. Alternatively, appointment of a registered builder is advised, to repoint large areas of decaying mortar. Where secondary structural defects have become evident, consultation with a structural engineer may be required.

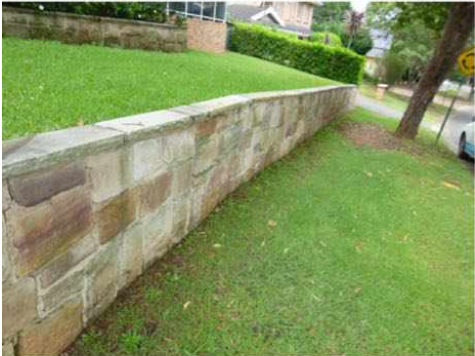
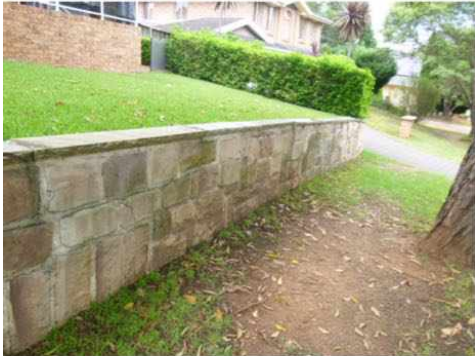
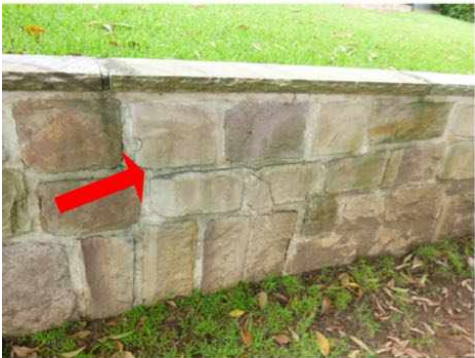
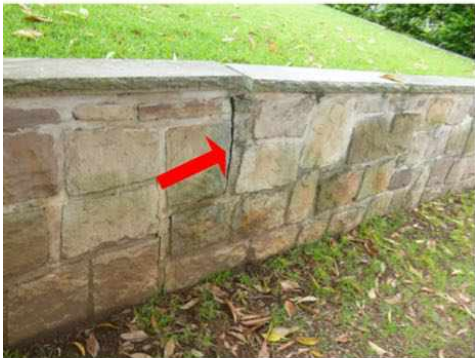
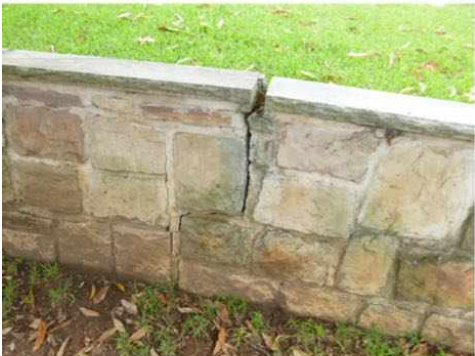
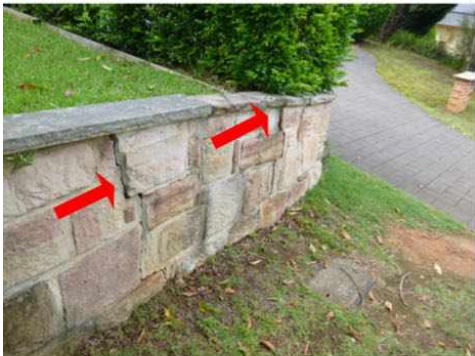
Defects 3.04

Building:	Main Building
Location:	Yard - Front
Finding:	Retaining wall - Defective
Information:	The retaining wall in this area was found to be defective at the time of inspection. Generally, defective retaining walls are caused by poor original design or material use. However, deteriorated retaining walls may also be a result of substandard

If left unmanaged, the retaining wall may become a safety hazard if it continues to destabilise. Where retaining walls further rot and decay, an environment is created that is conducive to termite and pest infestation.

Significant repair and replacement should be expected. A landscaper or retaining wall installer may be appointed to repair or replace the wall, at the discretion of the client.

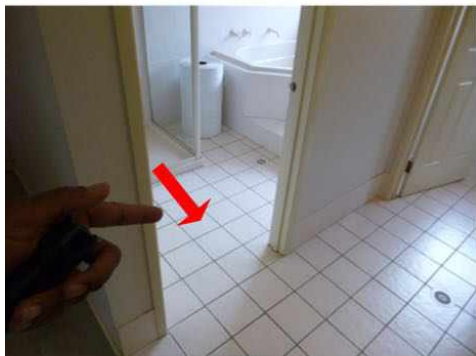
Defects 3.05

Building:	Main Building
Location:	Bathroom
Finding:	Tiles - Drummy
Information:	Drummy tiled areas were identified at the time of inspection. The term 'drummy' refers to tiles that have become detached from their fixing, despite otherwise being in relatively good condition. Such defects are generally caused by physical or moisture damage to the area. Drummy tiled areas may also be a direct result of poor workmanship during the construction process.

Tiled areas may swell and shrink with changes in air humidity if the area has sustained moisture damage. Any exposure to moisture is capable of causing tiled areas to

become drummy and/or cracked over a prolonged period of time. Drummy tiled areas generally require removal and replacement of affected tiles, with adequate sealant and grouting.

Specialist trades are available for these types of services. A registered builder may be required to undertake works if damage is extensive or if secondary building defects have resulted. Otherwise, it is advised that a tiling contractor be appointed to perform works as necessary. Immediate action is recommended to ensure that no further damage is sustained in the affected area.

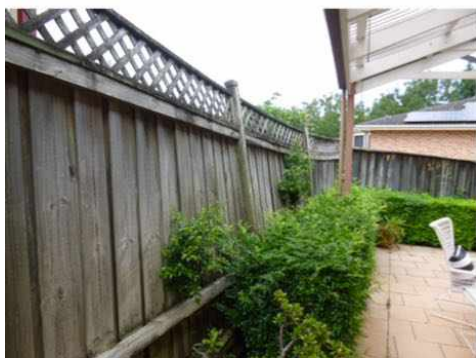
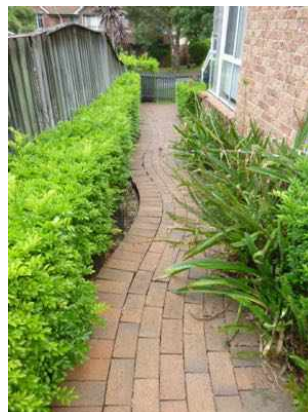
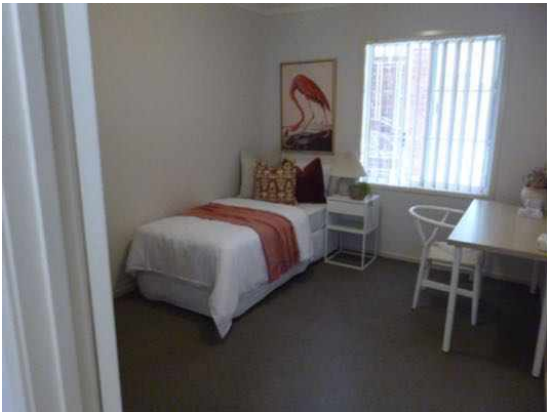
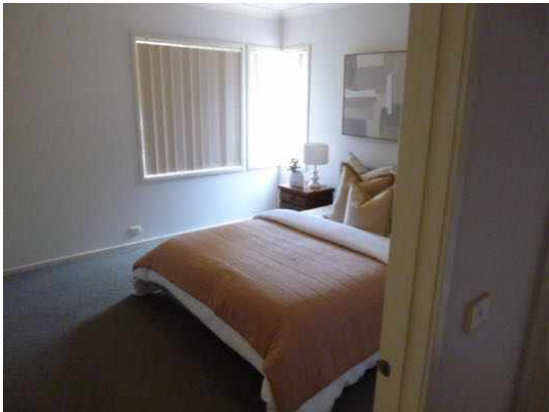
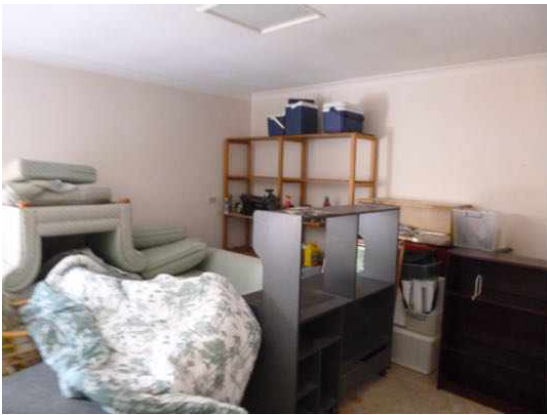
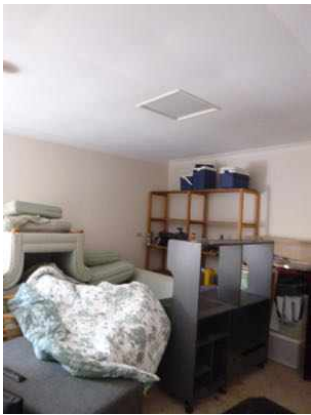
Defects 3.06

Building: Main Building
Location: All Areas
Finding: Additional Photos - Obstructions and Limitations
Information: These photographs are an indication of the obstructions and limitations which impeded full inspection of the property at the time of inspection. These obstructions can hide an array of defects and should be removed to allow full inspection to be carried out. A re-inspection is recommended once the areas are made accessible.

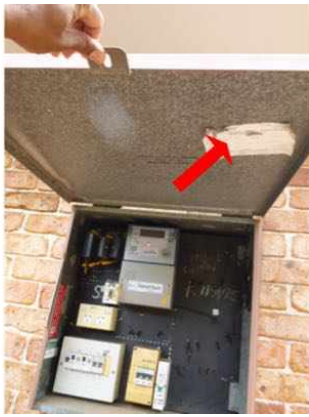
Noted Item

Building:	Main Building
Location:	Meter Box
Finding:	Termite Management System - Evidence of installation
Information:	<p>There are a number of factors which indicate the presence of a previously installed or applied termite barrier. The most common are a durable notice (to the inside of your meter box) observable physical barriers installed to building perimeter and in ground reticulation systems. Where a Termite Management System has been identified you should refer to the type of barrier date of installation warranty conditions and any documentation provided by a builder or past owner. Consult the company who installed the barrier to confirm whether the system is still under warranty.</p> <p>Most chemical termite management systems expire and require replenishment and all physical systems are primarily designed to prevent concealed entry. The client may consider gaining further advice from a pest controller as to the costs and procedures involved with this application. It is recommended that obtaining such advice be a short-term priority.</p>

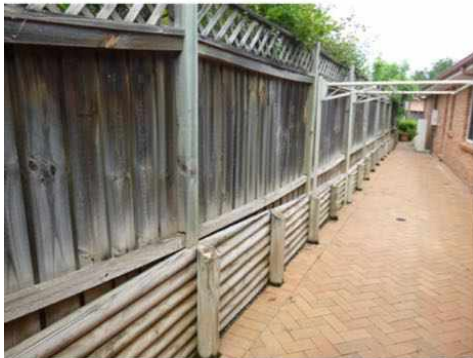
Noted Item

Building: Main Building
 Location: All External Areas
 Finding: Landscaping
 Information: There is no evidence of current termite damage in these timber.

Any timbers in direct ground contact provide opportunity for concealed termite entry and are likely to be subject to premature rot and decay as the soil retains moisture or damp conditions against the timbers. Remove untreated timber that is in direct contact with external grounds. If there is old tree stumps present frequent pest inspections are advised to readily identify any termite activity in these areas. Monitor treated landscape timbers within the garden area, as treated pine breaks down and rots over a period of time causing conducive conditions for termite activity.

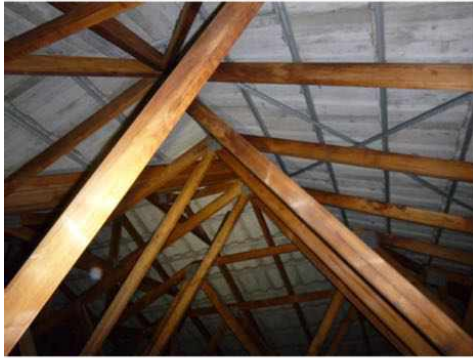
Noted Item

Building:	Main Building
Location:	Roof Void
Finding:	Sarking - Missing
Information:	Sarking is missing under the roof sheeting. Sarking acts as an insulator that helps with noise reduction and protects against water penetration. Sarking plays a key role in the operation and function of the overall roofing structure and its performance.

Although not a requirement at the time of construction, replacement of any missing

building element is advisable (although this can be quite expensive to do after the time of construction). Where sarking is missing, regular inspections of the roof tiles for cracking and potential moisture penetration is required.

Sarking may be retrospectively fitted by a registered builder at the discretion of the client.

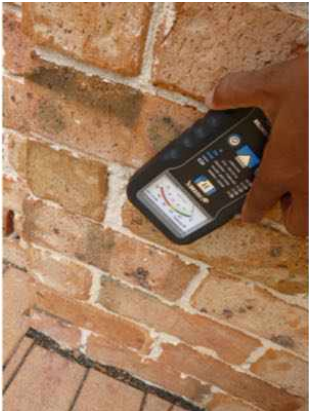
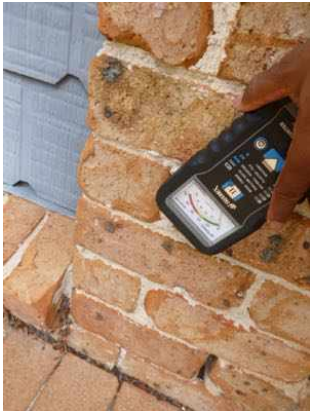
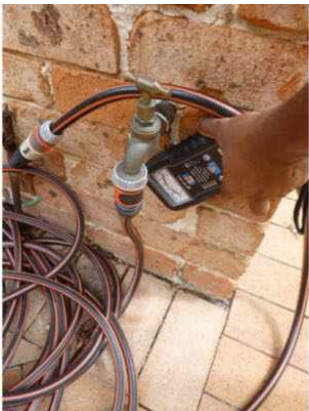
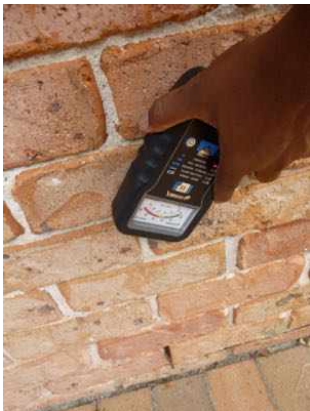
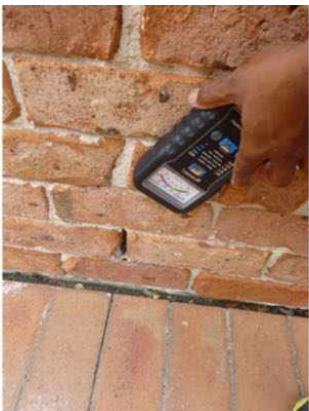
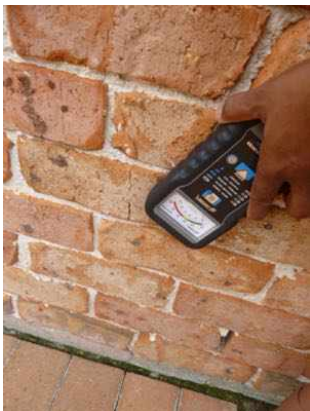
Noted Item

Building: Main Building
Location: All Areas
Finding: No Excessive Moisture
Information: All areas of the dwelling are checked with particular attention paid to wet areas which were closely assessed to check for excessive levels of moisture and temperature anomalies. No evidence of excessive moisture was found inside the house at the time of the inspection.

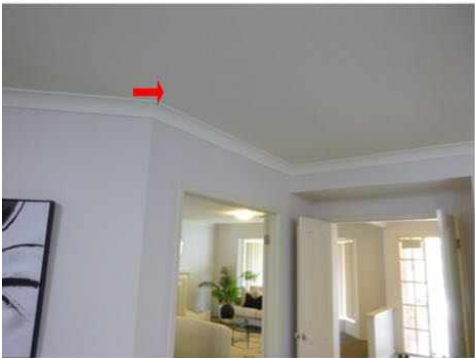
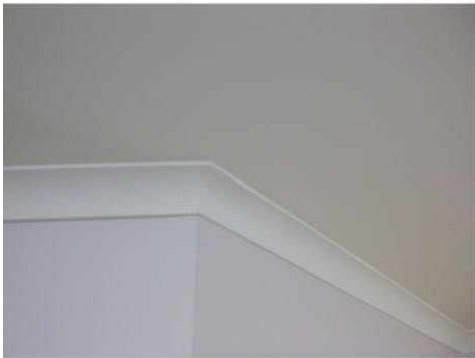
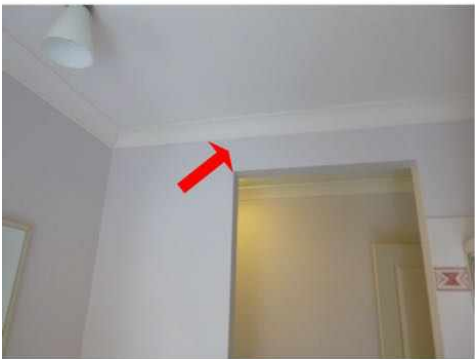
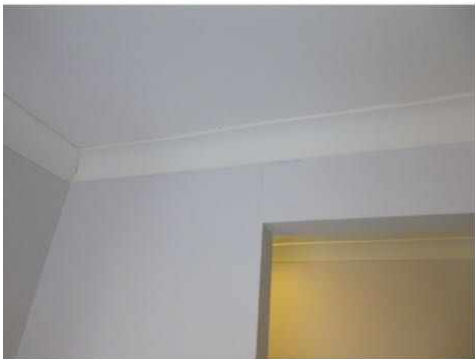
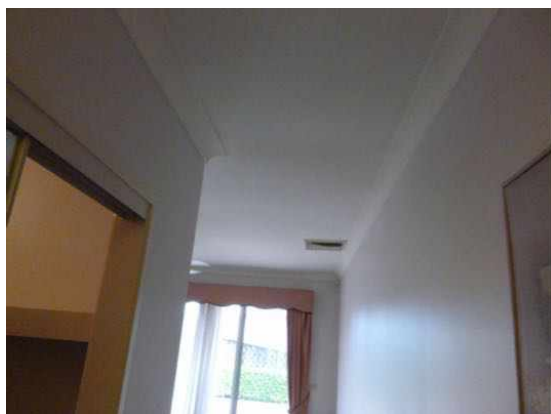
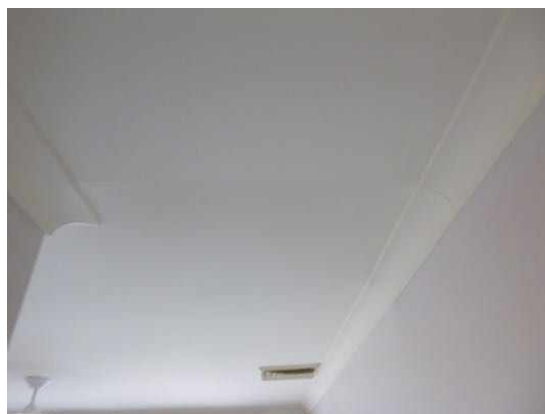
Noted Item

Building:	Main Building
Location:	All Areas
Finding:	Cracking - Damage Category 0 - Hairline (less than 1mm)
Information:	Hairline cracks are very minor in nature and generally are only ever an appearance defect. While such cracking may be noticeable in some cases, it is quite common and does not indicate any structural damage.

Cracking of this nature can generally be repaired with minor sanding, filling and/or repainting. Such works should be performed by a qualified painter or a general handyman.

Monitoring of all cracking should be conducted frequently. Always contact a building inspector should cracks widen, lengthen, or become more numerous.

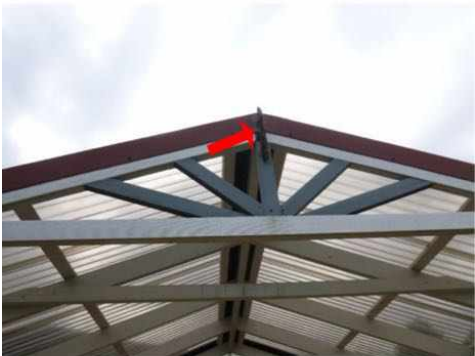
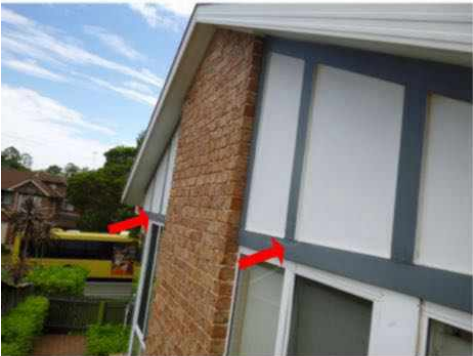
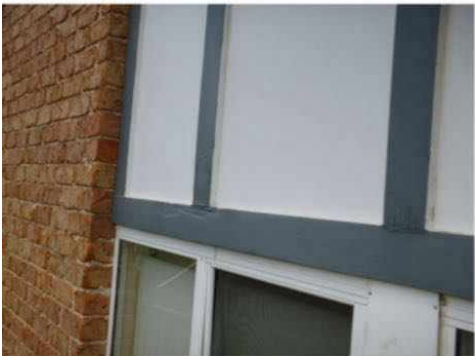
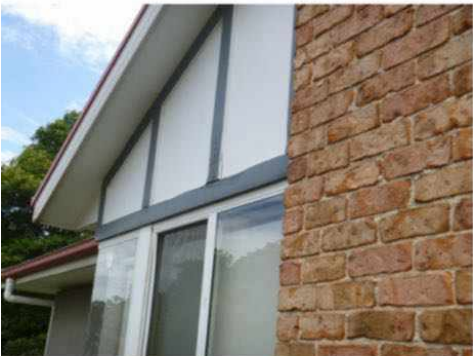
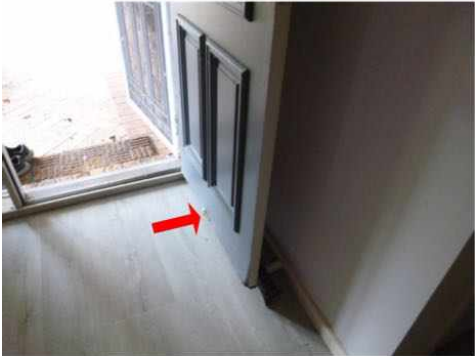
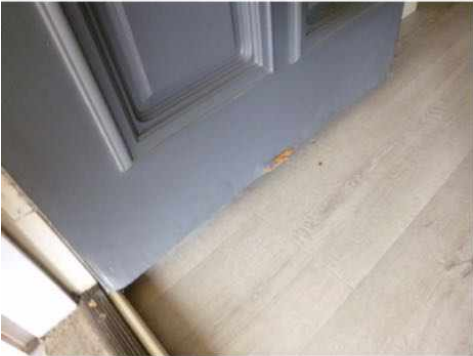
Noted Item

Building:	Main Building
Location:	All External Areas
Finding:	Wood rot
Information:	This building element shows evidence of wood rot. Wood rot, also known as Fungal Decay, occurs when timbers and other cellulose building materials are exposed to damp conditions on an ongoing basis. This could be the result of exposure to weathering over a prolonged period of time, or the attraction of excessive moisture from other abutting building materials. Contributing factors also include poor air ventilation in the area.

Wood rot is often associated with general damp problems and is evidenced by a 'musty' smell or mould and mildew occurring on surfaces. If left unmanaged, damp conditions can lead to further health problems and the decay of timbers will continue.

Early intervention and regular maintenance, particularly of exterior timbers, will prolong the useful life of these building elements. Prior to any works being performed, the cause of the moisture that has created the visible wood rot should be identified and addressed in a suitable manner. Replacement of affected timbers may then be a necessary step in protecting surrounding building elements from such deterioration.

A qualified plumber may be appointed to assess the cause of excessive moisture and to provide advice on any remedial works as required. A qualified carpenter or registered builder may also be required to replace affected building materials.

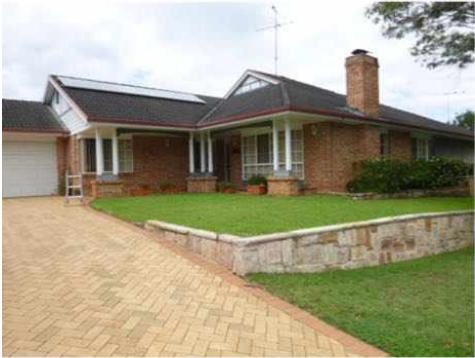
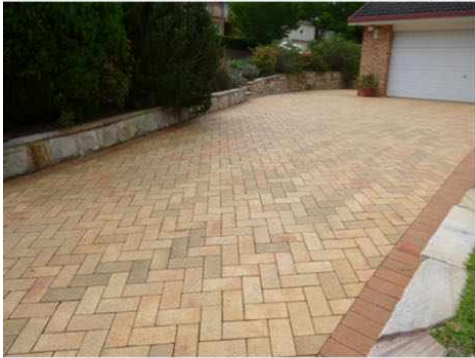
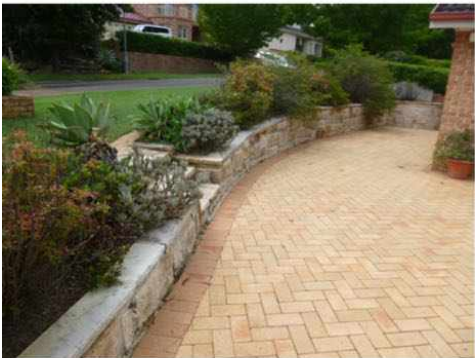
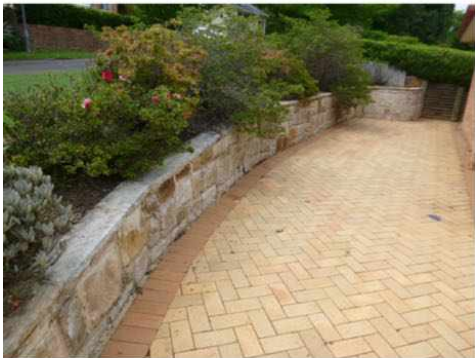
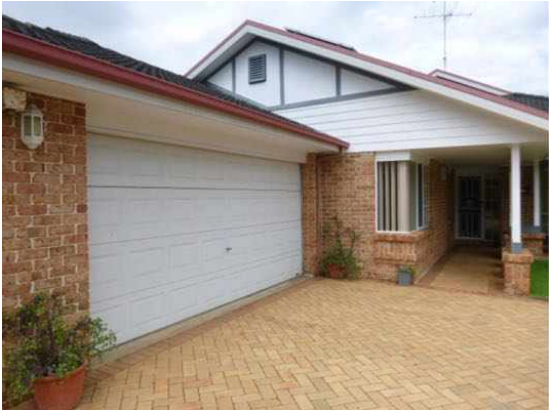
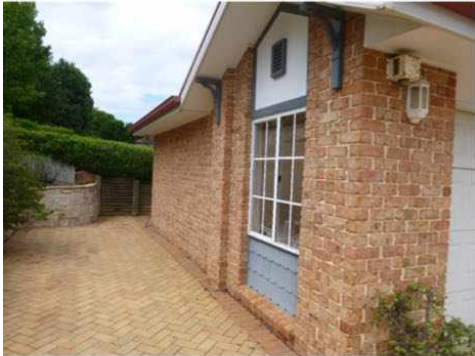
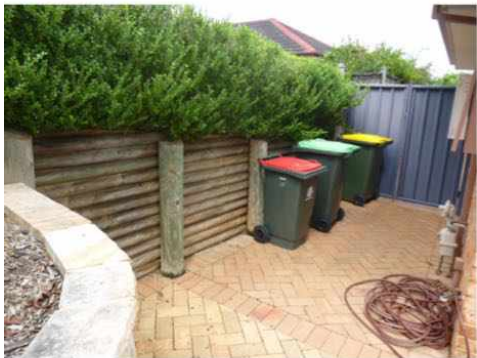
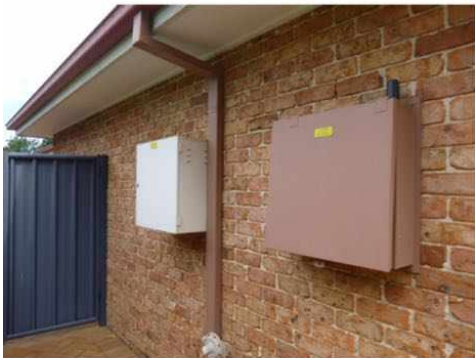
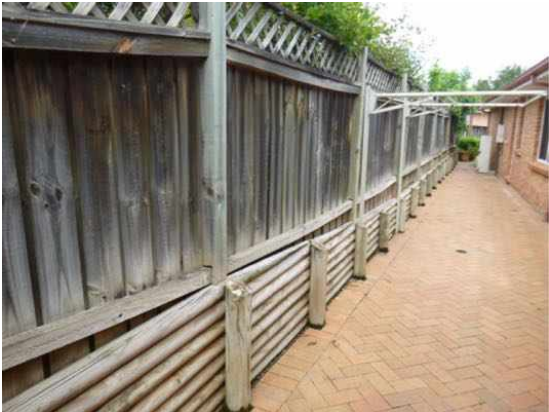
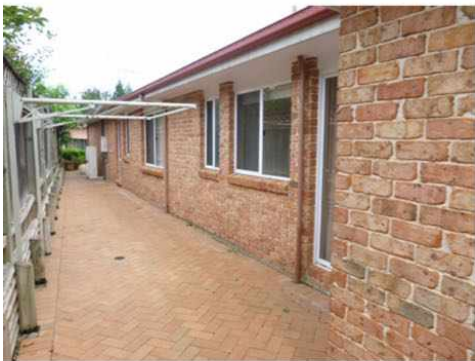
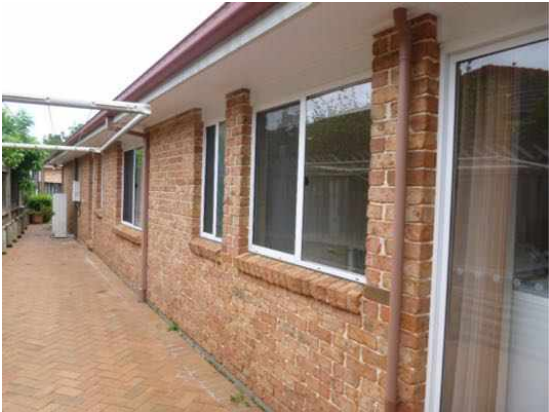
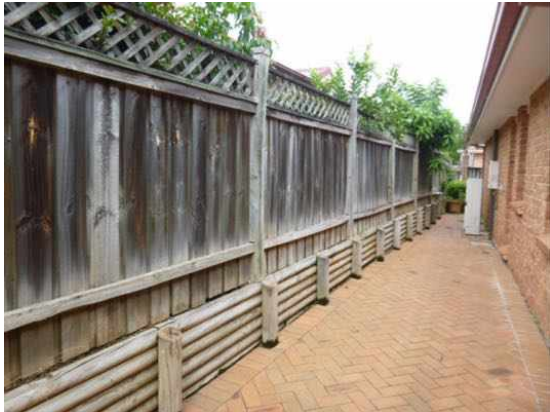
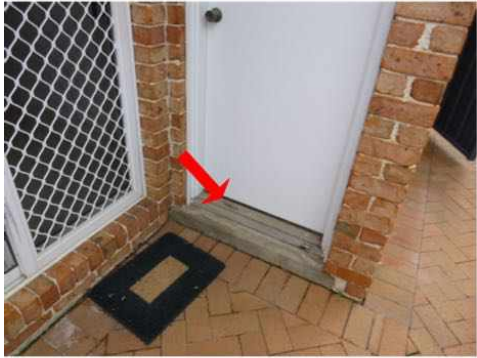
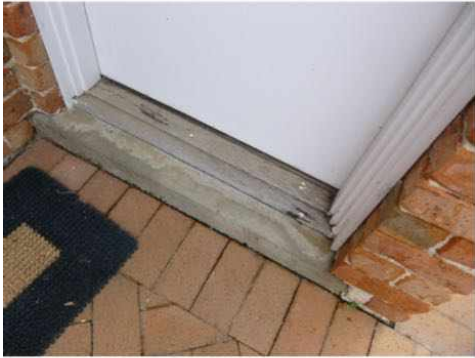
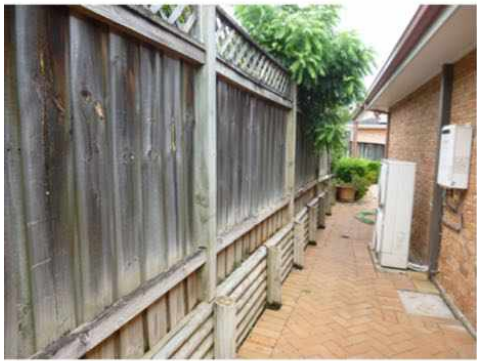
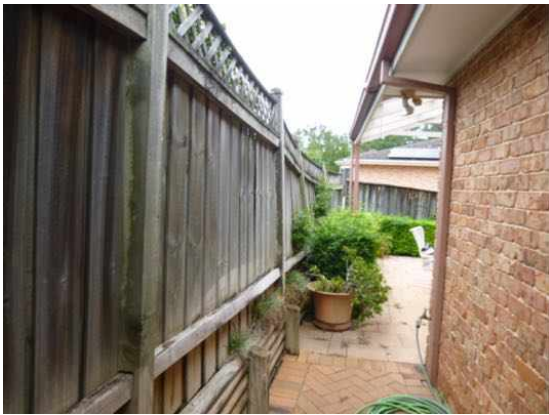
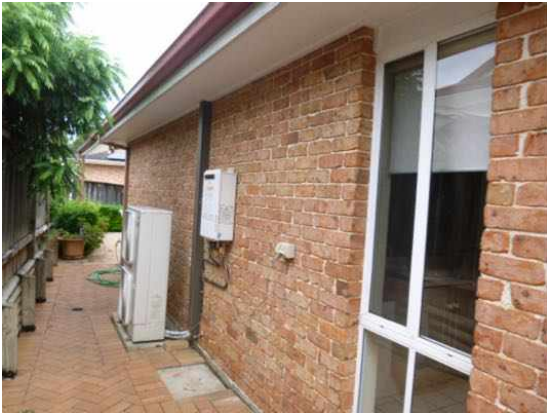
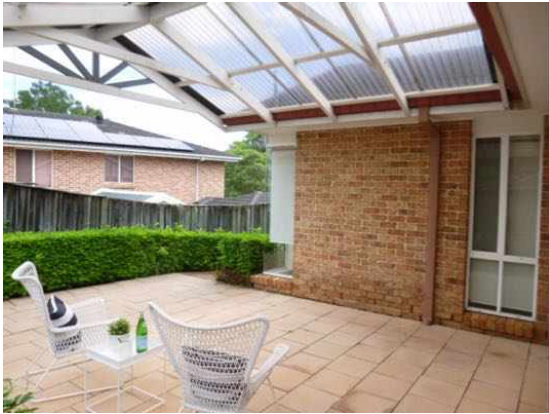
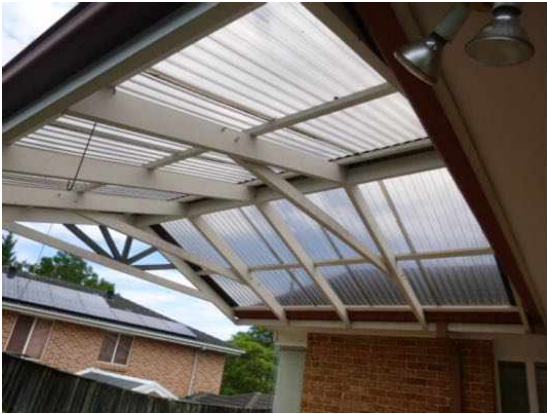
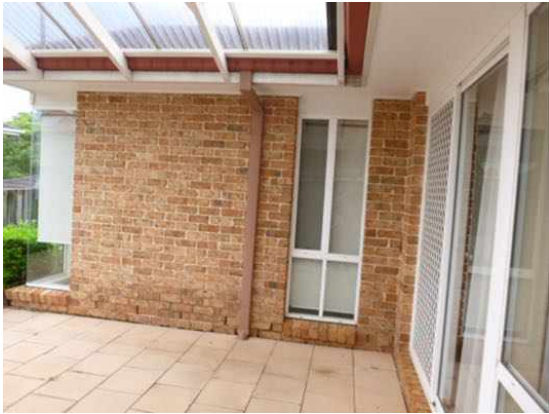
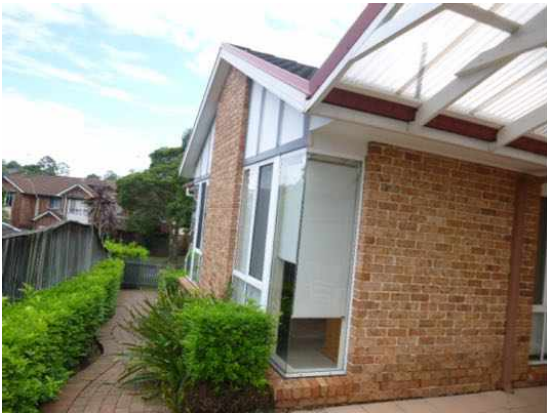
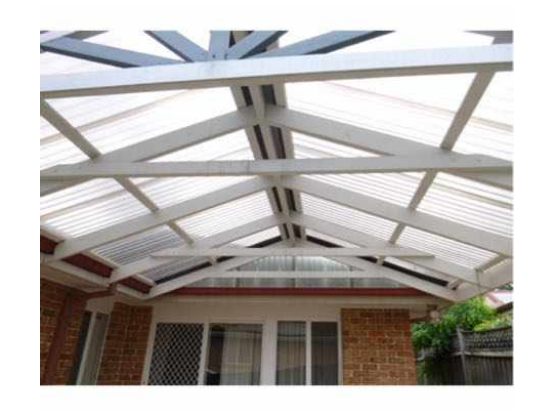
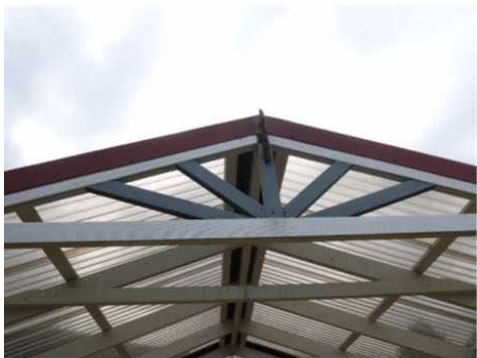
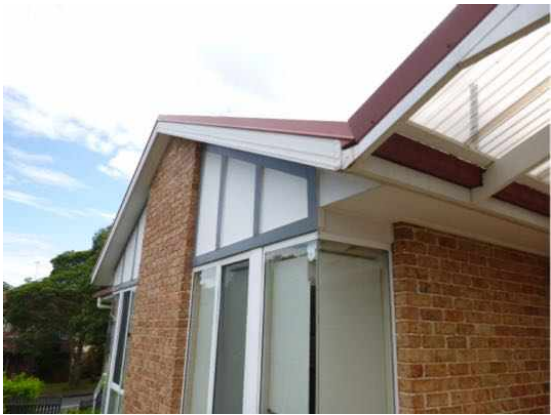
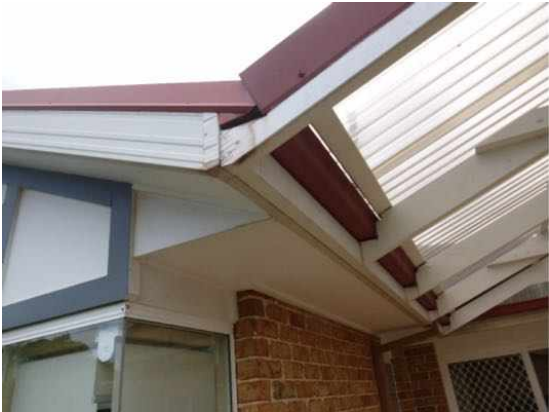
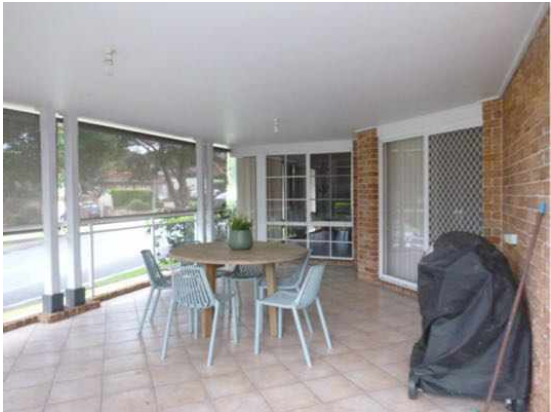
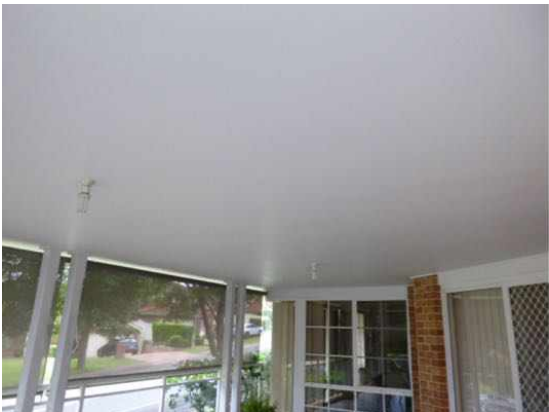
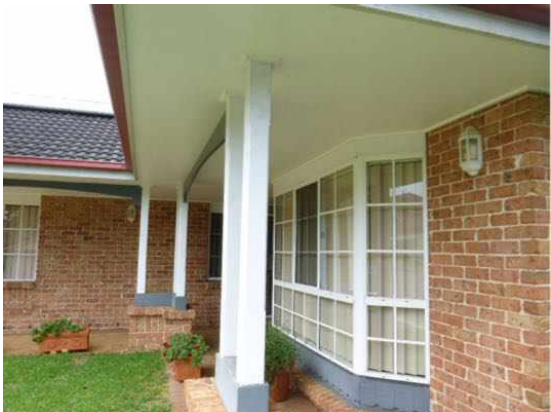
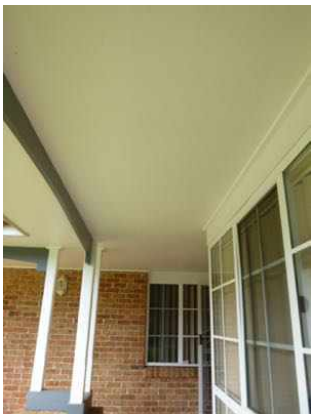
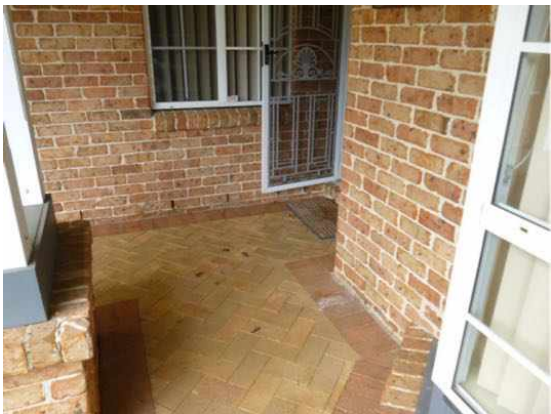
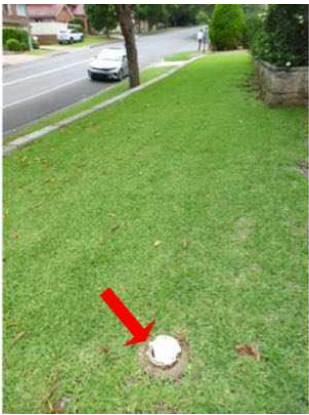
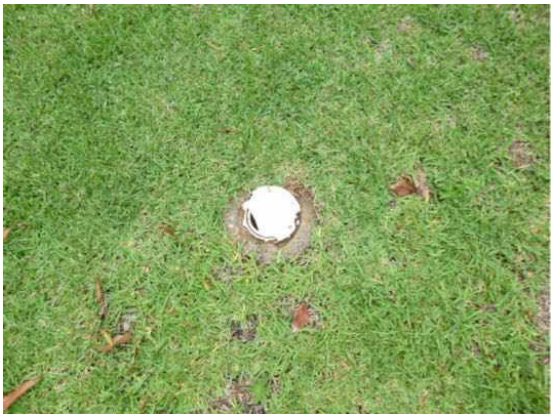
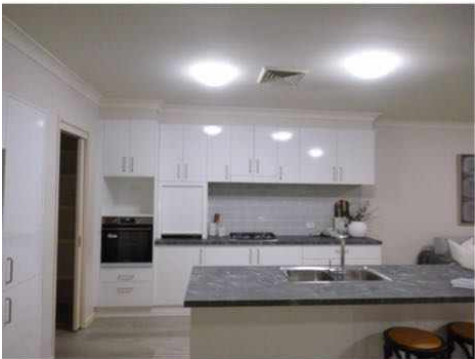
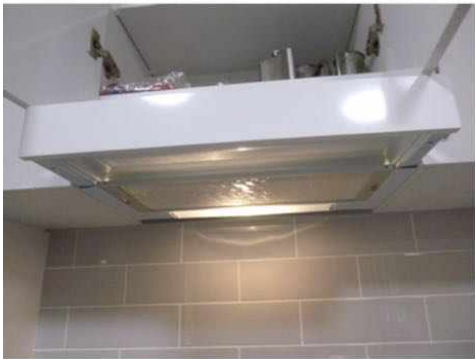
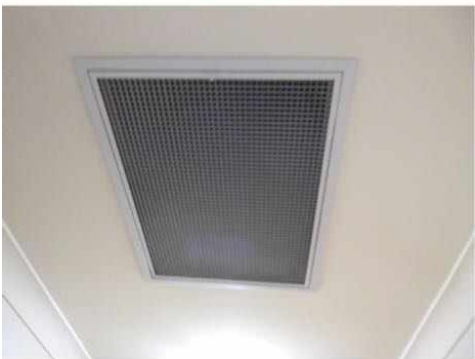
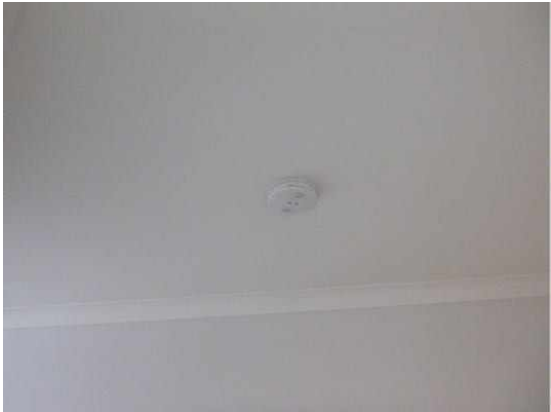
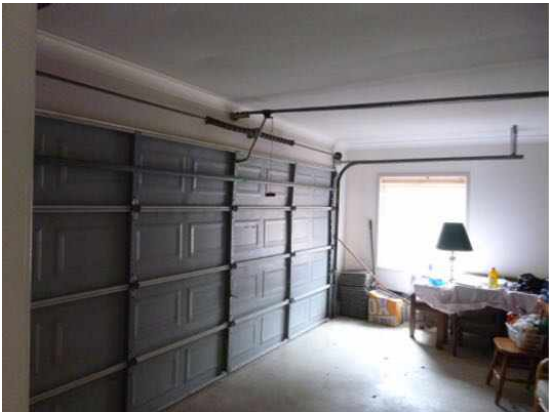
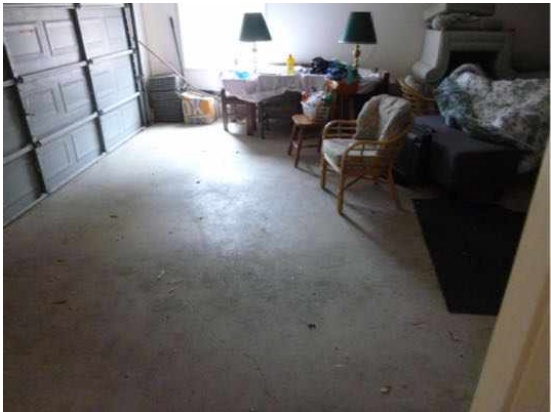
Building: Main Building
Location: All Areas
Finding: Additional Photos
Information: Additional photos are provided for your general reference. Arrows have been included to highlight areas of importance. Please discuss these photos with your building consultant for clarification.
