Building and Timber Pest Inspection Report

Inspection Date: Wed, 28 Jan 2026

Property Address: 23 Parkes Cres, Faulconbridge NSW 2776,
Australia

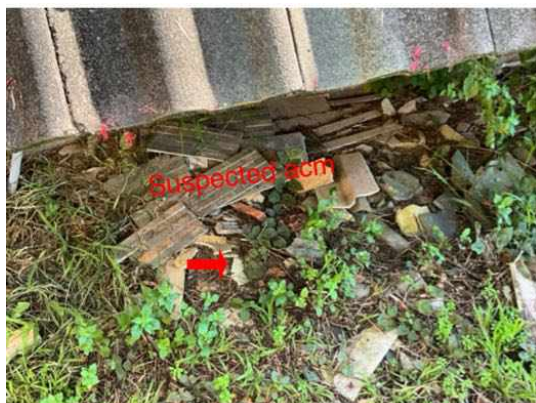
Building:	Main Building
Location:	All Areas
Finding:	Asbestos - Suspected ACM Identified on Site
Information:	Reporting on Asbestos is outside the Scope of this Report. This suspected defect is highlighted as a caution only. We suspect, based on our experience in the building industry, that there is a higher risk of the identified building element containing asbestos.

As Asbestos Reporting is outside the scope of this report, we advise that you consider a separate Asbestos Inspection and Condition Audit, which can include the taking of samples for definitive confirmation of the presence of Asbestos.

In the interim, the client is advised to act with caution, especially when considering any damage to building materials general wear and tear renovations extensions demolition and general maintenance activities due to the suspected presence of Asbestos.

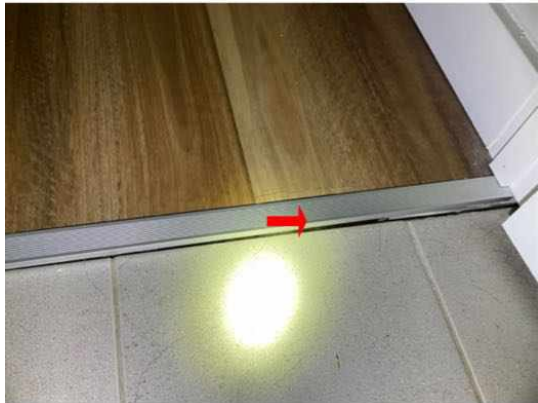
Finding 3.04

Building: Main Building
Location: Bathroom
Finding: Sealant and grouting - Missing or damaged
Information: It was noted on inspection that sealant or grout is degraded to the tiled shower alcove and or other areas of the bathroom.

Different materials and floor areas move at different rates, generally causing cracking to grout or sealant at this point. A flexible sealant is required to allow for expected expansion and contraction, while keeping the joint water tight and protective of all associated building materials.

There appears to be excessive mould to the sealant and grout which will likely require scraping out and replacement.

Flexible and mould resistant materials should be applied to affected areas to prevent any subsequent water damage that is likely to occur. Regular maintenance and replacement of damage or missing or damaged sealant and grout is highly recommended to the wet areas, as this is a regular wear and tear defect. Sealant and grouting in areas that come into regular contact with water should be maintained for the long term care of your property.

A sealant specialist or tiling contractor should be appointed to complete these works as soon as possible

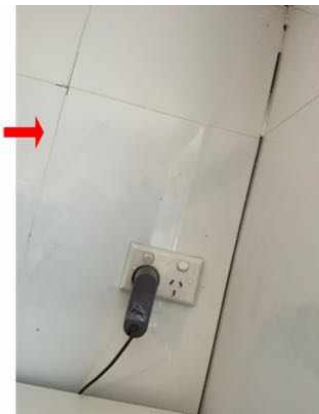
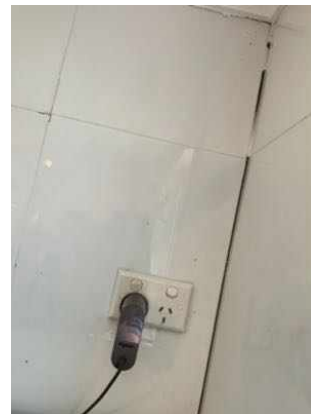
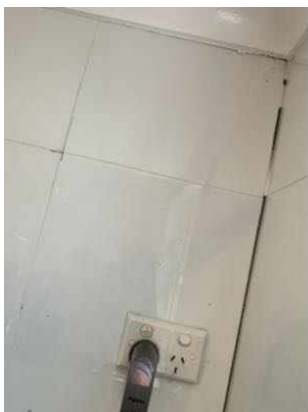
Finding 3.05

Information: Damp is evident to the lower 300mm of wall to the shower alcove. This defect is quite common, and is suspected to have been caused by moisture permeating through the grouting in this area, which shows evidence of deterioration. Leaking pipes within the adjoining wall is also a possible cause.

Damp (or structural damp) refers to the presence of unwanted moisture in the structure of a building, either as the result of intrusion from outside, or condensation from within the structure. In the shower area, internal water leaks or other sources of excessive moisture are generally the cause of damp.

Unmanaged damp in the shower recess is likely to facilitate the formation and development of mould and fungi growth, decaying associated building materials and compromising their structural integrity. It is important to address damp conditions, as the World Health Organisation notes that excess moisture leads - on almost all indoor materials - to growth of microbes such as moulds, fungi and bacteria, which subsequently emit spores and other matter into the indoor air. Exposure to these contaminants is associated with a wide range of respiratory and other health-related problems.

Consultation with a qualified plumber or bathroom specialist is advised immediately to identify the cause of damp and to perform remedial works as required. Where excessive mould growth is present, further inspection by a specialist environmental health inspector should also be considered.

Always ensure that sealant and grout is in good condition to prevent any moisture issues occurring in the future.

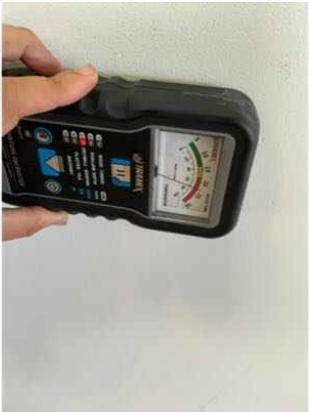
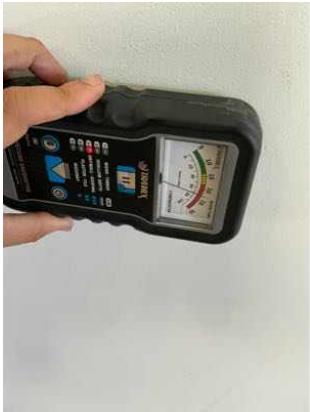
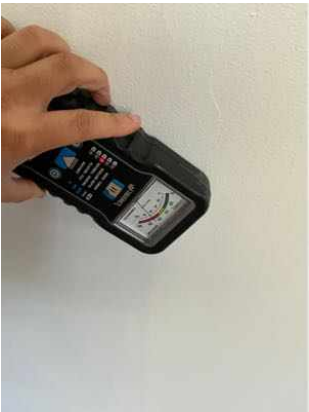
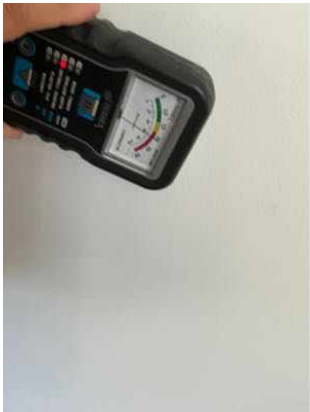
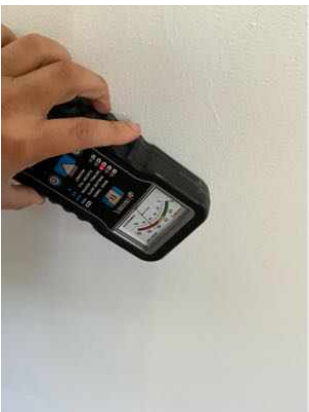
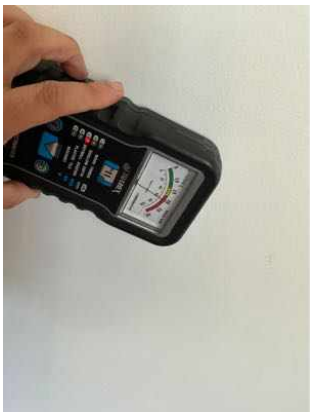
Finding: Evidence of excessive moisture - Drywall

Information: Excessive moisture is present at the time of , indicating a potential water leakage issue within the wall.

The prolonged presence of moisture can lead to mold growth, deteriorate the

structure, and create an environment conducive to health hazards. Additionally, it may compromise the adhesive holding the tiles, leading to their detachment.

A licensed plumber or a qualified contractor specializing in water damage remediation should investigate the source of the moisture, fix any leaks, and address the damage. Additionally, replacing affected tiles and ensuring proper waterproofing are crucial to preventing future issues.

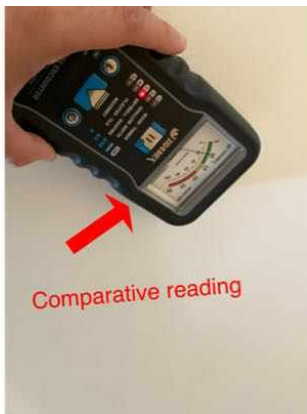
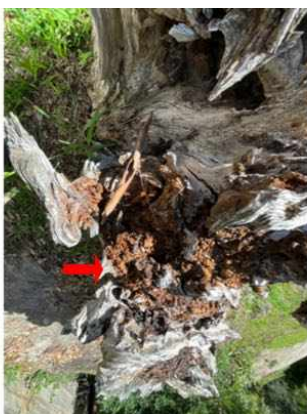
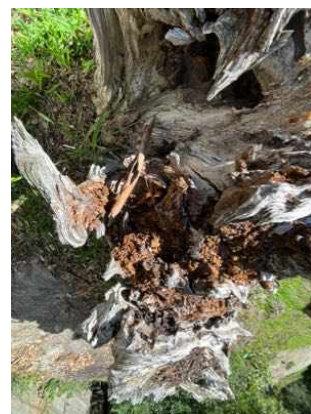
Building:	Main Building
Location:	Yard - Front
Finding:	Suspected - Timber pest damage
Information:	Despite no live termite or timber pest activity being indicated, suspected previous timber pest damage was found to have affected this area. This damage is considered to be inactive at the time of inspection.

It is advised that the area be visually inspected frequently to ensure that the condition of affected building materials does not worsen.

A licensed pest controller must be appointed to provide a further invasive inspection.

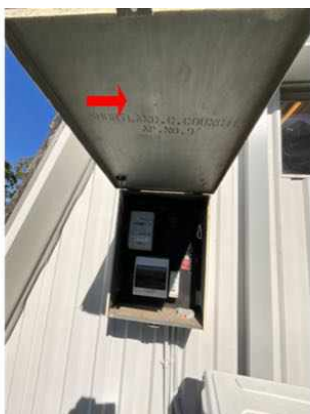
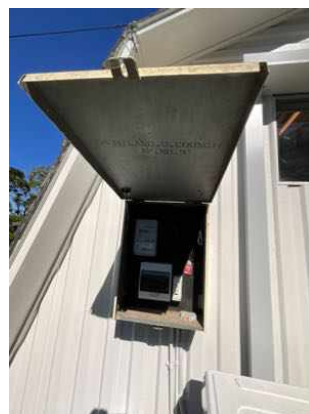
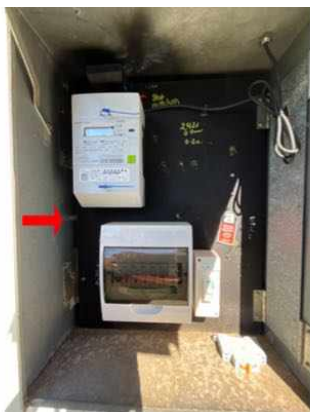
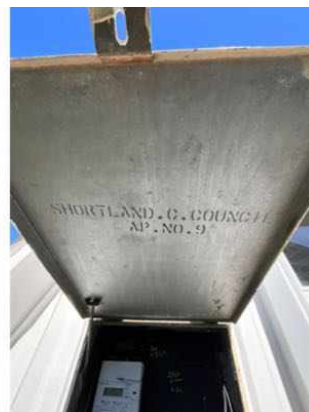
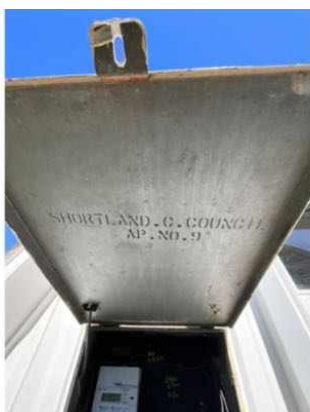
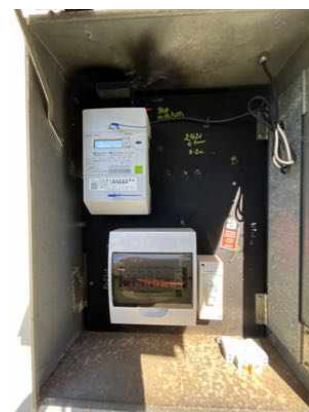
Finding 6.01

Building:	Main Building
Location:	Front Elevation
Finding:	No Evidence of Termite Management System - Durable notice / Legible Sticker
Information:	The application of a pre & post-construction chemical termite barrier is highly recommended for all properties. Such barriers are highly effective in preventing termite attack on any timber building elements throughout the property.

A durable notice was not placed in the switchboard unit to indicate current termite barriers is legible at the time of inspection.

Client must seek further information from the vendor or real estate agent if the conditions of termite management systems were maintained.

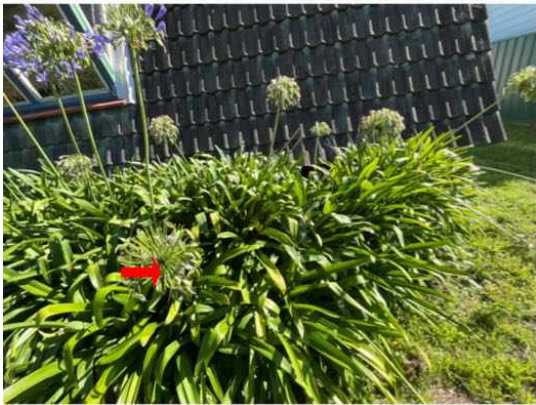
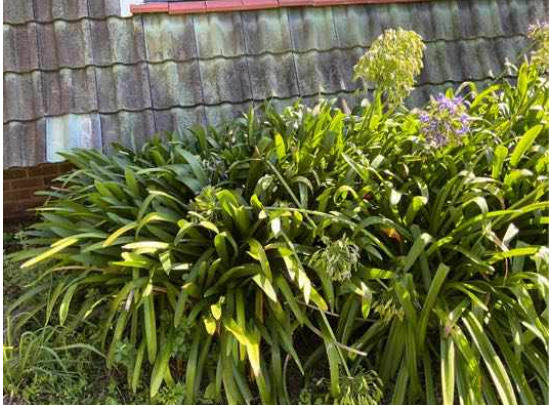
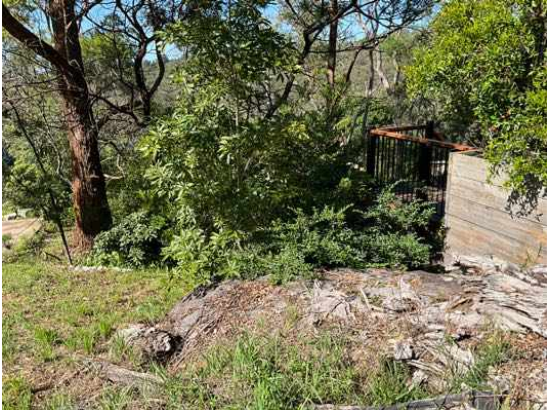
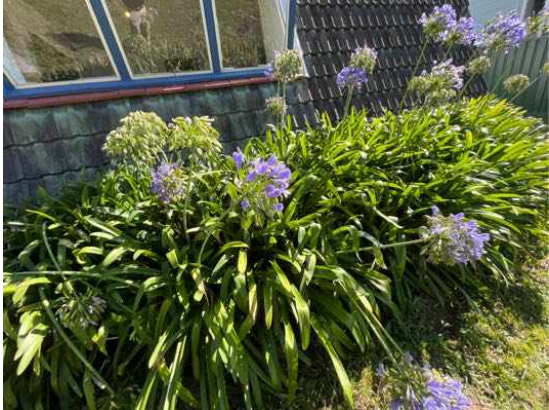
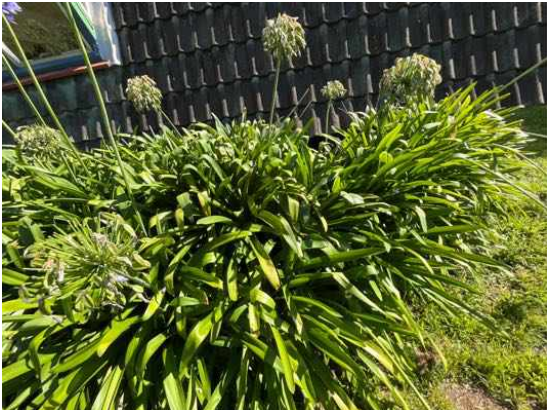
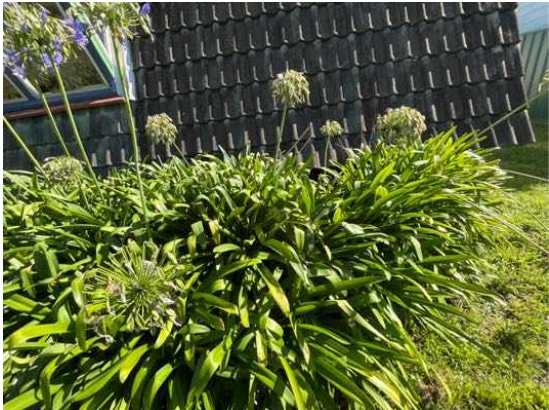
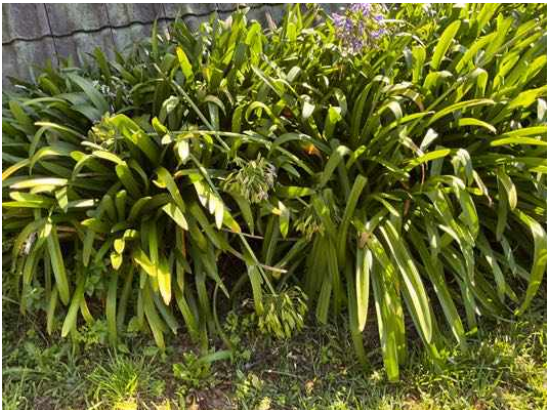
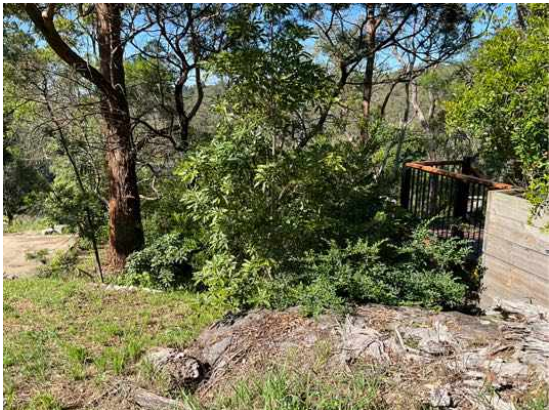
Finding 6.02

Building:	Main Building
Location:	All Areas
Finding:	Dense vegetation around a property can increase the risk of termite infestation
Information:	The presence of dense vegetation around a property can increase the risk of termite infestation, as it provides a conducive environment for them. To address this, consider maintaining a clear space between the vegetation and your home. If you suspect a termite issue, it's advisable to consult with a licensed pest control professional for inspection and treatment.

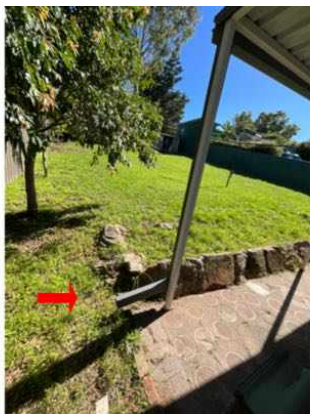
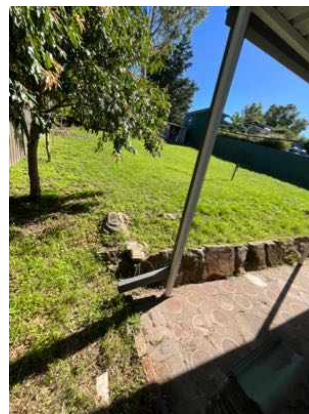
Finding 6.03

Building:	Main Building
Location:	Pergola
Finding:	Downpipes not connected- Conducive conditions for timber pest
Information:	<p>Unconnected downpipes can indeed pose a risk for attracting termites, as they provide a source of moisture near a building's foundation. Termites are attracted to moisture and wood, so it's important to address this issue to prevent potential infestations. Connecting downpipes to the stormwater system or ensuring proper drainage away from the building can help mitigate this a licensed plumber is the most qualified professional to handle plumbing-related tasks, including connecting downpipes to the stormwater system. They have the necessary expertise and tools to ensure proper installation.</p>

Please remember that proper installation is essential to ensure effective drainage and prevent future issues, so it's often best to hire a qualified professional, especially for complex or extensive downpipe installations.

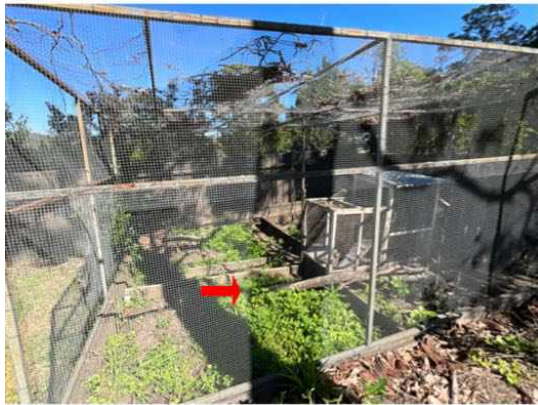
Building: Main Building
Location: All Areas
Finding: Timber on ground / conducive conditions to termite damage
Information: Timber on the ground is indeed conducive to termite damage. Termites are known to thrive in moist environments, and wood in contact with soil or moisture is more susceptible to infestation.

To prevent this, it's important to keep timber elevated and away from direct ground contact. Regular inspections and proper termite control measures are also essential to protect your wooden structures from termite damage.

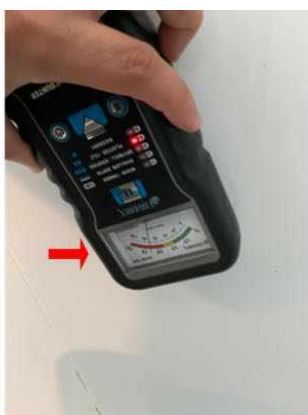
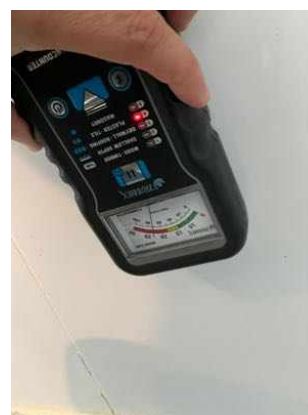
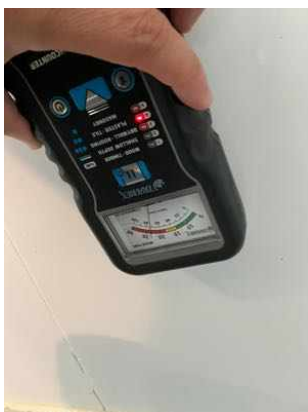
Finding 6.06

Building:	Main Building
Location:	Bathroom
Finding:	Excessive moisture - Conducive to Timber pest
Information:	Excessive moisture can attract termites and produce conditions that promote fungal growth and wood decay.

Excessive moisture is generally caused by deteriorated inadequate or missing roof drainage leaking plumbing pipes or fixtures poorly plumbed HWS overflows or condenser units and poor site drainage.

If mould growth has been found there may be environmental biological or health issues involved. In these cases an appropriately qualified inspector should also be contacted.

Prior to any remedial works being performed a qualified plumber should be appointed to further inspect the property and to identify the cause of the excessive moisture. Works to remove affected building elements may then be necessary and should be performed by an appropriate tradesperson.

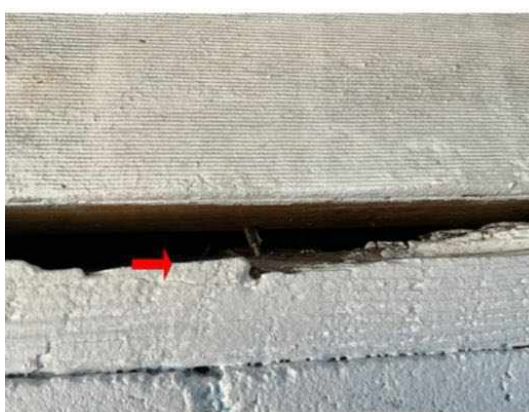
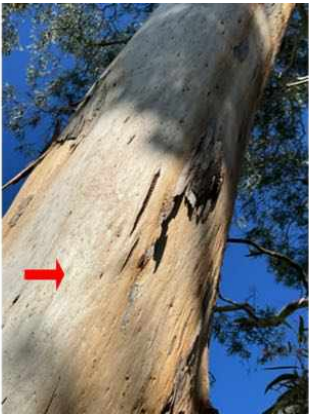
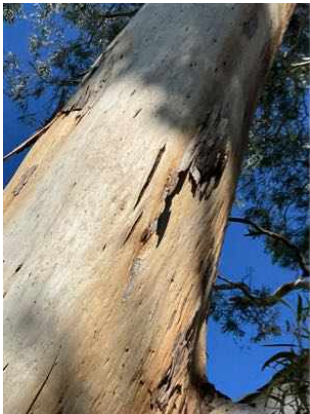
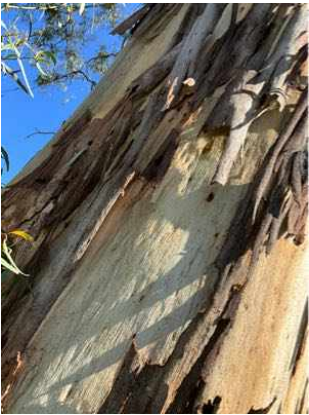
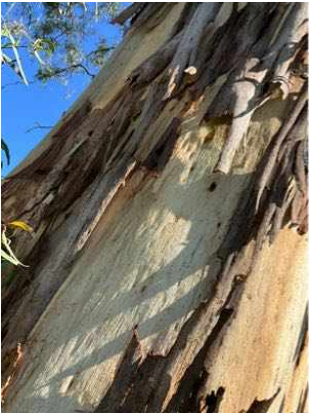
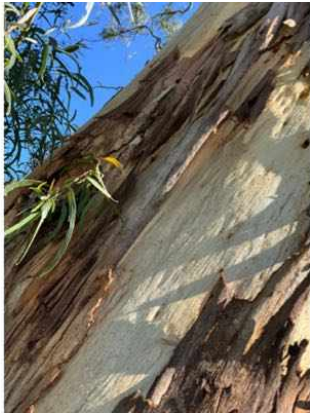
Finding 8.01

Evidence of wood borer activity and/or damage

Building:	Main Building
Location:	Yard - Back
Finding:	Wood Borer Activity - Trees
Information:	Numerous small to medium-sized exit holes and surface tunnelling marks were noted along the trunk and branches of a dead standing tree. The pattern and shape of the damage are consistent with wood borer infestation. No live activity was observed at the time of inspection, though damage is clearly evident.

- The tree maybe structurally compromised and may pose a fall or safety hazard, especially during wind events.
- Proximity to structures or power lines may increase the risk of damage or injury.
- Although native borers are not typically a threat to treated structural timbers, their presence indicates decay and weakened wood that could attract secondary pests.

- Engage a qualified arborist to assess the structural integrity of the tree and arrange for safe removal if required.
- If the tree is within falling distance of a building, fence, or utility infrastructure, urgent removal is recommended.
- Regular site monitoring is advised for surrounding trees to detect any early signs of similar pest activity.

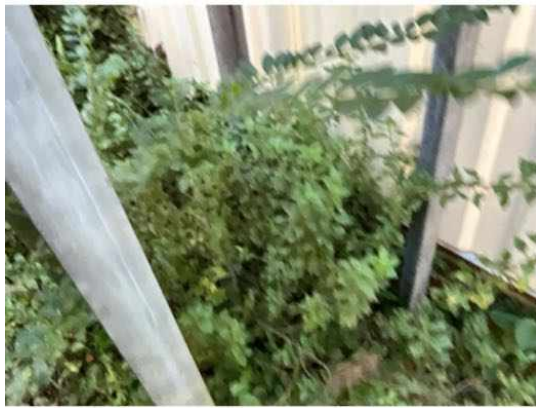
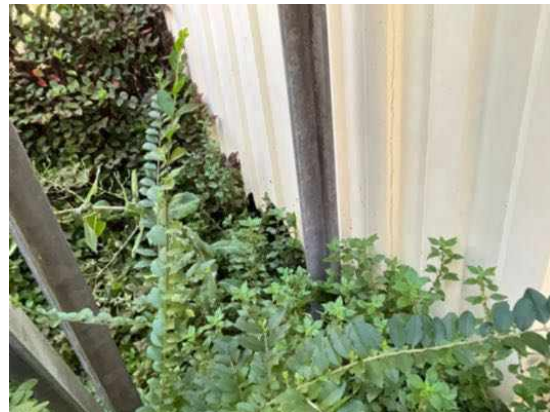
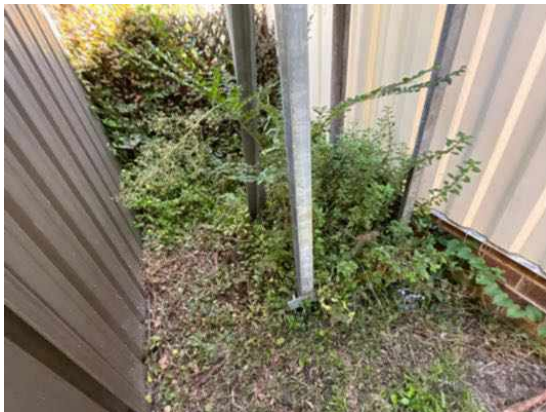
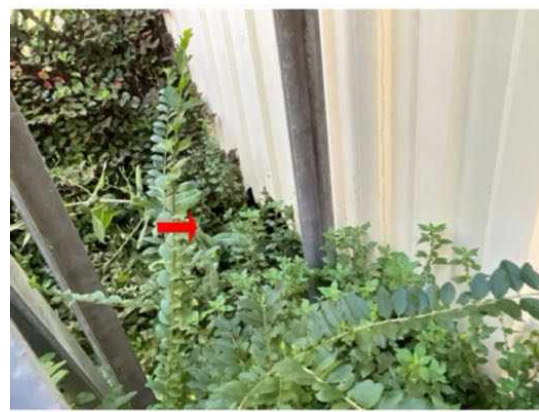
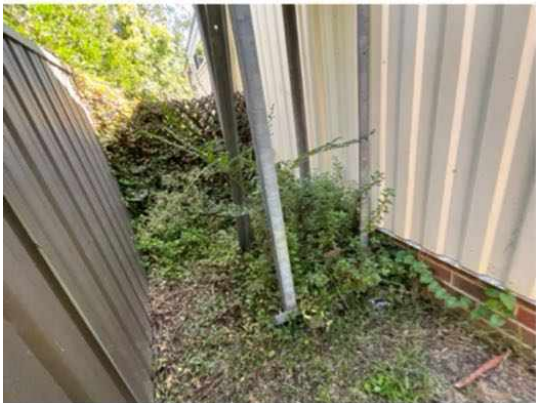
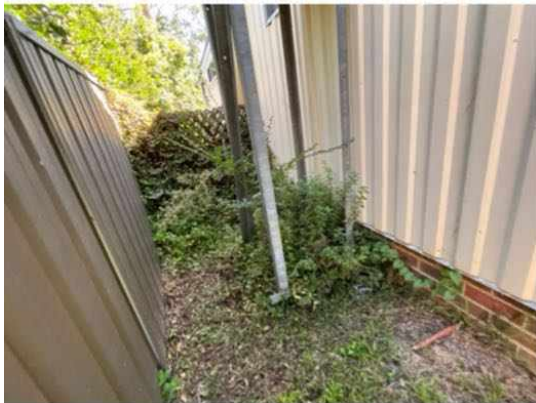
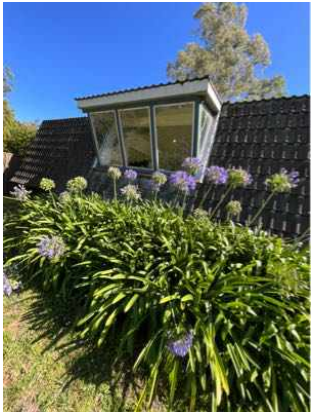
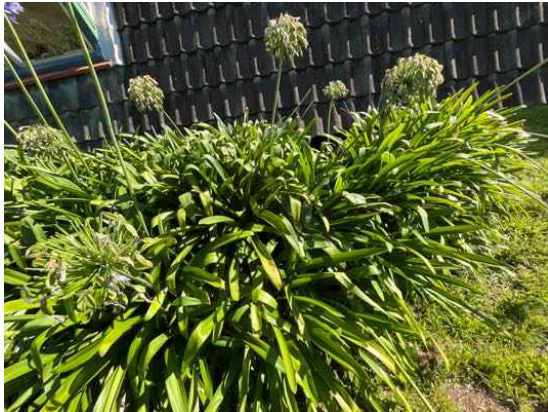
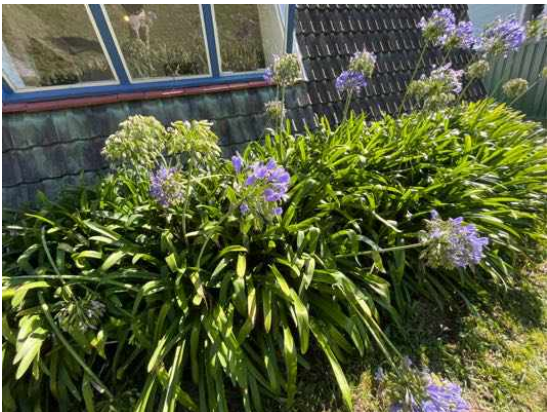
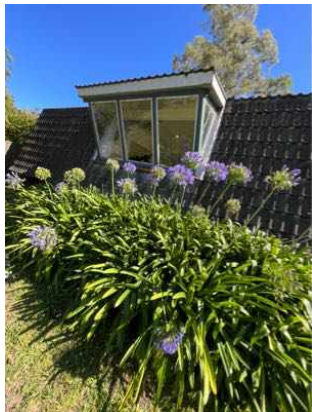
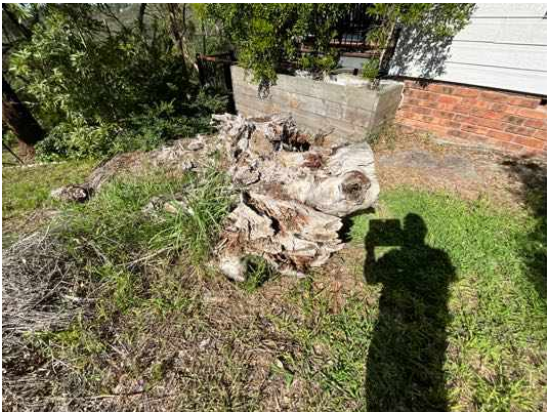
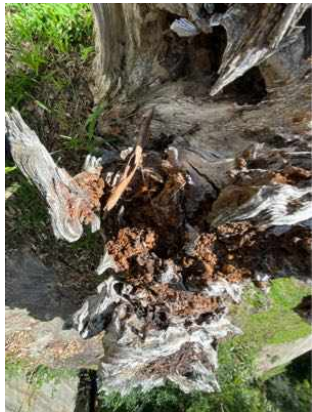
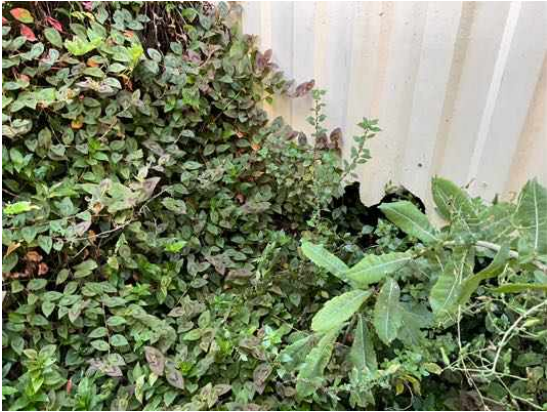
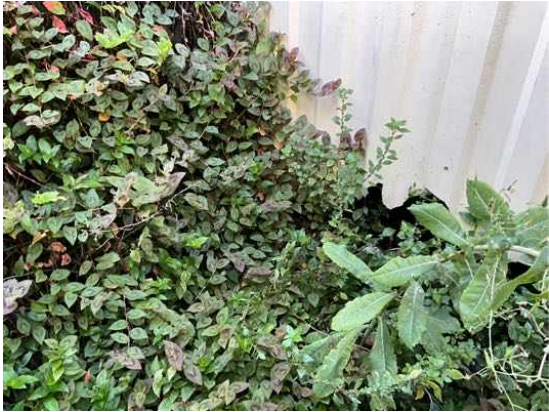
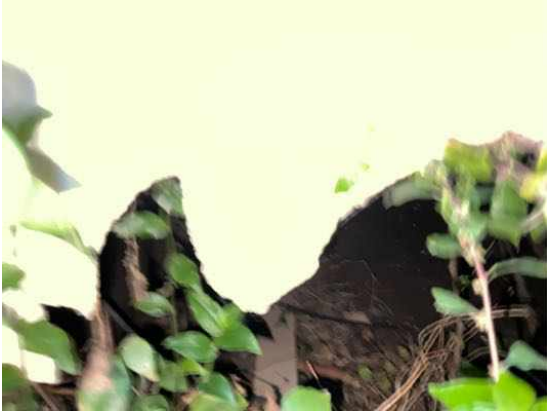
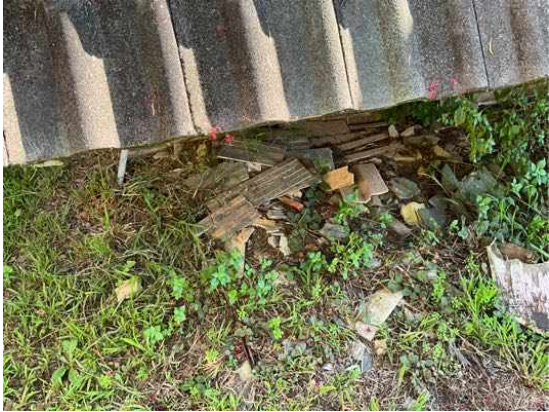
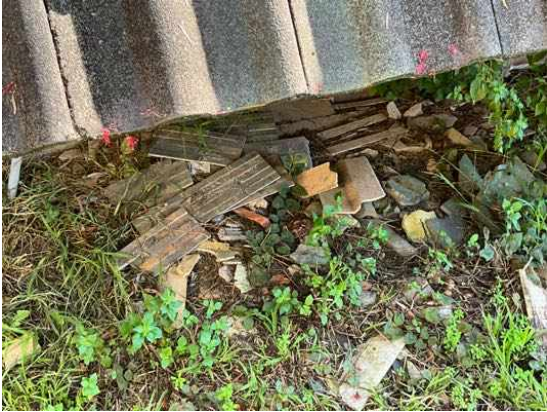
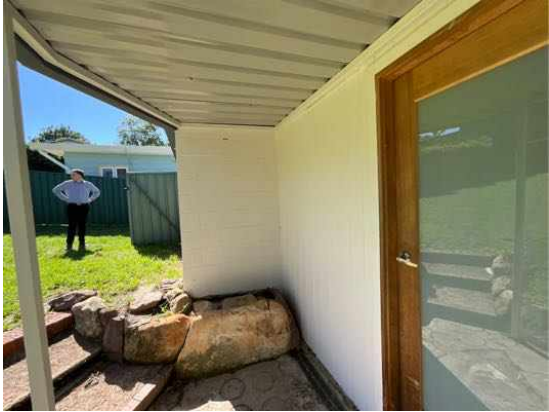
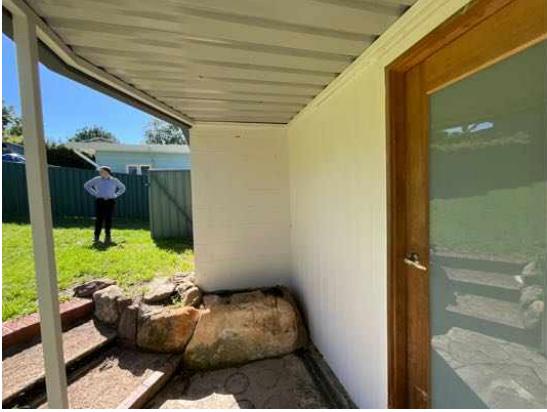
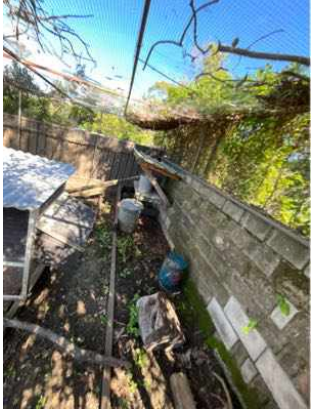
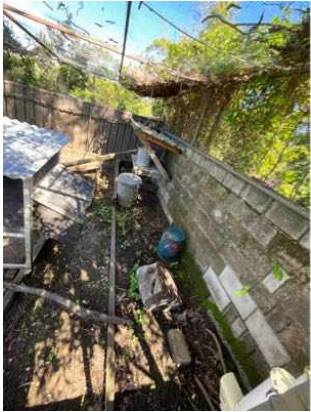
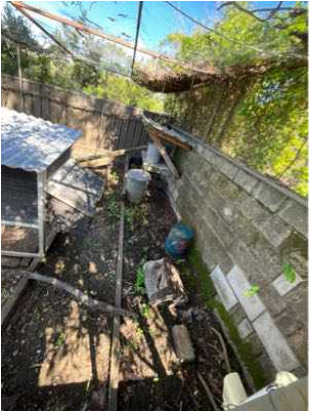
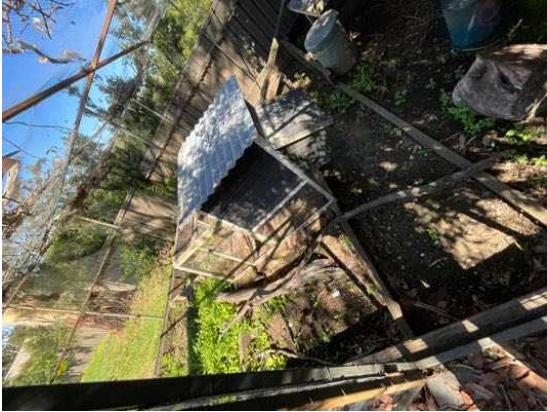
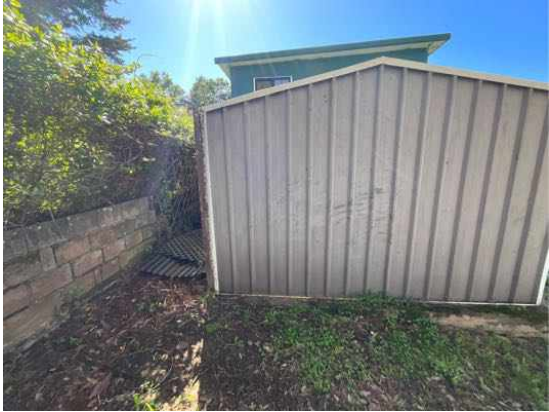
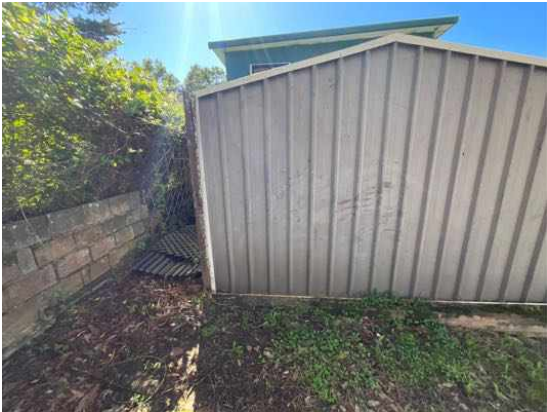
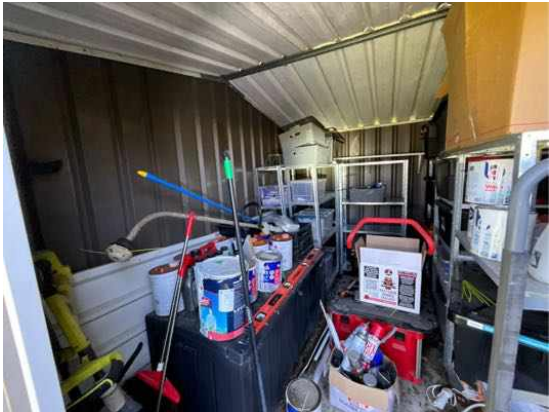
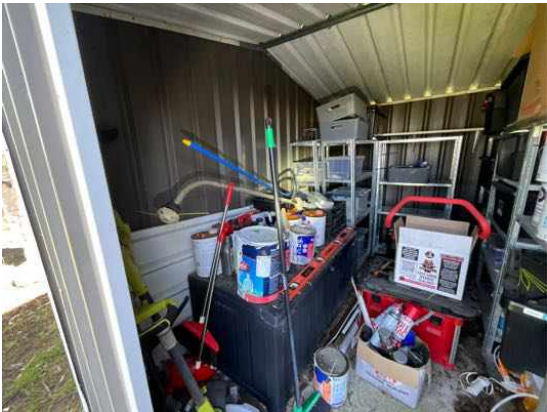
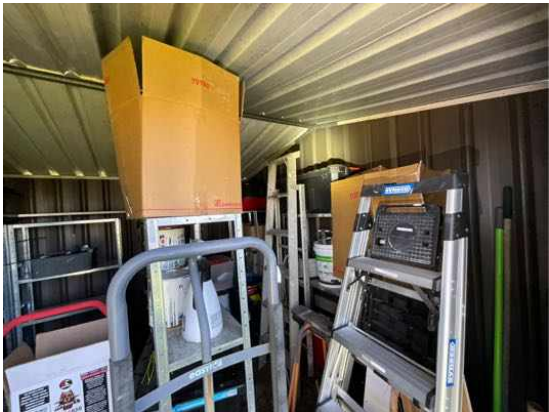
Finding: Additional Photos - Obstructions and Limitations

Information: These photographs are an indication of the obstructions and limitations which impeded full inspection of the property at the time of inspection. These obstructions can hide an array of defects and should be removed to allow full inspection to be carried out. A re-inspection is recommended once the areas are made accessible.

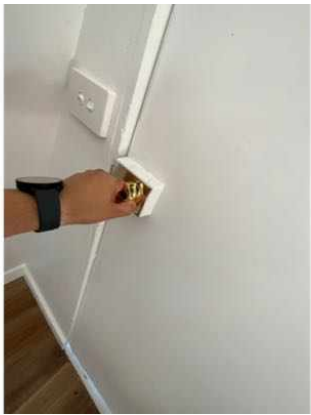
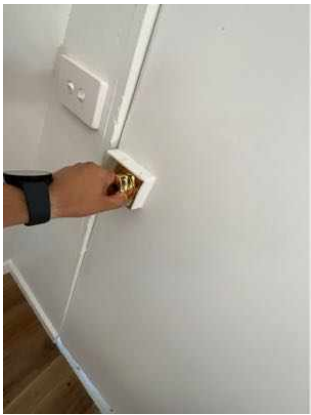
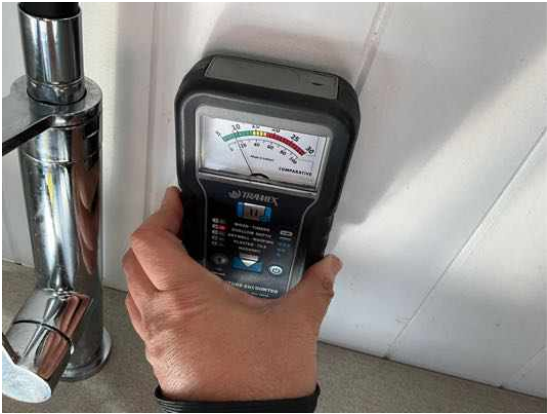
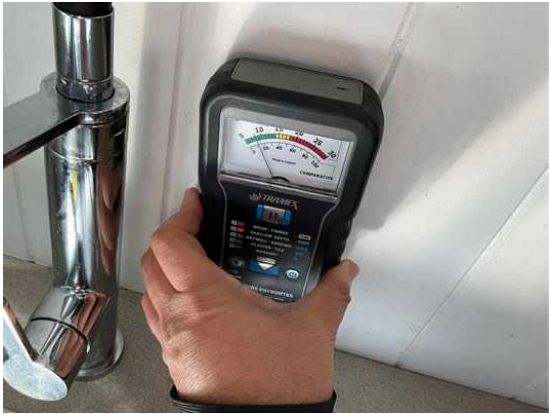
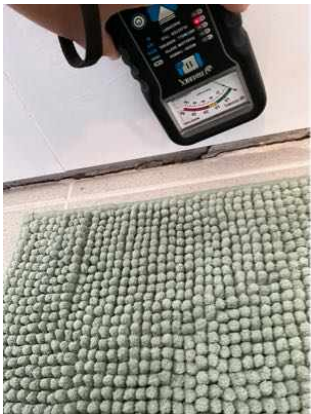
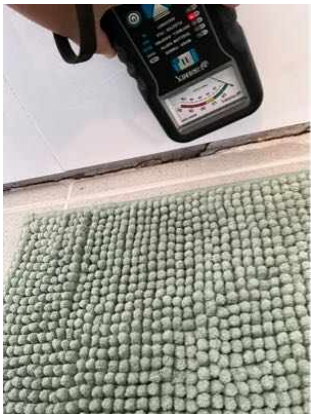
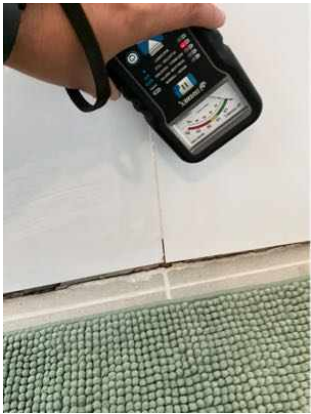
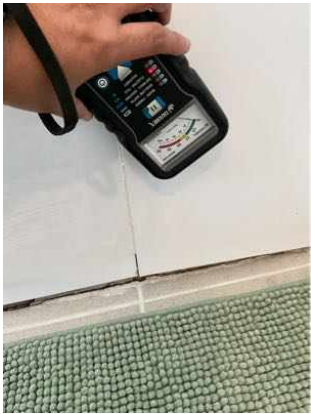
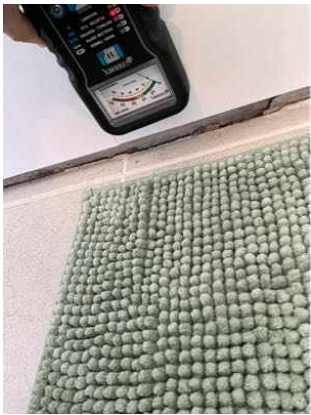
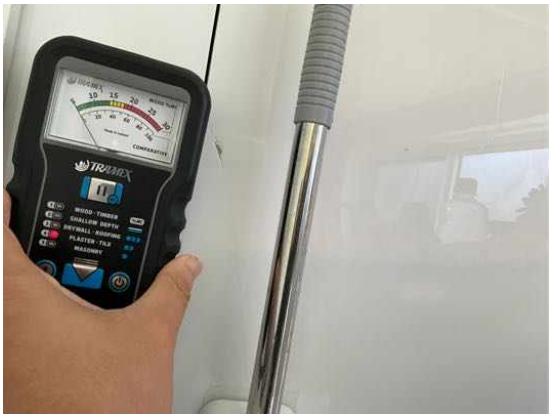
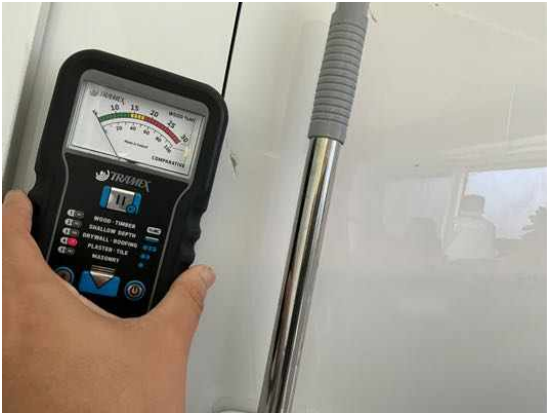
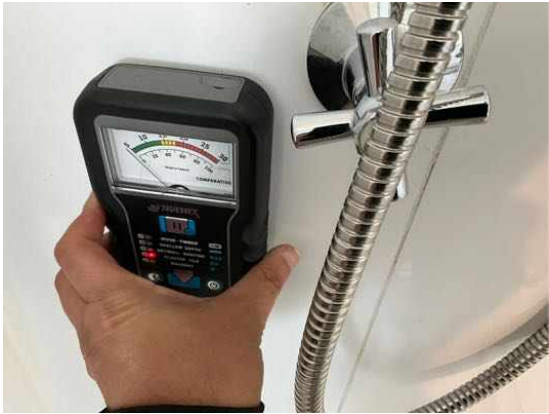
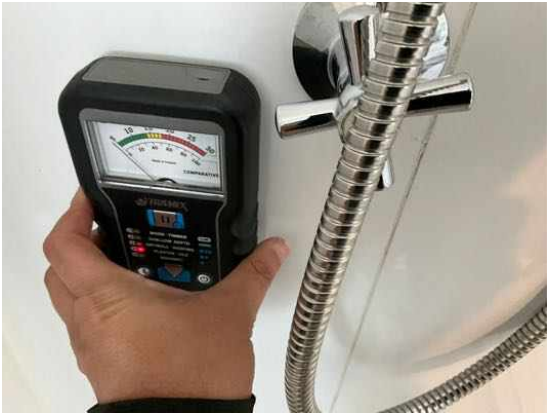
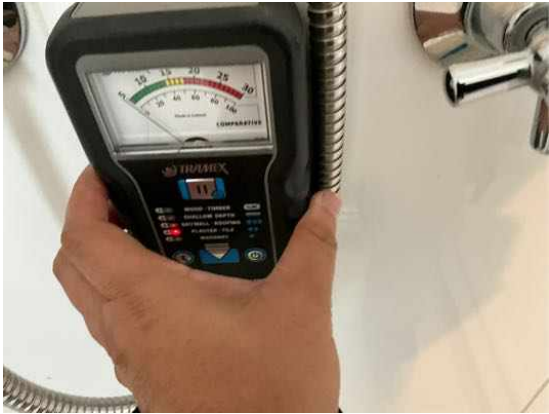
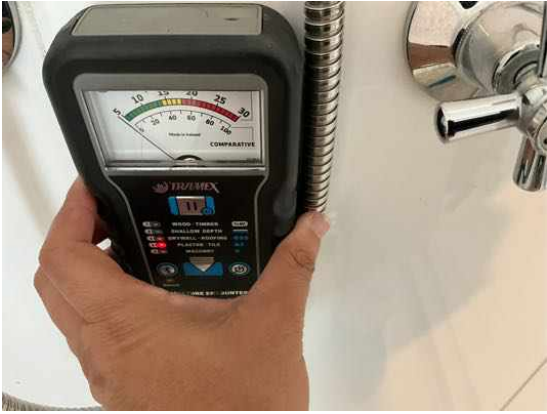
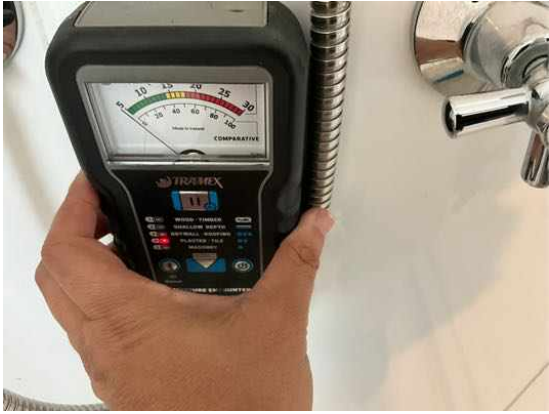
Building: Main Building
Location: All Areas
Finding: Additional Photos
Information: Additional photos are provided for your general reference
