Building and Timber Pest Inspection Report

Inspection Date: Thu, 5 Mar 2026

Property Address: 52 Hamilton Ave, Earlwood NSW 2206,
Australia

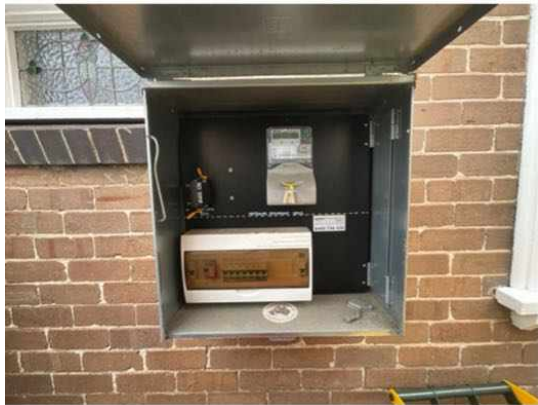
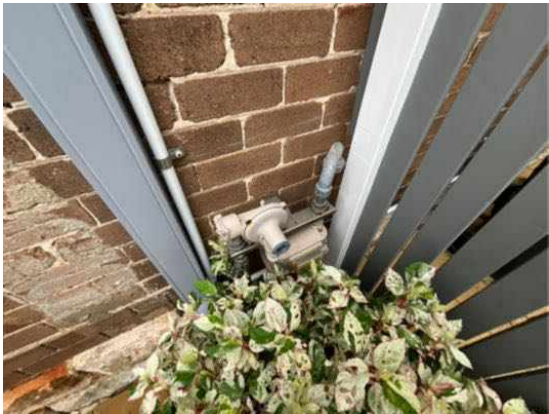
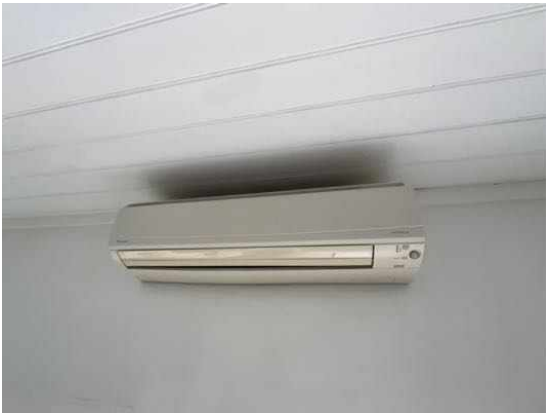
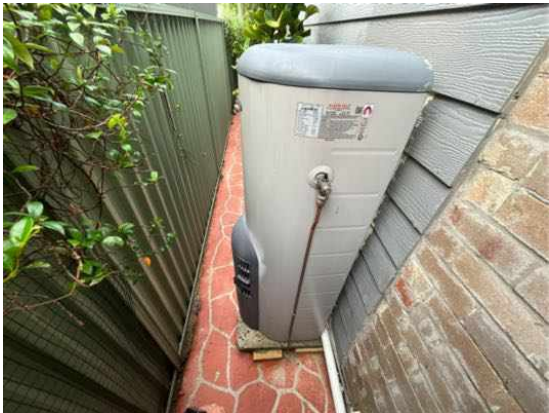
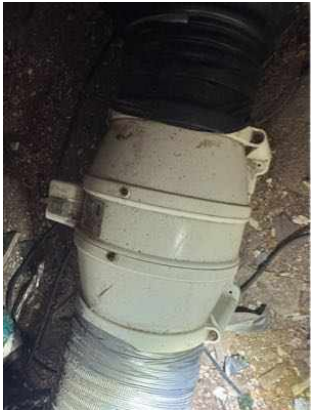
Building: Main Building
Location: All Areas
Finding: Photos Added
Information: Additional photos are provided for your general reference.

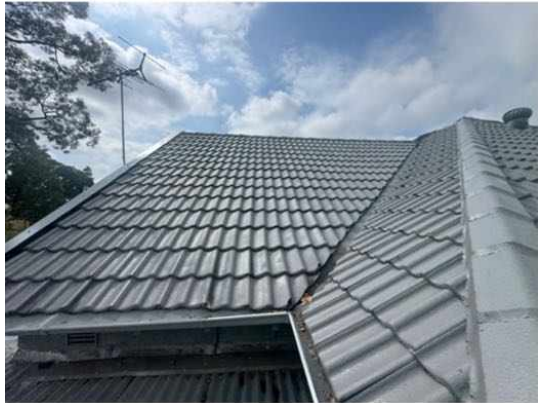
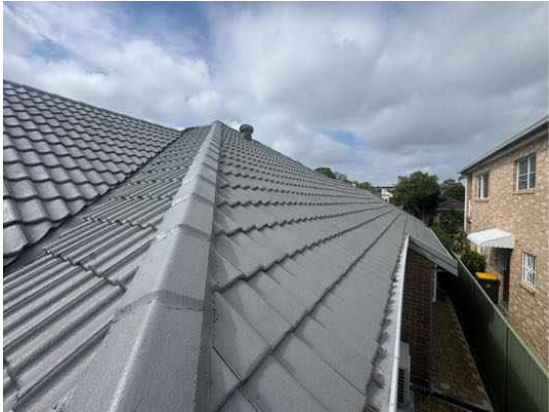
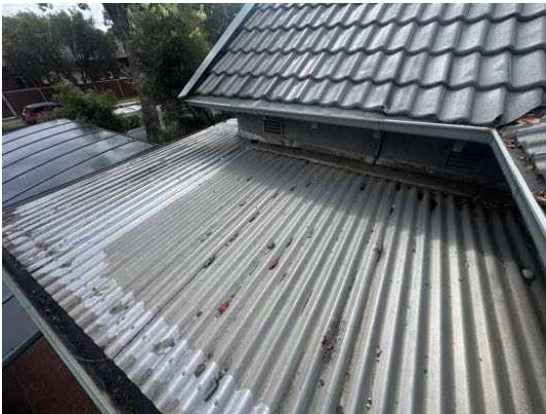
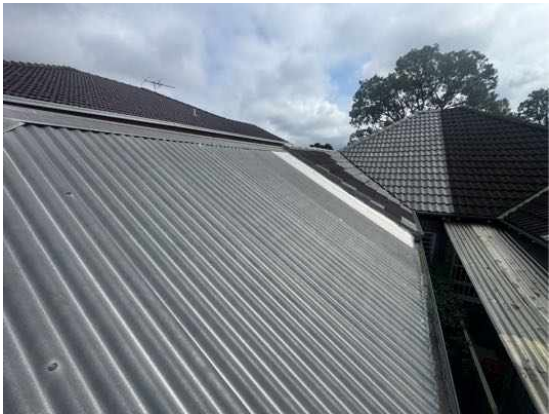
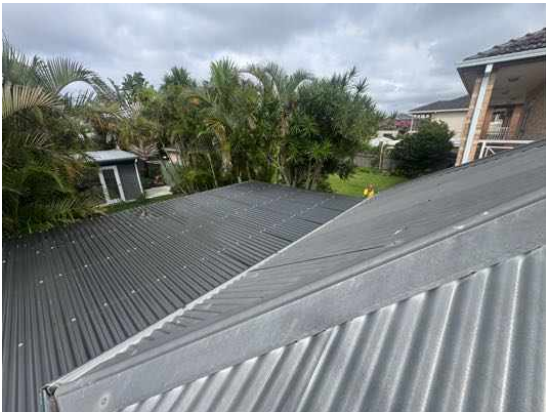
Building: Main Building
Location: Roof Exterior
Finding: Photos Added
Information: Additional photos are provided for your general reference.

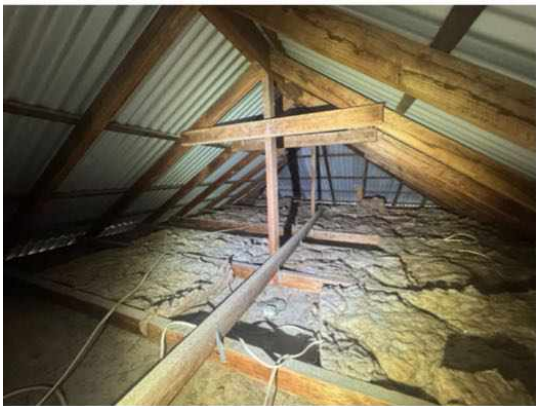
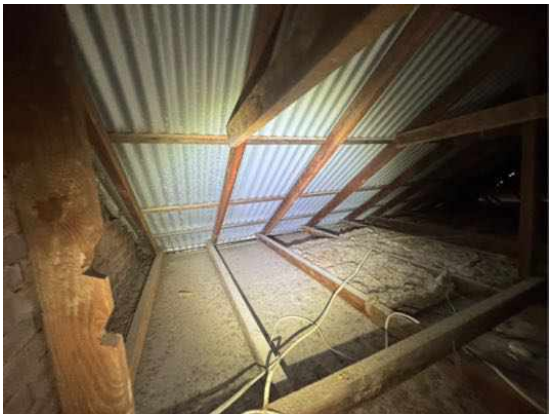
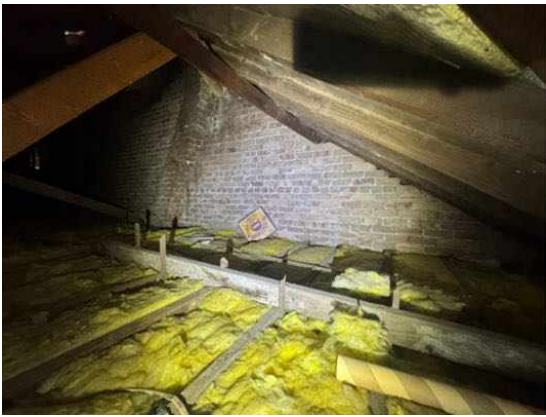
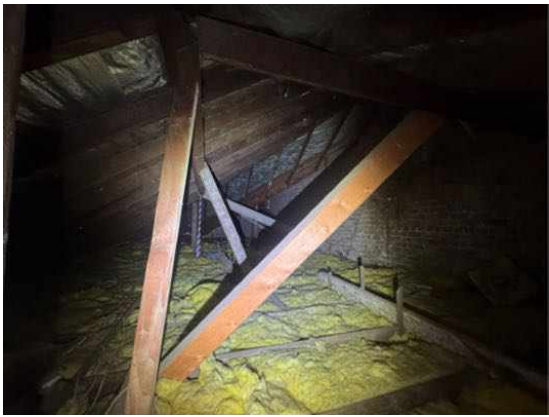
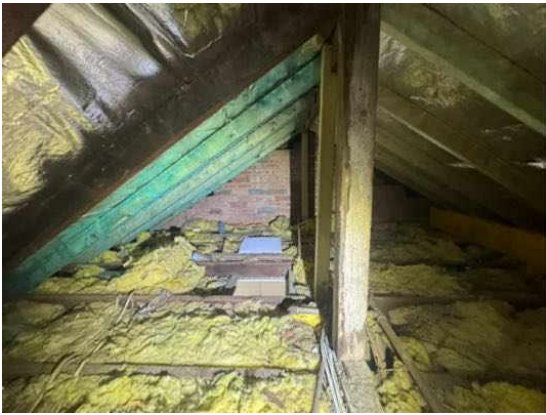
Building: Main Building
Location: Roof Void
Finding: Photos Added

Information: Additional photos are provided for your general reference.
