# Building and Timber Pest Inspection Report

Inspection Date: Wed, 8 Apr 2026

Property Address: 71a Nicholson Parade, Spring Farm NSW  
2570, Australia

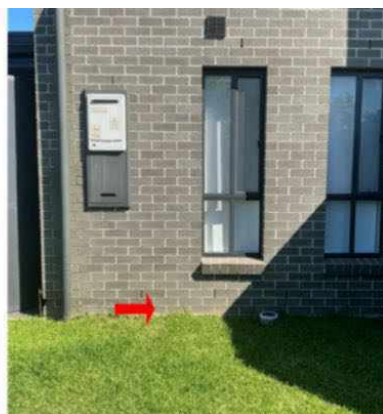
Building:	Main Building
Location:	All External Areas - Rear
Finding:	Site drainage - Inadequate
Information:	The site drainage in this area was found to be inadequate at the time of inspection, creating potential for subsequent water damage to associated building elements.

It is important that water does not lie against the base of walls; surrounding paths and ground levels should be sloped to drain water away from walls. Downpipes should not discharge stormwater onto lower walls or plinths. Stormwater should be carried away by large, regularly cleaned drains. Ground levels may need to be lowered to expose a buried DPC.

Where site drainage is inadequate, installation of an Agricultural (Aggie) Drain may be required. A qualified plumber should be appointed to further inspect the property and perform any remedial works as necessary. Water damage and secondary defects are likely to occur if left unmanaged.

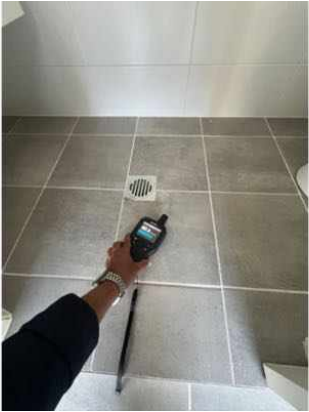
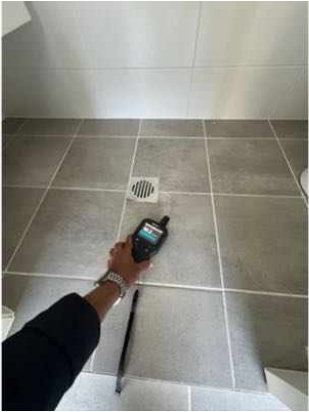
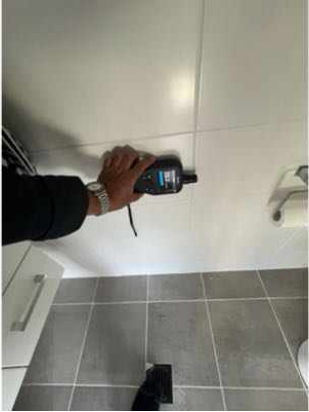
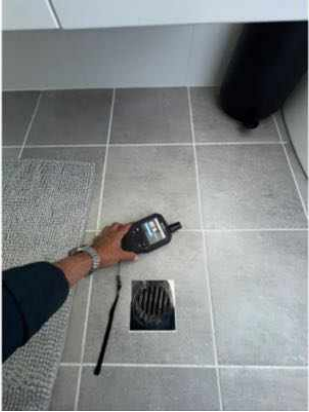
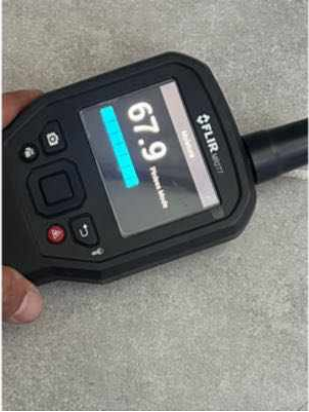
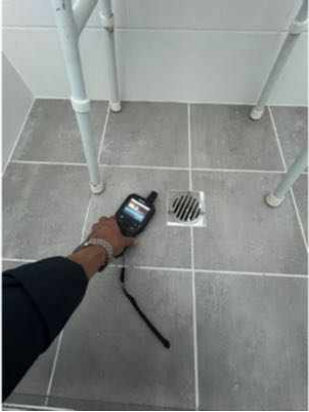
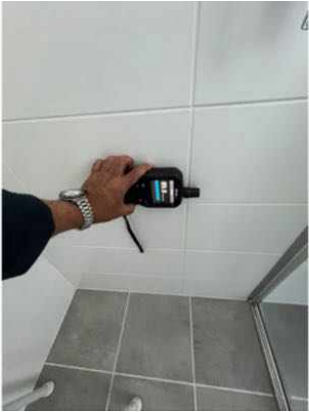
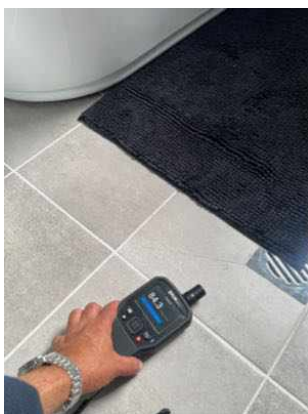
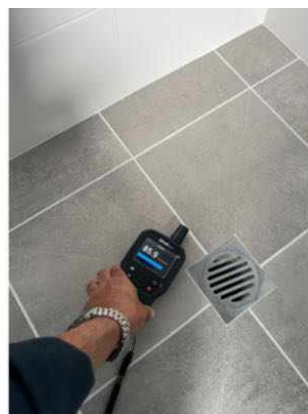
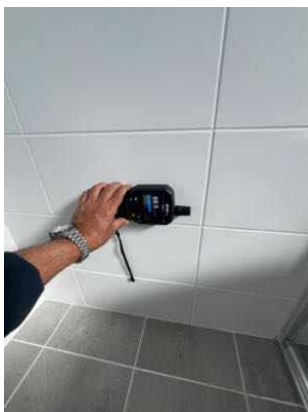
### Finding 3.03

Building:	Main Building
Location:	Bathrooms
Finding:	Elevated Moisture Bathroom (No visible deterioration noted)
Information:	Elevated moisture levels were detected to tiled surfaces in bathroom/shower areas. Persistent moisture ingress can lead to concealed damage, including timber rot and mould growth.

Elevated moisture readings in tiled wet areas can occur from normal shower use, age/deterioration of waterproofing membranes, plumbing leaks or moisture absorption through grout lines. While no damage was visible, elevated readings may indicate moisture retention behind tiles, which can be a conducive condition for future deterioration if not monitored.

Monitor the area over time for signs of drumming, efflorescence, tile movement, or grout deterioration. Further inspection by a licensed waterproofing is recommended (e.g., pressure testing, membrane assessment).

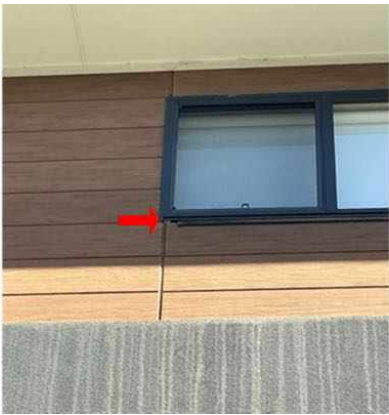
### Finding 3.04

Building:	Main Building
Location:	All External Areas
Finding:	Window seals - deteriorated
Information:	The window seals have deteriorated.

Where window seals have deteriorated, the window is no longer weather-tight; rain penetration and subsequent water damage is therefore likely to ensue. Insulation of the area against external weather conditions will also be compromised.

It is recommended that all deteriorated window seals be replaced by a general handyman or sealant expert to prevent any further damage and to restore the window to a fully functional level.

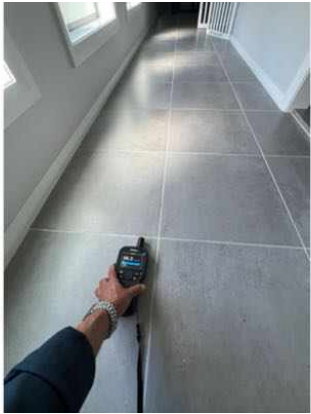
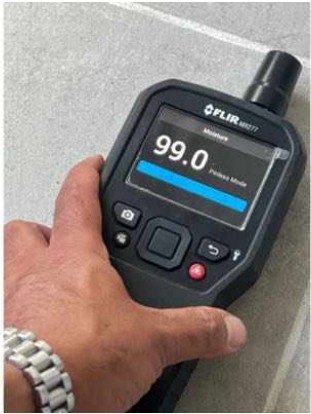
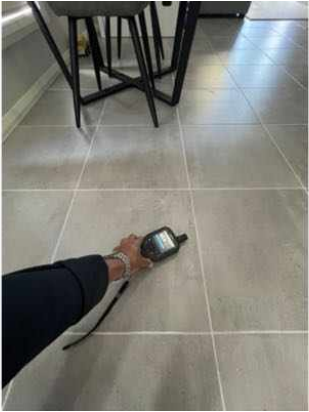
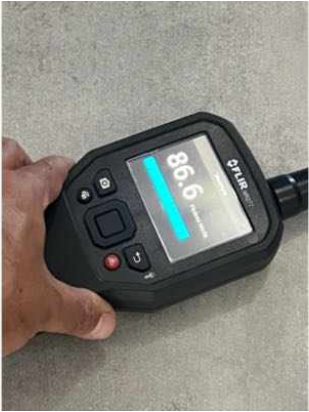
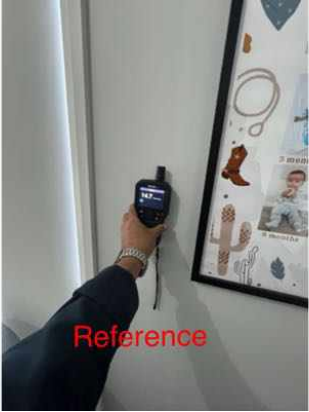
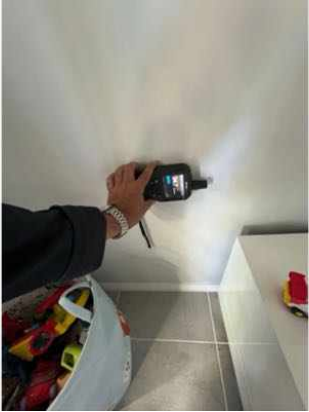
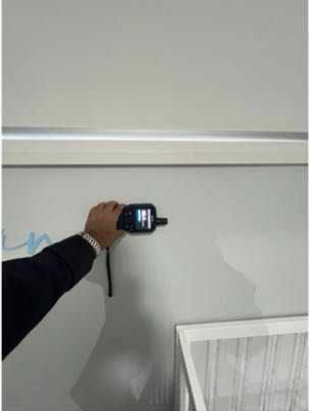
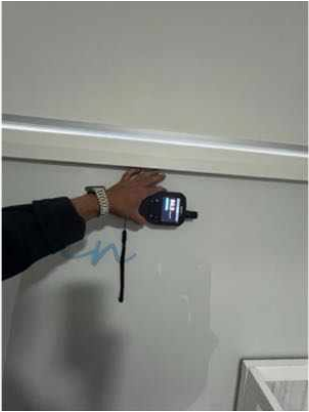
**Finding 3.05**

Finding: Elevated moisture - No visible deterioration

Information: Elevated moisture meter readings were recorded to the tiled floor surfaces , adjacent wall bases and first floor below windows when tested using a non-invasive (pinless) moisture meter. No visual evidence of moisture ingress, tile debonding, grout deterioration, staining, mould growth, or related moisture damage was observed at the time of inspection. Ongoing monitoring is recommended, and further investigation is warranted to check if there are concealed defects developing.

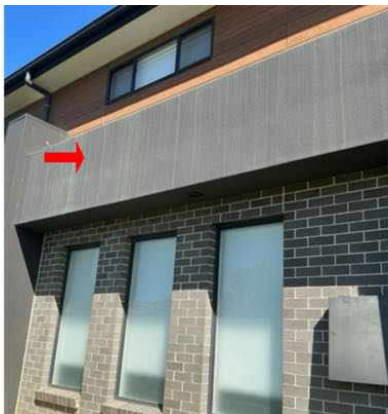
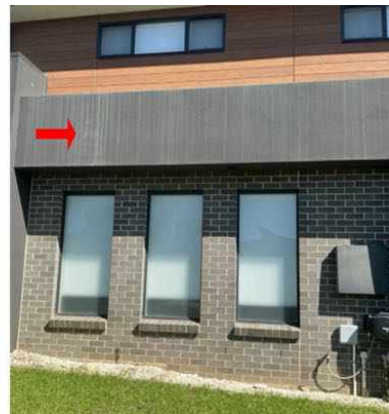
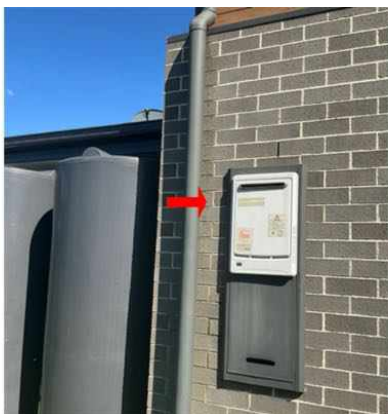
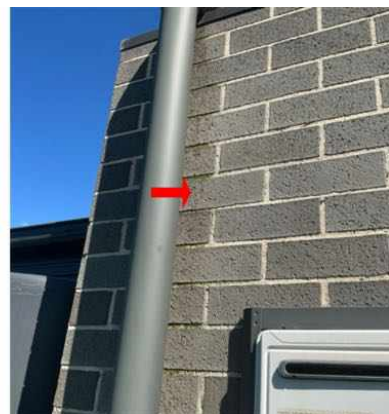
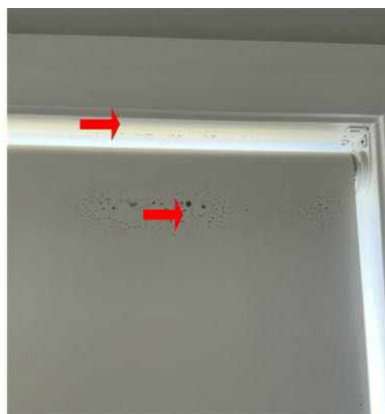
Finding 3.06

Building: Main Building  
Location: All External Areas  
Finding: Walls - Water stained  
Information: Water staining to sections of the walls in this area was evident at the time of inspection. Water staining indicates that surfaces have been exposed to moisture over time. The minerals and other elements in the water lead to staining, which may graduate to corrosion and deterioration if left unmanaged.

While mostly an appearance defect, water staining can be indicative of more serious defects, which may be currently concealed by wall linings.

Where water staining is active, a licensed plumber must be consulted to identify the cause of the staining and to provide advice on any reparation works that may be required. Replacement of any broken or damaged structures is advised.

Conversely, where water staining is old and inactive, affected building materials may be repaired or replaced at client discretion.

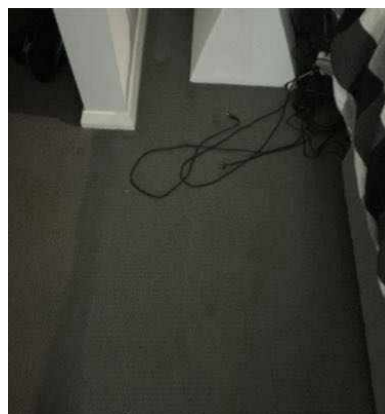
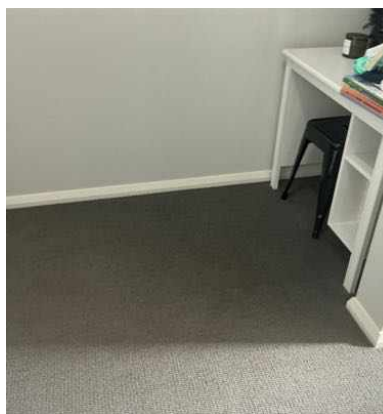
### Finding 3.07

Building:	Main Building
Location:	All Internal Areas
Finding:	Floor Flexing on First Floor - Bouncy Floor to some areas
Information:	Localised floor flexing was noted in isolated areas of the first floor during normal walking conditions. This condition is typical of timber-framed floor systems and may be attributed to minor deflection in floor joists, insufficient subfloor support, or age-related settlement of structural elements.

No visible signs of structural damage or distress were observed at the time of inspection. If the deflection worsens or causes concern, further assessment by a licensed builder or carpenter is recommended. Remedial work may include installation of additional support noggins, blocking, or subfloor stiffening to reduce bounce and improve floor rigidity.

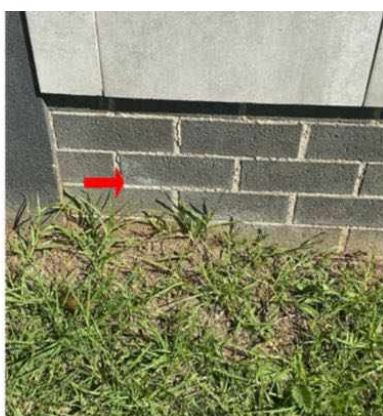
### Finding 3.08

Building:	Main Building
Location:	All External Areas
Finding:	Brickwork - Efflorescence
Information:	Efflorescence appears to be affecting the brickwork, concrete or tiles in this area. Efflorescence typically occurs when excess salts within the concrete or cement mortar is leached to the surface due to water transfer.

It is typically seen as white salt deposits on the surfaces of concrete pavement or mortar between bricks or tiles. While detracting from the overall appearance of the affected area, efflorescence is not likely to develop into secondary damage if left unmanaged.

Generally, soluble salt deposits can be removed by dry brushing with a stiff-bristled brush. Repeated dry brushing is an ideal treatment for eliminating this forming of efflorescence. A cleaning contractor or general handyperson may be appointed to perform these works at the discretion of the client.

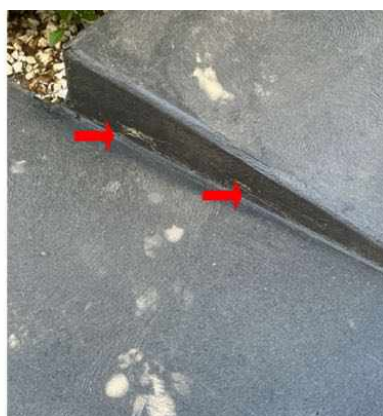
Building: Main Building  
 Location: All External Areas  
 Finding: Cracking - External Concrete Paving Damage Category 2 - Distinct (less than 3mm)  
 Information: Distinct cracks were identified in external concrete paving. Distinct cracks are generally found in older concrete paving, and may also present as a trip hazard as consequence of an uneven or curved surface.

General age and expected deterioration of the paved areas is a common cause of this

type of cracking. However, expansion and contraction of the slab may also have occurred due to environmental factors. Such factors include variable moisture and weather conditions, the presence of trees and their roots having a settling or lifting affect on the soil, or the effect of load bearing, e.g. heavy vehicles over a sustained period of time.

Cracking to this degree may also be due to poor original installation of the concrete. Factors such as poor compaction of the sub surface and/or inadequate reinforcing of the slab may create cracking and other secondary defects.

Repairs are likely to be required to prevent further cracking and to reduce hazards associated with cracking, such as tripping. Monitoring of all cracking should be conducted frequently. Always contact a building inspector should cracks widen, lengthen, or become more numerous.

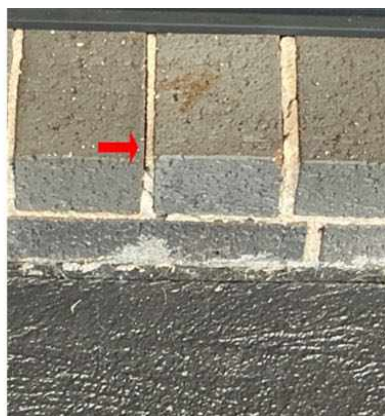
### Finding 3.12

Building:	Main Building
Location:	All External Areas
Finding:	Brickwork - Deteriorated mortar to some areas
Information:	Mortar, or 'bedding', is the material which fills joints and intersections between bricks in masonry walls and structures. Sections of mortar in this brickwork were identified as having deteriorated, which is generally expected for a property of this age and condition.

Mortar may deteriorate as a result of age of building materials, minor movement of bricks, or frequent exposure to weathering. Mortar should be replaced to ensure that bricks remain in their intended location and to prevent gaps, which would allow water or moisture ingress and secondary damage as a result.

Mortar deterioration can be addressed by a bricklayer where areas of deterioration are localised and easily accessible. Alternatively, appointment of a registered builder is advised, to repoint large areas of decaying mortar. Where secondary structural defects have become evident, consultation with a structural engineer may be required.

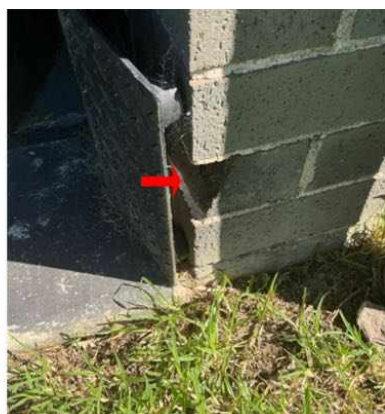
### Finding 3.13

Building:	Main Building
Location:	All External Areas
Finding:	Building element - Damaged - Brick damaged left side
Information:	Breakage occurs generally when the building materials have either aged and decayed, or as a result of damage (accidental or deliberate).

Repair and/or replacement of broken elements is advised to ensure that additional secondary defects do not arise as a consequence. Such works are necessary, as all building elements play a key role in the operation and function of the overall structure and its performance.

A relevant tradesperson should be appointed to repair or replace the affected building element prior to any subsequent damage being caused.

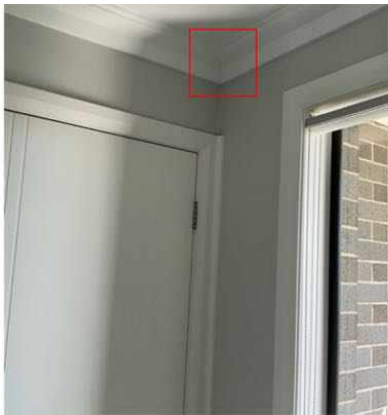
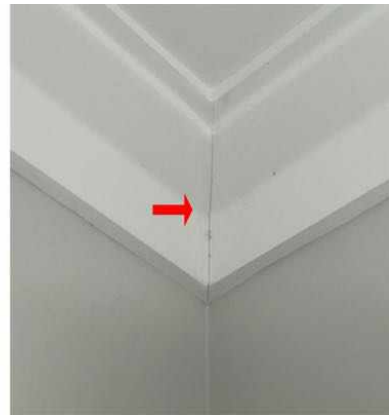
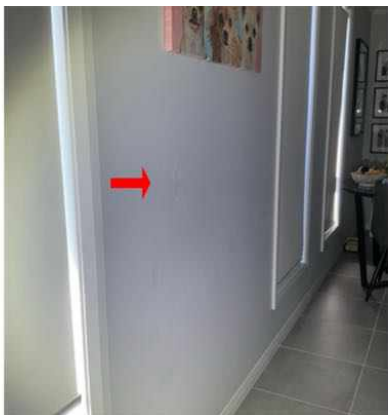
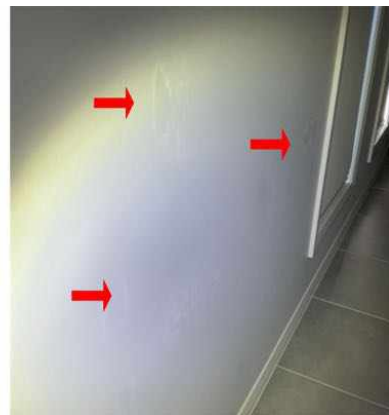
### Finding 3.14

Building:	Main Building
Location:	All Internal Areas
Finding:	Paint Finish & Hairline Cracking - To some areas
Information:	The paint finish in this area was identified as being incomplete at the time of inspection including some hairline minor cracking.

Whilst incomplete or missing paint and minor cracking and imperfections in finish is generally an appearance defect, it can also lead to the development of secondary building defects over time. Incomplete areas of paint finish expose the area to moisture, potentially accelerating the deterioration of underlying building materials.

Incomplete paint finishes should be sanded back, filled, leveled and painted, as applicable. Where inadequate or missing paint protection has led to the deterioration of the associated building element, repair and/or replacement of this building element may be required.

A painting contractor should be appointed as soon as possible to perform necessary works to aid the appearance of the affected area and to ensure the area is protected against further deterioration. Alternatively, the homeowner following manufacturer instructions may perform these works.

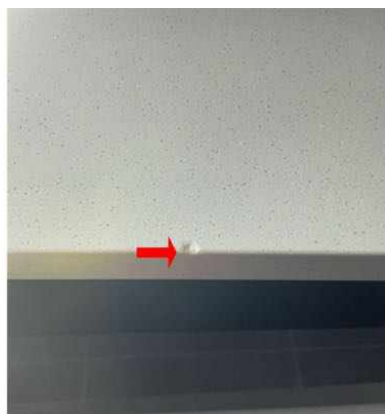
**Finding 3.15**

Building: Main Building  
Location: All Internal Areas  
Finding: Building element - Damaged - Kitchen top chipped  
Information: Breakage occurs generally when the building materials have either aged and decayed, or as a result of damage (accidental or deliberate).

Repair and/or replacement of broken elements is advised to ensure that additional secondary defects do not arise as a consequence. Such works are necessary, as all building elements play a key role in the operation and function of the overall structure and its performance.

A relevant tradesperson should be appointed to repair or replace the affected building element prior to any subsequent damage being caused.

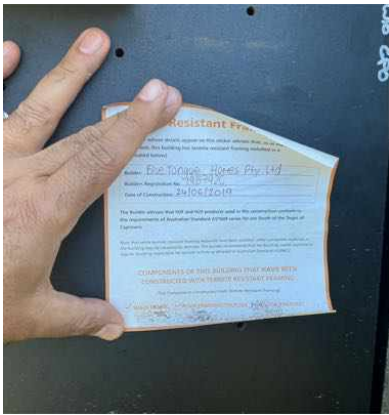
Building:	Main Building
Location:	All External Areas
Finding:	Termite Management System - no evidence of a chemical installation
Information:	The application of a post-construction chemical termite barrier is highly recommended for all properties, particularly if live termite activity has been found on the site previously. Such barriers are highly effective in preventing termite attack on any timber building elements throughout the property.

A durable notice should be placed in the switchboard unit to indicate current termite barriers. At the time of inspection, it appeared as though no termite management system has been installed, with no evidence to suggest preventative works taking place.

The client may consider gaining further advice from a pest controller as to the costs and procedures involved with this application. It is recommended that obtaining such advice be a short-term priority.

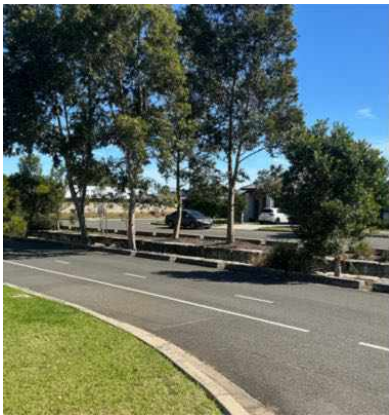
**Finding 6.02**

Building: Main Building  
 Location: All External Areas  
 Finding: Trees within 50m  
 Information: Trees within 50m of the property can be conducive to termite activity. It is recommended to monitor any potential signs of timber pest activity. An invasive inspection of trees with 50m to the property is recommended by a licensed timber pest technician

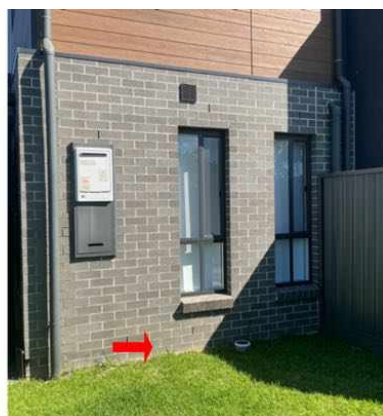
**Finding 6.03**

Building:	Main Building
Location:	All External Areas
Finding:	Slab Edge - Exposure
Information:	An inspection zone of at least 75mm in relation to the exposed slab edge, between the bottom brick and the perimeter pavement, is required. This inspection zone should be maintained in order to force termites into the open where they can be detected more readily during regular inspections. The slab edge should not be concealed by anything that may prevent inspection of the area, including render, landscaping, soil, turf, paving, concrete cladding or other structures.

If the slab edge is not properly exposed there is a high risk of termite attack. Sometimes, in order to determine the type of slab, a suitably qualified person such as an architect or builder may be required to consult the construction plans.

Where the slab edge cannot be properly inspected, it is highly recommended that termite or timber pest inspections be carried out every 6-12 months to aid protection of the property against infestation.

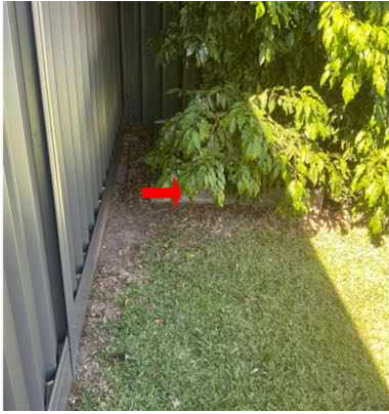
### Finding 6.04

Building:	Main Building
Location:	All External Areas
Finding:	In ground contact - Timber
Information:	Any timbers in direct ground contact provide opportunity for concealed termite entry and are likely to be subject to premature rot and decay as the soil retains moisture or damp conditions against the timbers.

Remove untreated timber that is in direct contact with external grounds. Consider replacement with more durable materials i.e. treated timber or non timber elements. Frequent pest inspections are advised to readily identify any termite activity in these areas.

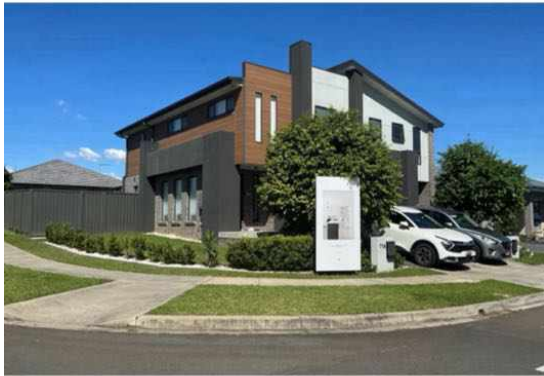
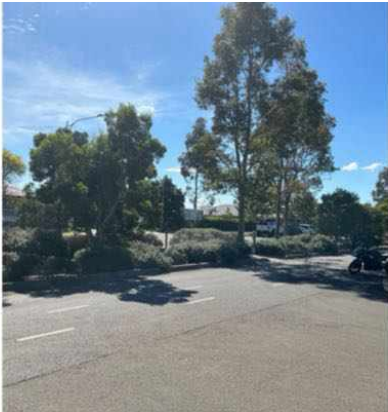
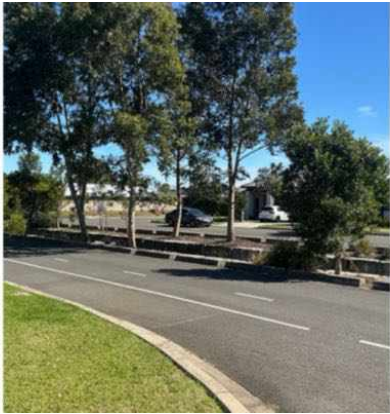
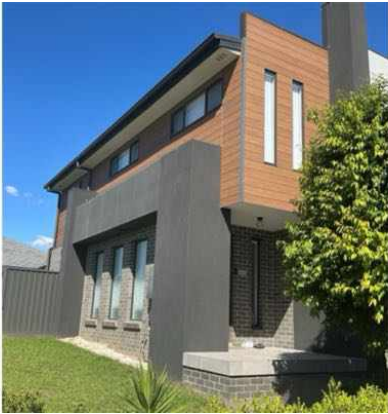
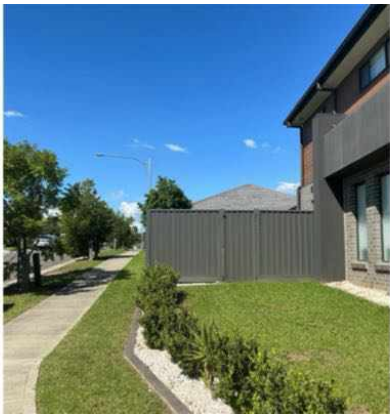
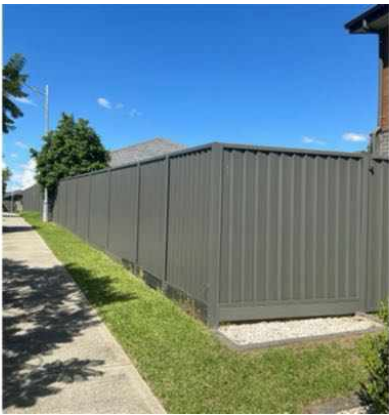
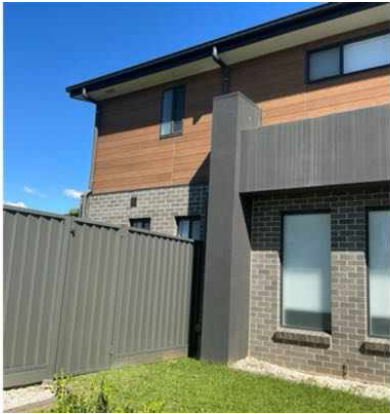
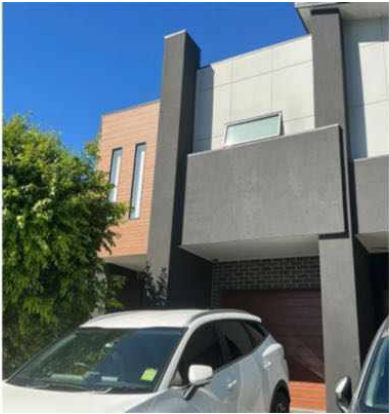
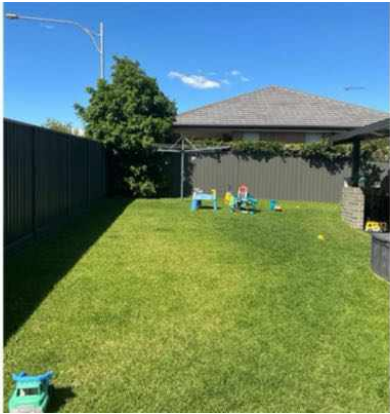
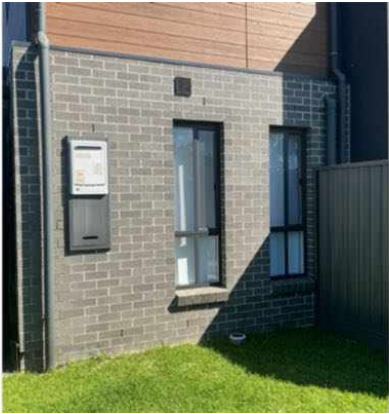
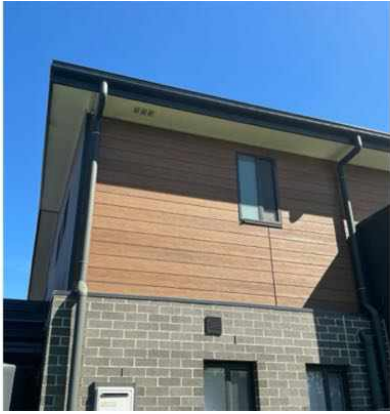
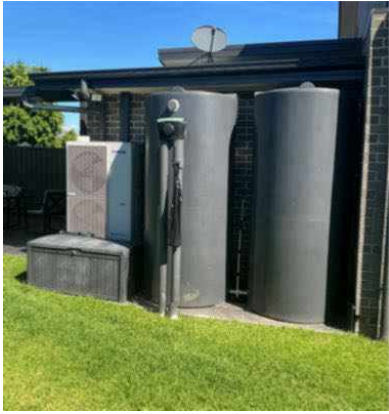
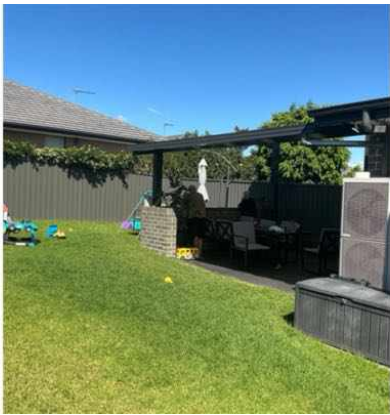
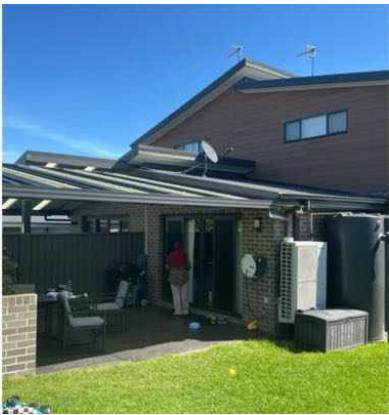
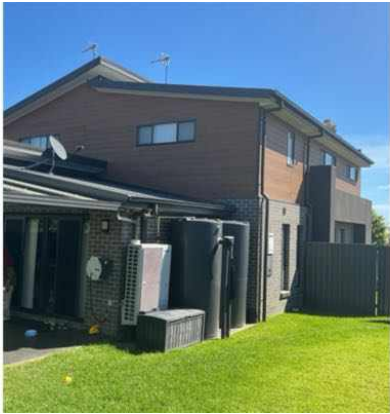
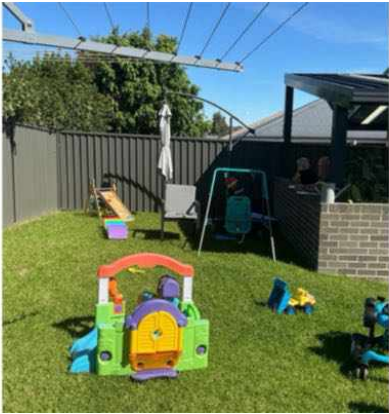
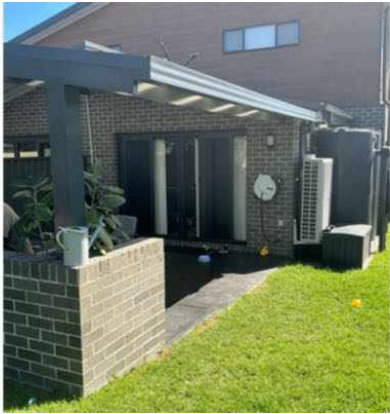
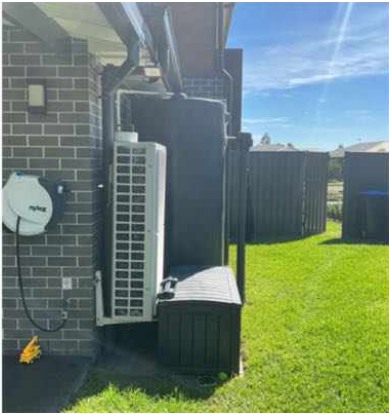
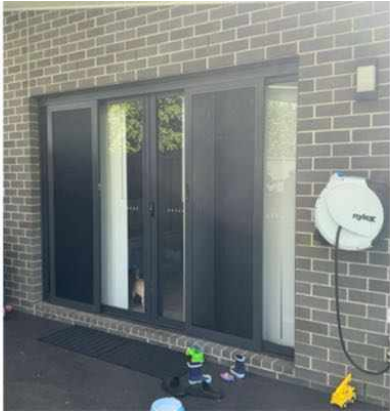
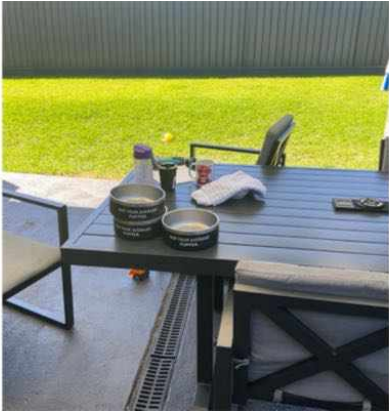
Building: Main Building  
Location: All External Areas  
Finding: Additional Photos - Obstructions and Limitations  
Information: These photographs are an indication of the obstructions and limitations which impeded full inspection of the property at the time of inspection. These obstructions can hide an array of defects and should be removed to allow full inspection to be carried out. A re-inspection is recommended once the areas are made accessible.

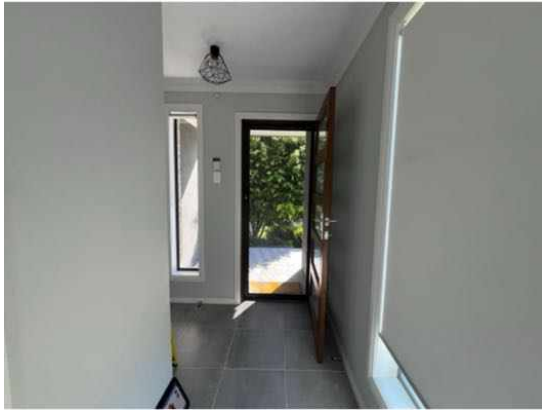
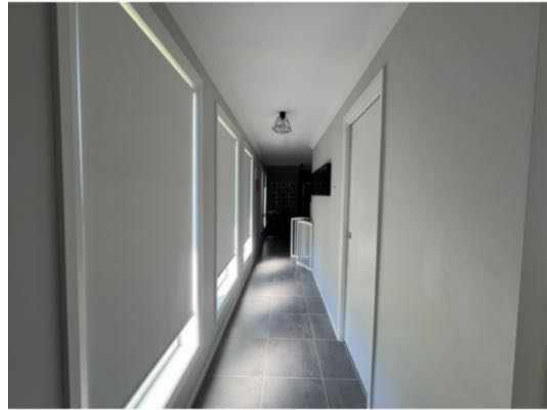
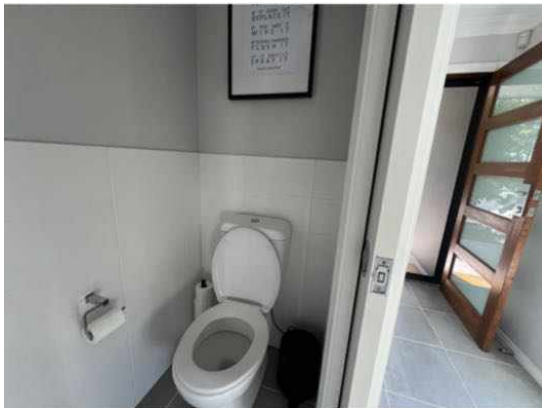
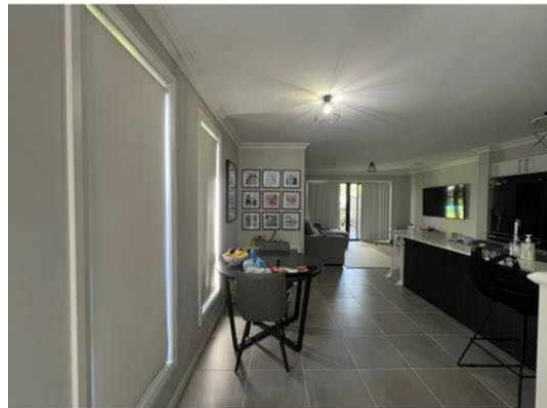
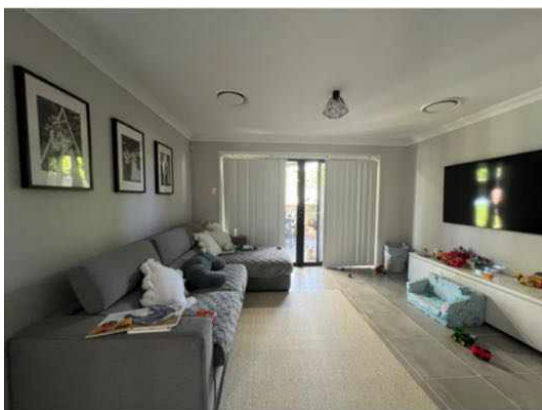
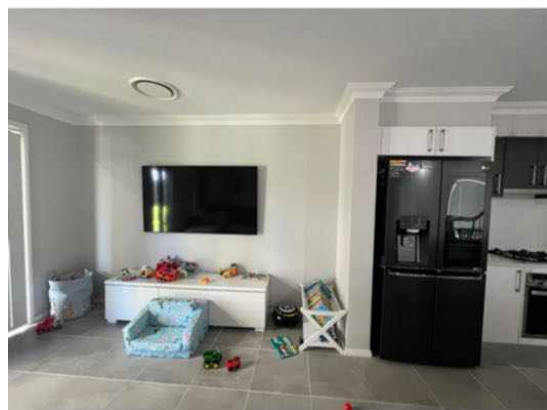
Building: Main Building  
Location: All Internal Areas  
Finding: Additional Photos - Obstructions and Limitations  
Information: These photographs are an indication of the obstructions and limitations which impeded full inspection of the property at the time of inspection. These obstructions can hide an array of defects and should be removed to allow full inspection to be carried out. A re-inspection is recommended once the areas are made accessible.

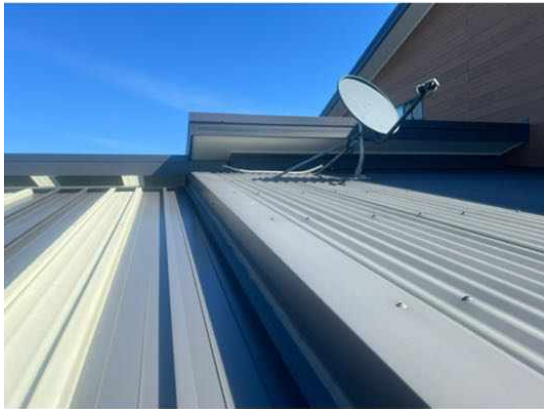
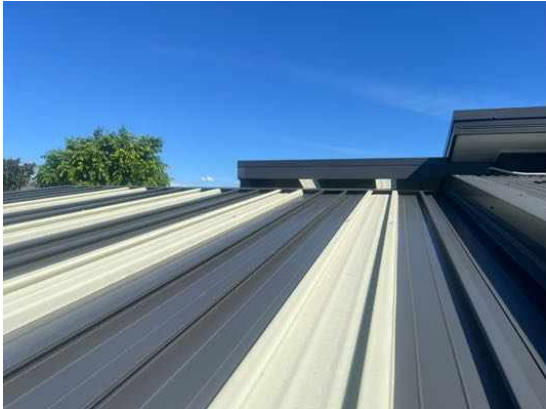
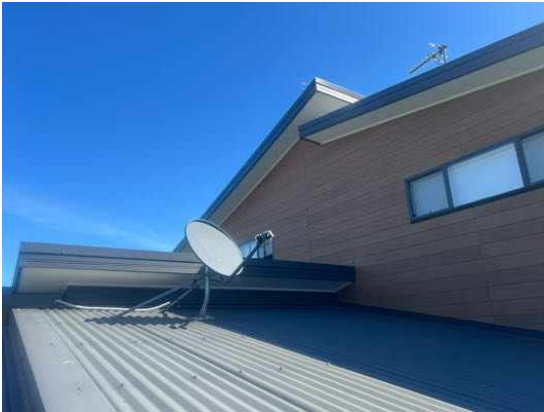
Building:	Main Building
Location:	Roof Exterior
Finding:	Additional Photos - Obstructions and Limitations
Information:	These photographs are an indication of the obstructions and limitations which impeded full inspection of the property at the time of inspection. These obstructions can hide an array of defects and should be removed to allow full inspection to be carried out. A re-inspection is recommended once the areas are made accessible.

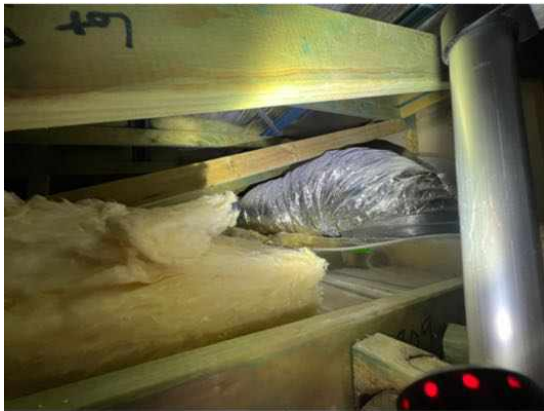
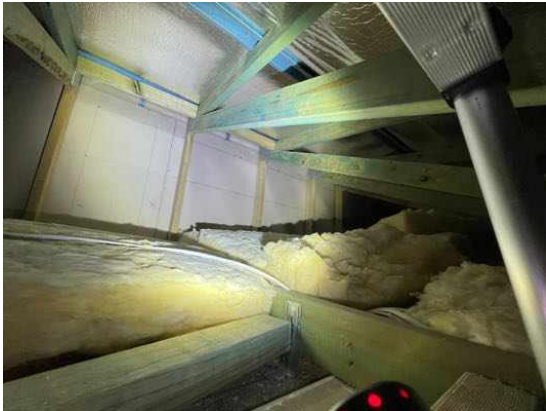
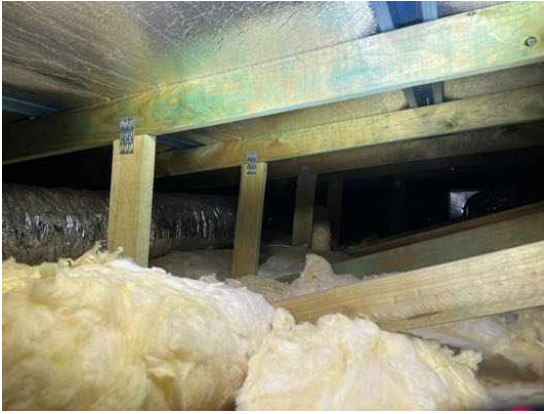
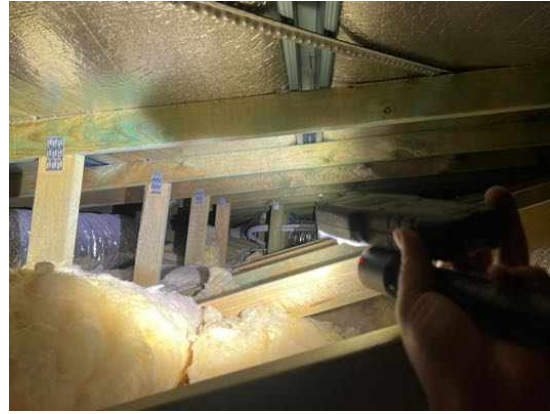
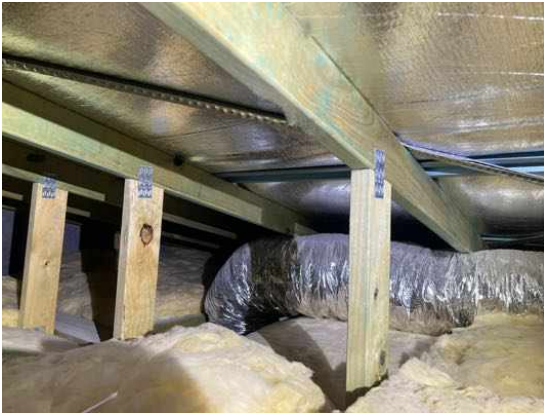
Building: Main Building  
Location: Roof Void  
Finding: Additional Photos - Obstructions and Limitations  
Information: These photographs are an indication of the obstructions and limitations which impeded full inspection of the property at the time of inspection. These obstructions can hide an array of defects and should be removed to allow full inspection to be carried out. A re-inspection is recommended once the areas are made accessible.

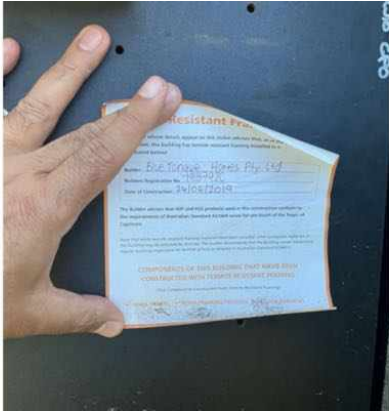
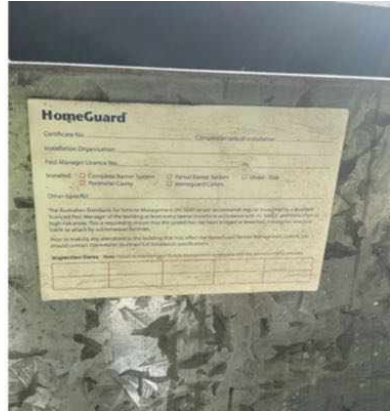
Where a Termite Management System has been identified you should refer to the type of barrier date of installation warranty conditions and any documentation provided by a builder or past owner. Consult the company who installed the barrier to confirm whether the system is still under warranty.

Most chemical termite management systems expire and require replenishment and all physical systems are primarily designed to prevent concealed entry.
