Building and Timber Pest Inspection Report

Inspection Date: Wed, 11 Feb 2026

Property Address: 213 Wire Ln, Berry NSW 2535, Australia

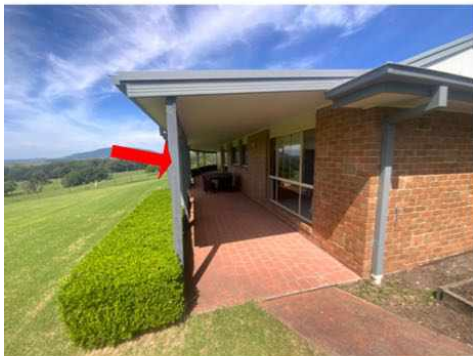
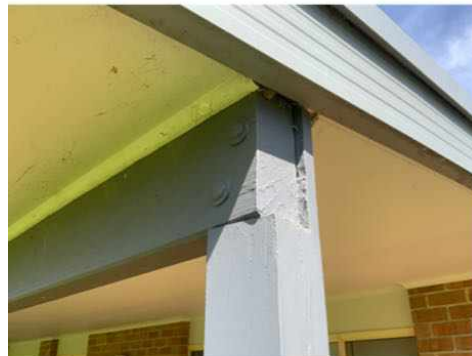
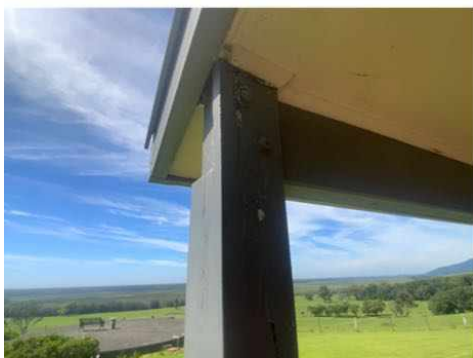
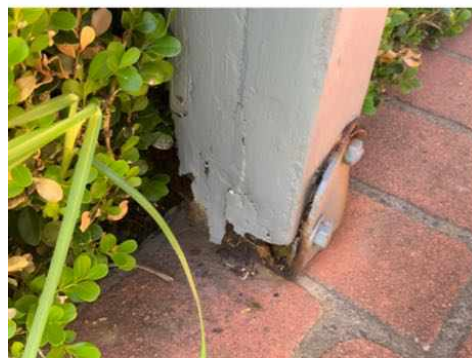
Finding 1.02

Building:	Main Building
-----------	---------------

Early intervention and regular maintenance, particularly of exterior timbers, will prolong the useful life of these building elements. Prior to any works being performed, the cause of the moisture that has created the visible wood rot should be identified and addressed in a suitable manner. Replacement of affected timbers may then be a necessary step in protecting surrounding building elements from such deterioration.

A qualified plumber may be appointed to assess the cause of excessive moisture and to provide advice on any remedial works as required. A qualified carpenter or registered builder may also be required to replace affected building materials.

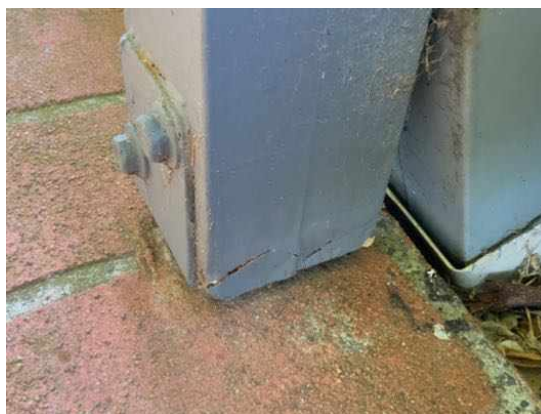
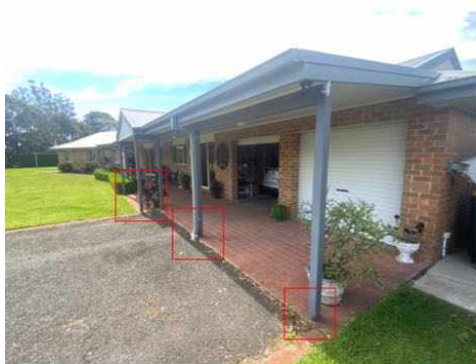
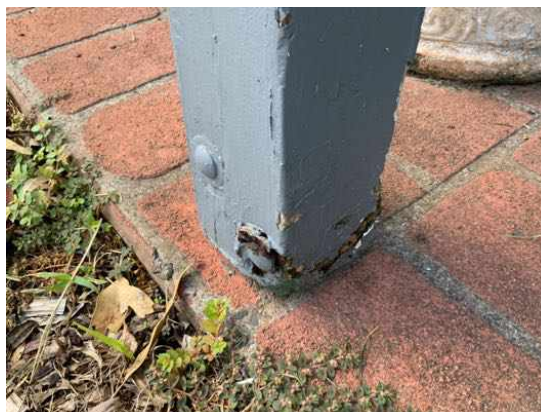
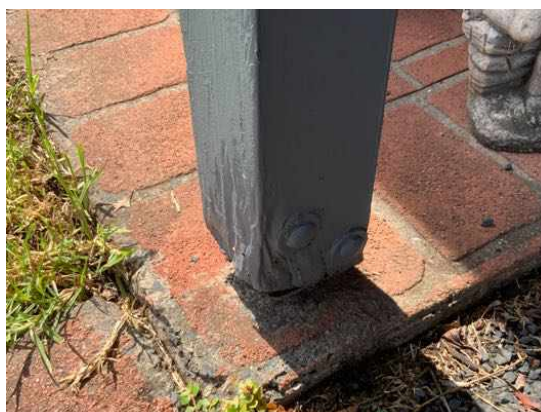
Finding 1.03

Building:	Main Building
Location:	Verandah - All Areas
Finding:	Post Supports and Post Bolts - Rusted to some areas - replacement required
Information:	This building element shows evidence of rusting and corrosion, which is likely to have developed as a result of excessive exposure to moisture and or inadequate coatings.

Rusting and corrosion should be managed by ideally removing or limiting the affected surface from exposure to moisture. A registered builder may be appointed to replace any building elements that have been severely affected by rust or water damage.

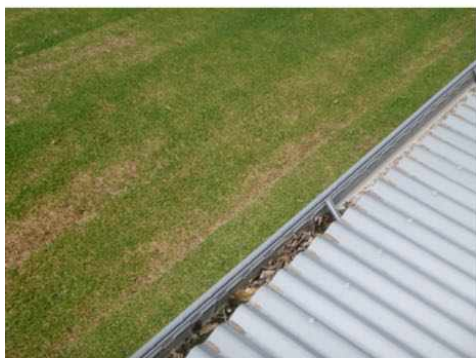
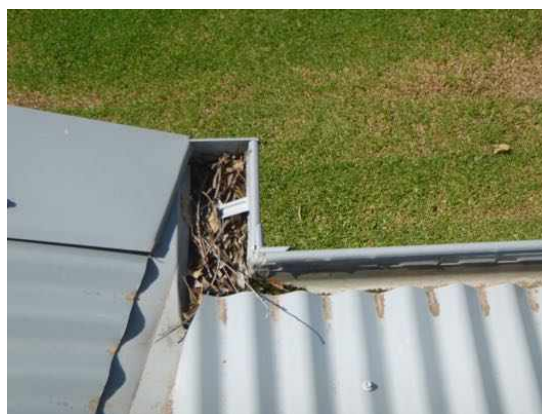
Finding 3.03

Building:	Main Building
Location:	Roof Exterior
Finding:	Gutters - Water pooling
Information:	Water was found to be pooling in sections of the roof guttering. This is generally a secondary defect caused by blocked or partially blocked gutters. Such blockages and subsequent water pooling are likely to lead to rust and water damage to associated structures if left unattended.

Any areas of guttering that shows evidence of water pooling should be checked for partial or full blockages and any secondary damage that may have occurred as a result. Depending on the extent of the damage, building elements may require repair and/or replacement to ensure adequate roof drainage and function of exterior plumbing system.

A roofing plumber should be appointed as soon as possible to rectify this issue. It is highly advised that all gutters be maintained on a frequent basis to ensure the condition of roof plumbing.

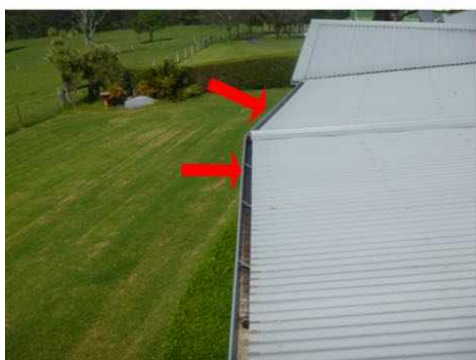
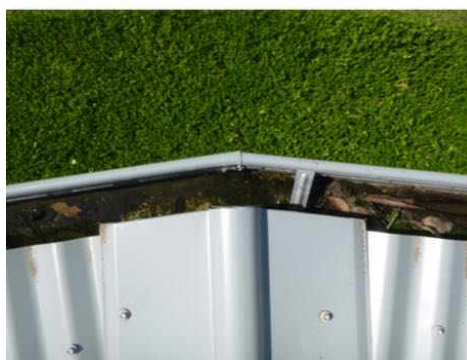
Finding 3.04

Building:	Main Building
Location:	Roof Exterior
Finding:	Installation - substandard or incomplete (roofing screws missing to some areas to the ends of the roof sheeting)
Information:	The installation of this building element appears to have been completed to a substandard level of workmanship or is incomplete. Generally substandard repairs or installation are related to poor workmanship, the use of inappropriate materials, or a failure to complete installation to a suitable standard.

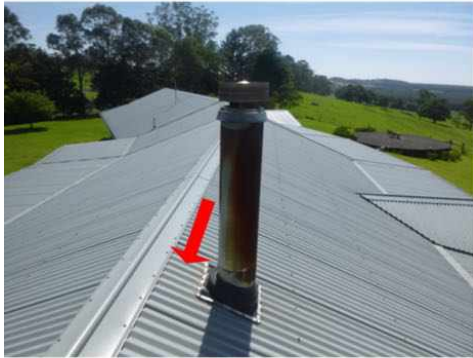
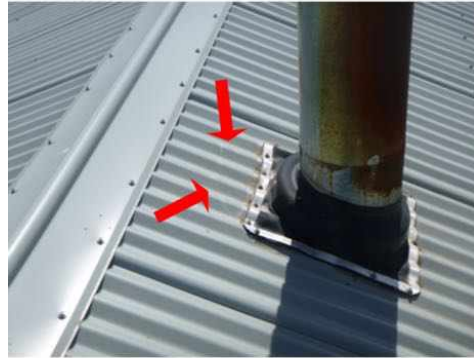
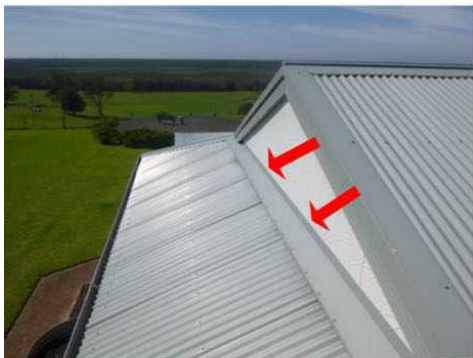
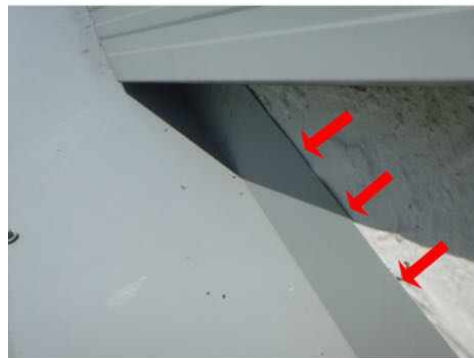
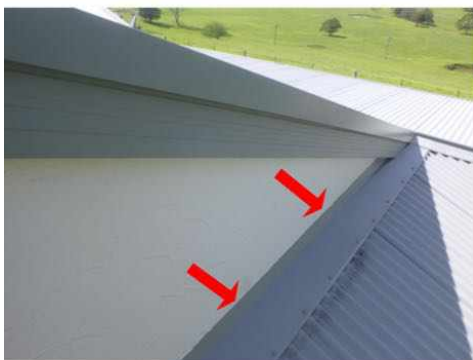
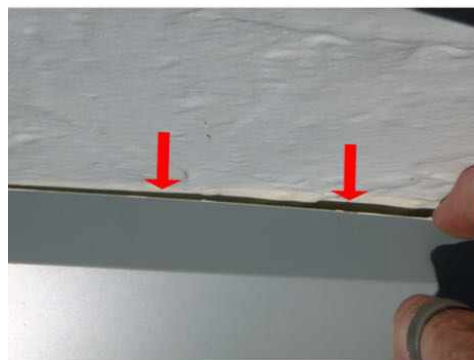
Finding 3.05

Building:	Main Building
Location:	Roof Exterior
Finding:	Roof plumbing - Flashings inadequate to the chimney Flu and Dutch Gable ends
Information:	Some sections of the roof are missing or have inadequate roof flashings. Flashings are metal and other materials which are applied to seals and intersections between roof coverings and building elements. They are designed to aid in weatherproofing of roof joins.

It appears that the flashings to the end Dutch gables are not flashed behind the wall sheet or sealed to the wall. The boot flashing to the chimney flu should have an apron flashing over the top of end and under the ridge flashing to reduce the risk of water leaks and relying on sealant alone.

Flashings that are not installed adequately or are missing are likely to result in water penetration to the interior of the property, as well as creating excessively damp conditions against the exterior surfaces and around the base perimeter of the building.

Premature ageing and secondary building defects are imminent where roof plumbing is missing or inadequately installed. Additionally, water pooling also creates an environment that is susceptible to termite and pest infestation.

A roofing plumber should be appointed as soon as possible to install relevant roof

plumbing materials, ensuring that no further damage is sustained.

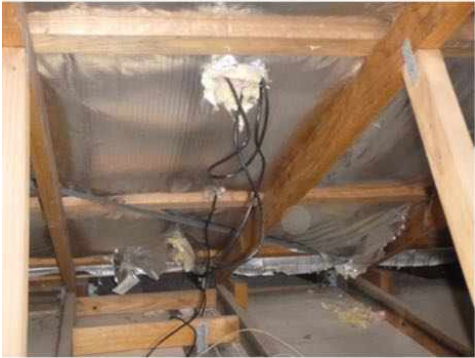
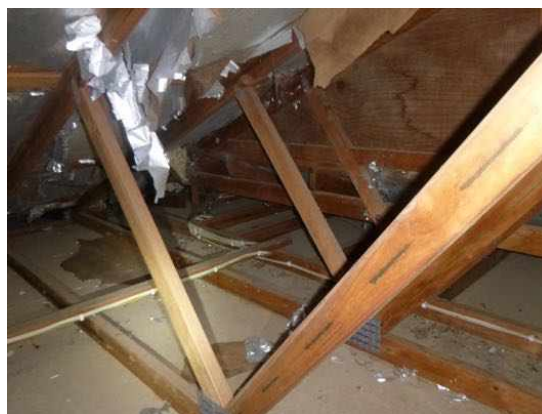
Finding 3.06

Building:	Main Building
Location:	Roof Void
Finding:	Sarking - Damaged or Loose
Information:	Sarking to under the roofing material is damaged, loose or has holes and gaps. Sarking acts as an insulator, helps with noise reduction & is a second barrier against water penetration from broken or slipped tile leaks & condensation.

assisting in insulation of the roof void and subsequently the household. Where sarking is damaged insulation of the property is inhibited creating a loss of energy and thus negatively impacting the energy efficiency of the property.

A Builder, Carpenter or handyman will be able to repair the holes with pieces of sarking and AS4254 tape specific foil tape for this product.

Consult a builder or insulation specialist for further advice.

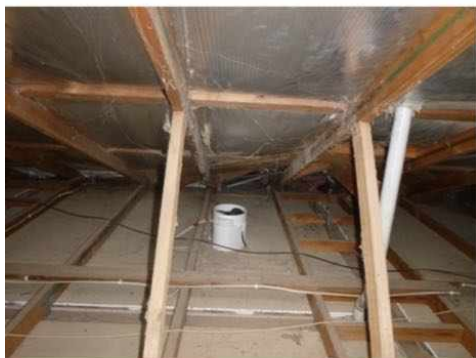
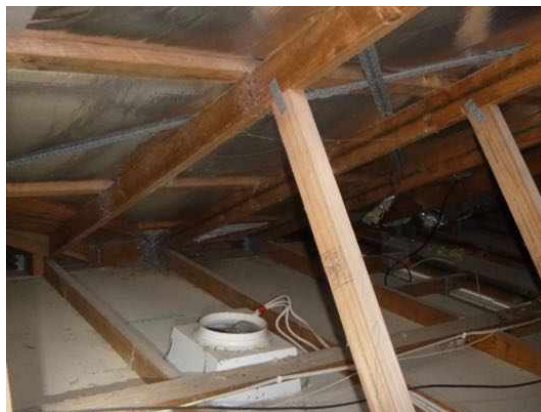
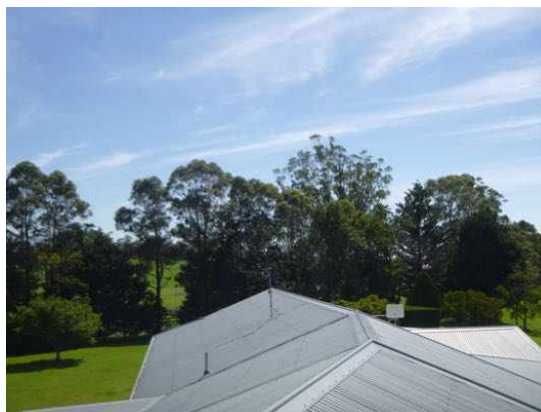
Finding 3.07

Building:	Main Building
Location:	Roof Void
Finding:	Exhaust fans - Sarking on roof (Ducting, Roof Vent or Eave Vents are recommended)
Information:	On inspection of the roof void, it was observed that the exhaust fans to the bathroom and ensuite do not exhaust directly to the outside of the building, which is recommended if sarking has been fitted, as it has in this home.

(B) is covered by roof tiles WITHOUT SARKING or similar materials which would prevent venting through gaps between the tiles.

High levels of moisture in the affected areas can provide conditions that are conducive to termite and timber pest activity. Consult a Licensed Builder or Plumber for further specific advice on remedial works that may be required.

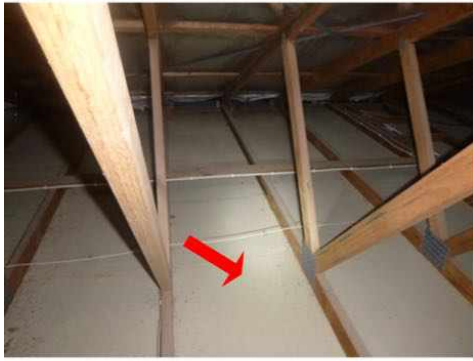
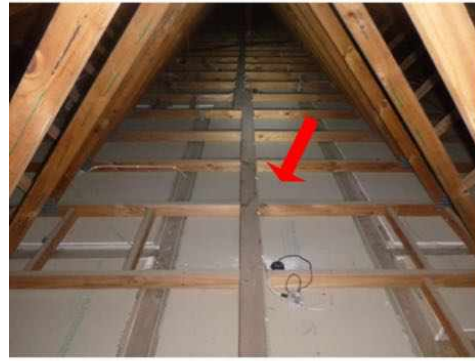
Finding 3.08

Building:	Main Building
Location:	Roof Void
Finding:	Ceiling Insulation - Missing
Information:	Upon inspection of the roof void it was noted that insulation is not present.

Insufficient insulation will result in a comparatively higher cost to heat and cool a property as there is a lack of Insulation (or uneven coverage of insulation) which works as a barrier to heat transfer. This helps to keep out unwanted heat in summer and preserves warmth inside your home in winter. It can also help soundproof your home from unwanted airborne noise transfer.

Where insulation is absent, the area does not meet current Australian Standards. Installation of adequate insulation is required and should be conducted as soon as possible.

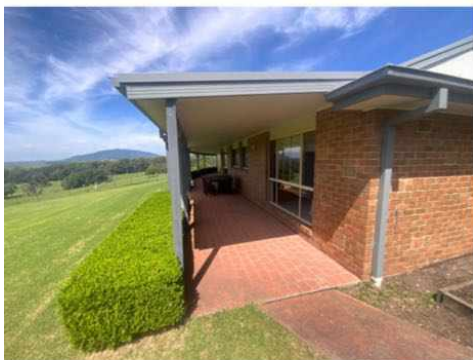
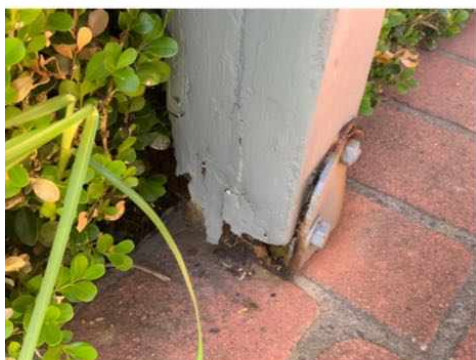
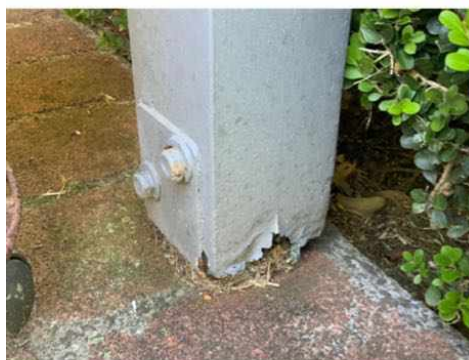
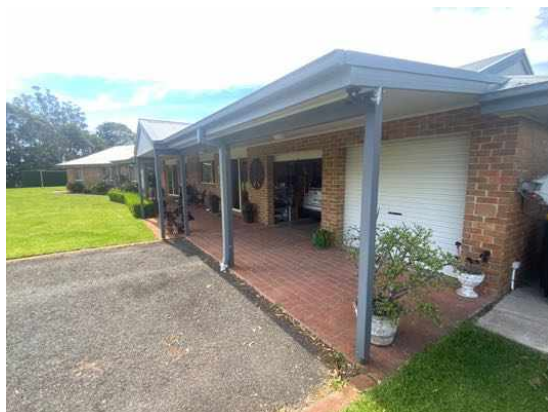
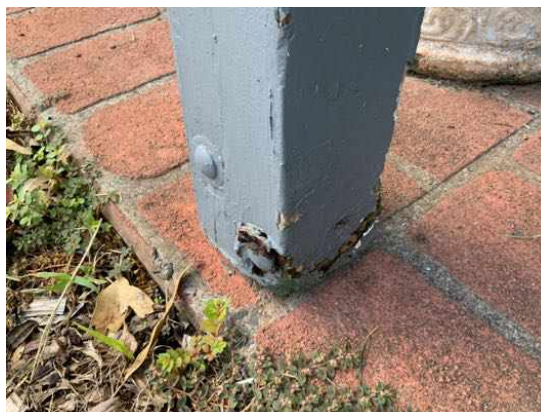
Finding 3.09

Building:	Main Building
Location:	All Areas
Finding:	External paint to timbers - deteriorated
Information:	Much of the external paintwork including but not limited to external timbers and trims have been neglected and require attention to prepare and re-paint.

Whilst incomplete or missing paint finish is generally an appearance defect, it can also lead to the development of secondary building defects over time. Incomplete areas of paint finish expose the area to moisture, potentially accelerating the deterioration of underlying building materials.

Degraded paint finishes should be sanded back, filled, leveled and painted, as applicable. Where inadequate or missing paint protection has led to the deterioration of the associated building element, repair and/or replacement of this building element may be required.

A painting contractor should be appointed as soon as possible to perform necessary works to aid the appearance of the affected area and to ensure the area is protected against further deterioration. Alternatively, the homeowner following manufacturer instructions may perform these works.

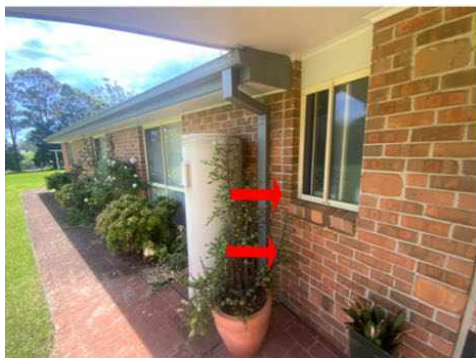
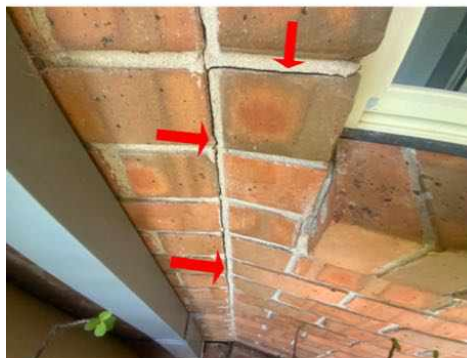
Finding 3.10

Building:	Main Building
Location:	Exterior walls - front
Finding:	Brickwork - Cracking noticeable
Information:	There were several cracks and or crack repairs evident to external brickwork.

Noticeable cracks are a common occurrence in external brickwork and are a likely result of age expected building movement, general expansion, and/or contraction of building materials in different weather conditions. Noticeable cracks in brickwork may develop if left unattended, with potential for necessitating major remedial works or replacement of the brickwork.

It is highly advised that a qualified bricklayer be appointed to provide necessary works to cracked brickwork to prevent any further damage. Such works should be conducted as soon as possible.

Always monitor these cracks and contact a building inspector should cracks widen, lengthen, or become more numerous.

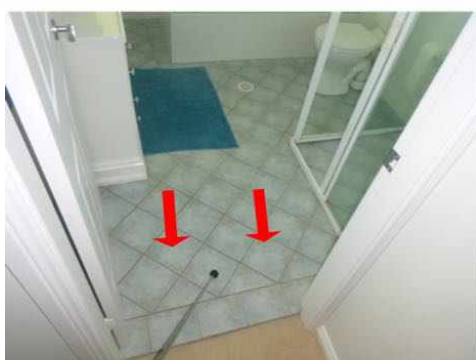
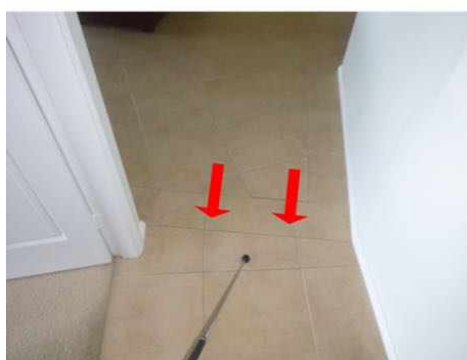
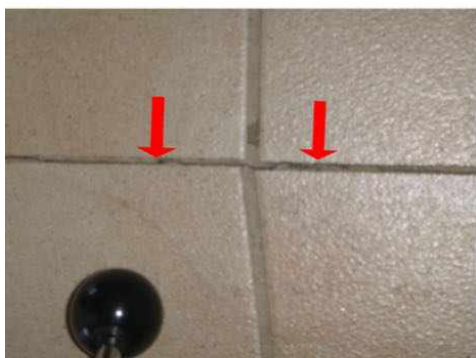
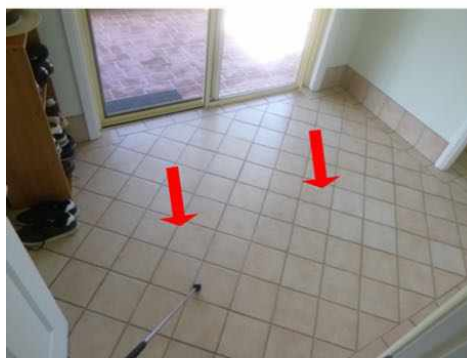
Finding 3.11

Building:	Main Building
Location:	All Areas
Finding:	Tiles - Drummy to several areas
Information:	Drummy tiled areas were identified at the time of inspection. The term 'drummy' refers to tiles that have become detached from their fixing, despite otherwise being in relatively good condition. Such defects are generally caused by physical or moisture damage to the area. Drummy tiled areas may also be a direct result of poor workmanship during the construction process.

Tiled areas may swell and shrink with changes in air humidity if the area has sustained moisture damage. Any exposure to moisture is capable of causing tiled areas to become drummy and/or cracked over a prolonged period of time. Drummy tiled areas generally require removal and replacement of affected tiles, with adequate sealant and grouting.

Specialist trades are available for these types of services. A registered builder may be required to undertake works if damage is extensive or if secondary building defects have resulted. Otherwise, it is advised that a tiling contractor be appointed to perform works as necessary. Immediate action is recommended to ensure that no further damage is sustained in the affected area.

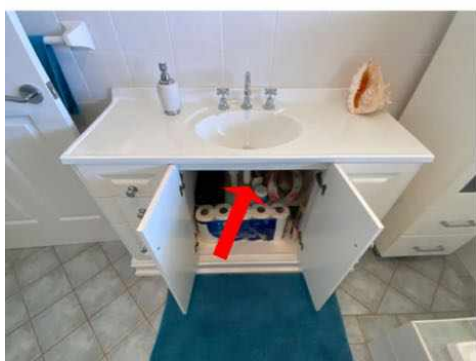
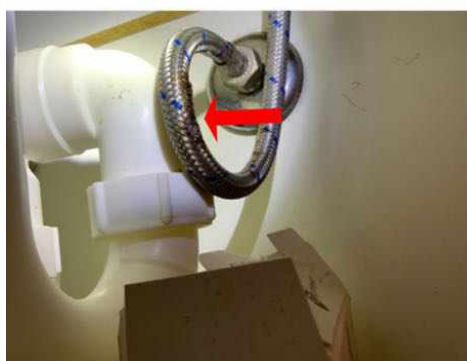
Finding 3.12

Building:	Main Building
Location:	Bathroom
Finding:	Flexi-Hose - Rusted or corroded
Information:	The water (flexi hose) underneath the kitchen sink is showing signs of rust & corrosion. Replacement of the hose is highly advisable as soon as possible to avoid a bursting pipe in the future. This building element shows evidence of rusting and corrosion which is likely to have developed as a result of excessive exposure to moisture and /or substandard coatings or materials. Surface rust provides no protection to the underlying iron so the condition will continue to worsen unless addressed. Rusting and corrosion should be managed by ideally removing or limiting the affected surface from exposure to moisture. A registered plumber or handyman may be appointed to replace any building elements that have been severely affected by rust or water damage.

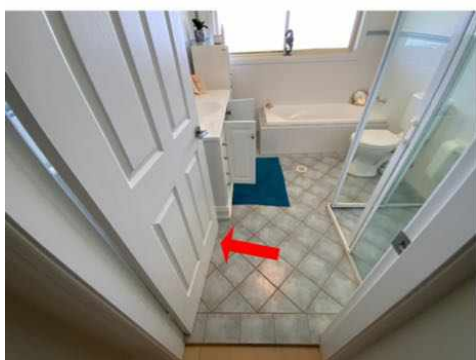
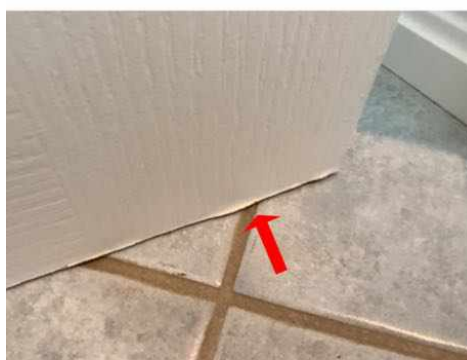
Finding 3.13

Building:	Main Building
Location:	Bathroom
Finding:	Door - Binding/jamming
Information:	Binding and/or jamming of this door is evident during standard operation. This defect inhibits the functionality of the affected door as well as creating potential for secondary

defects to associated building elements, such as damage to the floor covering.

A door that binds to flooring or to the associated door frame may have several causes, ranging from minor defects, such as poor installation of the door or deteriorated hinges, through to major structural issues, such as damage to subfloor structures.

Where door binding/jamming appears to indicate major structural issues, a registered builder specialising in re-stumping should be appointed to provide an estimate on the cost of rectification.

For minor causes, a qualified carpenter or general handyman should be appointed to perform minor rectification works at client discretion.

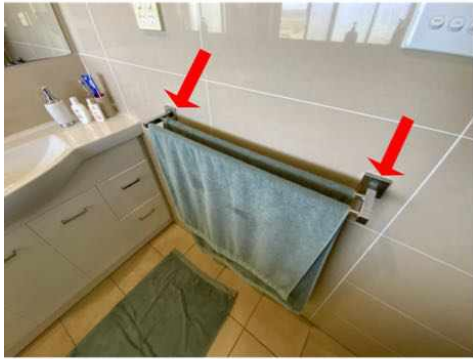
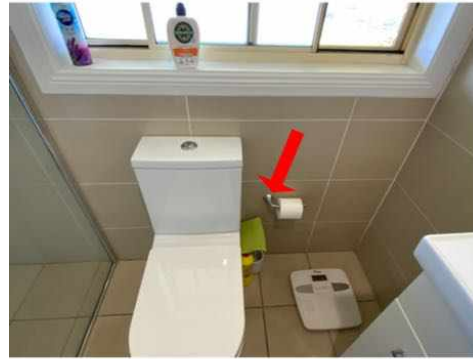
Finding 3.14

Building:	Main Building
Location:	Ensuite - Master
Finding:	Fitting or fixtures - Loose
Information:	The fitting in this area is loose and requires adjustment to tighten.

If left unmanaged, the fitting may further deteriorate, causing potential for the development of other minor secondary defects.

A relevant tradesperson should be appointed to perform these rectification works at discretion of the client.

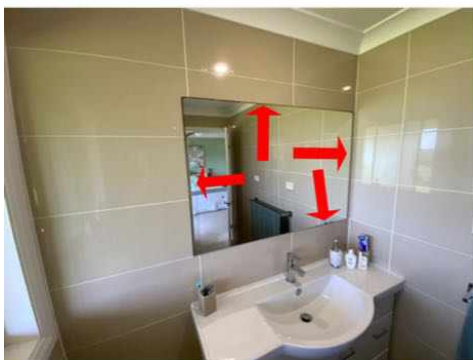
Finding 3.15

Building:	Main Building
Location:	Ensuite - Master
Finding:	Mirror Desilvering
Information:	Mirror desilvering or mirror rot is caused by moisture penetrating between the layer of glass and the layer of backing metal. Once water vapour has penetrated, the metal that makes your mirror shiny begins to react and oxidize (rusts), turning black.

Typically, the layer between the glass and metal becomes separated when the edge of the mirror is regularly exposed to powerful chemicals, most commonly ammonia. Once the separation occurs, any moisture — even just steam from showering can begin to cause the black spots to appear.

In some cases rectification is possible but replacement is generally the best option.

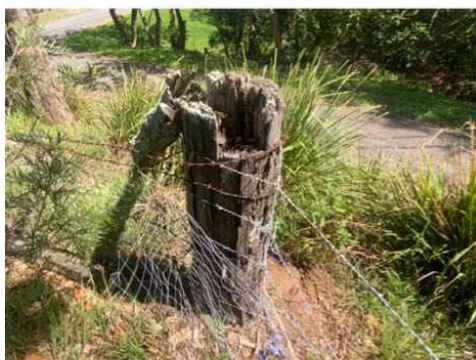
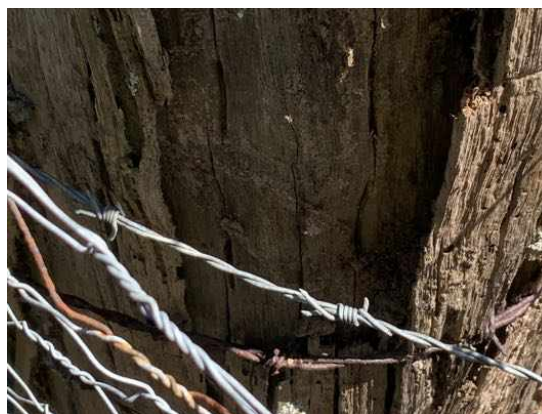
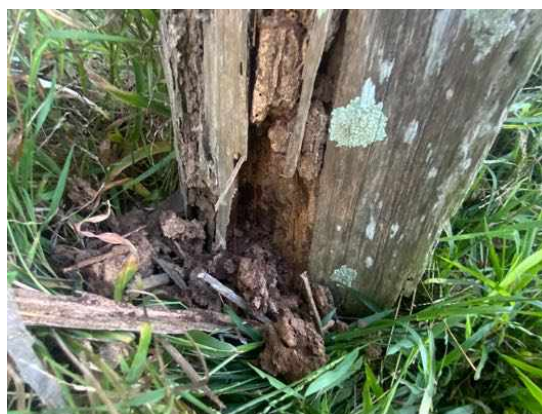
Building:	Main Building
Location:	Fencing posts
Finding:	Evidence of termite damage - minor
Information:	Despite no live termite or timber pest activity being indicated, previous termite damage was found to have affected this area. This damage is considered to be inactive and is minor in nature.

It is advised that the area be visually inspected frequently to ensure that the condition of affected building materials does not worsen. At the time of inspection, damage is not structural and is only considered to be superficial.

A building contractor may be appointed to provide a further invasive inspection if further damage is evident.

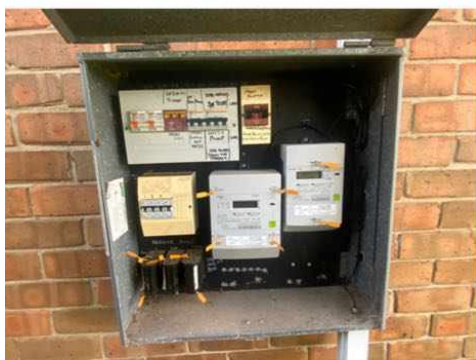
Finding 6.01

Finding: Termite Management System - no evidence of a chemical installation
Information: The application of a post-construction chemical termite barrier is highly recommended for all properties, particularly if live termite activity has been found on the site previously. Such barriers are highly effective in preventing termite attack on any timber building elements throughout the property.

A durable notice should be placed in the switchboard unit to indicate current termite barriers. At the time of inspection, it appeared as though no termite management system has been installed, with no evidence to suggest preventative works taking place.

The client may consider gaining further advice from a pest controller as to the costs and procedures involved with this application. It is recommended that obtaining such advice be a short-term priority.

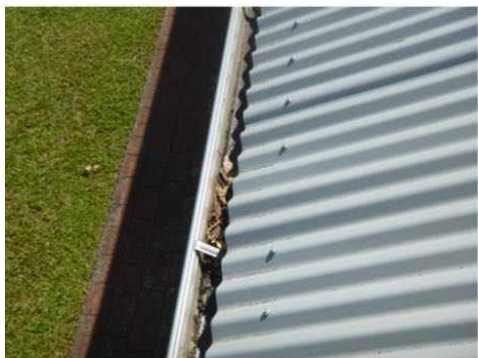
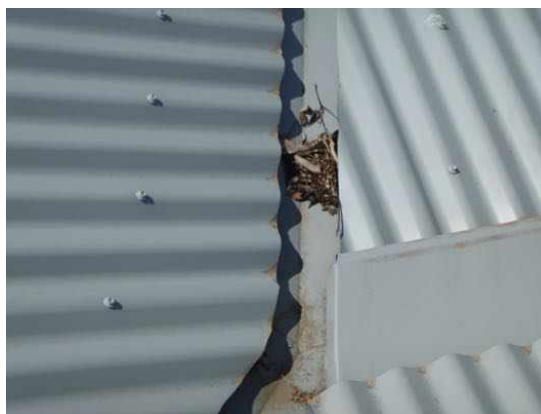
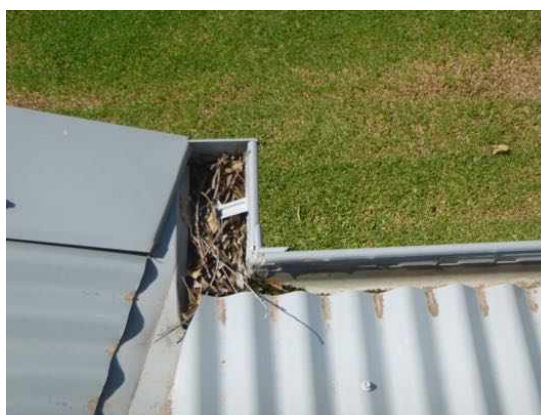
Blocked gutters are likely to lead to high levels of moisture in the affected areas. Such moisture will not only cause rust and decay of the associated building materials, but can also provide conditions that are conducive to termite and timber pest activity. Blockages in gutters should therefore be removed immediately to ensure dry conditions are maintained.

Consult a Licensed Plumber for further specific advice on remedial works that may be

required. In the interim, it is highly advised that blocked gutters be removed by the homeowner or a general handyperson as a matter of urgency.

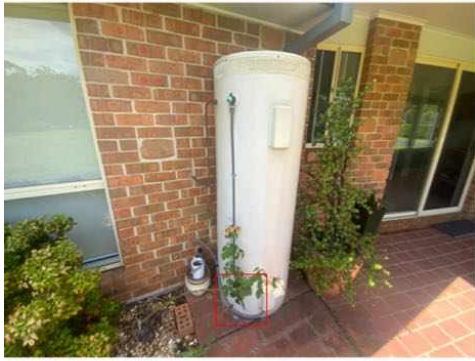
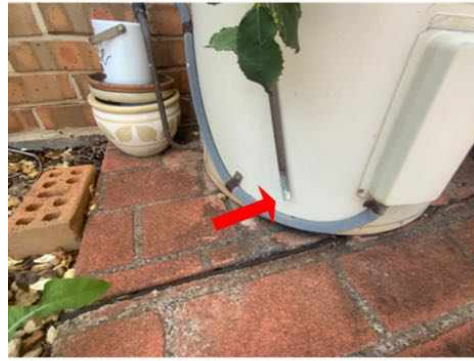
Finding 6.03

Building:	Main Building
Location:	All Areas
Finding:	HWS Overflow - Not Connected
Information:	The Hot Water System (HWS) overflow was found to be disconnected from storm water drainage and is creating excessive moisture in the surrounding area.

These damp conditions can lead to secondary defects such as rot, rust or corrosion of associated building elements, the formation of fungal decay, or even the creation of potential slip hazards. When coupled with poor site drainage, pooling of water may also attract termite activity to this area.

It is highly recommended that a licensed plumber be appointed to connect the HWS overflow in order to prevent such an environment from being created. These minor works should be carried out as soon as possible.

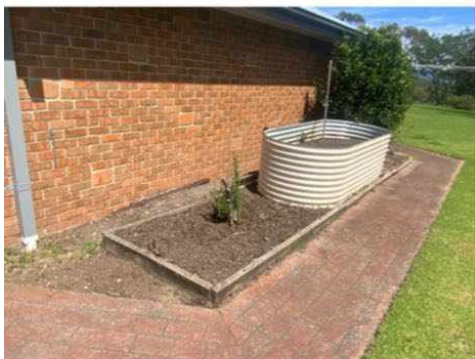
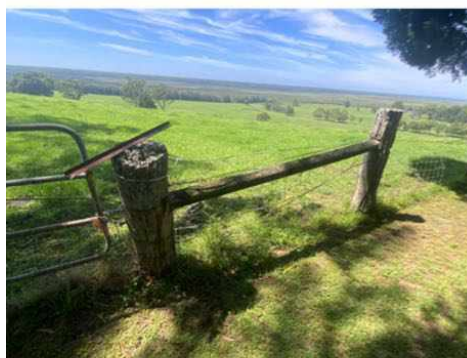
Finding 6.04

Building:	Main Building
Location:	All Areas
Finding:	Timber in ground contact
Information:	To reduce the risk of timber pest attack it is essential that timber used in a hazardous environment (e.g. in direct contact with the ground or frequently exposed to damp conditions) is of sufficient durability and/or is adequately preservative treated.

Untreated timbers in direct contact with the ground are likely to develop severe wood rot and/or fungal decay if left unattended creating attraction for subterranean termites to infest the timbers from surrounding areas.

If untreated or non-durable timbers are found to be in a hazardous environment it is highly advised that replacement of these building elements be performed as soon as possible to aid the protection of the property against termite / timber pest attack.

- Remove, replace or treat any non-treated timbers in direct contact with the ground.
- Treat, repair or replace any Fungal decay/wood rot found on the property.

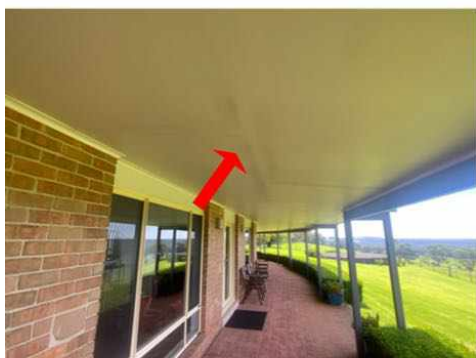
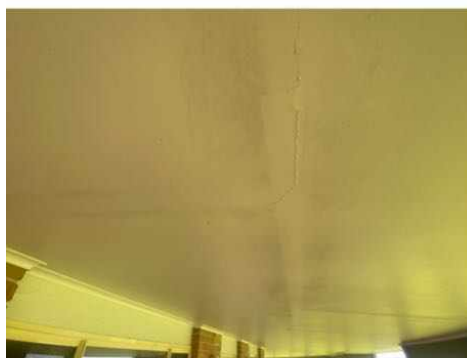
Finding 6.05

Building:	Main Building
Location:	All Areas
Finding:	Evidence of possible excessive moisture was present at the time of inspection (Verandah soffit)
Information:	Excessive moisture can attract termites and produce conditions that promote termite attack fungal growth and wood decay.

Excessive moisture is generally caused by deteriorated inadequate or missing roof drainage, leaking plumbing pipes or fixtures, poorly plumbed HWS overflows or condenser units and poor site drainage.

It is highly recommended that all plumbing and drainage fixtures and fittings be maintained regularly in order to prevent excessive moisture being present in the external / internal property.

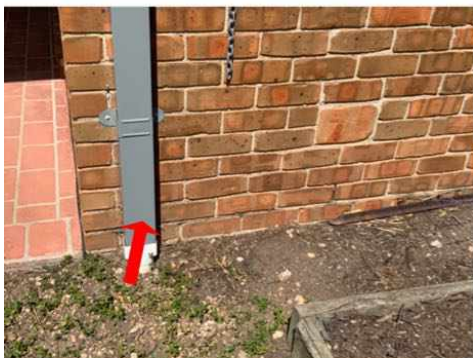
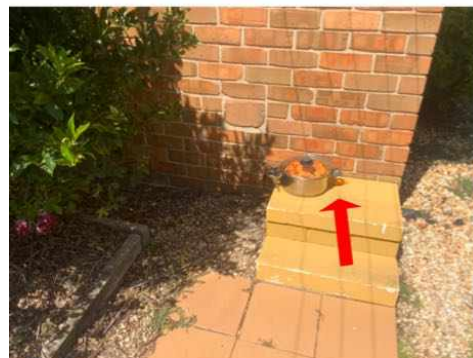
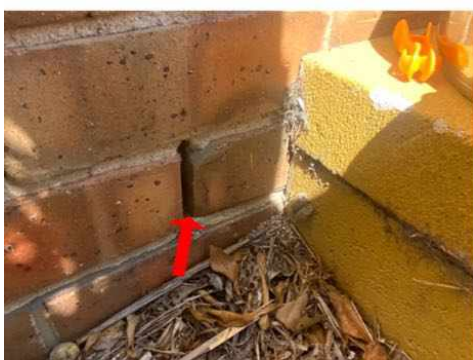
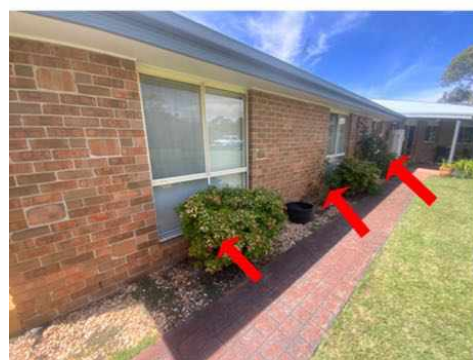
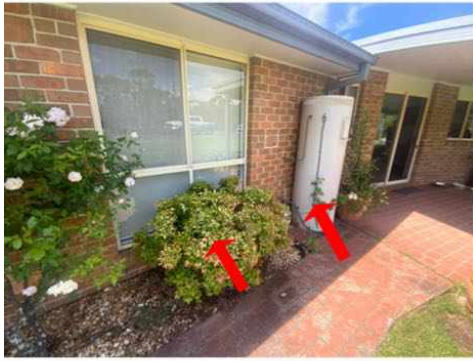
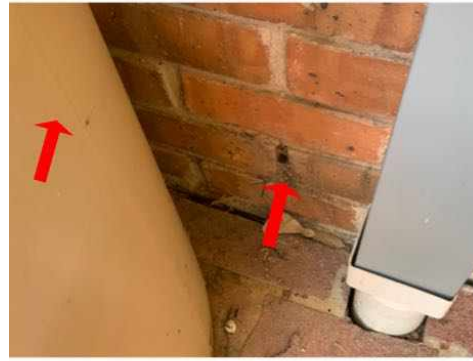
Finding 6.06

Building:	Main Building
Location:	Exterior walls
Finding:	Bridging or breaching of termite barriers - weep holes
Information:	Bridging is the spanning of a termite barrier or inspection zone so that subterranean

Weep holes in the exterior brickwork of the property are designed to allow condensation that may build up between the brickwork and subsequent timber framework to drain from within the wall hence preventing any deterioration of the timber building elements.

Additionally build-up of moisture is likely to occur if weep holes are covered further attracting termite activity to these areas.

It is highly recommended that weep holes are left exposed in all areas throughout the external property. Therefore if any termite activity leading into weep holes becomes easily detectable during frequent pest inspections.

- Clear any debris, garden beds or soil covering weep holes (to prevent concealed termite entry). (If this is not possible then the installation of a Chemical Termite management system is even more highly recommended). Consult a suitably qualified termite expert for further advice.

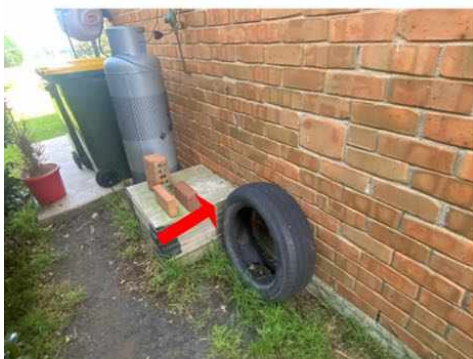
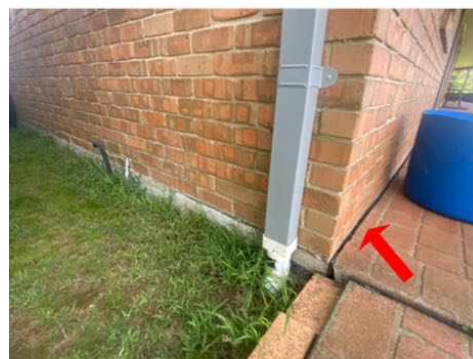
Finding 6.07

If the slab edge is not properly exposed there is a high risk of termite attack. Sometimes, in order to determine the type of slab, a suitably qualified person such as an architect or builder may be required to consult the construction plans.

Where the slab edge cannot be properly inspected, it is highly recommended that termite or timber pest inspections be carried out every 6-12 months to aid protection of the property against infestation.

- Expose the slab edges and keep them clear where possible (minimum of 75mm) for regular Termite inspections. (If this is not possible then the installation of a Chemical Termite management system is even more highly recommended). Consult a suitably qualified termite expert for further advice.

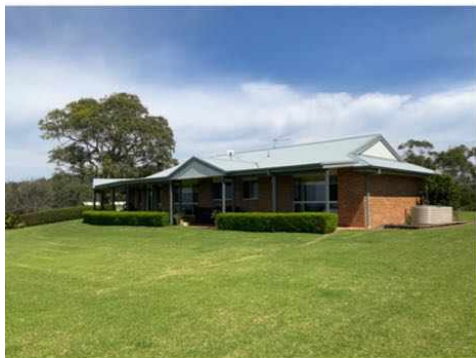
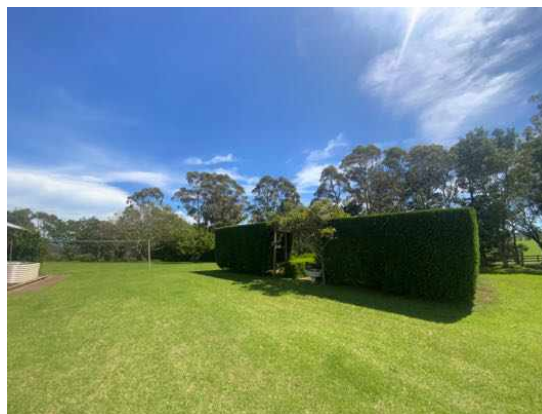
Finding 6.08

Finding:	Trees within 50m of the property
Information:	Trees within 50m of the property can be conducive to termite activity. It is recommended an invasive inspection of all trees with 50m to the property be carried out by a qualified pest control expert.

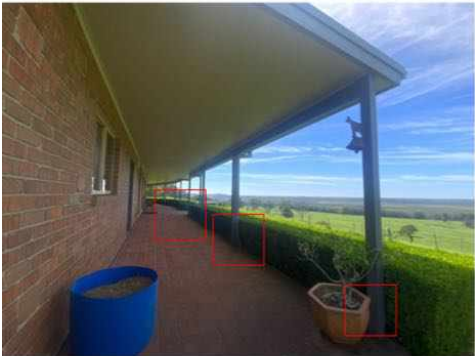
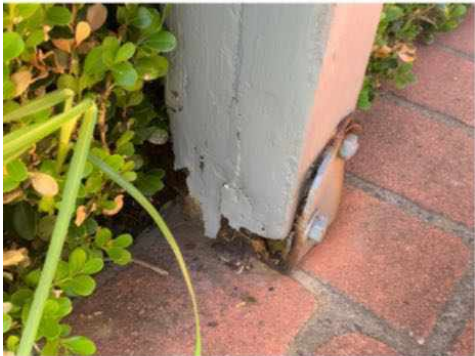
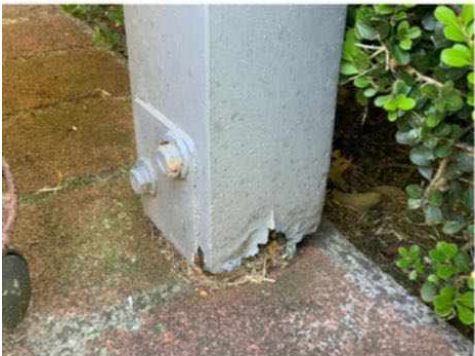
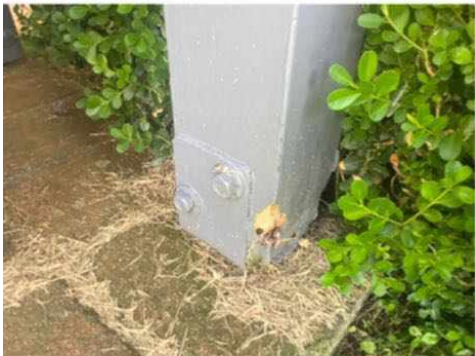
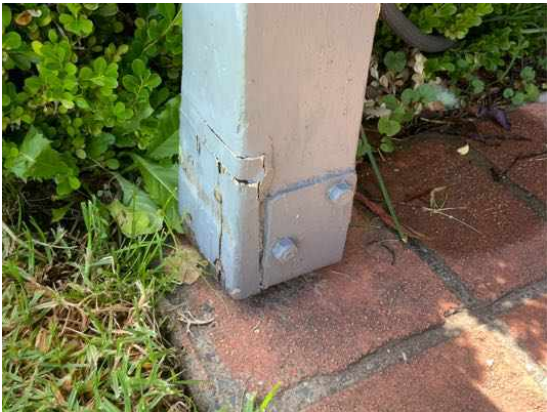
Finding 7.01

Building:	Main Building
Location:	Verandah posts
Finding:	Fungal decay - present (localised)
Information:	Fungal decay also known as wood decay or wood rot generally refers to the deterioration of timber elements when in contact with excessive levels of moisture for a prolonged period of time.

The development of fungal decay is accelerated by temperatures in the range of 5degreeC to 40degreeC as well as the presence of oxygen. Generally fungal decay develops on timber elements that are in use in an external environment which are exposed to rain penetration.

In this case although the affected timber element is in a decaying state the extent of any visible damage appears to be localised to a specific area and is yet to spread to other parts of the building element or affect adjoining structures. The fungal decay is therefore likely to be of a relatively superficial nature with minimal impact on the structural integrity or tensile strength of the timber element.

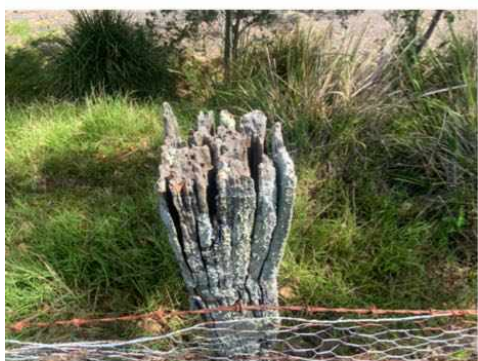
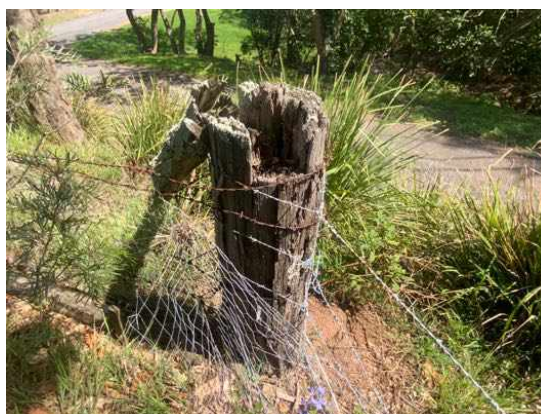
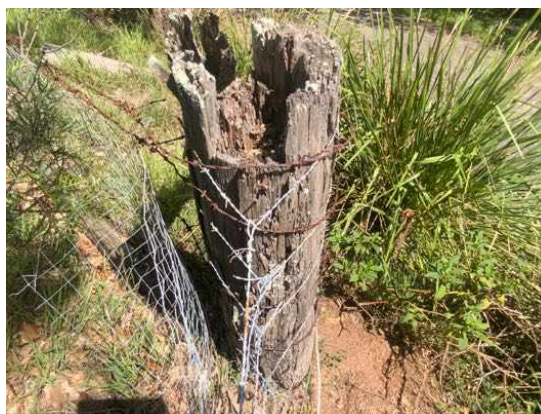
Finding 7.02

Building:	Main Building
Location:	Timber Fencing posts
Finding:	Fungal decay - present (localised)
Information:	Fungal decay also known as wood decay or wood rot generally refers to the deterioration of timber elements when in contact with excessive levels of moisture for a prolonged period of time.

The development of fungal decay is accelerated by temperatures in the range of 5degreeC to 40degreeC as well as the presence of oxygen. Generally fungal decay develops on timber elements that are in use in an external environment which are exposed to rain penetration.

In this case although the affected timber element is in a decaying state the extent of any visible damage appears to be localised to a specific area and is yet to spread to other parts of the building element or affect adjoining structures. The fungal decay is therefore likely to be of a relatively superficial nature with minimal impact on the structural integrity or tensile strength of the timber element.

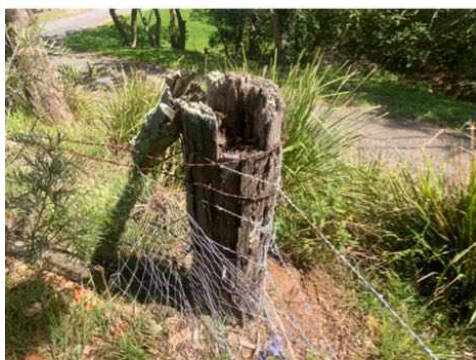
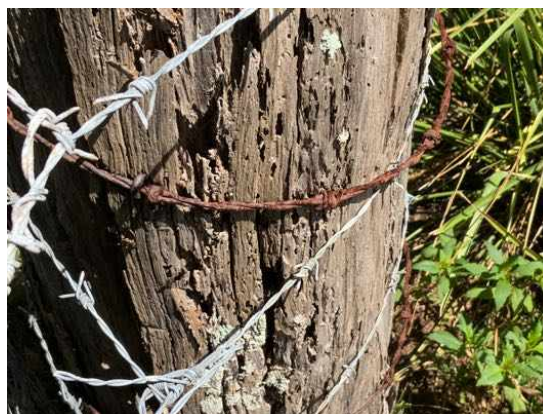
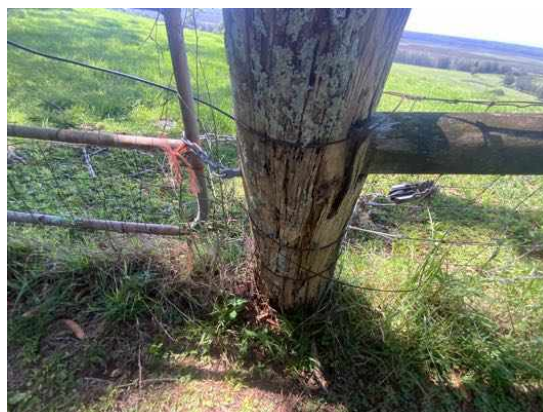
Finding 8.01

Building:	Main Building
Location:	Fencing posts
Finding:	Evidence of wood borer activity identified
Information:	Wood borers small beetles that colonise in exposed timber elements are a common timber pest that are regularly mistaken for termites. Although wood borer activity is generally not detrimental to the affected timber they may lead to serious damage and necessitate replacement of certain building elements if left unattended.

The other commonly known borer the Anobium borer is more likely to attack floorboards and may cause severe structural damage to flooring areas.

As no live wood borer activity was identified treatment is not required at this time. Replacement of affected timbers may be considered by the client for superficial reasons.

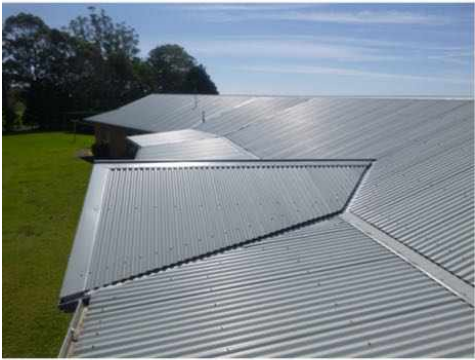
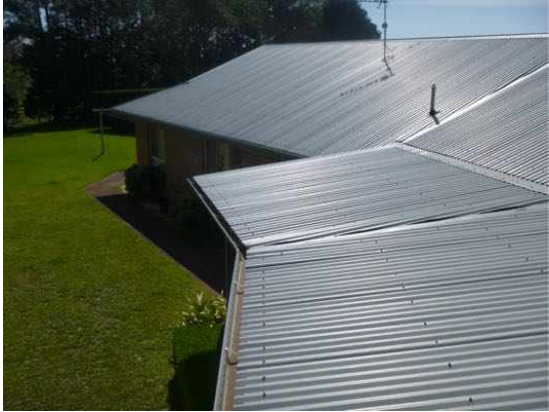
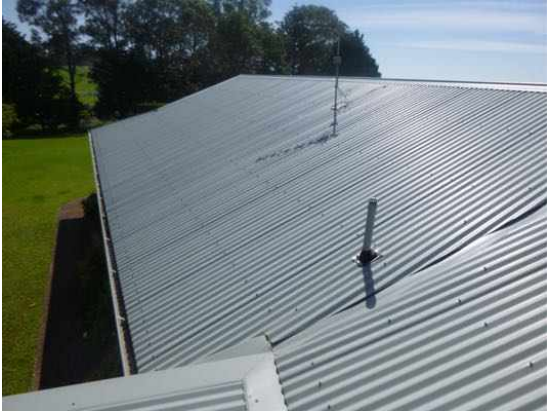
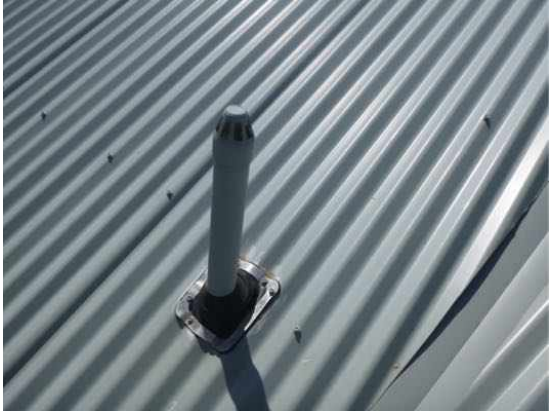
Noted Item

Building: Main Building
Location: Roof Exterior
Finding: Additional Photos - Obstructions and Limitations
Information: These photographs are an indication of the obstructions and limitations which impeded full inspection of the property at the time of inspection. These obstructions can hide an array of defects and should be removed to allow full inspection to be carried out. A re-inspection is recommended once the areas are made accessible.
