Building and Timber Pest Inspection Report

Inspection Date: Wed, 11 Feb 2026

Property Address: 213 Wire Ln, Berry NSW 2535, Australia

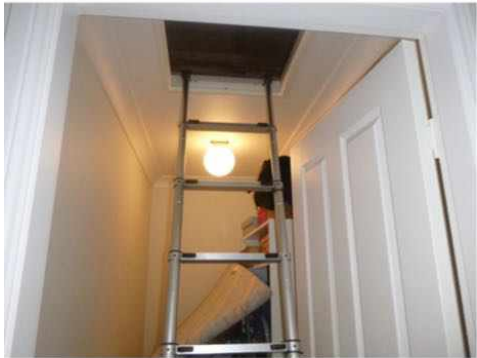
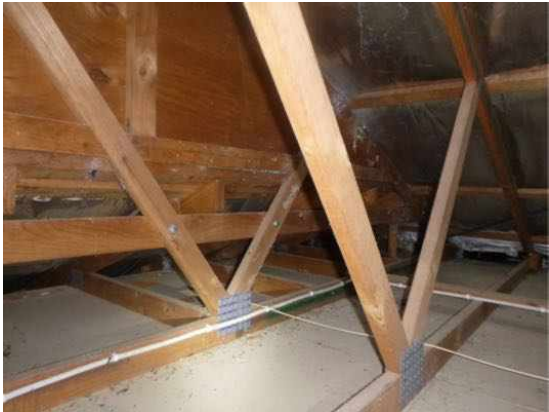
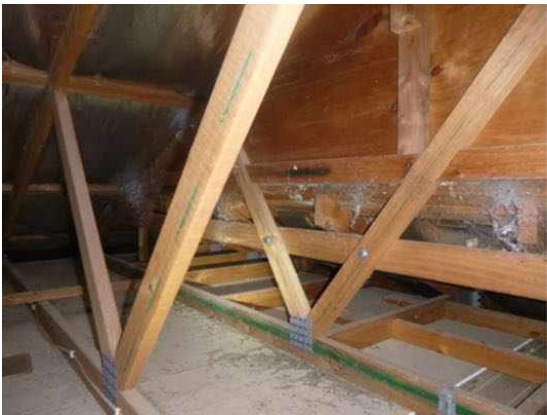
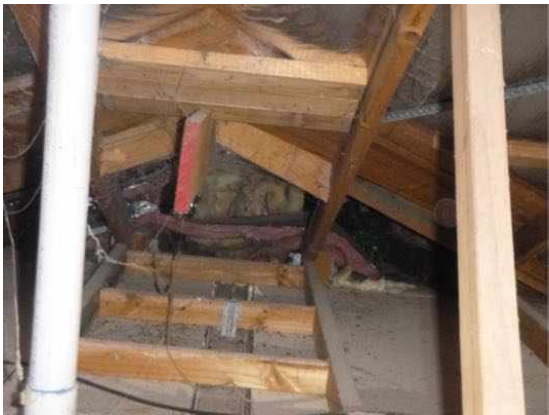
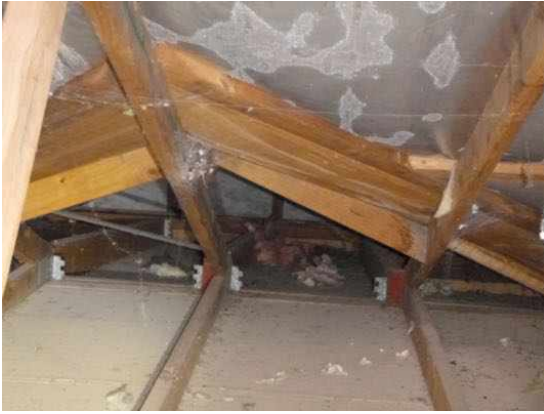
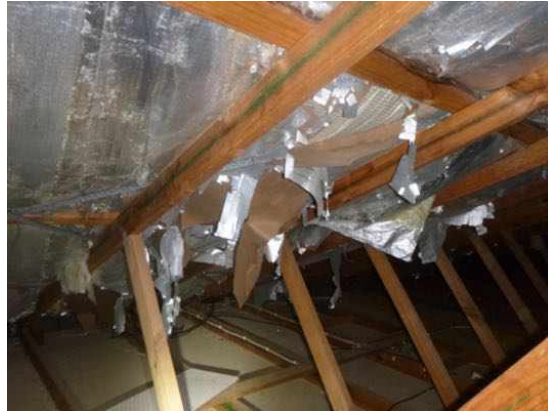
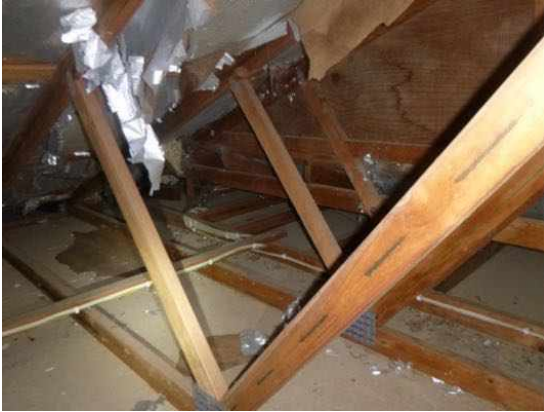
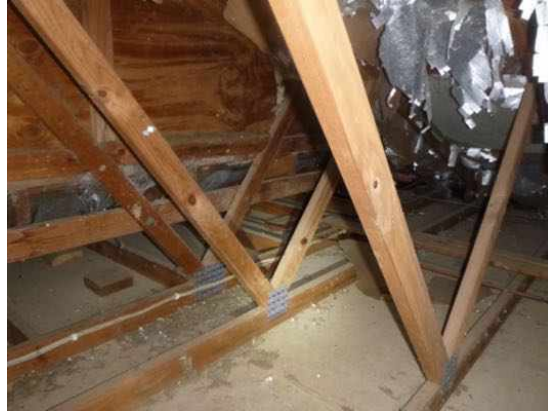
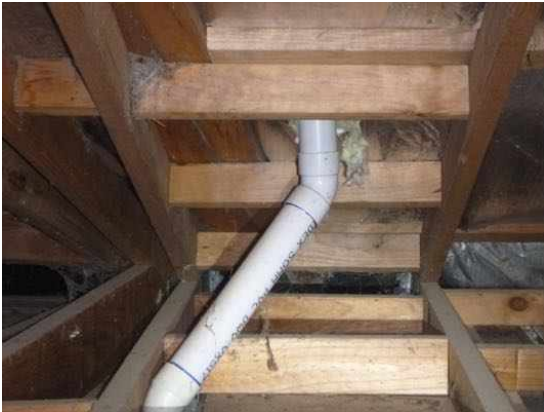
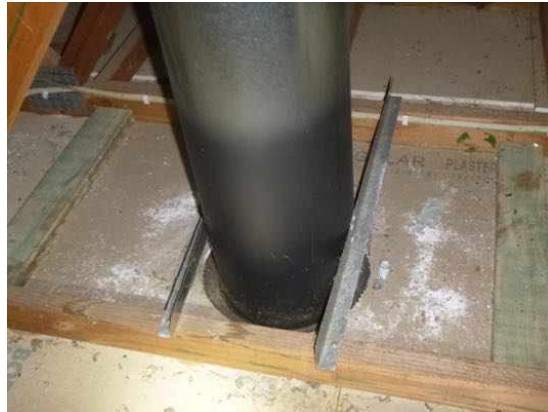
Building: Main Building
Location: Roof Void
Finding: Additional Photos - Obstructions and Limitations
Information: These photographs are an indication of the obstructions and limitations which impeded full inspection of the property at the time of inspection. These obstructions can hide an array of defects and should be removed to allow full inspection to be carried out. A re-inspection is recommended once the areas are made accessible.

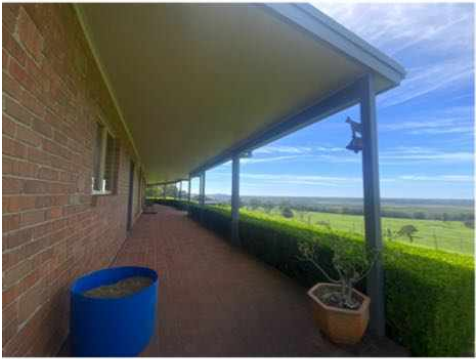
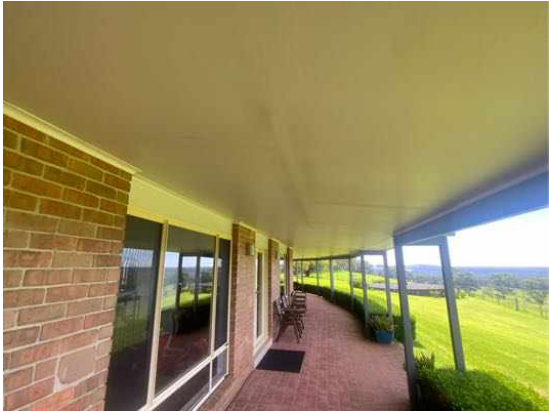
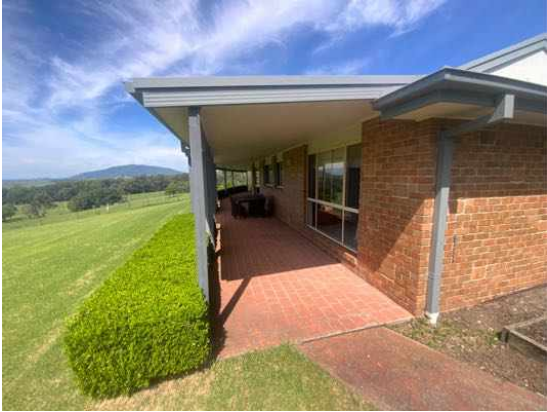
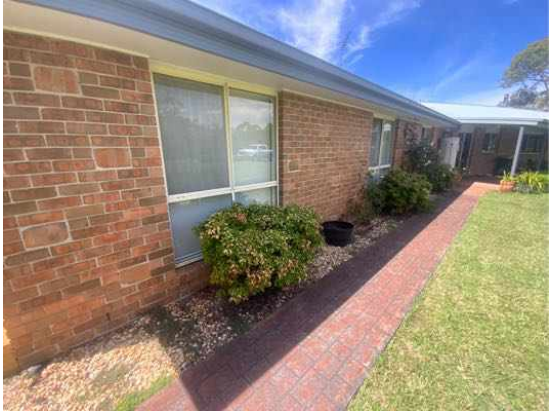
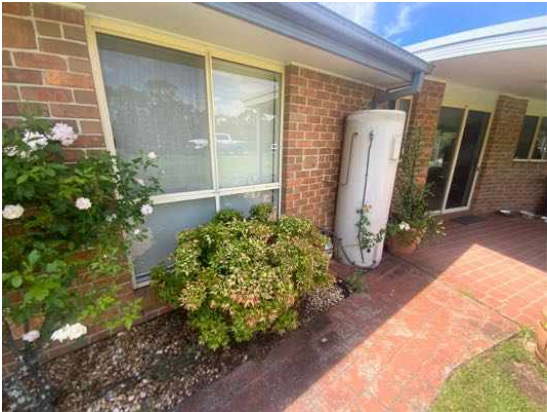
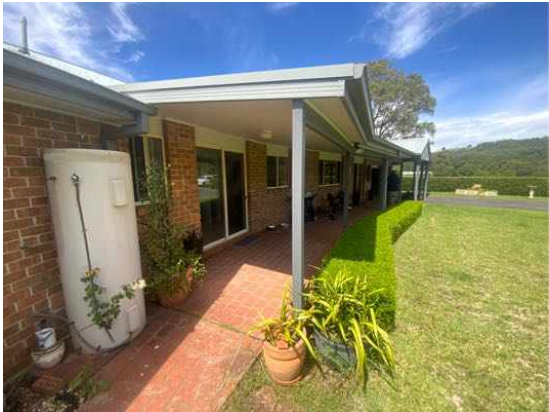
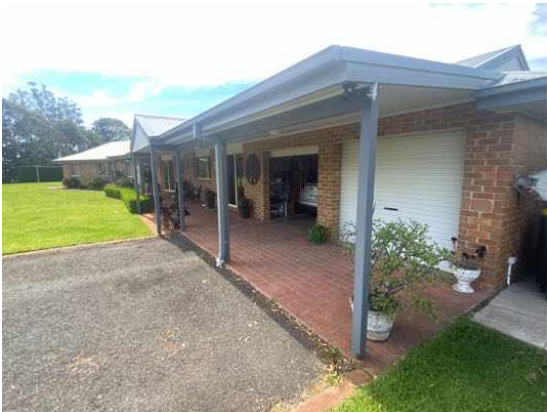
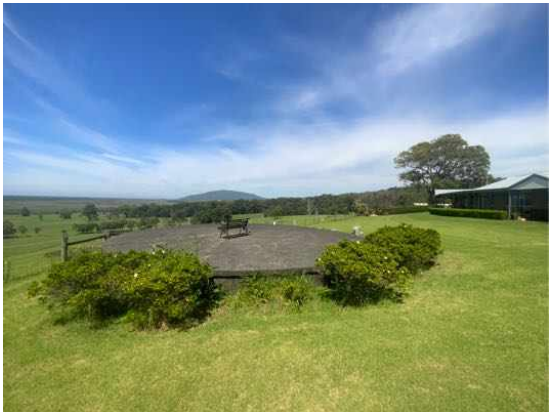
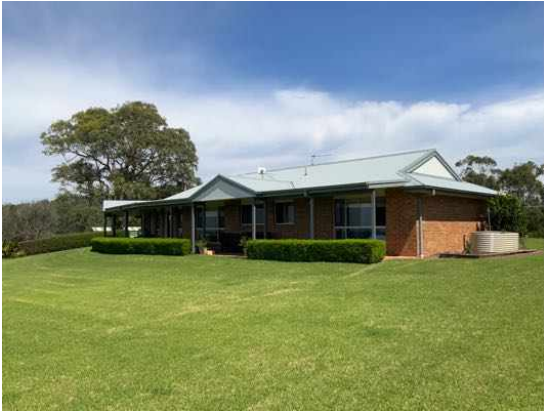
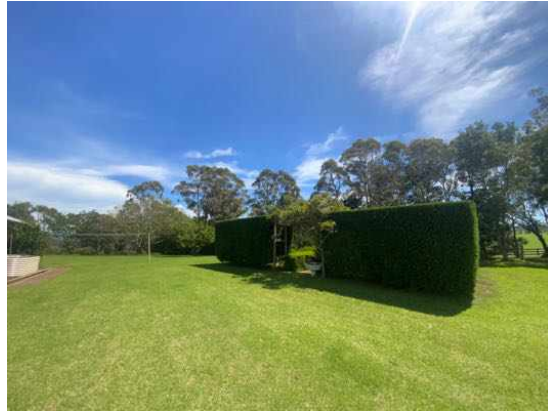
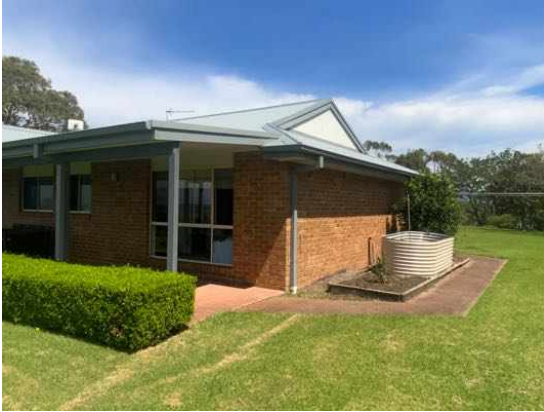
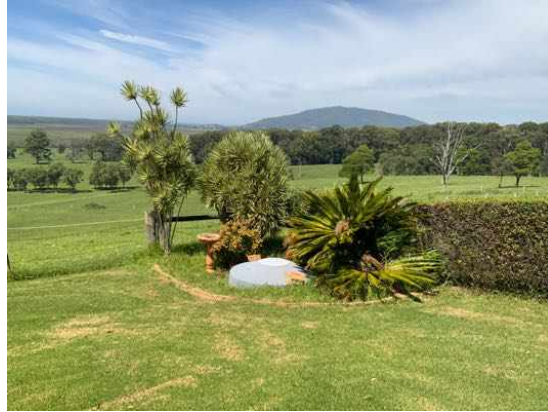
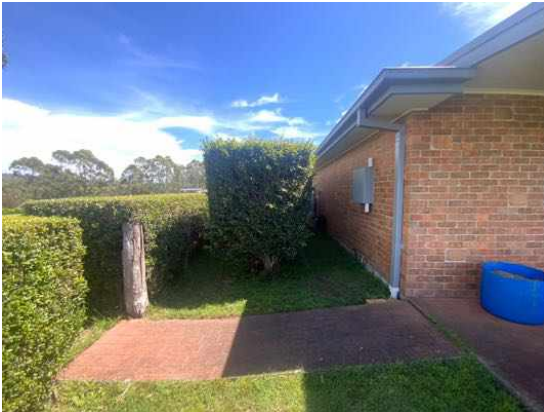
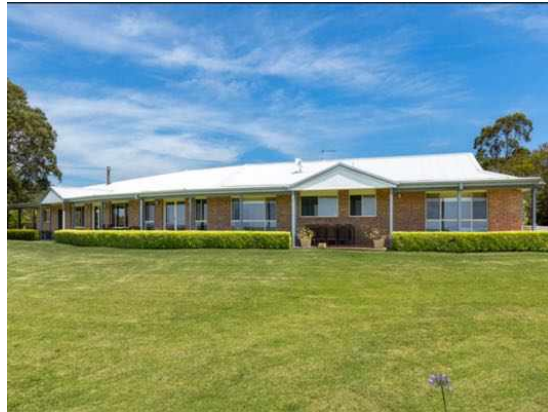
Building:	Main Building
Location:	All Areas
Finding:	Additional Photos - Obstructions and Limitations
Information:	These photographs are an indication of the obstructions and limitations which impeded full inspection of the property at the time of inspection. These obstructions can hide an array of defects and should be removed to allow full inspection to be carried out. A re-inspection is recommended once the areas are made accessible.

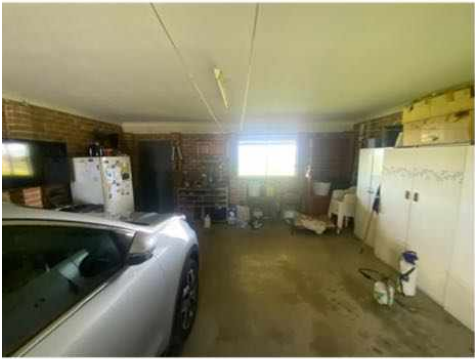
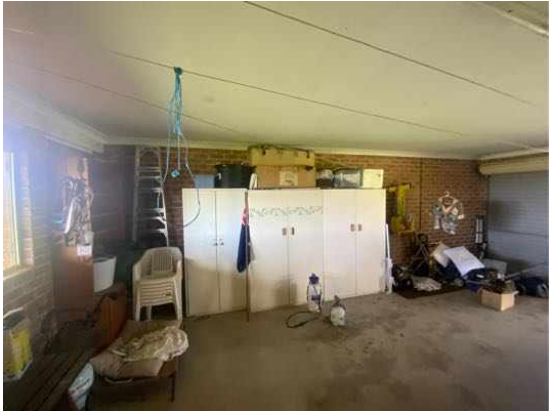
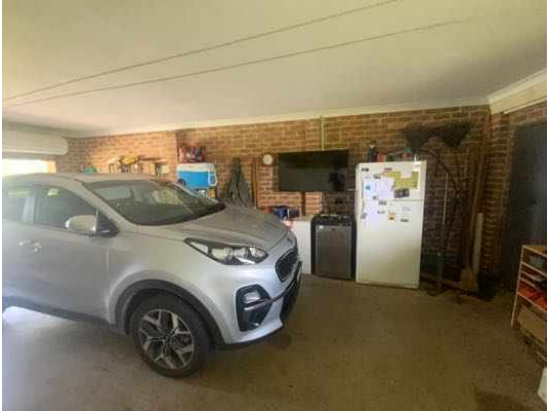
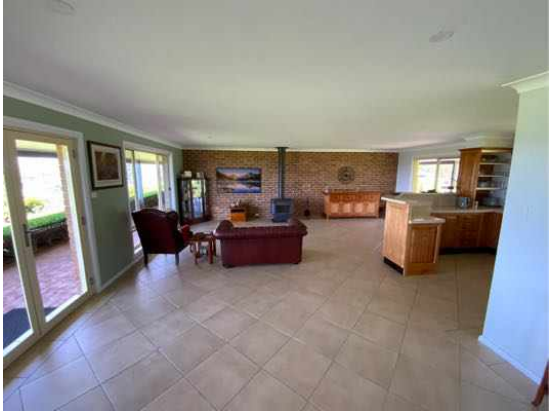
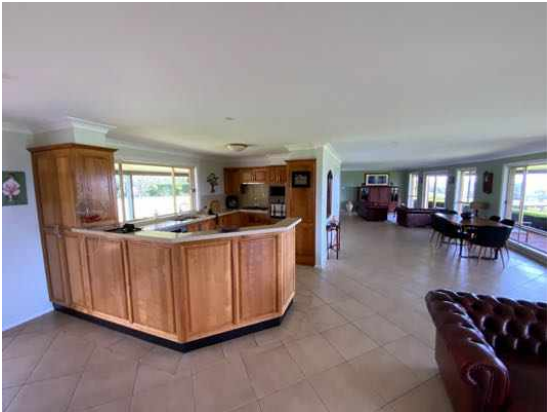
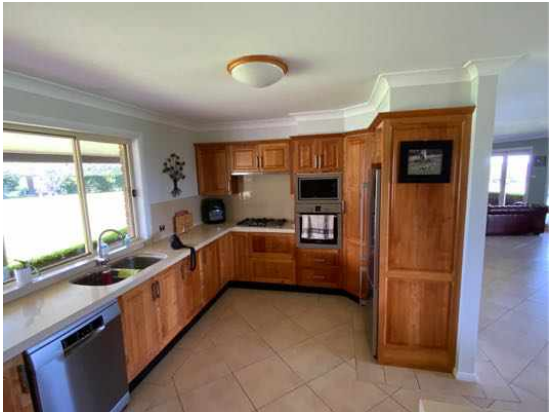
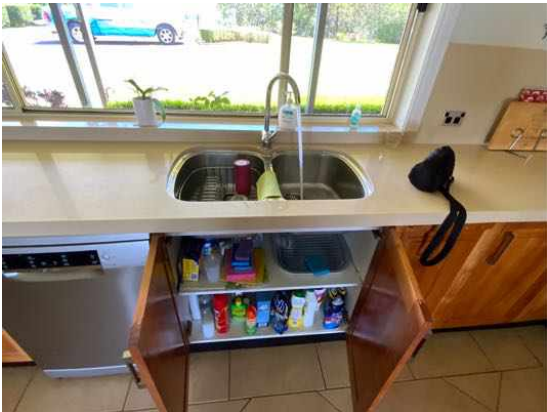
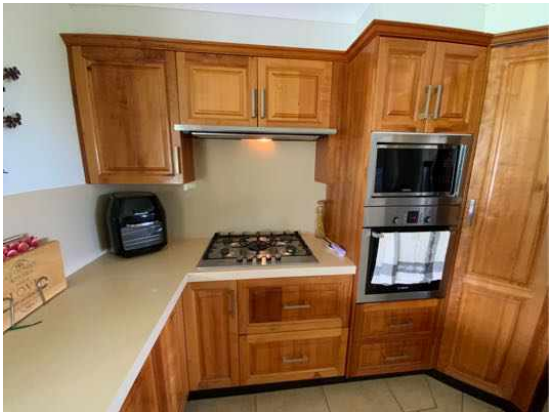
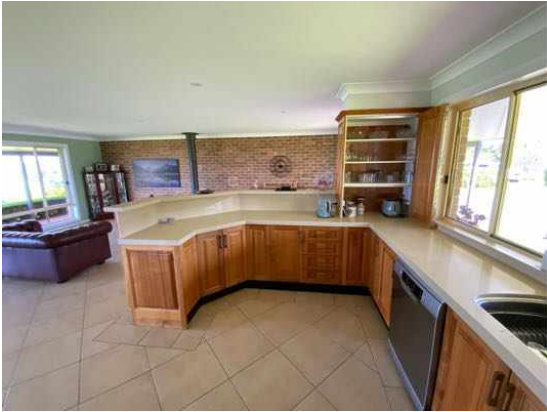
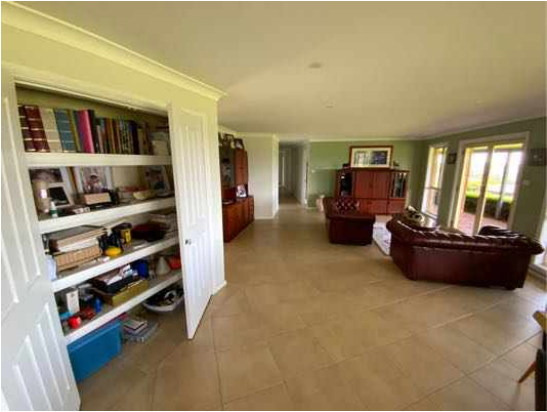
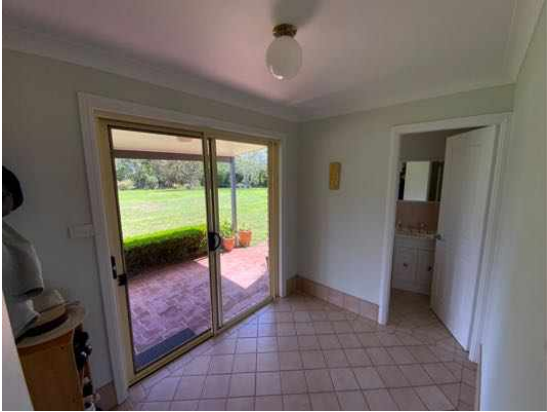
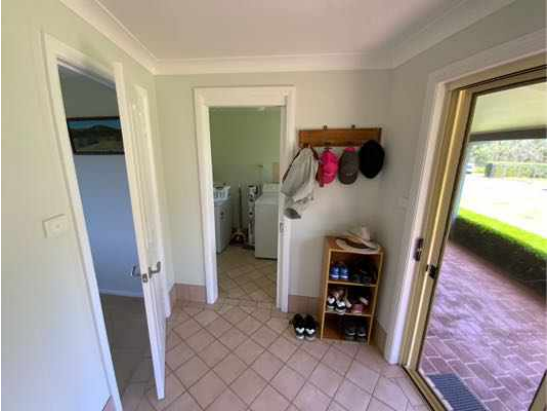
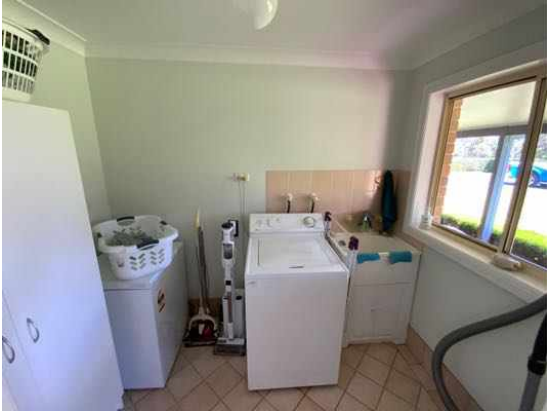
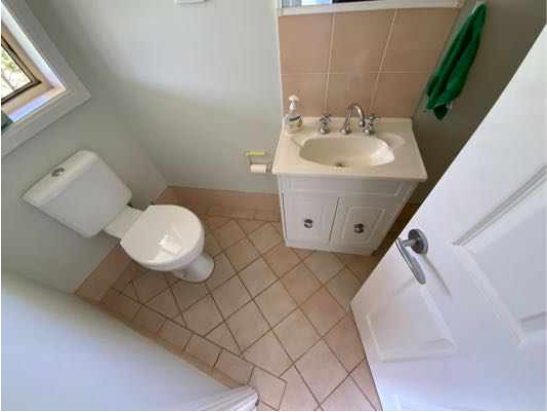
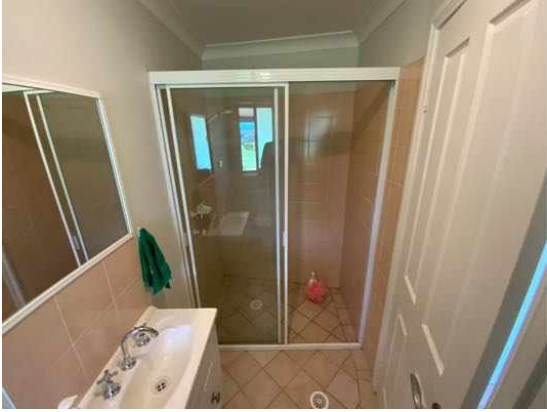
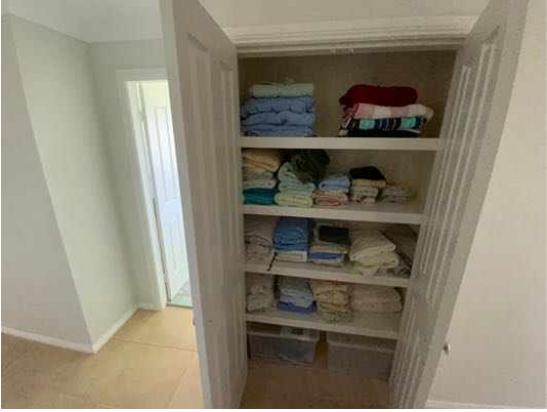
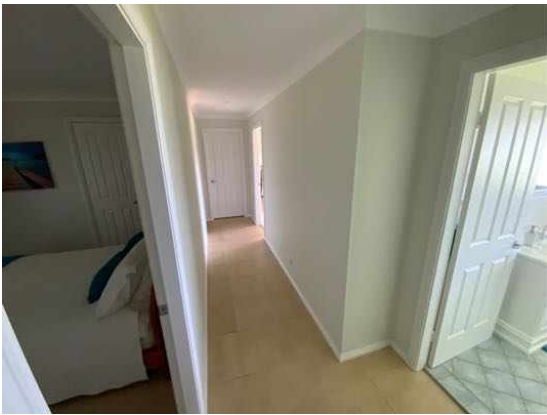
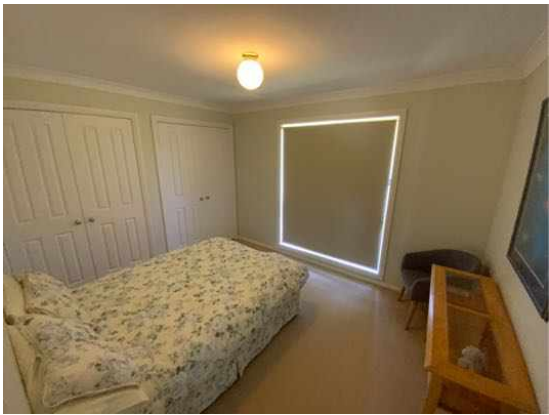
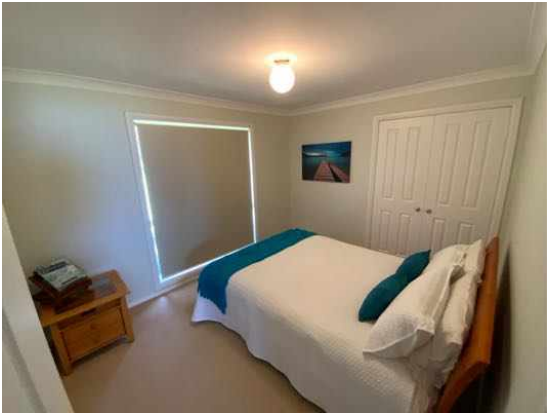
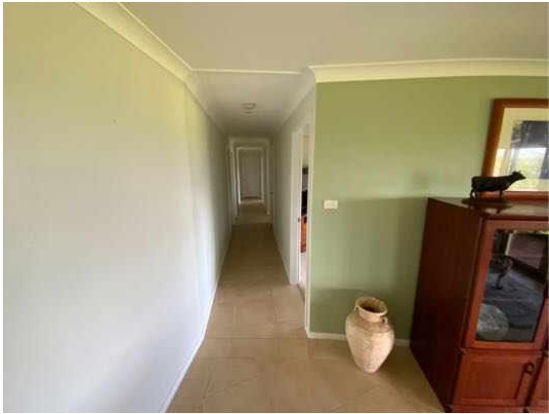
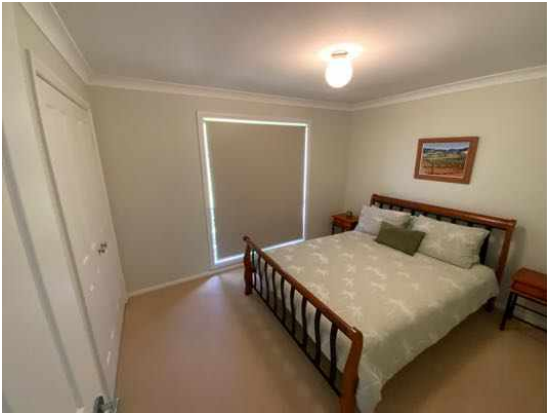
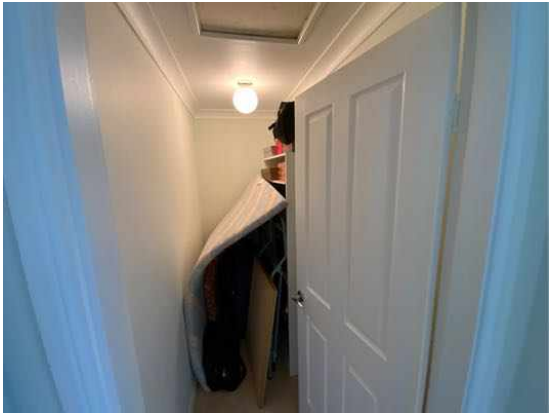
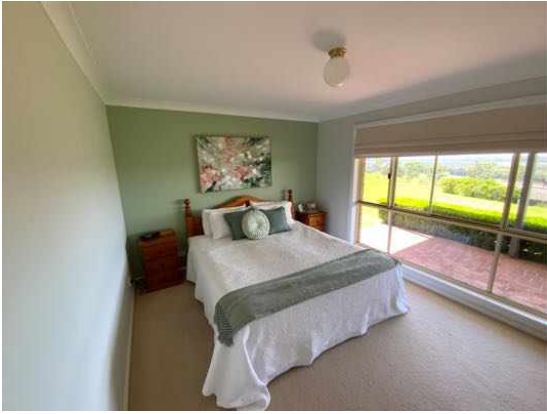
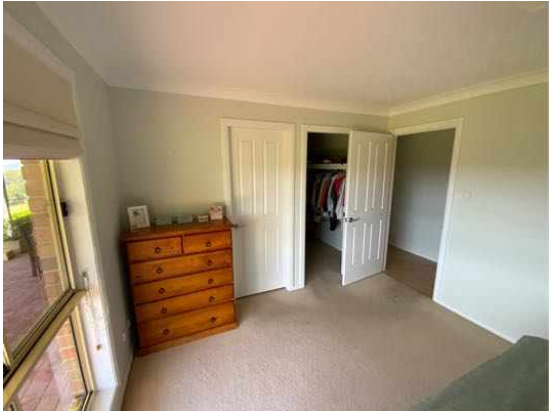
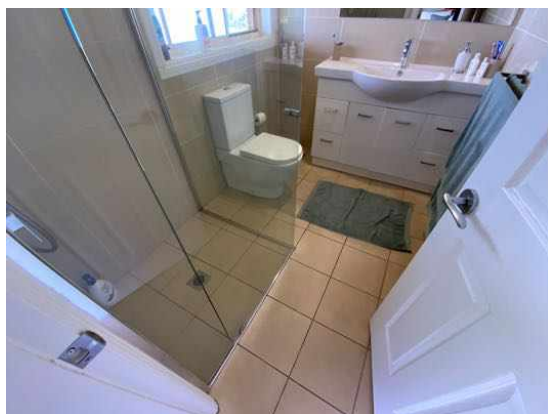
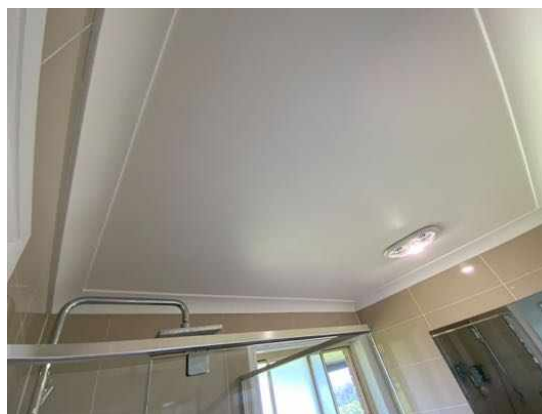
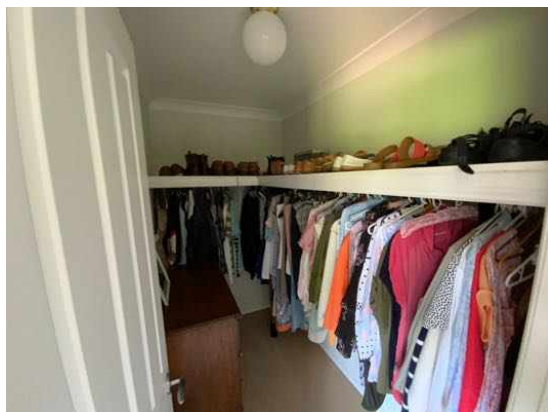
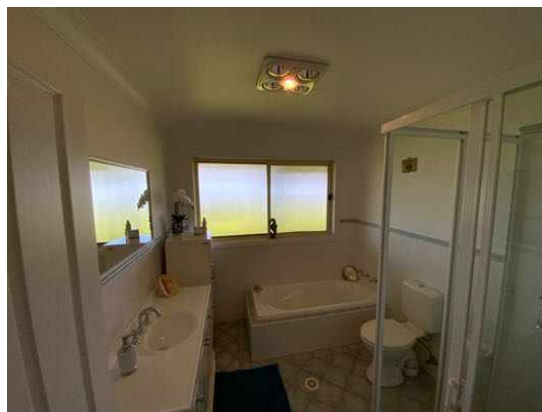
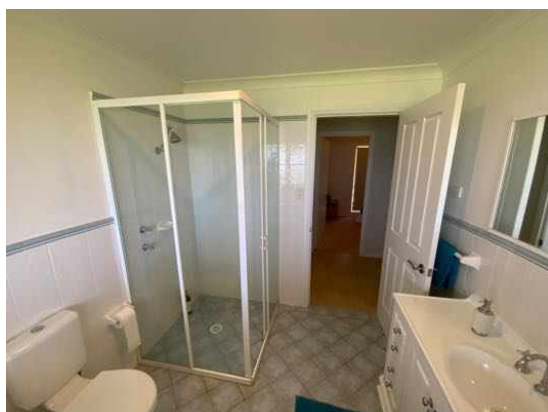
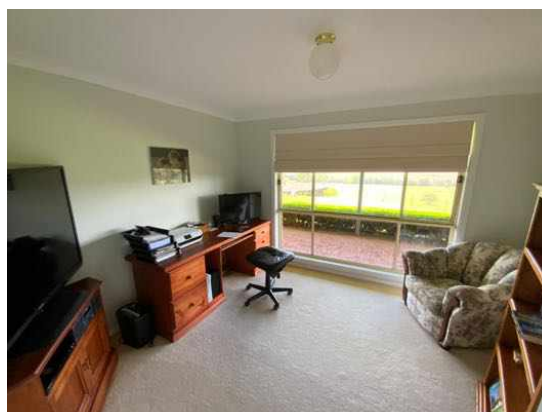
Building:	Main Building
Location:	All Areas
Finding:	Additional Photos - Obstructions and Limitations
Information:	These photographs are an indication of the obstructions and limitations which impeded full inspection of the property at the time of inspection. These obstructions can hide an array of defects and should be removed to allow full inspection to be carried out. A re-inspection is recommended once the areas are made accessible.

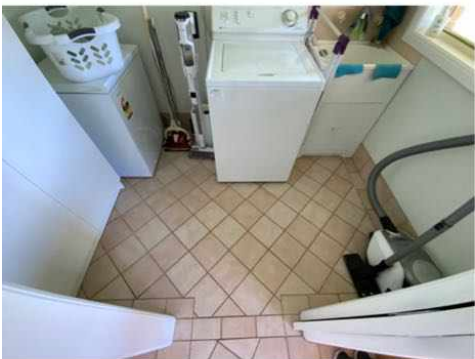
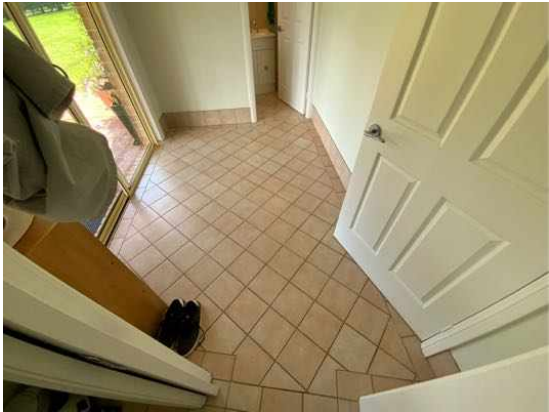
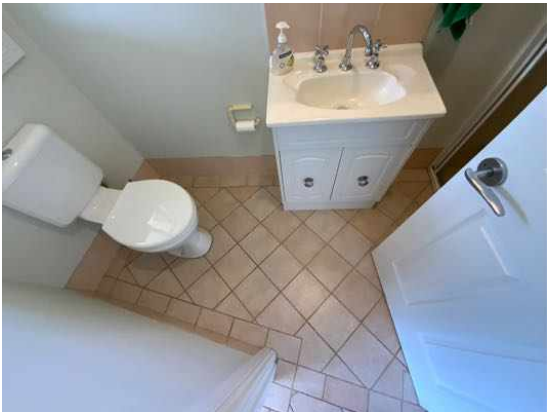
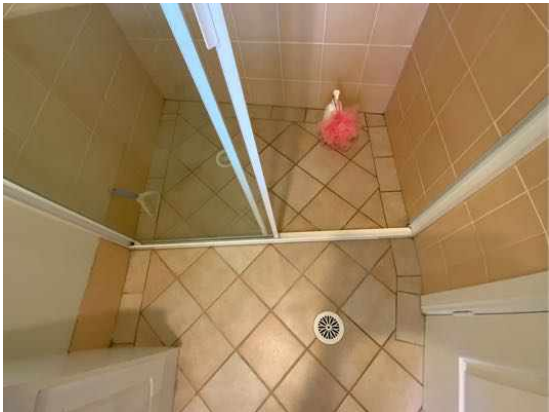
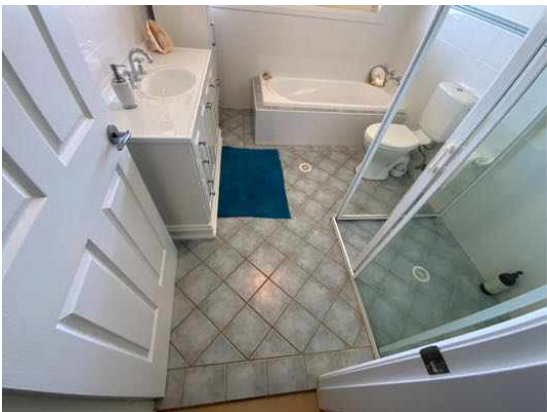
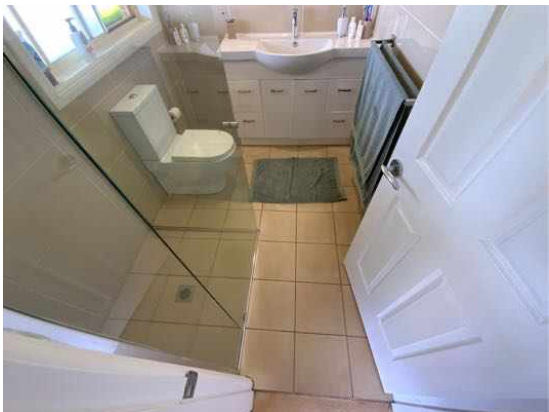
Building: Main Building
 Location: All Wet Areas
 Finding: Water Proofing Membranes - Information Only
 Information: Internal Water Proofing Membranes, are crucial in preventing water ingress into the property is important to know that the Membrane System used is to Australian Standards and has been installed correctly.

With older property's where this information is unavailable all wet areas should be monitored. Generally waterproofing certificates are only valid for approximately 7-8yrs. If any leaks, water staining, peeling or bubbling of the paint become evident to any adjacent walls or ceilings below a licensed builder or waterproofing specialist is recommended to investigate further.

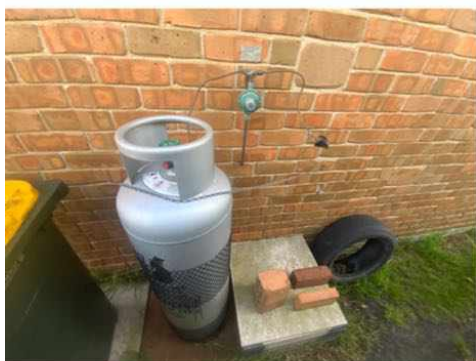
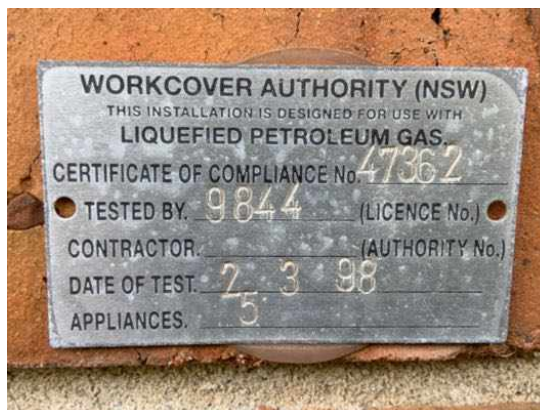
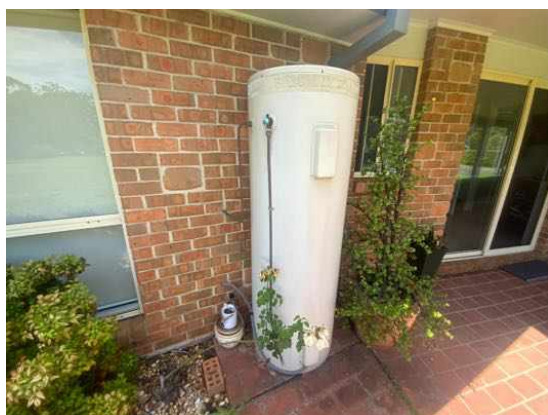
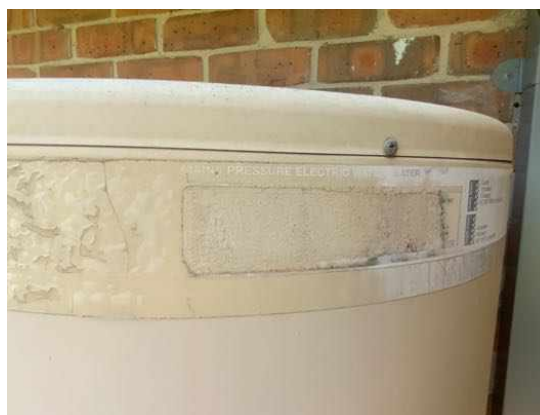
Additional photos are provided for your general reference. Arrows have been included to highlight areas of importance. Please discuss these photos with your building consultant for clarification.

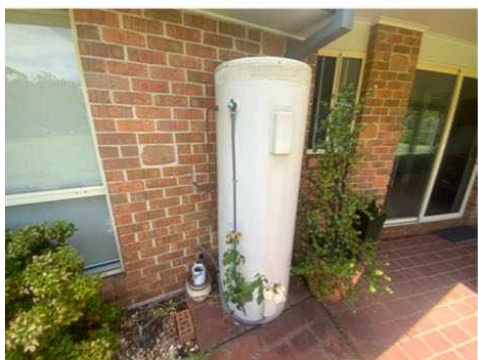
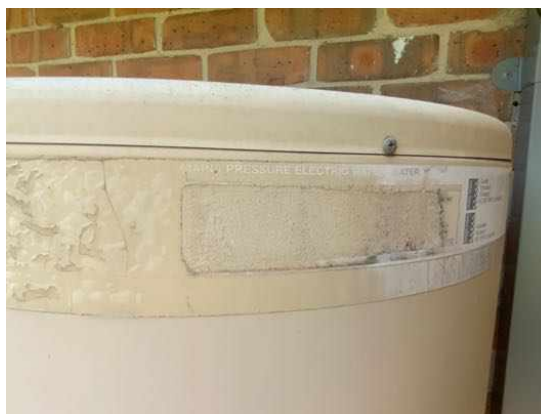
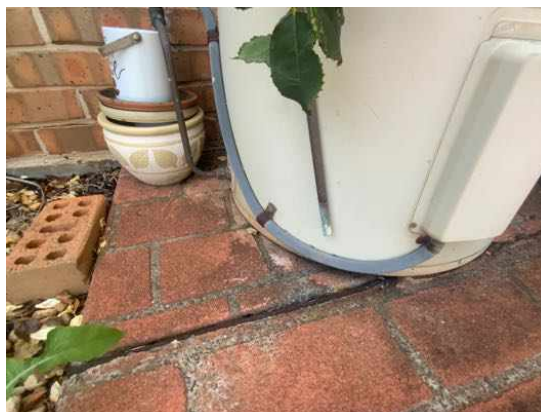
Finding: Hot water unit - Deteriorated (Old)

Information: The external hot water unit shows evidence of rust and general deterioration. This rust is likely to have developed due to minor leaks in the unit, providing excess moisture to affected areas. Such damage is expected of a building element of this age and with this level of exposure to excessive moisture.

While the hot water unit is still fully operational, any leaks should be identified and rectified by a licensed plumber as soon as possible. Prevention of further deterioration will delay the need for replacement of the unit in the near future.

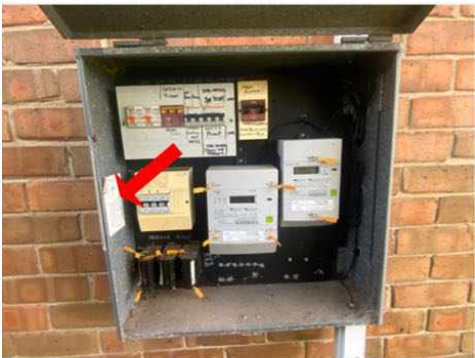
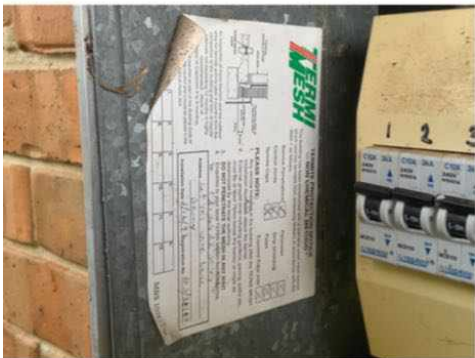
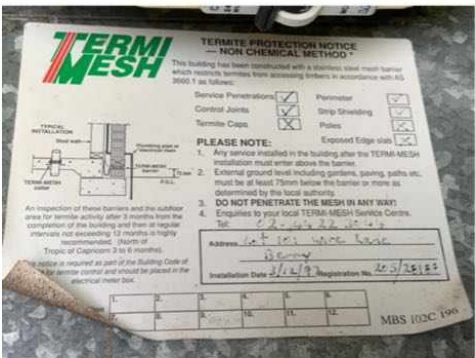
The following items were noted as - Evidence of a previous termite management program

Where a Termite Management System has been identified you should refer to the type of barrier date of installation warranty conditions and any documentation provided by a builder or past owner. Consult the company who installed the barrier to confirm whether the system is still under warranty.
