# Building and Timber Pest Inspection Report

Inspection Date: Wed, 25 Feb 2026

Property Address: 61 Cambridge Ave, Bankstown NSW 2200,  
Australia

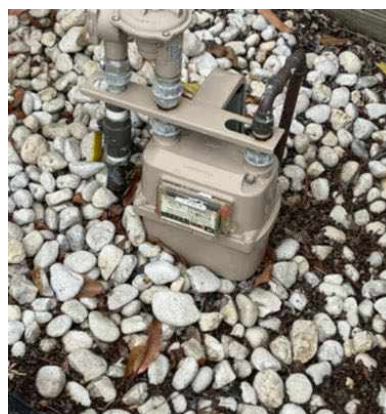
Building: Main Building  
 Location: All External Areas  
 Finding: Gas Installation - Gas Meter - Possible safety hazard  
 Information: It was noted at the time of inspection that the base of the gas meter was sitting on the ground.

Gas meter sitting on the ground could rust and erode causing a potential gas leak as a secondary defect.

It is advised to engage a qualified gas fitter to inspect repair , replace or adjust the meter as required as soon as possible

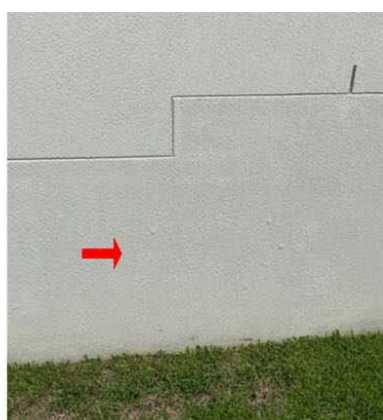
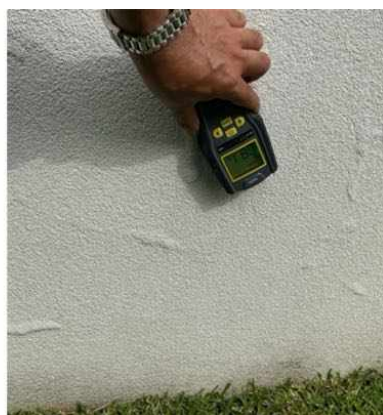
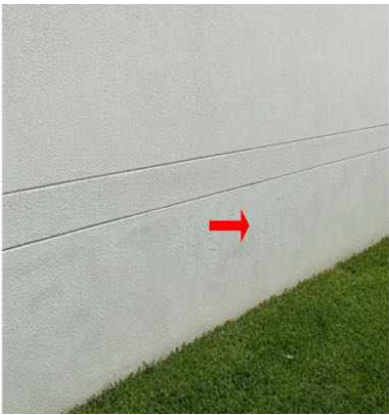
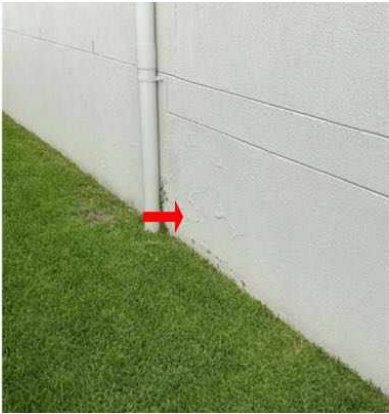
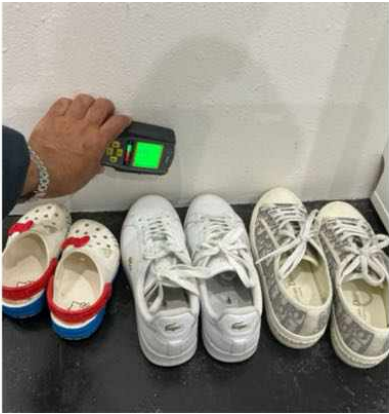
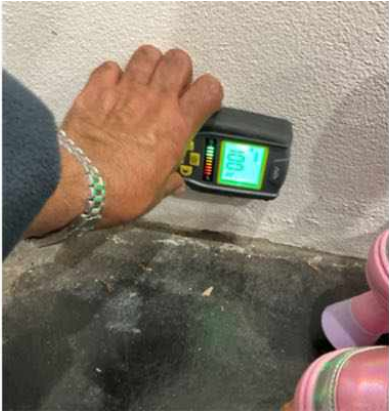
Building: Main Building  
 Location: All External Areas - Right side , Garage  
 Finding: Damp  
 Information: Damp (or structural damp) refers to the presence of unwanted moisture in the structure of a building, either as the result of intrusion from outside, or condensation from within the structure. Generally, structural damp is caused by rain penetration, rising damp, and leaks from plumbing pipes.

Unmanaged damp facilitates the formation and development of mould, fungi growth and wood rot, decaying associated building materials and compromising their structural integrity. Damage to finishes is also likely to occur, including lifting, bubbling, peeling and staining of paint, plaster and wallpaper.

Consultation with a qualified plumber is advised immediately to identify the cause of damp and perform remedial works as required. Where excessive mould growth is present, further inspection by a specialist environmental health inspector should also be considered.

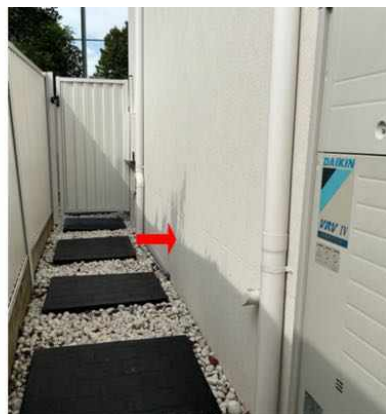
Finding 3.02

Building:	Main Building
Location:	All External Areas
Finding:	Render Finish Covering Damp Membrane
Information:	During the inspection, it was noted that the applied render finish is covering the damp-proof membrane. This is affecting the membrane's ability to prevent moisture movement above it, leading to moisture-related issues over time. It is recommended to consult a qualified builder to ensure the damp-proof membrane is properly exposed, maintaining its effectiveness in preventing moisture ingress.

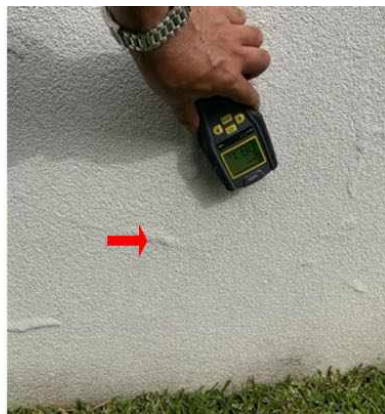
### Finding 3.03

Building:	Main Building
Location:	All External Areas
Finding:	Render - Drummy
Information:	Drummy rendered areas were identified at the time of inspection. The term 'drummy' refers to render that has become detached from its fixing, despite it still being solid. Such defects are generally caused by physical or moisture damage to the area. Drummy render may also be a direct result of poor workmanship during the construction process.

Render may swell and shrink with changes in air humidity if the area has sustained moisture damage. Any exposure to moisture is capable of causing rendered areas to become drummy and/or cracked over a prolonged period of time. Drummy render generally requires chipping off and re-rendering or painting.

Specialist trades are available for these types of services. A registered builder may be required to undertake works if damage is extensive, or if secondary building defects have resulted. Immediate action is recommended to ensure that no further damage is sustained in the affected area.

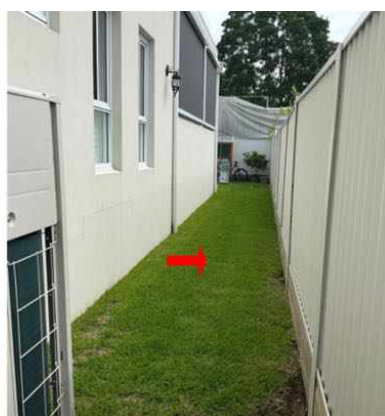
### Finding 3.04

Building:	Main Building
Location:	All External Areas
Finding:	Site drainage - Inadequate
Information:	The site drainage in this area was found to be inadequate at the time of inspection, creating potential for subsequent water damage to associated building elements.

It is important that water does not lie against the base of walls; surrounding paths and ground levels should be sloped to drain water away from walls. Downpipes should not discharge stormwater onto lower walls or plinths. Stormwater should be carried away by large, regularly cleaned drains. Ground levels may need to be lowered to expose a buried DPC.

Where site drainage is inadequate, installation of an Agricultural (Aggie) Drain may be required. A qualified plumber should be appointed to further inspect the property and perform any remedial works as necessary. Water damage and secondary defects are likely to occur if left unmanaged.

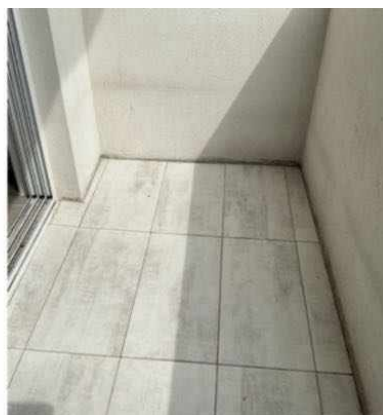
### Finding 3.05

Building:	Main Building
Location:	Balcony - Rear
Finding:	Balcony - No Drainage
Information:	The covered balcony floor is tiled with no visible floor waste, grated drain, or obvious surface drainage point within the area observed. Falls toward a drainage outlet are not clearly identifiable, and the perimeter junctions appear flush without discernible provision for surface runoff. In the absence of a visible drainage arrangement, there is a risk of water ponding during rainfall or cleaning, which may contribute to moisture accumulation at wall-floor junctions and potential waterproofing deterioration over time. Confirmation of compliant falls and drainage outlet location is recommended.

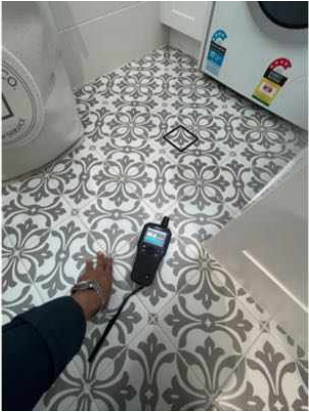
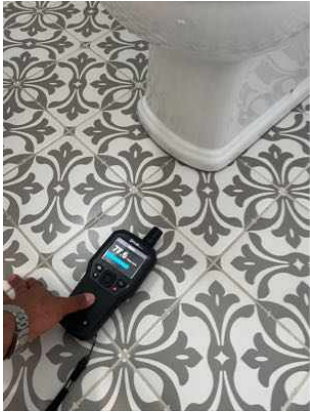
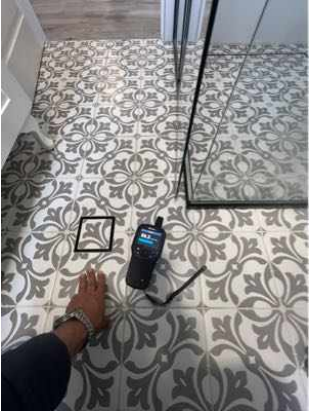
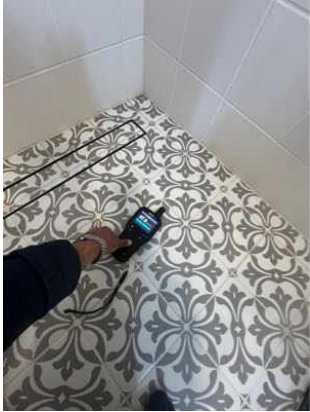
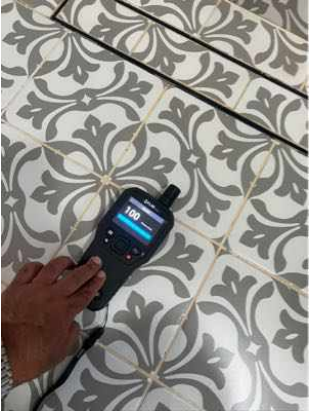
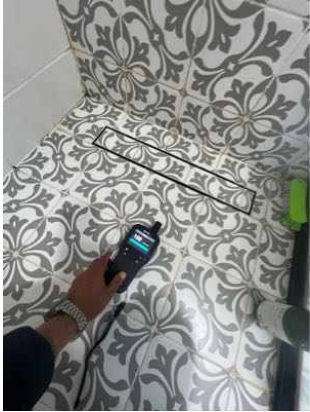
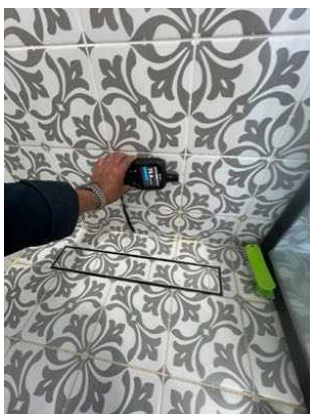
### Finding 3.06

Building:	Main Building
Location:	Bathrooms , Laundry
Finding:	Elevated Moisture Bathroom (No visible deterioration noted)
Information:	Elevated moisture levels were detected to tiled surfaces in bathroom/shower areas. Persistent moisture ingress can lead to concealed damage, including timber rot and mould growth.  Elevated moisture readings in tiled wet areas can occur from normal shower use,

age/deterioration of waterproofing membranes, plumbing leaks or moisture absorption through grout lines. While no damage was visible, elevated readings may indicate moisture retention behind tiles, which can be a conducive condition for future deterioration if not monitored.

. Monitor the area over time for signs of drumming, efflorescence, tile movement, or grout deterioration. If concerns arise, a licensed waterproofing specialist can perform further investigation (e.g., pressure testing, membrane assessment).

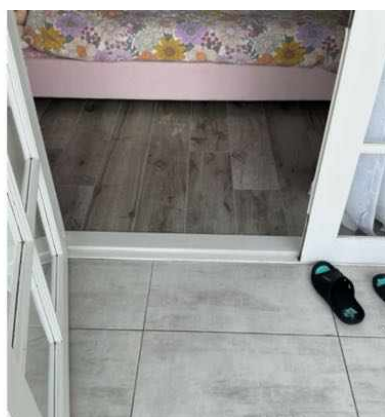
### Finding 3.07

Building:	Main Building
Location:	Balcony
Finding:	Balcony Floor Level Differential
Information:	The balcony finished surface appears to be close to, or at the same level as, the internal floor. Standard construction practice requires a step-down of approximately 50 mm unless a fully engineered threshold drainage system is provided. No such drainage features were visible during inspection. This configuration increases the risk of water ingress. Recommend further investigation by a licensed waterproofing contractor to check for adequate provisions for this arrangement.

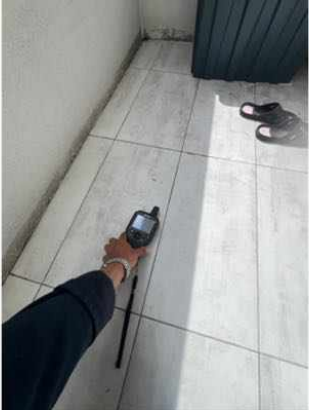
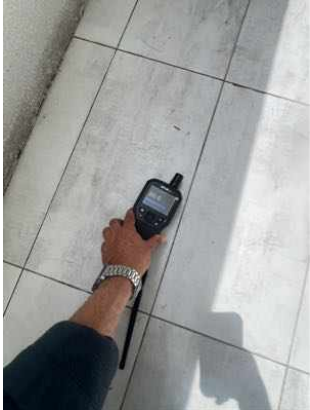
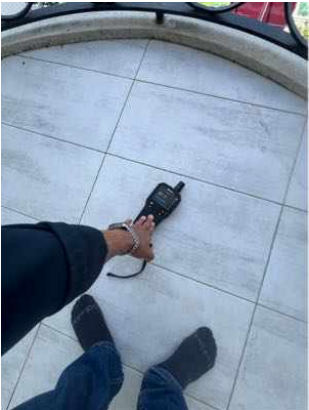
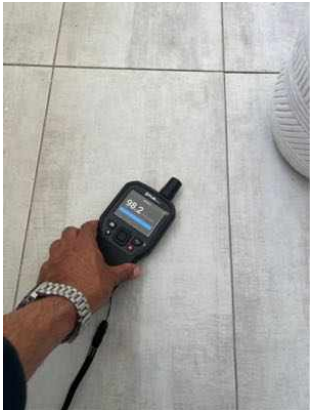
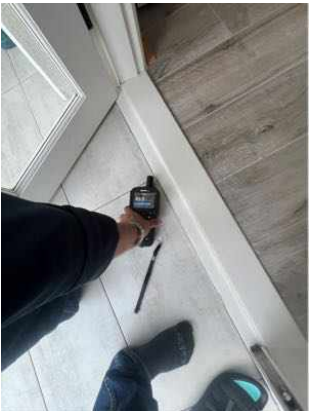
### Finding 3.08

Building:	Main Building
Location:	Balcony - Front & Rear
Finding:	Elevated moisture - No visible deterioration
Information:	Elevated moisture meter readings were recorded to the tiled floor surfaces when tested using a non-invasive (pinless) moisture meter. No visual evidence of moisture ingress, tile debonding, grout deterioration, staining, mould growth, or related moisture damage was observed at the time of inspection. Ongoing monitoring is recommended, and further investigation may be warranted should visible signs of moisture-related distress become evident.

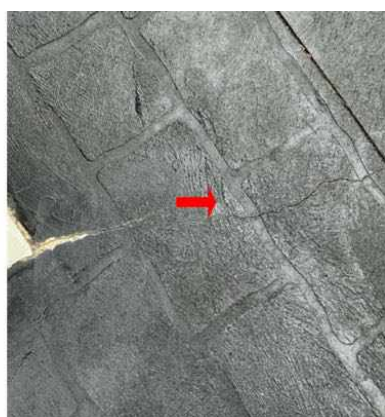
**Finding 3.09**

Building: Main Building  
Location: All External Areas  
Finding: Cracking - External Concrete Paving Damage Category 2 - Distinct (less than 3mm)  
Information: Distinct cracks were identified in external concrete paving. Distinct cracks are generally found in older concrete paving, and may also present as a trip hazard as consequence of an uneven or curved surface.

General age and expected deterioration of the paved areas is a common cause of this type of cracking. However, expansion and contraction of the slab may also have

occurred due to environmental factors. Such factors include variable moisture and weather conditions, the presence of trees and their roots having a settling or lifting affect on the soil, or the effect of load bearing, e.g. heavy vehicles over a sustained period of time.

Cracking to this degree may also be due to poor original installation of the concrete. Factors such as poor compaction of the sub surface and/or inadequate reinforcing of the slab may create cracking and other secondary defects.

Repairs are likely to be required to prevent further cracking and to reduce hazards associated with cracking, such as tripping. Monitoring of all cracking should be conducted frequently. Always contact a building inspector should cracks widen, lengthen, or become more numerous.

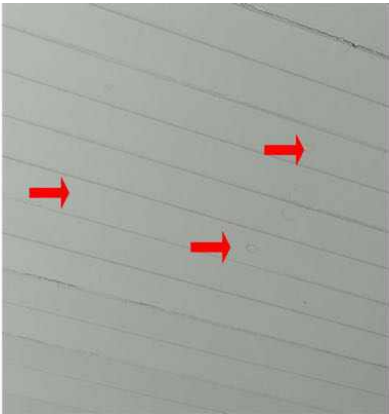
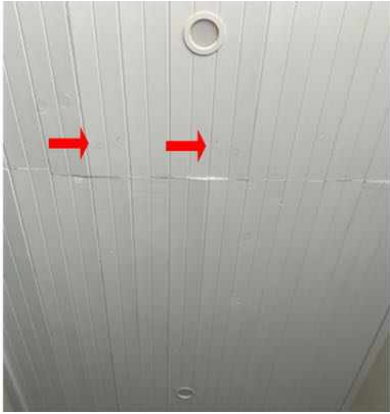
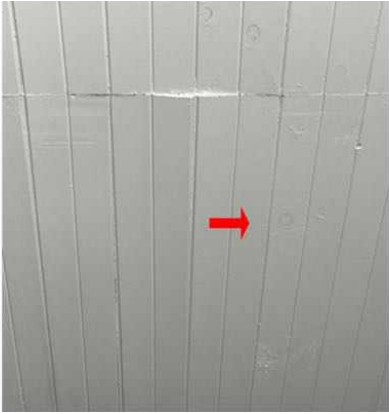
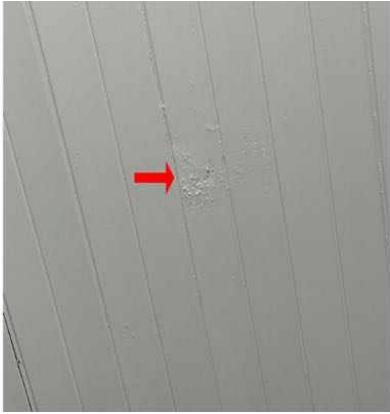
### Finding 3.10

Building:	Main Building
Location:	All External Areas - Rear
Finding:	Water staining
Information:	Water staining was evident in this area at the time of inspection. Water staining indicates that surfaces have been exposed to excessive moisture over time. The minerals and other elements in the water lead to staining, which may graduate to corrosion and deterioration if left unmanaged.

While mostly an appearance defect, water staining can be indicative of more serious defects, which may be currently concealed by other building elements.

Where water staining is active, a licensed plumber must be consulted to identify the cause of the staining and to provide advice on any reparation works that may be required. Replacement of any broken or damaged structures is advised.

Conversely, where water staining is old and inactive, affected building materials may be repaired or replaced at client discretion. A qualified carpenter or registered builder may be appointed to perform these works.

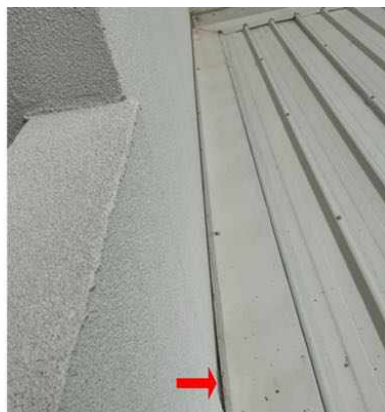
**Finding 3.11**

Building: Main Building  
Location: Roof Exterior  
Finding: Roof plumbing - Loose flashing  
Information: Metal and other material flashings are applied to seals and intersections between roof coverings and building elements. They are designed to aid in weatherproofing of roof joints, and require regular inspection and maintenance as they are more subject to rust-related deterioration.

The flashing in this section of the exterior roofing appears to have come loose from its original fixing. It is suspected that this minor defect has occurred as a result of general

deterioration over time.

Re-fixing and potential replacement of certain areas of flashing is advised to promote adequate roof drainage and protection from water penetration. Failure to perform these works may result in water damage and accelerated deterioration of associated building elements.

A roofing contractor or roofing plumber should be appointed as soon as possible to restore the flashing to a fully operational state and check against NCC standards including upturns.

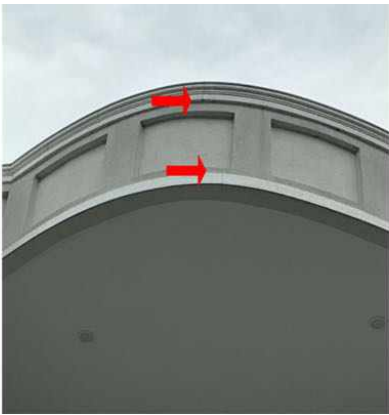
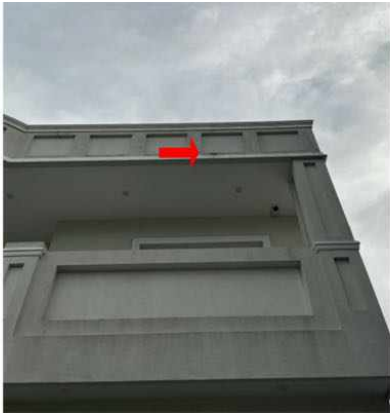
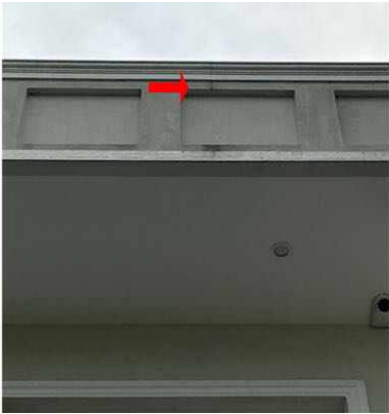
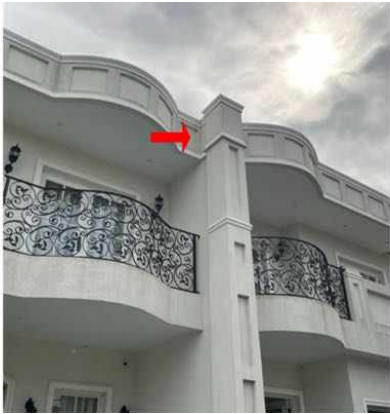
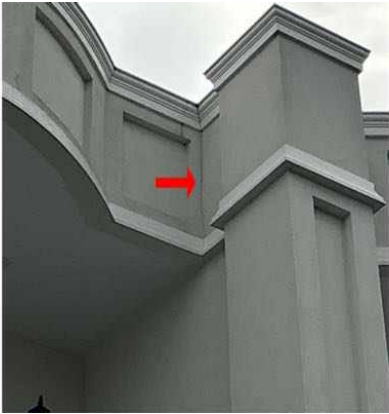
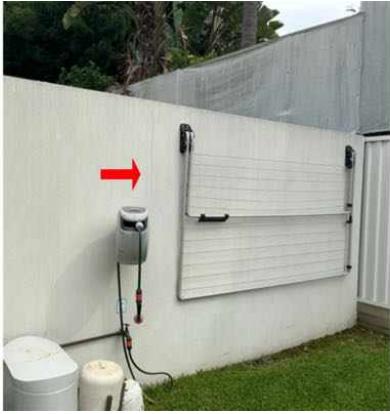
### Finding 3.12

Building:	Main Building
Location:	All External Areas
Finding:	Cracks to render - Category 1 to some areas
Information:	It has been observed that cracking to rendered surfaces has occurred. The degree of damage falls within Category 1, described as fine cracks that do not need repair and which are less than 1.0mm in width limit.

Damage of this category is not considered a defect for rectification. Always contact your building inspector should cracks widen, lengthen, or become more numerous.

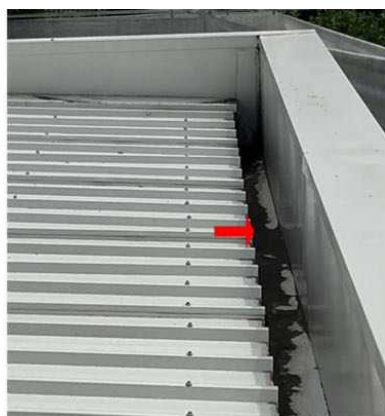
Finding 3.13

Building:	Main Building
Location:	All External Areas
Finding:	Gutters - Blocked
Information:	Roof plumbing structures, such as guttering and downpipes, should be free of all debris to prevent blockages. Blockages of the guttering and downpipes will lead to pooling and accumulated water overflows, which is likely to subsequently flood eaves and exterior walls.

Blocked gutters are likely to lead to high levels of moisture in the affected areas. Such moisture will not only cause rust and decay of the associated building materials, but can also provide conditions that are conducive to termite and timber pest activity. Blockages in gutters should therefore be removed immediately to ensure dry conditions are maintained.

Consult a Licensed Plumber for further specific advice on remedial works that may be required. In the interim, it is highly advised that blocked gutters be removed by the homeowner or a general handyperson as a matter of urgency.

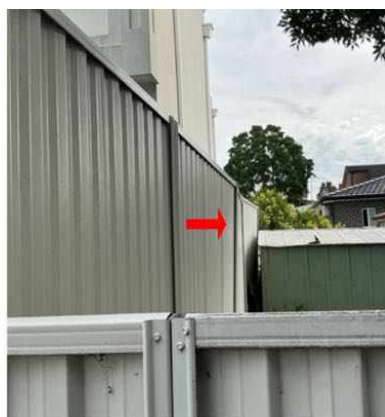
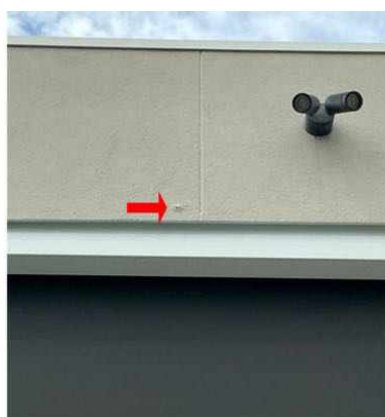
Building:	Main Building
Location:	All External Areas
Finding:	Building element - Damaged - Fence leaning , render damage rear
Information:	Breakage occurs generally when the building materials have either aged and decayed, or as a result of damage (accidental or deliberate).

Repair and/or replacement of broken elements is advised to ensure that additional secondary defects do not arise as a consequence. Such works are necessary, as all building elements play a key role in the operation and function of the overall structure and its performance.

A relevant tradesperson should be appointed to repair or replace the affected building

element prior to any subsequent damage being caused.

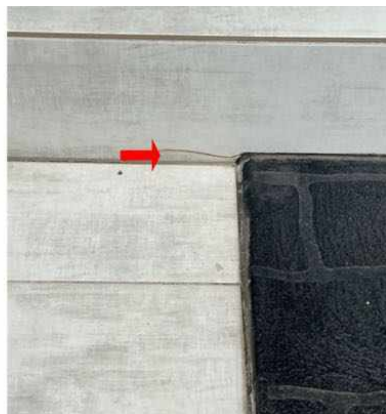
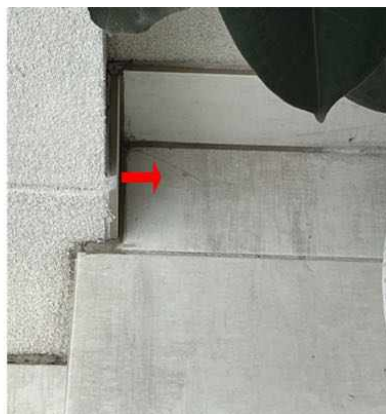
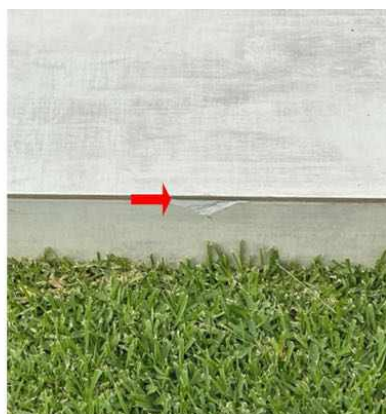
### Finding 3.15

Building:	Main Building
Location:	All External Areas
Finding:	Tiles - Cracked or damaged
Information:	Cracking was evident to the tiling in this area at the time of inspection. While the cracking appears to be minor, this area is frequently exposed to water, allowing potential for water penetration into adjoining sections of walls or flooring.

If left unmanaged, water penetration to these areas may lead to subsequent water damage, which is likely necessitate repair work to affected building elements.

A tiling contractor should be appointed to ensure that no further water damage occurs. The re-application of silicone and grouting throughout remaining tile work is also advised, to further protect the area against water penetration.

Where water penetration has led to water damage, appointment of a relevant tradesperson may be required to repair damaged building elements.

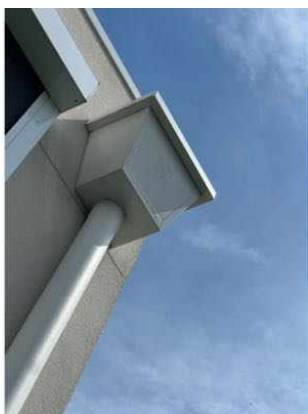
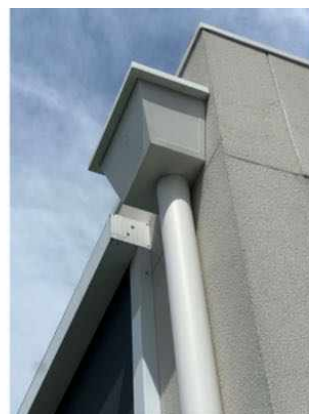
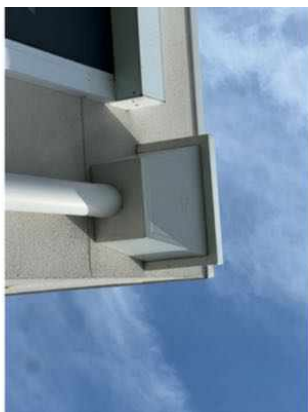
### Finding 3.16

Building:	Main Building
Location:	All External Areas
Finding:	Box Gutter Rainhead
Information:	The rainhead and downpipe installation were visually intact at the time of inspection, however, an overflow provision was not visible and may be concealed. The system's overall performance could not be confirmed without further inspection or testing during rainfall. Regular cleaning and maintenance of rainheads and downpipes are recommended to ensure effective roof drainage. It is recommended to consult with a qualified plumber to ensure it meets NCC requirements

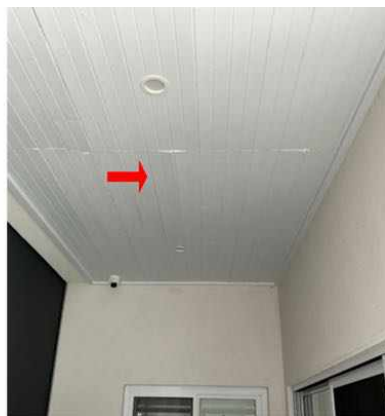
### Finding 3.17

Building:	Main Building
Location:	All External Areas - Rear
Finding:	Ceiling - Sagging
Information:	Sections of the ceiling were found to be sagging at the time of inspection. Sagging to the fixed ceiling structure generally indicates that the building materials have swollen, due to contact with water, or that fixings (e.g. nails or glue) have become loose and require reattachment.

In some cases, sagging ceiling linings may also indicate that there are structural issues, causing surfaces to warp, twist or sag. Where sagging appears to be major, appointment of a structural engineer is advised to further inspect the property and identify the source and rectification works required.

Where minor sagging is evident, comparatively minor works, such as re-gluing of ceiling sheets, may be required. Such works may be performed by relevant tradespeople, such as plasterers and painters. Where excessive moisture has caused the roofing structure to swell and sag, the source of the water leak should primarily be identified prior to any remedial works being performed.

The appropriate action should be taken by the client as soon as possible to ensure that any potential further damage is limited.

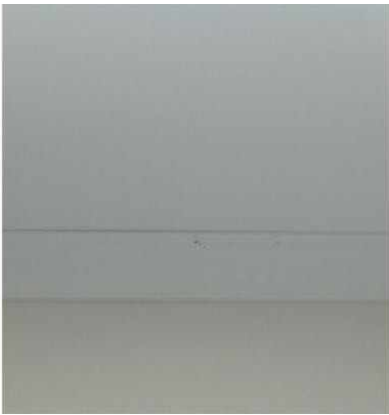
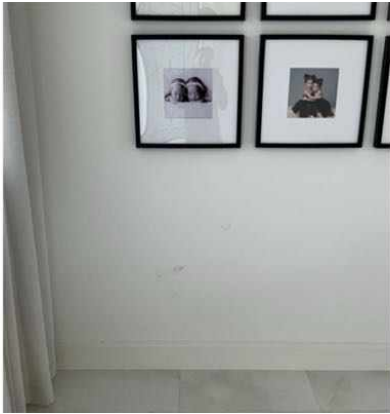
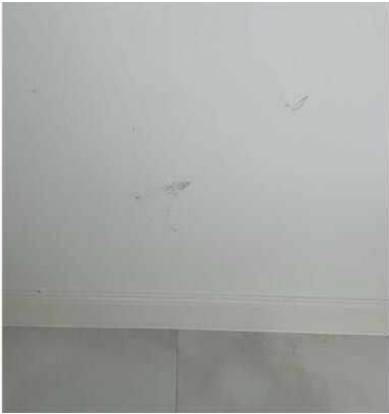
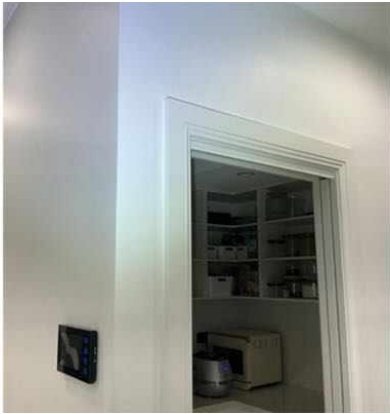
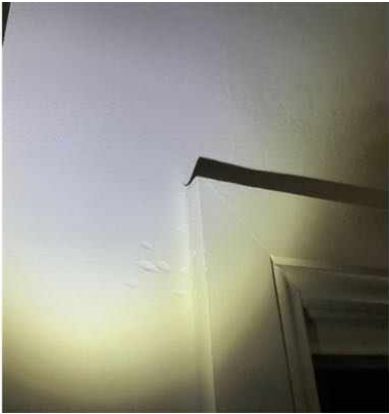
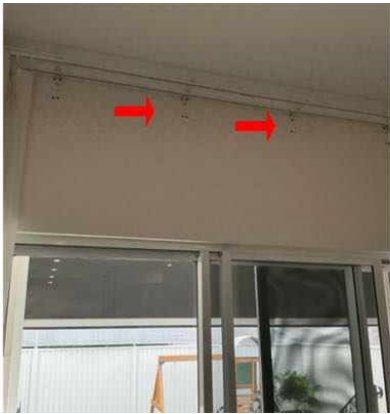
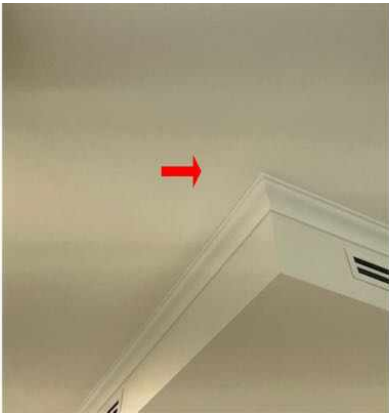
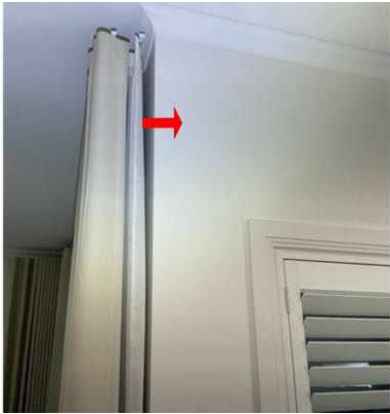
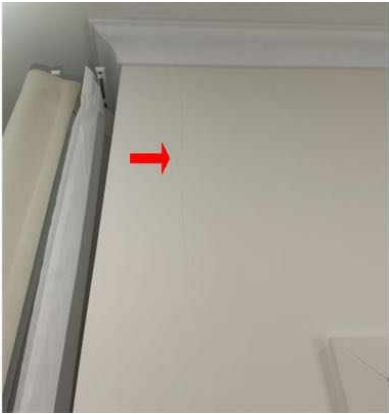
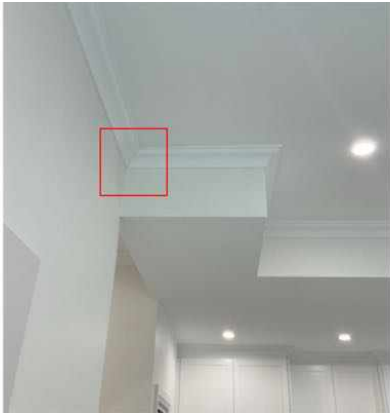
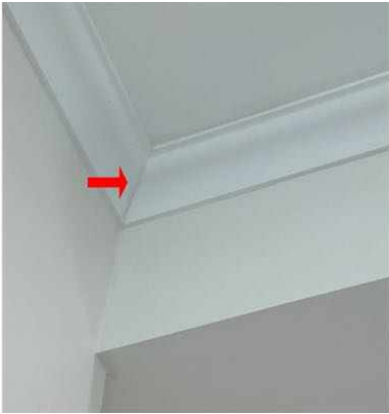
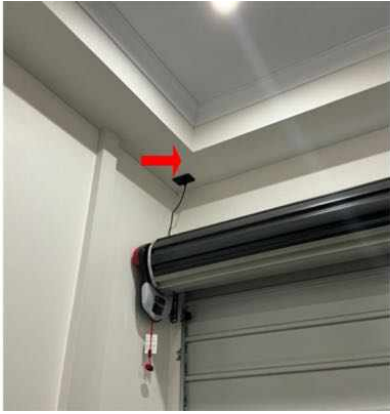
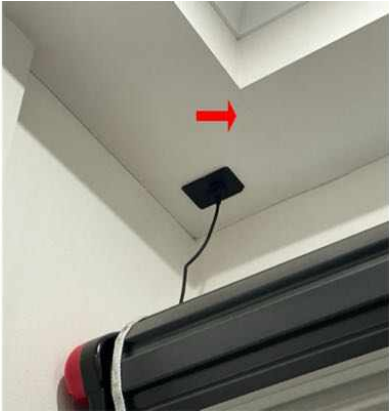
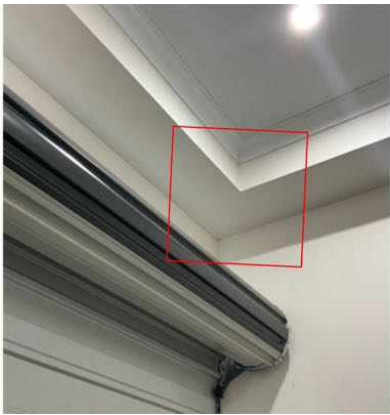
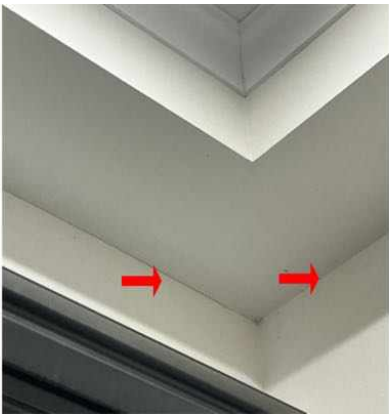
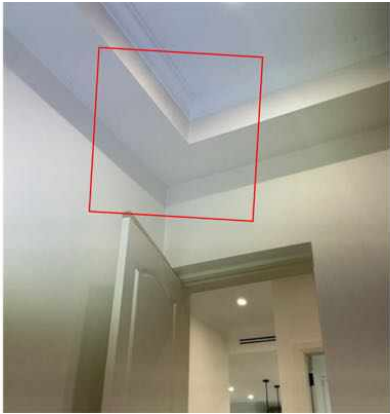
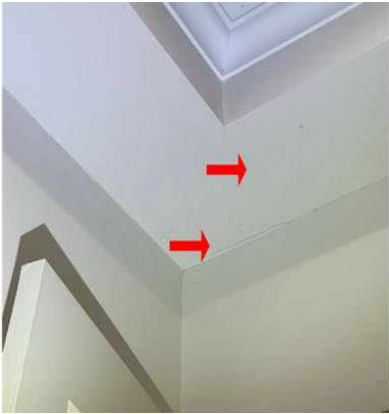
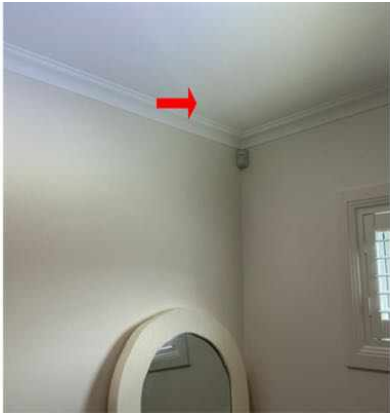
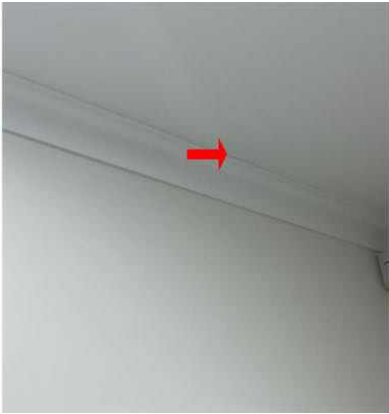
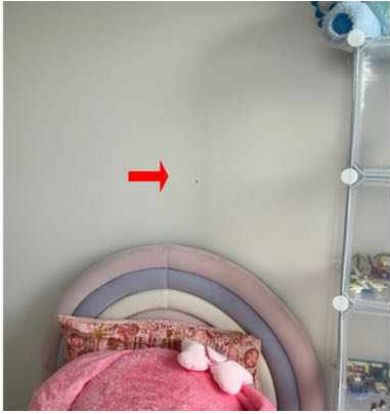
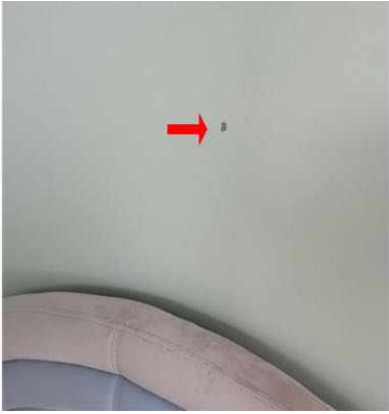
Building:	Main Building
Location:	All Internal Areas
Finding:	Paint Finish & Hairline Cracking - To some areas
Information:	The paint finish in this area was identified as being incomplete or substandard at the time of inspection including some hairline minor cracking/separation. Monitoring is recommended where cracking and separation is evident.

Whilst incomplete or missing paint finish is generally an appearance defect, it can also lead to the development of secondary building defects over time. Incomplete areas of paint finish expose the area to moisture, potentially accelerating the deterioration of underlying building materials.

Incomplete paint finishes should be sanded back, filled, leveled and painted, as applicable. Where inadequate or missing paint protection has led to the deterioration of the associated building element, repair and/or replacement of this building element may be required.

A painting contractor should be appointed as soon as possible to perform necessary works to aid the appearance of the affected area and to ensure the area is protected against further deterioration. Alternatively, the homeowner following manufacturer instructions may perform these works.

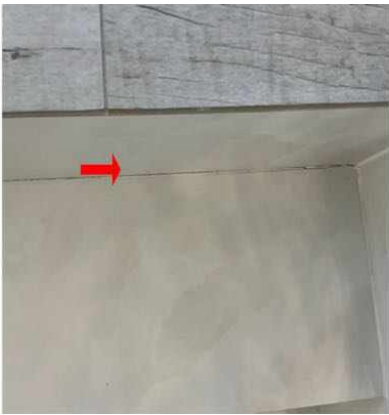
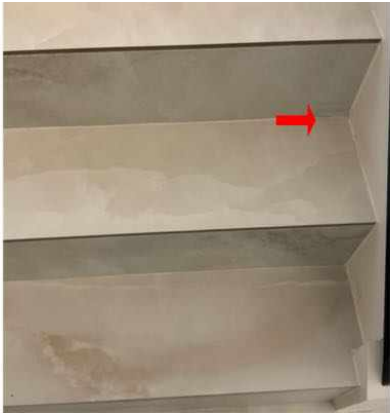
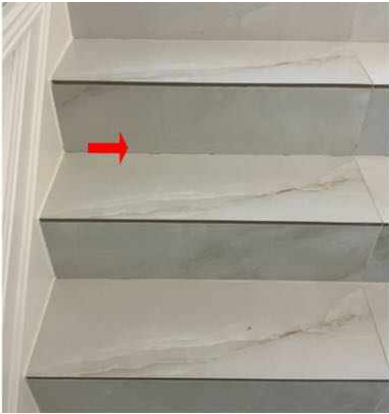
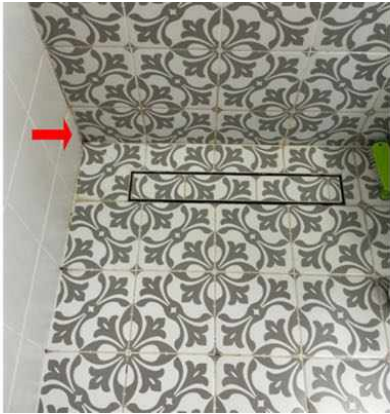
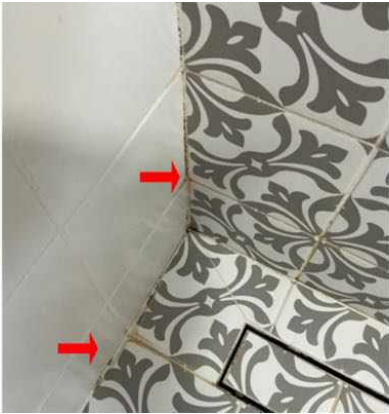
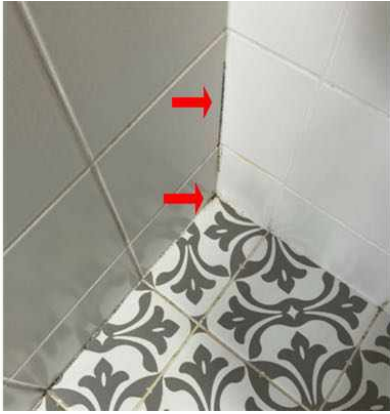
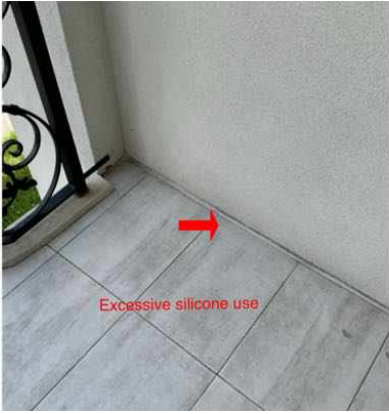
### Finding 3.21

Building:	Main Building
Location:	All Internal Areas
Finding:	Sealant and grouting - Missing or degraded to some areas
Information:	It was noted on inspection that sealant or grout is degraded.

Different materials and floor areas move at different rates, generally causing cracking to grout or sealant at this point. A flexible sealant is required to allow for expected expansion and contraction, while keeping the joint water tight and protective of all associated building materials.

Excessive mould to the sealant and grout may require scraping out and replacement.

Flexible and mould resistant materials should be applied to affected areas to prevent any subsequent water damage that is likely to occur. Regular maintenance and replacement of damage or missing or damaged sealant and grout is highly recommended to the wet areas, as this is a regular wear and tear defect. Sealant and grouting in areas that come into regular contact with water should be maintained for the long term care of your property.

A sealant specialist or tiling contractor should be appointed to complete these works as soon as possible

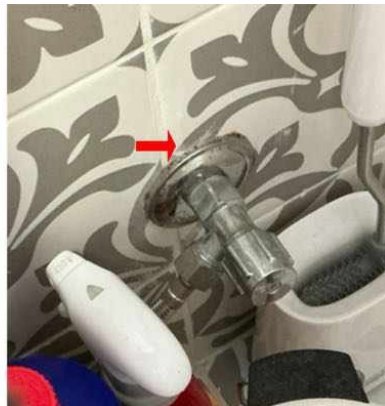
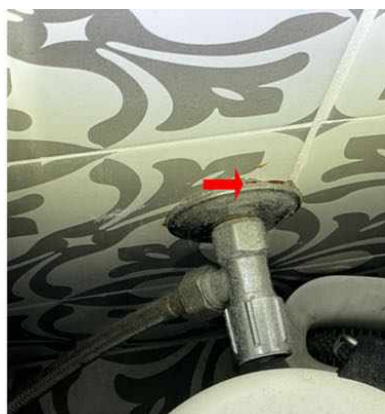
**Finding 3.22**

Building: Main Building  
Location: Bathroom  
Finding: Building element - Rusted or corroded  
Information: This building element shows evidence of rusting and corrosion, which is likely to have developed as a result of excessive exposure to moisture and or inadequate coatings.

As surface rust provides no protection to the underlying iron, the deteriorating condition is likely to worsen if not addressed in the short-term future.

Where possible, the use of galvanized (treated) metals or aluminium coated metals aid in rust prevention, as does regular general maintenance. Rust formation can be

controlled with coatings, such as paint, that isolate the iron from the environment.

Rusting and corrosion should be managed by ideally removing or limiting the affected surface from exposure to moisture. A registered builder may be appointed to replace any building elements that have been severely affected by rust or water damage.

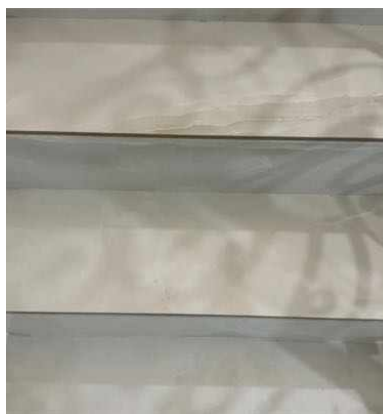
### Finding 3.23

Building:	Main Building
Location:	Stairs - Internal
Finding:	Incomplete or substandard works - No trim or nosing
Information:	The works to this area appear to be incomplete or have been completed to a substandard level.

Works that have not been completed to a satisfactory level create potential for the development of building defects and may impede on the safety and integrity of the overall structure.

It is highly recommended that the relevant trades be appointed to complete these works and ensure the safety of the area and the longevity of all associated building elements.

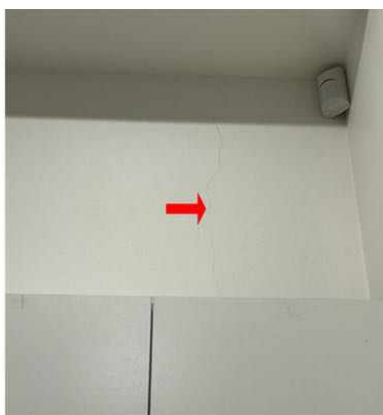
### Finding 3.24

Building:	Main Building
Location:	All Internal Areas
Finding:	Cracks to internal render - Category 1
Information:	It has been observed that cracking to internal rendered surfaces has occurred. The degree of damage falls within Category 1, described as fine cracks that do not need repair and which are less than 1.0mm in width limit.

Damage of this category is not considered a defect for rectification. Always contact your building inspector should cracks widen, lengthen, or become more numerous.

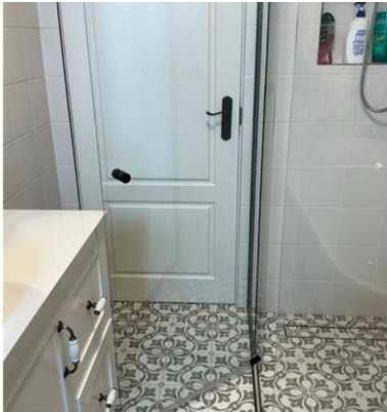
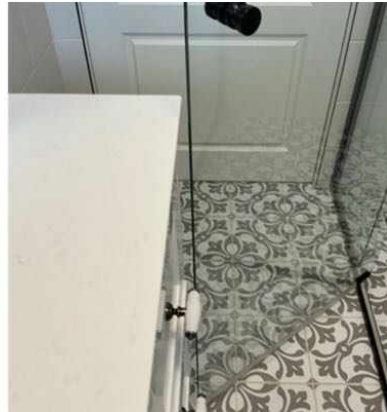
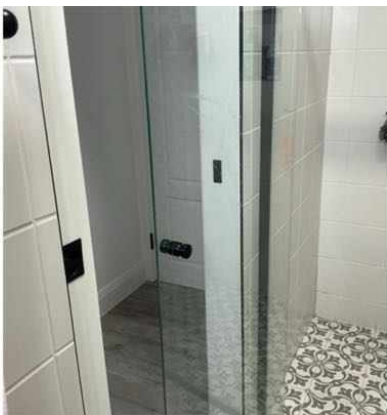
### Finding 3.25

Building:	Main Building
Location:	Bathroom, Ensuite
Finding:	Installation - substandard or incomplete - Shower
Information:	The shower screen door appears to be installed in close proximity to the vanity unit or adjacent walls, resulting in limited or no clearance between the glass panel and adjacent cabinetry. The current installation may restrict full door operation and compromise effective water containment within the shower area. Substandard installation can increase the risk of water escaping beyond the wet area, damage to door or cabinets/walls potentially affecting surrounding finishes over time. Adjustment

or rectification by a qualified installer is recommended to ensure proper alignment and adequate clearance.

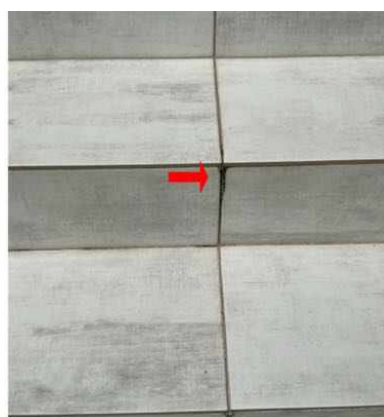
Building:	Main Building
Location:	All External Areas
Finding:	Sealant and grouting - Missing or degraded
Information:	It was noted on inspection that sealant or grout is degraded.

Different materials and floor areas move at different rates, generally causing cracking to grout or sealant at this point. A flexible sealant is required to allow for expected expansion and contraction, while keeping the joint water tight and protective of all associated building materials.

There appears to be excessive mould to the sealant and grout which will likely require scraping out and replacement.

Flexible and mould resistant materials should be applied to affected areas to prevent any subsequent water damage that is likely to occur. Regular maintenance and replacement of damage or missing or damaged sealant and grout is highly recommended to the wet areas, as this is a regular wear and tear defect. Sealant and grouting in areas that come into regular contact with water should be maintained for the long term care of your property.

A sealant specialist or tiling contractor should be appointed to complete these works as soon as possible

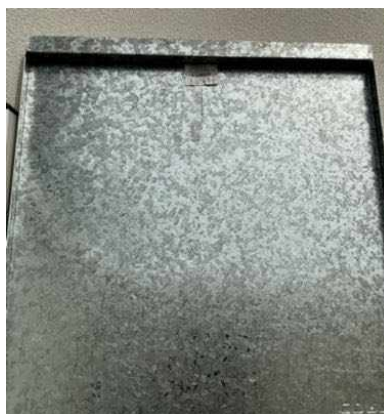
Building:	Main Building
Location:	All External Areas
Finding:	Termite Management System - no evidence of a chemical installation
Information:	The application of a post-construction chemical termite barrier is highly recommended for all properties, particularly if live termite activity has been found on the site previously. Such barriers are highly effective in preventing termite attack on any timber building elements throughout the property.

A durable notice should be placed in the switchboard unit to indicate current termite barriers. At the time of inspection, it appeared as though no termite management system has been installed, with no evidence to suggest preventative works taking place.

The client may consider gaining further advice from a pest controller as to the costs and procedures involved with this application. It is recommended that obtaining such advice be a short-term priority.

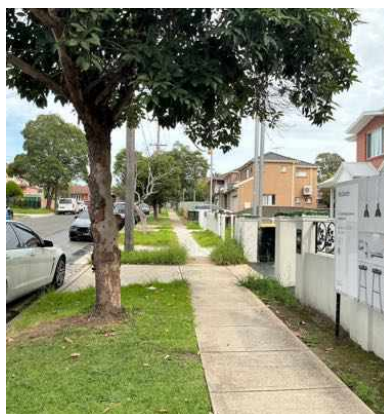
### Finding 6.02

Building:	Main Building
Location:	All External Areas
Finding:	Trees within 50m
Information:	Trees within 50m of the property can be conducive to termite activity. It is recommended an invasive inspection of all trees with 50m to the property be carried out by a qualified pest control expert.

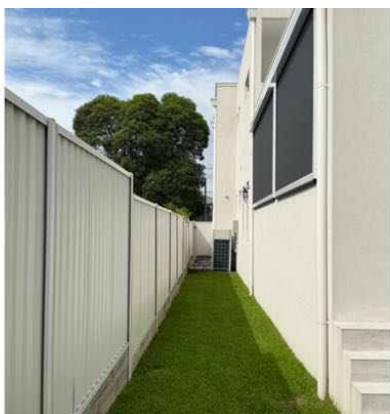
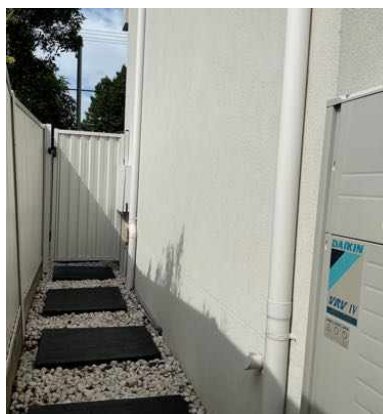
If the slab edge is not properly exposed there is a high risk of termite attack. Sometimes, in order to determine the type of slab, a suitably qualified person such as an architect or builder may be required to consult the construction plans.

Where the slab edge cannot be properly inspected, it is highly recommended that termite or timber pest inspections be carried out every 6-12 months to aid protection of the property against infestation.

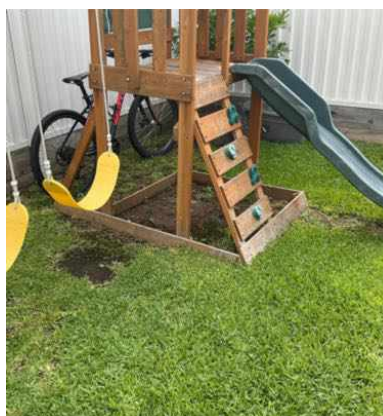
### Finding 6.05

Building:	Main Building
Location:	All External Areas
Finding:	In ground contact - Timber
Information:	Any timbers in direct ground contact provide opportunity for concealed termite entry and are likely to be subject to premature rot and decay as the soil retains moisture or damp conditions against the timbers.

Remove untreated timber that is in direct contact with external grounds. Consider replacement with more durable materials i.e. treated timber or non timber elements. Frequent pest inspections are advised to readily identify any termite activity in these areas.

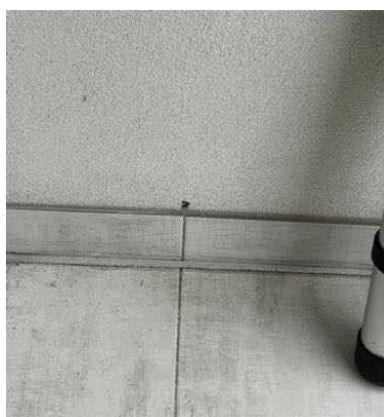
### Finding 6.06

Building:	Main Building
Location:	Subfloor
Finding:	Weep holes - Blocked
Information:	It was noted during the time of inspection that some of the weep holes to the brickwork were blocked. Weep holes are designed to allow water from leaks or seepages in brickwork to be directed to the external environment, prior to entering the wall cavity or associated building materials. Weep holes should therefore be kept clean

Blocked weep holes are likely to result in the presence of excessive moisture within the brickwork and associated structures, creating potential for water damage and moisture problems.

Depending on the nature of the blockage, the homeowner may be able to undertake remedial works to remove blockages. Alternatively, appointment of a registered builder may be required to remove blockages. Preventative works are necessary in ensuring the structural integrity of the affected brickwork and should be performed as soon as possible.
