# Building and Timber Pest Inspection Report

Inspection Date: Wed, 25 Feb 2026

Property Address: 61 Cambridge Ave, Bankstown NSW 2200,  
Australia

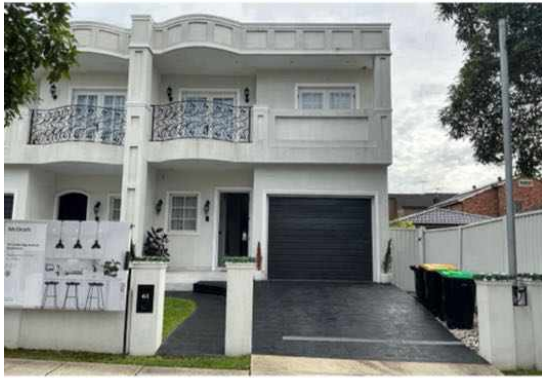
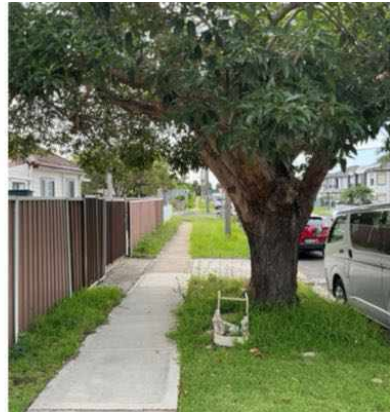
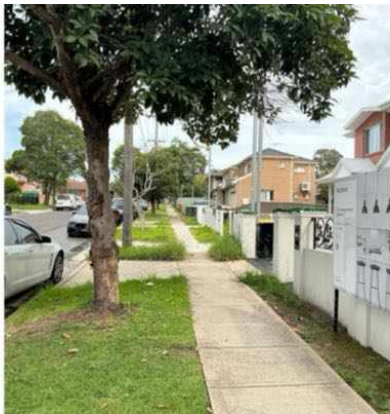
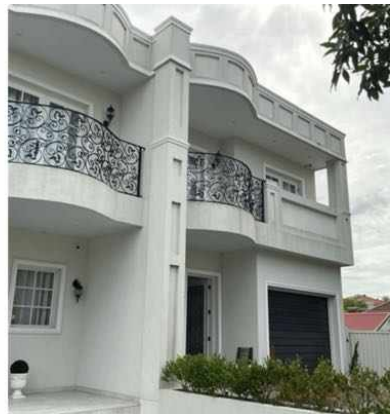
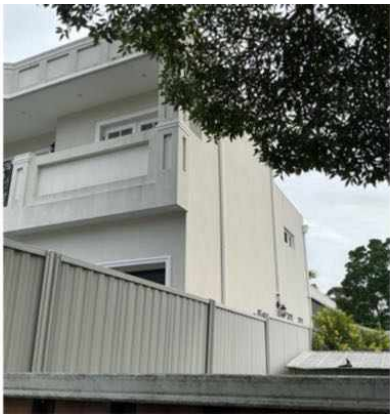
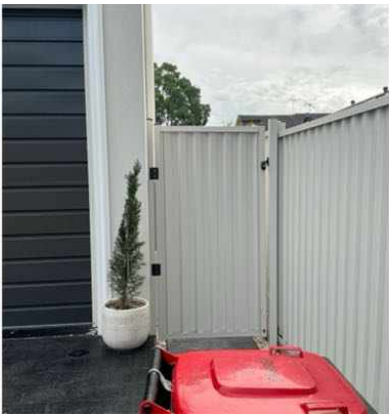
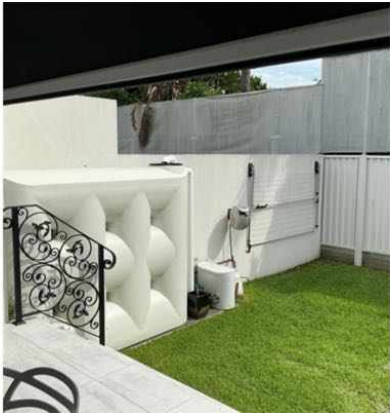
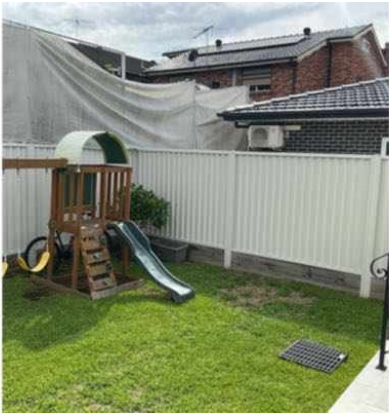
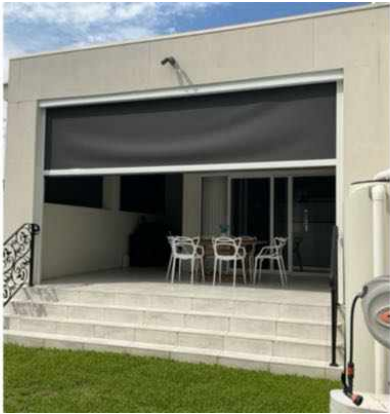
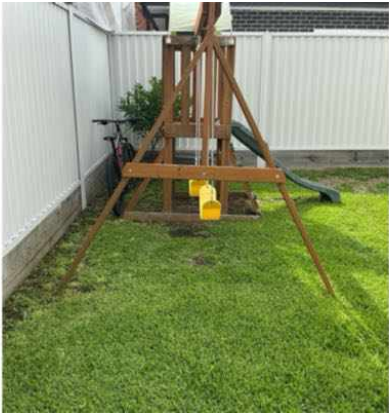
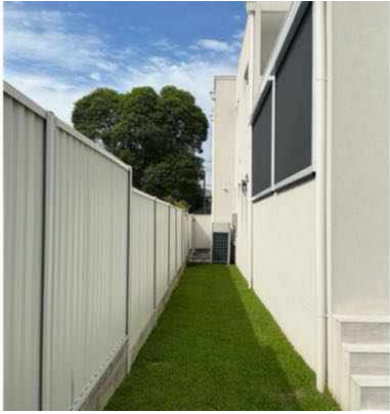
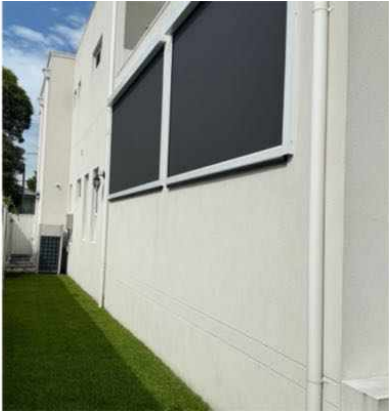
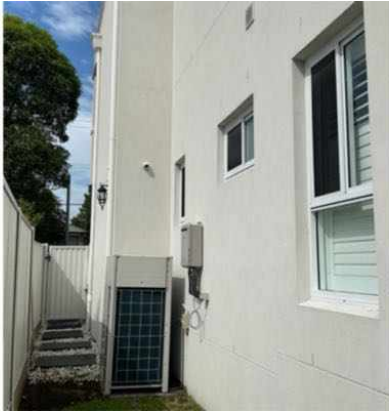
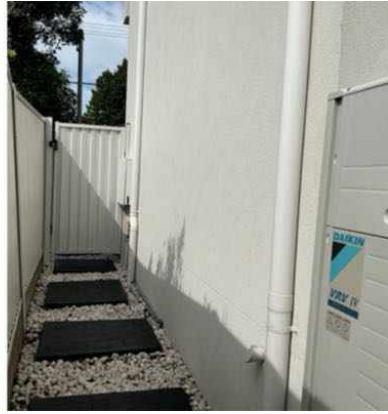
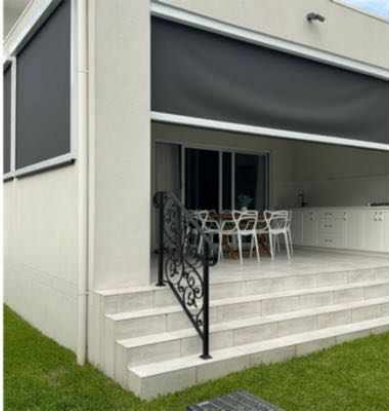
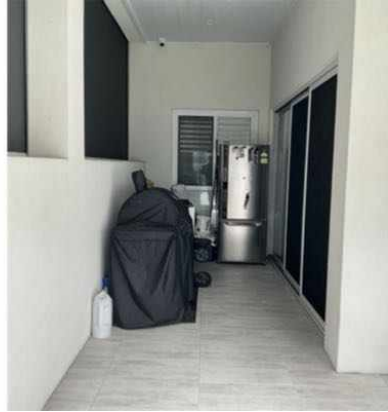
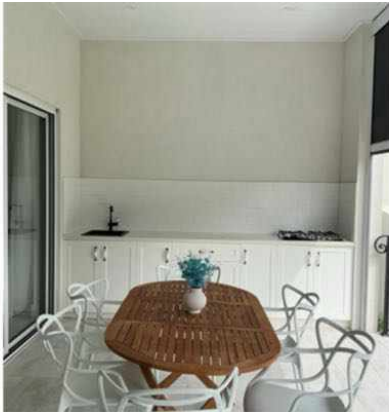
#### Noted Item

Building: Main Building  
Location: All External Areas  
Finding: Additional Photos - Obstructions and Limitations  
Information: These photographs are an indication of the obstructions and limitations which impeded full inspection of the property at the time of inspection. These obstructions can hide an array of defects and should be removed to allow full inspection to be carried out. A re-inspection is recommended once the areas are made accessible.

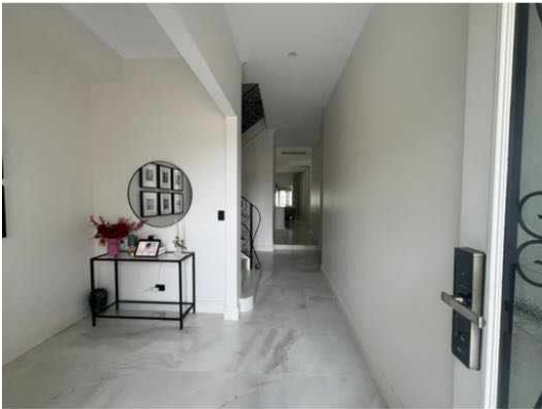
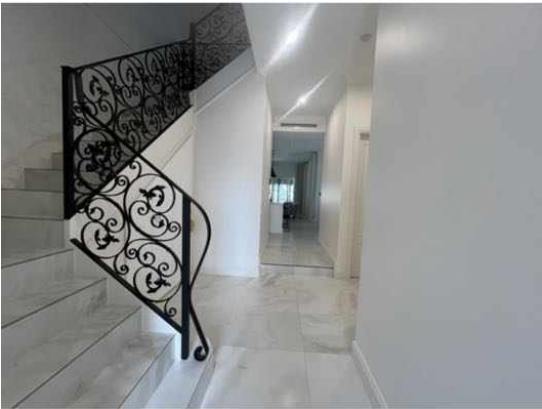
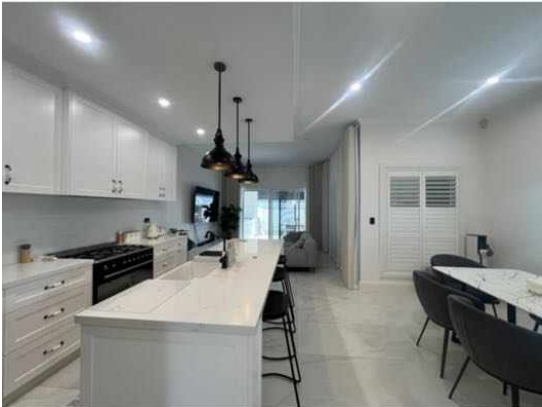
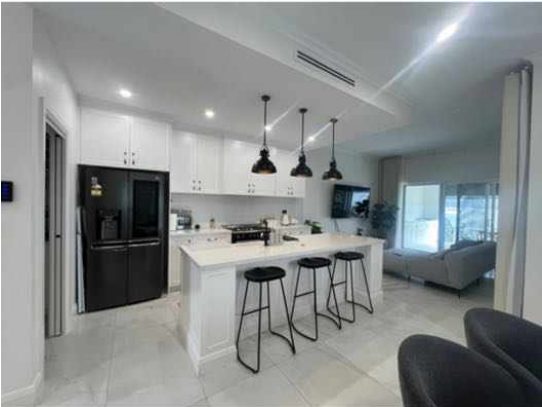
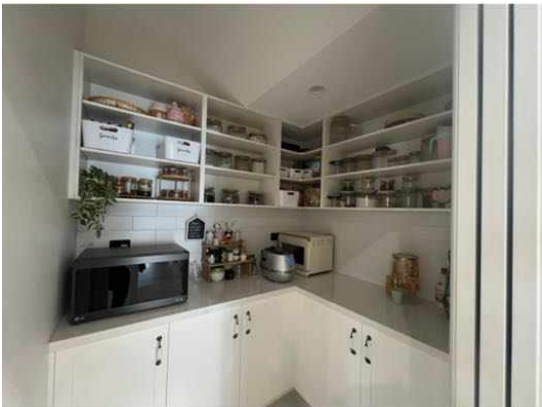
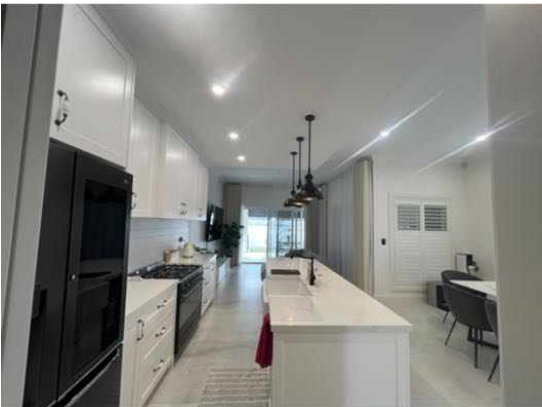
Building:	Main Building
Location:	All Internal Areas
Finding:	Additional Photos - Obstructions and Limitations
Information:	These photographs are an indication of the obstructions and limitations which impeded full inspection of the property at the time of inspection. These obstructions can hide an array of defects and should be removed to allow full inspection to be carried out. A re-inspection is recommended once the areas are made accessible.

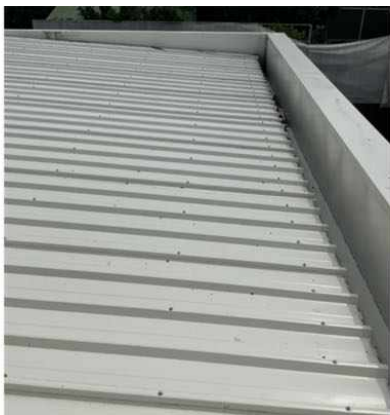
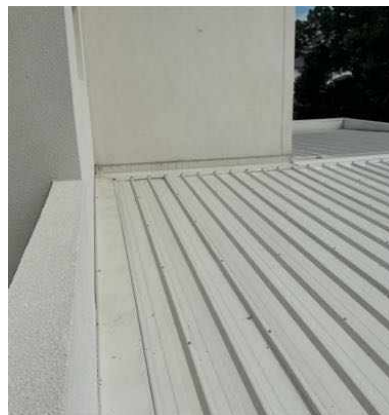
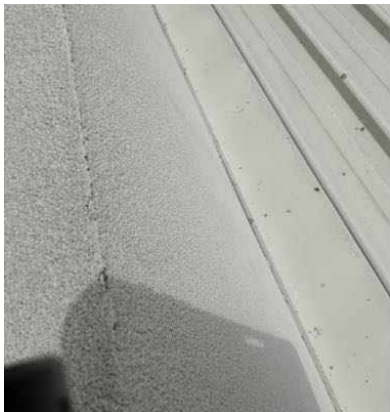
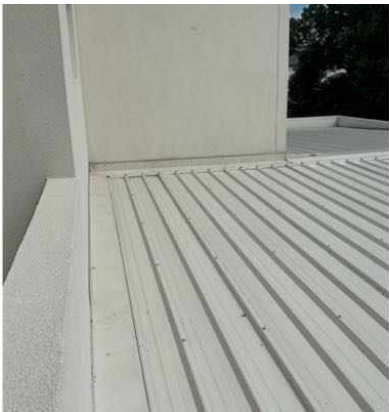
Building: Main Building  
 Location: Roof Exterior  
 Finding: Additional Photos - Obstructions and Limitations  
 Information: These photographs are an indication of the obstructions and limitations which impeded full inspection of the property at the time of inspection. These obstructions can hide an array of defects and should be removed to allow full inspection to be carried out. A re-inspection is recommended once the areas are made accessible.

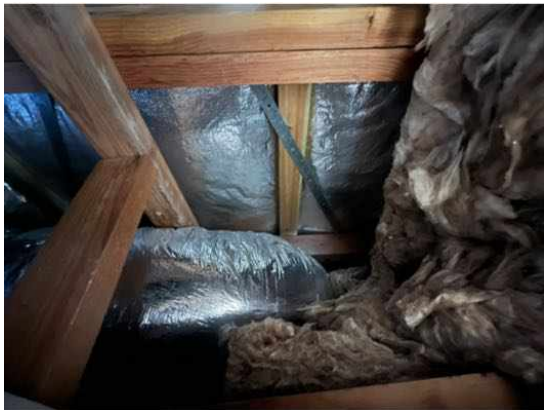
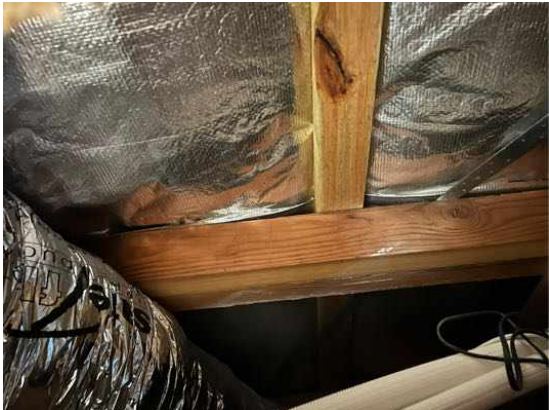
Building: Main Building  
Location: Roof Void  
Finding: Additional Photos - Obstructions and Limitations  
Information: These photographs are an indication of the obstructions and limitations which impeded full inspection of the property at the time of inspection. These obstructions can hide an array of defects and should be removed to allow full inspection to be carried out. A re-inspection is recommended once the areas are made accessible.
