Building and Timber Pest Inspection Report

Inspection Date: Fri, 13 Feb 2026

Property Address: 91 Fairmont Boulevard, HAMLYN
TERRACE 2259

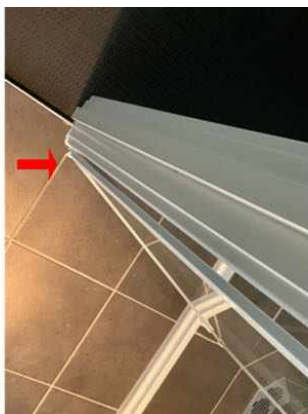
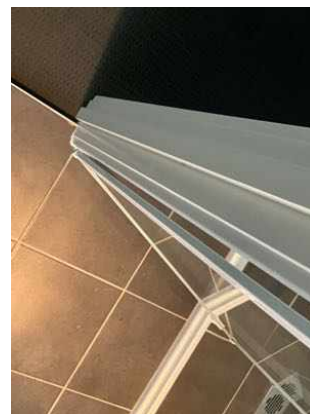
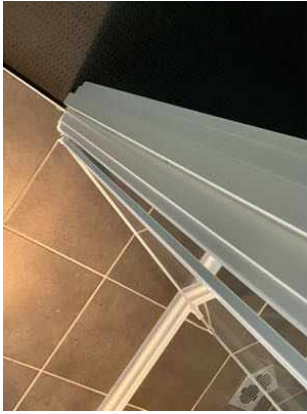
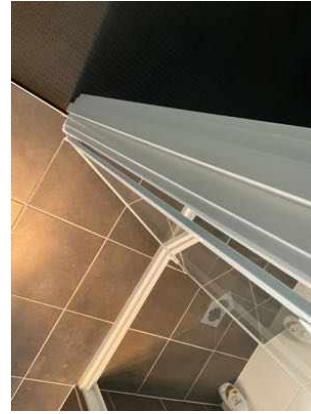
Information: During the inspection, it was noted that the shower screen door comes into direct contact with the door frame when opened. This creates a potential safety hazard due to repeated impact on the glass, which may lead to glass breakage or injury to occupants.

- Personal injury from shattered or broken glass in the event of sudden failure.
- Repeated impact may compromise the integrity of the shower screen door and door panel, leading to potential structural failure.
- Possible misalignment or damage to hinges, causing the door to operate incorrectly and posing a trip or entrapment hazard.

A qualified glazier or licensed bathroom renovator should be engaged to inspect and rectify this issue. Corrective action may involve adjusting the door alignment, repositioning the shower screen door, or installing door stop buffers to ensure safe and compliant operation of the door system.

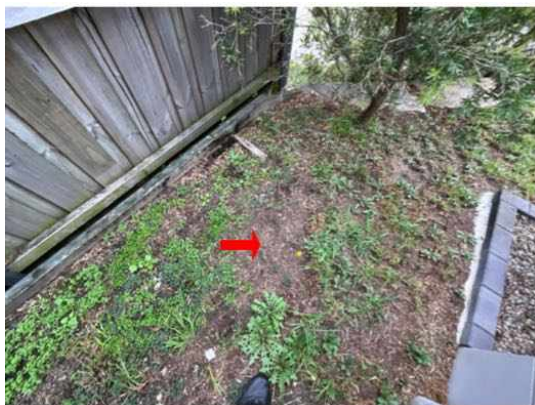
Building: Main Building
 Location: Yard - Side
 Finding: Perimeter - Insufficient Fall
 Information: The perimeter ground levels were found to have an inadequate slope away from the adjoining building structure, creating potential for water pooling in this area.

Perimeter is required to fall from the building by a minimum of 25mm in the first metre and bare ground should fall away from the house by 50mm in the first meter. This standard ensures that excessive moisture does not pool around the base of building structures, which creates potential for water and structural damage, as well as making the area susceptible to termite and timber pest activity.

Where ground levels do not have adequate fall, a licensed paving contractor should be appointed to install or remove and re-level pavement.

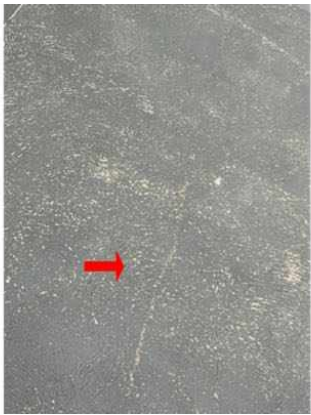
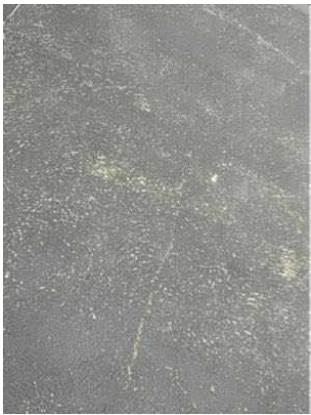
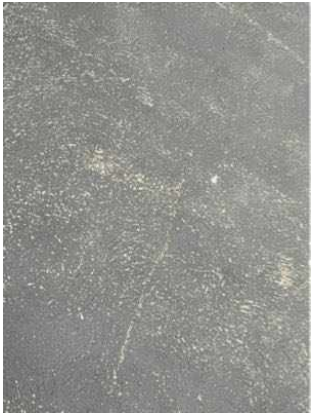
Finding 3.02

Finding: Crack in concrete slab - Category 0

Information: A crack coded as Category 0 was identified in the slab. A Category 0 crack is described as a hairline crack, representing insignificant movement of slab from level.

The approximate width of the crack to be considered Category 0 is 0.3mm, or change in offset of less than 8mm when a 3m straight edge is placed over the defect.

No rectification is required at this time. However, all cracking should be monitored over a 12 month period to identify any further damage in the area.

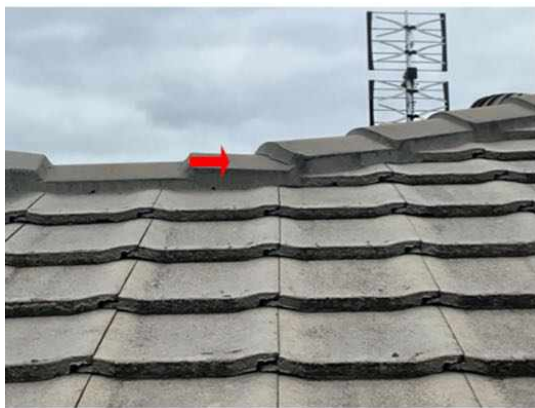
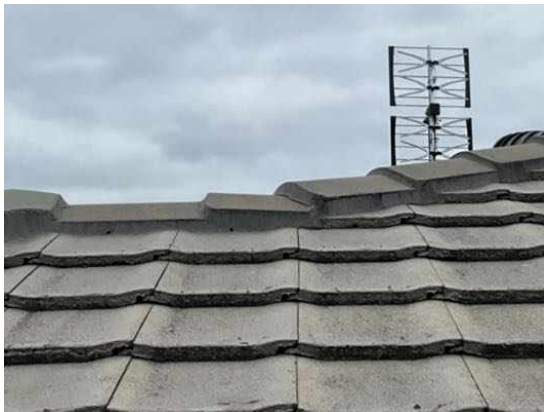
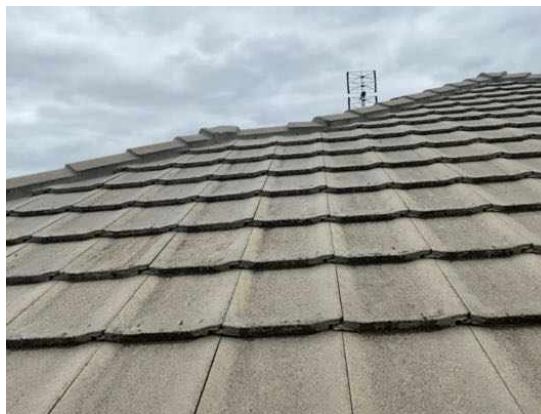
Finding 3.03

Building: Main Building
Location: All Areas
Finding: Roof Weathered
Information:

Inspection of the roof revealed widespread weathering to the tiled roof surface. The tiles show loss of surface finish, colour fading, and age-related deterioration typical of older roof coverings. Although no significant cracking was noted, weathering can lead to increased porosity, reduced water-shedding capability, and a higher risk of future cracking or displacement during adverse weather conditions.

A licensed roofer should be engaged to undertake a closer inspection, carry out routine maintenance, and replace any tiles that may be compromised. Ongoing monitoring is recommended due to the age and condition of the roof covering.

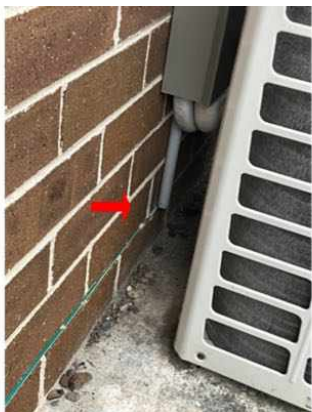
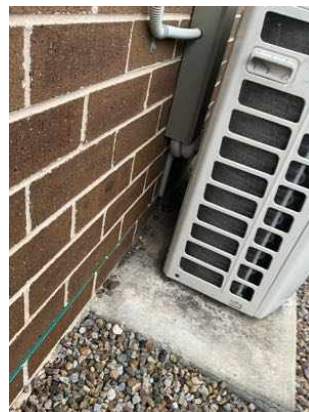
Finding 3.04

Building:	Main Building
Location:	Exterior walls - right side
Finding:	Air conditioner - Disconnected overflow
Information:	The Air Conditioner (A/C) overflow was found to be disconnected from storm water drainage and is creating excessive moisture in the surrounding area.

Such leaking creates an environment which is conducive to an array of defects, including water damage to associated building elements and the attraction of termite or timber pest infestation.

It is highly recommended that a licensed plumber be appointed to connect the A/C overflow in order to prevent such an environment from being created. These minor works should be carried out as soon as possible.

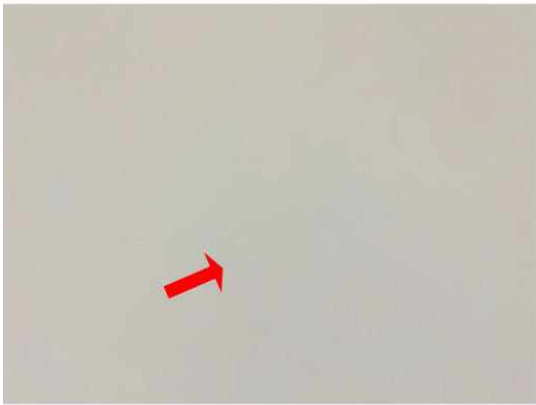
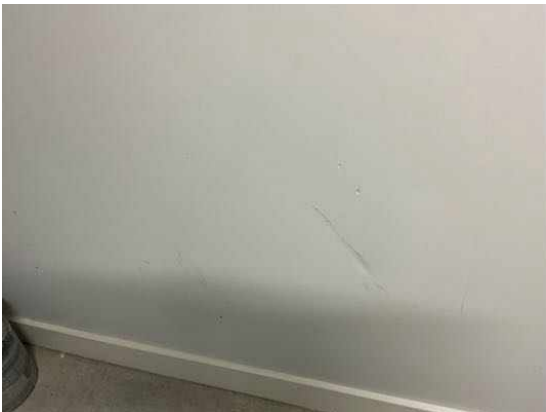
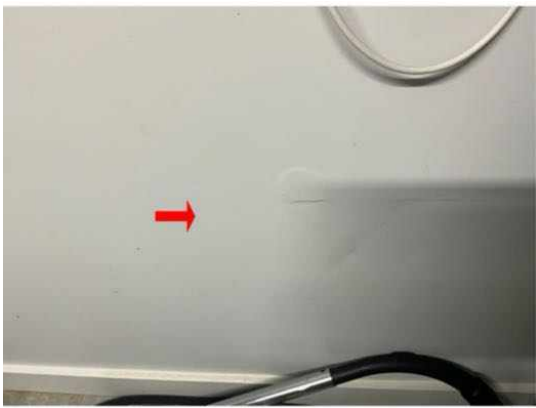
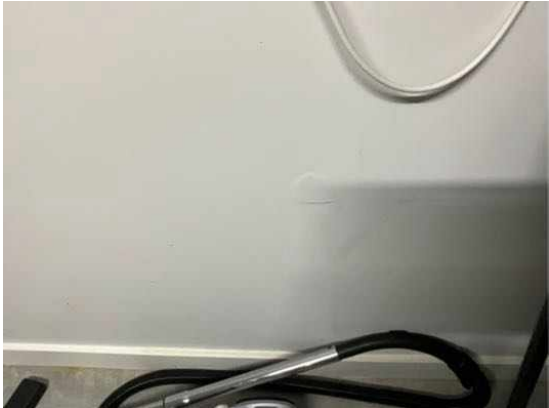
Finding 3.05

Building:	Main Building
Location:	All Areas
Finding:	Paint surface - Scratches
Information:	Scratches have been identified on the paint surface, detracting from the overall appearance and quality of the painted surface.

1. Aesthetic Degradation: Scratches mar the appearance of the painted surface, diminishing its visual appeal and potentially lowering property value.
2. Corrosion Vulnerability: Exposed areas of bare metal due to scratched paint are susceptible to corrosion, leading to structural damage and compromised durability.
3. Environmental Hazards: Scratched paint can release hazardous chemicals into the environment, posing risks to both human health and the ecosystem.

A qualified painter should address the issue promptly to repair the scratched paint. Depending on the severity of the scratches, repair options may include sanding, priming, and repainting the affected area to restore the integrity and appearance of the paint surface.

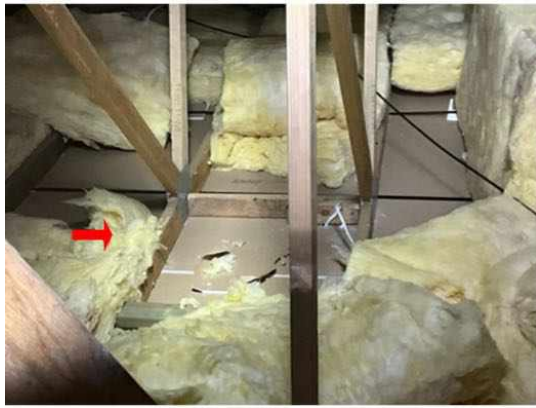
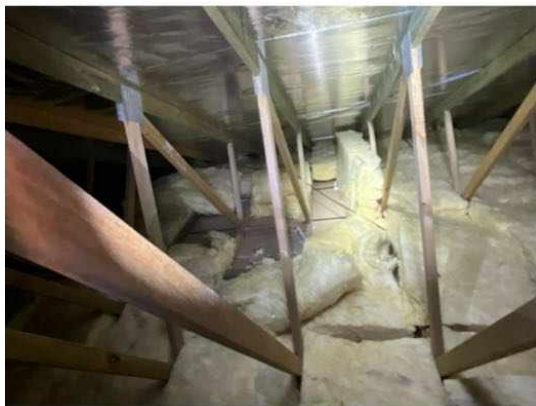
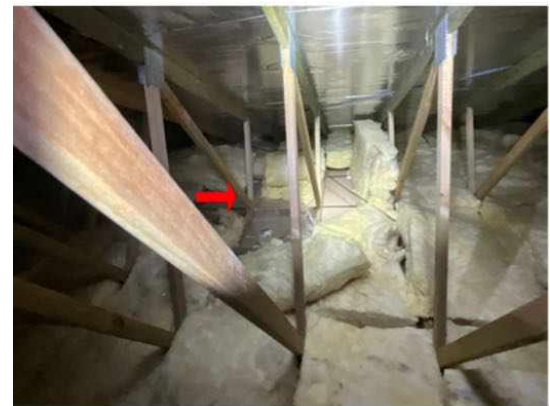
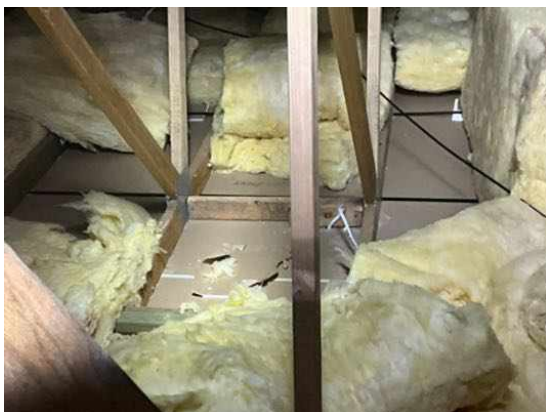
Finding 3.09

Building:	Main Building
Location:	Roof Void
Finding:	Insulation poorly placed
Information:	During the roof void inspection, it was observed that multiple insulation batts have been dislodged or are poorly placed, leaving significant gaps in coverage. This compromises the thermal performance of the ceiling insulation system.

- Reduced Energy Efficiency: Exposed areas without insulation can lead to increased heating and cooling costs as they allow for thermal bridging.
- Increased Moisture Risk: Uneven insulation may lead to condensation issues, especially in colder climates, potentially affecting timber framing and ceiling materials.
-

- Qualified Insulation Installer – A licensed insulation contractor should be engaged to reposition or replace the insulation batts, ensuring consistent and complete coverage across the ceiling.

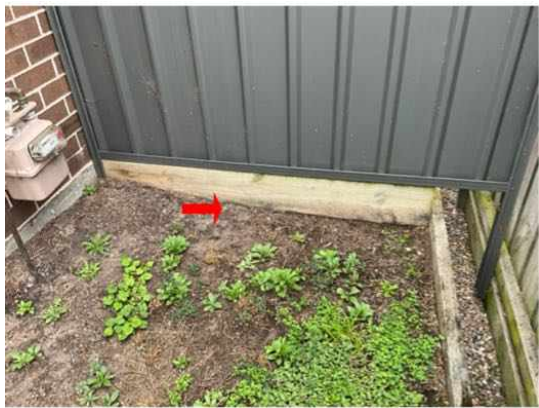
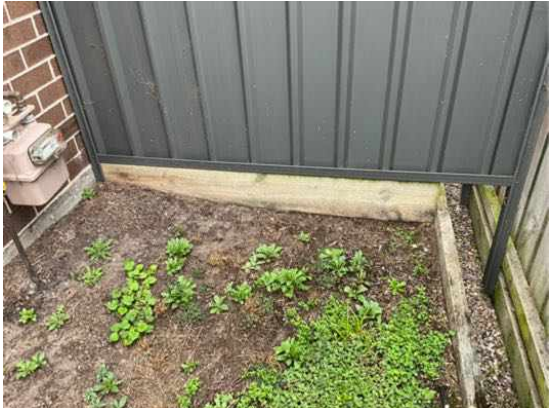
Finding 6.02

Building: Main Building
Location: All Areas
Finding: Timber on ground / conducive conditions to termite damage
Information: Timber on the ground is indeed conducive to termite damage. Termites are known to thrive in moist environments, and wood in contact with soil or moisture is more susceptible to infestation.

To prevent this, it's important to keep timber elevated and away from direct ground contact. Regular inspections and proper termite control measures are also essential to protect your wooden structures from termite damage.

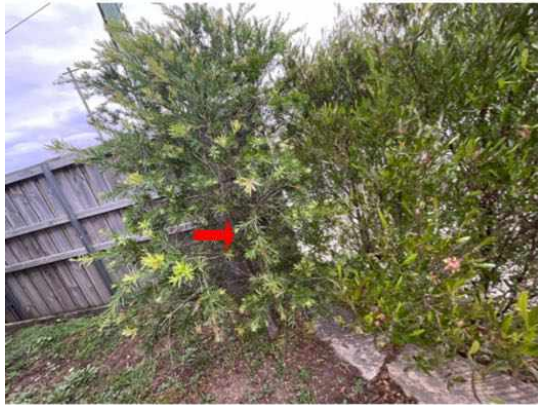
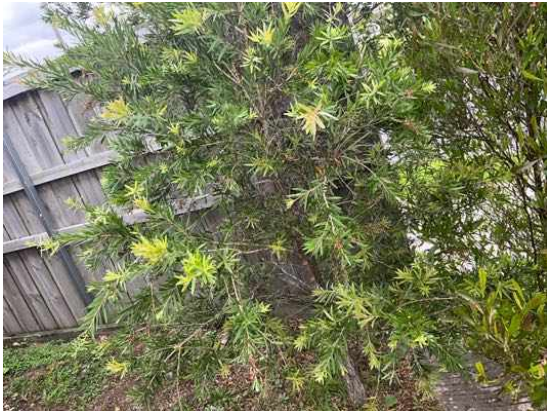
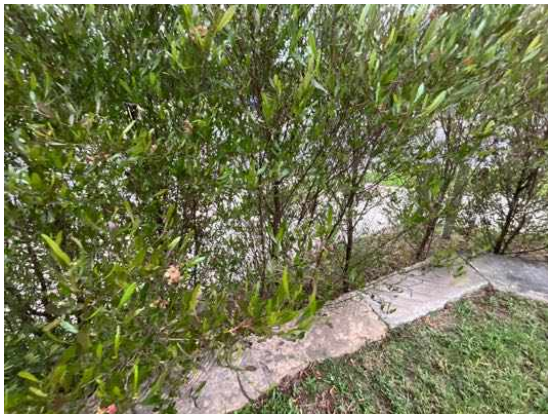
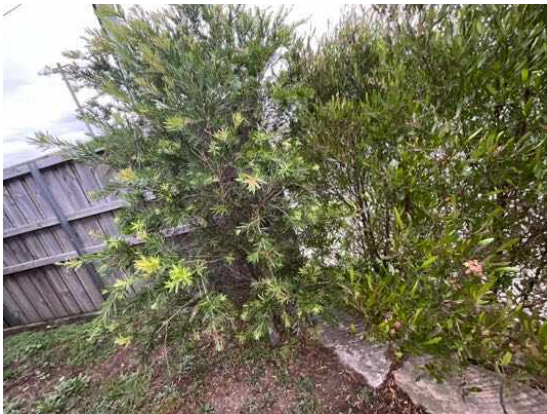
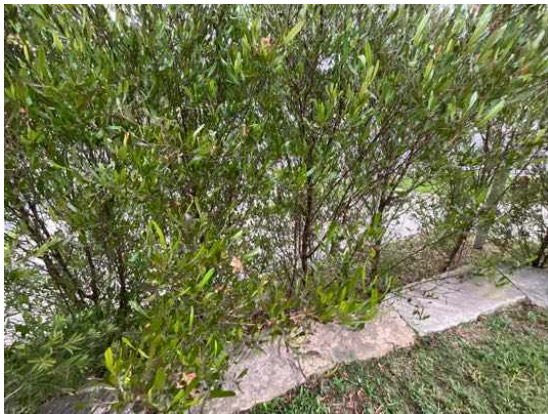
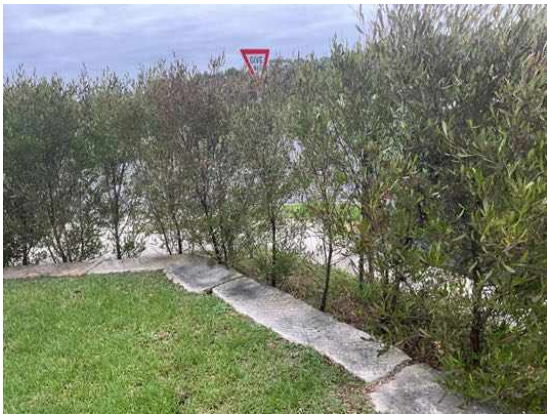
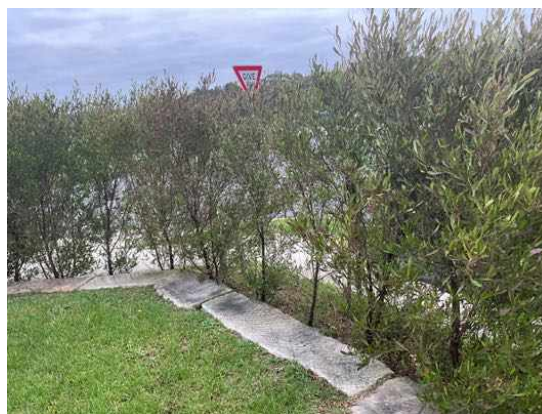
Finding 6.03

Building: Main Building
Location: All Areas
Finding: Dense vegetation around a property can increase the risk of termite infestation
Information: The presence of dense vegetation around a property can increase the risk of termite infestation, as it provides a conducive environment for them. To address this, consider maintaining a clear space between the vegetation and your home. If you suspect a termite issue, it's advisable to consult with a licensed pest control professional for inspection and treatment.

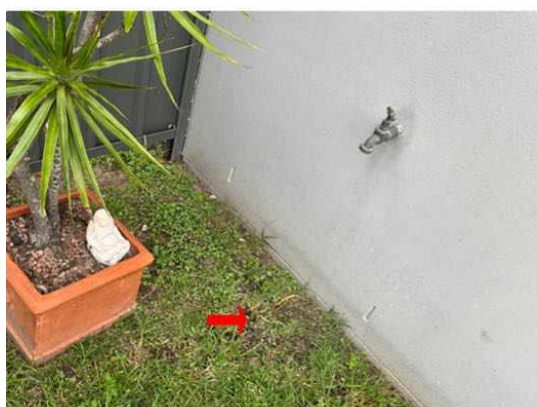
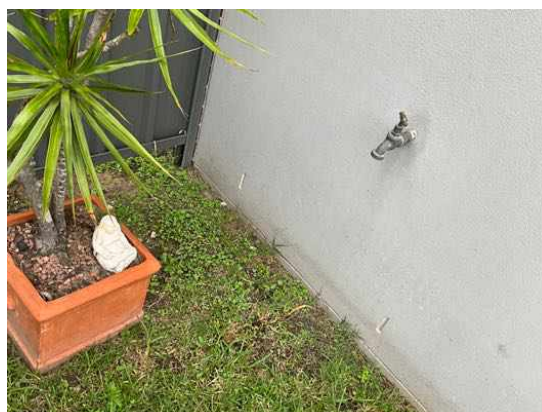
Finding 6.04

Building:	Main Building
Location:	All Areas
Finding:	No Drain under tap
Information:	There is no drain installed under the tap, leading to water accumulation and creating conducive conditions for timber pests. This defect needs immediate attention to prevent potential damage and pest infestation.

1. Water Accumulation: Without proper drainage, water can accumulate around the base of the tap, leading to persistent dampness in the surrounding area.
2. Timber Pest Infestation: The damp environment created by standing water is highly conducive to timber pests, such as termites and wood borers, which thrive in moist conditions and can cause significant damage to wooden structures.
3. Structural Damage: Prolonged exposure to moisture can lead to wood rot and deterioration of structural timber, compromising the integrity of the building.
4. Health Hazards: Persistent dampness can also promote mold and mildew growth, posing health risks to occupants.
5. Aesthetic Damage: Water stains and damage to finishes and materials around the

1. Assessment: Evaluating the area to determine the best approach for installing a proper drainage system under the tap.
2. Installation: Installing a drain that effectively channels water away from the base of the tap, preventing water accumulation and dampness.
3. Repair and Prevention: Inspecting and repairing any existing water damage and implementing measures to prevent future water accumulation and pest infestations.

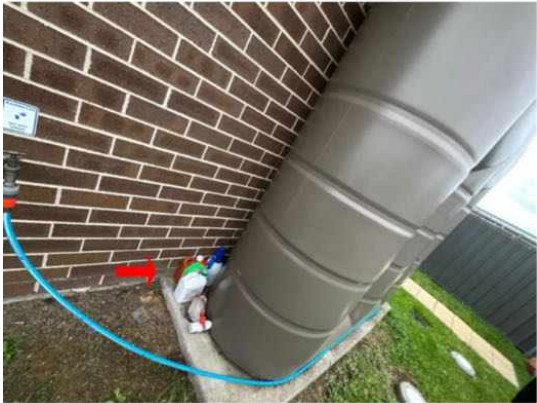
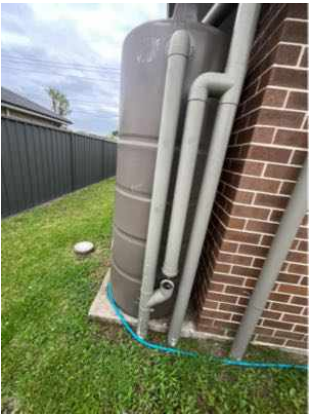
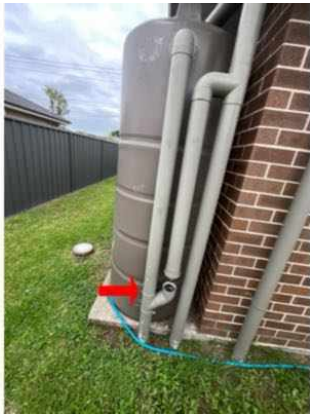
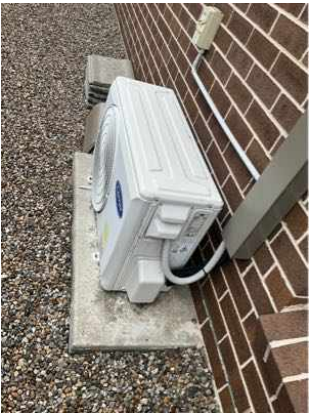
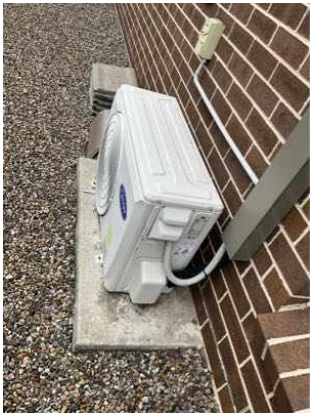
Finding 6.05

Building:	Main Building
Location:	All Areas
Finding:	Bridging or Obstruction Conducive environment for Termites
Information:	Bridging of termite barriers occurs when termites bridge (usually by building a mud tunnel) a termite barrier or inspection inspection zone or where termites have a passage, allowing them to bridge the barrier.

Where bridging has occurred full inspection is prevented and termites may enter a property in a concealed or undetected manner.

Recommended moving obstructions away from the external walls for further and future inspections.

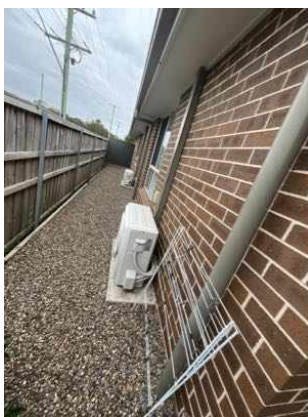
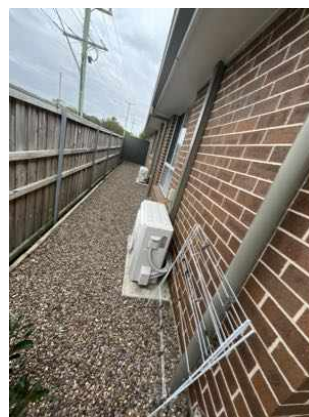
Finding 6.06

Building: Main Building
 Location: Exterior walls - right side
 Finding: Aircon - Excessive moisture conducive condition near Air-conditioner
 Information: Excessive moisture near an air conditioner can indeed create conducive conditions for termites. Termites are attracted to damp and decaying wood, which can be found in areas with high moisture levels. To fix this issue:

1. Fix Leaks: Check for any leaks or condensation around your air conditioning unit. Repair any damaged pipes, drains, or insulation

that may be causing moisture buildup.

2. Proper Drainage: Ensure that your air conditioner has proper drainage. Make sure the condensate drain line is clear and directed

away from your home's foundation.

3. Ventilation: Improve ventilation around the unit. Ensure that the area is well-ventilated to reduce humidity levels.

4. Regular Maintenance: Schedule regular maintenance for your air conditioning system. This can help prevent leaks and ensure

it's working efficiently, reducing the chance of moisture.

5. Please consult a HVAC Technician: HVAC (Heating, Ventilation, and Air Conditioning) technicians are trained to diagnose and

repair a wide range of air conditioning problems. They can handle issues with the cooling system, refrigerant, electrical components, and more.

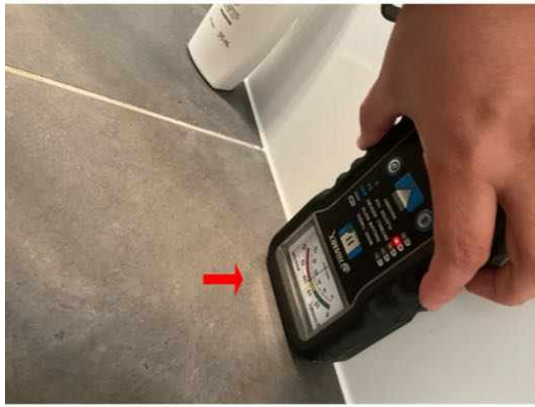
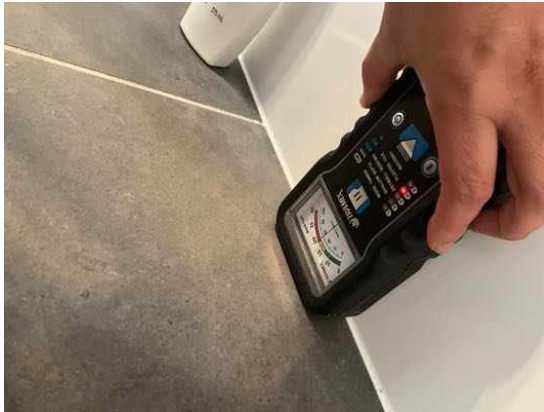
Building:	Main Building
Location:	Ensuite
Finding:	Excessive moisture - Conducive to Timber pest
Information:	Excessive moisture can attract termites and produce conditions that promote fungal growth and wood decay.

Excessive moisture is generally caused by deteriorated inadequate or missing roof drainage leaking plumbing pipes or fixtures poorly plumbed HWS overflows or condenser units and poor site drainage.

Prior to any remedial works being performed a qualified plumber should be appointed to further inspect the property and to identify the cause of the excessive moisture. Works to remove affected building elements may then be necessary and should be performed by an appropriate tradesperson.

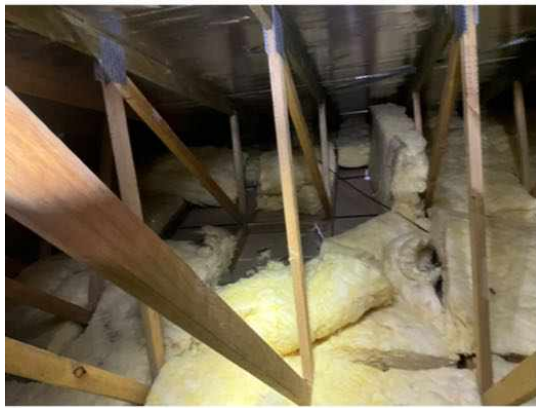
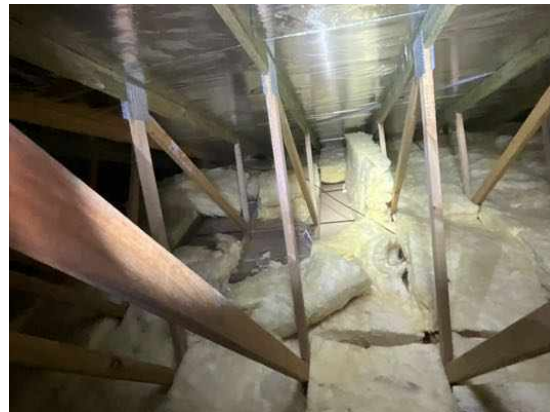
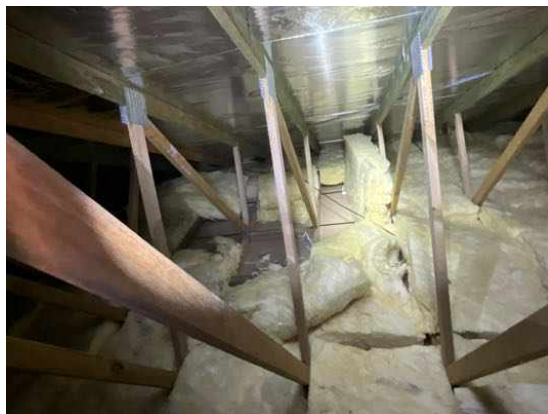
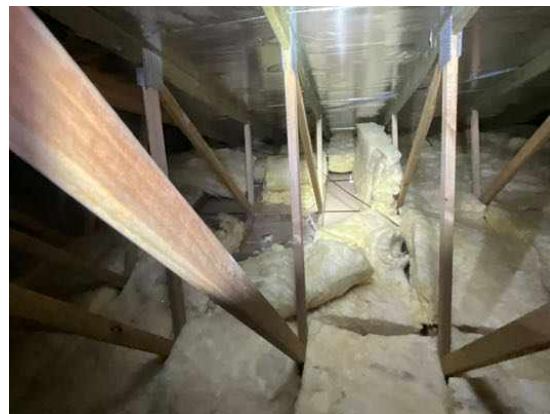
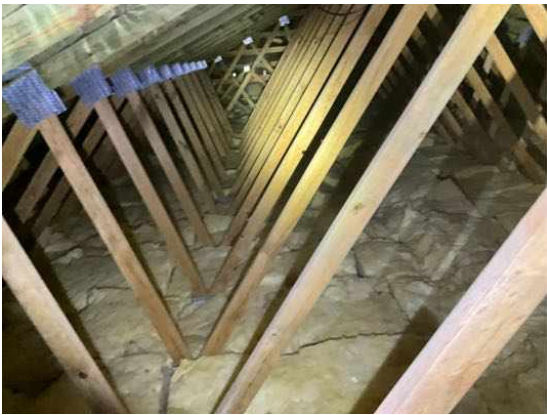
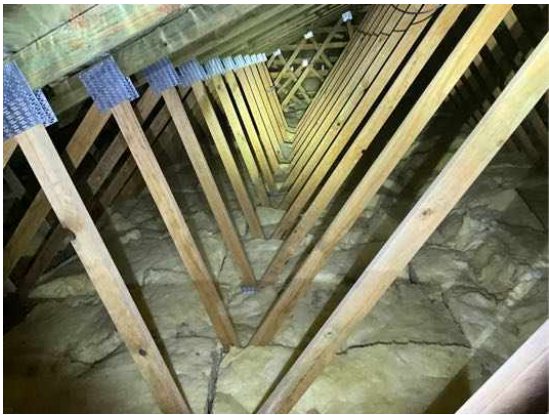
Building: Main Building
Location: All Areas
Finding: Additional Photos - Obstructions and Limitations
Information: These photographs are an indication of the obstructions and limitations which impeded full inspection of the property at the time of inspection. These obstructions can hide an array of defects and should be removed to allow full inspection to be carried out. A re-inspection is recommended once the areas are made accessible.

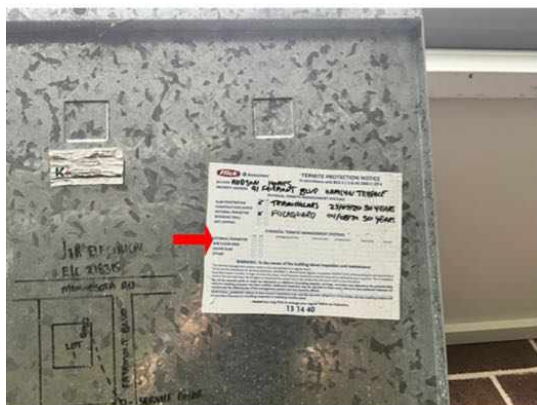
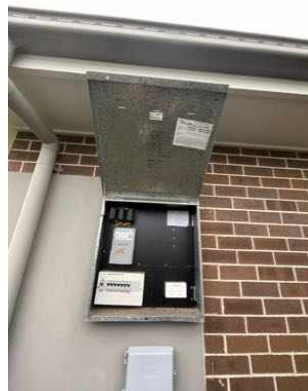
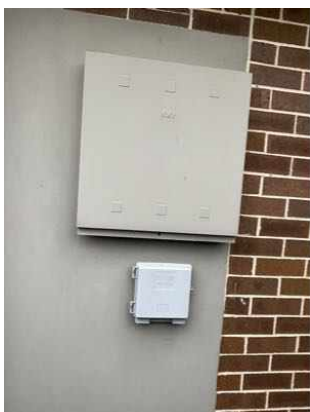
- Building: Main Building
Location: Exterior walls - right side
Finding: Evidence of Termite Management System - Durable notice / Legible Sticker - seek further information
Information: The application of a pre & post-construction chemical termite barrier is highly recommended for all properties. Such barriers are highly effective in preventing termite

A durable notice placed in the switchboard unit to indicate termite barriers at the time of inspection.

Client must seek further information from the vendor or real estate agent if the conditions of termite management systems were maintained as per the label or seek advise from licensed pest controller.
