# Building and Timber Pest Inspection Report

Inspection Date: Thu, 19 Mar 2026

Property Address: 81 Kane Dr, St Leonards VIC 3223, Australia

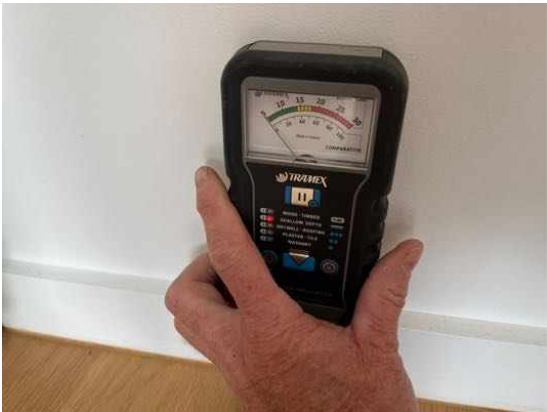
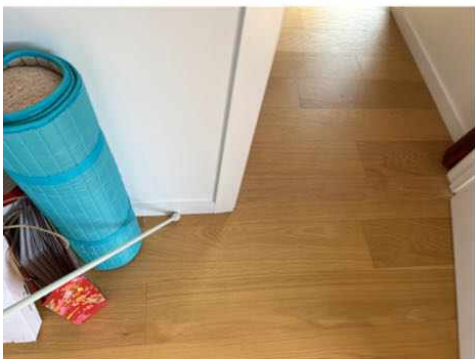
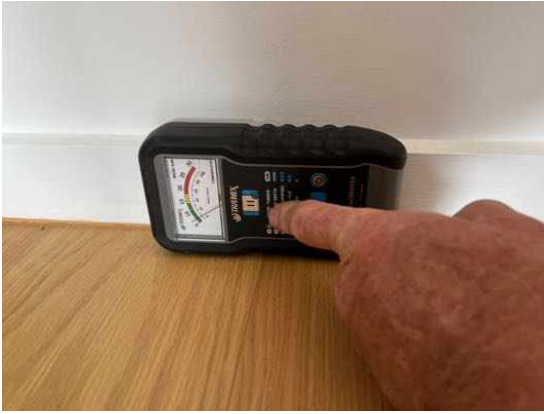
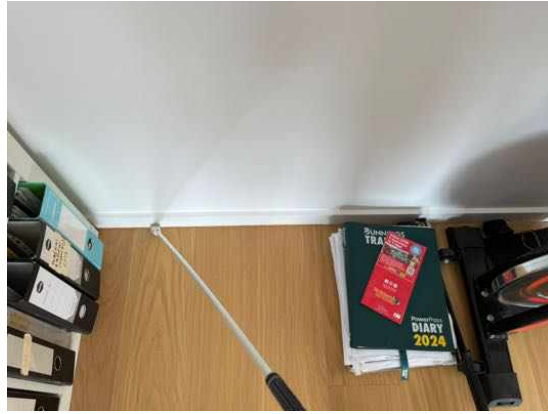
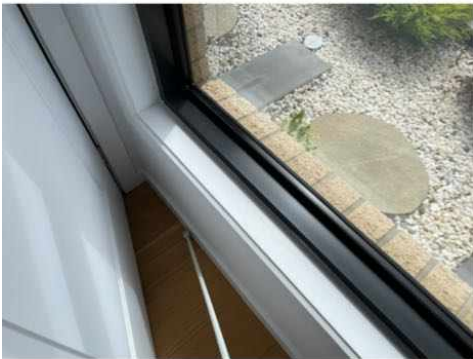
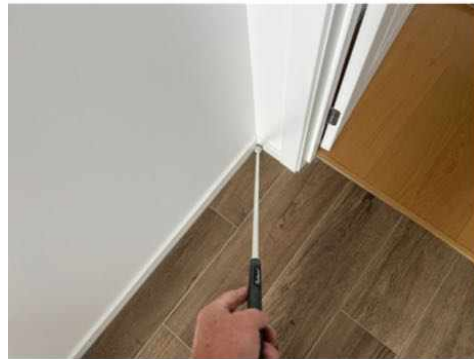
Termite activity generates high temperatures and moisture and if this irregularity is found it can be grounds for further investigation.

Wall paneling, floating timber flooring, carpet and fixed cabinetry can obscure termite activity.

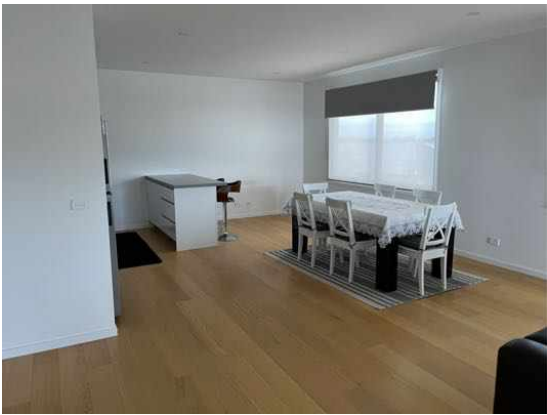
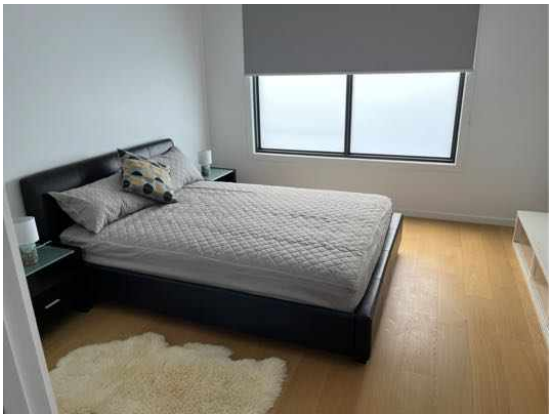
These obstructions can hide an array of defects and should be removed to allow full inspection to be carried out. A re-inspection is recommended once the areas are made accessible.
