# Building and Timber Pest Inspection Report

Inspection Date: Mon, 23 Feb 2026

Property Address: 9 Stanger Ct, Wodonga VIC 3690, Australia

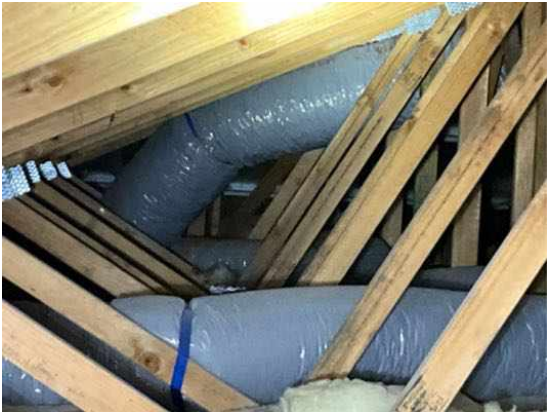
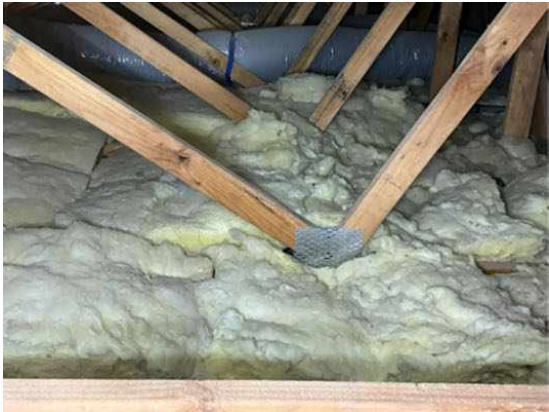
Building: Building 1  
 Location: All Areas  
 Finding: Additional Photos - Obstructions and Limitations  
 Information: These photographs are an indication of the obstructions and limitations which impeded full inspection of the property at the time of inspection. These obstructions can hide an array of defects and should be removed to allow full inspection to be carried out. A re-inspection is recommended once the areas are made accessible.
