Building and Timber Pest Inspection Report

Inspection Date: Thu, 15 Jan 2026

Property Address: 4/16 Baudin Ave, Shell Cove NSW 2529, Australia

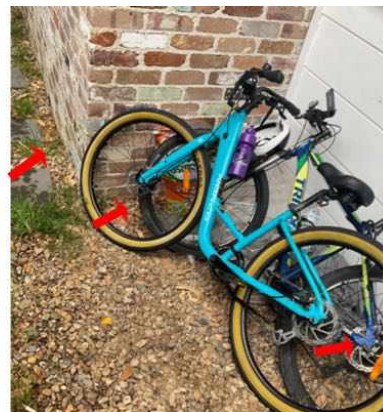
Finding 6.03

Building:	Building 1
Location:	Exterior walls
Finding:	Slab Edge - Exposure

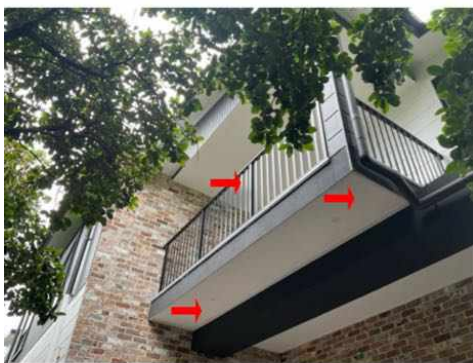
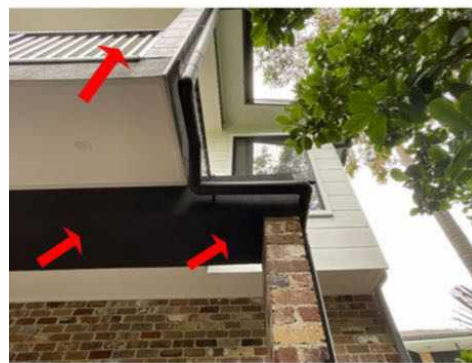
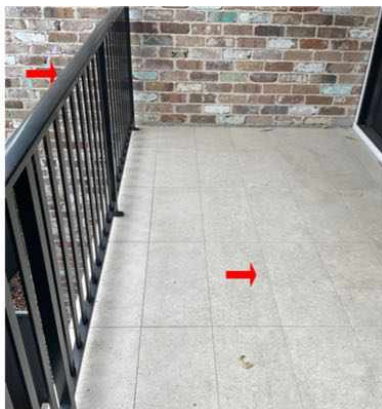
Noted Item

Building: Building 1
 Location: All External Areas
 Finding: Additional Photos - Obstructions and Limitations of EXTERNAL AREAS
 Information: These photographs are an indication of the obstructions and limitations which impeded full inspection of external areas at the time of inspection. These obstructions can hide an array of defects and should be removed to allow full inspection to be carried out. A re-inspection is recommended once the areas are made accessible.

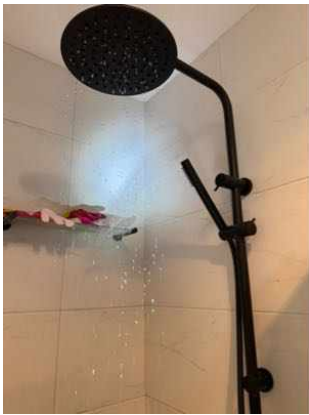
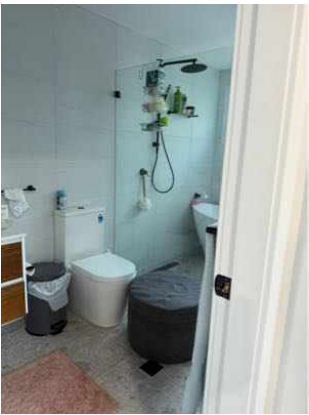
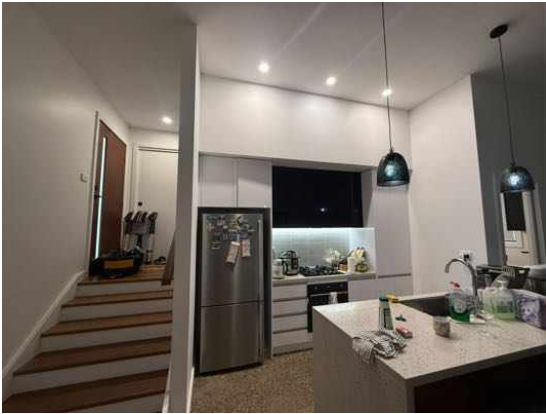
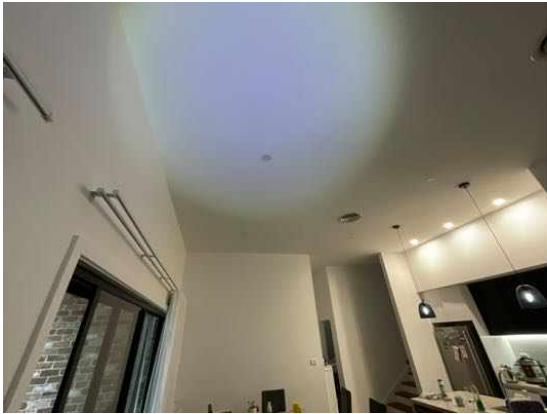
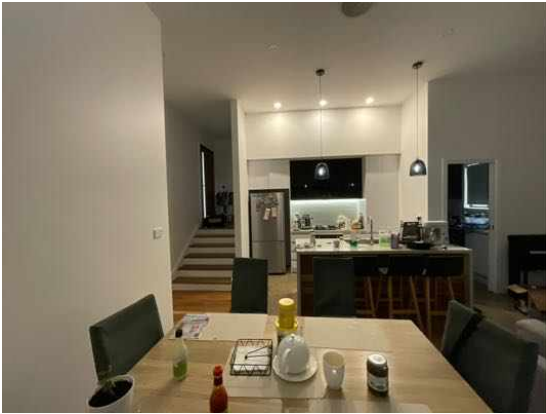
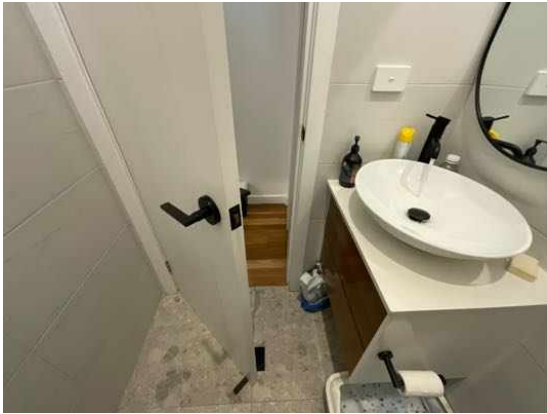
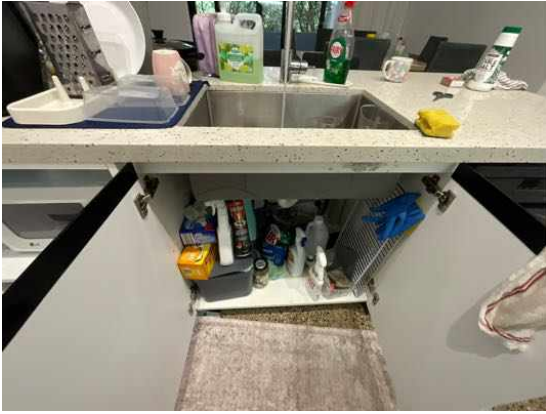
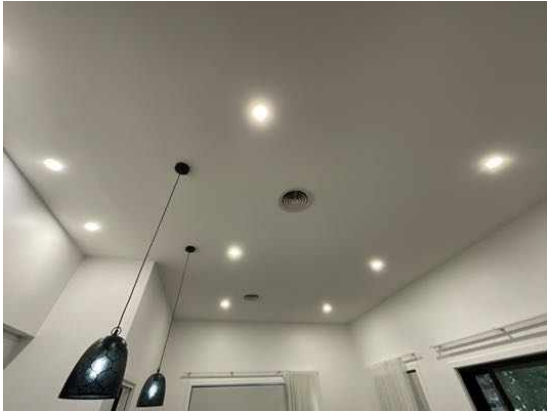
Noted Item

Building: Building 1
Location: All Internal Areas
Finding: Additional Photos
Information: Additional photos are provided for your general reference
