Building Inspection Report

Inspection Date: Wed, 1 Apr 2026

Property Address: 1/14 Milton Ave, Clayton South VIC 3169,
Australia

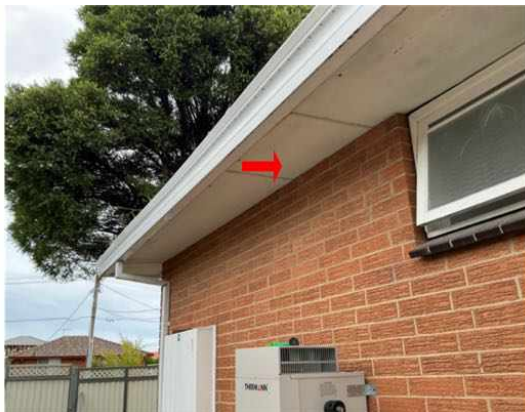
Defects 1.01

Building:	Main Building
Location:	Eaves
Finding:	Asbestos - Suspected ACM Identified on Site
Information:	Reporting on Asbestos is outside the Scope of this Report. This suspected defect is highlighted as a caution only. We suspect, based on our experience in the building industry, that there is a higher risk of the identified building element containing asbestos.

As Asbestos Reporting is outside the scope of this report, we advise that you consider a separate Asbestos Inspection and Condition Audit, which can include the taking of samples for definitive confirmation of the presence of Asbestos.

In the interim, the client is advised to act with caution, especially when considering any damage to building materials general wear and tear renovations extensions demolition and general maintenance activities due to the suspected presence of Asbestos.

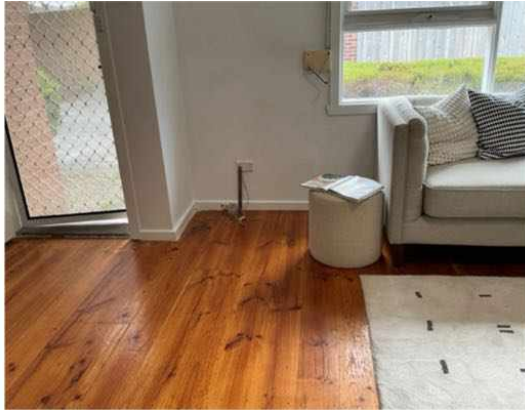
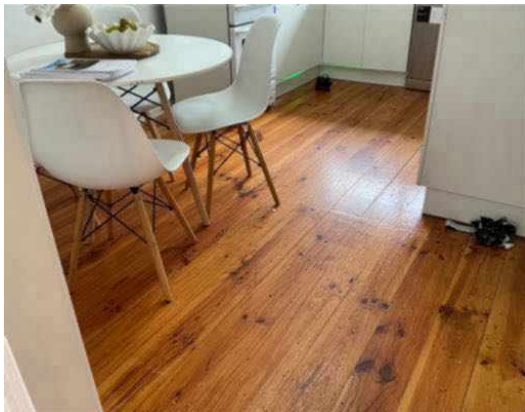
Defects 2.01

Building:	Main Building
Location:	All Areas
Finding:	Flooring - Uneven
Information:	The internal flooring in this area is out of level and uneven. Uneven flooring is likely to indicate minor defects such as expected movement of the foundations of the property, but may also indicate subsidence of the associated subfloor stumps.

It is advised that the flooring be closely monitored to identify any further movement. Where flooring remains relatively unchanged for an extended period of time (i.e. several months), it is likely that this defect has been caused by expected movement of the foundations of the property.

However, where flooring is uneven further, potentially invasive inspection of the subfloor structures and stumps in this area is required. In this case, works to repair are likely to be required, and would be carried out by a registered builder specialising in re-stumping.

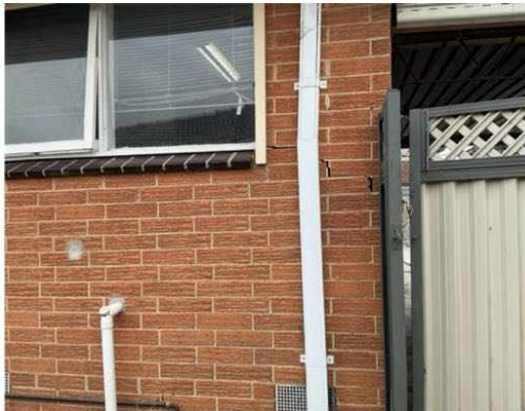
Defects 2.02

Building: Main Building
Location: All Areas
Finding: Brickwork cracking major and minor
Information: There are several minor cracks evident throughout the exterior of the dwelling. These cracks are commonly less than 5mm in width and are expected in a property of this age and can be easily filled and monitored in the future.

There are also several larger more noticeable major cracks and crack repairs evident to the dwelling. These cracks usually coincide with openings (windows and doors) however they can present in other areas also. Cracks of this type are likely to have been caused by minor expected movement of building elements, but may also have a structural cause that is more significant.

Noticeable cracks in brickwork may develop if left unattended with the potential of necessitating remedial works or replacement of sections of brickwork. Always monitor these cracks and contact a building inspector should cracks widen lengthen or become more numerous.

A qualified bricklayer should be contacted immediately to estimate and perform repair and restoration works. Consultation with a structural engineer may be required where structural instability is found to be the underlying cause of the cracking.

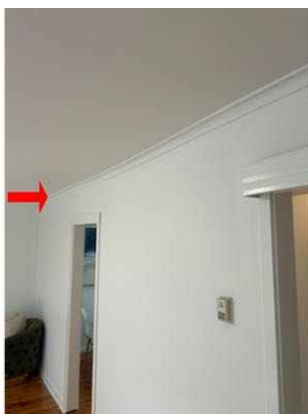
Defects 2.03

Building:	Main Building
Location:	Living Room
Finding:	Ceiling - Sagging
Information:	Sections of the ceiling were found to be sagging at the time of inspection. Sagging to the fixed ceiling structure generally indicates that the building materials have swollen, due to contact with water, or that fixings (e.g. nails or glue) have become loose and require reattachment.

In some cases, sagging ceiling linings may also indicate that there are structural issues, causing surfaces to warp, twist or sag. Where sagging appears to be major, appointment of a structural engineer is advised to further inspect the property and identify the source and rectification works required.

Where minor sagging is evident, comparatively minor works, such as re-gluing of ceiling sheets, may be required. Such works may be performed by relevant tradespeople, such as plasterers and painters. Where excessive moisture has caused the roofing structure to swell and sag, the source of the water leak should primarily be identified prior to any remedial works being performed.

The appropriate action should be taken by the client as soon as possible to ensure that any potential further damage is limited.

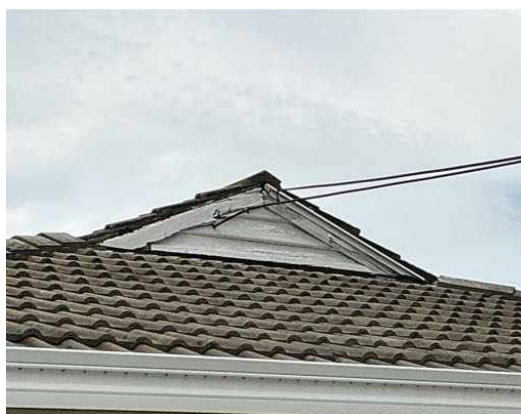
Defects 3.01

Building:	Main Building
Location:	Front Elevation
Finding:	Weatherboards - Rotting
Information:	The external weatherboards show signs of fungal decay (wood rot) in several sections. This wood rot is suspected to have developed over a prolonged period of time due to frequent weather exposure, which is expected in a property of this age and condition

Weatherboards are sealed and protected by paint and other sealants. When these sealants deteriorate over time, they allow water penetration to the weatherboards, causing wood rot. If left unmanaged, the wood rot is likely to develop further, possibly necessitating major repair or replacement works in the long-term future.

To maintain the condition of the external wall cladding, any severely affected weatherboards should be substituted as soon as possible with pre-treated replacements. Where weatherboards have rotted due to excessive moisture other than rain penetration, the cause of the moisture should be identified immediately by a licensed plumber. A qualified carpenter should be appointed to repair and replace rotting weatherboards.

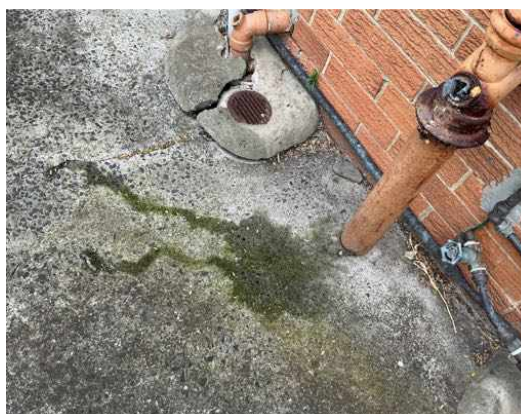
Defects 3.03

Building:	Main Building
Location:	Toilet plumbing
Finding:	Toilet - Leaking
Information:	At the time of inspection, the toilet showed evidence of leaking during operation.

Although common, internal water leaks can be detrimental to surrounding building elements. Rust, corrosion, decay and water damage are all potential outcomes of a water leak that is left unattended, which are then likely to develop into more serious defects and may necessitate major repair works. Additionally, internal water leaks may significantly increase the water usage within the property.

It is highly advised that internal water leak be addressed by a licensed plumber as soon as possible. Use of the leaking toilet should be minimised until such time.

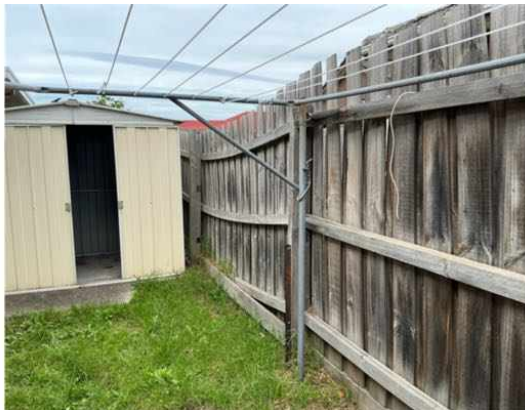
Defects 3.06

Finding: Fencing - Deteriorated

Information: It was noted at the time of inspection that sections of the fencing throughout the property have deteriorated. Typically fencing deteriorates due to age and or wear, rot and or rust which is generally expected for a structure of this age, due to prolonged exposure to weather conditions. Sometimes inadequate installation or maintenance can be to blame.

If left unattended, it is likely that further damage will occur. It is suspected that repair of several elements of the fencing may be required however replacement may be a consideration of the client also.

A licensed fencing contractor should be appointed to provide further advice and perform rectification works as necessary.

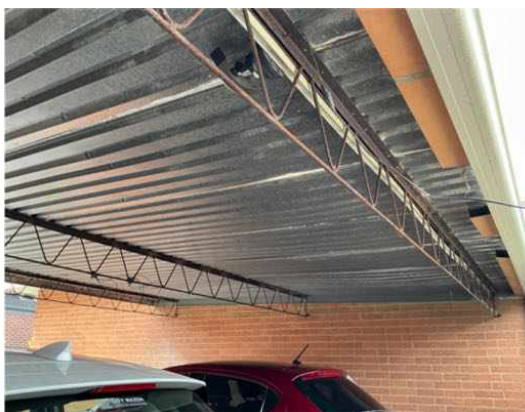
Defects 3.07

Building:	Main Building
Location:	Carport
Finding:	Roof sheets - Rusted
Information:	Metal roofs generally comprise numerous individual sheets, which join and overlap. These intersections are particularly prone to lift at the edge and consequently rust at these points.

Upon inspection of the exterior roofing structure, evidence of rust to these sections was identified. If left unmanaged, these degrading joints can allow water ingress to the internal roofing structures, potentially leading to secondary damage of building elements. Accelerated deterioration of the roofing sheets and any associated building elements is also likely to occur.

A roofing contractor should be appointed immediately to assess the damage to the roofing sheets and to perform remedial works as necessary. Works may include replacement of severely affected roofing sheets or minor works such as the application of rust-retardant surface protectors.

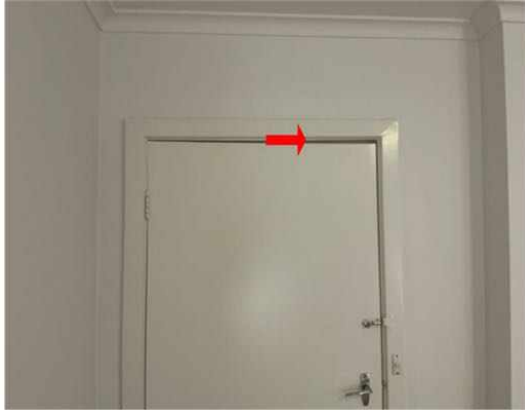
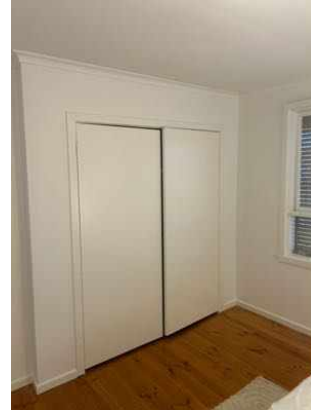
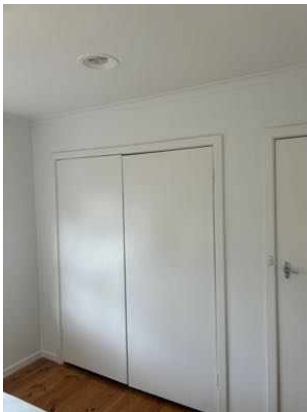
Defects 3.10

A gap to the head of the door may also indicate movement of the foundation of the property, which is a common occurrence and does not indicate structural damage.

A qualified carpenter should be appointed to perform remedial works to restore the door to a fully operational level.

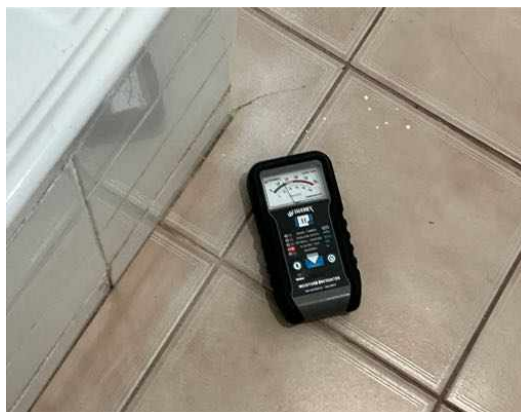
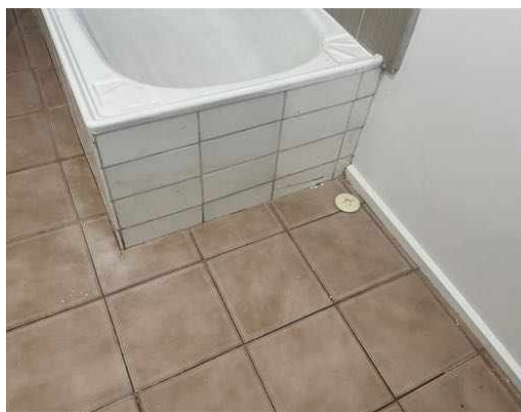
Defects 3.11

Finding: Cracked floor tiles

Information: Cracking in the floor tiles was evident in this area at the time of inspection. It is suspected that this cracking has occurred as a result of minor settlement or shrinkage of the slab.

While not considered a matter of urgency, replacement of cracked floor tiles is

recommended at the clients discretion. A tiling contractor may be appointed to perform these works. Where cracks become more numerous, contact a licensed building inspector for further investigation.

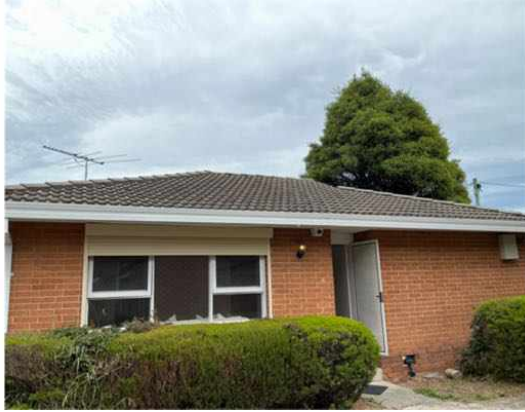
Defects 3.12

Building:	Main Building
Location:	Roof Exterior
Finding:	Roof tiles - Weathered
Information:	Upon inspection of the exterior roofing, the majority of roof tiles were considered to be in a fair condition. While weathering of the tiles is consistent with the age of the property, maintenance works are required.

Where left unmanaged, deteriorating roof tiles are likely to lead to a number of secondary defects, including minor water leaks and weather exposure to internal roofing structures.

Consultation with a roofing contractor is highly advised to gain advice on cost of remedial works that may be required in the short to medium term. Remedial works are likely to increase the longevity of the exterior roofing structure.

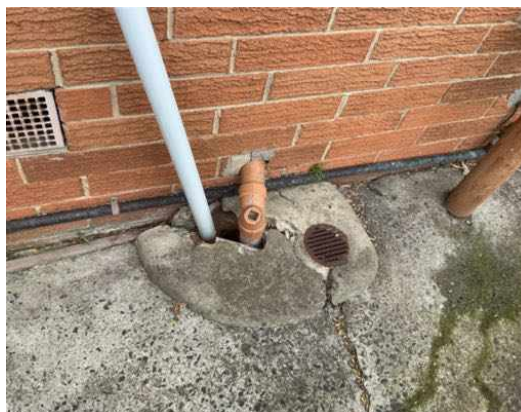
Noted Item

Building: Main Building
 Location: All Areas
 Finding: Terracotta pipes
 Information: Terracotta drainage pipes (sometimes referred to as clay or vitrified clay pipes) have been used for many many years. The use of clay drainage pipes dates back to the Romans, who used the clay pipe system as it was easy to manufacture, straightforward to lay and, for the most part, reliable. However, due to the rigid and brittle nature of clay or terracotta pipes problems can begin to occur over time. Even if they're functioning fine now, clay pipes will need replacing eventually.

The average lifespan of a clay pipe sewer system is 60 years — which means an upgrade is decades overdue for many homes. For your peace of mind you may wish to have your sewer pipes inspected and replaced before a major problem occurs
