# Building and Timber Pest Inspection Report

Inspection Date: Wed, 14 Jan 2026

Property Address: 180 Ryde Rd, West Pymble NSW 2073,  
Australia

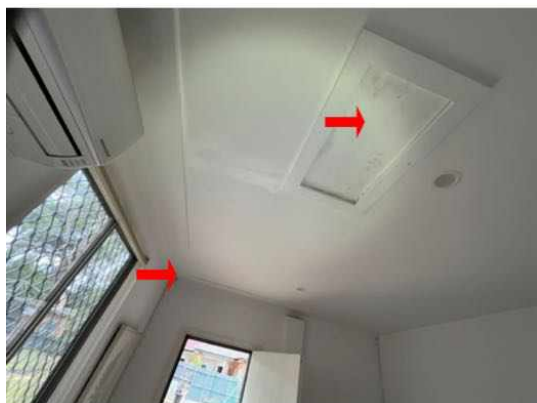
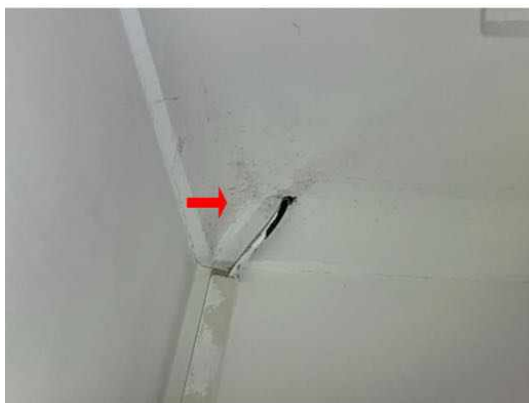
Building:	Main Building
Location:	Bedroom 5
Finding:	Mould - Present
Information:	Where evidence of mould growth was noted, there may be environmental, biological or health issues associated with the report. A specialist inspection by a suitably qualified environmental health inspector is warranted, where mould is extensive or where any queries regarding air quality spores or other related issues apply.

Generally, the client is advised to ensure that the general environment is free of moisture and humidity to aid in the prevention of mould formation and development. Any mould found during the inspection should be cleaned immediately by a cleaning contractor or the homeowner as applicable.

Please note that severely affected building elements may require replacement by a licensed builder or carpenter.

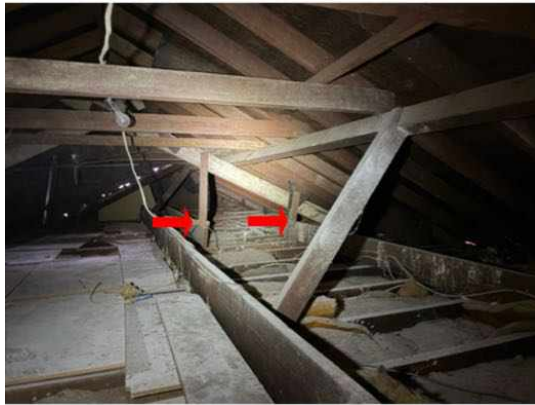
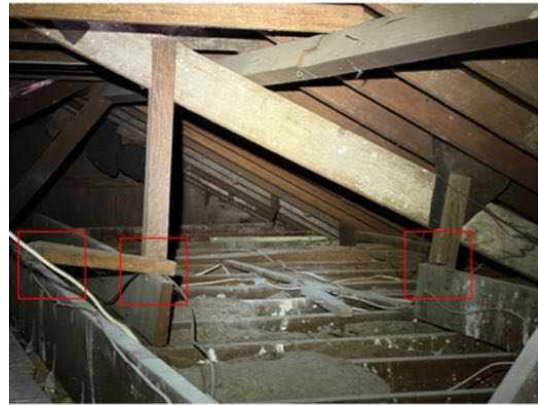
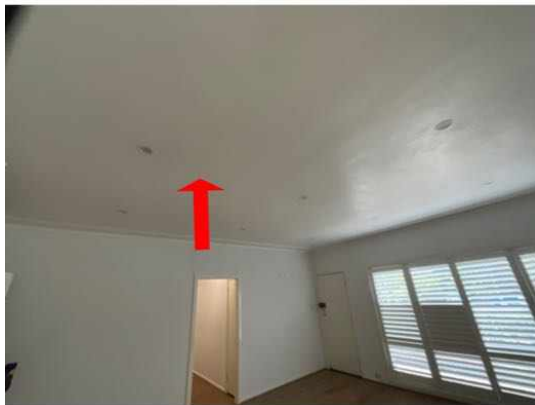
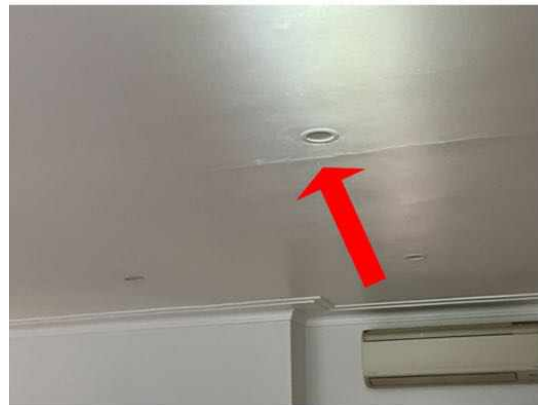
#### Finding 2.01

Building:	Main Building
Location:	Roof Void
Finding:	Roof Structure - Altered
Information:	The roofing structure was found to be altered in this area at the time of inspection.

Altered roof structures are likely to create strain on associated building elements, creating potential for secondary damage. The roof is also unlikely to have sufficient

Hanging beams must only support ceiling joists and attached ceiling materials. The hanging beam should be adequately supported on its ends over load bearing Walls.

Remedial works are highly advised and should be performed by a licensed builder or roofing contractor as soon as possible.

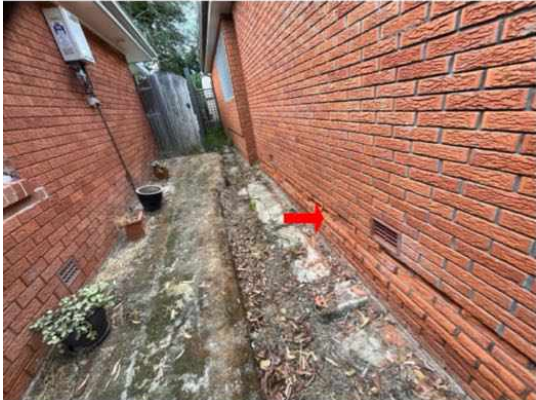
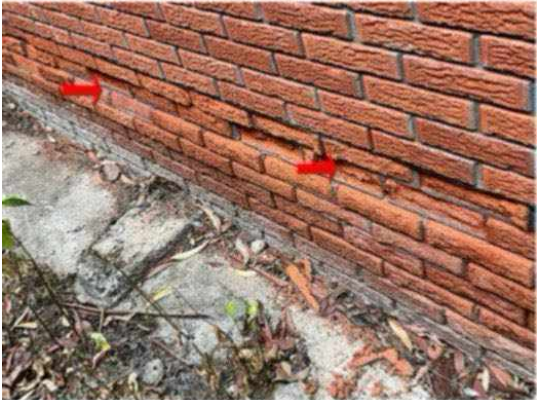
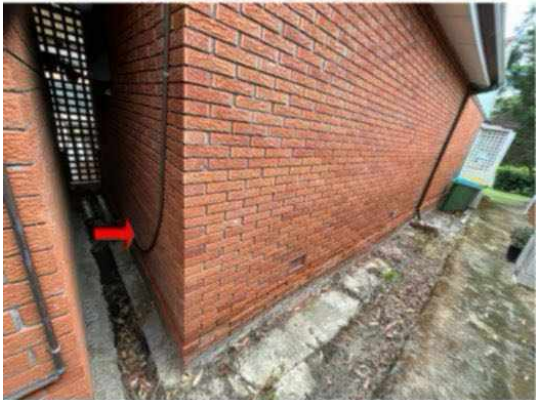
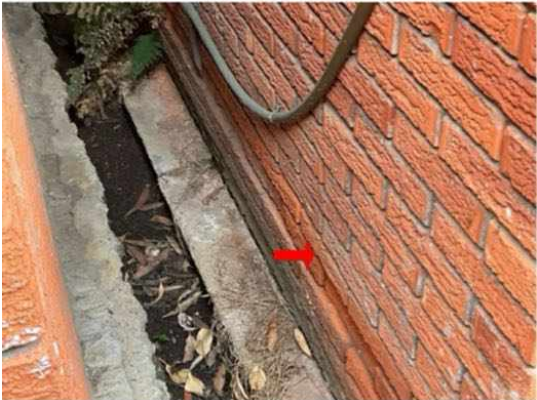
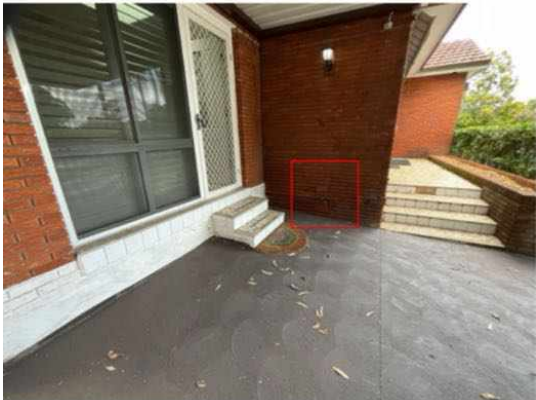
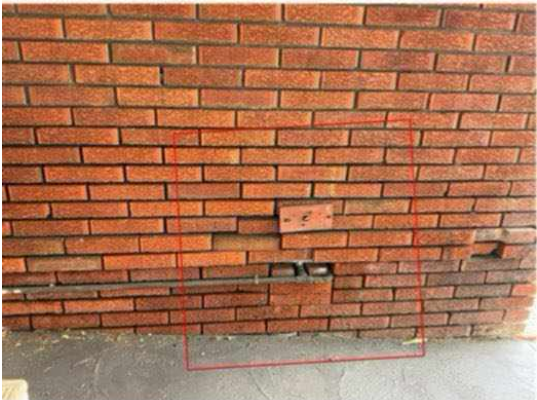
## Finding 2.02

Building:	Main Building
Location:	Multiple areas
Finding:	Brick and Mortar - Deteriorated (Erosion)
Information:	The masonry in this area was found to be deteriorated. Mortar, or 'bedding', is the material which fills joins and intersections between bricks in masonry walls and structures.

Commonly referred to as corrosion or erosion, the bricks and mortar are aged and likely to have been affected by a variety of factors, including moisture, salt-based deterioration, and more.

Mortar and brickwork should be replaced to ensure the structure remains in their intended location and to prevent gaps, which would allow water or moisture ingress and secondary damage as a result.

This can be addressed by a licensed bricklayer where areas of deterioration are localised and easily accessible.

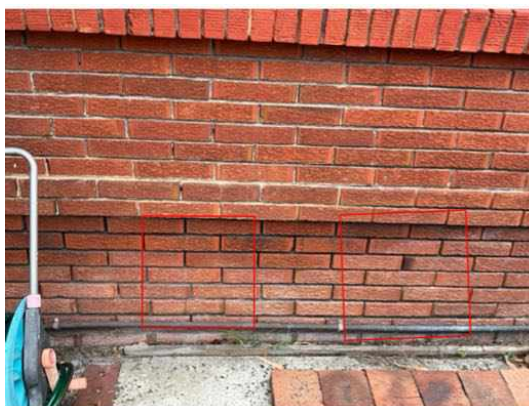
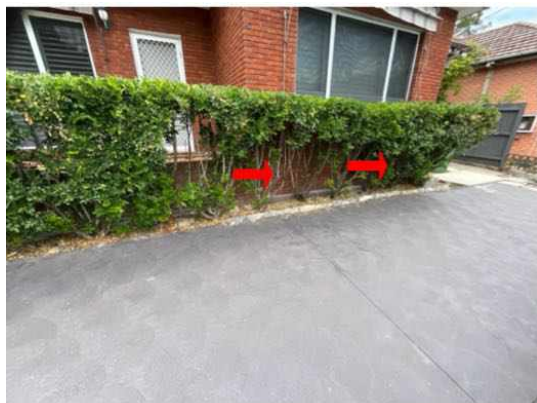
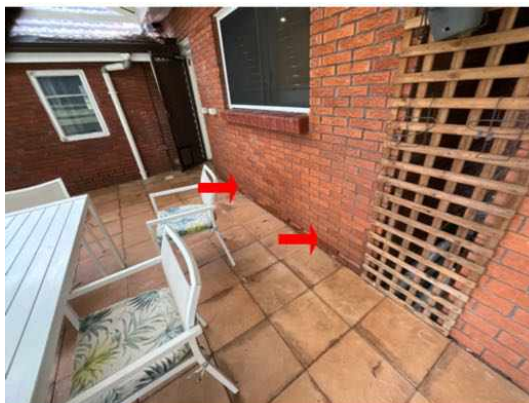
### Finding 2.03

Building:	Main Building
Location:	Multiple areas
Finding:	Site drainage— Inadequate
Information:	The site drainage in this area was found to be inadequate at the time of inspection, creating potential for subsequent water damage to associated building elements. This is additionally conducive to termite activity.

It is important that water does not lie against the base of walls; surrounding paths and ground levels should be sloped to drain water away from walls. Downpipes should not discharge stormwater onto lower walls or plinths. Stormwater should be carried away by large, regularly cleaned drains. Ground levels may need to be lowered to expose a buried DPC.

Where site drainage is inadequate, installation of an Agricultural (Aggie) Drain may be required. A licensed plumber should be appointed to further inspect the property and perform any remedial works as necessary. Water damage and secondary defects are likely to occur if left unmanaged.

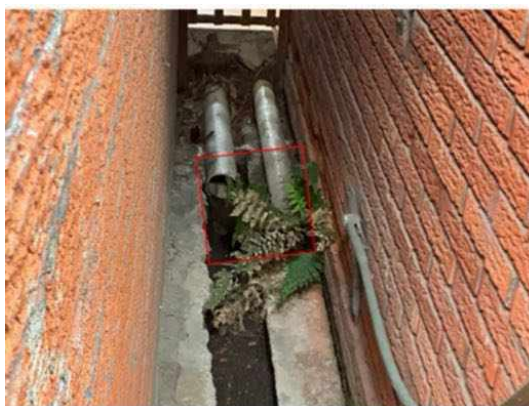
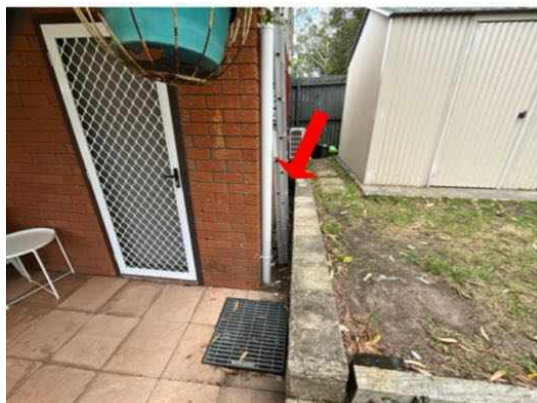
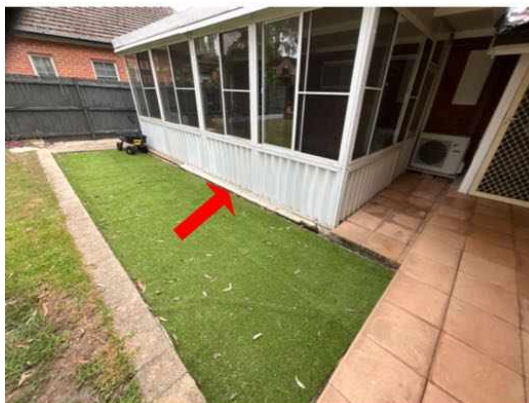
## Finding 2.04

Building:	Main Building
Location:	Retaining Walls
Finding:	Retaining wall — Defective
Information:	The retaining wall in this area was found to be defective at the time of inspection. Generally, defective retaining walls are caused by poor original design or material use. However, deteriorated retaining walls may also be a result of substandard construction, poor site drainage or unmanaged stormwater flows.

AS4349.1-2007 requires all retaining walls in excess of 700mm to be inspected by a licensed and practicing structural engineer.

The structural engineer may draft a scope of works for a licensed trade to carry out rectifications.

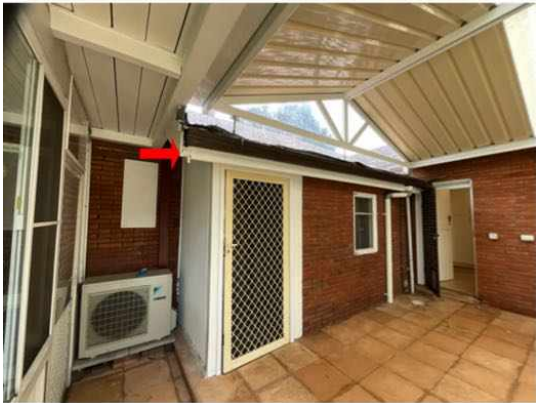
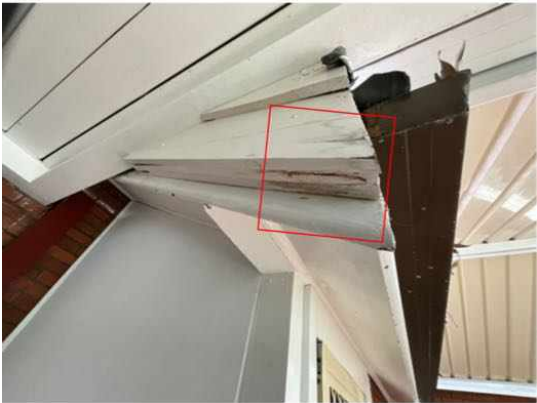
**Finding 3.02**

Building: Main Building  
 Location: Alfresco eaves

Information: Where evidence of mould growth was noted, there may be environmental, biological or health issues associated with the report. A possible cause could be excess moisture due to overflow of stormwater from the gutters as a result of gutters being blocked.

Generally, the client is advised to ensure that the general environment is free of moisture and humidity to aid in the prevention of mould formation and development. Any mould found during the inspection should be cleaned immediately by a cleaning contractor or the homeowner as applicable.

The client is advised to ensure the gutters are always maintained and free of debris.

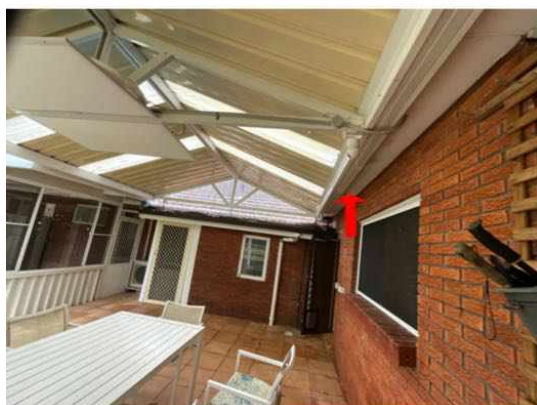
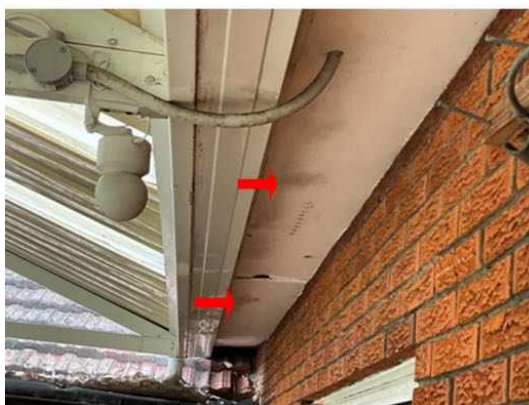
### Finding 3.03

Information: This handyman work appears to have been completed to a substandard level and does not comply with regular building practices. Where handyman work is not completed satisfactorily, accelerated deterioration of the associated building elements is likely to occur and secondary defects to surrounding structures may develop.

It is highly recommended that the substandard work be rectified by professional services. Works to improve this area are likely to increase the safety and the operation of the associated building elements.

The client should exercise care when coming into the immediate vicinity of the substandard works. Rectification works are advised as soon as possible by the appropriate trades.

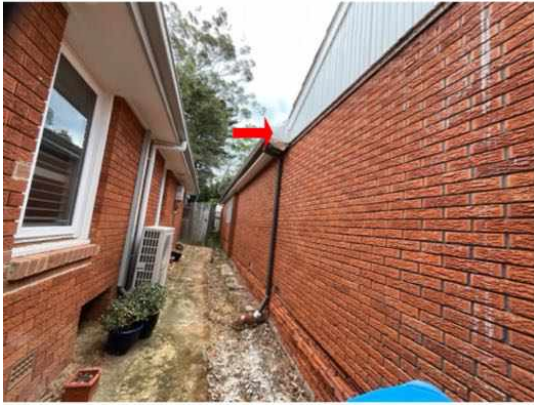
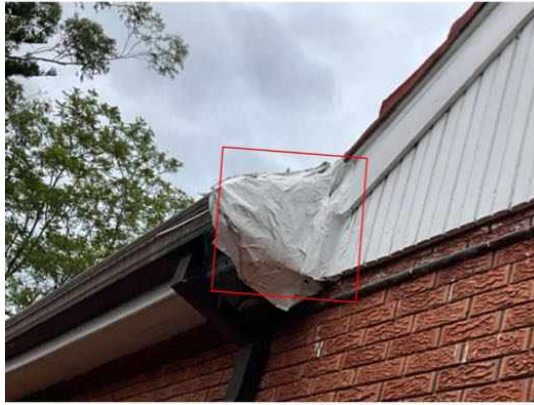
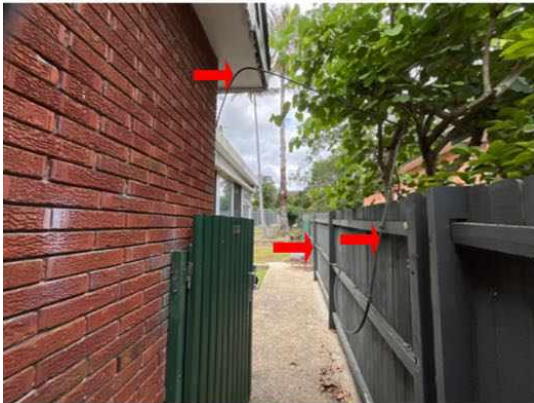
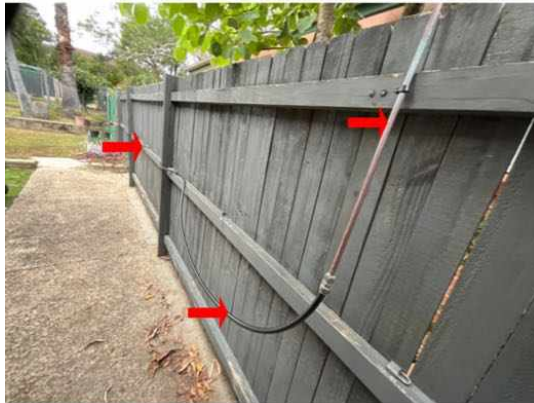
### Finding 3.04

Building:	Main Building
Location:	Multiple areas
Finding:	Plumbing - Point of connection non-compliant
Information:	At the time of inspection it was noted that connections between above ground pipe work and below ground sewer/storm water systems were incomplete.

Additionally, where sewer pipes are concerned, gases can escape from unsealed connections which can pose a serious health risk.

Engagement of a certified plumber is strongly recommended to ensure all connection points are sealed in accordance with the plumbing construction guidelines.

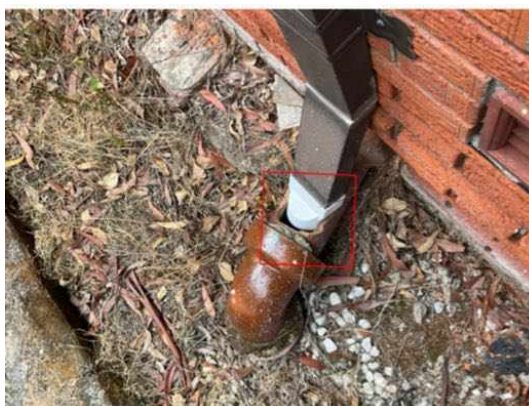
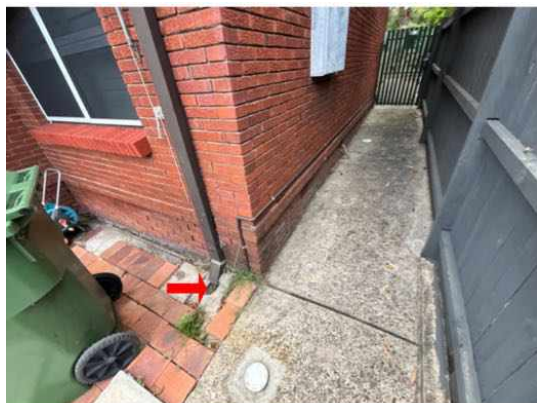
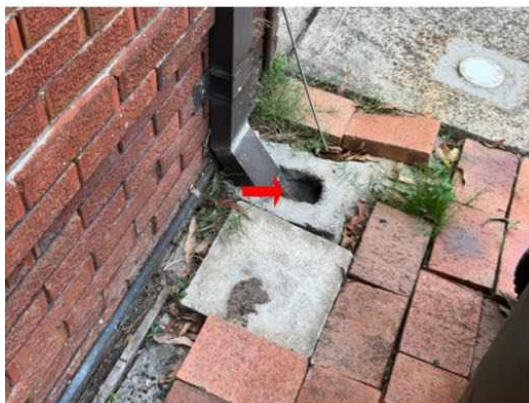
### Finding 3.05

Building:	Main Building
Location:	Verandah
Finding:	Stormwater drain - Not connected
Information:	The roof plumbing is not adequately connected to stormwater drainage on the site. This disconnection negatively impacts the functional capacity of the roof plumbing.

Where roof plumbing doesn't drain adequately, the area at the base perimeter can become excessively damp, potentially creating an environment that is susceptible to rust and corrosion of surrounding building elements, as well as attracting termites and other pests.

It is highly recommended that a plumber be appointed to further inspect the area and to install adequate drainage equipment where necessary.

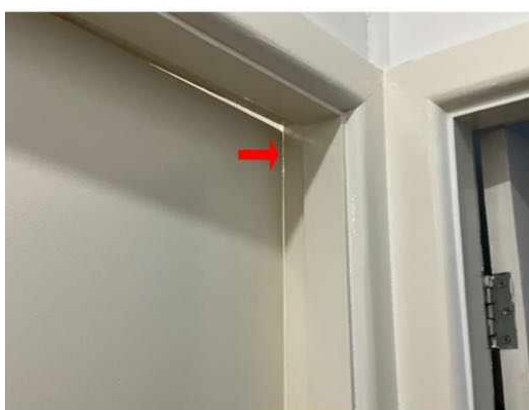
### Finding 3.18

Finding: Cracking - Damage Category 1 - Fine (up to 1mm)

Information: Although fine cracks are quite noticeable, they are often only considered to be an appearance defect, and usually do not indicate any structural damage. Generally, the cause of a fine crack is indicative of a separation between building materials and finishes (e.g. paint, plaster, etc.) along joins.

Cracking of this nature can generally be repaired with minor sanding, filling and/or repainting. Such works should be performed by a qualified painter or a general handyman.

Monitoring of all cracking should be conducted frequently. Always contact a building inspector should cracks widen, lengthen, or become more numerous.

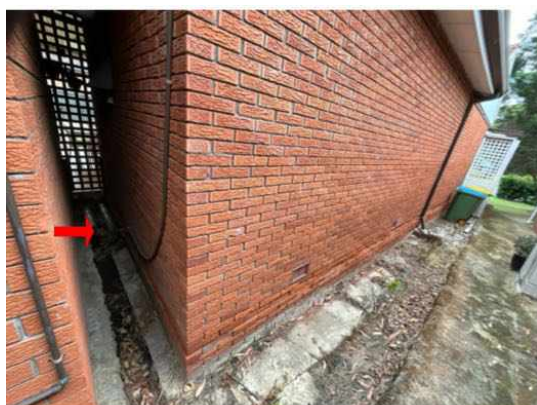
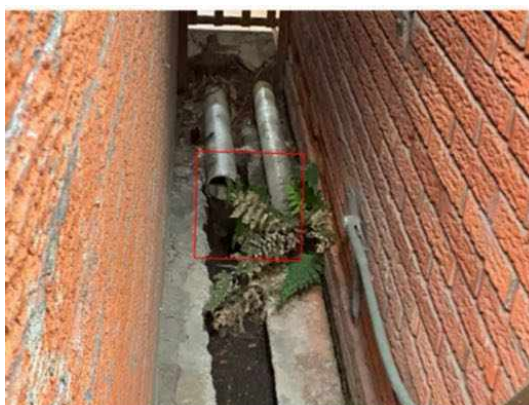
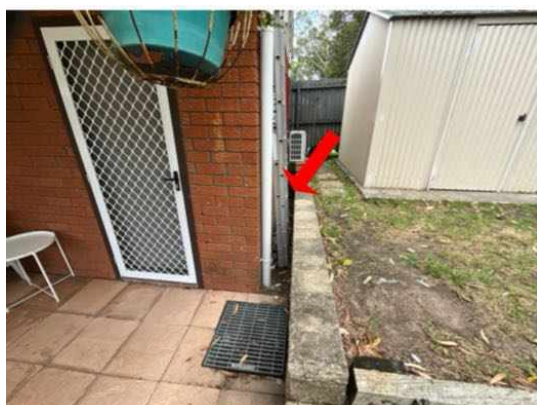
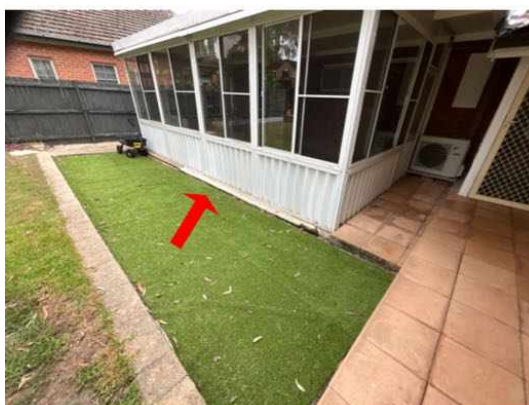
Building:	Main Building
Location:	Multiple areas
Finding:	Site drainage— Inadequate
Information:	The site drainage in this area was found to be inadequate at the time of inspection, creating potential for subsequent water damage to associated building elements. This is additionally conducive to termite activity.

It is important that water does not lie against the base of walls; surrounding paths and ground levels should be sloped to drain water away from walls. Downpipes should not discharge stormwater onto lower walls or plinths. Stormwater should be carried away by large, regularly cleaned drains. Ground levels may need to be lowered to expose a buried DPC.

Where site drainage is inadequate, installation of an Agricultural (Aggie) Drain may be required. A licensed plumber should be appointed to further inspect the property and perform any remedial works as necessary. Water damage and secondary defects are likely to occur if left unmanaged.

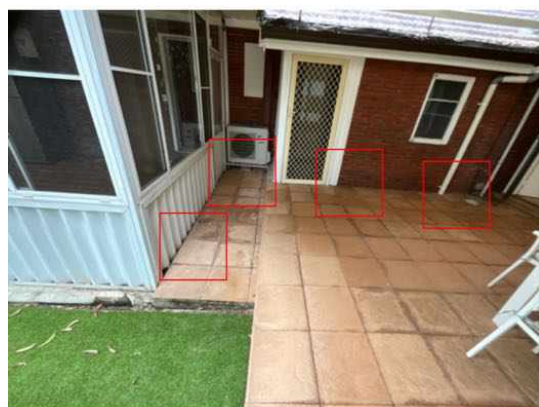
### Finding 6.03

Building: Main Building  
 Location: Rear Elevation  
 Finding: Bridging or breaching of termite barriers - damp course level  
 Information: Bridging is the spanning of a termite barrier or inspection zone so that subterranean termites are provided with passage over or around that barrier.

Damp proof course (DPC) is a barrier of impervious material built into a wall or pier to prevent moisture from moving to any part of the building. Where external ground levels are built up over this barrier ingress is provided for moisture from the exterior grounds into the base brickwork or other building material and allowed to rise.

Such conditions attract termites into these damp areas which is likely to lead to infestation if left untreated.

While retrospective fitting of DPC is considered to be impractical works are required in order to prevent the extraction of moisture from the external environment into exterior brickwork or wall materials. Landscaping or re-paving of external grounds may be considered by the client. Regular annual inspections are strongly advised.

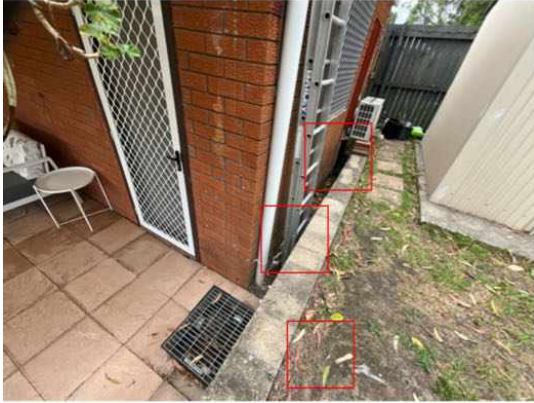
### Finding 6.04

Building:	Main Building
Location:	Verandah
Finding:	Stormwater drain - Not connected
Information:	The roof plumbing is not adequately connected to stormwater drainage on the site. This disconnection negatively impacts the functional capacity of the roof plumbing.

Where roof plumbing doesn't drain adequately, the area at the base perimeter can become excessively damp, potentially creating an environment that is susceptible to rust and corrosion of surrounding building elements, as well as attracting termites and other pests.

It is highly recommended that a plumber be appointed to further inspect the area and to install adequate drainage equipment where necessary.

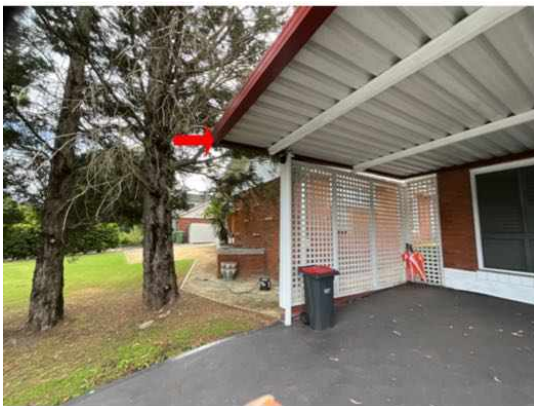
### Finding 6.05

Building:	Main Building
Location:	Meterbox
Finding:	Termite Management System - no evidence of installation
Information:	The application of a post-construction chemical termite barrier is highly recommended for all properties, particularly if live termite activity has been found on the site previously. Such barriers are highly effective in preventing termite attack on any timber building elements throughout the property.

The client may consider gaining further advice from a pest controller as to the costs and procedures involved with this application. It is recommended that obtaining such advice be a short-term priority.

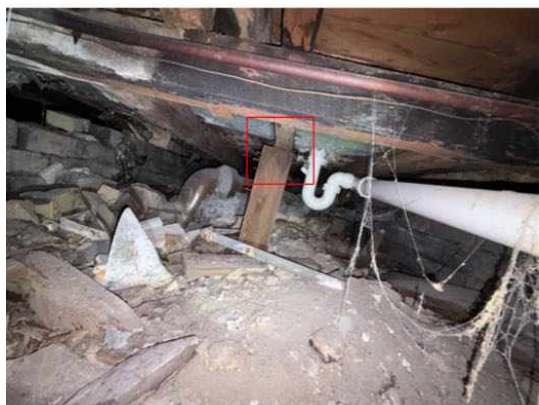
### Finding 6.09

Location: Fencing & Landscaping  
 Finding: Building materials in direct ground contact - conducive to termites  
 Information: Where timber elements are in direct contact with the ground and consequently moisture or dampness they become conducive to termite activity. Whether timber is used as a building element part of a fencing structure or stored as an unused item they can provide an environment that is attractive to termite infestation.

When met with excessive moisture timber begins to decay and develop wood rot. Any timbers that are in direct contact with external grounds especially if left untreated or non-durable also provide ingress for subterranean termites into that particular element.

The removal of any such materials that may be conducive to termite activity should be removed as soon as possible to minimise the risk of termite attack.

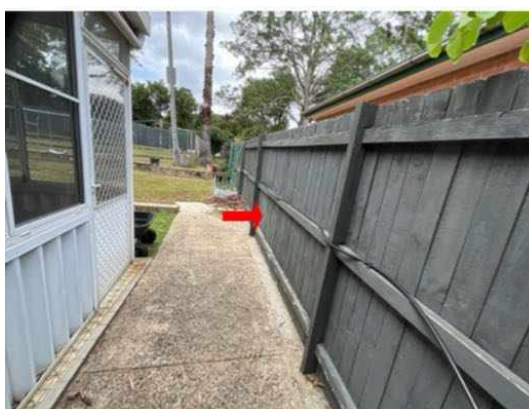
### Finding 6.10

Building: Main Building  
 Location: Yard, subfloor  
 Finding: Stored timbers - subfloor space or external area  
 Information: The storing of timbers in the subfloor space or around the external property increases the risk of termite activity being present. As they are likely to come into contact with weather conditions or excessive moisture wood rot is likely to develop on timbers that are not treated.

It is highly recommended that any stored timbers be immediately removed from areas in which they may attract any termite / timber pest attack. Minimisation of risk / prevention of termite attack is far more adequate than dealing with the presence of termite activity.

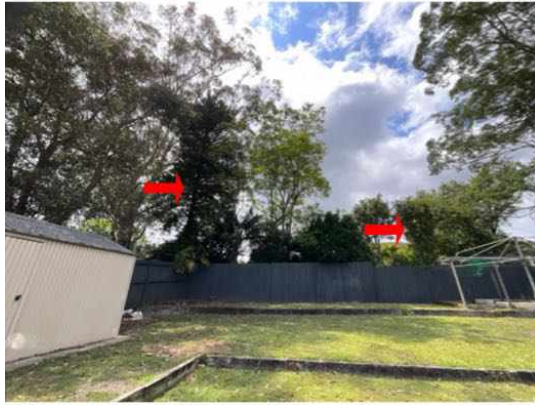
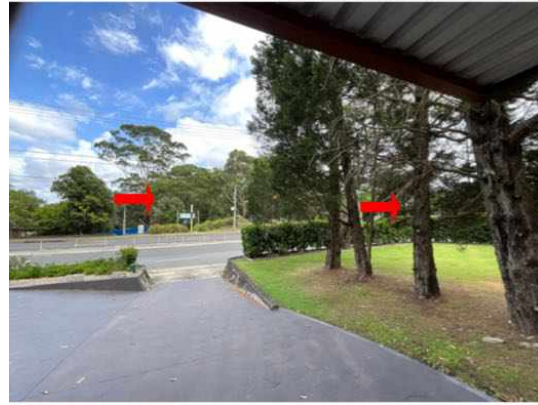
### Finding 6.13

Building:	Main Building
Location:	Vegetation
Finding:	Vegetation - Abutting property
Information:	Vegetation against external wall may have an invasive root system. If there are weak points in the brick work or concrete slab, it is possible for the roots to gain entry into these areas. Once the roots have gained entry, it is possible for termites to gain concealed entry via these roots. It is recommended to remove the vegetation and root system where possible.

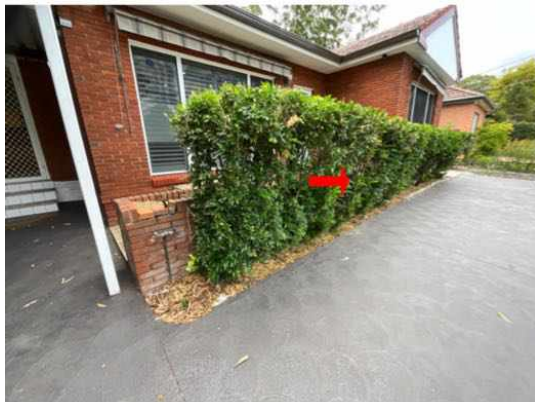
### Finding 6.14

Building:	Main Building
Location:	Garden beds
Finding:	Garden Beds
Information:	Garden beds were found to be evident in the garden area. These garden beds can include untreated timber, and with a combination of moisture from watering hosing can make conditions conducive to termite activity and termite ingress.

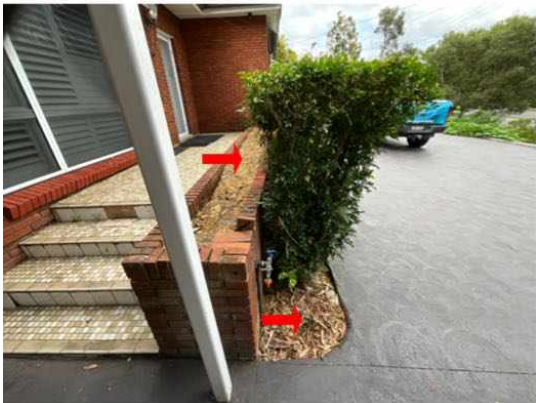
**Finding 6.15**

Building: Main Building  
Location: External tap  
Finding: Tap - No drain  
Information: The external tap in this area was noted to have no drain at the time of inspection.

This keeps the surrounding surfaces damp while using the tap, which becomes conducive to termite activity.

A licensed plumber must be appointed to ensure an appropriate drain is installed.

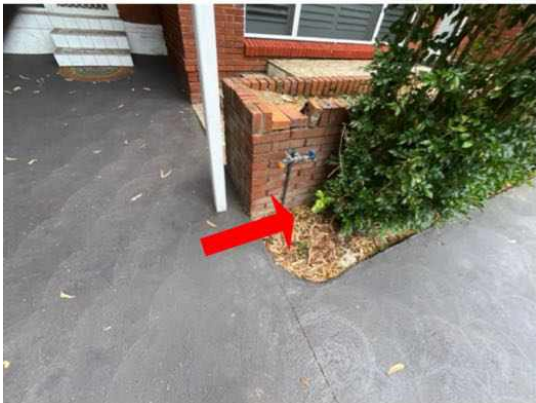
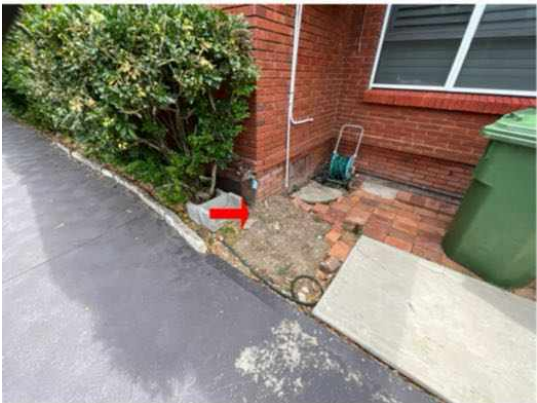
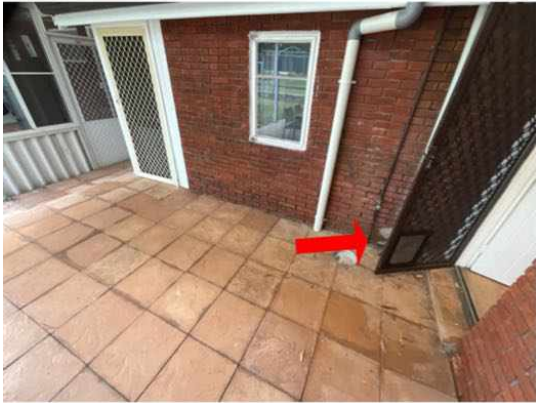
## Finding 6.16

Building:	Main Building
Location:	Extensions
Finding:	Slab Edge - Exposure
Information:	Slab Edge Exposure: Where external concrete slab edges are not exposed there is a high risk of concealed termite entry. In some buildings built since July 1995 the edge of the slab forms part of the termite shield system. In these buildings an inspection zone of at least 75mm should be maintained to permit detection of termite entry. The concrete edge should not be concealed by render, tiles, cladding, flashings, adjoining structures, paving, soil, turf or landscaping etc. Where this is the case you should arrange to have the slab edge exposed for inspection. Concealed termite entry may already be taking place but could not be detected at the time of the inspection. This may have resulted in concealed timber damage. Does the slab edge inspection zone fully comply?

Not able to comment. A very high proportion of termite attacks are over the edge of both Infill and other concrete slabs types. Covering the edge of a concrete slab makes concealed termite entry easy. Infill slab type construction has an even higher risk of concealed termite ingress as the slab edge is concealed due to the construction design and cannot be exposed. The type of slab may only be determined by assessment of the construction plans by a qualified person e.g. Builder, Architect. Construction Plans may be obtainable by your local Council or Builder. Termite activity and or damage may be present in concealed timbers of the building. We strongly recommend frequent regular inspections in accordance with AS 3660.2. Where the slab edge is not fully exposed or the slab is an infill slab or the slab type cannot be determined then we strongly recommend inspections every 3 to 6 months in accordance with AS 3660.2 or AS 4349.3.

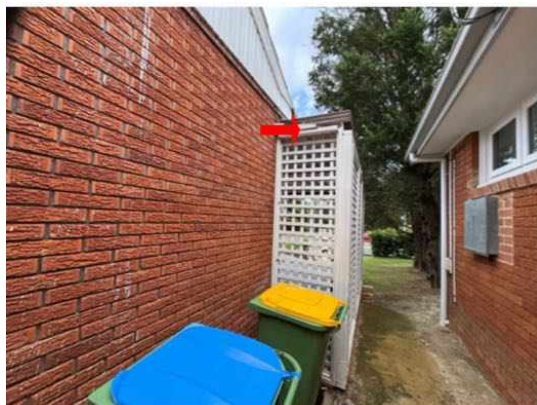
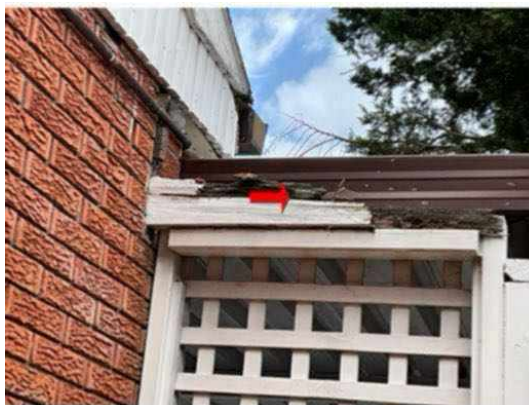
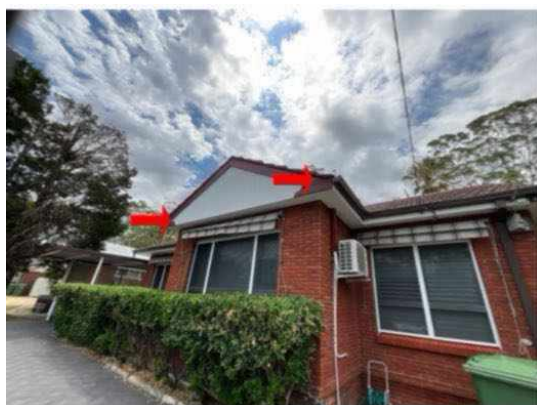
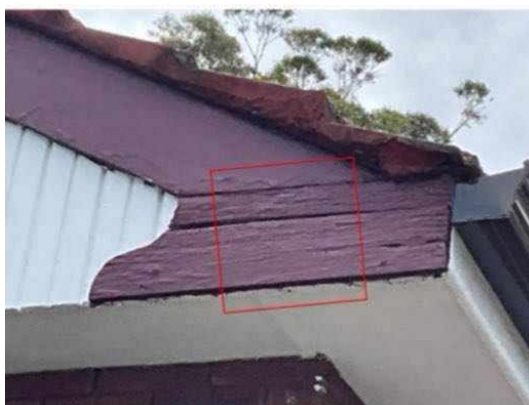
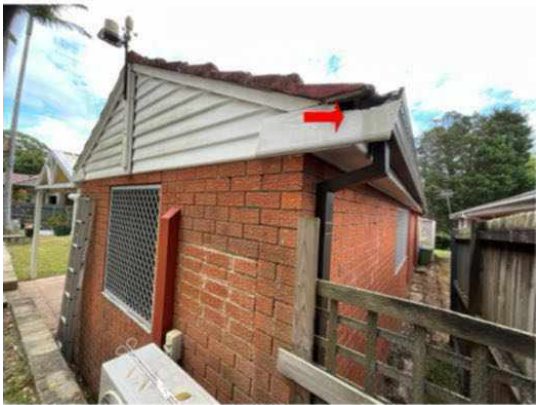
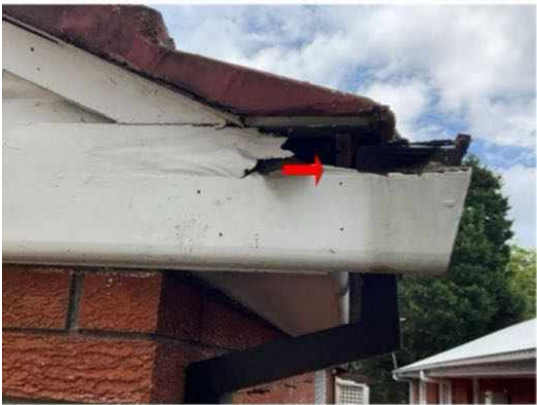
Building:	Main Building
Location:	Multiple areas
Finding:	Wood rot/decay
Information:	This building element shows evidence of wood rot. Wood rot, also known as Fungal Decay, occurs when timbers and other cellulose building materials are exposed to damp conditions on an ongoing basis. This could be the result of exposure to weathering over a prolonged period of time, or the attraction of excessive moisture from other abutting building materials. Contributing factors also include poor air ventilation in the area.

Wood rot is often associated with general damp problems and is evidenced by a `musty` smell or mould and mildew occurring on surfaces. If left unmanaged, damp conditions can lead to further health problems and the decay of timbers will continue.

Early intervention and regular maintenance, particularly of exterior timbers, will prolong the useful life of these building elements. Prior to any works being performed, the cause of the moisture that has created the visible wood rot should be identified and addressed in a suitable manner. Replacement of affected timbers may then be a necessary step in protecting surrounding building elements from such deterioration.

A licensed plumber may be appointed to assess the cause of excessive moisture and to provide advice on any remedial works as required. A licensed carpenter may also be required to replace affected building materials.

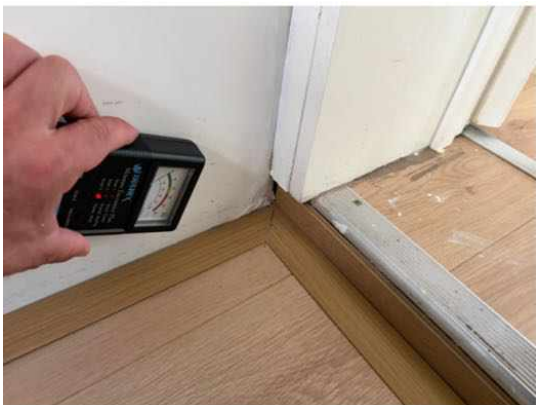
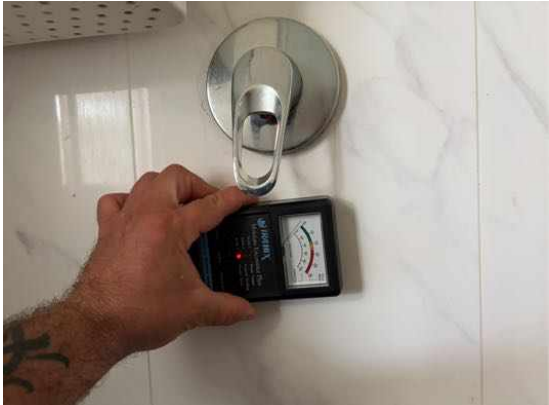
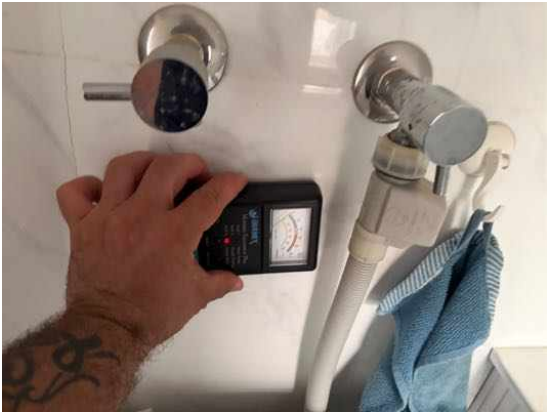
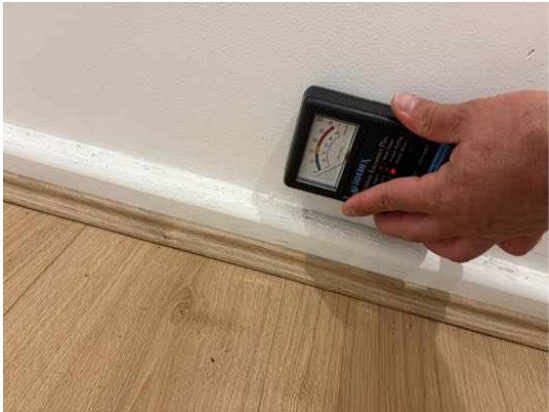
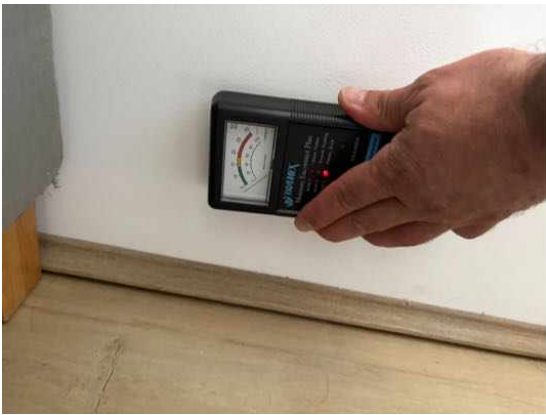
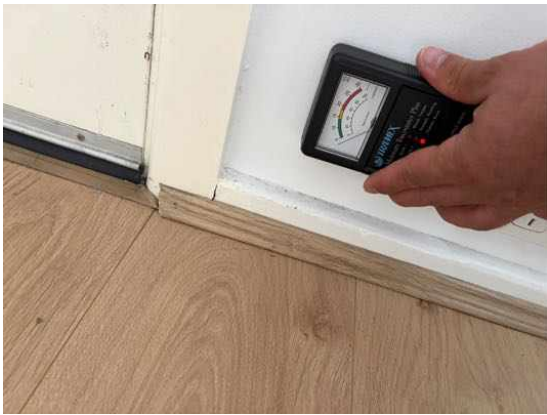
Building: Main Building  
Location: All Areas  
Finding: Moisture metre  
Information: During the inspection the property was checked for moisture using a moisture metre.

This is for information only.

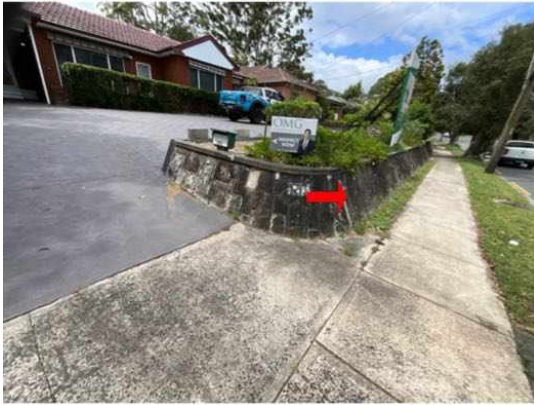
Building: Main Building  
 Location: Retaining walls  
 Finding: Retaining walls  
 Information: At the time of inspection the retaining walls were checked and no defects were observed other than those which May have been mentioned earlier in this report.

AS4349.1-2007 requires all retaining walls in excess of 700mm to be inspected by a licensed and practicing structural engineer.

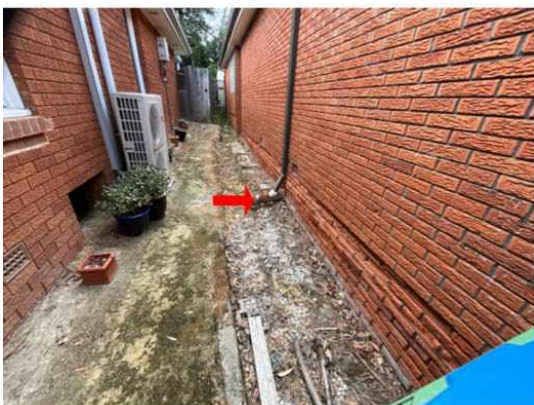
Building: Main Building  
 Location:  
 Finding: Pipework - Old urban wear pipes  
 Information: Old urban wear pipes were identified at the time of inspection.

Consultation with a licensed plumber is advised. CCTV inspection on pipes may be required.

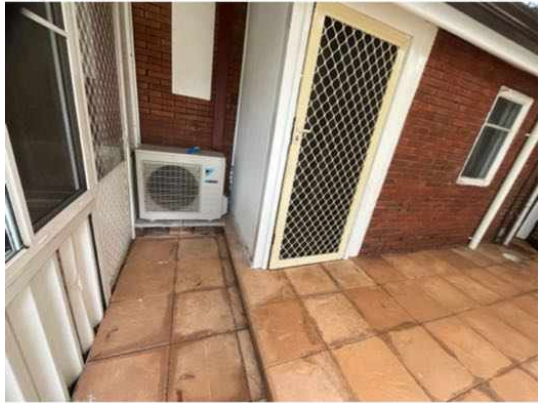
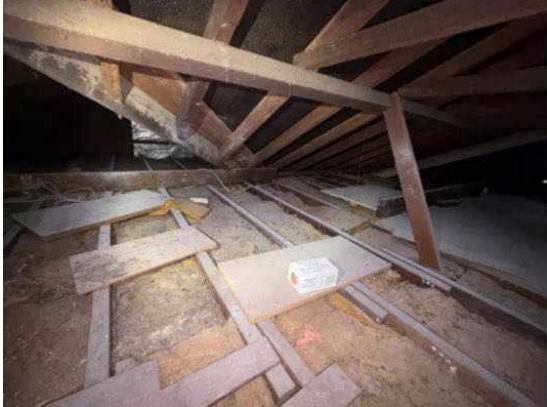
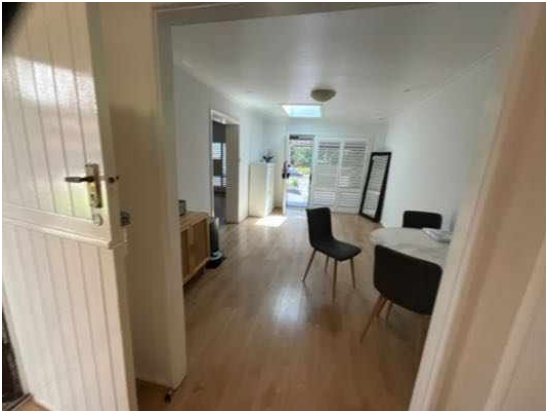
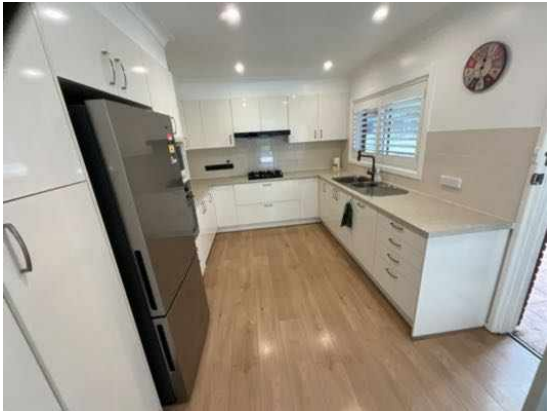
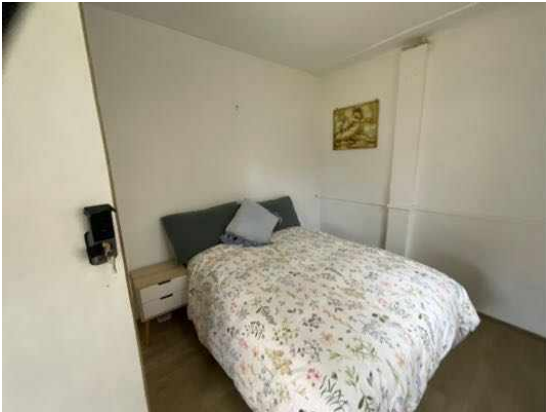
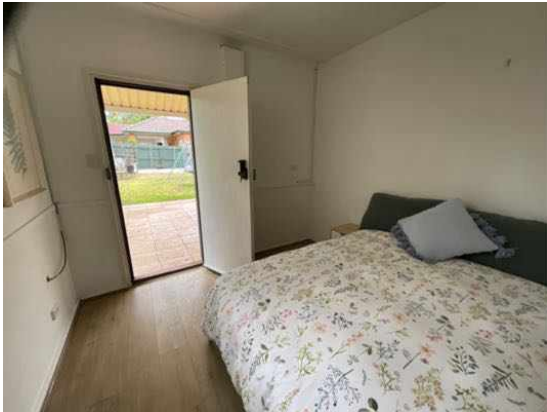
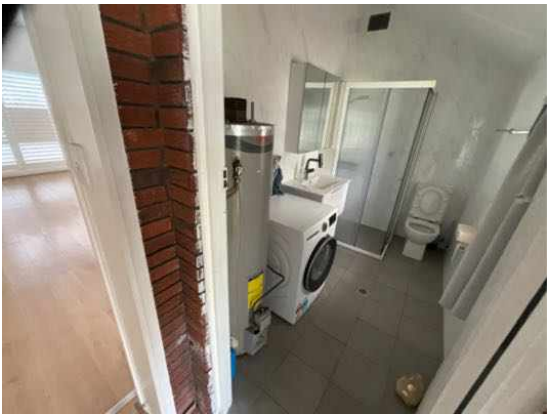
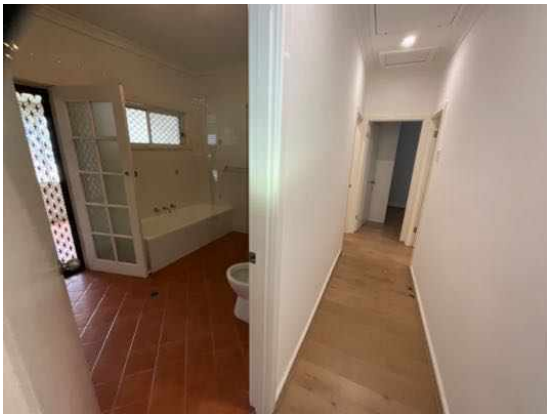
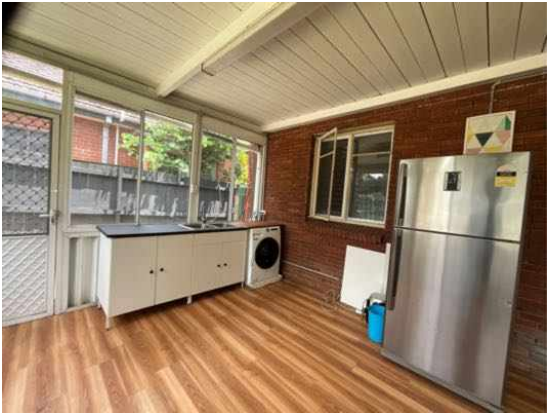
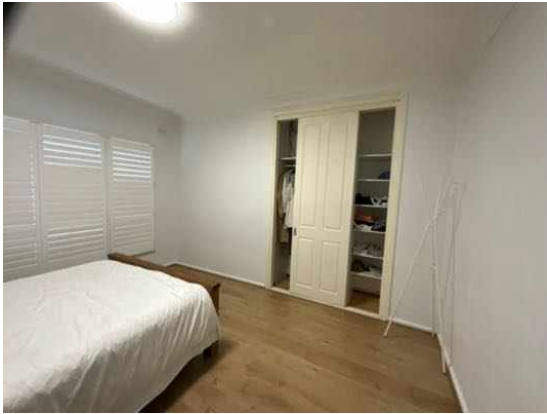
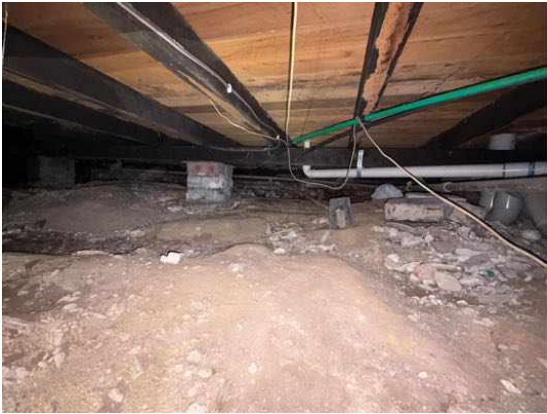
Finding: Additional Photos - Obstructions and Limitations  
Information:

These photographs are an indication of the obstructions and limitations which impeded full inspection of the property at the time of inspection. These obstructions can hide an array of defects and should be removed to allow full inspection to be carried out. A re-inspection is recommended once the areas are made accessible.
