Building and Timber Pest Inspection Report

Inspection Date: Mon, 19 Jan 2026

Property Address: 43 Red Gum Ave, Hazelbrook NSW 2779,
Australia

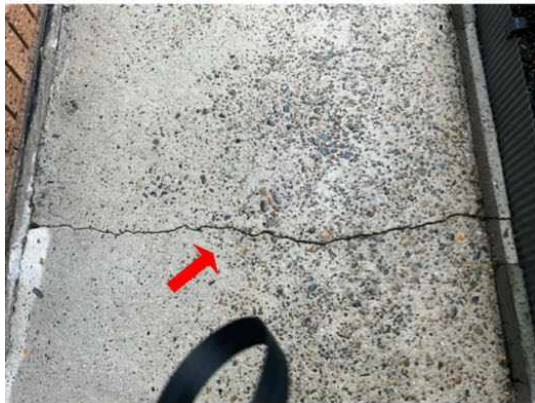
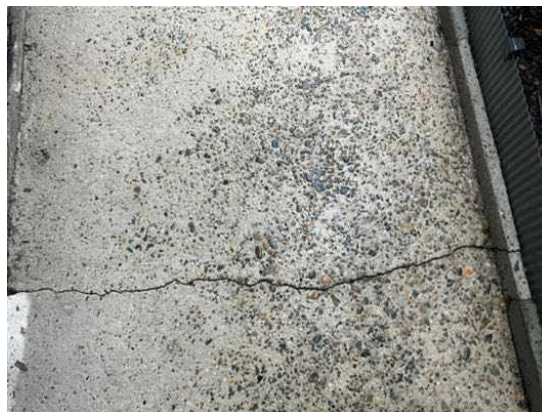
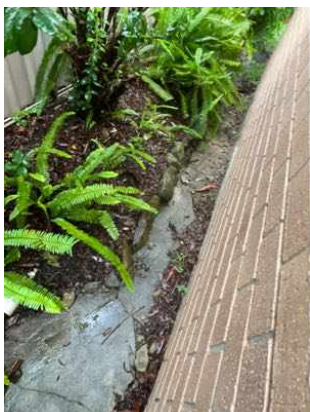
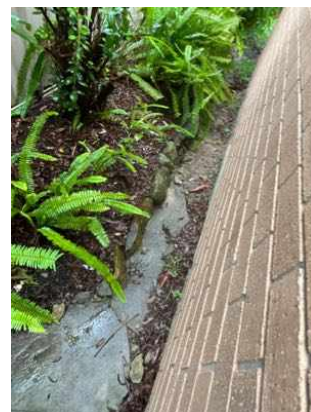
Finding 3.03

Building:	Main Building
Location:	All Areas
Finding:	Perimeter - Insufficient Fall
Information:	The perimeter ground levels were found to have an inadequate slope away from the adjoining building structure, creating potential for water pooling in this area.

Surface water drainage is defective if it is not in accordance with the requirements of the Building Code of Australia.

Such water pooling also increases the risk of termite activity and the development of fungal decay in the area.

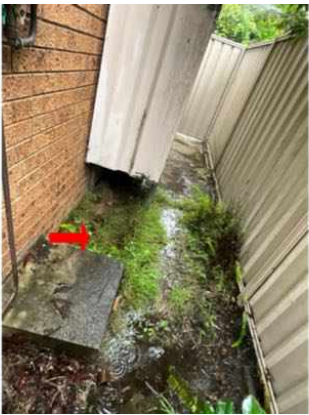
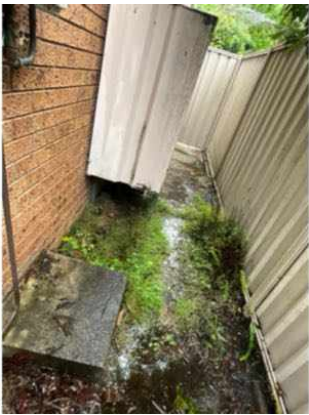
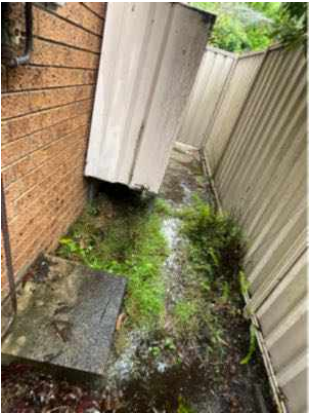
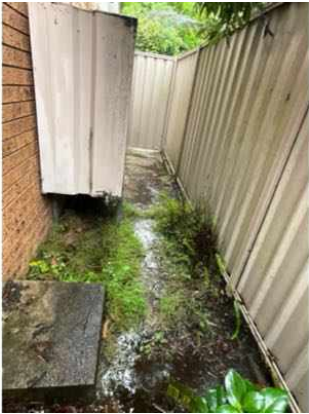
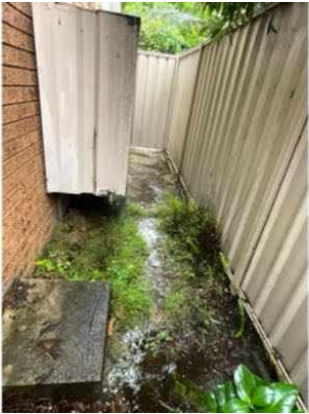
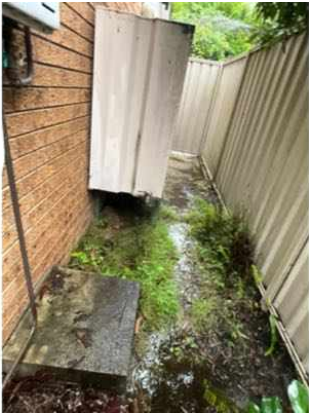
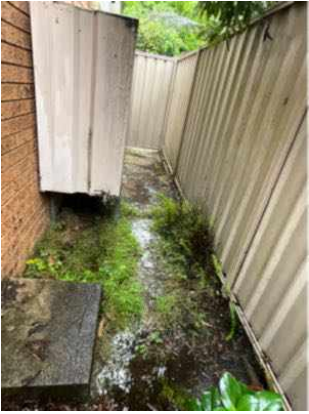
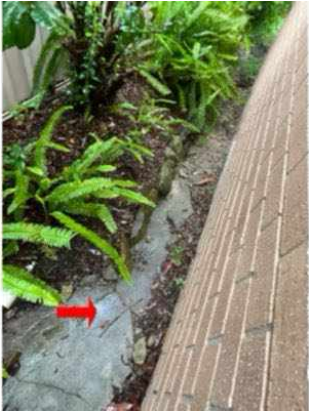
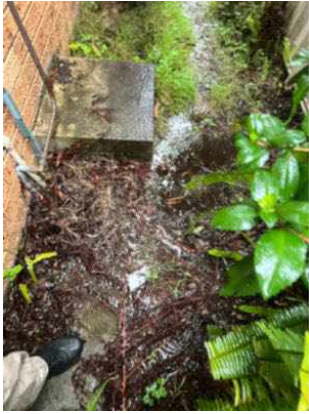
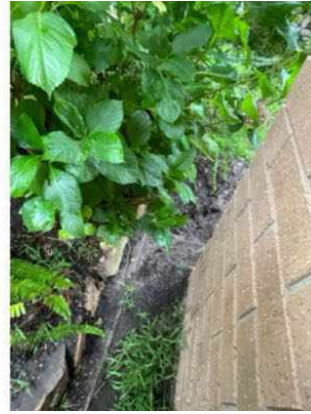
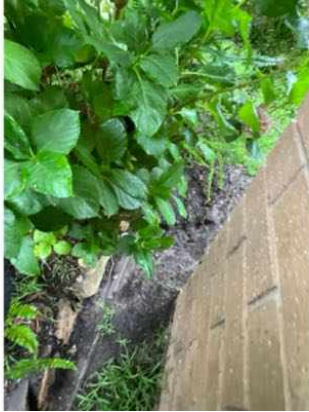
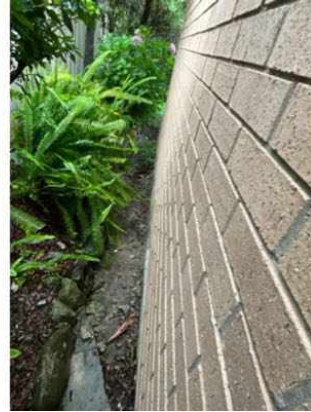
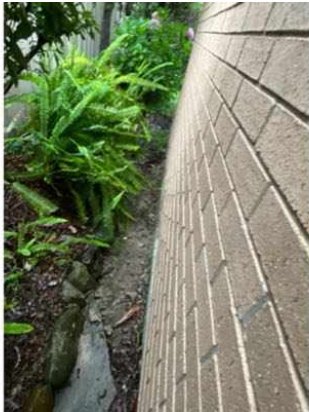
Perimeter is required to fall from the building by a minimum of 25mm in the first metre and bare ground should fall away from the house by 50mm in the first meter. This standard ensures that excessive moisture does not pool around the base of building structures, which creates potential for water and structural damage, as well as making the area susceptible to termite and timber pest activity.

Where ground levels do not have adequate fall, a licensed paving contractor should be appointed to install or remove and re-level pavement.

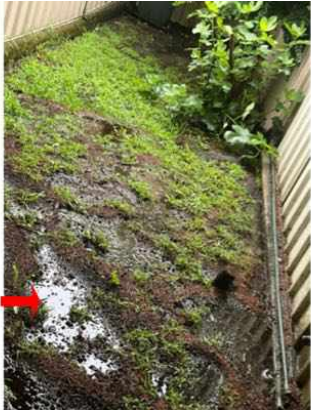
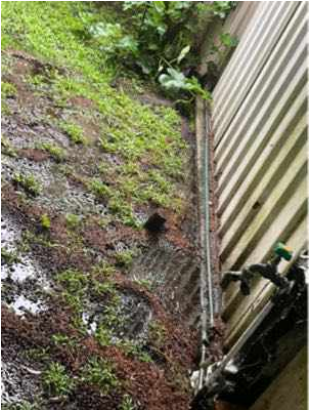
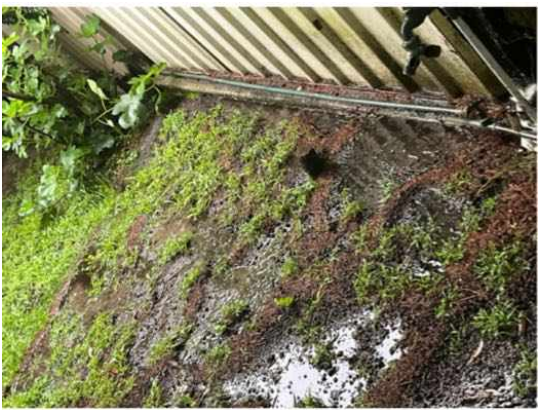
Finding 3.04

Building:	Main Building
Location:	All Areas
Finding:	Water pooling - poor surface drainage
Information:	Surface drainage

Consult a Licensed Plumber regarding the cost of potential site drainage rectification works.

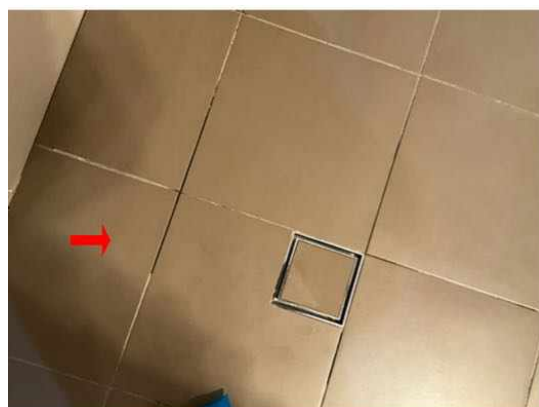
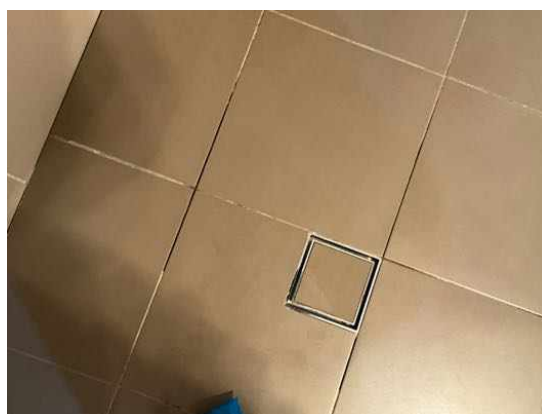
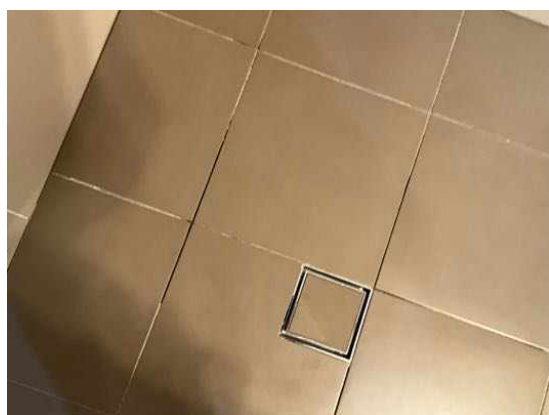
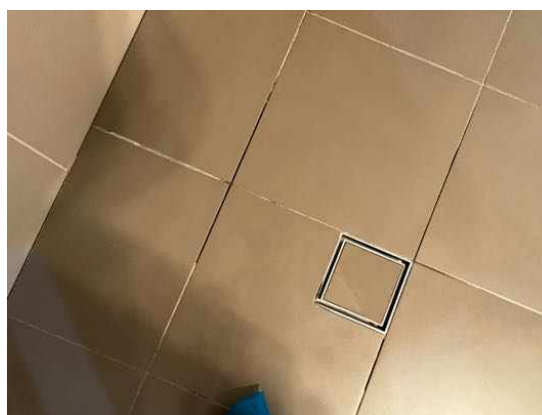
Finding 3.07

Information: Damp is evident to the lower 300mm of wall to the shower alcove. This defect is quite common, and is suspected to have been caused by moisture permeating through the grouting in this area, which shows evidence of deterioration. Leaking pipes within the adjoining wall is also a possible cause.

Damp (or structural damp) refers to the presence of unwanted moisture in the structure of a building, either as the result of intrusion from outside, or condensation from within the structure. In the shower area, internal water leaks or other sources of excessive moisture are generally the cause of damp.

Unmanaged damp in the shower recess is likely to facilitate the formation and development of mould and fungi growth, decaying associated building materials and compromising their structural integrity. It is important to address damp conditions, as the World Health Organisation notes that excess moisture leads - on almost all indoor materials - to growth of microbes such as moulds, fungi and bacteria, which subsequently emit spores and other matter into the indoor air. Exposure to these

Consultation with a qualified plumber or bathroom specialist is advised immediately to identify the cause of damp and to perform remedial works as required. Where excessive mould growth is present, further inspection by a specialist environmental health inspector should also be considered.

Always ensure that sealant and grout is in good condition to prevent any moisture issues occurring in the future.

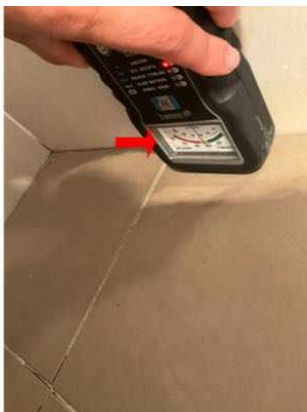
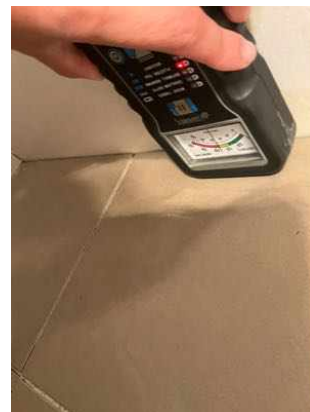
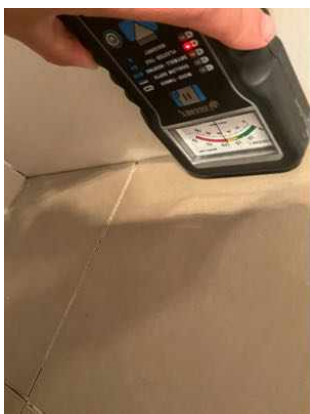
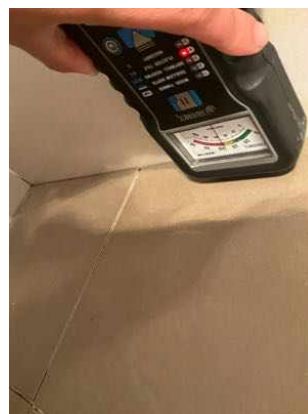
Finding 6.04

Building:	Main Building
Location:	Bathroom
Finding:	Excessive moisture - Conducive to Timber pest
Information:	Excessive moisture can attract termites and produce conditions that promote fungal growth and wood decay.

Excessive moisture is generally caused by deteriorated inadequate or missing roof drainage leaking plumbing pipes or fixtures poorly plumbed HWS overflows or condenser units and poor site drainage.

If mould growth has been found there may be environmental biological or health issues involved. In these cases an appropriately qualified inspector should also be contacted.

Prior to any remedial works being performed a qualified plumber should be appointed to further inspect the property and to identify the cause of the excessive moisture. Works to remove affected building elements may then be necessary and should be performed by an appropriate tradesperson.

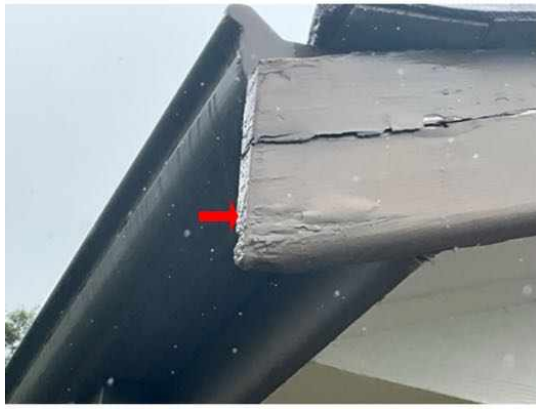
Evidence of fungal decay activity and/or damage

Building:	Main Building
Location:	All Areas
Finding:	Wood rot
Information:	This building element shows evidence of wood rot. Wood rot, also known as Fungal Decay, occurs when timbers and other cellulose building materials are exposed to damp conditions on an ongoing basis. This could be the result of exposure to weathering over a prolonged period of time, or the attraction of excessive moisture from other abutting building materials. Contributing factors also include poor air ventilation in the area.

Wood rot is often associated with general damp problems and is evidenced by a 'musty' smell or mould and mildew occurring on surfaces. If left unmanaged, damp conditions can lead to further health problems and the decay of timbers will continue.

Early intervention and regular maintenance, particularly of exterior timbers, will prolong the useful life of these building elements. Prior to any works being performed, the cause of the moisture that has created the visible wood rot should be identified and addressed in a suitable manner. Replacement of affected timbers may then be a necessary step in protecting surrounding building elements from such deterioration.

A qualified plumber may be appointed to assess the cause of excessive moisture and to provide advice on any remedial works as required. A qualified carpenter or registered builder may also be required to replace affected building materials.

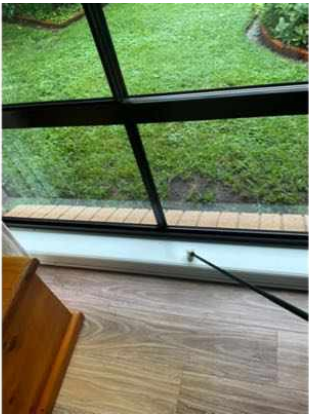
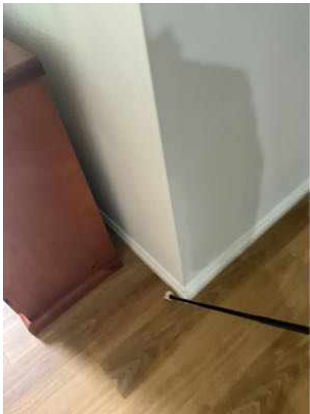
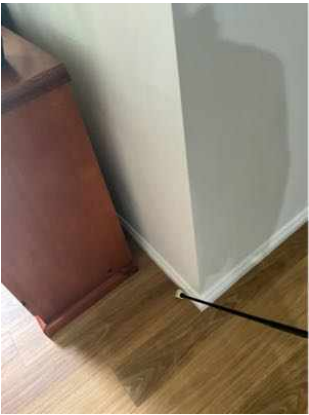
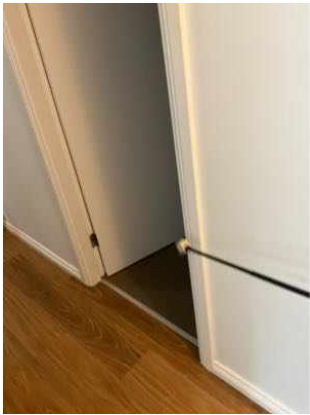
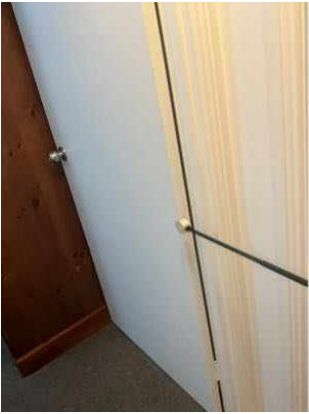
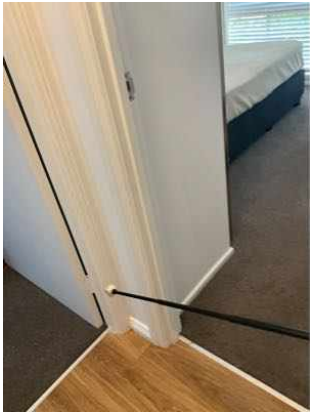
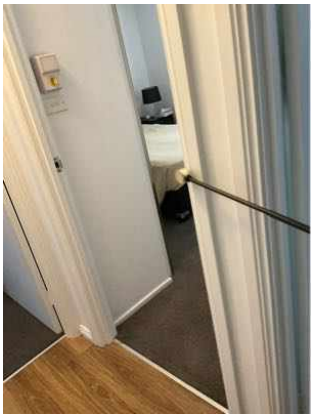
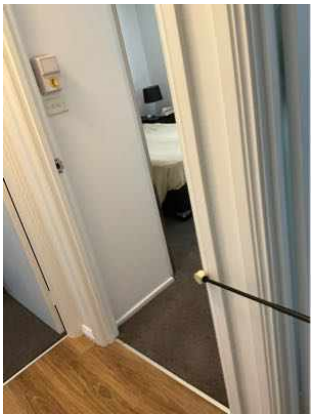
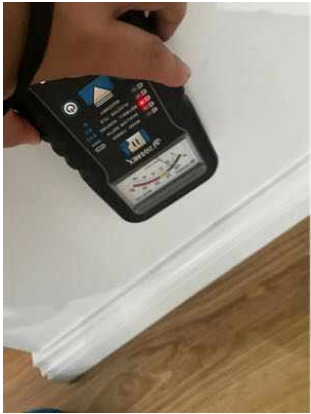
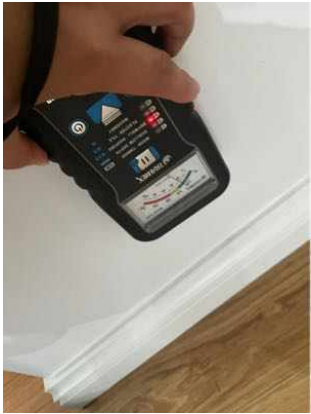
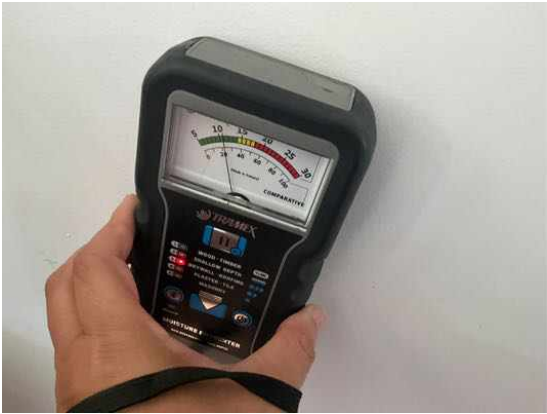
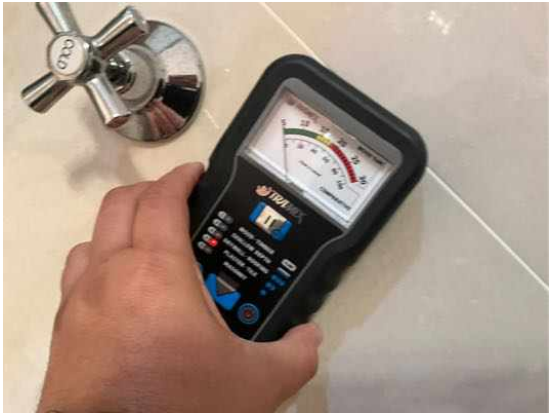
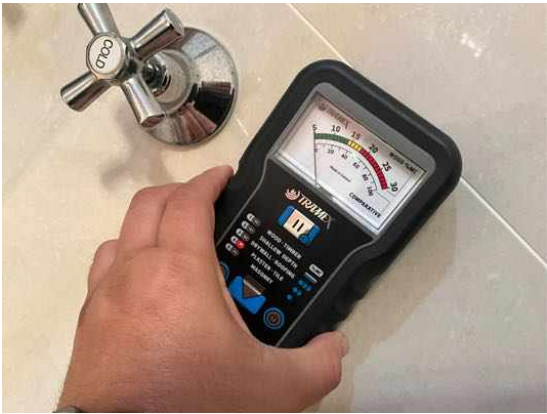
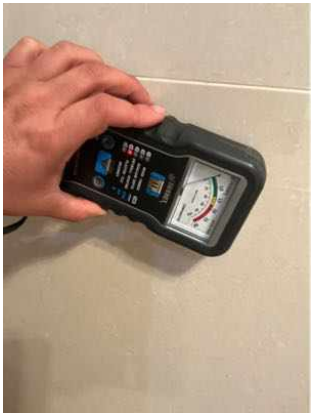
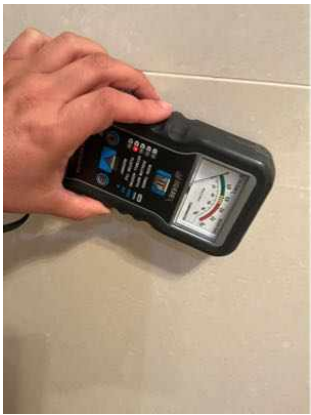
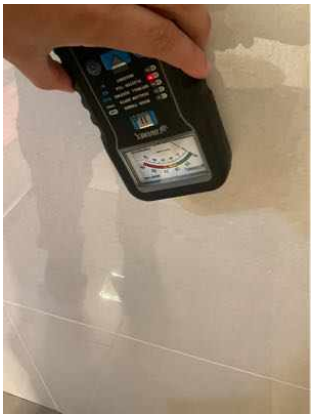
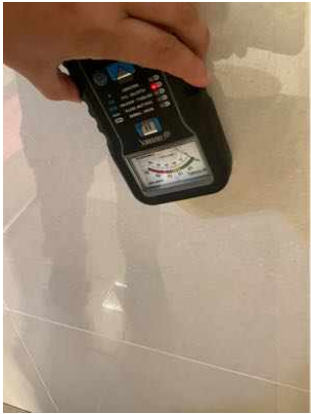
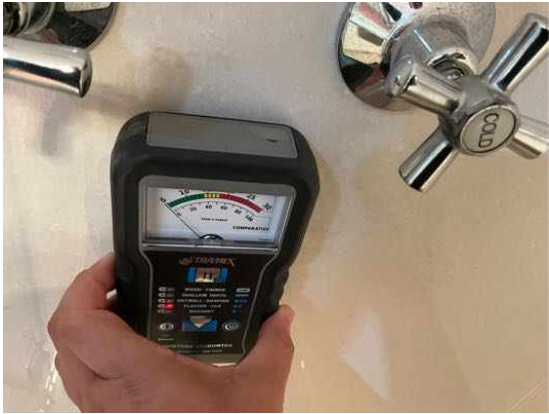
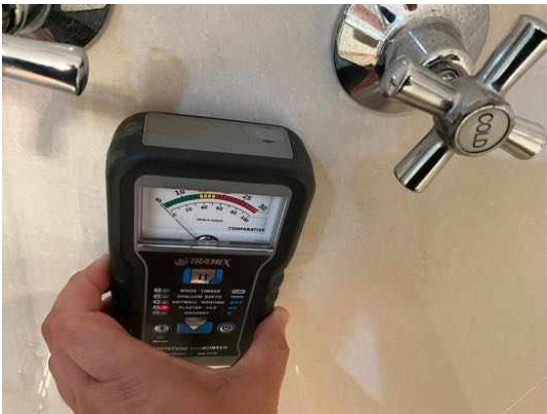
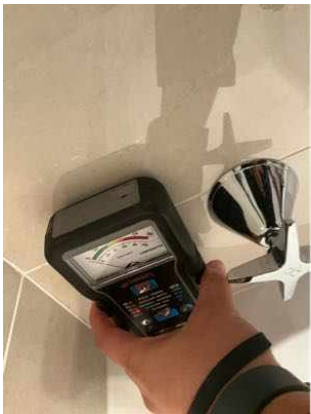
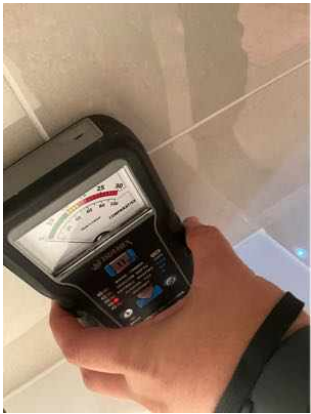
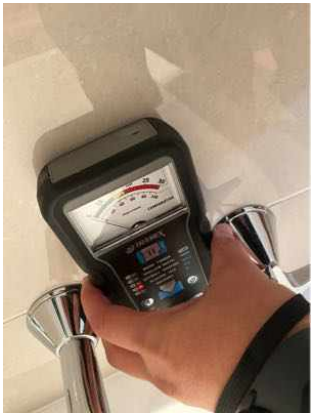
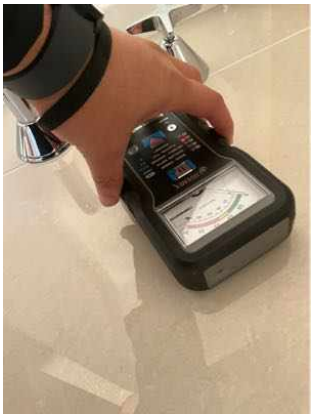
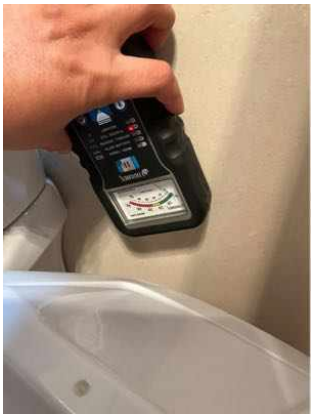
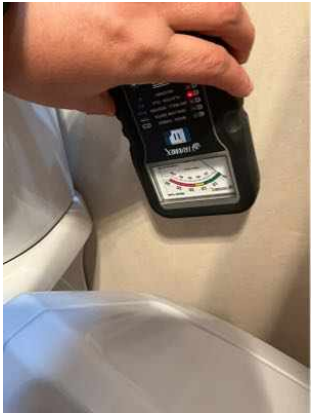
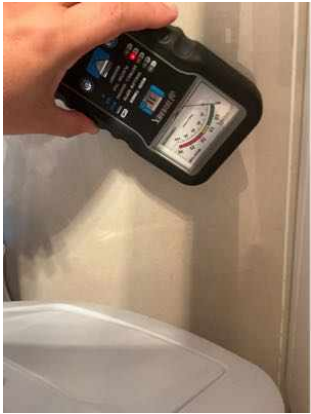
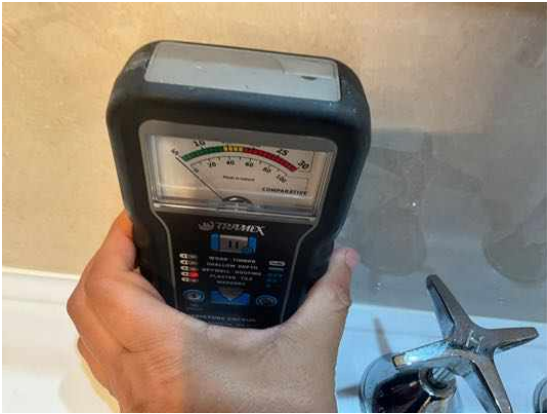
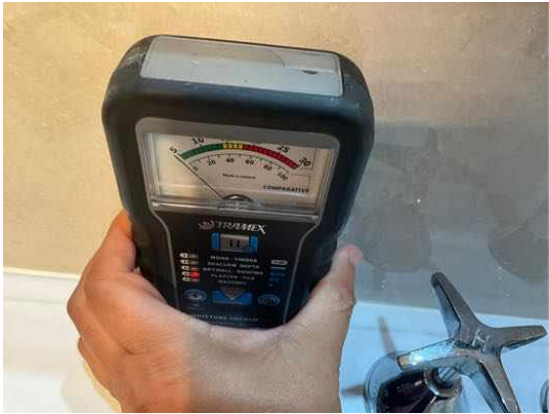
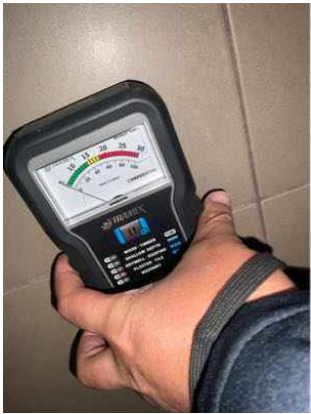
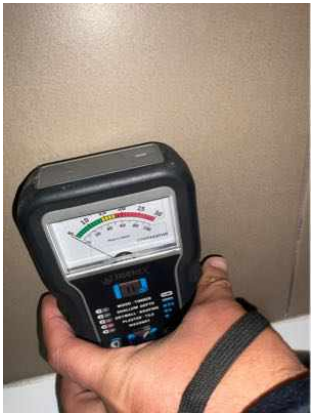
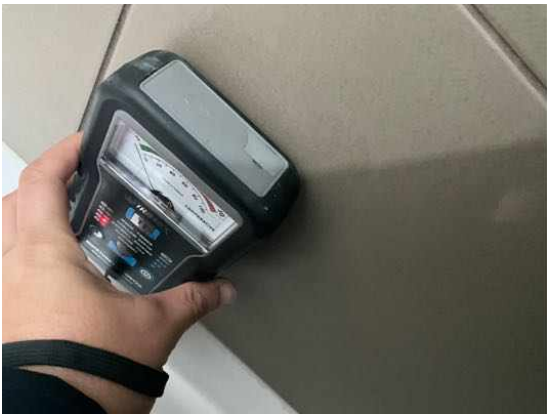
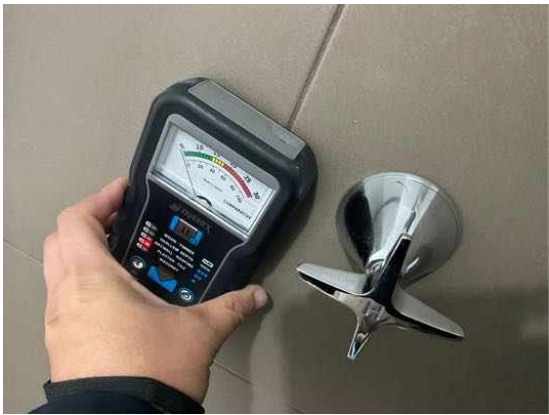
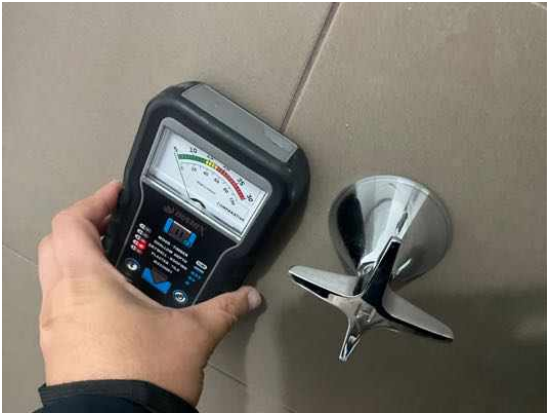
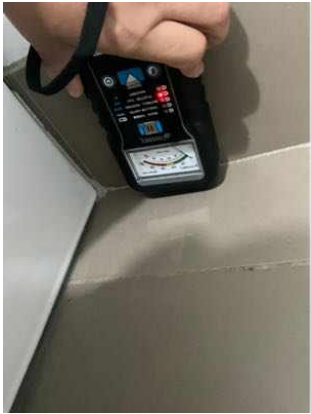
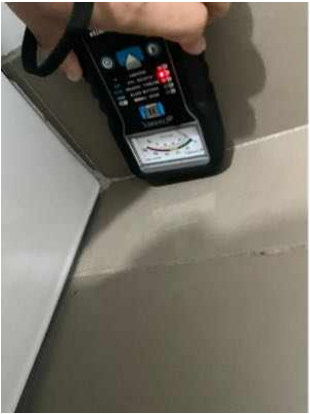
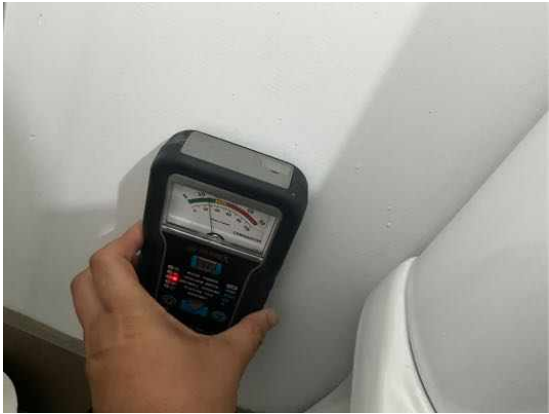
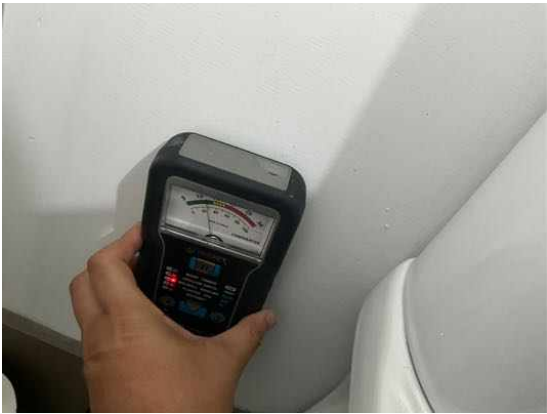
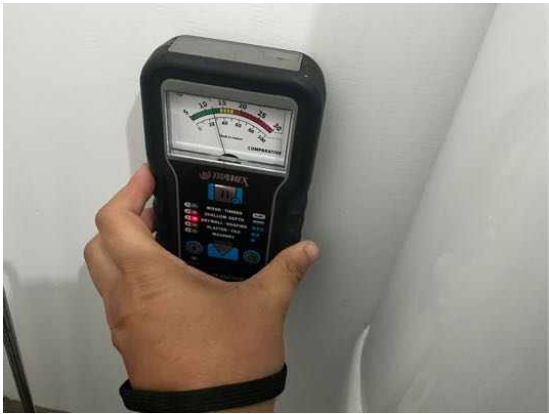
Building: Main Building
Location: All Areas
Finding: Additional Photos
Information: Additional photos are provided for your general reference

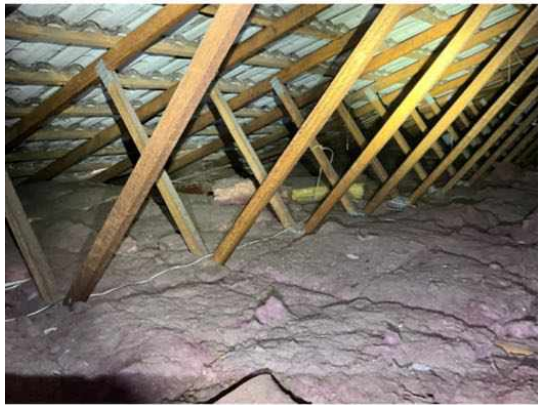
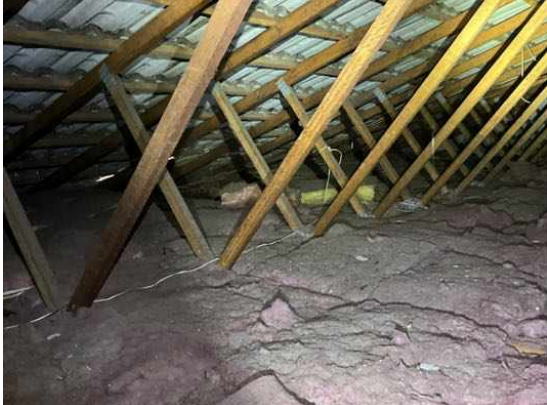
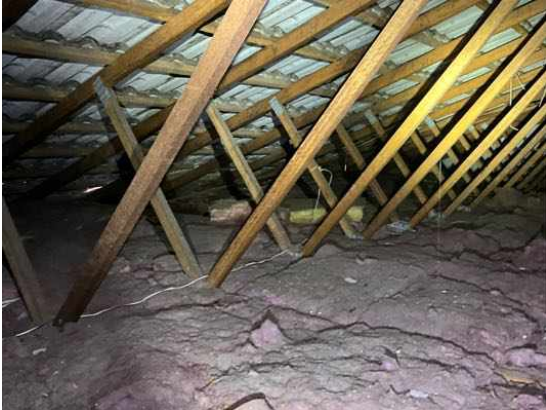
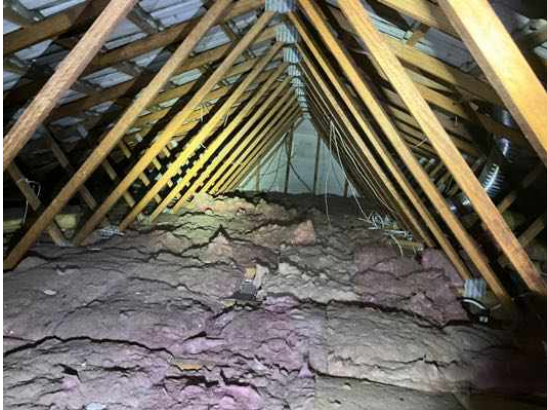
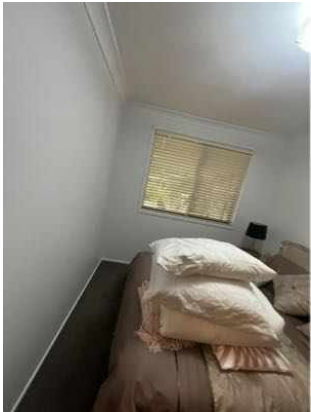
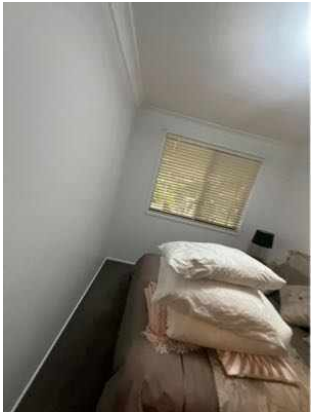
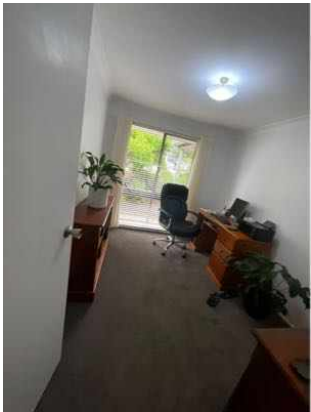
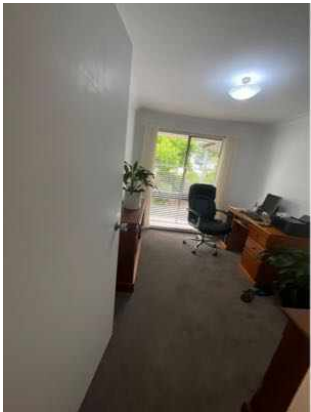
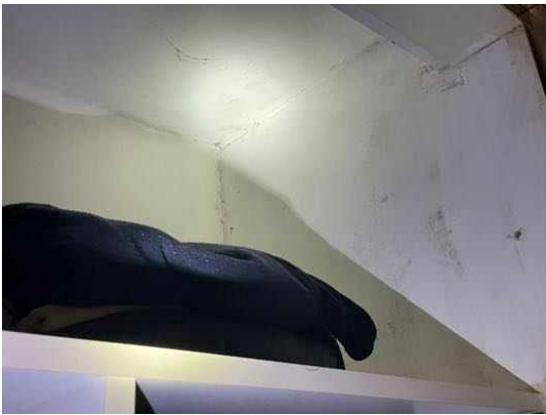
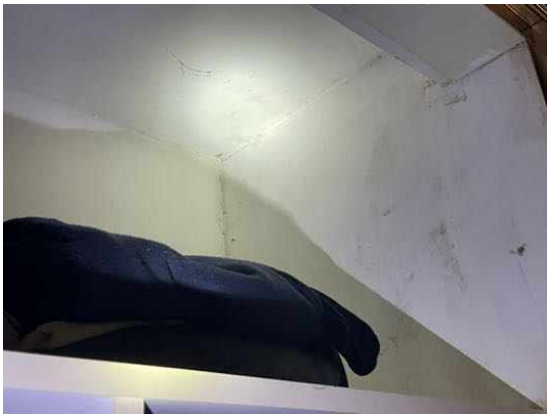
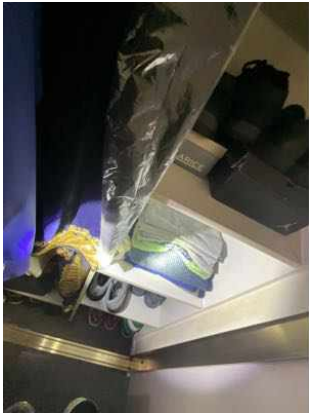
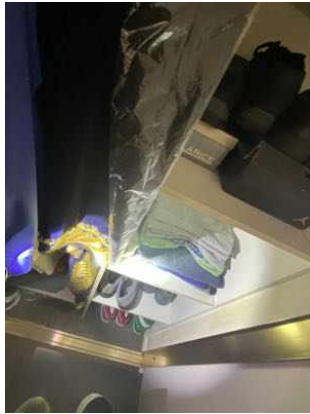
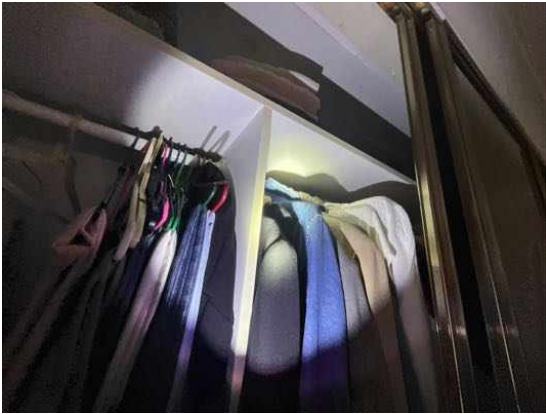
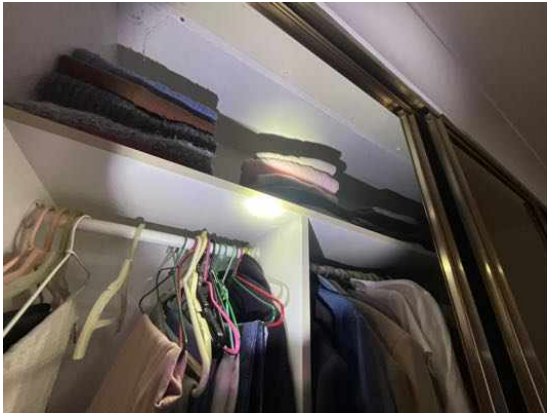
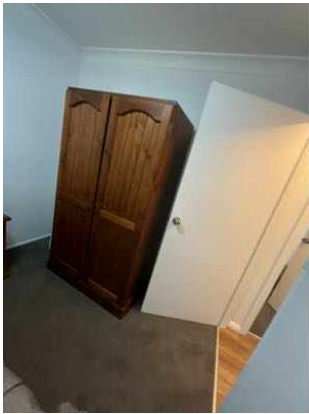
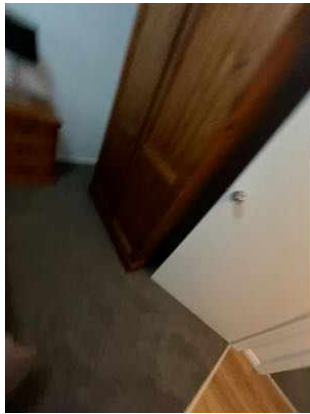
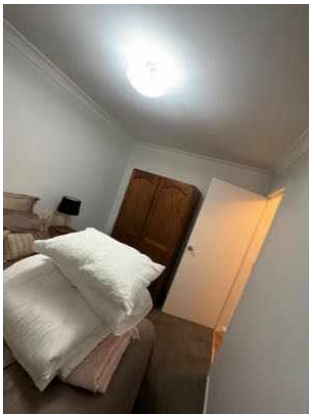
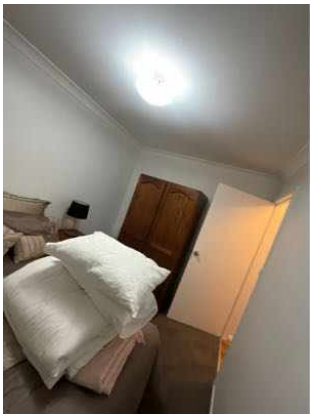
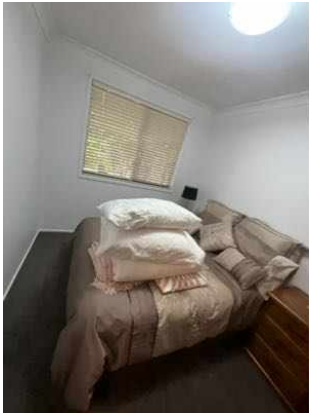
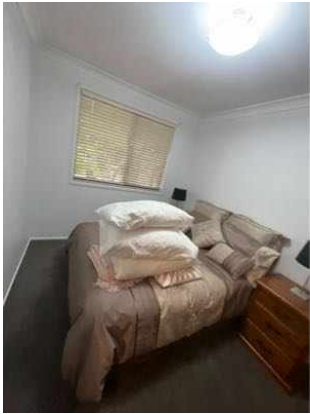
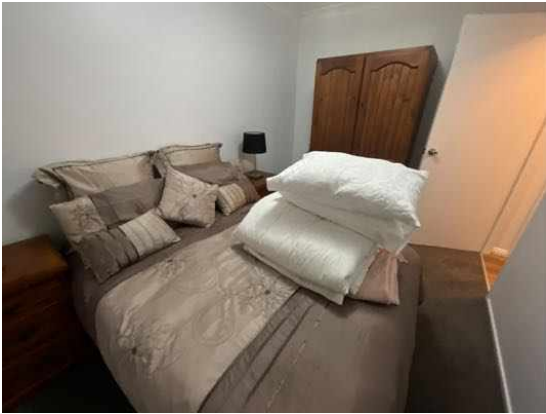
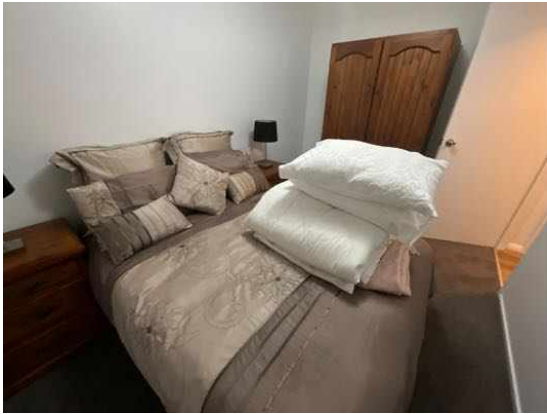
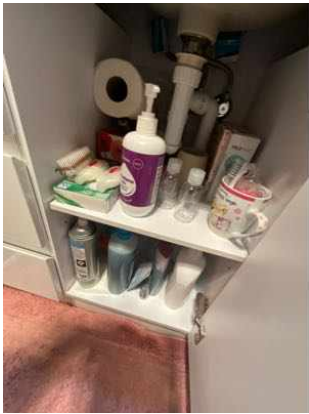
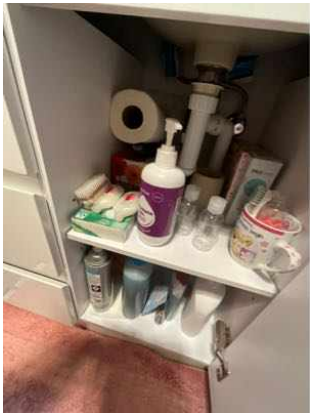
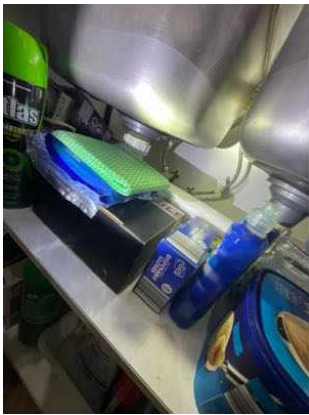
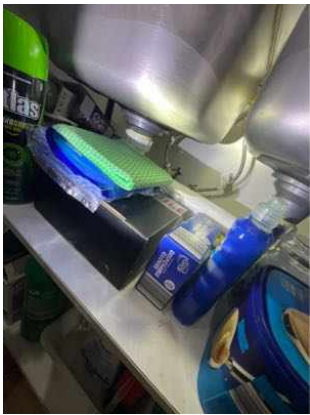
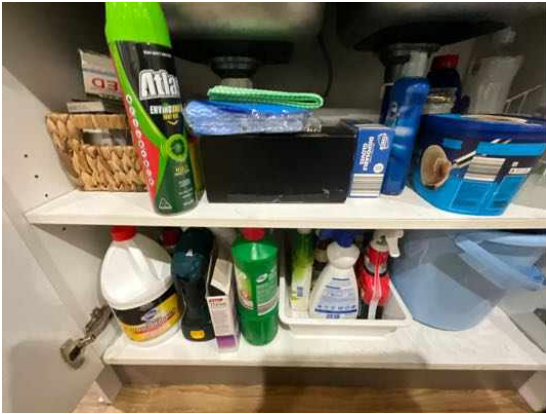
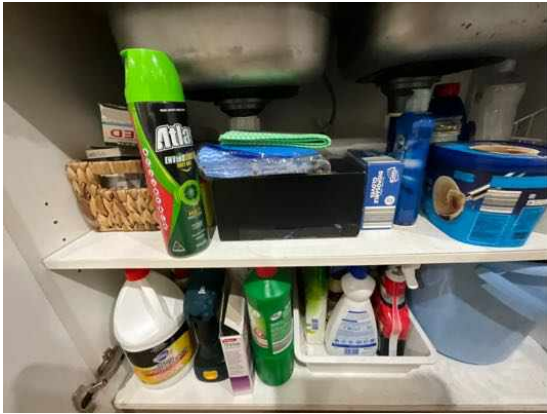
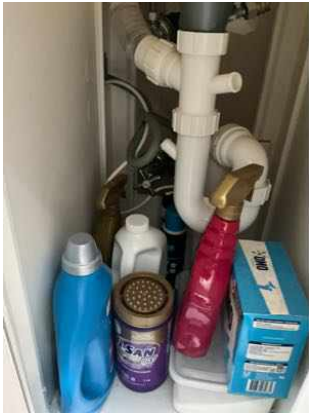
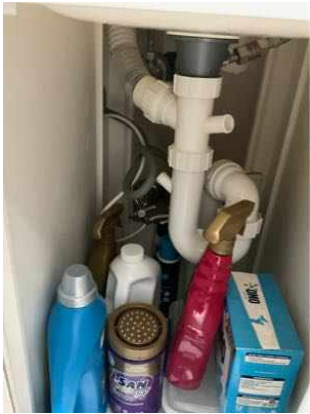
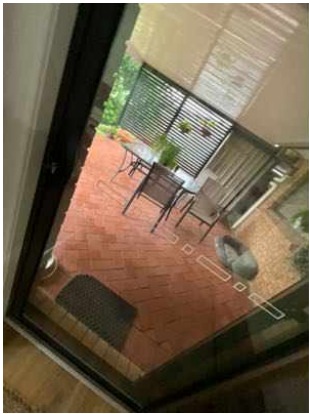
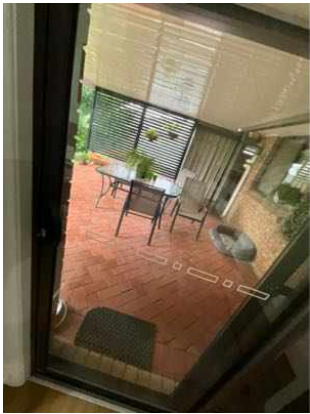
Noted Item

Building:	Main Building
Location:	All Areas
Finding:	Additional Photos - Obstructions and Limitations
Information:	These photographs are an indication of the obstructions and limitations which impeded full inspection of the property at the time of inspection. These obstructions can hide an array of defects and should be removed to allow full inspection to be carried out. A re-inspection is recommended once the areas are made accessible.

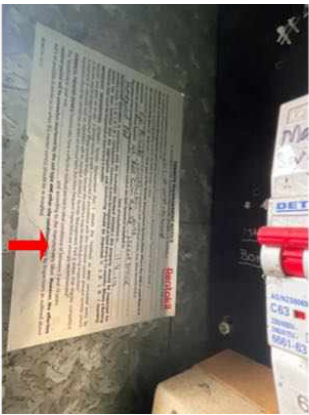
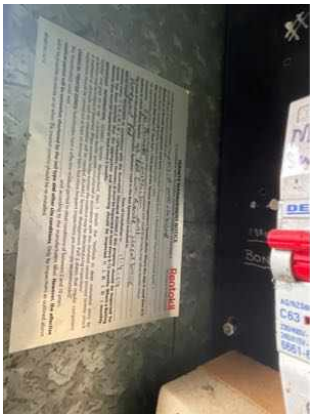
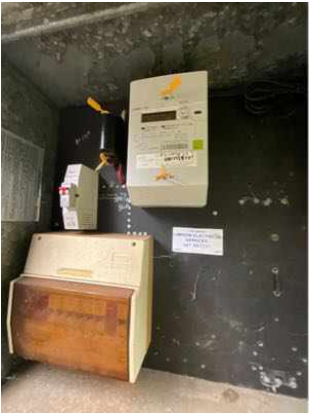
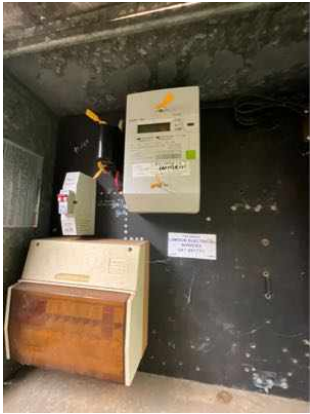
Building:	Main Building
Location:	Exterior walls - left side
Finding:	Evidence of Termite Management System - Durable notice / Legible Sticker - seek further information
Information:	The application of a pre & post-construction chemical termite barrier is highly recommended for all properties. Such barriers are highly effective in preventing termite attack on any timber building elements throughout the property.

A durable notice placed in the switchboard unit to indicate termite barriers at the time of inspection.

Client must seek further information from the vendor or real estate agent if the conditions of termite management systems were maintained as per the label or seek advise from licensed pest controller.
