Building and Timber Pest Inspection Report

Inspection Date: Mon, 12 Jan 2026

Property Address: 20 Grandview Ave, Rye VIC 3941, Australia

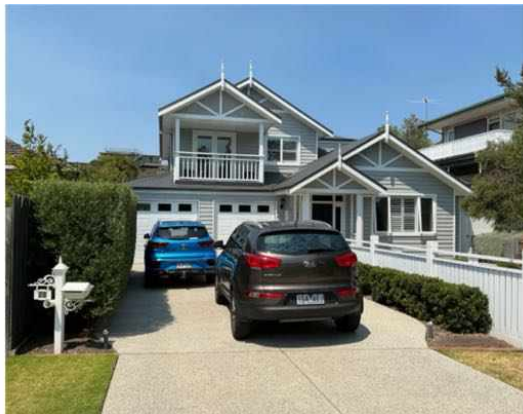
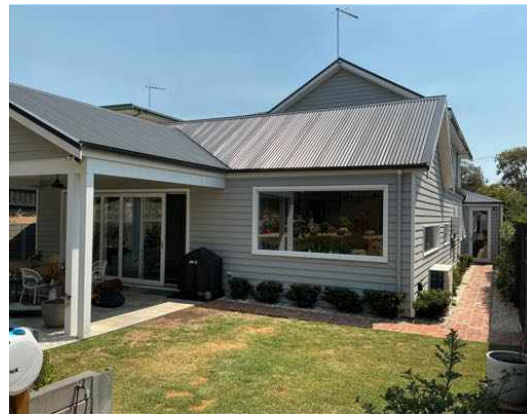
Building:	Main Building
Location:	All External Areas
Finding:	Additional Photos - Obstructions and Limitations
Information:	These photographs are an indication of the obstructions and limitations which impeded full inspection of the property at the time of inspection. These obstructions can hide an array of defects and should be removed to allow full inspection to be carried out. A re-inspection is recommended once the areas are made accessible.

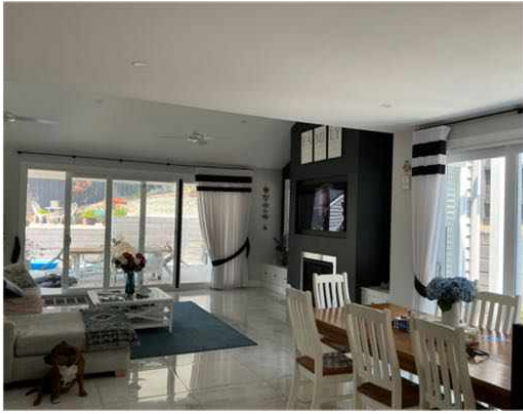
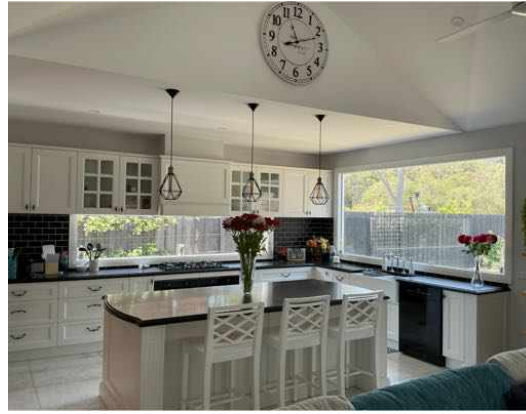
Building:	Main Building
Location:	All Internal Areas
Finding:	Additional Photos - Obstructions and Limitations
Information:	These photographs are an indication of the obstructions and limitations which impeded full inspection of the property at the time of inspection. These obstructions can hide an array of defects and should be removed to allow full inspection to be carried out. A re-inspection is recommended once the areas are made accessible.

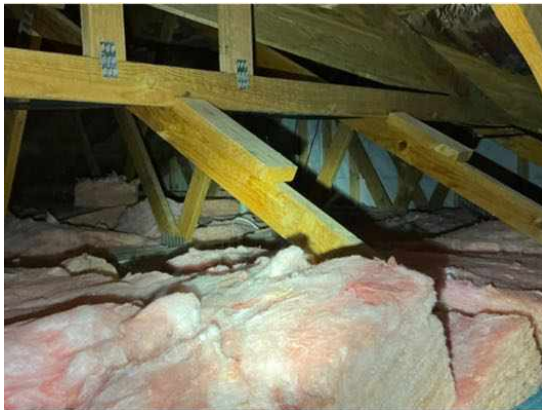
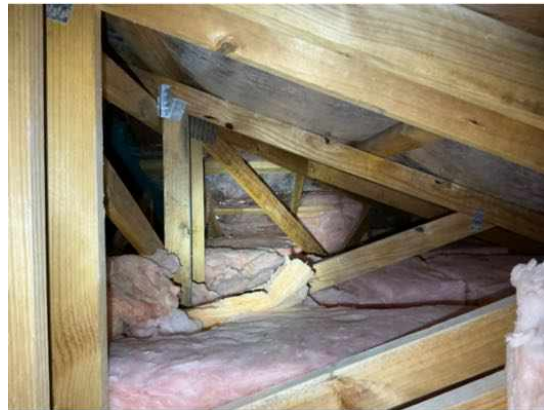
Building: Main Building
 Location: Roof Void
 Finding: Obstructions and Limitations -roof cavity
 Information: These photographs are an indication of the obstructions and limitations which impeded full inspection of the roof cavity at the time of inspection. These obstructions can hide an array of defects and should be removed to allow full inspection to be carried out. A re-inspection is recommended once the areas are made accessible.
