Building and Timber Pest Inspection Report

Inspection Date: Tue, 27 Jan 2026

Property Address: 71 Peartree Cct, WERRINGTON, NSW,
2747, Australia

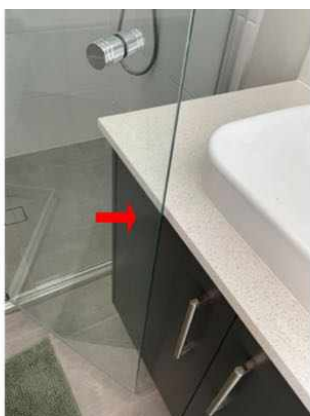
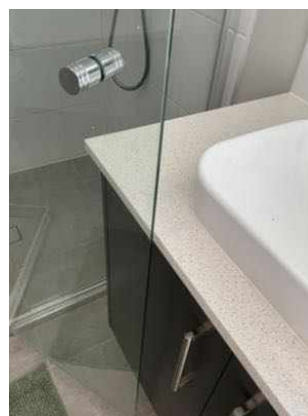
Building: Main Building
 Location: Bathroom
 Finding: shower screen door hitting vanity unit
 Information: The shower screen door makes contact with the edge of the vanity unit when opened. This indicates inadequate clearance between the shower screen and the fixed bathroom fixture. The door's operation is impeded and presents a safety concern.

- Potential for impact damage to the vanity and shower screen.
- Increased risk of glass breakage, posing a personal injury hazard.
- Ongoing stress may lead to hardware failure or misalignment of the door.

This condition does not comply with the intent of AS 4349.1-2007, Appendix C – Significant Items, under “Defects in the condition of secondary and finishing elements,” specifically where normal use may cause failure or injury.

Engage a licensed glazier or shower screen installer to adjust or replace the screen to ensure proper clearance and safe operation. A cabinetmaker may be consulted if modification to the vanity is more feasible.

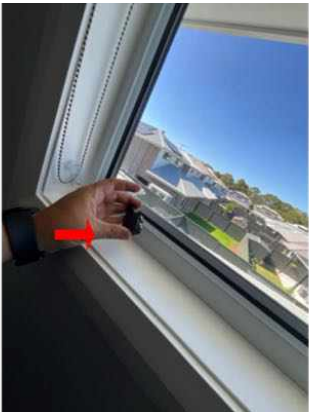
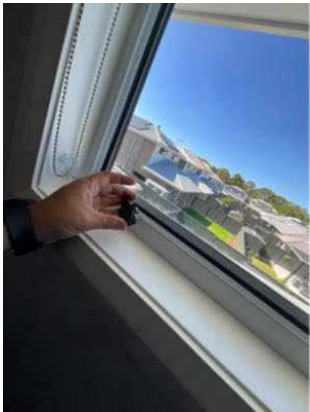
Finding 1.02

Building: Main Building
Location: All Areas
Finding: Window child lock missing
Information: The window in question lacks a child lock mechanism, which poses a potential safety risk to young occupants in the premises. As per Australian Standards windows accessible to children should be equipped with appropriate child safety locks to prevent accidental opening, reducing the risk of falls and ensuring compliance with safety regulations.

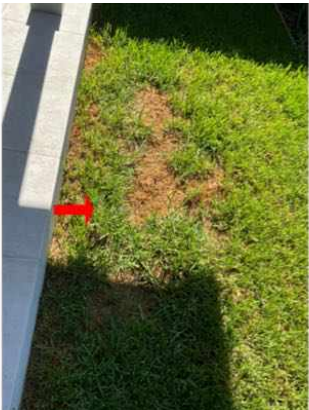
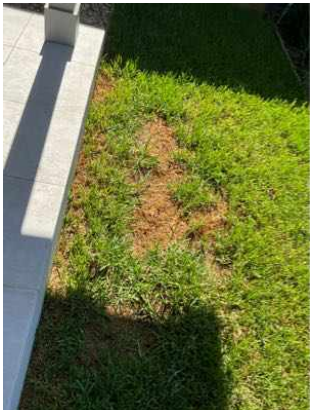
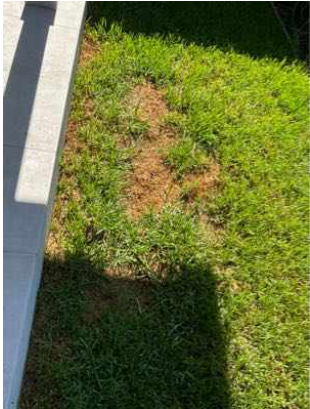
Surface water drainage is defective if it is not in accordance with the requirements of the Building Code of Australia.

Such water pooling also increases the risk of termite activity and the development of fungal decay in the area.

Consult a Licensed Plumber regarding the cost of potential site drainage rectification works.

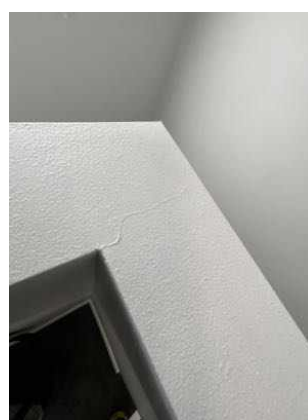
Finding 3.02

Building: Main Building
 Location: Upstairs
 Finding: Cracking - Damage Category 0 - Hairline (less than 1mm)
 Information: Hairline cracks are very minor in nature and generally are only ever an appearance defect. While such cracking may be noticeable in some cases, it is quite common and does not indicate any structural damage.

Cracking of this nature can generally be repaired with minor sanding, filling and/or repainting. Such works should be performed by a qualified painter or a general handyman.

Monitoring of all cracking should be conducted frequently. Always contact a building inspector should cracks widen, lengthen, or become more numerous.

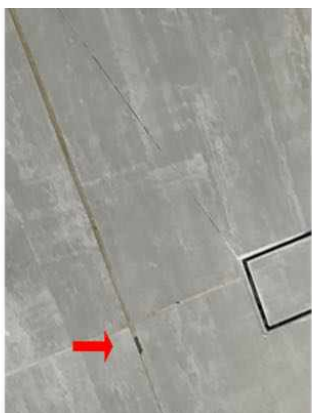
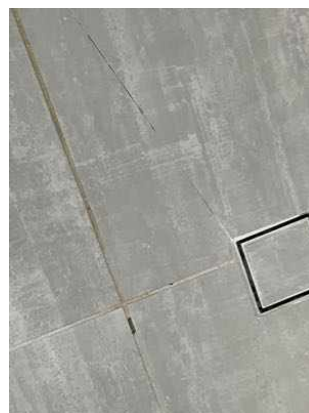
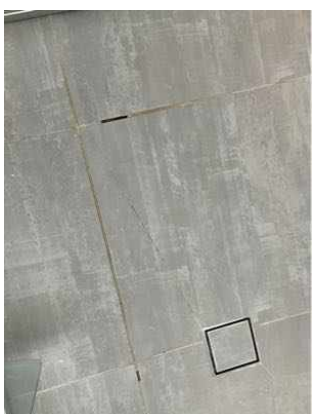
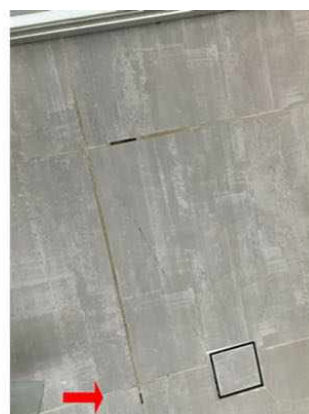
Finding 3.03

Building: Main Building
 Location: Bathroom
 Finding: Sealant and grouting - Missing or damaged
 Information: It was noted on inspection that sealant or grout is degraded to the tiled shower alcove and or other areas of the bathroom.

Different materials and floor areas move at different rates, generally causing cracking to grout or sealant at this point. A flexible sealant is required to allow for expected expansion and contraction, while keeping the joint water tight and protective of all associated building materials.

There appears to be excessive mould to the sealant and grout which will likely require scraping out and replacement.

Flexible and mould resistant materials should be applied to affected areas to prevent any subsequent water damage that is likely to occur. Regular maintenance and replacement of damage or missing or damaged sealant and grout is highly recommended to the wet areas, as this is a regular wear and tear defect. Sealant and grouting in areas that come into regular contact with water should be maintained for

A sealant specialist or tiling contractor should be appointed to complete these works as soon as possible

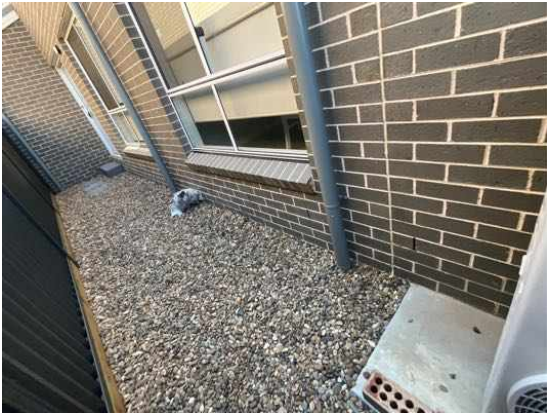
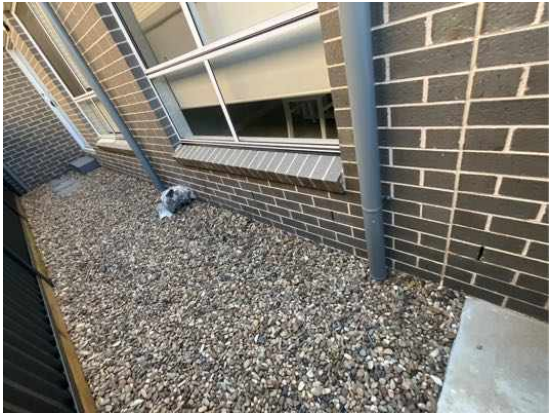
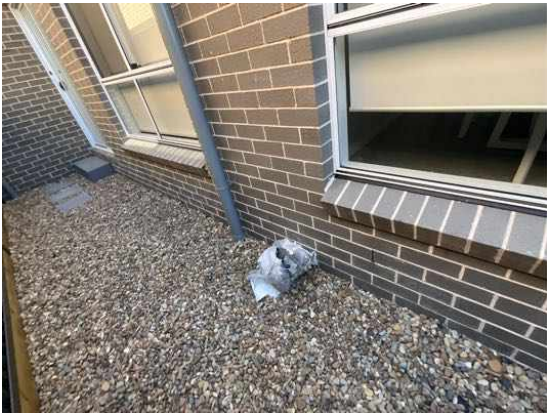
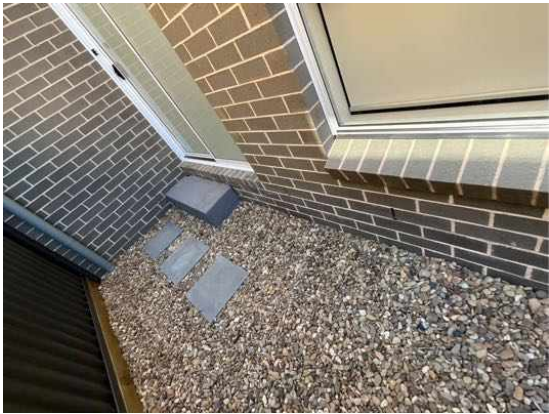
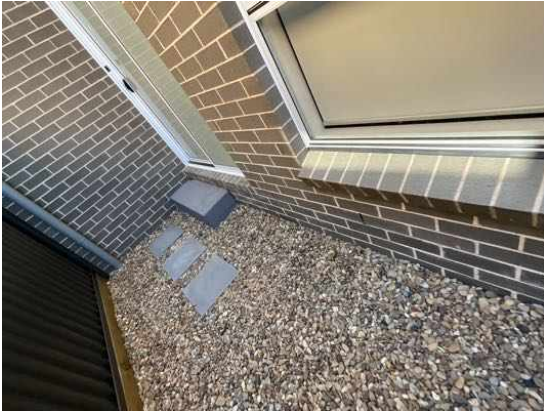
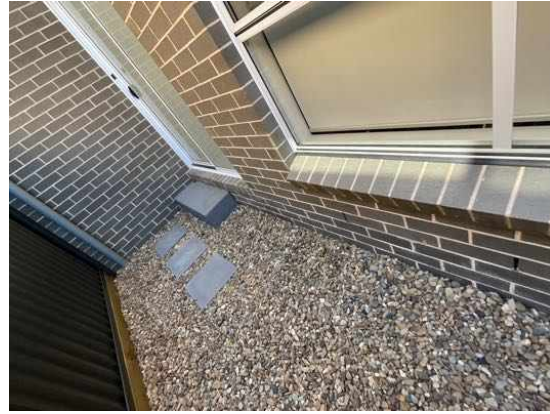
Where the slab edge cannot be properly inspected, it is highly recommended that termite or timber pest inspections be carried out every 6-12 months to aid protection of the property against infestation.

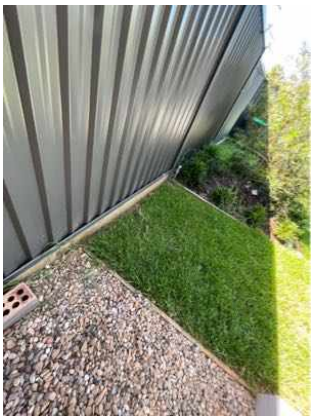
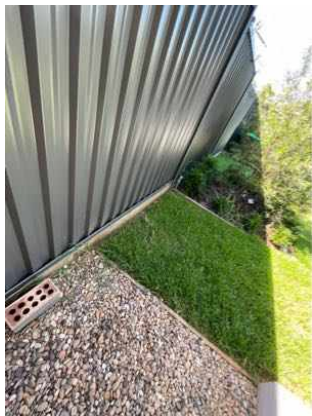
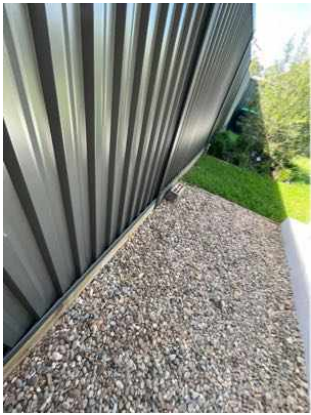
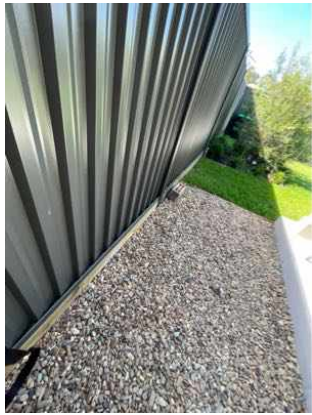
Building: Main Building
Location: All Areas
Finding: Timber on ground / conducive conditions to termite damage
Information: Timber on the ground is indeed conducive to termite damage. Termites are known to thrive in moist environments, and wood in contact with soil or moisture is more susceptible to infestation.

To prevent this, it's important to keep timber elevated and away from direct ground contact. Regular inspections and proper termite control measures are also essential to protect your wooden structures from termite damage.

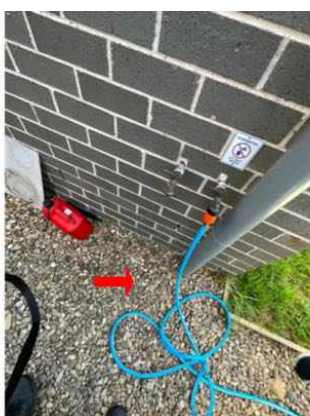
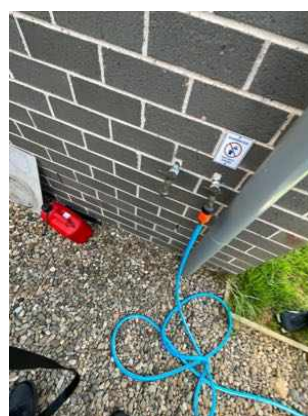
Finding 6.04

Building: Main Building
Location: Exterior walls - right side
Finding: No Drain under tap
Information: There is no drain installed under the tap, leading to water accumulation and creating conducive conditions for timber pests. This defect needs immediate attention to prevent potential damage and pest infestation.

3. Repair and Prevention: Inspecting and repairing any existing water damage and implementing measures to prevent future water accumulation and pest infestations.

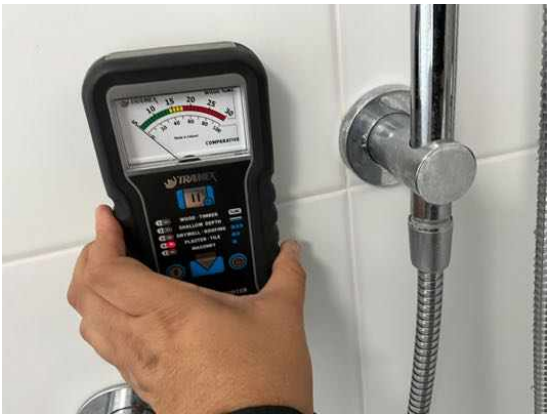
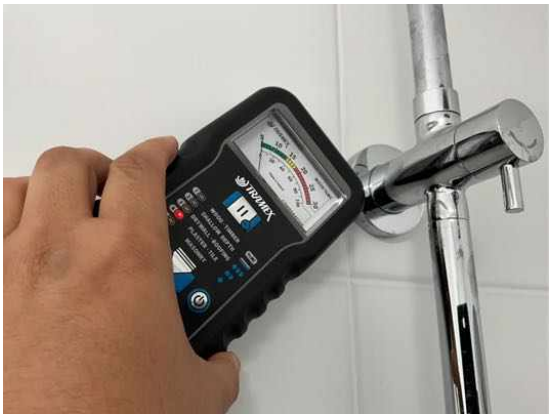
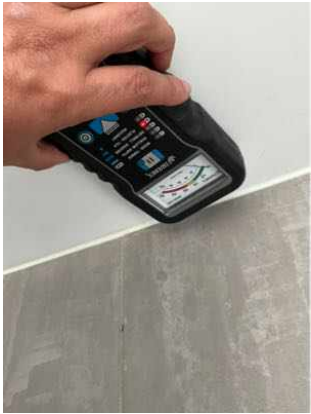
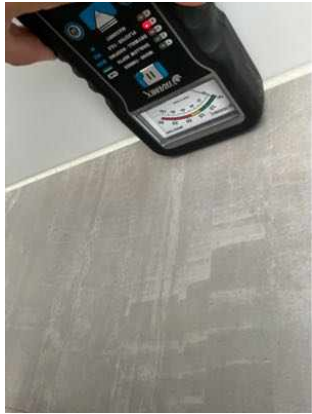
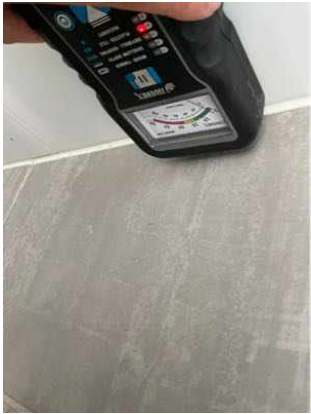
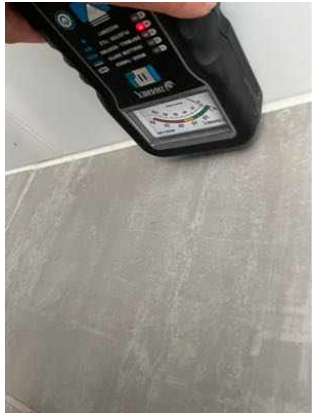
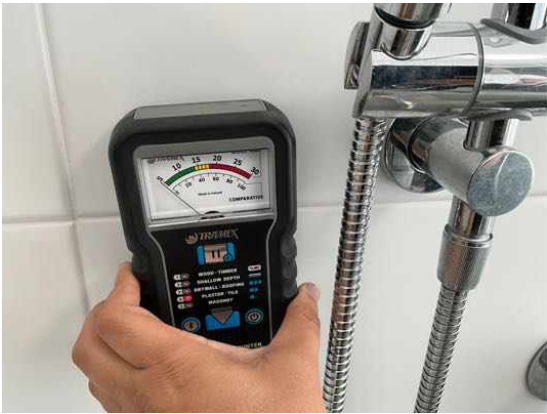
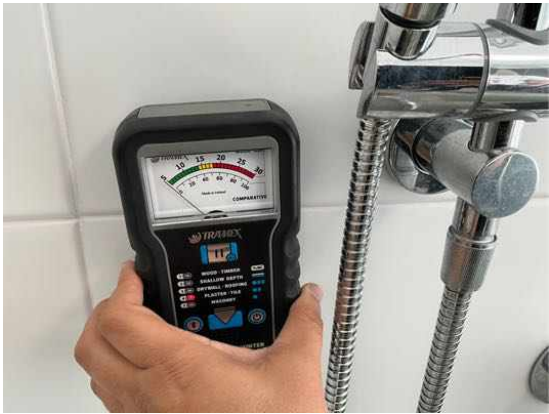
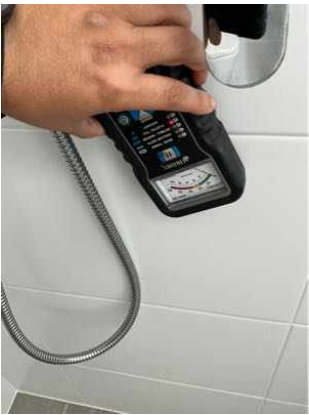
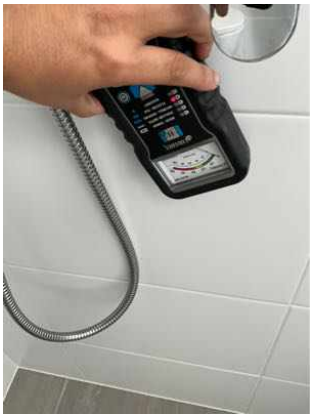
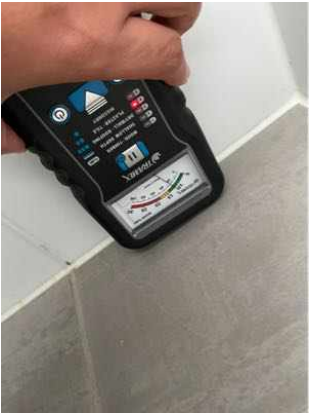
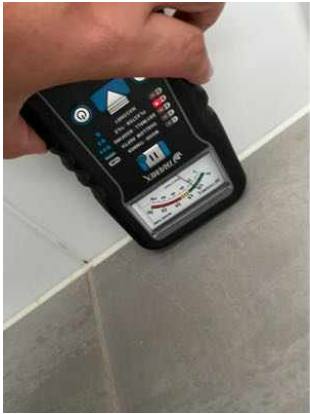
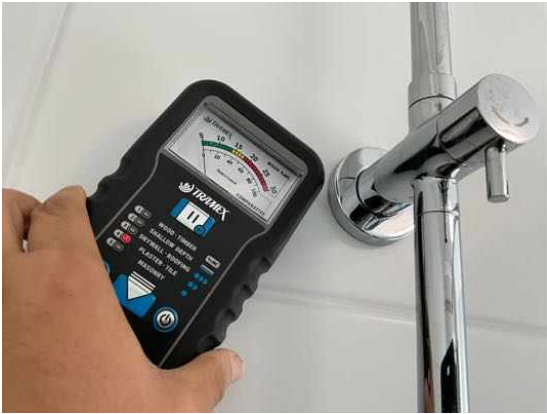
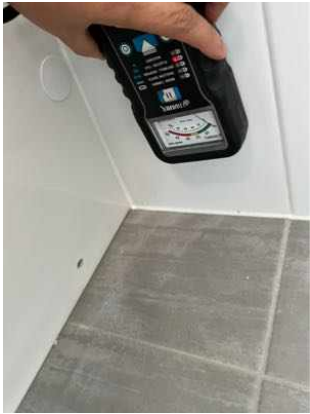
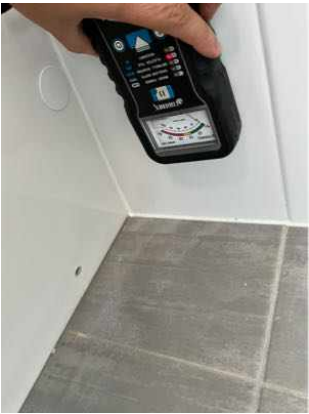
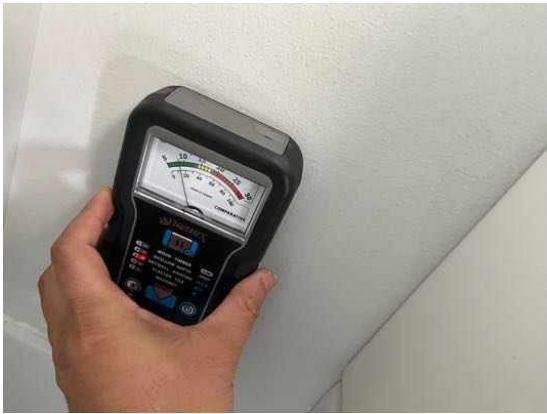
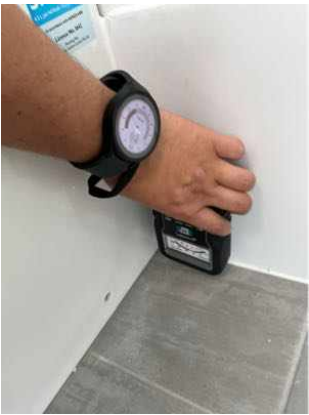
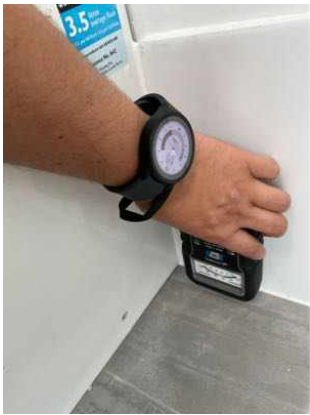
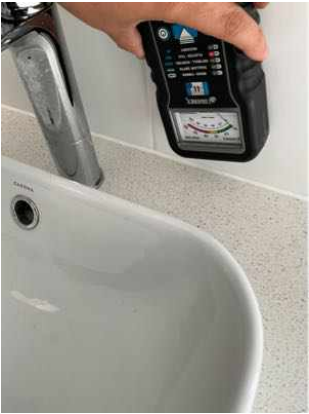
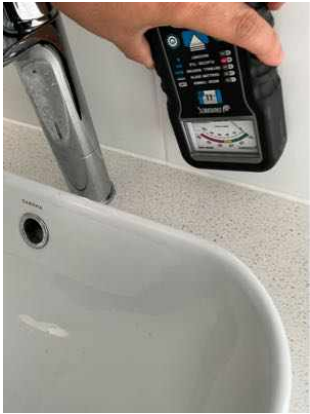
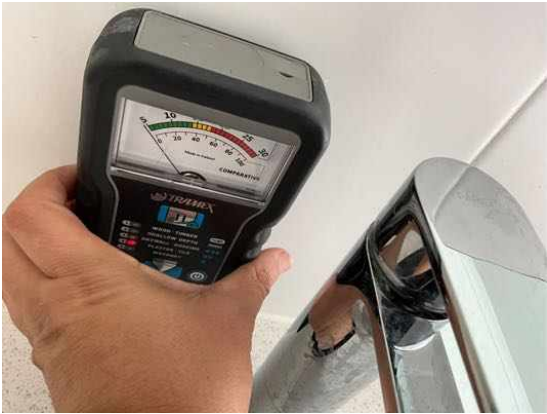
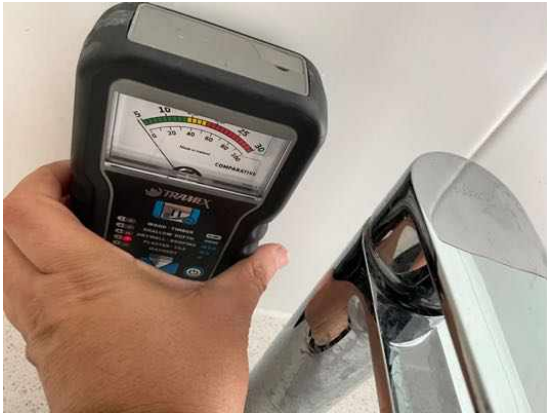
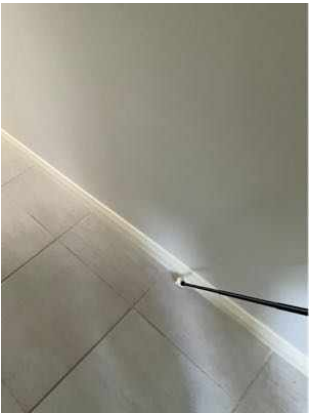
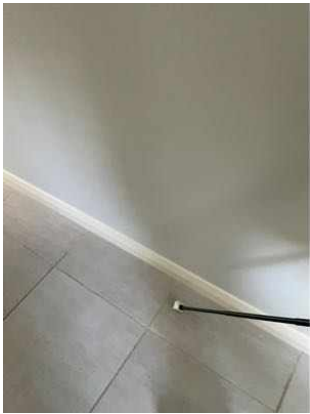
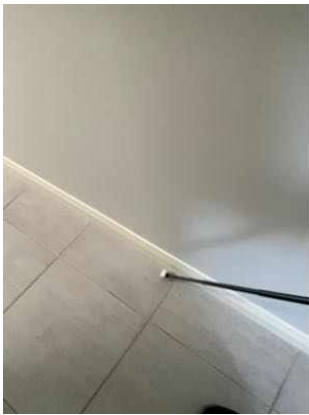
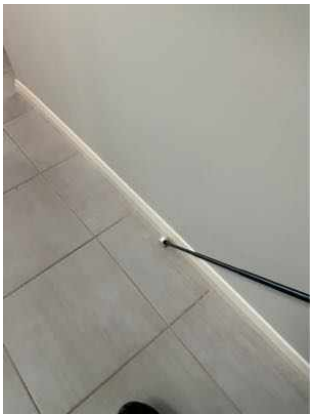
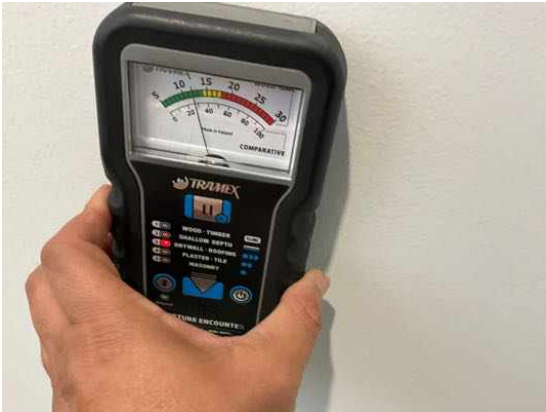
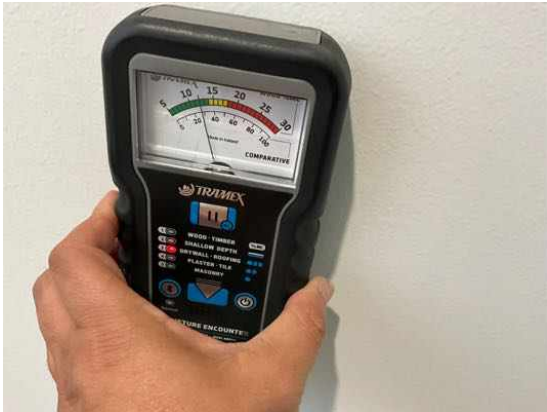
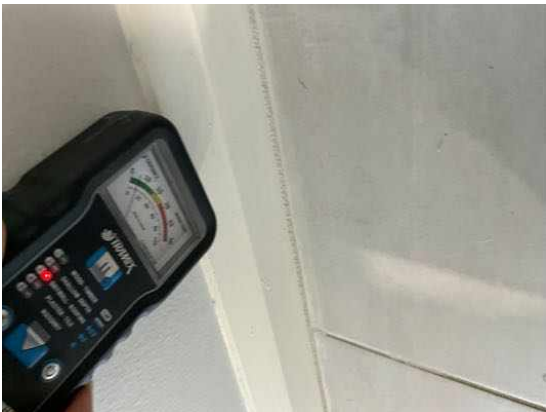
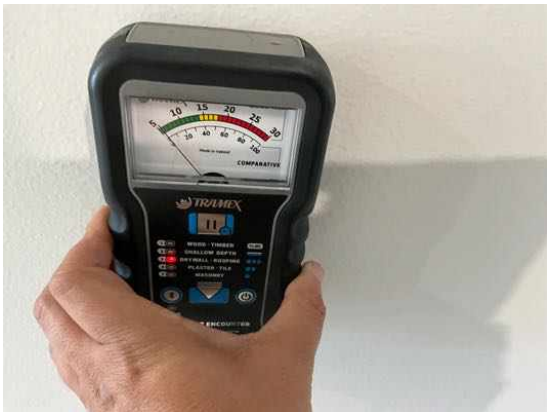
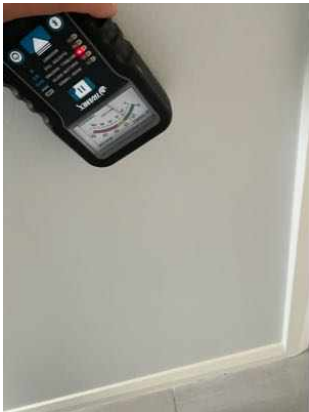
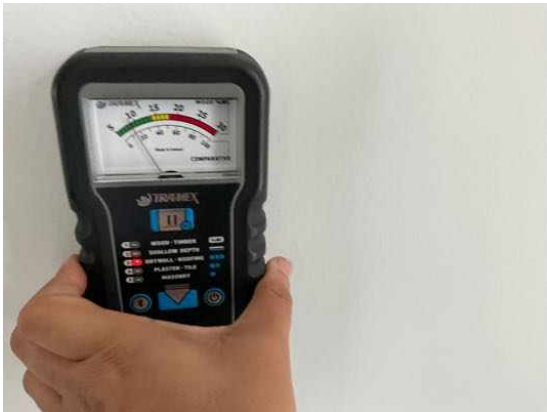
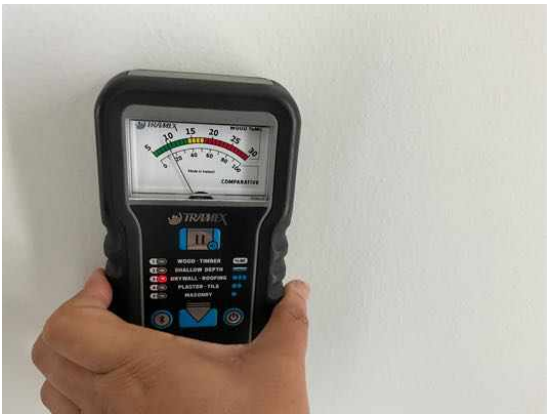
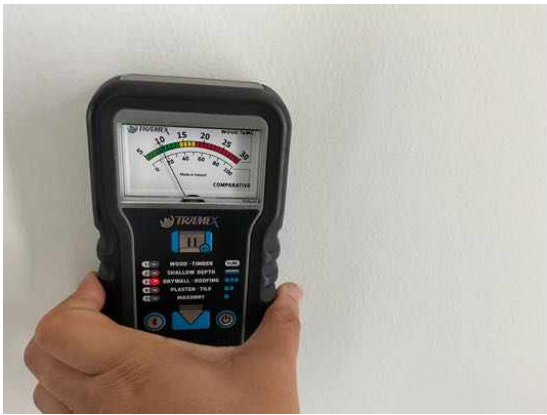
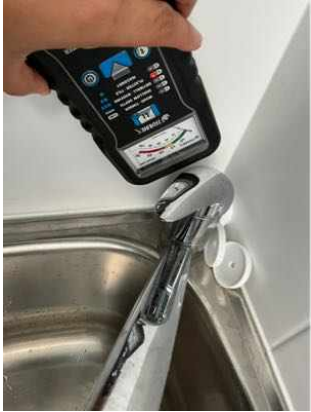
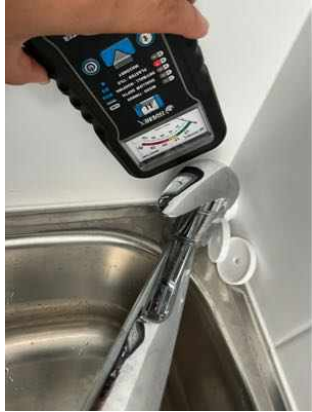
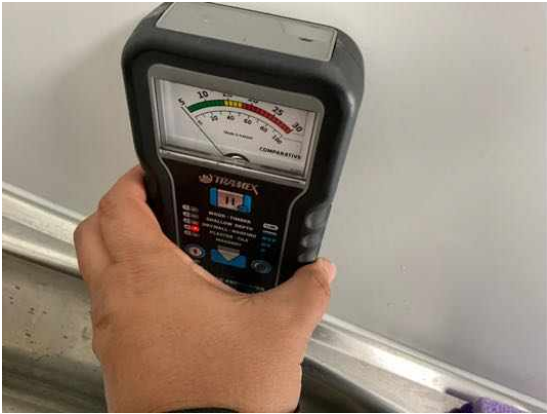
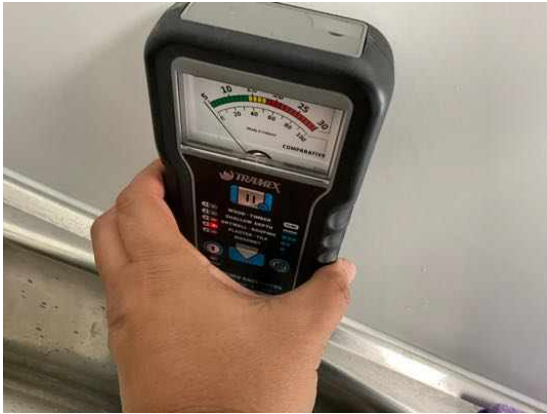
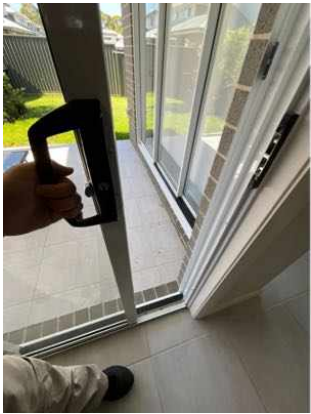
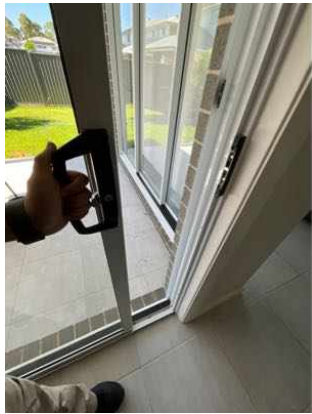
Building: Main Building
Location: All Areas
Finding: Additional Photos
Information: Additional photos are provided for your general reference

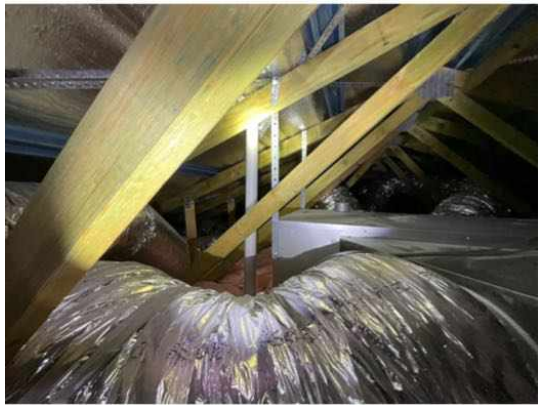
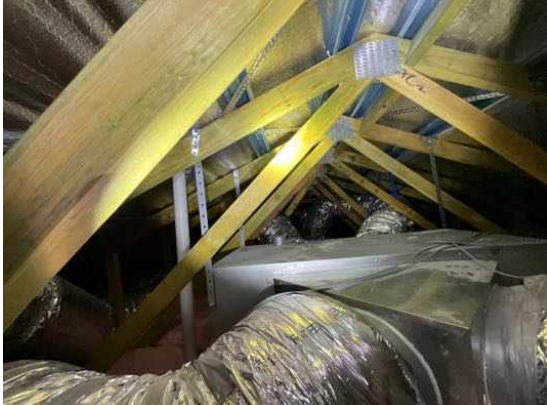
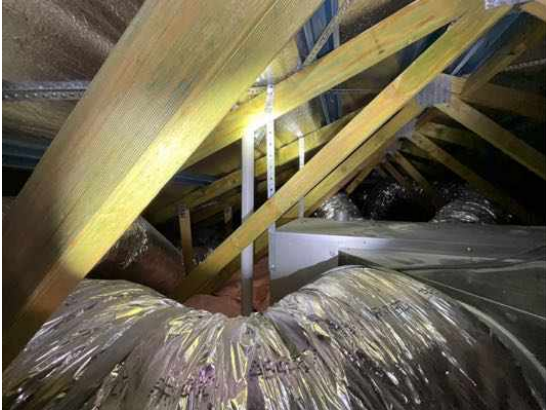
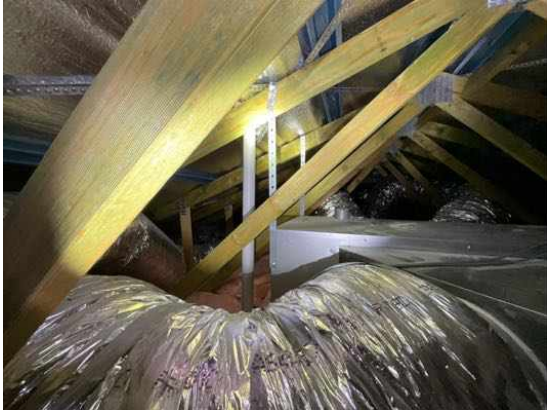
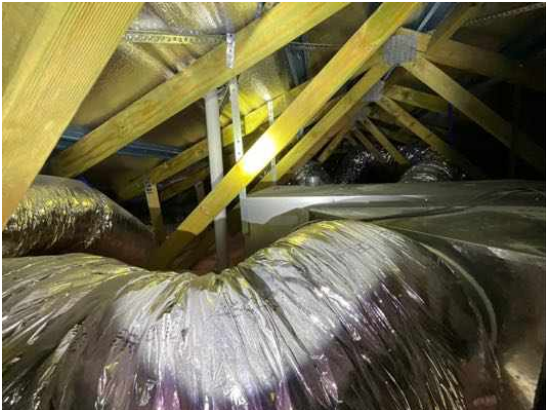
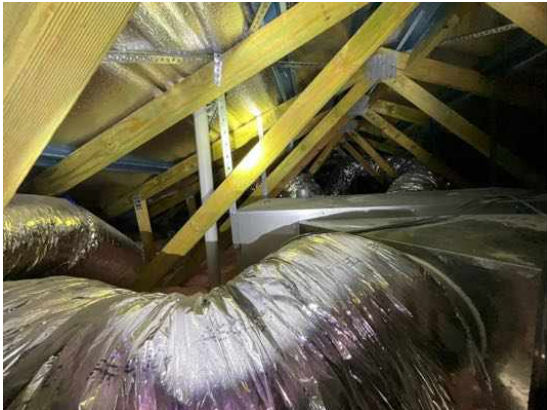
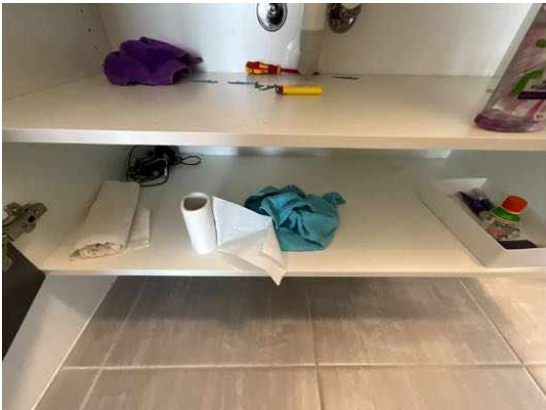
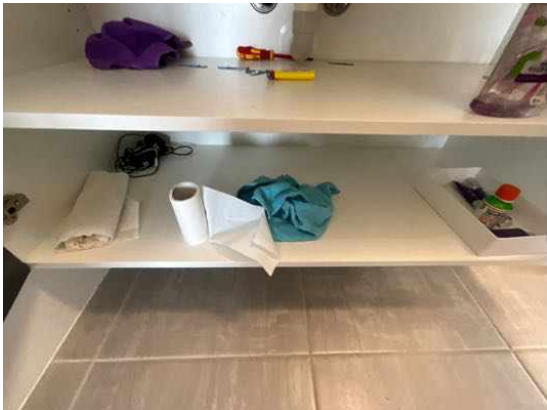
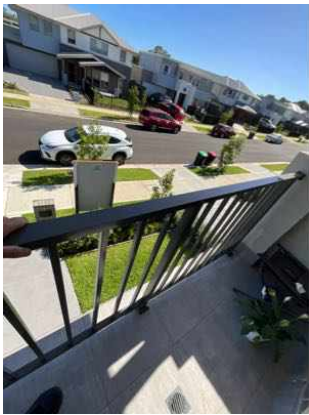
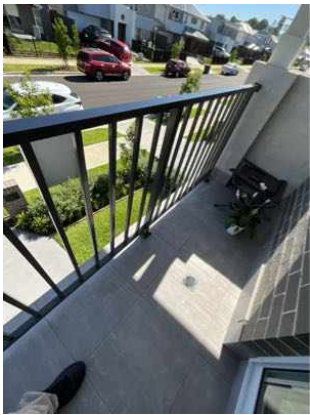
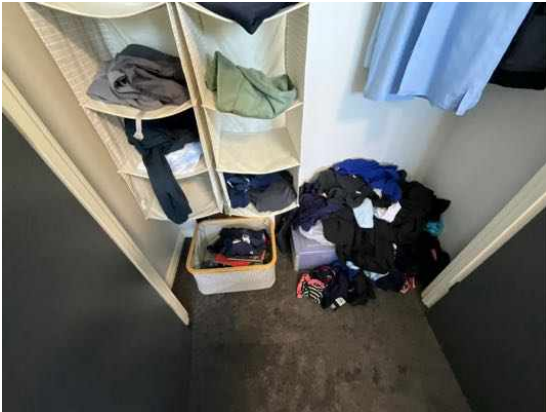
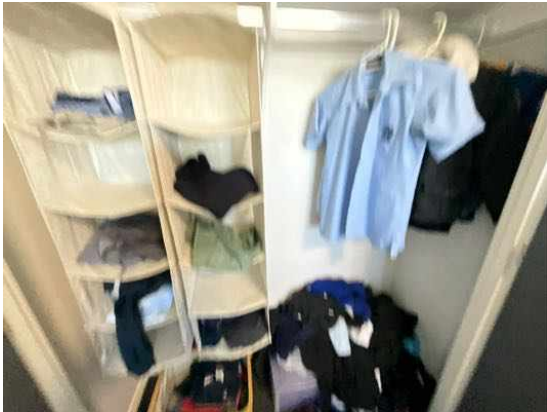
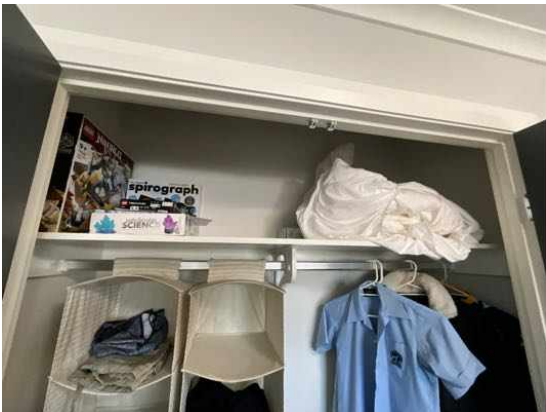
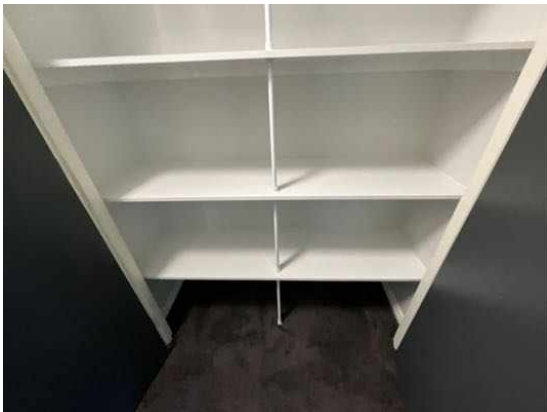
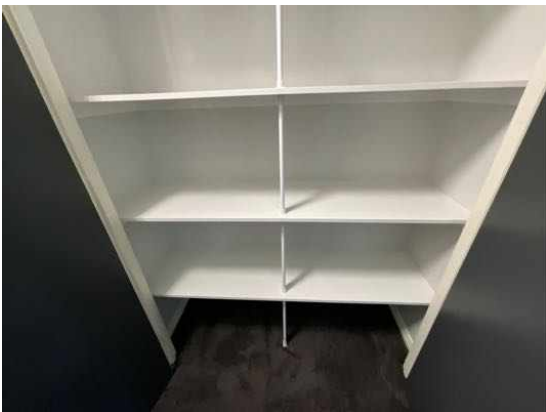
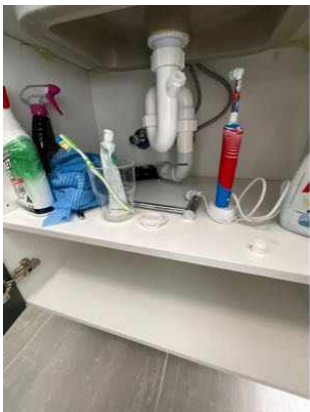
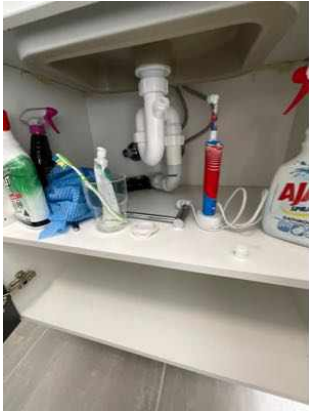
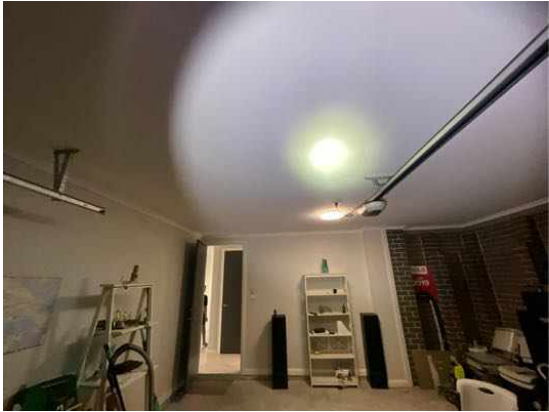
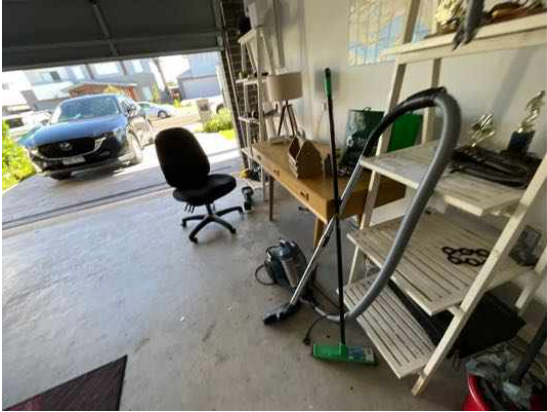
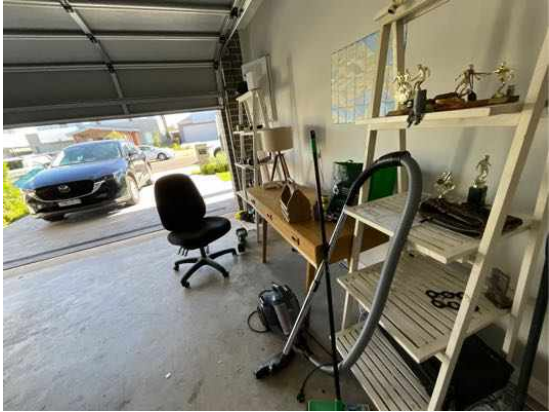
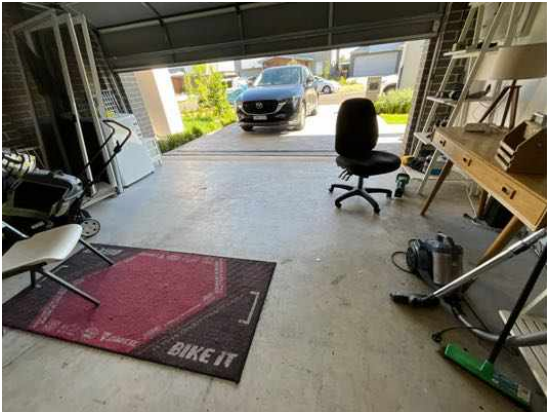
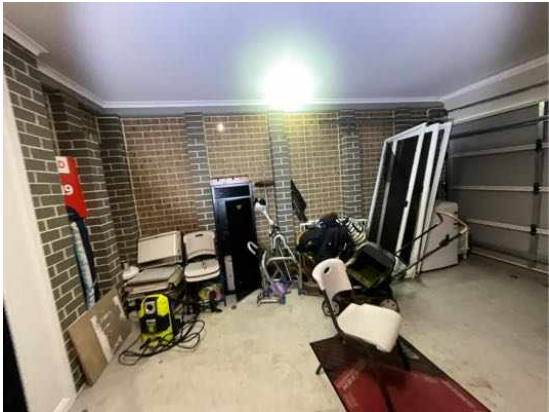
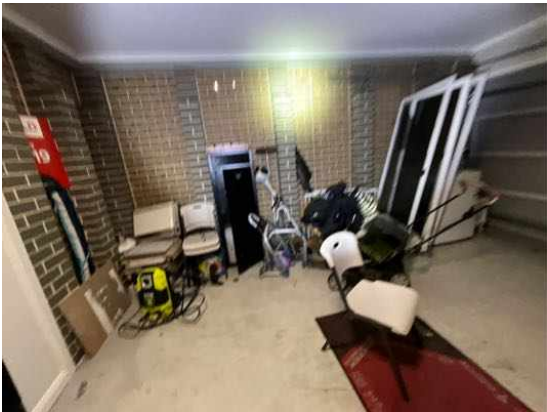
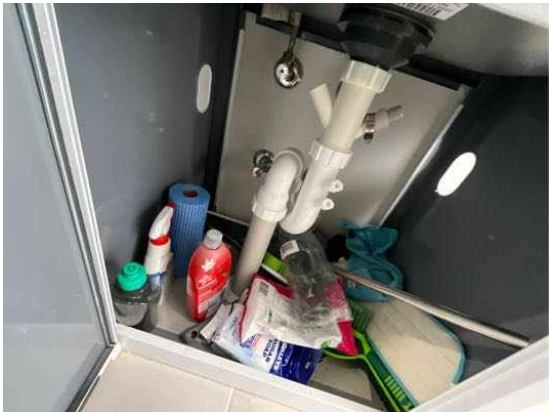
Building:	Main Building
Location:	All Areas
Finding:	Additional Photos - Obstructions and Limitations
Information:	These photographs are an indication of the obstructions and limitations which impeded full inspection of the property at the time of inspection. These obstructions can hide an array of defects and should be removed to allow full inspection to be carried out. A re-inspection is recommended once the areas are made accessible.

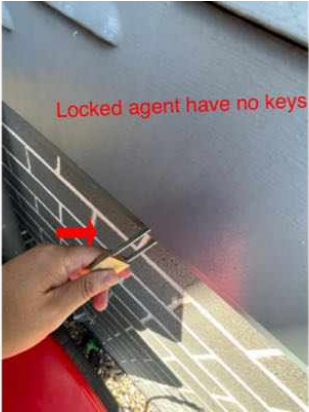
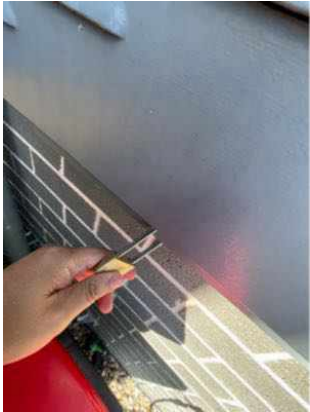
- Building: Main Building
- Location: Exterior walls - left side
- Finding: Evidence of Termite Management System - Durable notice / Legible Sticker - seek further information
- Information: The application of a pre & post-construction chemical termite barrier is highly recommended for all properties. Such barriers are highly effective in preventing termite

A durable notice was not sighted in the switchboard unit to indicate termite barriers however agent showed a copy at the time of inspection.

Client must seek further information from the vendor or real estate agent if the conditions of termite management systems were maintained as per the label or seek advise from licensed pest controller.
