Building and Timber Pest Inspection Report

Inspection Date: Tue, 3 Feb 2026

Property Address: 48 Panorama Dr, Farmborough Heights
NSW 2526, Australia

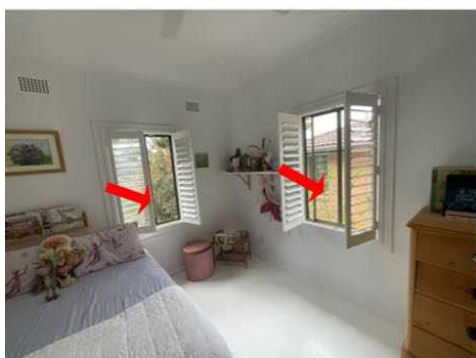
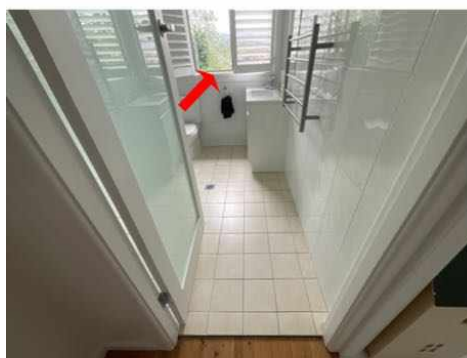
Building:	Building 1
Location:	Pictured upstairs windows
Finding:	Window opening restrictors missing.
Information:	The Building Code of Australia rules require all openable windows (where the internal floor is more than 2m above the ground outside) in residential rooms to be fitted with a suitable screen or restrictor. Windows located 1.7m above the floor level do not require protection.

Window restrictors are required where people who are vulnerable to the risk of falling have access to windows. This means all windows above ground level which do not have another fall prevention safety measure in place, such as a balcony or balustrade should have a restrictor.

These need to be added urgently for the safety of all persons.

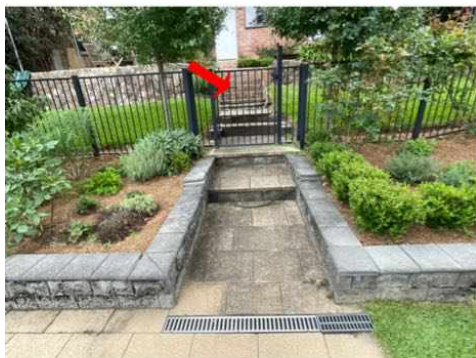
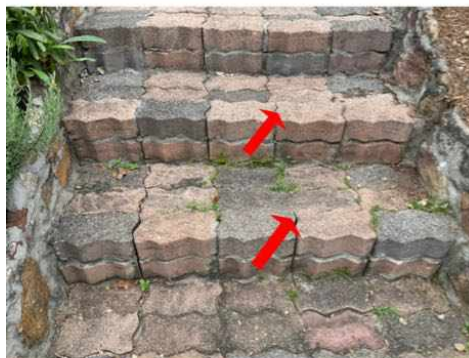
Finding 1.02

Building:	Building 1
Location:	Pictured external areas
Finding:	Trip safety hazard
Information:	A few raised sections of the rear steps have created a trip hazard on the rear footpath to the pool. The uneven surface poses a risk to pedestrians, particularly the elderly, children, and individuals with mobility impairments. This requires urgent repair by a concreting contractor.

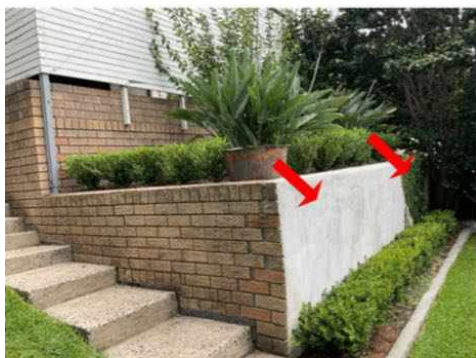
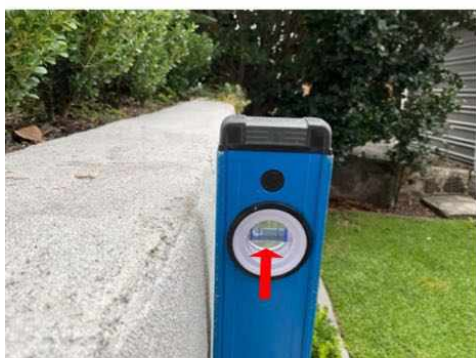
Finding 2.01

Building:	Building 1
Location:	Front retaining walls
Finding:	Retaining wall - Defective
Information:	The retaining wall in this left area was found to be defective at the time of inspection. It is leaning toward the house. Generally, defective retaining walls are caused by poor original design or material use. Retaining walls are normally constructed in blockwork or timber with adequate drainage installed. However, deteriorated retaining walls may also be a result of substandard construction, poor site drainage or unmanaged stormwater flows. No drainage was evident and it cannot be determined if any drainage exits behind these retaining wall areas.

The owner on request provided a page from the building inspection undertaken in June 2022, see below, indicating it appears this wall had some damage over 3 years ago.

If left unmanaged, the retaining wall may continue to move. Significant repair and replacement should be expected at some time in the future, It is recommended to seek advice from a structural engineer regarding repair of both front retaining walls.

A landscaper or retaining wall installer may the be appointed to repair or replace the wall, at the discretion of the client.

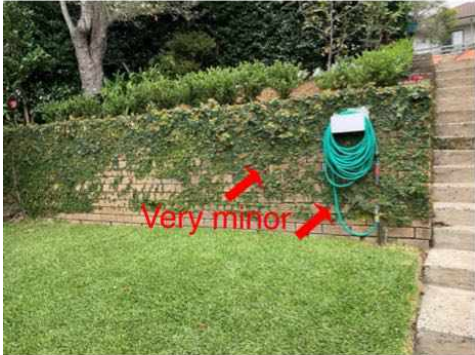
Finding 2.02

Building:	Building 1
Location:	Exterior front walls around stairs
Finding:	Step cracking to brickwork major
Information:	Step cracking was identified to the brickwork in the front external wall areas at the time of inspection.

The NSW Standards and Tolerances 2017 states cracks over 5mm in width are a major defect requiring rectification work. This applies to the two brick walls either side of the front stairs that show step cracking of 11mm and 12mm. Other very small cracks under 3mm were found under the vines on the right side wall.

Step cracking, which is similar to other forms of cracking, has a variety of possible causes. However, the most common is the subsidence of adjacent footings.

Where step cracking is extensive or severe, the client is advised to consult a structural engineer. Minor step cracking can be used as a warning sign to address factors causing stress to the wall, which can include the effect of surrounding trees, water

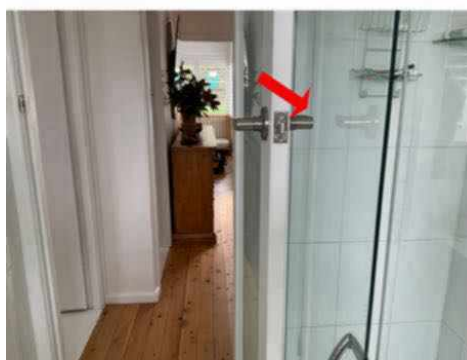
Finding 3.01

Building: Building 1
 Location: Pictured external areas
 Finding: Building elements - Damaged or missing
 Information: Evidence of minor missing or damaged areas was identified at the time of the inspection. These include -

1. One bedroom is missing a door and the front doggy door flap is also missing.
2. The bathroom door needs a doorstop to stop the shower screen breaking from impacts.
3. The front garage timber is very loose requiring refixing in place.
4. The laundry tap only had cold water, all other taps worked normally.

A carpenter would be the trade responsible for rectification of most of these areas when convenient.

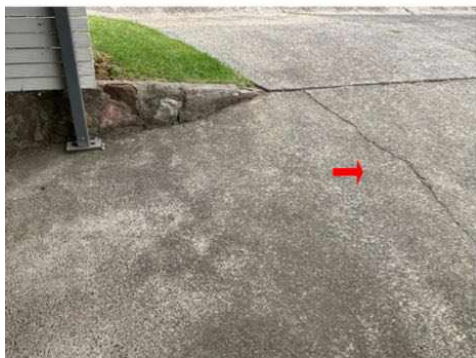
Finding 3.02

Building:	Building 1
Location:	Slabs front & rear
Finding:	Crack in concrete slabs - Category 1
Information:	Cracks coded as Category 1 was identified in these pictured slabs. A Category 1 crack is described as a fine but noticeable crack, with the slab at an otherwise reasonable level. To be considered Category 1, the approximate width of the crack is less than 1.0mm, or a less than 10mm change in offset when a 3m straight edge is placed over the defect.

Category 1 cracks should be monitored for a period of 12 months. At the end of the

monitoring period, identified cracks that are rated greater than Category 2 are considered defects, and require rectification.

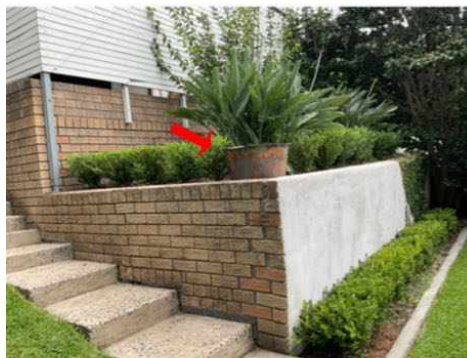
Building:	Building 1
Location:	Retaining and house wall areas
Finding:	Site drainage - Inadequate
Information:	The site drainage in these areas appears to be inadequate with no visible AG drains evident at the time of inspection.

Where site drainage is inadequate, installation of an Agricultural (Aggie) Drain may be required. A qualified plumber should be appointed to further inspect the property and perform any remedial works as necessary. Secondary defects are likely to occur if left unmanaged.

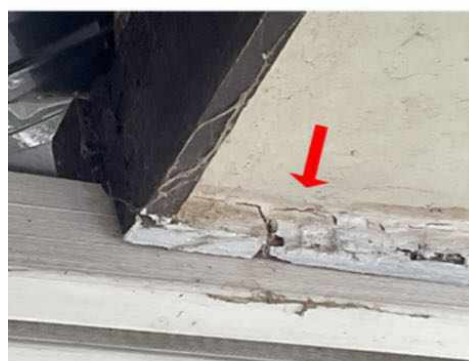
Finding: Wood rot

Information: The building shows evidence of wood rot, common to timber roof areas lacking paint. Wood rot, also known as Fungal Decay, occurs when timbers and other cellulose building materials are exposed to damp conditions on an ongoing basis. This could be the result of exposure to weathering over a prolonged period of time, or the attraction of excessive moisture from other abutting building materials.

Early intervention and regular maintenance, particularly of exterior timbers, will prolong the useful life of these building elements. Prior to any works being performed, the cause of the moisture that has created the visible wood rot should be identified and addressed in a suitable manner. Replacement of affected timbers may then be a necessary step in protecting surrounding building elements from such deterioration.

A qualified carpenter or registered builder may also be required to replace affected building materials.

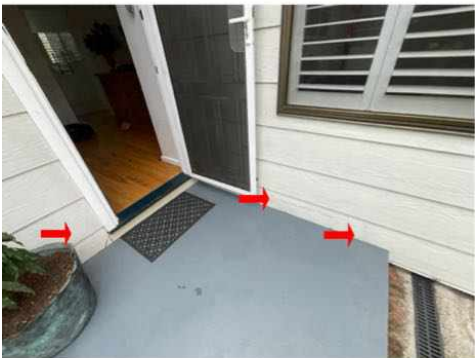
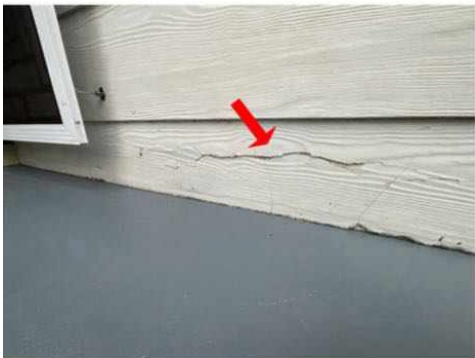
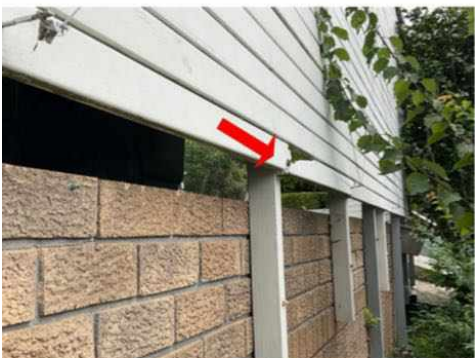
Finding 3.07

Building: Building 1
Location: Pictured external front hose and garage areas
Finding: Cladding damaged
Information: Evidence of damage was identified to the house and garage walls where the cladding has minor damage. A carpenter would be the trade responsible for rectification of this wall areas when convenient.

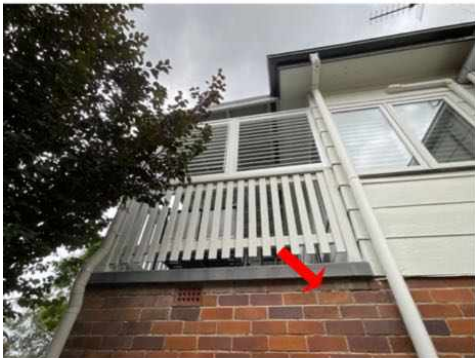
Finding 3.08

Location: Pictured external areas
Finding: Brickwork mortar missing in small areas
Information: Small areas of mortar was found to be missing at the time of the inspection. Mortar, or 'bedding', is the material which fills joints and intersections between bricks.

Mortar that is missing may allow water ingress into these areas, putting associated building elements at risk of water damage.

Missing mortar can be attended to by bricklayer as soon as possible.

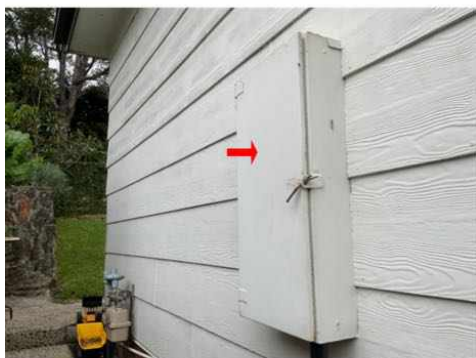
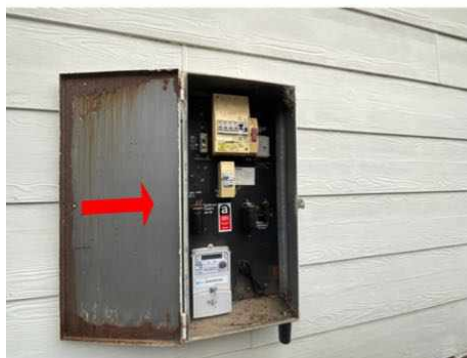
Building:	Building 1
Location:	Meter Box
Finding:	Termite Management System - no evidence of a chemical installation
Information:	The application of a post-construction chemical termite barrier is highly recommended for all properties. Such barriers are highly effective in preventing termite attack on any timber building elements throughout the property.

A durable notice should be placed in the switchboard unit to indicate current termite barriers. At the time of inspection, no durable notice was evident and it appeared as though no chemical termite management system has been installed, with no evidence to suggest preventative works taking place since the property was built.

The client may consider gaining further advice from a pest controller as to the costs and procedures involved with a 'chemical' application. It is recommended that obtaining such advice be a short-term priority.

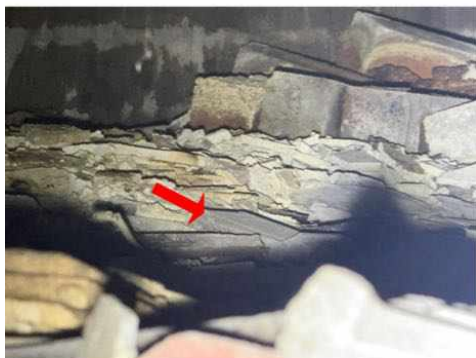
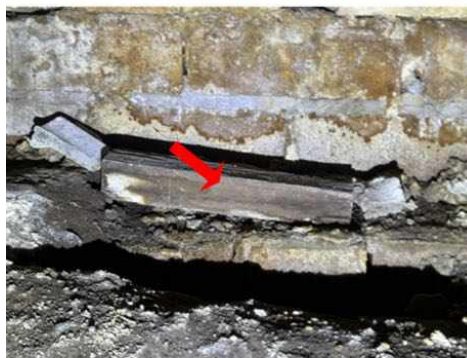
Building:	Building 1
Location:	Subfloor
Finding:	Timber in contact with the ground
Information:	Any timbers in direct ground contact provide opportunity for concealed termite entry and are likely to be subject to premature rot and decay as the soil retains moisture or damp conditions against the timbers.

Removal of all waste timber that is in direct contact with ground is highly advised. This timber is promoting mould and wood rot and is very attractive to termites.

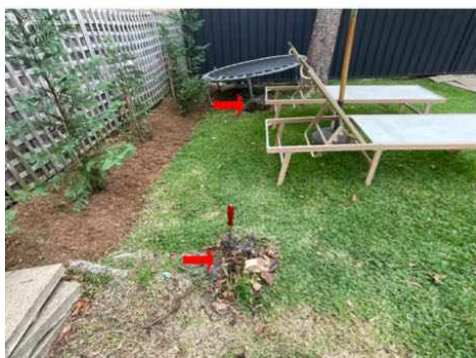
Finding 6.04

Building:	Building 1
Location:	Pictured yard area
Finding:	Tree stumps - left in ground
Information:	Tree stumps left in ground provide opportunity for termite attack as they are likely to be subject to rot and decay providing an attractive food source. Treatment and/or Removal of the stump is highly recommended. A pest controller and tree removalist

should be engaged to perform such works.

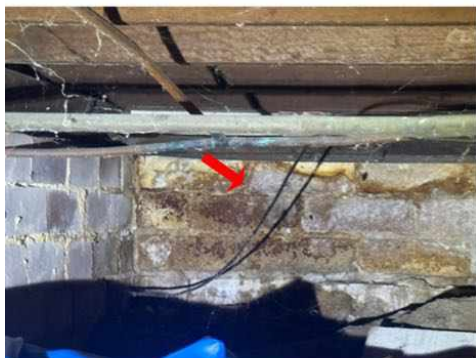
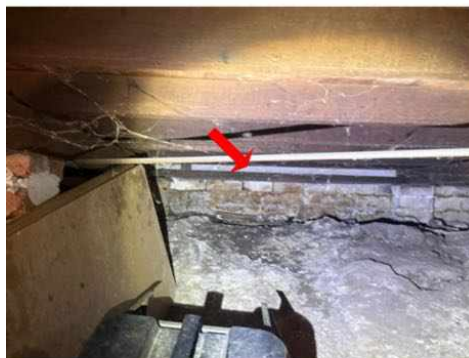
Finding 6.05

Building:	Building 1
Location:	Subfloor
Finding:	Damp - Rising
Information:	Rising damp describes the upward movement of water in low sections of building elements (e.g. walls) by capillary action - the movement of water through porous materials such as bricks, sandstone or mortar.

Consultation with a qualified plumber is advised immediately to identify the cause of the damp and perform remedial works as required.

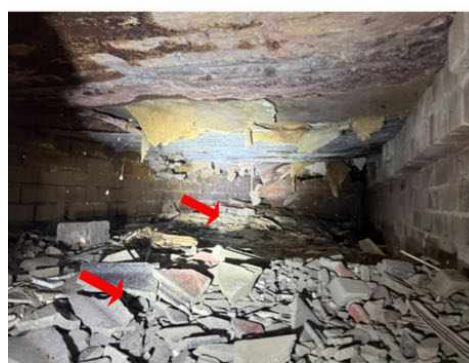
Information: An array of debris was found in the subfloor area at the time of inspection. Debris in this area restricts subfloor ventilation and creates potential for concealed pest entry. Stored timbers and other materials may also make the area susceptible to termite activity and wood rot.

Debris in the subfloor should be removed as soon as possible. Depending on the location and amount of debris and stored items, the homeowner may elect to undertake this task. Alternatively there are a large number of rubbish removal subcontractors that could undertake these works.

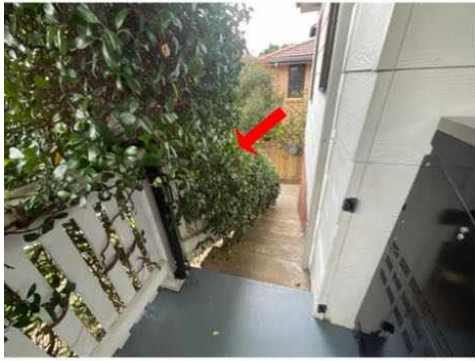
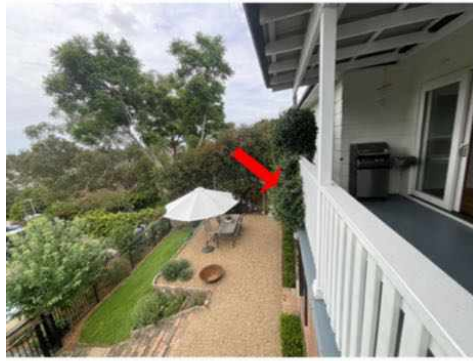
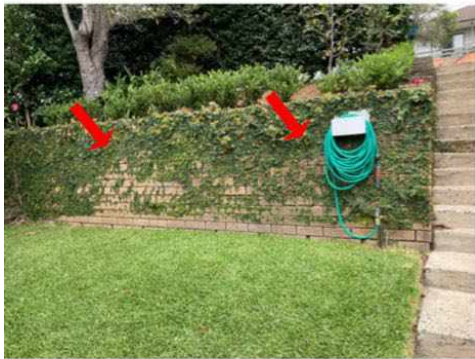
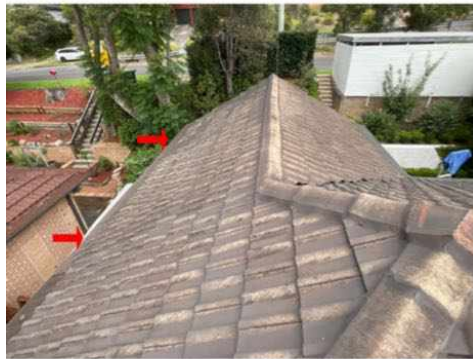
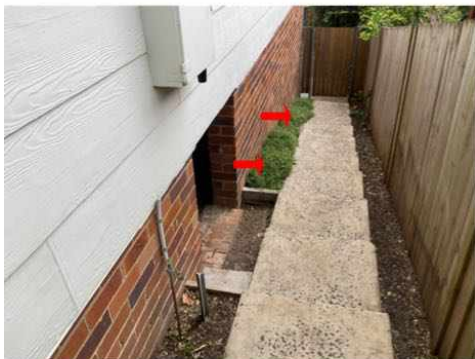
Building: Building 1
 Location: All External Areas
 Finding: Additional Photos - Obstructions and Limitations of EXTERNAL AREAS
 Information: These photographs are an indication of the obstructions and limitations which impeded full inspection of external areas at the time of inspection. These obstructions can hide an array of defects and should be removed to allow full inspection to be carried out. A re-inspection is recommended once the areas are made accessible.

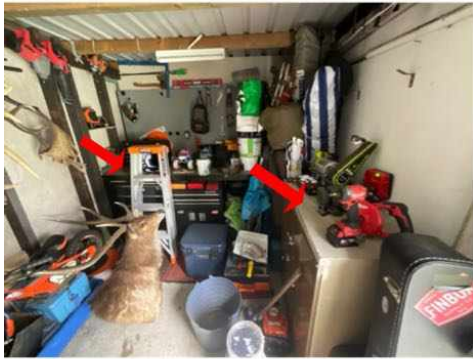
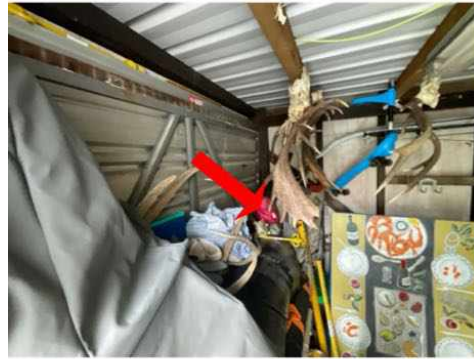
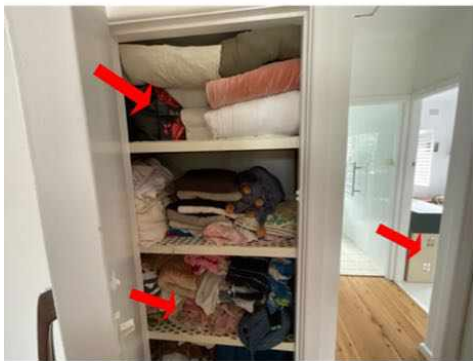
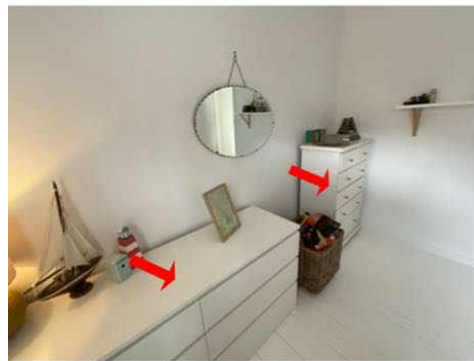
Building: Building 1
Location: All Internal Areas
Finding: Additional Photos - Obstructions and Limitations of INTERNAL AREAS
Information: These photographs are an indication of the obstructions and limitations which impeded full inspection of Internal areas at the time of inspection. These obstructions can hide an array of defects and should be removed to allow full inspection to be carried out. A re-inspection is recommended once the areas are made accessible.

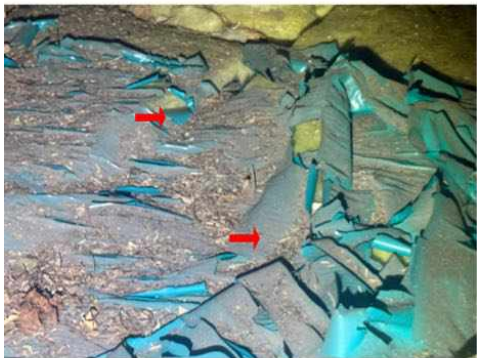
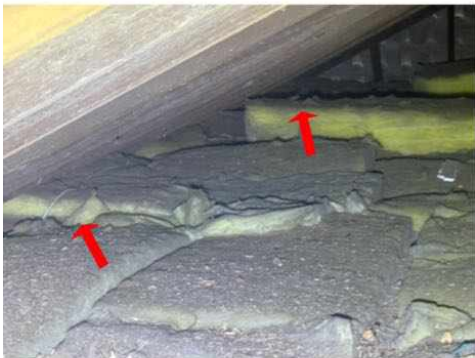
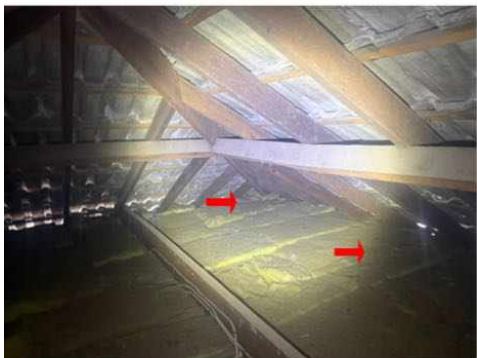
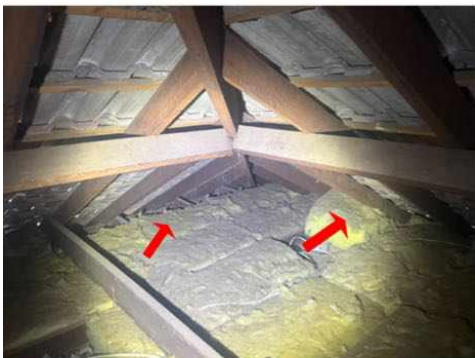
Building: Building 1
 Location: All Roof cavity areas
 Finding: Additional Photos - Obstructions and Limitations of the ROOF CAVITY
 Information: These photographs are an indication of the obstructions and limitations which impeded full inspection of roof cavity areas at the time of inspection. These obstructions can hide an array of defects and should be removed to allow full inspection to be carried out if applicable. A re-inspection is recommended once the areas are made accessible.

The inspection was also limited to areas with an allowable crawl space of 600mm x 600mm, in particular towards the external walls where the roof line diminishes, these areas were not accessible.

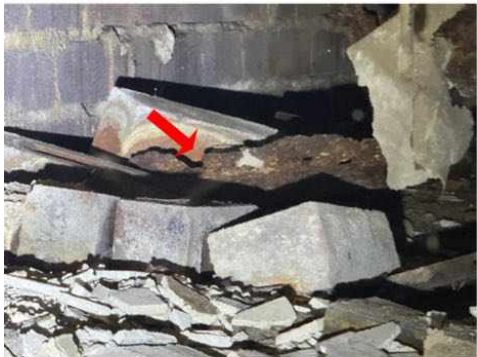
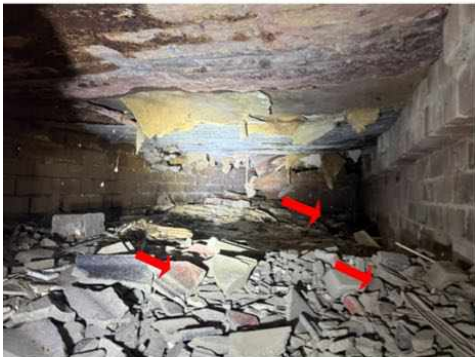
Building: Building 1
Location: All Subfloor Areas
Finding: Additional Photos - Obstructions and Limitations of SUBFLOOR AREAS
Information: These photographs are an indication of the obstructions and limitations which impeded full inspection of subfloor areas at the time of inspection. These obstructions can hide an array of defects and should be removed to allow full inspection to be carried out. A re-inspection is recommended once the areas are made accessible.

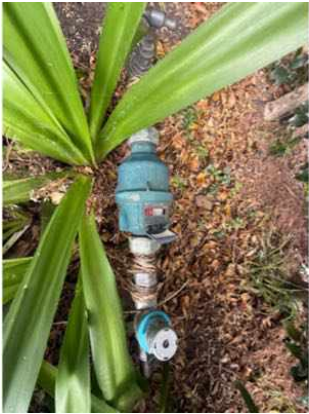
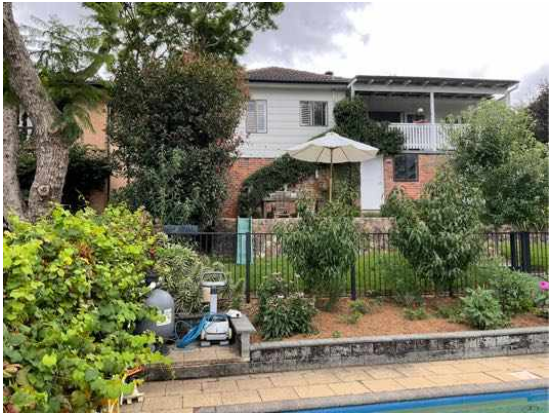
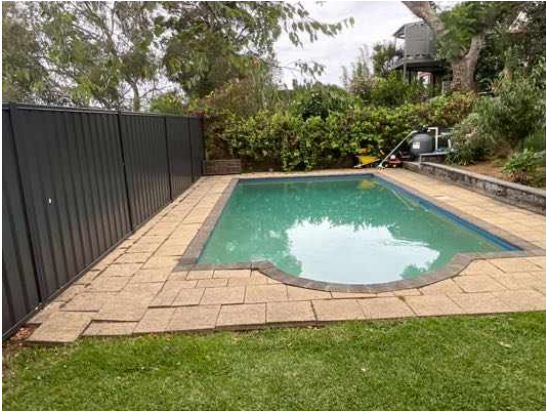
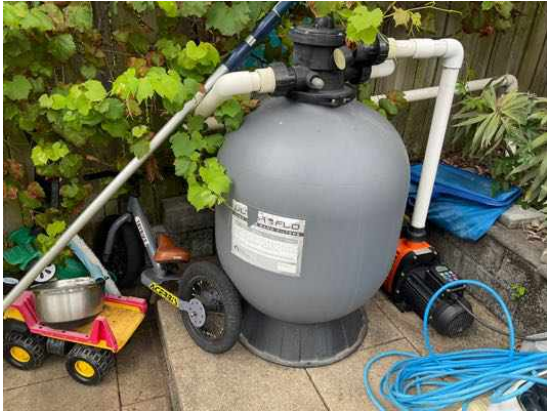
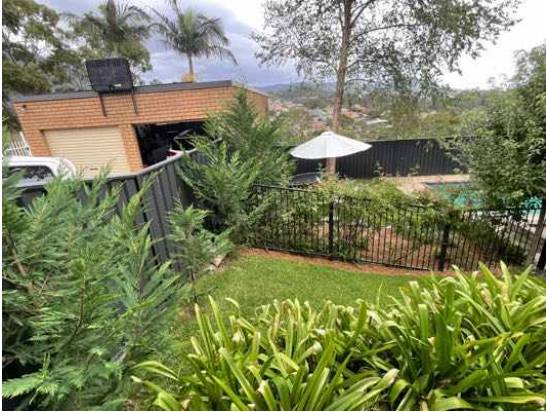
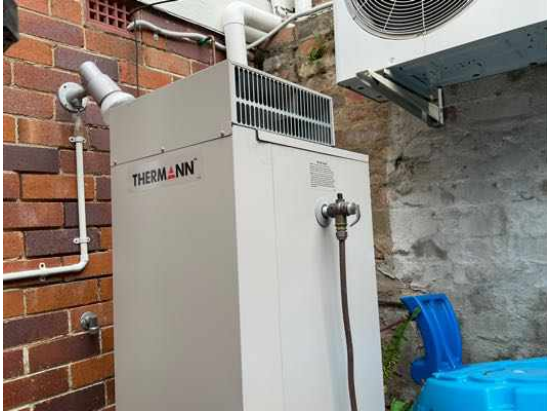
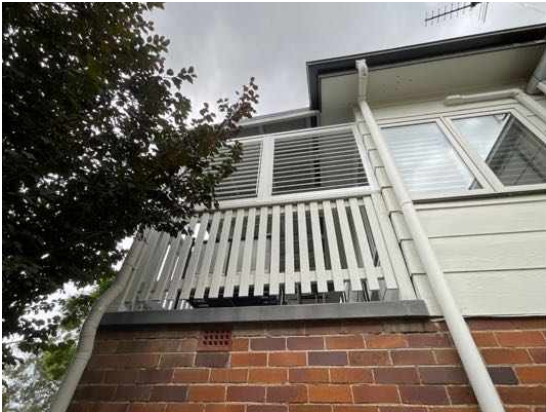
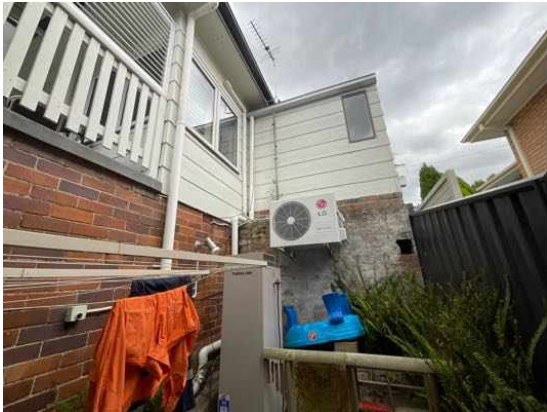
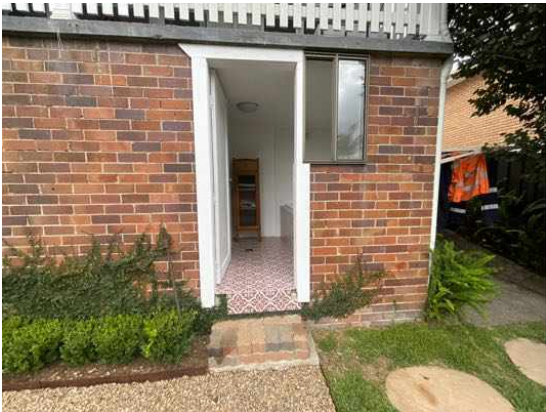
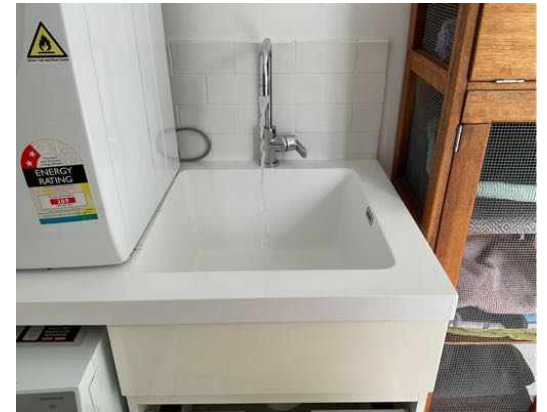
Building: Building 1
Location: All External Areas
Finding: Additional Photos
Information: Additional photos are provided for your general reference

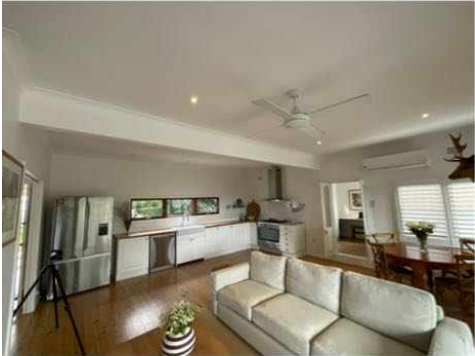
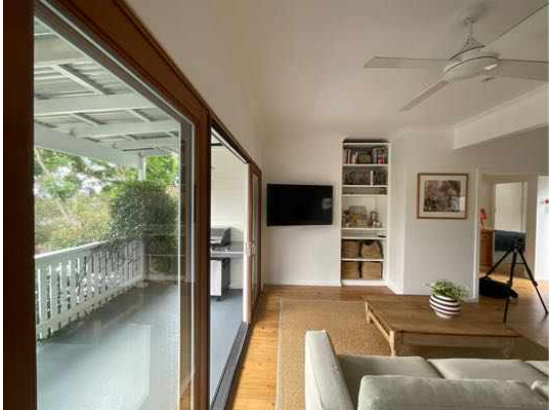
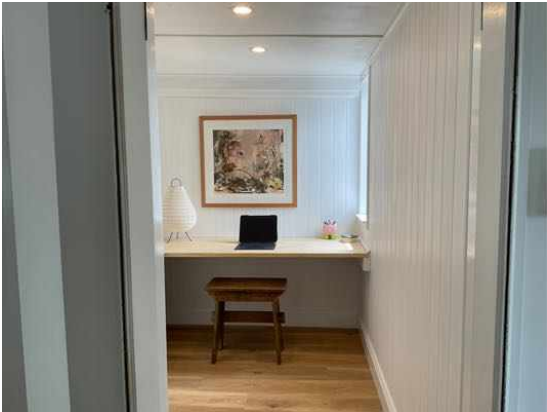
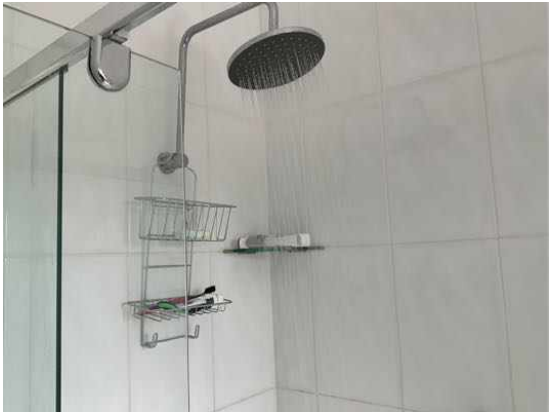
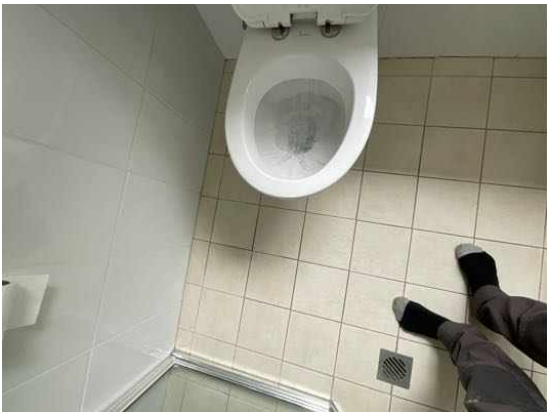
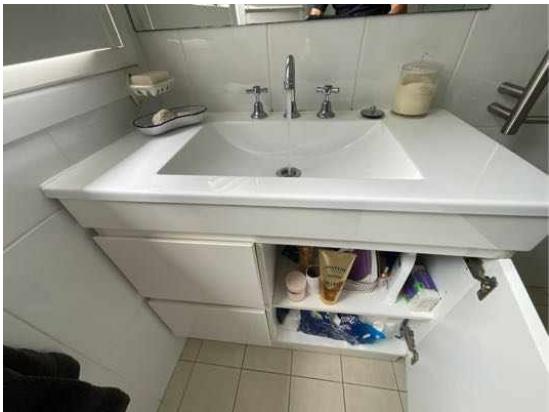
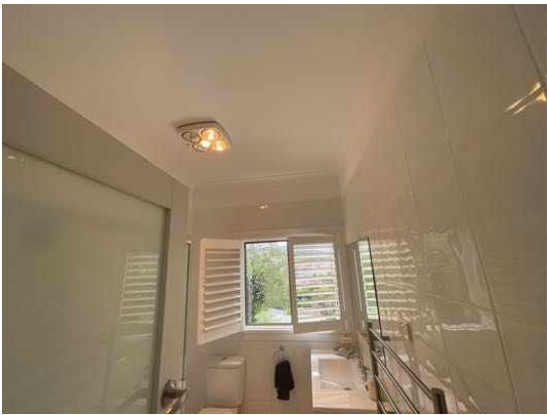
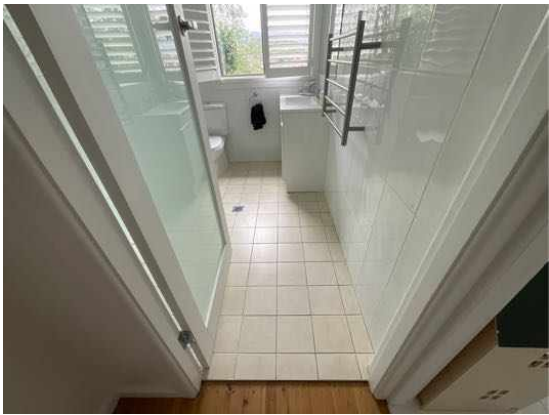
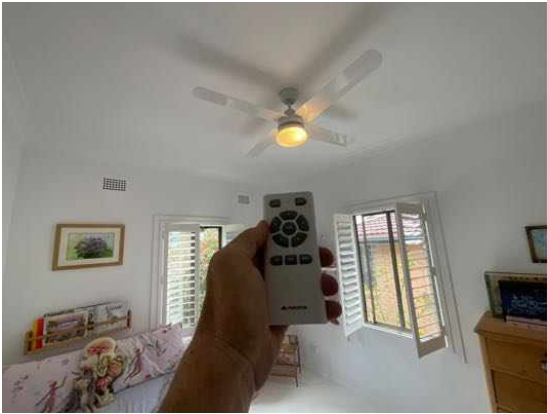
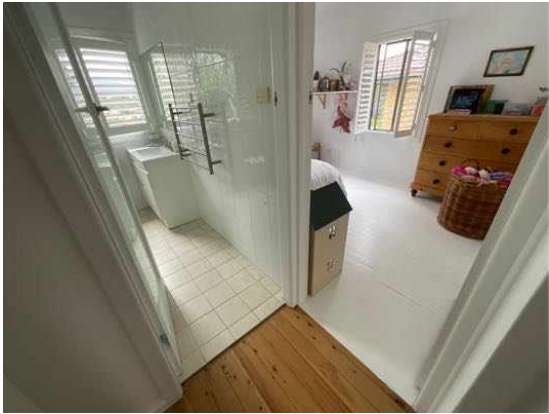
Building: Building 1
Location: All Internal Areas
Finding: Additional Photos
Information: Additional photos are provided for your general reference

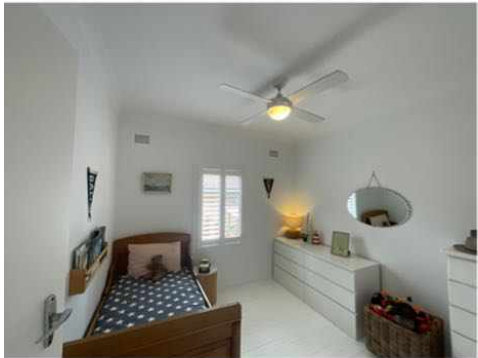
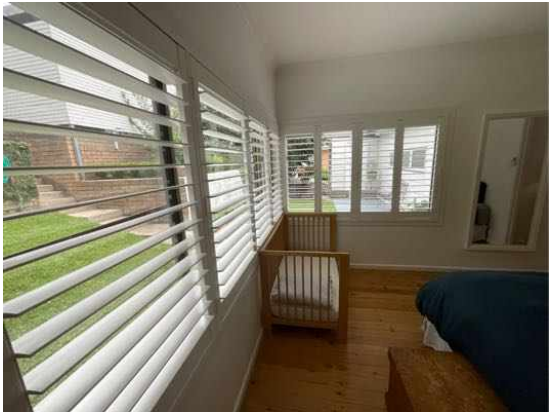
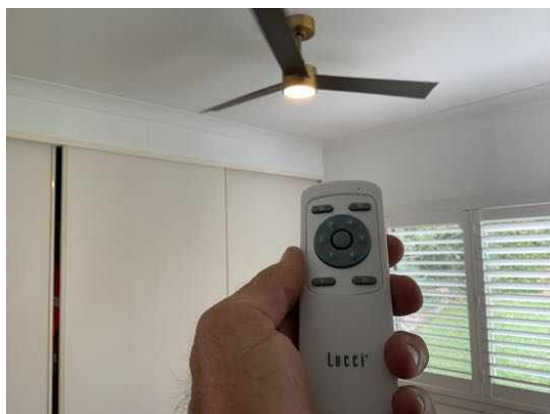
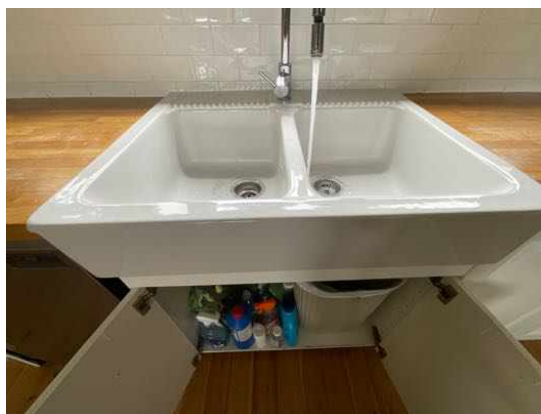
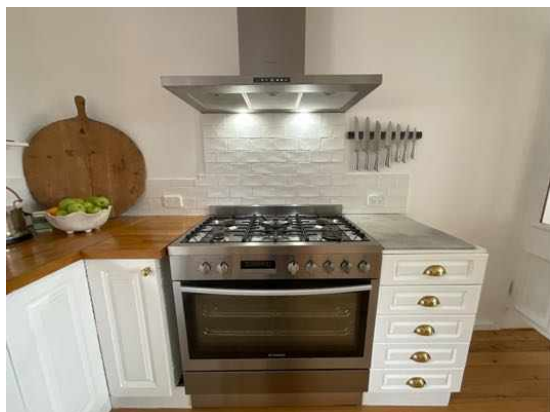
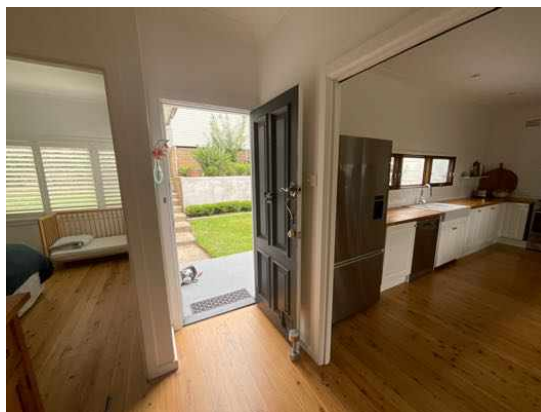
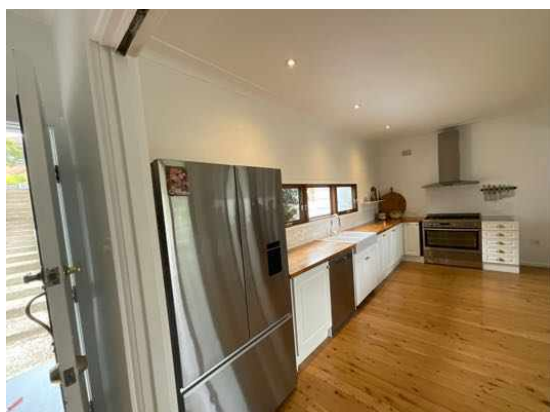
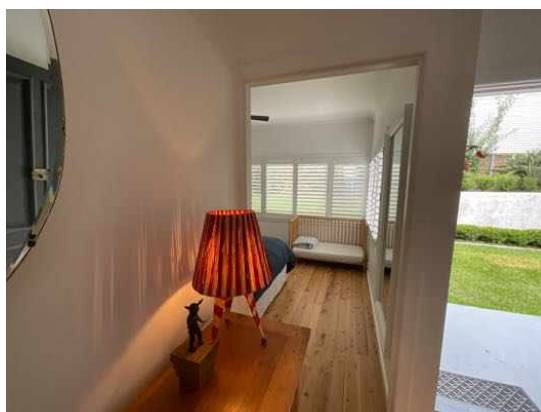
Building: Building 1
Location: All Internal Areas
Finding: Additional Photos
Information: Additional photos are provided for your general reference

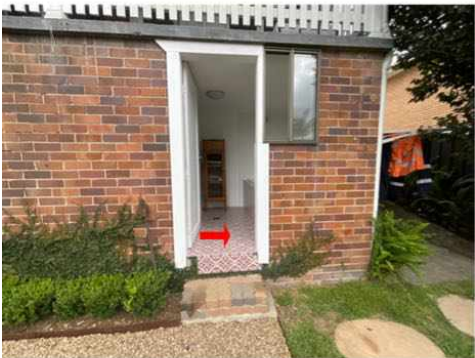
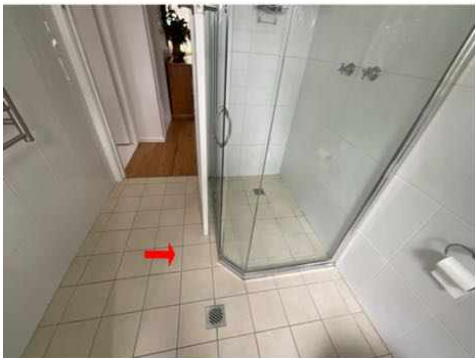
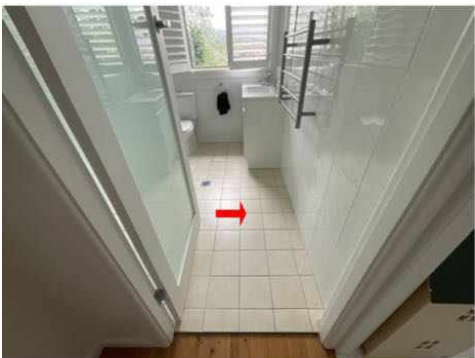
- Membrane used and Manufacturers Specifications. - The Installer and Installation Certification.

With older property's where this information is unavailable all wet areas should be monitored. If any leaks, water staining, peeling or bubbling of the paint become evident to any adjacent walls or ceilings below a licensed builder or waterproofing specialist is recommended to investigate further.
