Building and Timber Pest Inspection Report

Inspection Date: Tue, 17 Feb 2026

Property Address: 3/75 Collins St, Corrimal NSW 2518,
Australia

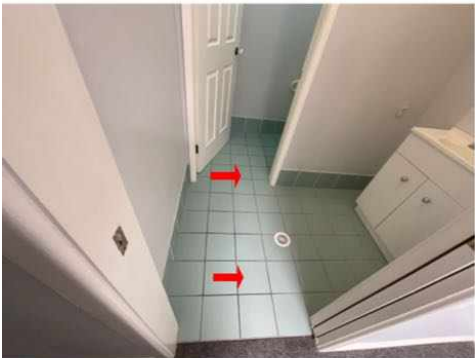
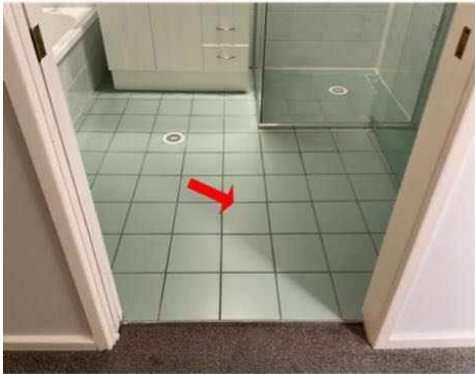
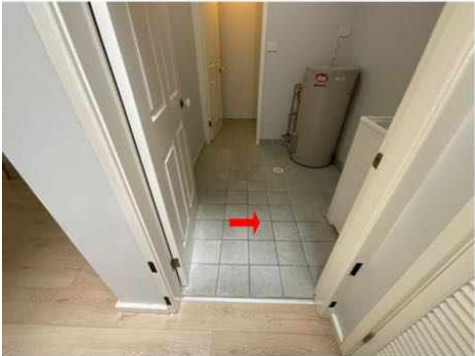
With older property's where this information is unavailable all wet areas should be monitored. If any leaks, water staining, peeling or bubbling of the paint become evident to any adjacent walls or ceilings below a licensed builder or waterproofing specialist is recommended to investigate further.
