## Building Inspection Report

Inspection Date: Sat, 24 Jan 2026

Property Address: a405/22 Rhodes St, Hillsdale NSW 2036,  
Australia

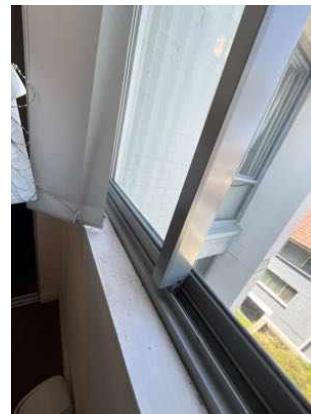
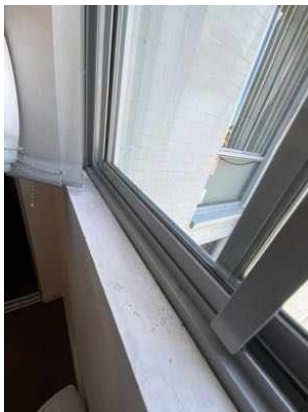
#### Defects 1.01

Building:	Main Building
Location:	All Areas
Finding:	Window child lock missing
Information:	The window in question lacks a child lock mechanism, which poses a potential safety risk to young occupants in the premises. As per Australian Standards windows accessible to children should be equipped with appropriate child safety locks to prevent accidental opening, reducing the risk of falls and ensuring compliance with safety regulations.

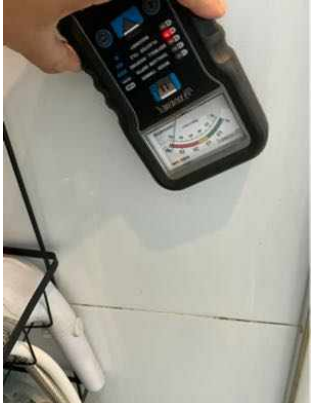
### Defects 2.01

Building:	Main Building
Location:	Ensuite
Finding:	Evidence of excessive moisture was present at the time of inspection
Information:	Excessive moisture is present behind the bathroom tiles, indicating a potential water leakage issue within the wall.

The prolonged presence of moisture can lead to mold growth, deteriorate the structure, and create an environment conducive to health hazards. Additionally, it may compromise the adhesive holding the tiles, leading to their detachment.

A licensed plumber or a qualified contractor specializing in water damage remediation should investigate the source of the moisture, fix any leaks, and address the damage. Additionally, replacing affected tiles and ensuring proper waterproofing are crucial to preventing future issues.

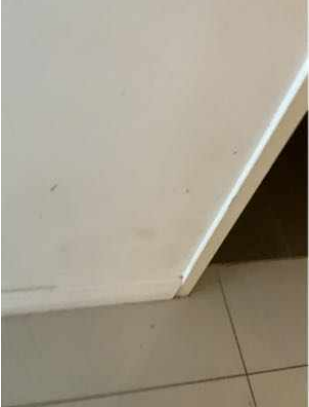
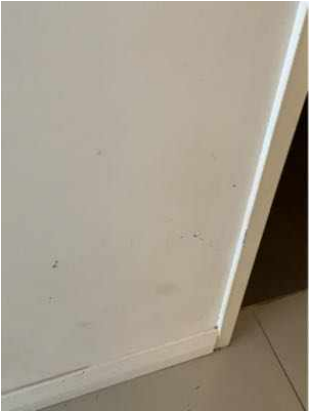
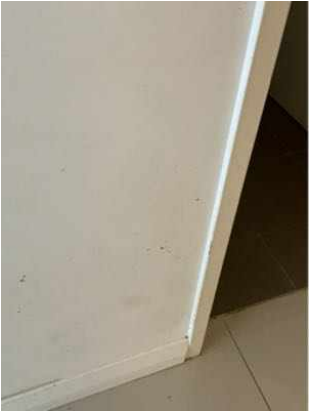
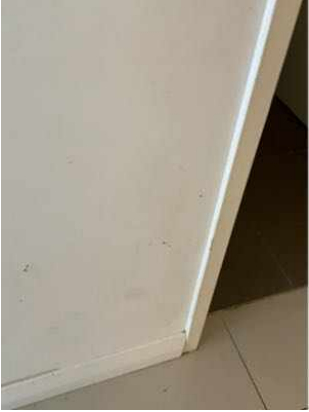
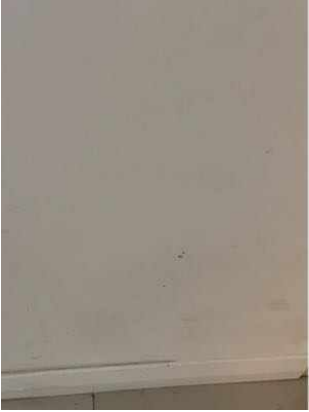
### Defects 3.03

1. Aesthetic Degradation: Scratches mar the appearance of the painted surface, diminishing its visual appeal and potentially lowering property value.
2. Corrosion Vulnerability: Exposed areas of bare metal due to scratched paint are susceptible to corrosion, leading to structural damage and compromised durability.
3. Environmental Hazards: Scratched paint can release hazardous chemicals into the environment, posing risks to both human health and the ecosystem.

A qualified painter should address the issue promptly to repair the scratched paint. Depending on the severity of the scratches, repair options may include sanding,

priming, and repainting the affected area to restore the integrity and appearance of the paint surface.

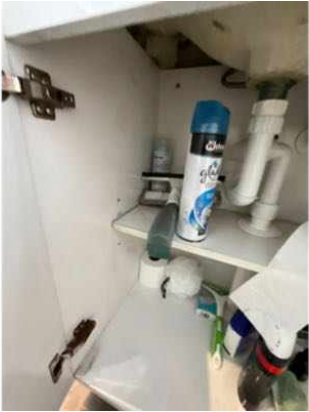
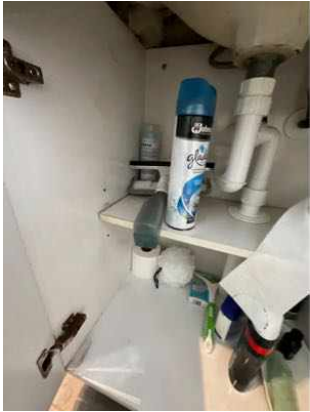
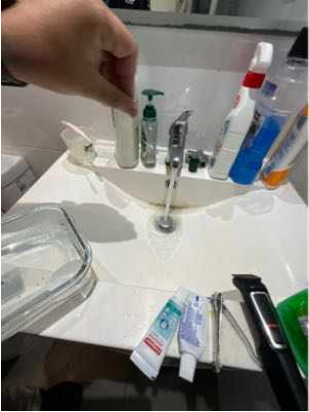
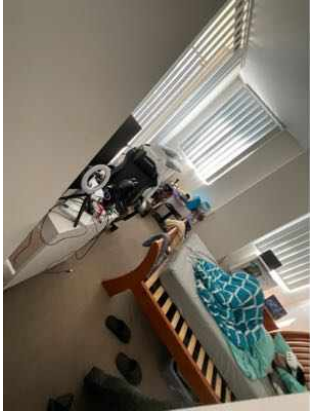
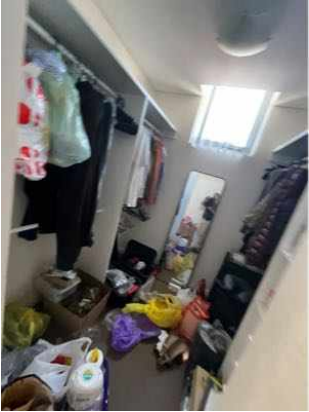
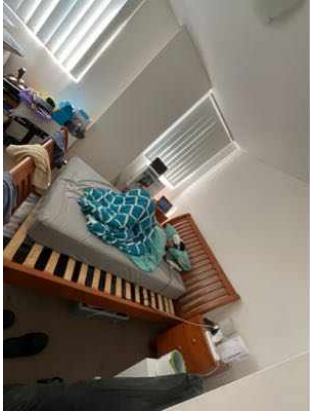
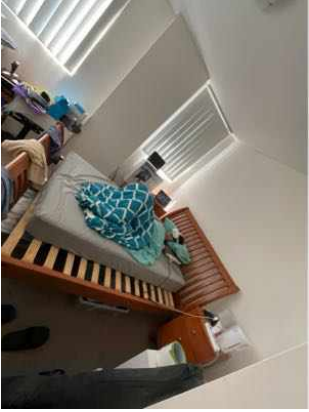
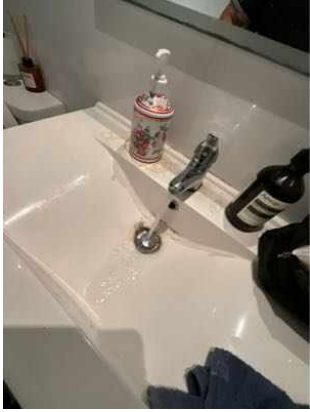
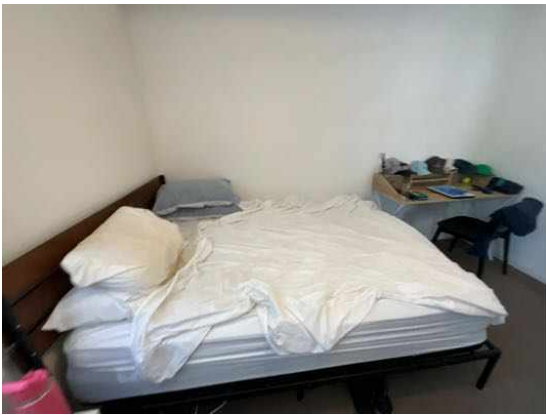
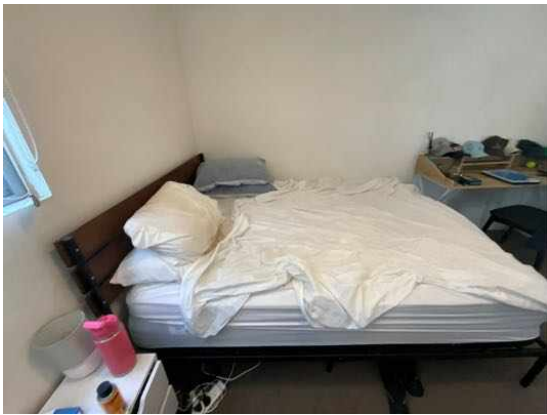
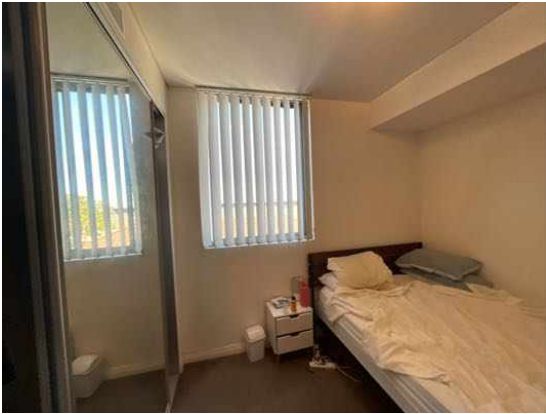
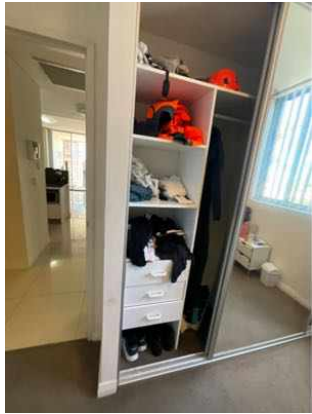
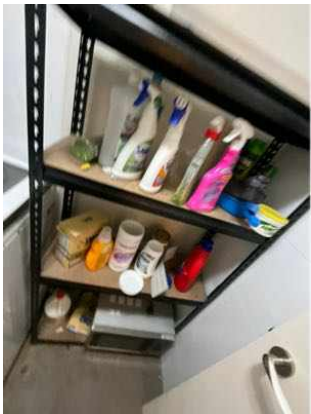
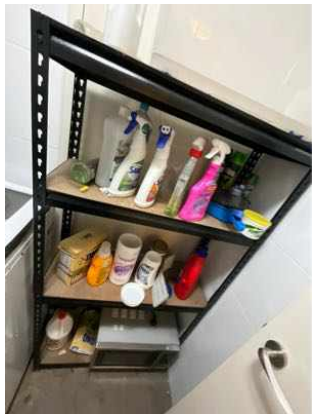
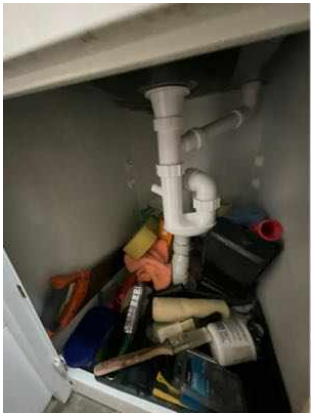
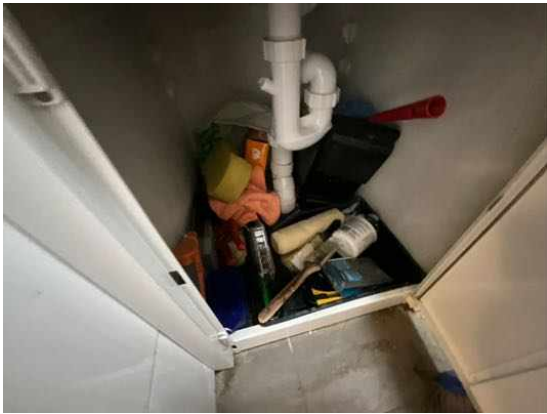
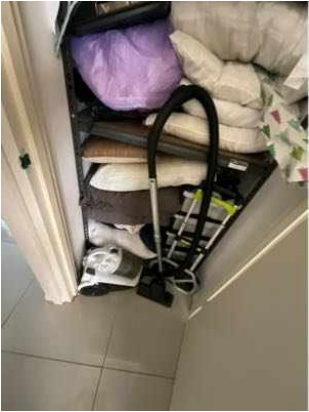
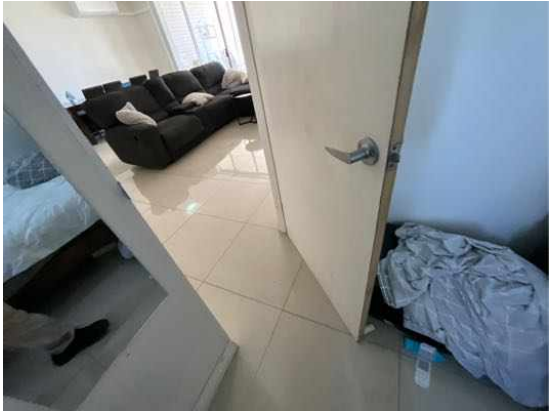
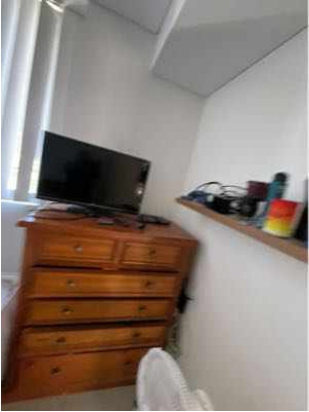
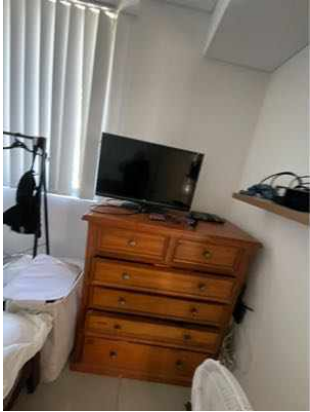
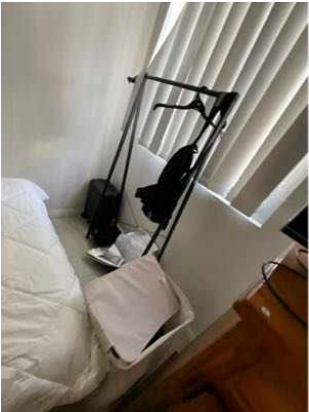
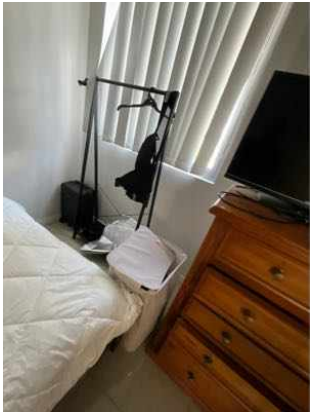
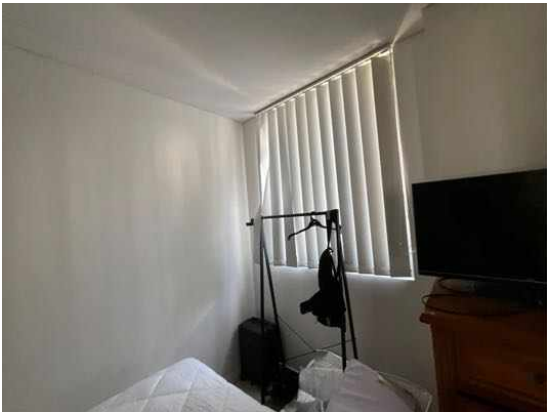
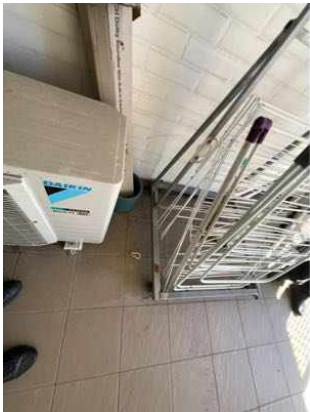
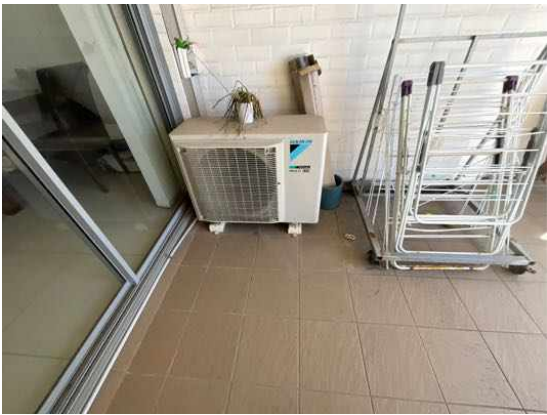
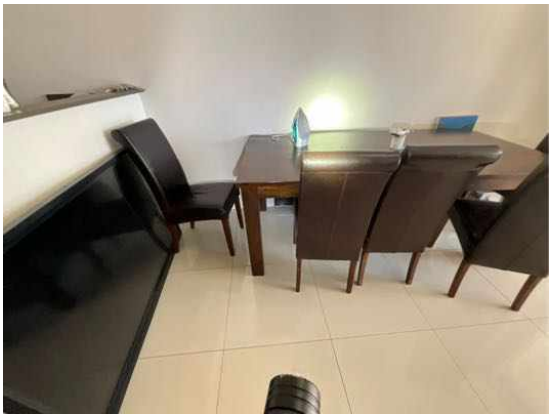
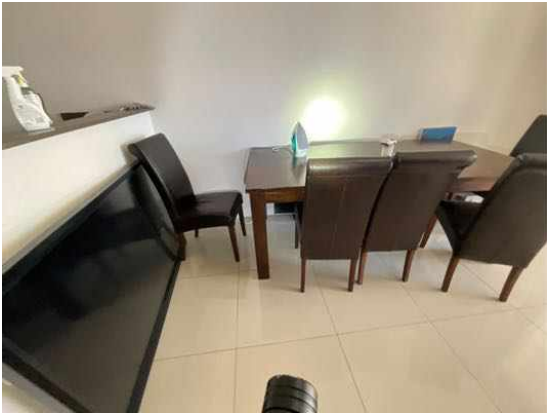
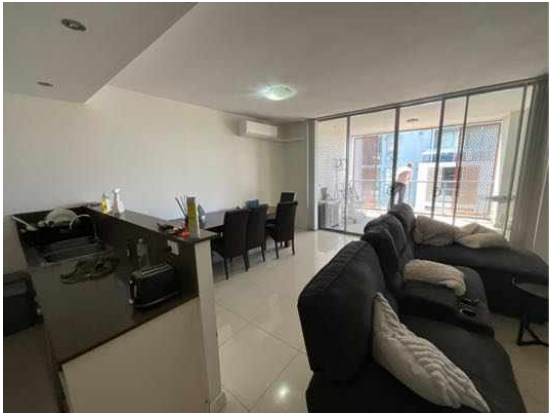
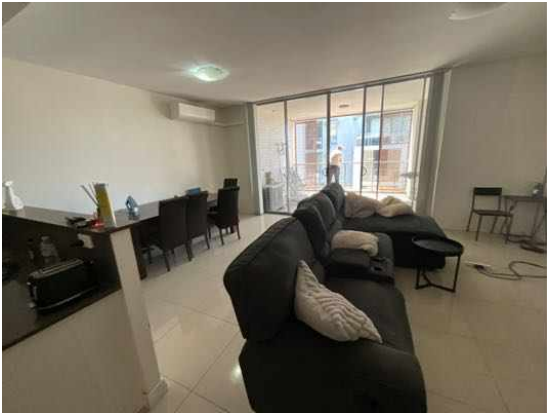
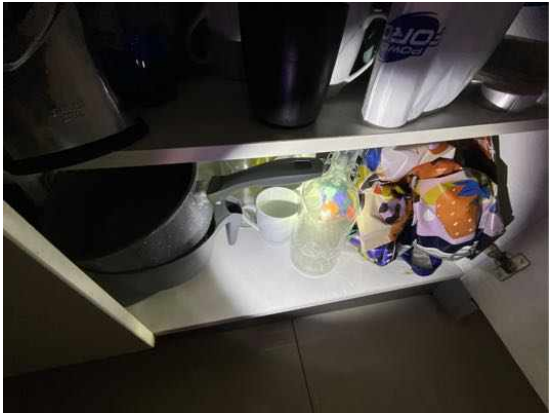
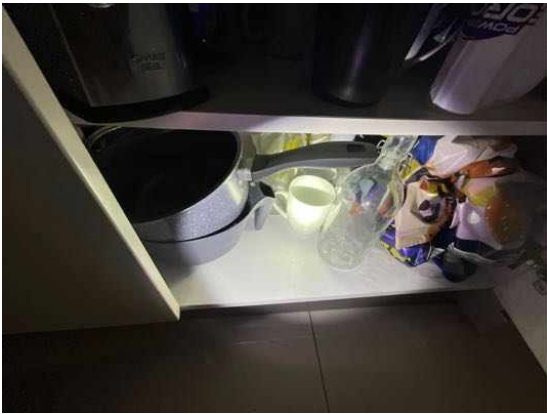
Building:	Main Building
Location:	All Areas
Finding:	Additional Photos - Obstructions and Limitations
Information:	These photographs are an indication of the obstructions and limitations which impeded full inspection of the property at the time of inspection. These obstructions can hide an array of defects and should be removed to allow full inspection to be carried out. A re-inspection is recommended once the areas are made accessible.
