# Building and Timber Pest Inspection Report

Inspection Date: Tue, 13 Jan 2026

Property Address: 159 Waminda Ave, Campbelltown NSW  
2560, Australia

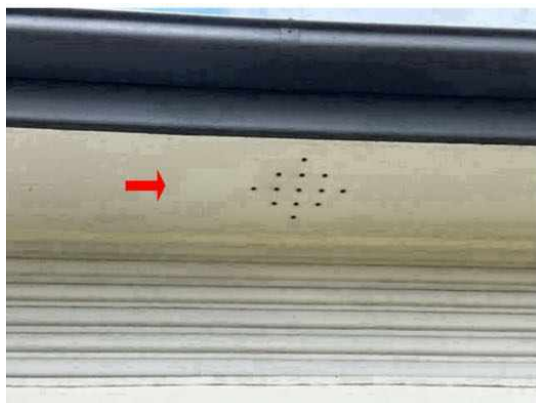
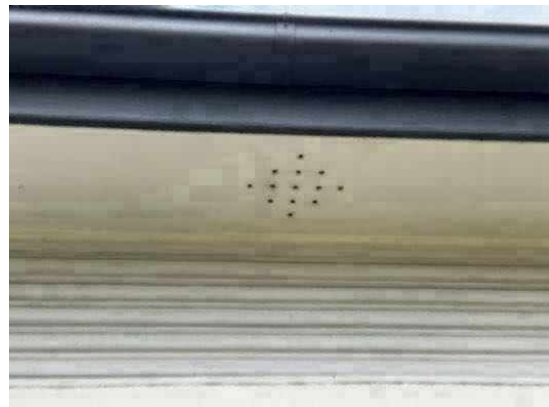
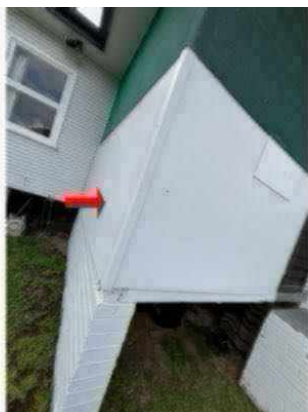
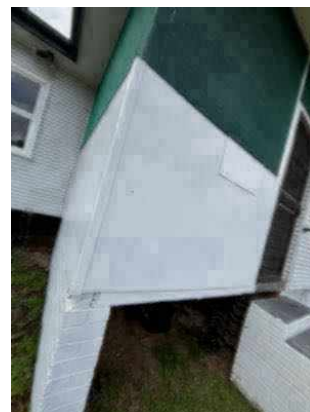
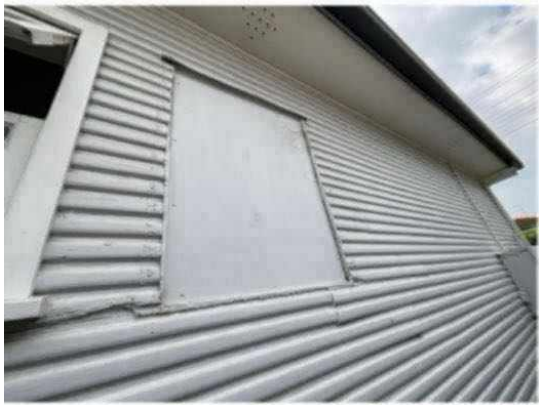
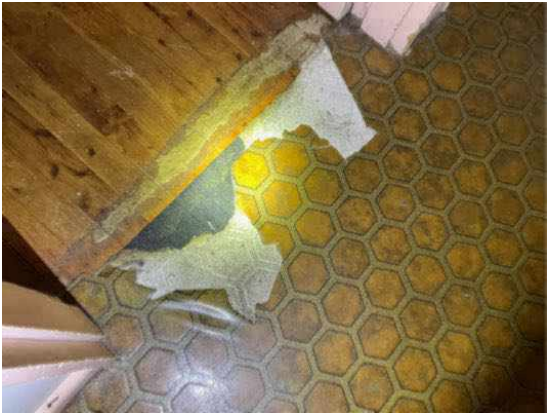
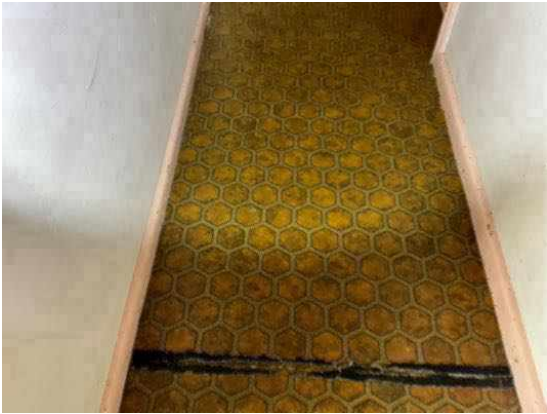
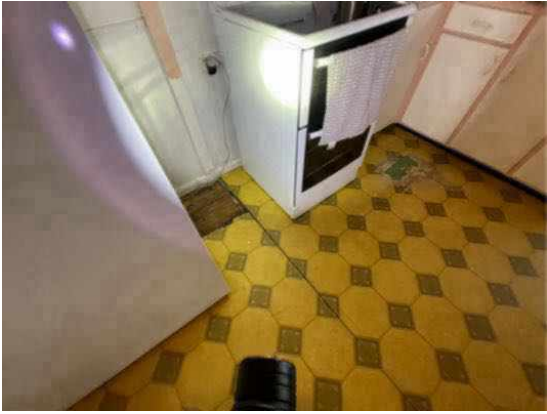
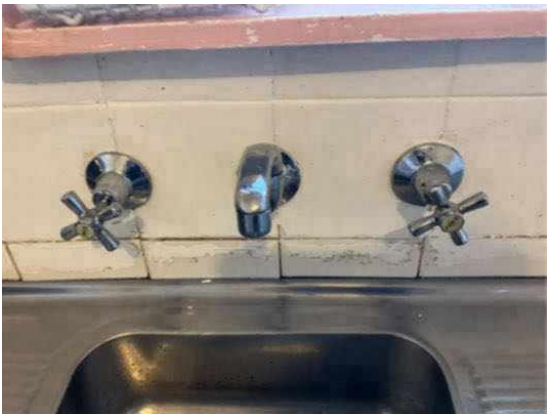
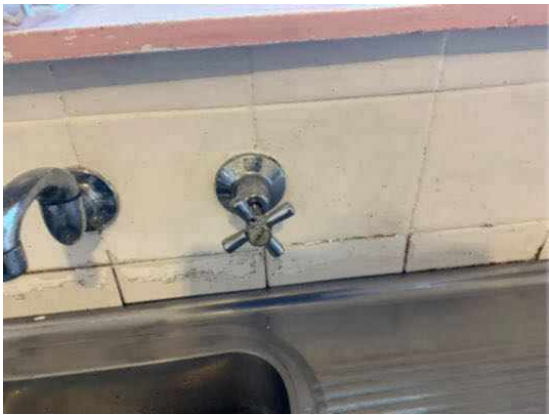
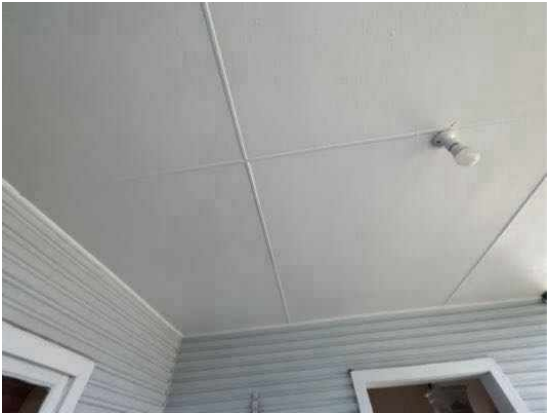
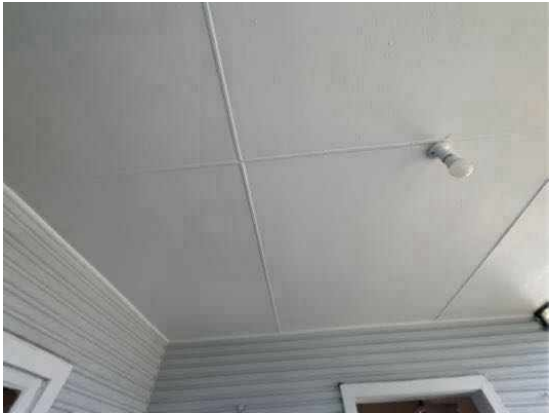
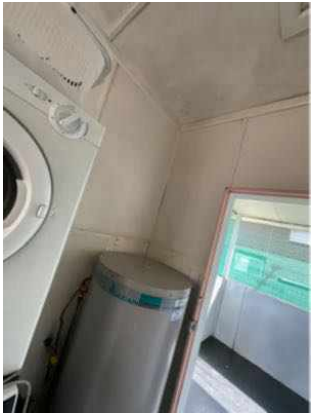
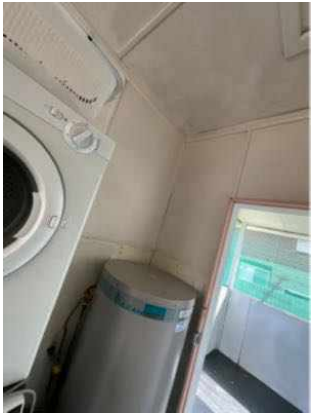
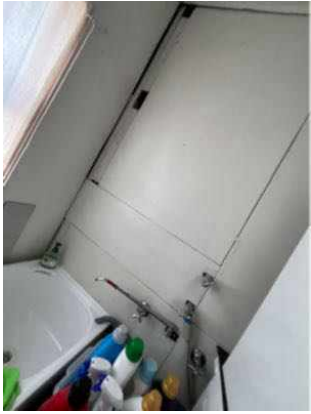
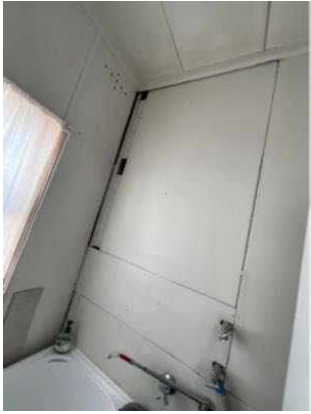
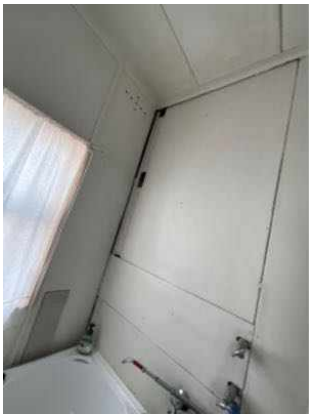
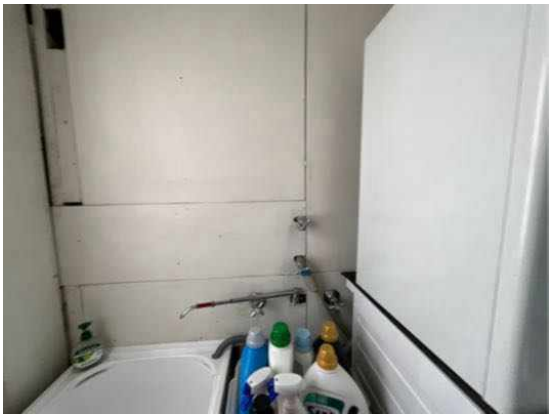
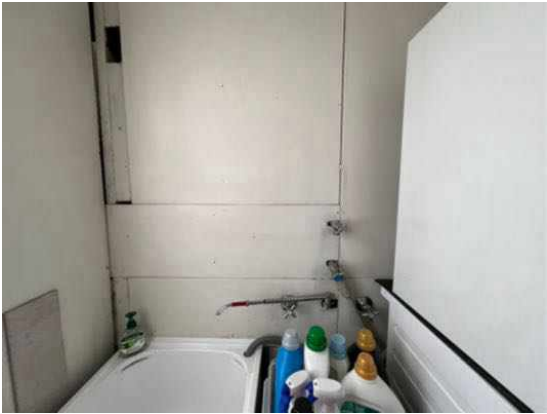
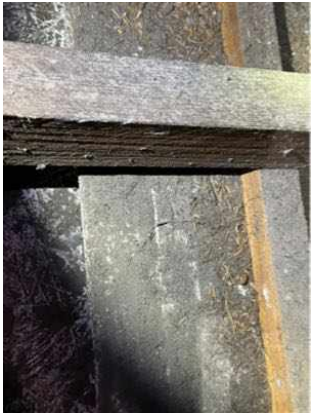
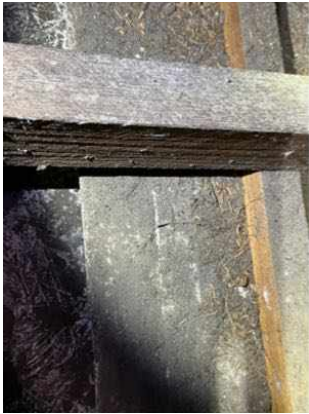
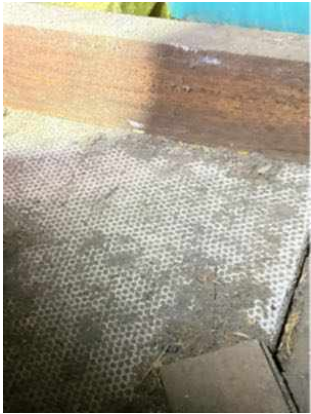
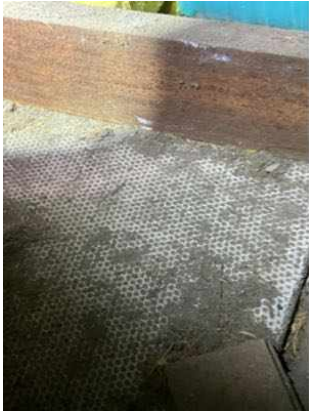
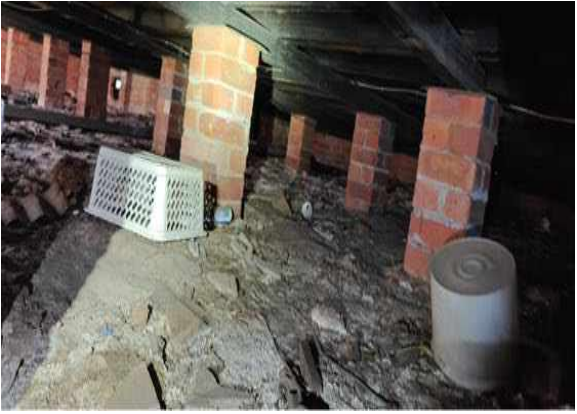
Building: Main Building  
Location: All Areas  
Finding: Asbestos - Suspected ACM Identified on Site  
Information: Reporting on Asbestos is outside the Scope of this Report. This suspected defect is highlighted as a caution only. We suspect, based on our experience in the building industry, that there is a higher risk of the identified building element containing asbestos.

As Asbestos Reporting is outside the scope of this report, we advise that you consider a separate Asbestos Inspection and Condition Audit, which can include the taking of samples for definitive confirmation of the presence of Asbestos.

In the interim, the client is advised to act with caution, especially when considering any damage to building materials general wear and tear renovations extensions demolition and general maintenance activities due to the suspected presence of Asbestos.

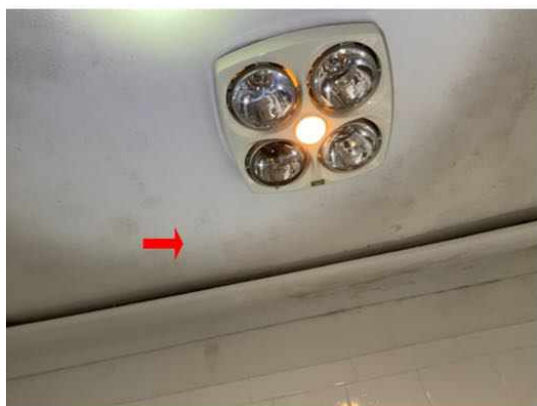
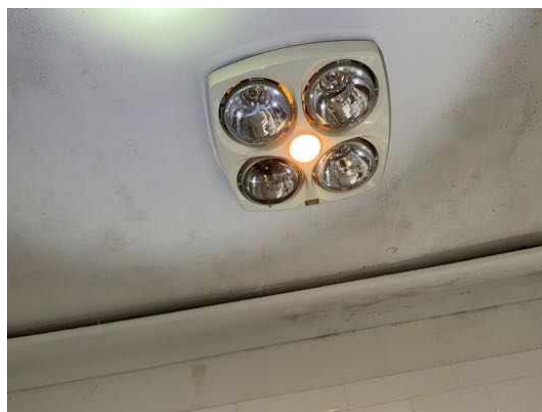
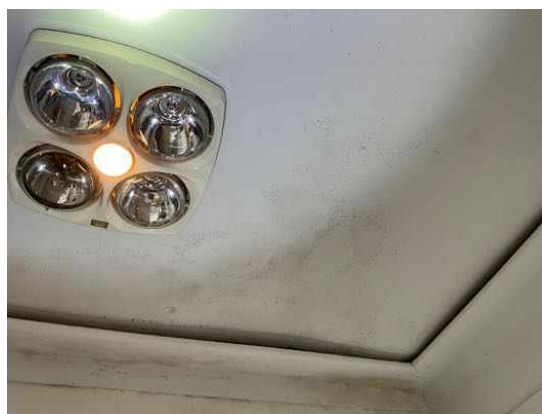
## Finding 1.02

Building:	Main Building
Location:	Bathroom
Finding:	Mould - Present
Information:	Mold growth is present throughout the property, primarily due to inadequate ventilation. Poor airflow and moisture accumulation within the house have created ideal conditions for mold to thrive.

- **Health Hazards**: Mold growth can pose serious health risks to occupants, particularly those with allergies, asthma, or other respiratory conditions. Prolonged exposure to mold spores can cause respiratory issues, skin irritation, and other allergic reactions.
- **Structural Damage**: Mold can degrade building materials over time, leading to rot and weakening of the structural components such as timber, drywall, and insulation, which can result in costly repairs.
- **Decreased Property Value**: The presence of mold can significantly reduce the value of the property, as it indicates underlying moisture and ventilation issues that need addressing.

A licensed mold remediation specialist should be engaged to remove the mold and treat affected areas. In addition, a ventilation expert or builder should assess and improve the house's ventilation system, possibly installing exhaust fans, vents, or mechanical ventilation systems to ensure adequate airflow and prevent future mold growth.

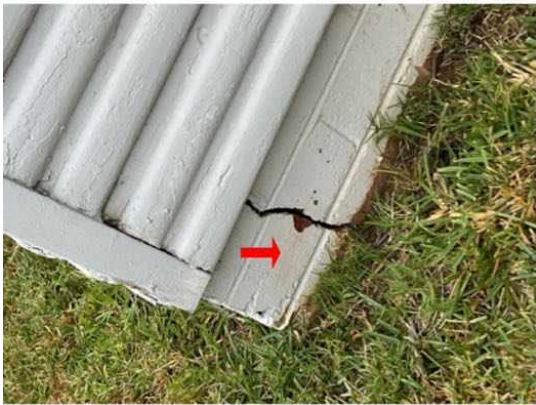
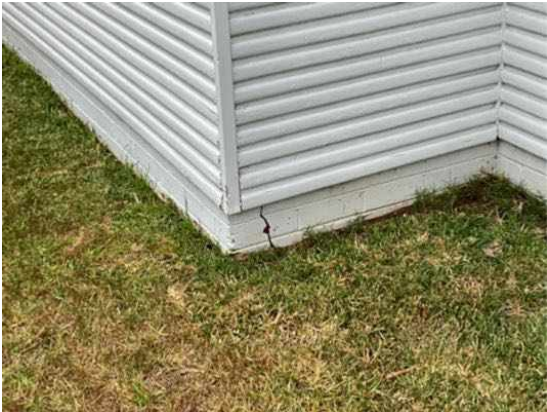
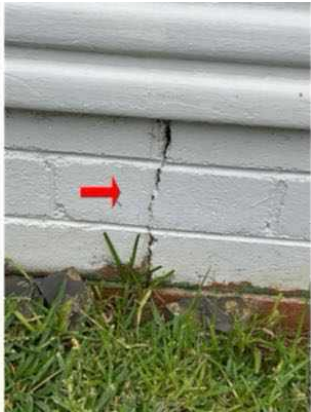
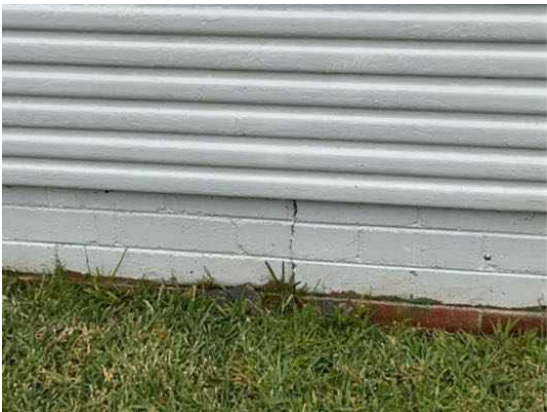
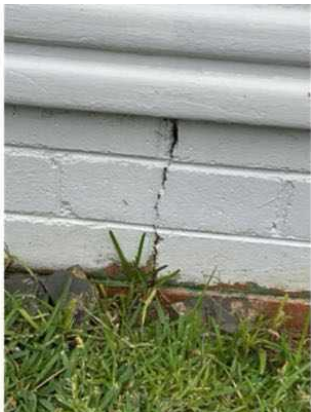
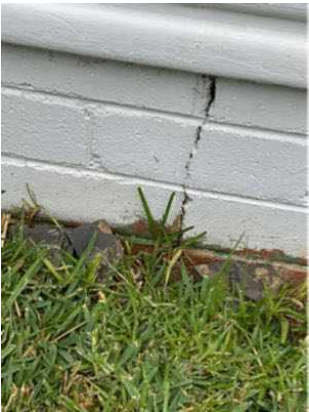
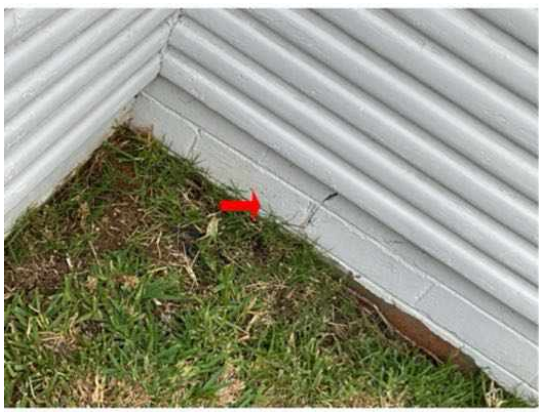
### Finding 2.01

Building:	Main Building
Location:	All Areas
Finding:	Brickwork - Cracking [Repair required]
Information:	Major cracking was identified to the brickwork in this area. Cracks of this type are likely to have been caused by minor expected movement of building elements, but may also have a structural cause that is more significant.

A crack of this size may be repaired by extensive filling. Additionally, further remedial works to associated building elements, such as eave sheeting or external door frames, is likely to be required.

A qualified bricklayer should be contacted immediately to estimate and perform repair and restoration works. Consultation with a structural engineer may be required where structural instability is found to be the underlying cause of the cracking.

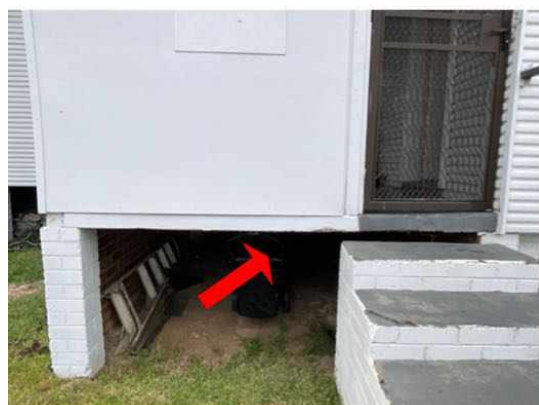
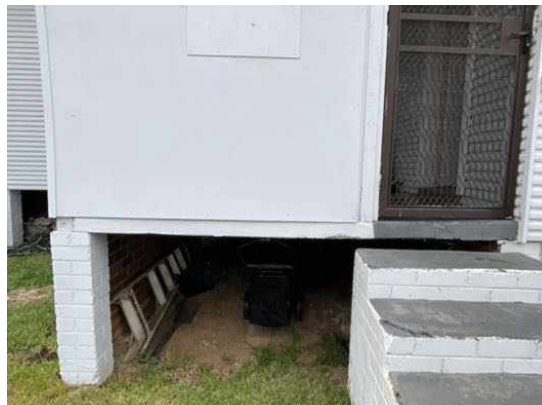
### Finding 2.03

Building:	Main Building
Location:	Exterior walls - rear
Finding:	Concrete Slab – Bowing / Deformation (AS 4349)
Information:	Bowing and deformation were observed to the exposed concrete slab edge. This condition may indicate movement, inadequate support, or deterioration over time. Further movement may occur if the underlying cause is not addressed. Assessment by a structural engineer or licensed builder is recommended to determine the cause and appropriate rectification.

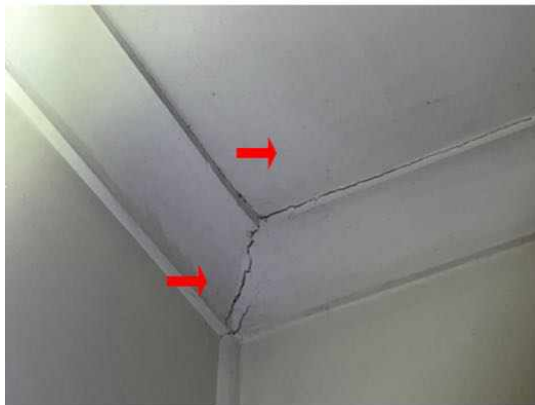
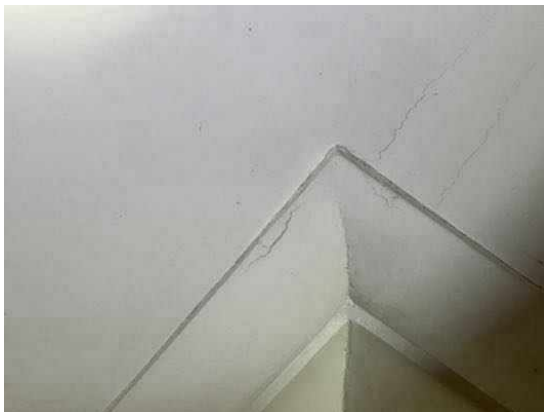
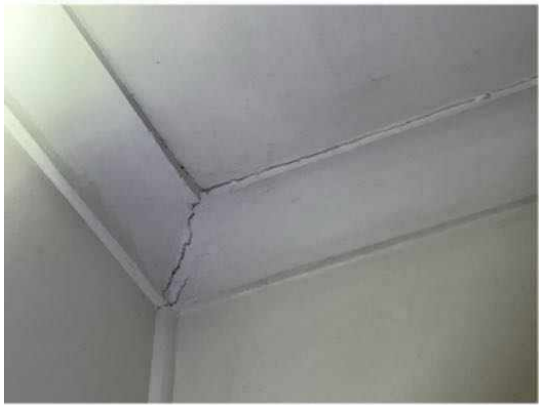
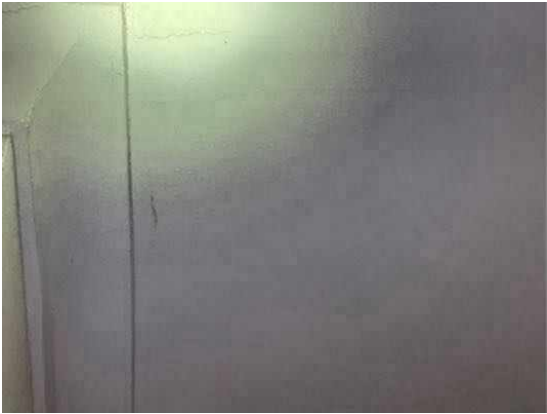
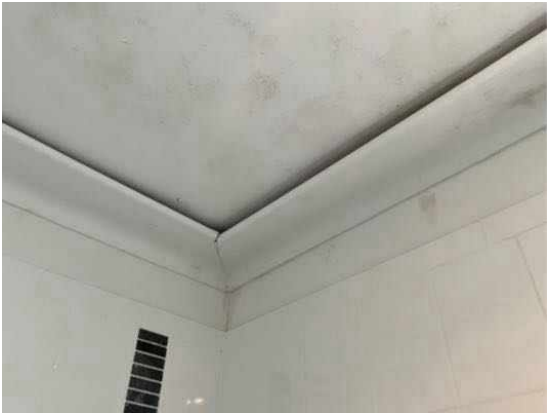
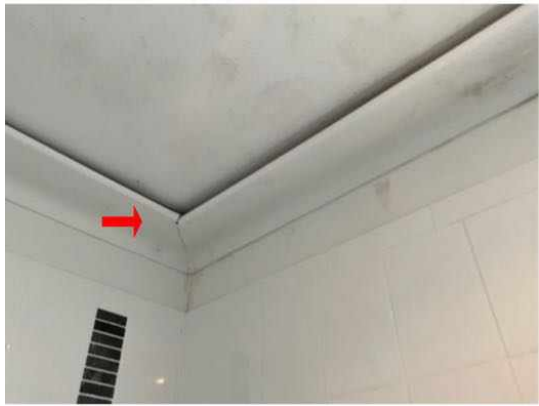
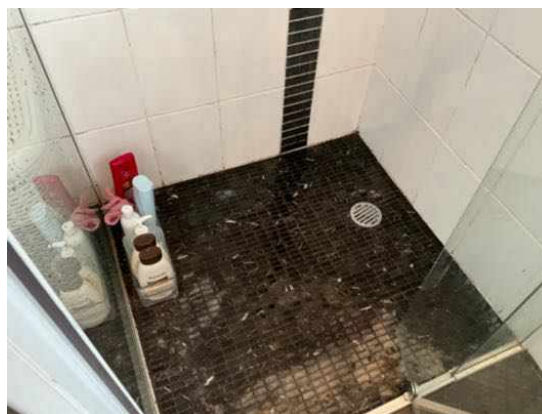
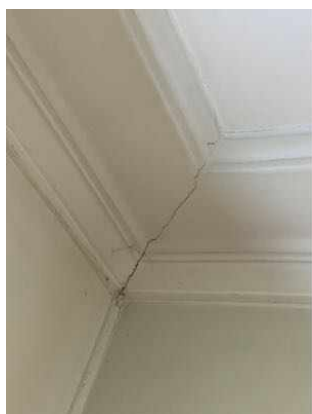
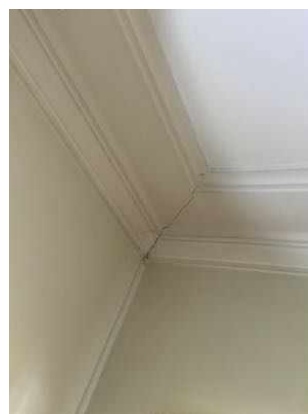
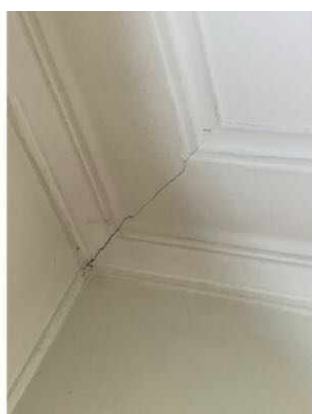
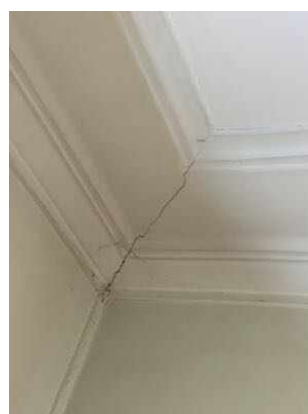
### Finding 2.04

Building:	Main Building
Location:	All Areas
Finding:	Ceiling & Cornice - Cracking / Separation
Information:	Observed condition: <ul style="list-style-type: none"> <li>• Step and diagonal cracking through plaster/cornice at ceiling–wall junctions.</li> <li>• Open joints/gaps at cornice mitres and along a ceiling back-blocking/joint line.</li> <li>• Minor displacement to cornice edge; previous patching visible.</li> </ul>

Likely cause(s):

Typical building movement and differential settlement/shrink–swell (seasonal moisture, framing movement, or door-head/beam deflection at opening). Contributing factors may include inadequate fixing/back-blocking, aged compounds, or prior repairs.

- Builder to check for movement or leaks.
- Plasterer to repair joints, reset cornice, and patch cracks.
- Painter to finish.
- If ongoing movement is observed, a structural engineer may be needed.

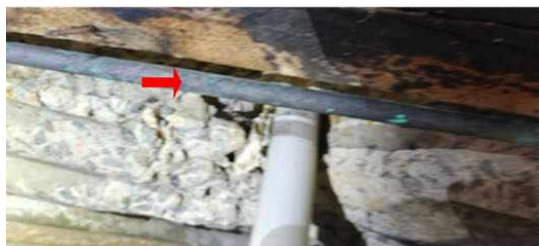
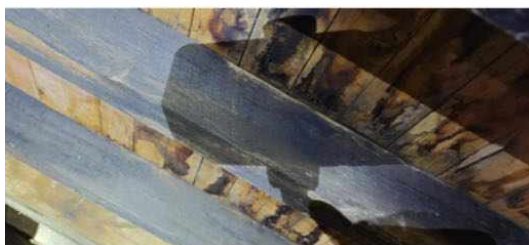
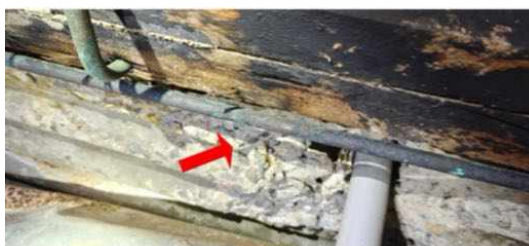
### Finding 2.06

Building: Main Building  
 Location: Subfloor  
 Finding: Subfloor- leaking plumbing fittings  
 Information: Evidence of leaking plumbing fittings was observed within the subfloor area. Moisture staining and timber deterioration suggest prolonged water exposure from faulty pipe joints or fixtures.

- Structural damage to timber framing and flooring due to continuous moisture exposure.
- Mould growth and decay, posing potential health risks and further degradation of building materials.
- Pest attraction, as damp environments are conducive to termites and other pests.
- Non-compliance with plumbing standards and risk of escalation if not addressed promptly.

- A licensed plumber should be engaged to identify the exact source of leakage,

repair or replace faulty fittings, and confirm watertight integrity. A builder may also be required to assess and rectify any structural damage.

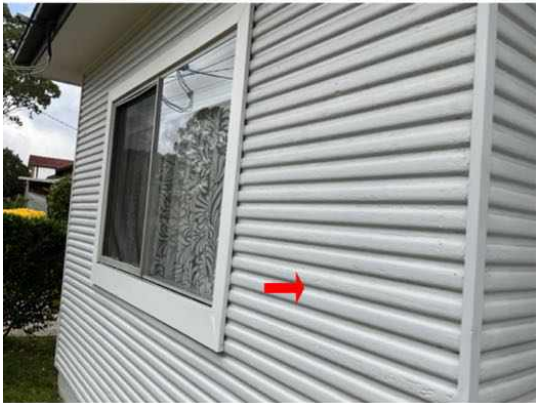
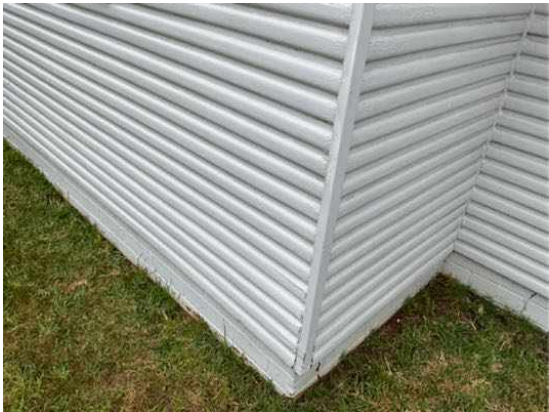
### Finding 3.01

Building:	Main Building
Location:	All Areas
Finding:	Timber - exposed to weather
Information:	External timbers that are frequently exposed to harsh weather conditions require

adequate protection in order to maintain their condition. Where timbers have not been painted or treated adequately, general deterioration is likely to occur at an accelerated rate.

If left unattended, replacement of these timbers is likely to be necessary in the short-term future. Adequate treatment of these timbers is required as soon as possible by a painting contractor or general handyman.

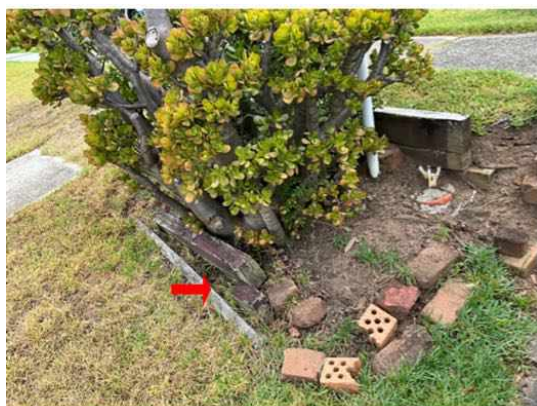
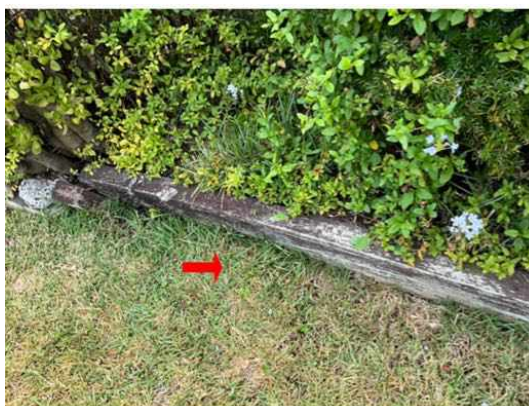
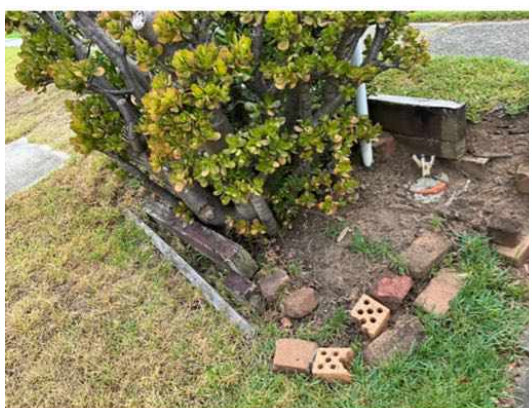
**Finding 3.02**

**Finding:** Retaining wall - Defective

**Information:** The retaining wall in this area was found to be defective at the time of inspection. Generally, defective retaining walls are caused by poor original design or material use. However, deteriorated retaining walls may also be a result of substandard construction, poor site drainage or unmanaged stormwater flows.

If left unmanaged, the retaining wall may become a safety hazard if it continues to destabilise. Where retaining walls further rot and decay, an environment is created that is conducive to termite and pest infestation.

Significant repair and replacement should be expected. Where retaining walls are considered structural walls, a structural engineer / surveyor should be consulted regarding required remedial works. Otherwise, a landscaper or retaining wall installer may be appointed to repair or replace the wall, at the discretion of the client.

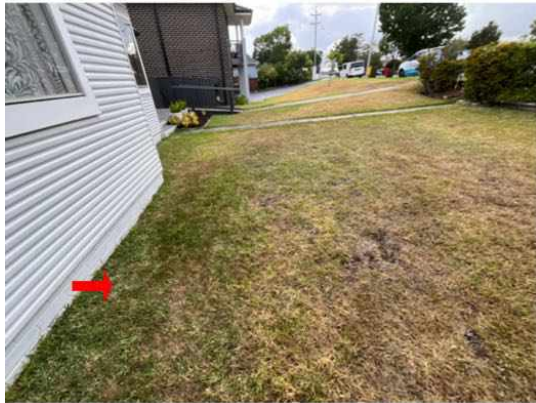
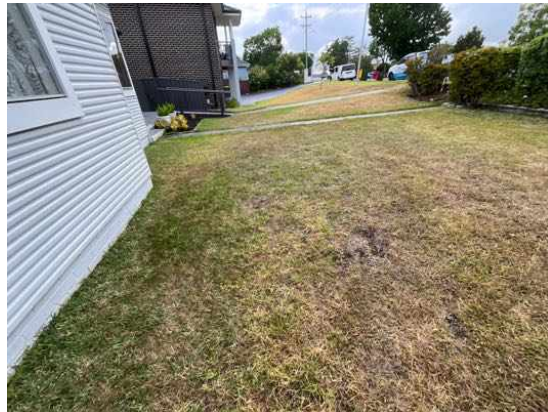
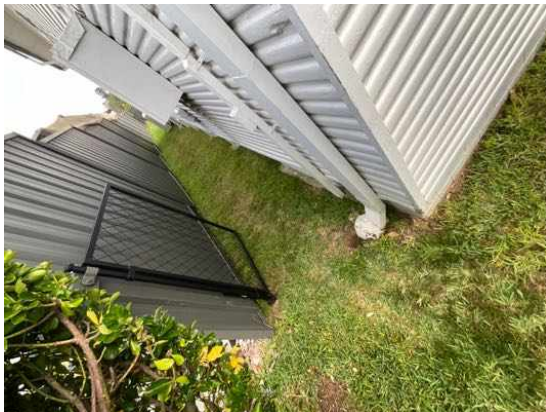
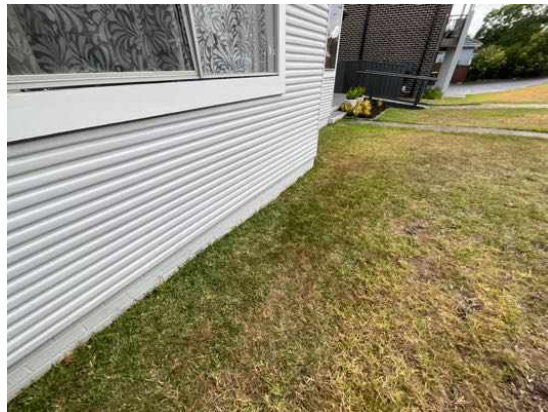
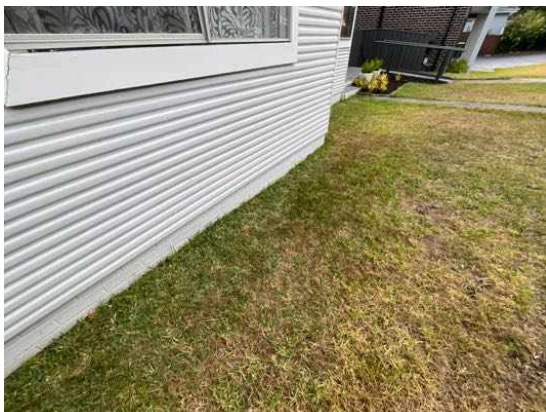
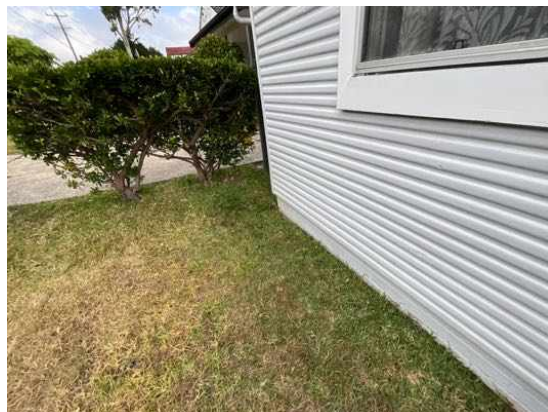
### Finding 3.03

**Information:** The perimeter ground levels were found to have an inadequate slope away from the adjoining building structure, creating potential for water pooling in this area.

Perimeter is required to fall from the building by a minimum of 25mm in the first metre and bare ground should fall away from the house by 50mm in the first meter. This standard ensures that excessive moisture does not pool around the base of building structures, which creates potential for water and structural damage, as well as making the area susceptible to termite and timber pest activity.

Where ground levels do not have adequate fall, a licensed paving contractor should be appointed to install or remove and re-level pavement.

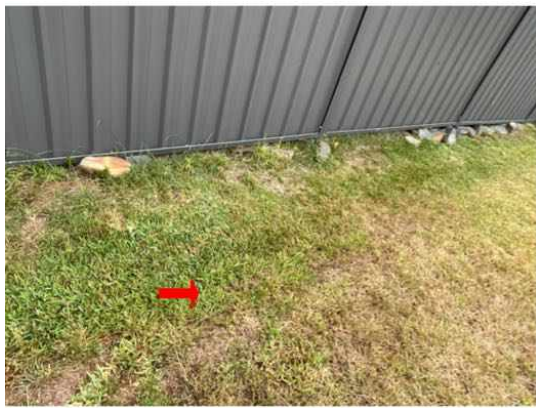
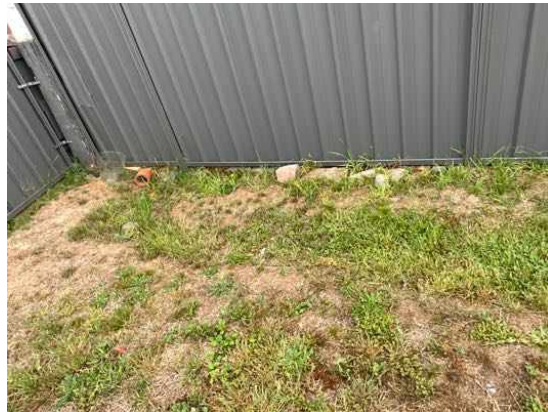
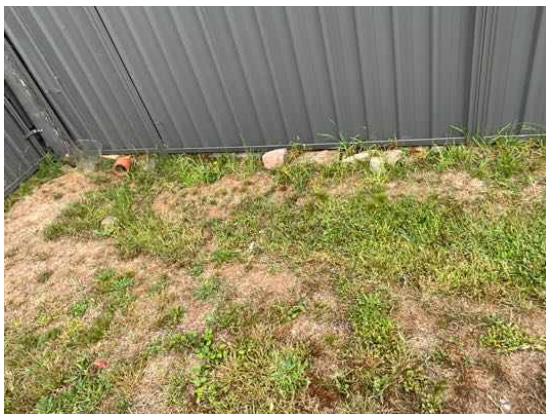
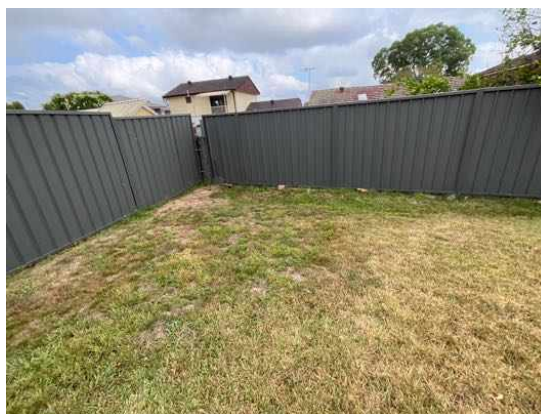
Surface water drainage is defective if it is not in accordance with the requirements of the Building Code of Australia.

Such water pooling also increases the risk of termite activity and the development of fungal decay in the area.

Consult a Licensed Plumber regarding the cost of potential site drainage rectification works.

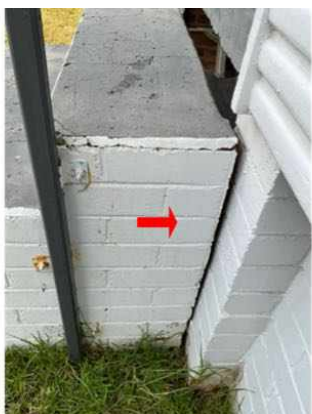
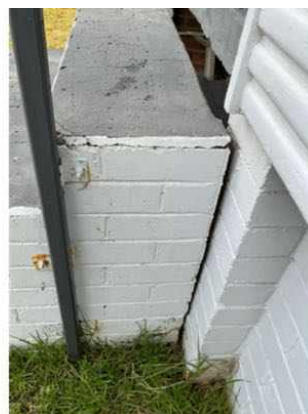
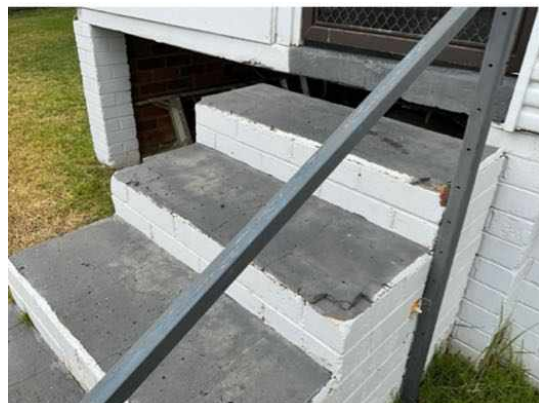
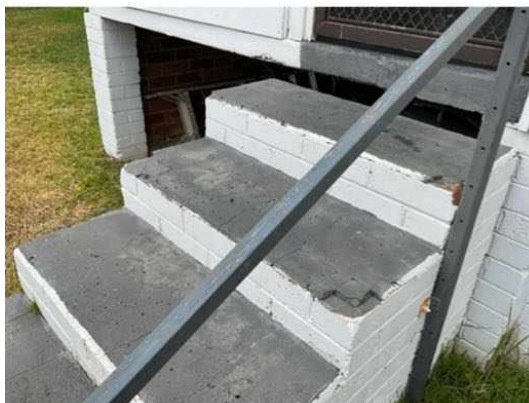
### Finding 3.05

Building:	Main Building
Location:	Exterior walls - rear
Finding:	Subsidence - Structure
Information:	It appears that the structure has been affected by movement of the foundations, often referred to as sinking or subsidence. Whilst a degree of movement is expected over time, especially as environmental conditions change and buildings 'settle' after construction, this degree of subfloor movement requires attention.

General subsidence is usually initiated by changes in soil moisture content. The most critical factor is identifying the specific causes, and identifying if this is a recurring or ongoing problem, or one that has been resolved by previous works in the past.

Subsidence can have complex and varying causes, which will influence the required remedial works. It is advised to begin by consulting a structural engineer to determine the required scope of works. This generally includes some form of underpinning, as well as addressing the underlying cause. Consultation with a geotechnical engineer may also be necessary where changes to soil moisture content is apparent.

A Registered Builder specialising in carry out works as advised by an Engineer.

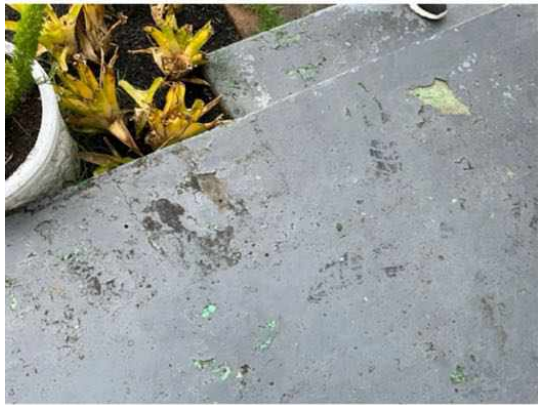
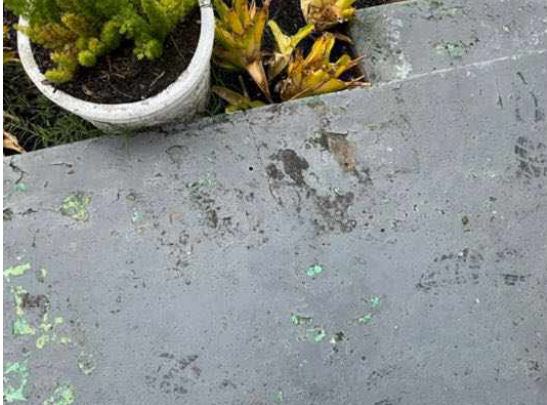
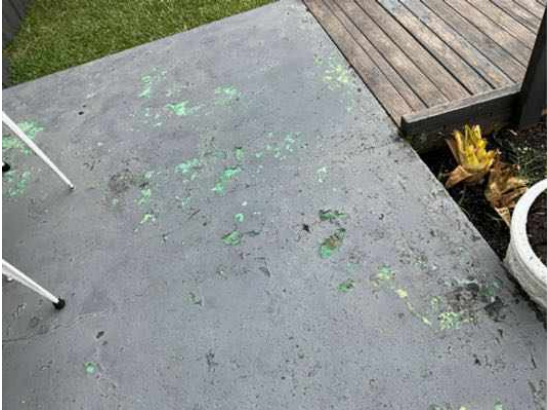
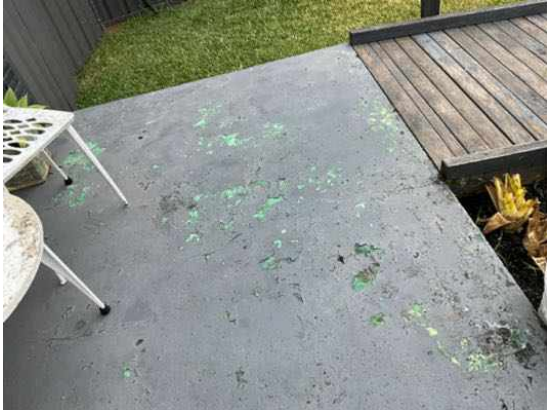
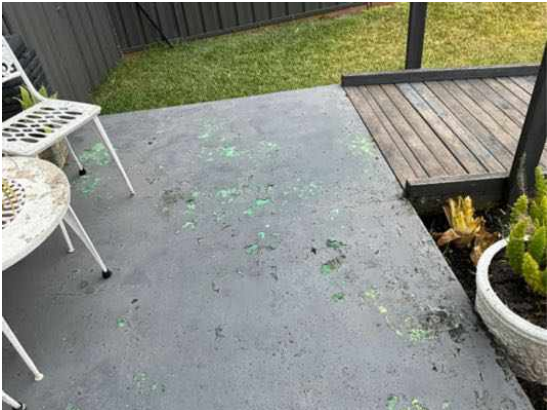
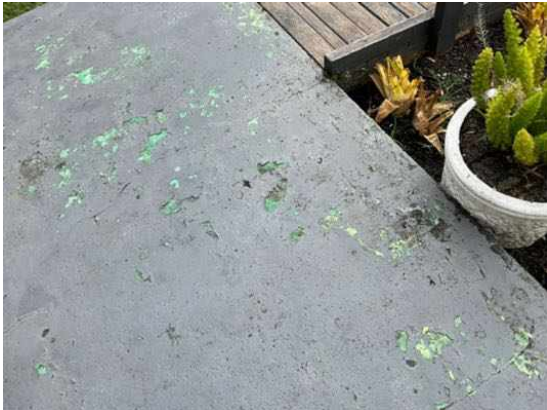
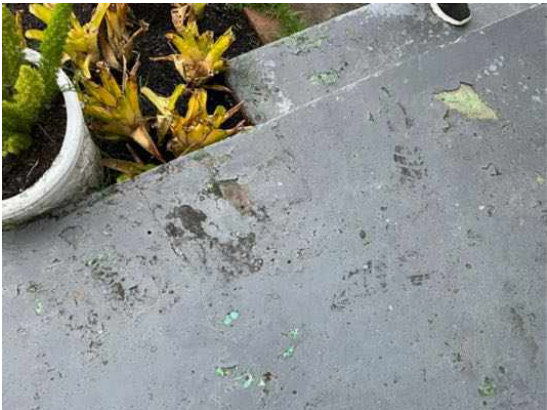
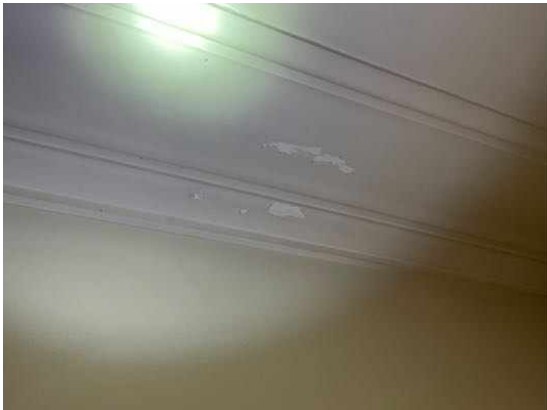
### Finding 3.06

Information: Sections of the paint in this area was found to have deteriorated. Paint deteriorating is generally an indication of excessive moisture in the area that is currently hidden by the painted surface.

The presence of excessive moisture can have major implications on associated building elements if left unattended. While only seemingly minor at this stage, the damage cannot be determined due to the paint, obstructing any further inspection of the damage.

It is highly advised that the affected paint to be cleaned to allow a further, more invasive inspection by a licensed builder/painter. Failure to act on this defect may necessitate major works in the future.

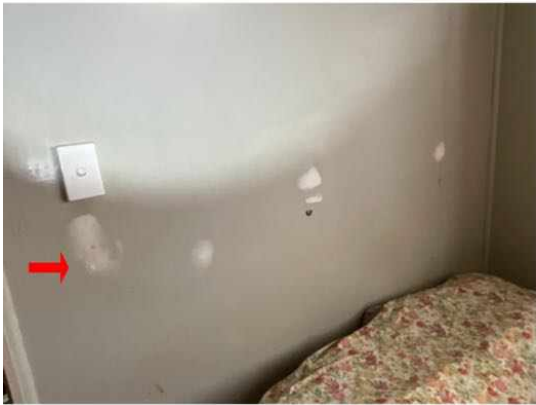
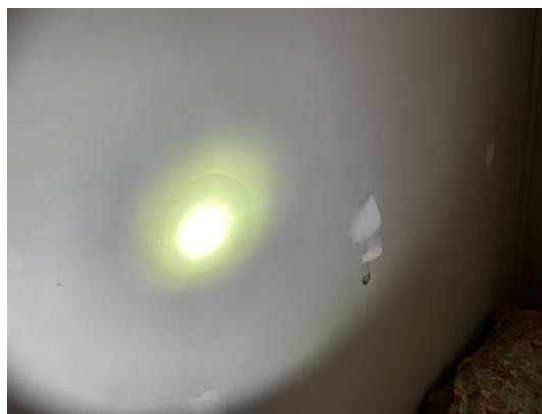
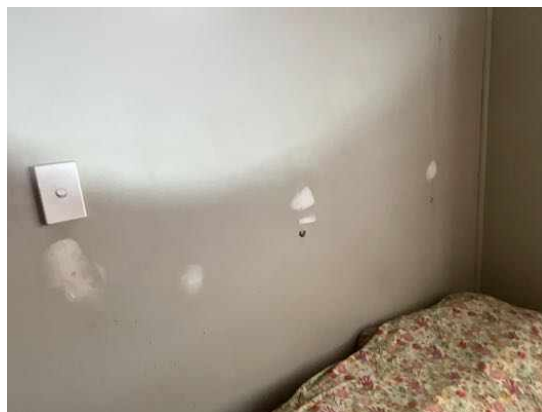
**Finding 3.07**

Risk: Poor workmanship poses a range of risks, including compromised structural integrity, potential safety hazards, and a decreased lifespan of the structure. It may also lead to aesthetic and functional issues.

Resolution: A qualified contractor or construction professional should be consulted to assess and address the poor workmanship. They can implement corrective measures to ensure structural soundness, safety, and overall quality of the construction.

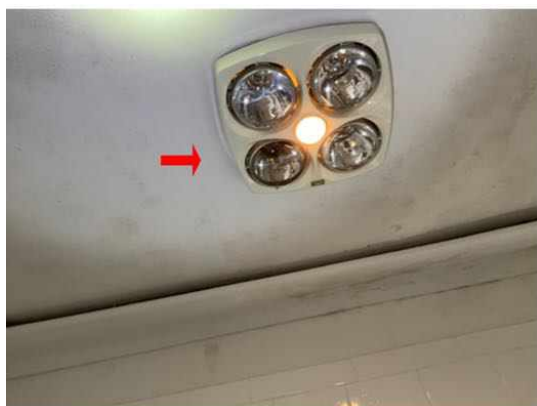
### Finding 3.08

Building: Main Building  
 Location: Bathroom  
 Finding: Heating light in exhaust fan not working / operating  
 Information: "The heating light in the exhaust fan is not operating, failing to provide the intended heating function."

A qualified electrician or HVAC technician can fix the issue by inspecting the heating element, wiring, and controls to identify and repair any faults or damages.

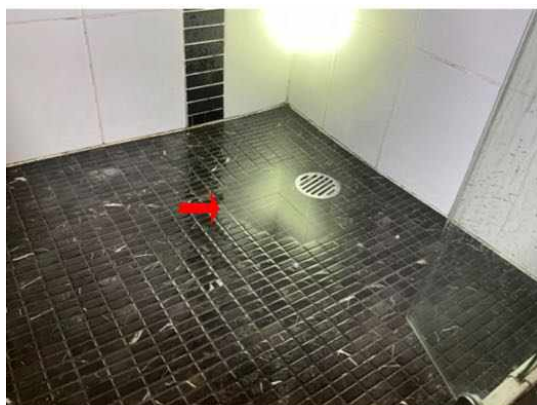
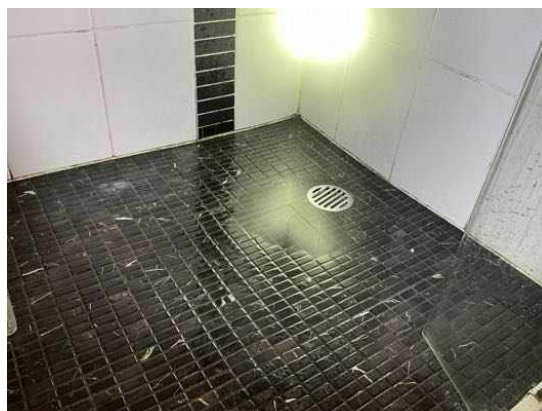
Building:	Main Building
Location:	Bathroom
Finding:	Shower base - Water pooling
Information:	Evidence of water pooling around the floor waste in the shower recess was noticed at the time of inspection. It is suspected that this excessive moisture is attributed to insufficient fall in the shower floor tiles.

This pooling is minor overall but is still considered unsatisfactory, as standard tiling practices would not permit this situation to occur. Pooling water around floor wastes can create a slip hazard in extreme cases and create conditions that are conducive to mould growth over time. Where left unmanaged, the degradation of sealant and grouting is also likely to occur, possibly necessitating further repair works.

Remedial works may involve some sections of tiling and flooring repair and replacement. A tiling contractor or bathroom specialist should be appointed to provide further advice on reparation options and to perform works as necessary.

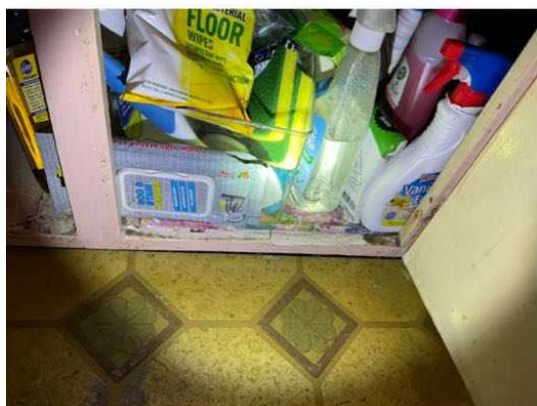
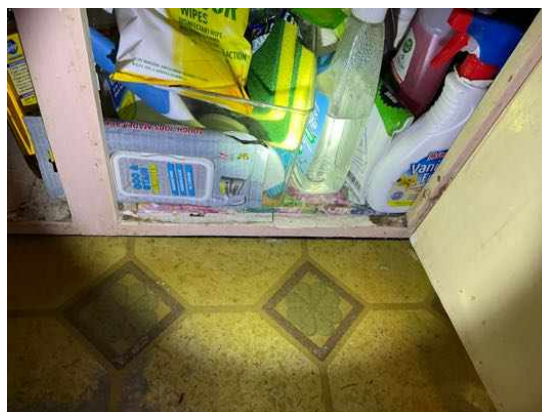
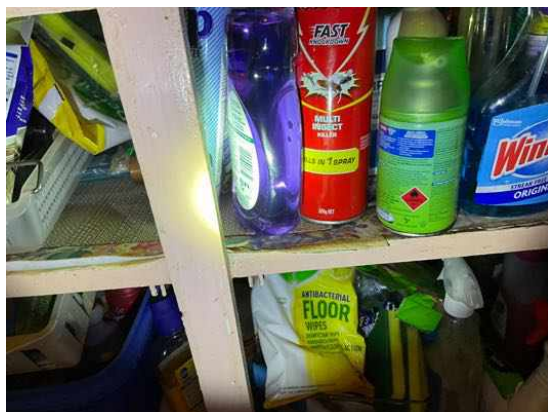
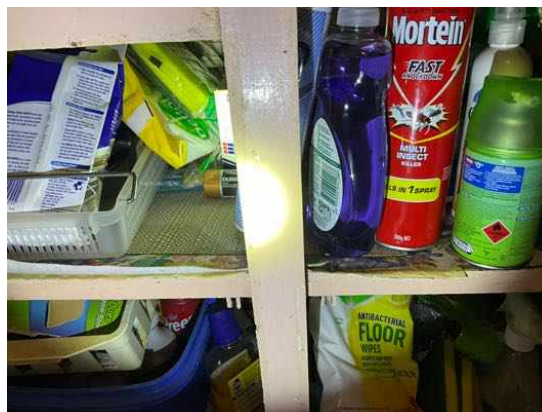
### Finding 3.11

Building:	Main Building
Location:	Kitchen
Finding:	Water damage / Vanity
Information:	"The vanity in the shower area has sustained water damage, resulting in swelling and discoloration of the wood, as well as potential structural issues. This damage compromises both the aesthetic and functional aspects of the vanity."

1. **Carpenter or Woodworker:** They can assess and repair the damage to the vanity, potentially replacing any irreparable parts.
2. **Plumber:** If the water damage is due to plumbing issues, a plumber can fix leaks and ensure there are no further water-related problems.
3. **General Contractor:** If the damage is extensive and affects the surrounding area, a general contractor can coordinate the repair work, including both the vanity and any related structural or cosmetic repairs.

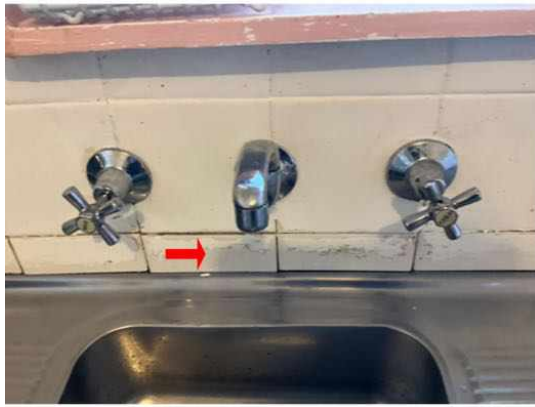
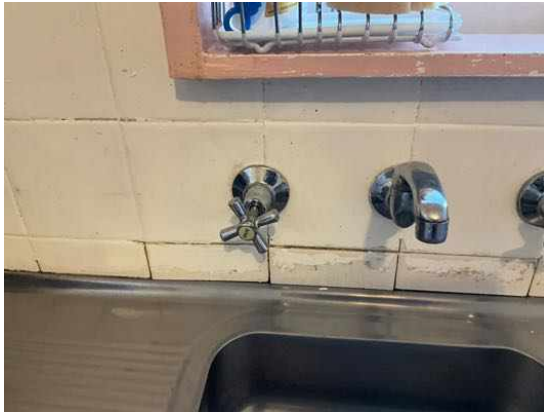
### Finding 3.12

Finding: Grouting - Missing or damaged

Information: It was noted on inspection that sealant or grout is Missing or damaged. A flexible sealant is required to allow for expected expansion and contraction, while keeping the joint water tight and protective of all associated building materials.

Flexible and mould resistant materials should be applied to affected areas to prevent any subsequent water damage that is likely to occur. Regular maintenance and replacement of damage or missing or damaged sealant and grout is highly recommended, as this is a regular wear and tear defect.

A sealant specialist or tiling contractor should be appointed to complete these works as soon as possible

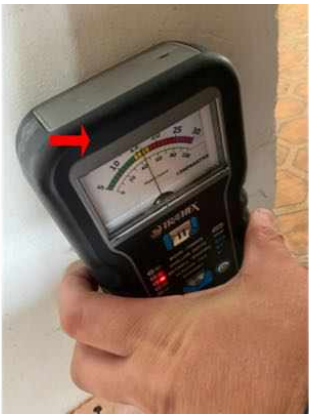
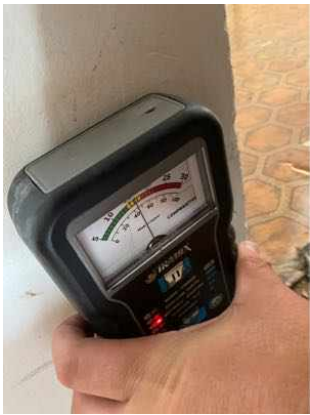
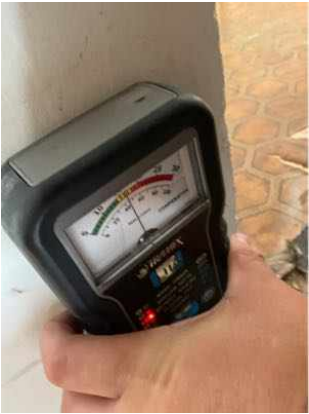
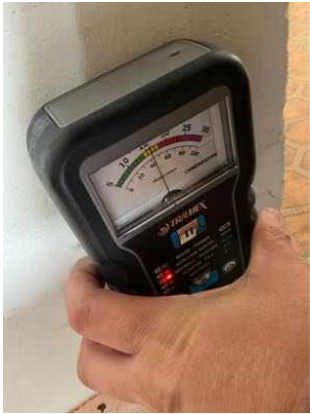
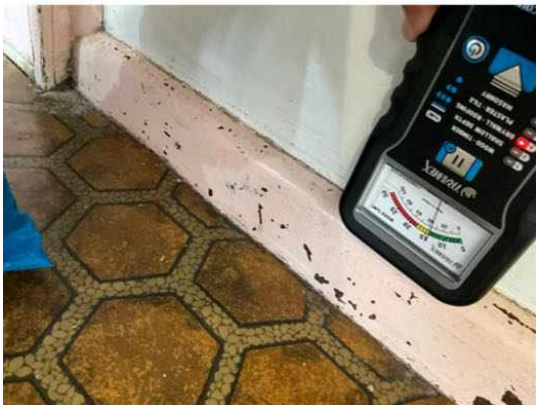
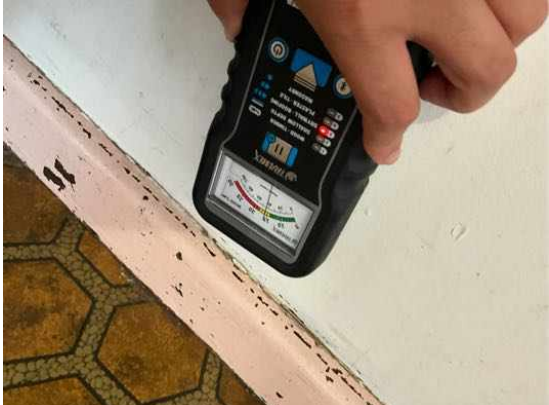
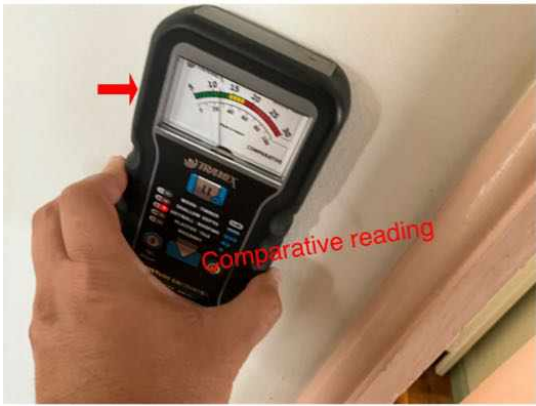
### Finding 3.13

Building:	Main Building
Location:	All Areas
Finding:	Evidence of excessive moisture - Drywall
Information:	Excessive moisture is present at the time of , indicating a potential water leakage issue within the wall.

The prolonged presence of moisture can lead to mold growth, deteriorate the structure, and create an environment conducive to health hazards. Additionally, it may compromise the adhesive holding the tiles, leading to their detachment.

A licensed plumber or a qualified contractor specializing in water damage remediation should investigate the source of the moisture, fix any leaks, and address the damage. Additionally, replacing affected tiles and ensuring proper waterproofing are crucial to preventing future issues.
