# Building and Timber Pest Inspection Report

Inspection Date: Tue, 13 Jan 2026

Property Address: 159 Waminda Ave, Campbelltown NSW  
2560, Australia

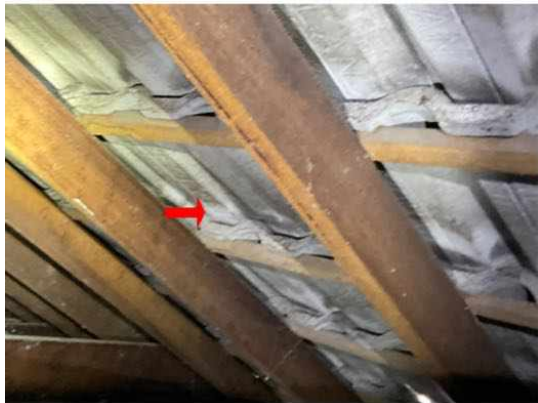
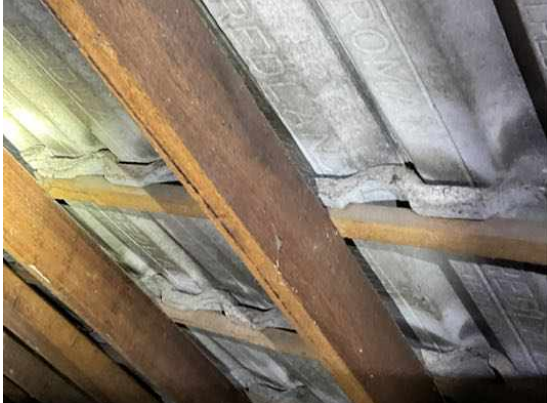
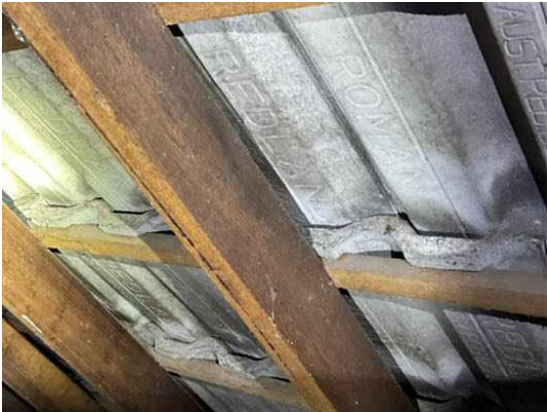
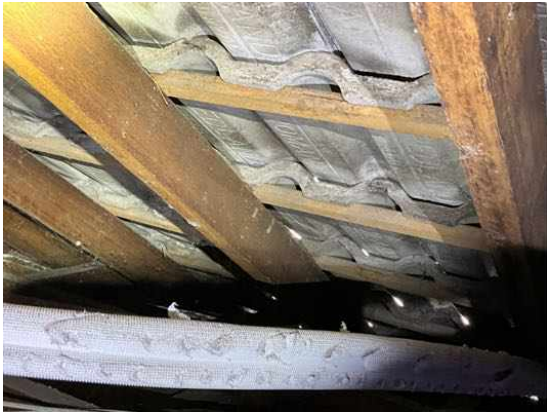
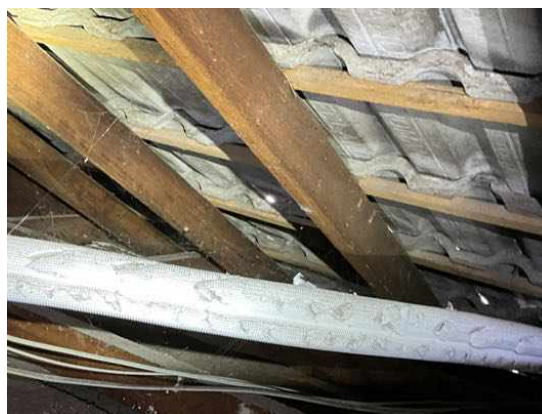
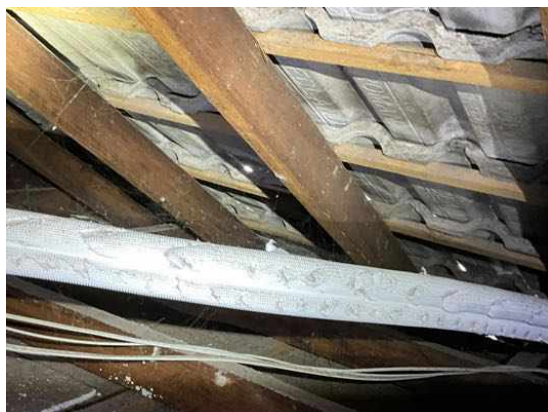
Building: Main Building  
Location: Roof Void  
Finding: Sarking - Missing  
Information: Sarking is missing under the roof sheeting. Sarking acts as an insulator that helps with noise reduction and protects against water penetration. Sarking plays a key role in the operation and function of the overall roofing structure and its performance.

Although not a requirement at the time of construction, replacement of any missing building element is advisable (although this can be quite expensive to do after the time of construction). Where sarking is missing, regular inspections of the roof tiles for cracking and potential moisture penetration is required.

Sarking may be retrospectively fitted by a registered builder at the discretion of the client.

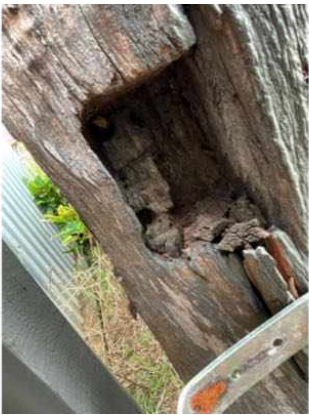
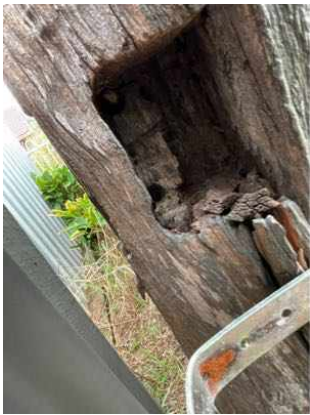
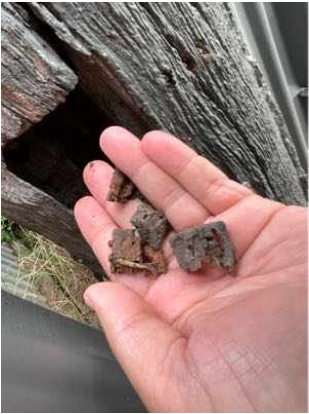
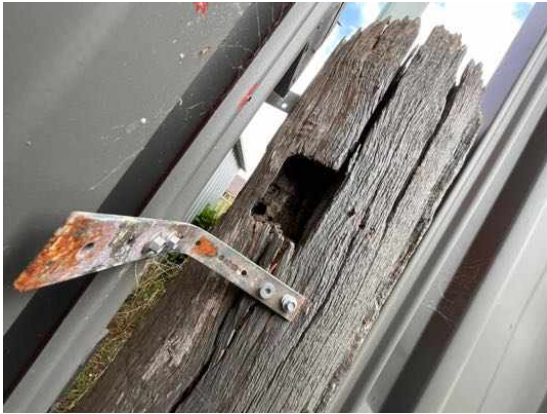
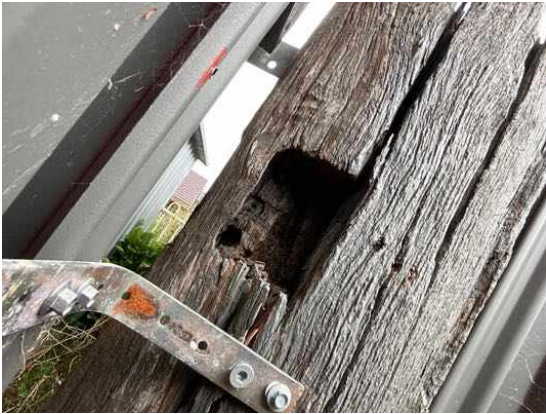
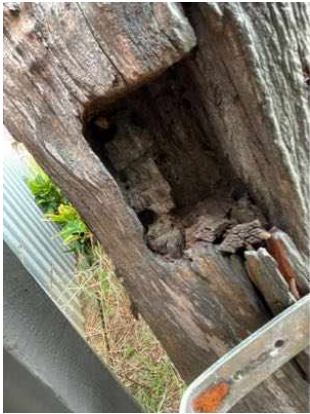
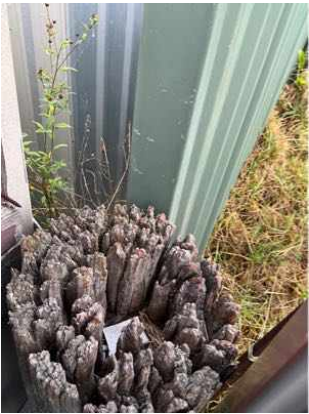
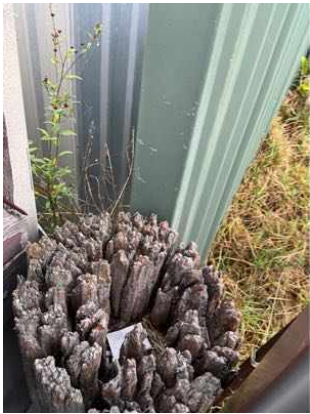
Building:	Main Building
Location:	Fencing
Finding:	Suspected - Timber pest damage
Information:	Despite no live termite or timber pest activity being indicated, suspected previous timber pest damage was found to have affected this area. This damage is considered to be inactive at the time of inspection.

It is advised that the area be visually inspected frequently to ensure that the condition of affected building materials does not worsen.

A licensed pest controller must be appointed to provide a further invasive inspection.

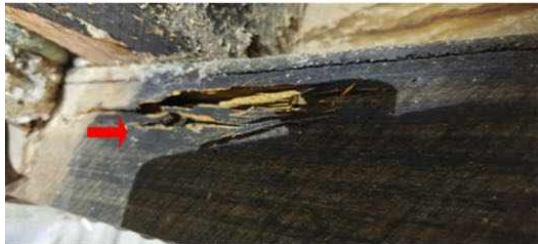
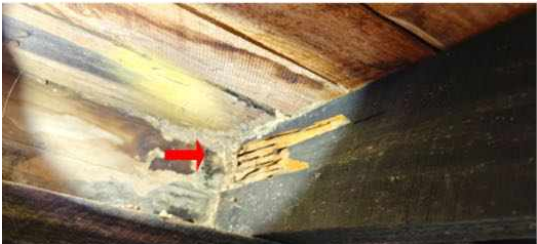
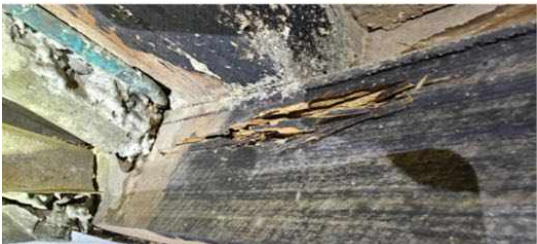
Finding 5.02

Building: Main Building  
Location: Subfloor  
Finding: Termite damage detected in the subfloor  
Information: Termite damage has been detected in the subfloor, compromising the structural integrity of the building's foundation.

The presence of termite damage increases the risk of further structural deterioration, weakening the subfloor and potentially causing instability in the entire structure. If left unaddressed, this may lead to severe structural issues, compromising safety and necessitating extensive repairs.

A licensed pest control professional should conduct a thorough inspection to assess the extent of termite damage. Subsequently, a qualified contractor experienced in subfloor repairs should be engaged to address and rectify the damage. Swift action is crucial to prevent further harm and ensure the long-term stability of the building.

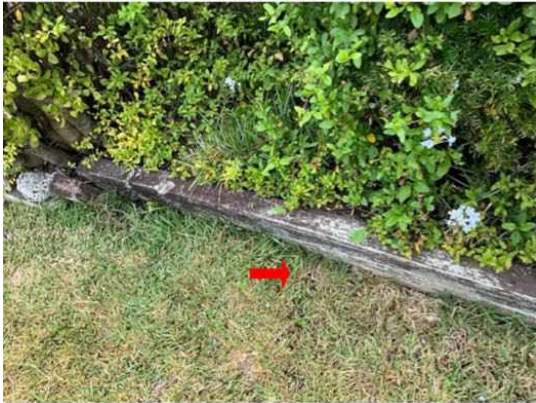
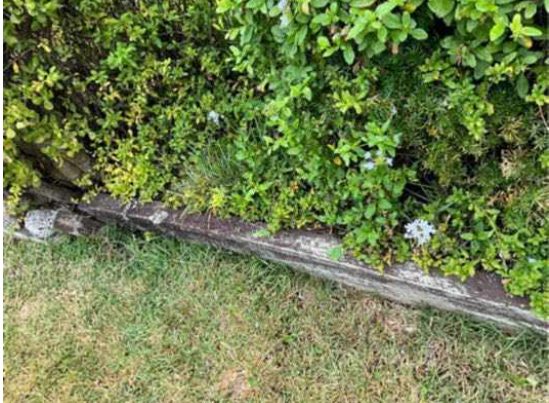
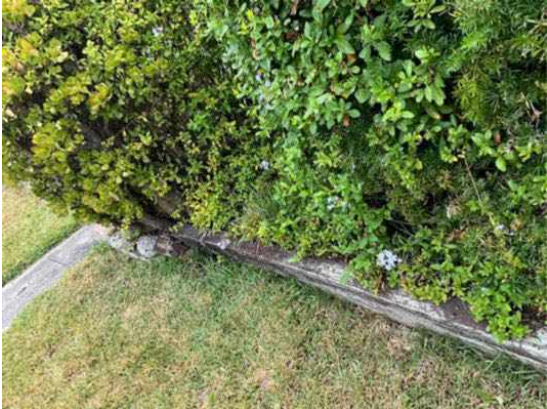
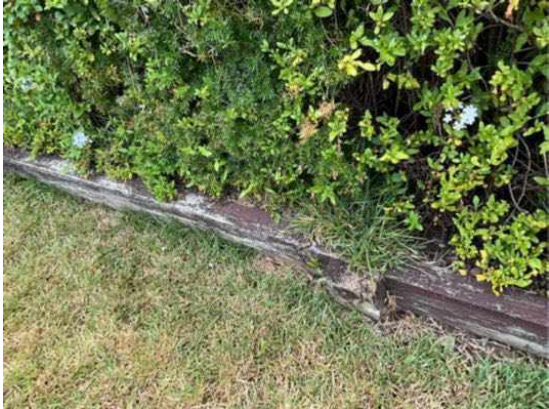
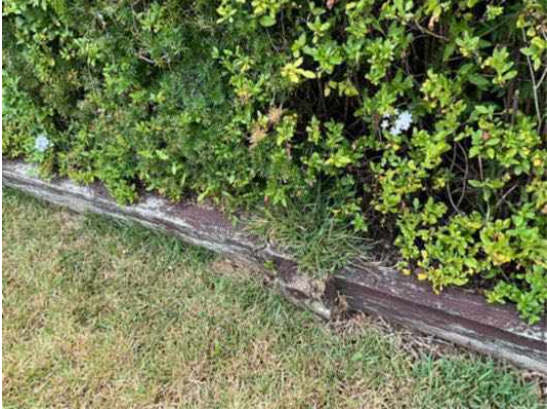
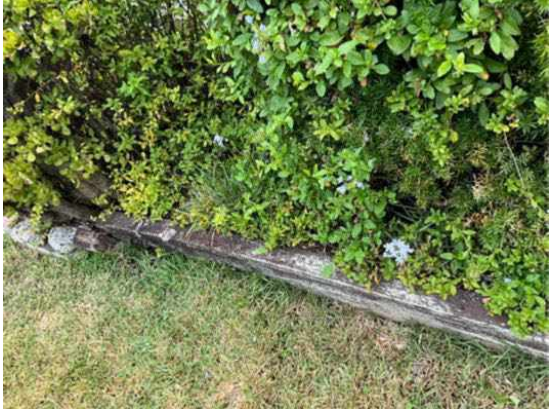
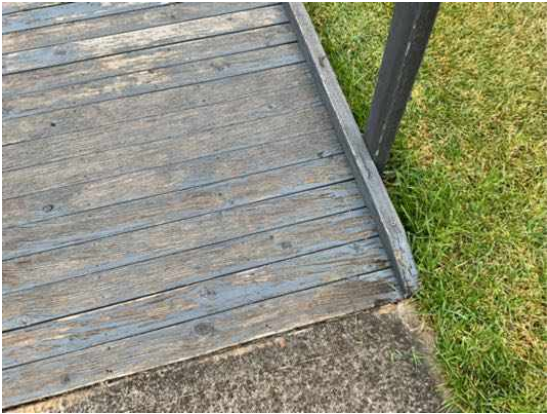
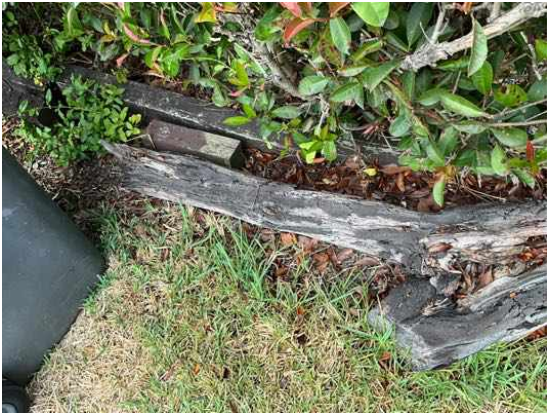
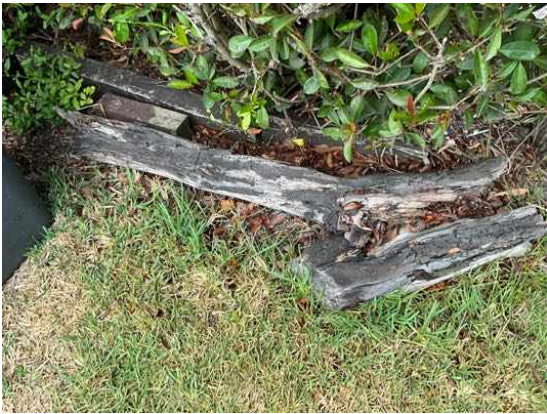
Building:	Main Building
Location:	All Areas
Finding:	Timber on ground / conducive conditions to termite damage
Information:	Timber on the ground is indeed conducive to termite damage. Termites are known to thrive in moist environments, and wood in contact with soil or moisture is more susceptible to infestation.

To prevent this, it's important to keep timber elevated and away from direct ground contact. Regular inspections and proper termite control measures are also essential to protect your wooden structures from termite damage.

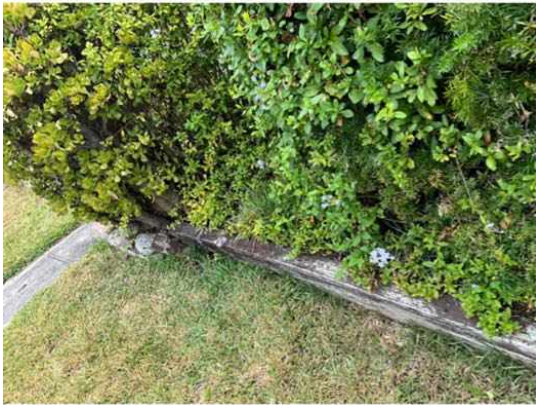
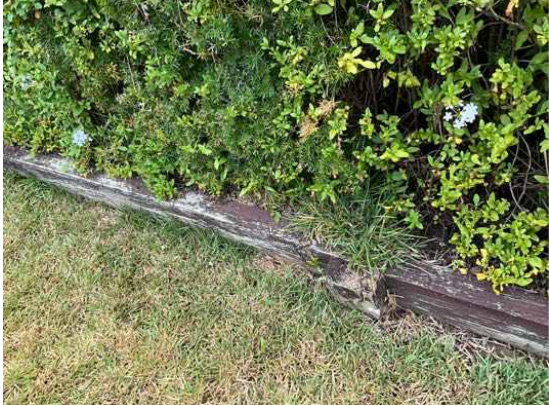
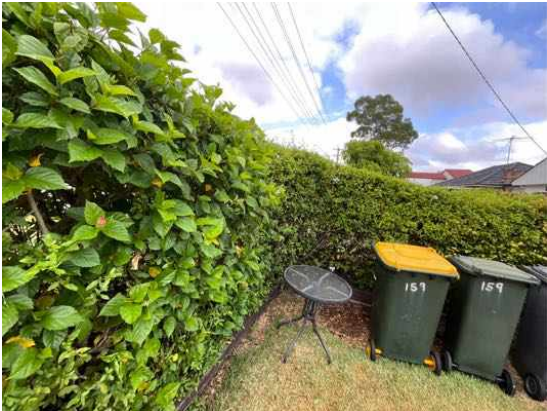
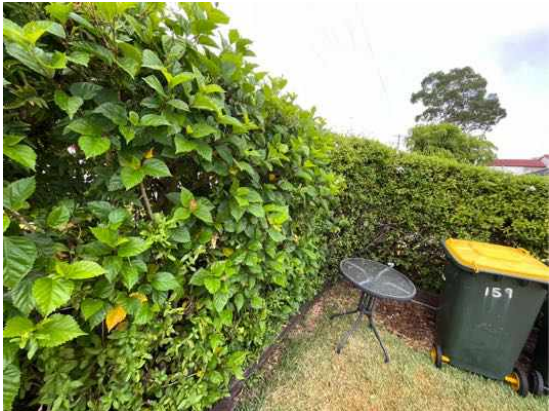
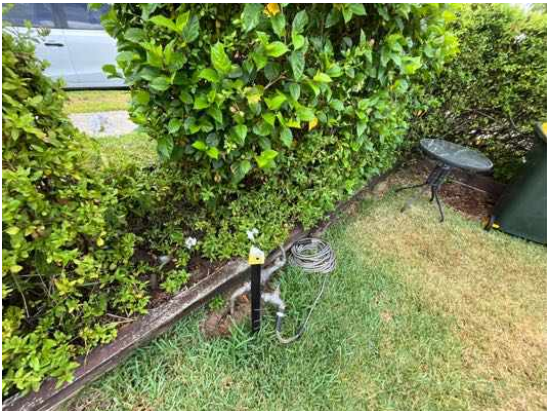
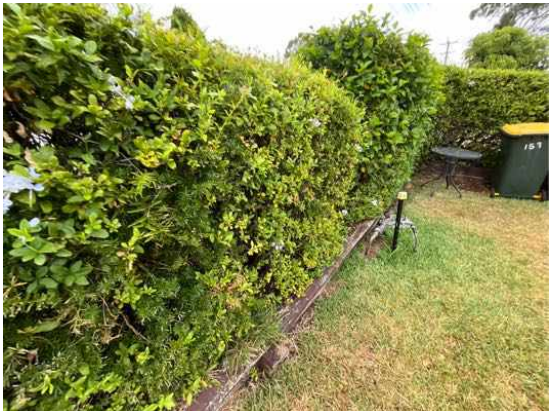
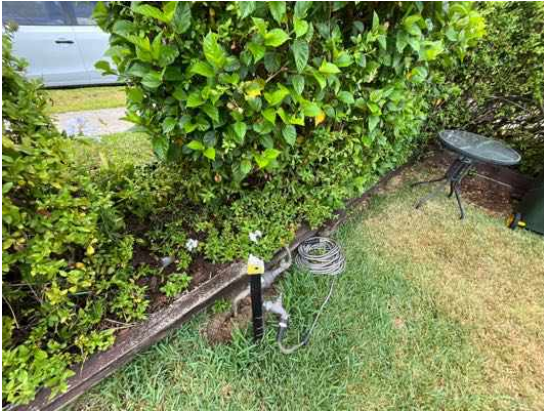
Finding 6.02

Building: Main Building  
Location: All Areas  
Finding: Dense vegetation around a property can increase the risk of termite infestation  
Information: The presence of dense vegetation around a property can increase the risk of termite infestation, as it provides a conducive environment for them. To address this, consider maintaining a clear space between the vegetation and your home. If you suspect a termite issue, it's advisable to consult with a licensed pest control professional for inspection and treatment.

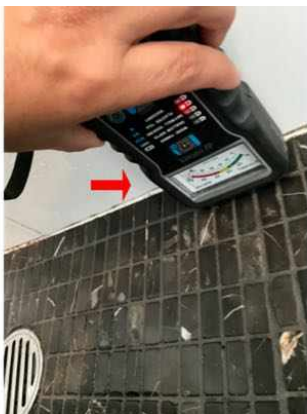
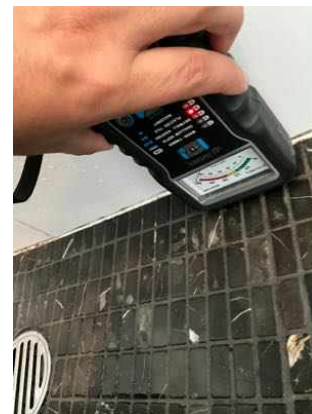
### Finding 6.03

Building:	Main Building
Location:	Bathroom
Finding:	Excessive moisture - Conducive to Timber pest
Information:	Excessive moisture can attract termites and produce conditions that promote fungal growth and wood decay.

Excessive moisture is generally caused by deteriorated inadequate or missing roof drainage leaking plumbing pipes or fixtures poorly plumbed HWS overflows or condenser units and poor site drainage.

If mould growth has been found there may be environmental biological or health issues involved. In these cases an appropriately qualified inspector should also be contacted.

Prior to any remedial works being performed a qualified plumber should be appointed to further inspect the property and to identify the cause of the excessive moisture. Works to remove affected building elements may then be necessary and should be performed by an appropriate tradesperson.

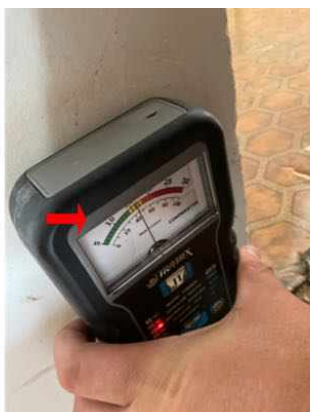
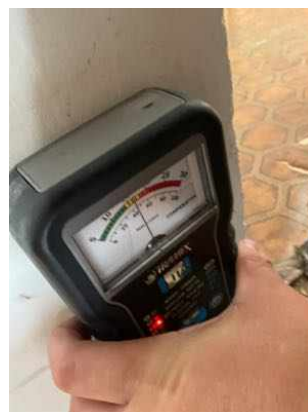
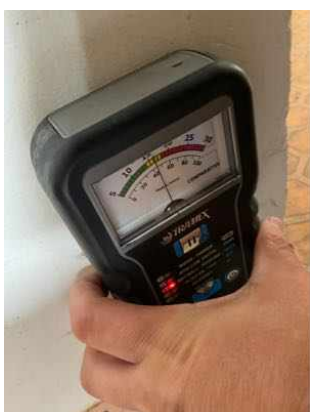
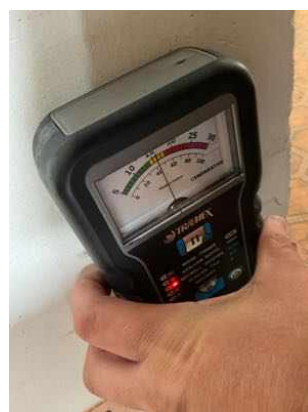
### Finding 6.04

Location:	All Areas
Finding:	Excessive moisture - Conducive to Timber pest
Information:	Excessive moisture can attract termites and produce conditions that promote fungal growth and wood decay.

Excessive moisture is generally caused by deteriorated inadequate or missing roof drainage leaking plumbing pipes or fixtures poorly plumbed HWS overflows or condenser units and poor site drainage.

If mould growth has been found there may be environmental biological or health issues involved. In these cases an appropriately qualified inspector should also be contacted.

Prior to any remedial works being performed a qualified plumber should be appointed to further inspect the property and to identify the cause of the excessive moisture. Works to remove affected building elements may then be necessary and should be performed by an appropriate tradesperson.

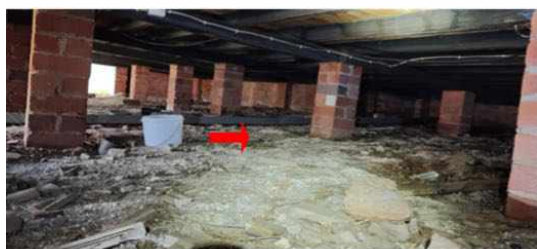
### Finding 6.05

Building:	Main Building
Location:	Subfloor
Finding:	Subfloor - poor ventilation, inadequate site drainage, water stains

Information: The subfloor lacks adequate ventilation, suffers from inadequate site drainage, exhibits water stains, creating conducive conditions for timber pests such as termites.

Risk: The combination of poor ventilation, inadequate drainage, water stains significantly increases the risk of timber pest infestations. Termites are attracted to moist environments and can thrive in subfloors with high humidity levels and water damage. The lack of proper ventilation and drainage exacerbates moisture retention, providing an ideal habitat for timber pests to establish colonies and cause extensive damage to the subfloor structure. Additionally, water stains indicate previous or ongoing moisture issues, which further attract timber pests and contribute to the deterioration of timber materials.

A licensed pest control professional specializing in timber pest management should be consulted to assess the extent of the infestation and develop a comprehensive treatment plan. They can implement strategies to eliminate existing timber pests, such as termites and prevent future infestations by addressing underlying moisture issues. Additionally, a qualified plumber or builder may be needed to improve subfloor ventilation, enhance site drainage, repair water-damaged areas. Regular inspections and maintenance are essential to ensure ongoing protection against timber pests and maintain the structural integrity of the subfloor.

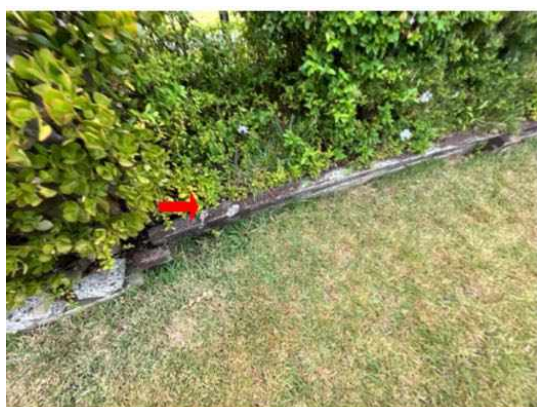
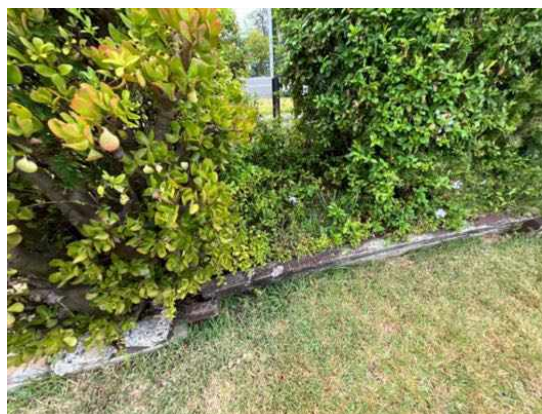
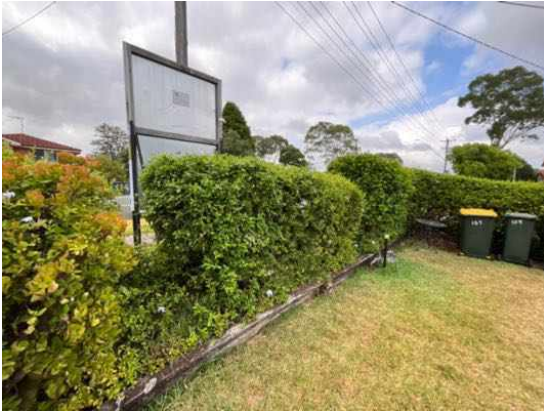
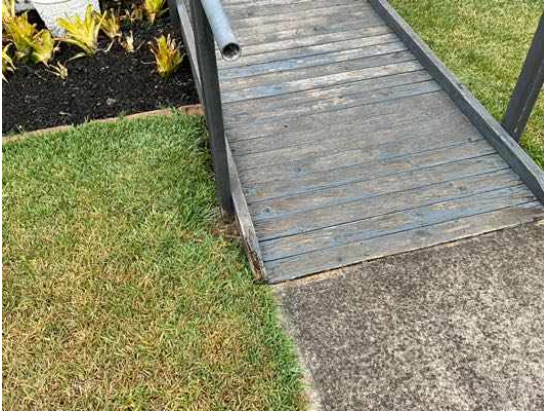
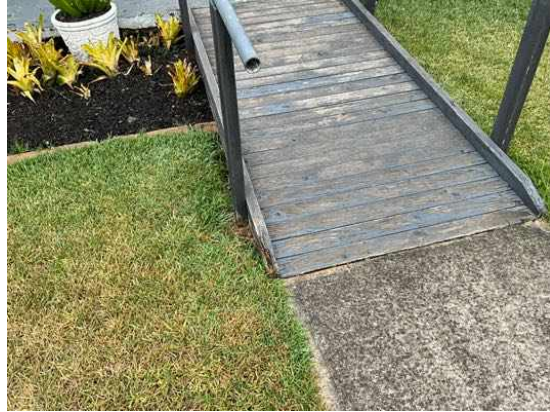
### Finding 7.01

Building:	Main Building
Location:	All Areas
Finding:	Wood rot
Information:	This building element shows evidence of wood rot. Wood rot, also known as Fungal Decay, occurs when timbers and other cellulose building materials are exposed to damp conditions on an ongoing basis. This could be the result of exposure to weathering over a prolonged period of time, or the attraction of excessive moisture from other abutting building materials. Contributing factors also include poor air ventilation in the area.

Wood rot is often associated with general damp problems and is evidenced by a 'musty' smell or mould and mildew occurring on surfaces. If left unmanaged, damp conditions can lead to further health problems and the decay of timbers will continue.

Early intervention and regular maintenance, particularly of exterior timbers, will prolong the useful life of these building elements. Prior to any works being performed, the cause of the moisture that has created the visible wood rot should be identified and addressed in a suitable manner. Replacement of affected timbers may then be a necessary step in protecting surrounding building elements from such deterioration.

A qualified plumber may be appointed to assess the cause of excessive moisture and to provide advice on any remedial works as required. A qualified carpenter or registered builder may also be required to replace affected building materials.

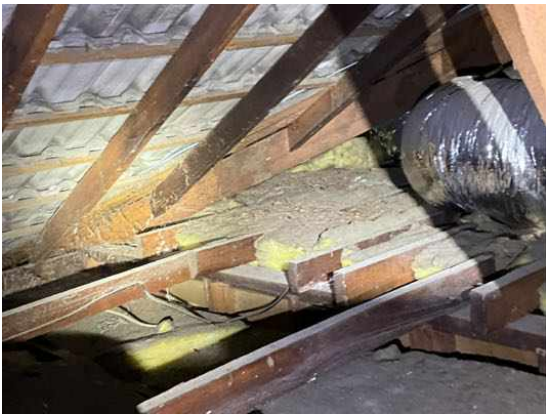
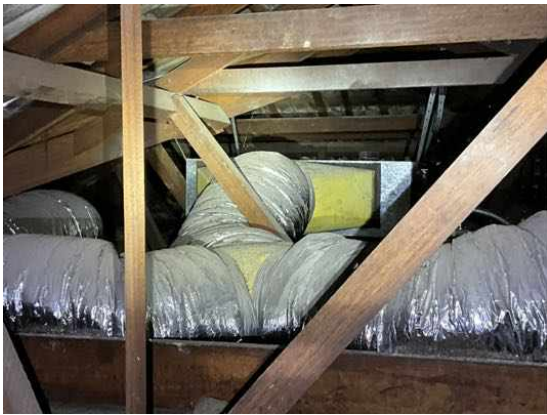
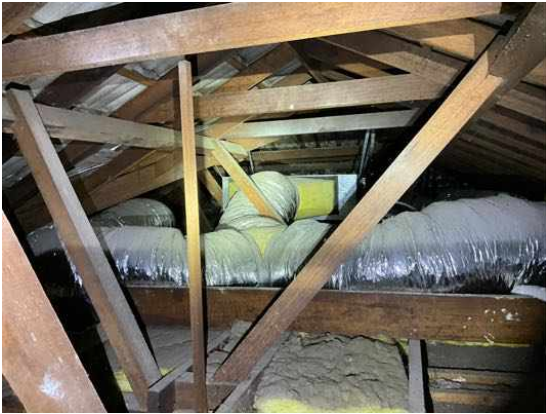
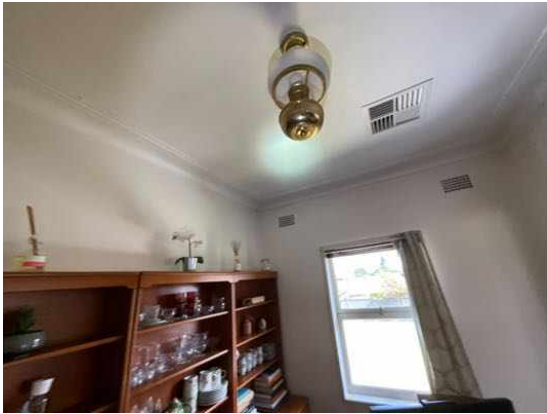
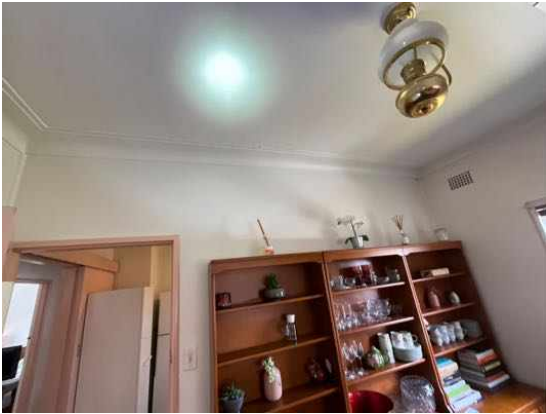
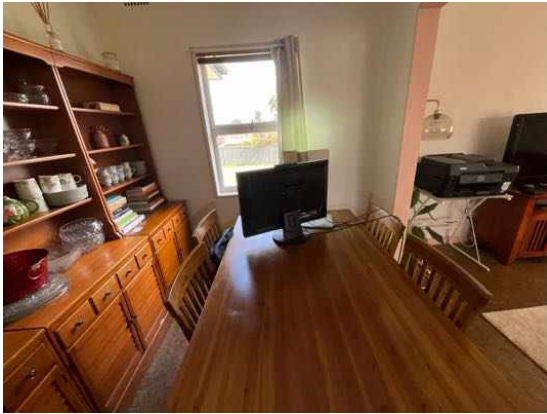
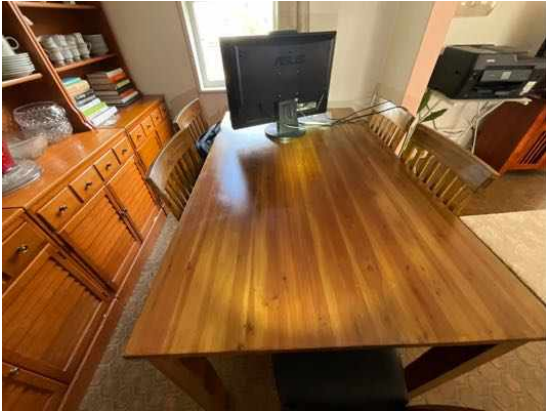
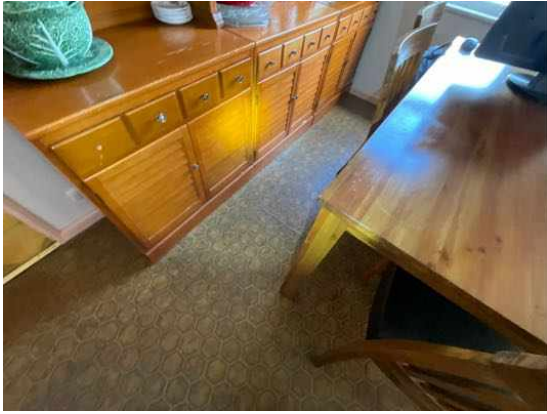
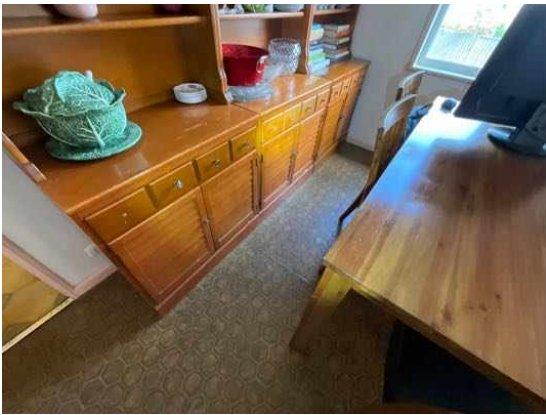
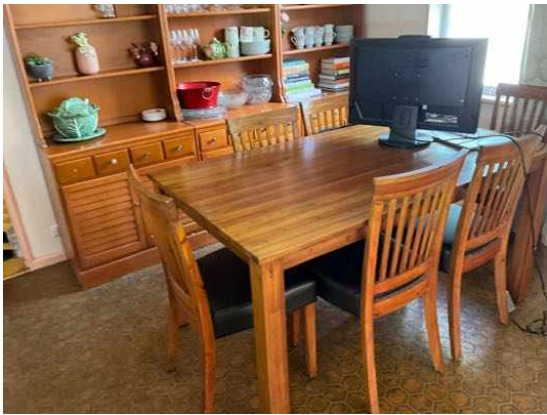
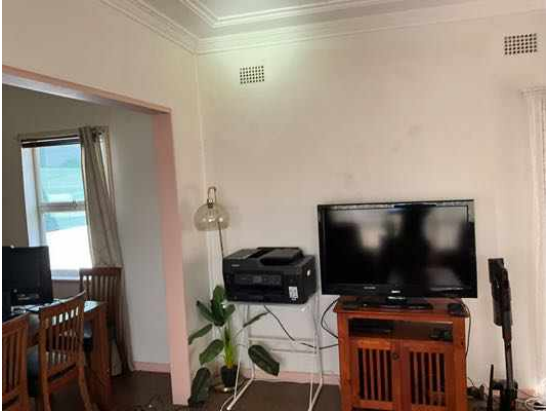
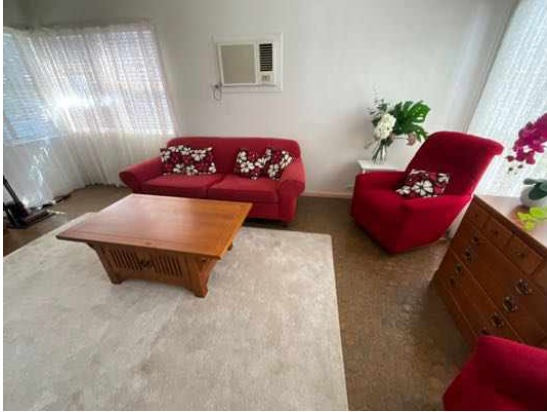
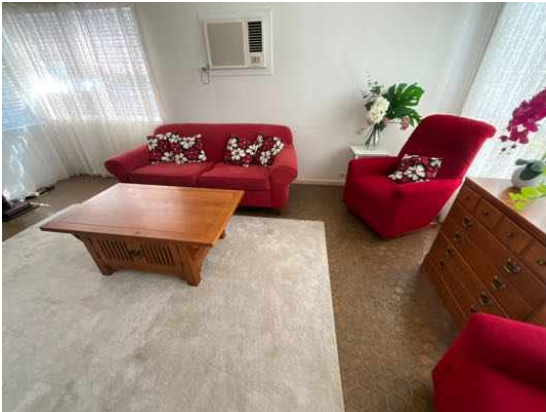
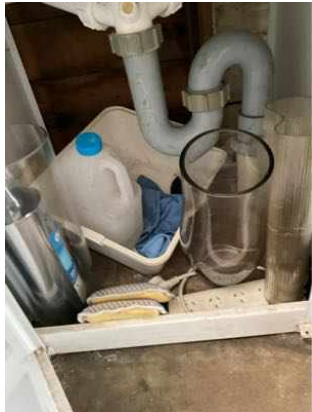
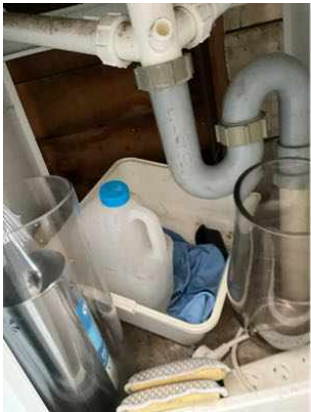
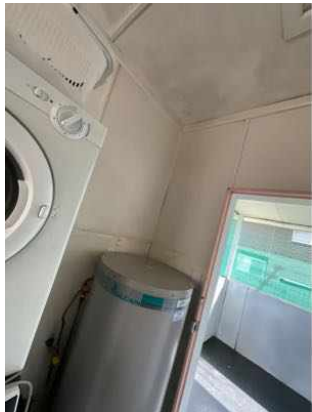
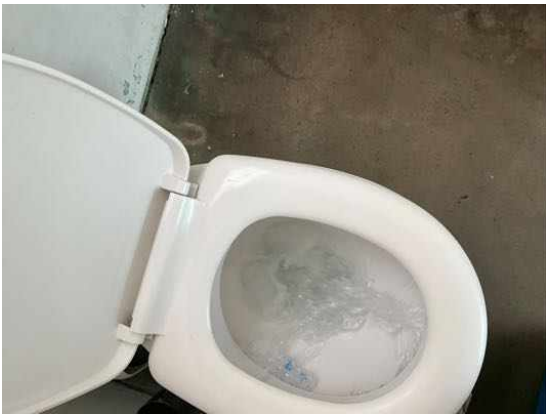
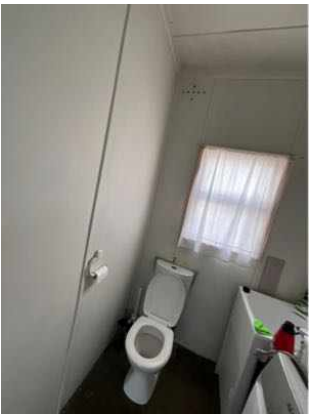
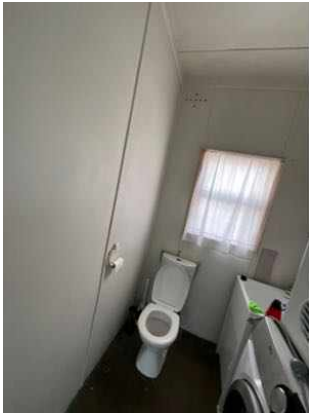
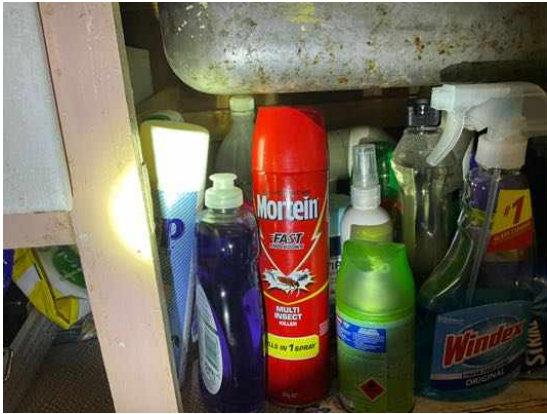
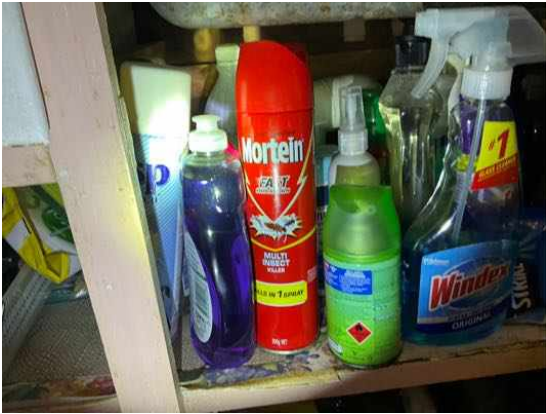
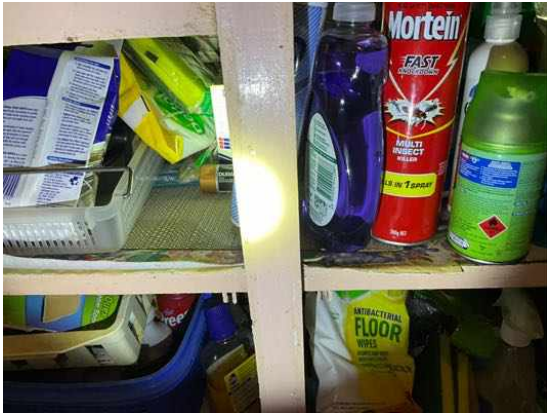
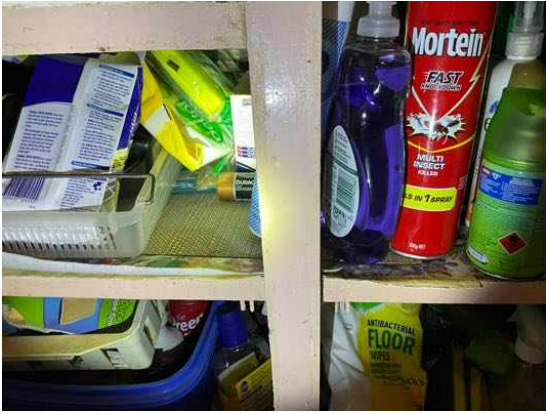
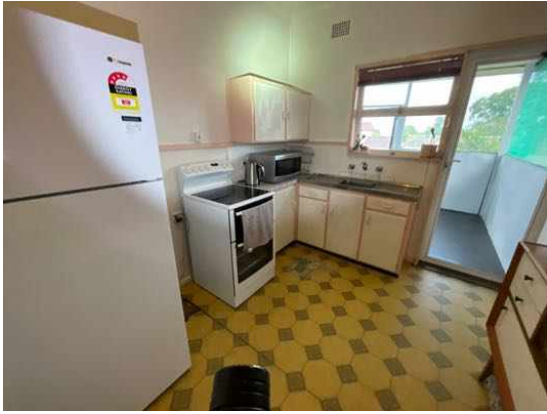
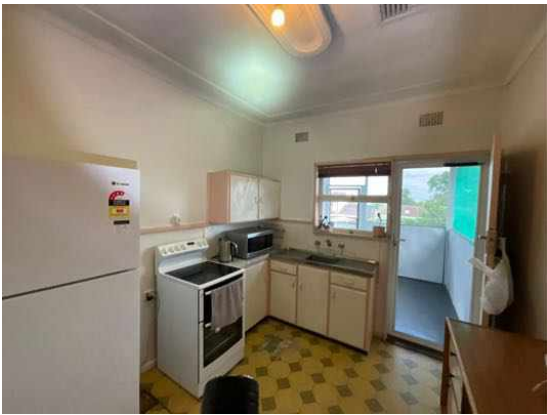
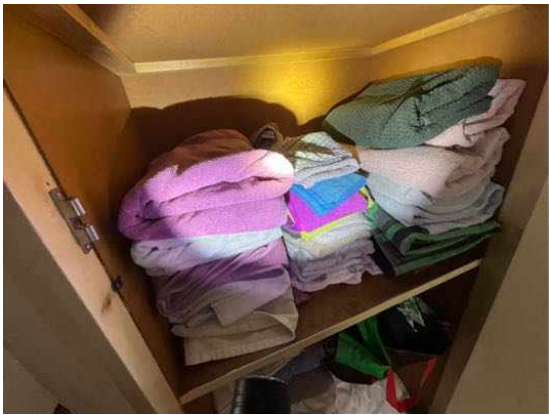
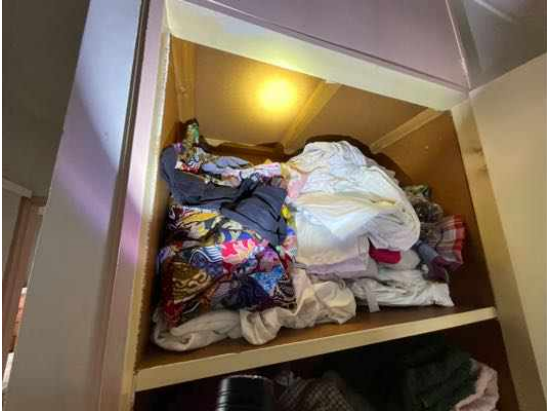
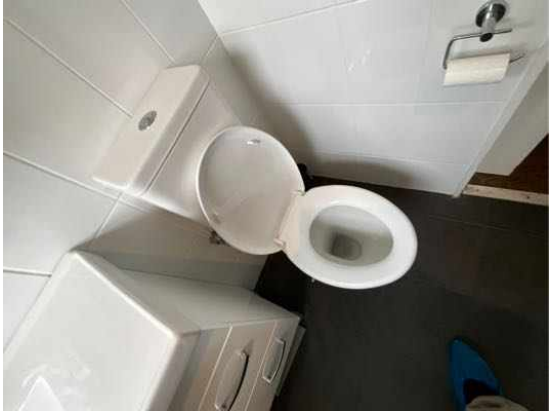
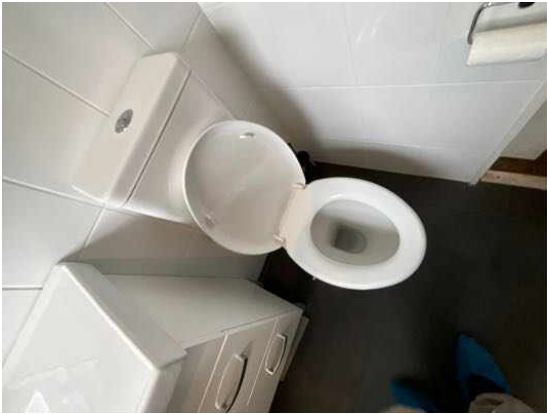
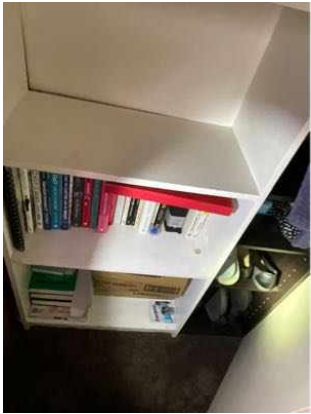
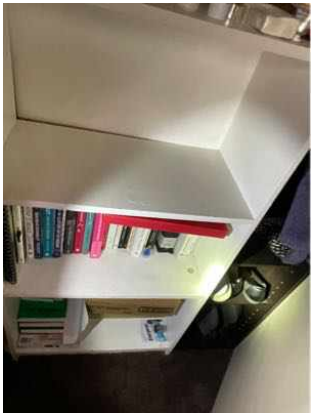
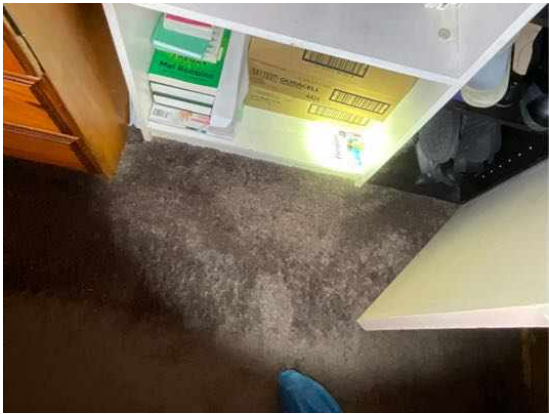
**Noted Item**

Building: Main Building  
 Location: All Areas  
 Finding: Additional Photos - Obstructions and Limitations  
 Information: These photographs are an indication of the obstructions and limitations which impeded full inspection of the property at the time of inspection. These obstructions can hide an array of defects and should be removed to allow full inspection to be carried out. A re-inspection is recommended once the areas are made accessible.

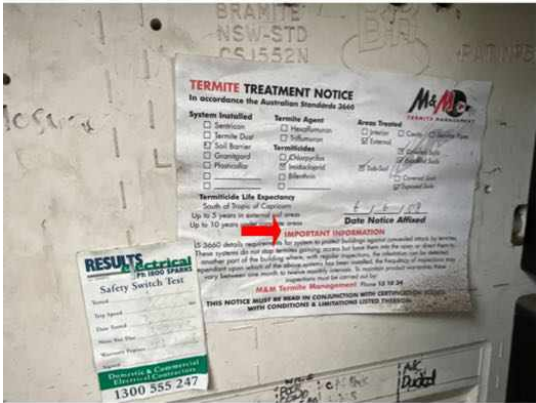
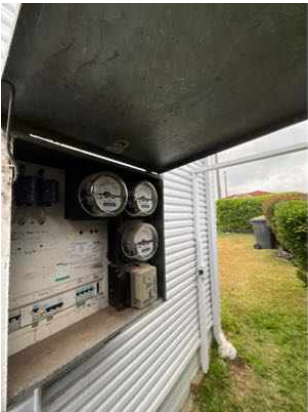
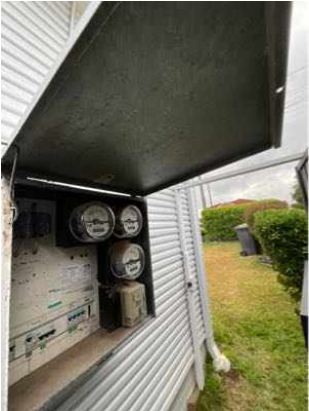
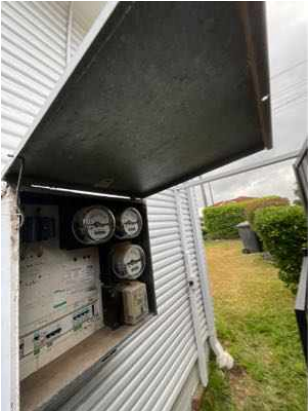
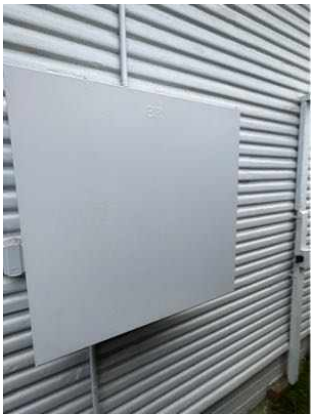
Building: Main Building  
 Location: Exterior walls - left side  
 Finding: Evidence of Termite Management System - Durable notice / Legible Sticker - seek further information  
 Information: The application of a pre & post-construction chemical termite barrier is highly recommended for all properties. Such barriers are highly effective in preventing termite attack on any timber building elements throughout the property.

A durable notice placed in the switchboard unit to indicate termite barriers at the time of inspection.

Client must seek further information from the vendor or real estate agent if the conditions of termite management systems were maintained as per the label or seek advise from licensed pest controller.
