Building and Timber Pest Inspection Report

Inspection Date: Thu, 5 Feb 2026

Property Address: 12/2 Hythe St, Mount Druitt NSW 2770,
Australia

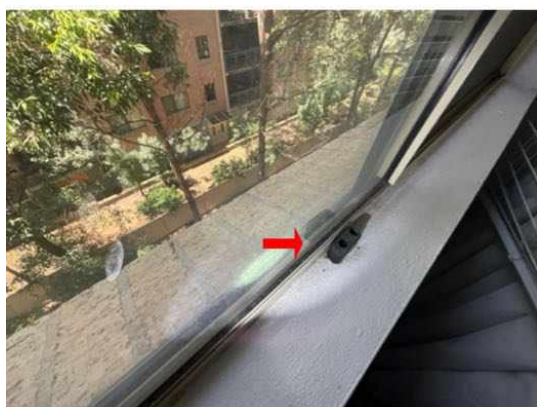
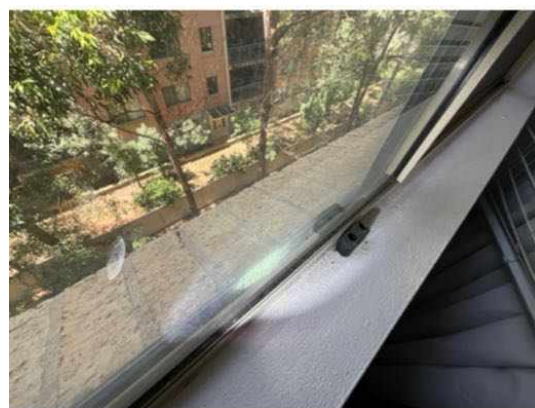
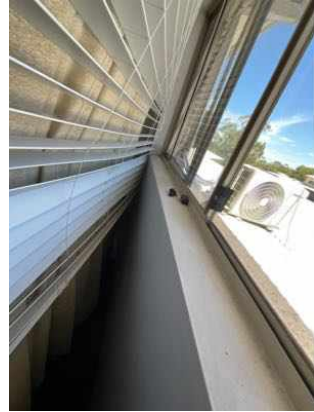
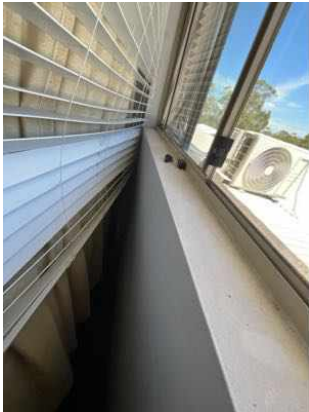
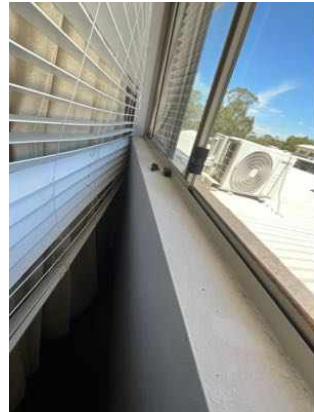
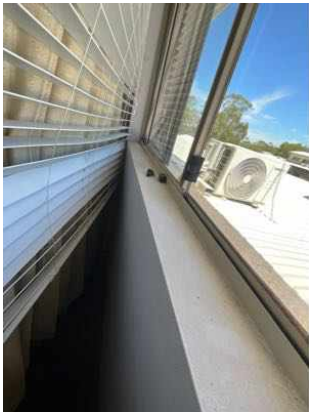
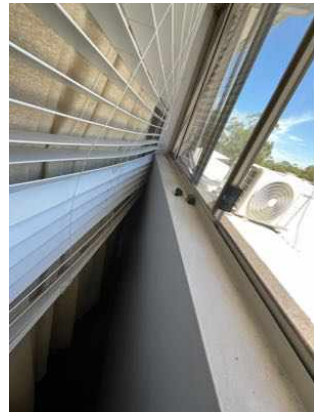
Finding 1.01

Building:	Main Building
Location:	All Areas
Finding:	Window child lock missing
Information:	The window in question lacks a child lock mechanism, which poses a potential safety risk to young occupants in the premises. As per Australian Standards windows accessible to children should be equipped with appropriate child safety locks to prevent accidental opening, reducing the risk of falls and ensuring compliance with safety regulations.

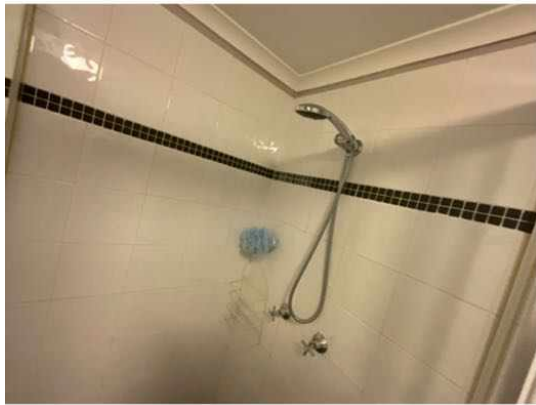
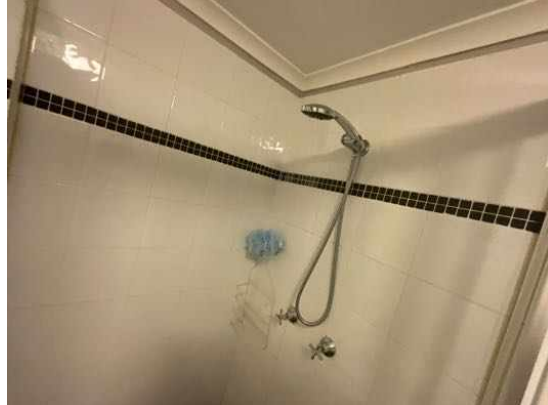
Finding 2.01

- May lead to long-term damage of internal plumbing components.
- Can cause wear and tear at joints and fittings.
- Potential for leaks or water damage if left unresolved.

A licensed plumber should be engaged to investigate and rectify the issue. Solutions may include installing water hammer arrestors, securing pipework, or adjusting water pressure.

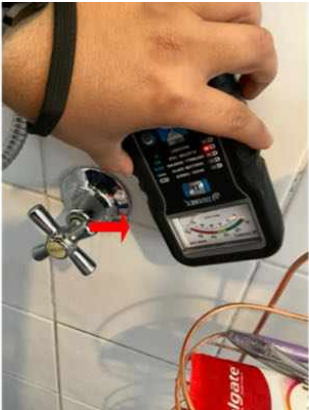
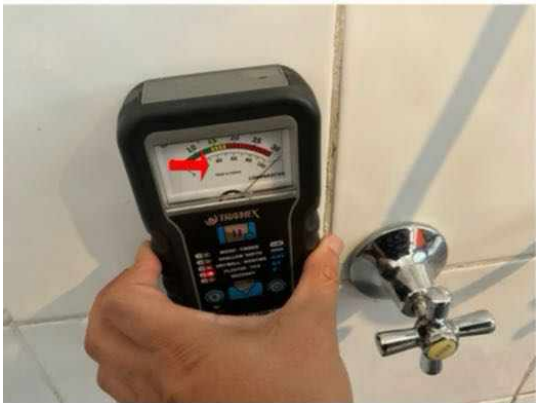
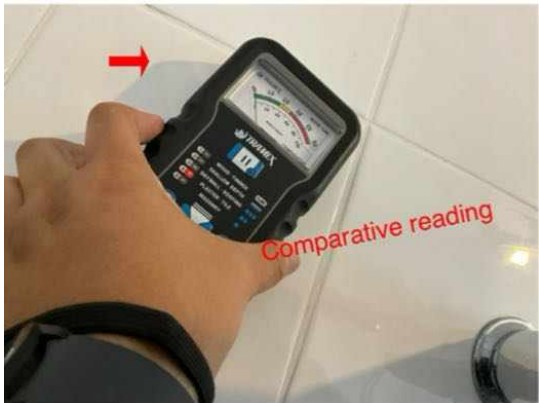
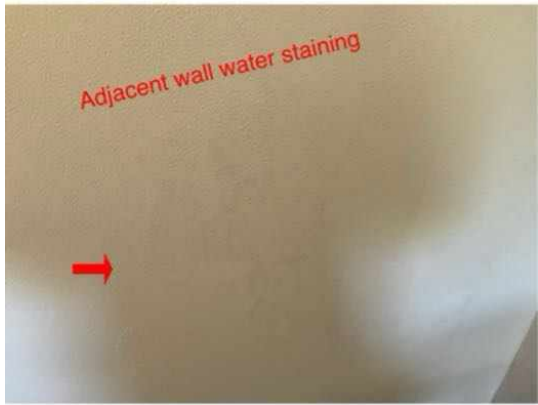
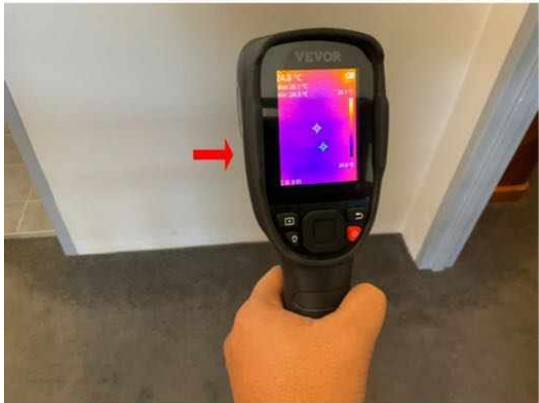
Finding 2.02

Building: Main Building
Location: Bathroom upstairs
Finding: Evidence of excessive moisture was present at the time of inspection
Information: Excessive moisture is present behind the bathroom tiles, indicating a potential water leakage issue within the wall.

The prolonged presence of moisture can lead to mold growth, deteriorate the structure, and create an environment conducive to health hazards. Additionally, it may compromise the adhesive holding the tiles, leading to their detachment.

A licensed plumber or a qualified contractor specializing in water damage remediation should investigate the source of the moisture, fix any leaks, and address the damage. Additionally, replacing affected tiles and ensuring proper waterproofing are crucial to preventing future issues.

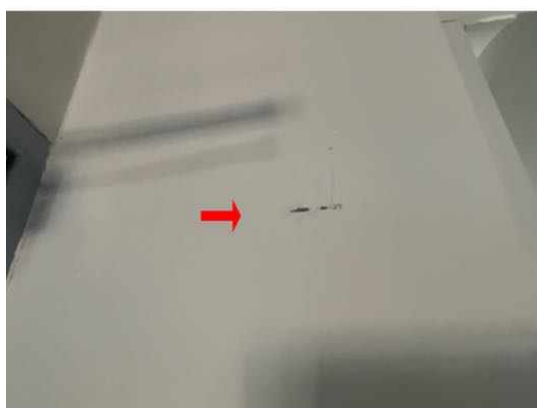
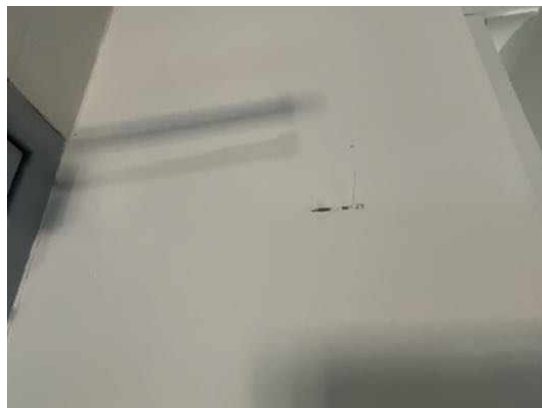
Finding 3.01

Building: Main Building
Location: Front door
Finding: Wall Gyprock damaged
Information: Sections of plaster sheeting in this area appear to be damaged .

The most common causes of plaster failure are physical damage and moisture damage. Moisture causes plaster to swell and shrink as the humidity of the air

changes, or as a consequence of leaks.

Plaster generally needs chemical re-adhesion or to be screwed back to the substrate, with minor consequent patching and painting required.

Ensure that the general environment is free from physical damage such as door handles in this instance . Appointment of a qualified plasterer is advised in order to complete remedial works as necessary.

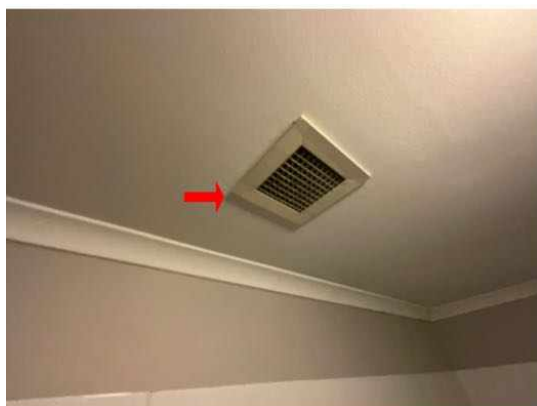
Finding 3.02

Building:	Main Building
Location:	Bathroom
Finding:	Exhaust fan - Not operating
Information:	The exhaust fan in this area appears to be damaged or blocked and is not operating as intended. If left unmanaged, a lack of general maintenance is likely to lead to the development of more significant defects, such as water damage to surrounding building materials from inadequate ventilation. If left unattended for a prolonged period of time, poor ventilation in this area may also be conducive to the development of mould.

Where no secondary damage has developed, the Homeowner may undertake minor cleaning of the area and consider replacement of the exhaust fan. Alternatively, consultation with a Licensed Electrician is required to check for any secondary or concealed damage and consider repair or replacement.

Please be advised that a cabinet maker or qualified carpenter may also be required if water damage has occurred and that an additional specialist mould inspection may be required if severe mould has resulted.

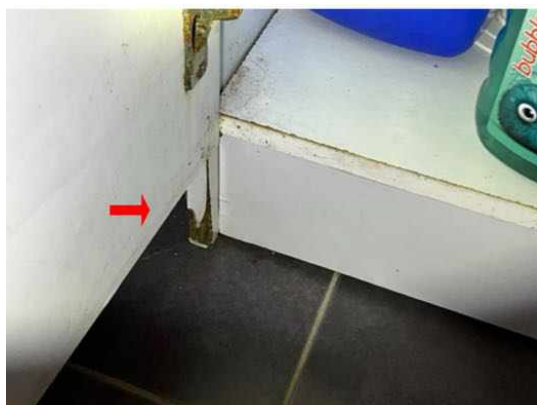
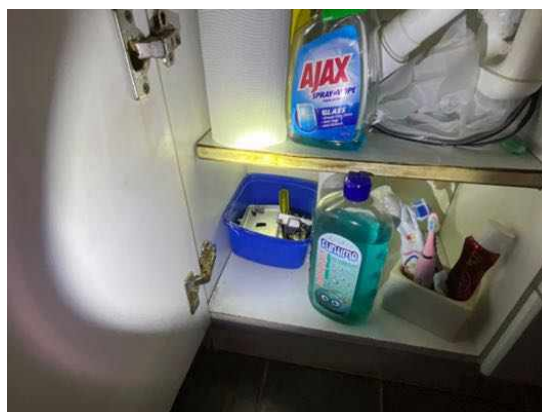
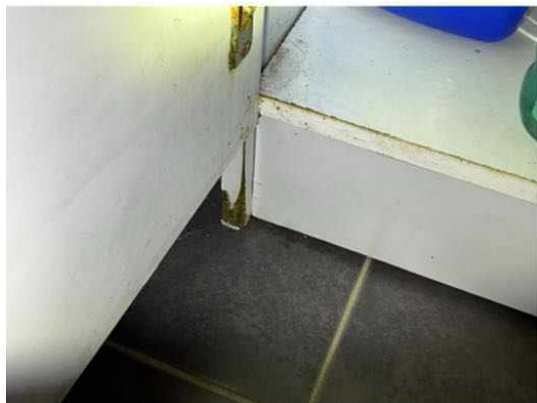
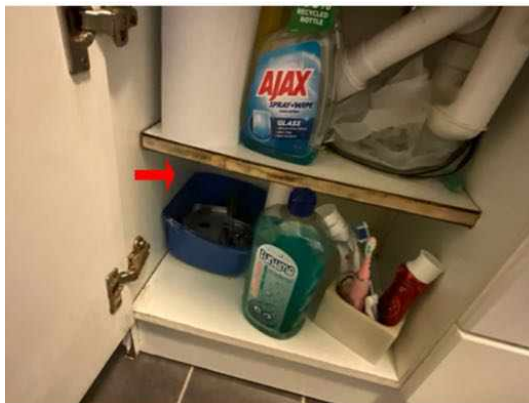
Finding 3.03

Building:	Main Building
Location:	Bathroom
Finding:	Water damage / Vanity
Information:	"The vanity in the shower area has sustained water damage, resulting in swelling and discoloration of the wood, as well as potential structural issues. This damage compromises both the aesthetic and functional aspects of the vanity."

1. **Carpenter or Woodworker:** They can assess and repair the damage to the vanity, potentially replacing any irreparable parts.
2. **Plumber:** If the water damage is due to plumbing issues, a plumber can fix leaks and ensure there are no further water-related problems.
3. **General Contractor:** If the damage is extensive and affects the surrounding area, a general contractor can coordinate the repair work, including both the vanity and any related structural or cosmetic repairs.

Make sure to obtain quotes from these professionals to determine the most cost-effective and efficient solution for your specific situation.

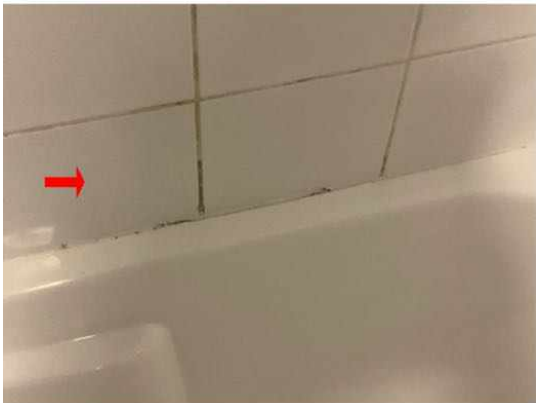
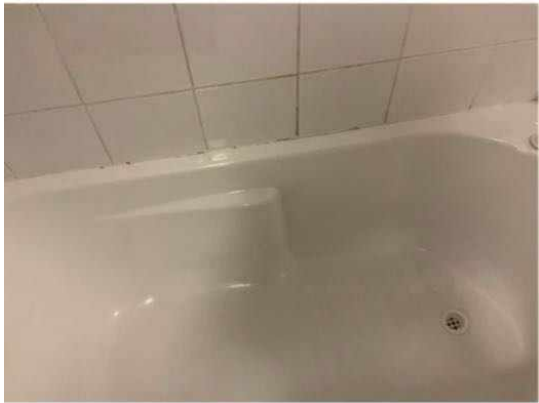
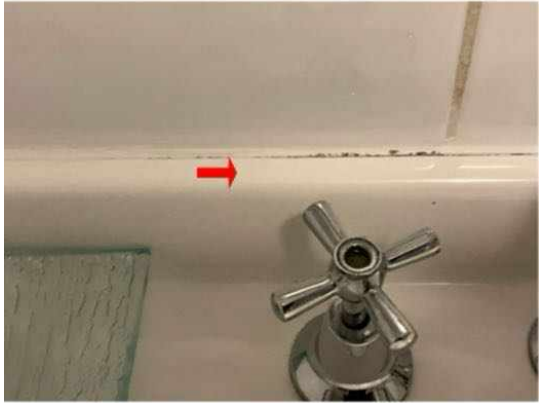
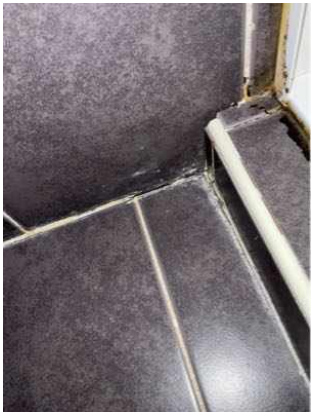
Finding 3.04

Building:	Main Building
Location:	Bathroom
Finding:	Sealant and grouting - Missing or damaged
Information:	It was noted on inspection that sealant or grout is degraded to the tiled shower alcove and or other areas of the bathroom.

Different materials and floor areas move at different rates, generally causing cracking to grout or sealant at this point. A flexible sealant is required to allow for expected expansion and contraction, while keeping the joint water tight and protective of all associated building materials.

There appears to be excessive mould to the sealant and grout which will likely require scraping out and replacement.

Flexible and mould resistant materials should be applied to affected areas to prevent any subsequent water damage that is likely to occur. Regular maintenance and replacement of damage or missing or damaged sealant and grout is highly recommended to the wet areas, as this is a regular wear and tear defect. Sealant and grouting in areas that come into regular contact with water should be maintained for the long term care of your property.

A sealant specialist or tiling contractor should be appointed to complete these works

as soon as possible

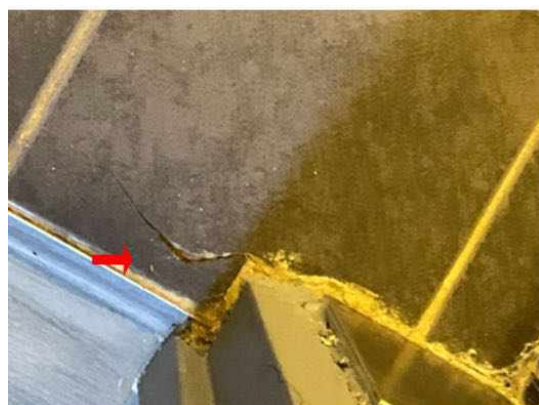
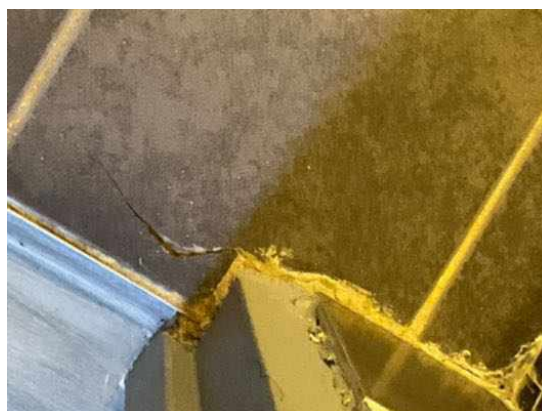
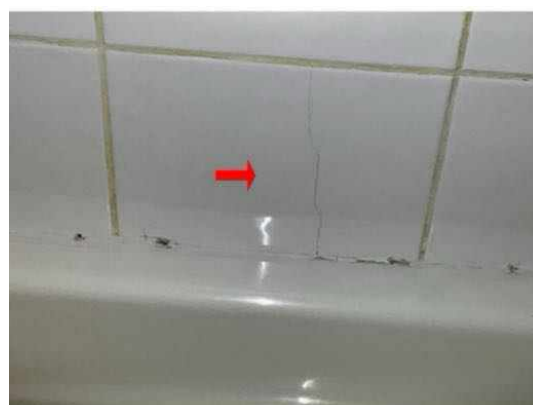
Finding 3.05

Building: Main Building
Location: Bathroom
Finding: Tiles - Cracked or damaged
Information: Cracking was evident to the tiling in this area at the time of inspection. While the cracking appears to be minor, this area is frequently exposed to water, allowing potential for water penetration into adjoining sections of walls or flooring.

If left unmanaged, water penetration to these areas may lead to subsequent water damage, which is likely necessitate repair work to affected building elements.

A tiling contractor should be appointed to ensure that no further water damage occurs. The re-application of silicone and grouting throughout remaining tile work is also advised, to further protect the area against water penetration.

Where water penetration has led to water damage, appointment of a relevant tradesperson may be required to repair damaged building elements.

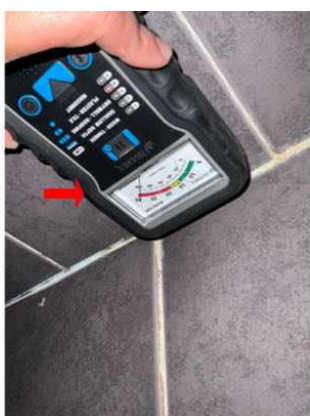
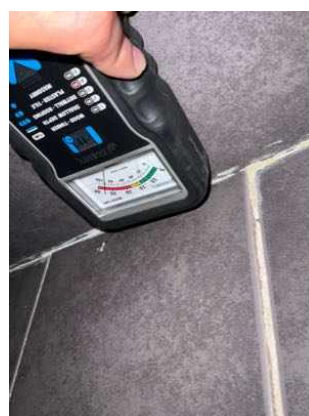
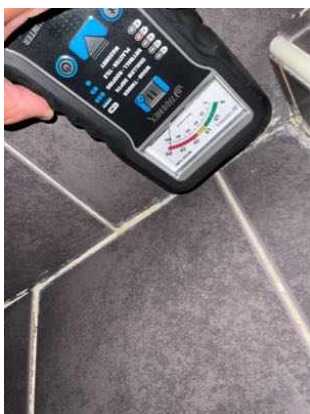
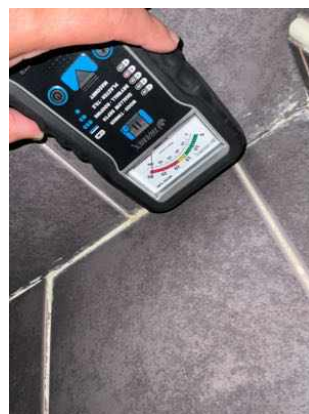
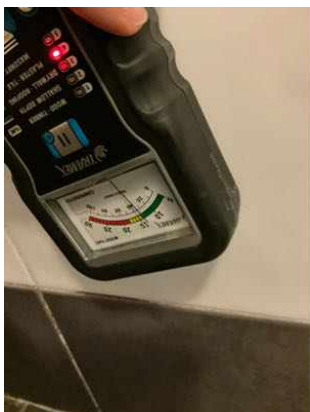
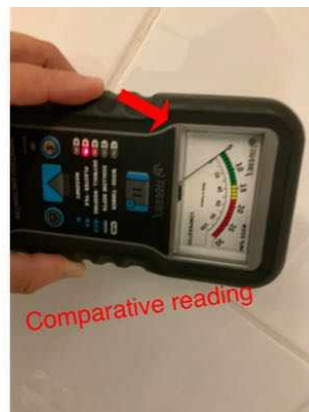
Finding 3.06

Building:	Main Building
Location:	Bathroom
Finding:	Shower - Damp
Information:	Damp is evident to the lower 300mm of wall to the shower alcove. This defect is quite common, and is suspected to have been caused by moisture permeating through the grouting in this area, which shows evidence of deterioration. Leaking pipes within the adjoining wall is also a possible cause.

Damp (or structural damp) refers to the presence of unwanted moisture in the structure of a building, either as the result of intrusion from outside, or condensation from within the structure. In the shower area, internal water leaks or other sources of excessive moisture are generally the cause of damp.

Unmanaged damp in the shower recess is likely to facilitate the formation and development of mould and fungi growth, decaying associated building materials and compromising their structural integrity. It is important to address damp conditions, as the World Health Organisation notes that excess moisture leads - on almost all indoor materials - to growth of microbes such as moulds, fungi and bacteria, which subsequently emit spores and other matter into the indoor air. Exposure to these contaminants is associated with a wide range of respiratory and other health-related problems.

Consultation with a qualified plumber or bathroom specialist is advised immediately to identify the cause of damp and to perform remedial works as required. Where excessive mould growth is present, further inspection by a specialist environmental health inspector should also be considered.

Always ensure that sealant and grout is in good condition to prevent any moisture issues occurring in the future.

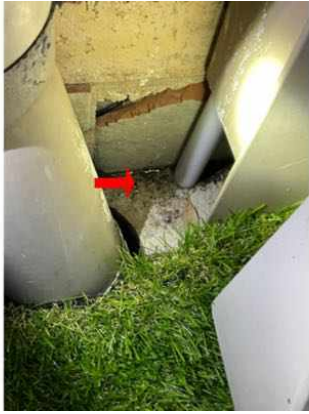
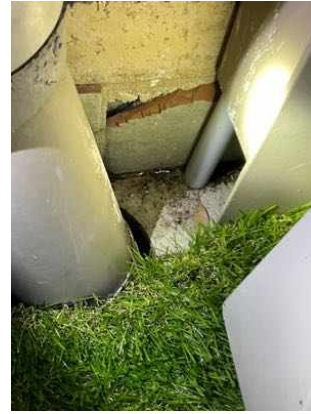
Finding 3.07

Building:	Main Building
Location:	Balcony
Finding:	Air conditioner - Disconnected overflow
Information:	The Air Conditioner (A/C) overflow was found to be disconnected from storm water drainage and is creating excessive moisture in the surrounding area.

Such leaking creates an environment which is conducive to an array of defects, including water damage to associated building elements and the attraction of termite or timber pest infestation.

It is highly recommended that a licensed plumber be appointed to connect the A/C overflow in order to prevent such an environment from being created. These minor works should be carried out as soon as possible.

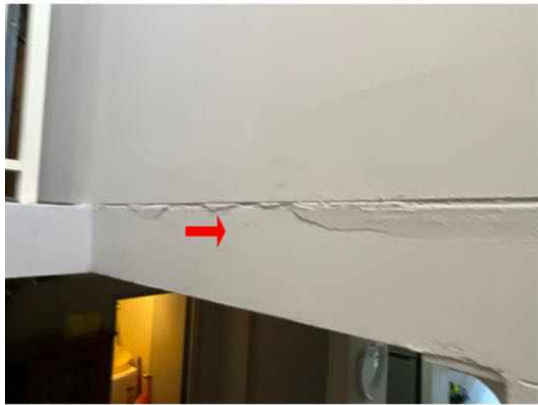
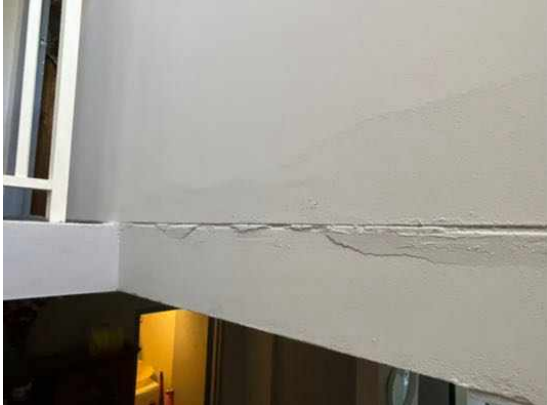
Finding 3.08

Building: Main Building
 Location: Stairs - Internal
 Finding: Poor workmanship
 Information: The structure exhibits signs of poor workmanship, evident in various aspects of construction and finishing.

Risk: Poor workmanship poses a range of risks, including compromised structural integrity, potential safety hazards, and a decreased lifespan of the structure. It may also lead to aesthetic and functional issues.

Resolution: A qualified contractor or construction professional should be consulted to assess and address the poor workmanship. They can implement corrective measures to ensure structural soundness, safety, and overall quality of the construction.

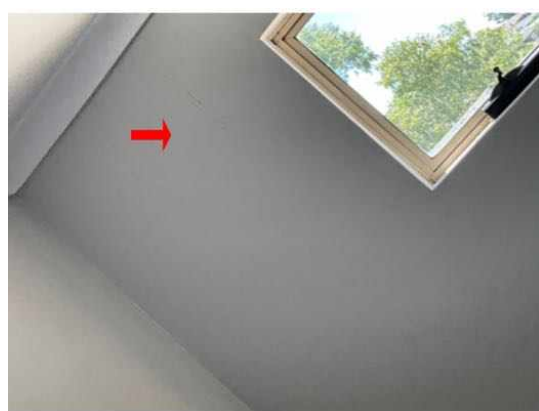
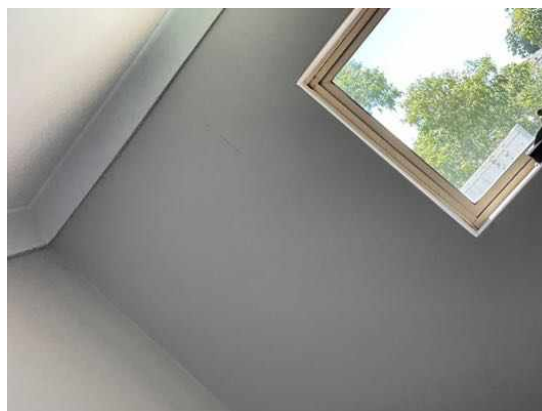
Building: Main Building
 Location: Stairs - Internal
 Finding: Brickwork - Cracking [Fine]
 Information: Although fine cracks are quite noticeable, they are often only considered to be an appearance defect and usually do not indicate any structural damage. Generally, the cause of a fine crack is indicative of a separation between brickwork and mortar throughout the structure, but single bricks may also show cracks of this nature.

Cracking of this nature can generally be repaired with minor filling and should be conducted by a qualified bricklayer.

Always contact a building inspector should cracks widen lengthen or become more numerous.

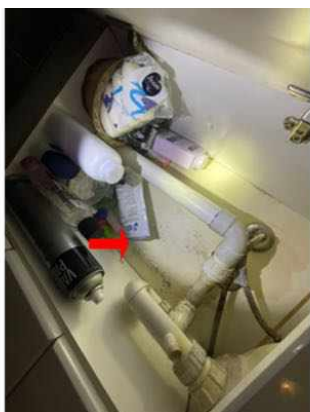
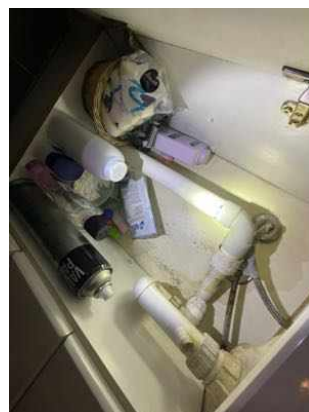
Finding 3.10

Building: Main Building
 Location: Bathroom upstairs
 Finding: Water damage / Vanity
 Information: "The vanity in the shower area has sustained water damage, resulting in swelling and discoloration of the wood, as well as potential structural issues. This damage compromises both the aesthetic and functional aspects of the vanity."

1. ****Carpenter or Woodworker:**** They can assess and repair the damage to the vanity, potentially replacing any irreparable parts.
2. ****Plumber:**** If the water damage is due to plumbing issues, a plumber can fix leaks and ensure there are no further water-related problems.
3. ****General Contractor:**** If the damage is extensive and affects the surrounding area, a general contractor can coordinate the repair work, including both the vanity and any related structural or cosmetic repairs.

Make sure to obtain quotes from these professionals to determine the most cost-effective and efficient solution for your specific situation.

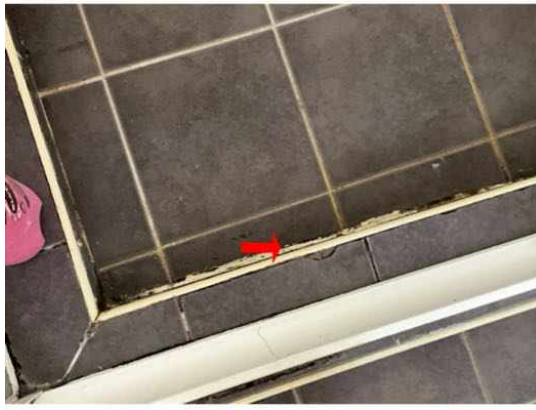
Finding 3.11

Building:	Main Building
Location:	Bathroom upstairs
Finding:	Tiles - Cracked or damaged
Information:	Cracking was evident to the tiling in this area at the time of inspection. While the cracking appears to be minor, this area is frequently exposed to water, allowing potential for water penetration into adjoining sections of walls or flooring.

If left unmanaged, water penetration to these areas may lead to subsequent water damage, which is likely necessitate repair work to affected building elements.

A tiling contractor should be appointed to ensure that no further water damage occurs. The re-application of silicone and grouting throughout remaining tile work is also advised, to further protect the area against water penetration.

Where water penetration has led to water damage, appointment of a relevant tradesperson may be required to repair damaged building elements.

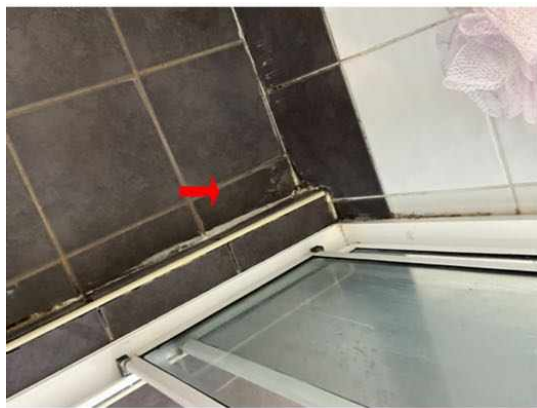
Finding 3.12

Building:	Main Building
Location:	Bathroom upstairs
Finding:	Sealant and grouting - Missing or damaged
Information:	It was noted on inspection that sealant or grout is degraded to the tiled shower alcove and or other areas of the bathroom.

Different materials and floor areas move at different rates, generally causing cracking to grout or sealant at this point. A flexible sealant is required to allow for expected expansion and contraction, while keeping the joint water tight and protective of all associated building materials.

There appears to be excessive mould to the sealant and grout which will likely require scraping out and replacement.

Flexible and mould resistant materials should be applied to affected areas to prevent any subsequent water damage that is likely to occur. Regular maintenance and replacement of damage or missing or damaged sealant and grout is highly recommended to the wet areas, as this is a regular wear and tear defect. Sealant and grouting in areas that come into regular contact with water should be maintained for the long term care of your property.

A sealant specialist or tiling contractor should be appointed to complete these works as soon as possible

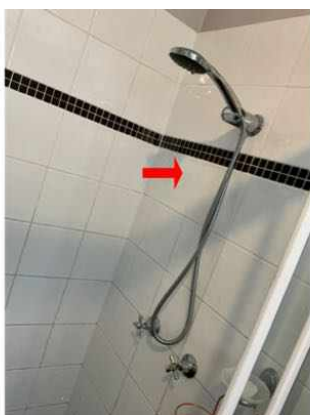
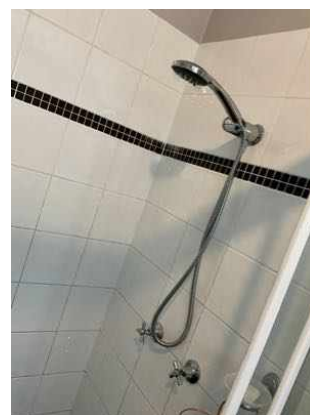
Finding 3.13

Building: Main Building
 Location: Bathroom upstairs
 Finding: Water Hammer in Plumbing Fitting
 Information: Water hammering noise was detected when operating the plumbing fixture, suggesting a sudden pressure surge within the pipework.

- May lead to long-term damage of internal plumbing components.
- Can cause wear and tear at joints and fittings.
- Potential for leaks or water damage if left unresolved.

A licensed plumber should be engaged to investigate and rectify the issue. Solutions may include installing water hammer arrestors, securing pipework, or adjusting water pressure.

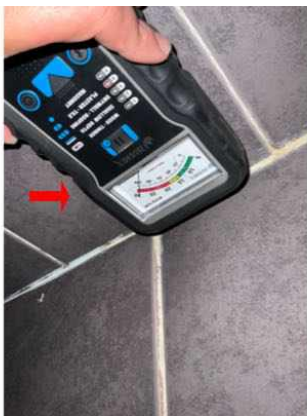
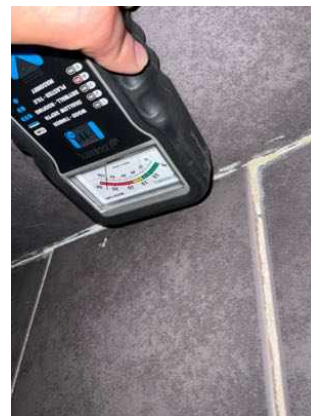
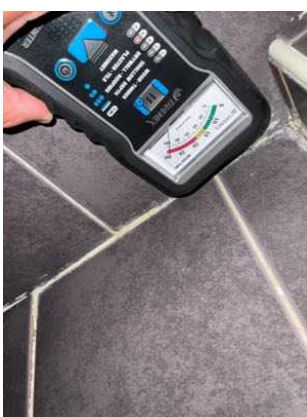
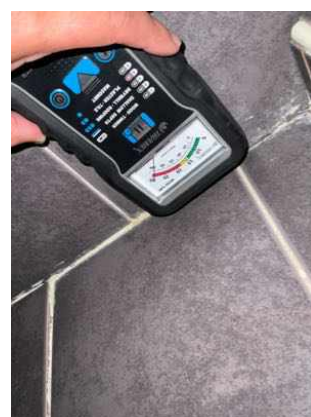
Building:	Main Building
Location:	Bathroom
Finding:	Excessive moisture - Conducive to Timber pest
Information:	Excessive moisture can attract termites and produce conditions that promote fungal growth and wood decay.

Excessive moisture is generally caused by deteriorated inadequate or missing roof drainage leaking plumbing pipes or fixtures poorly plumbed HWS overflows or condenser units and poor site drainage.

If mould growth has been found there may be environmental biological or health issues involved. In these cases an appropriately qualified inspector should also be contacted.

Prior to any remedial works being performed a qualified plumber should be appointed to further inspect the property and to identify the cause of the excessive moisture. Works to remove affected building elements may then be necessary and should be performed by an appropriate tradesperson.

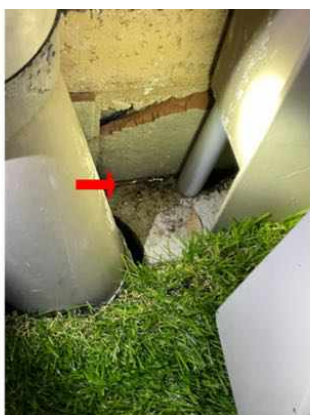
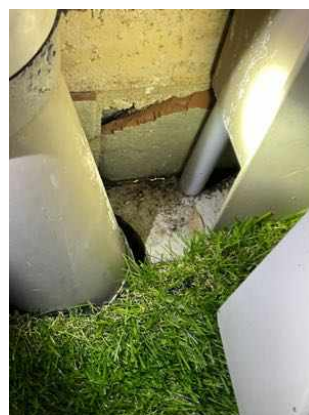
Finding 6.02

Building:	Main Building
Location:	Balcony

Finding: Aircon - Excessive moisture conducive condition near Air-conditioner
Information: Excessive moisture near an air conditioner can indeed create conducive conditions for termites. Termites are attracted to damp and decaying wood, which can be found in areas with high moisture levels. To fix this issue:

1. Fix Leaks: Check for any leaks or condensation around your air conditioning unit. Repair any damaged pipes, drains, or insulation

that may be causing moisture buildup.

2. Proper Drainage: Ensure that your air conditioner has proper drainage. Make sure the condensate drain line is clear and directed

away from your home's foundation.

3. Ventilation: Improve ventilation around the unit. Ensure that the area is well-ventilated to reduce humidity levels.

4. Regular Maintenance: Schedule regular maintenance for your air conditioning system. This can help prevent leaks and ensure

it's working efficiently, reducing the chance of moisture.

5. Please consult a HVAC Technician: HVAC (Heating, Ventilation, and Air Conditioning) technicians are trained to diagnose and

repair a wide range of air conditioning problems. They can handle issues with the cooling system, refrigerant, electrical components, and more.

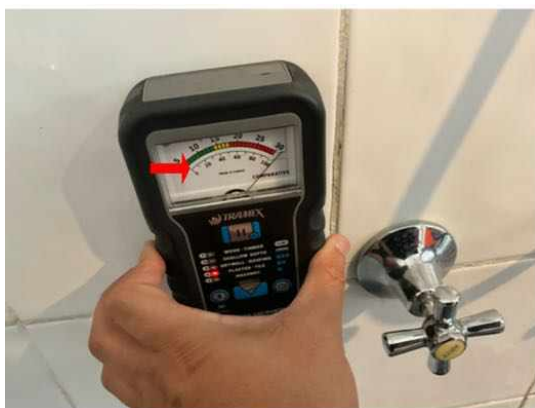
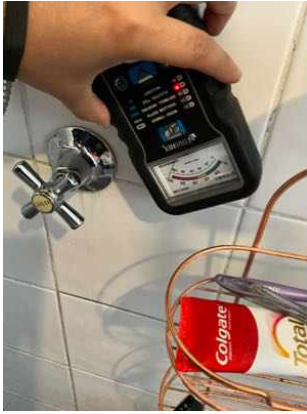
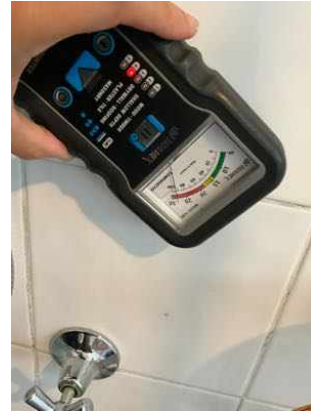
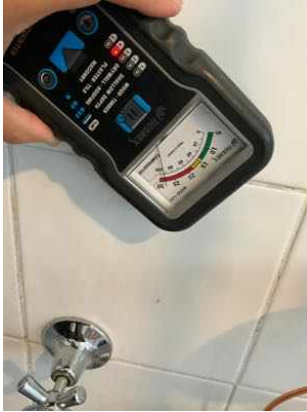
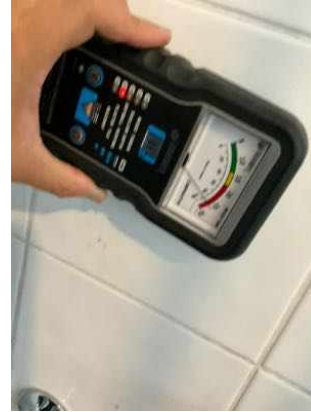
Finding 6.03

Building:	Main Building
Location:	Bathroom upstairs
Finding:	Excessive moisture - Conducive to Timber pest
Information:	Excessive moisture can attract termites and produce conditions that promote fungal growth and wood decay.

Excessive moisture is generally caused by deteriorated inadequate or missing roof drainage leaking plumbing pipes or fixtures poorly plumbed HWS overflows or condenser units and poor site drainage.

If mould growth has been found there may be environmental biological or health issues involved. In these cases an appropriately qualified inspector should also be contacted.

Prior to any remedial works being performed a qualified plumber should be appointed to further inspect the property and to identify the cause of the excessive moisture. Works to remove affected building elements may then be necessary and should be performed by an appropriate tradesperson.

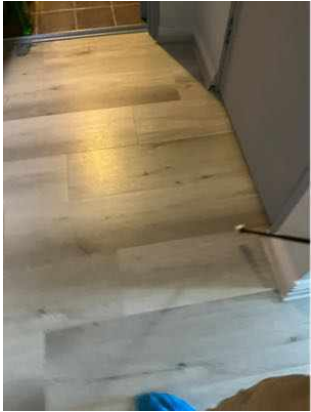
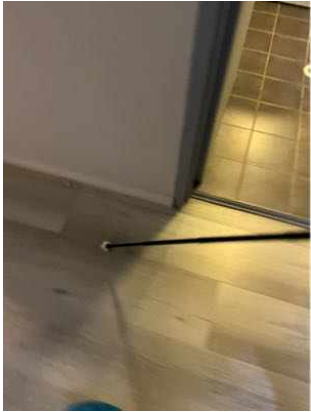
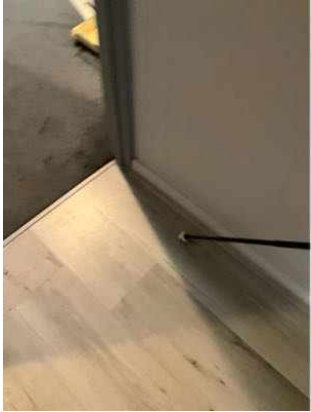
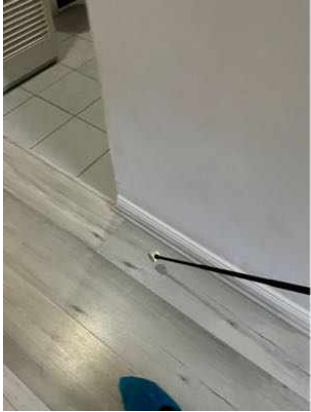
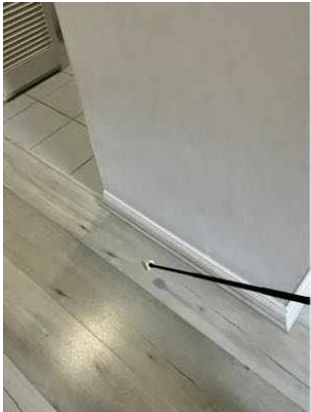
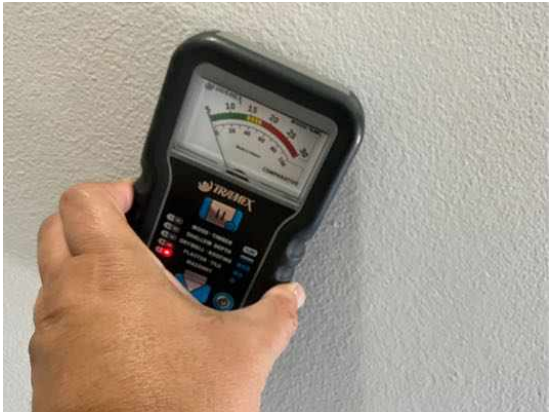
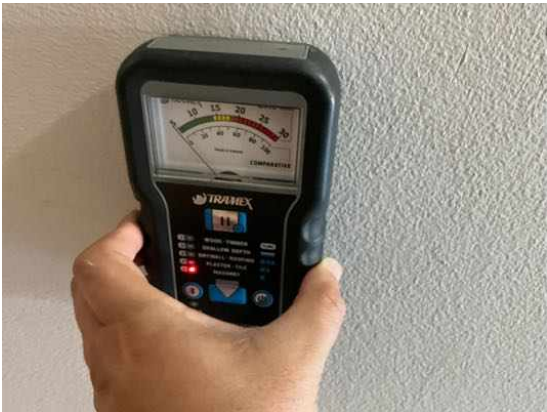
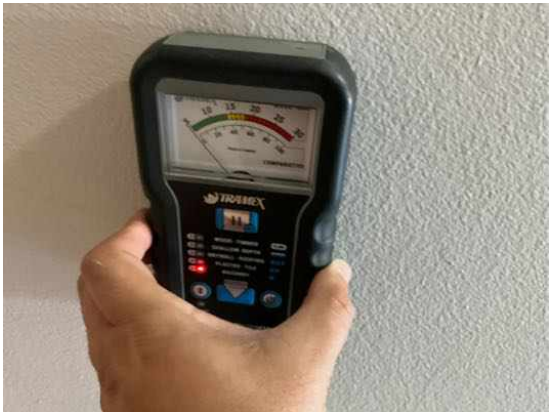
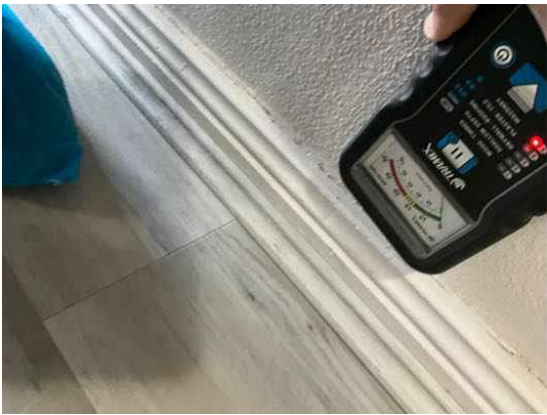
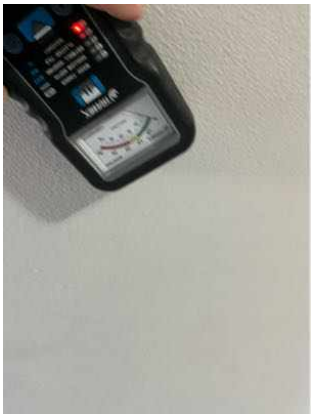
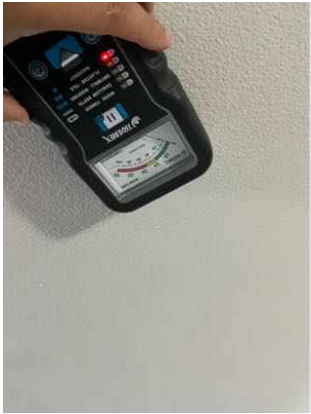
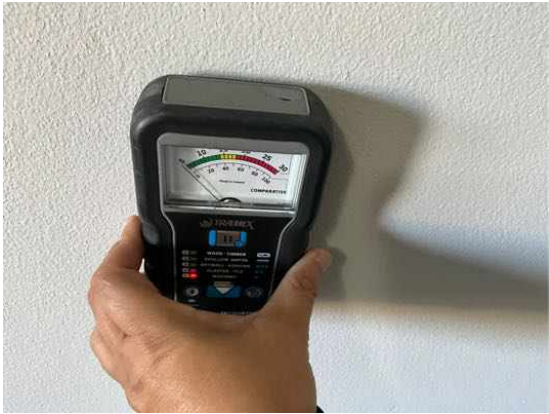
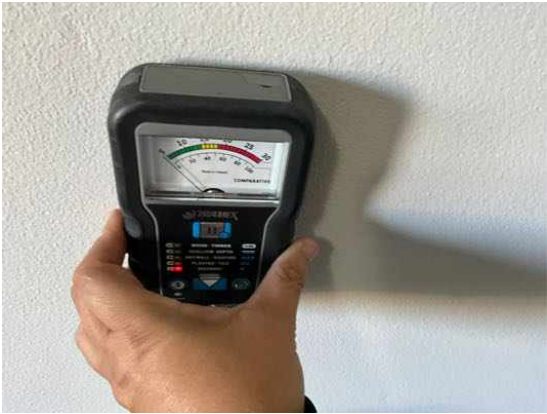
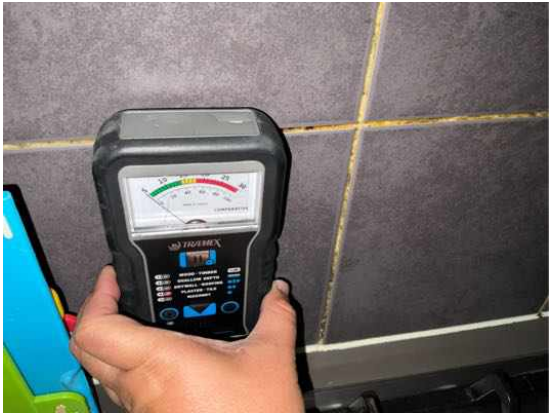
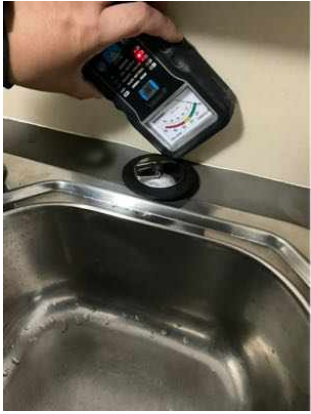
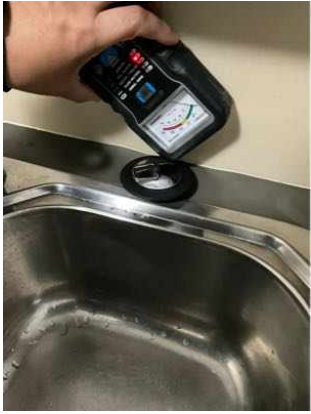
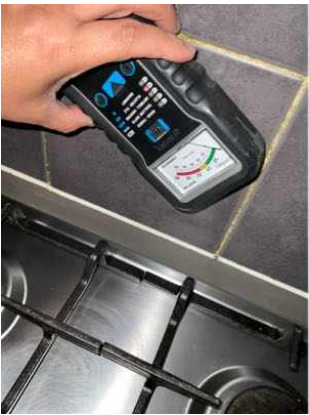
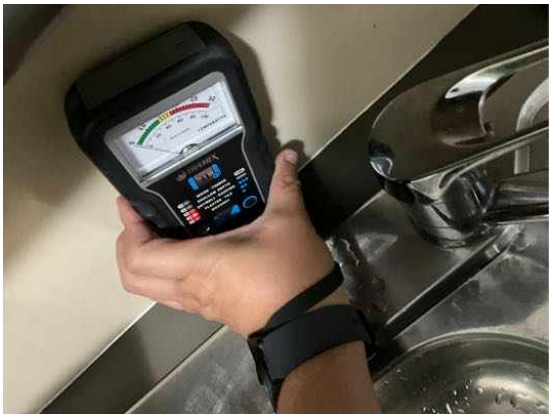
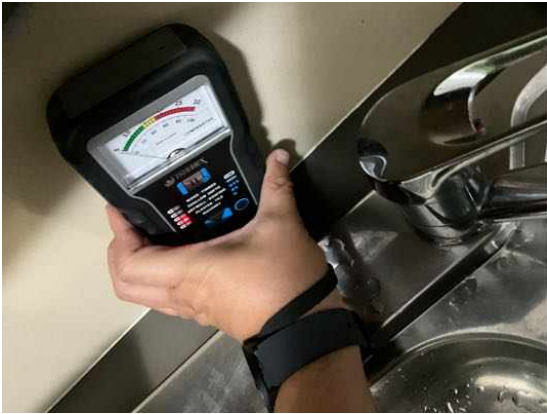
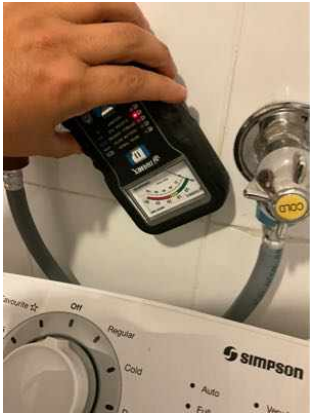
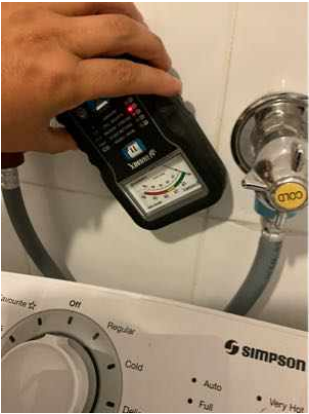
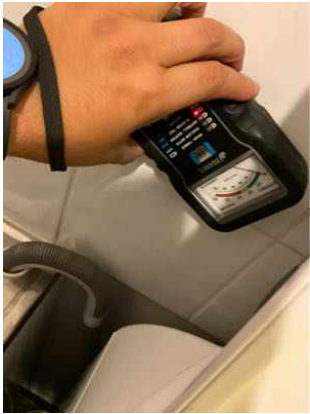
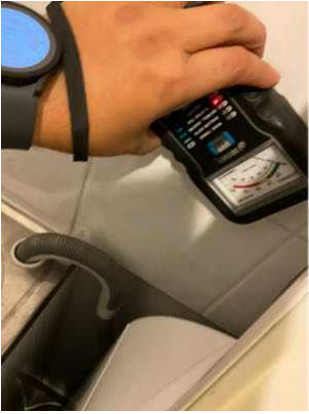
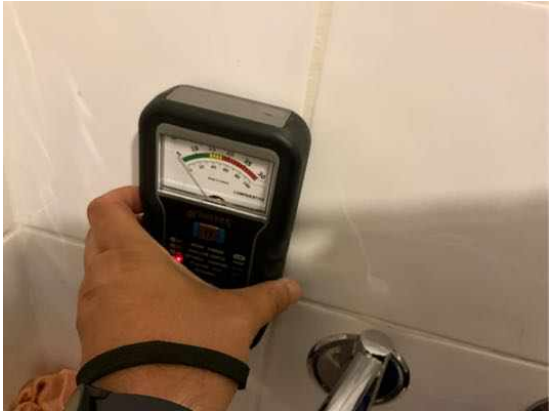
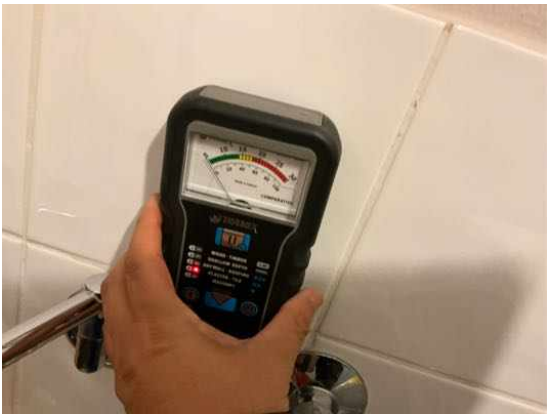
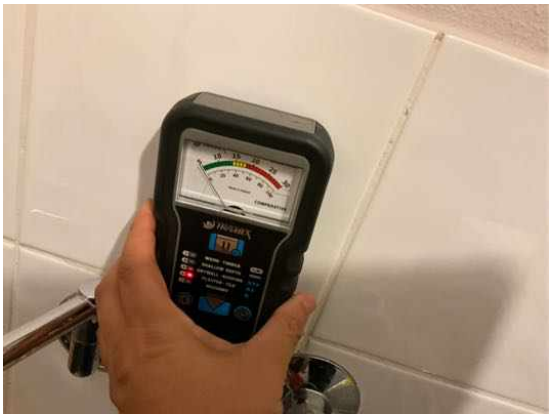
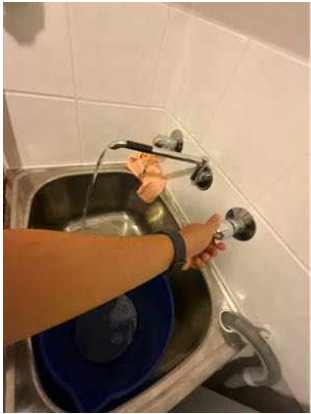
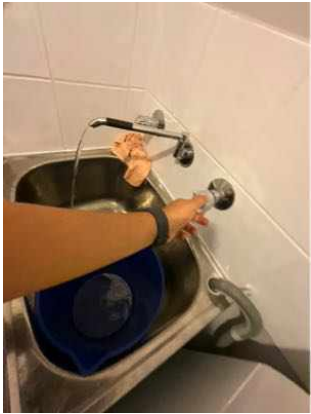
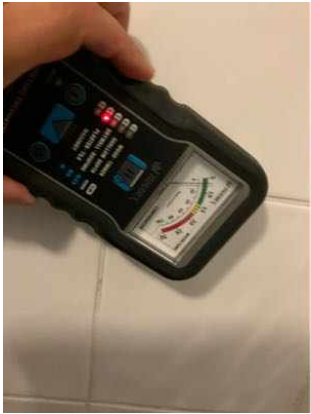
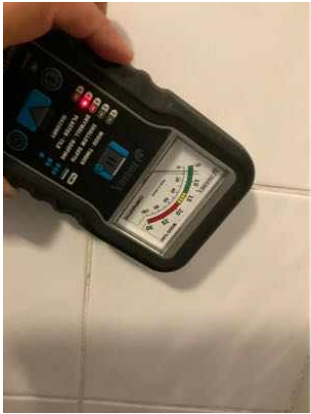
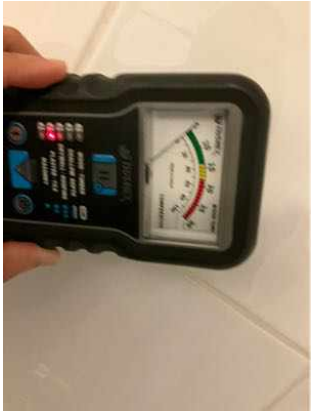
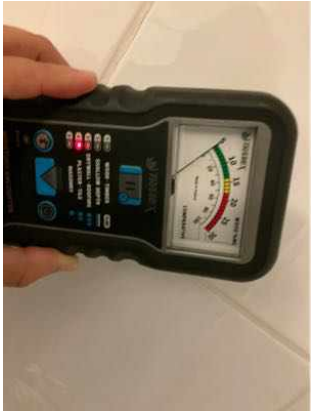
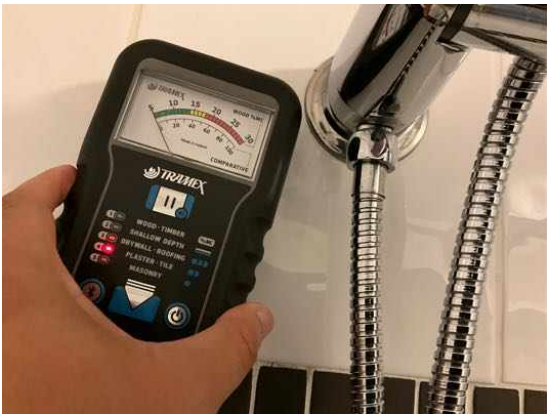
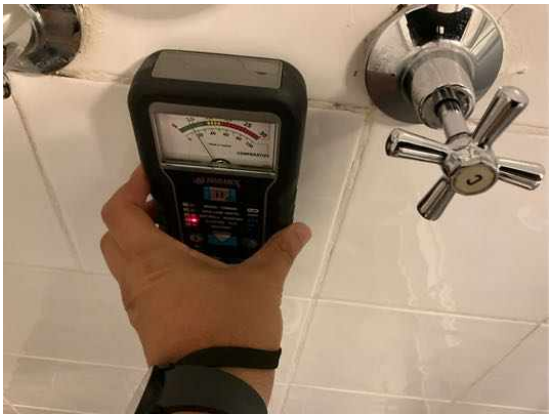
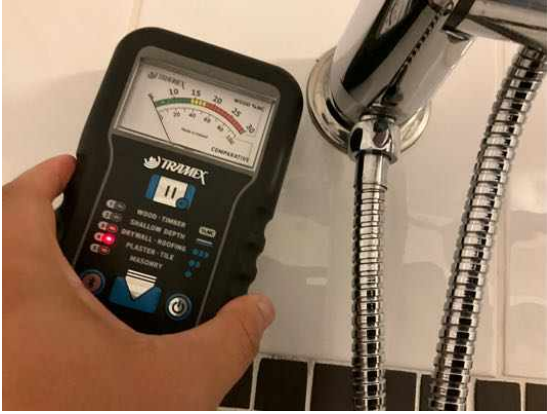
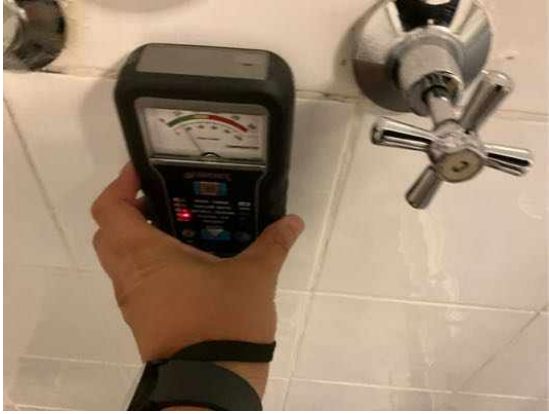
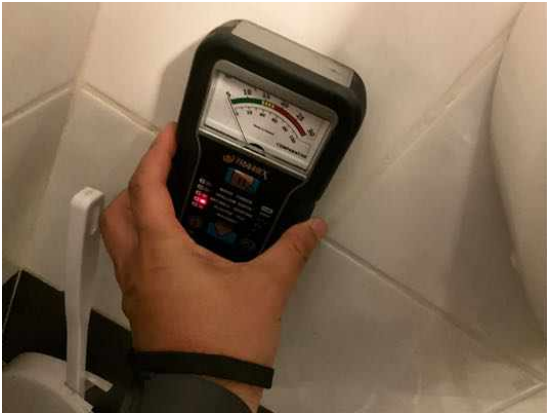
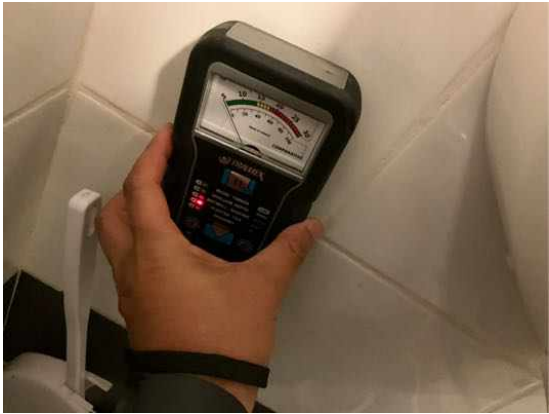
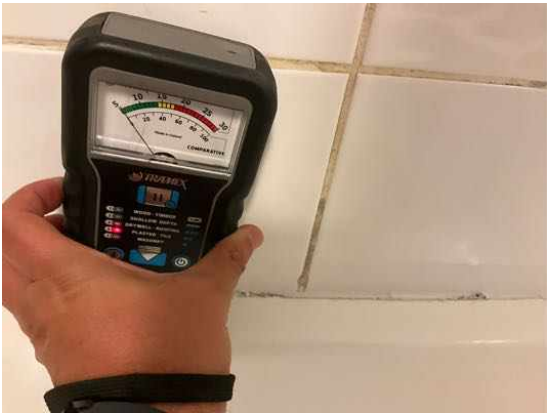
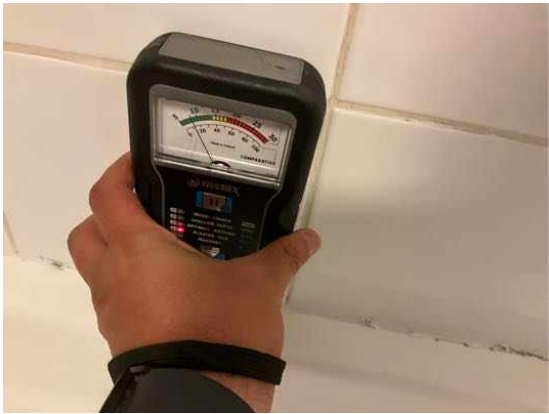
Building: Main Building
Location: All Areas
Finding: Additional Photos - Obstructions and Limitations
Information: These photographs are an indication of the obstructions and limitations which impeded full inspection of the property at the time of inspection. These obstructions can hide an array of defects and should be removed to allow full inspection to be carried out. A re-inspection is recommended once the areas are made accessible.
