Building and Timber Pest Inspection Report

Inspection Date: Thu, 5 Feb 2026

Property Address: 12/2 Hythe St, Mount Druitt NSW 2770,
Australia

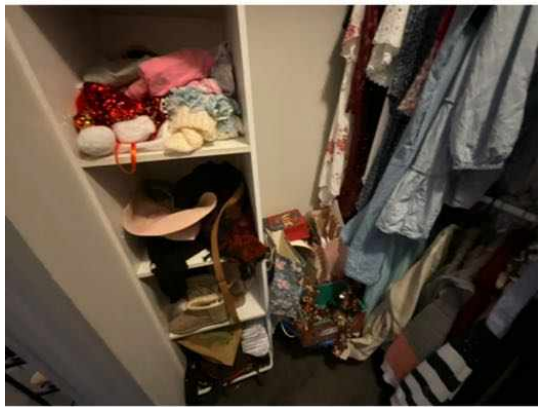
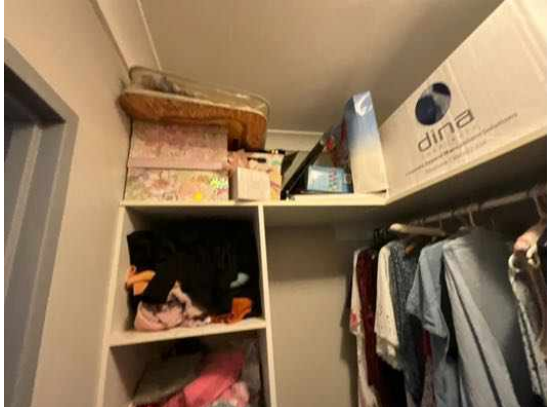
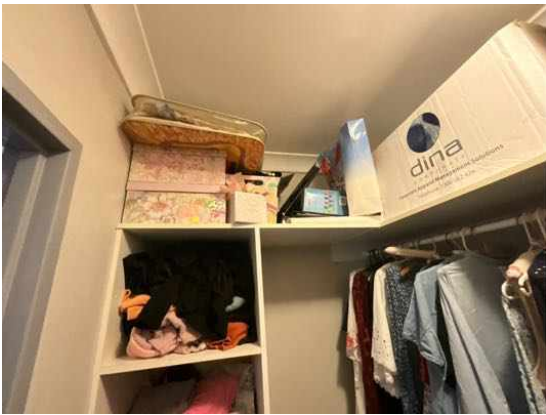
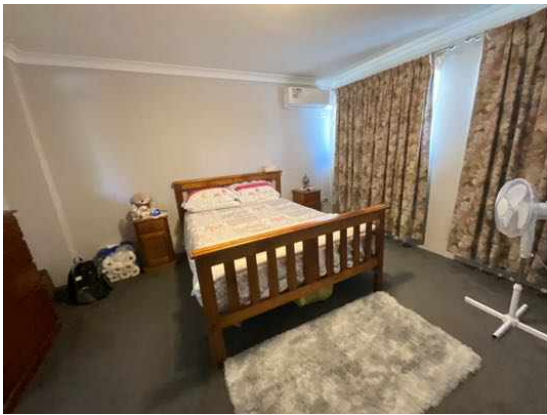
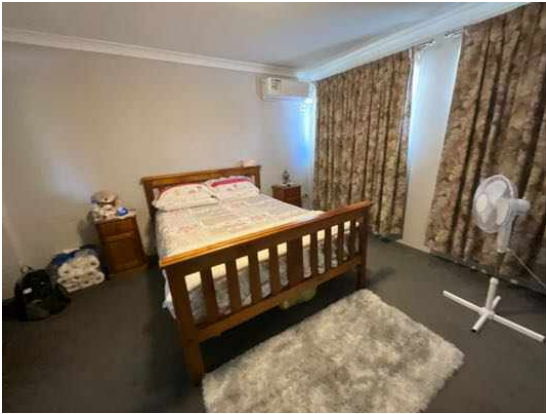
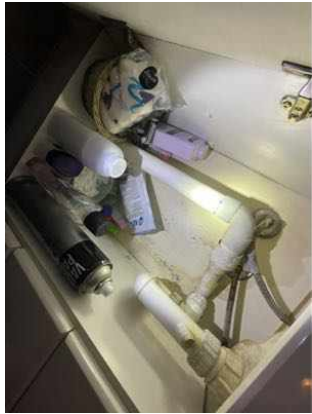
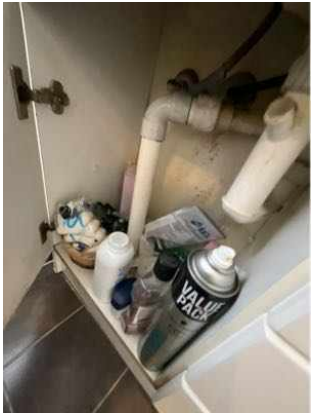
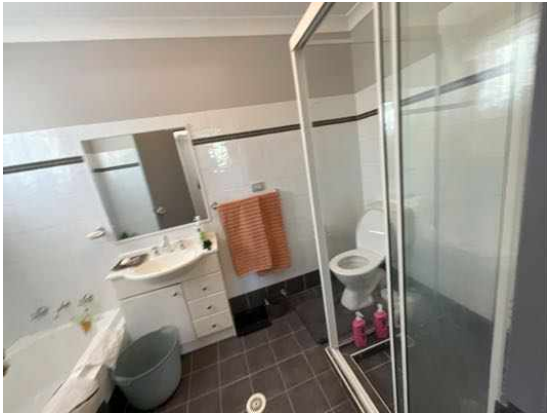
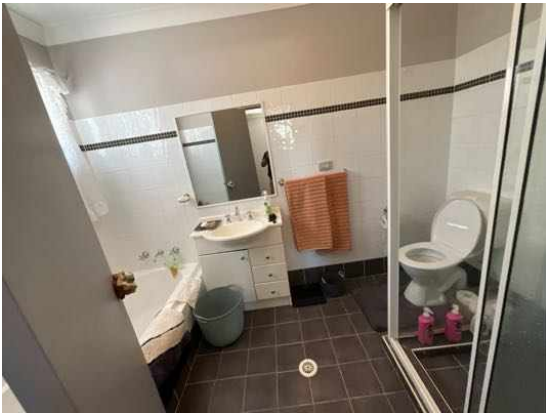
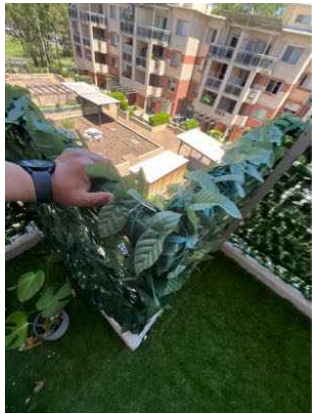
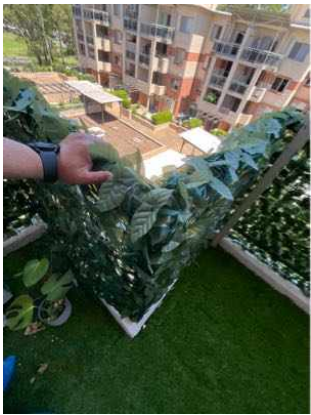
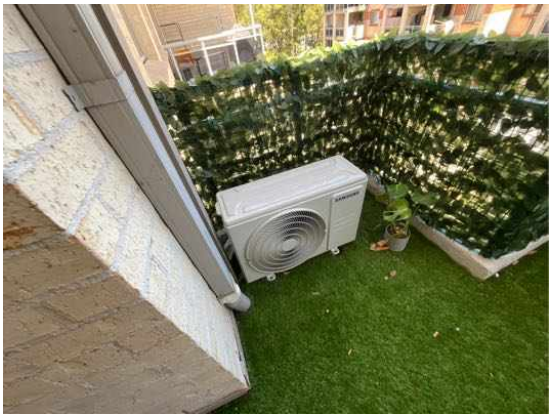
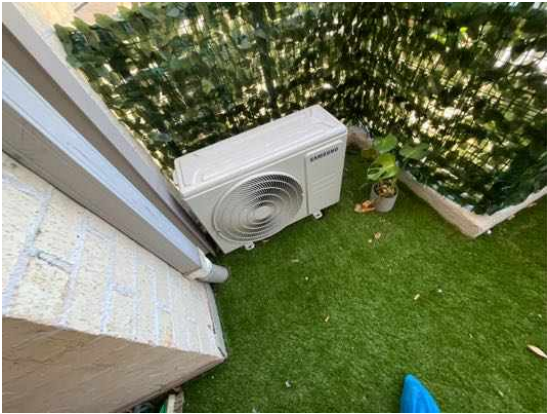
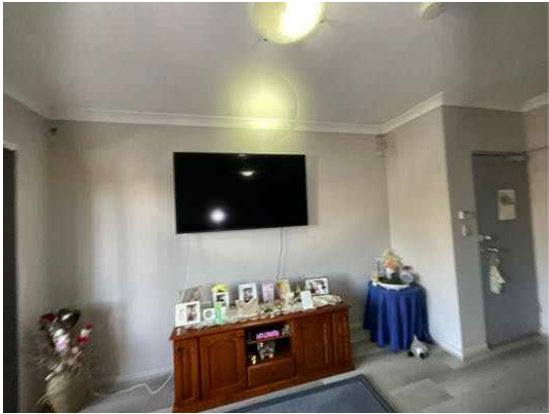
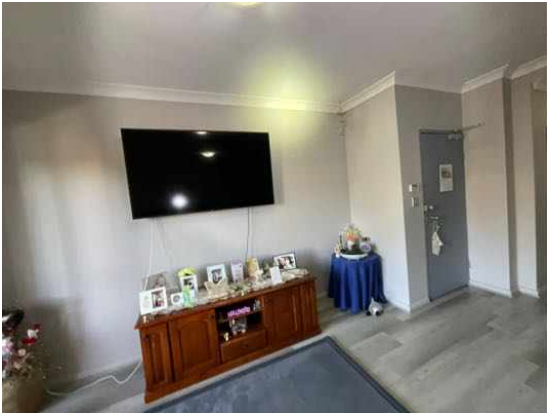
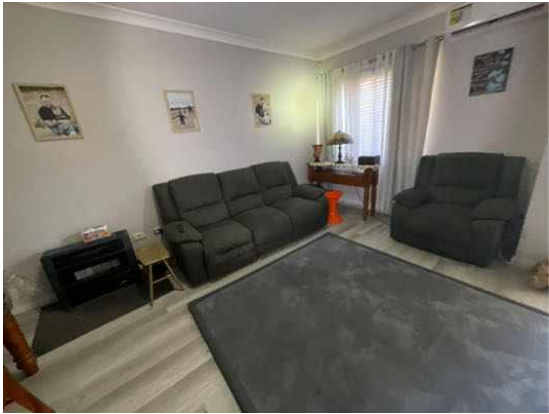
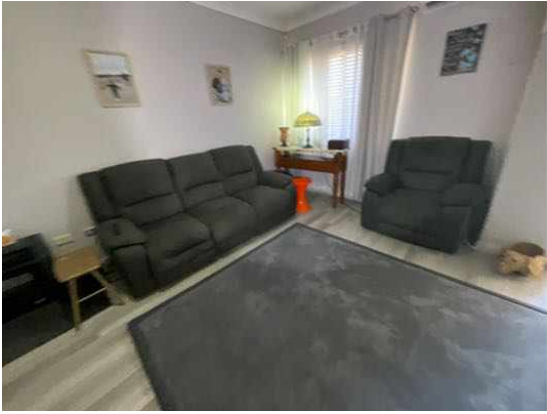
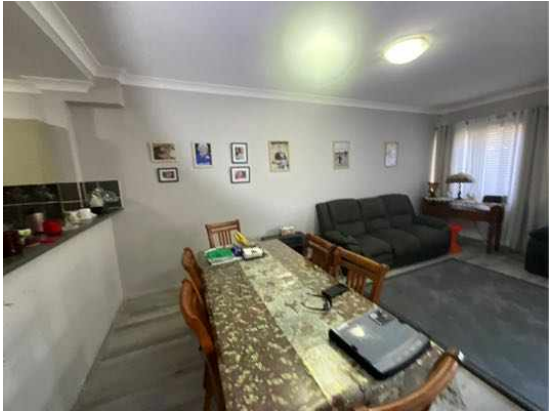
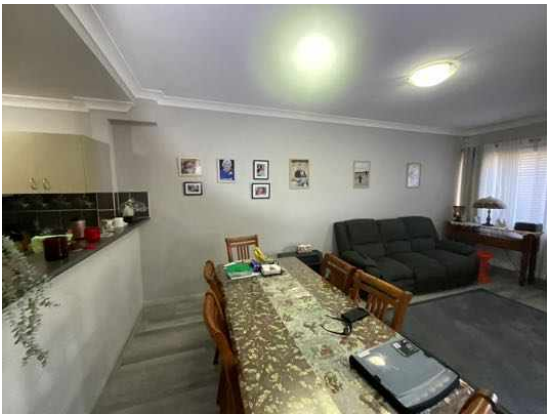
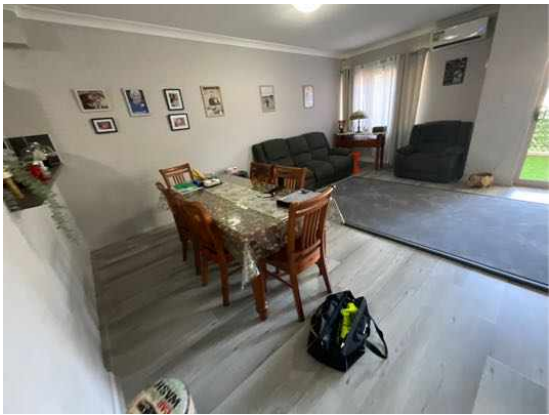
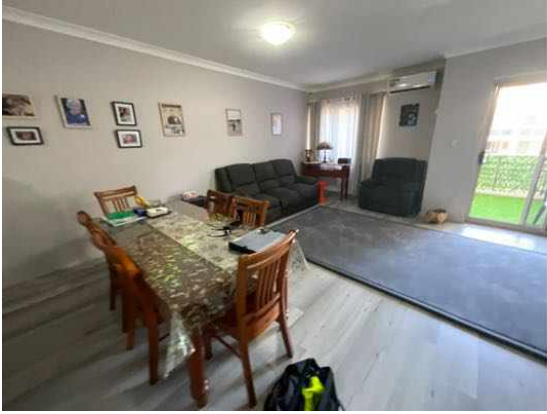
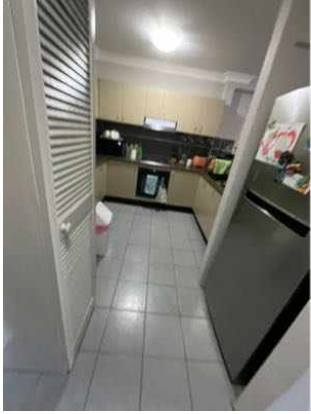
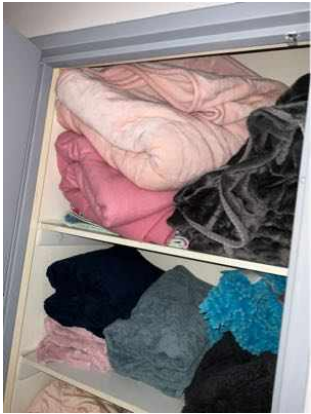
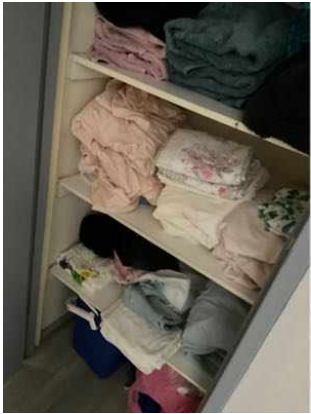
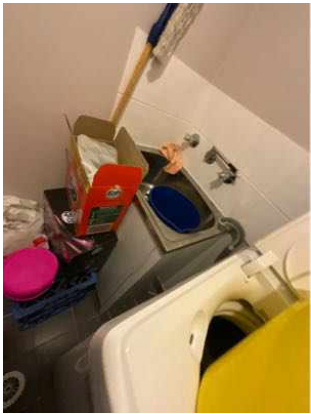
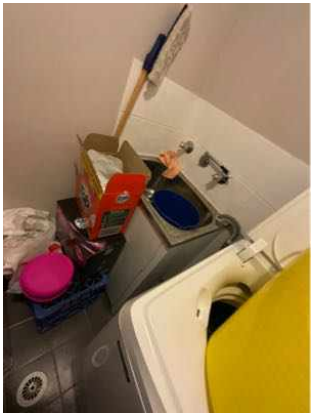
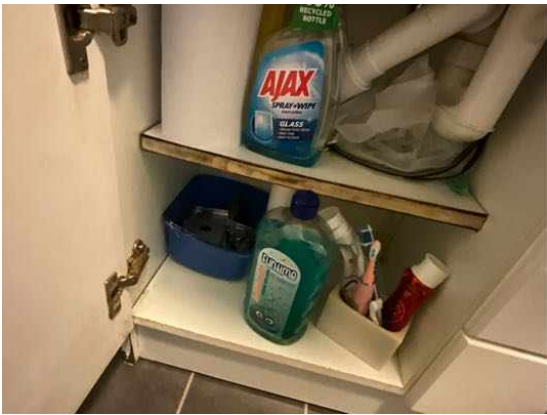
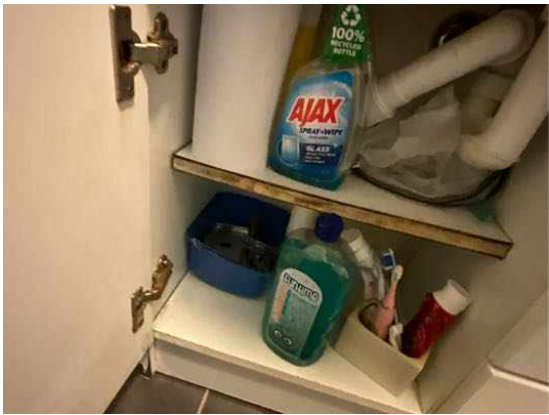
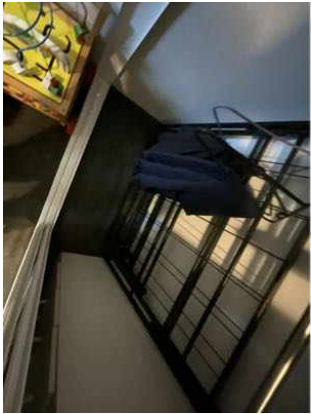
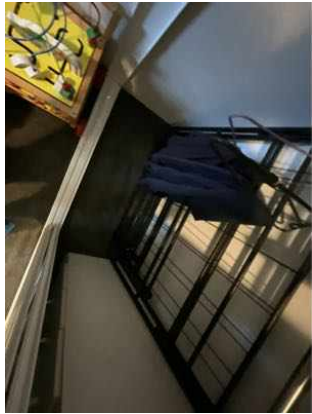
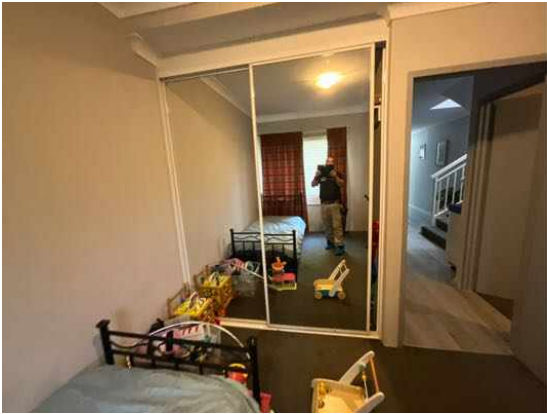
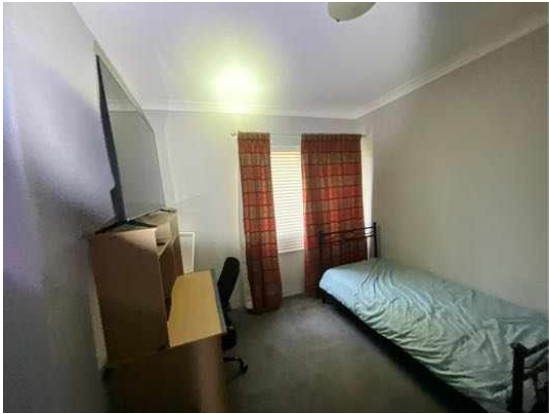
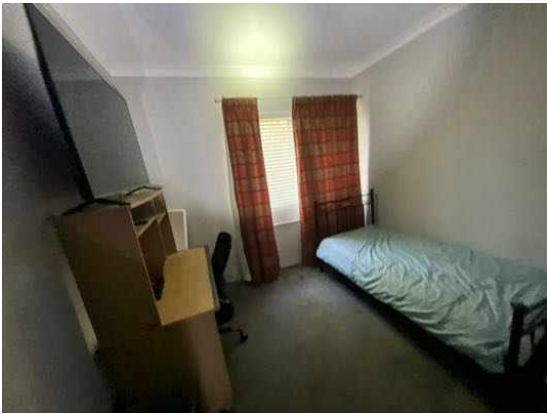
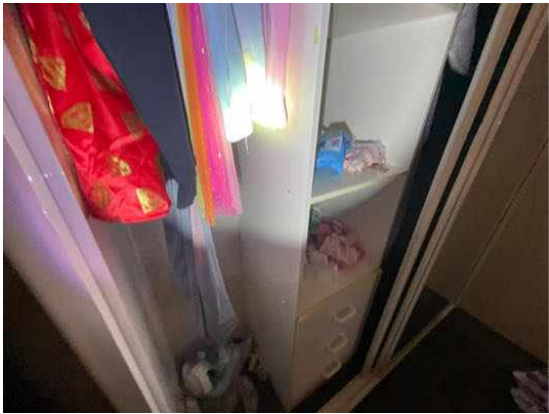
Noted Item

Building: Main Building
Location: All Areas
Finding: Additional Photos - Obstructions and Limitations
Information: These photographs are an indication of the obstructions and limitations which impeded full inspection of the property at the time of inspection. These obstructions can hide an array of defects and should be removed to allow full inspection to be carried out. A re-inspection is recommended once the areas are made accessible.
