Building and Timber Pest Inspection Report

Inspection Date: Fri, 23 Jan 2026

Property Address: 13/12a russel St, Strathfield NSW 2135,
Australia

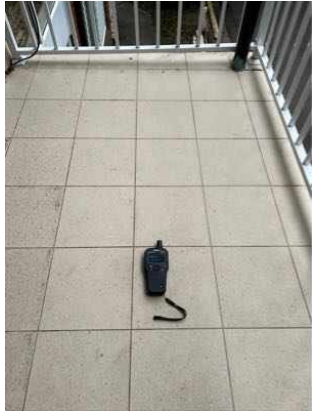
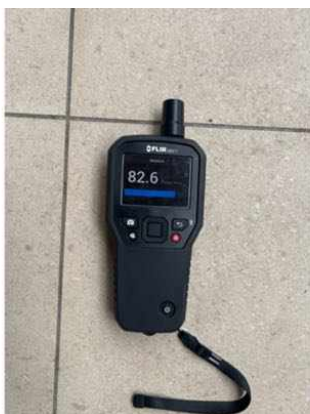
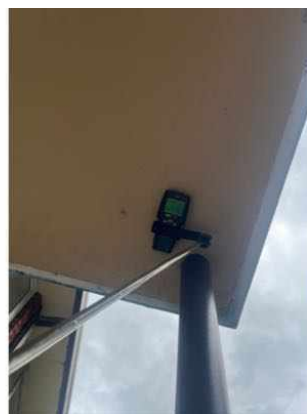
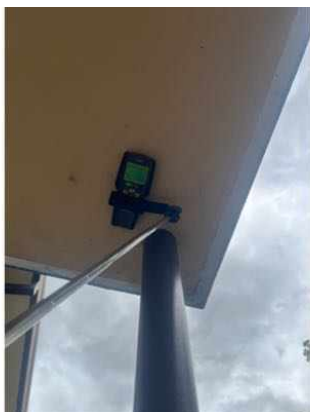
Finding 3.02

Building:	Main Building
Location:	Balcony
Finding:	Balcony Elevated Moisture - Strata
Information:	Elevated moisture was recorded at the base of the balcony above and tiles, with associated minor staining consistent with water exposure. While no internal damage was visible at the time of inspection, balconies in multi-unit dwellings are high-risk areas for waterproofing failure, which can lead to leaks into adjoining units and significant rectification costs. Further investigation by a licensed waterproofing contractor is strongly recommended.

Depending on the strata plan, this area may form part of the common property, in which case remedial responsibility may rest with the owners corporation (strata). Purchasers should seek clarification from the strata manager and legal adviser prior to purchase.

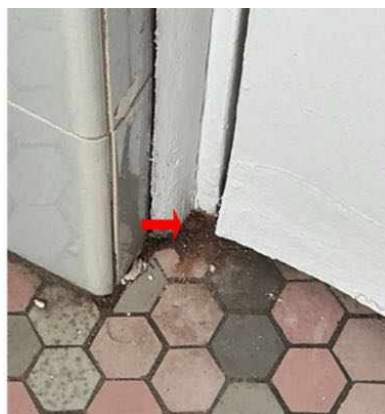
Finding 3.03

Building:	Main Building
Location:	All Internal Areas
Finding:	Wet-Area Door Jamb – Moisture Staining / Decay
Information:	Minor moisture staining and early signs of deterioration were observed at the base of the wet-area door jamb and architraves. This is commonly due to water splashing or moisture tracking from the bathroom floor into adjacent joinery. At the time of inspection, the condition appears superficial and non-structural, consistent with general wear typical of wet-area use.

It is recommended that the door junctions be resealed with a suitable moisture-resistant sealant and that ventilation and drainage within the bathroom be maintained to reduce further dampness. Where timber swelling or decay has progressed, localised repair or replacement using moisture-resistant materials (H3-treated or equivalent) should be undertaken.

For information only — further inspection by a licensed carpenter or waterproofing contractor is recommended to confirm the extent of deterioration and verify whether remedial sealing or minor replacement works are warranted.

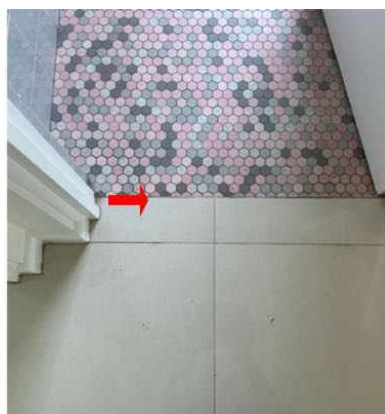
Finding 3.04

Information: The bathroom floor is at the same level as the adjoining timber flooring. This configuration is typical in modern apartments and is permitted where compliant waterproofing and floor falls are provided. No evidence of moisture damage was observed at the time of inspection; however, waterproofing performance cannot be confirmed without invasive inspection.

Care should be taken to avoid excessive water migration beyond the bathroom during use.

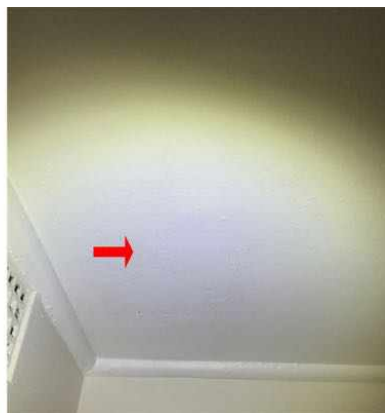
Finding 3.05

Finding: Water Staining - Humidity or Ventilation

Information: The ceiling surface shows peeling paint and water staining on the walls faint commonly consistent with humidity-related staining, often found in bathroom or wet areas with insufficient ventilation. While there is no visible sagging or major water damage, the pattern suggests prolonged moisture exposure, possibly due to steam

accumulation or minor condensation issues. According to AS 4349.1–2007 (Appendix C), this would be classified as a minor defect unless further deterioration or active leaks are found. Recommend improving mechanical or natural ventilation, cleaning the surface with mould treatment, and monitoring for recurrence.

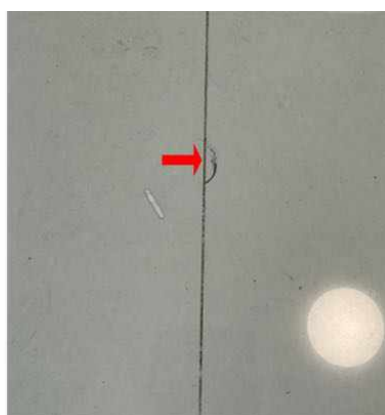
Finding 3.06

Building: Main Building
 Location: All Internal Areas - Kitchen, bedroom left
 Finding: Tiles - Cracked or damaged to some areas
 Information: Cracking was evident to the tiling in this area at the time of inspection. While the cracking appears to be minor, this area is frequently exposed to water, allowing potential for water penetration into adjoining sections of walls or flooring.

If left unmanaged, water penetration to these areas may lead to subsequent water damage, which is likely necessitate repair work to affected building elements.

A tiling contractor should be appointed to ensure that no further water damage occurs. The re-application of silicone and grouting throughout remaining tile work is also advised, to further protect the area against water penetration.

Where water penetration has led to water damage, appointment of a relevant tradesperson may be required to repair damaged building elements.

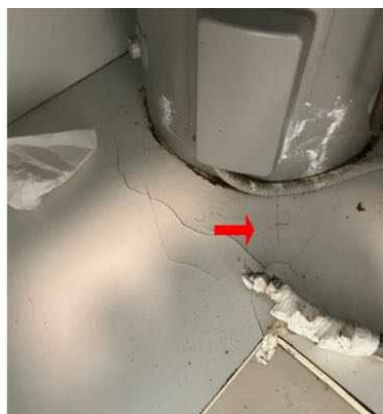
Finding 3.10

Building:	Main Building
Location:	All Internal Areas
Finding:	Paint finish and hairline cracking
Information:	The paint finish in this area was identified as being incomplete at the time of inspection including some hairline minor cracking.

Whilst incomplete or missing paint finish is generally an appearance defect, it can also lead to the development of secondary building defects over time. Incomplete areas of paint finish expose the area to moisture, potentially accelerating the deterioration of underlying building materials.

Incomplete paint finishes should be sanded back, filled, leveled and painted, as applicable. Where inadequate or missing paint protection has led to the deterioration of the associated building element, repair and/or replacement of this building element may be required.

A painting contractor should be appointed as soon as possible to perform necessary works to aid the appearance of the affected area and to ensure the area is protected

against further deterioration. Alternatively, the homeowner following manufacturer instructions may perform these works.

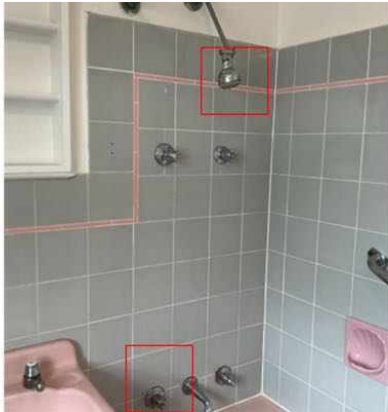
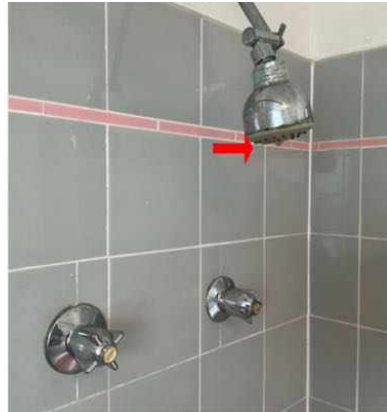
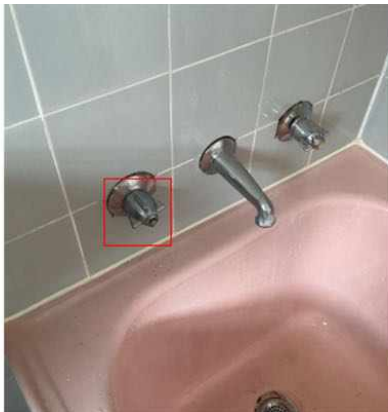
Building:	Main Building
Location:	Bathroom
Finding:	Water leak - External - Shower head and tap in tub not working
Information:	Water leaks were found to be present to exterior plumbing work. Leaks are generally caused by deterioration of the plumbing elements over time, due to exposure to

weather conditions, but may have also been caused by minor impact damage.

Such leaking creates damp conditions in the affected area, causing potential for water pooling and subsequent water damage if left unattended. These conditions may also attract termite attack, particularly if the area is subject to minimal levels of sun throughout daylight hours.

It is highly advised that a licensed plumber be appointed to rectify any water leaks that may be present. Areas of repair and replacement of plumbing fittings and fixtures may be required and, as such, a quotation should be sought.

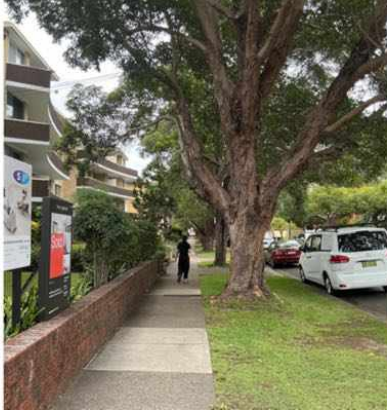
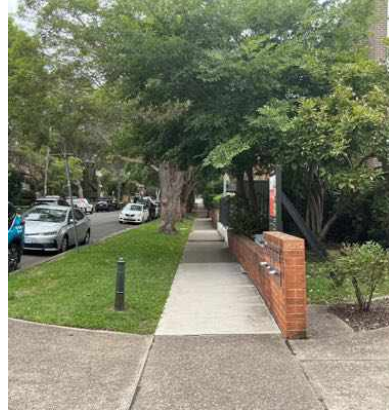
Finding 6.01

Building: Main Building
Location: All External Areas
Finding: Trees within 50m
Information: Trees within 50m of the property can be conducive to termite activity. It is recommended an invasive inspection of all trees with 50m to the property be carried out by a qualified pest control expert.

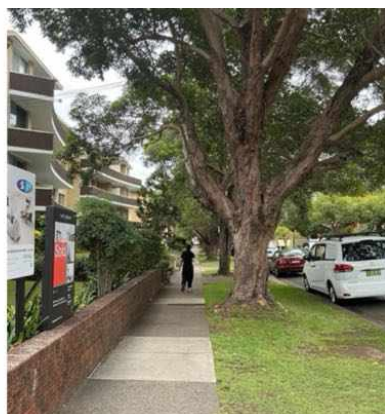
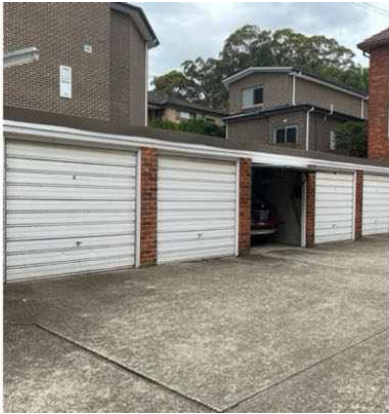
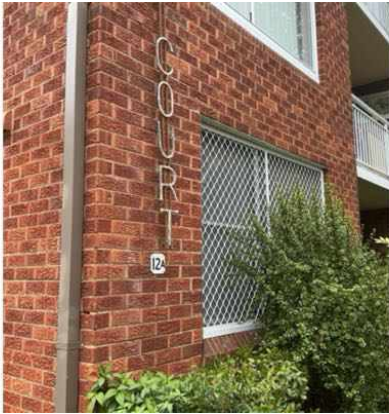
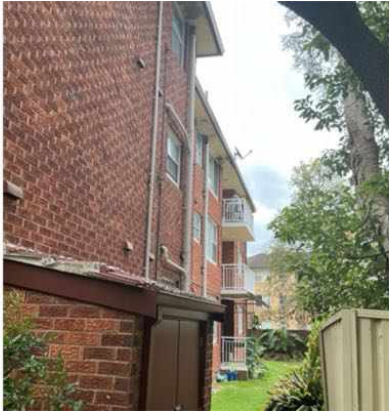
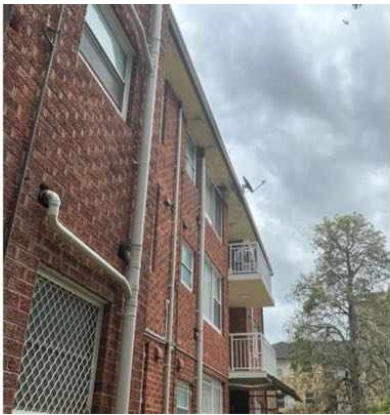
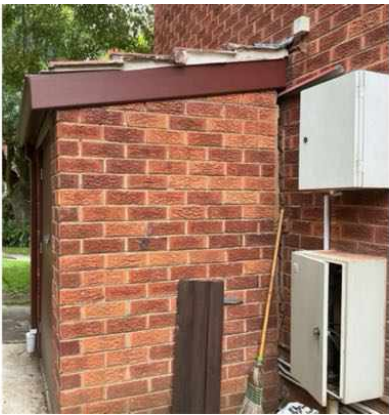
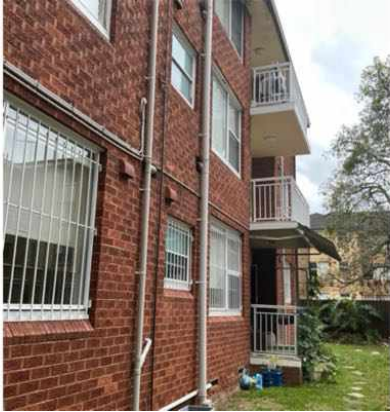
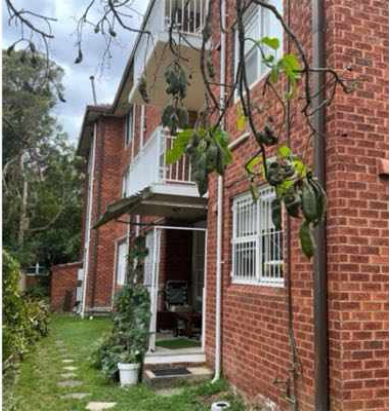
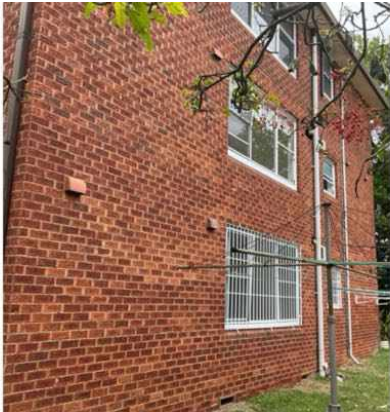
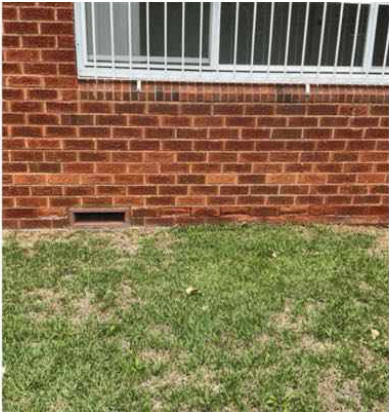
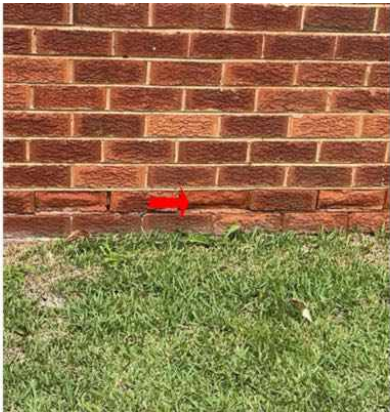
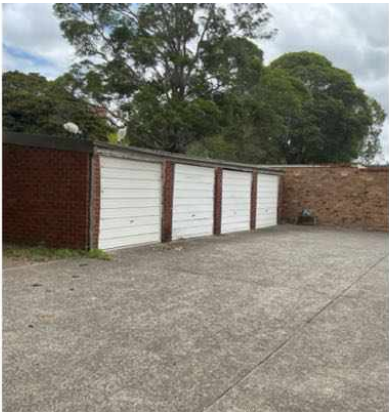
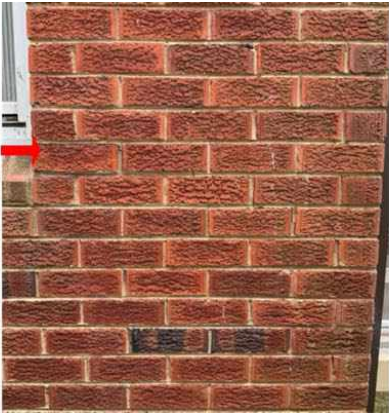
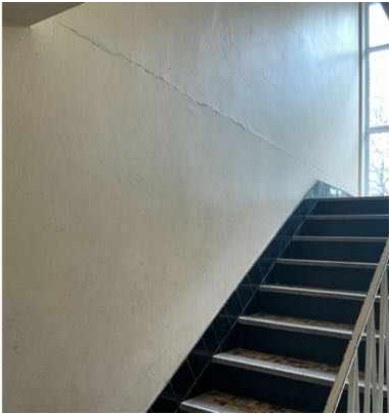
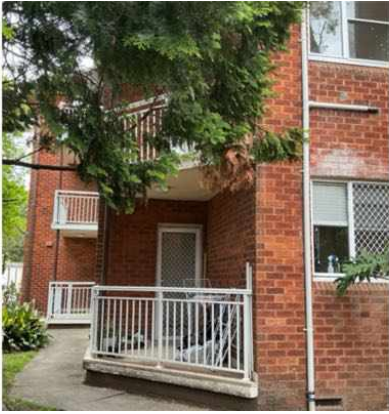
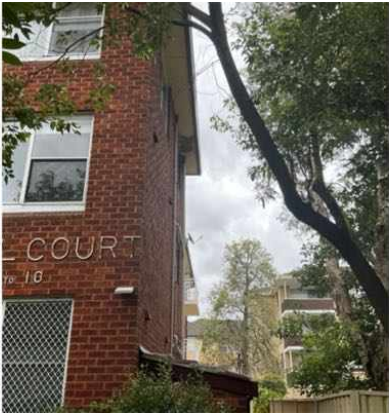
Building: Main Building
Location: All External Areas
Finding: Additional Photos - Obstructions and Limitations
Information: These photographs are an indication of the obstructions and limitations which impeded full inspection of the property at the time of inspection. These obstructions can hide an array of defects and should be removed to allow full inspection to be carried out. A re-inspection is recommended once the areas are made accessible.

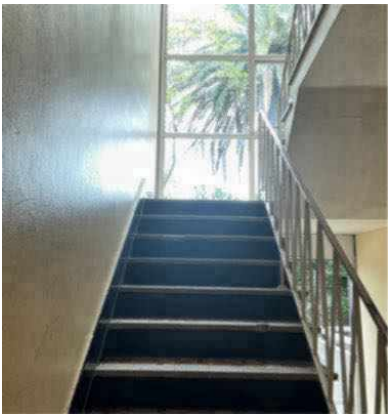
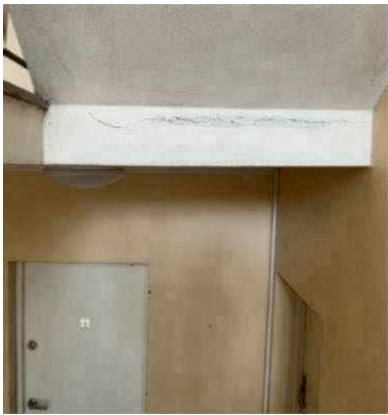
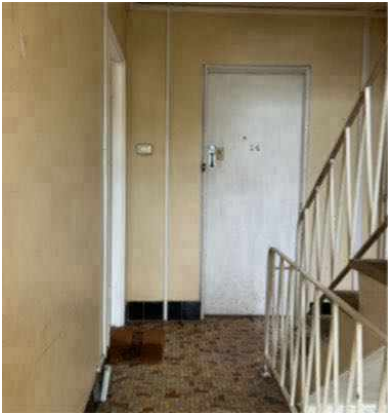
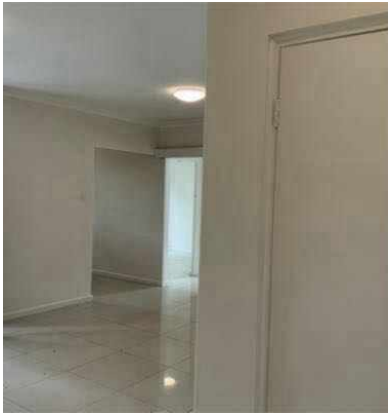
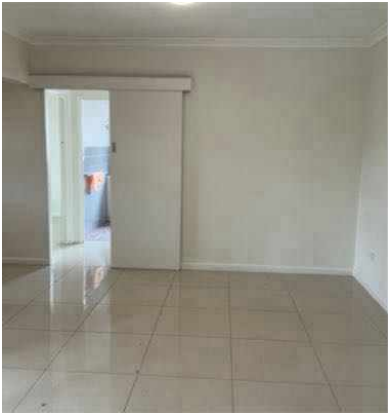
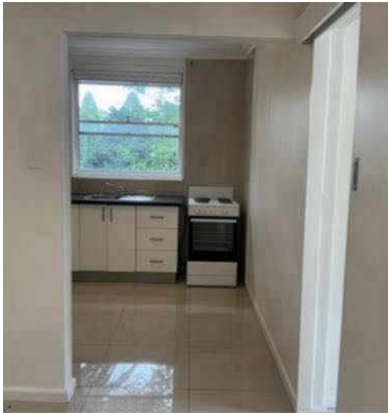
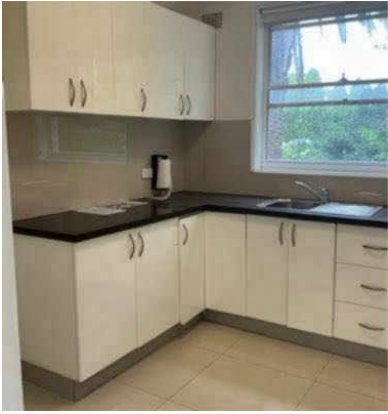
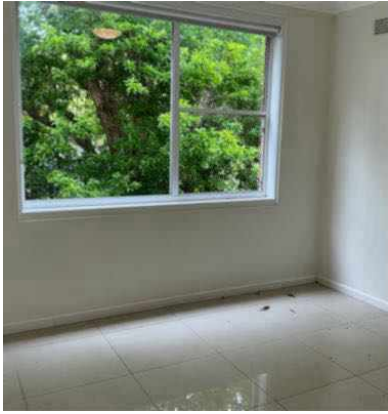
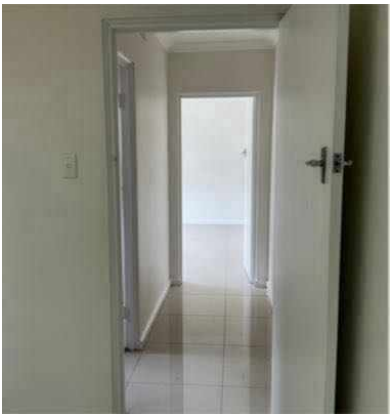
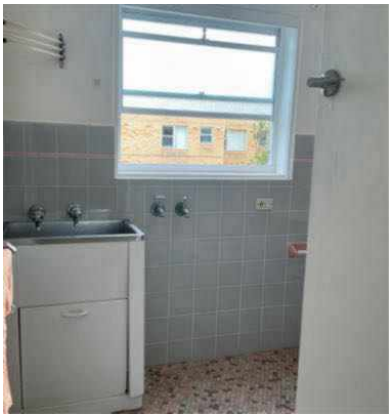
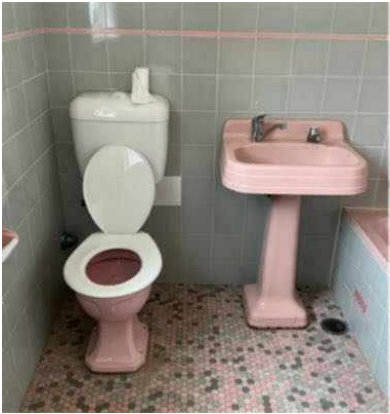
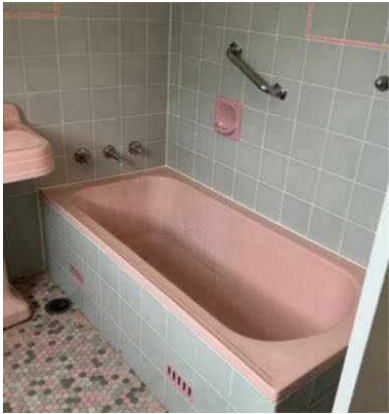
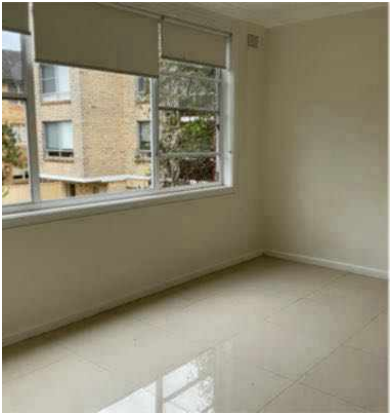
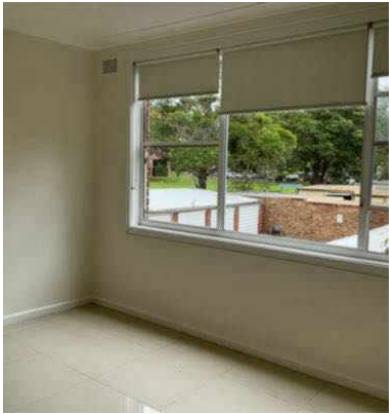
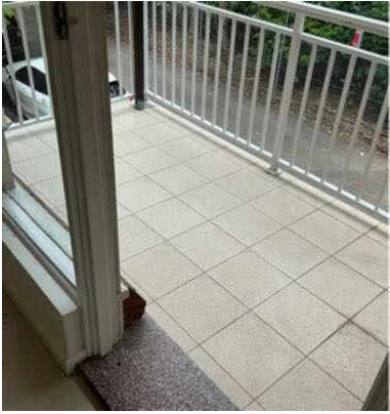
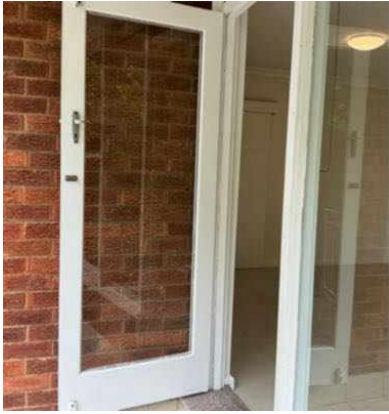
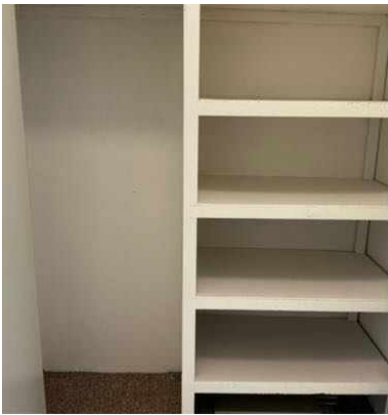
Building: Main Building
Location: All Internal Areas
Finding: Additional Photos - Obstructions and Limitations
Information: These photographs are an indication of the obstructions and limitations which impeded full inspection of the property at the time of inspection. These obstructions can hide an array of defects and should be removed to allow full inspection to be carried out. A re-inspection is recommended once the areas are made accessible.
