Building and Timber Pest Inspection Report

Inspection Date: Fri, 13 Mar 2026

Property Address: 3 Seaforth St, Bomaderry NSW 2541,
Australia

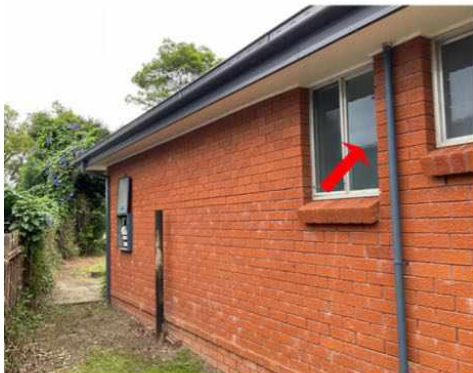
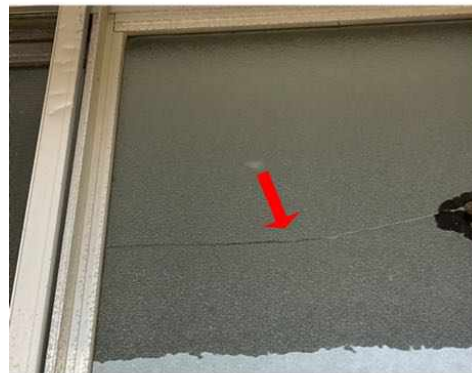
Building:	Building 1
Location:	Exterior walls - right side
Finding:	Window - Cracked
Information:	Cracks were identified in the window in this area. Cracking in windows is generally the result of impact damage, and is likely to develop further when left unmanaged.

The likelihood of this windowpane further cracking and shattering is increased exponentially, providing a safety hazard in the area. The cracked window also impairs the weather tightness of the building, creating potential for minor water leaks.

A qualified glazier is required to repair the window as soon as possible. Depending on the extent of the cracking, replacement of the window may be required. Please be advised that any persons coming into contact with the cracked window should do so with due caution to avoid any personal injury that may ensue.

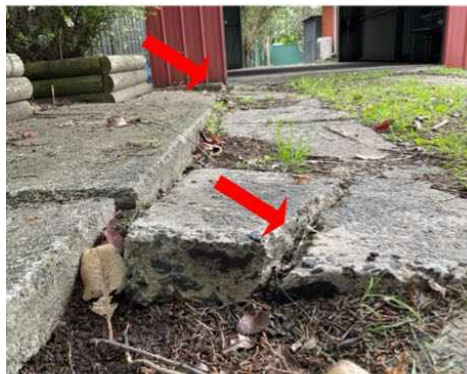
Finding 2.01

Building:	Building 1
Location:	Driveway
Finding:	Crack in concrete slab - Category 4
Information:	A crack coded as Category 4 was identified in the slab. A Category 4 crack is described as a crack that appears as a gap in the slab, with disturbing curvature or change in level affecting the slab.

The approximate width of the crack or gap is 4mm-10mm or a change in offset of

greater than 25mm when a 3m straight edge is placed over the defect.

Category 4 cracking to slabs exceeds allowable Standards and Tolerances, and are therefore considered as major defects that require rectification.

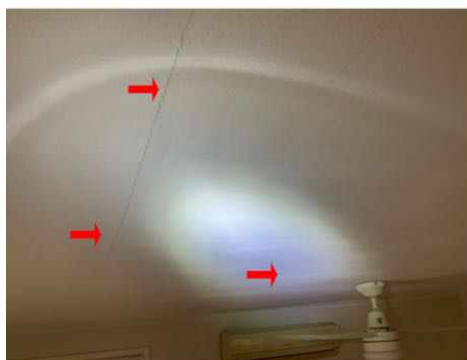
Finding 3.01

Building:	Building 1
Location:	Pictured areas
Finding:	Ceiling - Sagging/deflection evident
Information:	The ceiling in the loungeroom was found to have minor sagging and cracking evident at the time of inspection. Sagging to the fixed ceiling structure generally indicates that the building materials have swollen, due to contact with water, or that fixings (e.g. nails or glue) have become loose and require reattachment.

No moisture was evident in the roof void above this area and this appears to be minor in nature required refixing in place.

Where minor sagging is evident, comparatively minor works, such as re-gluing of ceiling sheets, may be required. Such works may be performed by relevant tradespeople, such as plasterers and painters.

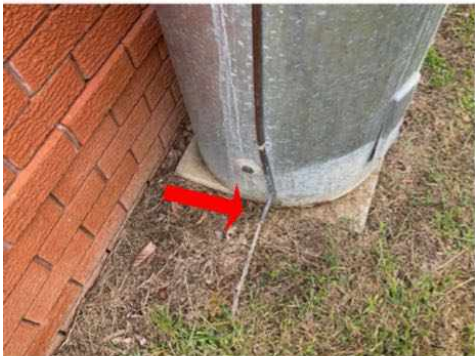
Finding 3.02

Building:	Building 1
Location:	Walls, shed,
Finding:	Site drainage - Inadequate
Information:	The site drainage in these areas was found to be inadequate at the time of inspection, creating potential for subsequent water damage to associated building elements.

The bathroom and laundry floor wastes, air conditioner and hot water system overflows all run against the house walls. The front shed roof has no fall resting this roof.

Where site drainage is inadequate, installation of an Agricultural (Aggie) Drain may be required. A qualified plumber should be appointed to further inspect the property and perform any remedial works as necessary. Secondary defects are likely to occur if left

unmanaged.

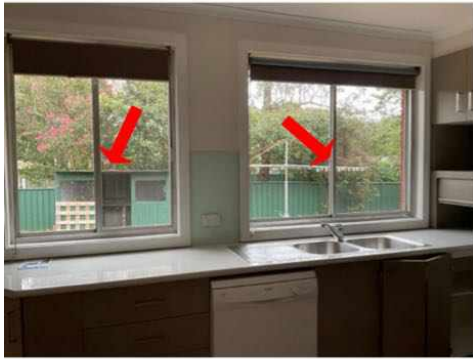
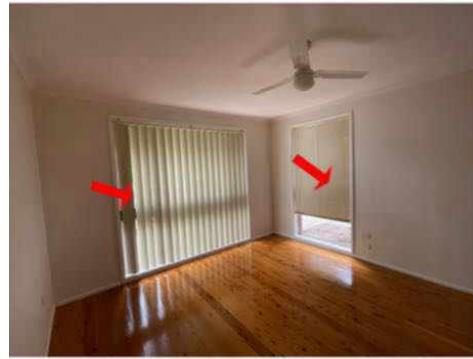
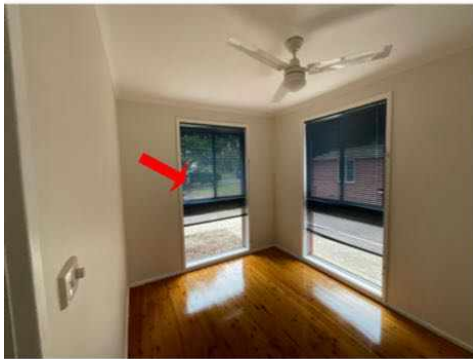
Building:	Building 1
Location:	Kitchen & front bedrooms
Finding:	Windows - Stiff to slide
Information:	Several windows throughout the property were jammed and difficult to operate at the time of the inspection. Windows provide ventilation to the adjoining area and should be at a fully operational level to ensure user comfort. Restricted function of the window may also pose as a potential safety hazard if required for emergency egress from the building.

Generally, factors such as general age of the building element and a lack of maintenance are the usual causes for this type of defect.

Replacement of window hardware or frame may be required, as well as minor repairs and cleaning. A registered builder or general handy person will be required to repair the affected windows.

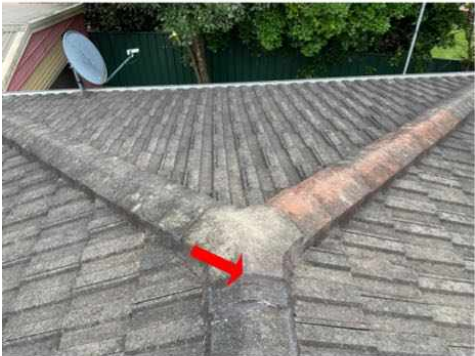
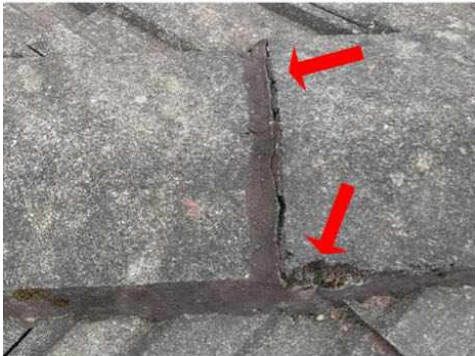
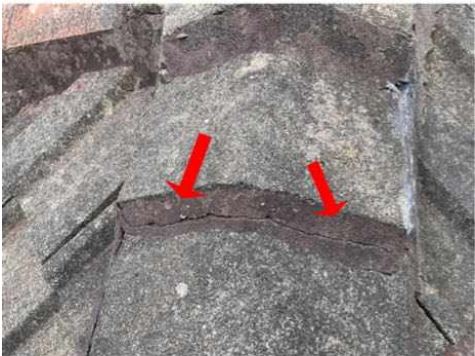
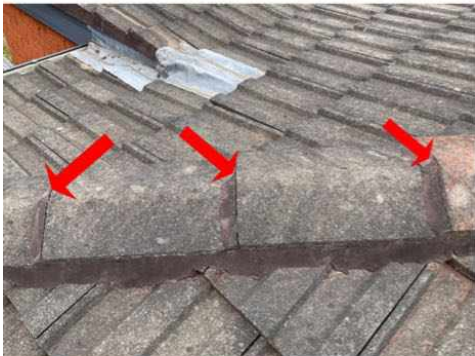
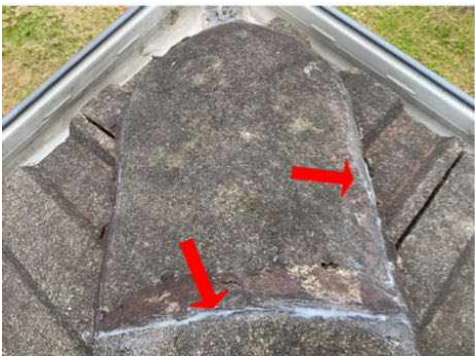
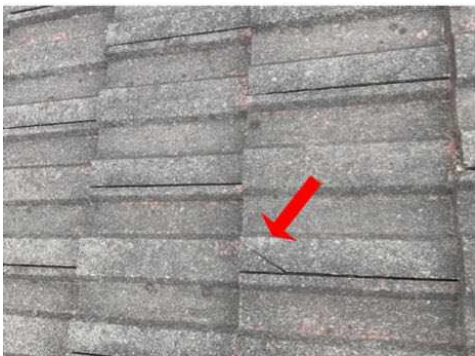
Building:	Building 1
Location:	All External Areas
Finding:	Roofing areas - minor weathering & rusted valleys
Information:	Upon inspection of the exterior roofing, the majority of the roof areas were considered to be in a good condition. While weathering of these pictured areas is consistent with the age of the property, maintenance works are required. Some repairs in a few areas have been undertaken however this clear sealant is likely to last for many years.

Re-sealing and replacing small areas of gaps, damage or rust the may be considered as an interim solution by the client to help preserve and extend the life span of these roofing areas. Rust guard can lengthen the life of the rusted roof valleys. Where left unmanaged, deteriorating roofing materials are likely to lead to a number of secondary defects, including minor water leaks and weather exposure to internal roofing structures.

Consultation with a roofing contractor is highly advised to gain advice on cost of remedial works that may be required in the short to medium term.

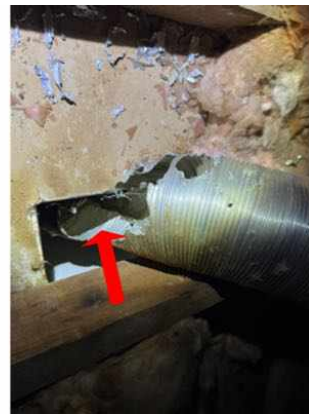
Finding 3.07

Building:	Building 1
Location:	Rear Roof cavity
Finding:	Rangehood and rangehood ducting damaged
Information:	The rangehood ducting was found to be damaged in the roof cavity, possibly by rodents. This will mean the rangehood is not functioning effectively and exhaust gases from cooking can create a potential fire risk if not replaced. This is a relatively simple job. The rangehood was also not operating with only one light working.

It is highly recommended that a skilled handy person or A/c installer be appointed to reconnect the ducting in order to prevent a loss of air into the roof void.

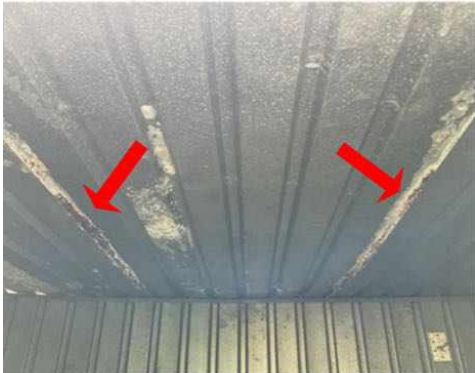
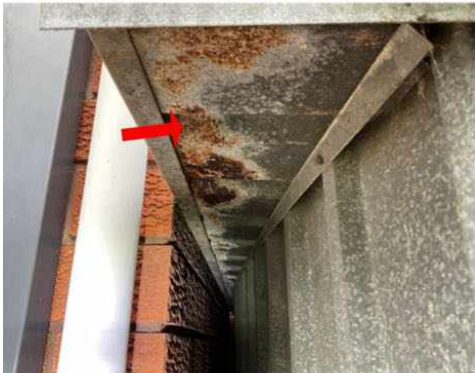
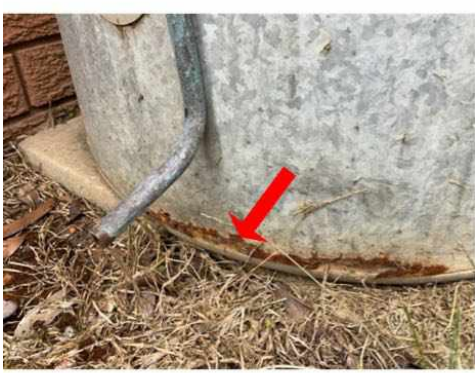
Finding 3.08

Building:	Building 1
Location:	Pictured sheds, water tank, roof valleys
Finding:	Areas rusted or corroded
Information:	These areas shows evidence of rusting and corrosion, which is likely to have developed as a result of excessive exposure to moisture and or inadequate coatings.

As surface rust provides no protection to the underlying iron, the deteriorating condition is likely to worsen if not addressed in the short-term future.

Rusting and corrosion should be managed by ideally removing or limiting the affected surface from exposure to moisture. A registered plumber or skilled handy person should be appointed immediately to repair or replace these areas that have been severely affected by rust or water damage.

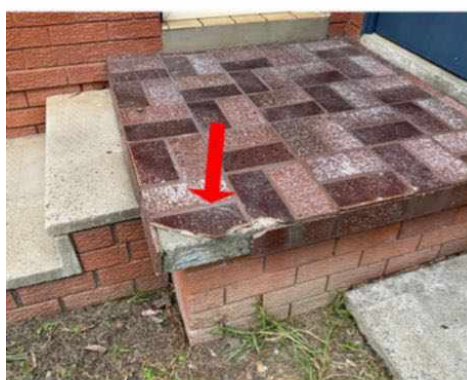
Finding: Tiles cracked
 Information: Cracked tiles were evident in these pictured areas at the time of inspection. It is suspected that this cracking has occurred as a result of minor settlement or impact damage.

Cracked tiles throughout the household detract from the overall appearance of the affected areas. In wet areas of kitchens and bathrooms, it can lead to water damage of adjoining walls and floors.

Replacement of cracked tiles is recommended as soon as possible. A tiling contractor may be appointed to perform these works. Where cracks become more numerous, contact a licensed building inspector for further investigation.

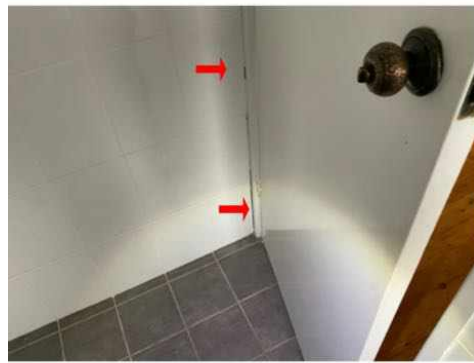
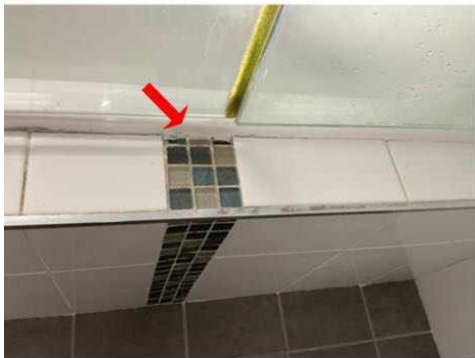
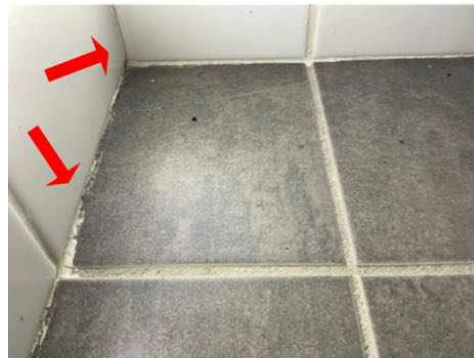
Finding 3.11

Building: Building 1
 Location: Bathroom
 Finding: Sealant and grouting - Missing or damaged
 Information: It was noted on inspection that sealant or grout is degraded to these pictured wet areas.

Different materials and floor areas move at different rates, generally causing cracking to grout or sealant at this point. A flexible sealant is required to allow for expected expansion and contraction, while keeping the joint water tight and protective of all associated building materials.

Flexible and mould resistant materials should be applied to affected areas to prevent any subsequent water damage that is likely to occur. Regular maintenance and replacement of damage or missing or damaged sealant and grout is highly recommended to the wet areas, as this is a regular wear and tear defect. Sealant and grouting in areas that come into regular contact with water should be maintained for the long term care of your property.

A sealant specialist or tiling contractor should be appointed to complete these works as soon as possible

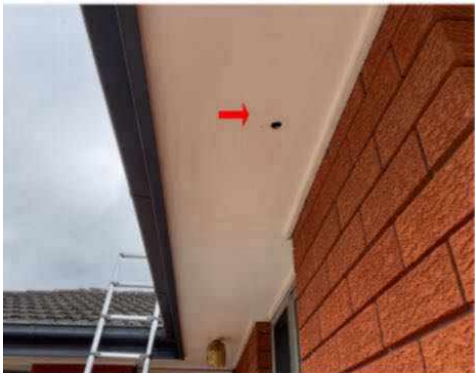
Finding 3.12

Building: Building 1
 Location: Pictured Areas
 Finding: Sealant (external) - Missing.
 Information: It was noted on inspection that areas of external sealant was missing to small areas of the external walls and many windows.

Flexible sealants should be applied to these affected areas to prevent any subsequent water damage that is likely to occur.

A sealant specialist or skilled handy person should be appointed to complete these works as soon as possible

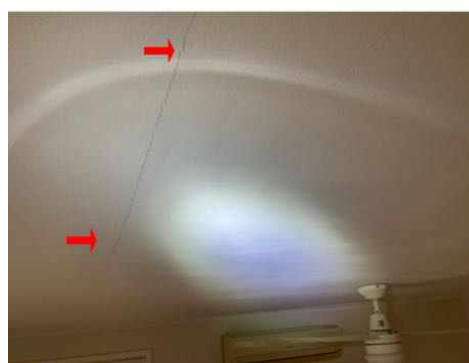
Finding 3.13

Building:	Building 1
Location:	Lounge Room, laundry
Finding:	Cracking - minor
Information:	Although fine cracks are quite noticeable, they are often only considered to be an appearance defect, and usually do not indicate any structural damage. Generally, the cause of a fine crack is indicative of a separation between building materials and finishes (e.g. paint, plaster, etc.) along joins.

Cracking of this nature can generally be repaired with minor sanding, filling and/or repainting. This cracking also requires additional screws to stop the minor sagging evident. Such works should be performed by a plasterer, carpenter or skilled general handyman.

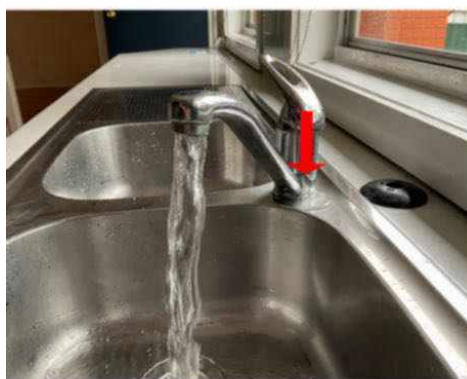
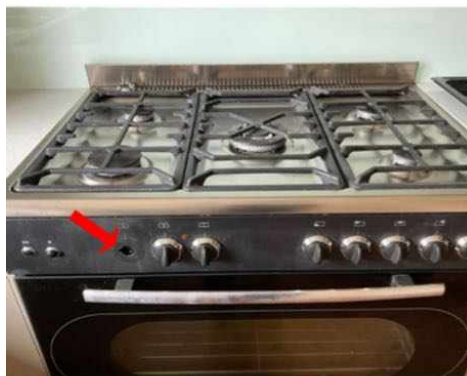
Finding 3.14

Building:	Building 1
Location:	Pictured external areas
Finding:	Building elements - Damaged

Information: Evidence of minor missing or damaged areas was identified at the time of the inspection. These include -

1. The front yard and kitchen taps are leaking when turned on.
2. Some eave areas appear to have been constructed out of level.
3. Testing stoves in not in the scope of NSW building reports, this stove has a missing knob.

A carpenter and plumber would be the trades responsible for rectification of these areas when convenient.

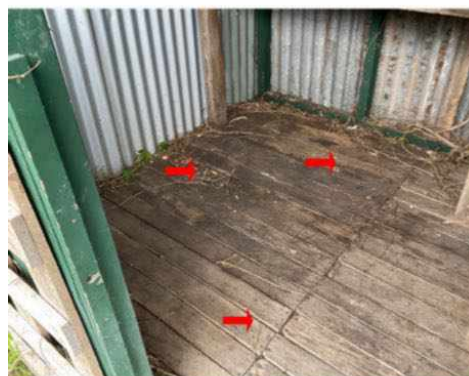
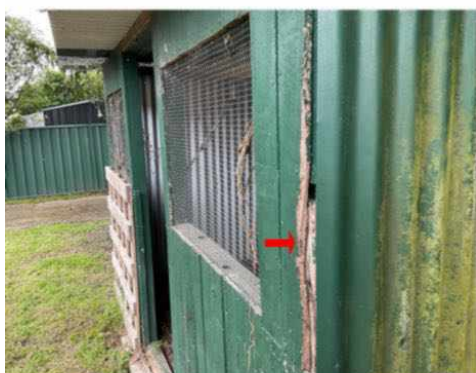
Finding 3.15

Building: Building 2
 Location: Pictured shed areas
 Finding: Wood rot
 Information: The building shows evidence of wood rot. Wood rot, also known as Fungal Decay, occurs when timbers and other cellulose building materials are exposed to damp conditions on an ongoing basis. This could be the result of exposure to weathering over a prolonged period of time, or the attraction of excessive moisture from other abutting building materials.

Early intervention and regular maintenance, particularly of exterior timbers, will prolong the useful life of these building elements. Prior to any works being performed, the cause of the moisture that has created the visible wood rot should be identified and addressed in a suitable manner. Replacement of affected timbers may then be a necessary step in protecting surrounding building elements from such deterioration.

A qualified carpenter or registered builder may also be required to replace affected building materials.

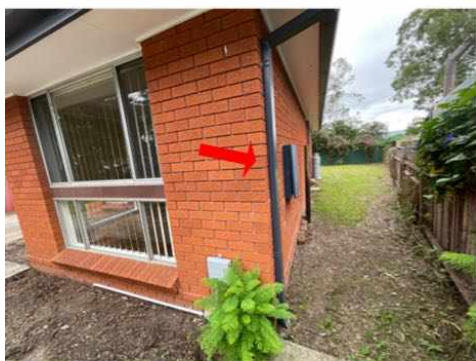
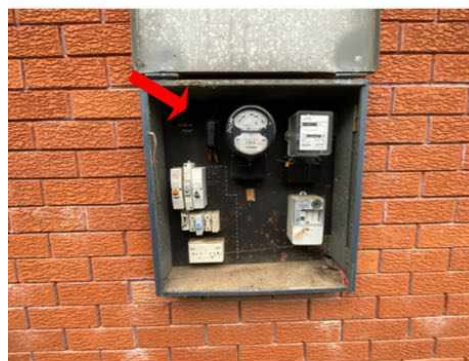
Location: Meter Box
 Finding: Termite Management System - no evidence of a chemical installation
 Information: The application of a post-construction chemical termite barrier is highly recommended for all properties. Such barriers are highly effective in preventing termite attack on any timber building elements throughout the property.

A durable notice should be placed in the switchboard unit to indicate current termite barriers. At the time of inspection, no durable notice was evident and it appeared as though no chemical termite management system has been installed, with no evidence to suggest preventative works taking place since the property was built.

The client may consider gaining further advice from a pest controller as to the costs and procedures involved with a 'chemical' application. It is recommended that obtaining such advice be a short-term priority.

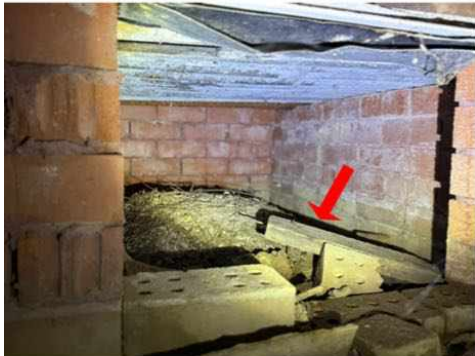
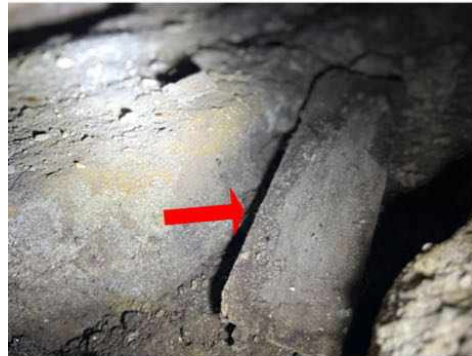
Building:	Building 1
Location:	Subfloor
Finding:	Timber in contact with the ground
Information:	Any timbers in direct ground contact provide opportunity for concealed termite entry and are likely to be subject to premature rot and decay as the soil retains moisture or damp conditions against the timbers.

Removal of all waste timber that is in direct contact with ground is highly advised. This timber is promoting mould and wood rot and is very attractive to termites.

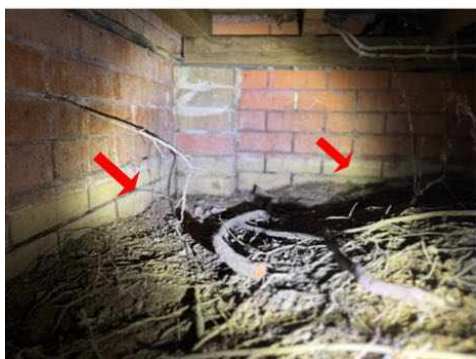
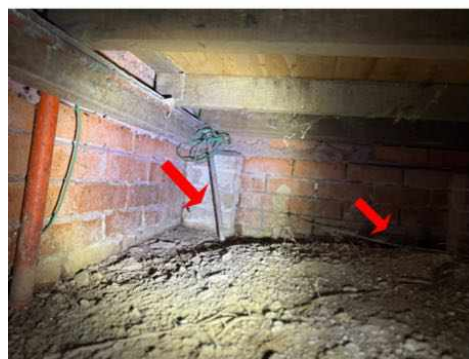
Finding 6.04

Building:	Building 1
Location:	Subfloor
Finding:	Damp - Rising
Information:	Rising damp describes the upward movement of water in low sections of building elements (e.g. walls) by capillary action - the movement of water through porous materials such as bricks, sandstone or mortar.

The first step in addressing rising damp is to diagnose the cause. Adding external drainage should reduce the small areas of rising damp evident.

Consultation with a qualified plumber is advised immediately to identify the cause of the damp and perform remedial works as required.

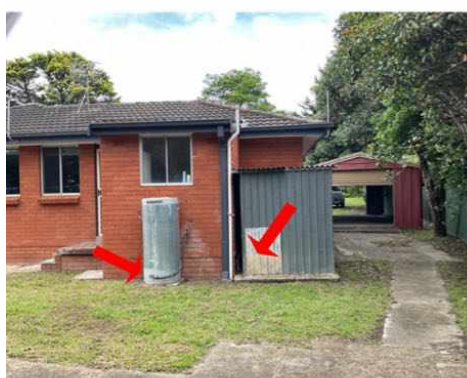
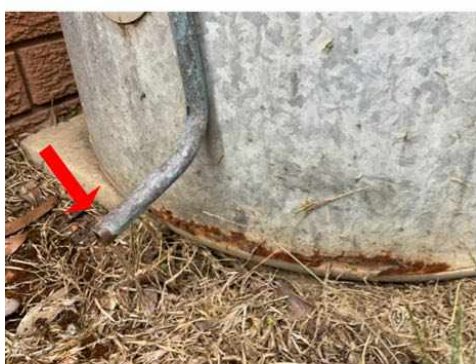
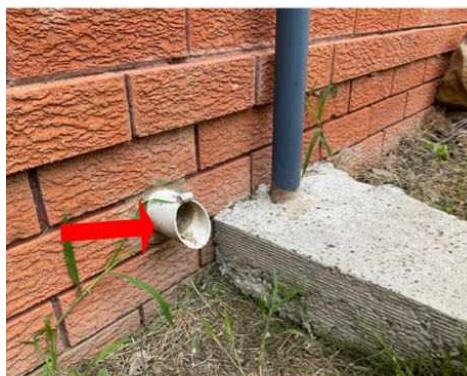
Building:	Building 1
Location:	Pictured external wall areas
Finding:	Overflows - Not plumbed for drainage
Information:	The pictured overflow pipes are not plumbed or connected to suitable drainage, which has resulted in the surrounding area becoming excessively damp.

These damp conditions can lead to secondary defects such as rot, rust or corrosion of associated building elements, the formation of fungal decay, or even the creation of potential slip hazards. When coupled with poor site drainage, pooling of water may also attract termite activity to this area. It is highly recommended that a qualified plumber be appointed to install adequate drainage to these areas. These works will ensure that the area remains dry and free of any secondary defects.

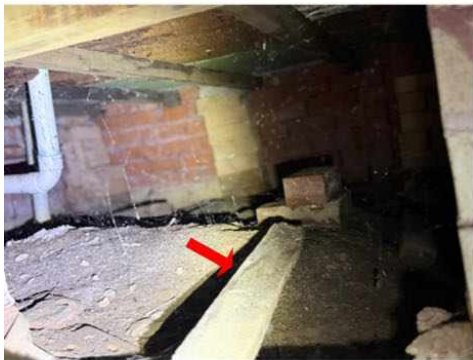
Finding 7.01

Building:	Building 1
Location:	Shed, fence, subfloor areas
Finding:	Fungal decay - present (localised)
Information:	Fungal decay also known as wood decay or wood rot generally refers to the deterioration of timber elements when in contact with excessive levels of moisture for a

The development of fungal decay is accelerated by temperatures from 5degreeC to 40degreeC as well as the presence of oxygen. Generally fungal decay develops on timber elements that are in use in an external environment which are exposed to rain penetration.

In this case, the affected timber elements are in a decaying state and will need removal or replacement by a carpenter or licensed builder.

Note - See ALL wood rot photos, all these show fungal decay.

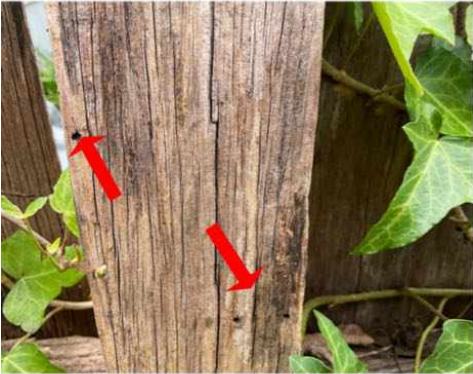
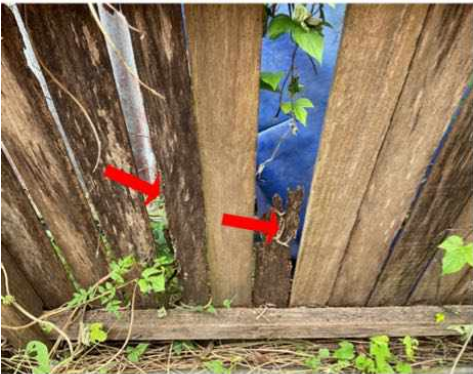
Finding 8.01

Building:	Building 1
Location:	Pictured fences
Finding:	Evidence of wood borer activity identified
Information:	Wood borers small beetles that colonise in exposed timber elements are a common timber pest that are regularly mistaken for termites. Although wood borer activity is generally not detrimental to the affected timber they may lead to serious damage and

necessitate replacement of certain building elements if left unattended.

The other commonly known borer the Anobium borer is more likely to attack floorboards and may cause severe structural damage to flooring areas.

As no live wood borer activity was identified treatment is not required at this time. Replacement of affected timbers may be considered by the client for superficial reasons.

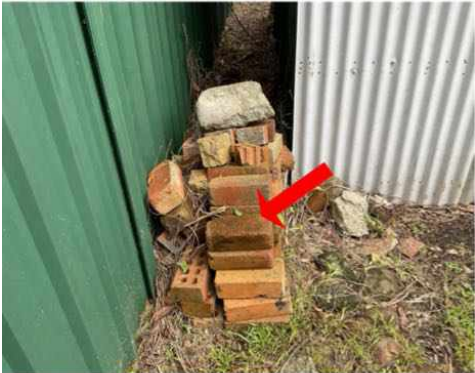
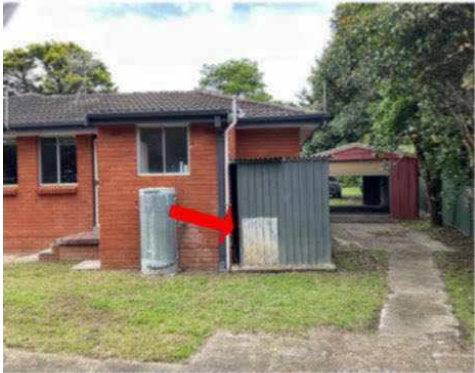
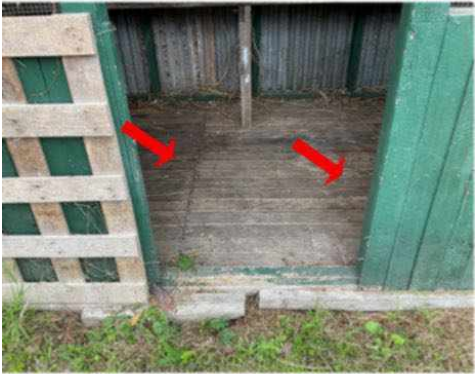
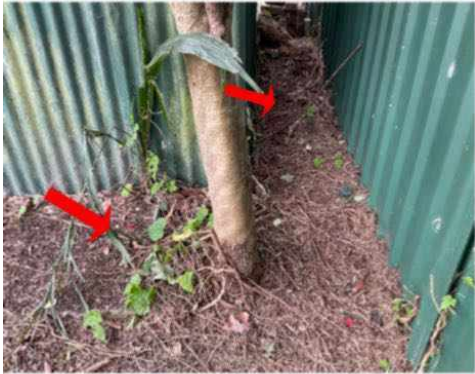
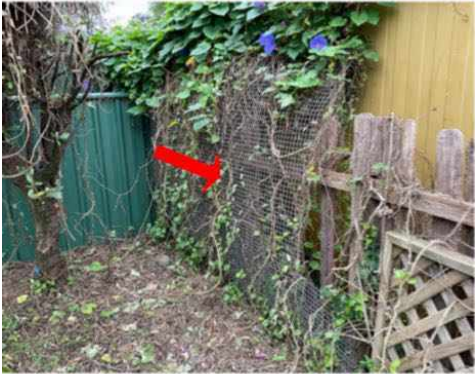
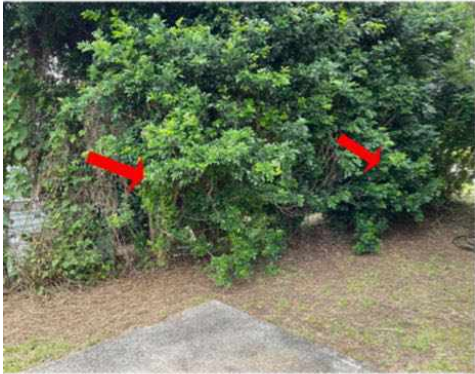
Building:	Building 1
Location:	All External Areas
Finding:	Additional Photos - Obstructions and Limitations of EXTERNAL AREAS
Information:	These photographs are an indication of the obstructions and limitations which impeded full inspection of external areas at the time of inspection. These obstructions can hide an array of defects and should be removed to allow full inspection to be carried out. A re-inspection is recommended once the areas are made accessible.

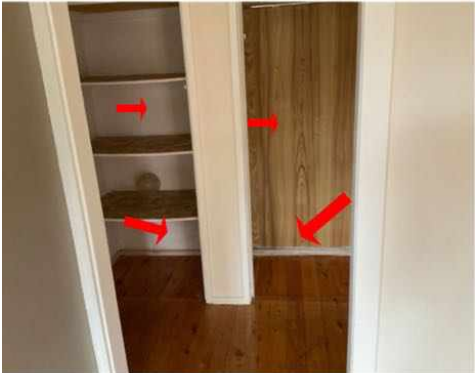
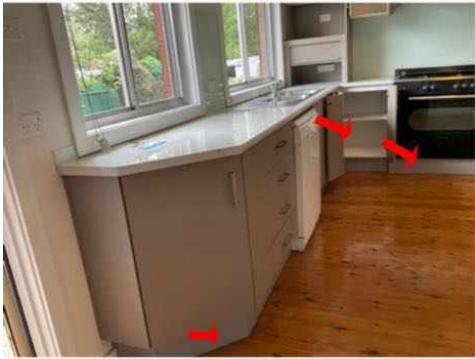
Building: Building 1
Location: All Internal Areas
Finding: Additional Photos - Obstructions and Limitations of INTERNAL AREAS
Information: These photographs are an indication of the obstructions and limitations which impeded full inspection of Internal areas at the time of inspection. These obstructions can hide an array of defects and should be removed to allow full inspection to be carried out. A re-inspection is recommended once the areas are made accessible.

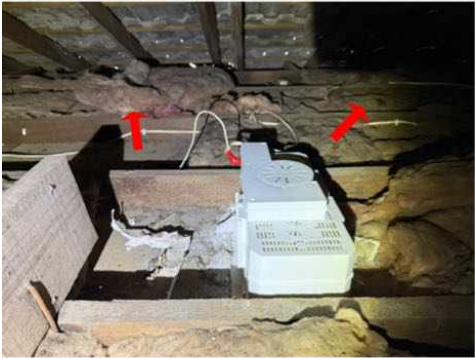
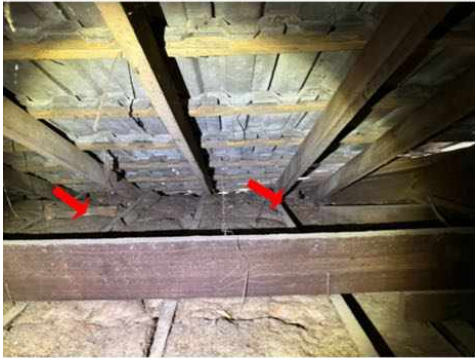
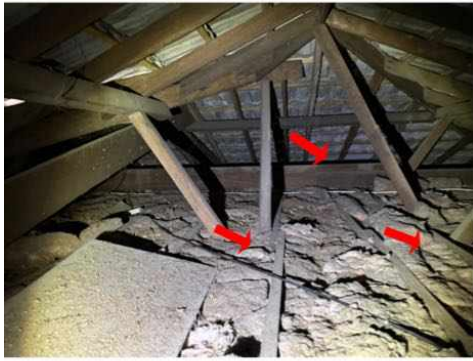
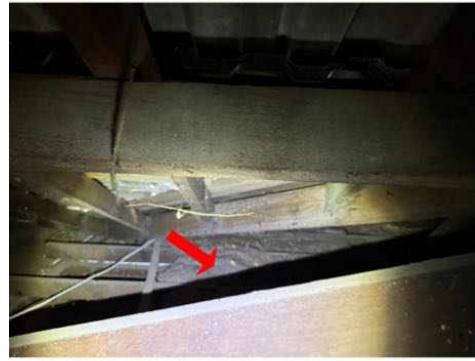
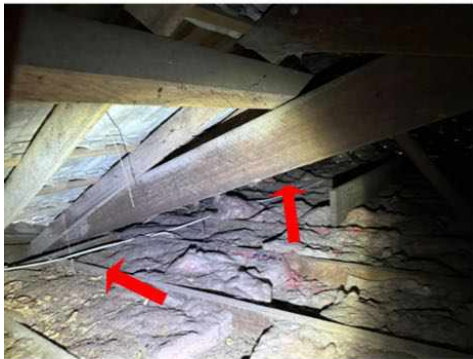
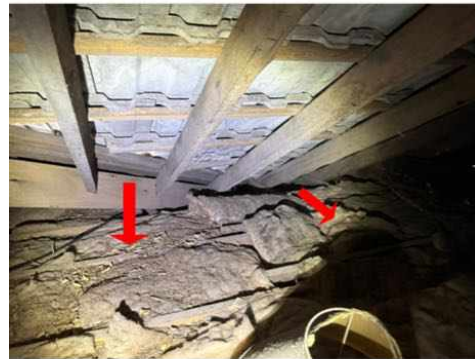
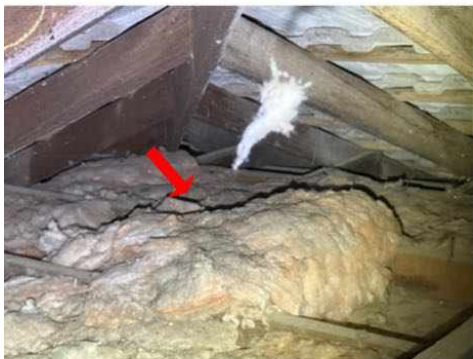
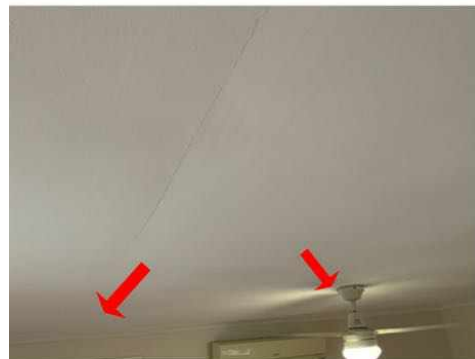
Building: Building 1
Location: All Roof cavity areas
Finding: Additional Photos - Obstructions and Limitations of the ROOF CAVITY
Information: These photographs are an indication of the obstructions and limitations which impeded full inspection of roof cavity areas at the time of inspection. These obstructions can hide an array of defects and should be removed to allow full inspection to be carried out if applicable. A re-inspection is recommended once the areas are made accessible.

The inspection was also limited to areas with an allowable crawl space of 600mm x 600mm, in particular towards the external walls where the roof line diminishes, these areas were not accessible.

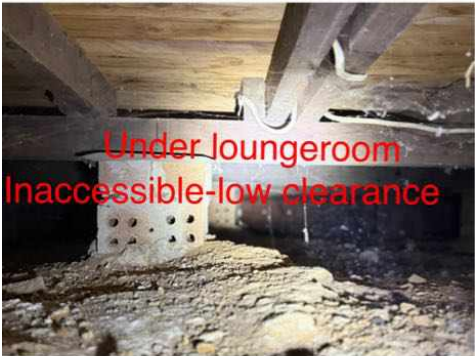
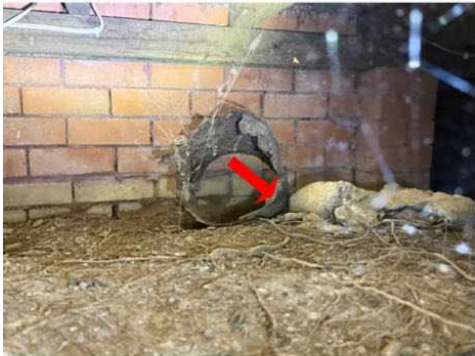
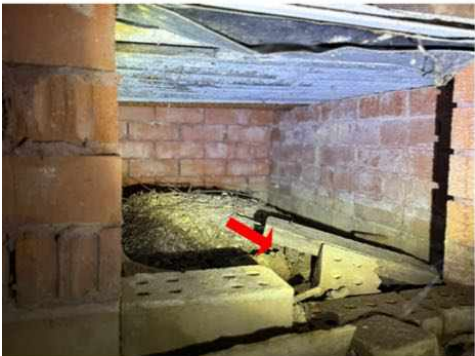
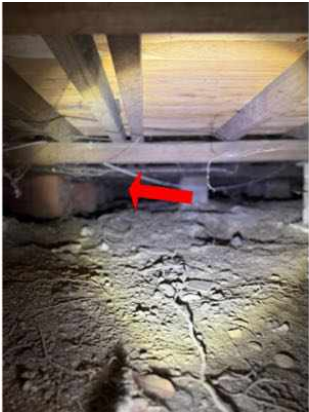
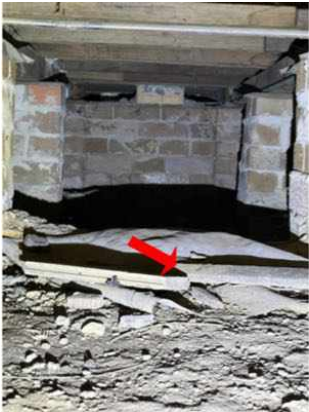
Building:	Building 1
Location:	All Subfloor Areas
Finding:	Additional Photos - Obstructions and Limitations of SUBFLOOR AREAS
Information:	These photographs are an indication of the obstructions and limitations which impeded full inspection of subfloor areas at the time of inspection. These obstructions can hide an array of defects and should be removed to allow full inspection to be carried out. A re-inspection is recommended once the areas are made accessible.

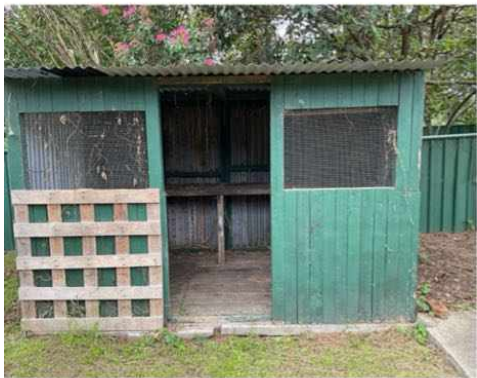
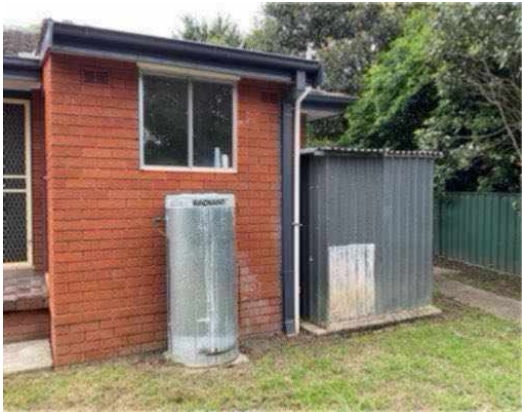
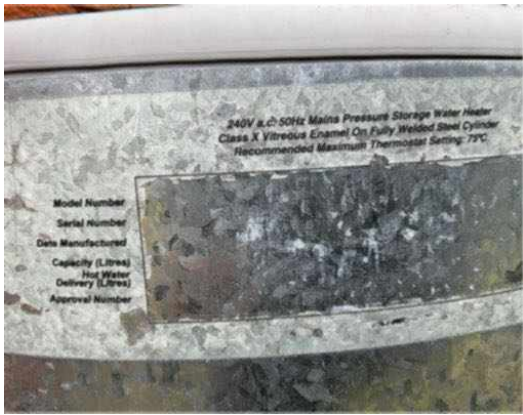
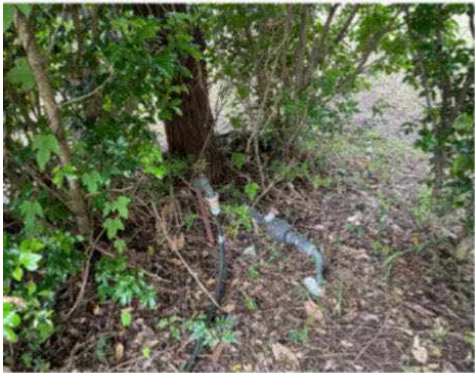
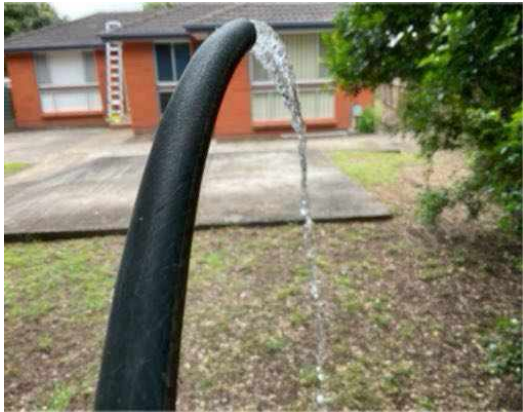
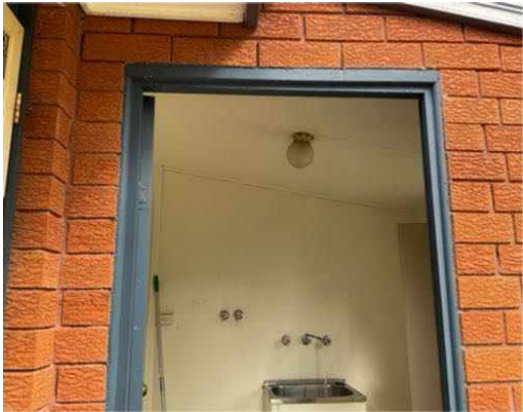
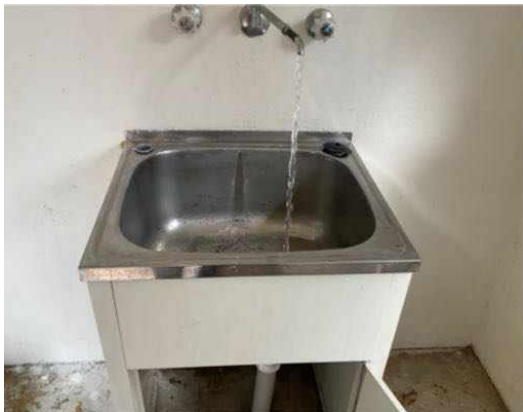
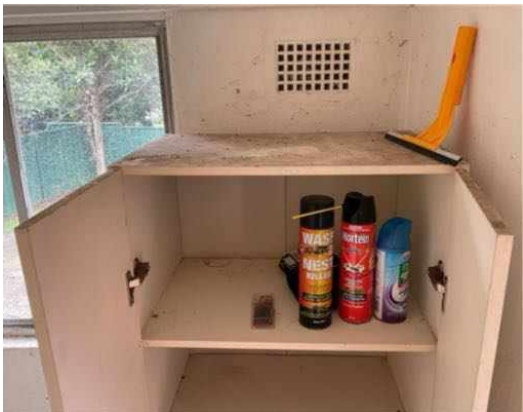
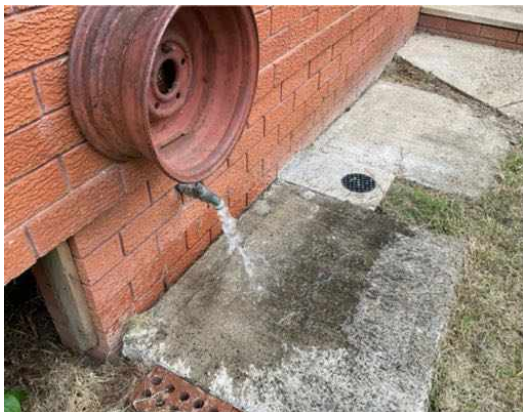
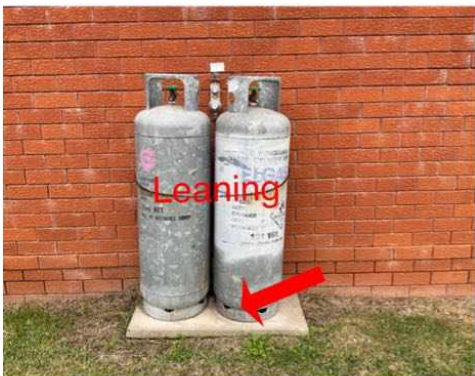
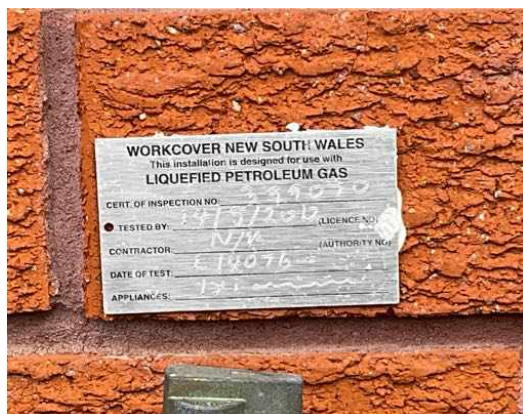
Building: Building 1
Location: All External sheds, laundry, other areas
Finding: Additional Photos
Information: Additional photos are provided for your general reference

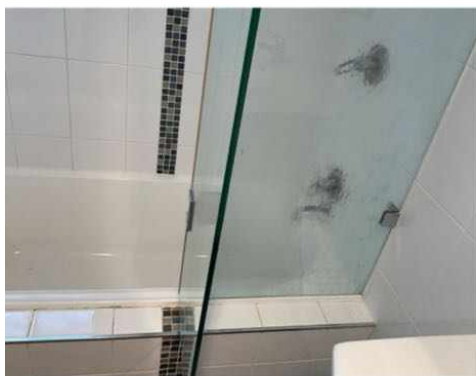
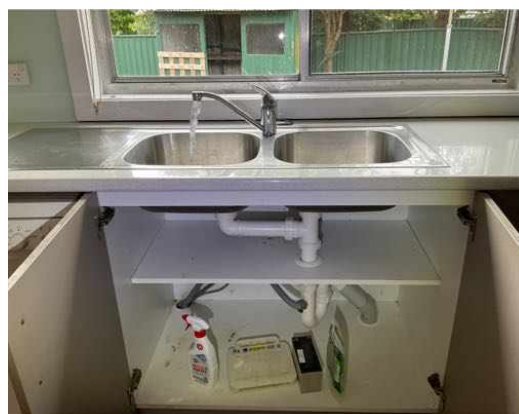
Building: Building 1
 Location: All Internal Areas
 Finding: Additional Photos
 Information: Additional photos are provided for your general reference

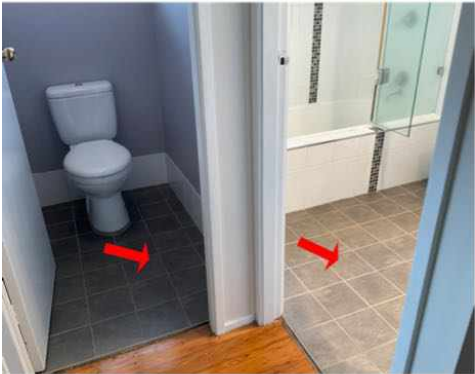
Building: Building 1
 Location: Bathrooms and laundry
 Finding: Waterproofing membranes - Information Only
 Information: Internal Water Proofing Membranes, are crucial in preventing water ingress into the property is important to know that the Membrane System used is to Australian Standards and has been installed correctly.

With older property's where this information is unavailable all wet areas should be monitored. If any leaks, water staining, peeling or bubbling of the paint become

evident to any adjacent walls or ceilings below a licensed builder or waterproofing specialist is recommended to investigate further.
