Building and Timber Pest Inspection Report

Inspection Date: Tue, 3 Mar 2026

Property Address: 56 Queensville St, Kingsville VIC 3012,
Australia

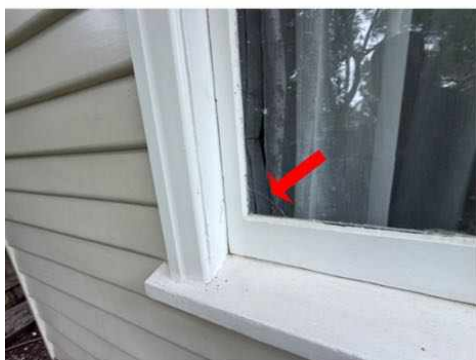
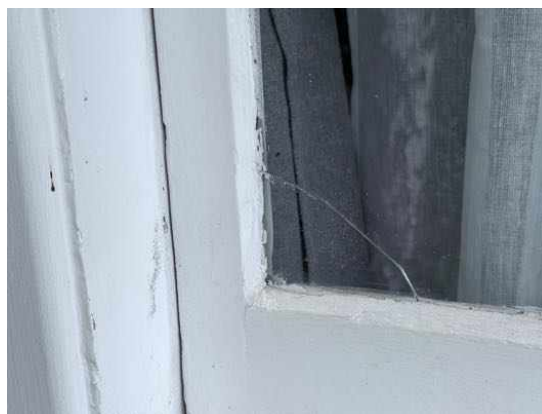
Building:	Main Building
Location:	Bedroom
Finding:	Cracked Glass
Information:	There appears to be a window which is cracked or was accidentally damaged.

Broken glass creates a potential safety hazard in the area. Care must be taken by anyone using the space in its vicinity until its replaced by a glazier or a building maintenance provider.

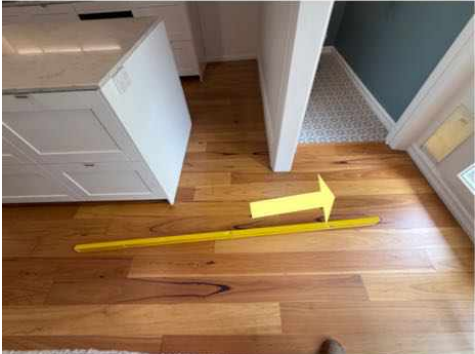
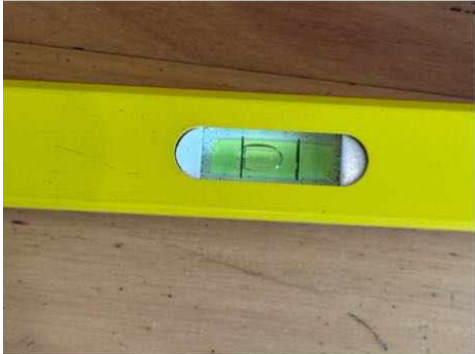
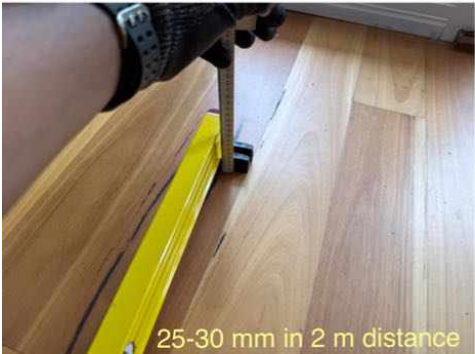
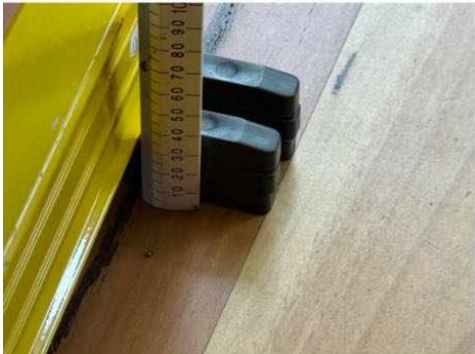
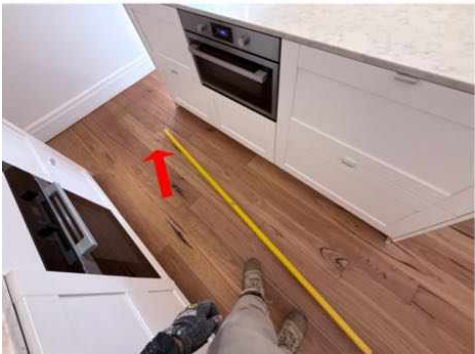
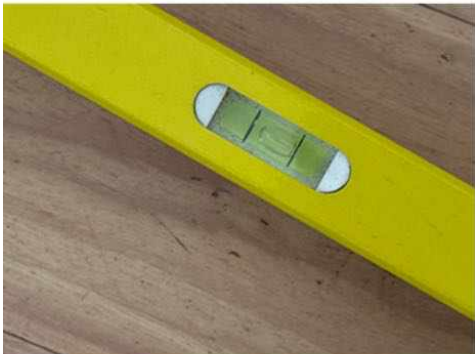
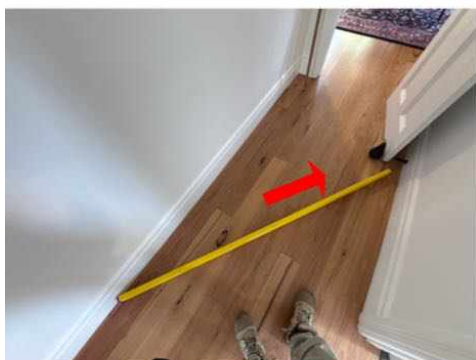
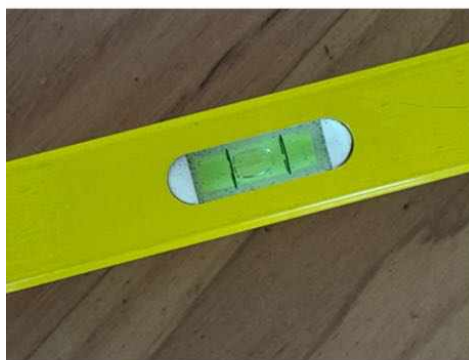
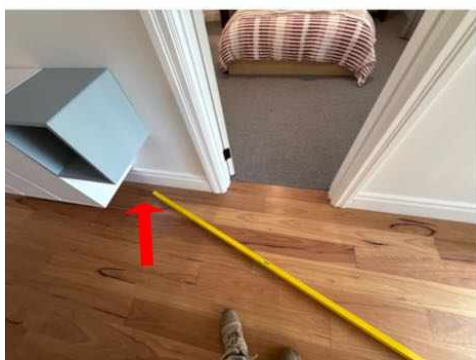
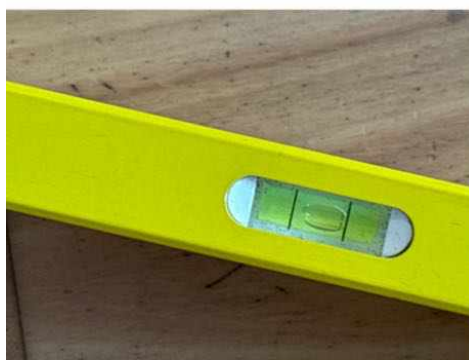
Finding 2.01

Building:	Main Building
Location:	All Internal Areas
Finding:	Subsidence (moderate to major)
Information:	It appears that the subfloor structure has been affected by movement of the foundations, often referred to as sinking or subsidence. Whilst a degree of movement is expected in subfloors over time, especially as environmental conditions change and buildings 'settle' after construction, this degree of subfloor movement requires attention.

General subsidence is usually initiated by changes in soil moisture content. The most critical factor is identifying the specific causes, and identifying if this is a recurring or ongoing problem, or one that has been resolved by previous works in the past. The max documented deviation was between 25-30 mm in 2 m distance (becomes major after 30 mm). Some of the secondary defects (internal cracking/ door binding) have

Subsidence can have complex and varying causes, which will influence the required remedial works. It is advised to begin by consulting a structural engineer to determine the required scope of works. This generally includes some form of underpinning, as well as addressing the underlying cause. Consultation with a geotechnical engineer may also be necessary where changes to soil moisture content is apparent.

A Registered Builder specialising in re-stumping would then generally carry out works as advised by an Engineer.

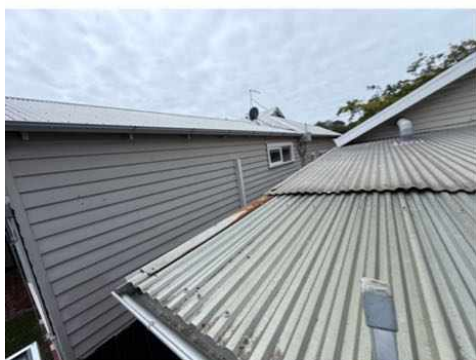
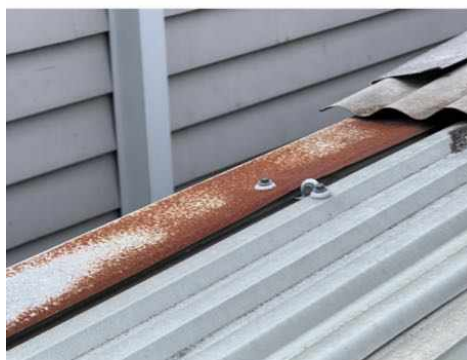
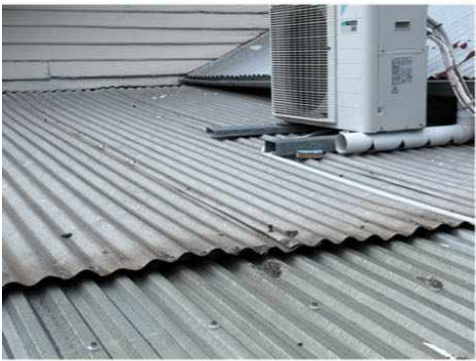
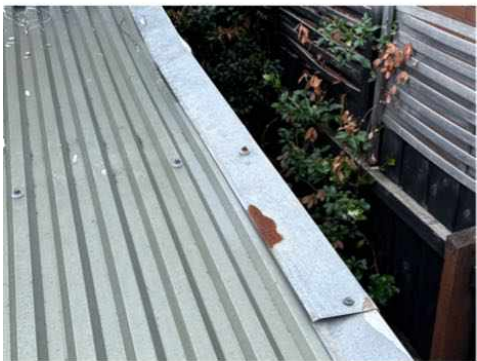
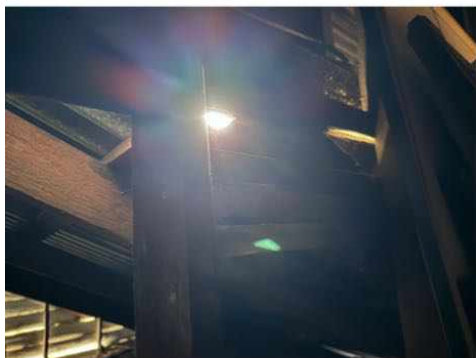
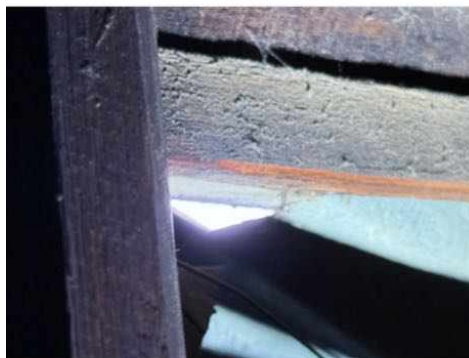
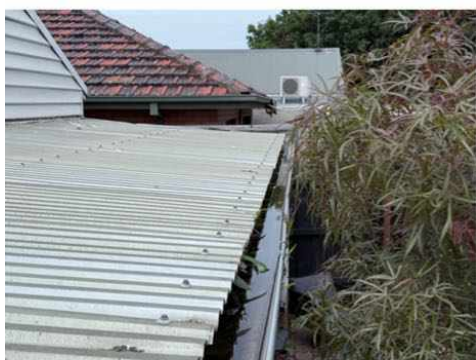
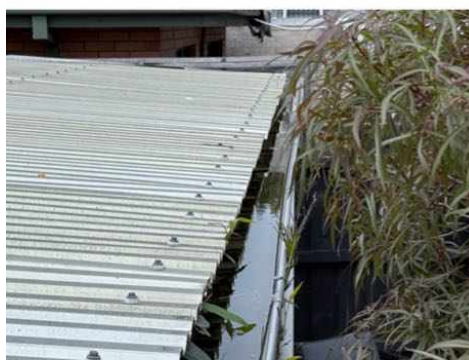
Finding 2.02

Building:	Main Building
Location:	Roof Void
Finding:	Roofing Deterioration – Loose Fixings, Rusted Flashings & Drainage Concerns (Moderate to Major)
Information:	During the inspection, multiple defects were observed to the metal roof covering and associated flashings. Significant corrosion is present to several flashings, particularly at abutments and transitions. In some areas, corrosion has progressed beyond surface oxidation, indicating material thinning which may compromise long-term weatherproofing performance.

Roofing screws were found to be loose and/or partially lifted at numerous locations. Several fixings appear inadequately seated, and some roof sheets exhibit minor movement, suggesting reduced wind uplift resistance and compromised fixing integrity. Over time, this condition increases the likelihood of water ingress through enlarged penetrations and deteriorated neoprene washers.

Sections of the roof sheeting were observed to be inadequately secured, and minor lifting was evident along sheet laps. This condition, combined with loose fasteners, may allow capillary action or wind-driven rain to penetrate beneath the sheets.

Gutters were observed to be holding/pooling water, indicating inadequate fall or possible minor deformation. Persistent ponding accelerates corrosion, particularly at

While no active internal leaks were noted, the cumulative effect of corroded flashings, loose fixings, minor sheet movement, and gutter ponding presents an elevated risk of future water ingress, especially during prolonged or wind-driven rainfall events.

- Re-secure or replace loose roofing screws with appropriate cyclone-rated fixings and new neoprene washers.
- Replace heavily corroded flashings.
- Assess and rectify sheet fixing integrity and laps.
- Correct gutter fall and ensure free drainage.

If corrosion is widespread, partial re-roofing or staged replacement may need to be considered in the medium term to prevent progressive deterioration.

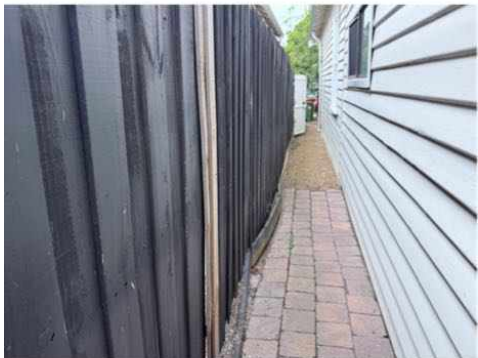
Finding 3.01

Building:	Main Building
Location:	Yard
Finding:	Timber Boundary Fence Deterioration
Information:	The timber boundary fence was observed to be deteriorating in sections, with visible warping, splitting and separation of palings. Some boards appear weathered and loosely fixed, and minor distortion is evident along the lower rail. While the fence remains generally standing at the time of inspection, continued exposure to weather and moisture may result in progressive weakening and potential instability over time.

Maintenance and selective replacement of damaged palings/rails is recommended in the short to medium term to prevent further deterioration and to maintain adequate boundary support and presentation.

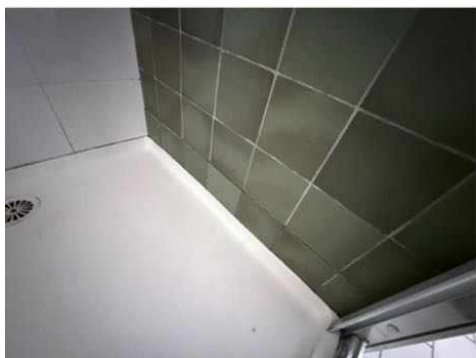
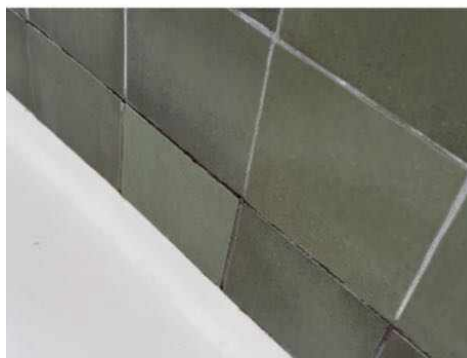
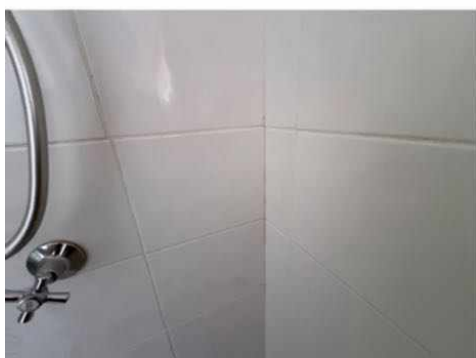
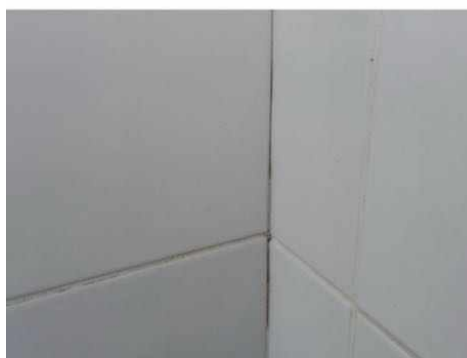
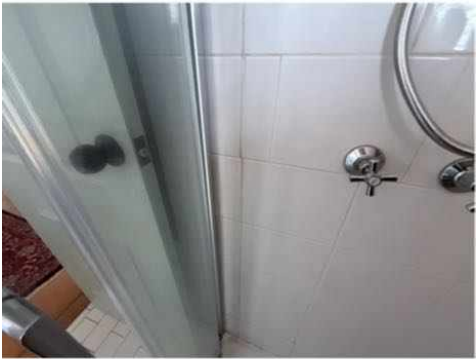
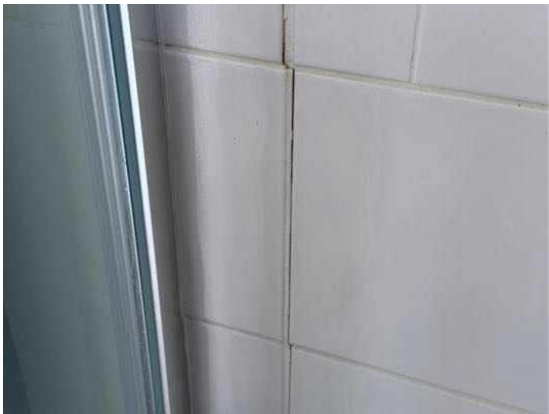
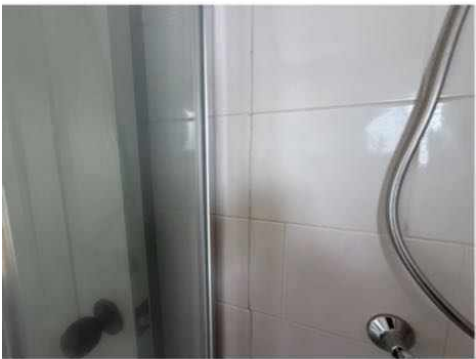
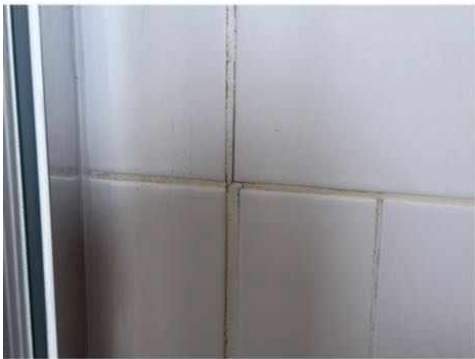
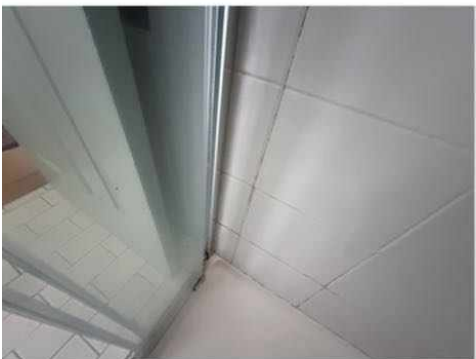
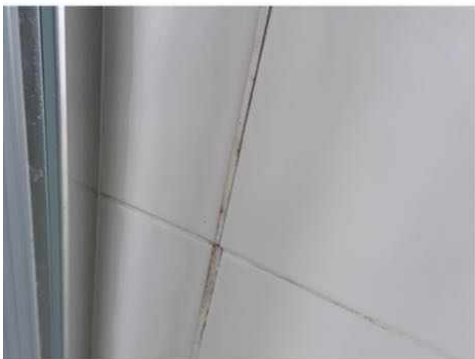
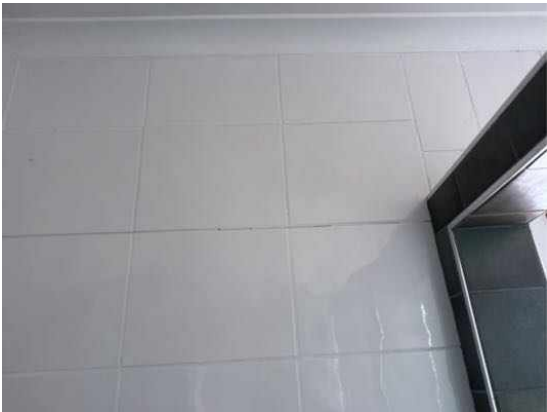
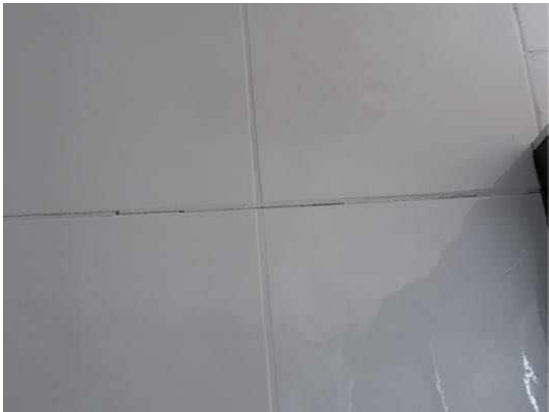
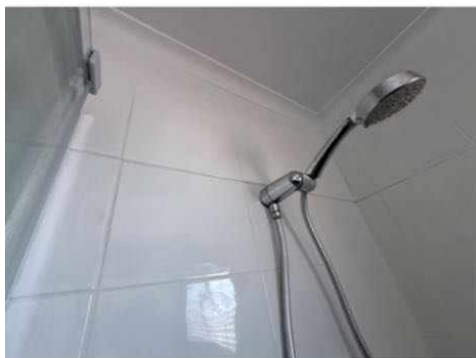
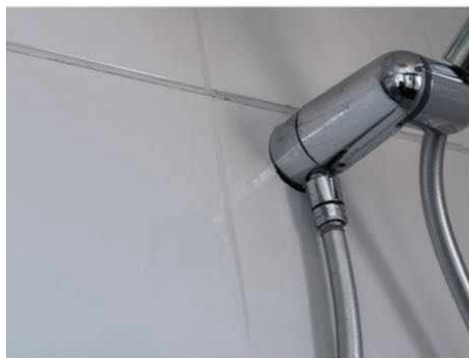
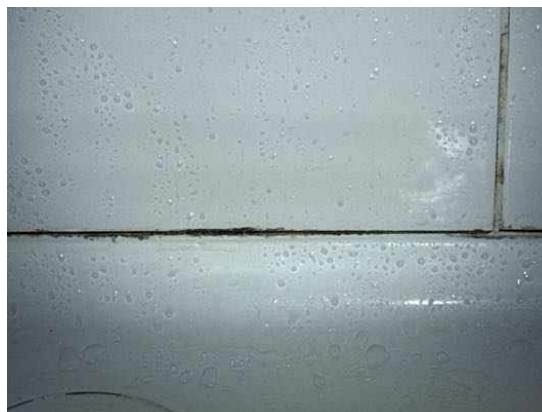
Finding 3.02

Building: Main Building
Location: Bathroom
Finding: Sealant or Grout- degraded/ fine cracks (moderately significant)
Information: It was noted on inspection that sealant or grout is degraded or cracked to the tiled shower alcove and or other areas of the bathroom.

Flexible and mould resistant materials should be applied to affected areas to prevent any subsequent water damage that is likely to occur. Regular maintenance and replacement of damage or missing or damaged sealant and grout is highly recommended to the wet areas, as this is a regular wear and tear defect. Sealant and grouting in areas that come into regular contact with water should be maintained for the long term care of your property.

A sealant specialist or tiling contractor should be appointed to complete these works as soon as possible.

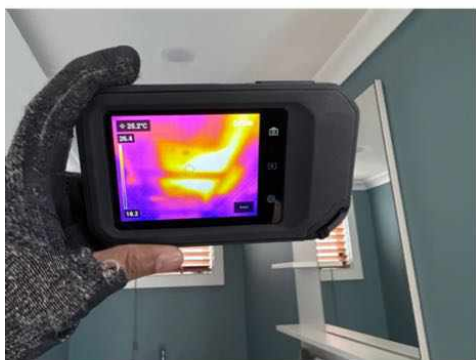
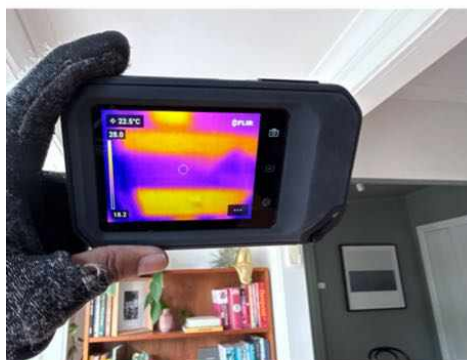
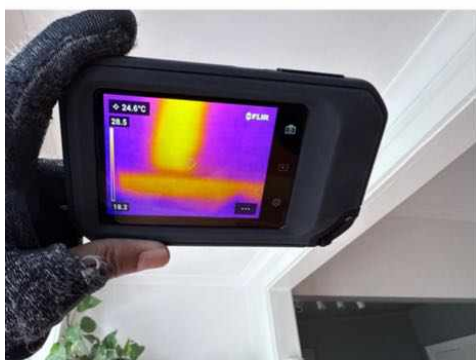
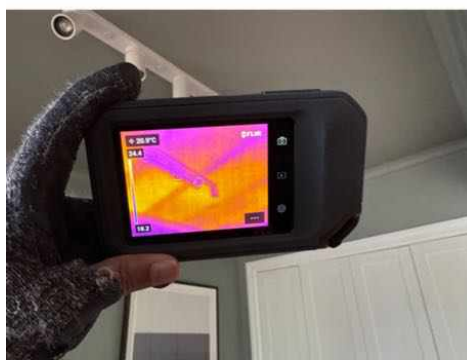
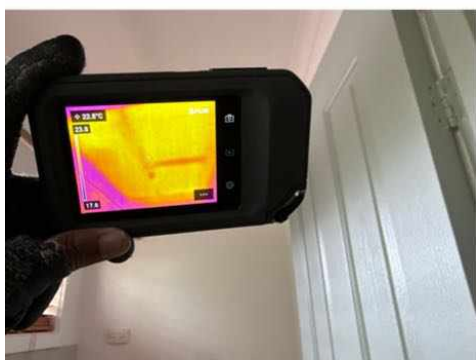
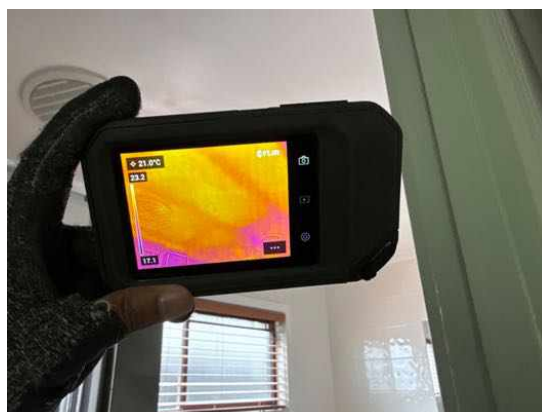
Building:	Main Building
Location:	Roof Void (extended section of the house)
Finding:	Insulation - Missing
Information:	Upon inspection of the roof void it was noted that insulation is not present.

Insufficient insulation will result in a comparatively higher cost to heat and cool a property as there is a lack of Insulation (or uneven coverage of insulation) which works as a barrier to heat transfer. This helps to keep out unwanted heat in summer and preserves warmth inside your home in winter. It can also help soundproof your home from unwanted airborne noise transfer.

Where insulation is absent, the area does not meet current Australian Standards. Installation of adequate insulation is required and should be conducted as soon as possible.

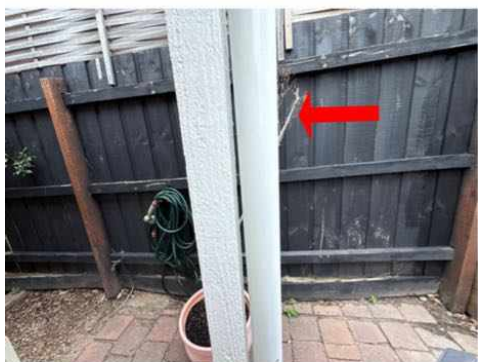
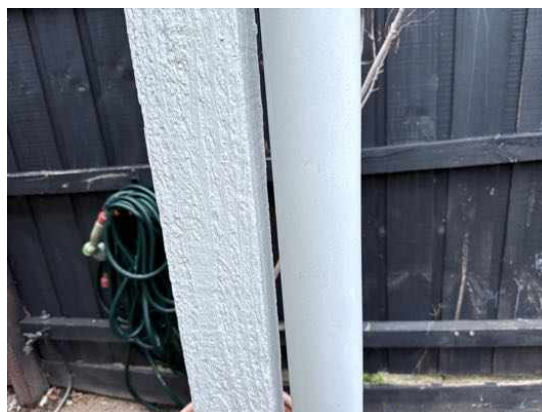
Finding 3.04

Building: Main Building
 Location: Yard
 Finding: Pipework - Not clipped off
 Information: Plumbing pipes in this area have not been correctly clipped off (secured) to the adjoining structure. Where pipes have not been clipped off, they are more susceptible to impact damage and moisture damage, particularly if they are in direct contact with the ground.

A qualified plumber should be appointed immediately to provide adequate clipping for the plumbing pipes. Failure to do so may necessitate repair works to affected plumbing pipes, which may be a costly exercise.

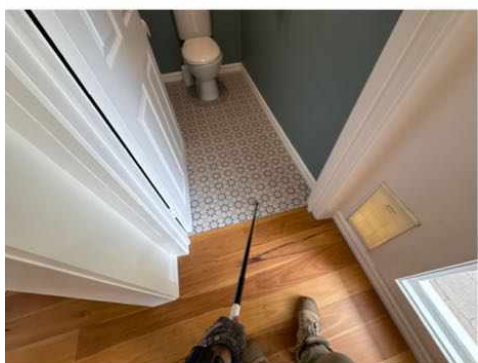
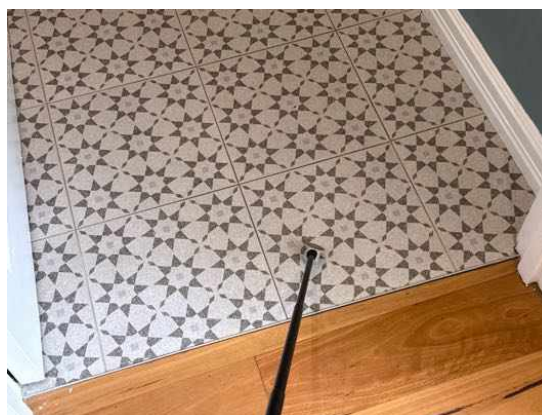
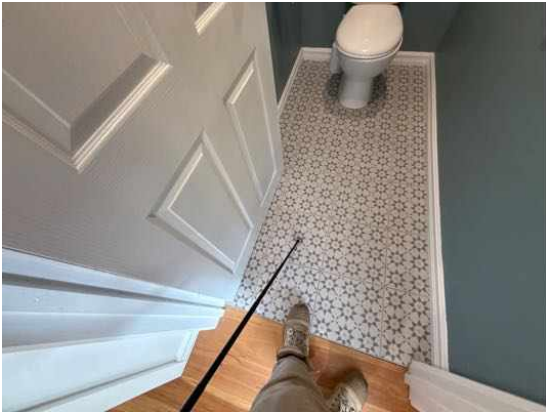
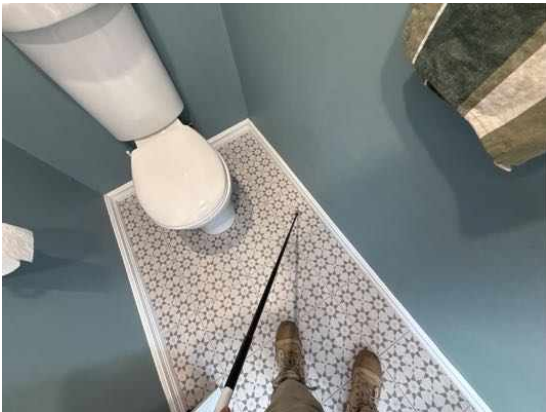
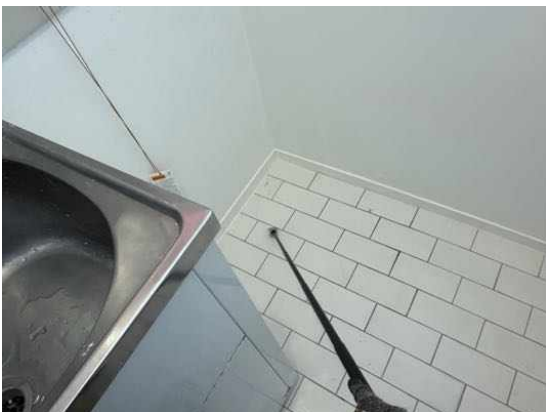
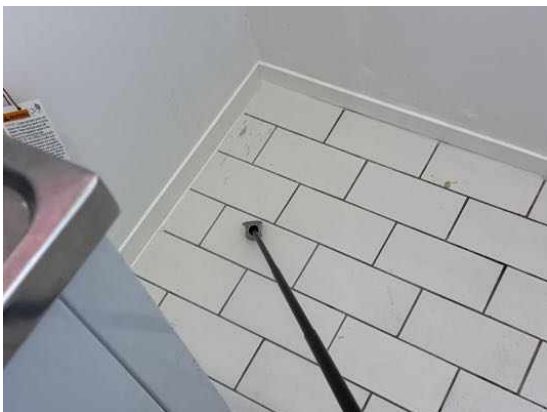
Finding 3.05

Building:	Main Building
Location:	Some Internal Areas
Finding:	Tiles - Drummy
Information:	Drummy tiled areas were identified at the time of inspection. The term 'drummy' refers to tiles that have become detached from their fixing, despite otherwise being in relatively good condition. Such defects are generally caused by physical or moisture damage to the area. Drummy tiled areas may also be a direct result of poor workmanship during the construction process.

Tiled areas may swell and shrink with changes in air humidity if the area has sustained moisture damage. Any exposure to moisture is capable of causing tiled areas to become drummy and/or cracked over a prolonged period of time. Drummy tiled areas generally require removal and replacement of affected tiles, with adequate sealant and grouting.

Specialist trades are available for these types of services. A registered builder may be required to undertake works if damage is extensive or if secondary building defects have resulted. Otherwise, it is advised that a tiling contractor be appointed to perform works as necessary. Immediate action is recommended to ensure that no further damage is sustained in the affected area.

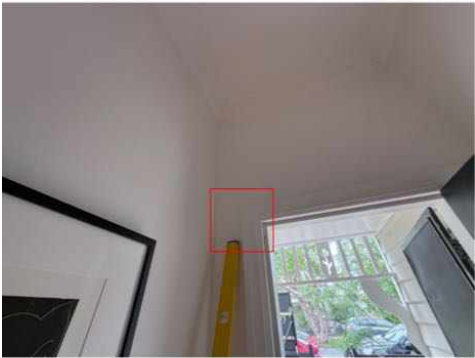
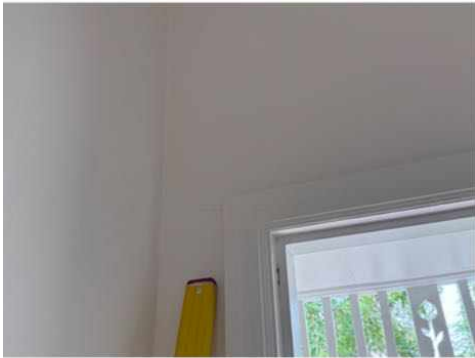
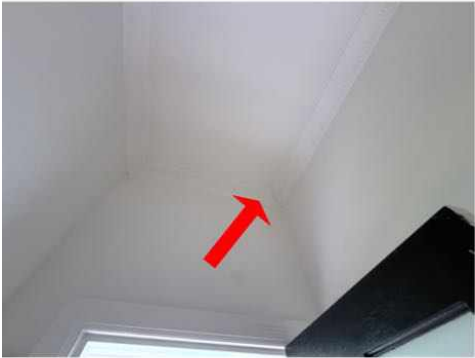
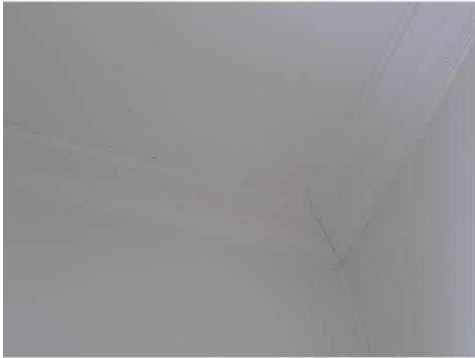
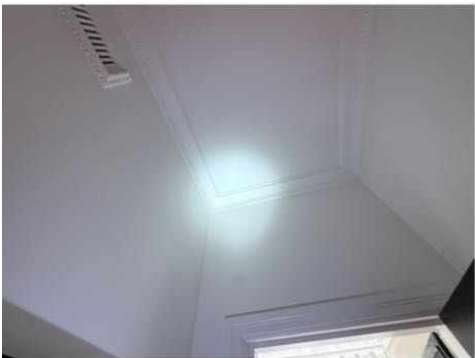
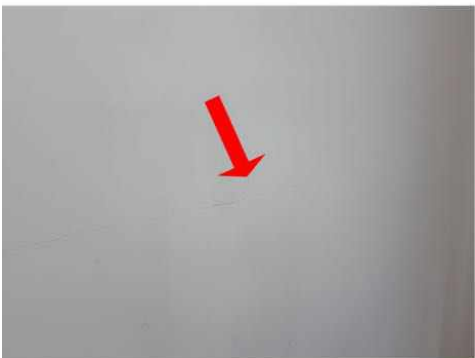
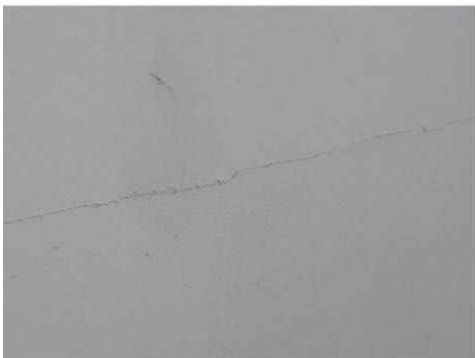
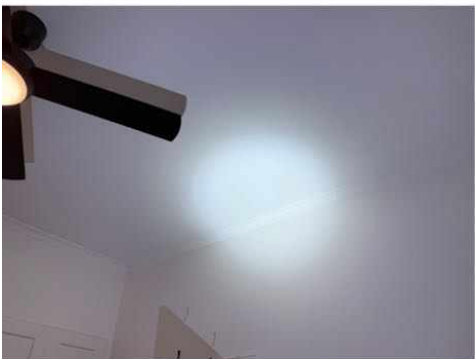
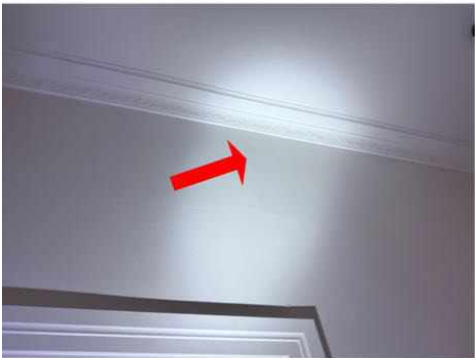
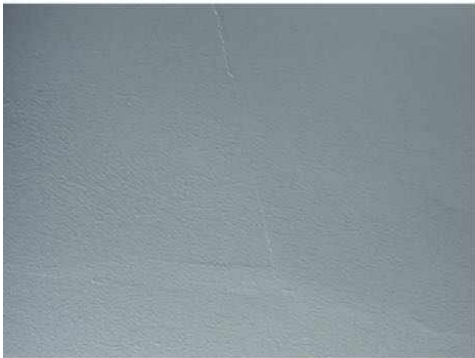
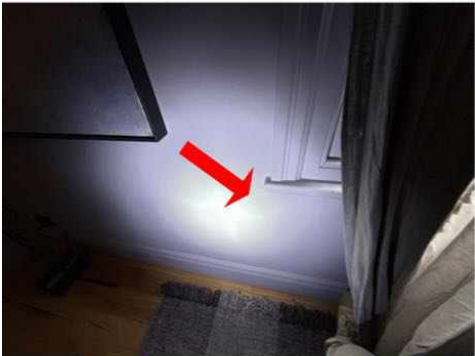
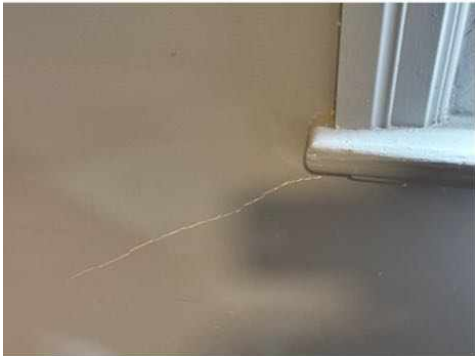
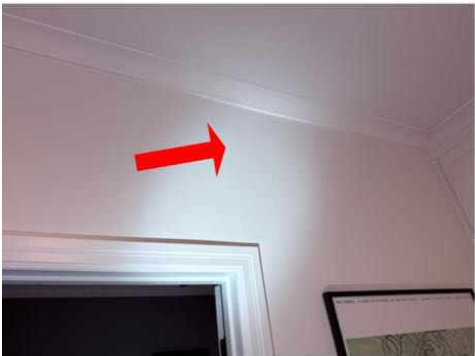
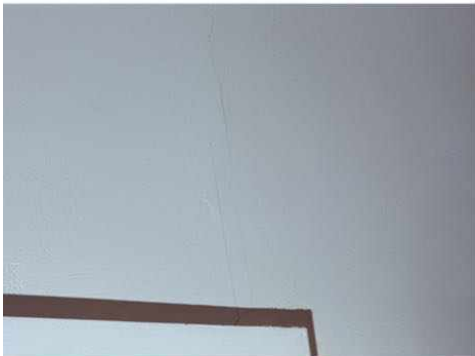
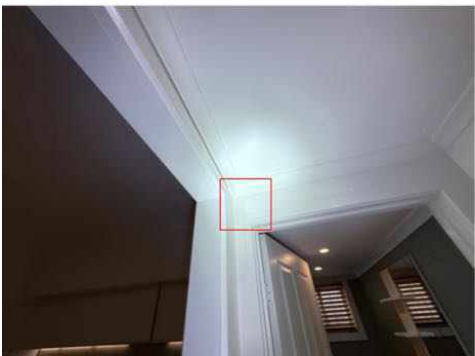
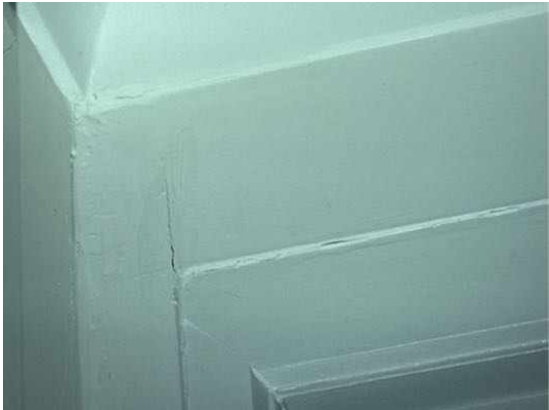
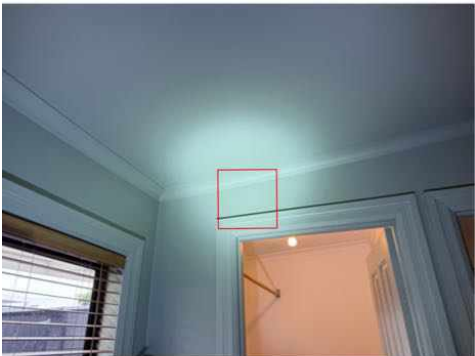
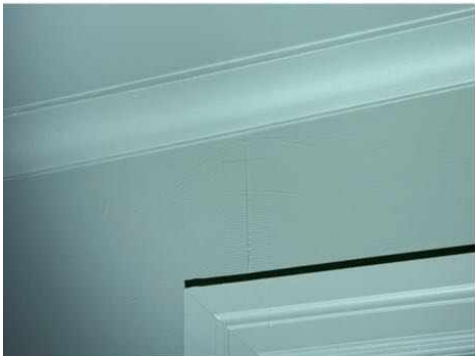
Finding 3.06

Building: Main Building
Location: Some Internal Areas
Finding: Cracking - Damage Category 1 - Fine (up to 1mm)
Information: Although fine cracks are quite noticeable, they are often only considered to be an appearance defect, and usually do not indicate any structural damage. Generally, the cause of a fine crack is indicative of a separation between building materials and finishes (e.g. paint, plaster, etc.) along joins.

Cracking of this nature can generally be repaired with minor sanding, filling and/or repainting. Such works should be performed by a qualified painter or a general handyman.

Monitoring of all cracking should be conducted frequently. Always contact a building inspector should cracks widen, lengthen, or become more numerous.

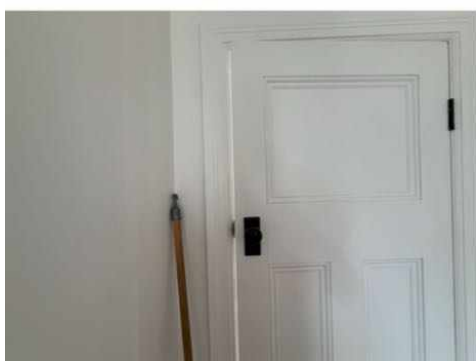
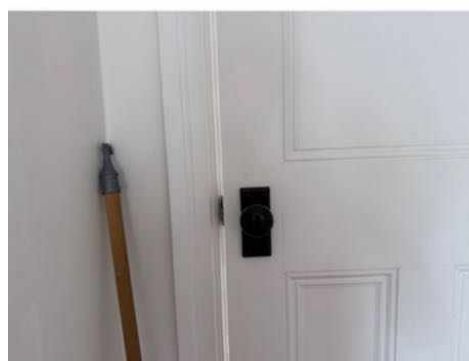
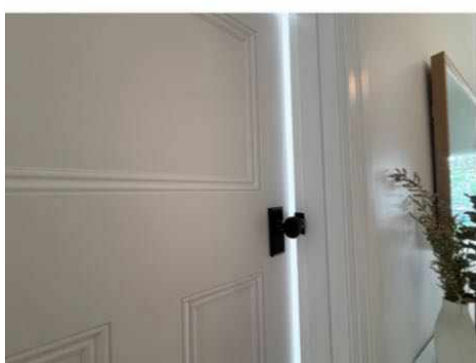
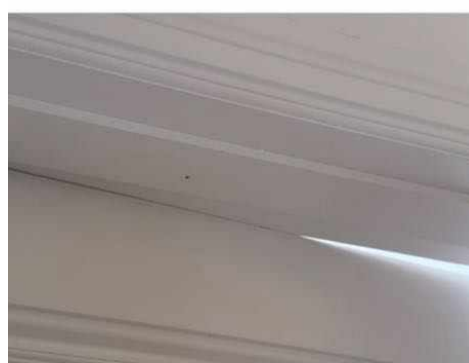
Finding 3.07

Building:	Main Building
Location:	Some Internal Areas
Finding:	Door - Binding/jamming
Information:	Binding and/or jamming of this door is evident during standard operation. This defect inhibits the functionality of the affected door as well as creating potential for secondary defects to associated building elements, such as damage to the floor covering.

A door that binds to flooring or to the associated door frame may have several causes, ranging from minor defects, such as poor installation of the door or deteriorated hinges, through to major issues, such as damage to subfloor structures.

Where door binding/jamming appears to indicate major structural issues, a registered builder specialising in re-stumping should be appointed to provide an estimate on the cost of rectification.

For minor causes, a qualified carpenter or general handyman should be appointed to perform minor rectification works at client discretion.

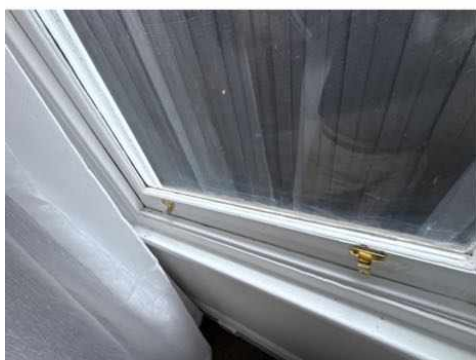
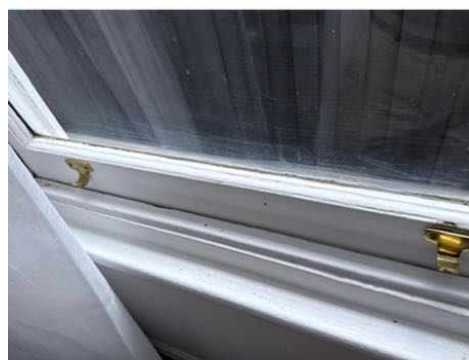
Finding 3.08

Building:	Main Building
Location:	Some Internal Areas
Finding:	Window - Stiff to slide

Information: The window in this area was jammed and difficult to operate at the time of the inspection. Windows provide ventilation to the adjoining area and should be at a fully operational level to ensure user comfort. Restricted function of the window may also pose as a potential safety hazard if required for emergency egress from the building.

Generally, factors such as general age of the building element and a lack of maintenance are the usual causes for this type of defect.

Replacement of window hardware or frame may be required, as well as minor repairs and cleaning. A registered builder or general handy person will be required to repair the window.

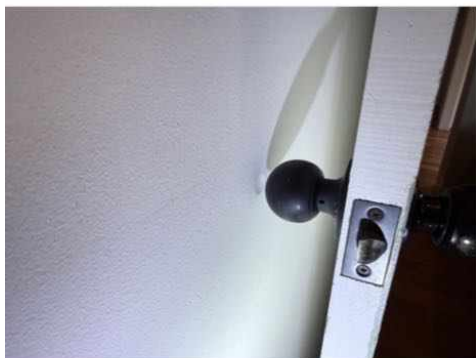
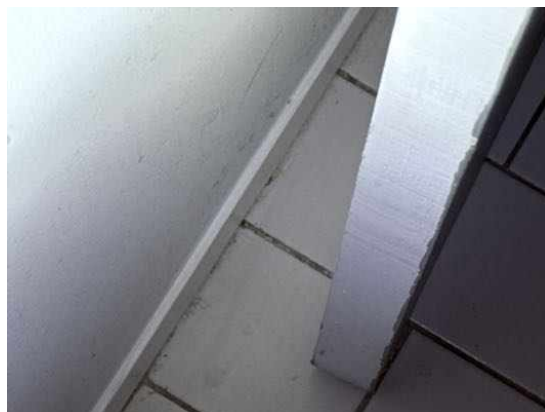
Finding 3.09

Building: Main Building
 Location: Laundry
 Finding: Door stop - Missing
 Information: The door stop is missing or is inadequate to stop the door handle from damaging the wall. Although some building elements may seem irrelevant or unnecessary, all building elements play a key role in the operation and function of the overall structure and its performance.

Re-installation or replacement of the door stop is advised as soon as possible to prevent any subsequent damage to the door or associated structures. A general handyman may be appointed to perform these works at client discretion.

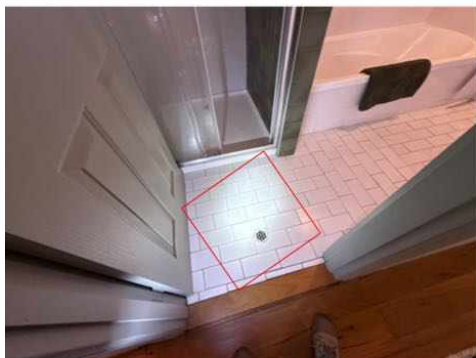
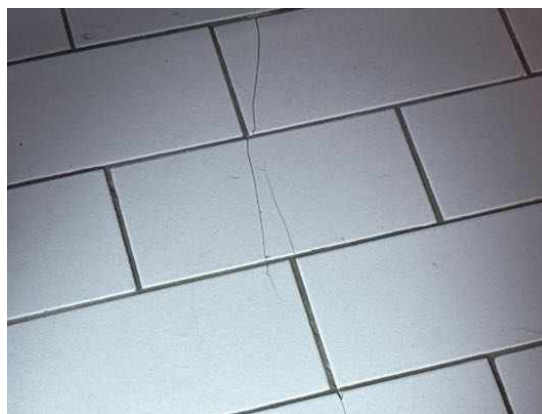
Building:	Main Building
Location:	Bathroom
Finding:	Cracked floor tiles
Information:	Cracking in the floor tiles was evident in this area at the time of inspection. It is suspected that this cracking has occurred as a result of minor settlement or shrinkage of the slab.

Cracked tiles throughout the household detract from the overall appearance of the affected areas however it is unlikely to create or lead to any secondary defects.

While not considered a matter of urgency, replacement of cracked floor tiles is recommended at the clients discretion. A tiling contractor may be appointed to perform these works. Where cracks become more numerous, contact a licensed building inspector for further investigation.

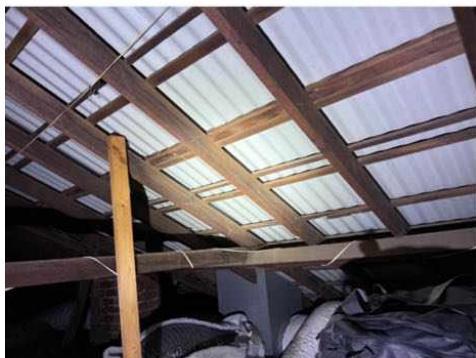
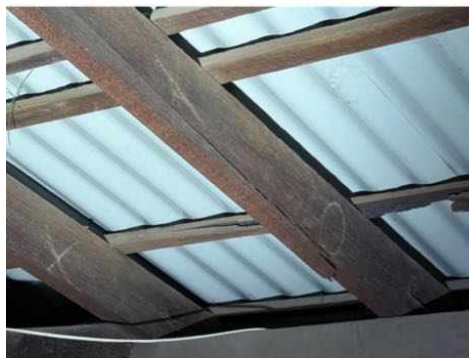
Finding 3.11

Building:	Main Building
Location:	Roof Void
Finding:	Timber Roof Truss Member Showing Partial Cracking (Moderately significant)
Information:	During inspection of the roof void, a longitudinal crack was noted to a roof truss/rafter member. The cracking appears to follow the natural grain of the timber and is consistent with age-related shrinkage and timber checking commonly observed in seasoned structural members.

At the time of inspection, no significant deflection, distortion, or immediate structural distress was evident. However, where splitting extends deeper into the section, there is potential for some reduction in member stiffness over time if left unmonitored.

As a precaution, it is recommended that the affected member be reviewed by a qualified carpenter during routine maintenance to confirm no reinforcement is required. Periodic monitoring is advised to ensure the crack does not progressively widen or extend.

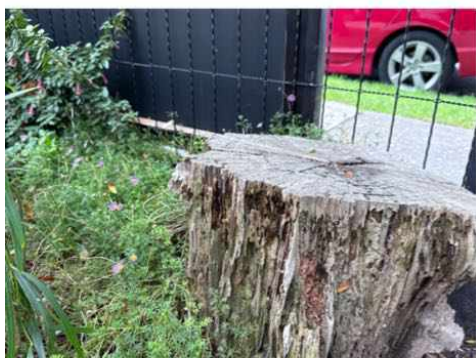
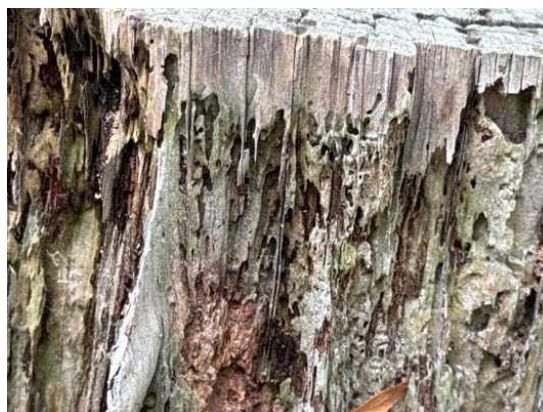
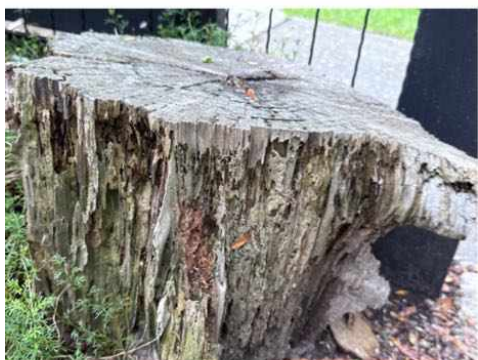
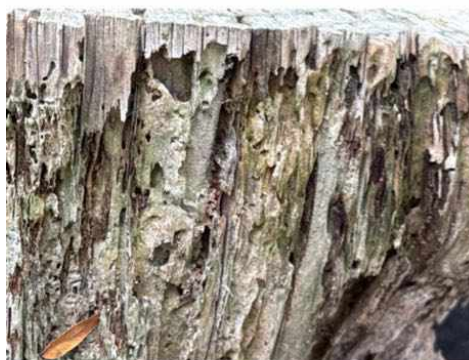
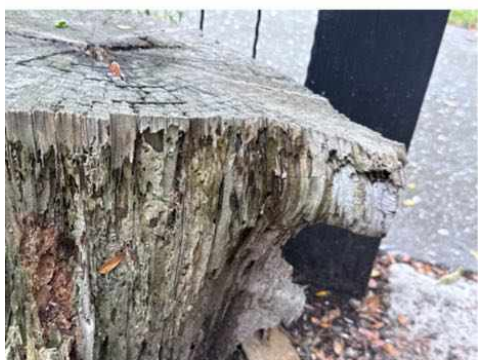
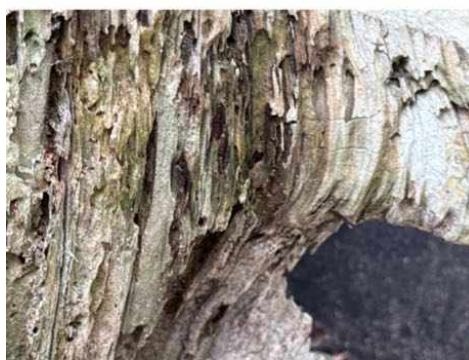
Building:	Main Building
Location:	Yard
Finding:	Evidence of termite damage - minor
Information:	Despite no live termite or timber pest activity being indicated, previous termite damage was found to have affected this area. This damage is considered to be inactive and is minor in nature.

It is advised that the area be visually inspected frequently to ensure that the condition of affected building materials does not worsen. At the time of inspection, damage is not structural and is only considered to be superficial.

A building contractor may be appointed to provide a further invasive inspection if further damage is evident.

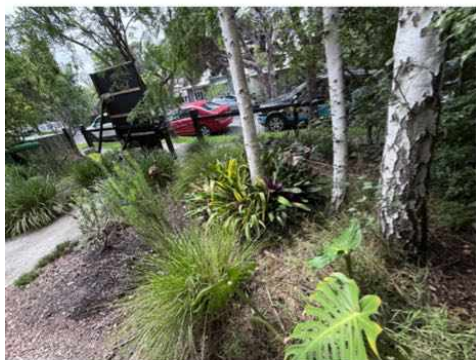
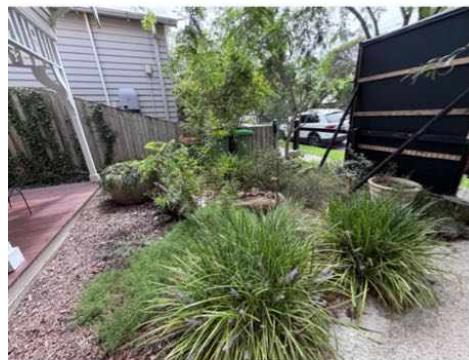
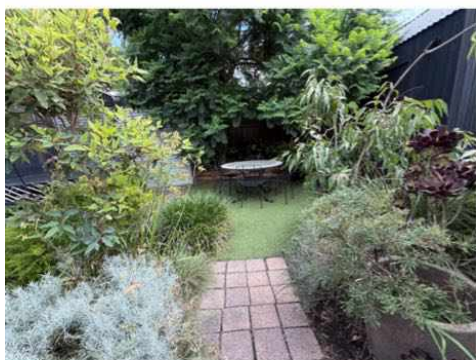
Finding 6.02

Building:	Main Building
Location:	All External Areas
Finding:	Garden Bed/ Mulch - Conditions Conducive to Termites
Information:	Mulch were found around the property. These areas can include untreated timber, and with a combination of moisture from watering hosing can make conditions conducive to termite activity and termite ingress.

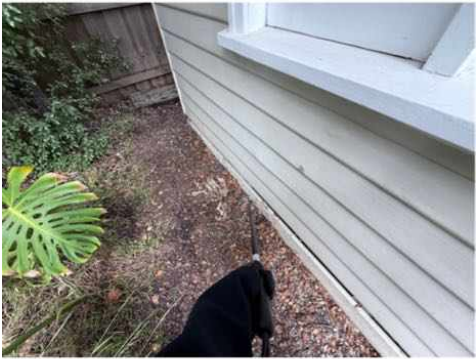
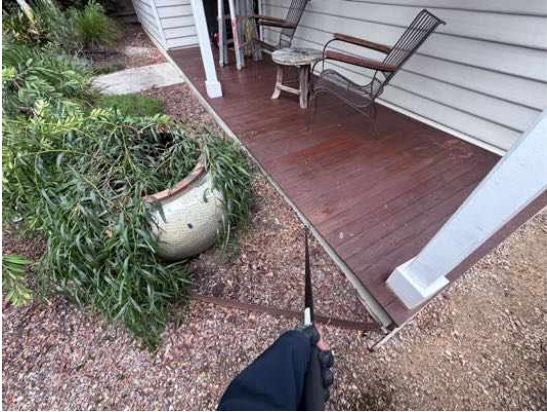
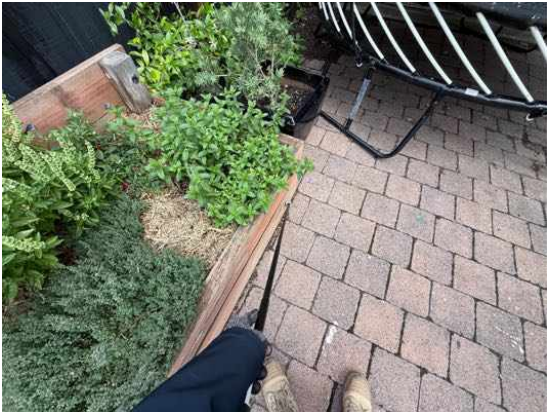
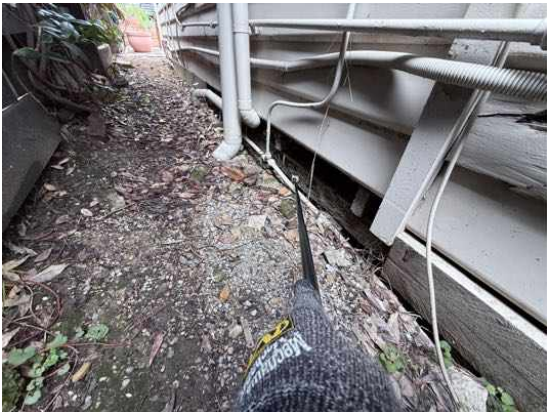
Finding 6.03

Building:	Main Building
Location:	All External Areas
Finding:	In ground contact
Information:	Any timbers in direct ground contact provide opportunity for concealed termite entry and are likely to be subject to premature rot and decay as the soil retains moisture or damp conditions against the timbers.

Remove untreated timber that is in direct contact with external grounds. Consider replacement with more durable materials i.e. treated timber or non timber elements. Frequent pest inspections are advised to readily identify any termite activity in these areas.

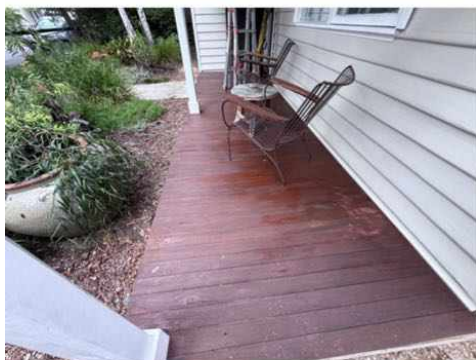
Finding 6.04

Building: Main Building
 Location: Entry
 Finding: Timber deck- High conducive condition.
 Information: We are unable to inspect under the timber deck if its in close proximity to the ground.

Where we are unable to inspect timber structures, decks and subfloor areas the risk of undetected termite activity is rated as extremely High.

We strongly recommend the purchaser prioritise a termite treatment by a Licensed Pest Controller to protect and maintain the asset as it is a timber structure.
