Building and Timber Pest Inspection Report

Inspection Date: Tue, 3 Mar 2026

Property Address: 56 Queensville St, Kingsville VIC 3012,
Australia

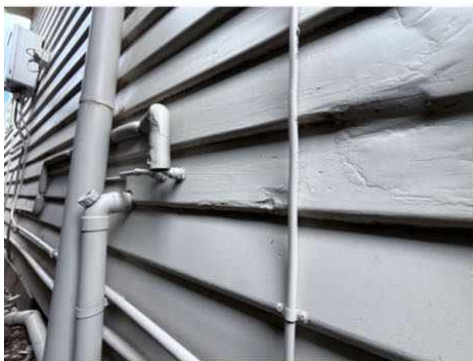
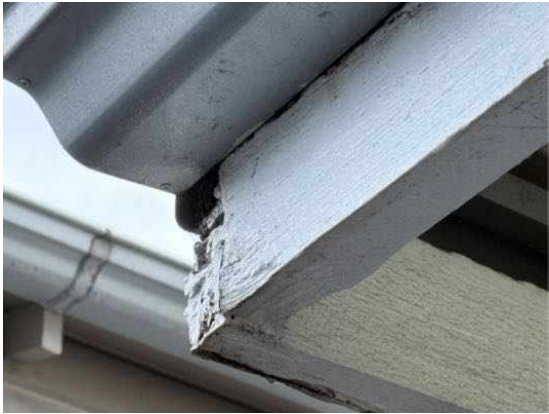
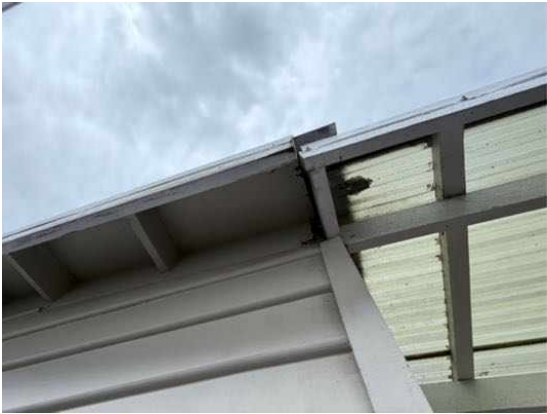
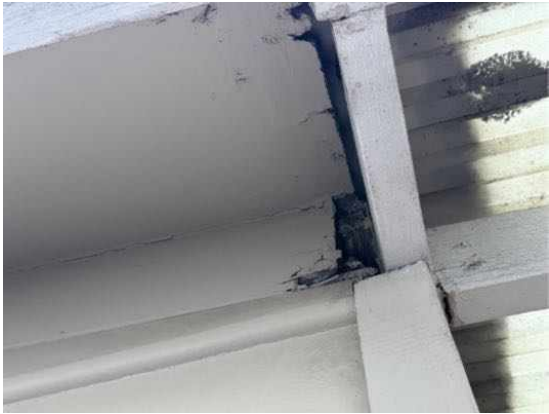
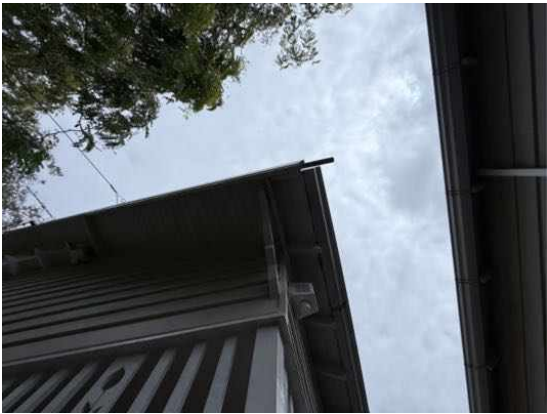
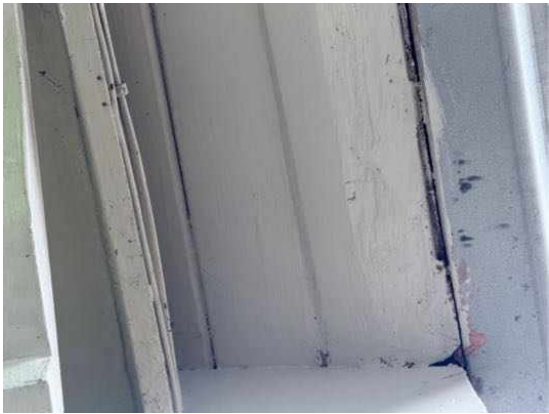
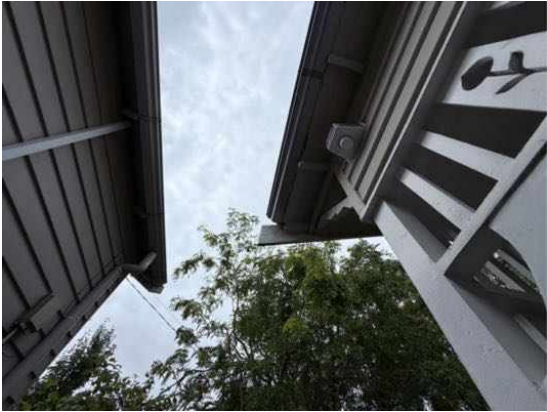
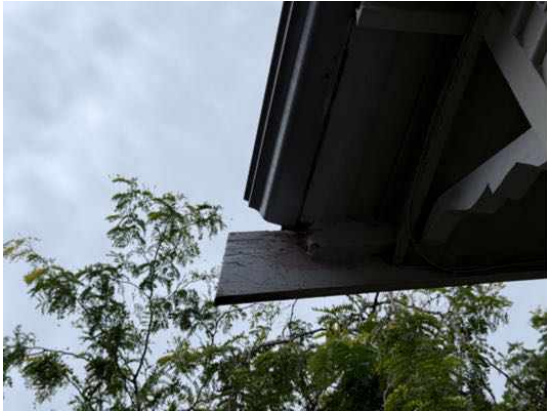
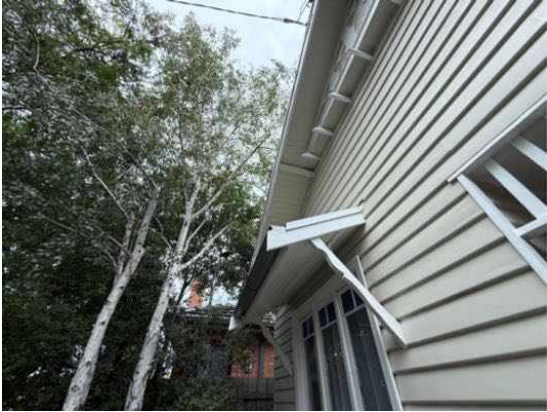
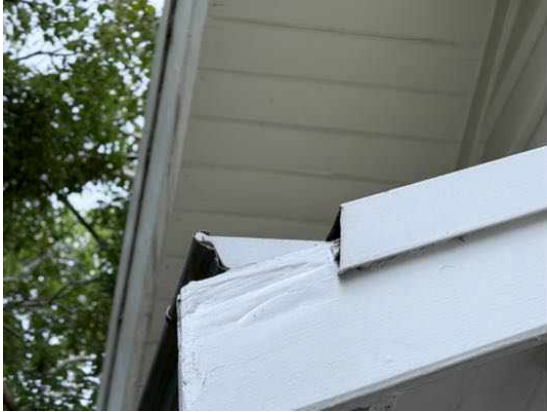
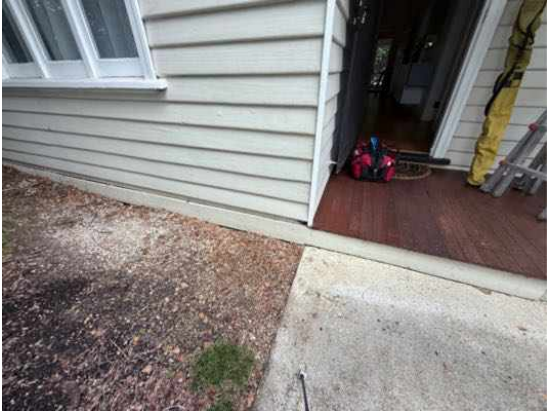
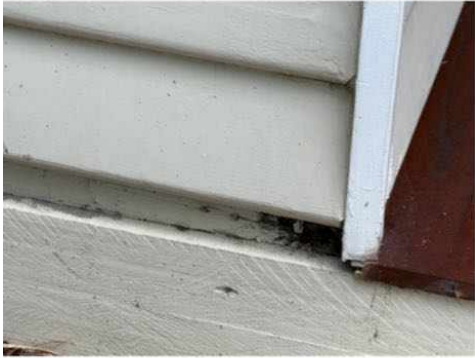
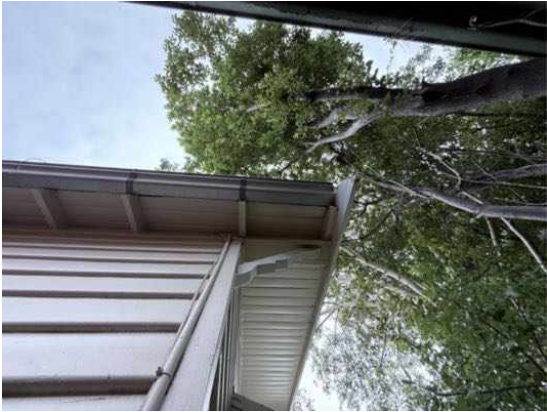
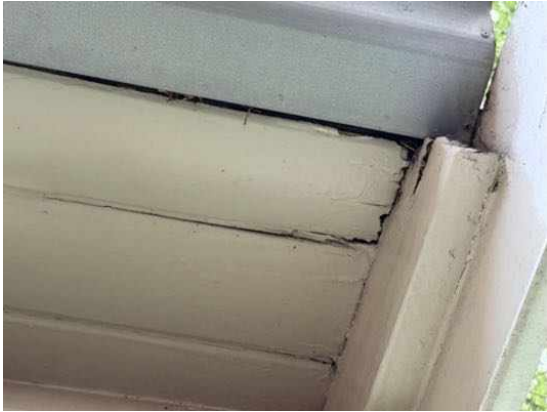
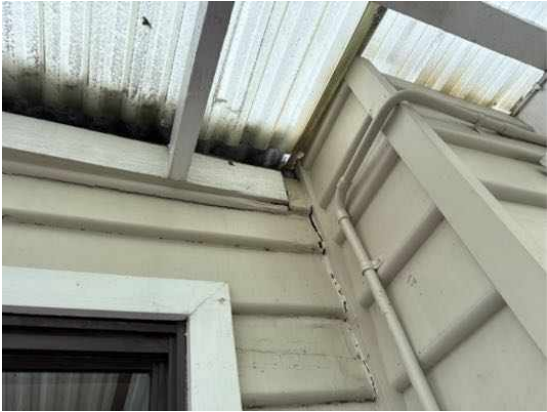
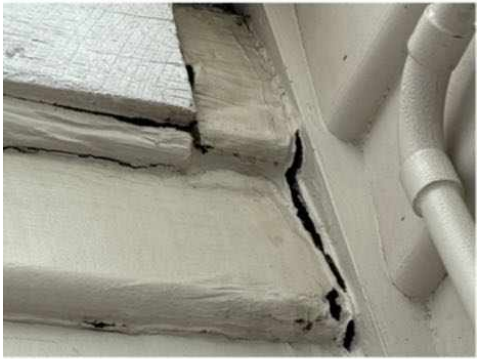
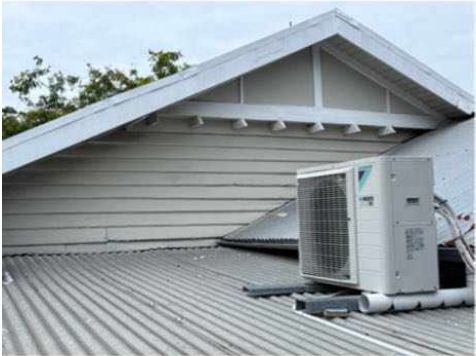
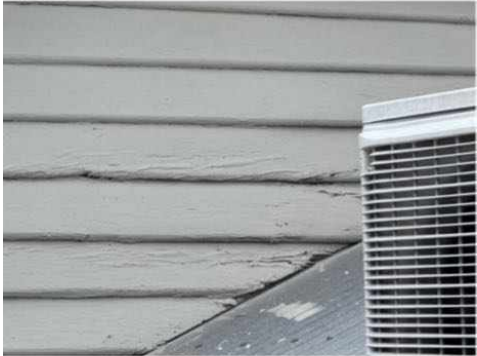
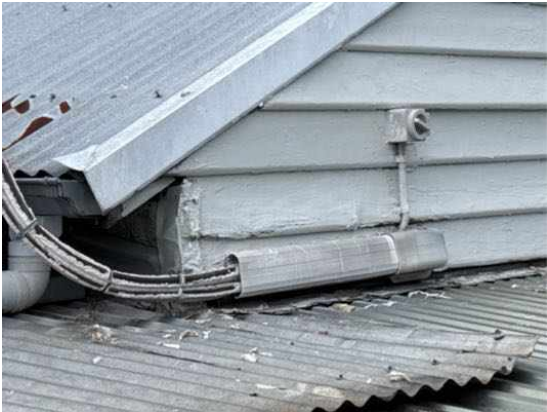
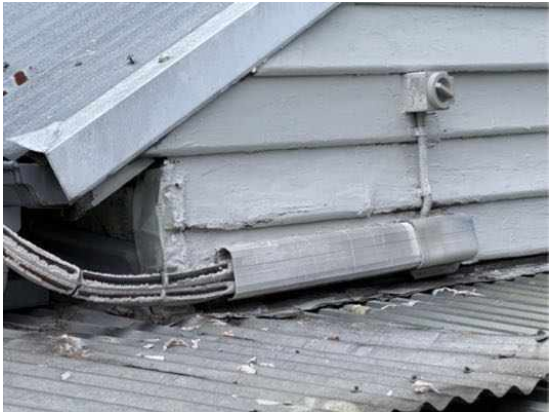
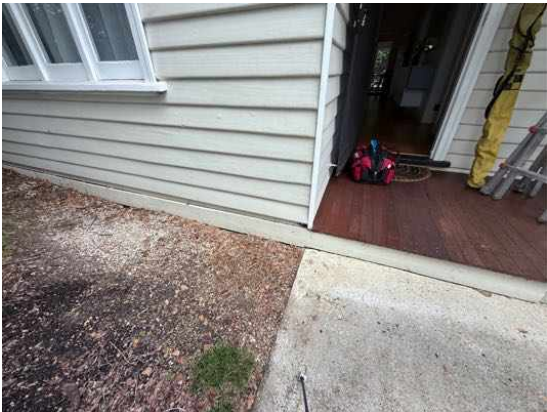
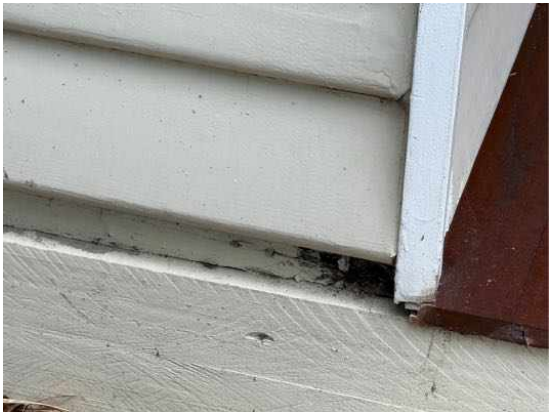
Finding 7.01

Building: Main Building
 Location: All Areas
 Finding: Wood rot
 Information: These building elements shows evidence of wood rot. Wood rot, also known as Fungal Decay, occurs when timbers and other cellulose building materials are exposed

to damp conditions on an ongoing basis. This could be the result of exposure to weathering over a prolonged period of time, or the attraction of excessive moisture from other abutting building materials. Contributing factors also include poor air ventilation in the area.

Wood rot is often associated with general damp problems and is evidenced by a 'musty' smell or mould and mildew occurring on surfaces. If left unmanaged, damp conditions can lead to further health problems and the decay of timbers will continue.

Early intervention and regular maintenance, particularly of exterior timbers, will prolong the useful life of these building elements. Prior to any works being performed, the cause of the moisture that has created the visible wood rot should be identified and addressed in a suitable manner. Replacement of affected timbers may then be a necessary step in protecting surrounding building elements from such deterioration.

A qualified plumber may be appointed to assess the cause of excessive moisture and to provide advice on any remedial works as required. A qualified carpenter or registered builder may also be required to replace affected building materials.

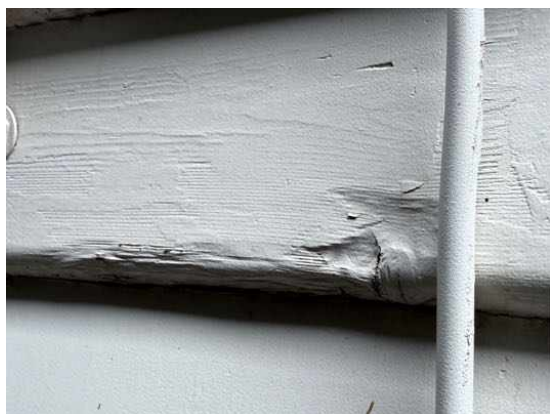
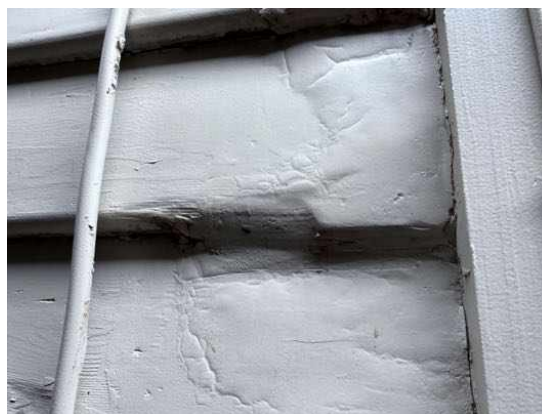
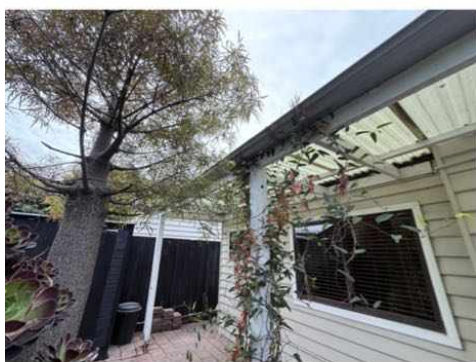
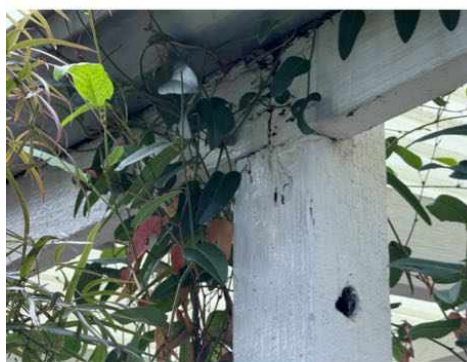
Evidence of fungal decay activity and/or damage

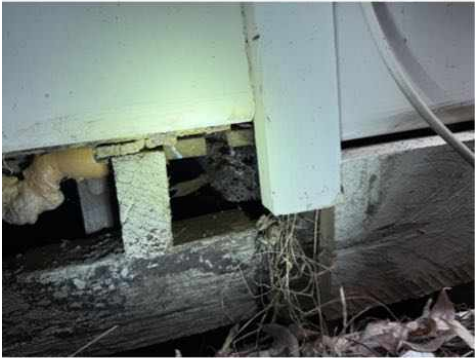
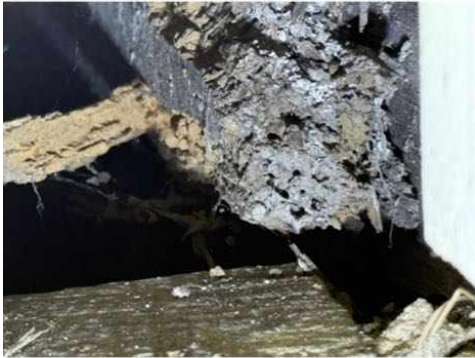
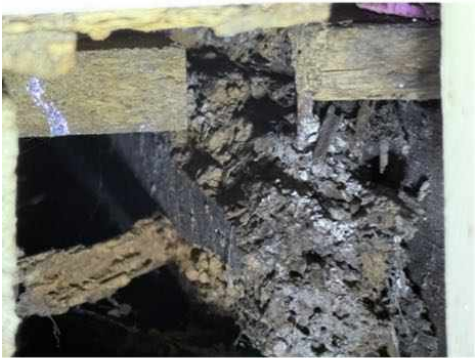
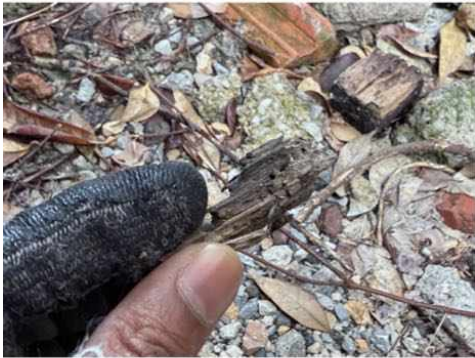
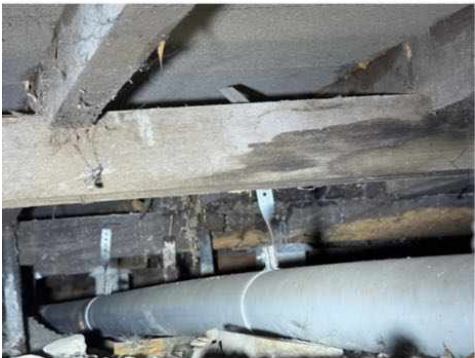
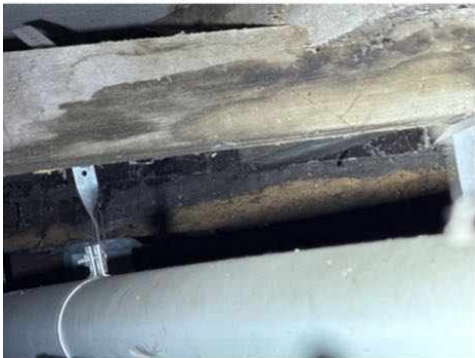
Finding 8.01

Building:	Main Building
Location:	Subfloor
Finding:	Suspected Borer Damage to Subfloor Structural Members (Moderate to Major)
Information:	Evidence of timber borer activity was observed to subfloor elements, including bearers and associated timber components. Localised surface deterioration and the presence of excessive fine timber dust (frass) were noted, which is indicative of ongoing or previous borer infestation. While this condition is generally not as immediately destructive as active termite attack, the volume of fine dust suggests that the affected timber may have experienced prolonged internal deterioration.

No full subfloor access was available to determine the complete extent of infestation or structural compromise. If primary structural members such as bearers or joists are significantly affected internally, their load-bearing capacity may reduce progressively and at an accelerated rate once section loss becomes substantial. Timber strength can deteriorate internally before obvious surface failure becomes visible.

Given the structural role of these elements, further investigation by a licensed pest control specialist and/or qualified structural practitioner is recommended to assess the depth of damage and determine whether treatment, reinforcement, or partial

replacement of affected members is required (after subfloor access is made possible). Ongoing monitoring is advised to ensure structural integrity is maintained.

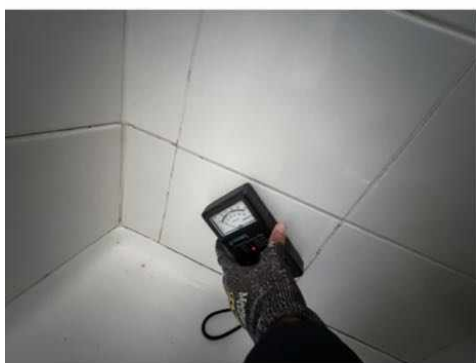
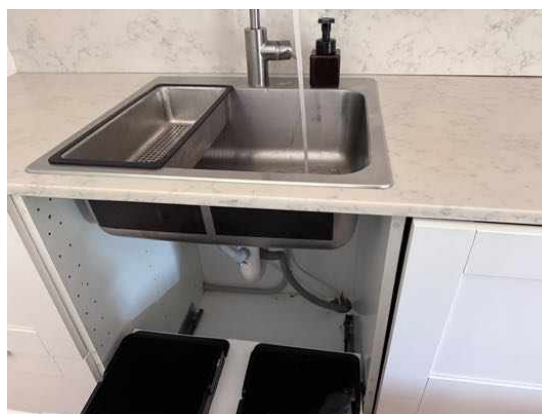
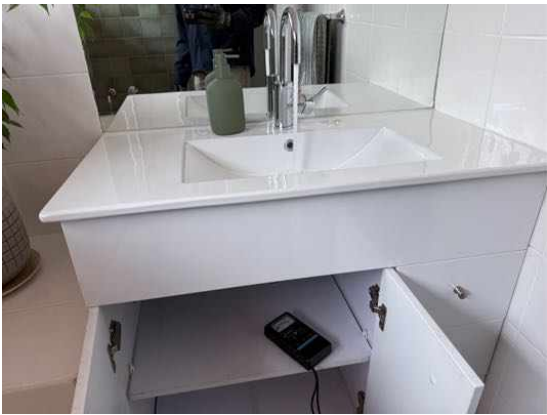
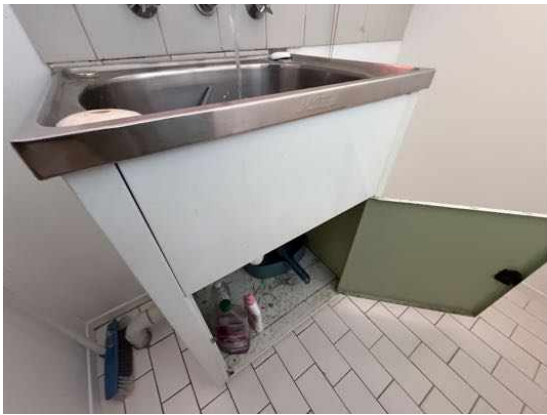
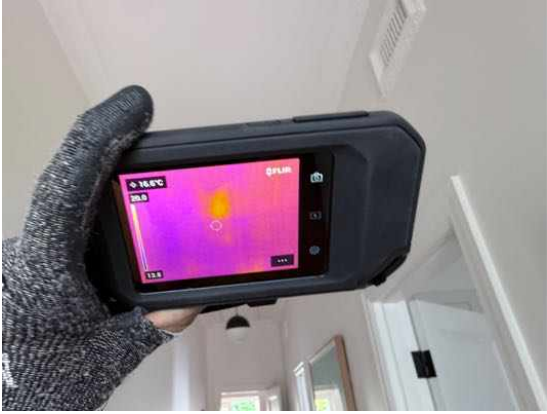
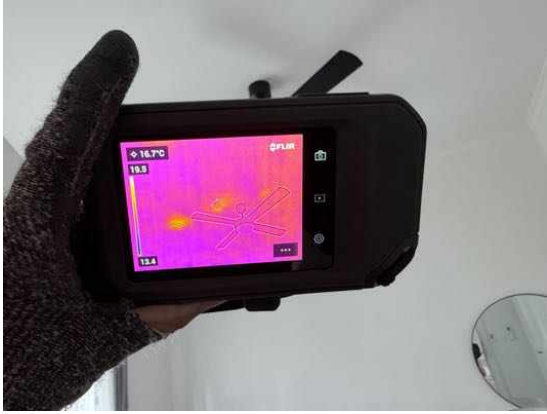
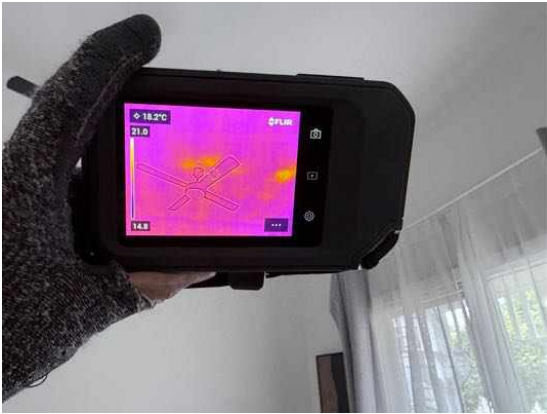
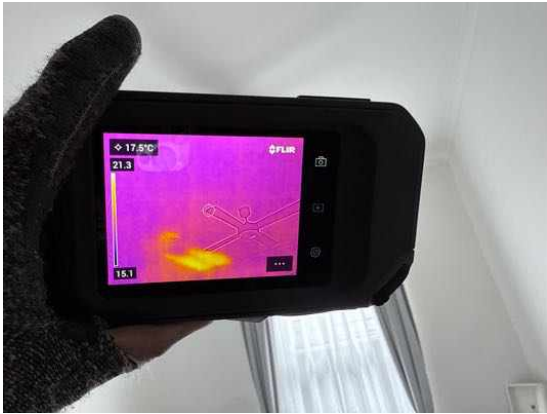
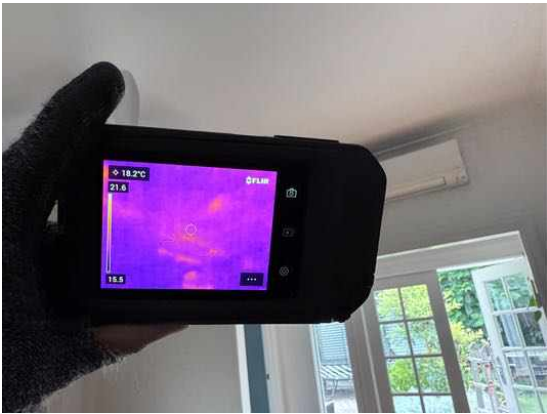
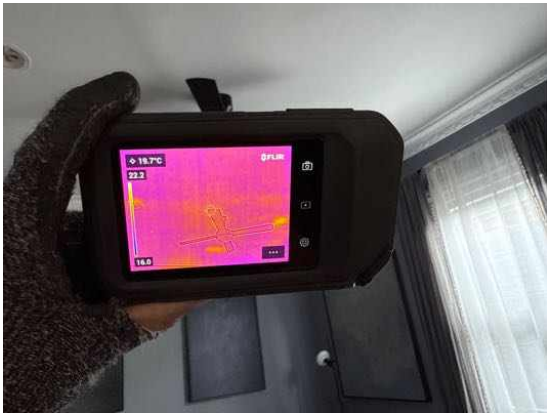
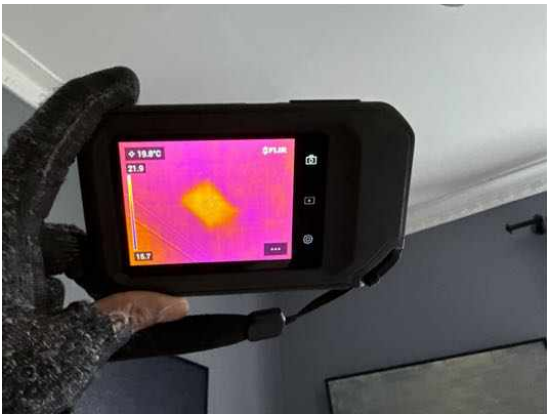
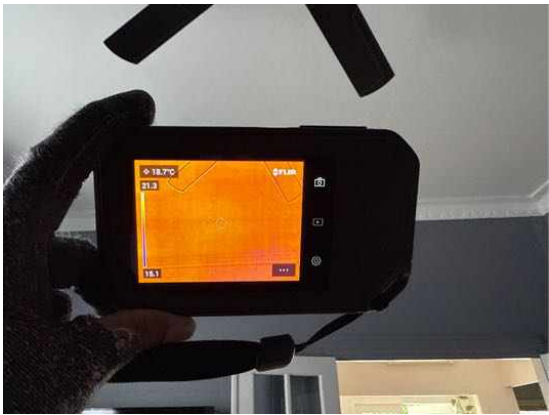
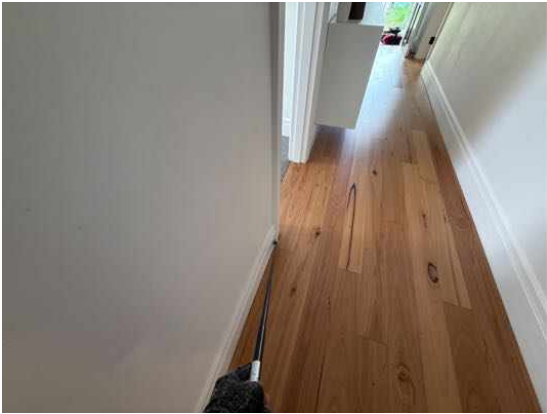
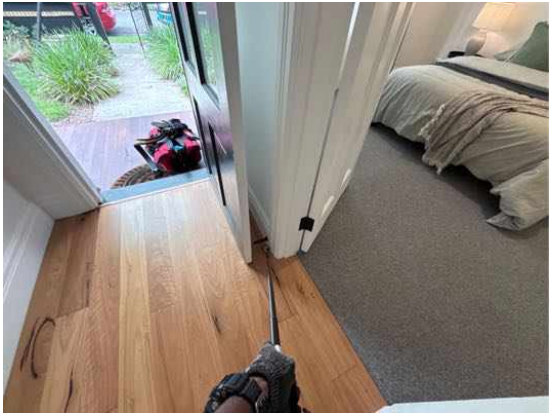
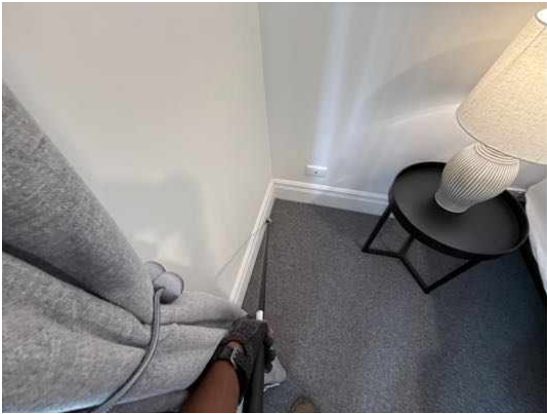
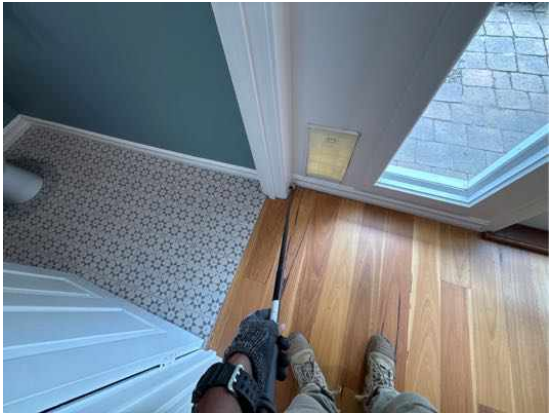
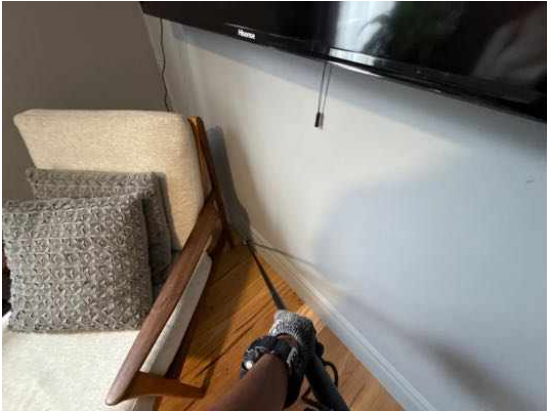
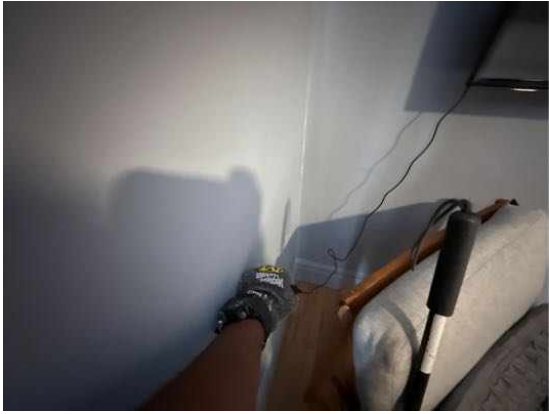
Building: Main Building
Location: All Areas
Finding: Termite Techniques
Information: All areas of the dwelling are checked with particular attention paid to wet areas which were closely assessed to check for excessive levels of moisture and temperature anomalies.

No evidence of termite activity was found inside the house at the time of the inspection.

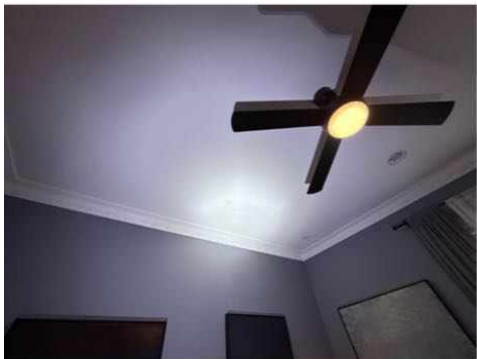
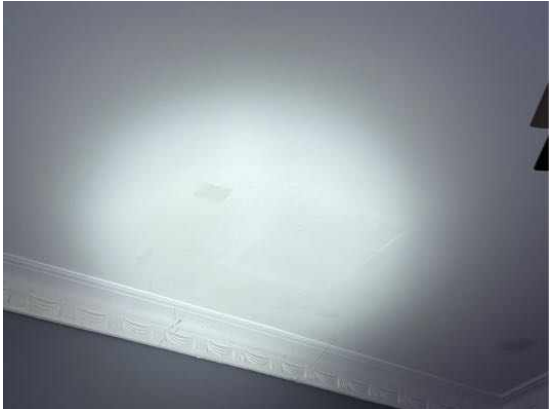
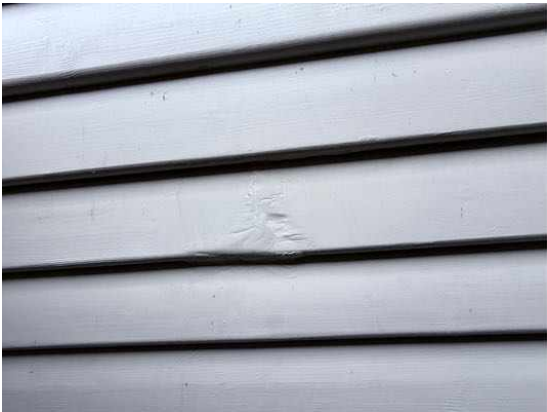
Building: Main Building
Location: All Areas
Finding: Evidence of recent renovations.
Information: Whenever a property is refurbished, majority of the defects if present could get obscured beneath the revamped work. The same can be said for this property as well. Some fine cracks are filled over, walls have been painted etc. It is difficult to pinpoint on any particular defects present below such layers.

Once the property is occupied, all areas should be monitored for a period of 12-24 months to lookout for any arising defects. If staining or cracking is noticed extensively in that period, always consult your building inspector.

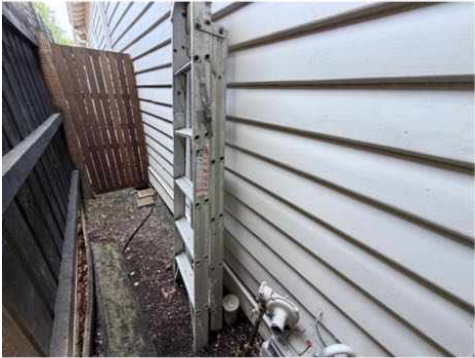
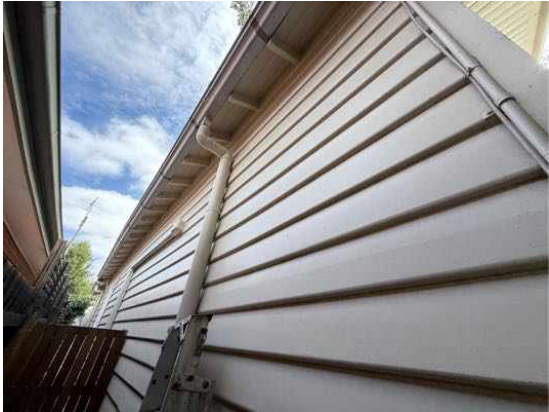
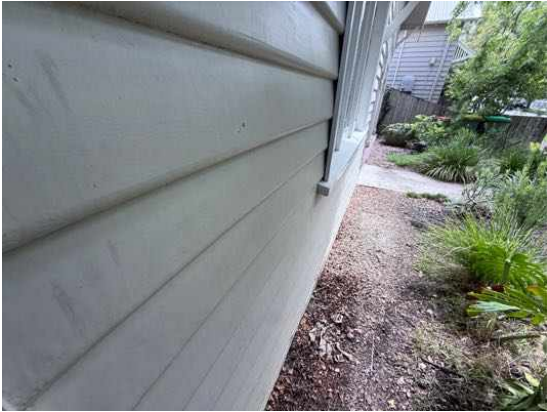
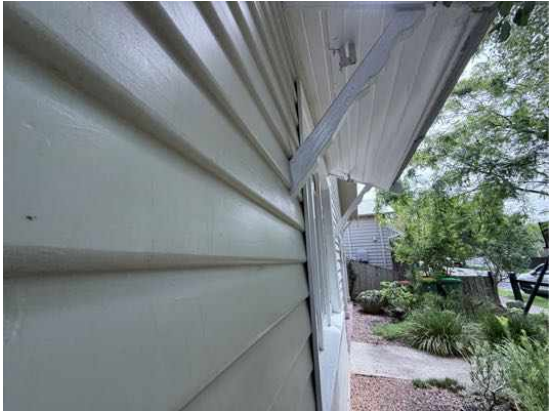
Building: Main Building
Location: All Areas
Finding: Additional photos & Obstruction/Limitations.
Information: Additional photos for general documentation. May have some minor maintenance items not listed in the defects section.

Furthermore, some photographs are an indication of the obstructions and limitations which impeded full inspection of the property at the time of inspection. These obstructions can hide an array of defects and should be removed to allow full inspection to be carried out. A re-inspection is recommended once the areas are made accessible.
