Building and Timber Pest Inspection Report

Inspection Date: Thu, 12 Mar 2026

Property Address: 3 Mckevitte Ave, East Hills NSW 2213,
Australia

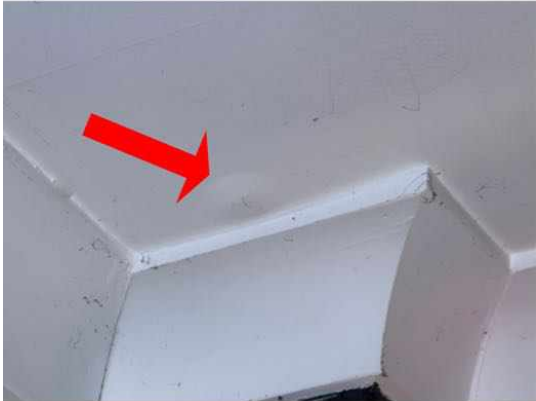
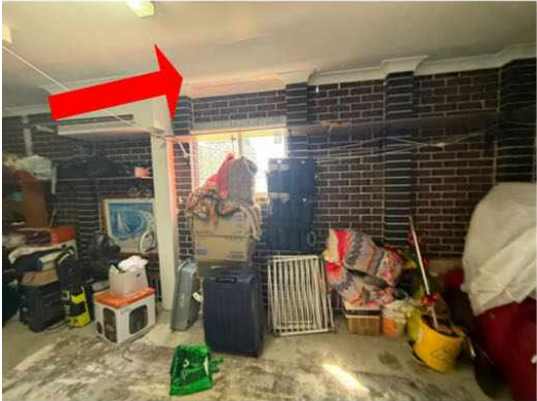
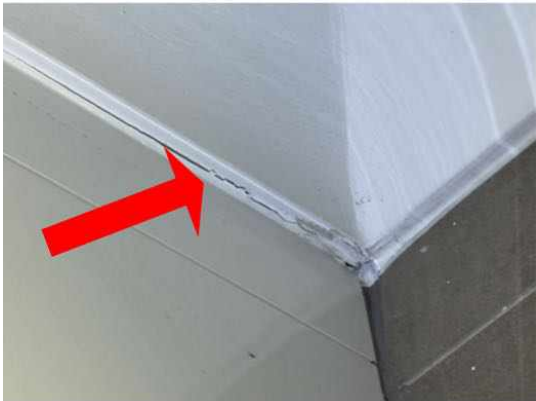
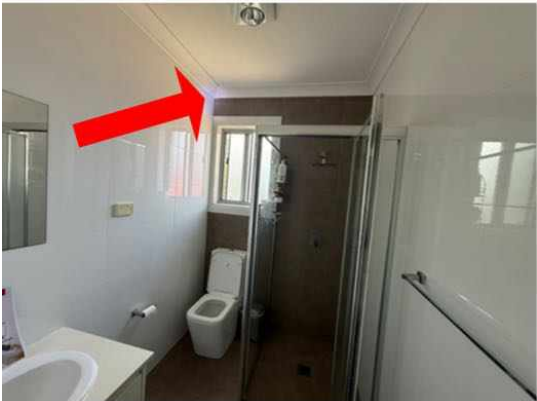
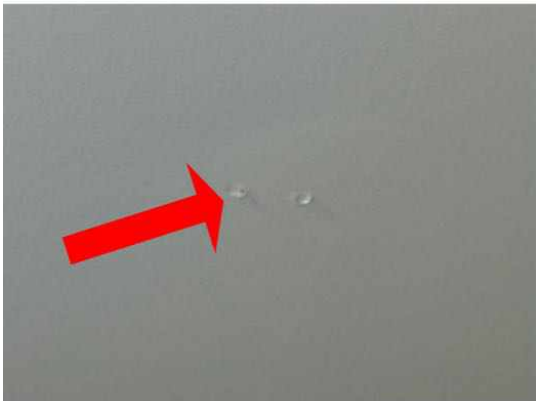
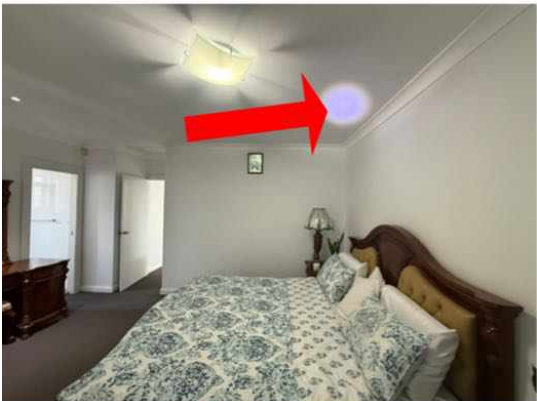
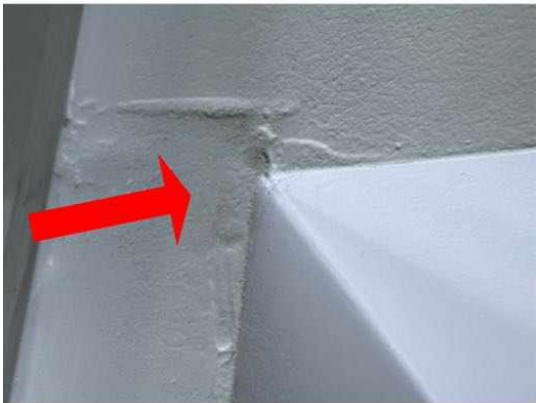
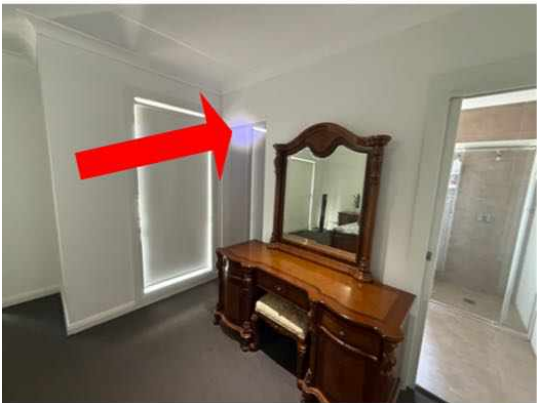
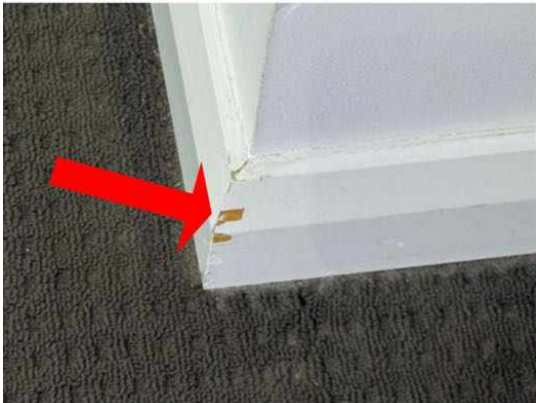
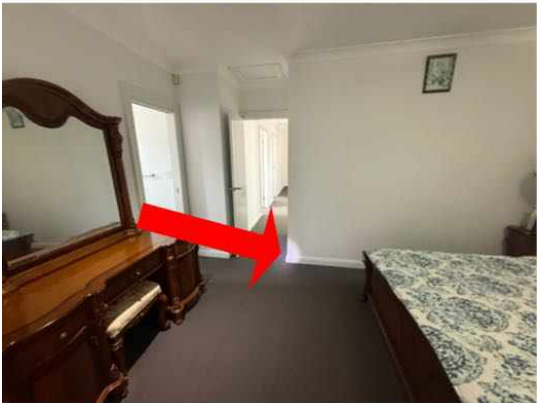
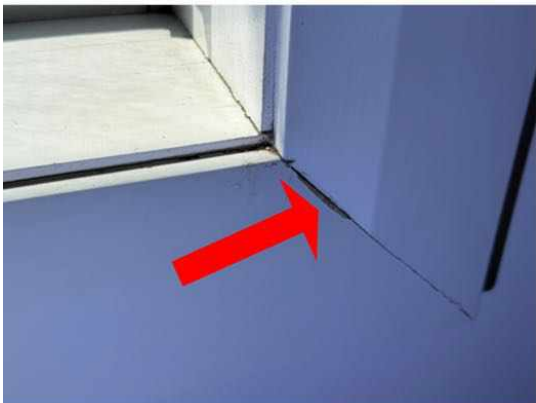
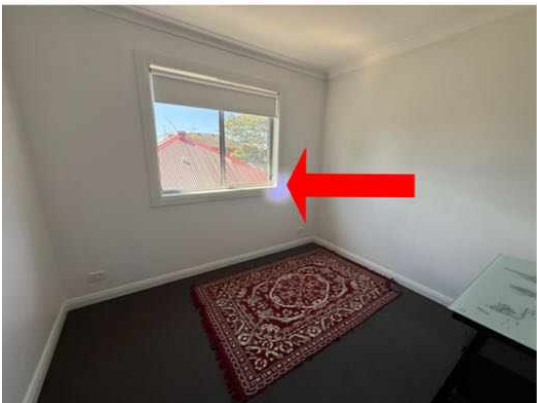
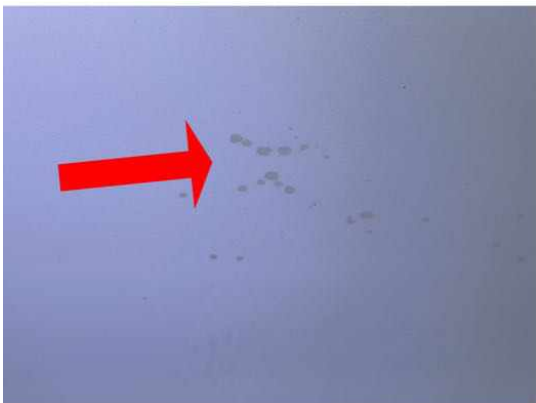
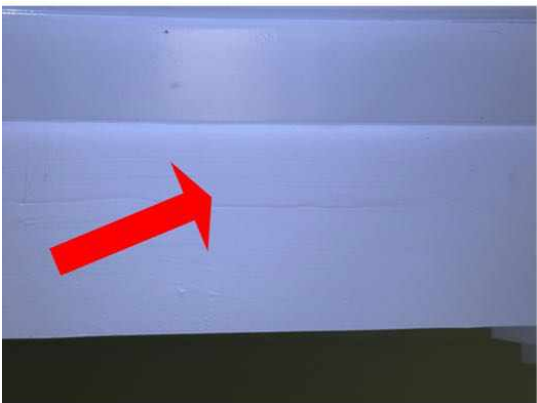
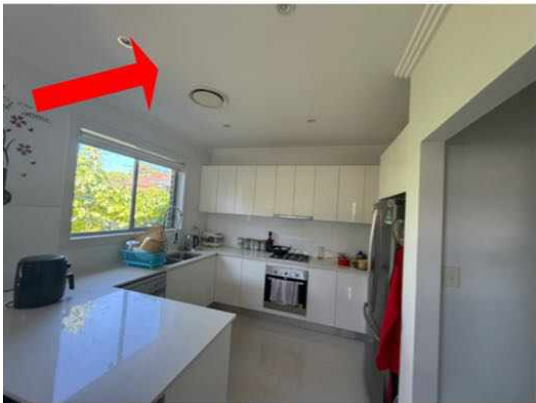
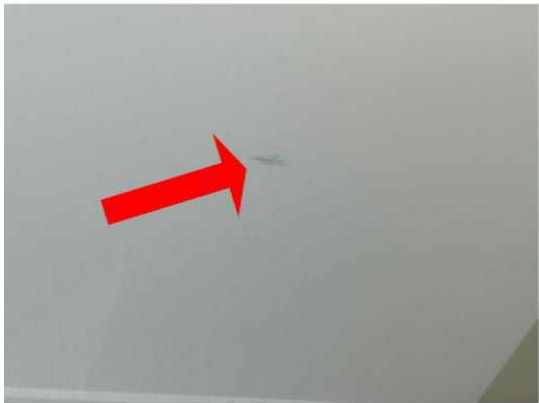
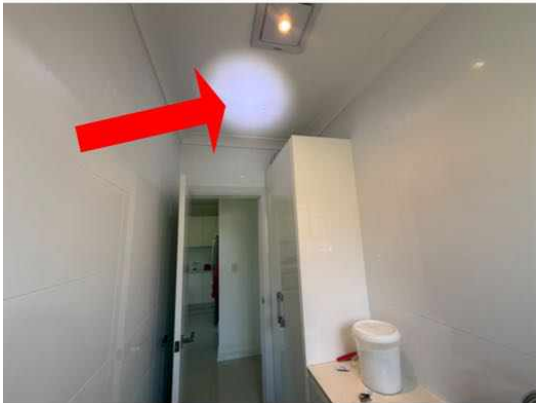
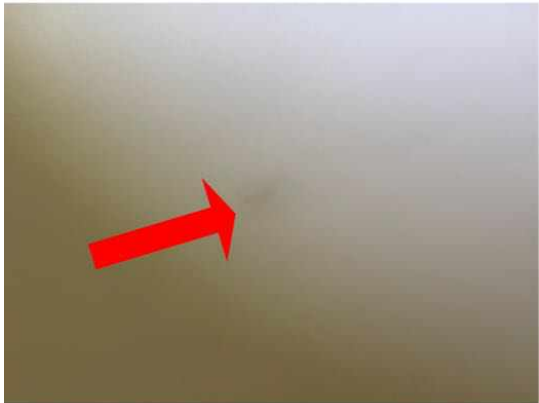
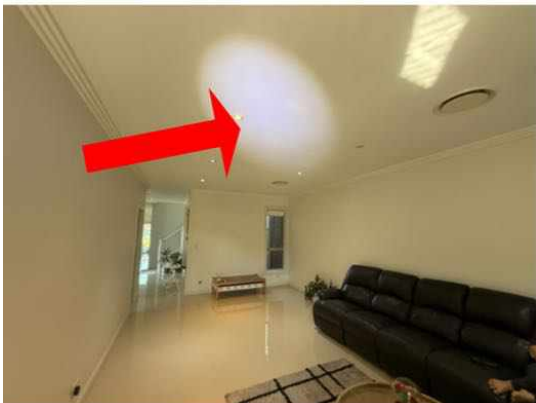
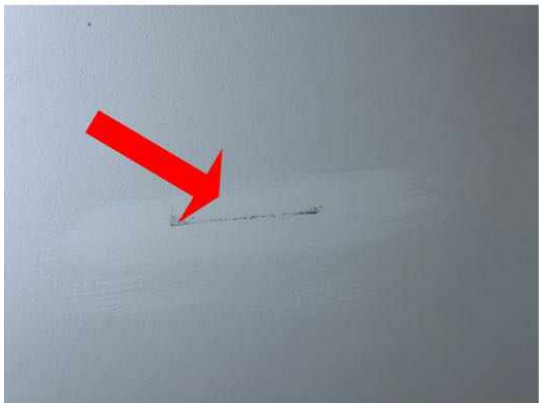
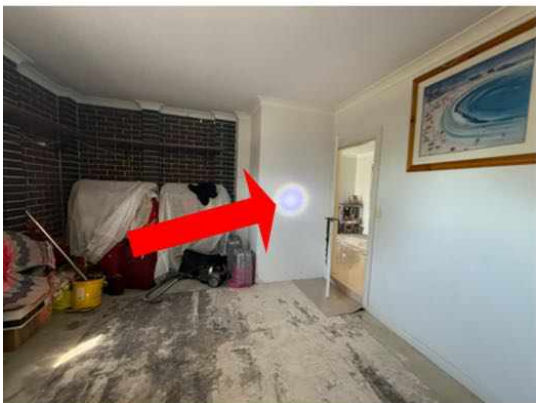
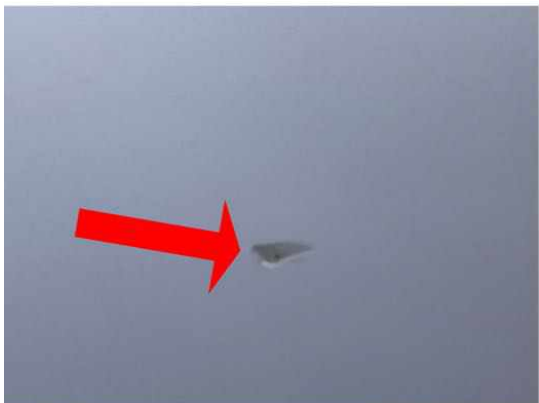
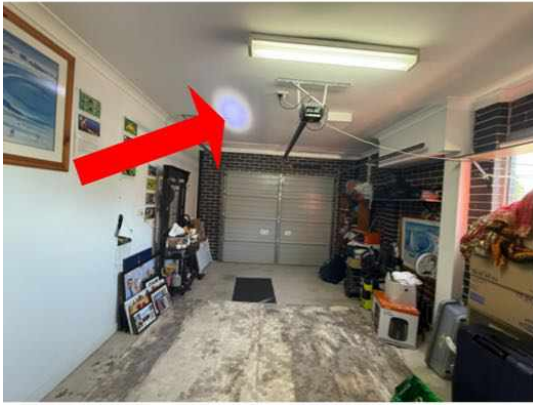
Building:	Main Building
Location:	All Internal Areas
Finding:	Paint finish - Substandard, Wear and Tear
Information:	The paint finish in this area was found to have been completed to a substandard level or wear and tear as the normal deterioration of a property from ordinary, everyday use. Exposure to the elements, time, as well as day to day living can cause fair wear and tear.

If this applies, further areas of poor and incomplete finishes could develop over time. Furthermore, substandard, wear and tear paint finishes in areas exposed to moisture, e.g. external areas or wet areas, could lead to deterioration of underlying building materials.

Substandard, wear and tear paint finishes should be sanded back, filled, leveled and repainted, as applicable. Where inadequate paint protection has led to the deterioration of the associated building element, repair and/or replacement of this building element may be required.

A painting contractor should be appointed as soon as possible to perform necessary works to aid the appearance of the affected area and to ensure that the area is protected against further deterioration. Alternatively, the homeowner following manufacturer instructions may be able to provide this service.

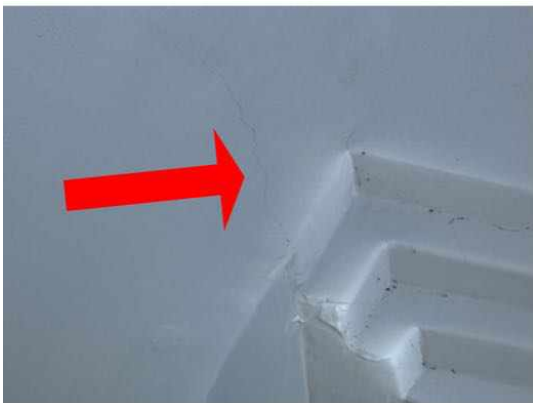
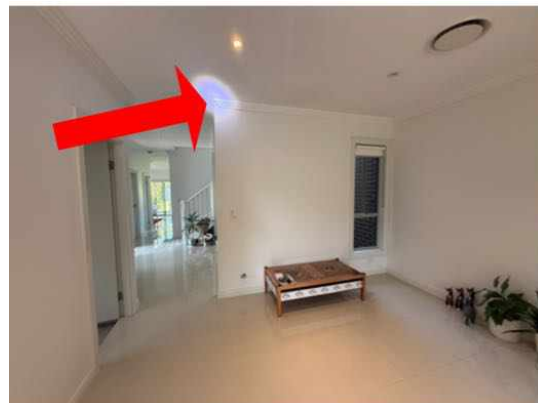
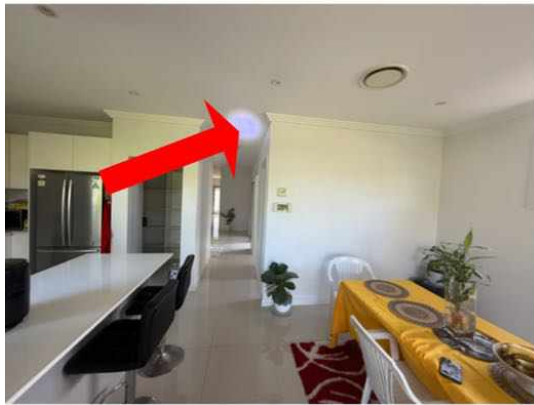
Finding 3.02

Building:	Main Building
Location:	All Internal Areas
Finding:	Cracking - Damage Category 1 - Fine (up to 1mm)
Information:	Although fine cracks are quite noticeable, they are often only considered to be an appearance defect, and usually do not indicate any structural damage. Generally, the cause of a fine crack is indicative of a separation between building materials and finishes (e.g. paint, plaster, etc.) along joins.

Cracking of this nature can generally be repaired with minor sanding, filling and/or repainting. Such works should be performed by a qualified painter or a general handyman.

Monitoring of all cracking should be conducted frequently. Always contact a building inspector should cracks widen, lengthen, or become more numerous.

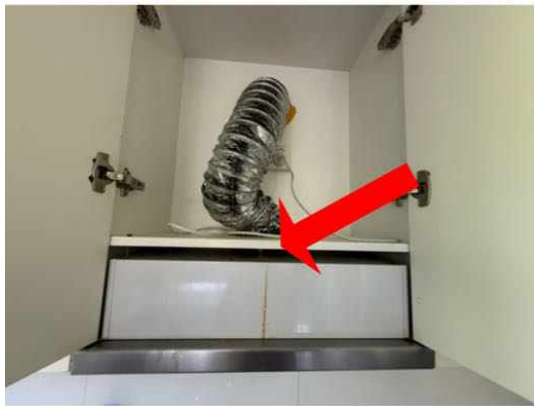
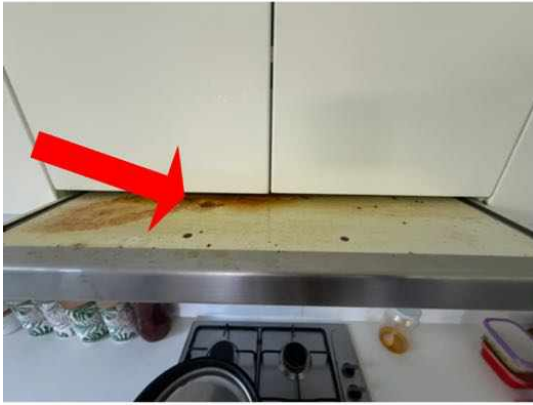
Finding 3.03

Building: Main Building
 Location: Kitchen
 Finding: Rangehood - Fan not working properly
 Information: While the range hood appears to be working at a satisfactory level, the fan to the structure was not working at the time of inspection.

Without a functional fan, a build-up of grease and evaporative moisture is likely to accelerate deterioration of the range hood and associated flue. This potential build up may also create a minor fire hazard, particularly if left uncleaned.

A licensed electrician should be appointed to replace the fan on the range hood to restore it to a fully operational state.

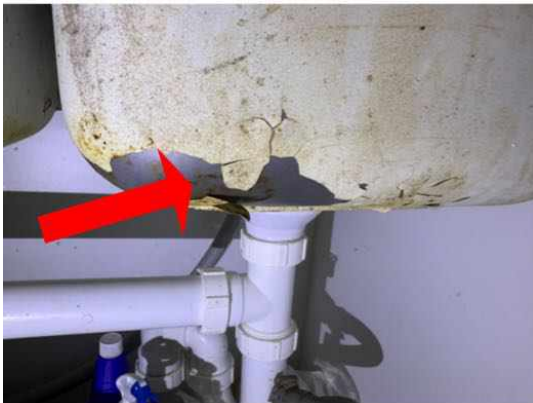
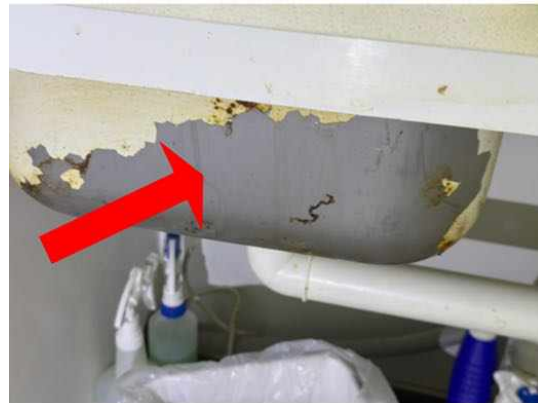
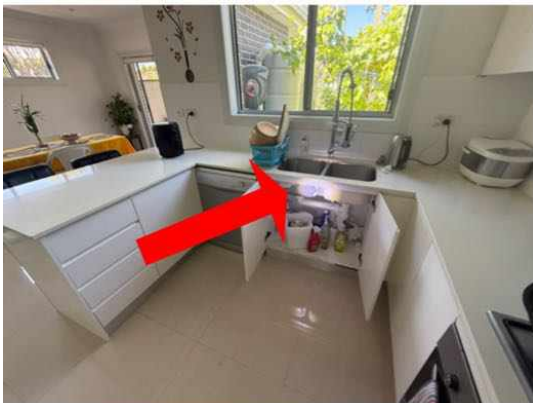
Finding 3.04

Information: Delamination is one means by which composite materials. Where building materials have become delaminated, they lose their structural strength, and are likely to have a variety of appearance and serviceability defects as a result.

Repair and replacement estimates should be sought from a qualified plumber.

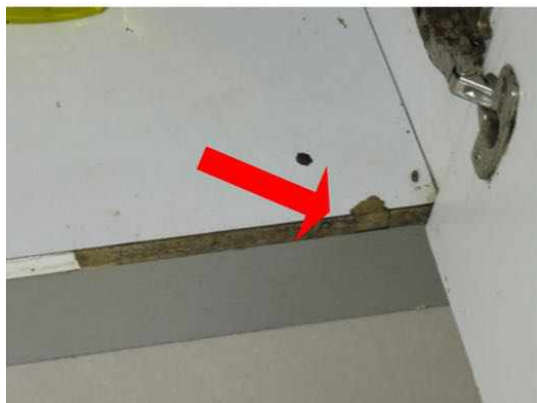
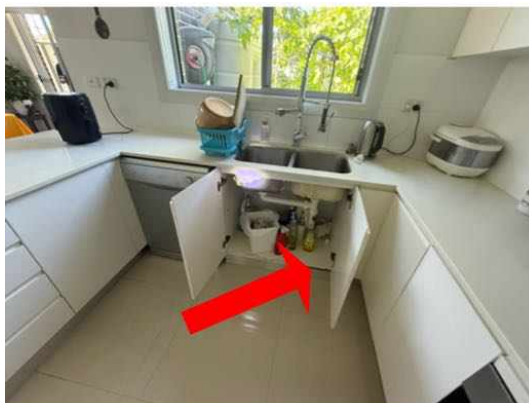
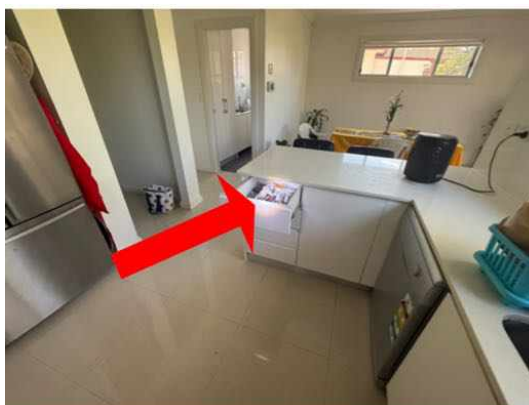
Finding 3.05

Building: Main Building
 Location: Kitchen
 Finding: Kitchen Cabinetry - Scratches, Surface Damage & Laminate Delamination
 Information: Scratches, scuff marks, chipped edges and visible delamination of the laminate surface were observed on several sections of the kitchen cabinetry. Laminate is lifting at the edges and joints, and multiple panels show surface wear and damage.

Delamination and surface damage can:

- Permit moisture ingress, leading to swelling and further failure of the substrate.
- Reduce the durability and service life of the cabinetry.
- Be considered below acceptable workmanship under NCC and AS installation requirements.

Engage a qualified cabinet maker/joiner to:

- Repair or replace damaged panels,
- Re-adhere or re-laminate lifted sections, and
- Seal exposed edges to prevent moisture penetration.

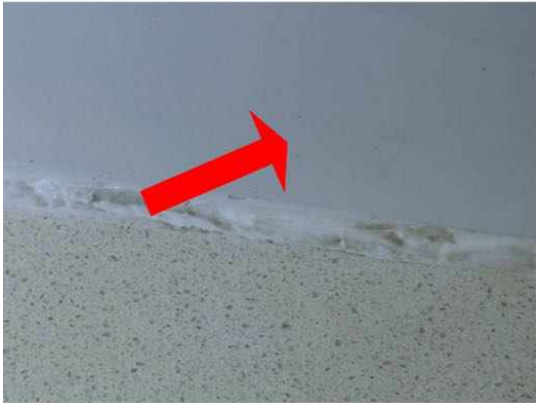
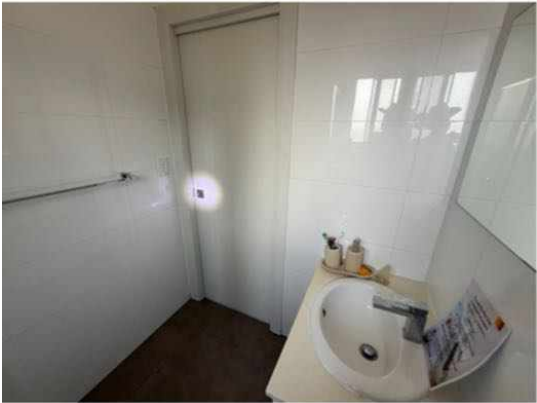
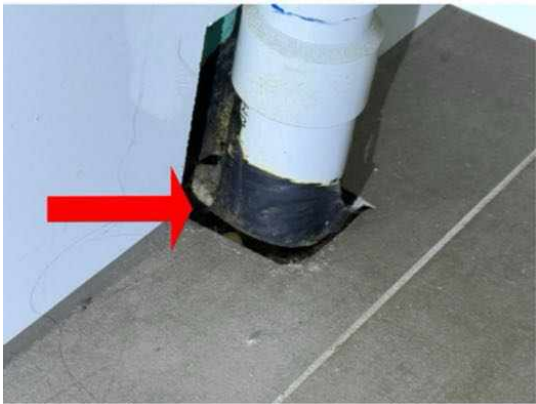
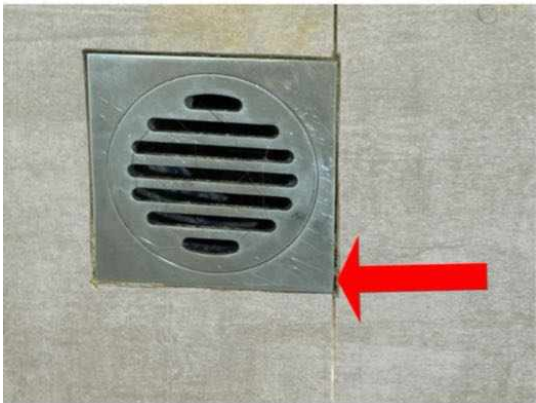
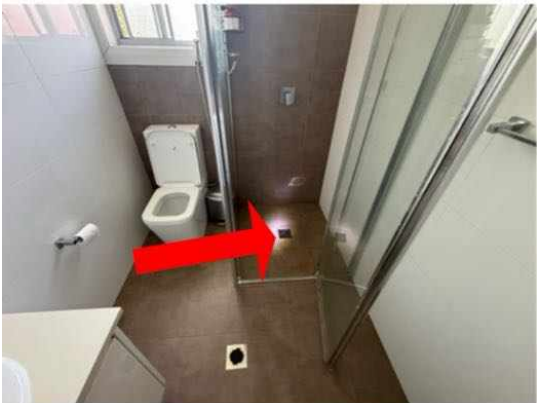
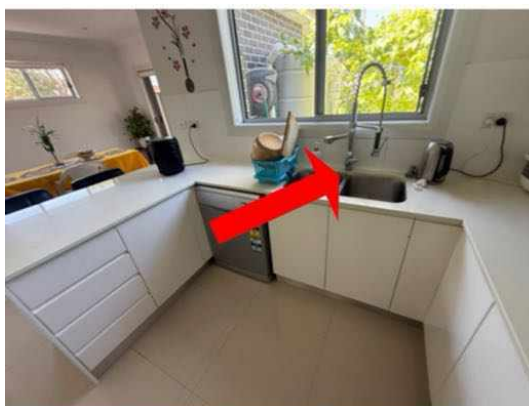
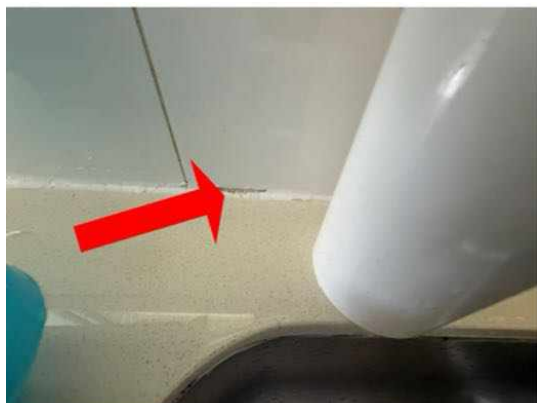
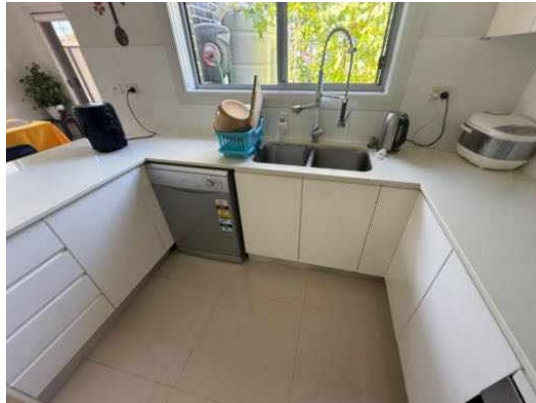
Building:	Main Building
Location:	Bathroom
Finding:	Sealant and grouting - Missing or damaged
Information:	It was noted on inspection that sealant or grout is degraded to the tiled shower alcove and or other areas of the bathroom.

Different materials and floor areas move at different rates, generally causing cracking to grout or sealant at this point. A flexible sealant is required to allow for expected expansion and contraction, while keeping the joint water tight and protective of all associated building materials.

There appears to be excessive mould to the sealant and grout which will likely require scraping out and replacement.

Flexible and mould resistant materials should be applied to affected areas to prevent any subsequent water damage that is likely to occur. Regular maintenance and replacement of damage or missing or damaged sealant and grout is highly recommended to the wet areas, as this is a regular wear and tear defect. Sealant and grouting in areas that come into regular contact with water should be maintained for the long term care of your property.

A sealant specialist or tiling contractor should be appointed to complete these works as soon as possible

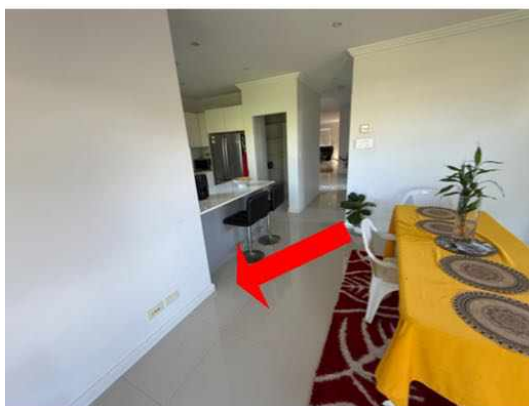
Finding 3.07

Building:	Main Building
Location:	Kitchen
Finding:	Cracked floor tiles
Information:	Cracking in the floor tiles was evident in this area at the time of inspection. It is suspected that this cracking has occurred as a result of minor settlement or shrinkage of the slab.

Cracked tiles throughout the household detract from the overall appearance of the affected areas however it is unlikely to create or lead to any secondary defects.

While not considered a matter of urgency, replacement of cracked floor tiles is recommended at the clients discretion. A tiling contractor may be appointed to perform these works. Where cracks become more numerous, contact a licensed building inspector for further investigation.

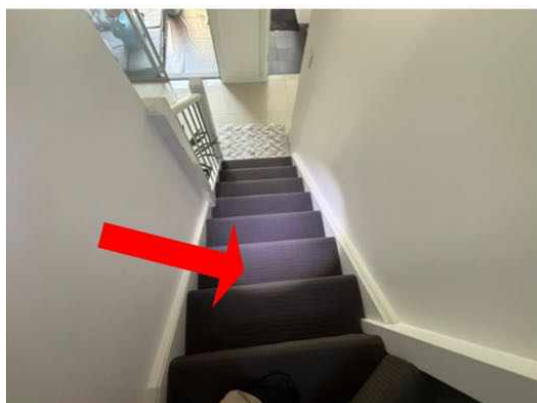
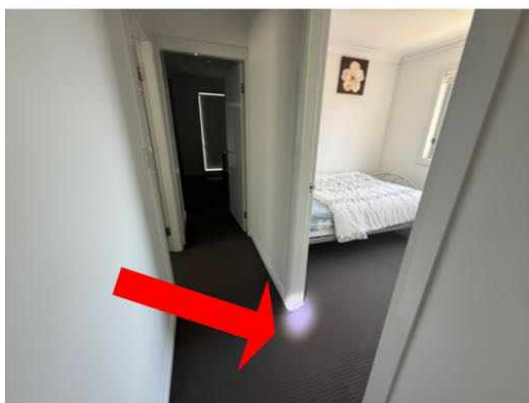
Finding 3.08

Building:	Main Building
Location:	All Internal Areas
Finding:	Upper Floors & Stairs - bouncy
Information:	The internal flooring and stair in this area was identified as being bouncy at the time of inspection. A bouncy floor surface generally presents as a discernible change in level as they are walked across, in noisy or creaking flooring, or in consequent movement of surrounding furniture and fixtures.

Bouncy floors / stairs generally indicate that the floorboards or the structures are coming loose from the joists that they are installed on. Bouncy flooring may also be the result of gaps between flooring and stumps or joist structures, which require packing.

The client is advised to seek quotations for required repairs from a qualified carpenter. The potential resolution may range from packing gaps in the structures through to replacing and refixing of flooring.

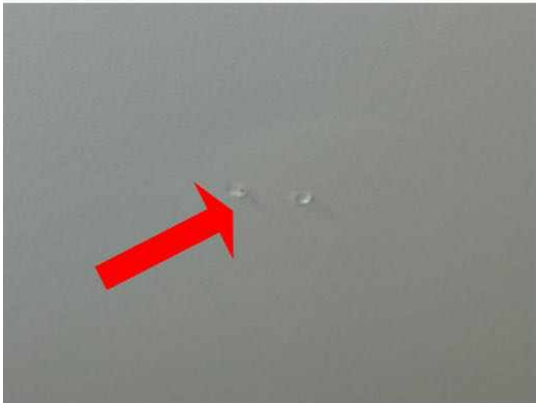
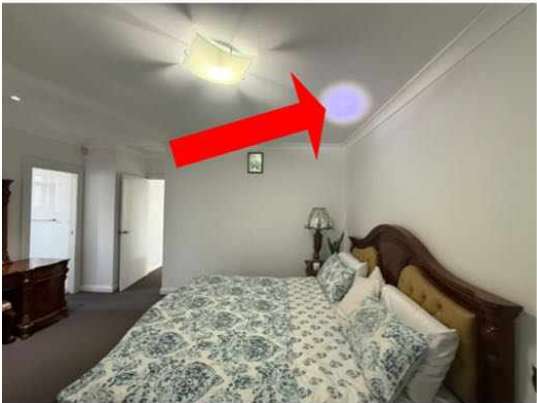
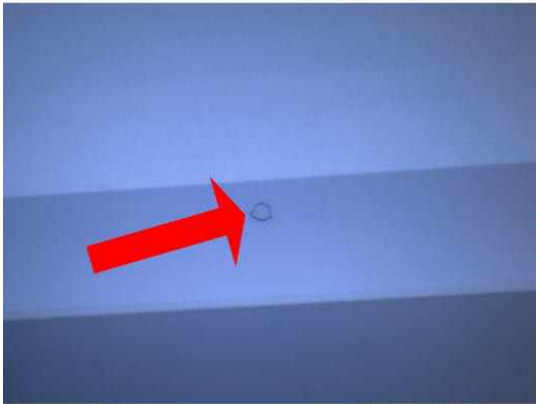
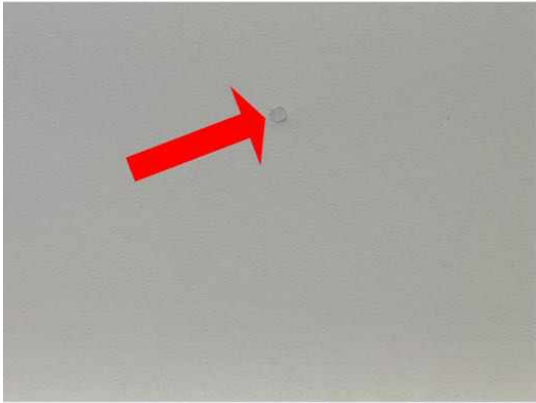
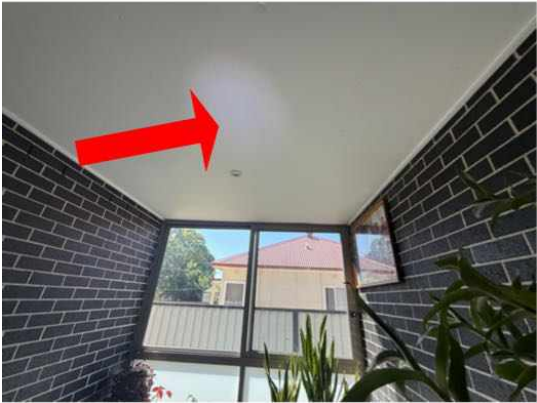
Finding 3.09

Building:	Main Building
Location:	All Internal Areas
Finding:	Ceiling Nail - Popping

Nail/screw popping was observed to the ceiling lining. This is indicated by visible protrusions and minor cracking around the fixing points of the plasterboard. This condition is typically caused by inadequate fixing, movement of framing members, or poor installation workmanship.

Installation of plasterboard should comply with AS/NZS 2589:2017 – Gypsum Linings – Application and Finishing and NCC 2022 – Housing Provisions H2D2 (Construction in accordance with good building practice).

It is recommended that the builder rectify the affected areas by re-fixing the plasterboard where necessary and making good the ceiling finish.

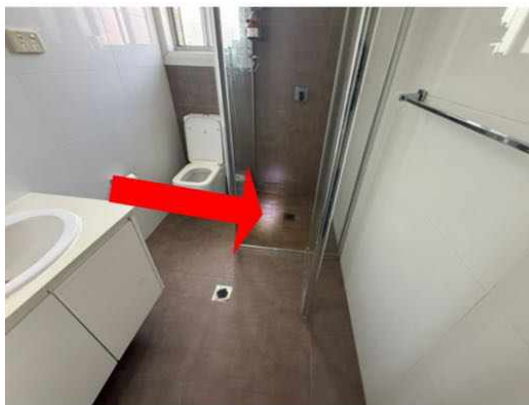
Finding 3.10

Building:	Main Building
Location:	Ensuite
Finding:	Shower base - Water pooling
Information:	Evidence of water pooling around the floor waste in the shower recess was noticed at the time of inspection. It is suspected that this excessive moisture is attributed to insufficient fall in the shower floor tiles.

This pooling is minor overall but is still considered unsatisfactory, as standard tiling practices would not permit this situation to occur. Pooling water around floor wastes can create a slip hazard in extreme cases and create conditions that are conducive to mould growth over time. Where left unmanaged, the degradation of sealant and grouting is also likely to occur, possibly necessitating further repair works.

Remedial works may involve some sections of tiling and flooring repair and replacement. A tiling contractor or bathroom specialist should be appointed to provide further advice on reparation options and to perform works as necessary.

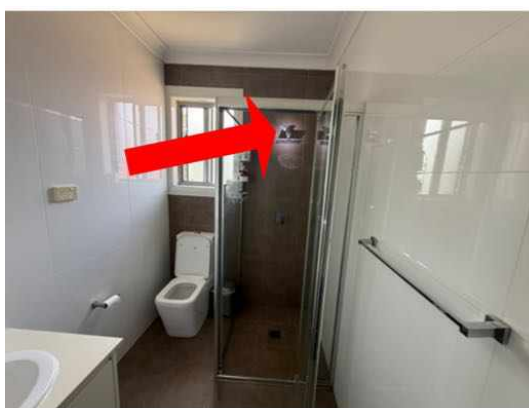
Finding 3.11

Building:	Main Building
Location:	Ensuite
Finding:	Shower Head Leaking
Information:	The handheld shower head was observed leaking at the hose connection point. The fitting is not watertight, resulting in water escaping during use.

- NCC 2022 – Volume Two, P2.2.1 (Health and Amenity – Sanitary Facilities): Plumbing and sanitary fixtures must be installed to avoid water leakage and provide

safe, sanitary conditions.

- AS/NZS 3500.1:2021 – Plumbing and Drainage (Water Services): Requires all plumbing fittings and fixtures to be installed in a way that prevents leakage and ensures durability.
- Guide to Standards and Tolerances 2017 (Section 11.02 – Plumbing Fixtures): Plumbing fixtures and fittings are defective if they leak when tested under normal operating conditions.

- Water wastage and increased utility costs.
- Risk of water damage to adjacent finishes and building elements.
- Reduced serviceability of the plumbing fixture.

The builder is to rectify the leaking shower head by checking the hose and fitting connections, ensuring they are correctly installed and sealed. If required, the faulty shower head or hose is to be replaced to achieve compliance with AS/NZS 3500.1.

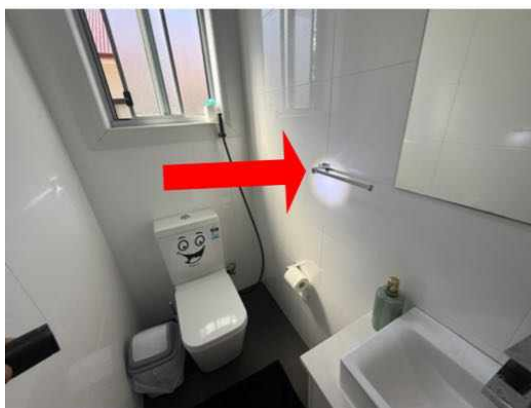
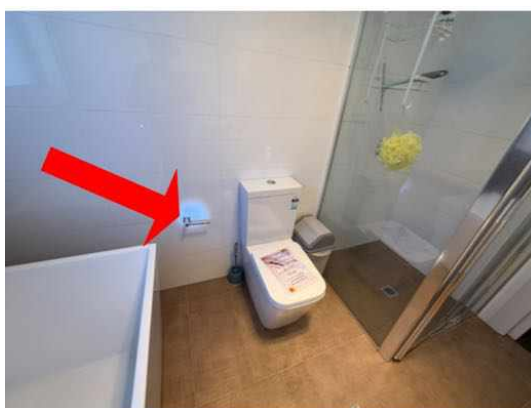
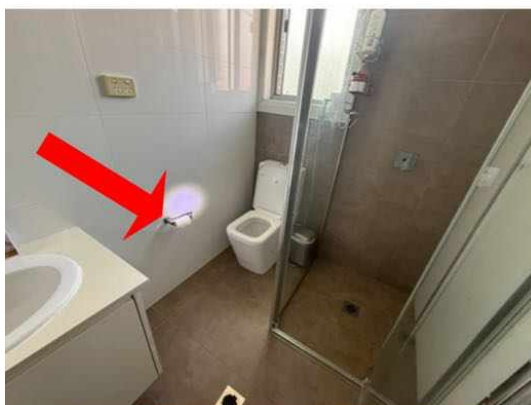
Finding 3.12

Building:	Main Building
Location:	Bathroom
Finding:	Bathroom holders - Loose
Information:	The bathroom holder was found to be loose at the time of inspection. While not a major operational defect, function can deteriorate if the problem is left unmanaged.

It is advised that the homeowner performs remedial works to re-attach the bathroom holder to its original fixing. A general handyperson may be required to perform these works.

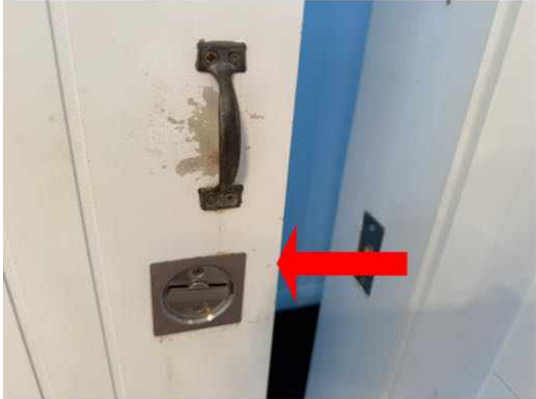
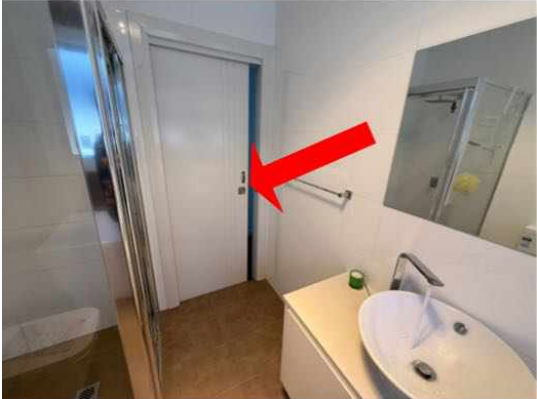
Finding 3.13

Building: Main Building
 Location: Ensuite
 Finding: Door handle - Not latching
 Information: It was noted that the door in this area was not latching during operation at the time of inspection. Whilst detracting from the functionality of this building element, this minor defect may also be a security risk, and may therefore have serious implications if left unattended.

It is suspected that this defect has occurred due to minor issues with the associated hinges. Such damage is identified as general wear and tear, which is expected for

building elements of this age.

A qualified carpenter or general handyperson may be appointed to perform rectification works as necessary, at client discretion. If left unattended, further functional impairment is likely to occur.

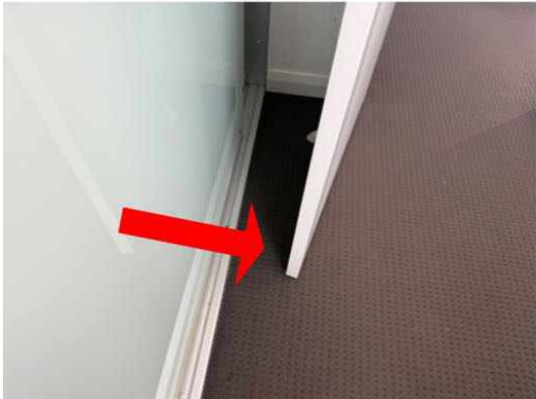
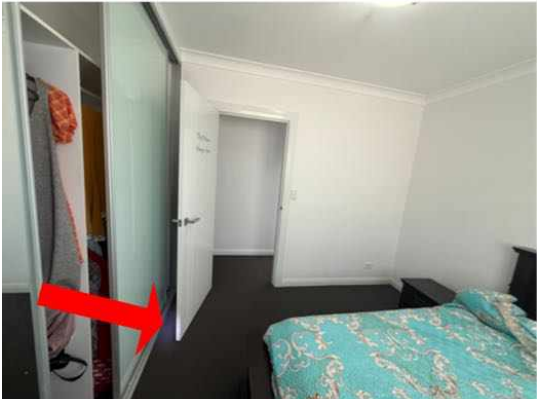
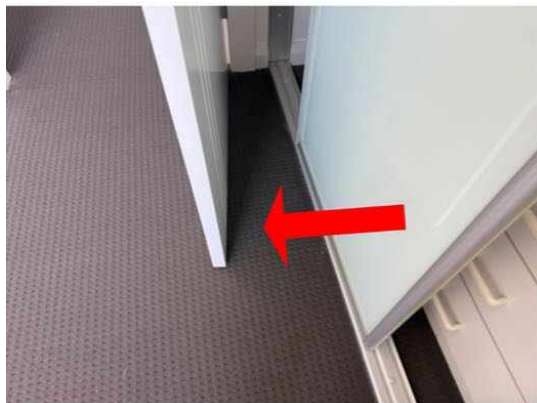
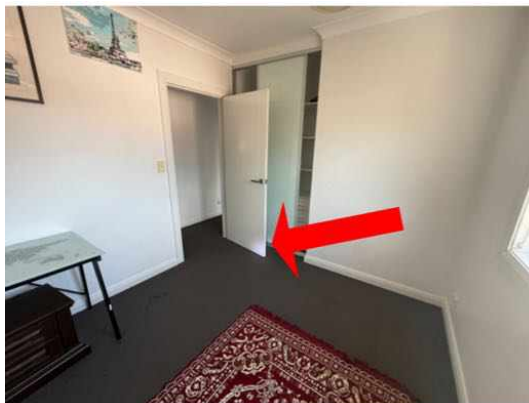
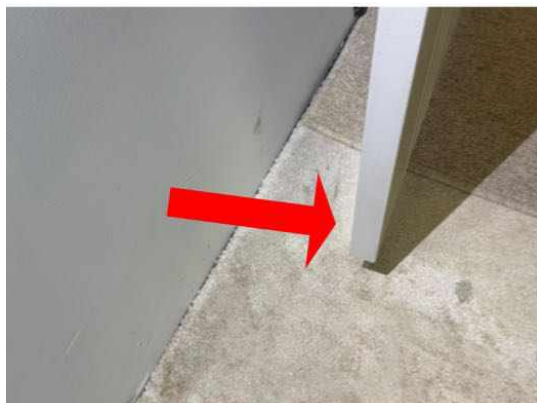
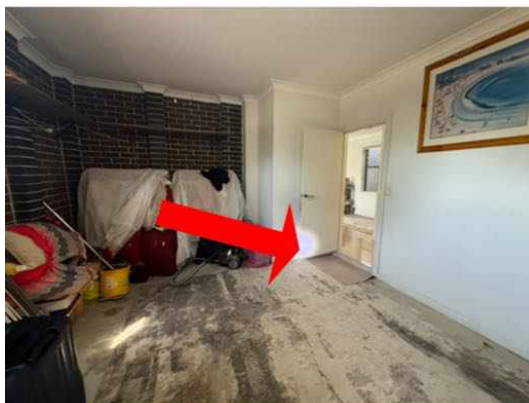
Finding 3.14

Building: Main Building
Location: All Internal Areas
Finding: Door stop - Missing
Information: The door stop is missing or is inadequate to stop the door handle from damaging the wall. Although some building elements may seem irrelevant or unnecessary, all building elements play a key role in the operation and function of the overall structure and its performance.

Re-installation or replacement of the door stop is advised as soon as possible to prevent any subsequent damage to the door or associated structures. A general handyman may be appointed to perform these works at client discretion.

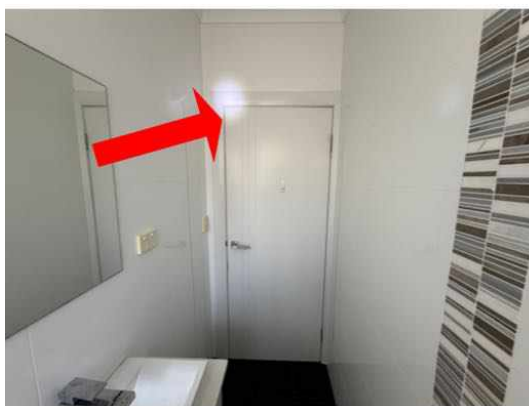
Finding 3.15

Building:	Main Building
Location:	All Internal Areas
Finding:	Door - Binding/jamming
Information:	Binding and/or jamming of this door is evident during standard operation. This defect inhibits the functionality of the affected door as well as creating potential for secondary defects to associated building elements, such as damage to the floor covering.

A door that binds to flooring or to the associated door frame may have several causes, ranging from minor defects, such as poor installation of the door or deteriorated hinges, through to major structural issues, such as damage to subfloor structures.

Where door binding/jamming appears to indicate major structural issues, a registered builder specialising in re-stumping should be appointed to provide an estimate on the cost of rectification.

For minor causes, a qualified carpenter or general handyperson should be appointed to perform minor rectification works at client discretion.

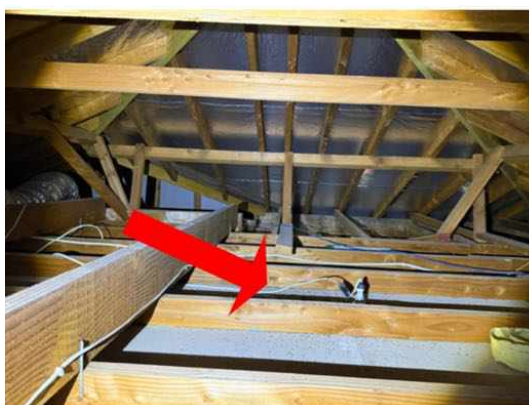
Finding 3.16

Building:	Main Building
Location:	Roof Void
Finding:	Insulation - Missing
Information:	Upon inspection of the roof void it was noted that insulation is not present.

Insufficient insulation will result in a comparatively higher cost to heat and cool a property as there is a lack of Insulation (or uneven coverage of insulation) which works as a barrier to heat transfer. This helps to keep out unwanted heat in summer and preserves warmth inside your home in winter. It can also help soundproof your home from unwanted airborne noise transfer.

Where insulation is absent, the area does not meet current Australian Standards. Installation of adequate insulation is required and should be conducted as soon as possible.

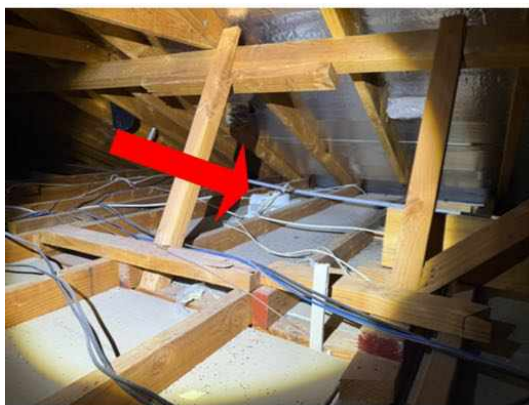
Finding 3.17

Building:	Main Building
Location:	Roof Void
Finding:	Extractor Fan - Vented into Roof Space
Information:	The bathroom extractor flue was found to lead directly into the roof space, rather than

venting to the exterior of the building. The positioning of this flue is likely to lead to a build-up of grease and grime in the surrounding area within the ceiling void, which can pose as a fire hazard in the roof void. The presence of insulation surrounding the flue adds to this fire safety risk. Without re-direction to the exterior of the building, the Rangehood is not considered fully operational and is deemed a minor safety hazard. It is therefore preferable that the flue be re-directed to vent into the external environment. A licensed plumber should be appointed as soon as possible to provide further consultation on the scope of these works and to provide quotations for any necessary works.

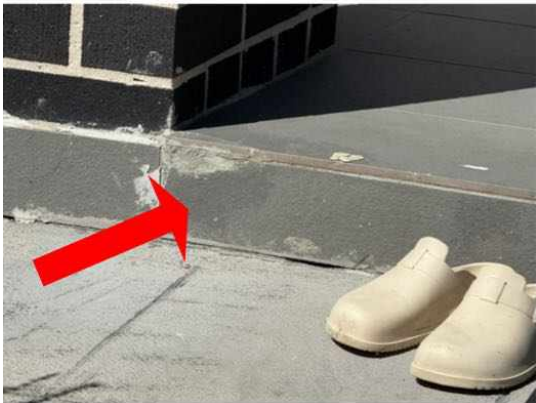
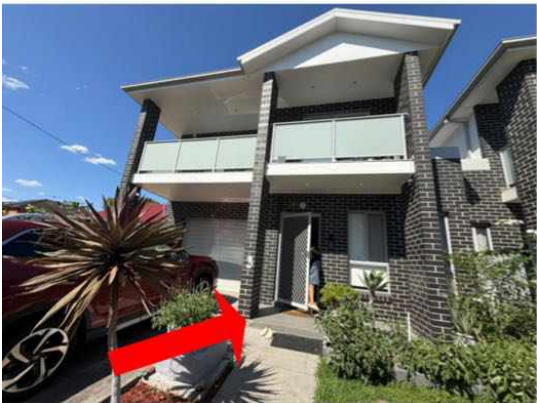
Finding 3.18

Building:	Main Building
Location:	Porch
Finding:	Tiles - Drummy
Information:	Drummy tiled areas were identified at the time of inspection. The term 'drummy' refers to tiles that have become detached from their fixing, despite otherwise being in relatively good condition. Such defects are generally caused by physical or moisture damage to the area. Drummy tiled areas may also be a direct result of poor workmanship during the construction process.

Tiled areas may swell and shrink with changes in air humidity if the area has sustained moisture damage. Any exposure to moisture is capable of causing tiled areas to become drummy and/or cracked over a prolonged period of time. Drummy tiled areas generally require removal and replacement of affected tiles, with adequate sealant and grouting.

Specialist trades are available for these types of services. A registered builder may be required to undertake works if damage is extensive or if secondary building defects have resulted. Otherwise, it is advised that a tiling contractor be appointed to perform works as necessary. Immediate action is recommended to ensure that no further damage is sustained in the affected area.

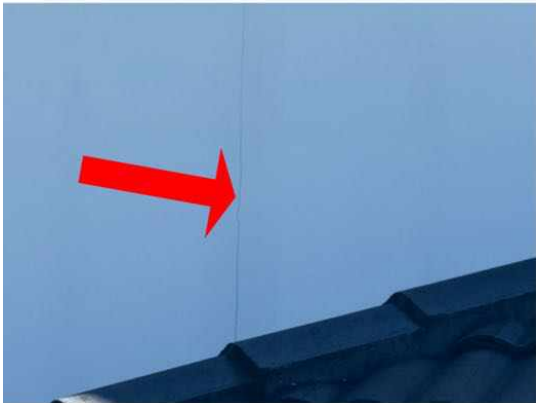
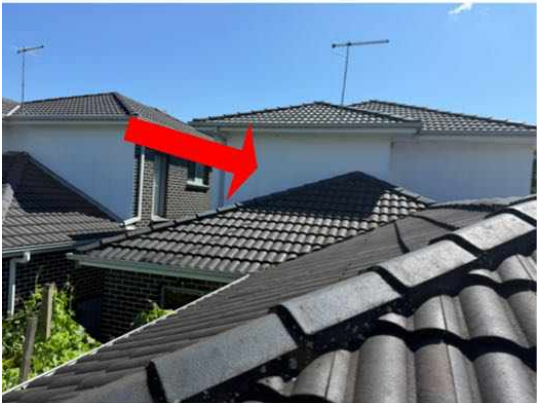
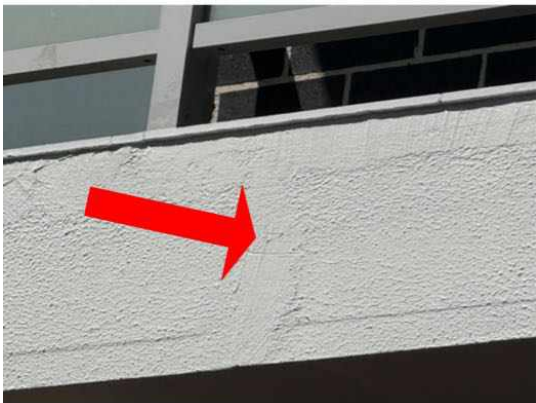
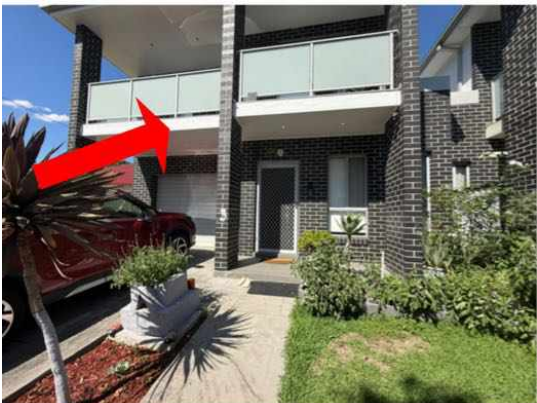
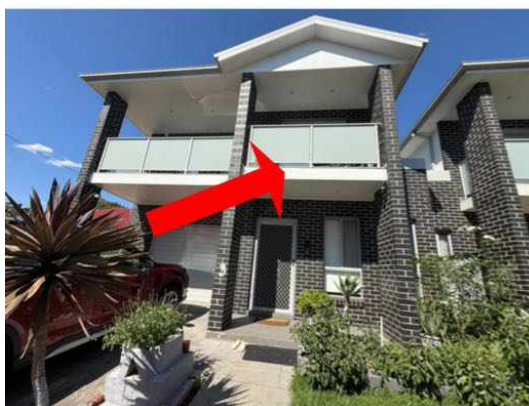
Finding 3.19

Building: Main Building
Location: Exterior walls
Finding: Wall cladding - cracking or other distortion
Information: Cracking or other distortion affecting the wall cladding was identified this is considered to be a defect under Standards and Tolerances.

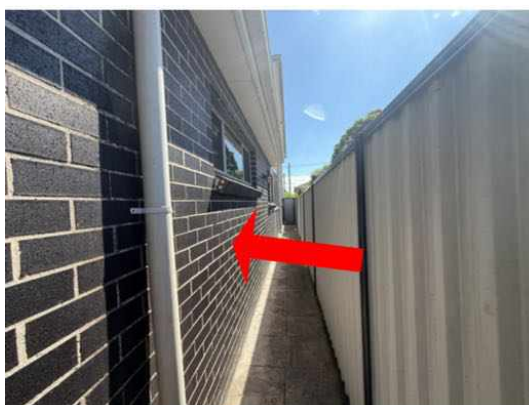
Finding 3.20

Building:	Main Building
Location:	Exterior walls
Finding:	Articulation joints - Inadequate
Information:	The articulation or control joints throughout the exterior brickwork were deemed as insufficient at the time of inspection. Mortar, a non-compressive material, is still evident in some of the joints, not allowing the joints to do their job and allow the brick walls to expand and contract as required during different weather conditions.

Articulation joints must be cleaned of all non-compressive material and then sealed with an appropriate flexible sealant. Failure to perform these necessary works is likely to lead to excessive moisture ingress into these joints, or cracking to the brick walls during extreme weather conditions, which may carry major implications for associated building elements if left unmanaged.

These preventative works are important in ensuring the structural integrity of the associated brickwork. Appointment of a qualified builder or bricklayer is advised to perform remedial works as necessary.

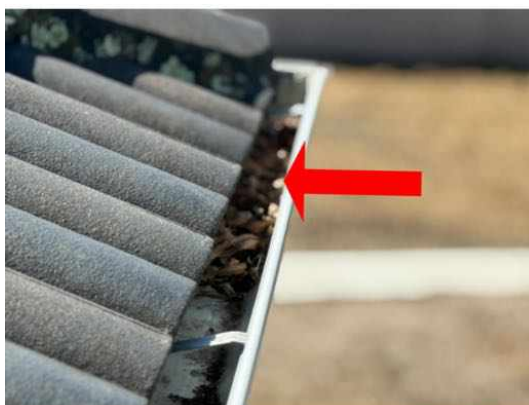
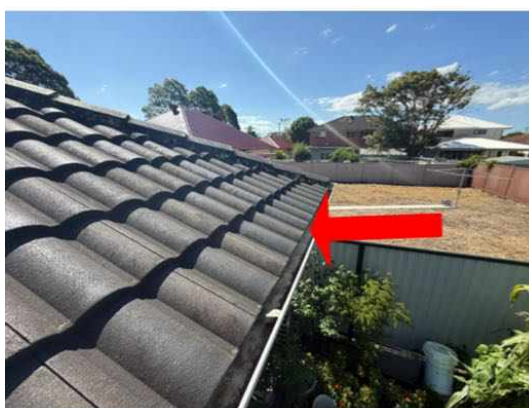
Blocked gutters are likely to lead to high levels of moisture in the affected areas. Such moisture will not only cause rust and decay of the associated building materials, but can also provide conditions that are conducive to termite and timber pest activity. Blockages in gutters should therefore be removed immediately to ensure dry conditions are maintained.

Consult a Licensed Plumber for further specific advice on remedial works that may be required. In the interim, it is highly advised that blocked gutters be removed by the homeowner or a general handyperson as a matter of urgency.

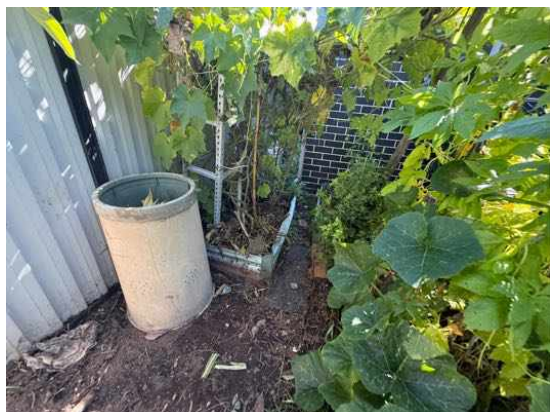
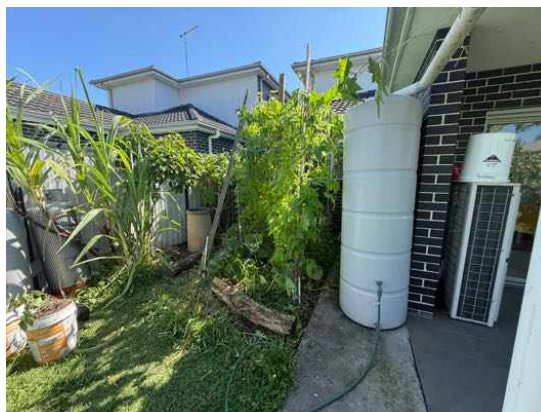
Building:	Main Building
Location:	All Areas
Finding:	Garden Beds - Conditions Conducive to Termites
Information:	Garden beds were found to be evident in the garden area. These garden beds can include untreated timber, and with a combination of moisture from watering hosing can make conditions conducive to termite activity and termite ingress.

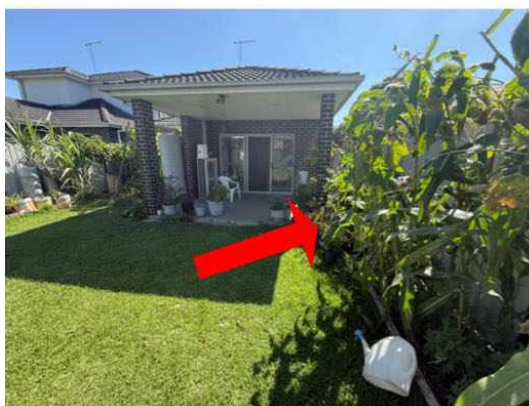
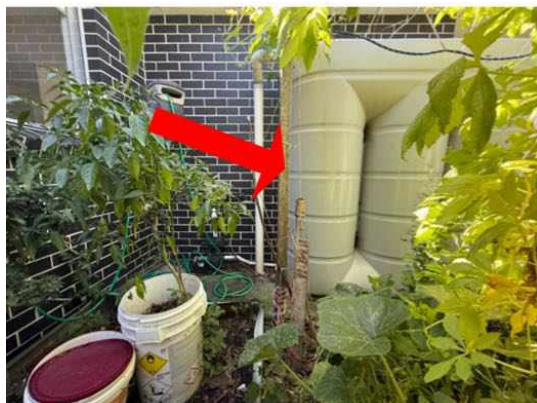
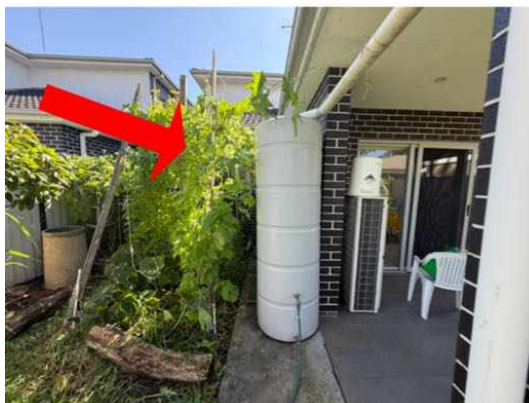
Finding 6.02

Building:	Main Building
Location:	All Areas
Finding:	Bridging of termite barrier/inspection zones
Information:	Bridging is the spanning of a termite barrier or inspection zone so that subterranean termites are provided with passage over or around that barrier.

Where bridging has occurred, full inspection is prevented and termites may enter a property in a concealed or undetectable manner.

It is recommended that minimum 75mm clearance below the bottom of weep or ventilation holes be maintained where possible, otherwise annual inspections should be conducted by a licensed pest control company. Vegetation should also be kept clear of walls to allow regular inspection of all areas.
