Building and Timber Pest Inspection Report

Inspection Date: Thu, 12 Mar 2026

Property Address: 3 Mckevitte Ave, East Hills NSW 2213,
Australia

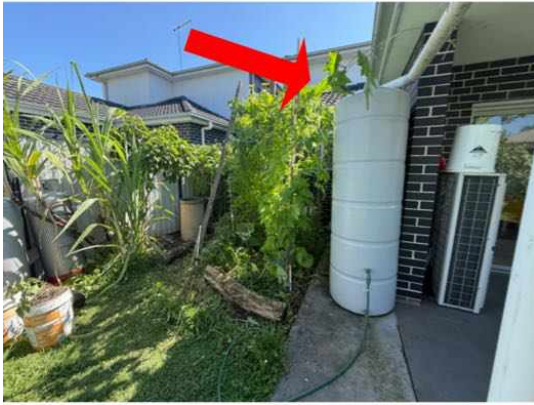
Finding 6.03

Building:	Main Building
Location:	All Areas
Finding:	Trees - Overhanging and filling gutters
Information:	Overhanging trees often result in excessive amounts of leaf debris accumulating in gutters.

Gutters are a critical part of the building's management of storm water and rain. It is therefore important that they be kept clear to prevent secondary damage to associated building elements, including exterior and interior walls, ceiling linings and any adjoining building elements. Where gutters are blocked, pooling of rainwater is likely to occur, fast-tracking rust and corrosion of the roof plumbing elements.

It is highly advised that all overhanging tree branches be removed as soon as possible to prevent any further damage. Repair and/or replacement of sections of damaged guttering may also be required where the extent of the damage necessitates.

Such works should be performed by the homeowner; however, appointment of a landscape contractor or an arborist may be required. Consultation with a licensed roof plumber is required where guttering has been damaged.

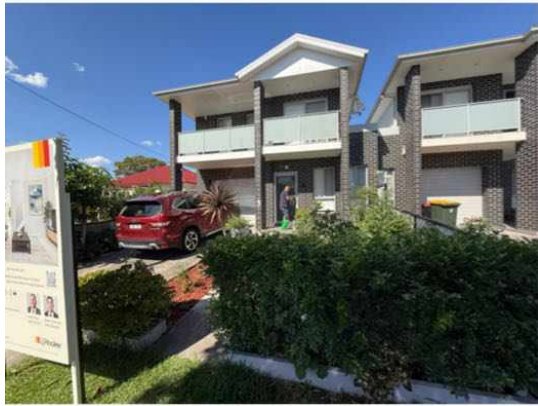
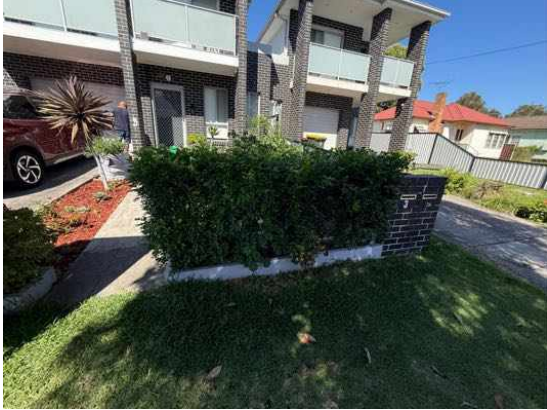
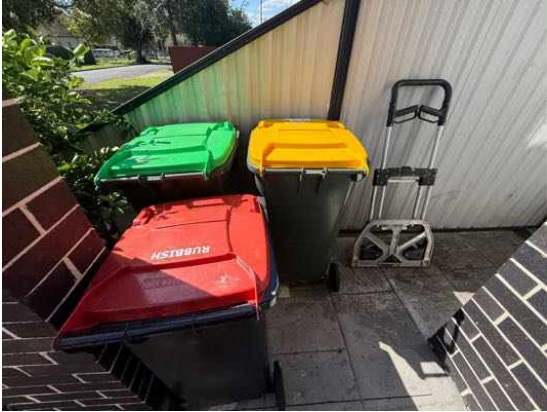
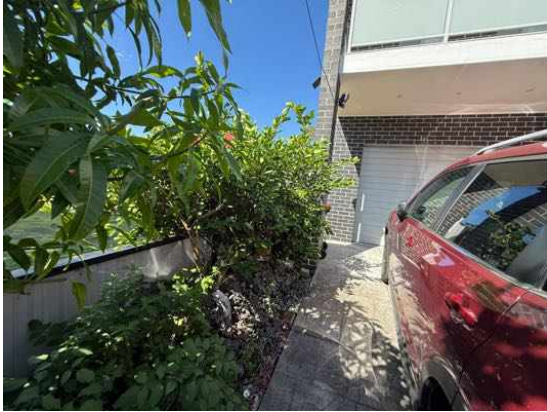
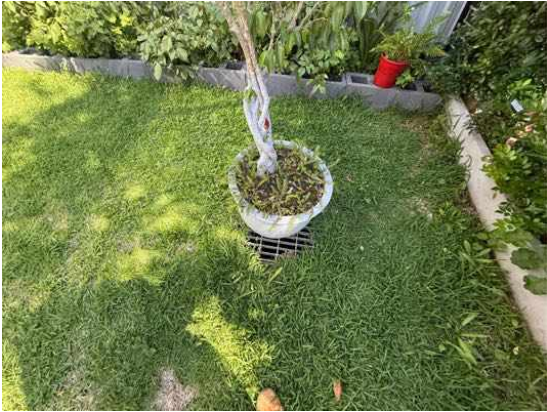
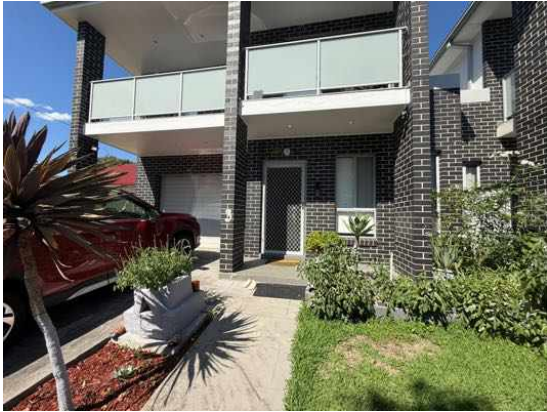
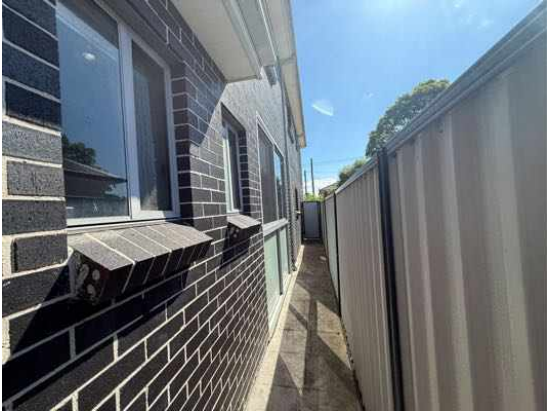
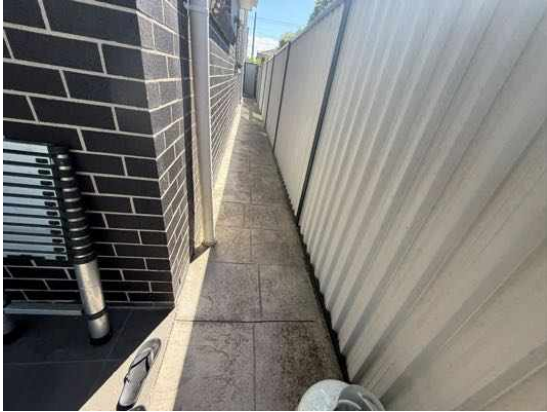
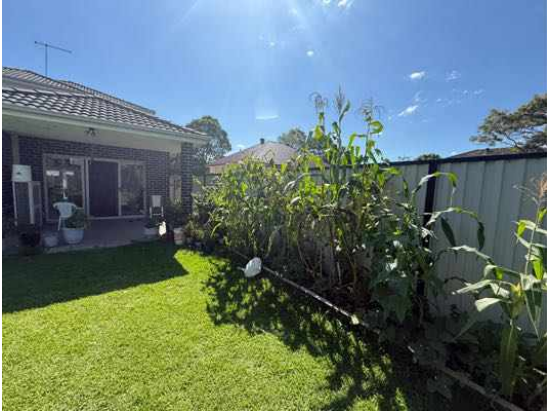
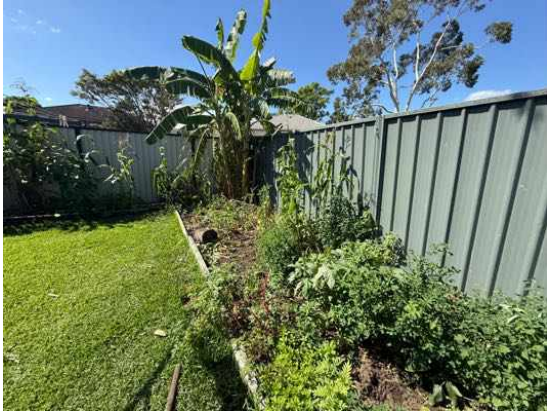
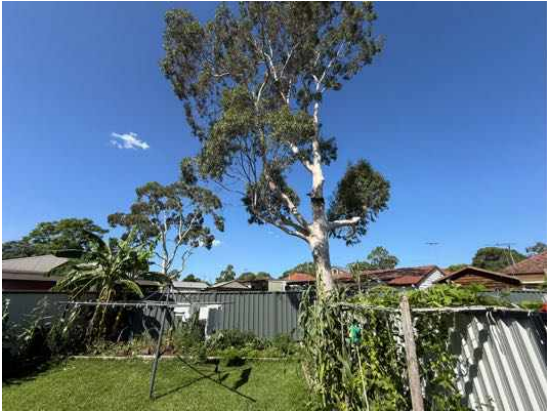
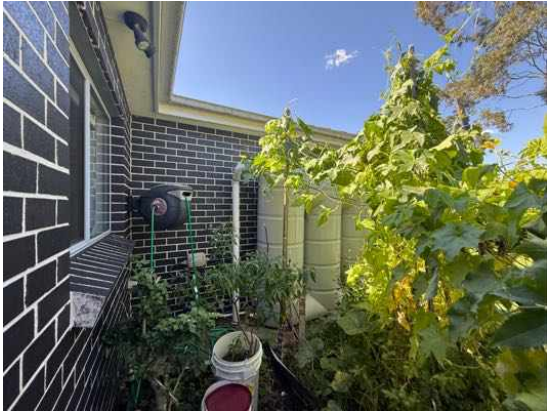
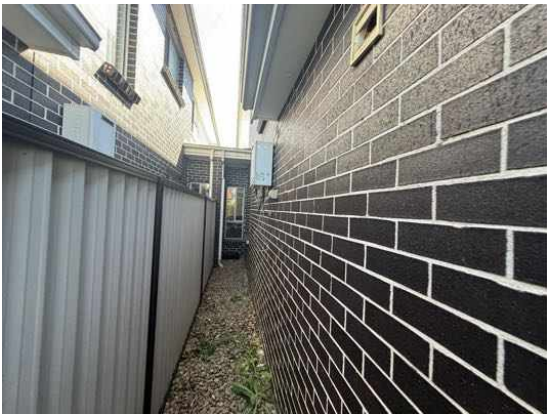
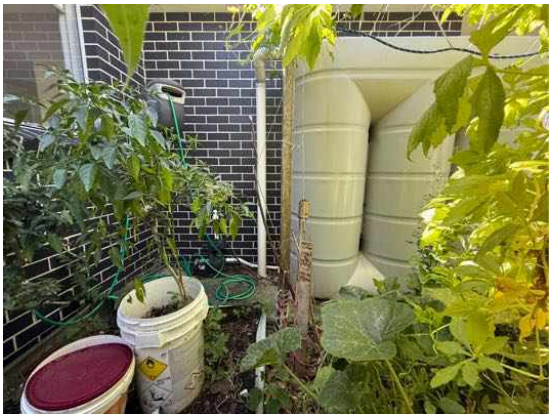
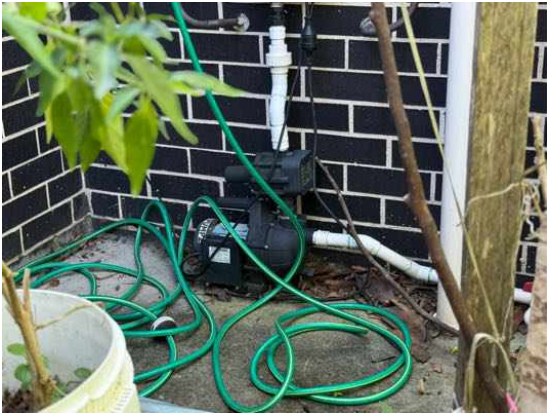
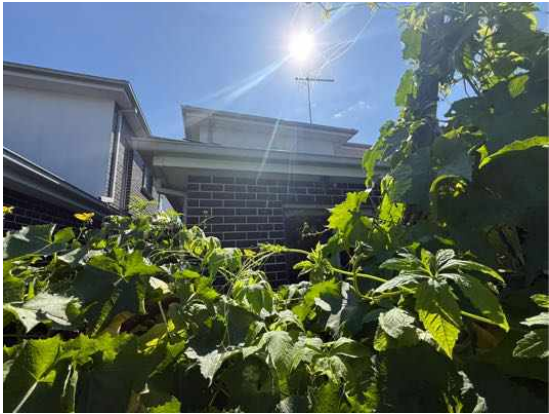
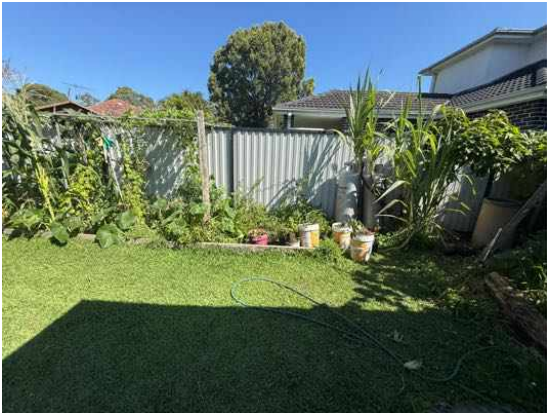
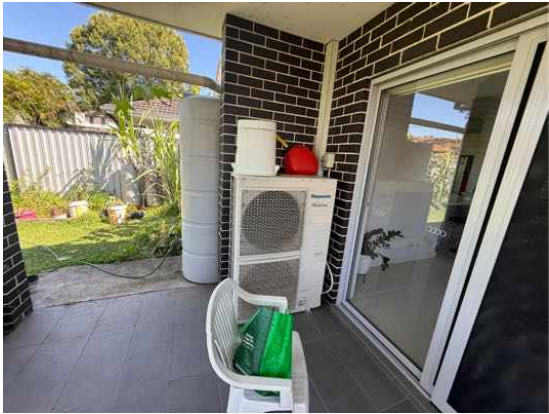
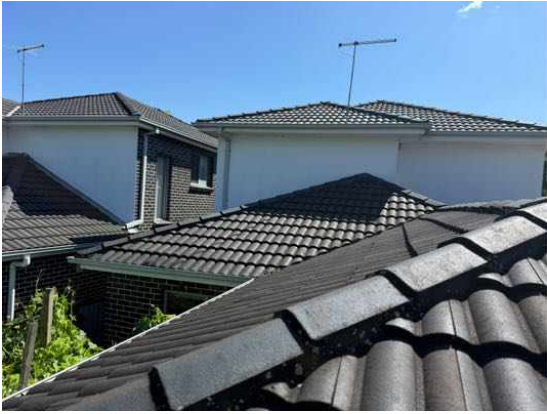
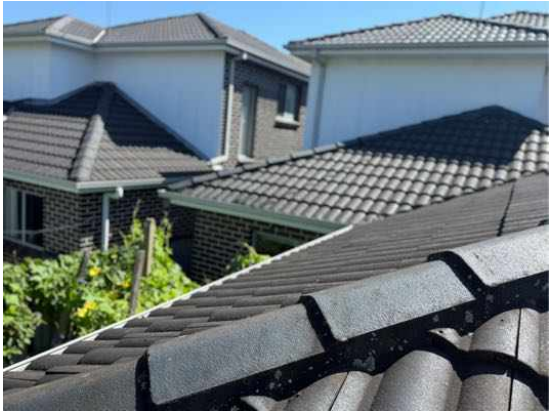
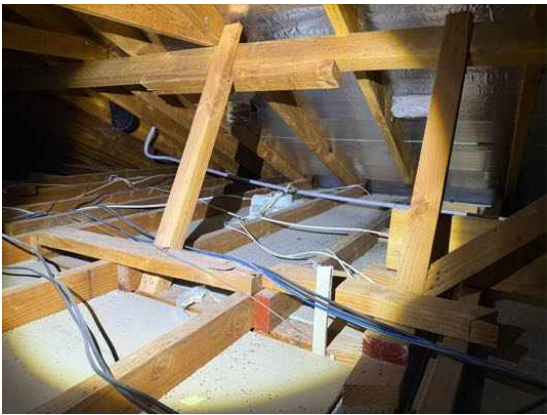
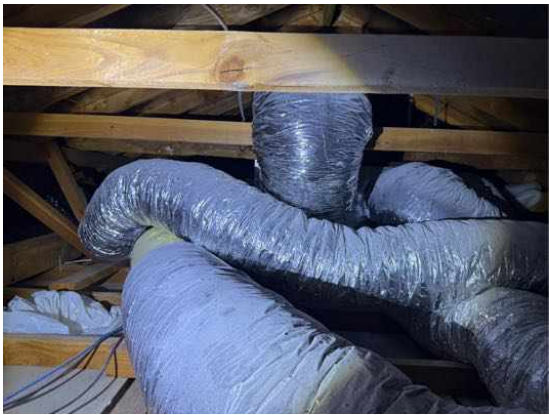
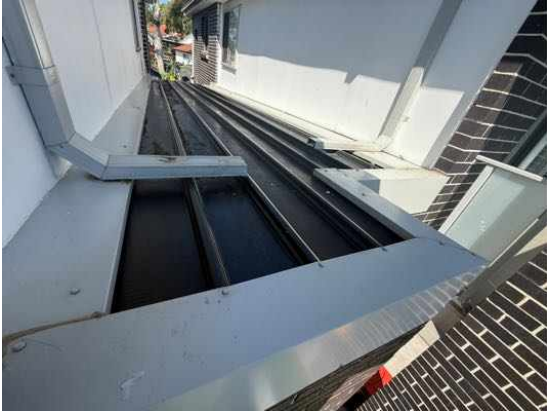
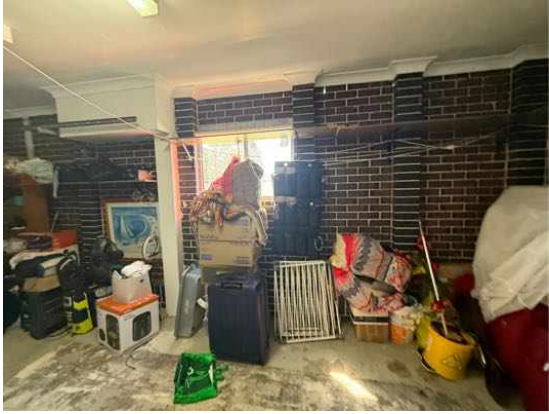
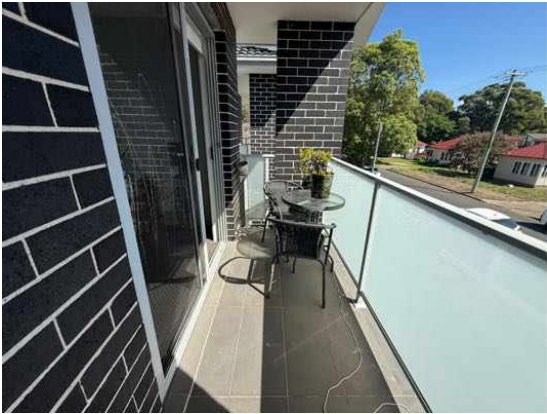
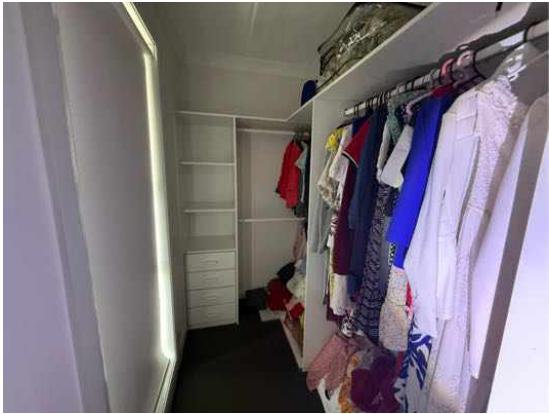
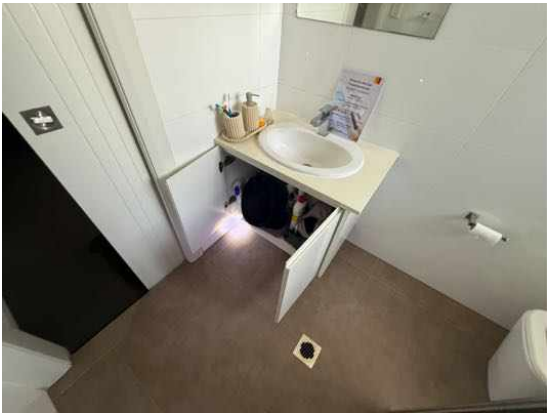
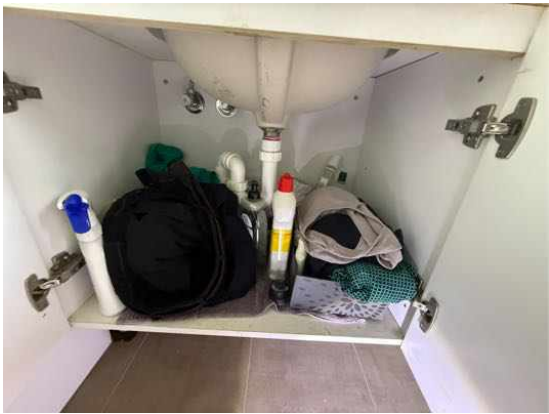
Noted Item

Building: Main Building
Location: All Areas
Finding: Additional Photos - Obstructions and Limitations
Information: These photographs are an indication of the obstructions and limitations which impeded full inspection of the property at the time of inspection. These obstructions can hide an array of defects and should be removed to allow full inspection to be carried out. A re-inspection is recommended once the areas are made accessible.

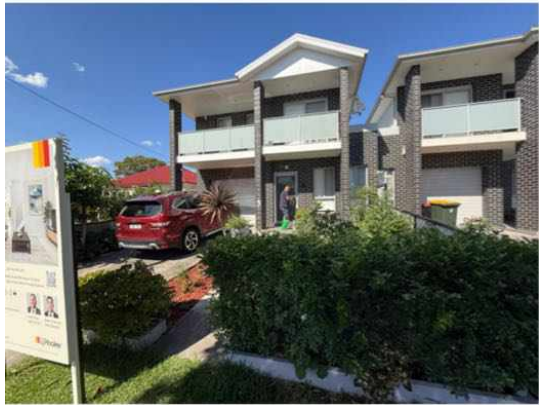
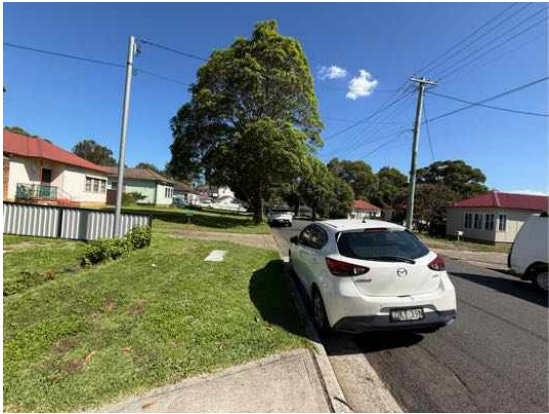
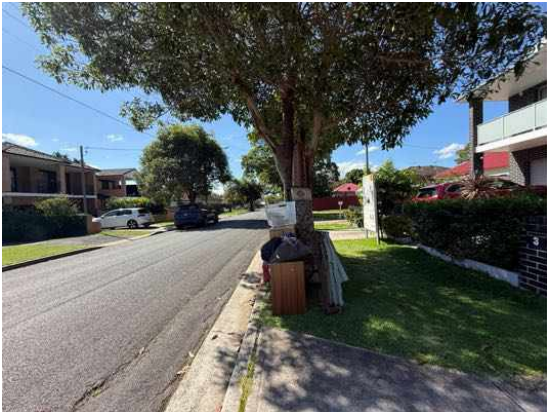
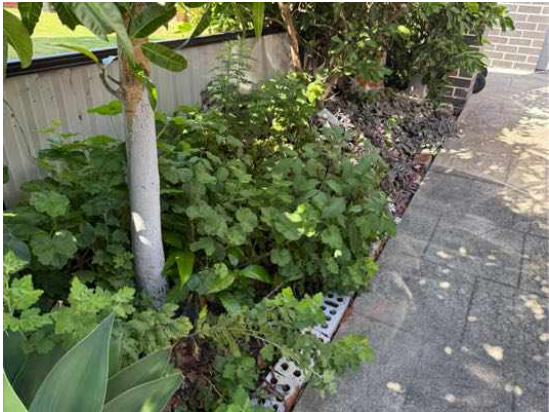
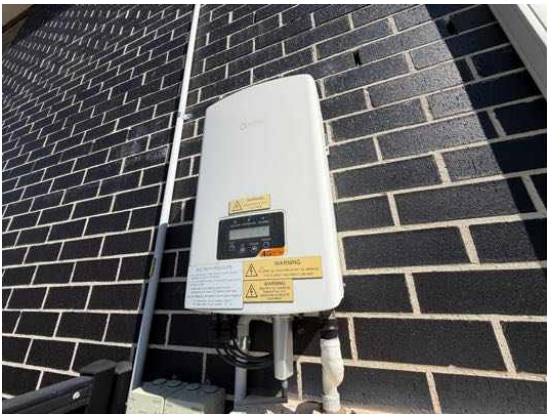
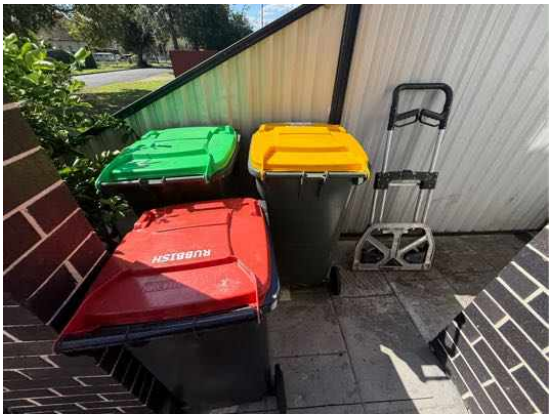
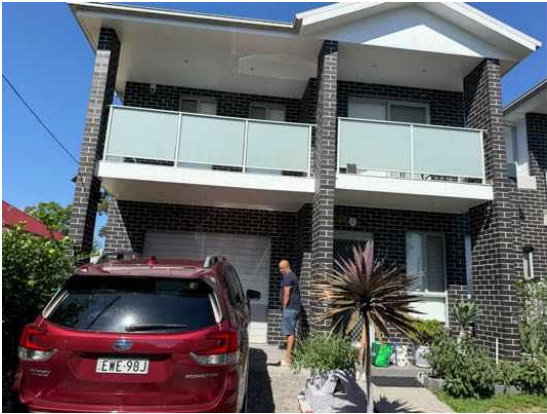
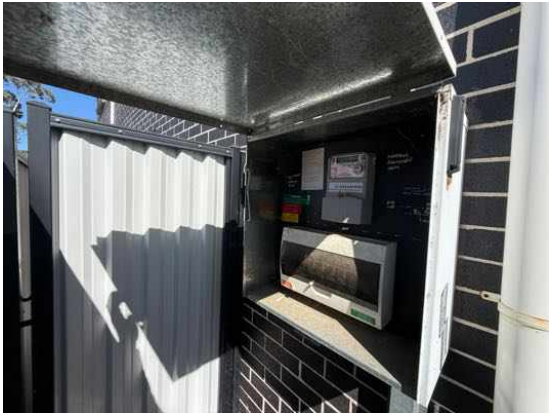
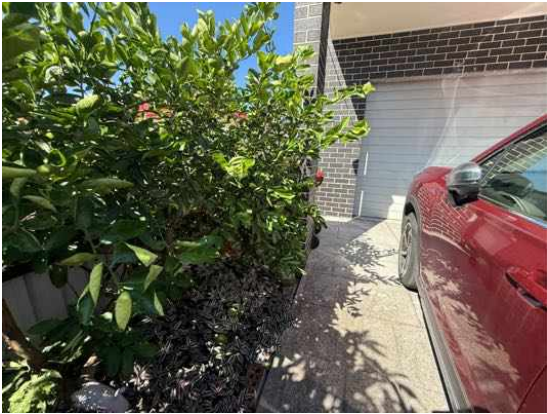
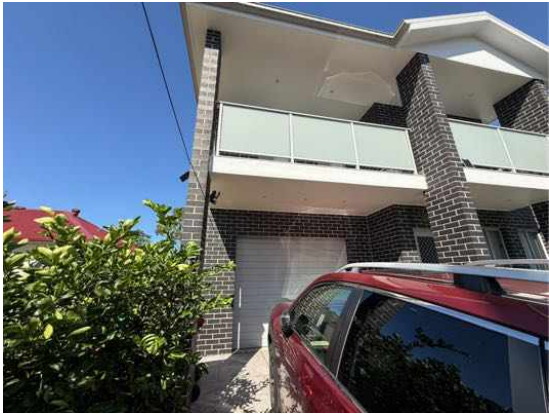
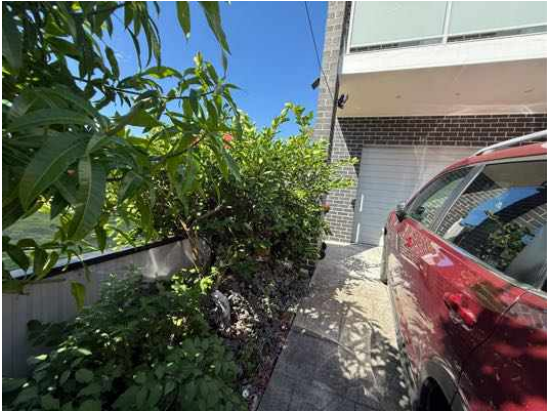
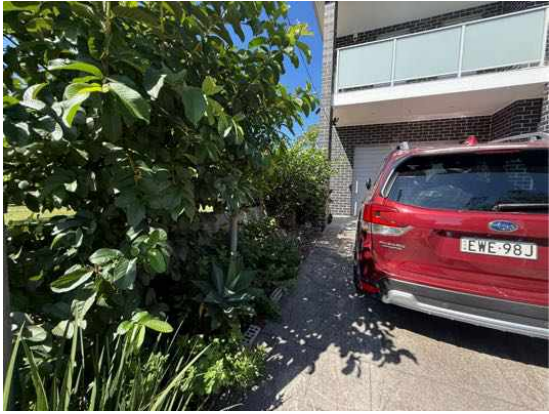
Building: Main Building
Location: All Areas
Finding: Additional Photos
Information: Additional photos are provided for your general reference

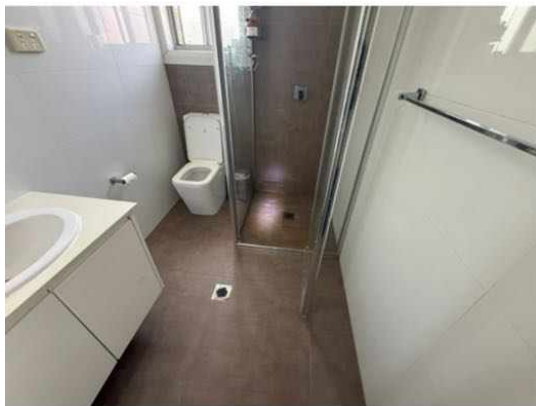
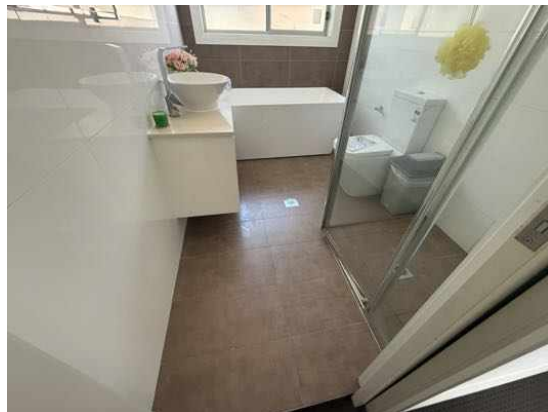
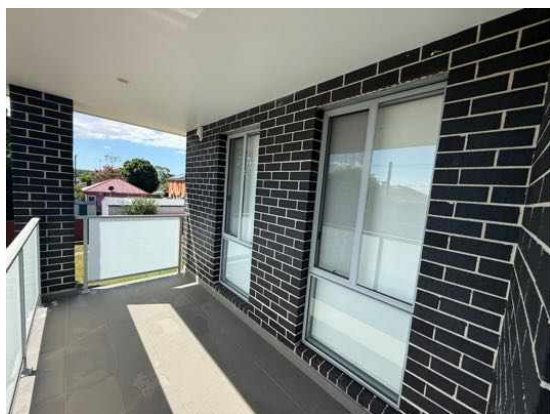
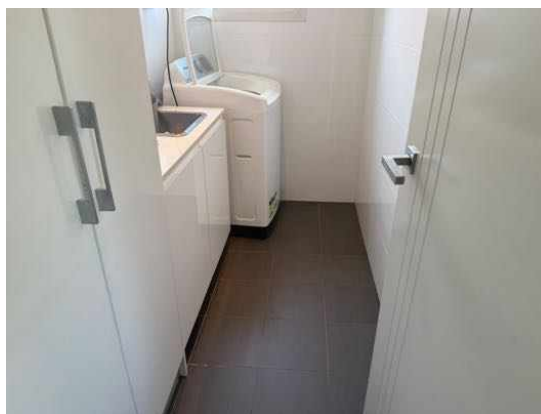
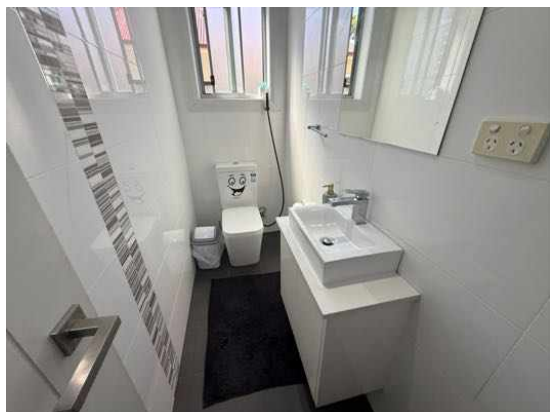
Noted Item

Building: Main Building
 Location: All Areas
 Finding: Water Proofing Membranes - Information Only
 Information: Internal Water Proofing Membranes, are crucial in preventing water ingress into the property is important to know that the Membrane System used is to Australian Standards and has been installed correctly. Please refer to the original Building Documents or Maintenance Schedule for the relevant information including; - Membrane used and Manufacturers Specifications. - The Installer and Installation Certification. Especially with older property's where this information is unavailable, all wet areas should be monitored. Generally new waterproofing with a certificate may only have a guarantee of 8yrs. If any leaks, water staining, peeling or bubbling of the paint become evident to any adjacent walls or ceilings below a licensed builder or waterproofing specialist is recommended to investigate further.

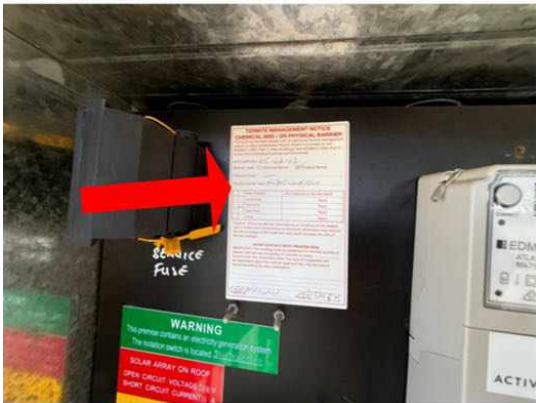
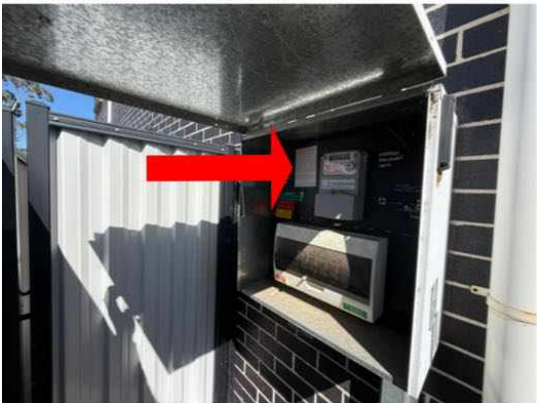
Noted Item

Building:	Main Building
Location:	All Areas
Finding:	Evidence of a chemical treated zone barrier was identified
Information:	During inspection of the property, it was noted that works to install a chemical treated zone barrier had previously been completed. A chemical treated zone barrier is likely to ensure effective protection against termites.

However, we strongly recommend annual inspections of the barrier and surrounding areas as there are several factors that can lead to deterioration of the barrier and decrease its effectiveness.

Where a Termite Management System has been identified, the client should identify to the type of barrier, date of installation, warranty conditions and any documentation provided by a builder or past owner. Consult the company who installed the barrier to confirm whether the system is still under warranty.
