Building and Timber Pest Inspection Report

Inspection Date: Tue, 17 Mar 2026

Property Address: 65 Grasslad Grove Leopold, Vic

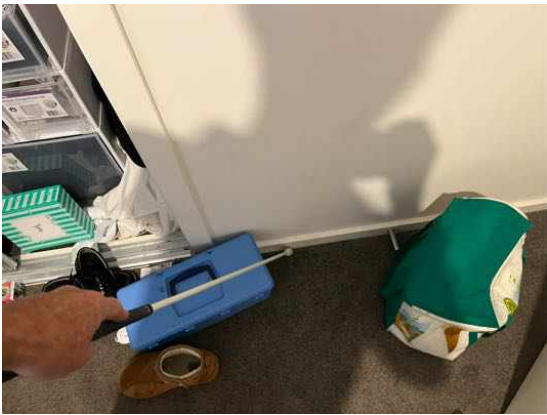
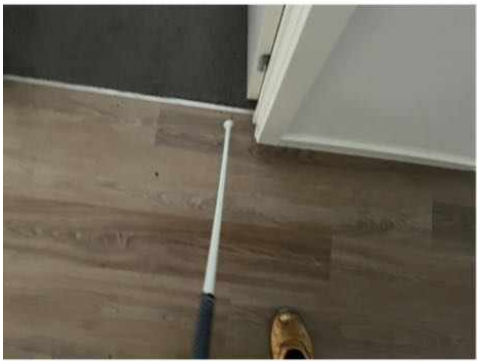
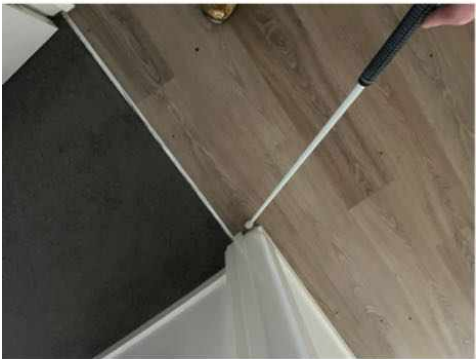
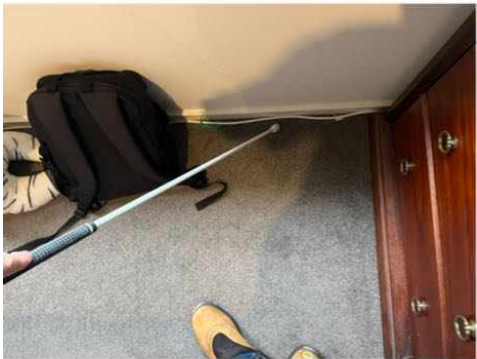
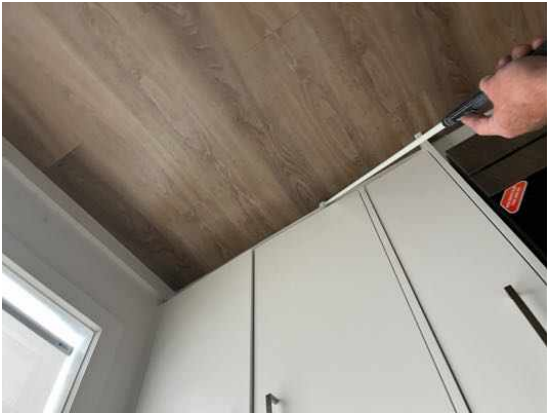
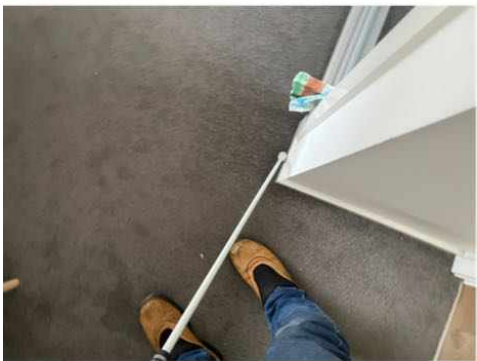
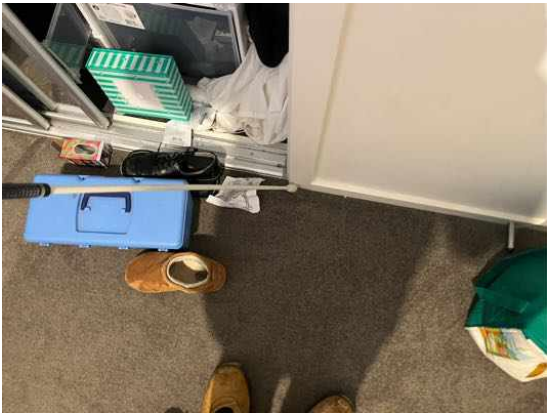
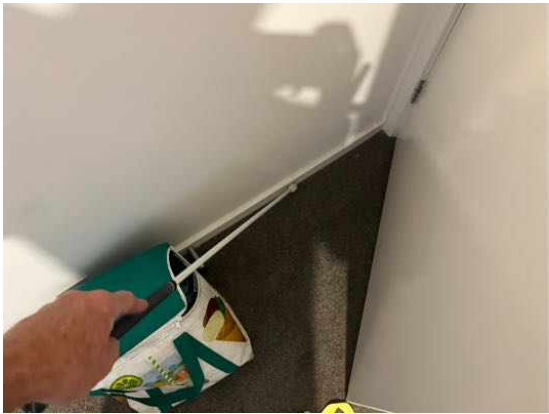
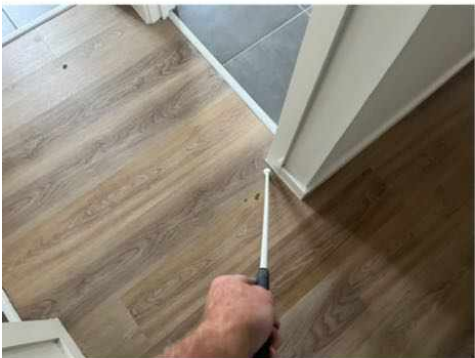
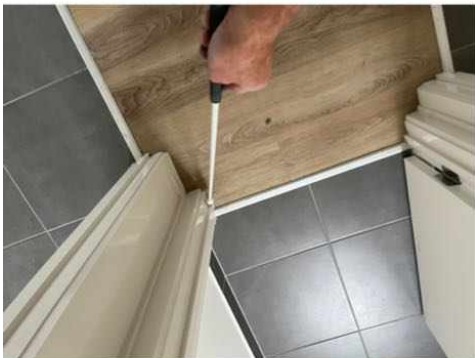
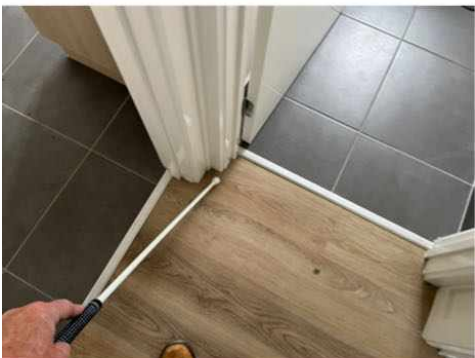
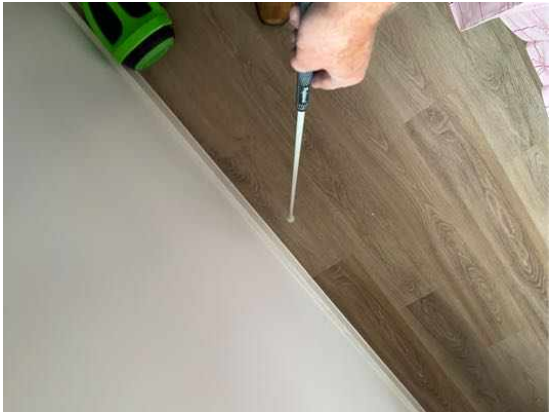
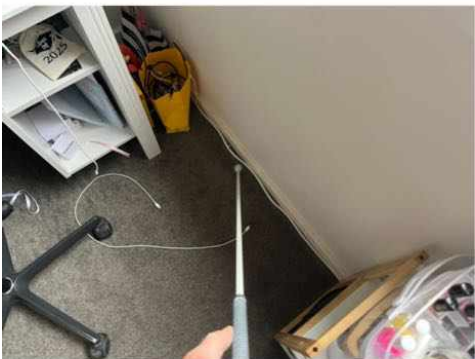
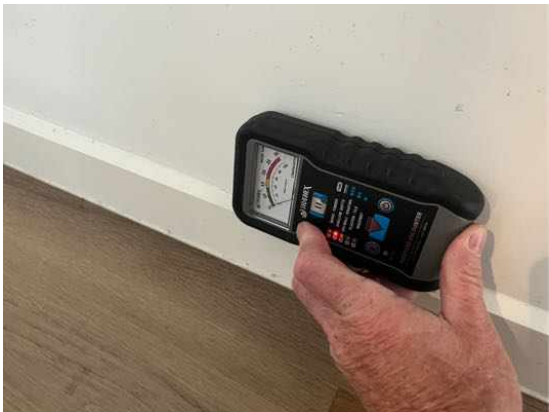
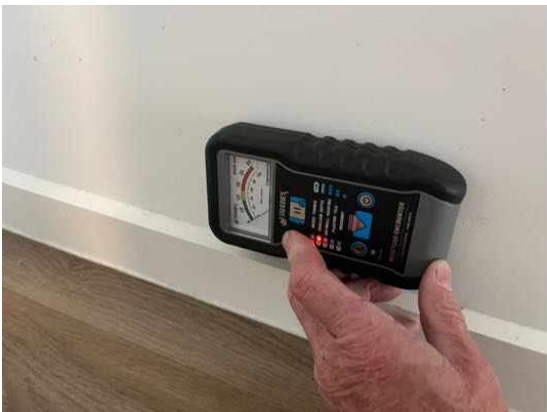
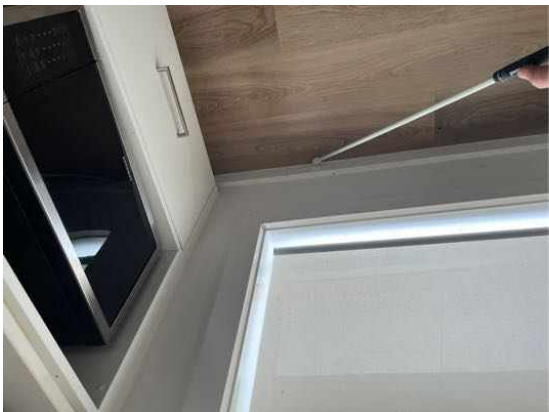
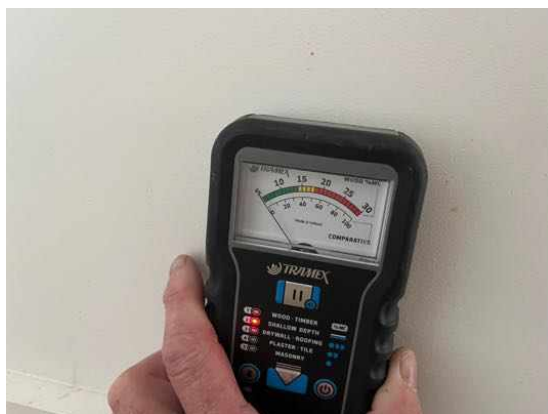
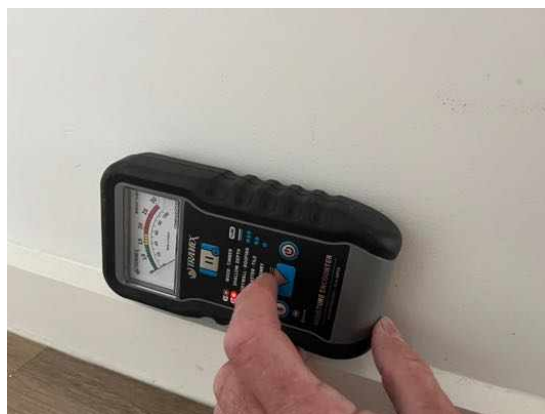
Building:
 Location: Roof Void
 Finding: Additional Photos - Obstructions and Limitations
 Information: These photographs are an indication of the obstructions and limitations which impeded full inspection of the property at the time of inspection.
