# Building and Timber Pest Inspection Report

Inspection Date: Mon, 2 Feb 2026

Property Address: 23 Bambil Cres, Dapto NSW 2530, Australia

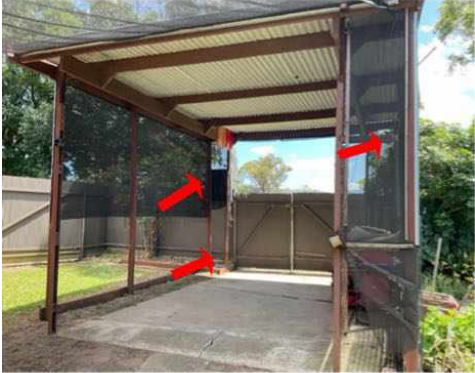
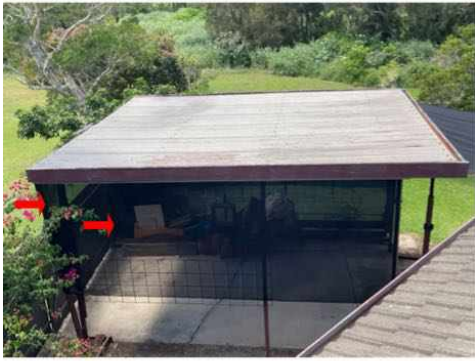
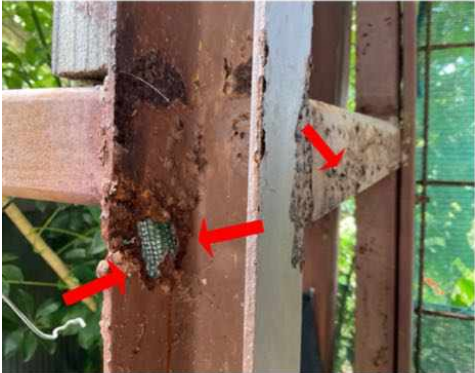
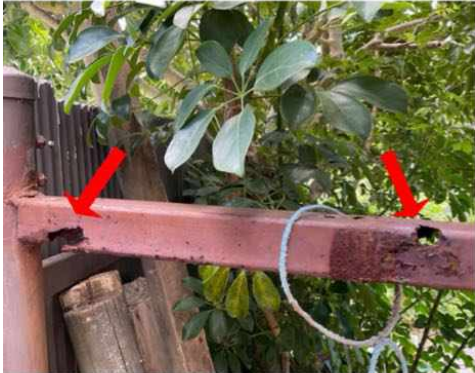
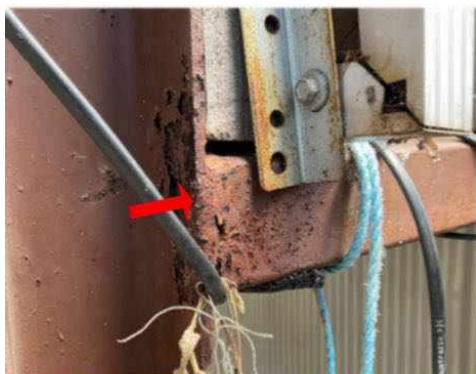
Building: Building 1  
Location: Carport  
Finding: Carport unsafe  
Information: This carport shows evidence of severe rust and corrosion, as well as insufficient cross bracing and leaning support posts and is likely to collapse at any time.

Note some posts are covered by stored items and could not be inspected.

A registered builder must be appointed to replace the areas id severe rust and strengthen or demolish this ageing structure.

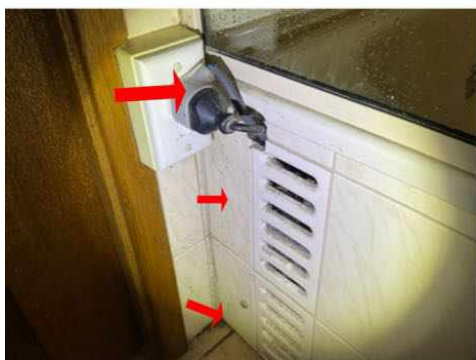
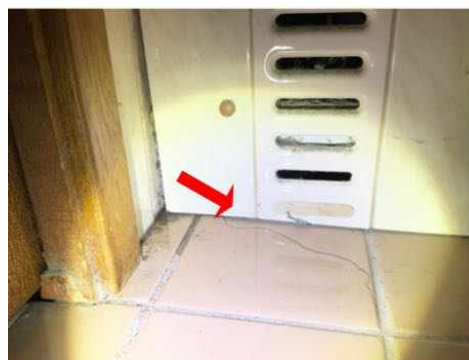
### Finding 1.02

Building:	Building 1
Location:	Bathroom
Finding:	Shower screen - Leaking around power point
Information:	Leaking was evident to the shower screening next to this electrical outlet which requires decommissioning. It is suspected that the leaking has occurred as a result missing sealant. Leaking from the shower in this area may lead to electrocution.

Appointment of a sealant expert is required to repair or replace this missing sealant and an electrician to move the PowerPoint before using this shower.

Such works should be performed immediately to ensure that no injury occurs.

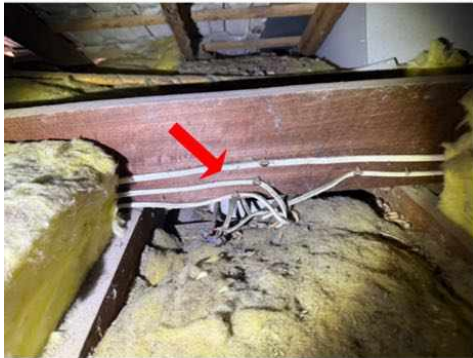
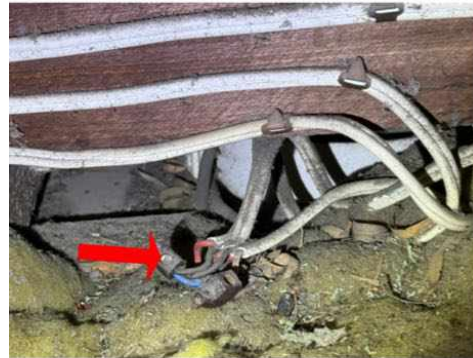
### Finding 1.03

Building:	Building 1
Location:	Roof Cavity
Finding:	Electrical cables missing a junction box
Information:	The electrical fitting in this roof area was found to be missing a junction box at the time of inspection.

This missing fitting and loose cables does expose electrical works, and may create a safety hazard if there is potential contact with persons in the area.

A Licensed electrician should be appointed to rectify these areas immediately.

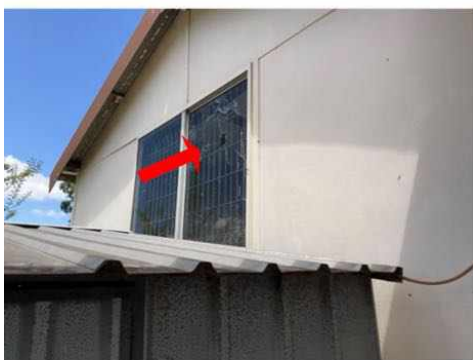
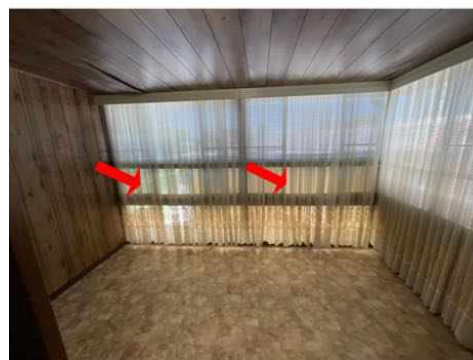
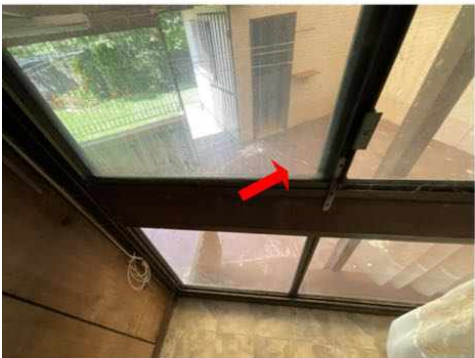
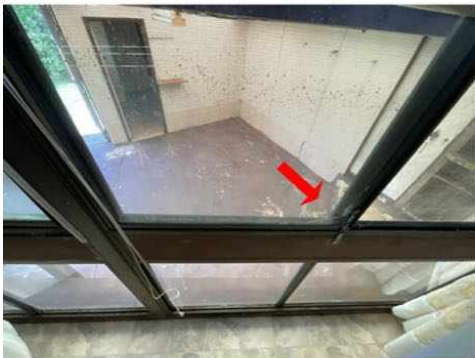
### Finding 1.04

Building:	Building 1
Location:	Garage and rear house walls
Finding:	Windows - Cracked
Information:	Cracks were identified in 3 windows. Cracking in windows is generally the result of impact damage, and is likely to develop further when left unmanaged.

The likelihood of this windowpanes further cracking and shattering is increased exponentially, providing a safety hazard in the area. The cracked windows also impairs the weather tightness of the building, creating potential for minor water leaks.

A qualified glazier is required to repair the windows as soon as possible. Depending on the extent of the cracking, replacement of the windows may be required. Please be advised that any persons coming into contact with the cracked windows should do so with due caution to avoid any personal injury that may ensue.

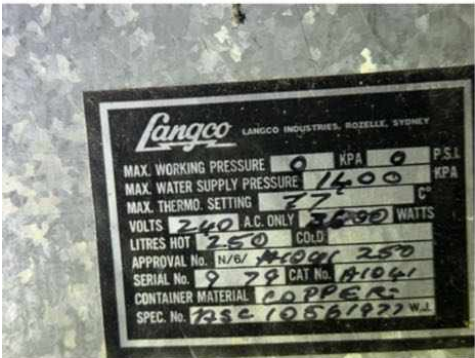
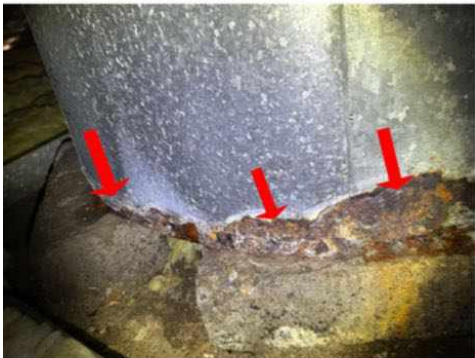
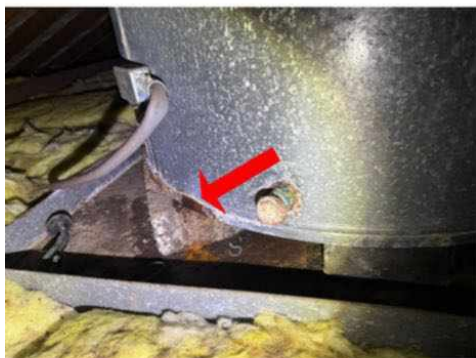
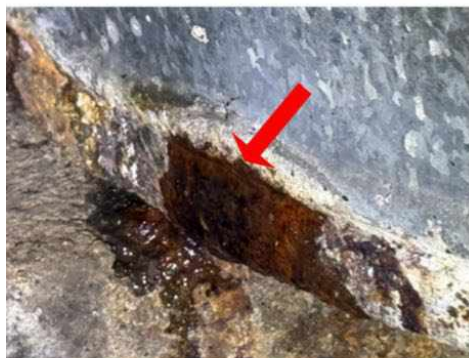
**Finding 2.01**

Building: Building 1  
 Location: Roof cavity area - left  
 Finding: Hot water unit - Rusted and leaking  
 Information: The original hot water unit shows evidence of severe rust. Small leaks into the bottom tray were evident. It a major leak occurs, the 250 litres of water may flood the loungeroom/hall. This rusted tank will developed to a more major leak in the near future. Such damage is expected of a building element of this age and with this level of exposure to excessive moisture.

While the ageing hot water unit is still fully functional, replacement is required by licensed plumber. A new unit may be able to be reused when the block is further developed.

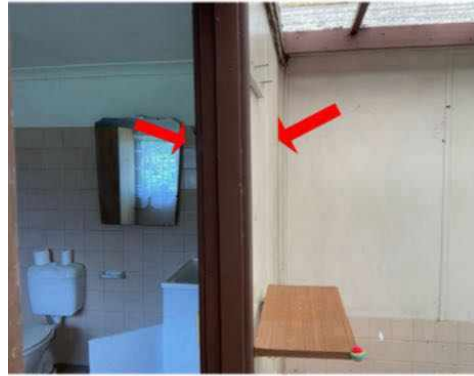
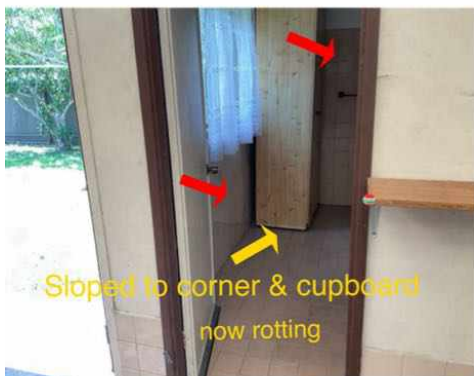
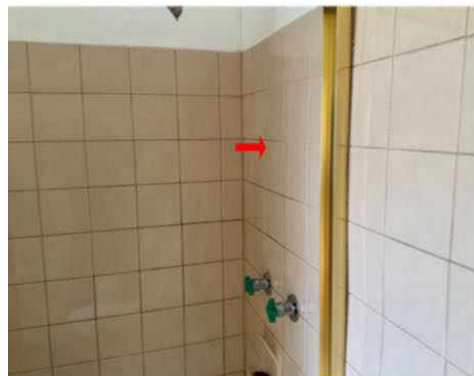
## Finding 2.02

Building:	Building 3
Location:	Verandahs, Bathrooms
Finding:	Bowing in all walls
Information:	Bulging / bowing was noted to all walls in the rear building 3 - bathroom and the main house bathroom. This has led to many cracked tiles. It is suspected that this bulging is caused by lack of or failure in adhesion to framing, and water ingress.

Other defects in the rear building 3 area are as follows -

1. Leaking shower screen.
2. Cracked tiles
3. Substandard sealant.
4. Uneven tiling falling to the rear left leading to rotting the base of the portable cupboard.

Building works required to fix bulging building elements should be completed as the cause may be significant and may indicate a structural defect which would require extensive works in the long-term future, including works to floor structures, walls, and associated finishes.

Further invasive inspection is required to determine the actual cause. If the cause is structural it is advisable that an Engineer also inspects the building.

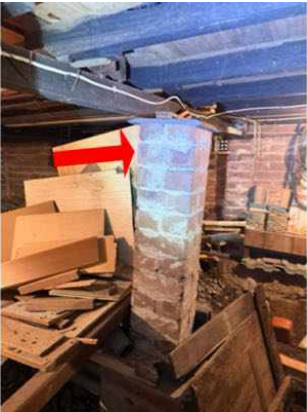
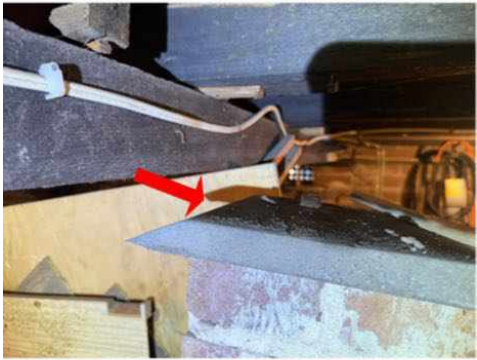
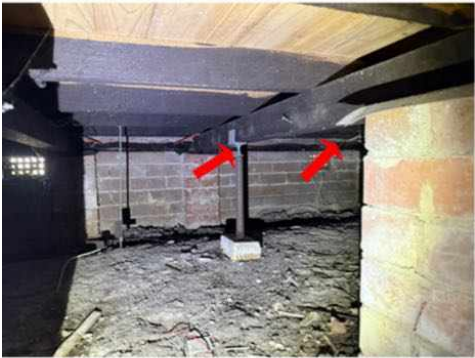
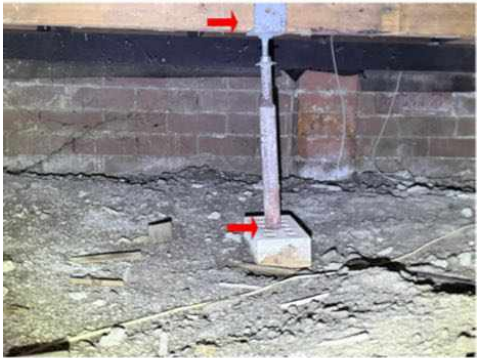
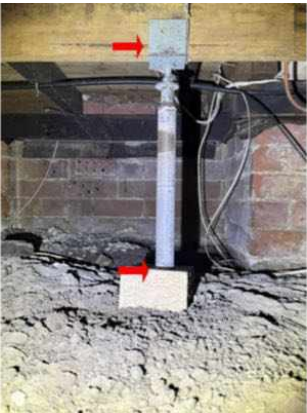
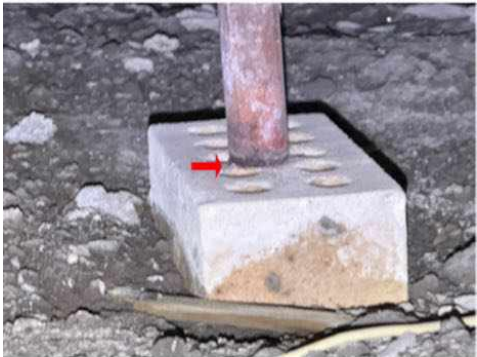
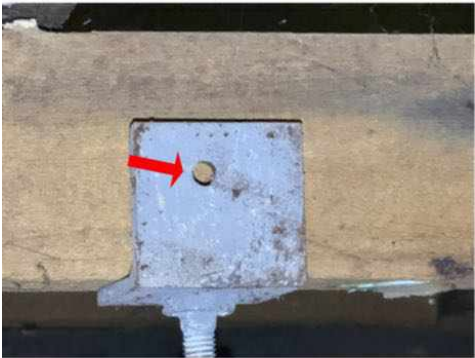
### Finding 2.03

Building:	Building 1
Location:	Subfloor
Finding:	Piers on a lean and substandard works
Information:	Evidence of the rear left brick pier leaning was identified. This pier is now not supporting the floor. The front left flooring under the loungeroom also has support added and this support is substandard. There are no fixings to hold this support in place and the south end is not touching the floor bearer. The rear leaning pier needs the expertise of pier repair specialists or licensed builder to assess your foundations and decide on the best course of action. This will involve rebuilding or replacing this rear brick pier in the near future.

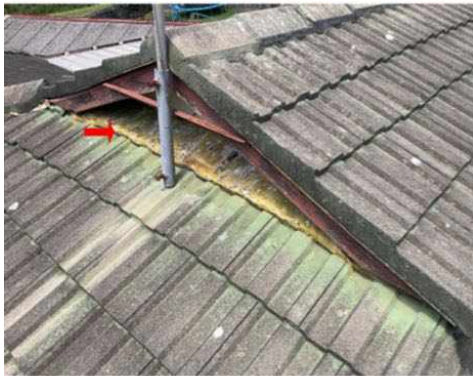
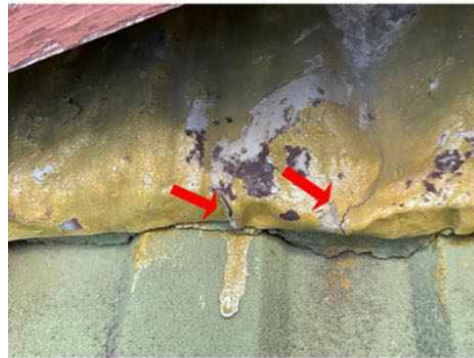
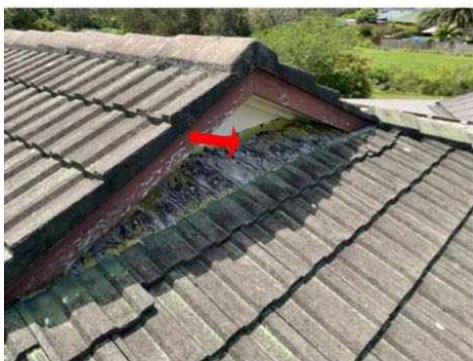
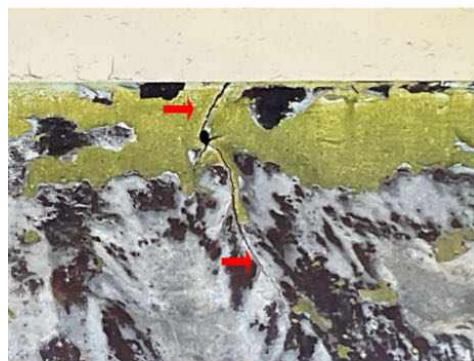
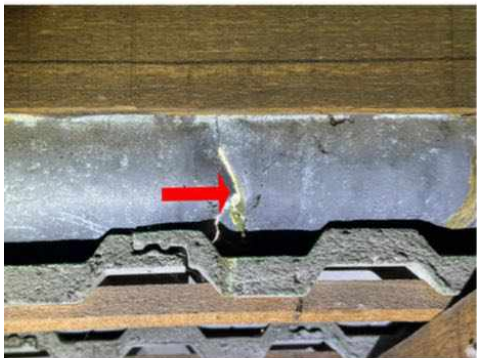
### Finding 3.01

Building:	Building 1
Location:	Garage and rear areas
Finding:	Roof plumbing - Flashing cracked
Information:	Water leaks generally occur when a particular area of the property is not weather or water tight. Cracks were evident to some of the roof flashings at the time of inspection.

Regardless of the location, if left unmanaged, even minor leaks can lead to serious damage of associated building elements, potentially resulting in the need for replacement of building materials. Damage to ceilings, wood rot, mould and other hazards, such as electrical hazards, may also arise if left unmanaged.

Further inspection by a qualified carpenter or licensed plumber is advised to repair these flashings.

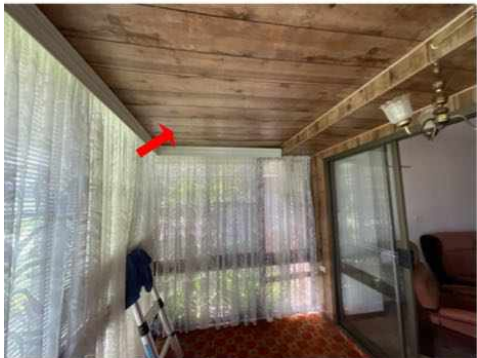
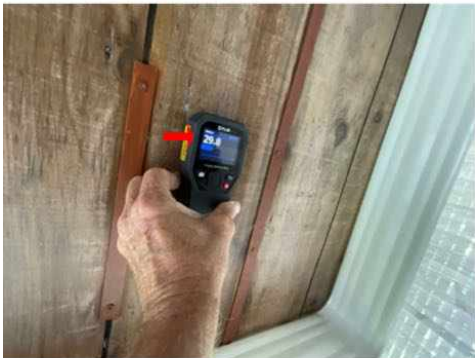
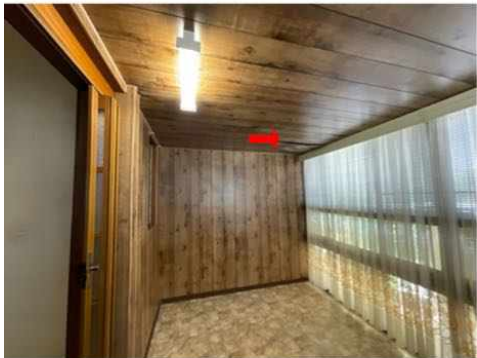
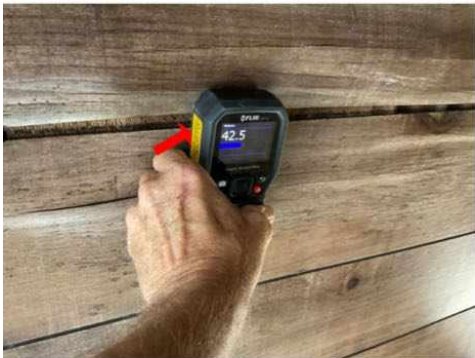
**Finding 3.02**

Building: Building 1  
 Location: Rear and front verandah ceilings  
 Finding: Evidence of excessive moisture was present at the time of inspection  
 Information: Excessive moisture found in the front and rear internal verandah rooms. This can attract termites and produce conditions that promote termite attack, fungal growth and wood decay. Excessive moisture is generally caused by deteriorated, inadequate or missing roof drainage, damaged external sealant, leaking plumbing pipes or fixtures and poor site drainage. It is highly recommended that all roofing sheets and fittings be maintained regularly in order to prevent excessive moisture being present in the internal property.

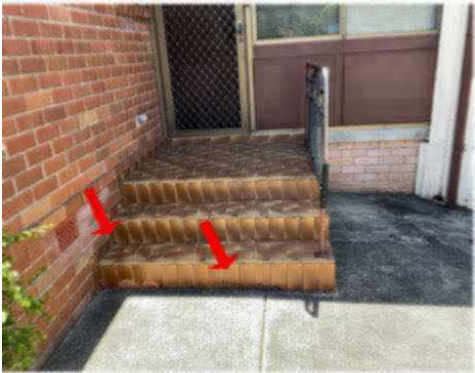
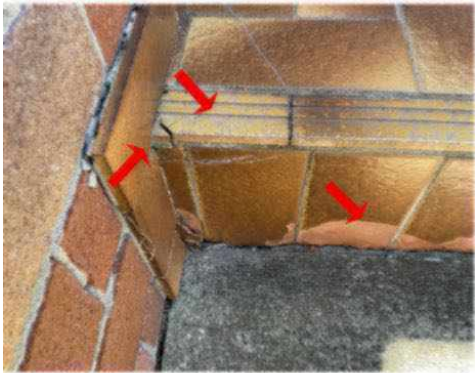
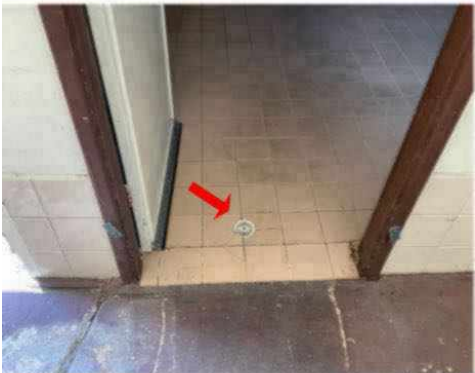
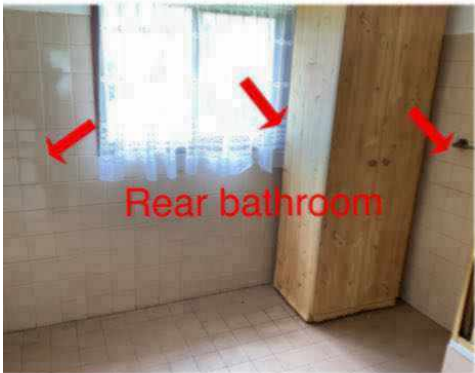
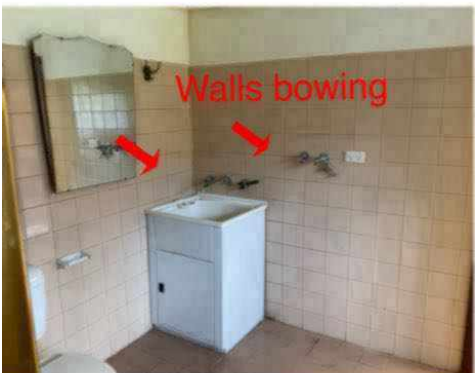
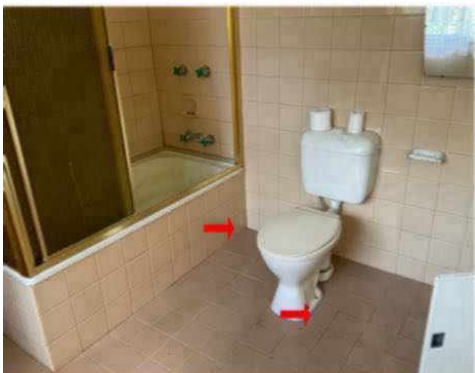
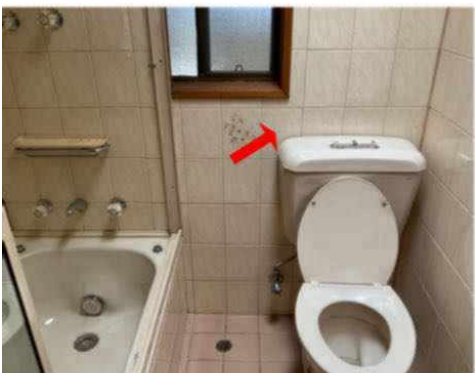
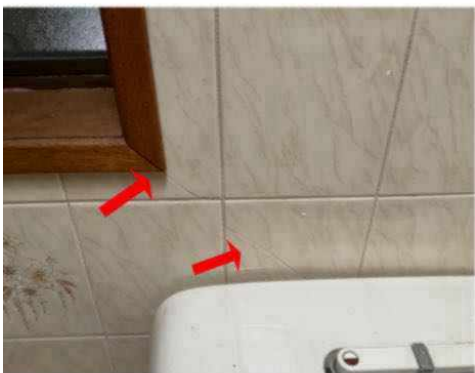
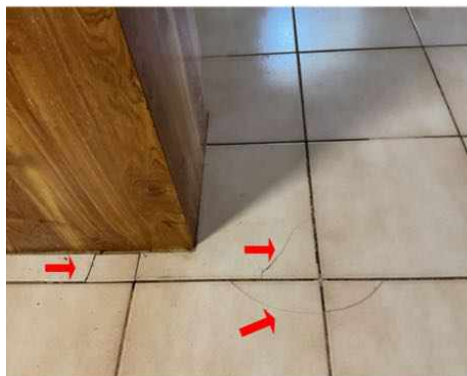
Building:	Building 1
Location:	Verandahs, bathrooms, kitchen.
Finding:	Tiles cracked
Information:	Over 3 dozen cracked tiles were evident on the external porches, wet areas, kitchen etc at the time of inspection. It is suspected that this cracking has occurred as a result of both minor settlement and impact damage. Cracked tiles throughout the household detract from the overall appearance of the affected areas. In wet areas of kitchens and bathrooms, it can lead to water damage of adjoining walls and floors.

Replacement of any sharp cracked tiles is recommended to prevent injury. A tiling contractor may be appointed to perform these works.

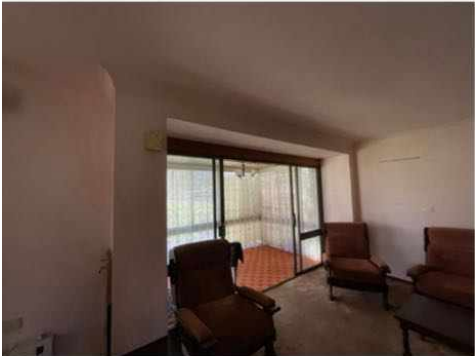
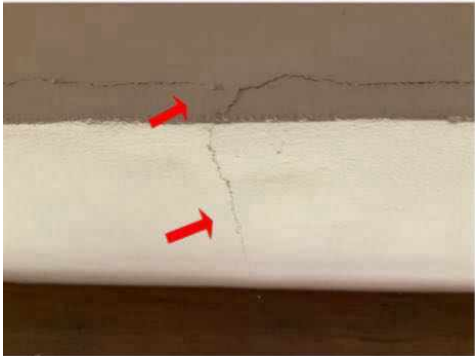
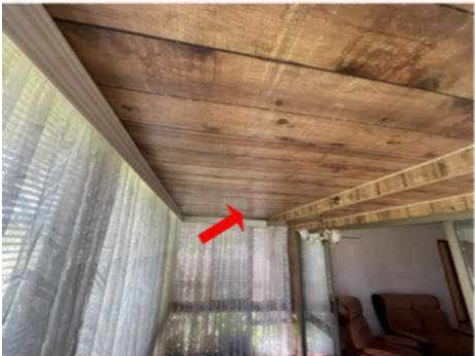
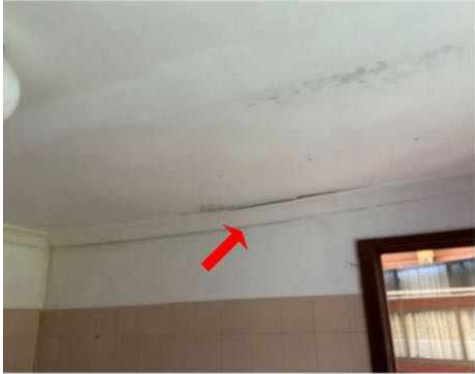
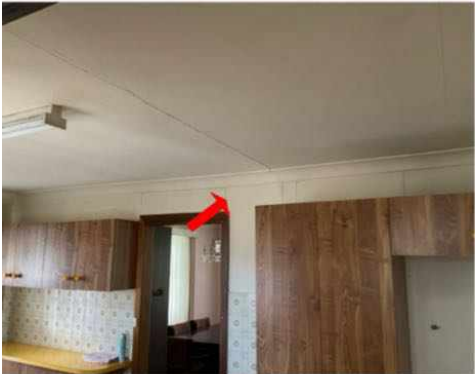
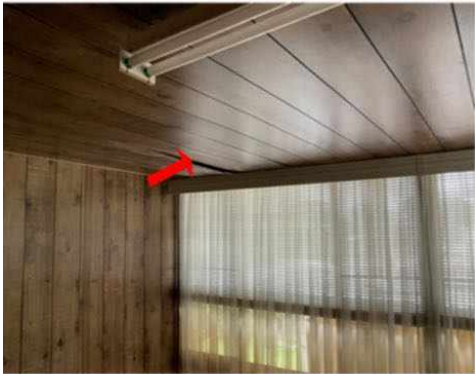
### Finding 3.04

Building:	Building 1
Location:	Porch, lounge room, kitchen, rear bedroom
Finding:	Ceilings - Sagging
Information:	Sections of these ceilings were found to be sagging at the time of inspection. Sagging to the fixed ceiling structure generally indicates that the building materials have swollen, due to contact with water, or that fixings (e.g. nails or glue) have become loose and require reattachment.

Rear bedroom ceiling sag  
Roof void inaccessible  
here

Where minor sagging is evident, comparatively minor works, such as re-gluing of ceiling sheets, may be required. Such works may be performed by relevant tradespeople, such as plasterers and painters. Where excessive moisture has caused the roofing structure to swell and sag, the source of the water leak should primarily be identified prior to any remedial works being performed.

In some cases, sagging ceiling linings may also indicate that there are structural issues, causing surfaces to warp, twist or sag. Where sagging appears to be major, appointment of a structural engineer is advised to further inspect the property and identify the source and rectification works required.

The appropriate action should be taken by the client as soon as possible to ensure that any potential further damage is limited.

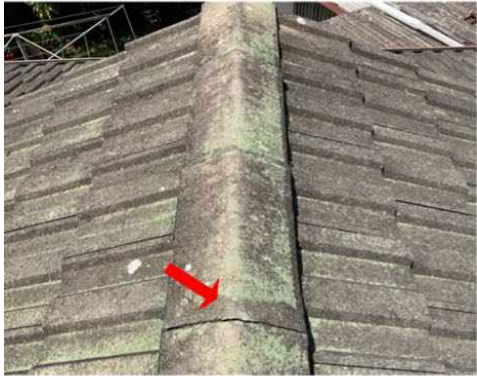
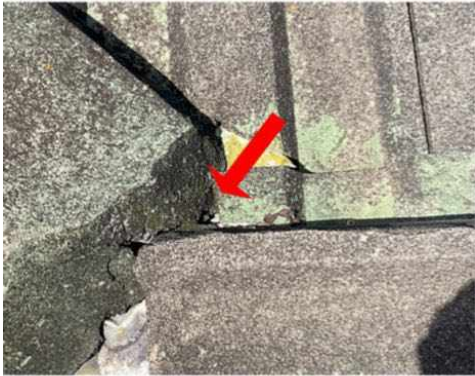
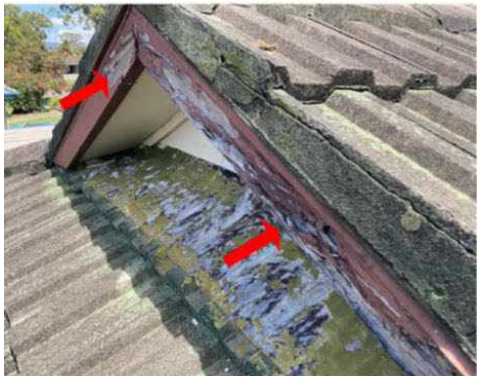
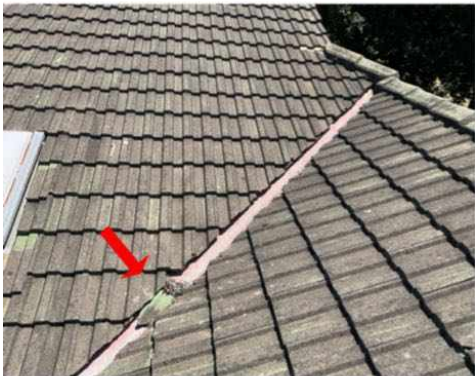
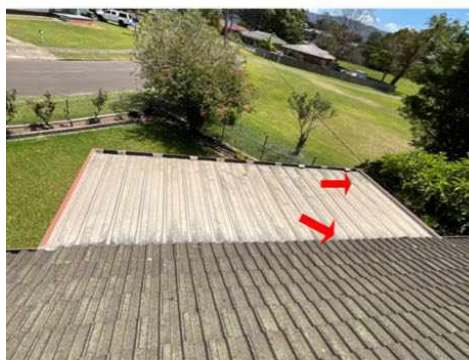
Finding 3.05

Building: Building 1  
Location: Roof Exterior  
Finding: Roofing areas - Weathered  
Information: Upon inspection of the exterior roofing, the majority of the roof areas were considered to be in a fair condition. While weathering of these pictured areas is consistent with the age of the property, maintenance works are required. The many areas of repaired sealant in the front and rear verandahs appear to be still leaking.

Re-sealing and replacing small areas of gaps, damage or rust the may be considered as an interim solution by the client to help preserve and extend the life span of these roofing areas. Where left unmanaged, deteriorating roofing materials are likely to lead to a number of secondary defects, including minor water leaks and weather exposure to internal roofing structures.

Consultation with a roofing contractor is highly advised to gain advice on cost of remedial works that may be required in the short to medium term.

Remedial works are likely to increase the longevity of the exterior roofing structure.

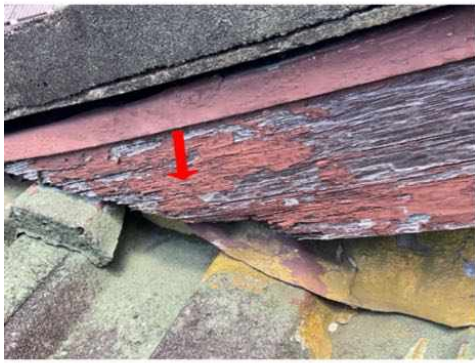
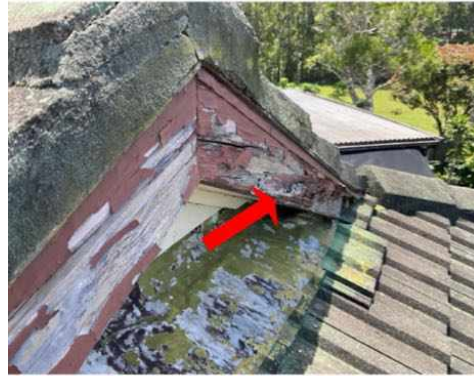
Building:	Building 1
Location:	Garage and rear areas
Finding:	Wood rot to all buildings
Information:	The buildings shows evidence of wood rot. Wood rot, also known as Fungal Decay, occurs when timbers and other cellulose building materials are exposed to damp conditions on an ongoing basis. This could be the result of exposure to weathering over a prolonged period of time, or the attraction of excessive moisture from other abutting building materials.

Early intervention and regular maintenance, particularly of exterior timbers, will prolong the useful life of these building elements. Prior to any works being performed, the cause of the moisture that has created the visible wood rot should be identified and addressed in a suitable manner. Replacement of affected timbers may then be a necessary step in protecting surrounding building elements from such deterioration.

A qualified carpenter or registered builder may also be required to replace affected building materials.

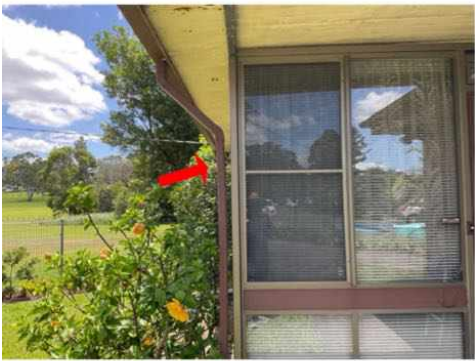
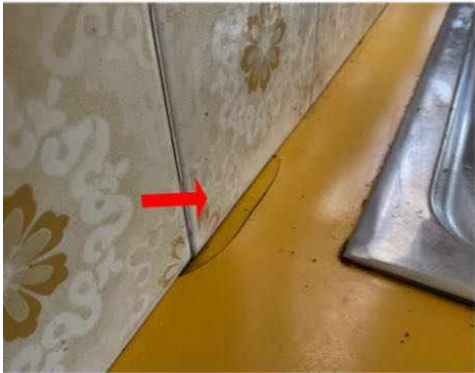
### Finding 3.08

Building: Building 1  
Location: Pictured front downpipe and kitchen bench  
Finding: Building elements - Damaged  
Information: Evidence of minor missing or damaged areas was identified at the time of the inspection. These include -

1. The front downpipe is loose requiring a handy person/carpenter to add additional fixings.
2. The kitchen bench has minor cracking.

A carpenter would be the trade responsible for rectification of these areas when convenient.

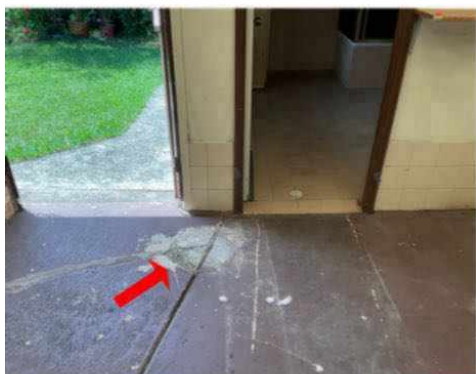
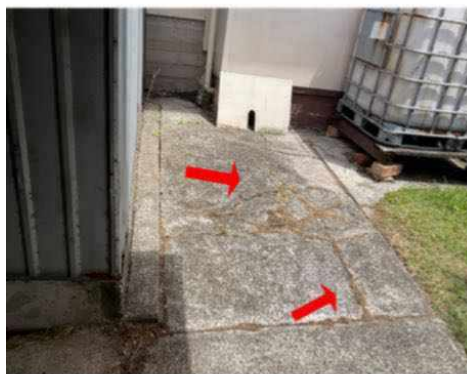
**Finding 3.09**

Building: Building 1  
Location: Yard - front & rear  
Finding: Crack in concrete areas - Category 3  
Information: Cracks coded as Category 3 was identified in the slab. A Category 3 crack is described as a wide crack with obvious curvature or change in level, affecting the slab.

The approximate width of the crack to be considered Category 3 is greater than 2.0mm, or a change in offset of 15-25mm when a 3m straight edge is placed over the defect.

Category 3 cracks to slabs exceed allowable Standards and Tolerances, and are considered defects requiring rectification.

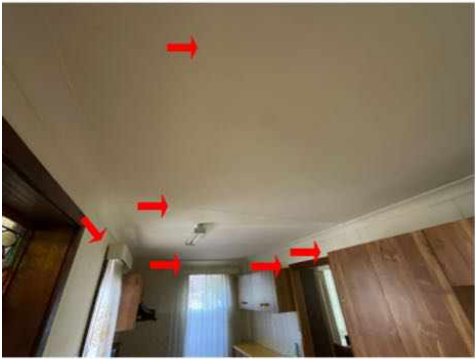
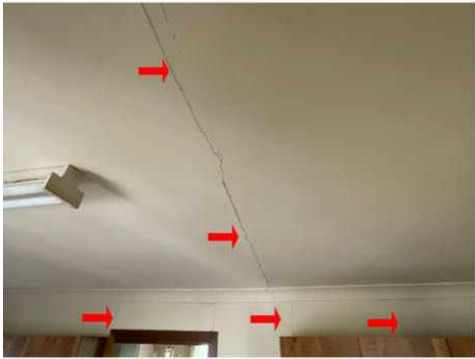
### Finding 3.10

Building:	Building 1
Location:	Many areas
Finding:	Cracking - Damage Category 2 - Noticeable (up to 5mm)
Information:	Numerous noticeable cracks are a common occurrence as a result of many primary defects. Such causes may include age, general wear and tear, expected building movement, general expansion/contraction of building materials in different weather conditions, and/or minor failings in the installation or application of building materials.

Noticeable cracks may result in minor sticking or jamming of associated doors and windows, which require easement. However, noticeable cracks are easily filled and repaired. A plasterer can be consulted to install an expansion joint at this point to allow for this movement during different weather conditions.

Monitoring of all cracking should be conducted frequently. Always contact a building inspector should cracks widen, lengthen, or become more numerous. Additionally, your building inspector should also be contacted if associated building elements such as doors and windows become more difficult to operate over time.

Relevant tradespeople, such as carpenters, painters and plasterers, should be appointed to perform remedial works, as deemed necessary.

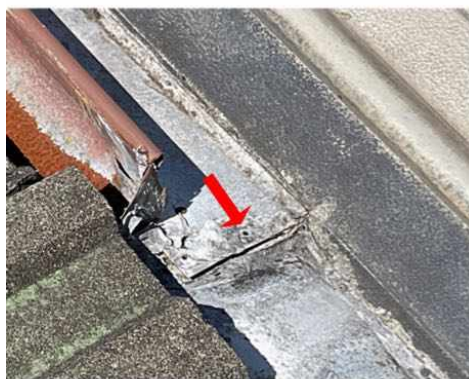
Building:	Building 1
Location:	Pictured Areas
Finding:	Sealant (external) - Missing.
Information:	It was noted on inspection that areas of external sealant was missing to small areas of the external walls and rooves.

Flexible sealants should be applied to these affected areas to prevent any subsequent water damage that is likely to occur.

A sealant specialist or skilled handy person should be appointed to complete these works as soon as possible

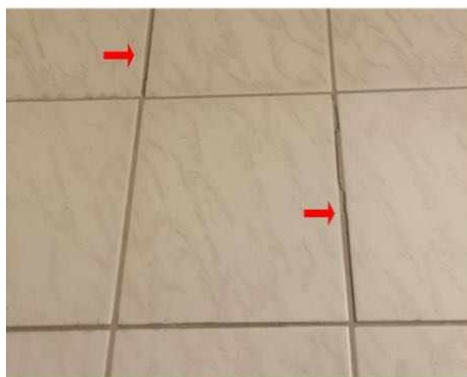
### Finding 3.13

Building:	Building 1
Location:	Kitchen and bathroom
Finding:	Sealant and grouting - Missing or damaged
Information:	It was noted on inspection that sealant or grout is degraded to these pictured wet

Different materials and floor areas move at different rates, generally causing cracking to grout or sealant at this point. A flexible sealant is required to allow for expected expansion and contraction, while keeping the joint water tight and protective of all associated building materials.

Flexible and mould resistant materials should be applied to affected areas to prevent any subsequent water damage that is likely to occur. Regular maintenance and replacement of damage or missing or damaged sealant and grout is highly recommended to the wet areas, as this is a regular wear and tear defect. Sealant and grouting in areas that come into regular contact with water should be maintained for the long term care of your property.

A sealant specialist or tiling contractor should be appointed to complete these works as soon as possible

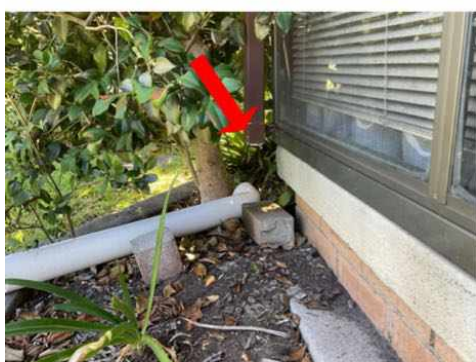
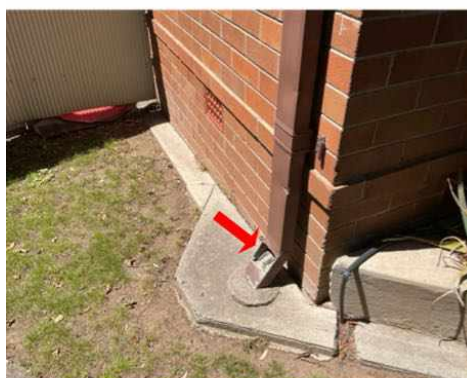
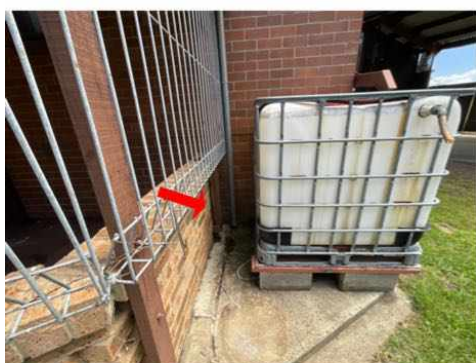
### Finding 3.14

Building:	Building 1
Location:	Walls
Finding:	Site drainage - Inadequate
Information:	The site drainage in this area was found to be inadequate at the time of inspection, creating potential for subsequent water damage to associated building elements.

The air conditioner and hot water system overflow run against the house walls.

It is important that water does not lie against the base of walls; surrounding paths and ground levels should be sloped to drain water away from walls. Downpipes should not discharge stormwater onto lower walls or plinths. Stormwater should be carried away by large, regularly cleaned drains. Ground levels may need to be lowered to expose a buried DPC.

Where site drainage is inadequate, installation of an Agricultural (Aggie) Drain may be required. A qualified plumber should be appointed to further inspect the property and perform any remedial works as necessary. Secondary defects are likely to occur if left unmanaged.

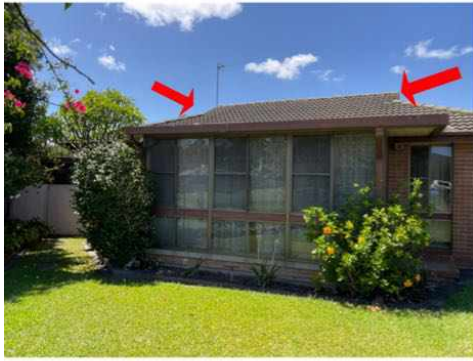
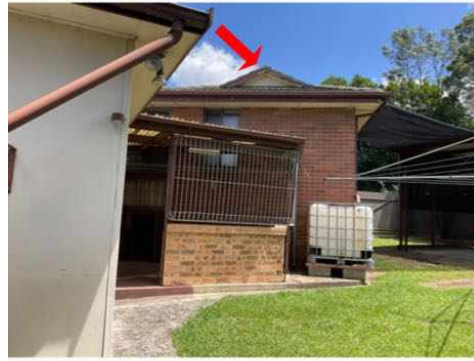
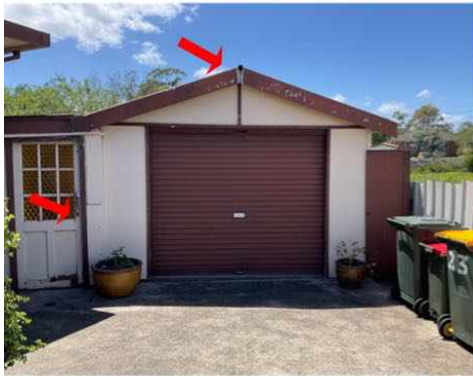
Building:	Building 1
Location:	Pictured areas
Finding:	Painting deteriorated
Information:	Much of the external paintwork has been neglected and require attention to prepare and re-paint.

Whilst incomplete or missing paint finish is generally an appearance defect, it can also lead to the development of secondary building defects over time. Incomplete areas of paint finish expose the area to moisture, potentially accelerating the deterioration of underlying building materials.

Degraded paint finishes should be sanded back, filled, leveled and painted, as applicable. Where inadequate or missing paint protection has led to the deterioration of the associated building element, repair and/or replacement of this building element may be required.

A painting contractor should be appointed as soon as possible to perform necessary works to aid the appearance of the affected area and to ensure the area is protected against further deterioration. Alternatively, the homeowner following manufacturer instructions may perform these works.

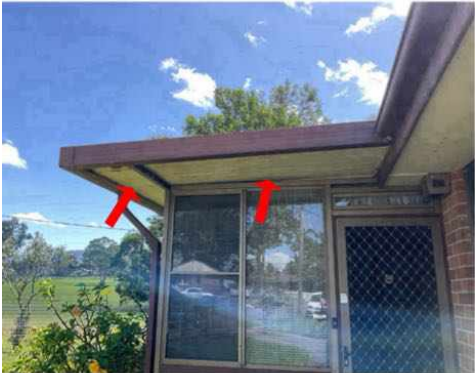
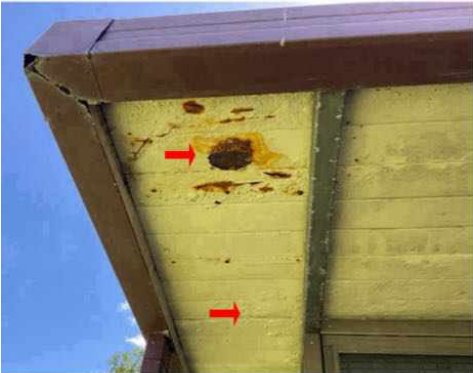
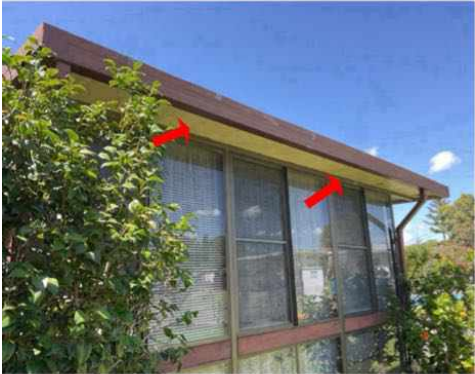
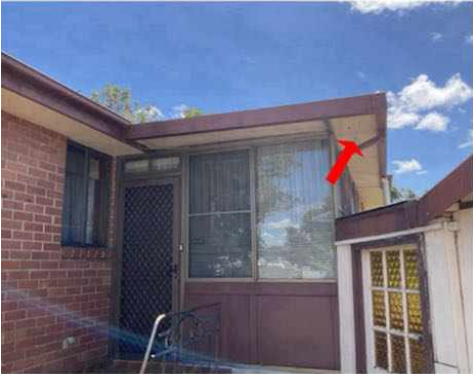
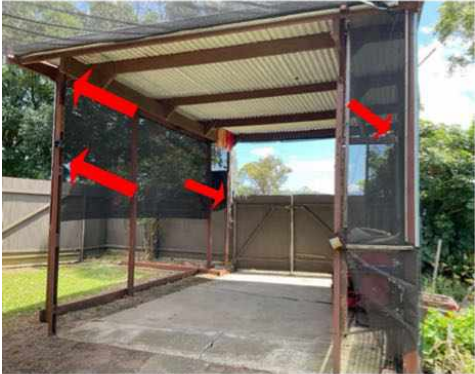
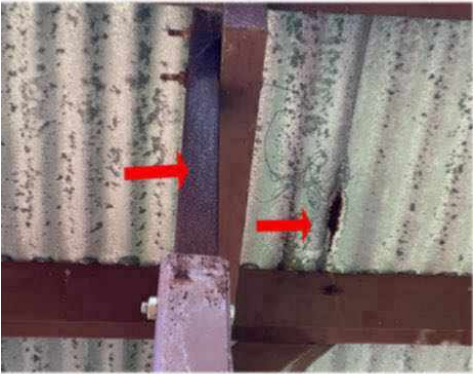
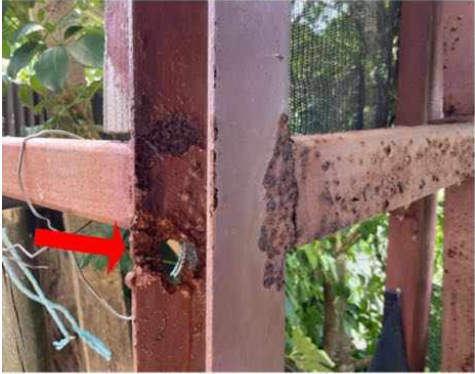
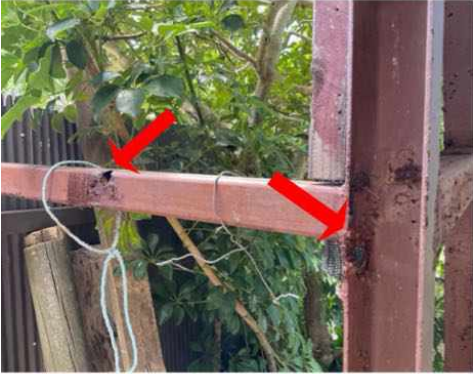
Building:	Building 1
Location:	Many areas
Finding:	Roof and carport - Rusted or corroded
Information:	These areas shows evidence of rusting and corrosion, which is likely to have developed as a result of excessive exposure to moisture and or inadequate coatings.

As surface rust provides no protection to the underlying iron, the deteriorating condition is likely to worsen if not addressed in the short-term future.

Where possible, the use of galvanized (treated) metals or aluminium coated metals aid in rust prevention, as does regular general maintenance. Rust formation can be controlled with coatings, such as paint, that isolate the iron from the environment.

Rusting and corrosion should be managed by ideally removing or limiting the affected surface from exposure to moisture. A registered builder may be appointed to replace any building elements that have been severely affected by rust or water damage.

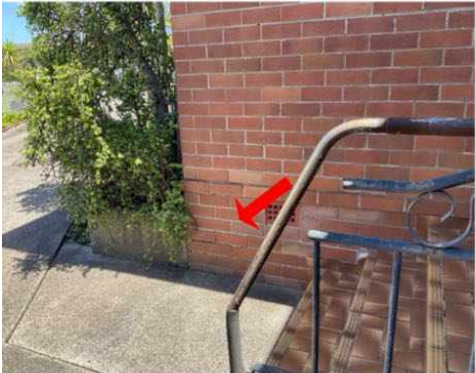
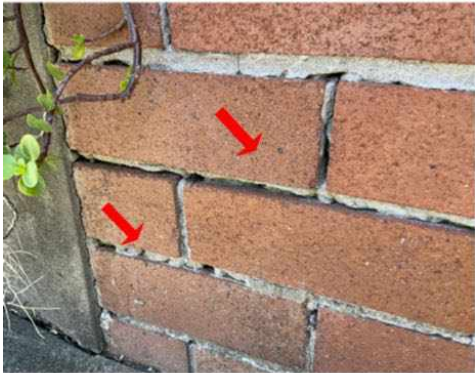
### Finding 3.19

Building:	Building 2
Location:	Small wall areas
Finding:	Brickwork - Deteriorated mortar
Information:	Mortar, or 'bedding', is the material which fills joints and intersections between bricks in masonry walls and structures. Sections of mortar in this brickwork were identified as having deteriorated, which is generally expected for a property of this age and condition.

Mortar may deteriorate as a result of age of building materials, minor movement of bricks, or frequent exposure to weathering. Mortar should be replaced to ensure that bricks remain in their intended location and to prevent gaps, which would allow water or moisture ingress and secondary damage as a result.

Mortar deterioration can be addressed by a bricklayer where areas of deterioration are localised and easily accessible.

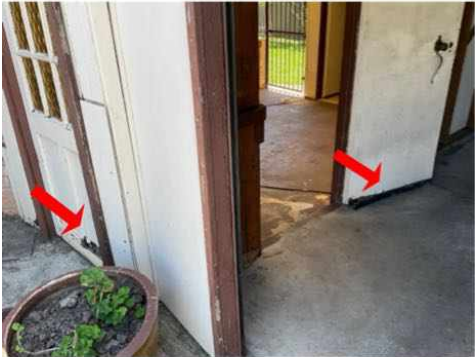
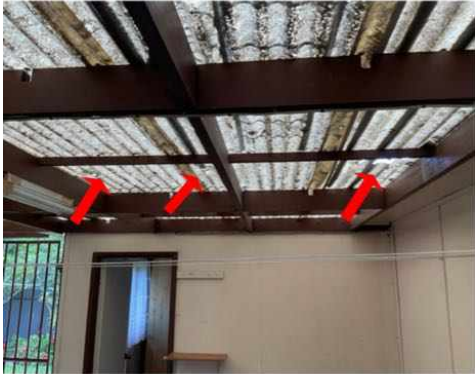
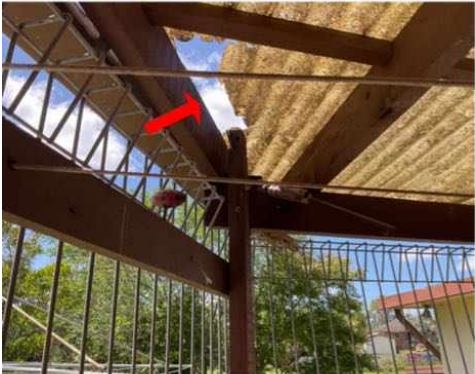
**Finding 3.20**

Building: Building 2  
Location: Garage & pergola  
Finding: Doors and roof damaged  
Information: These pictured doors and roof sheets were found to be damaged at the time of the inspection. They are coming apart and split. Replacement of these broken doors and roof sheets is advised to improve the operational state of the associated door.

A qualified carpenter or general handyman should be appointed to repair these doors as soon as possible.

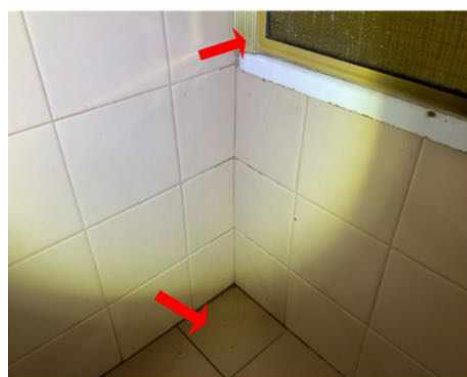
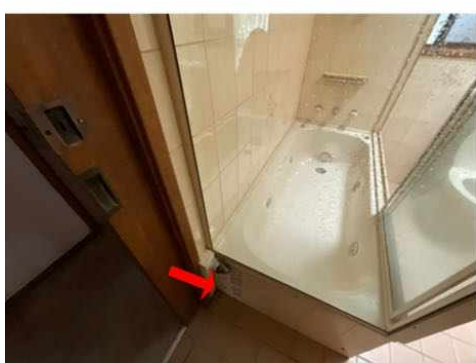
### Finding 3.21

Building:	Building 1
Location:	Both showers
Finding:	Shower screens - Leaking
Information:	Leaking was evident to the shower screens at the time of inspection. It is suspected that the leaking has occurred as a result missing sealant. Leaking from the showers , where left unattended, is likely to lead to water damage to adjoining flooring and walls. Such damage can lead to water damage and necessitate extensive remedial works being required. Active water leaks may also create an environment that is susceptible to the formation and development of mould.

Appointment of a sealant expert is required to repair or replace this missing sealant. Such works should be performed as soon as possible to ensure that no further damage occurs.

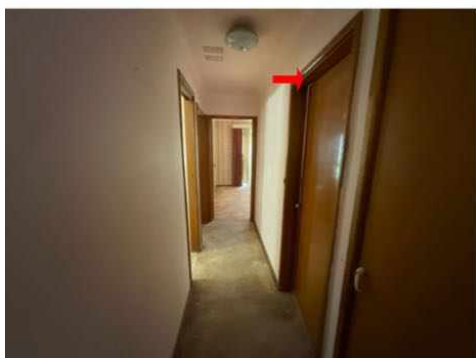
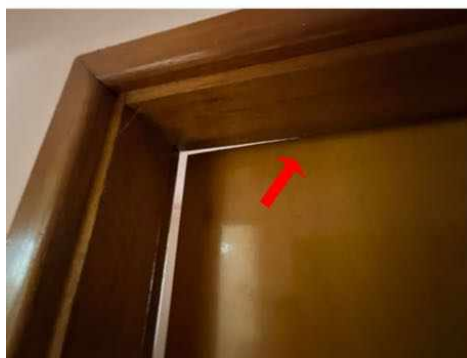
Building: Building 1  
 Location: Left middle bedroom  
 Finding: Door - Binding/jamming  
 Information: Binding and/or jamming of this door is evident during standard operation and it will not close. This defect inhibits the functionality of the affected door as well as creating potential for secondary defects to associated building elements, such as damage to the floor covering.

A door that binds to flooring or to the associated door frame may have several causes, ranging from minor defects, such as poor installation of the door or deteriorated hinges, through to major structural issues, such as damage to subfloor structures.

Where door binding/jamming appears to indicate major structural issues, a registered builder specialising in re-stumping should be appointed to provide an estimate on the cost of rectification.

For minor causes, a qualified carpenter or general handyperson should be appointed to perform minor rectification works at client discretion.

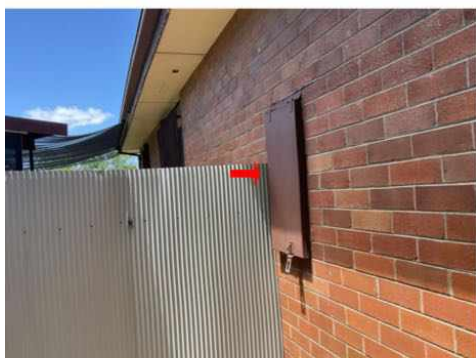
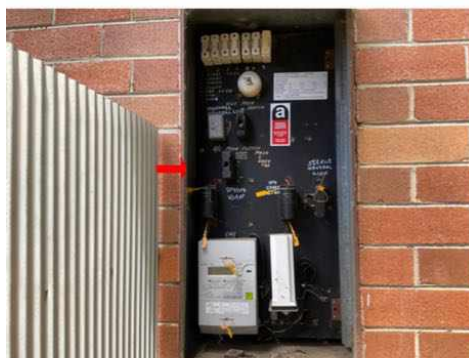
Building:	Building 1
Location:	Meter Box
Finding:	Termite Management System - no evidence of a chemical installation
Information:	The application of a post-construction chemical termite barrier is highly recommended for all properties. Such barriers are highly effective in preventing termite attack on any timber building elements throughout the property.

A durable notice should be placed in the switchboard unit to indicate current termite barriers. At the time of inspection, no durable notice was evident and it appeared as though no chemical termite management system has been installed, with no evidence to suggest preventative works taking place since the property was built.

The client may consider gaining further advice from a pest controller as to the costs and procedures involved with a 'chemical' application. It is recommended that obtaining such advice be a short-term priority.

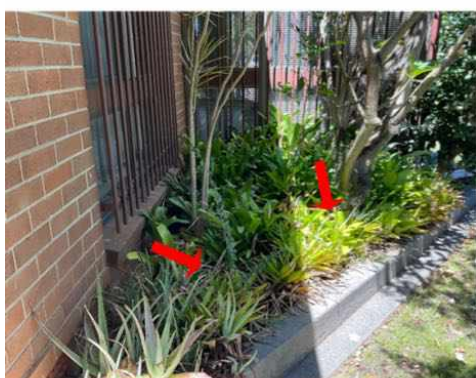
### Finding 6.02

Building:	Building 1
Location:	Yard - front
Finding:	Bridging - Vegetation and decking
Information:	Where vegetation and decking obstructs inspection of building elements, also known as bridging as it provides a bridging point for the access of termites, full inspection can not be achieved. Consequently moisture or dampness may be present and the areas becomes conducive to termite activity. Plants and decks against or very close to buildings provide cover, shade and can provide an environment that is attractive to termite infestation.

The removal and replanting of plant species that do not provide "cover" or cutting back of existing vegetation and leaving a small gap between decking and the building walls will assist greatly in preventing Bridging from occurring.

The removal of any such stored building or plant materials that may be conducive to termite activity should be carried out as soon as possible and arrange re inspection to minimize the risk of termite attack.
