# Building and Timber Pest Inspection Report

Inspection Date: Mon, 2 Feb 2026

Property Address: 23 Bambil Cres, Dapto NSW 2530, Australia

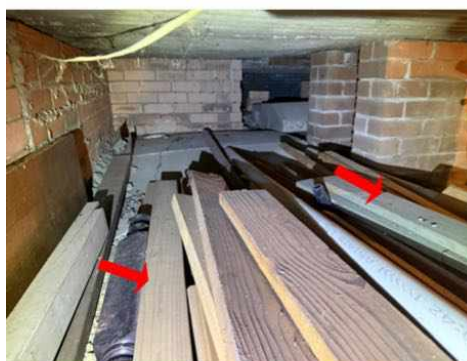
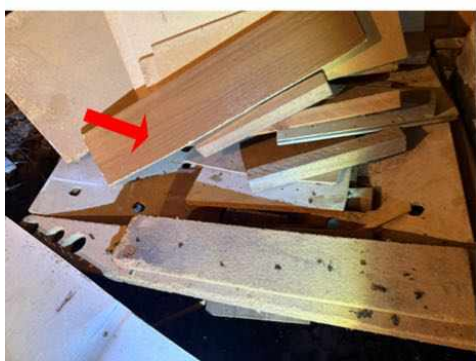
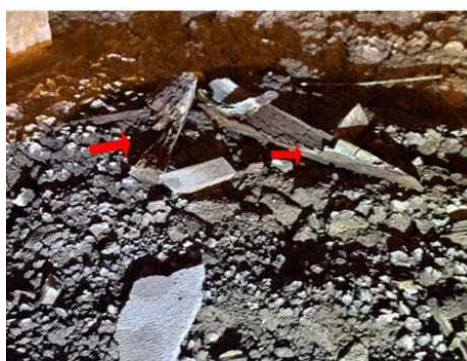
### Finding 6.03

Building:	Building 1
Location:	Yard - Back

Finding: Timber in contact with the ground  
 Information: Any timbers in direct ground contact provide opportunity for concealed termite entry and are likely to be subject to premature rot and decay as the soil retains moisture or damp conditions against the timbers.

Removal of all waste timber that is in direct contact with ground is highly advised. This timber is promoting mould and wood rot and is very attractive to termites.

Frequent pest inspections are advised to readily identify any termite activity in these areas.

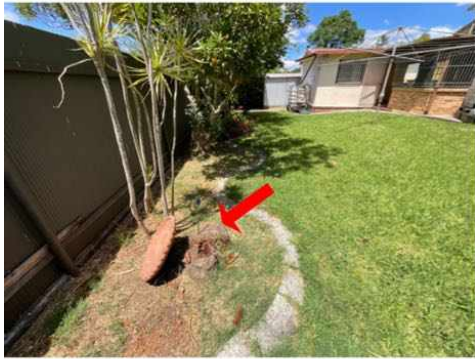
### Finding 6.04

Building: Building 1  
 Location: Pictured yard area  
 Finding: Tree stumps - left in ground  
 Information: Tree stumps left in ground provide opportunity for termite attack as they are likely to be subject to rot and decay providing an attractive food source. Treatment and/or Removal of the stump is highly recommended. A pest controller and tree removalist should be engaged to perform such works.

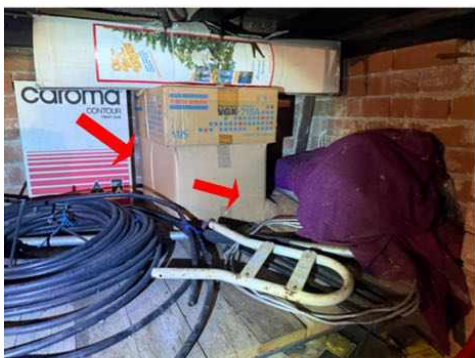
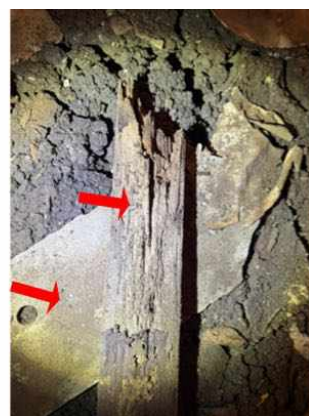
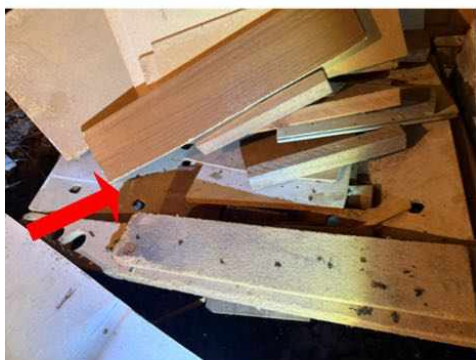
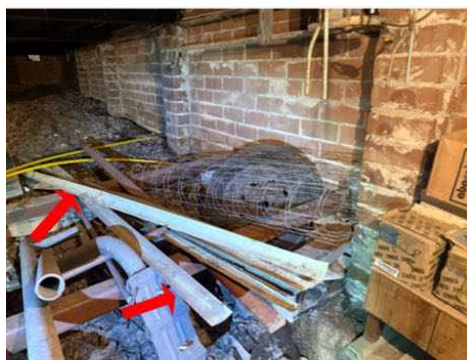
### Finding 6.05

Building:	Building 1
Location:	Subfloor
Finding:	Subfloor - Debris and stored items
Information:	An array of debris and material was found in the subfloor area at the time of inspection. Debris in this area restricts subfloor ventilation and creates potential for concealed pest entry. Stored timbers and other materials may also make the area susceptible to termite activity and wood rot.

A clear and empty subfloor will be better ventilated and easier to maintain in a dry condition. The removal of any timber debris is vital in minimising the risk of termite or wood borer activity.

Debris in the subfloor should be removed as soon as possible. Depending on the location and amount of debris and stored items, the homeowner may elect to undertake this task. Alternatively there are a large number of rubbish removal subcontractors that could undertake these works.

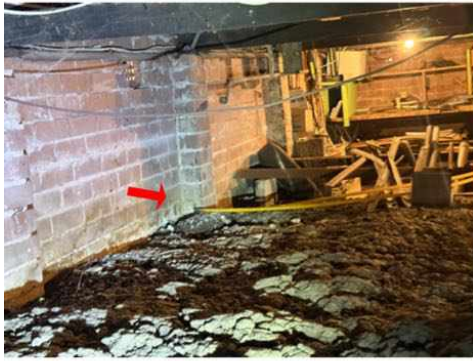
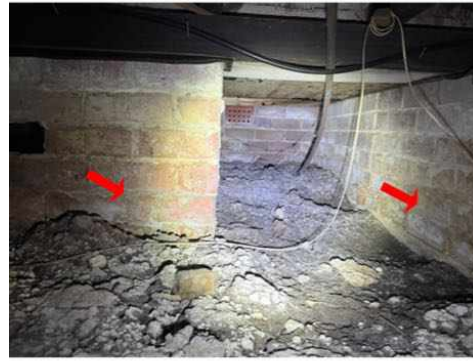
## Finding 6.06

Building:	Building 1
Location:	Subfloor
Finding:	Damp - Rising
Information:	Rising damp describes the upward movement of water in low sections of building elements (e.g. walls) by capillary action - the movement of water through porous materials such as bricks, sandstone or mortar.

Rising damp is generally managed by the installation of a damp proof course during construction. A Damp Proof Course (DPC) is an impermeable barrier at the base of the wall above ground level. However, many 19th Century buildings have no damp course installed, or the materials have failed. The DPC may have been omitted as a consequence of poor workmanship, or it may have been bridged where materials built up against the side of the house allow moisture ingress above the DPC level.

The first step in addressing rising damp is to diagnose the cause. The identified cause should be addressed first before addressing the appearance and other defects which have resulted from the rising damp. If the original cause is not resolved, further cases of damp are likely to ensue, resulting in secondary defects.

Consultation with a qualified plumber is advised immediately to identify the cause of the damp and perform remedial works as required.

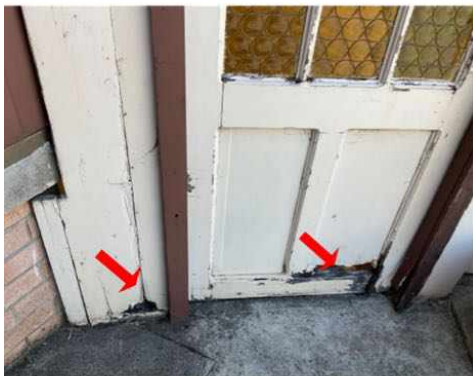
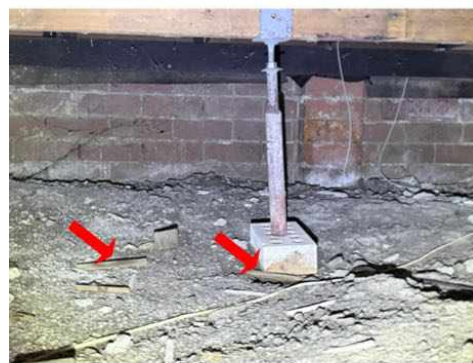
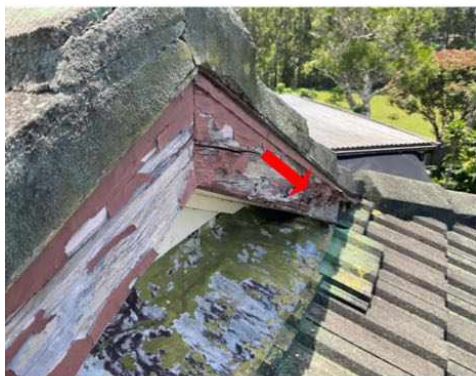
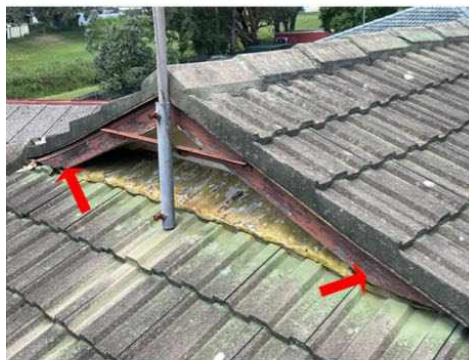
### Finding 7.01

Building:	Building 1
Location:	Verandah
Finding:	Fungal decay - present (localised)
Information:	Fungal decay also known as wood decay or wood rot generally refers to the deterioration of timber elements when in contact with excessive levels of moisture for a prolonged period of time.

The development of fungal decay is accelerated by temperatures from 5degreeC to 40degreeC as well as the presence of oxygen. Generally fungal decay develops on timber elements that are in use in an external environment which are exposed to rain penetration.

Note - See ALL wood rot photos, all these show fungal decay.

In this case, the affected timber element is in a decaying state and will need replacement by a carpenter or licensed builder.

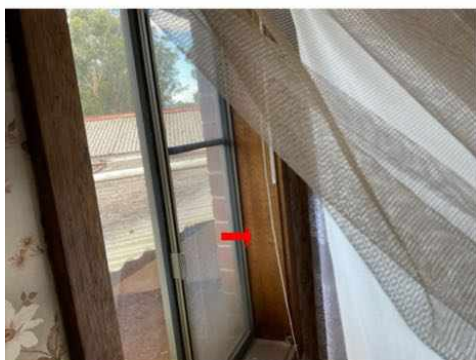
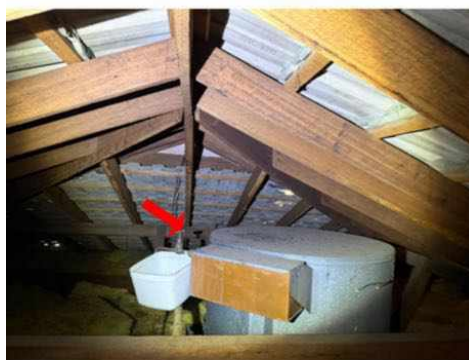
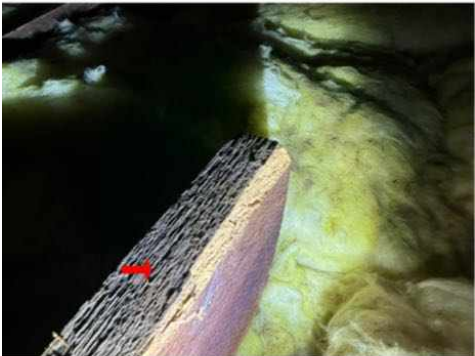
### Finding 8.01

Building: Building 1  
 Location: Roof cavity- left and rear window frame  
 Finding: Evidence of wood borer activity identified  
 Information: Wood borers small beetles that colonise in exposed timber elements are a common timber pest that are regularly mistaken for termites. Although wood borer activity is generally not detrimental to the affected timber they may lead to serious damage and necessitate replacement of certain building elements if left unattended.

The other commonly known borer the Anobium borer is more likely to attack floorboards and may cause severe structural damage to flooring areas.

As no live wood borer activity was identified treatment is not required at this time. Replacement of affected timbers may be considered by the client for superficial reasons.

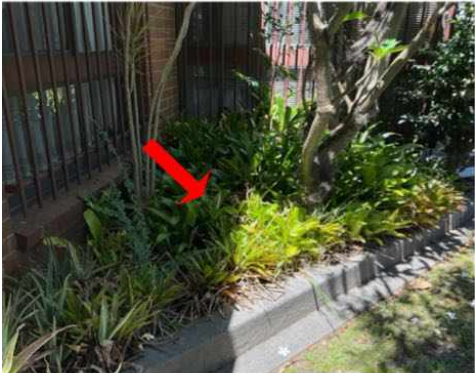
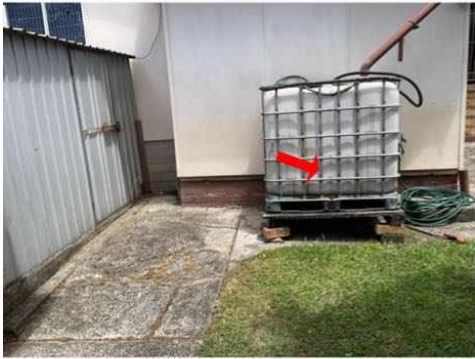
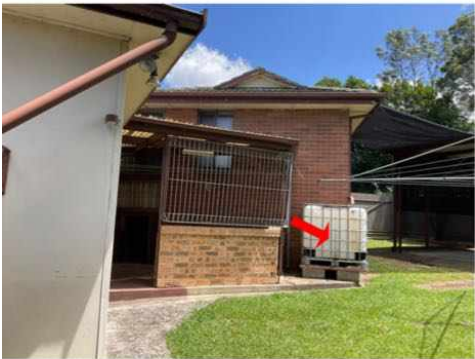
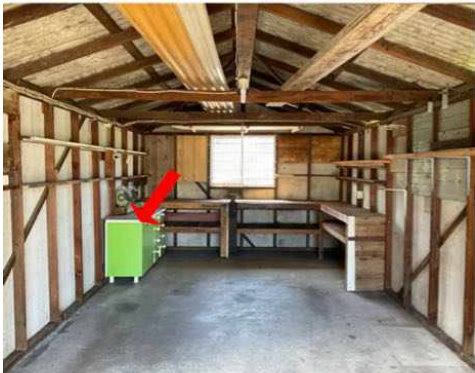
Building: Building 1  
 Location: All External Areas  
 Finding: Additional Photos - Obstructions and Limitations of EXTERNAL AREAS  
 Information: These photographs are an indication of the obstructions and limitations which impeded full inspection of external areas at the time of inspection. These obstructions can hide an array of defects and should be removed to allow full inspection to be carried out. A re-inspection is recommended once the areas are made accessible.

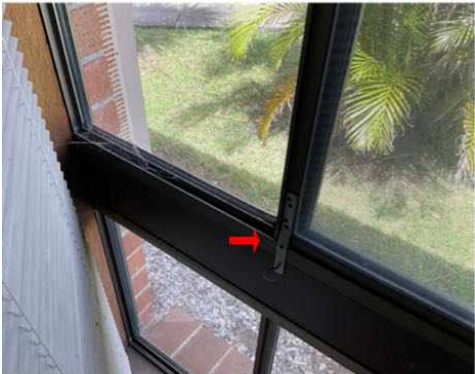
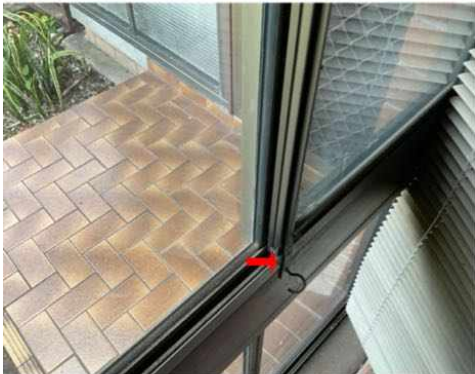
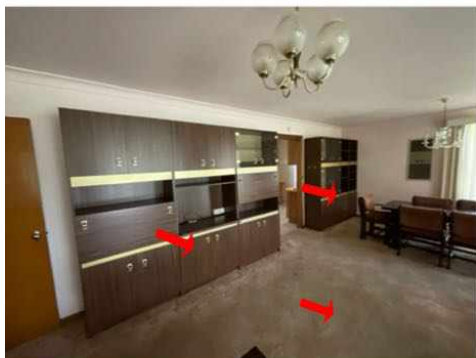
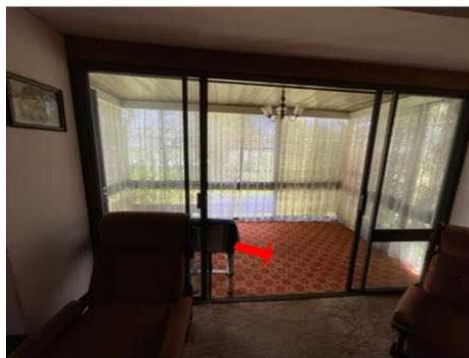
Building: Building 1  
Location: All Internal Areas  
Finding: Additional Photos - Obstructions and Limitations of INTERNAL AREAS  
Information: These photographs are an indication of the obstructions and limitations which impeded full inspection of Internal areas at the time of inspection. These obstructions can hide an array of defects and should be removed to allow full inspection to be carried out. A re-inspection is recommended once the areas are made accessible.

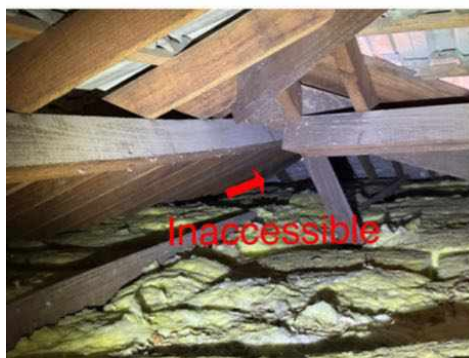
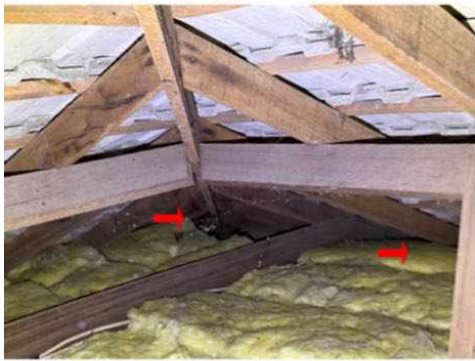
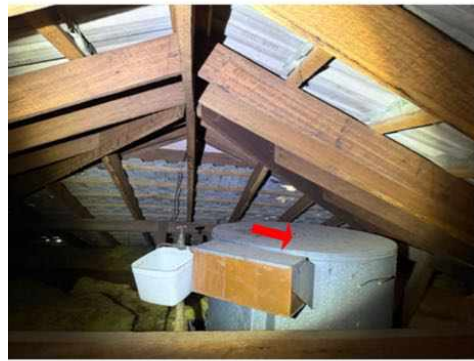
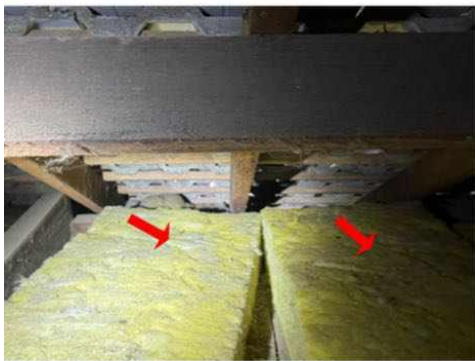
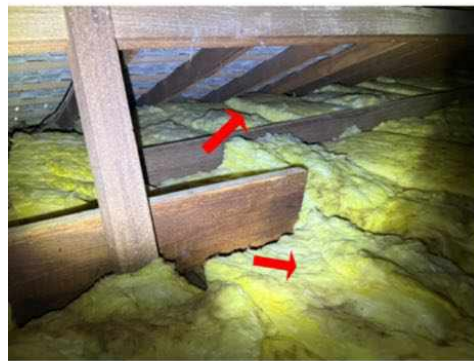
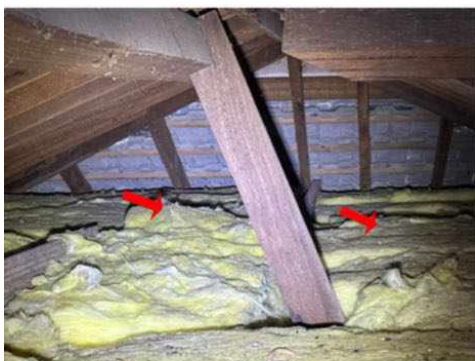
Building: Building 1  
 Location: All Roof cavity areas  
 Finding: Additional Photos - Obstructions and Limitations of the ROOF CAVITY  
 Information: These photographs are an indication of the obstructions and limitations which impeded full inspection of roof cavity areas at the time of inspection. These obstructions can hide an array of defects and should be removed to allow full inspection to be carried out if applicable. A re-inspection is recommended once the areas are made accessible.

The inspection was also limited to areas with an allowable crawl space of 600mm x 600mm, in particular towards the external walls where the roof line diminishes, these areas were not accessible.

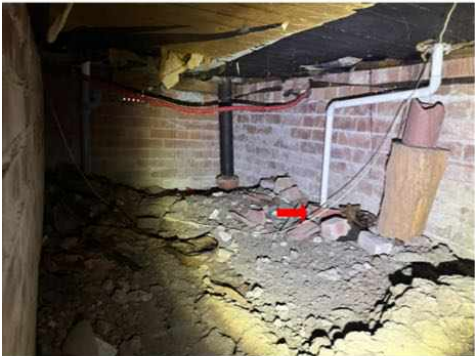
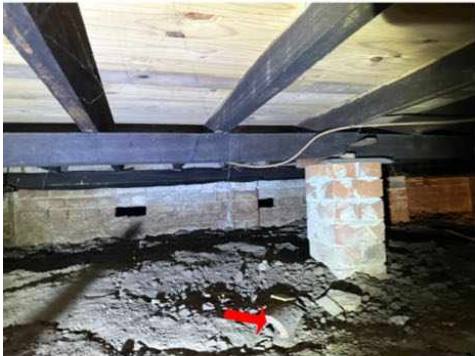
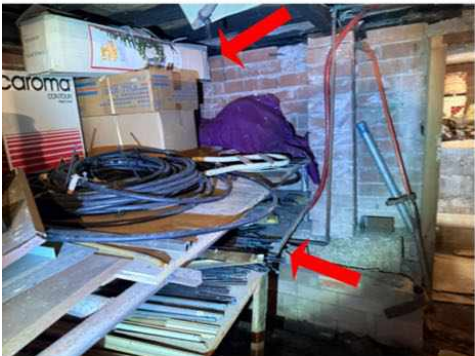
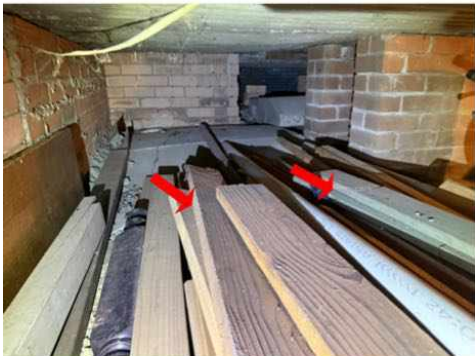
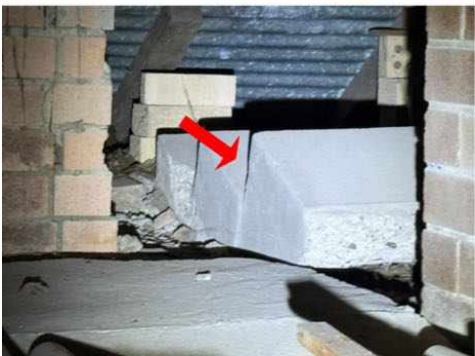
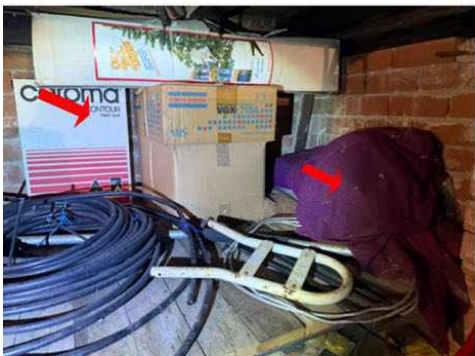
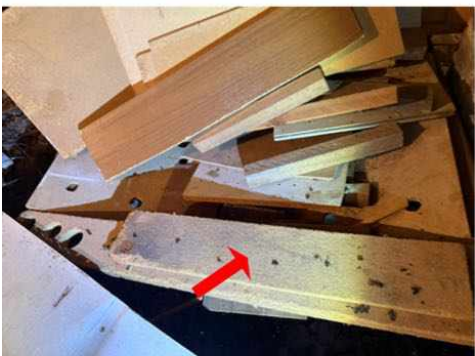
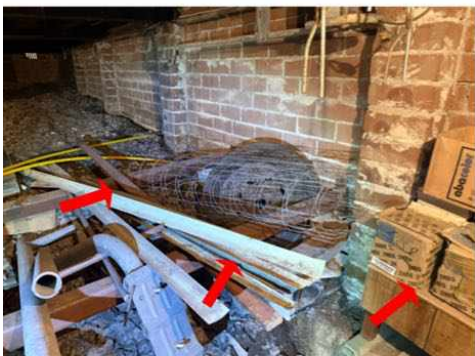
Building:	Building 1
Location:	All Subfloor Areas
Finding:	Additional Photos - Obstructions and Limitations of SUBFLOOR AREAS
Information:	These photographs are an indication of the obstructions and limitations which impeded full inspection of subfloor areas at the time of inspection. These obstructions can hide an array of defects and should be removed to allow full inspection to be carried out. A re-inspection is recommended once the areas are made accessible.

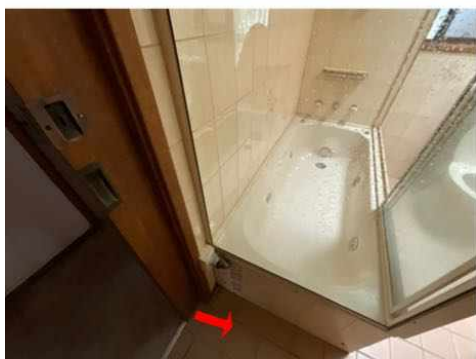
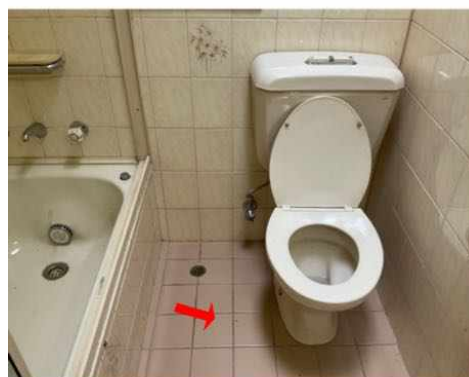
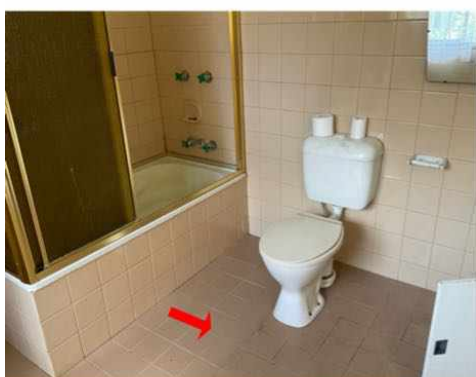
Building: Building 1  
 Location: Bathrooms and laundry  
 Finding: Waterproofing membranes - Information Only  
 Information: Internal Water Proofing Membranes, are crucial in preventing water ingress into the property is important to know that the Membrane System used is to Australian Standards and has been installed correctly.

With older property's where this information is unavailable all wet areas should be monitored. If any leaks, water staining, peeling or bubbling of the paint become evident to any adjacent walls or ceilings below a licensed builder or waterproofing specialist is recommended to investigate further.

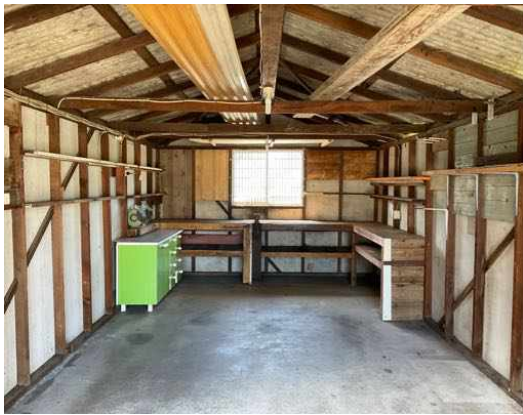
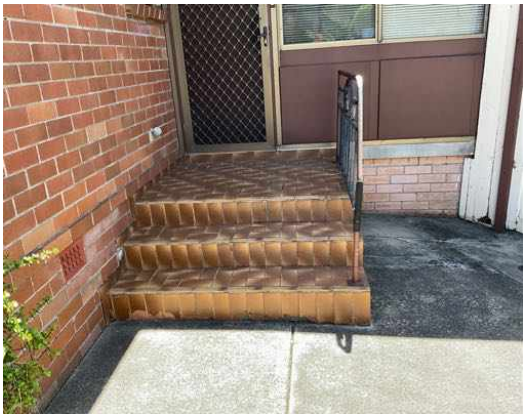
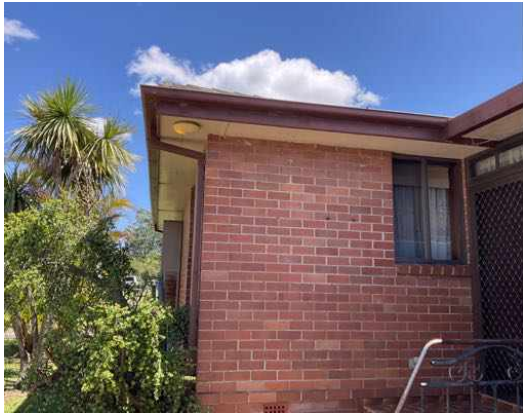
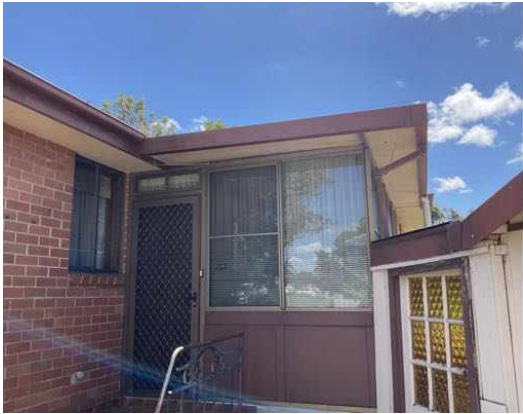
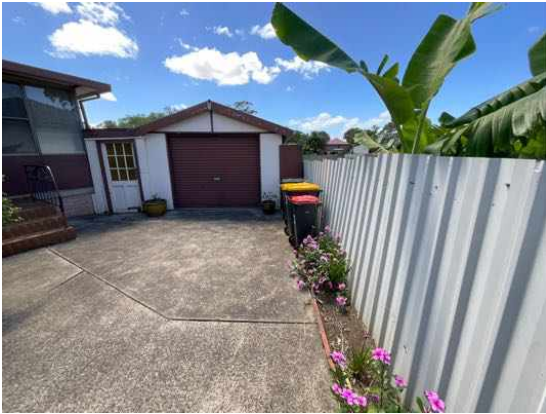
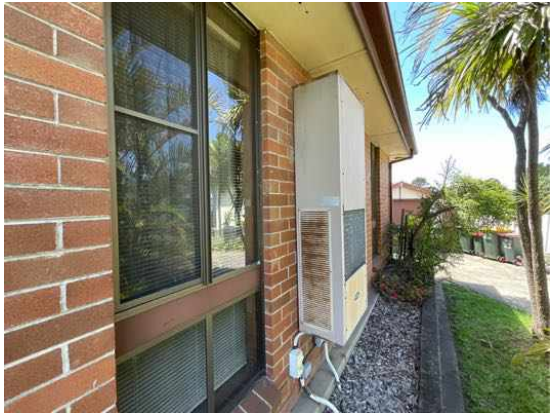
Building: Building 1  
Location: All External Areas  
Finding: Additional Photos  
Information: Additional photos are provided for your general reference

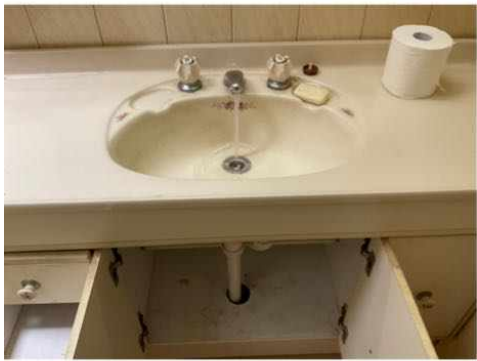
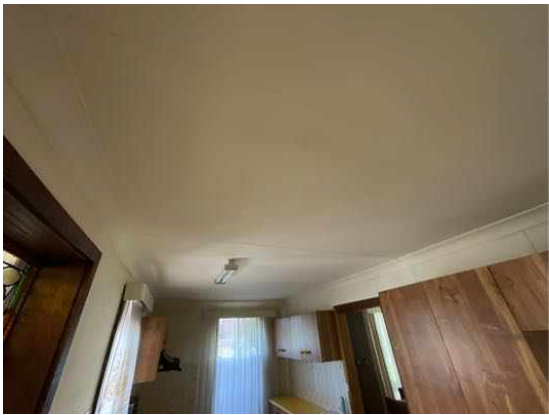
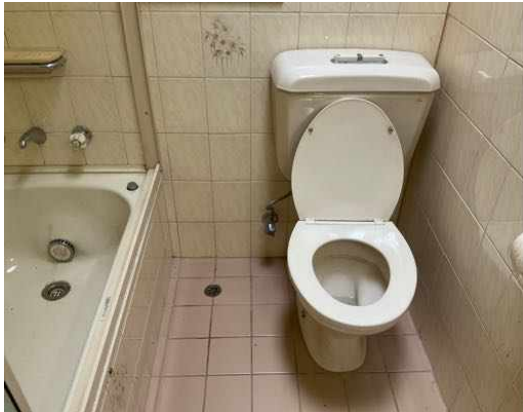
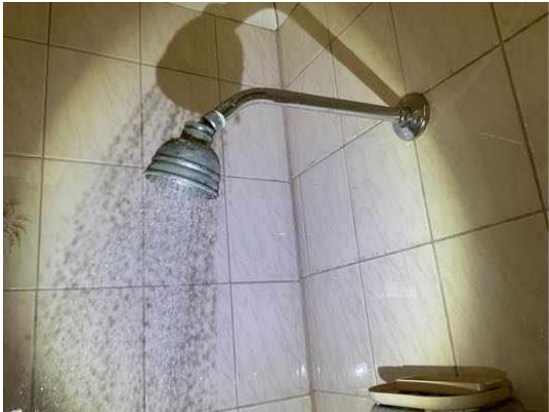
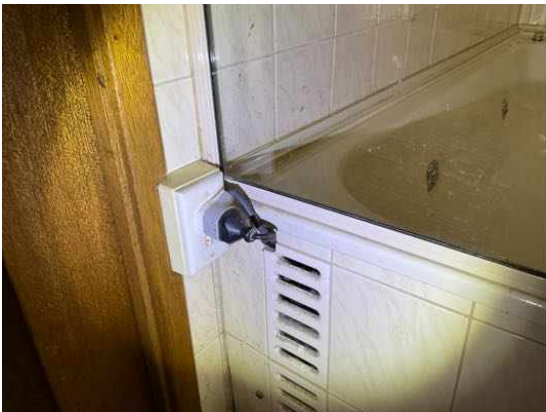
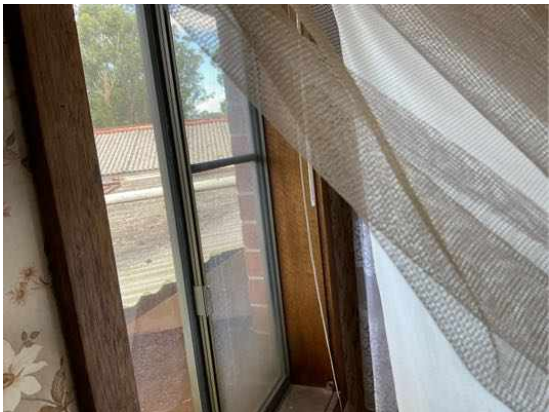
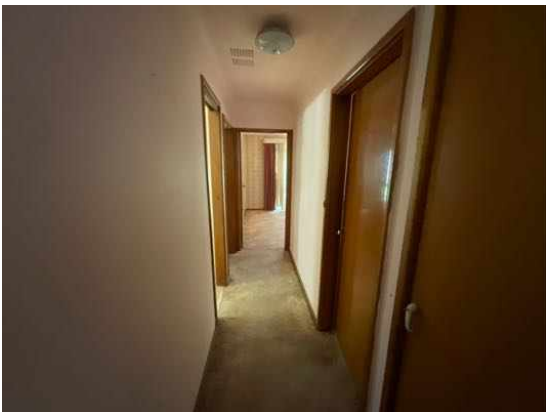
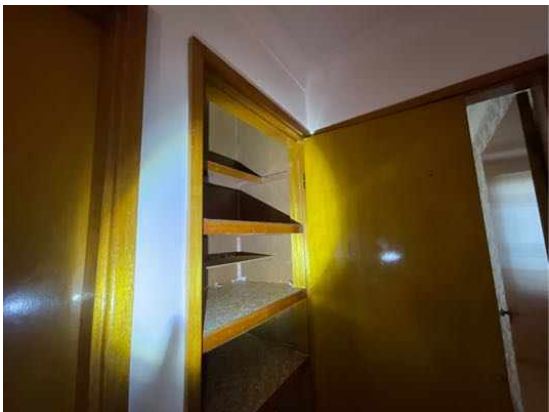
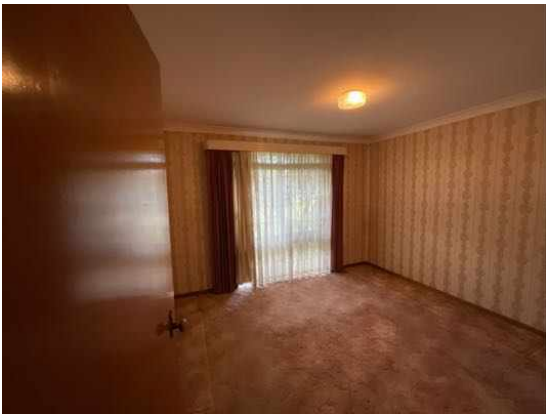
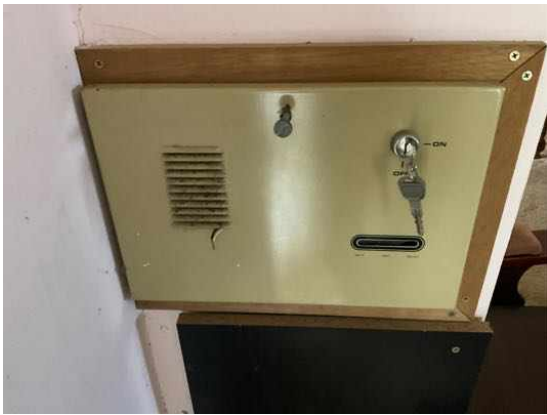
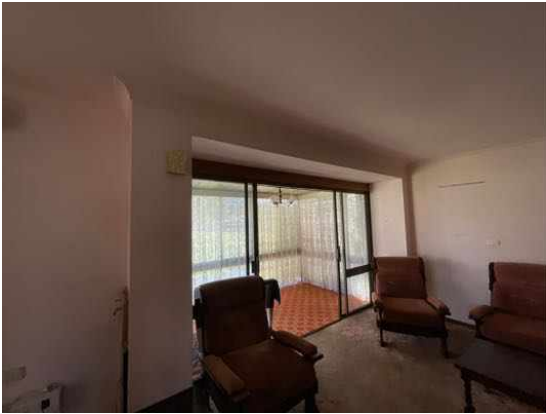
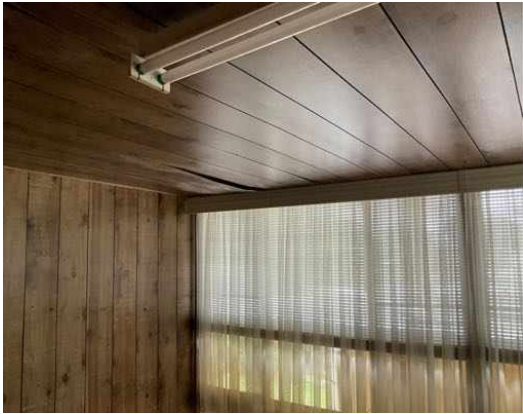
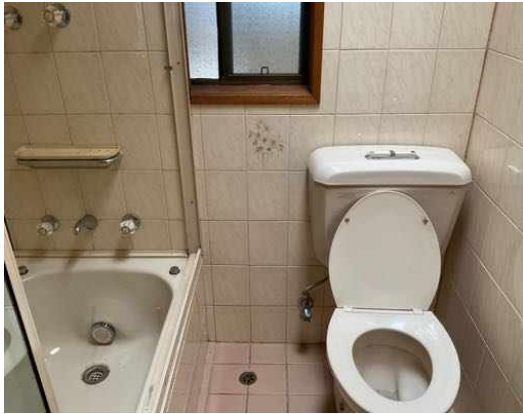
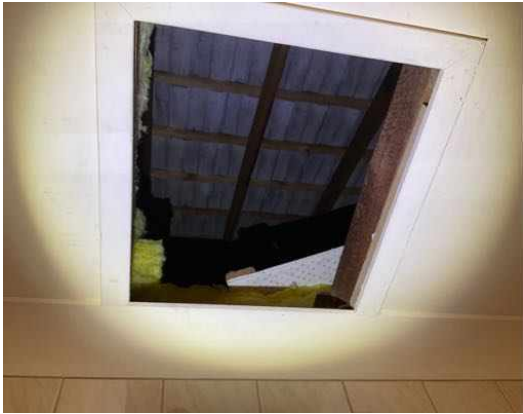
Building: Building 1  
Location: All Internal Areas  
Finding: Additional Photos  
Information: Additional photos are provided for your general reference
