Building and Timber Pest Inspection Report

Inspection Date: Wed, 28 Jan 2026

Property Address: 84 Venezia St, Prestons NSW 2170,
Australia

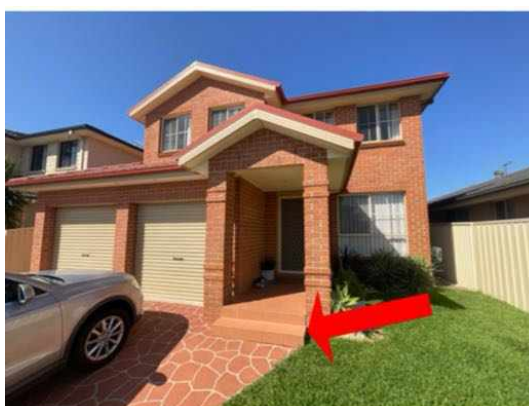
Building: Main Building
Location: Porch
Finding: Tiles - Cracked or damaged
Information: Cracking was evident to the tiling in this area at the time of inspection. While the cracking appears to be minor, this area is frequently exposed to water, allowing potential for water penetration into adjoining sections of walls or flooring.

If left unmanaged, water penetration to these areas may lead to subsequent water damage, which is likely necessitate repair work to affected building elements.

A tiling contractor should be appointed to ensure that no further water damage occurs. The re-application of silicone and grouting throughout remaining tile work is also advised, to further protect the area against water penetration.

Where water penetration has led to water damage, appointment of a relevant tradesperson may be required to repair damaged building elements.

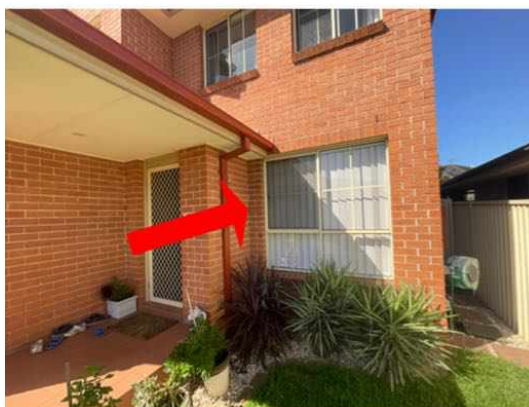
Finding 3.02

Location: Exterior walls
 Finding: Articulation joints - Inadequate
 Information: The articulation or control joints throughout the exterior brickwork were deemed as insufficient at the time of inspection. Mortar, a non-compressive material, is still evident in some of the joints, not allowing the joints to do their job and allow the brick walls to expand and contract as required during different weather conditions.

Articulation joints must be cleaned of all non-compressive material and then sealed with an appropriate flexible sealant. Failure to perform these necessary works is likely to lead to excessive moisture ingress into these joints, or cracking to the brick walls during extreme weather conditions, which may carry major implications for associated building elements if left unmanaged.

These preventative works are important in ensuring the structural integrity of the associated brickwork. Appointment of a qualified builder or bricklayer is advised to perform remedial works as necessary.

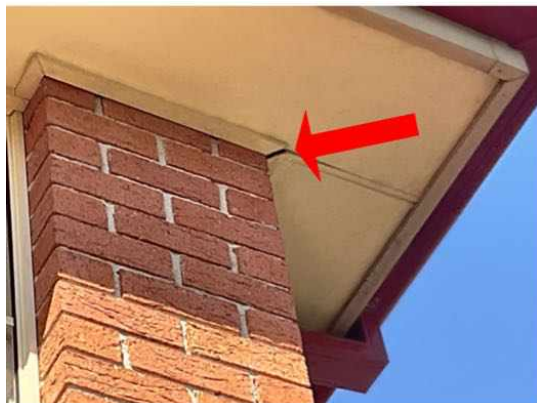
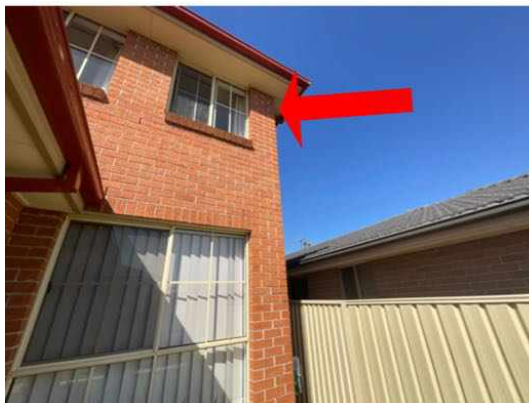
Finding: Beads - damage

Information: Where beading (also known as 'quad') are damaged from the eaves It was noted at the time of inspection that beading in this area has deteriorated. Beading is important in weatherproofing the surrounding building elements and preventing termite or pest ingress. Furthermore, beading works to protect the joins of building materials, which are more susceptible to deterioration and decay. Repair or replacement of the beading is advised to ensure the protection and longevity of any associated building elements. Such works may be performed by a general handyperson or qualified carpenter.

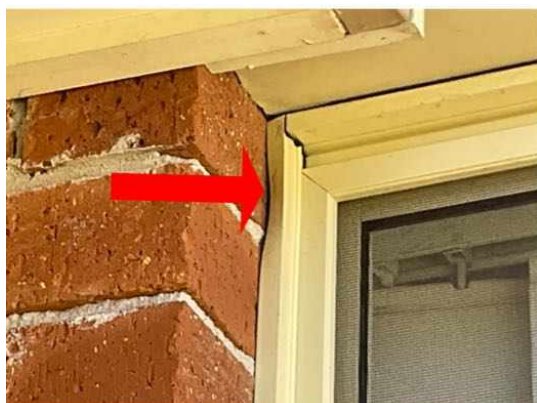
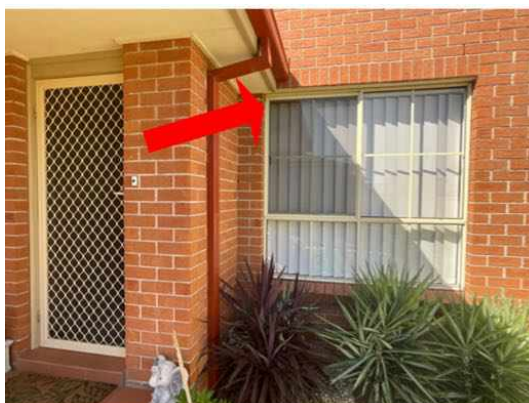
Finding 3.05

Building: Main Building
 Location: Exterior walls - front
 Finding: Damaged Aluminium Door Frame
 Information: The aluminium frame of the sliding door is visibly bent and damaged near the top corner. The deformation may affect the operation and weatherproofing performance of the door.

Compromised door function, water ingress, and reduced weather

Replace or repair the damaged aluminium frame to restore proper alignment, operation, and compliance with AS 2047 performance requirements.

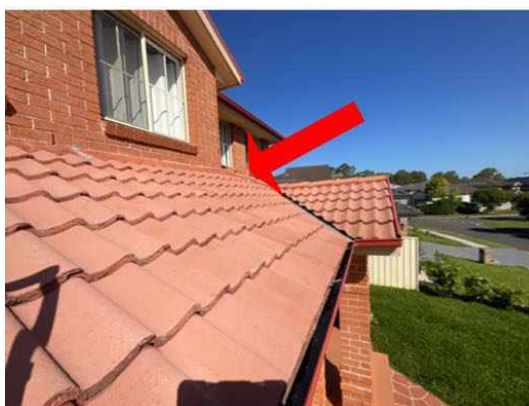
Finding 3.06

Building: Main Building
 Location: Roof Exterior
 Finding: Mortar - Deterioration
 Information: Mortar, or 'bedding', is the material which fills joints and intersections between tiles and other building elements on the exterior roof covering, such as gable ends, hip capping and valleys. Upon inspection of the exterior roof, it was noted that sections of the

mortar show varying levels of deterioration.

Mortar generally deteriorates as a result of frequent exposure to weather conditions over a prolonged period of time. Mortar that is deteriorating may allow water ingress into the roof void, putting associated building elements and roofing structures at risk of water damage. Deteriorated mortar also detracts from the functionality of roof tiles and other roofing elements, potentially decreasing weather tightness and roof drainage.

Mortar deterioration can be attended to by a handyperson where areas of deterioration are localised and easily accessible. Otherwise, consultation with a roofing contractor is advised where greater works are required.

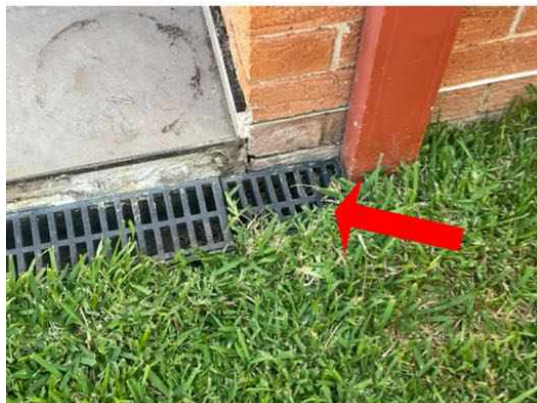
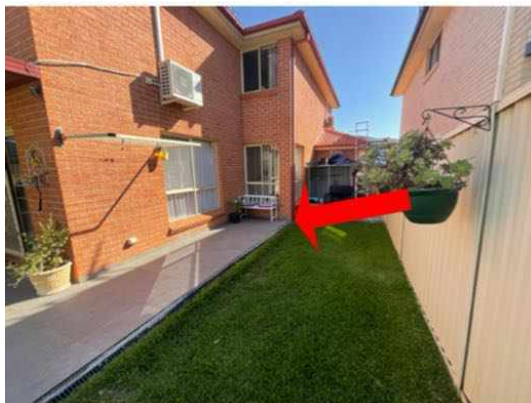
Finding 3.07

| Finding: | Site drainage - Inadequate |
| Information: | The site drainage in this area was found to be inadequate at the time of inspection, creating potential for subsequent water damage to associated building elements. |

It is important that water does not lie against the base of walls; surrounding paths and ground levels should be sloped to drain water away from walls. Downpipes should not discharge stormwater onto lower walls or plinths. Stormwater should be carried away by large, regularly cleaned drains. Ground levels may need to be lowered to expose a buried DPC.

Where site drainage is inadequate, installation of an Agricultural (Aggie) Drain may be required. A qualified plumber should be appointed to further inspect the property and perform any remedial works as necessary. Water damage and secondary defects are likely to occur if left unmanaged.

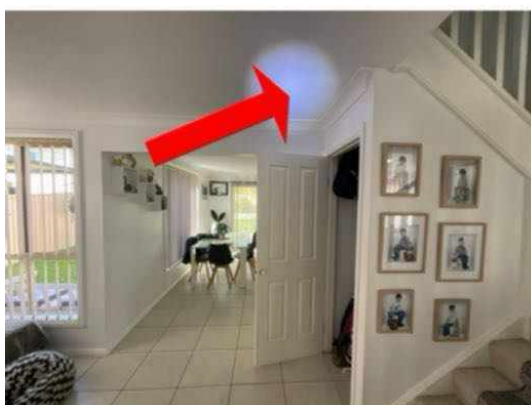
Finding 3.08

| Information: | Numerous popped nails were identified in the internal ceiling at the time of inspection. Nails and screws hold simply by the friction between them and the surface they are applied to. Over time, the nails and screws can back out, which is often a result of general ageing and deterioration of the building structure. |

If left unmanaged, the ceiling sheets may become loose and unstable, increasing the rate of deterioration of the internal ceiling and creating potential for the development of secondary defects.

Re-fastening of popped nails will help to maintain the stability of the internal ceiling and associated building elements. Such minor works will also help to improve the appearance of the affected area and secure the ceiling sheets, so as to prevent the onset of ceiling sagging. These works should be performed by a qualified carpenter or plasterer at client discretion.

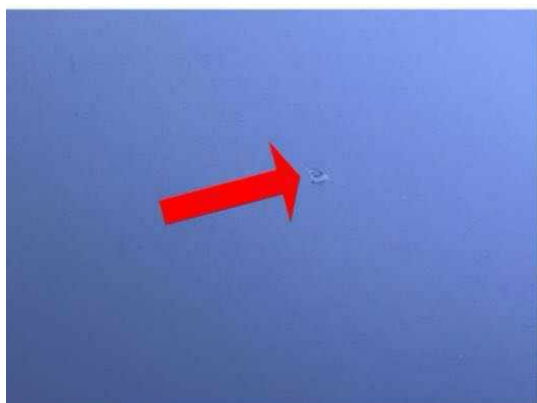
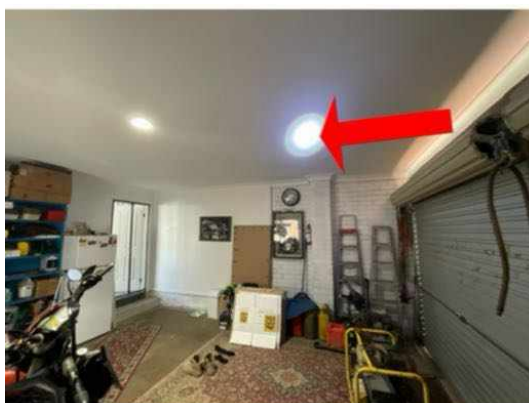
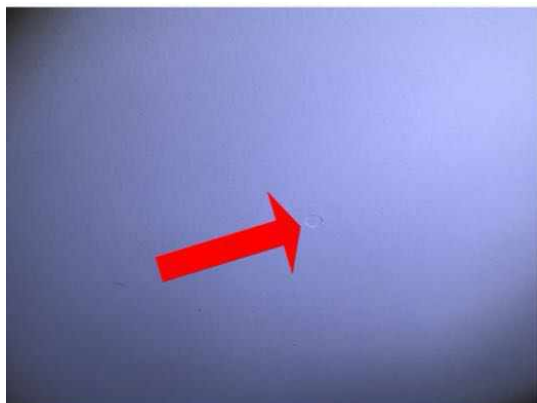
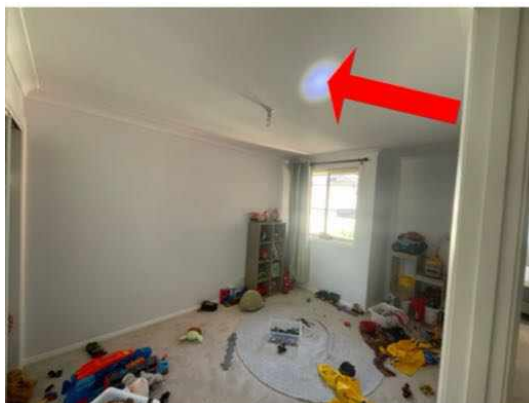
Finding 3.09

| Finding: | Cracking - Damage Category 1 - Fine (up to 1mm) |
| Information: | Although fine cracks are quite noticeable, they are often only considered to be an appearance defect, and usually do not indicate any structural damage. Generally, the cause of a fine crack is indicative of a separation between building materials and finishes (e.g. paint, plaster, etc.) along joins. |

Cracking of this nature can generally be repaired with minor sanding, filling and/or repainting. Such works should be performed by a qualified painter or a general handyman.

Monitoring of all cracking should be conducted frequently. Always contact a building inspector should cracks widen, lengthen, or become more numerous.

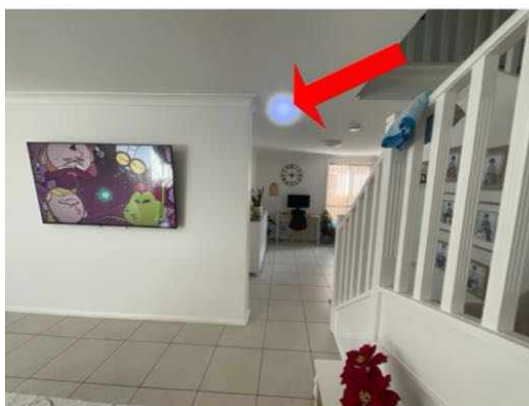
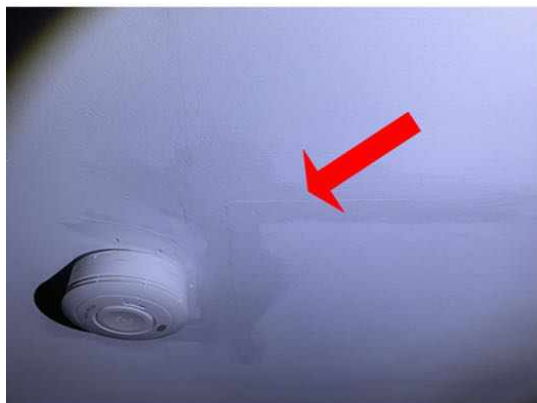
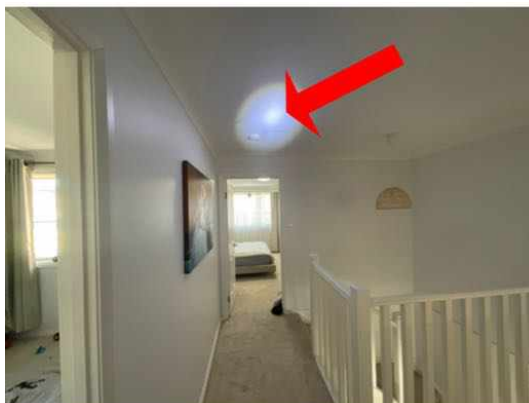
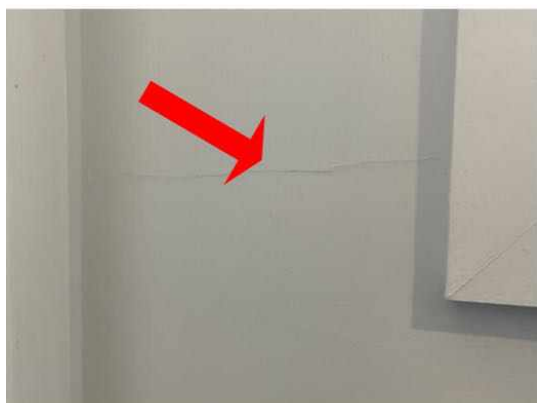
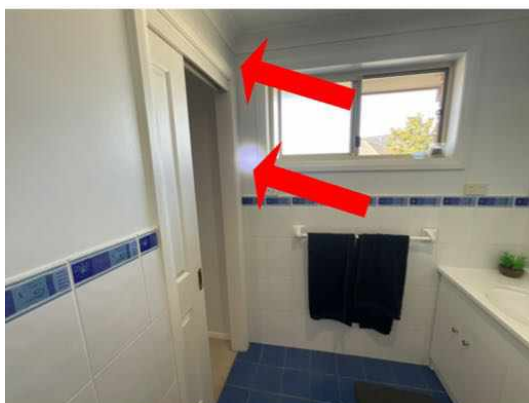
Finding 3.10

| Information: | Delamination is one means by which composite materials (e.g. layered timber composites) may fail over time. In laminated materials, repeated cyclic stresses may lead to the formation of mini-structures of separate layers, with significant loss of mechanical toughness. Water penetration or the presence of excessive moisture also generally contributes to delamination. |

Where building materials have become delaminated, they lose their structural strength, and are likely to have a variety of appearance and serviceability defects as a result.

Delamination of timbers may be repaired where the area affected is minor and/or easily accessible, by gluing and screwing layers back together. However, this is an interim repair, and where delamination has occurred, the client should plan for the replacement of affected timbers sooner than would otherwise be expected.

All timber structures affected by delamination should be replaced as soon as possible to avoid any further damage. Repair and replacement estimates should be sought from a registered builder or qualified carpenter.

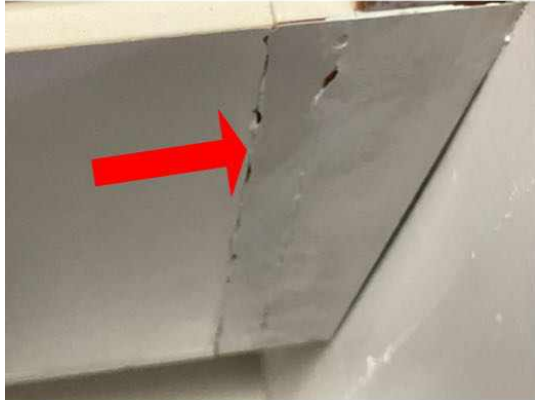
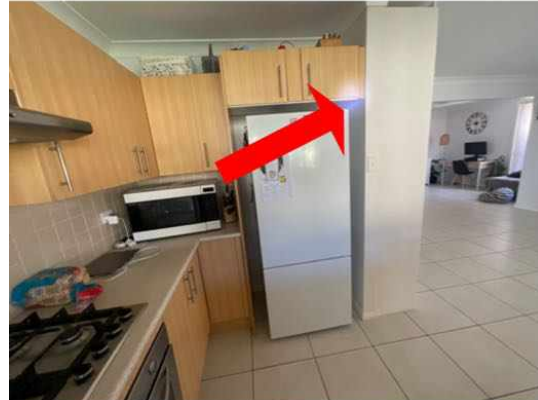
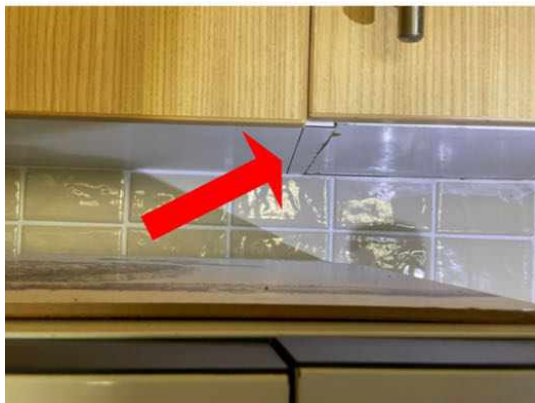
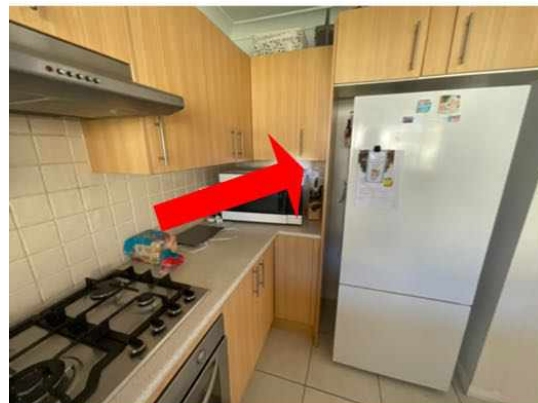
Finding 3.11

| Finding: | Cabinet doors - misaligned |
| Information: | It is observed that some of the cabinet doors are not aligned and / or have inconsistent gaps between the doors. |

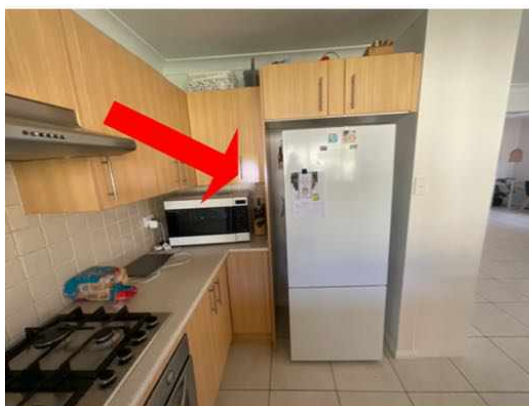
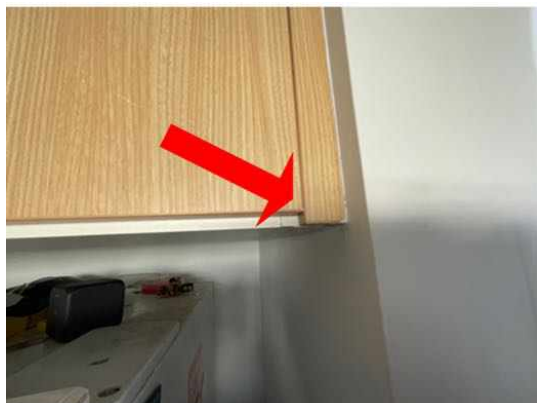
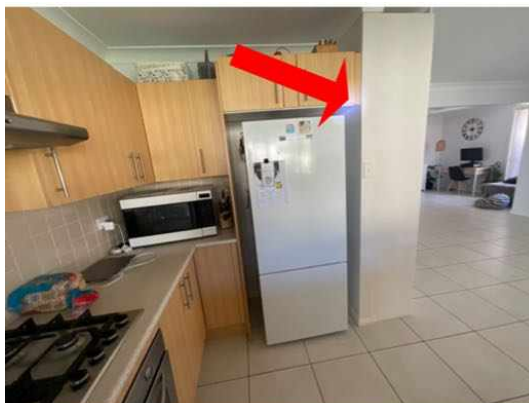
Finding 3.12

| Finding: | Paint finish - Substandard, Wear and Tear |
| Information: | The paint finish in this area was found to have been completed to a substandard level or wear and tear as the normal deterioration of a property from ordinary, everyday use. Exposure to the elements, time, as well as day to day living can cause fair wear and tear. |

If this applies, further areas of poor and incomplete finishes could develop over time. Furthermore, substandard, wear and tear paint finishes in areas exposed to moisture, e.g. external areas or wet areas, could lead to deterioration of underlying building materials.

Substandard, wear and tear paint finishes should be sanded back, filled, leveled and repainted, as applicable. Where inadequate paint protection has led to the deterioration of the associated building element, repair and/or replacement of this building element may be required.

A painting contractor should be appointed as soon as possible to perform necessary works to aid the appearance of the affected area and to ensure that the area is protected against further deterioration. Alternatively, the homeowner following manufacturer instructions may be able to provide this service.

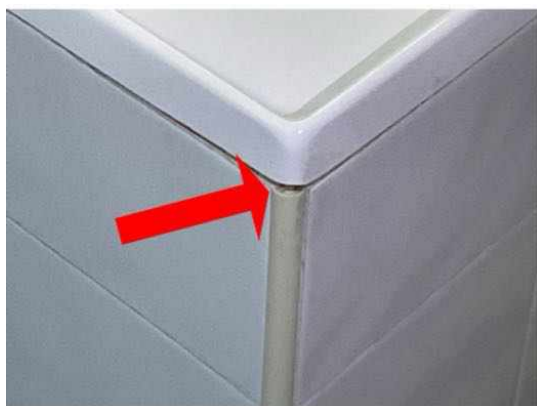
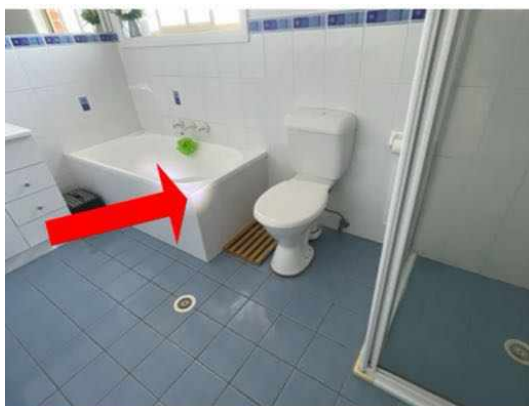
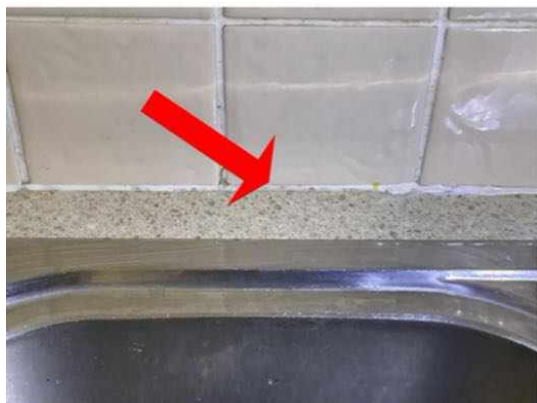
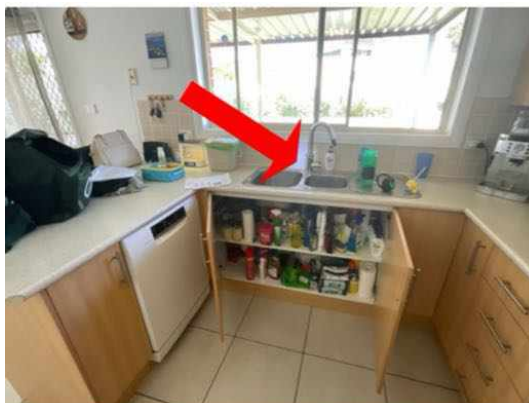
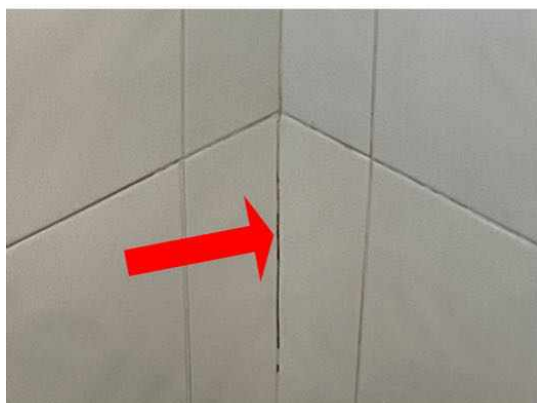
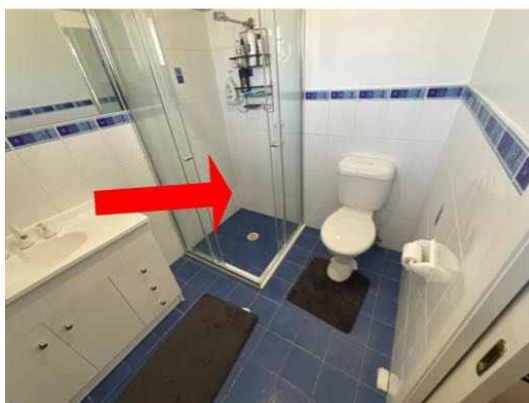
| Finding: | Sealant and grouting - Missing or damaged |
| Information: | It was noted on inspection that sealant or grout is degraded to the tiled shower alcove and or other areas of the bathroom. |

Different materials and floor areas move at different rates, generally causing cracking to grout or sealant at this point. A flexible sealant is required to allow for expected expansion and contraction, while keeping the joint water tight and protective of all associated building materials.

There appears to be excessive mould to the sealant and grout which will likely require scraping out and replacement.

Flexible and mould resistant materials should be applied to affected areas to prevent any subsequent water damage that is likely to occur. Regular maintenance and replacement of damage or missing or damaged sealant and grout is highly recommended to the wet areas, as this is a regular wear and tear defect. Sealant and grouting in areas that come into regular contact with water should be maintained for the long term care of your property.

A sealant specialist or tiling contractor should be appointed to complete these works as soon as possible

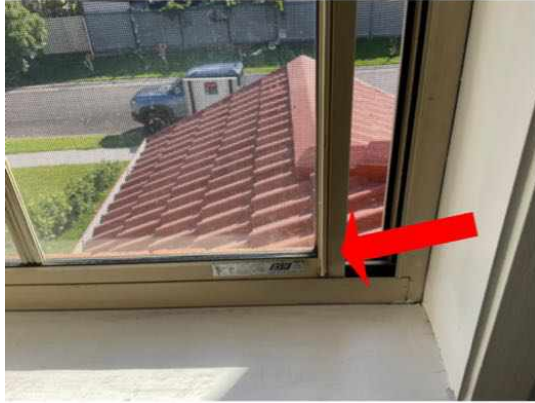
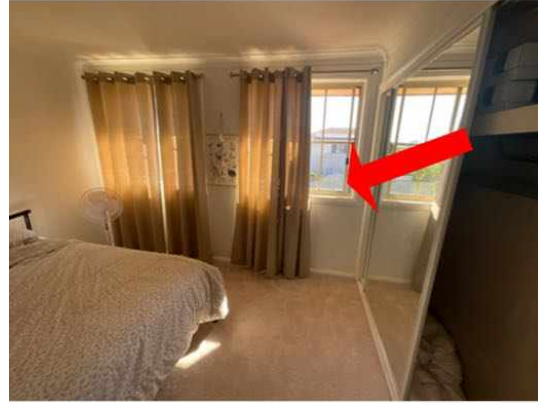
Finding 3.14

| Information: | The Window / Sliding Door in this area was jammed and difficult to operate at the time of the inspection. Windows / Sliding Doors provide ventilation or access to the adjoining area and should be at a fully operational level to ensure user comfort. Restricted function of the Window / Sliding Doors may also pose as a potential safety hazard if required for emergency egress from the building. |

Generally, factors such as general age of the building element and a lack of maintenance are the usual causes for this type of defect.

Replacement of Window / Sliding Doors hardware or frame may be required, as well as minor repairs and cleaning. A registered builder or general handy person will be required to repair the window.

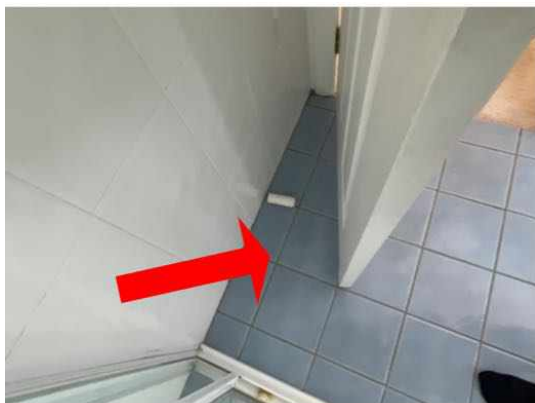
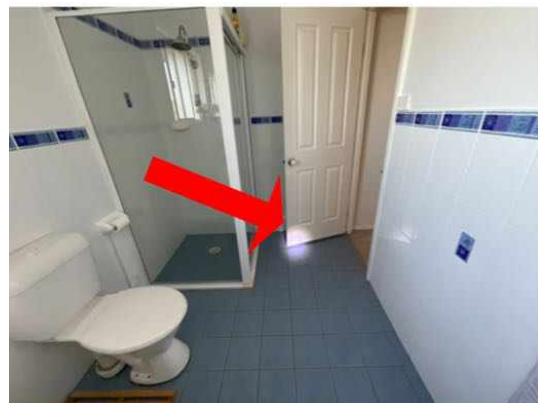
Finding 3.15

Building: Main Building
 Location: Bathroom
 Finding: Door stop - inadequate
 Information: The door stop is missing or is inadequate to stop the door handle from damaging the wall. Although some building elements may seem irrelevant or unnecessary, all building elements play a key role in the operation and function of the overall structure and its performance.

Re-installation or replacement of the door stop is advised as soon as possible to prevent any subsequent damage to the door or associated structures. A general handyman may be appointed to perform these works at client discretion.

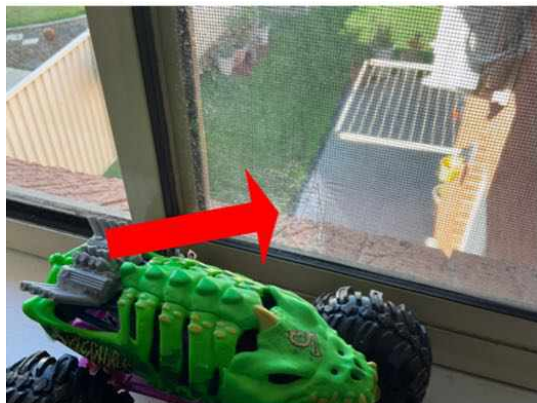
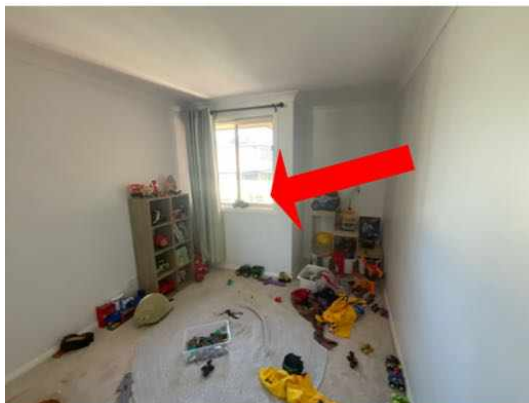
Finding 3.16

Building: Main Building
 Location: Bedroom 2

Finding: Flyscreens - Damaged
 Information: Flyscreens were found to be damaged to the windows in this area at the time of inspection. This damaged building element detracts from the operational state of the window. Where not replaced, damaged flyscreens allow pest and insect ingress into the adjoining room/s. It is advised that all damaged building elements be replaced in order to ensure the full function of all building structures. A general handyperson may be appointed to replace flyscreens at the discretion of the client.

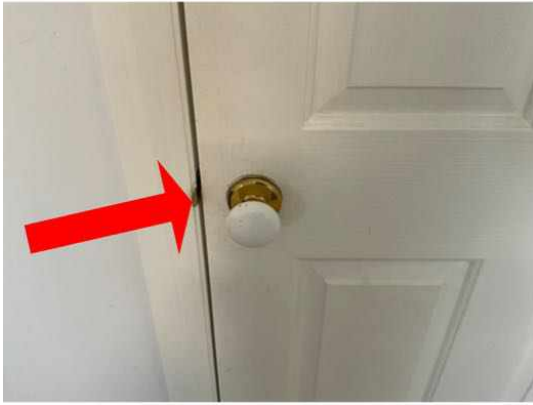
Finding 3.17

Building: Main Building
 Location: Bedroom - Master
 Finding: Door handle - Not latching
 Information: It was noted that the door in this area was not latching during operation at the time of inspection. Whilst detracting from the functionality of this building element, this minor defect may also be a security risk, and may therefore have serious implications if left unattended.

It is suspected that this defect has occurred due to minor issues with the associated hinges. Such damage is identified as general wear and tear, which is expected for building elements of this age.

A qualified carpenter or general handyperson may be appointed to perform rectification works as necessary, at client discretion. If left unattended, further functional impairment is likely to occur.

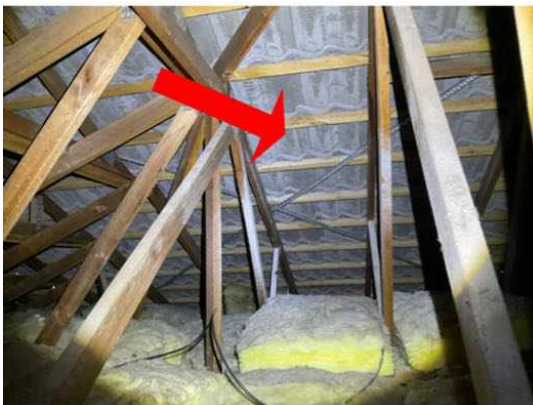
Finding 3.18

| Finding: | Sarking - Missing |
| Information: | Sarking is missing under the roof sheeting. Sarking acts as an insulator that helps with noise reduction and protects against water penetration. Sarking plays a key role in the operation and function of the overall roofing structure and its performance. |

Although not a requirement at the time of construction, replacement of any missing building element is advisable (although this can be quite expensive to do after the time of construction). Where sarking is missing, regular inspections of the roof tiles for cracking and potential moisture penetration is required.

Sarking may be retrospectively fitted by a registered builder at the discretion of the client.

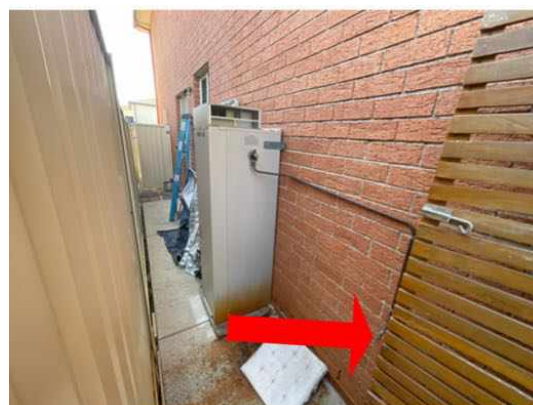
Building: Main Building
 Location: All Areas
 Finding: HWS Overflow - Not Connected
 Information: The Hot Water System (HWS) overflow was found to be disconnected from storm water drainage and is creating excessive moisture in the surrounding area.

These damp conditions can lead to secondary defects such as rot, rust or corrosion of associated building elements, the formation of fungal decay, or even the creation of potential slip hazards. When coupled with poor site drainage, pooling of water may also attract termite activity to this area.

It is highly recommended that a licensed plumber be appointed to connect the HWS overflow in order to prevent such an environment from being created. These minor works should be carried out as soon as possible.

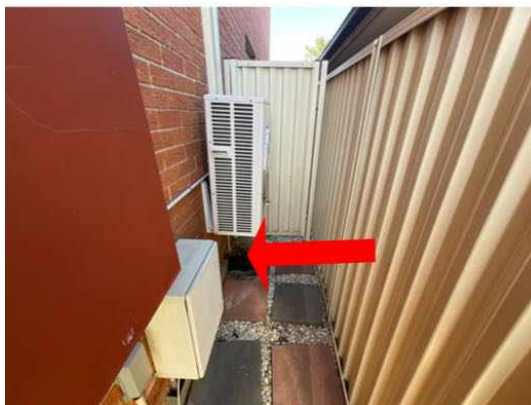
Finding 6.03

Building: Main Building
 Location: All Areas
 Finding: Air conditioner - Disconnected overflow
 Information: The Air Conditioner (A/C) overflow was found to be disconnected from storm water

drainage and is creating excessive moisture in the surrounding area.

Such leaking creates an environment which is conducive to an array of defects, including water damage to associated building elements and the attraction of termite or timber pest infestation.

It is highly recommended that a licensed plumber be appointed to connect the A/C overflow in order to prevent such an environment from being created. These minor works should be carried out as soon as possible.

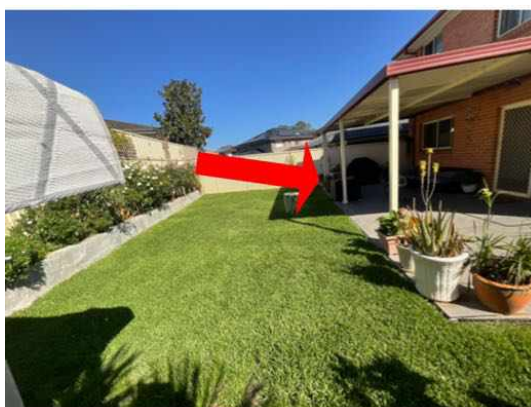
Finding 6.04

Building: Main Building
 Location: All Areas
 Finding: Overflow - Not plumbed for drainage
 Information: The overflow is not plumbed or connected to suitable drainage, which has resulted in the surrounding area becoming excessively damp. These damp conditions can lead to secondary defects such as rot, rust or corrosion of associated building elements, the formation of fungal decay, or even the creation of potential slip hazards. When coupled with poor site drainage, pooling of water may also attract termite activity to this area. It is highly recommended that a qualified plumber be appointed to install adequate drainage to the overflow. These works will ensure that the area remains dry and free of any secondary defects.

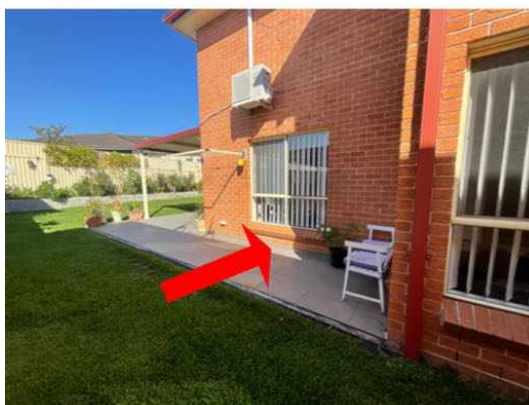
Finding 6.05

Weep holes in the exterior brickwork of the property are designed to allow condensation that may build up between the brickwork and subsequent timber framework to drain from within the wall hence preventing any deterioration of the timber building elements.

Additionally build-up of moisture is likely to occur if weep holes are covered further attracting termite activity to these areas.

It is highly recommended that weep holes are left exposed in all areas throughout the external property. Therefore if any termite activity leading into weep holes becomes easily detectable during frequent pest inspections.

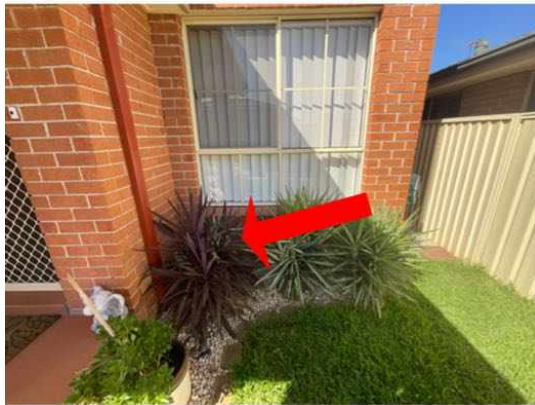
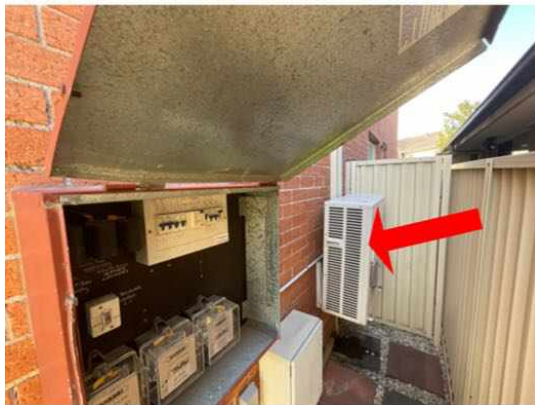
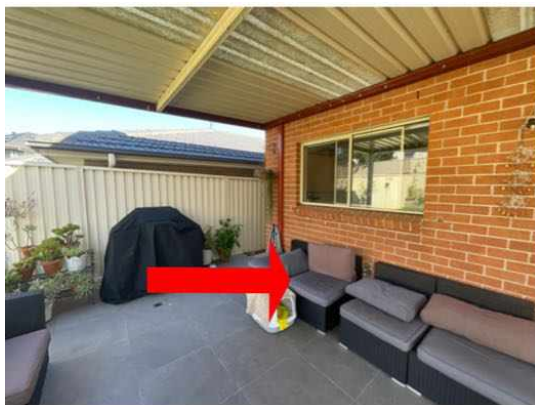
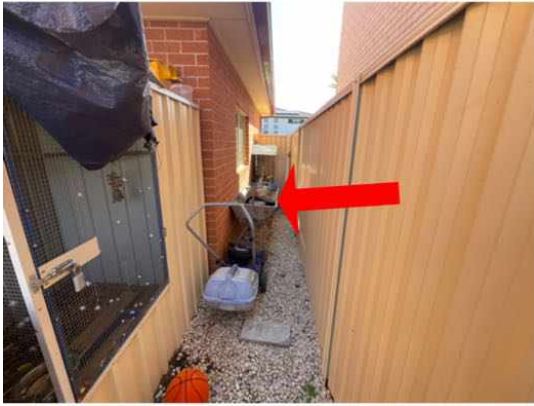
Finding 6.06

Where bridging has occurred, full inspection is prevented and termites may enter a property in a concealed or undetectable manner.

It is recommended that minimum 75mm clearance below the bottom of weep or ventilation holes be maintained where possible, otherwise annual inspections should be conducted by a licensed pest control company. Vegetation should also be kept clear of walls to allow regular inspection of all areas.

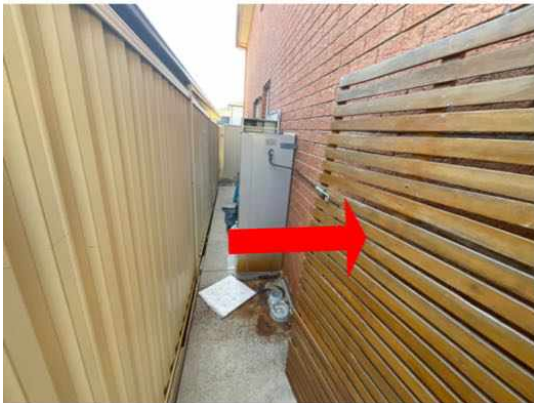
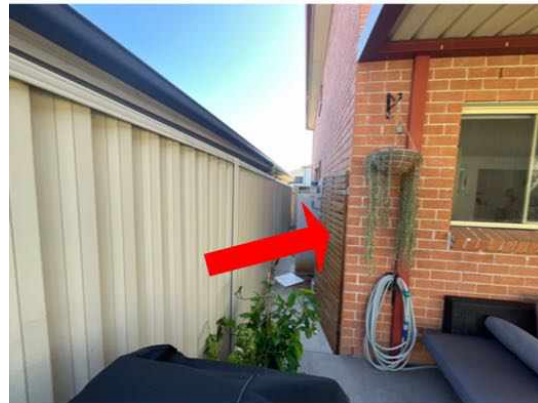
Finding 6.07

| Information: | External timbers that are frequently exposed to harsh weather conditions require adequate protection in order to maintain their condition. Where timbers have not been painted or treated adequately, general deterioration is likely to occur at an accelerated rate. |

If left unattended, replacement of these timbers is likely to be necessary in the short-term future. Adequate treatment of these timbers is required as soon as possible by a painting contractor or general handyman.

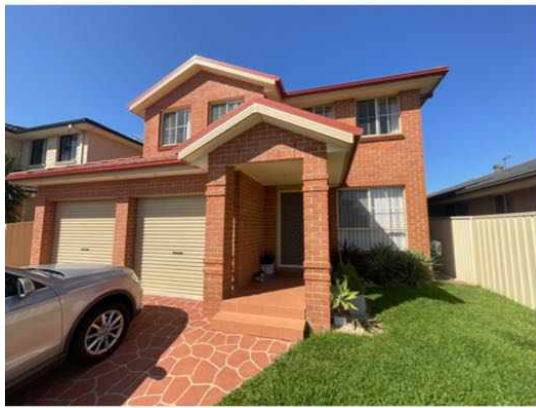
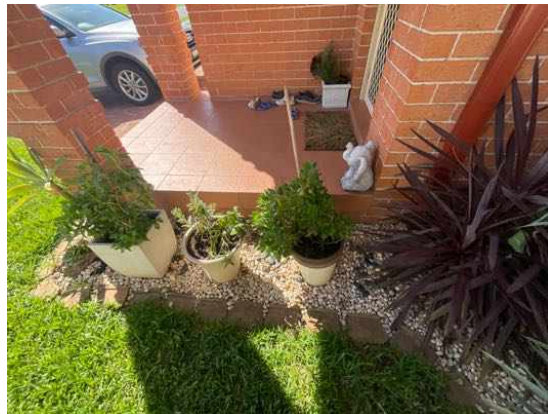
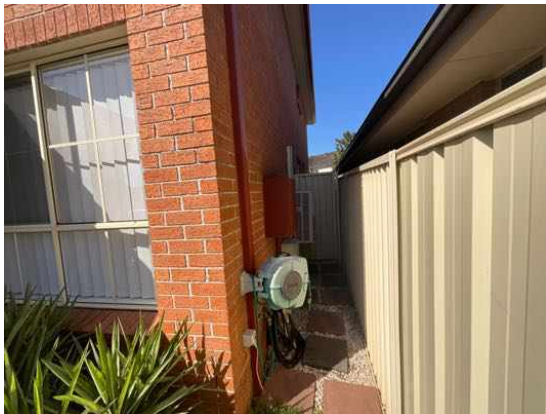
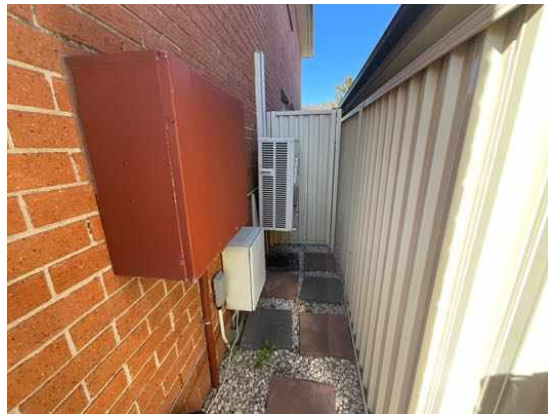
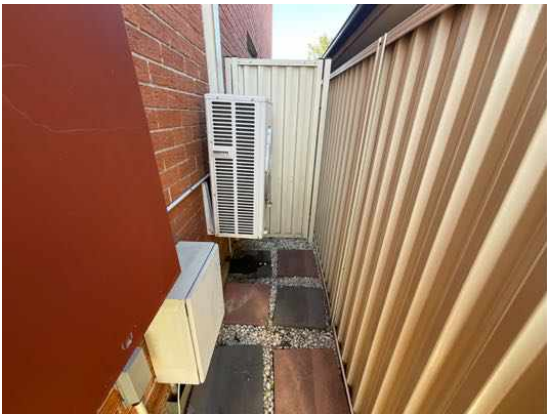
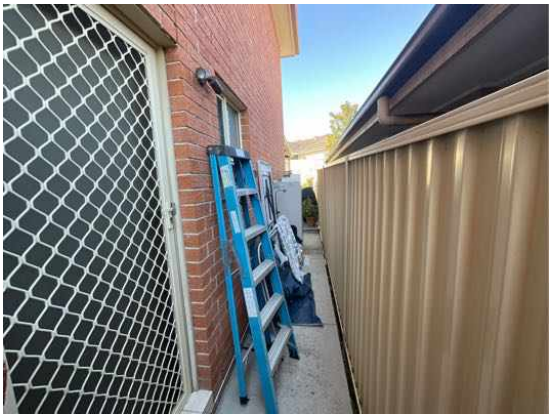
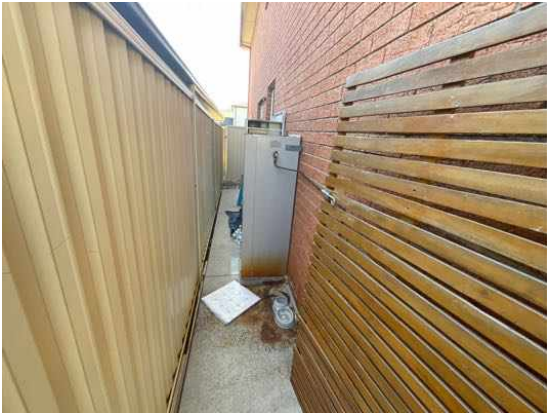
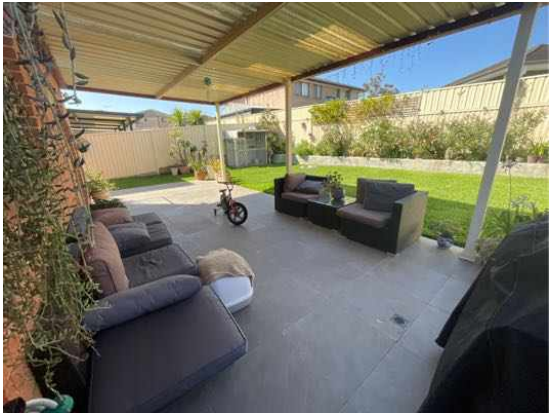
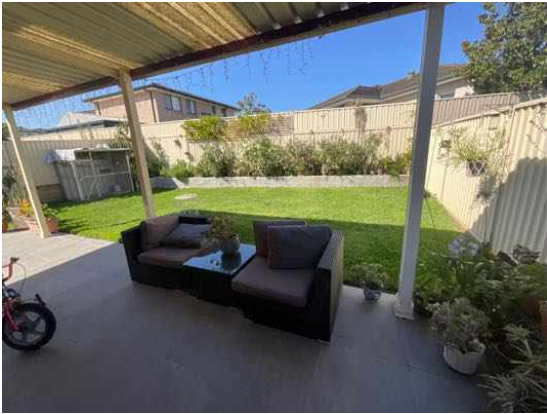
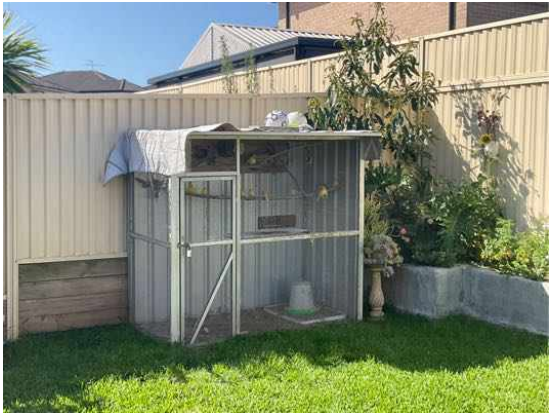
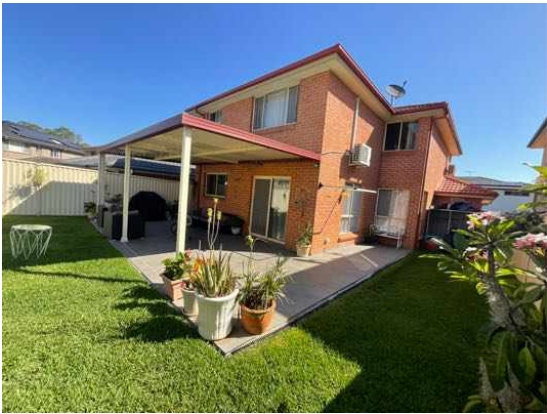
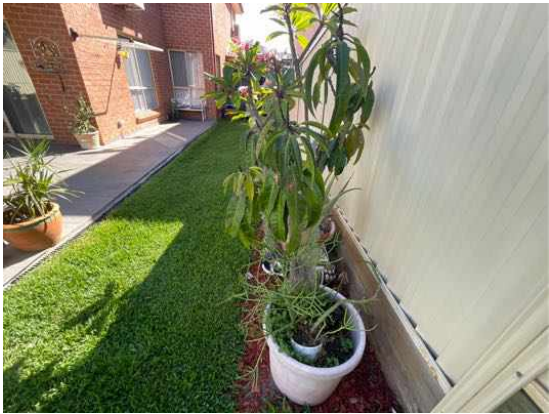
Building: Main Building
Location: All Areas
Finding: Additional Photos - Obstructions and Limitations
Information: These photographs are an indication of the obstructions and limitations which impeded full inspection of the property at the time of inspection. These obstructions can hide an array of defects and should be removed to allow full inspection to be carried out. A re-inspection is recommended once the areas are made accessible.
