Building and Timber Pest Inspection Report

Inspection Date: Wed, 28 Jan 2026

Property Address: 84 Venezia St, Prestons NSW 2170,
Australia

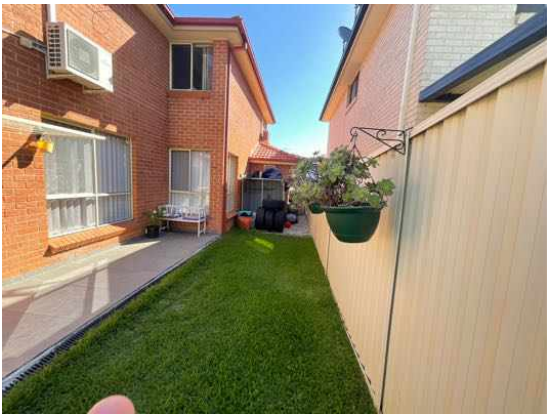
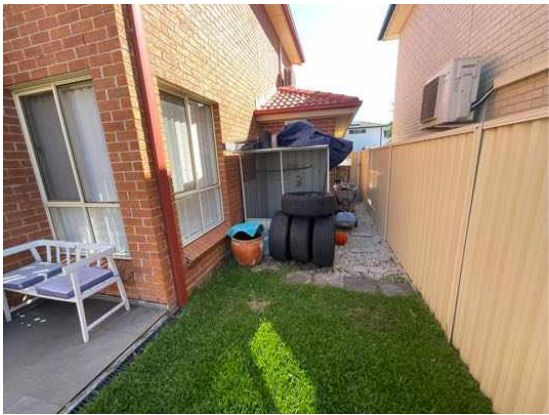
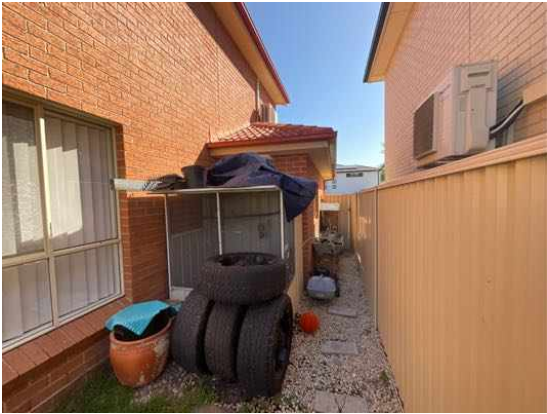
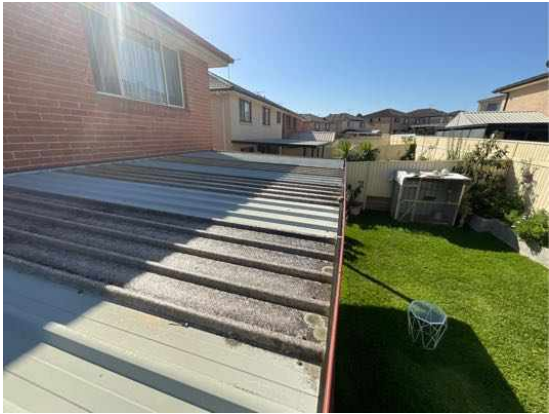
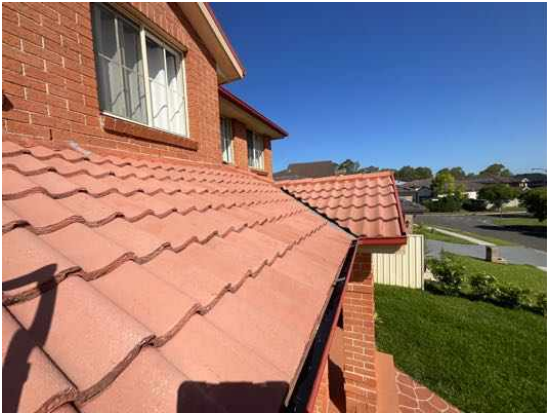
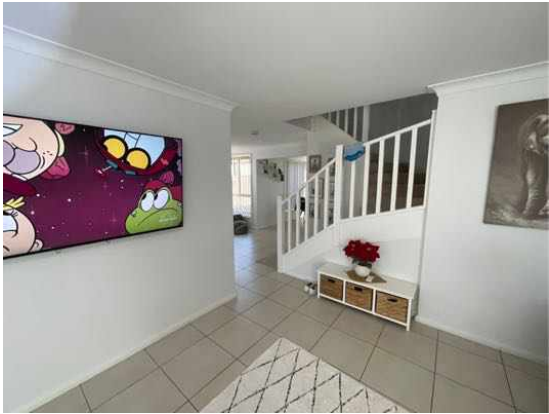
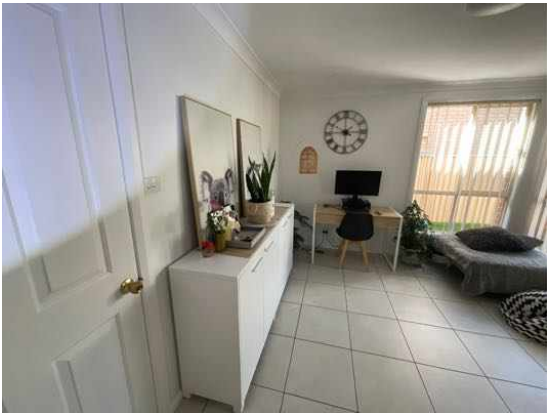
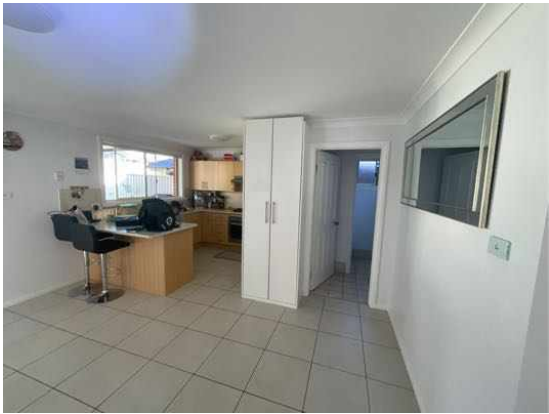
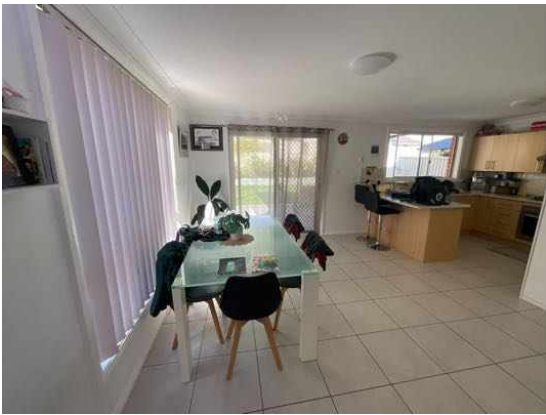
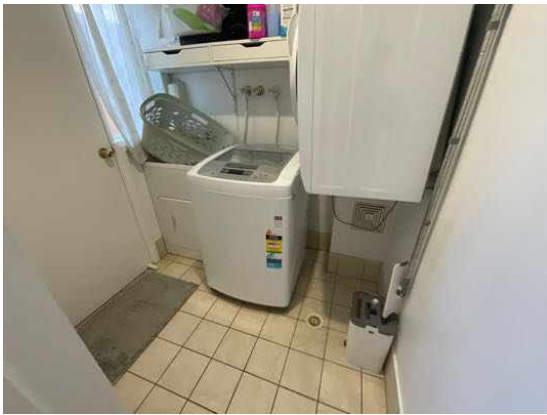
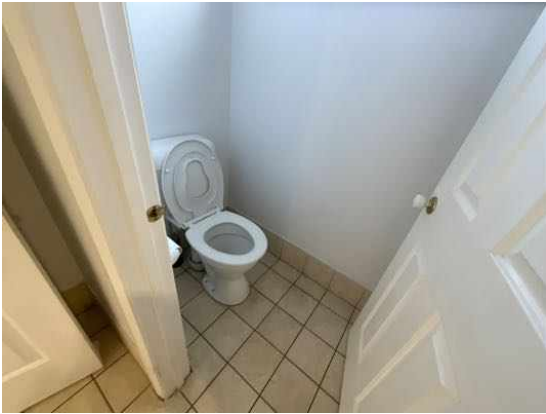
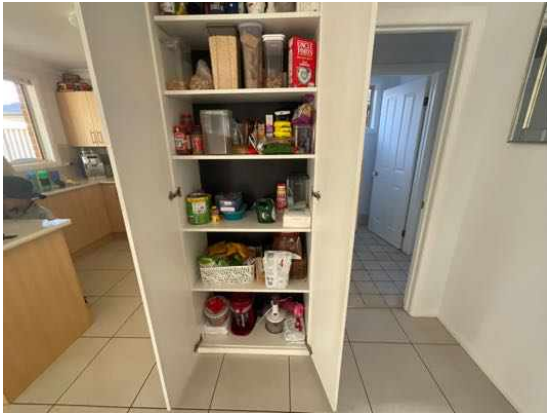
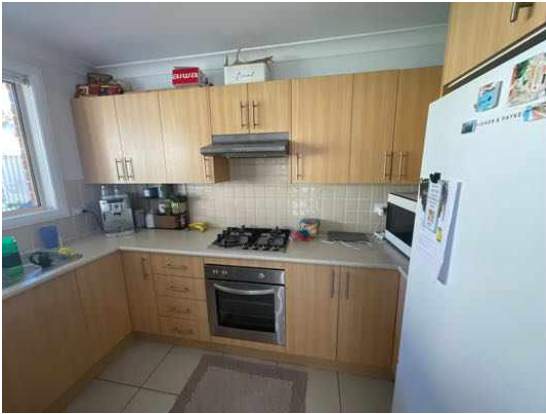
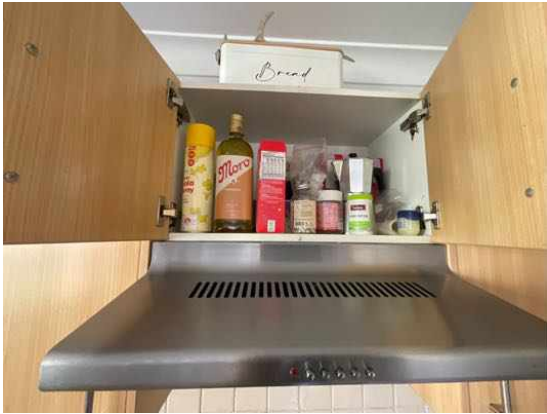
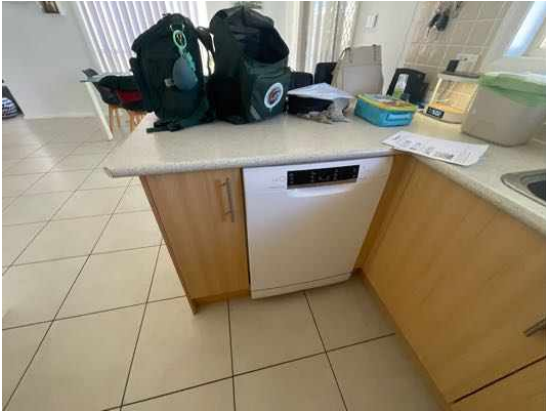
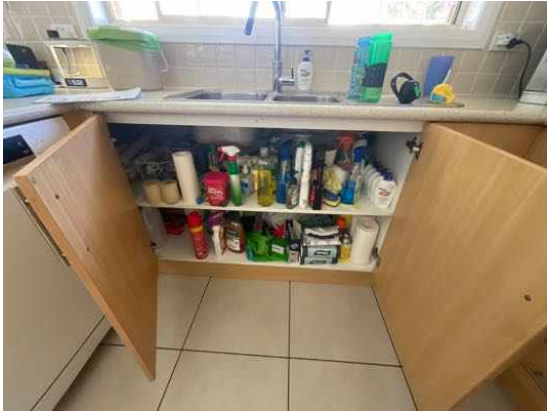
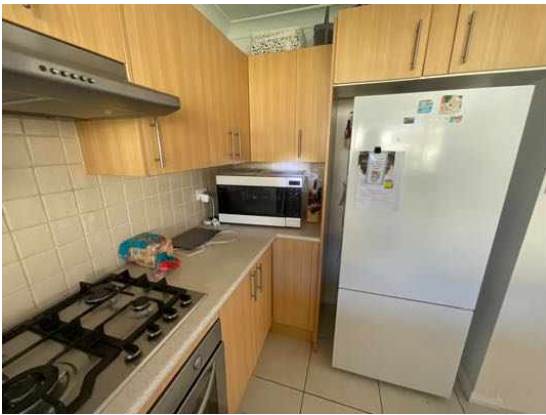
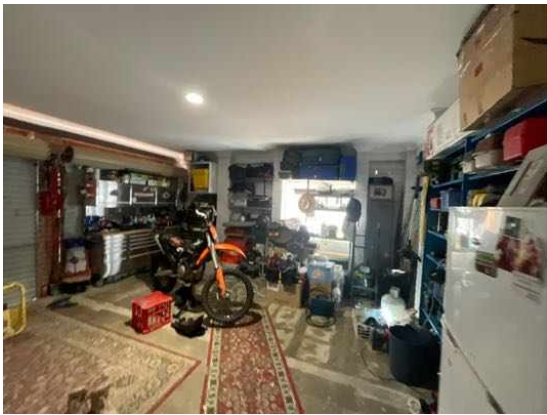
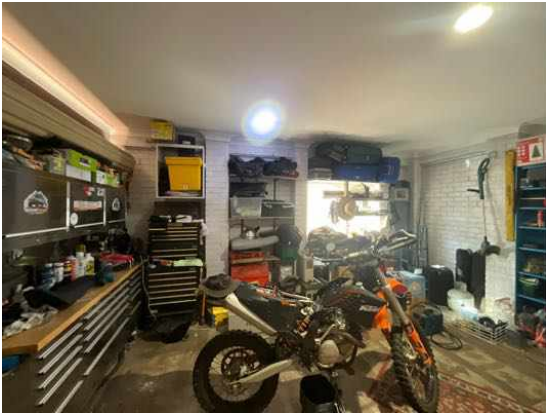
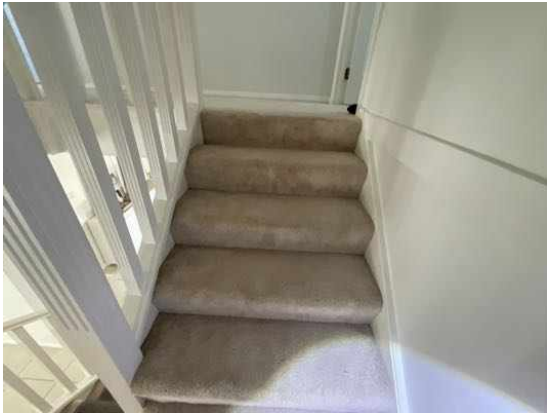
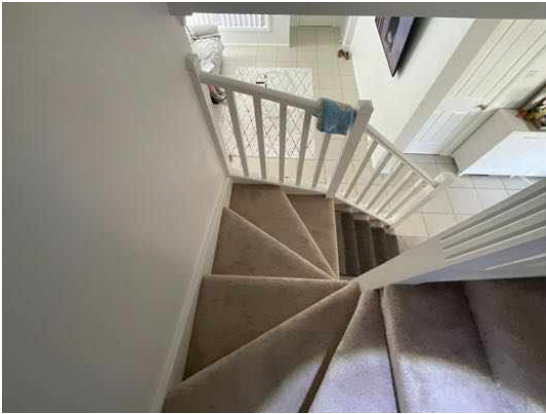
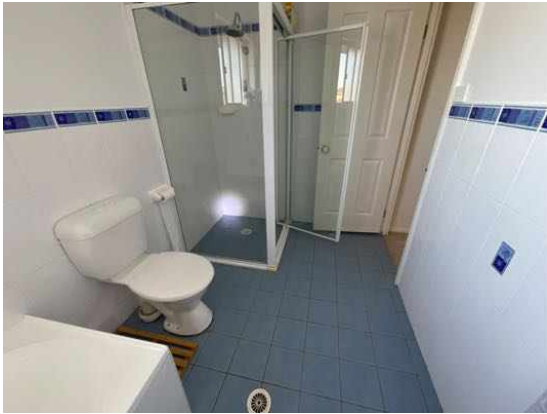
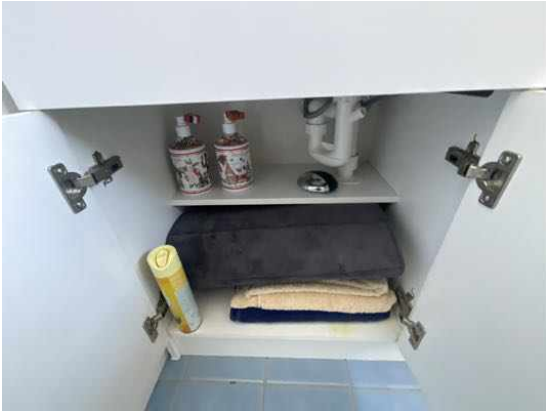
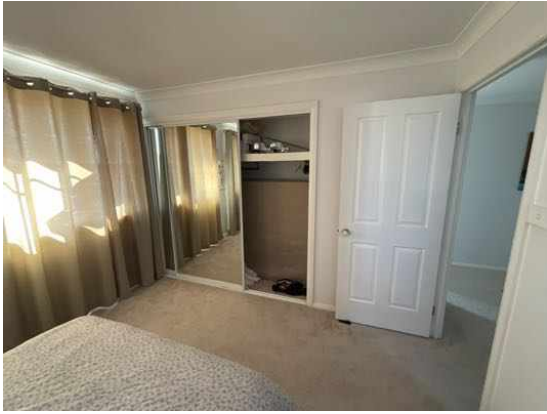
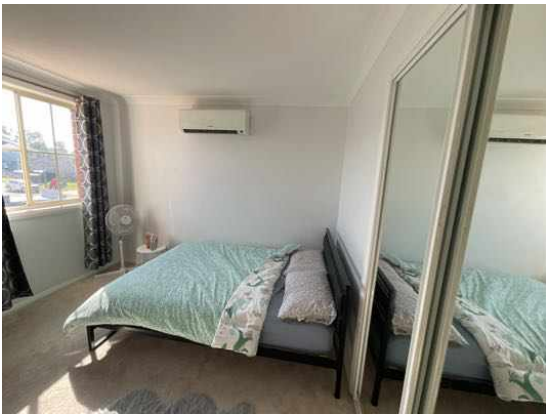
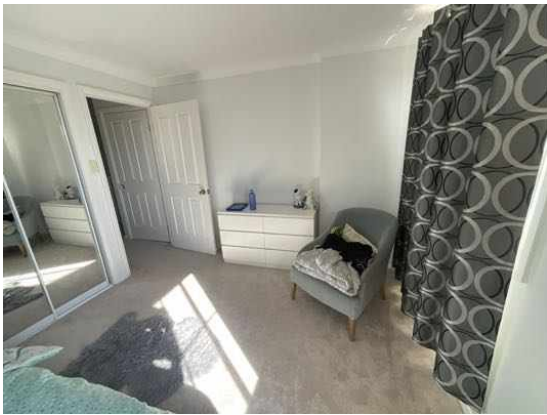
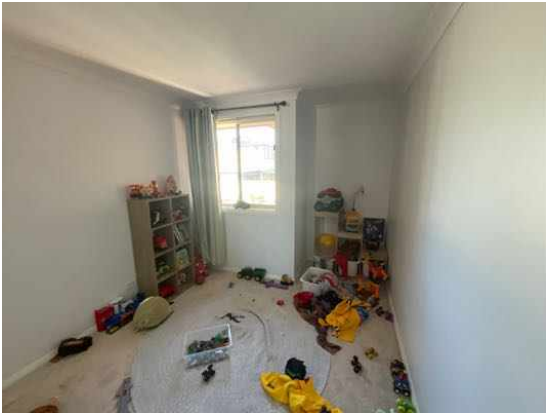
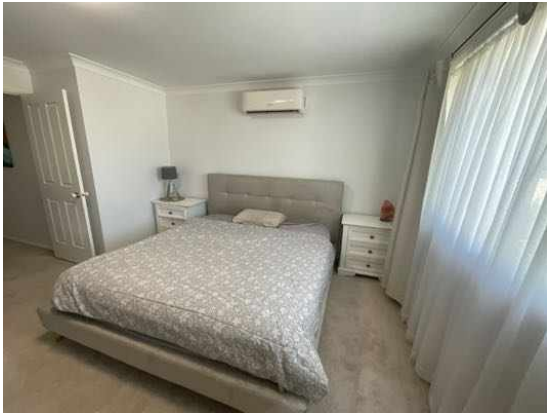
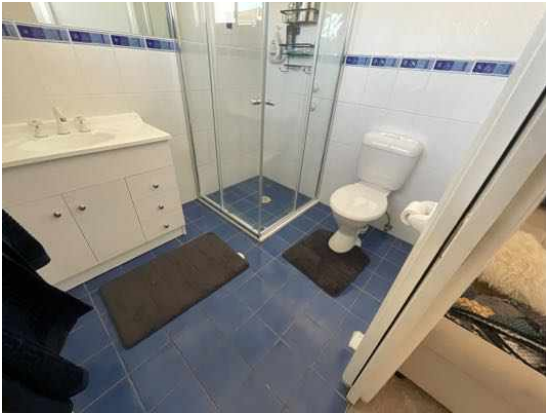
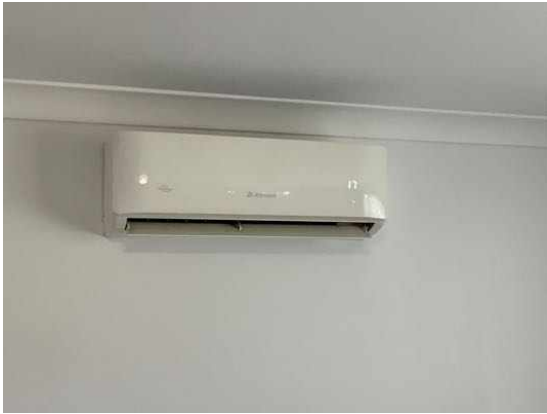
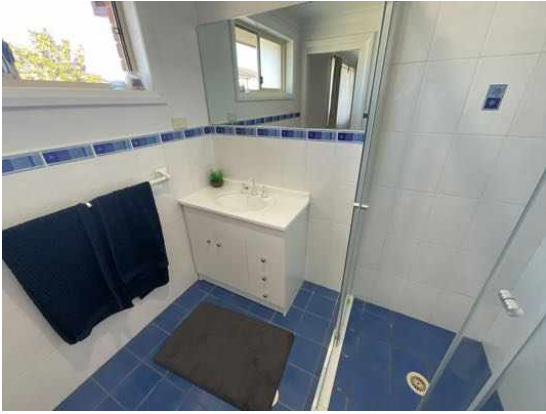
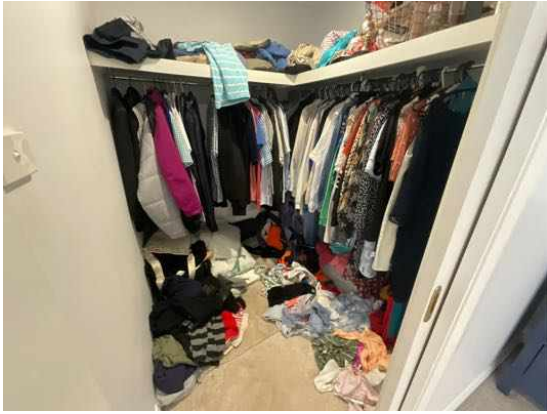
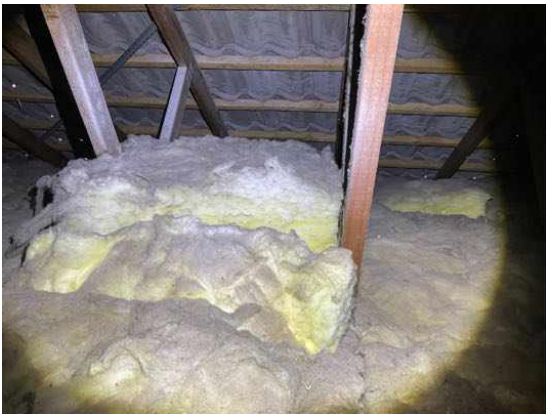
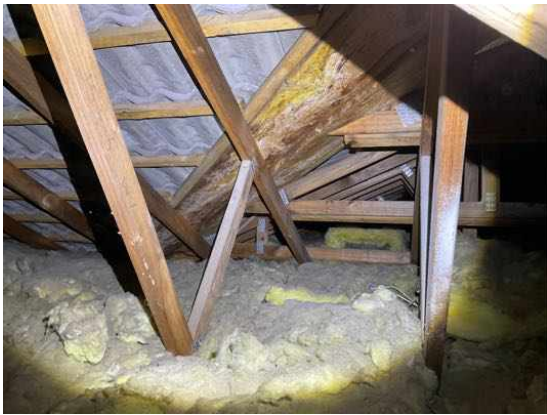
Building: Main Building
Location: All Areas
Finding: Additional Photos - Obstructions and Limitations
Information: These photographs are an indication of the obstructions and limitations which impeded full inspection of the property at the time of inspection. These obstructions can hide an array of defects and should be removed to allow full inspection to be carried out. A re-inspection is recommended once the areas are made accessible.

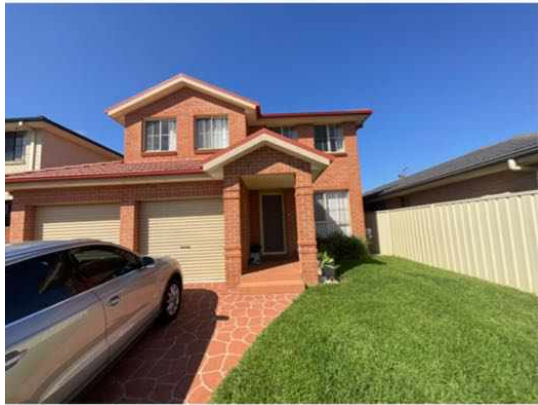
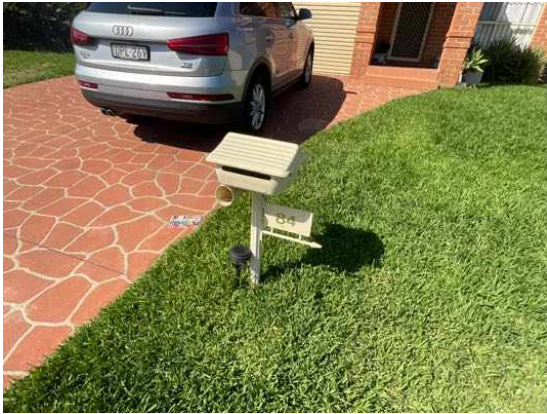
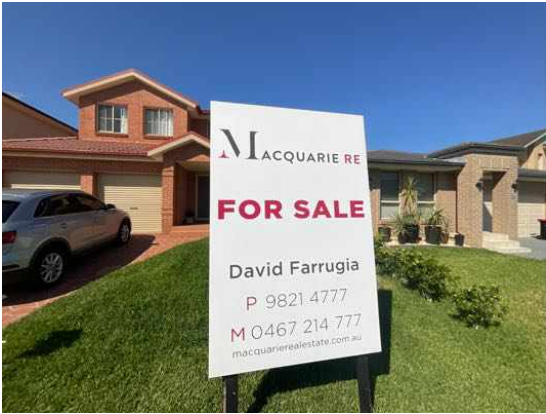
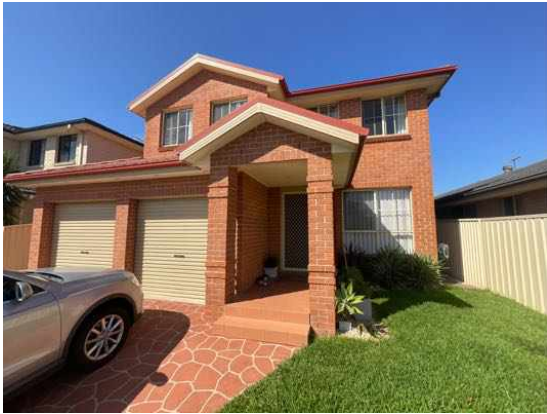
Building: Main Building
Location: All Areas
Finding: Additional Photos
Information: Additional photos are provided for your general reference

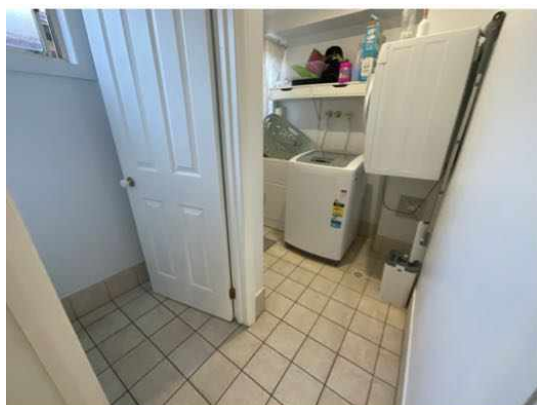
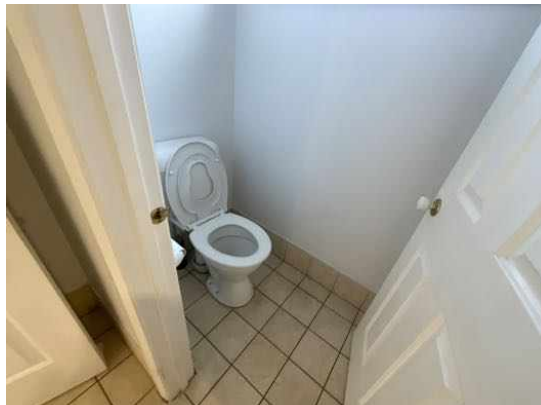
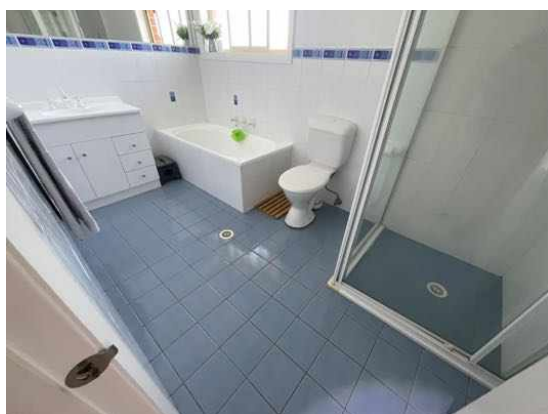
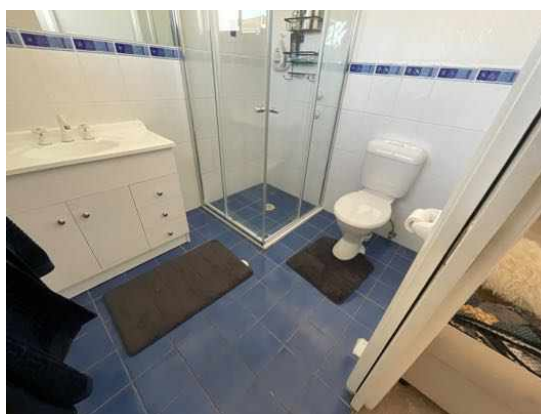
| Information: | Internal Water Proofing Membranes, are crucial in preventing water ingress into the property is important to know that the Membrane System used is to Australian Standards and has been installed correctly. Please refer to the original Building Documents or Maintenance Schedule for the relevant information including; - Membrane used and Manufacturers Specifications. - The Installer and Installation Certification. Especially with older property's where this information is unavailable, all wet areas should be monitored. Generally new waterproofing with a certificate may |

only have a guarantee of 8yrs. If any leaks, water staining, peeling or bubbling of the paint become evident to any adjacent walls or ceilings below a licensed builder or waterproofing specialist is recommended to investigate further.

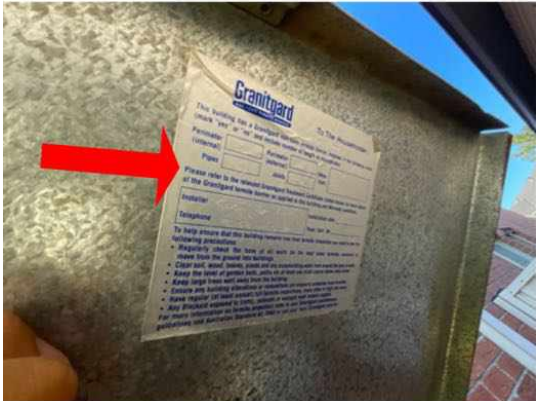
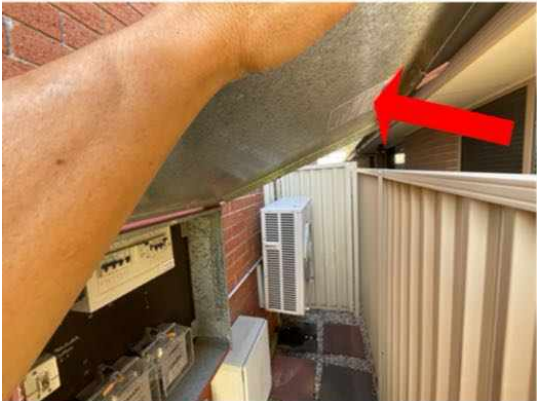
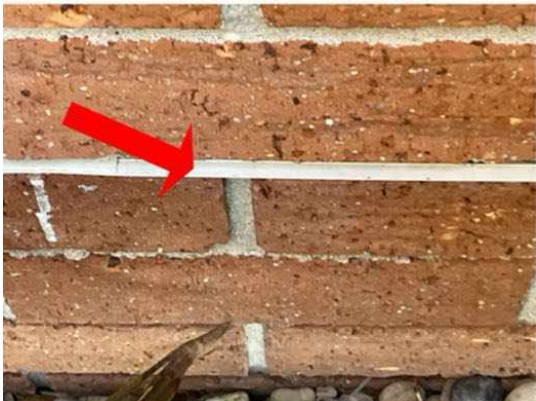
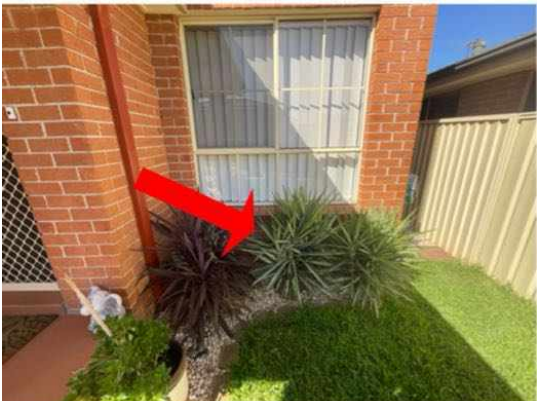
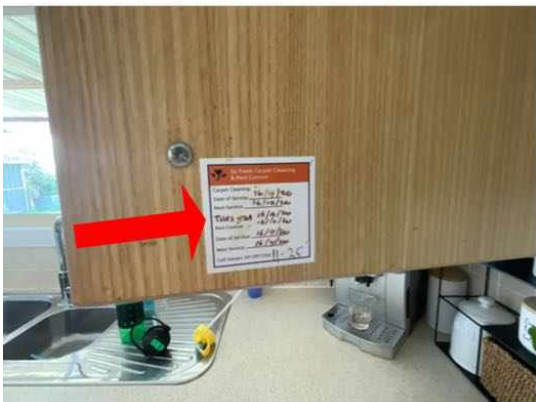
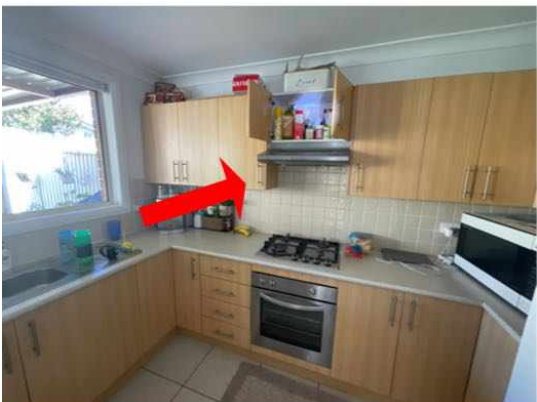
| Information: | During inspection of the property, it was noted that works to install a chemical treated zone barrier had previously been completed. A chemical treated zone barrier is likely to ensure effective protection against termites. |

However, we strongly recommend annual inspections of the barrier and surrounding areas as there are several factors that can lead to deterioration of the barrier and decrease its effectiveness.

Where a Termite Management System has been identified, the client should identify to the type of barrier, date of installation, warranty conditions and any documentation provided by a builder or past owner. Consult the company who installed the barrier to confirm whether the system is still under warranty.
