Building and Timber Pest Inspection Report

Inspection Date: Fri, 23 Jan 2026

Property Address: 18/162 Kanahooka Rd, Kanahooka NSW
2530, Australia

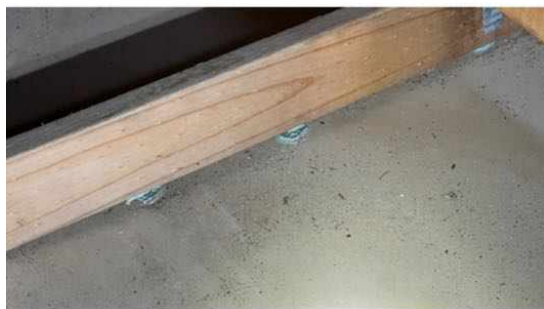
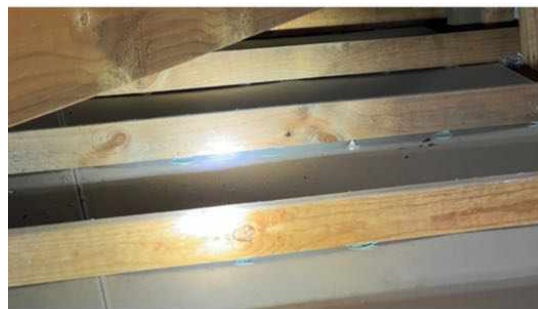
Building: Main Building
Location: Garage
Finding: Ceiling sagging - Garage
Information: Sections of the ceiling were found to be sagging at the time of inspection. Sagging to the fixed ceiling structure generally indicates that the building materials have swollen, due to contact with water, or that fixings (e.g. nails or glue) have become loose and require reattachment. This is a very common defect in carports due to their lack of insulation and or their susceptibility to moisture. Condensation builds up in the roof and rests on the plasterboard softening it somewhat which makes it more likely to sag and release from its fixing points.

Ceilings detached from joist throughout garage

Where minor sagging is evident, comparatively minor works, such as re-gluing of ceiling sheets, may be required. Such works may be performed by relevant tradespeople, such as plasterers and painters. Where excessive moisture has caused the roofing structure to swell and sag, the source of the water leak should primarily be identified prior to any remedial works being performed.

While damage is minimal at this stage a licensed plasterboard contractor should be appointed to repair the ceiling. Insulating the area could be a considered by the client once repaired.

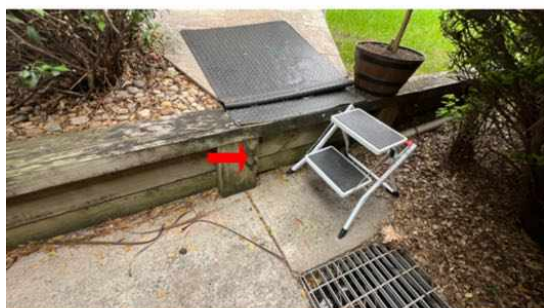
Finding 1.02

Building: Yard
 Location: Yard - Back
 Finding: Stairs - Missing
 Information: The stairs were found to be missing, creating a potential trip hazard for users of this area. According to normal building practices, all stairs should be measured and levelled to exact heights so as to prevent tripping.

Steps required.

Consultation with a qualified carpenter as to the cost of potential solutions is recommended stairs for safe egress as soon as possible.

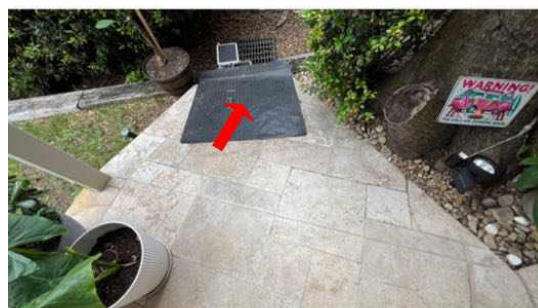
Potential slip hazard when wet

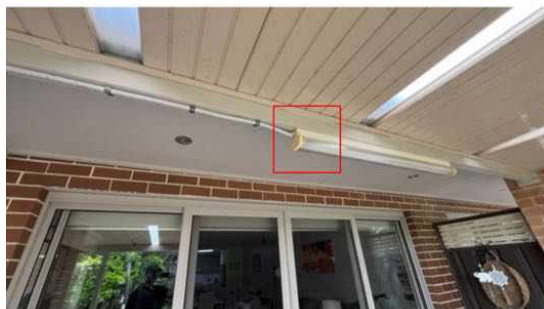
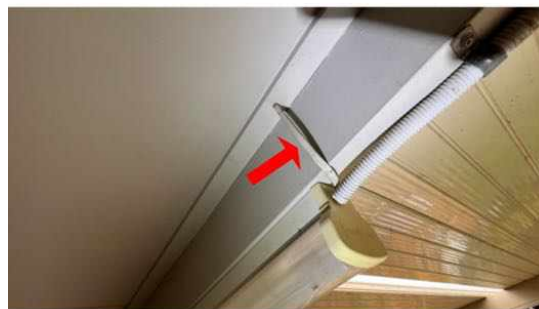
Finding 1.03

Building: Main Building
 Location: Alfresco
 Finding: Electrical wires exposed
 Information: Exposed electrical wiring was identified. Exposed electrical wiring represents a potential safety hazard including for fire and personal contact. Contact a licensed electrician urgently for further inspection investigation and rectification.

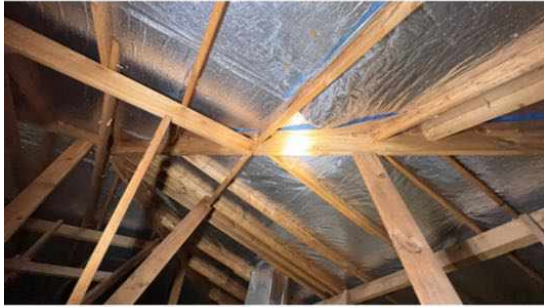
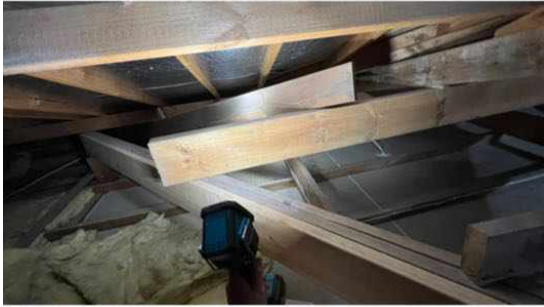
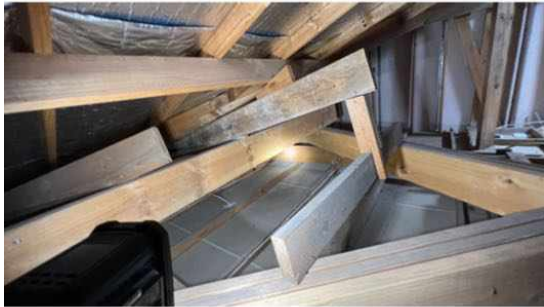
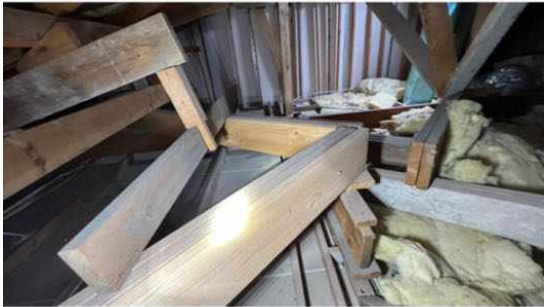
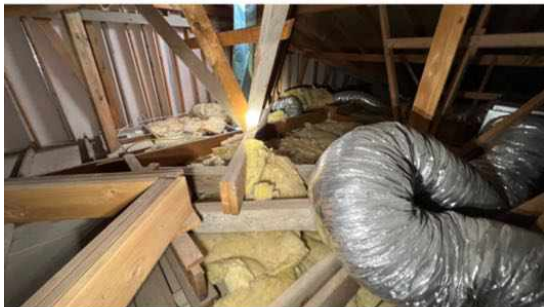
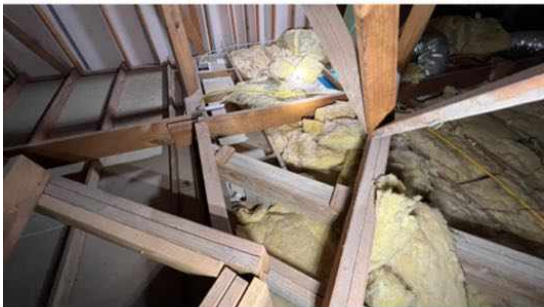
Finding 2.01

Building:	Main Building
Location:	Roof Void
Finding:	Roof structure - Altered Conventional Framing
Information:	Alterations to the original conventional roof framing were observed within the roof void. The configuration of purlins, struts, and associated members is irregular and not consistent with typical or accepted construction practices for conventional roof structures. Several members appear to rely on ad-hoc packing, non-uniform bearing points, and interrupted load paths, which raises concern regarding the adequacy of structural support and long-term performance of the roof system.

The extent and nature of these alterations indicate that the roof structure may not be performing as originally intended and may be subject to abnormal load transfer or localised overstressing of framing members. As this inspection was visual only and non-invasive, the full extent of the alterations and their structural implications could not be determined.

Further assessment by a registered builder or a structural engineer experienced in conventional roof construction is recommended as a matter of priority to determine compliance, structural adequacy, and whether remedial works are required to reinstate the roof structure to an acceptable standard.

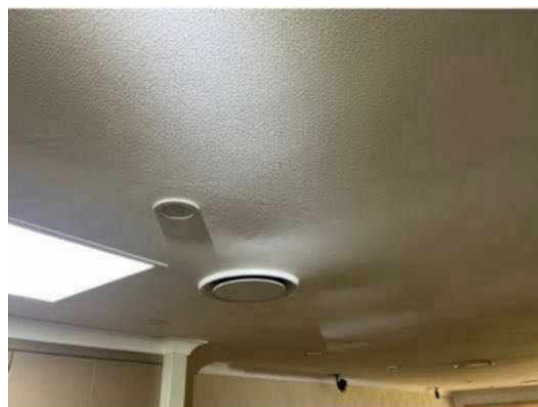
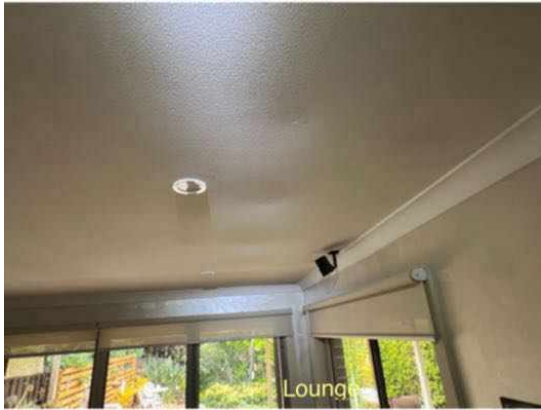
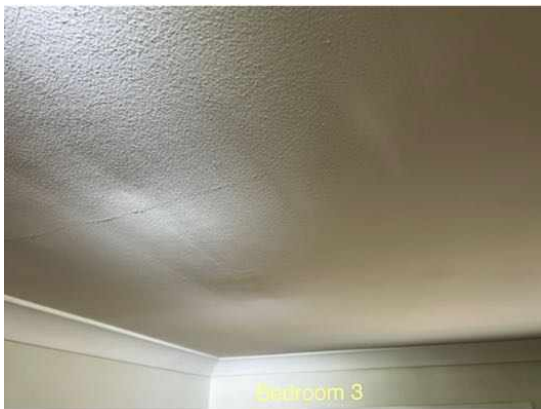
Building:	Main Building
Location:	Kitchen, Dining Room, Lounge Room, Bedroom 3, Bedroom - Master
Finding:	Ceiling Defects – Poor Finishing and Localised Sagging
Information:	Visual inspection revealed several ceiling defects, including localised sagging, nail popping, and inconsistent flushing of join lines. Minor sagging across ceiling surfaces suggests that back-blocking may have been omitted or poorly executed during installation. Additionally, evidence of substandard patching and finishing was noted in areas where previous defects have been addressed, but not to an acceptable visual standard.

Nail popping and poor join treatment, while generally not structural, can lead to further deterioration of ceiling linings if left unmanaged. These issues detract from the ceiling's appearance and may compromise the long-term durability of the plasterboard fixing.

Rectification by a qualified plasterer is recommended. Works should include securing loose fixings, re-flushing affected joints, and applying back-blocking where necessary to stabilise the ceiling structure and improve the visual condition.

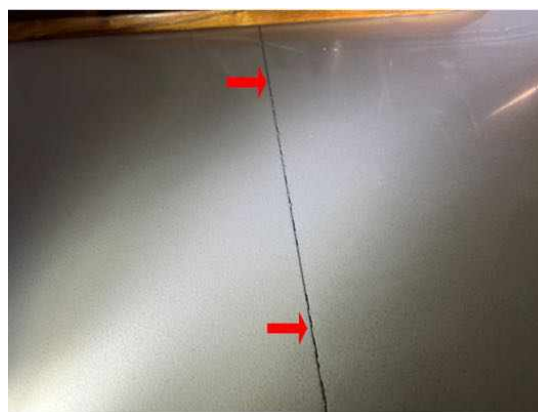
Building:	Main Building
Location:	Kitchen
Finding:	Stone Benchtop - join Separation/Deterioration
Information:	The stone benchtop joints were observed to have separated and deteriorated at the time of inspection. This is commonly caused by natural movement, thermal expansion and contraction, or substandard installation.

If left unmanaged, gaps in the benchtop joints may allow moisture ingress, leading to further deterioration, potential bacterial growth, and compromising the integrity and appearance of the surface.

It is recommended that a qualified stonemason or benchtop specialist be engaged to assess and repair the affected joints to restore functionality and durability.

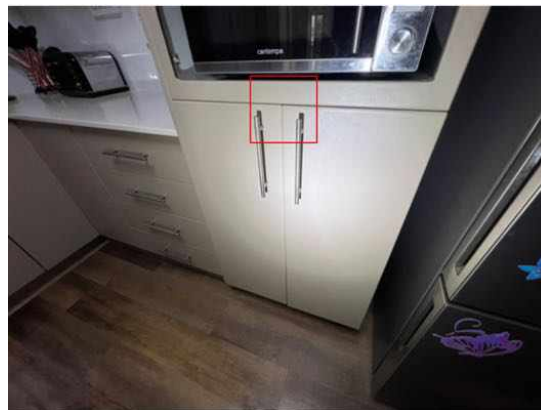
Finding 3.06

Building:	Main Building
Location:	Kitchen
Finding:	Joinery Doors - Binding
Information:	Binding of joinery doors is evident during standard operation. This defect inhibits the functionality of the affected door as well as creating potential for secondary defects to associated building elements, such as damage to the adjacent joinery.

A door that binds may have several causes, ranging from minor defects, such as poor installation of the door or deteriorated hinges.

Recommend a qualified carpenter or general handyperson should be appointed to perform minor rectification works at client discretion.

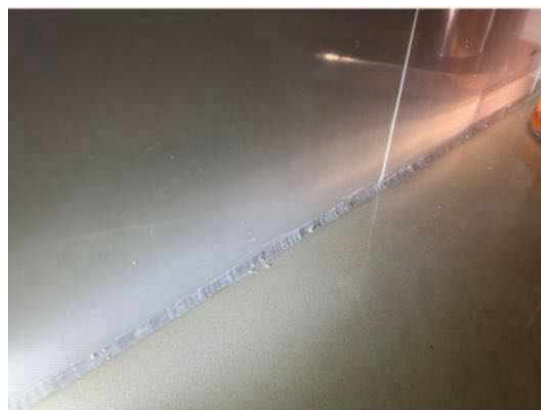
Finding 3.07

Building:	Main Building
Location:	Kitchen, Laundry
Finding:	Sealant - degraded
Information:	It was noted on inspection that sealant or grout is degraded to this area.

Different materials move at different rates, generally causing cracking to grout or sealant at this point. A flexible sealant is required to allow for expected expansion and contraction, while keeping the joint water tight and protective of all associated building materials.

Flexible and mould resistant materials should be applied to affected areas to prevent any subsequent water damage that is likely to occur. Regular maintenance and replacement of damage or missing or damaged sealant and grout is highly recommended to the wet areas, as this is a regular wear and tear defect. Sealant and grouting in areas that come into regular contact with water should be maintained for the long term care of your property.

A sealant specialist or tiling contractor should be appointed to complete these works as soon as possible

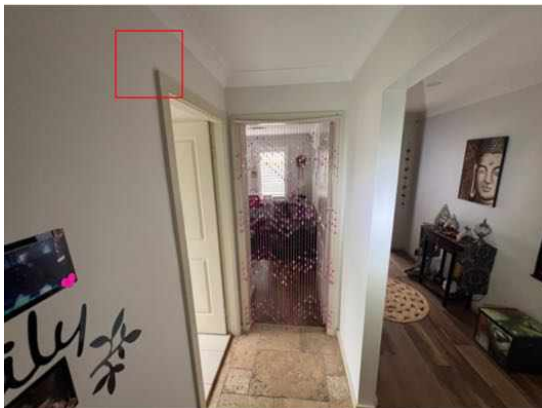
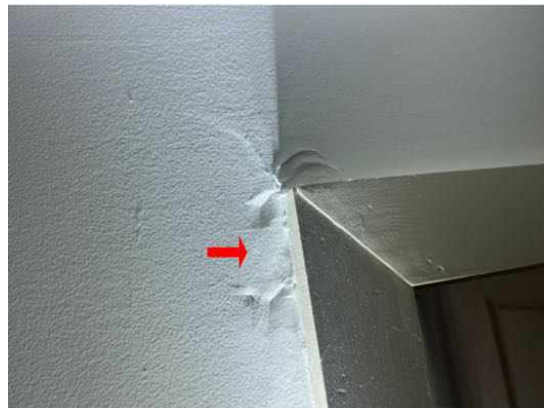
Works that have not been completed to a satisfactory level create potential for the development of building defects and may impede on the safety and integrity of the overall structure.

It is highly recommended that a licensed plasterboard contractor should be appointed to repair the wall. To ensure the safety of the area and the longevity of all associated building elements.

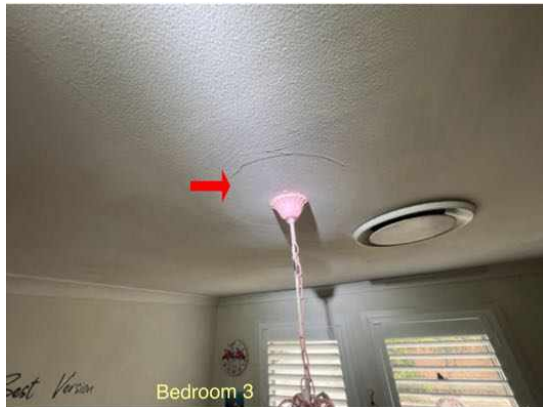
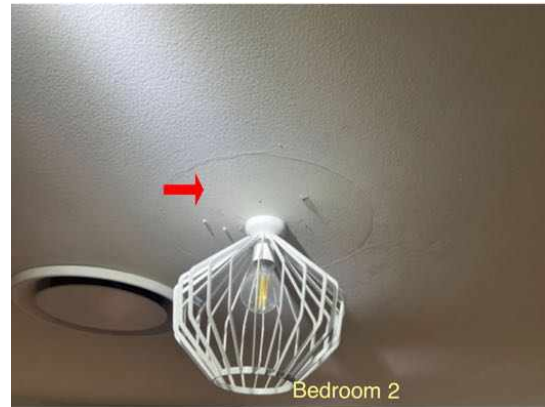
Finding 3.10

Building:	Main Building
Location:	Bedroom 3, Bedroom 2
Finding:	Ceiling - Incomplete or substandard works
Information:	The works to this area appear to be incomplete or have been completed to a substandard level.

Works that have not been completed to a satisfactory level create potential for the development of building defects and may impede on the safety and integrity of the overall structure.

It is highly recommended that a licensed plasterboard contractor and or painter should be appointed to repair the ceiling. To ensure the safety of the area and the longevity of all associated building elements.

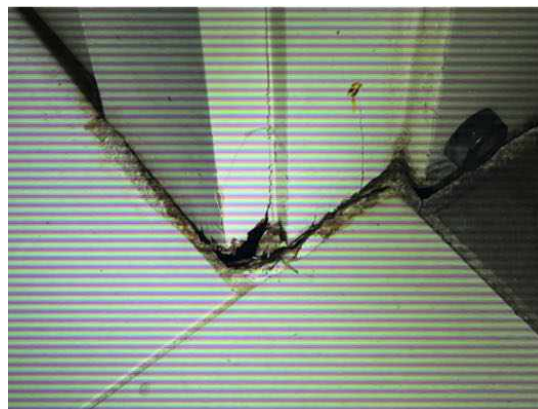
Finding 3.11

Finding: Door Jamb – Water Damage

Information: Water damage was observed to the base of the door jamb in this area. This type of defect is typically caused by moisture exposure from wet areas, inadequate sealing, or failed waterproofing at adjoining tiled surfaces.

If left unmanaged, water ingress may result in swelling, decay, or deterioration of the timber, potentially affecting the operation of the door and compromising surrounding finishes.

It is recommended that a qualified carpenter or builder assess the extent of damage and carry out repairs or replacement of the affected section as required. Improved

sealing or waterproofing should also be considered to minimise recurrence.

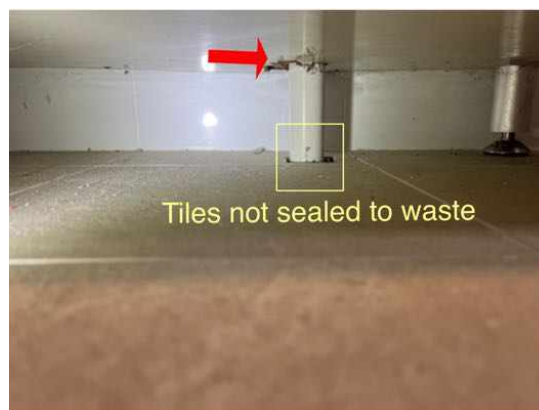
Building:	Main Building
Location:	Bathroom, Ensuite
Finding:	Sealant and grouting - Missing or damaged
Information:	It was noted on inspection that sealant or grout is degraded to the tiled shower alcove and or other areas of the bathroom.

Different materials and floor areas move at different rates, generally causing cracking to grout or sealant at this point. A flexible sealant is required to allow for expected expansion and contraction, while keeping the joint water tight and protective of all associated building materials.

There appears to be excessive mould to the sealant and grout which will likely require scraping out and replacement.

Flexible and mould resistant materials should be applied to affected areas to prevent any subsequent water damage that is likely to occur. Regular maintenance and replacement of damage or missing or damaged sealant and grout is highly recommended to the wet areas, as this is a regular wear and tear defect. Sealant and grouting in areas that come into regular contact with water should be maintained for the long term care of your property.

A sealant specialist or tiling contractor should be appointed to complete these works as soon as possible

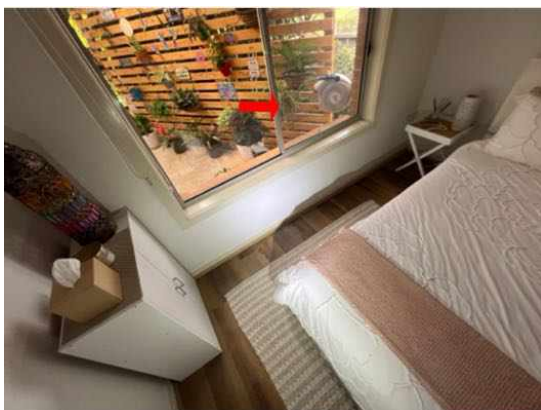
Building: Main Building
 Location: Bedroom 2, Bedroom - Master
 Finding: Window service recommended
 Information: Some windows throughout the property were found not to be fully operational. This may be due to the fact that they did not open, stiff to open, did not stay open or were binding at time of inspection. A window service is recommended.

Windows provide ventilation to the adjoining area and should be at a fully operational level to ensure user comfort.

A competent general handyman or carpenter may be engaged at the clients discretion.

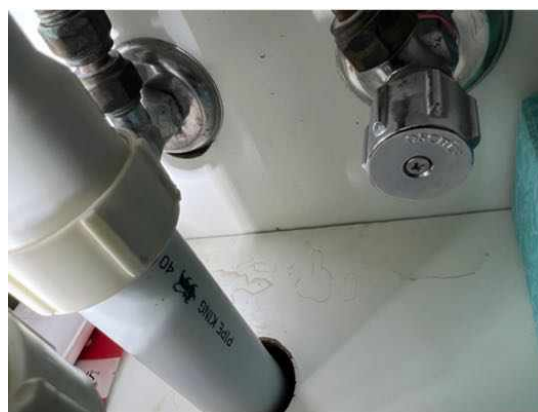
Building:	Main Building
Location:	Ensuite
Finding:	Water staining - sink cabinetry
Information:	A water staining was observed to the cabinetry beneath the sink at the time of inspection. Water staining in this area is generally indicative of a previous or active leak from plumbing fixtures, waste connections, or sealant deterioration around the sink junction.

If left unmanaged, persistent moisture can lead to material deterioration, mould growth, and potential damage to adjacent cabinetry or flooring. It is advised that a licensed plumber be engaged to inspect the area, determine if an active leak is present, and undertake any necessary rectification works.

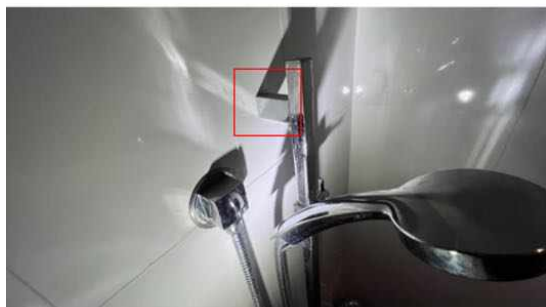
Finding 3.20

Building:	Main Building
Location:	Ensuite
Finding:	Shower rail - Loose
Information:	The shower rail was observed to be loose at its connection to the wall at the time of inspection. This condition is commonly caused by poor installation, deterioration of sealant, or movement in the fixture over time.

A shower rail may lead to water leakage behind the wall, potentially causing moisture damage and deterioration of associated building elements if left unmanaged.

It is recommended that a licensed plumber be engaged to assess and properly secure the spout to prevent further movement and potential water ingress.

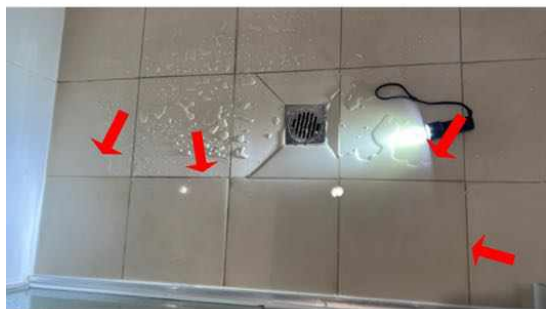
Finding 3.21

Building:	Main Building
Location:	Ensuite
Finding:	Shower base - Water pooling
Information:	Evidence of water pooling around the floor waste in the shower recess was noticed at the time of inspection. It is suspected that this excessive moisture is attributed to insufficient fall in the shower floor tiles.

This pooling is minor overall but is still considered unsatisfactory, as standard tiling practices would not permit this situation to occur. Pooling water around floor wastes can create a slip hazard in extreme cases and create conditions that are conducive to mould growth over time. Where left unmanaged, the degradation of sealant and grouting is also likely to occur, possibly necessitating further repair works.

Remedial works may involve some sections of tiling and flooring repair and replacement. A tiling contractor or bathroom specialist should be appointed to provide further advice on reparation options and to perform works as necessary.

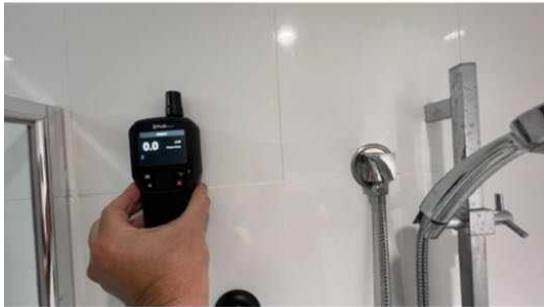
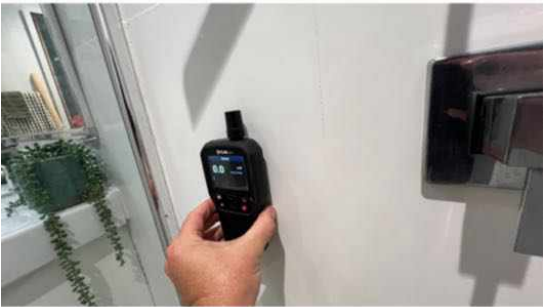
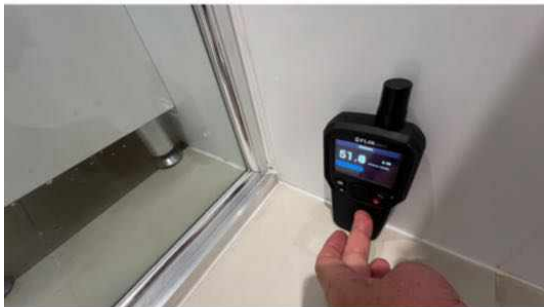
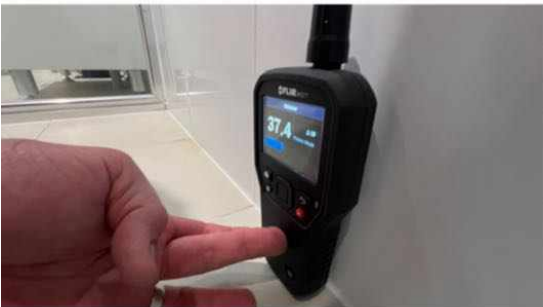
Building:	Main Building
Location:	Ensuite
Finding:	Moisture in Shower
Information:	Moisture is evident behind the tiles to the shower alcove. This defect is quite common, and is suspected to have been caused by moisture permeating through the grouting in this area. Leaking pipes within the adjoining wall is also a possible cause.

Damp (or structural damp) refers to the presence of unwanted moisture in the structure of a building, either as the result of intrusion from outside, or condensation from within the structure. In the shower area, internal water leaks or other sources of excessive moisture are generally the cause of damp. Always ensure that sealant and grout is in good condition to prevent any moisture issues occurring in the future.

Please note, the moisture meter used operates on the principle of electrical impedance, generating a low-frequency alternating electric field between its electrodes. The instrument measures moisture content within the material at a maximum depth of 19mm below the surface, rather than on the surface itself.

Consultation with a qualified plumber or bathroom specialist is advised to identify the cause of damp and to perform remedial works as required.

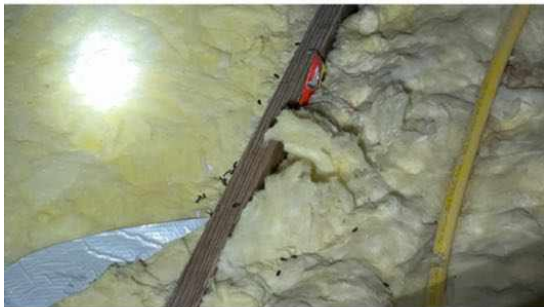
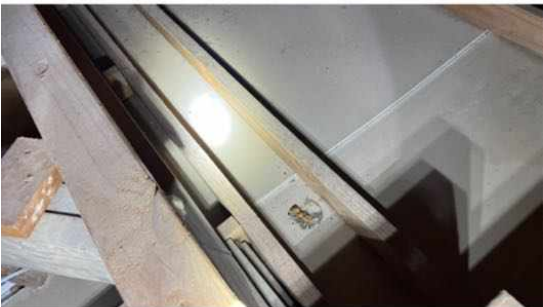
Finding 3.23

Building: Main Building
Location: Roof Void
Finding: Evidence of Vermin
Information: Evidence of pests or rodents faeces and carcass in the roof space at time of inspection. Rodents can cause issues ranging from smells and stains through to physical damage to wiring and other elements in the roof void. A licensed pest controller should be appointed to free the roof void of any pests and to install deterrents or seal access points to ensure that rodents cannot enter the roof space as easily.

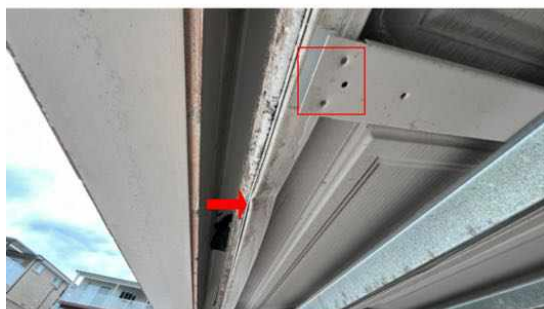
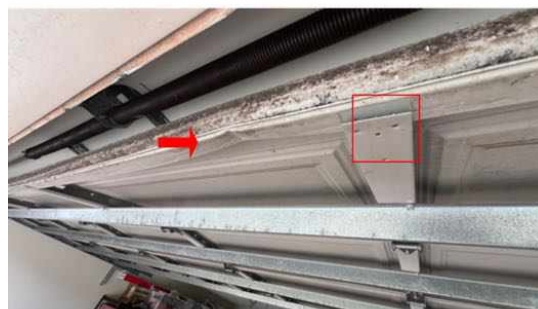
Finding 3.24

Building:	Main Building
Location:	Garage
Finding:	Garage door - Superficial markings
Information:	The garage roller door has a number of marks and dents likely to have resulted from impact damage be it accidental or deliberate impact at sometime.

Garage roller doors can fail when the building materials have aged but may be indicative of impact damage (accidental or deliberate). While superficial markings detract from the aesthetics of the building element, the functionality has not been hindered in any way.

Repair and/or replacement of the two garage doors would improve the condition of the garage but certainly not an urgent item

A qualified roller door installer or supplier should be engaged to check out the operation and overall condition of the doors to determine if repair is an option otherwise replacement may need to be considered.

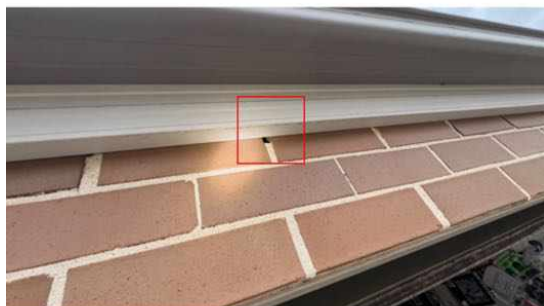
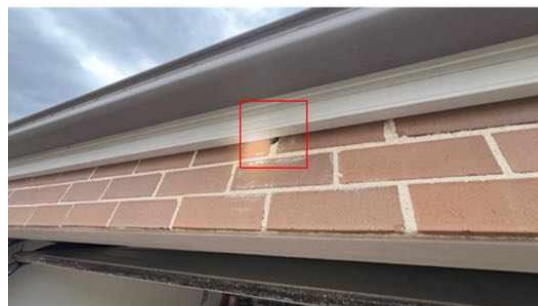
Finding 3.25

Building:	Main Building
Location:	Garage
Finding:	Brickwork - voids/holes in mortar
Information:	Small voids or holes were identified in the mortar beds between bricks at the time of inspection. These imperfections are often the result of incomplete filling during construction or minor deterioration over time.

While currently minor, such voids can allow water ingress and contribute to damp conditions within the wall cavity. Over time, this may lead to secondary defects such as mortar erosion, brick movement, or even pest entry in severe cases.

It is recommended that a qualified bricklayer or mason be engaged to repoint the

affected areas, ensuring the mortar beds are properly sealed to maintain the integrity and weatherproofing of the brickwork.

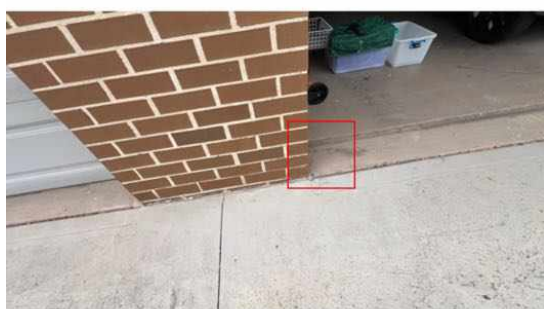
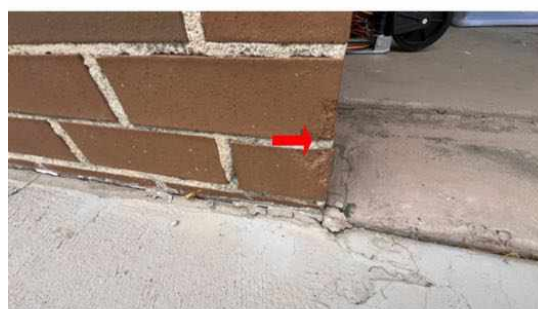
Finding 3.26

Building:	Main Building
Location:	Garage
Finding:	Brickwork - Damaged
Information:	Breakage occurs generally when the building materials have either aged and decayed, or as a result of damage (accidental or deliberate).

Repair and/or replacement of broken elements is advised to ensure that additional secondary defects do not arise as a consequence. Such works are necessary, as all building elements play a key role in the operation and function of the overall structure and its performance.

A bricklayer should be appointed to repair or replace the affected building element prior to any subsequent damage being caused.

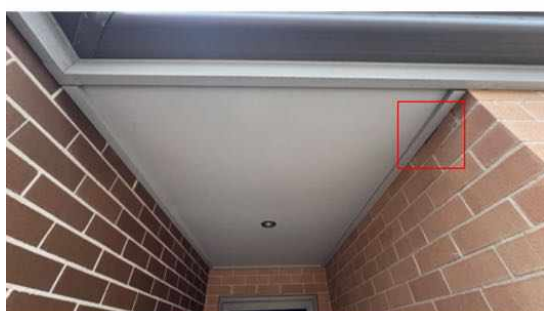
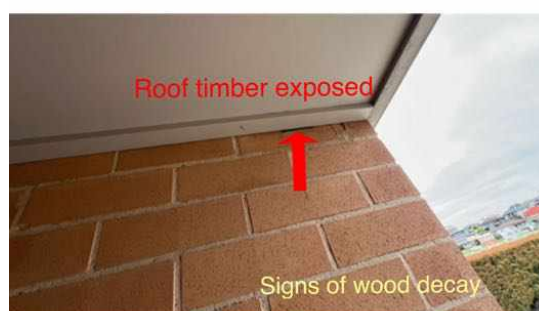
Finding 3.27

Building:	Main Building
Location:	Porch

Finding: Timber - exposed to weather
 Information: External timbers that are frequently exposed to harsh weather conditions require adequate protection in order to maintain their condition. Where timbers have not been painted or treated adequately, general deterioration is likely to occur at an accelerated rate.

If left unattended, replacement of these timbers is likely to be necessary in the short-term future. Adequate treatment of these timbers is required as soon as possible by a painting contractor or general handyman.

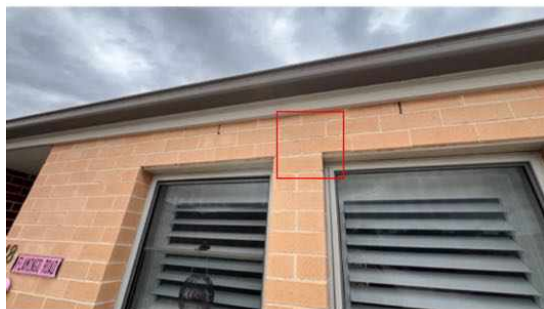
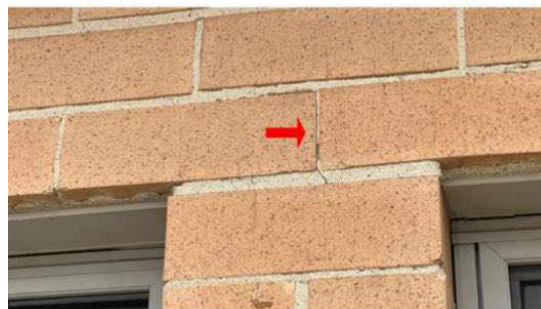
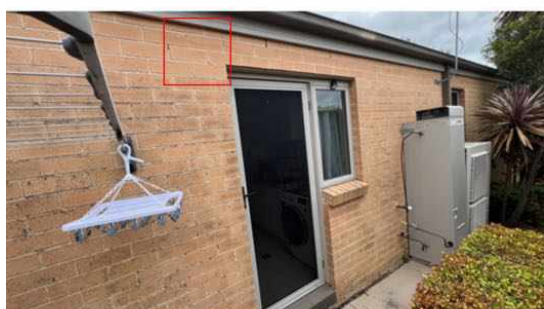
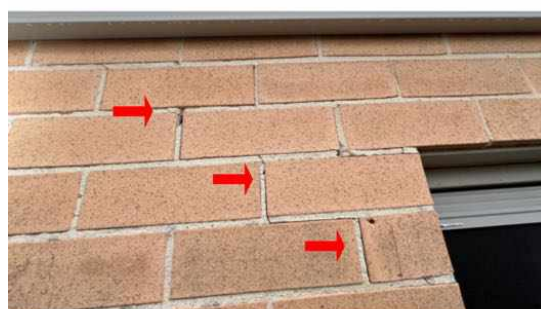
Finding 3.28

Building: Main Building
 Location: Exterior walls - front, right side
 Finding: Brickwork - Cracking [Fine]
 Information: Although fine cracks are quite noticeable, they are often only considered to be an appearance defect and usually do not indicate any structural damage. Generally, the cause of a fine crack is indicative of a separation between brickwork and mortar throughout the structure, but single bricks may also show cracks of this nature.

Cracking of this nature can generally be repaired with minor filling and should be conducted by a qualified bricklayer.

Always contact a building inspector should cracks widen lengthen or become more numerous.

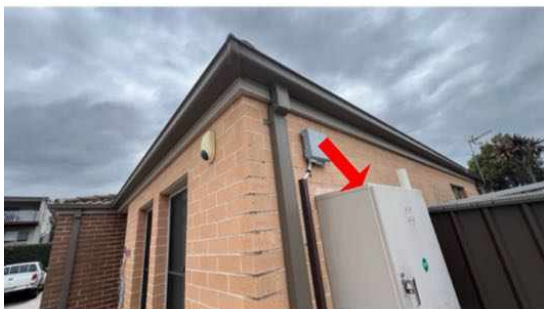
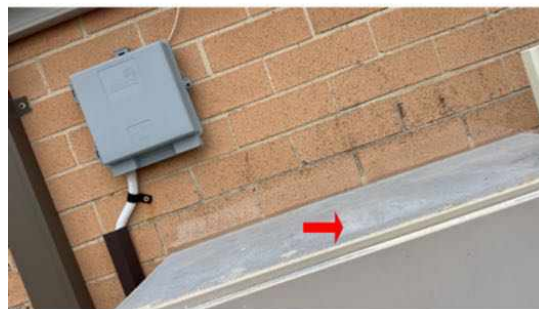
Finding 3.29

Building:	Main Building
Location:	Exterior walls - right side
Finding:	Paint finish - Incomplete
Information:	The paint finish in this area was identified as being incomplete at the time of inspection.

Whilst incomplete or missing paint finish is generally an appearance defect, it can also lead to the development of secondary building defects over time. Incomplete areas of paint finish expose the area to moisture, potentially accelerating the deterioration of underlying building materials.

Incomplete paint finishes should be sanded back, filled, leveled and painted, as applicable. Where inadequate or missing paint protection has led to the deterioration of the associated building element, repair and/or replacement of this building element may be required.

A painting contractor should be appointed as soon as possible to perform necessary works to aid the appearance of the affected area and to ensure the area is protected against further deterioration. Alternatively, the homeowner following manufacturer instructions may perform these works.

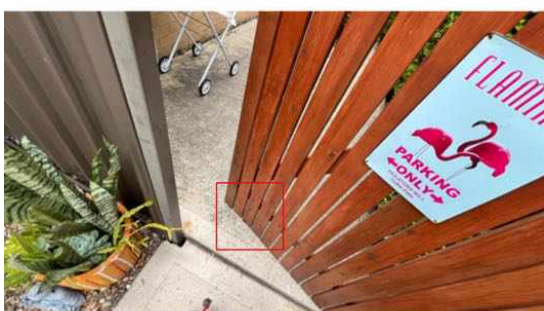
Finding 3.30

Building:	Main Building
Location:	Exterior walls - right side
Finding:	Gate - Binding/jamming
Information:	Binding and/or jamming of this gate is evident during standard operation. This defect inhibits the functionality of the affected door as well as creating potential for secondary defects to associated building elements.

A gate that binds to paving or to the associated gate frame may have several causes, ranging from minor defects, such as poor installation of the door or deteriorated hinges.

For minor causes, a qualified carpenter or general handyperson should be appointed to perform minor rectification works at client discretion.

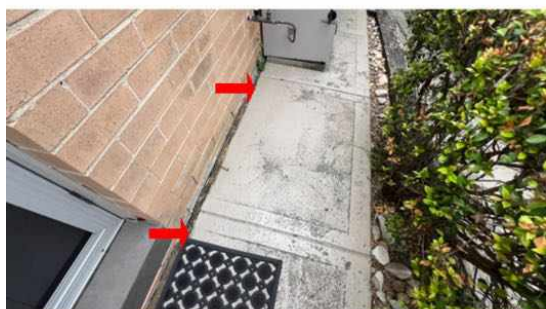
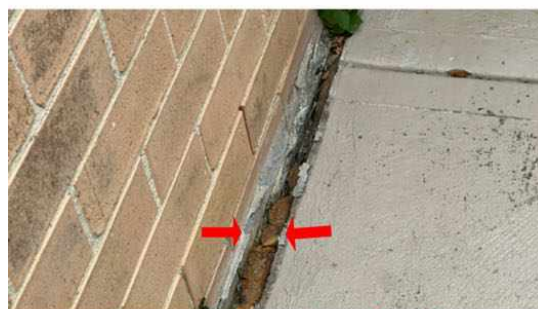
Finding 3.31

Building:	Main Building
Location:	Exterior walls - right side
Finding:	Cracking - External Concrete Paving Damage Category 4 - Gaps in Slab (4mm - 10mm +)
Information:	Gaps in the slab were identified in external concrete paving. Gaps in the slab are

significant and are likely to lead to the development of safety hazards and secondary defects if left unmanaged, such as the creation of a trip hazard.

General age and expected deterioration of the paved areas is a common cause of this type of cracking. However, expansion and contraction of the slab may also have occurred due to environmental factors. Such factors include variable moisture and weather conditions, the presence of trees and their roots having a settling or lifting affect on the soil, or the effect of load bearing, e.g. heavy vehicles over a sustained period of time.

Cracking to this degree may also be due to poor original installation of the concrete. Factors such as poor compaction of the sub surface and/or inadequate reinforcing of the slab may create cracking and other secondary defects. Gaps in the concrete paving may also have a more significant structural cause, such as subsidence of soils.

Detached from wall considerably

Where gaps in the concrete paving are adjacent to structural elements of the building, the advice of a Structural Engineer is advisable before undertaking repairs. Significant repair and likely replacement of the concrete paving is probable.

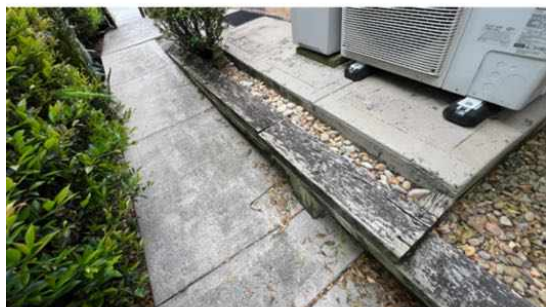
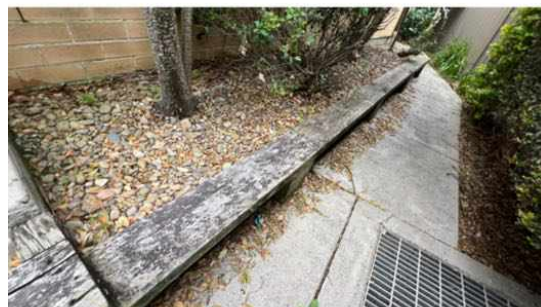
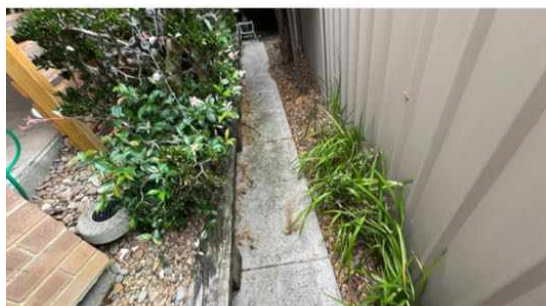
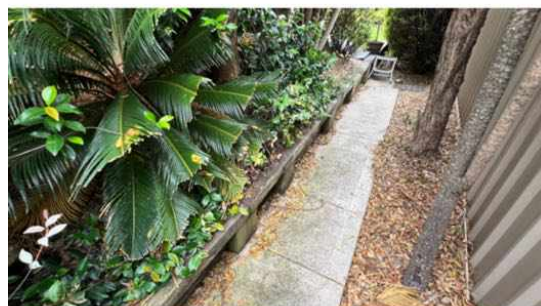
Finding 3.32

Building:	Yard
Location:	Exterior walls - right side
Finding:	Timber Retaining - leaning
Information:	The timber retaining wall in this area was found to be defective at the time of inspection, with visible leaning noted. Generally, defective retaining walls are caused by poor original design, material selection, or construction practices. Deterioration of timber retaining walls may also result from ground movement, poor site drainage, unmanaged stormwater flows, or additional loading from retained soil, gardens, or vegetation located behind the wall.

While the retaining wall is less than approximately 400mm in height, which limits the overall risk, continued movement or deterioration may lead to further destabilisation over time. Where timber retaining walls rot or decay, an environment may also be created that is conducive to termite and pest infestation.

It is recommended that a registered builder or landscaper assess the timber retainer and undertake rectification as required to restore alignment and stability.

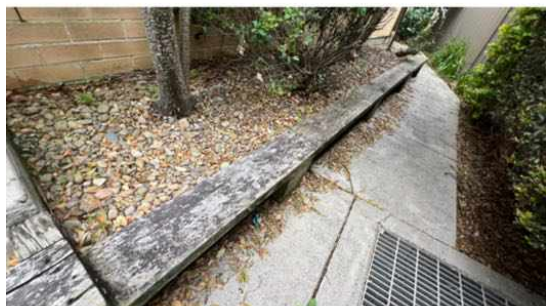
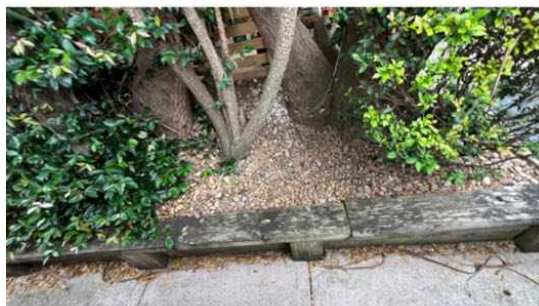
Finding 3.33

Building:	Yard
Location:	Exterior walls - right side
Finding:	Retainer - Wood rot
Information:	This building element shows evidence of wood rot. Wood rot, also known as Fungal Decay, occurs when timbers and other cellulose building materials are exposed to damp conditions on an ongoing basis. This could be the result of exposure to weathering over a prolonged period of time, or the attraction of excessive moisture from other abutting building materials. Contributing factors also include poor air ventilation in the area.

Wood rot is often associated with general damp problems and is evidenced by a 'musty' smell or mould and mildew occurring on surfaces. If left unmanaged, damp conditions can lead to further health problems and the decay of timbers will continue.

Early intervention and regular maintenance, particularly of exterior timbers, will prolong the useful life of these building elements. Prior to any works being performed, the cause of the moisture that has created the visible wood rot should be identified and addressed in a suitable manner. Replacement of affected timbers may then be a

necessary step in protecting surrounding building elements from such deterioration.

A qualified plumber may be appointed to assess the cause of excessive moisture and to provide advice on any remedial works as required. A qualified carpenter or registered builder may also be required to replace affected building materials.

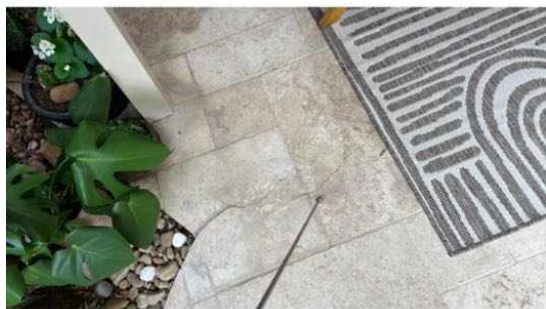
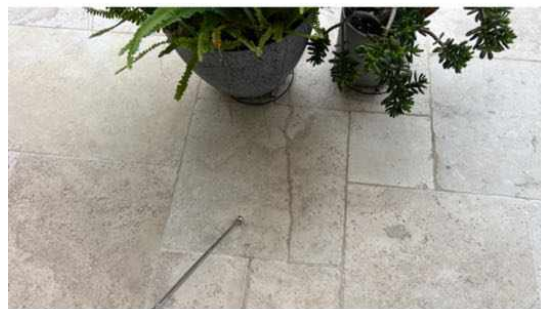
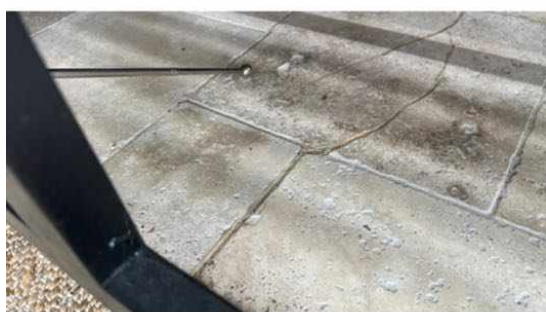
Finding 3.34

Building:	Yard
Location:	Alfresco
Finding:	Tiles - Drummy
Information:	Drummy tiled areas were identified at the time of inspection. The term 'drummy' refers to tiles that have become detached from their fixing, despite otherwise being in relatively good condition. Such defects are generally caused by physical or moisture damage to the area. Drummy tiled areas may also be a direct result of poor workmanship during the construction process.

Tiled areas may swell and shrink with changes in air humidity if the area has sustained moisture damage. Any exposure to moisture is capable of causing tiled areas to become drummy and/or cracked over a prolonged period of time. Drummy tiled areas generally require removal and replacement of affected tiles, with adequate sealant and grouting.

Specialist trades are available for these types of services. A registered builder may be required to undertake works if damage is extensive or if secondary building defects have resulted. Otherwise, it is advised that a tiling contractor be appointed to perform works as necessary. Immediate action is recommended to ensure that no further damage is sustained in the affected area.

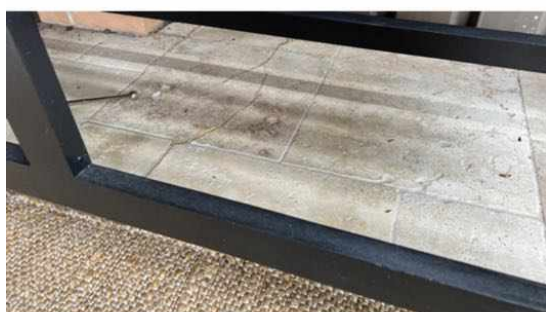
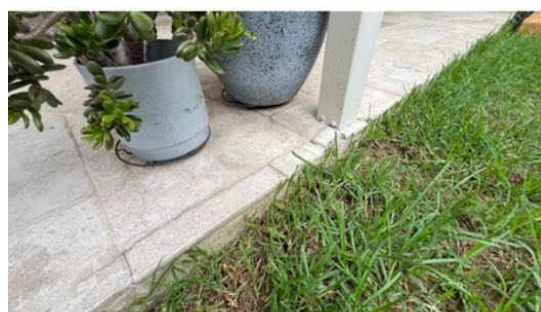
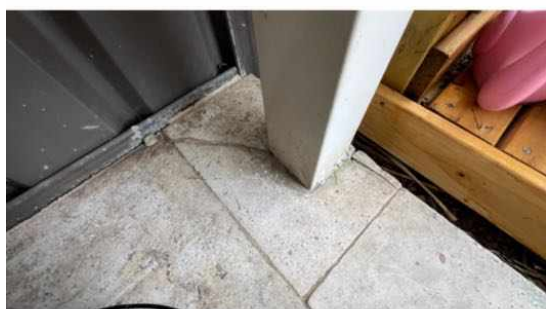
Finding 3.35

Building:	Yard
Location:	Alfresco
Finding:	Tiles - Cracked or damaged
Information:	Cracking was evident to the tiling in this area at the time of inspection. While the cracking appears to be minor, this area is frequently exposed to water, allowing potential for water penetration into adjoining sections of walls or flooring.

If left unmanaged, water penetration to these areas may lead to subsequent water damage, which is likely necessitate repair work to affected building elements.

A tiling contractor should be appointed to ensure that no further water damage occurs. The re-application of silicone and grouting throughout remaining tile work is also advised, to further protect the area against water penetration.

Where water penetration has led to water damage, appointment of a relevant tradesperson may be required to repair damaged building elements.

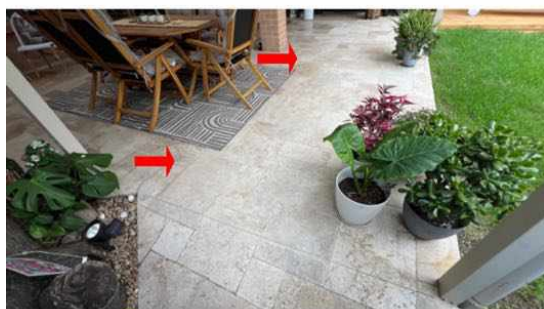
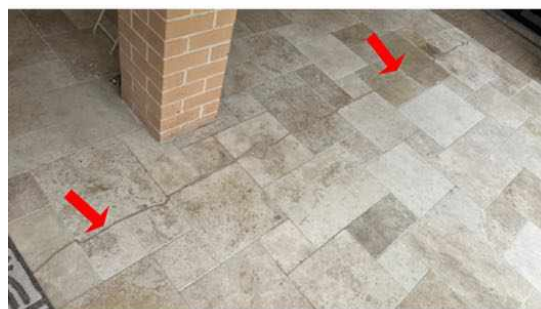
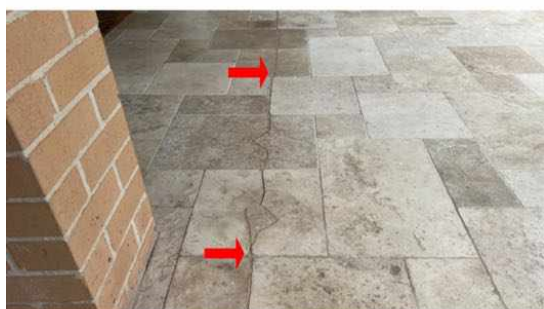
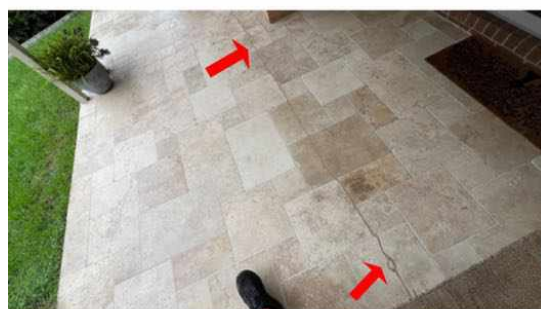
Finding 3.36

Building:	Yard
Location:	Alfresco
Finding:	Tiling – Linear Cracking
Information:	A long, linear crack was observed through the tiled surface within the alfresco area. The cracking follows a consistent line and the surrounding tiles present with a rough and uneven finish.

Cracking of this nature is commonly associated with inadequate provision for movement, such as the absence or ineffective placement of expansion joints, and may also be influenced by movement or irregularities within the underlying substrate. Where tiled surfaces are unable to accommodate thermal or structural movement,

stresses are transferred to the tiles, resulting in cracking.

If left unmanaged, further cracking or loss of tile adhesion may occur over time, particularly in exposed external areas subject to temperature variation and moisture.

It is recommended that a licensed tiler assess the extent of cracking and the adequacy of movement joints and substrate conditions to determine appropriate rectification.

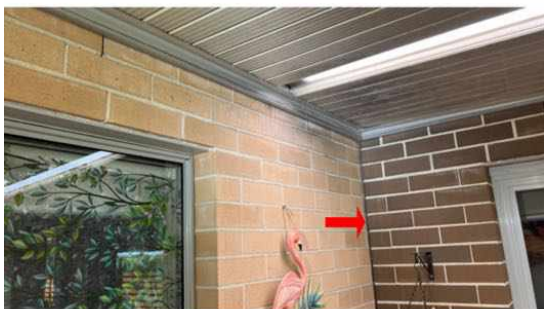
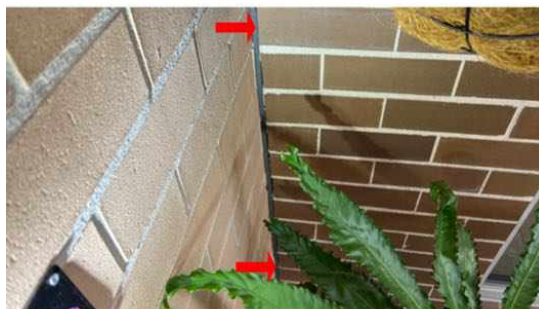
Building:	Yard
Location:	Alfresco
Finding:	Expansion Joint – Incomplete
Information:	An expansion joint was identified with foam backing material in place but no evidence of flexible sealant having been applied over the joint. Expansion joints are intended to accommodate movement while preventing moisture ingress, pest entry, and air leakage.

Where only backing rod is installed without a compatible sealant, the joint remains incomplete and may not perform as intended over time.

The client should engage a qualified sealant contractor or experienced handyman to assess and complete the sealing of the joint where necessary.

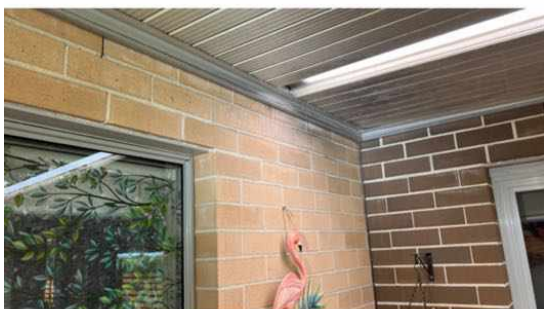
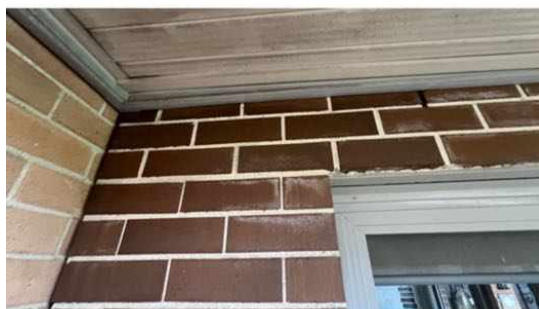
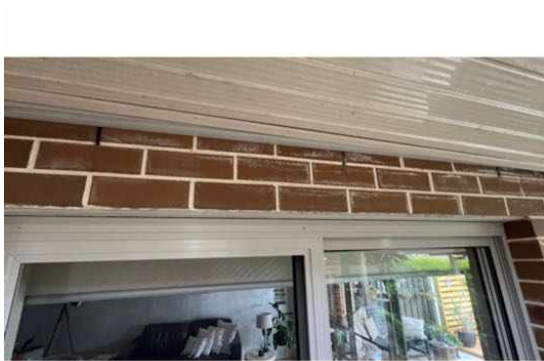
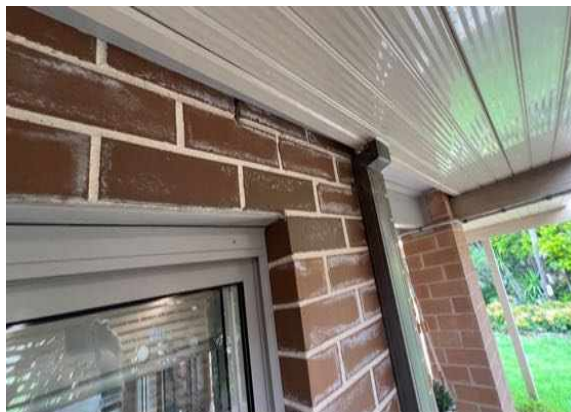
Finding 3.38

Building:	Yard
Location:	Alfresco
Finding:	Brickwork - Efflorescence
Information:	Efflorescence appears to be affecting the brickwork, concrete or tiles in this area. Efflorescence typically occurs when excess salts within the concrete or cement mortar is leached to the surface due to water transfer.

It is typically seen as white salt deposits on the surfaces of concrete pavement or mortar between bricks or tiles. While detracting from the overall appearance of the affected area, efflorescence is not likely to develop into secondary damage if left unmanaged.

Generally, soluble salt deposits can be removed by dry brushing with a stiff-bristled brush. Repeated dry brushing is an ideal treatment for eliminating this forming of efflorescence. A cleaning contractor or general handyperson may be appointed to perform these works at the discretion of the client.

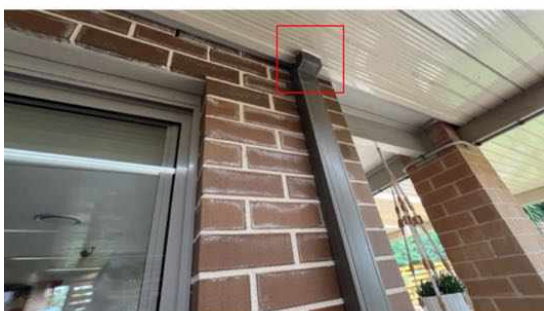
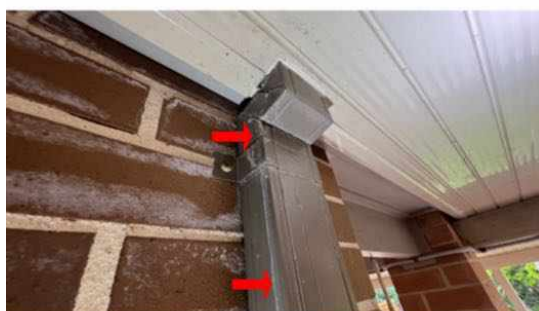
Finding 3.39

Building:	Yard
Location:	Alfresco
Finding:	Downpipe - Water staining
Information:	Water staining was evident in this area at the time of inspection. Water staining indicates that surfaces have been exposed to excessive moisture over time. The minerals and other elements in the water lead to staining, which may graduate to corrosion and deterioration if left unmanaged.

While mostly an appearance defect, water staining can be indicative of more serious defects, which may be currently concealed by other building elements.

Where water staining is active, a licensed roof plumber must be consulted to identify the cause of the staining and to provide advice on any reparation works that may be required. Replacement of any broken or damaged structures is advised.

Conversely, where water staining is old and inactive, affected building materials may be repaired or replaced at client discretion. A qualified carpenter or registered builder may be appointed to perform these works.

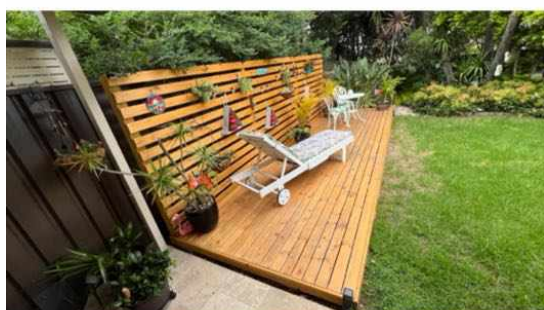
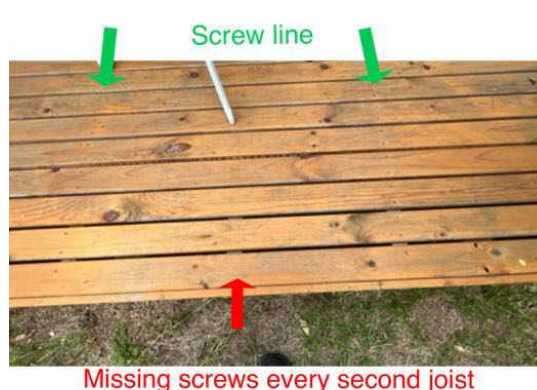
Finding 3.40

Bouncy boards likely due to insufficient thickness, excessive spacing of joists, or material deterioration. It also typically indicates that the deck boards or subframe structures are inadequately secured to the supporting joists or bearers. It may also result from gaps between the subframe and support posts, which require packing.

A registered builder, licensed carpenter or deck specialist should be engaged to assess and rectify the issue to ensure the deck's stability and longevity.
