Building and Timber Pest Inspection Report

Inspection Date: Fri, 23 Jan 2026

Property Address: 18/162 Kanahooka Rd, Kanahooka NSW
2530, Australia

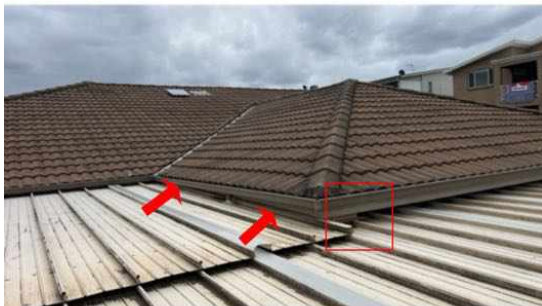
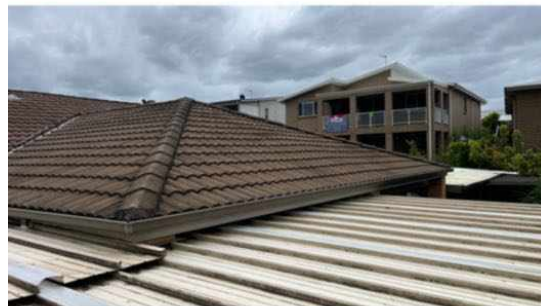
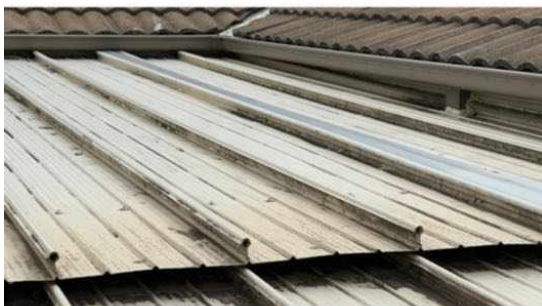
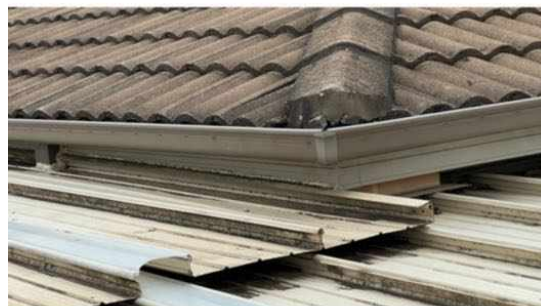
Finding 3.41

Building: Main Building
 Location: Pergola
 Finding: Roof plumbing - Flashing inadequate
 Information: Some sections of the roof are missing or have inadequate roof flashings. Flashings are metal and other materials which are applied to seals and intersections between roof coverings and building elements. They are designed to aid in weatherproofing of roof joins.

Flashings that are not installed adequately or are missing are likely to result in water penetration to the interior of the property, as well as creating excessively damp conditions against the exterior surfaces and around the base perimeter of the building.

Premature ageing and secondary building defects are imminent where roof plumbing is missing or inadequately installed. Additionally, water pooling also creates an environment that is susceptible to termite and pest infestation.

A roofing plumber should be appointed as soon as possible to install relevant roof plumbing materials, ensuring that no further damage is sustained.

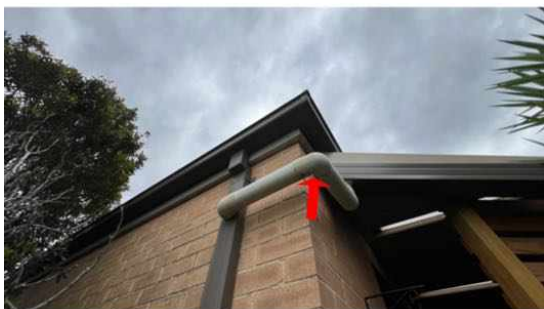
Finding 3.42

Information: It is suspected that the roof plumbing to the exterior roof is insufficient in capacity and is not adequately managing the volume of rainwater that it is required to drain. The result is generally that the plumbing overflows during periods of heavy rainfall, creating damp conditions against external surfaces and the base of the building perimeter.

If left unmanaged, the excess moisture in this areas may allow the formation and development of an environment that is conducive to rust, corrosion and rot, creating potential for secondary defects to all associated building elements. Damp conditions are also conducive to termite and pest activity, further exacerbating the risk of the environment.

Appointment of a roofing plumber is recommended to replace any inadequate drainage systems to ensure proper drainage to this area. In the interim, it is important to ensure that all roof plumbing is free of any debris or blockages.

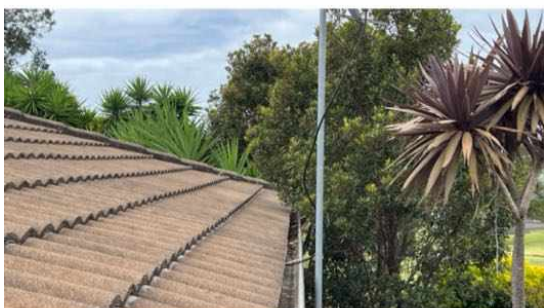
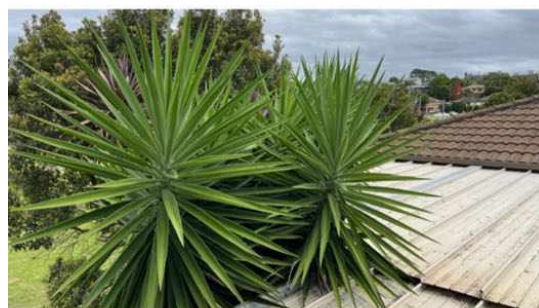
Finding 3.43

Building:	Main Building
Location:	Roof Exterior
Finding:	Trees - Overhanging and filling gutters
Information:	Overhanging trees often result in excessive amounts of leaf debris accumulating in gutters.

Gutters are a critical part of the building's management of storm water and rain. It is therefore important that they be kept clear to prevent secondary damage to associated building elements, including exterior and interior walls, ceiling linings and any adjoining building elements. Where gutters are blocked, pooling of rainwater is likely to occur, fast-tracking rust and corrosion of the roof plumbing elements.

It is highly advised that all overhanging tree branches be removed as soon as possible to prevent any further damage. Repair and/or replacement of sections of damaged guttering may also be required where the extent of the damage necessitates.

Such works should be performed by the homeowner; however, appointment of a landscape contractor or an arborist may be required. Consultation with a licensed roof plumber is required where guttering has been damaged.

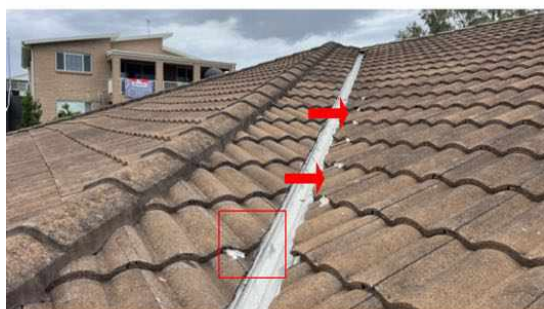
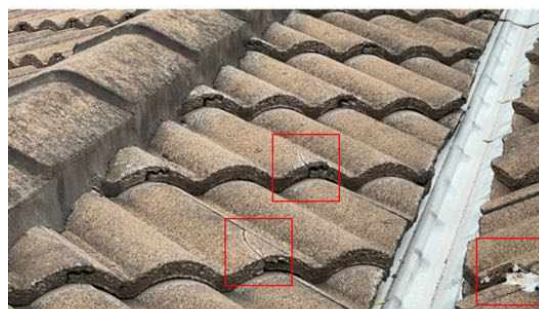
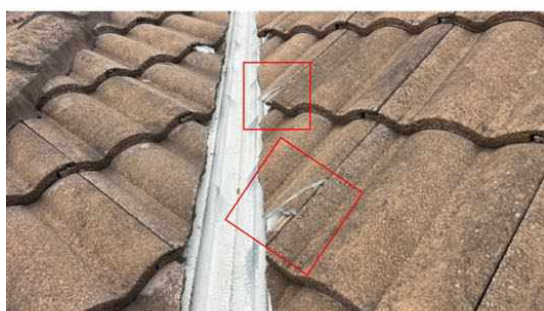
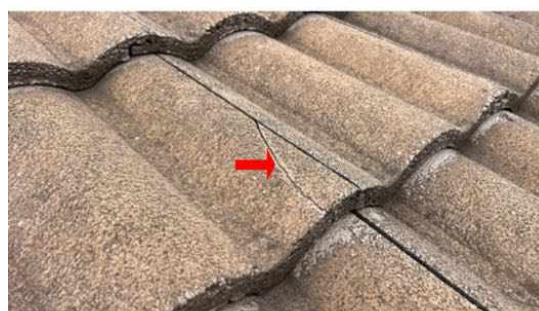
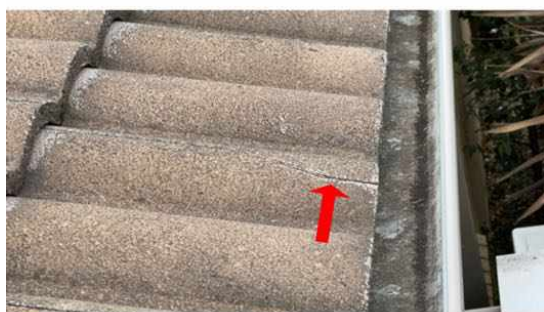
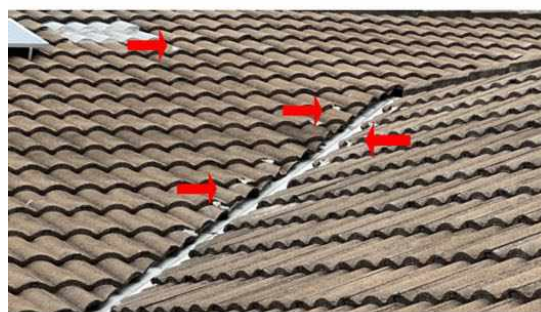
Finding 3.44

Building: Main Building
Location: Roof Exterior
Finding: Roof tiles - Broken
Information: Upon inspection of the exterior roof covering, broken roofing tiles were identified. Broken and friable roof tiles are generally the result of ageing and weathering of what is essentially a porous material.

If left to further deteriorate, broken and brittle roof tiles are likely to lead to water penetration via the roof into the ceiling space, causing secondary damage to ceiling linings, insulation and roof structures. Broken roof tiles are also likely to detract from the effectiveness of the roof drainage system, creating potential for secondary damage to the exterior roof covering and roof plumbing.

Replacement of broken tiles is required and should be performed by a roofing contractor as soon as possible.

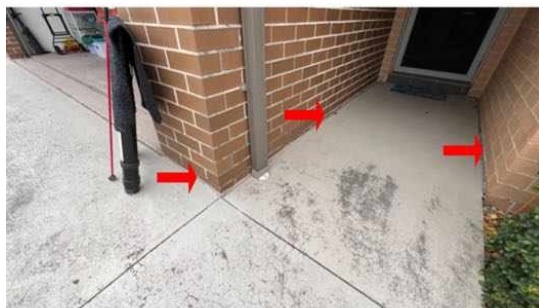
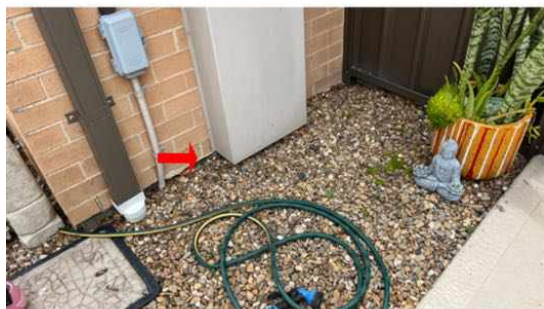
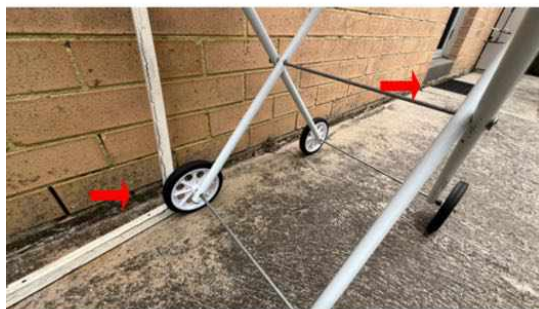
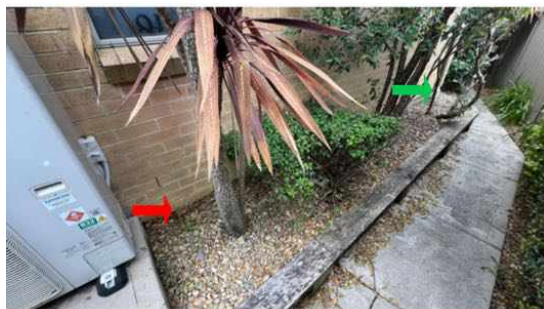
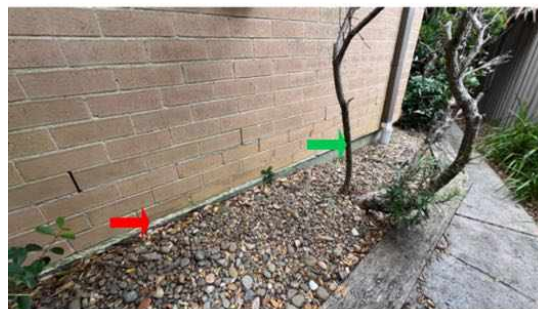
Where the slab edge cannot be properly inspected, it is highly recommended that termite or timber pest inspections be carried out every 6-12 months to aid protection of the property against infestation.

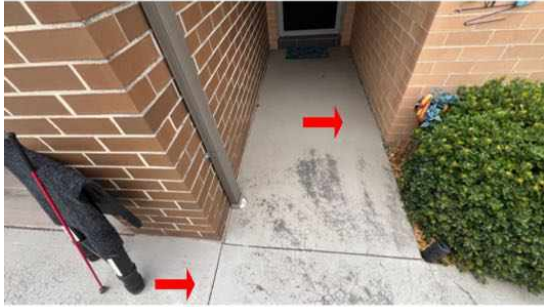
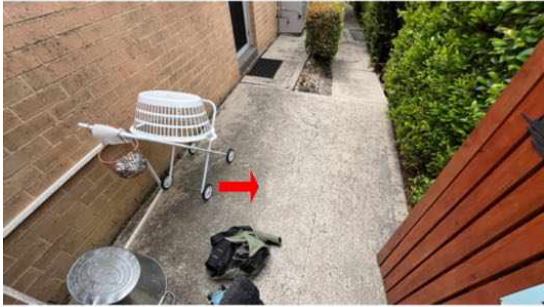
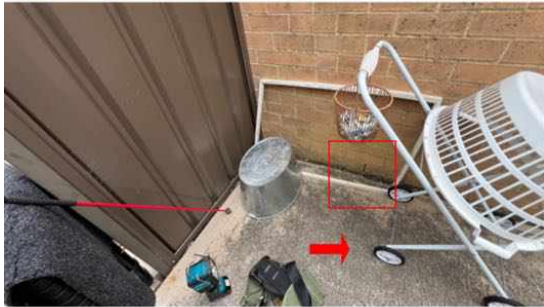
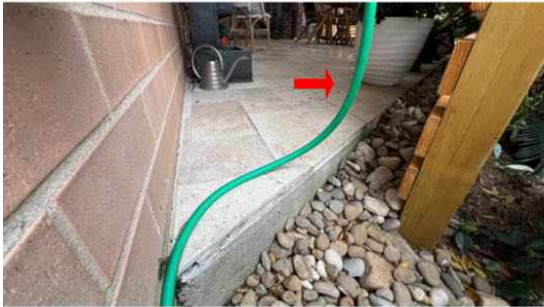
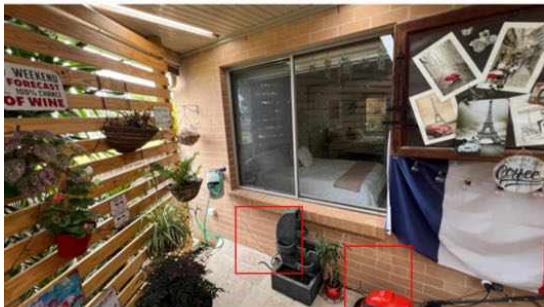
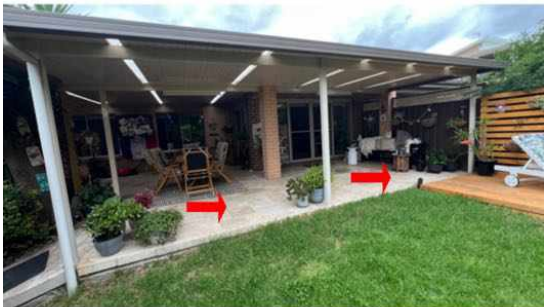
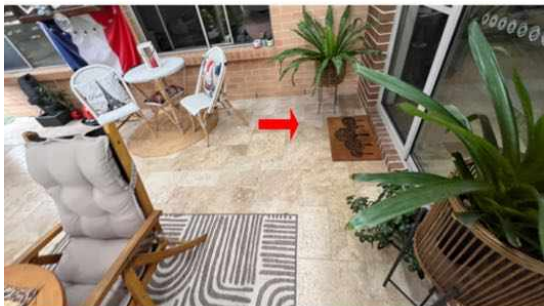
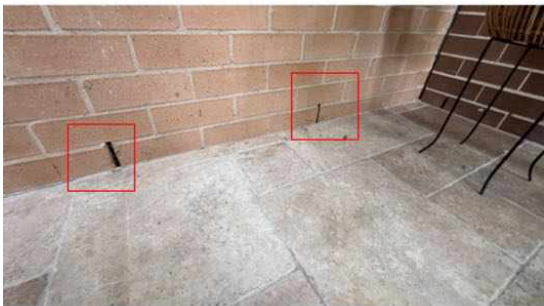
Weep holes in the exterior brickwork of the property are designed to allow condensation that may build up between the brickwork and subsequent timber framework to drain from within the wall hence preventing any deterioration of the timber building elements.

Additionally build-up of moisture is likely to occur if weep holes are covered further attracting termite activity to these areas.

It is highly recommended that weep holes are left exposed in all areas throughout the external property. Therefore if any termite activity leading into weep holes becomes easily detectable during frequent pest inspections.

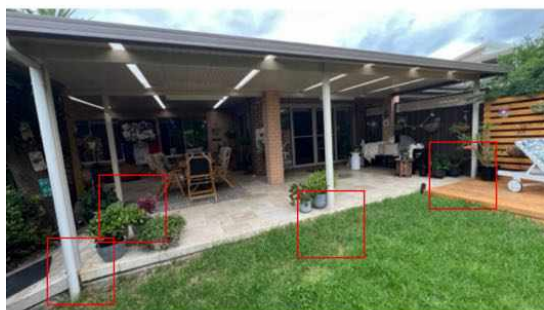
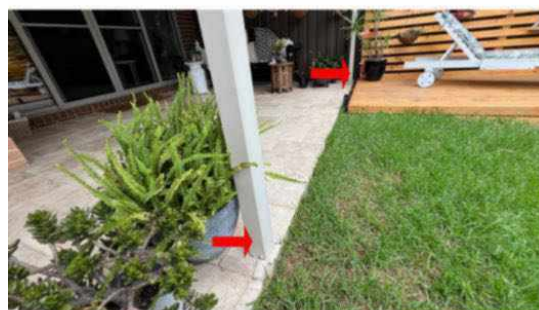
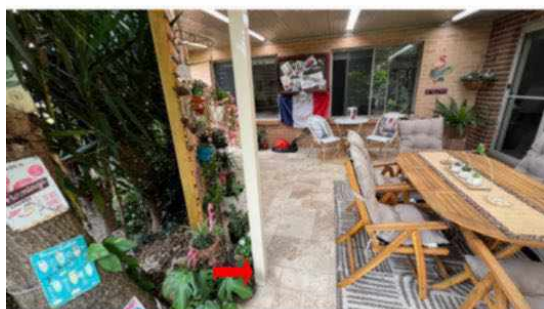
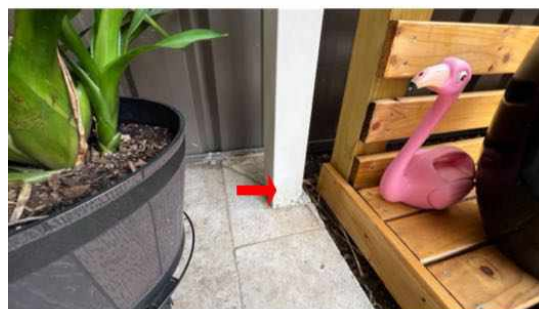
Finding 6.05

Building: Main Building
 Location: Porch, Alfresco
 Finding: Post (hollow) - Concealed Entry
 Information: Posts extending from the ground to the structure without a visible inspection zone create a potential bridging point for concealed termite entry. Where posts are suspected to be hollow, the risk is increased due to the inability to visually inspect internal cavities.

These conditions may allow termites to bypass barriers undetected and gain access to the structure. Further investigation by a licensed timber pest technician is recommended to assess the risk and implement appropriate termite management strategies.

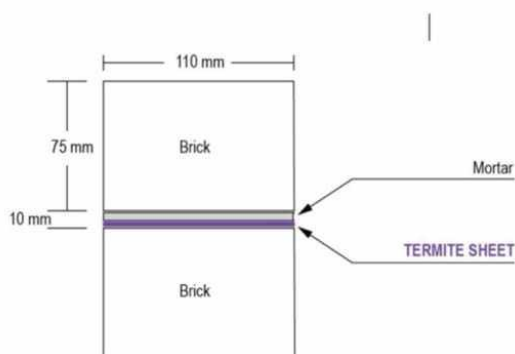
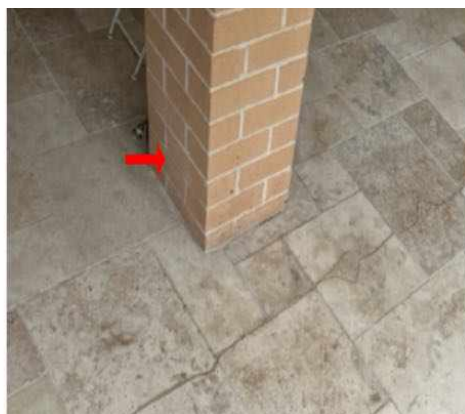
Finding 6.06

Building: Main Building
 Location: Porch, Alfresco
 Finding: Bridging of termite barrier - brick piers.
 Information: Brick pier that are attached from ground to structure without a visible inspection zone (barrier 75mm AFL) causes a bridging point. Bridging of termite barriers occurs when termites bridge (usually by building a mud tunnel) a termite barrier or inspection zone or where termites have a passage allowing them to bridge the barrier.

Generally this takes the form of finished ground levels external paving or concrete being retrospectively installed above the damp course level the adjacent internal floor level or weep and ventilation holes.

Where bridging has occurred full inspection is prevented and termites may enter a property in a concealed or undetectable manner.

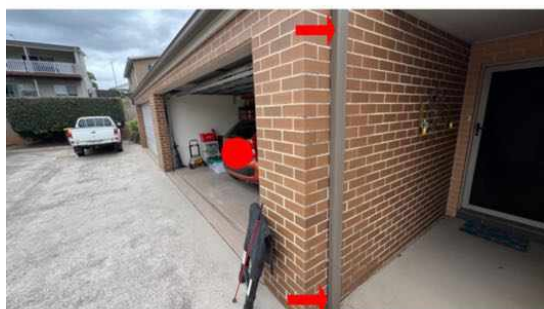
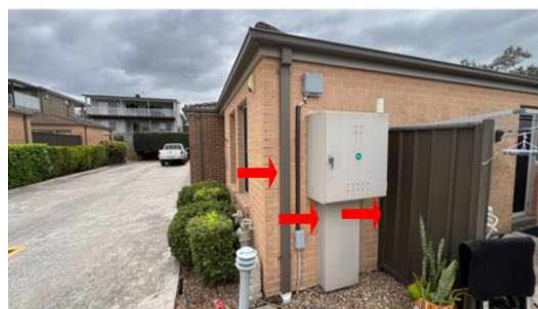
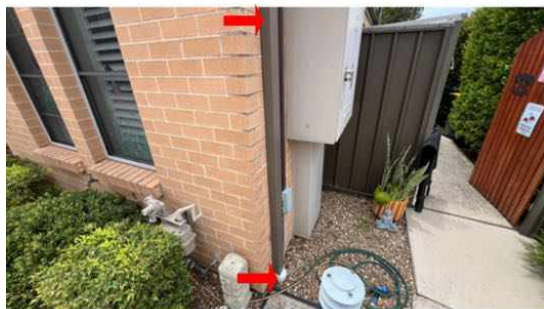
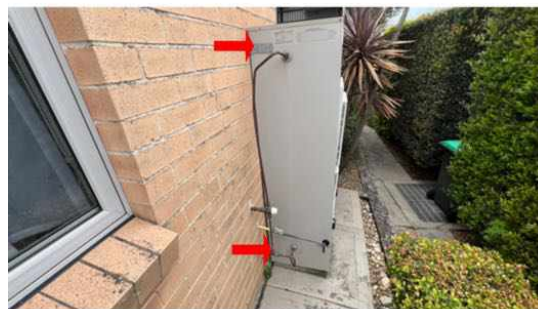
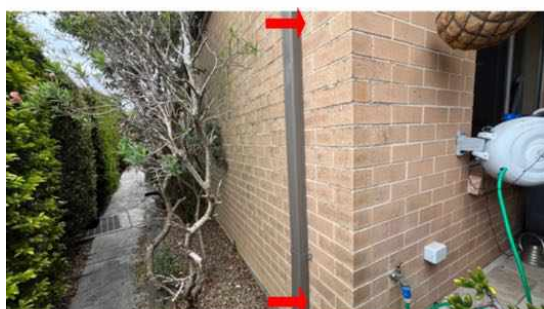
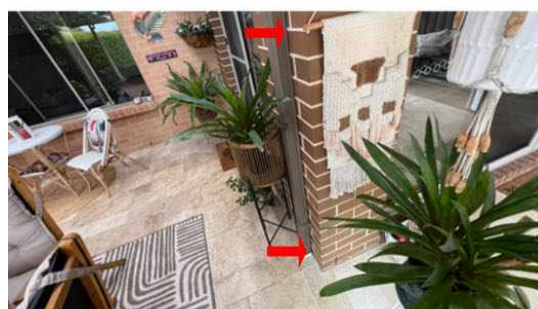
Finding 6.07

Building: Main Building
 Location: All External Areas
 Finding: Bridging - Attachments to Buildings.
 Information: Bridging occurs when items against a building provide a concealed entry point for termites into the building or by passing around a termite management system.

Where any part of an attachment to a building is not isolated and is not provided with a clear gap of not less than 25mm from the building, bridging occurs. Attachments to buildings such as hot water services, downpipes, verandahs, decks, steps, fences, service conduits and the like provide the opportunity for concealed entry.

Building attachments of this nature need to be frequently inspected for termite activity by a qualified inspector

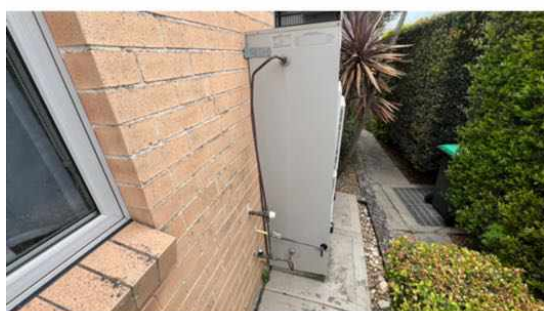
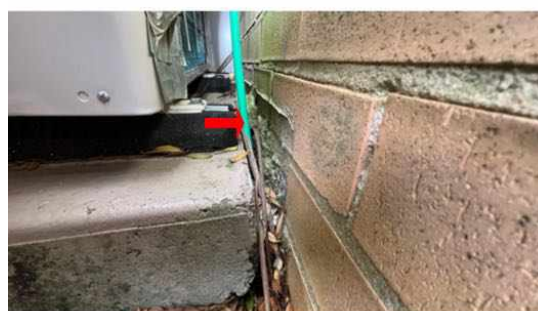
Finding: HWS Overflow - Not Connected
 Information: The Hot Water System (HWS) overflow was found to be disconnected from storm water drainage and is creating excessive moisture in the surrounding area.

These damp conditions can lead to secondary defects such as rot, rust or corrosion of associated building elements, the formation of fungal decay, or even the creation of potential slip hazards. When coupled with poor site drainage, pooling of water may also attract termite activity to this area.

It is highly recommended that a licensed plumber be appointed to connect the HWS overflow in order to prevent such an environment from being created. These minor works should be carried out as soon as possible.

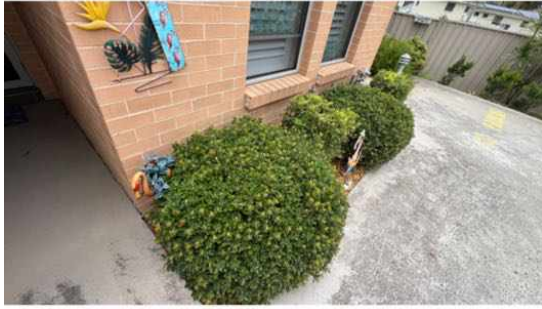
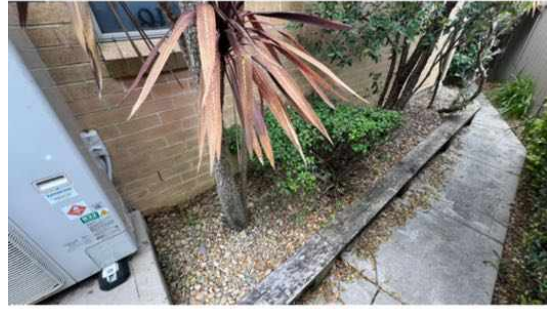
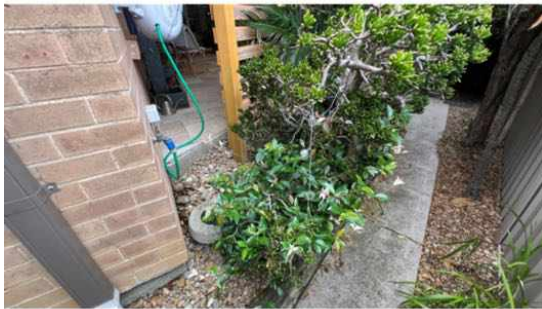
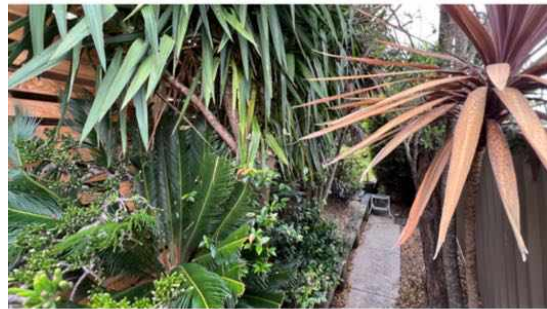
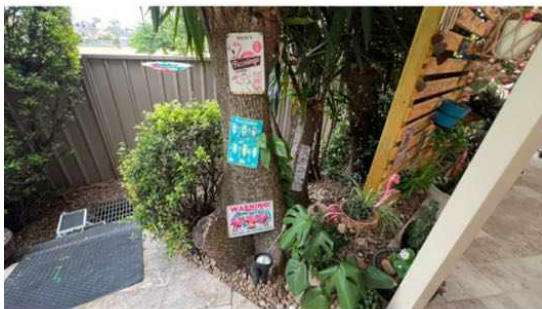
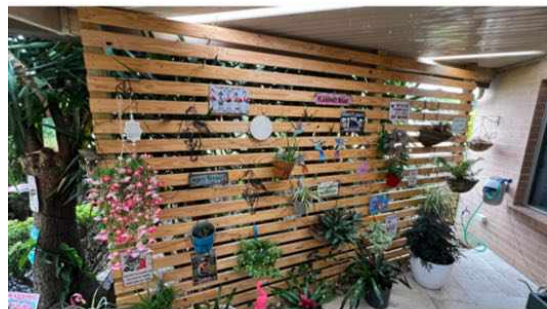
Finding 6.10

Building: Main Building
 Location: All External Areas
 Finding: Garden Beds - Conditions Conducive to Termites
 Information: Garden beds were observed around the perimeter of the building, obstructing visual inspection of lower wall areas and providing potential concealed termite entry points.

Raised soil levels and retained moisture from watering can allow termites to access wall cavities or weep holes undetected, while timber edging materials may further encourage activity.

It is recommended that garden beds be reduced or cleared from the building perimeter, or that regular timber pest inspections be carried out in accordance with AS 4349.3 or AS 3660.2 to monitor risk.

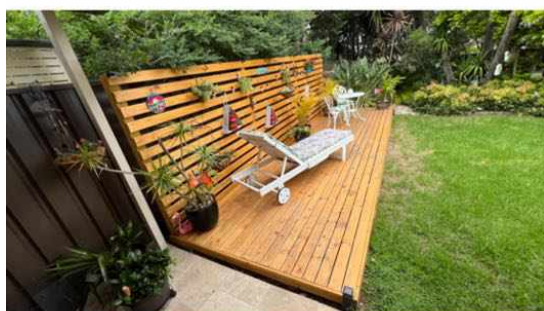
Finding 6.11

Building:	Yard
Location:	Deck
Finding:	Deck - In ground contact
Information:	Any timbers in direct ground contact provide opportunity for concealed termite entry and are likely to be subject to premature rot and decay as the soil retains moisture or damp conditions against the timbers.

Remove untreated timber that is in direct contact with external grounds. Consider replacement with more durable materials i.e. treated timber or non timber elements. Frequent pest inspections are advised to readily identify any termite activity in these areas.

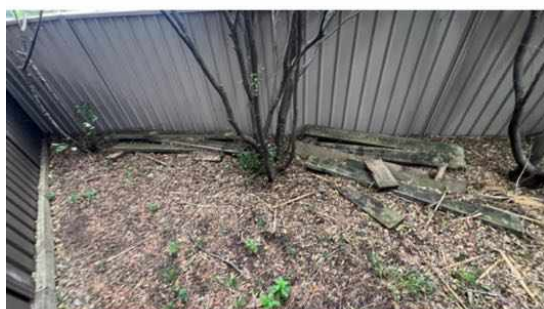
Finding 6.12

Building:	Yard
Location:	Yard - Back
Finding:	Stored timbers - subfloor space or external area
Information:	The storing of timbers in the subfloor space or around the external property increases the risk of termite activity being present. As they are likely to come into contact with weather conditions or excessive moisture wood rot is likely to develop on timbers that are not treated.

It is highly recommended that any stored timbers be immediately removed from areas in which they may attract any termite / timber pest attack. Minimisation of risk / prevention of termite attack is far more adequate than dealing with the presence of termite activity.

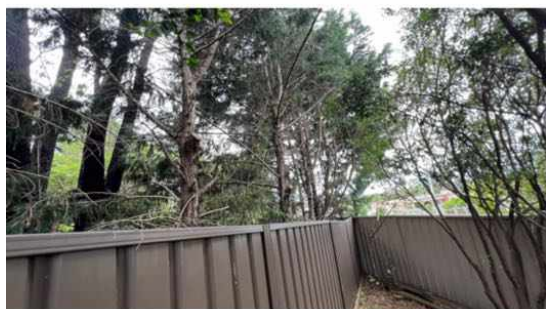
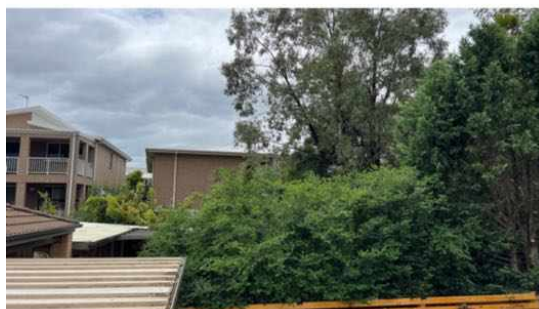
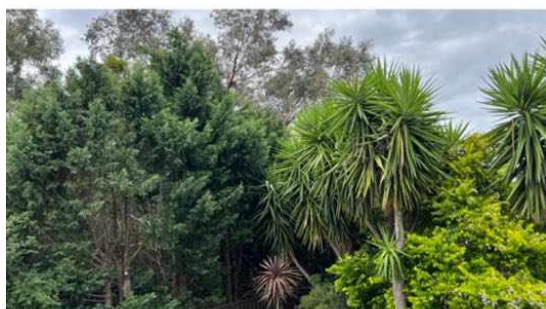
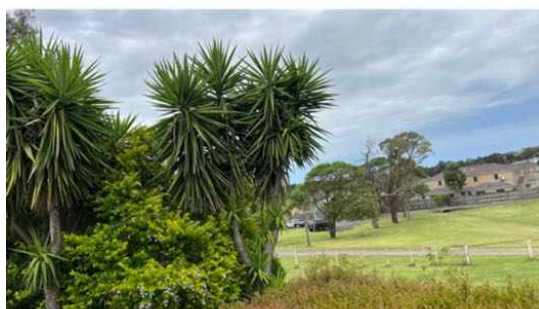
Finding 6.13

Building:	Yard
Location:	The Site
Finding:	Timber Pest Risk – Trees Within 50m of Dwelling
Information:	Mature trees were identified within 50 metres of the dwelling. The presence of trees in close proximity to the structure increases the risk of termite activity, as trees provide a

natural food source and nesting environment for termites. Tree roots can also contribute to excessive moisture retention in the soil, creating conducive conditions for timber pest activity.

Regular monitoring for signs of termite activity is advised. A licensed pest inspector should be engaged to assess the area and provide further recommendations on risk mitigation and management.

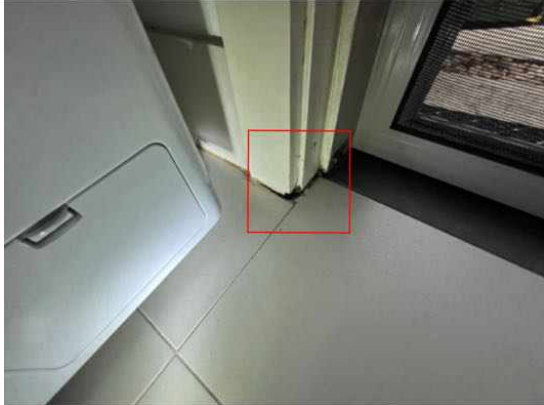
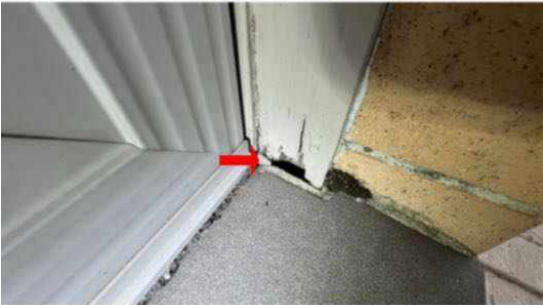
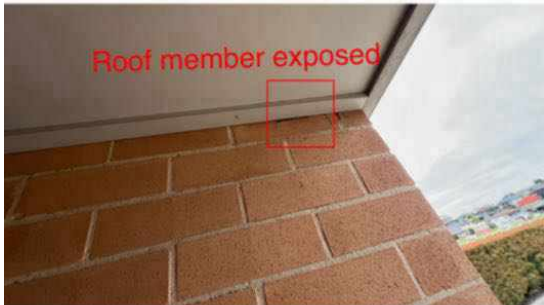
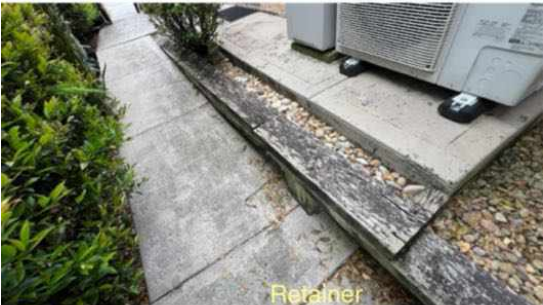
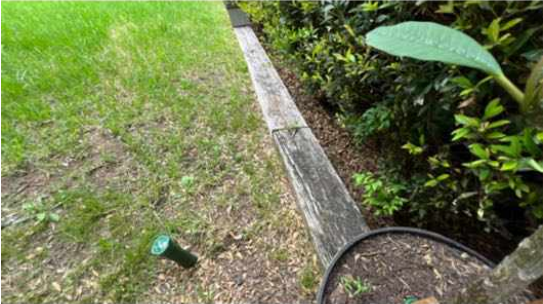
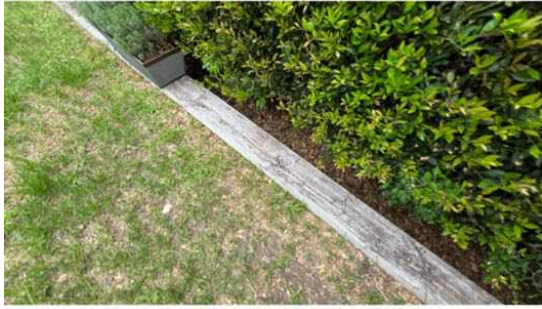
Finding 7.01

Building:	Yard
Location:	Laundry, Porch, Retainer, Back Yard
Finding:	Fungal decay - present (localised)
Information:	Fungal decay also known as wood decay or wood rot generally refers to the deterioration of timber elements when in contact with excessive levels of moisture for a prolonged period of time.

In this case although the affected timber element is in a decaying state the extent of any visible damage appears to be localised to a specific area and is yet to spread to other parts of the building element or affect adjoining structures. The fungal decay is therefore likely to be of a relatively superficial nature with minimal impact on the structural integrity or tensile strength of the timber element.

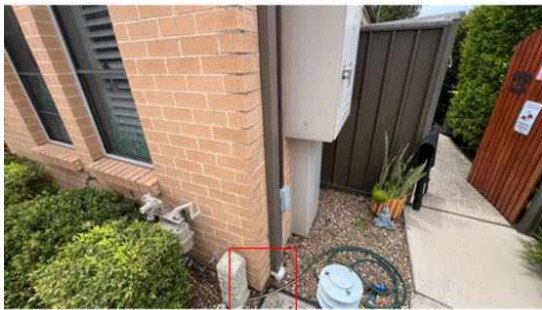
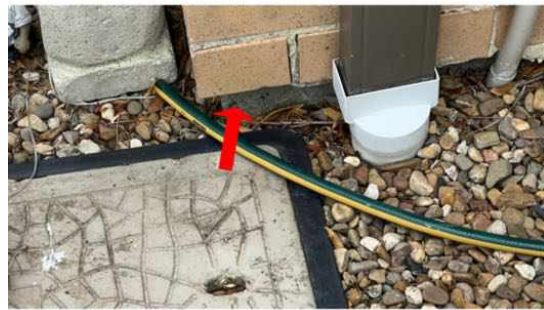
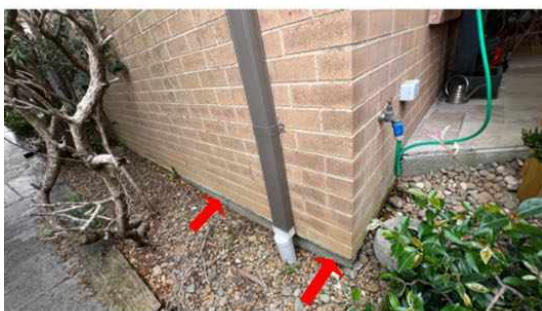
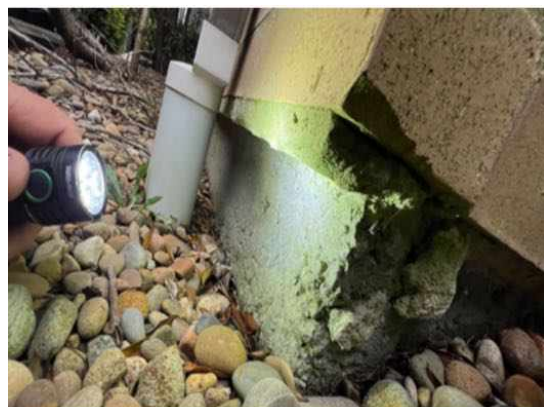
Building: Main Building
 Location: Exterior walls - right side
 Finding: Brickwork - Overhang to Slab Edge
 Information: Sections of external brickwork were observed to overhang the edge of the supporting concrete slab. This condition indicates that portions of the masonry are not fully supported by the slab below.

Brickwork with inadequate bearing support is more susceptible to cracking, movement, and long-term deterioration, particularly where exposure to moisture or ground movement is present. Reduced support may also compromise the durability and stability of the affected masonry over time.

It is recommended that a registered builder or bricklayer assess the extent of the overhang and determine whether rectification or support works are required to ensure the brickwork is adequately supported.

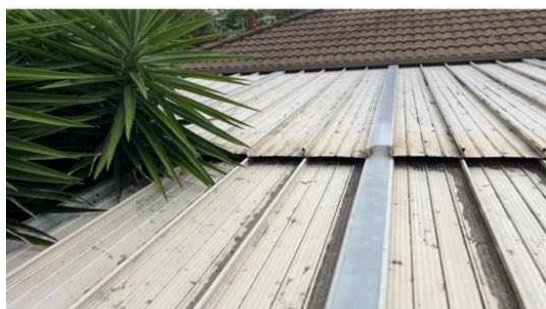
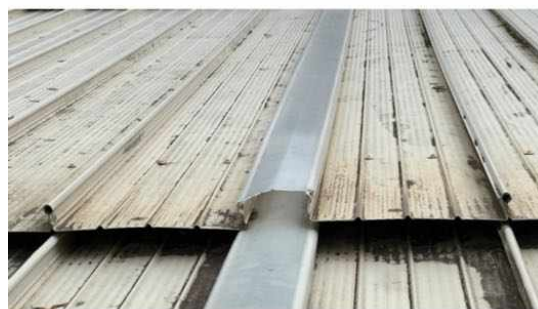
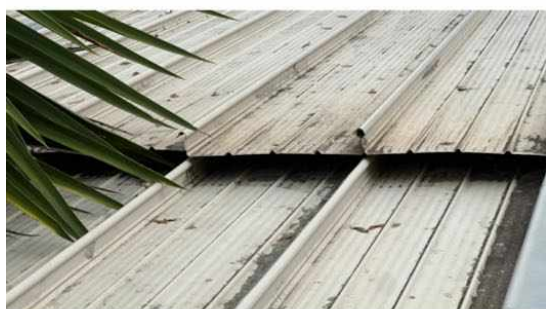
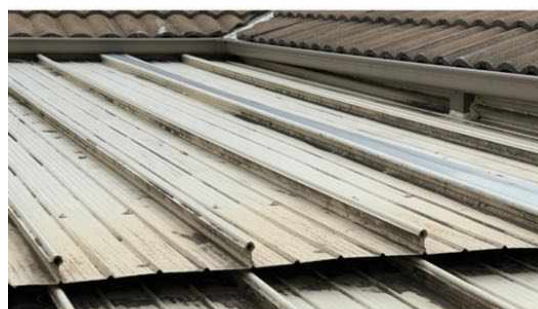
Building: Main Building
 Location: Pergola
 Finding: Additional structure - Non-compliant
 Information: The additional structure that has been affixed to this area of the dwelling does not appear to comply with contemporary building practices and current Australian Standards. While the structure does not currently appear to be unsafe, compliance with such standards ensures the structural integrity of the main dwelling and abutting addition.

As building standards have not been followed, this area provides a heightened risk of the development of building defects. The structural integrity of the area may have been compromised, which creates potential for the development or presence of major safety issues.

It is highly recommended that any planned repair, remodeling or demolition works be carried out by registered builders. Such works may be necessary in the short-term future to ensure the safety and functionality of the area.

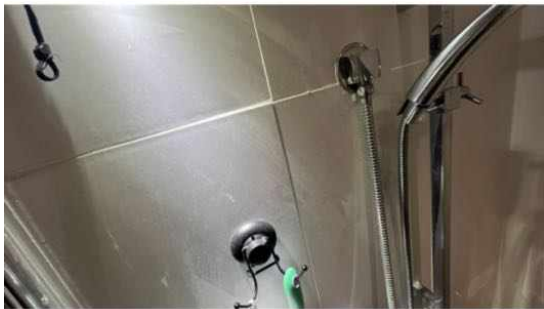
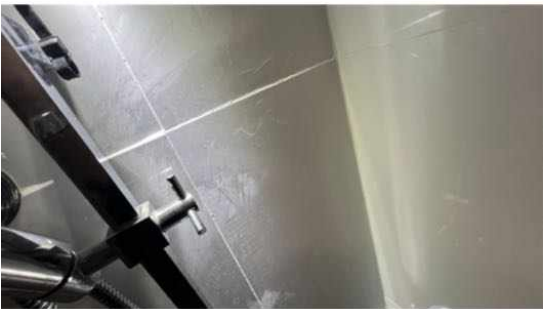
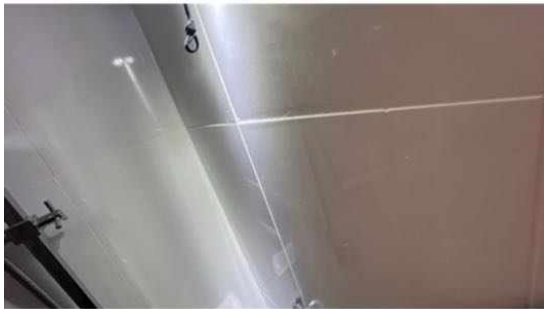
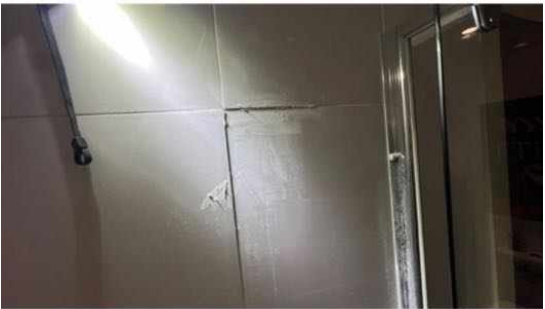
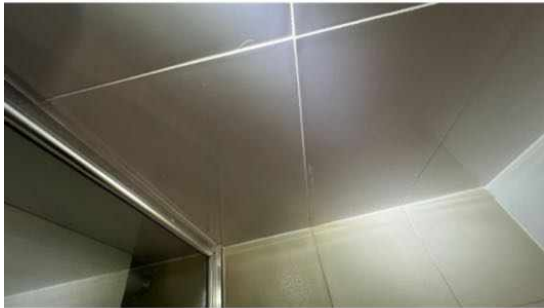
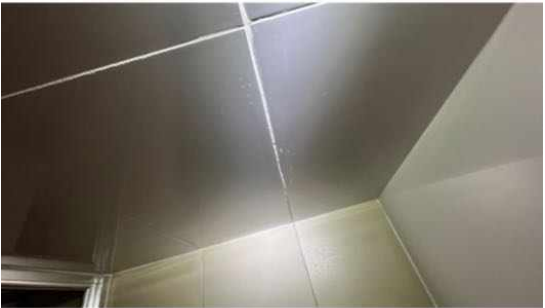
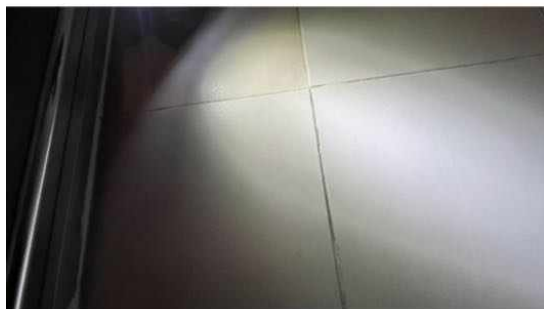
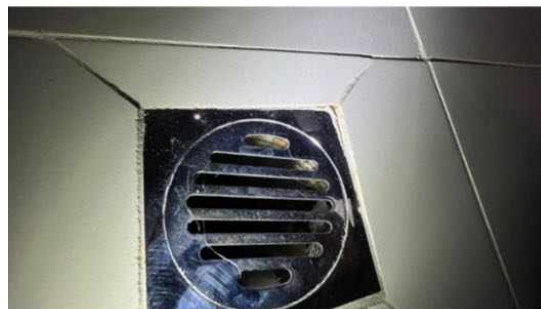
Building: Main Building
 Location: Ensuite
 Finding: Installation - substandard or incomplete

The installation of this building element appears to have been completed to a substandard level of workmanship or is incomplete. Generally substandard repairs or installation are related to poor workmanship, the use of inappropriate materials, or a failure to complete installation to a suitable standard.

Where installation is substandard and/or incomplete, the client should contact the responsible trade to undertake rectification. Unfinished and substandard building works are likely to degrade more quickly and may create potential for secondary defects to associated building elements.

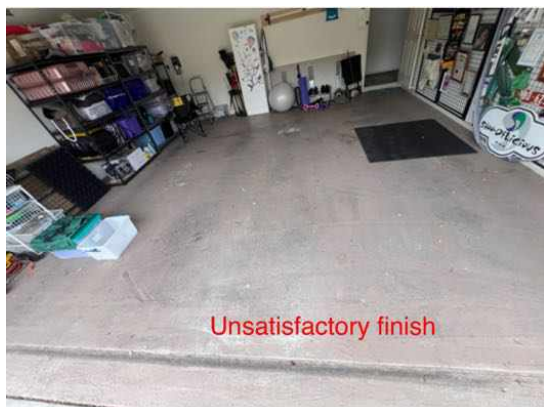
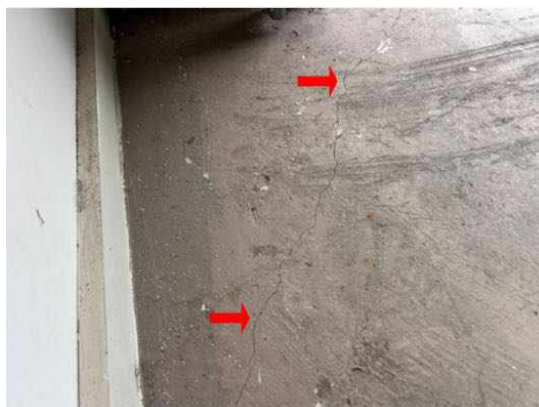
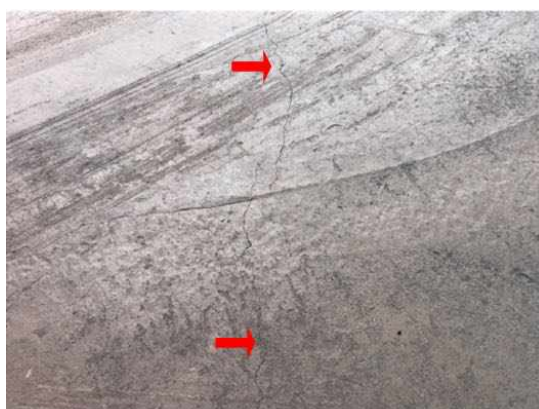
Building:	Main Building
Location:	Garage
Finding:	Cracking - Damage Category 0 - Hairline (less than 1mm)
Information:	Hairline cracks are very minor in nature and generally are only ever an appearance defect. While such cracking may be noticeable in some cases, it is quite common and does not indicate any structural damage.

Cracking of this nature can generally be repaired with minor sanding, filling and/or repainting. Such works should be performed by a qualified painter or a general handyman.

Monitoring of all cracking should be conducted frequently. Always contact a building inspector should cracks widen, lengthen, or become more numerous.

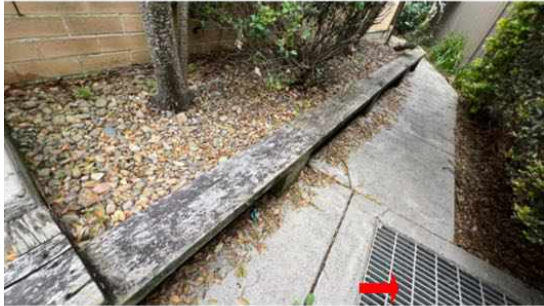
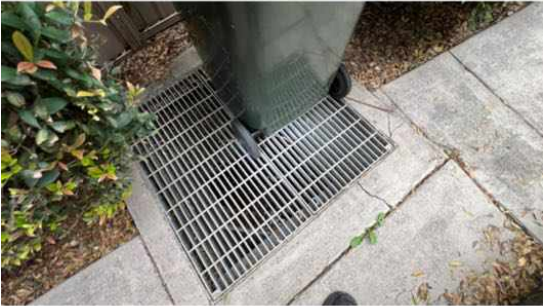
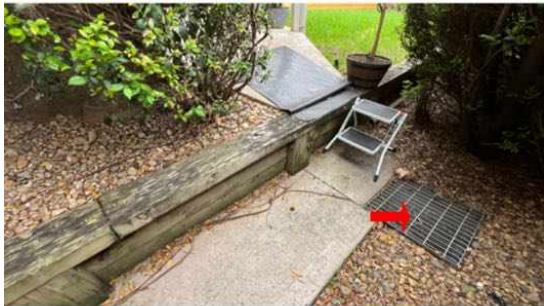
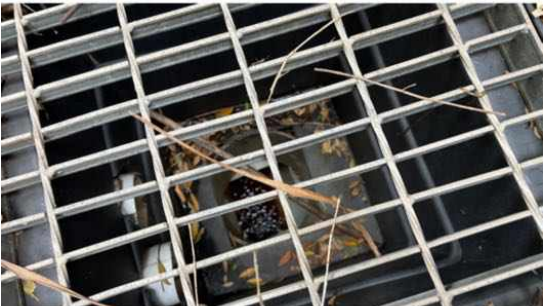
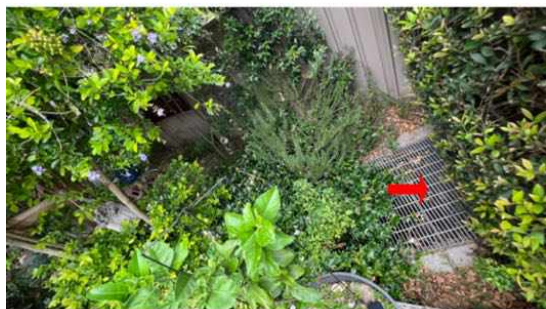
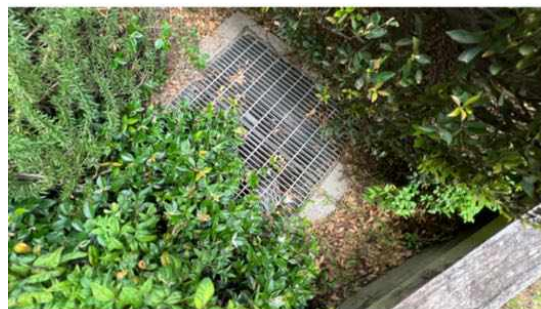
Building: Yard
Location: Yard - Side
Finding: Additional Photos - Drains
Information: Additional photos are provided for your general reference - Large drains
