Building and Timber Pest Inspection Report

Inspection Date: Fri, 23 Jan 2026

Property Address: 18/162 Kanahooka Rd, Kanahooka NSW
2530, Australia

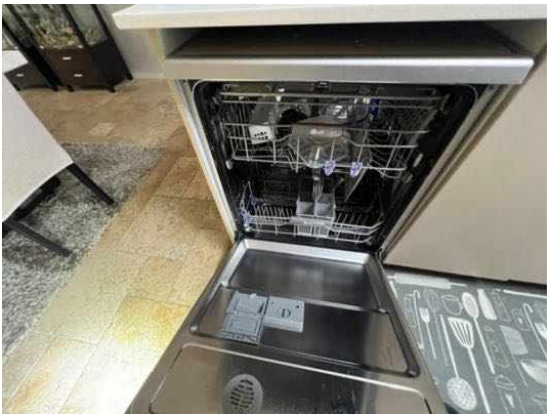
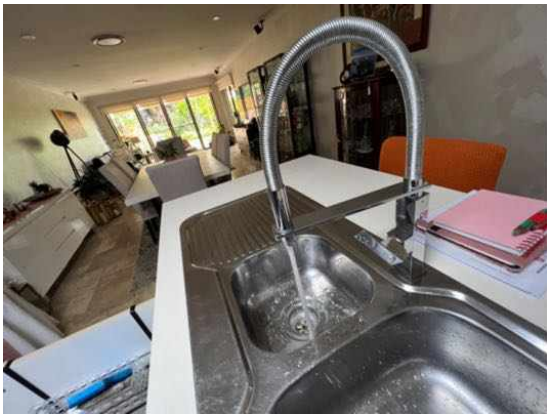
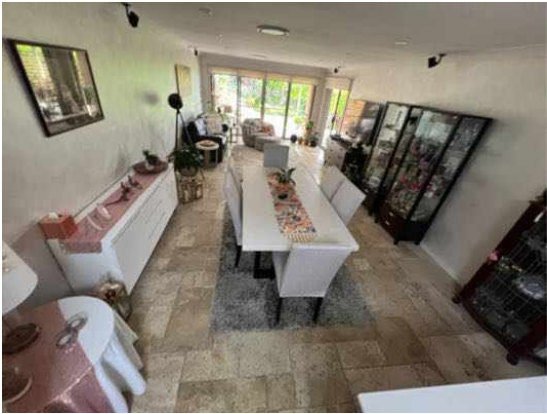
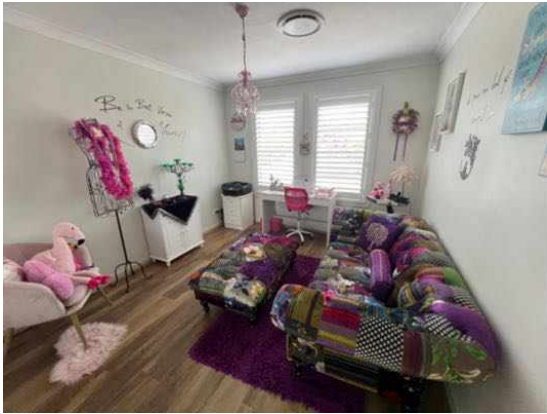
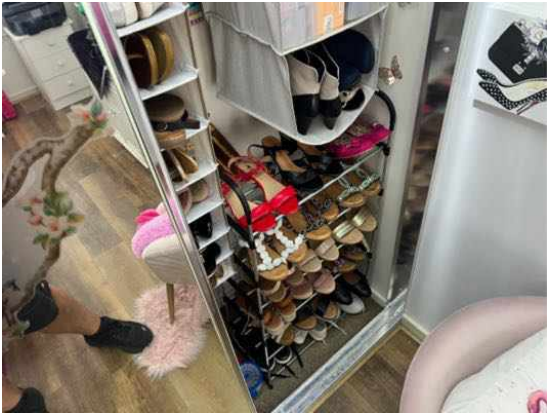
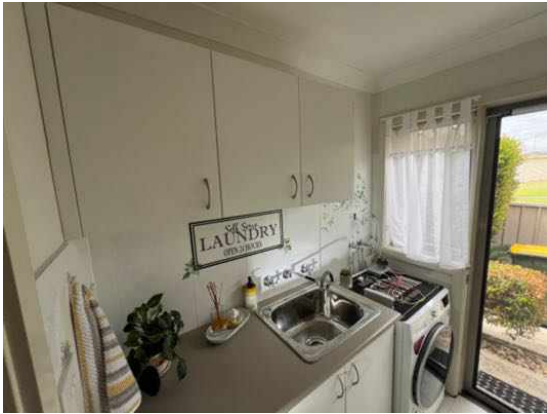
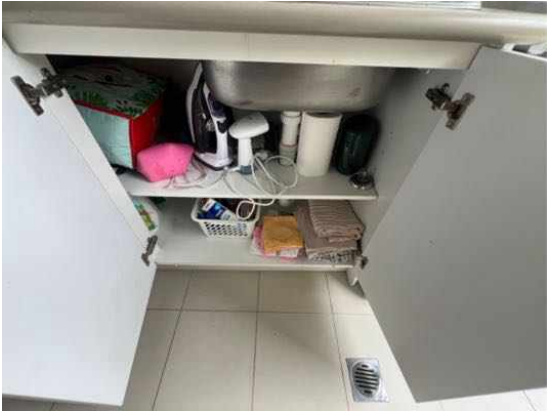
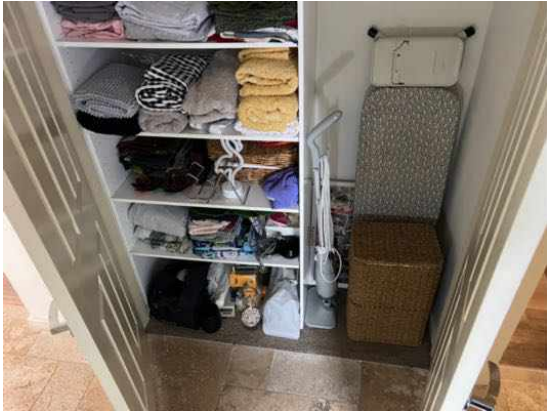
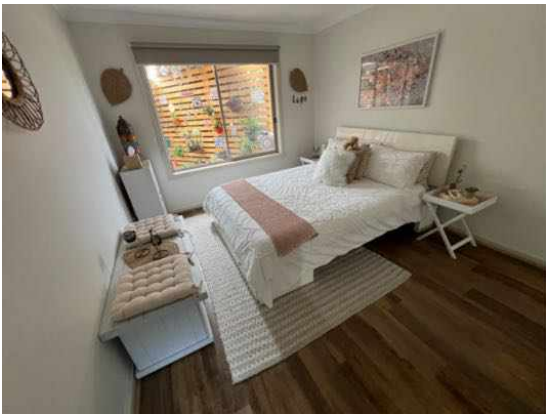
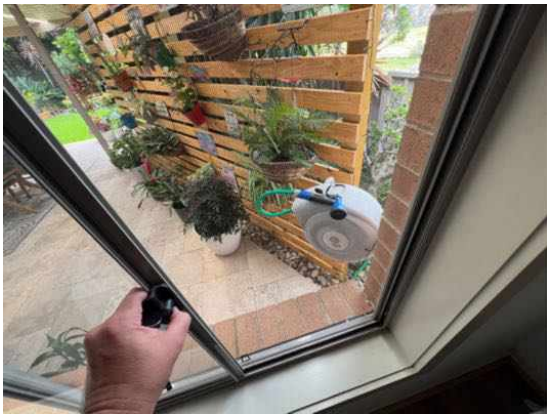
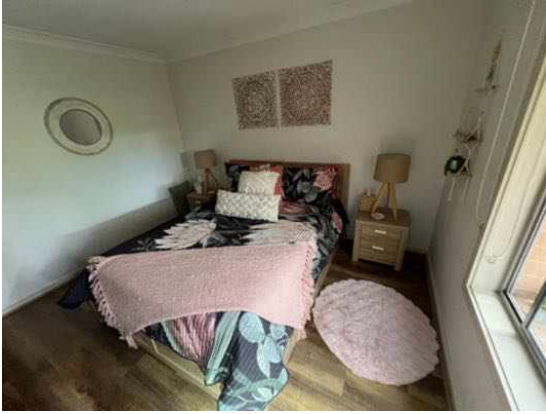
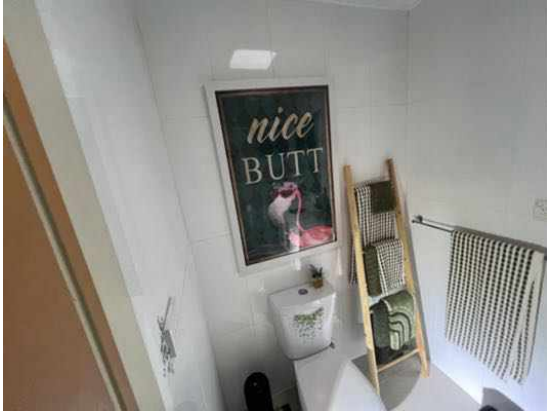
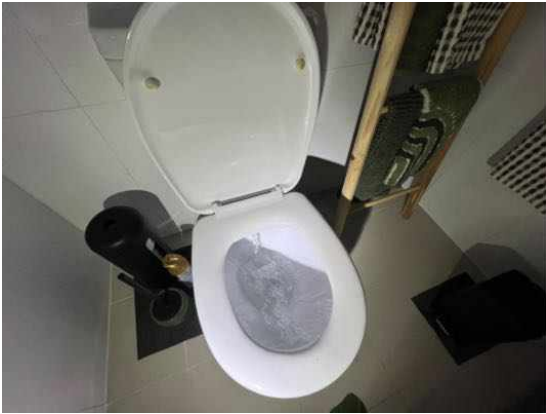
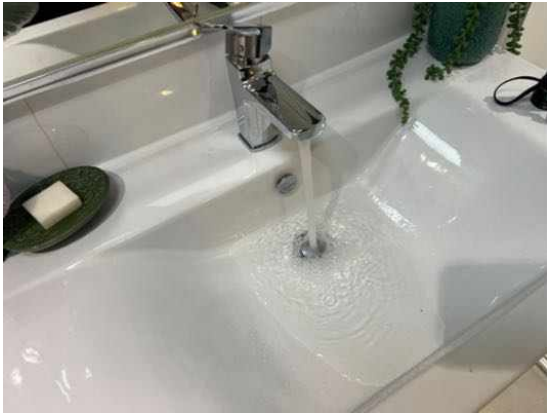
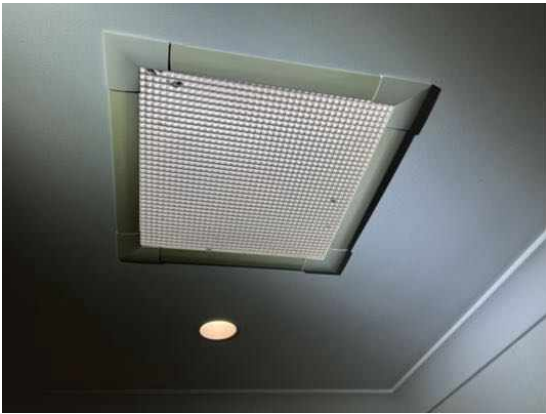
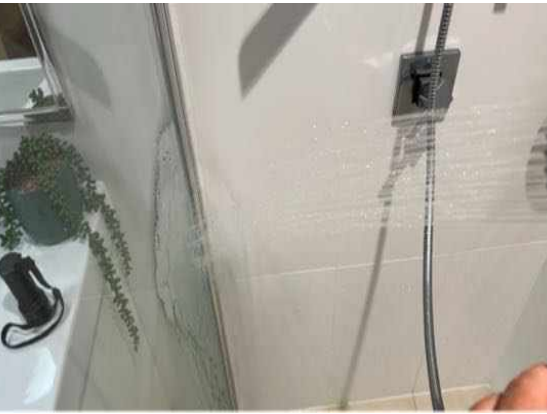
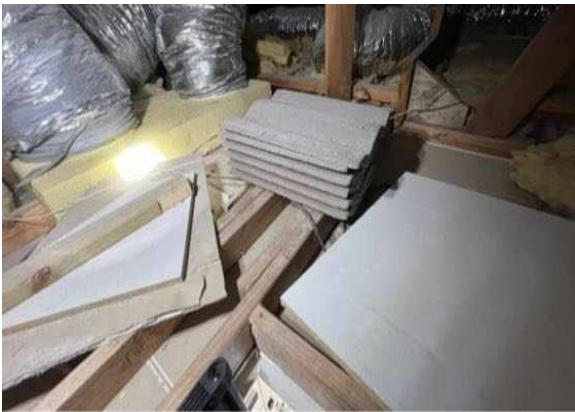
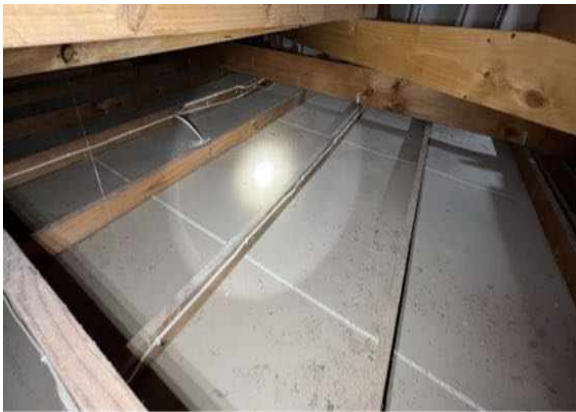
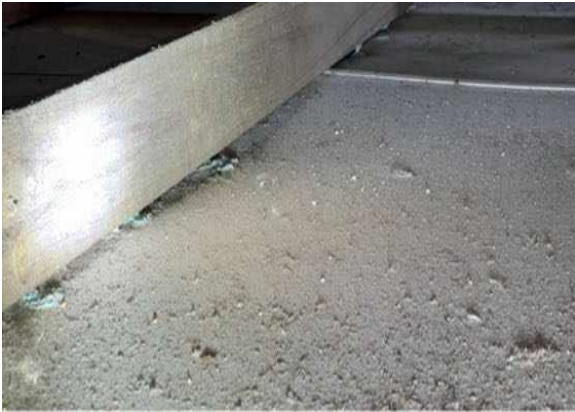
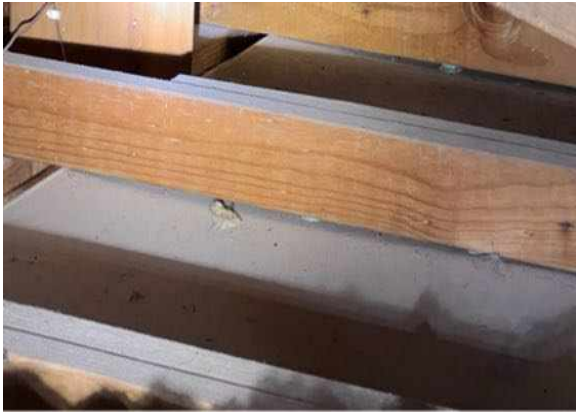
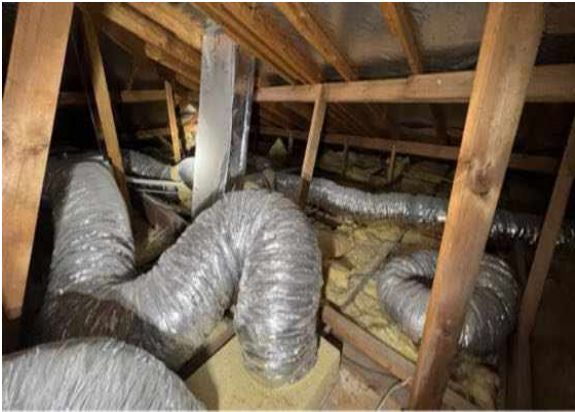
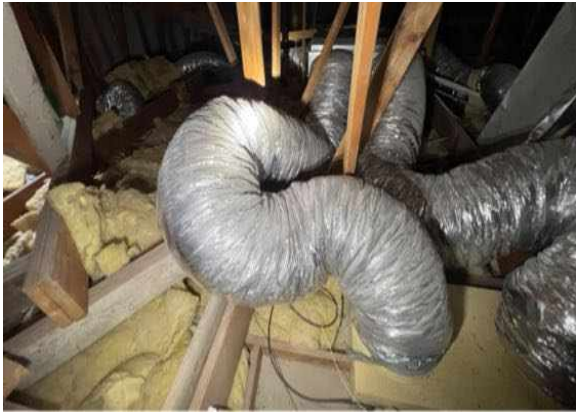
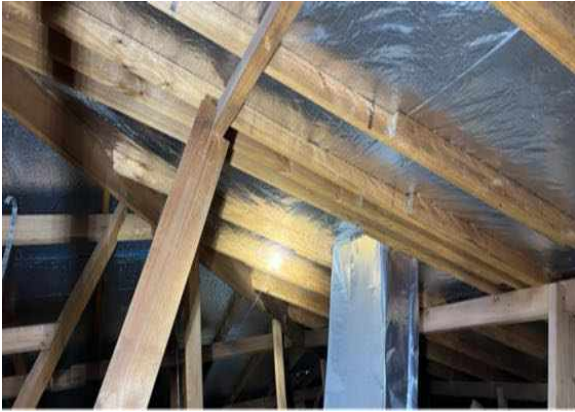
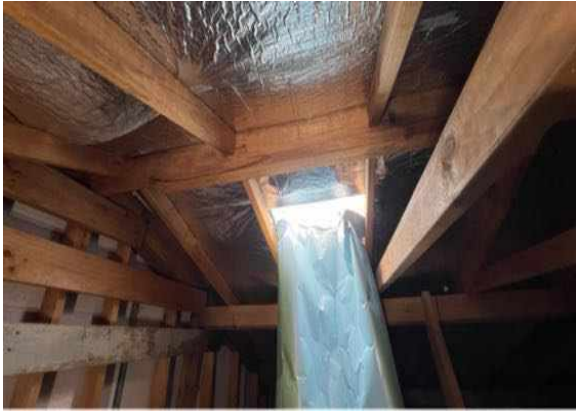
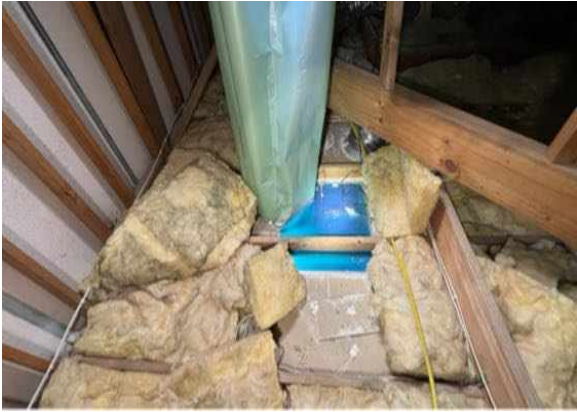
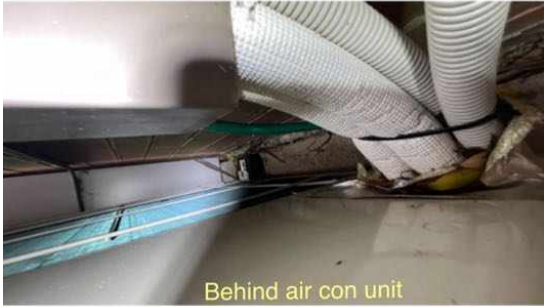
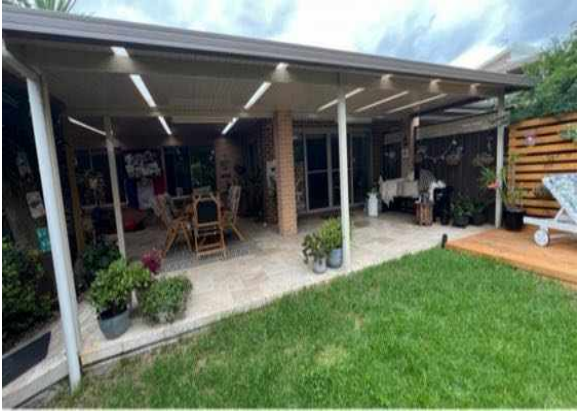
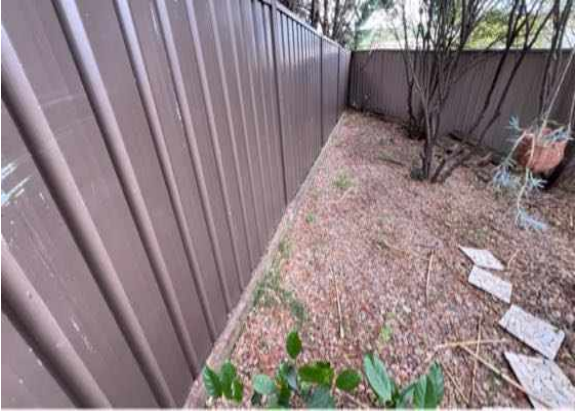
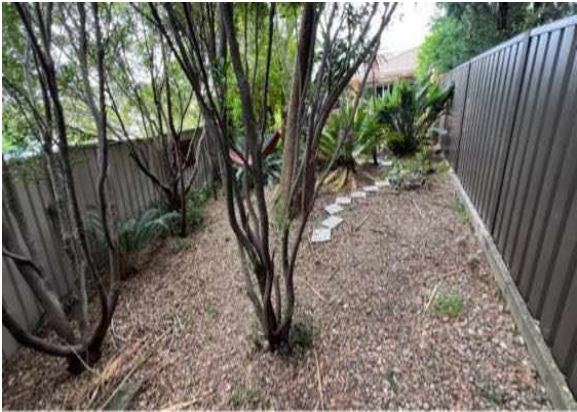
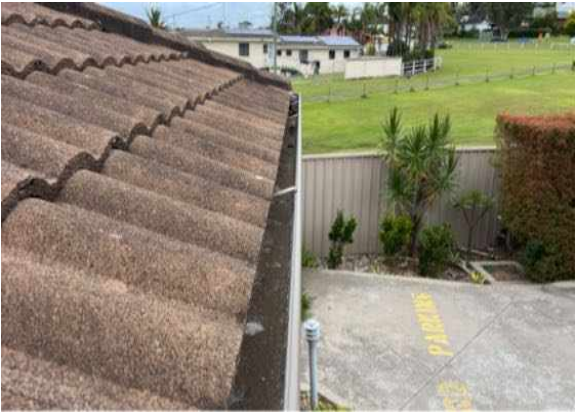
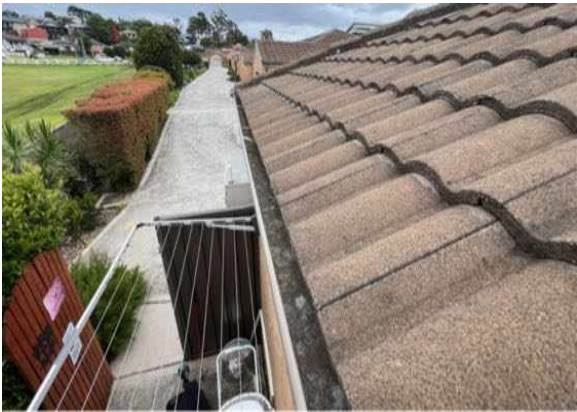
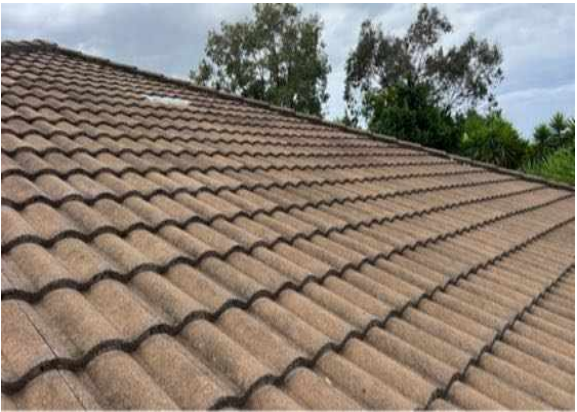
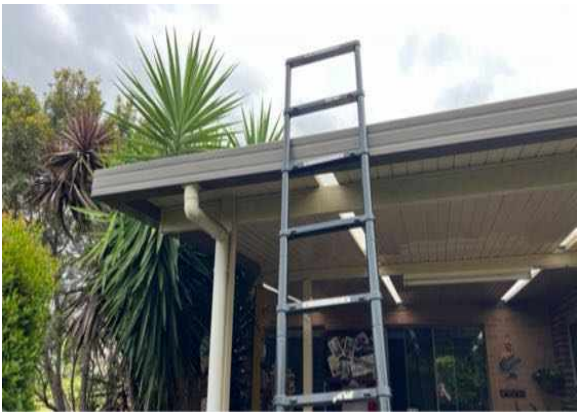
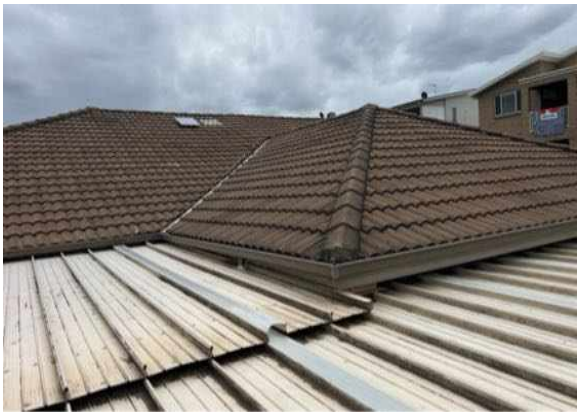
Noted Item

Building: Main Building
Location:
Finding: FYI - Additional Photos
Information: Additional photos are provided for your general reference and may include obstructions, testing of water & windows, moisture readings or minor maintenance items.
