Building and Timber Pest Inspection Report

Inspection Date: Thu, 26 Feb 2026

Property Address: 19 Archer St, Concord NSW 2137, Australia

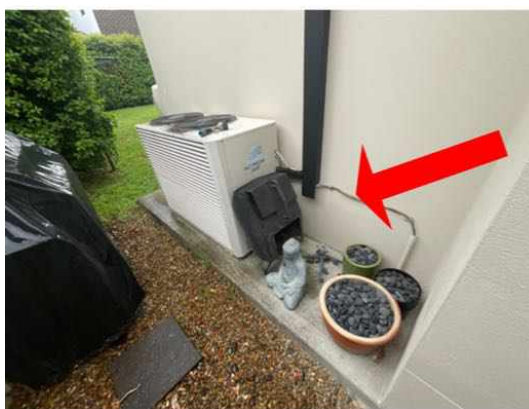
Finding 1.01

Building:	Main Building
Location:	All External Areas
Finding:	Electrical wires exposed
Information:	Exposed electrical wiring was identified. Exposed electrical wiring represents a potential safety hazard including for fire and personal contact. Contact a licensed electrician urgently for further inspection investigation and rectification.

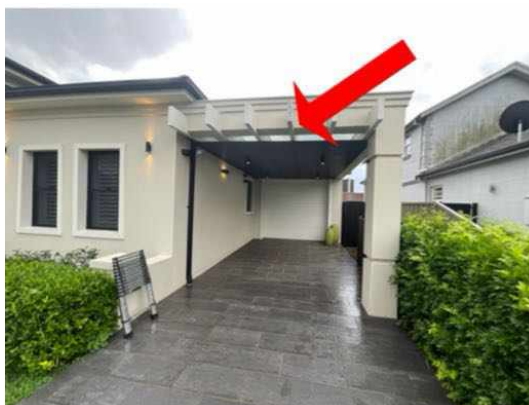
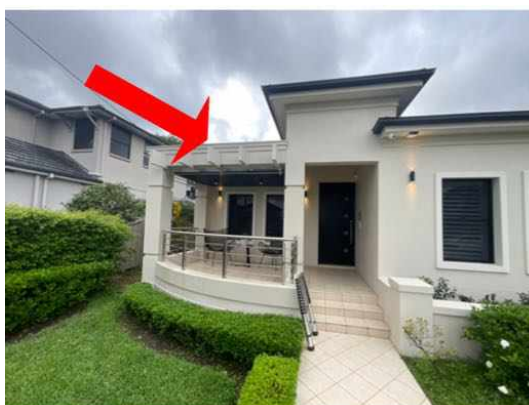
Finding 2.01

Building:	Main Building
Location:	Roof Exterior
Finding:	Exterior roof - Leaking
Information:	Active roof leaks were evident at the time of inspection. Roof leaks can have a number of causes, including damage to roof coverings, deterioration of roof fixtures and fittings, or loosely associated materials (fascias etc.).

Where water leaks are active, rain penetration is likely to cause water damage to associated structures and building elements in this area, which can have a range of implications. If left unmanaged, the development of major structural damage to the roofing and associated structures may occur.

A roof plumber should be appointed as soon as possible to primarily identify the cause of the leak, and to provide subsequent repair works as necessary. Depending on the extent of the damage, replacement of sections of the roof covering and/or roofing structures may be required, and may be performed by a registered builder or

qualified carpenter.

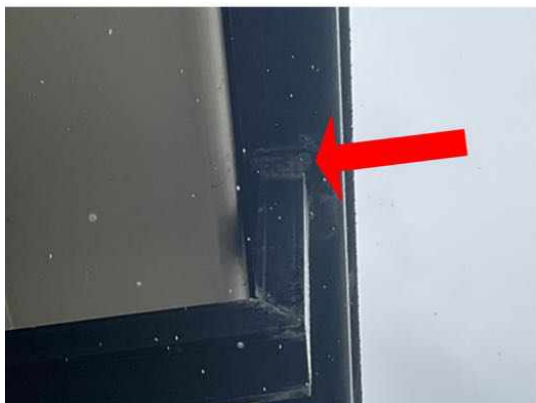
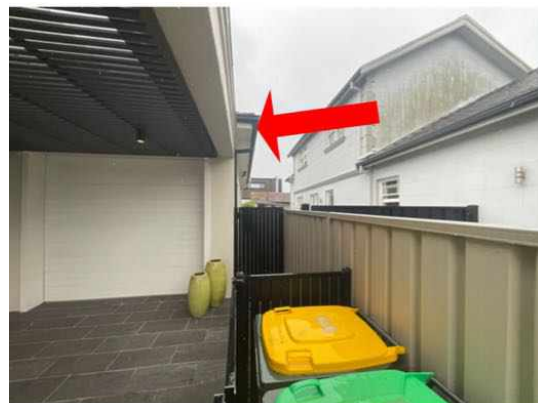
Building:	Main Building
Location:	Roof Exterior
Finding:	Water Leak - Gutters
Information:	Water leaks were found to be present to exterior plumbing work. Leaks are generally caused by deterioration of the plumbing elements over time, due to exposure to weather conditions, but may have also been caused by minor impact damage.

Such leaking creates damp conditions in the affected area, causing potential for water pooling and subsequent water damage if left unattended. These conditions may also attract termite attack, particularly if the area is subject to minimal levels of sun throughout daylight hours.

It is highly advised that a licensed plumber be appointed to rectify any water leaks that may be present. Areas of repair and replacement of plumbing fittings and fixtures may be required and, as such, a quotation should be sought.

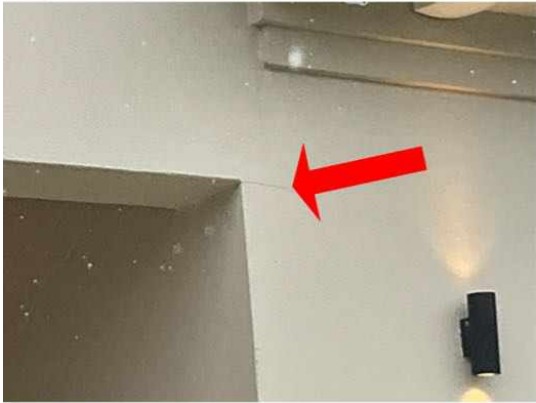
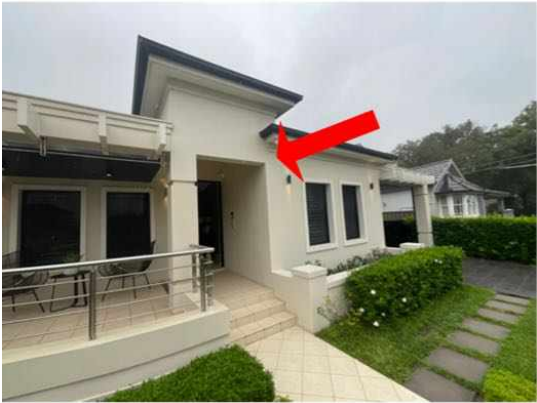
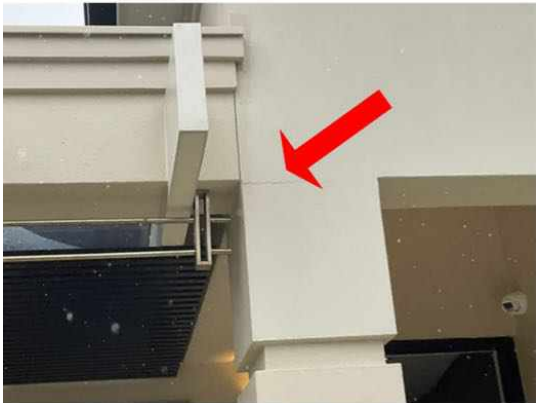
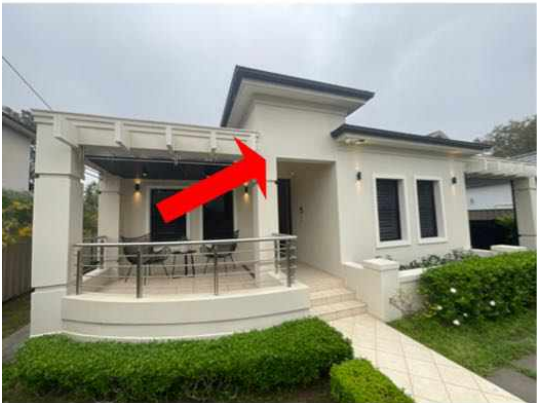
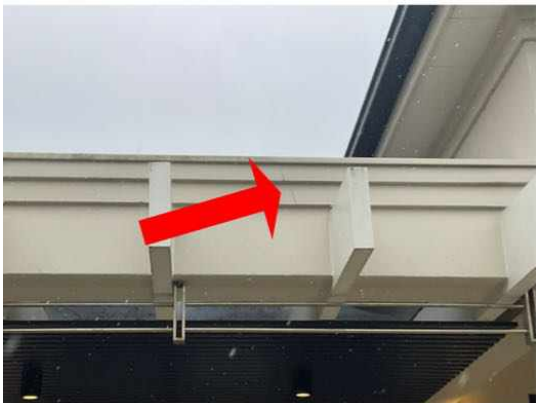
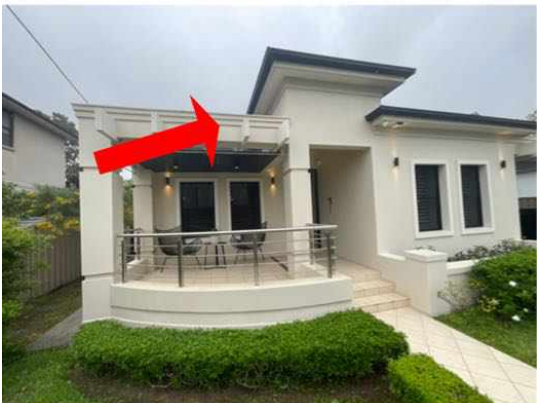
Finding 3.03

Building:	Main Building
Location:	Exterior walls
Finding:	Cracks to external render - Category 1

It has been observed that cracking to external rendered surfaces has occurred. The degree of damage falls within Category 1, described as fine cracks that do not need repair and which are less than 1.0mm in width limit.

Damage of this category is not considered a defect for rectification. Always contact your building inspector should cracks widen, lengthen, or become more numerous.

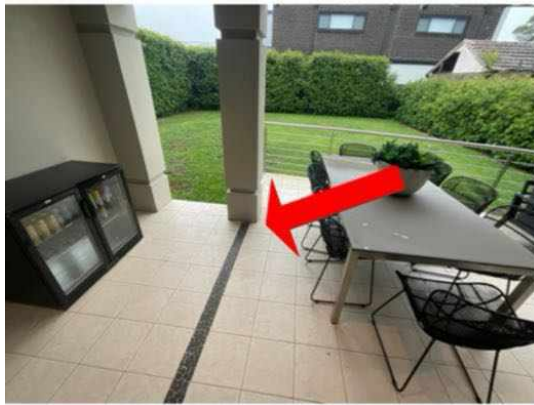
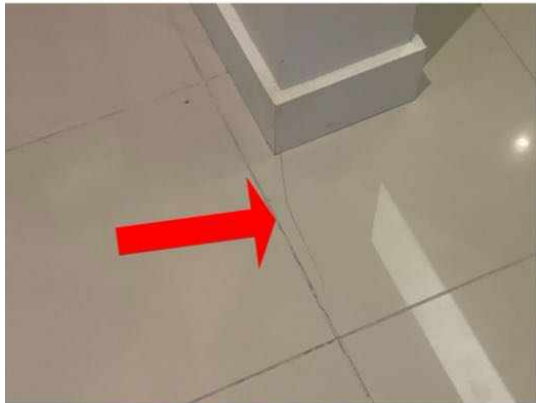
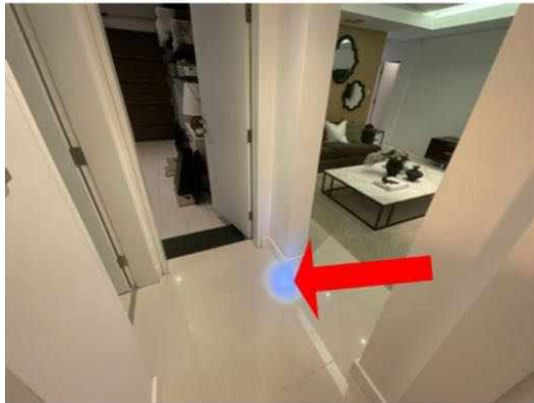
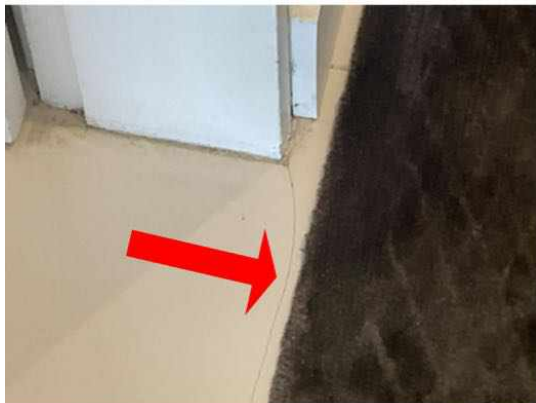
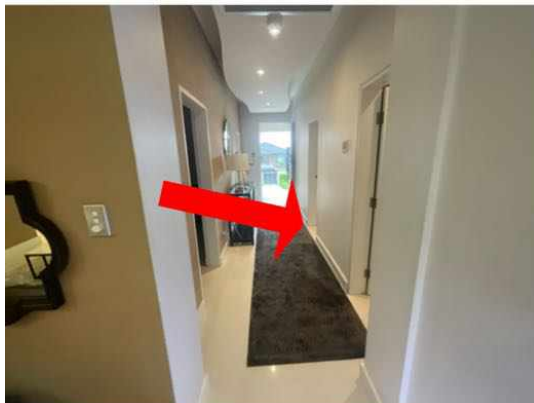
Finding 3.05

Finding: Cracking - Damage Category 1 - Fine (up to 1mm)

Information: Although fine cracks are quite noticeable, they are often only considered to be an appearance defect, and usually do not indicate any structural damage. Generally, the cause of a fine crack is indicative of a separation between building materials and finishes (e.g. paint, plaster, etc.) along joints.

Cracking of this nature can generally be repaired with minor sanding, filling and/or repainting. Such works should be performed by a qualified painter or a general handyman.

Monitoring of all cracking should be conducted frequently. Always contact a building inspector should cracks widen, lengthen, or become more numerous.

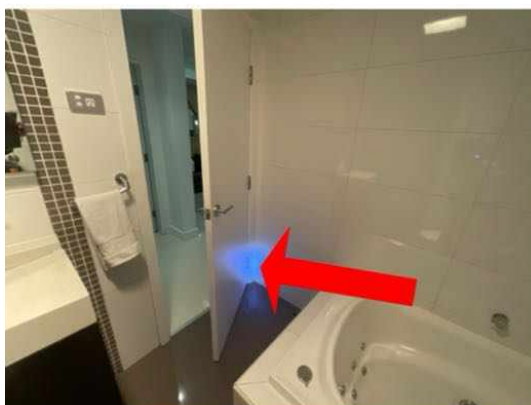
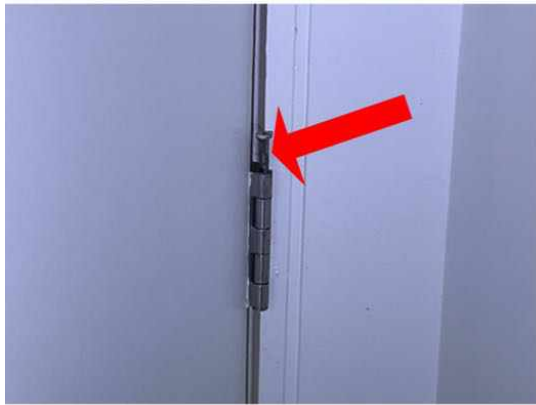
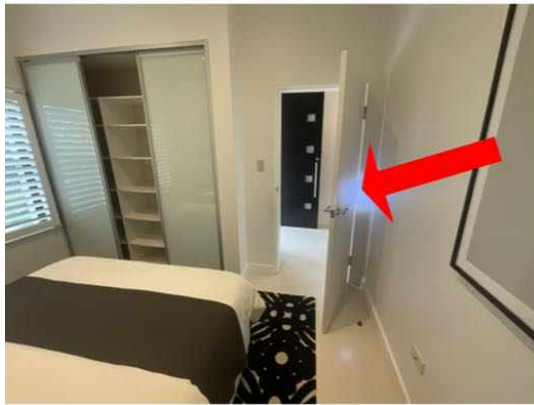
Finding 3.09

Building: Main Building
 Location: Bathroom >
 Finding: Door - Loose hinges
 Information: This door is not level and detract from the operational state of the door jamb. Upon further inspection, it was noted that the hinges to the door have deteriorated over time and, as a result, have come loose from their original fixing. To improve operation of the affected door, a general handyman may be appointed to replace the faulty hinges. Such works should be completed at discretion of the client.

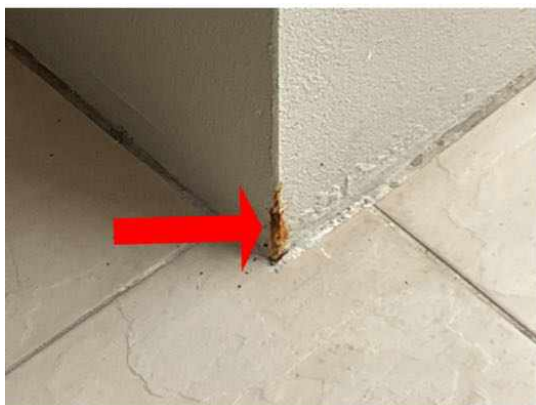
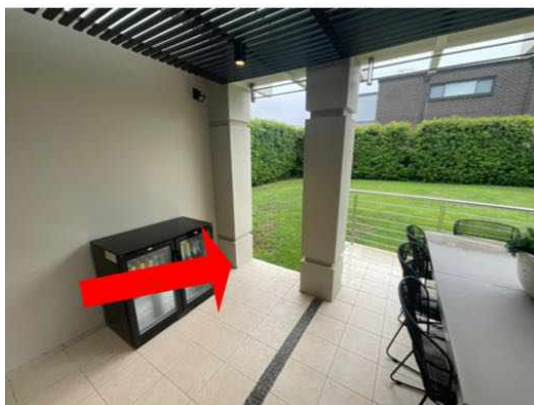
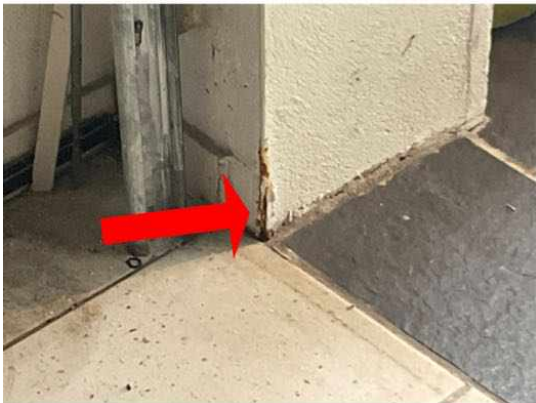
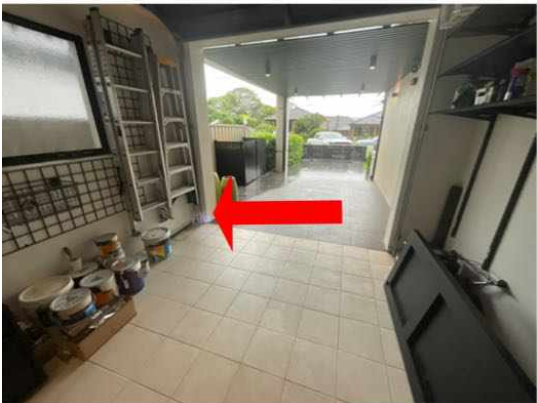
Finding 3.10

Building:	Main Building
Location:	Alfresco / Garage
Finding:	Building element - Rusted or corroded
Information:	This building element shows evidence of rusting and corrosion, which is likely to have developed as a result of excessive exposure to moisture and or inadequate coatings.

As surface rust provides no protection to the underlying iron, the deteriorating condition is likely to worsen if not addressed in the short-term future.

Where possible, the use of galvanized (treated) metals or aluminium coated metals aid in rust prevention, as does regular general maintenance. Rust formation can be controlled with coatings, such as paint, that isolate the iron from the environment.

Rusting and corrosion should be managed by ideally removing or limiting the affected surface from exposure to moisture. A registered builder may be appointed to replace any building elements that have been severely affected by rust or water damage.

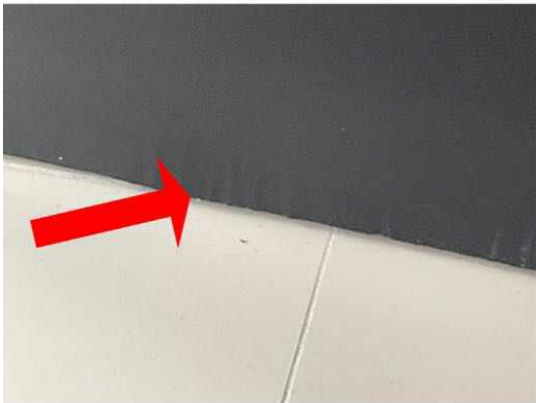
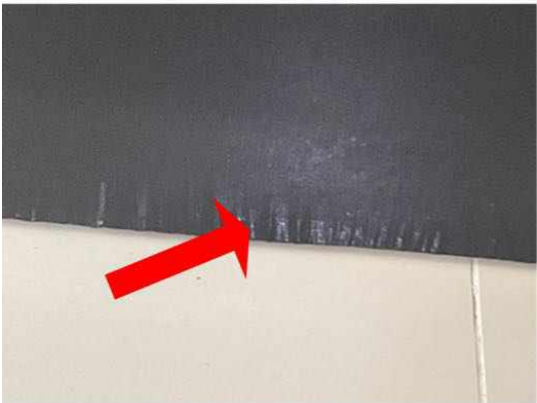
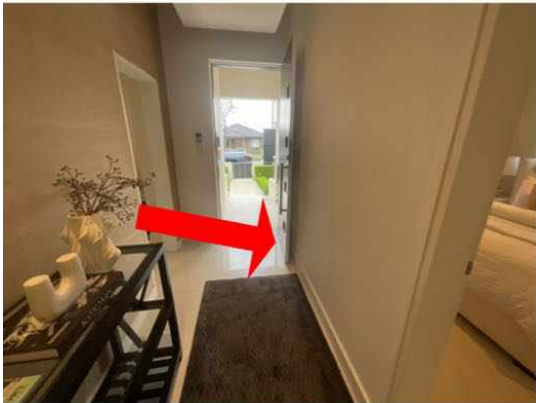
Finding 3.11

Building: Main Building
Location: Entry
Finding: Door - swelling and damage at the bottom edge
Information: Swollen and damaged door base at the the entry due to moisture exposure. Edges show fraying and surface degradation.

Replace or seal the affected door. Ensure door edges are properly sealed to prevent future water damage.

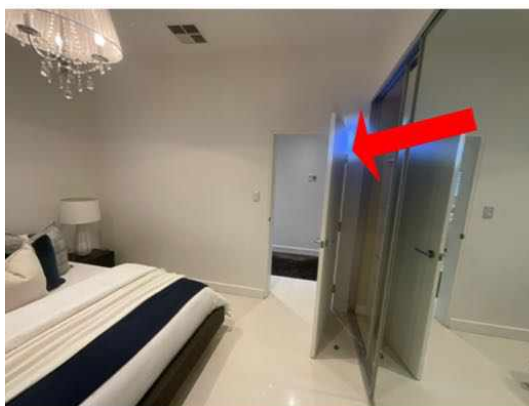
Finding 3.12

Building: Main Building
Location: Bedroom 1
Finding: Paint finish - Substandard, Wear and Tear
Information: The paint finish in this area was found to have been completed to a substandard level or wear and tear as the normal deterioration of a property from ordinary, everyday use. Exposure to the elements, time, as well as day to day living can cause fair wear and tear.

If this applies, further areas of poor and incomplete finishes could develop over time. Furthermore, substandard, wear and tear paint finishes in areas exposed to moisture, e.g. external areas or wet areas, could lead to deterioration of underlying building materials.

Substandard, wear and tear paint finishes should be sanded back, filled, leveled and repainted, as applicable. Where inadequate paint protection has led to the deterioration of the associated building element, repair and/or replacement of this building element may be required.

A painting contractor should be appointed as soon as possible to perform necessary works to aid the appearance of the affected area and to ensure that the area is protected against further deterioration. Alternatively, the homeowner following manufacturer instructions may be able to provide this service.

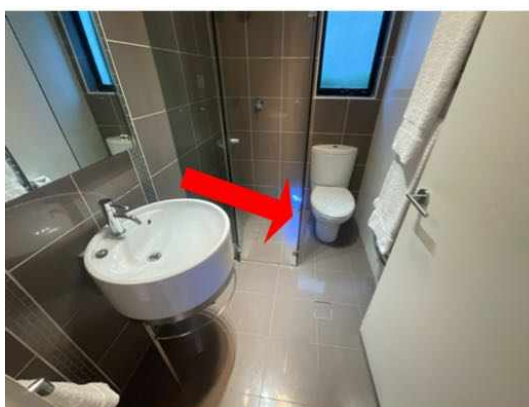
Finding 3.13

Building:	Main Building
Location:	Ensuite
Finding:	Mould Growth to Sealant – Bathroom Area
Information:	Mould is visible to the silicone sealant at the junction between the basin / tiles and the wall tiles. Mould growth indicates excess moisture and inadequate maintenance, which may lead to deterioration of the sealant and potential water ingress into adjoining surfaces. Recommend removal and replacement of the affected sealant with a suitable mould-resistant silicone and ensuring proper cleaning and ventilation to prevent recurrence.

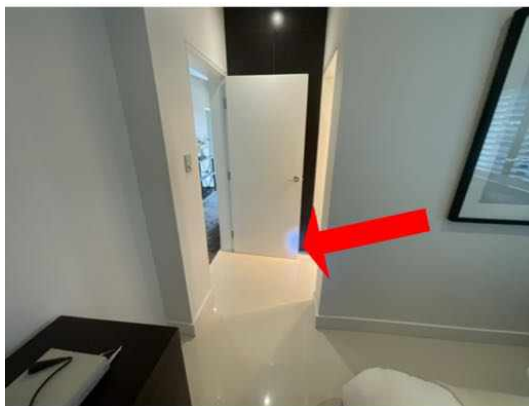
Finding 3.14

Building:	Main Building
Location:	Bedroom - Master
Finding:	Door stop - Missing
Information:	The door stop is missing or is inadequate to stop the door handle from damaging the wall. Although some building elements may seem irrelevant or unnecessary, all building elements play a key role in the operation and function of the overall structure and its performance.

Re-installation or replacement of the door stop is advised as soon as possible to

prevent any subsequent damage to the door or associated structures. A general handyman may be appointed to perform these works at client discretion.

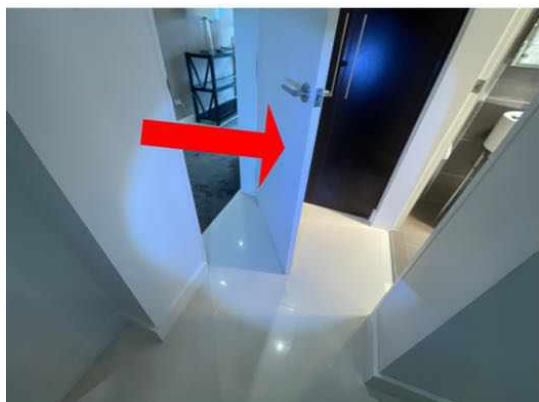
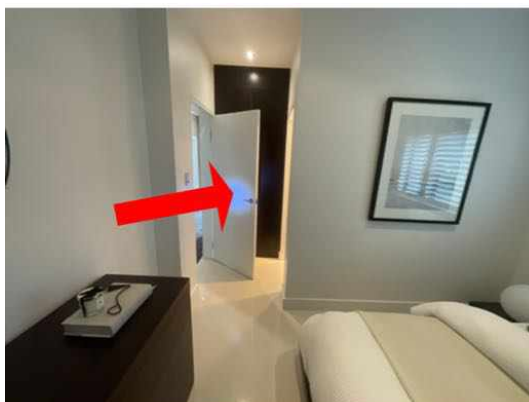
Finding 3.15

Building:	Main Building
Location:	Bedroom - Master
Finding:	Door frames - not square
Information:	It appears that one and / or more doors have been installed in a manner which is not consistent with acceptable standards of workmanship. The door frames are not square and or plumb and require rectification.

Deviation from the manufacturer's installation instructions is considered a defect with reference to Standards and Tolerances.

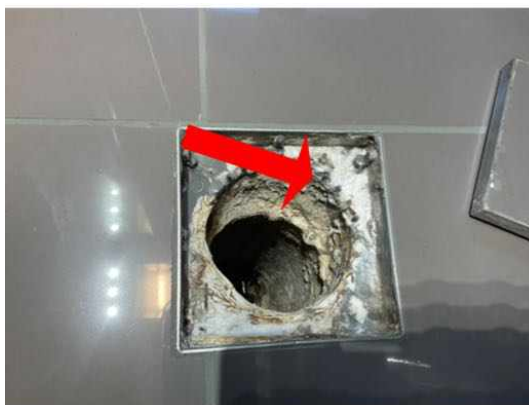
Finding 3.16

Building:	Main Building
Location:	Ensuite
Finding:	Bathroom Floor Waste Installation
Information:	The bathroom floor waste was observed to be poorly sealed with deteriorated sealant and debris accumulation around the waste collar. Gaps are visible between the floor tiles and waste fitting.

The installation appears incomplete and may not provide a watertight seal at the waterproof membrane termination point.

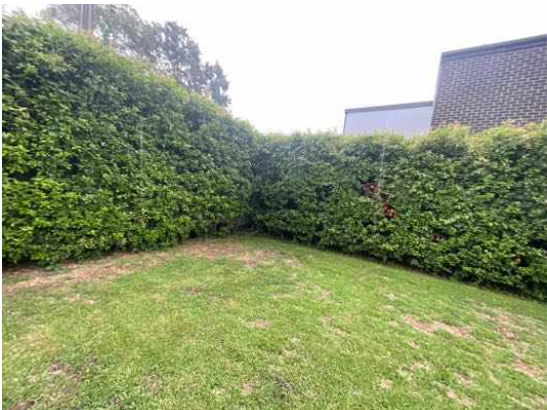
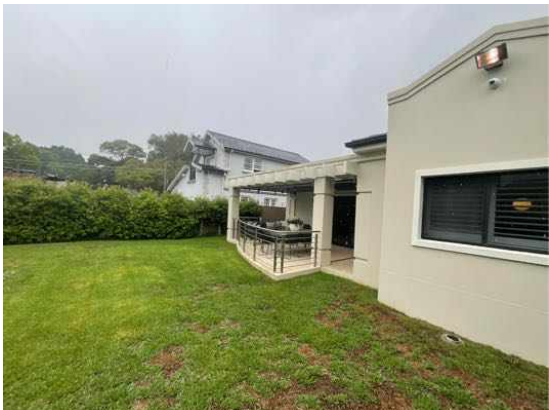
Finding 6.01

Building:	Main Building
Location:	All Areas
Finding:	Garden Beds - Conditions Conducive to Termites
Information:	Garden beds were found to be evident in the garden area. These garden beds can include untreated timber, and with a combination of moisture from watering hosing can make conditions conducive to termite activity and termite ingress.

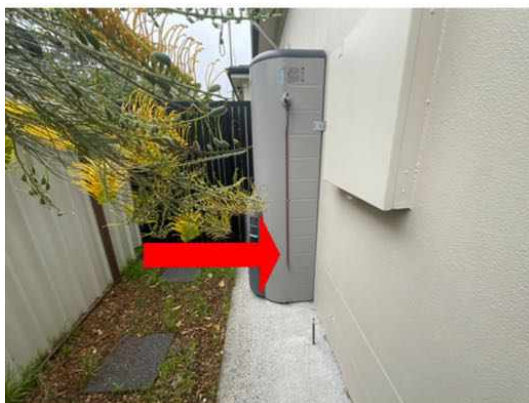
Finding 6.02

Building: Main Building
 Location: All Areas
 Finding: HWS Overflow - Not Connected
 Information: The Hot Water System (HWS) overflow was found to be disconnected from storm water drainage and is creating excessive moisture in the surrounding area.

These damp conditions can lead to secondary defects such as rot, rust or corrosion of associated building elements, the formation of fungal decay, or even the creation of potential slip hazards. When coupled with poor site drainage, pooling of water may also attract termite activity to this area.

It is highly recommended that a licensed plumber be appointed to connect the HWS overflow in order to prevent such an environment from being created. These minor works should be carried out as soon as possible.

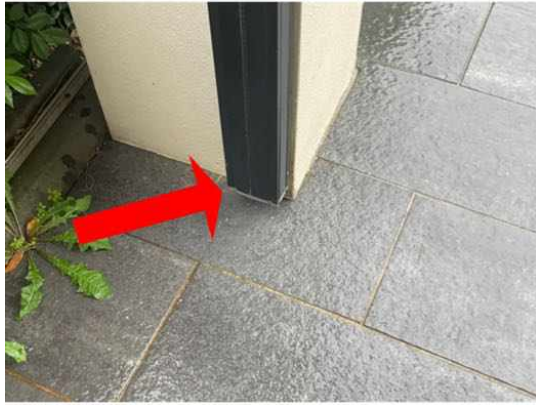
Finding 6.03

Building: Main Building
 Location: All Areas
 Finding: Overflow - Not plumbed for drainage
 Information: The overflow is not plumbed or connected to suitable drainage, which has resulted in the surrounding area becoming excessively damp. These damp conditions can lead to secondary defects such as rot, rust or corrosion of associated building elements, the formation of fungal decay, or even the creation of potential slip hazards. When coupled with poor site drainage, pooling of water may also attract termite activity to this area. It is highly recommended that a qualified plumber be appointed to install adequate drainage to the overflow. These works will ensure that the area remains dry and free of any secondary defects.

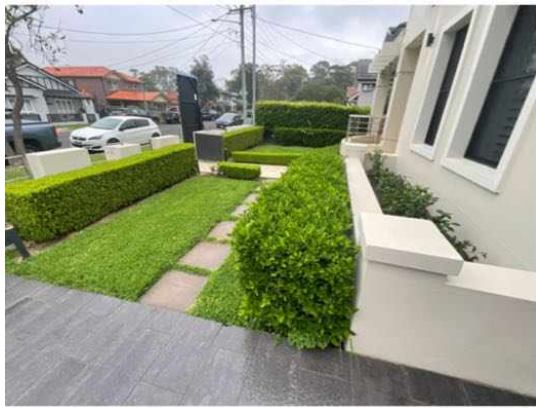
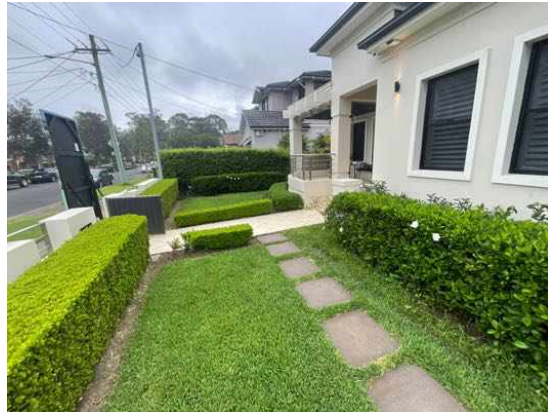
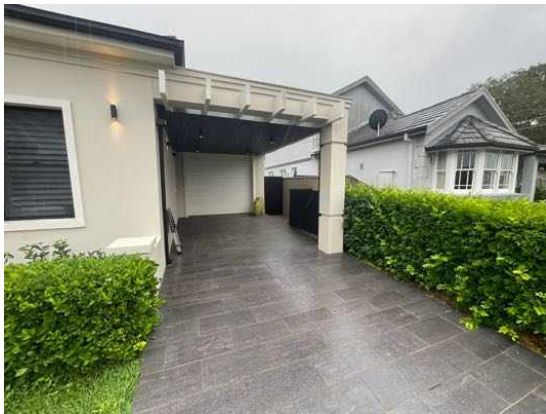
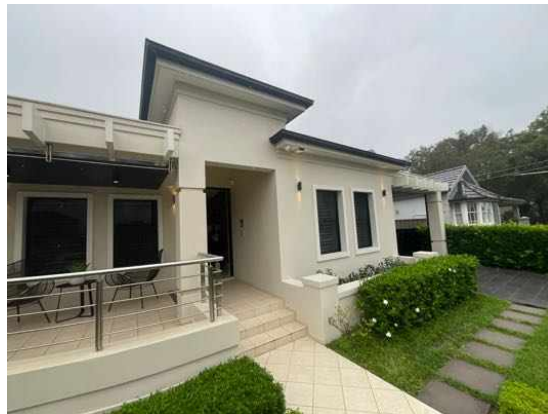
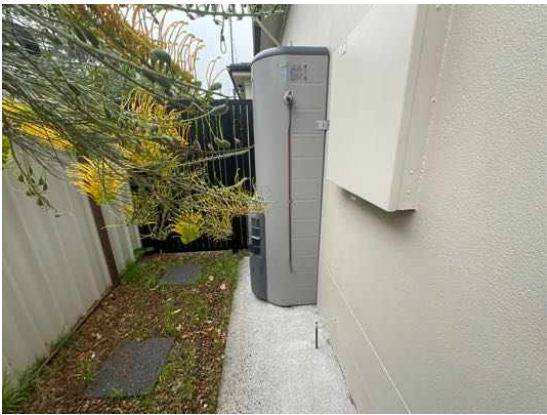
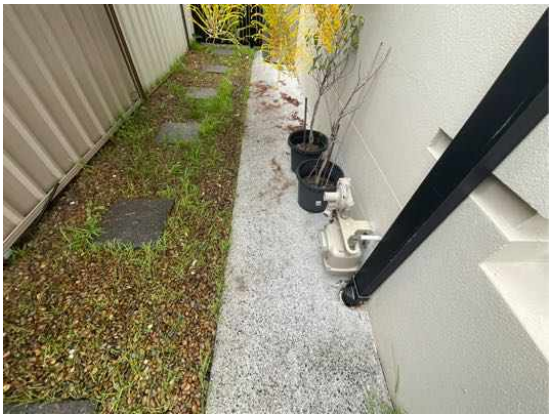
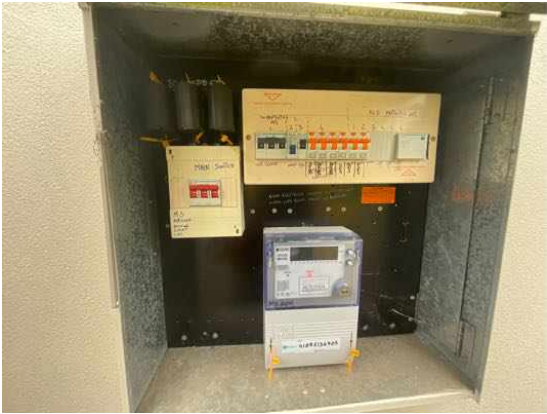
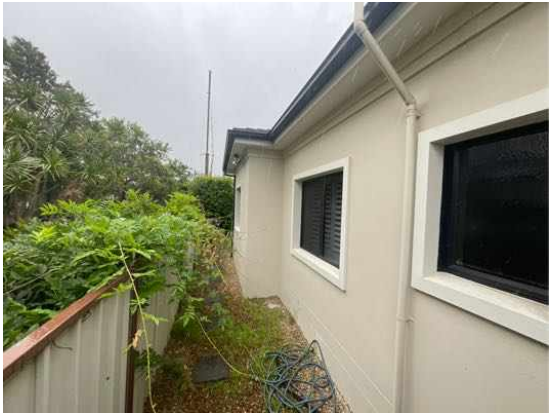
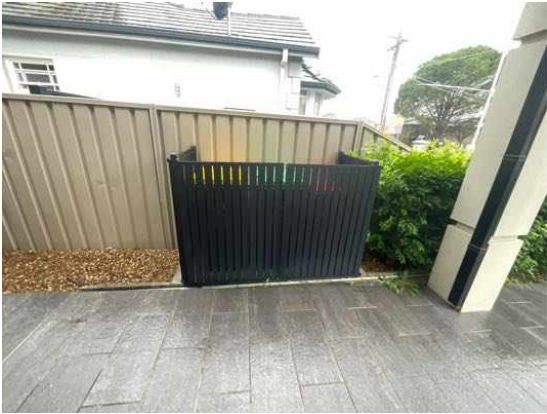
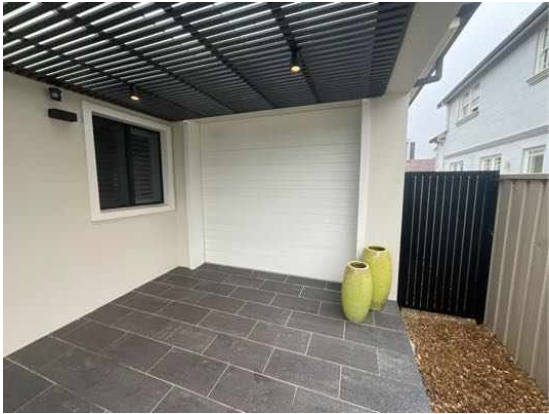
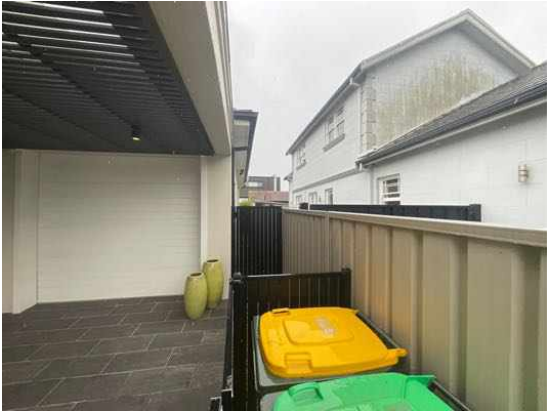
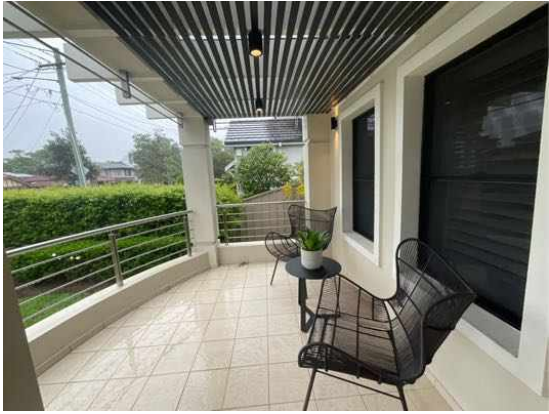
Noted Item

Building: Main Building
Location: All Areas
Finding: Additional Photos - Obstructions and Limitations
Information: These photographs are an indication of the obstructions and limitations which impeded full inspection of the property at the time of inspection. These obstructions can hide an array of defects and should be removed to allow full inspection to be carried out. A re-inspection is recommended once the areas are made accessible.

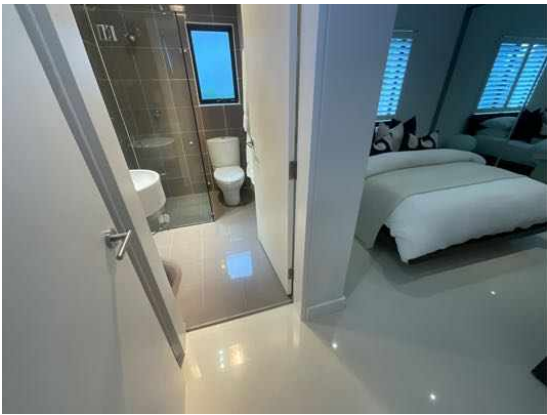
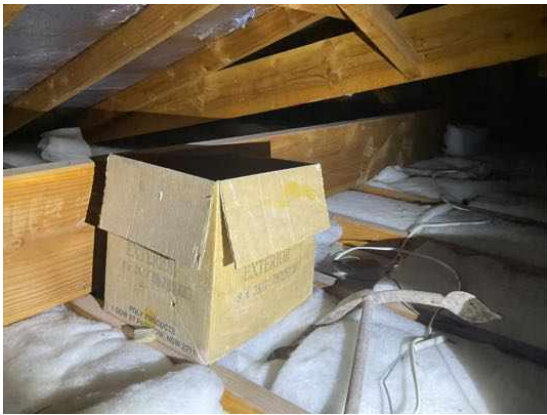
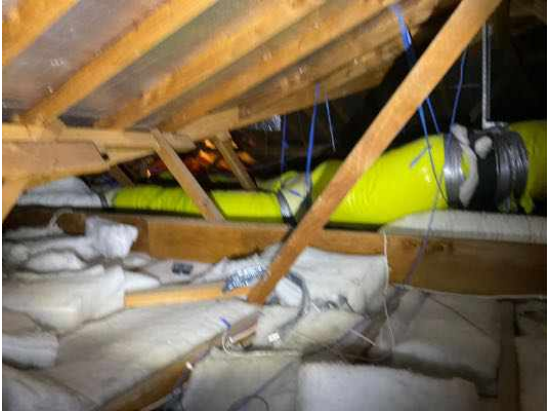
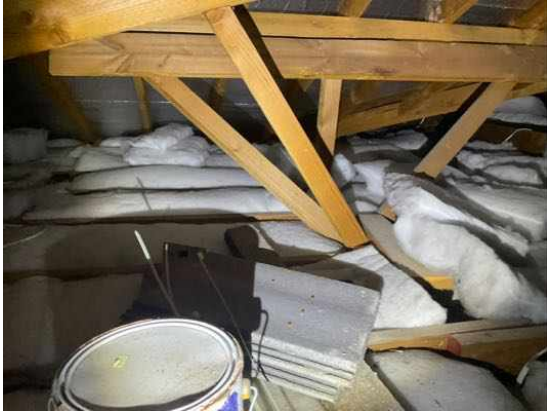
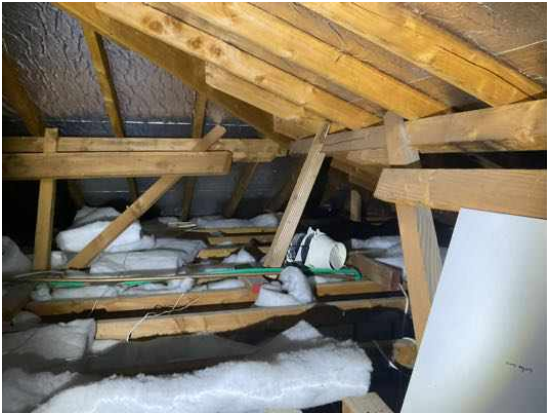
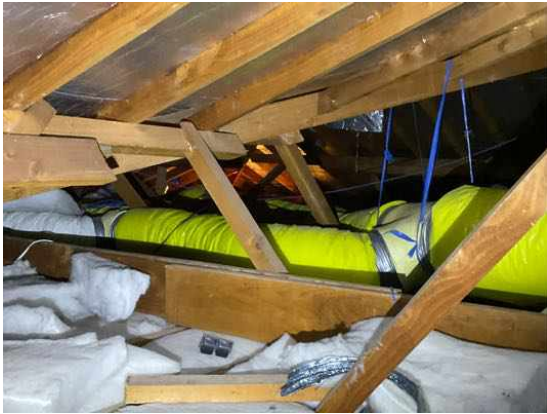
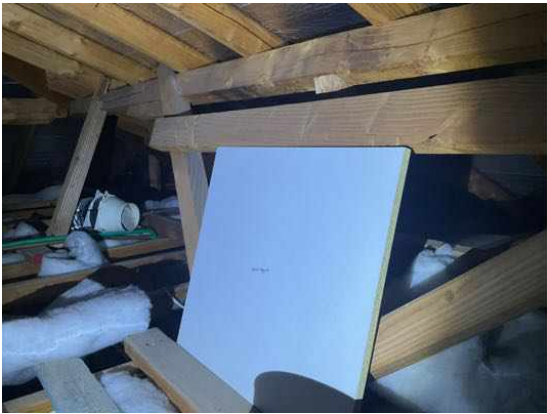
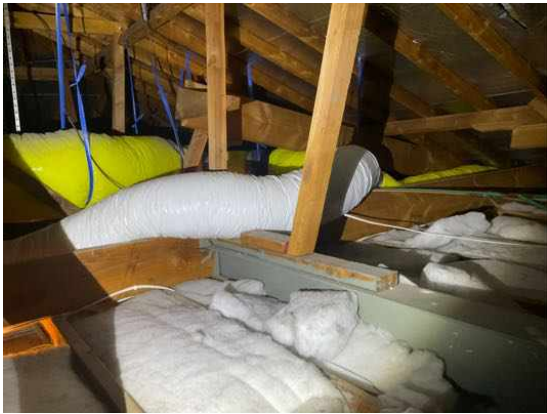
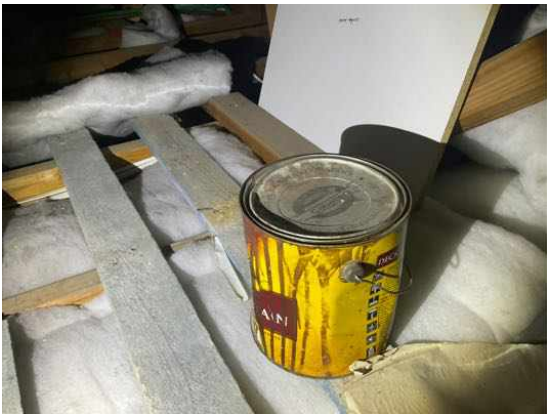
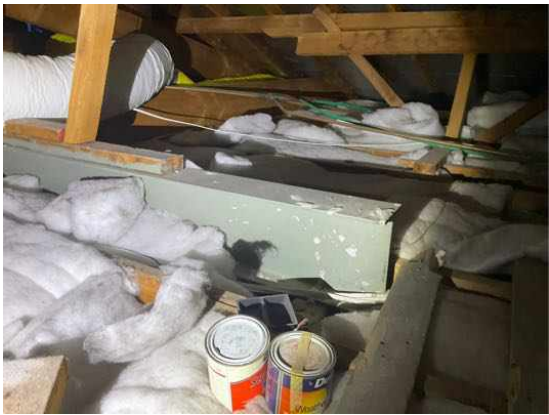
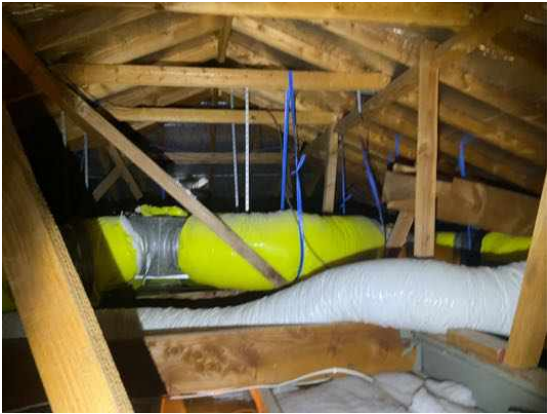
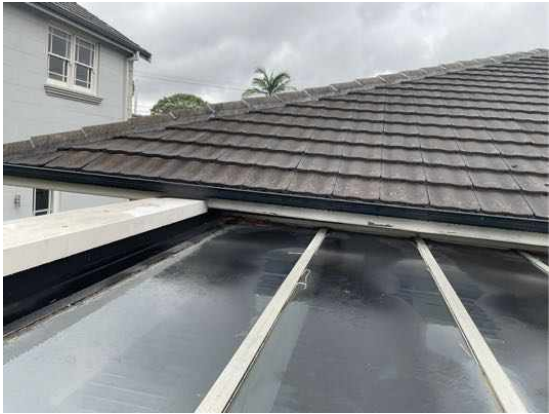
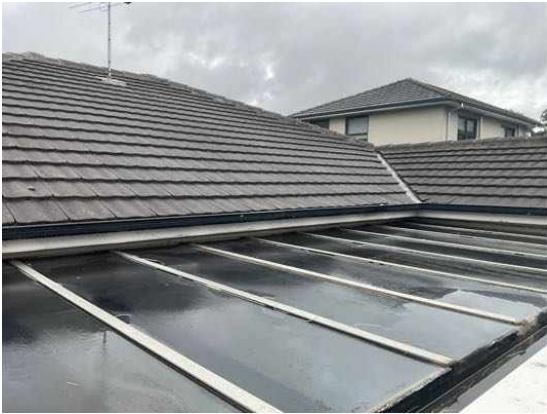
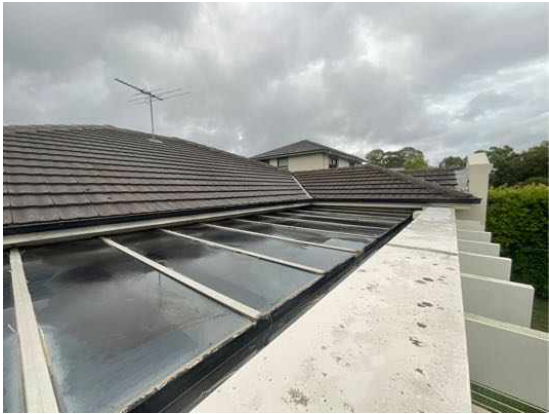
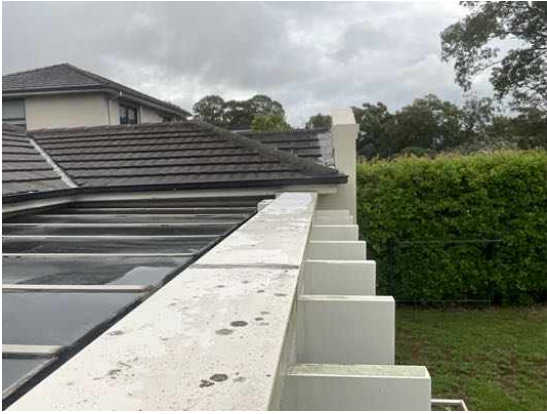
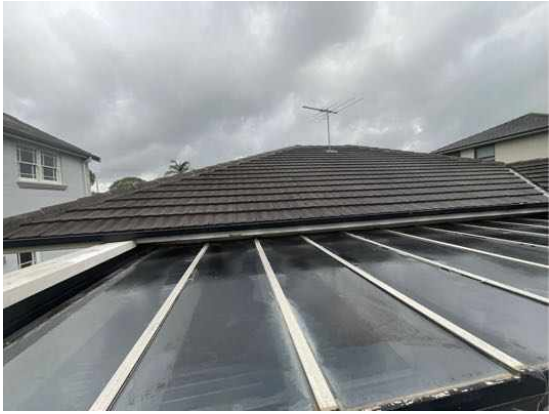
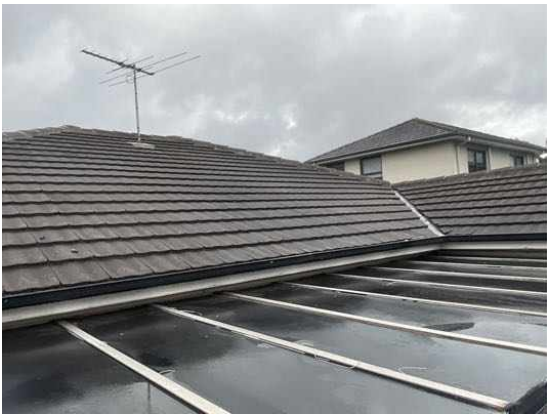
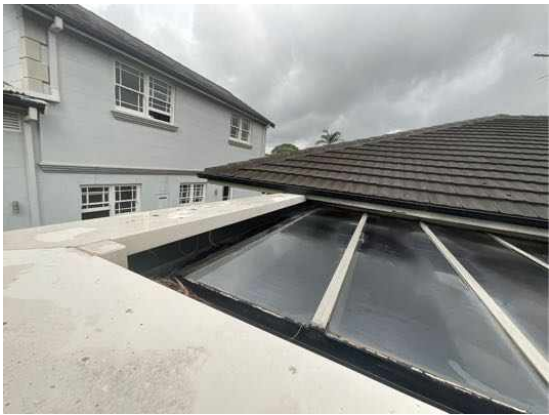
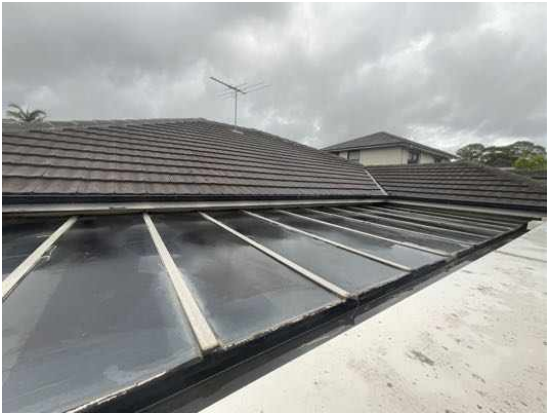
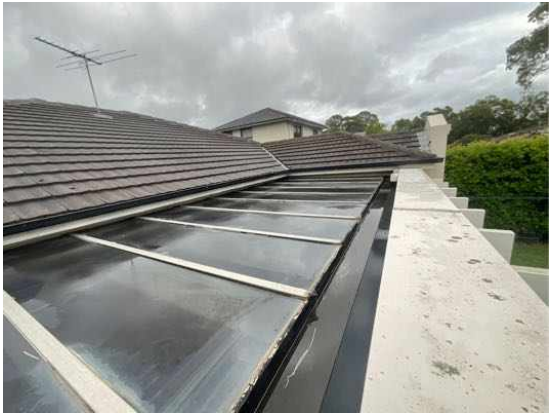
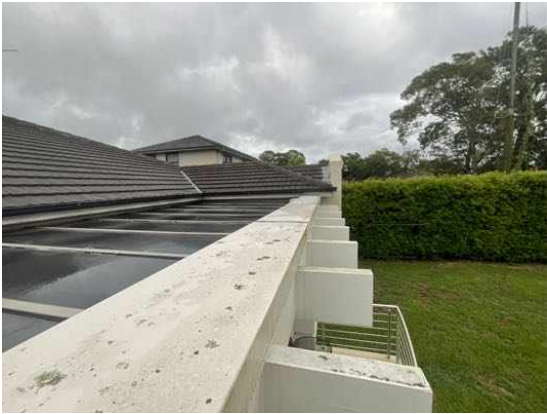
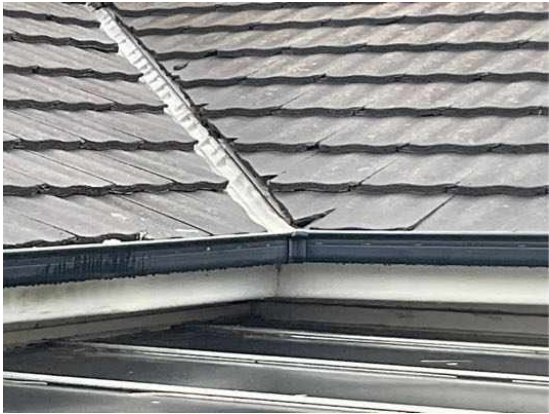
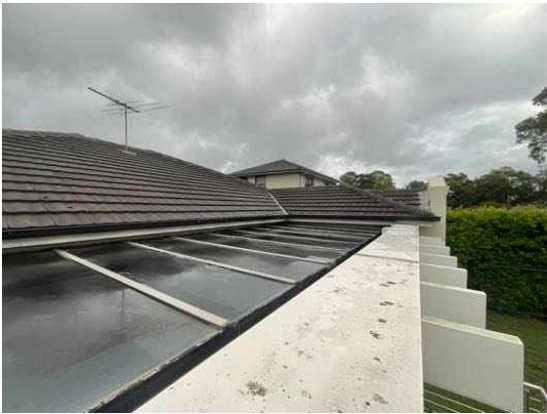
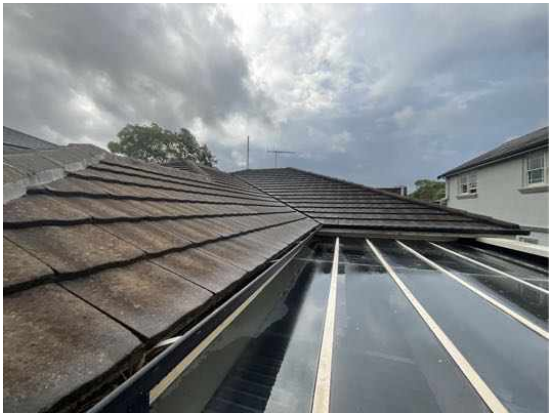
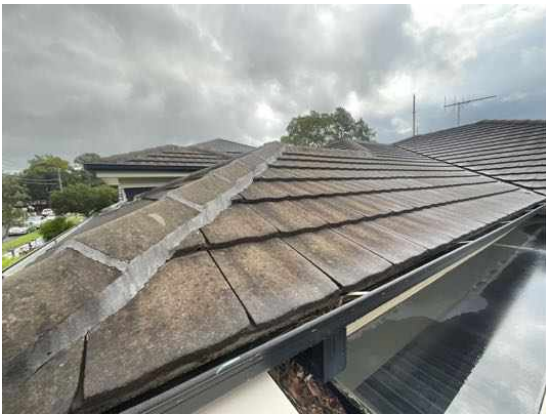
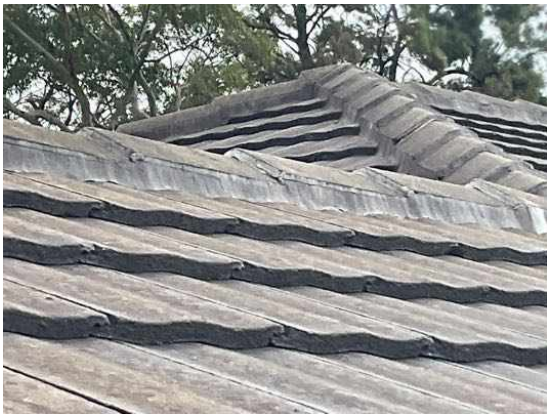
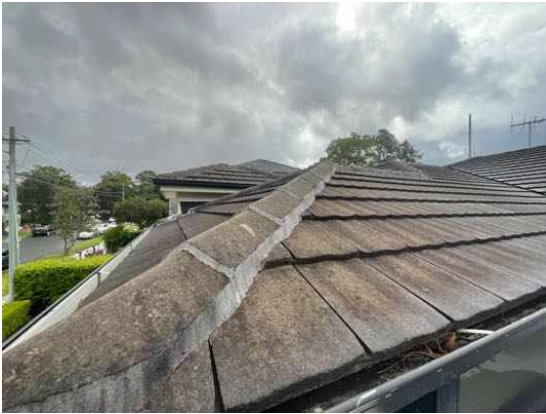
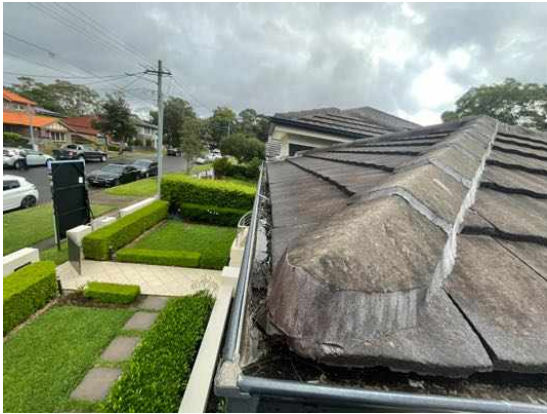
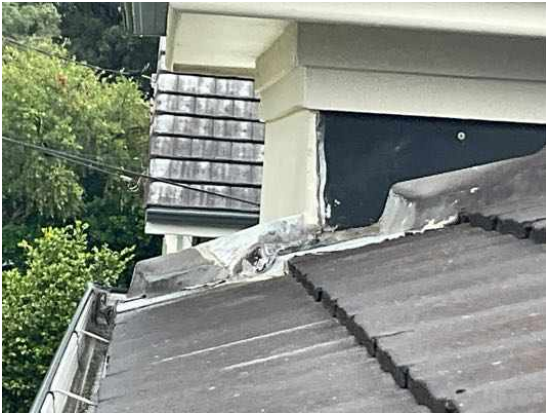
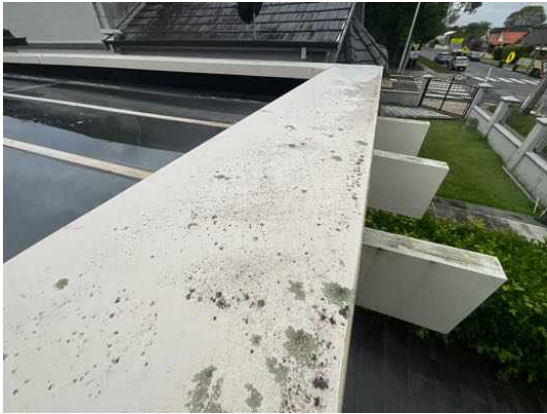
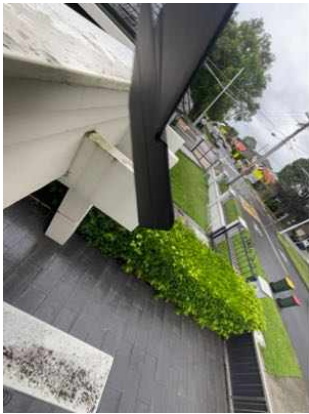
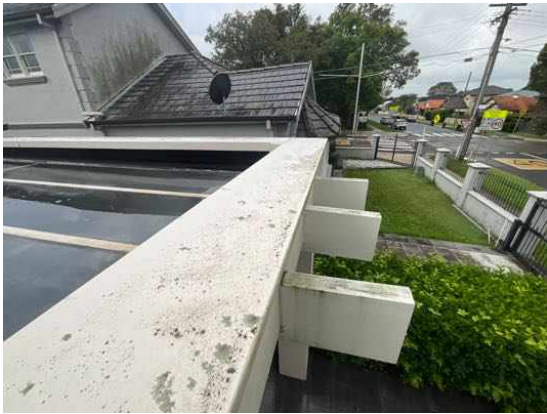
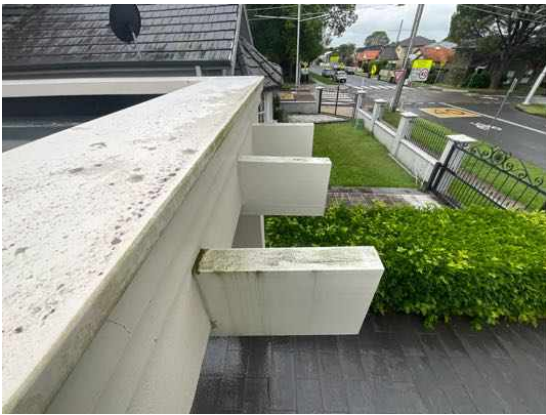
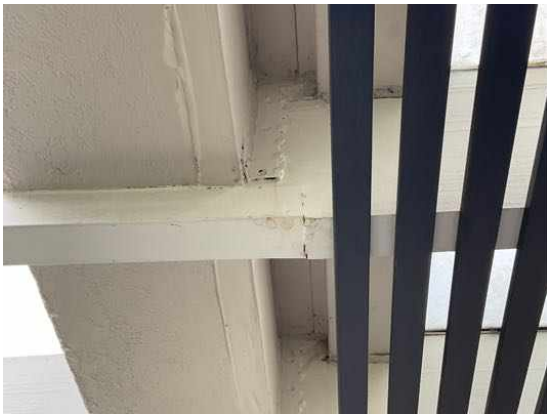
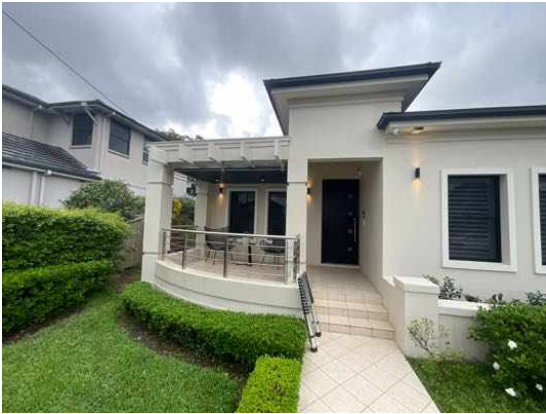
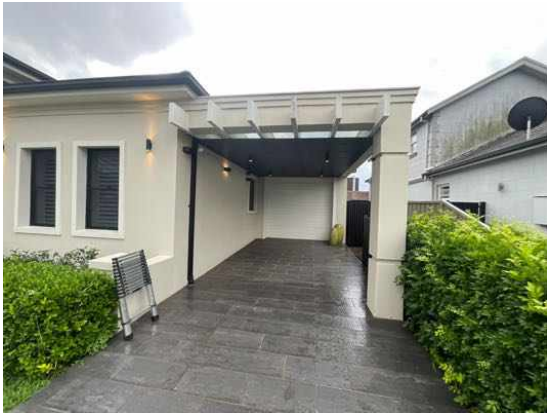
Building: Main Building
Location: All Areas
Finding: Water Proofing Membranes - Information Only
Information: Internal Water Proofing Membranes, are crucial in preventing water ingress into the property is important to know that the Membrane System used is to Australian Standards and has been installed correctly. Please refer to the original Building Documents or Maintenance Schedule for the relevant information including; - Membrane used and Manufacturers Specifications. - The Installer and Installation Certification. Especially with older property's where this information is unavailable, all wet areas should be monitored. Generally new waterproofing with a certificate may only have a guarantee of 8yrs. If any leaks, water staining, peeling or bubbling of the paint become evident to any adjacent walls or ceilings below a licensed builder or waterproofing specialist is recommended to investigate further.
