Building Inspection Report

Inspection Date: Fri, 20 Feb 2026

Property Address: 3/58 Crisp St, Hampton VIC 3188, Australia

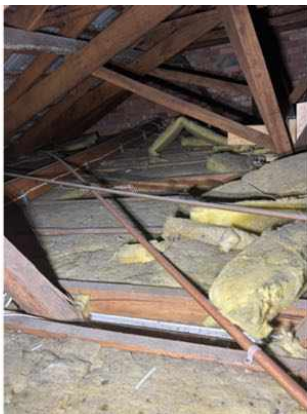
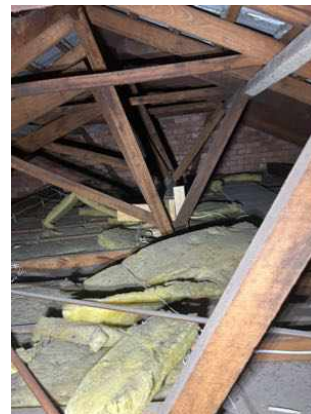
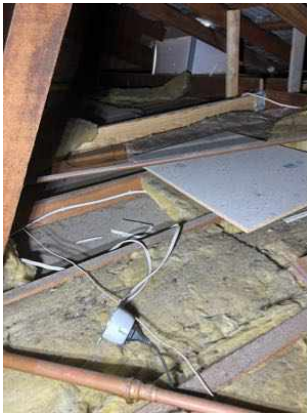
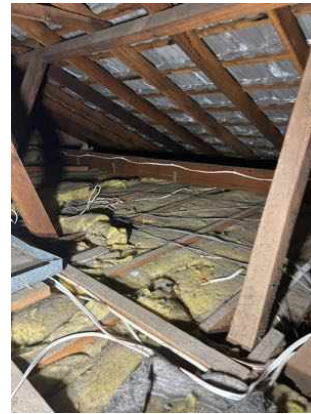
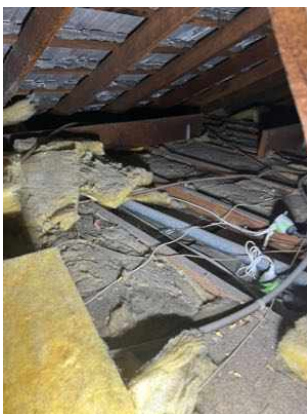
Defects 3.08

Building: Main Building
Location: Roof Void
Finding: Insulation - Inadequate
Information: Upon inspection of the roof void it was noted that there is a lack of adequate insulation.

The level of insulation in the property does not meet current Australian Standards. Installation of adequate insulation is required and should be conducted as soon as possible.

Caution should be exercised when accessing the roof void. Do not attempt to stand on the framework to the underside of the trusses and be aware there is a potential for electric shock if contact is made with exposed or faulty electrical wiring.

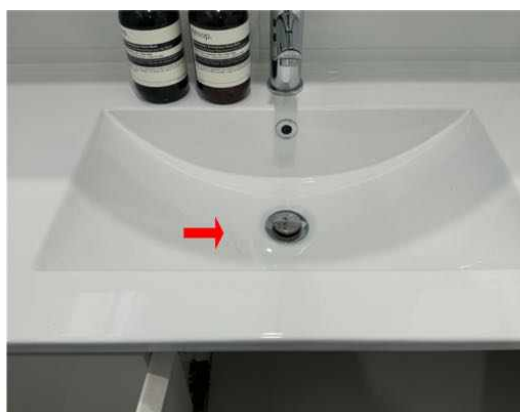
Defects 3.09

Building:	Main Building
Location:	Bathroom
Finding:	Basin - Cracked
Information:	Cracking was evident to the basin at the time of inspection, which is suspected to have been by minor impact damage. While the cracking appears to be minor, any further impact damage sustained by the basin may lead to additional cracking.

As the cracking provides potential ingress for water, secondary water damage may occur to associated cabinetry, walls or flooring, if the cracking is left unmanaged.

Consultation with a plumber regarding basin repair or replacement is required. Remedial works may be required to protect against any further damage.

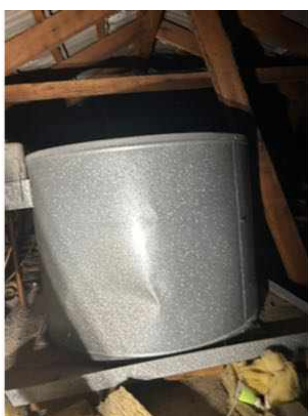
Despite this plumbing structure being unused, it is likely to be storing residual water, and is therefore susceptible to rust and corrosion. If allowed to continue, rust and corrosion is likely to lead to damage to adjoining building elements, and may also make the area susceptible to termite or timber pest activity.

While it is a costly exercise to remove the disused gravity-fed HWS, it is advisable in the short-term future to prevent any further damage to the area. Further consultation with a licensed plumber is required to gain further advice on removal of the structure.

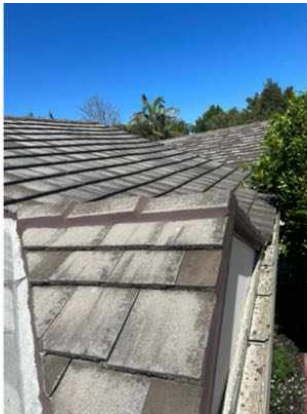
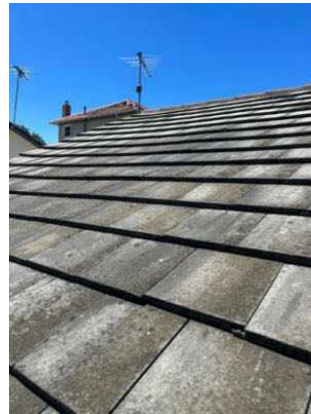
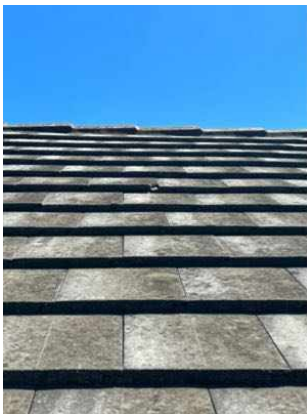
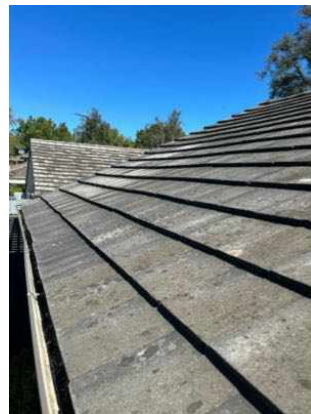
Defects 3.13

Building:	Main Building
Location:	All Areas
Finding:	Roof tiles - Weathered
Information:	Upon inspection of the exterior roofing, the majority of roof tiles were considered to be

Where left unmanaged, deteriorating roof tiles are likely to lead to a number of secondary defects, including minor water leaks and weather exposure to internal roofing structures.

Consultation with a roofing contractor is highly advised to gain advice on cost of remedial works that may be required in the short to medium term. Remedial works are likely to increase the longevity of the exterior roofing structure.

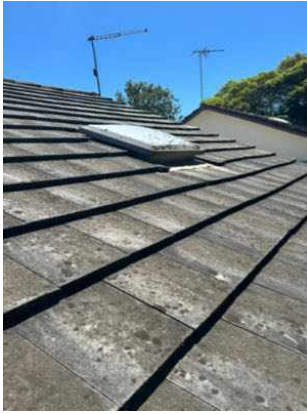
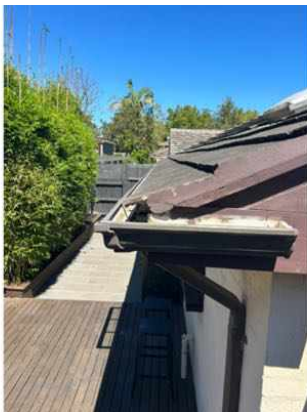
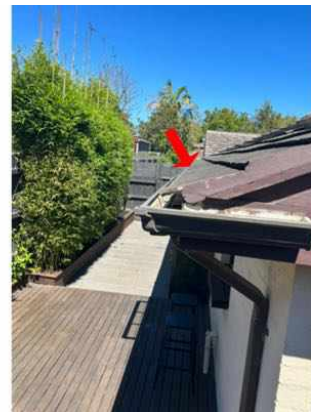
Defects 3.14

Building: Main Building
 Location: Rear Elevation
 Finding: Roof Tiles -Installed incorrectly
 Information: On inspection of this Building it was noted that the roof tiles are installed incorrectly as they protrude past the fascias too much and will overshoot the gutters in heavy rains.

To Achieve this on this Building all the Roof tiles will need removed and relocated correctly or a bigger gutters will need to be installed. If left unmanaged the water from the roof will deteriorate the surrounding Building elements.

It is Recommended that a registered builder be contacted to coordinate the relevant trades to rectify this defect.

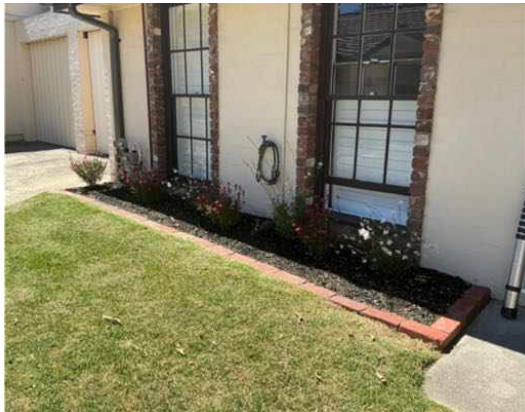
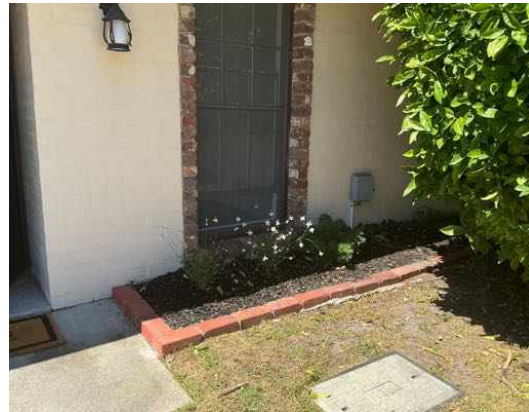
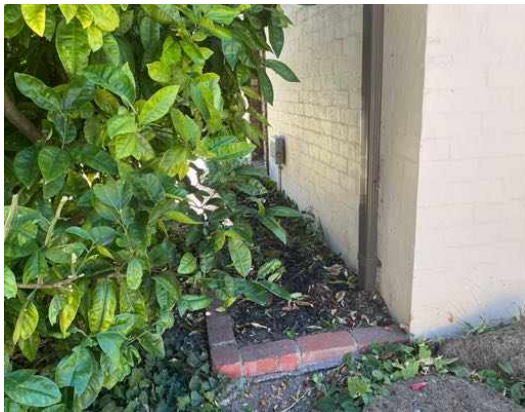
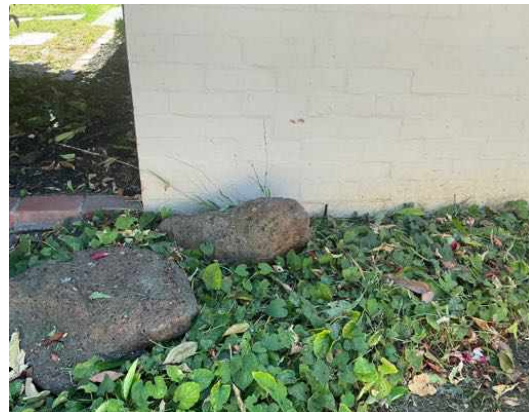
Defects 3.15

Building: Main Building
 Location: All Areas
 Finding: Bridging - Vegetation
 Information: Where vegetation obstructs inspection of building elements, also known as bridging

The removal and replanting of species that do not provide "cover" or cutting back of existing vegetation will assist greatly in preventing Bridging from occurring.

The removal of any such materials that may be conducive to termite activity should be carried out as soon as possible and arrange re inspection to minimize the risk of termite attack.

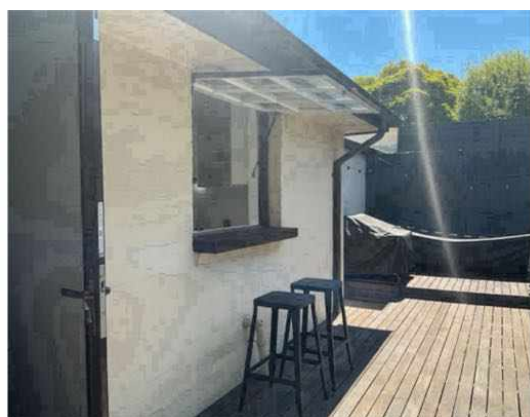
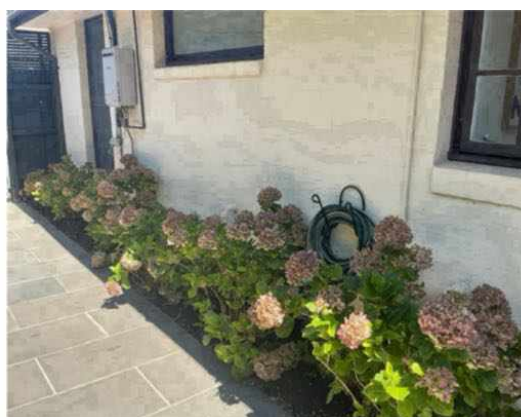
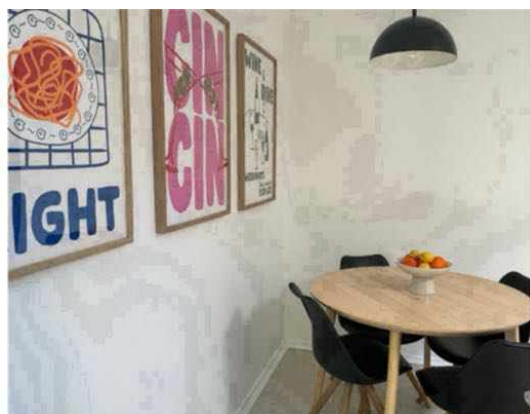
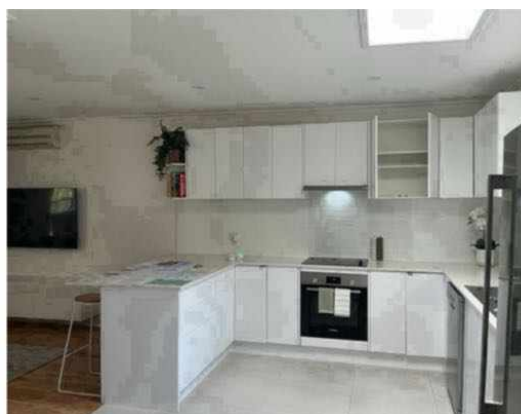
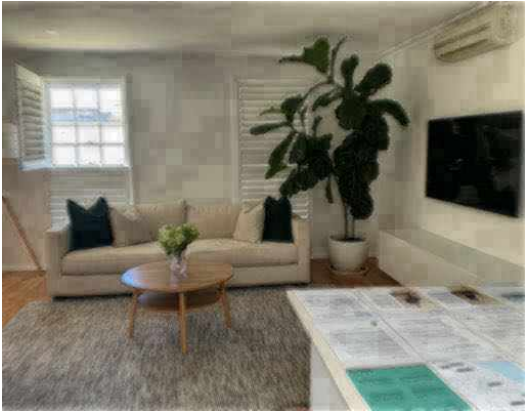
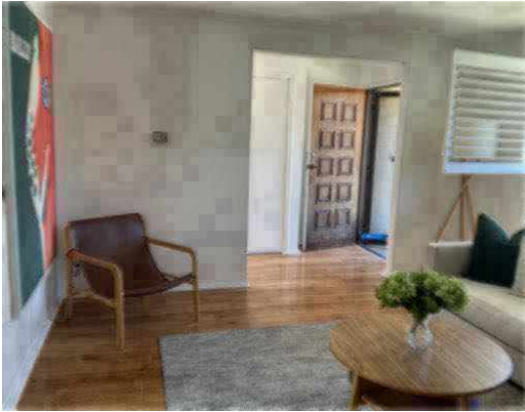
Noted Item

Building: Main Building
Location: All Areas
Finding: Additional Photos and Obstructions and Limitations
Information: These are additional photographs and photographs of the obstructions and limitations inside and outside (furniture, landscaping etc) which may impede full inspection of the property at the time of inspection. These obstructions can hide an array of defects and may be removed to allow full inspection to be carried out. A re-inspection may be made if clients require once the areas are made accessible.
