# Building and Timber Pest Inspection Report

Inspection Date: Fri, 27 Mar 2026

Property Address: 13 Monti Place, North Richmond NSW 2754

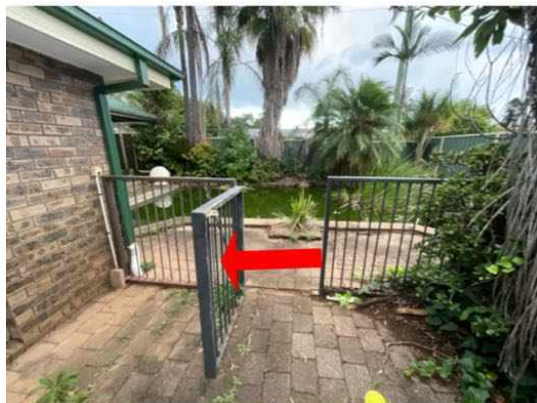
Building:	Yard
Location:	Pool Area
Finding:	Safety Hazard – Defective Pool Gates.
Information:	Observation:

During the inspection, it was noted that the pool gates appeared to be defective and may not comply with current pool safety standards.

Defective or non-compliant pool gates can pose a serious safety risk, particularly to children, and may result in non-compliance with local council regulations and relevant pool safety legislation.

- It is strongly recommended that a licensed pool safety inspector be engaged to conduct a comprehensive inspection of:
  - The pool gates and barriers
  - The pool structure
  - All associated equipment and surrounds
- Any identified safety or compliance issues should be rectified without delay to ensure the area meets current safety requirements and minimises risk.

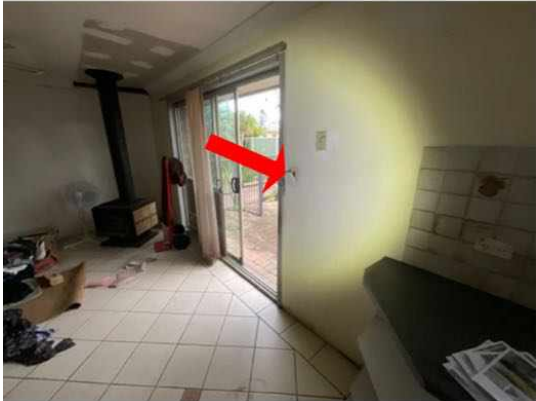
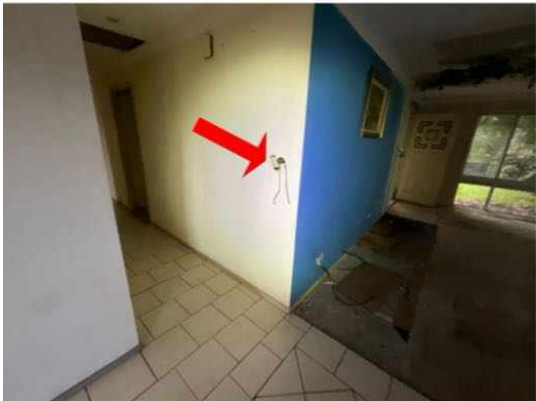
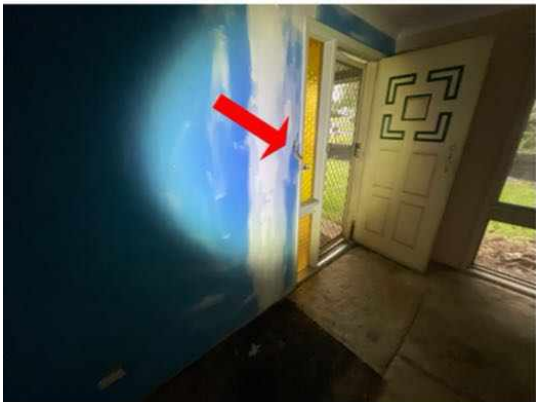
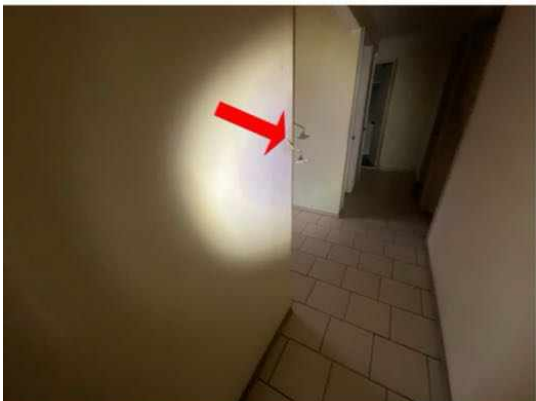
Building:	Main Building
Location:	All Internal Areas
Finding:	Safety Hazard – Electrical Fittings
Information:	Observation:

At the time of inspection, a number of light switches and power outlets throughout the dwelling were observed to be loose, displaced, or removed, with sections of exposed wiring visible. The property was noted to be in poor overall condition and unoccupied at the time of inspection. Based on the presentation, it is suspected that the fittings have been intentionally removed, possibly for testing or inspection purposes, rather than as a result of general wear and tear.

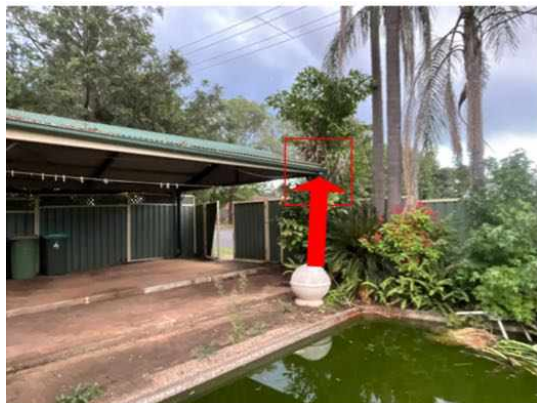
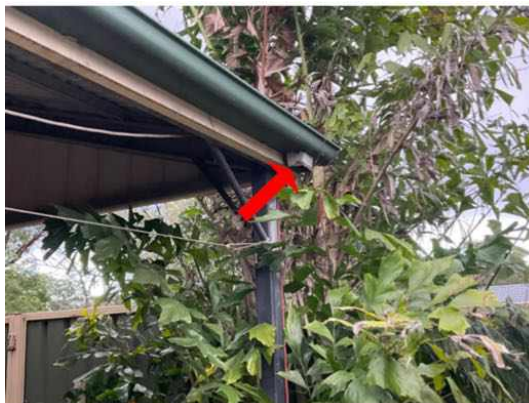
### Finding 3.05

Building: Carport  
 Location: Roof Exterior  
 Finding: Roof Plumbing – Loose Gutter  
 Information: Findings:

The absence of guttering and proper stormwater drainage in this area presents both functional and compliance issues. Prompt installation by a qualified roofing plumber is strongly recommended to mitigate moisture-related risks and ensure compliance with building standards.

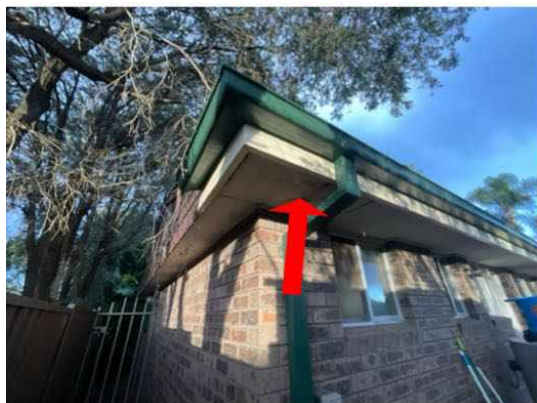
### Finding 3.08

Building: Main Building  
Location: Eaves - Front & Rear/right  
Finding: Eaves - Mould present.  
Information: Observation:

Mould growth and associated staining were observed on the eave linings in this area. This is typically caused by elevated moisture levels, which may result from a roof or gutter leak, or in some cases, excessive condensation within the roof space.

The source of moisture should be identified and rectified as necessary to prevent further mould development and potential damage. This may involve inspection of the roof covering, flashings, or guttering in the affected area.

Cleaning and/or repainting the eaves to restore appearance is at the client's discretion. A licensed painting contractor may be appointed to carry out such cosmetic works once the underlying cause has been addressed.

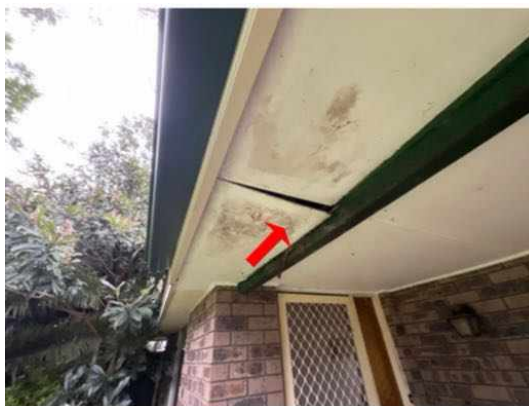
### Finding 3.09

Building: Main Building  
 Location: Eaves - Front  
 Finding: Sagging Eaves – Maintenance Required  
 Information: Observation:

- Eaves play a vital role in diverting water away from the building and shielding external walls and structural elements from excessive moisture exposure.
- Sagging may indicate moisture damage, structural fatigue, or failure of fixings, and if left unaddressed, can lead to water ingress, timber deterioration, or further

- Minor rectification works are recommended. A qualified carpenter or general handyman should be appointed to reinstate and secure the eaves to ensure proper function and alignment.
- Early maintenance will help prevent more costly repairs from developing over time.

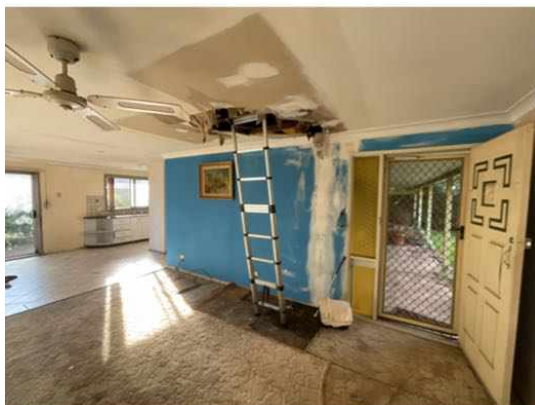
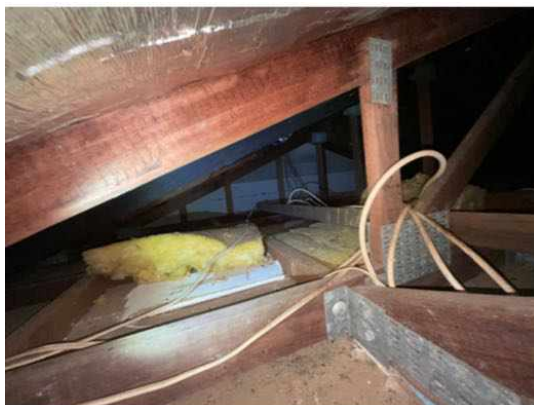
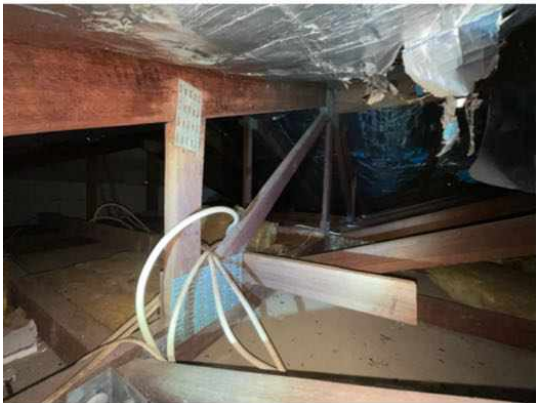
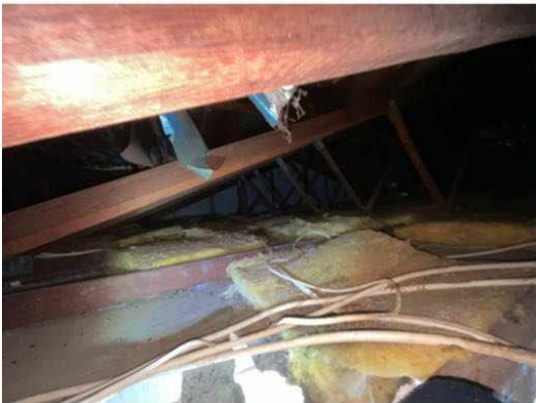
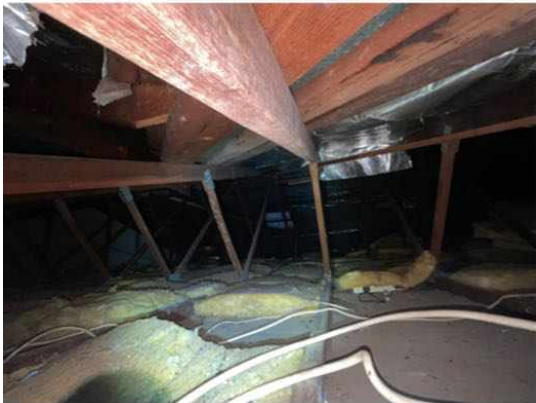
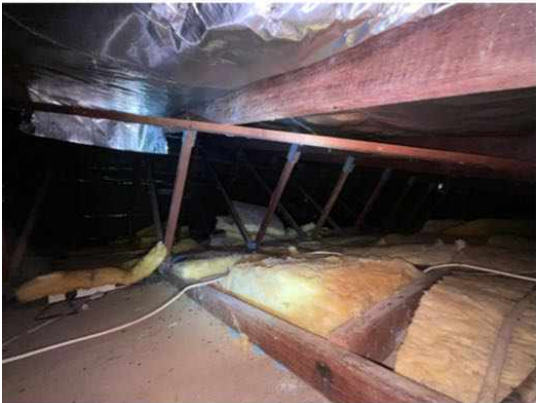
### Finding 3.10

Building: Main Building  
 Location: Roof Void  
 Finding: Roof Void Inspection Summary  
 Information: Access & Limitations

The roof void was partially accessible at the time of inspection. Access was restricted by low clearance and the presence of insulation, limiting movement and visibility within the space. Entry was obtained via a single access hatch. In addition, a large opening in the living room ceiling (previously identified as water damaged) provided partial visibility to a low-pitch section of the roof void.

Bulk insulation was present within the roof void; however, coverage was noted to be inadequate in areas, and sections appeared disturbed or damaged. Insulation above the documented leak-affected area has been impacted by moisture and requires replacement.

Sarking was present beneath the roof covering; however, sections were noted to be damaged or torn. Moisture staining was also visible in isolated areas.

Evidence of significant water ingress was observed, including a large opening in the living room ceiling associated with water damage and visible mould growth. Dampness and water staining were also noted in other isolated areas within the roof void. An active leak is suspected, likely associated with a blocked roof valley. Ceiling linings and insulation have been affected.

The roof void inspection identified evidence of active or recent water ingress resulting in damage to internal linings, insulation, and roof components. Access limitations restricted a full assessment; however, the extent of visible damage indicates the need for prompt investigation and repair. Early rectification is recommended to prevent further deterioration and potential secondary issues such as mould growth and structural damage.

Replace all moisture-affected insulation and reinstate to achieve consistent and adequate coverage across the roof void.

Damaged sarking should be repaired or replaced in conjunction with roof repairs to maintain weatherproofing integrity.

Immediate investigation and rectification by a licensed roofing contractor is required to identify and repair the source of water ingress, including clearing any blocked roof drainage elements. Damaged internal linings and insulation should be replaced following rectification.

Further investigation and remedial works are recommended by suitably qualified trades, including a licensed builder and roofing contractor.

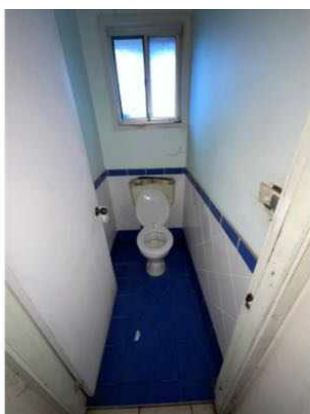
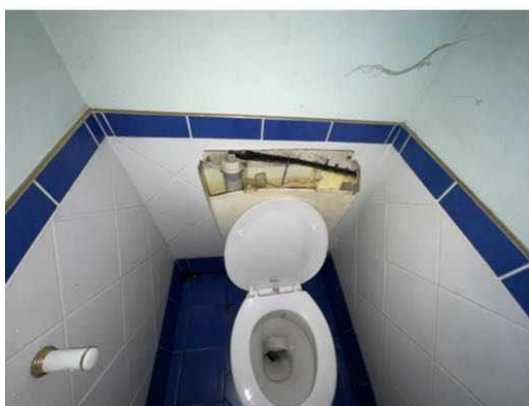
Finding 3.11

Building: Main Building  
Location: Toilet (WC)  
Finding: Toilet - Leaking.  
Information: Observation

At the time of inspection, the toilet was observed to be leaking and the cistern cover is missing.

While currently considered a minor defect, ongoing leakage may result in moisture damage to surrounding building elements, including flooring, wall linings, cabinetry, and structural timbers. If left unattended, continued moisture exposure may lead to decay, corrosion, and more extensive repair requirements.

It is recommended that a licensed plumber be engaged to inspect and repair the toilet as soon as practicable to prevent further deterioration and secondary moisture-related damage.

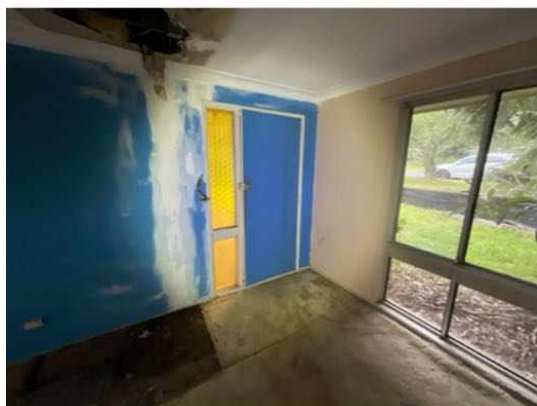
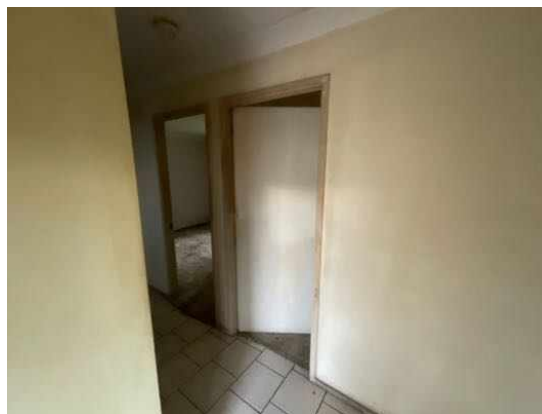
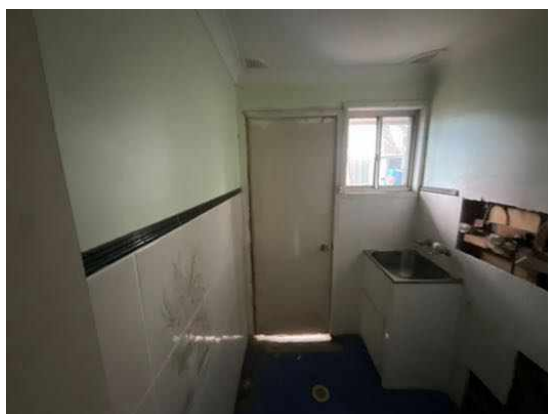
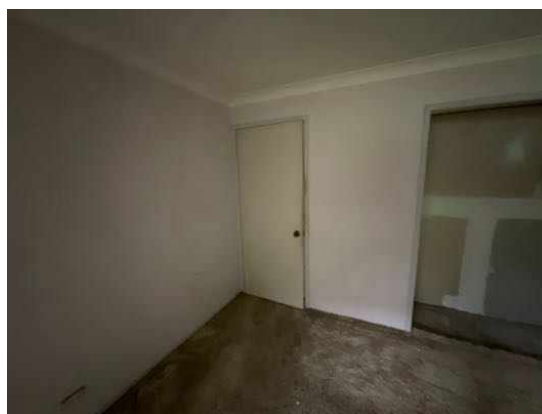
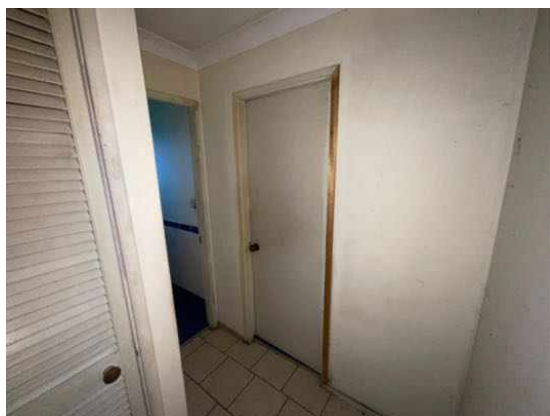
### Finding 3.12

Location: All Areas  
Finding: Door - Binding and/or Jamming.  
Information: Functional Defect Identified

- Where the issue is minor in nature, a qualified carpenter or general handyperson may be appointed to carry out corrective works at the client's discretion.

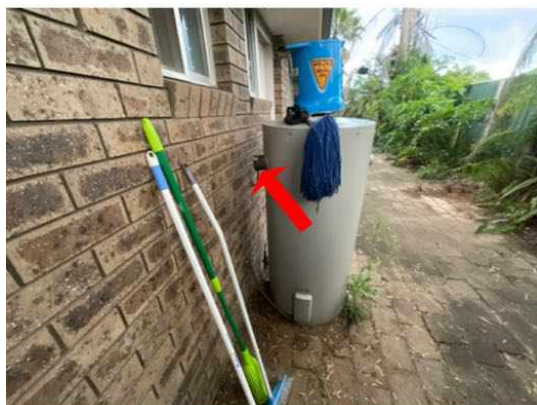
These minor corrective works should be undertaken promptly to minimise the risk of both termite ingress and potential structural damage due to ongoing moisture

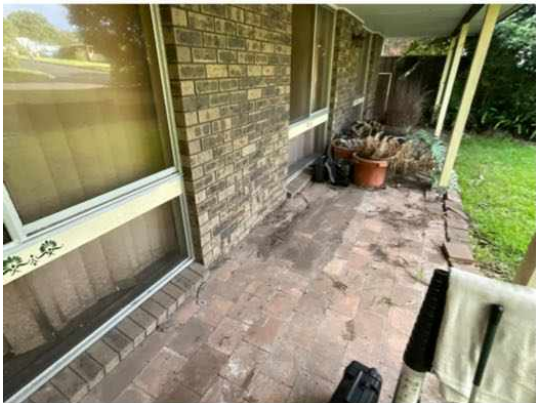
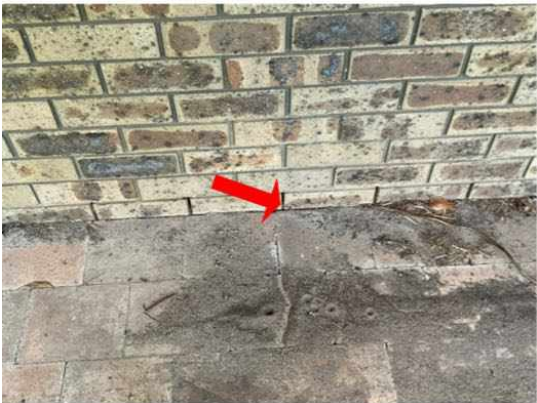
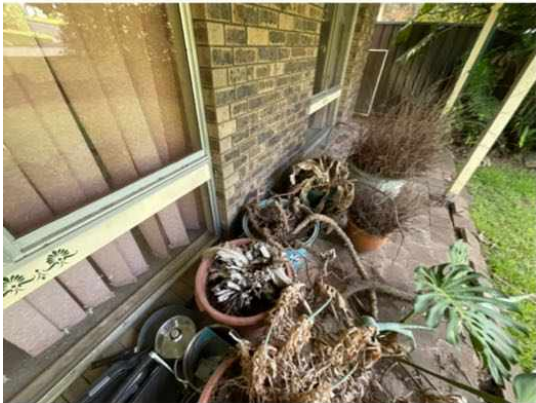
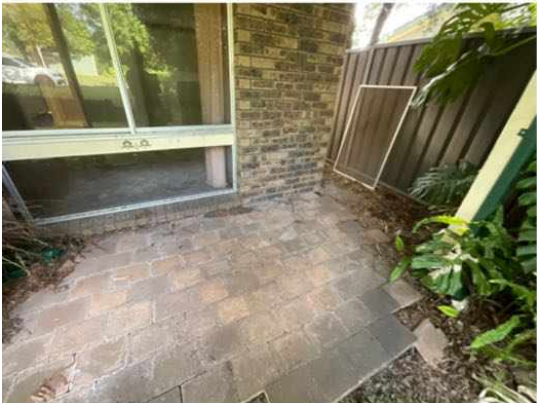
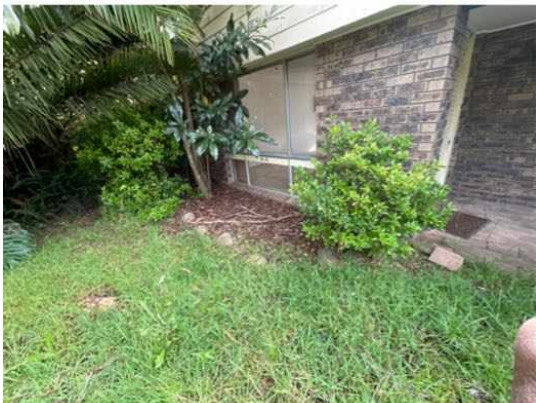
### Finding 6.03

Building:	Main Building
Location:	Exterior walls - front & rear
Finding:	Bridging of Termite Barriers – Concealed Weep Holes..
Information:	Observation:

- All weep holes should remain exposed and unobstructed across the entire property to allow for effective drainage and visual termite inspections.
- It is strongly advised that any material or structure covering weep holes be removed promptly, and a re-inspection carried out to ensure termite entry is not occurring undetected.
- Where removal of obstructions is not feasible, it is recommended that the area be inspected regularly, ideally every 3 to 6 months, to monitor for signs of termite activity or moisture-related damage.

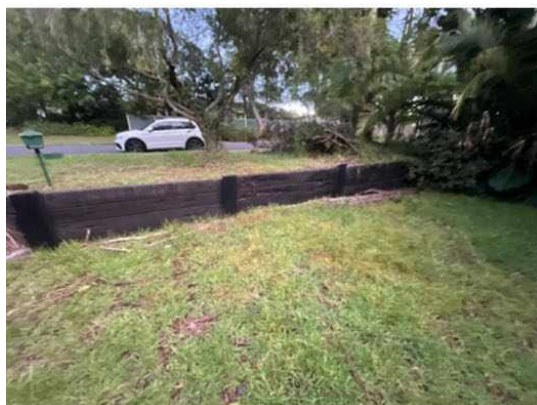
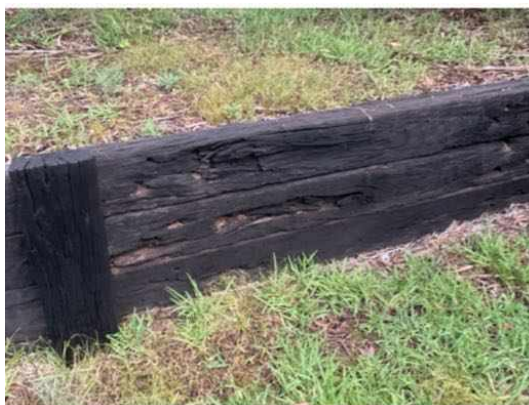
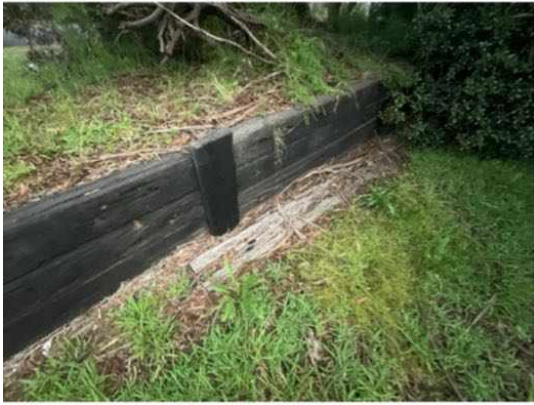
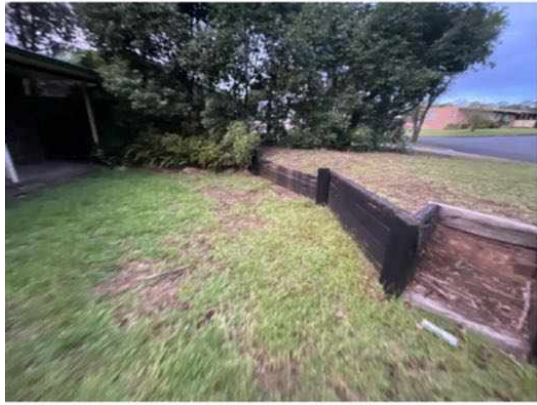
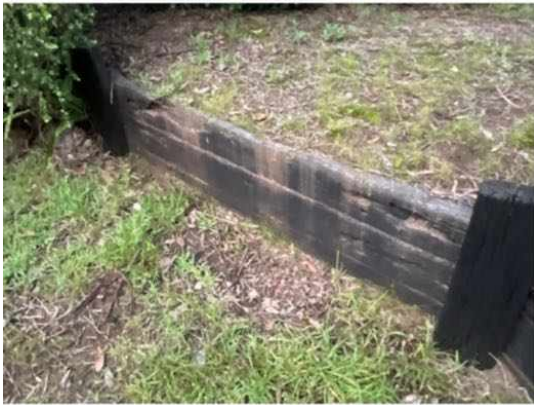
**Finding 7.01**

**Evidence of fungal decay activity and/or damage**

- Prompt removal of decayed or untreated timber is recommended to eliminate conducive conditions.
- Where necessary, replace susceptible materials with non-susceptible or treated timber suitable for external use.

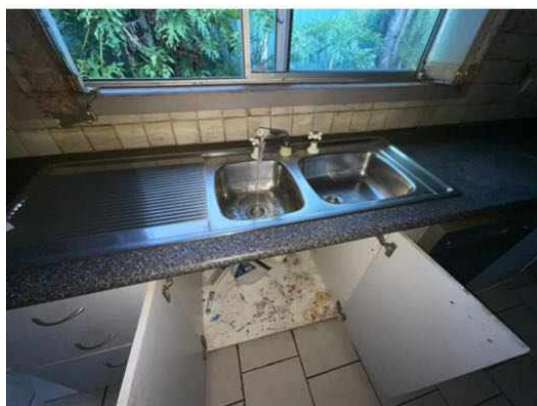
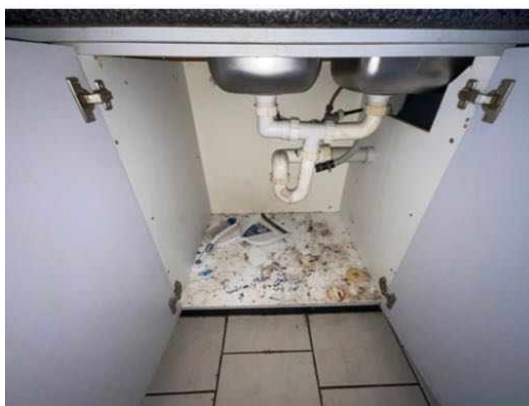
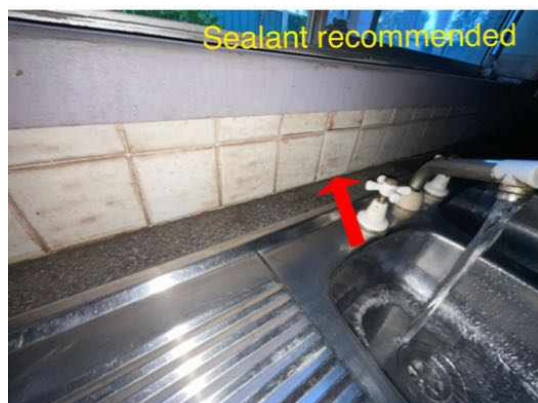
Building: Main Building  
 Location: Kitchen  
 Finding: Kitchen Sink – Overall Condition & Recommendations.  
 Information: Observations:

- The kitchen sink tap(s) were water tested at the time of inspection, with no evidence of leaks or blockages observed in the visible plumbing or drainage.
- No significant water damage was observed to the cabinetry/unit, however, minor water damage was noted, which may be indicative of past moisture exposure.

- Further monitoring and testing are recommended once the tap(s) are in constant use, to identify any drainage issues or signs of slow leaks not evident during the limited inspection.
- Flexible, mould-resistant sealant should be applied at wall junctions and other wet-area interfaces to prevent water ingress and potential damage. This is considered routine maintenance, and damaged or missing sealant should be replaced as needed.
- For long-term property care, it is advised that sealant and grouting in water-exposed areas be regularly inspected and maintained. A sealant specialist or tiling contractor may be engaged to carry out these works where necessary.

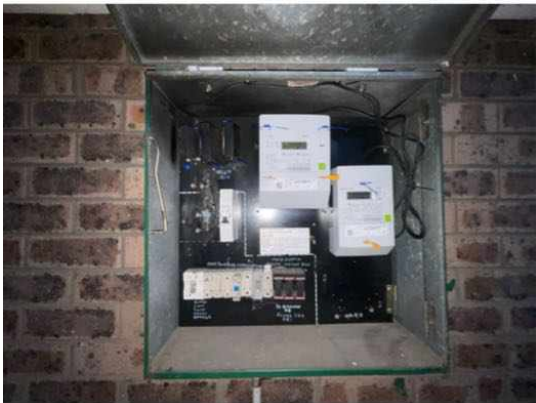
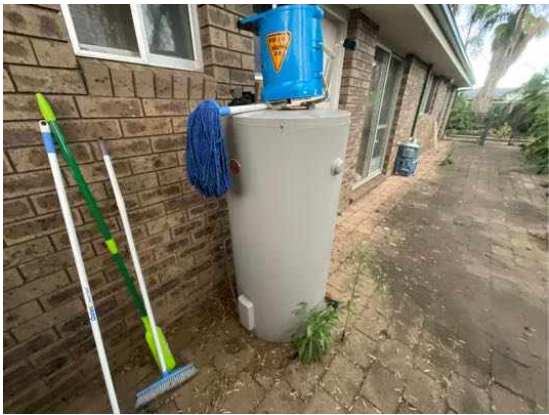
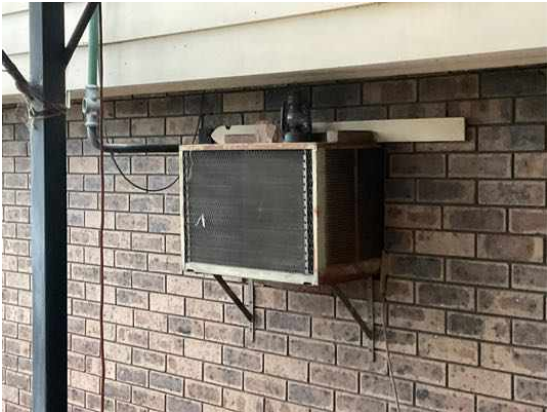
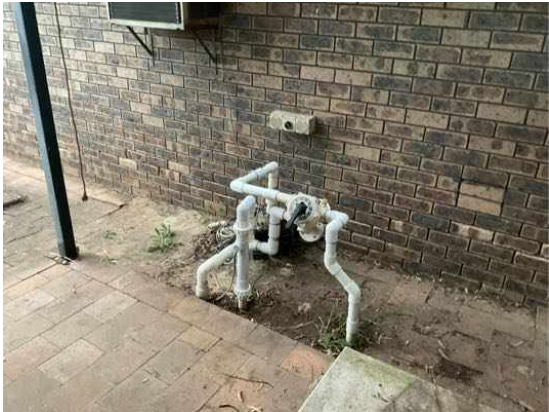
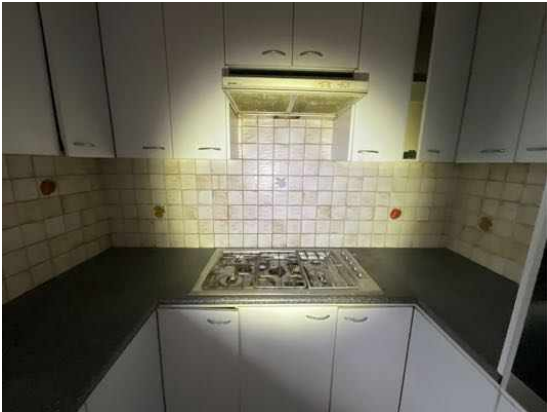
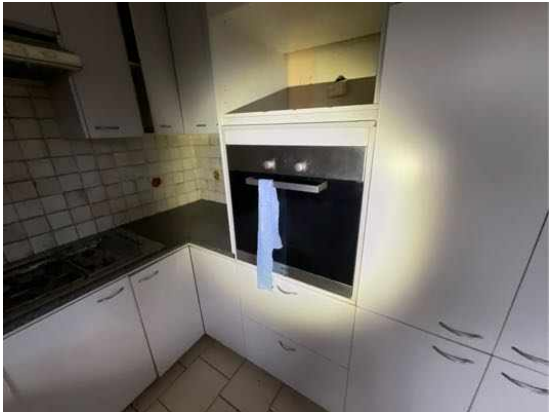
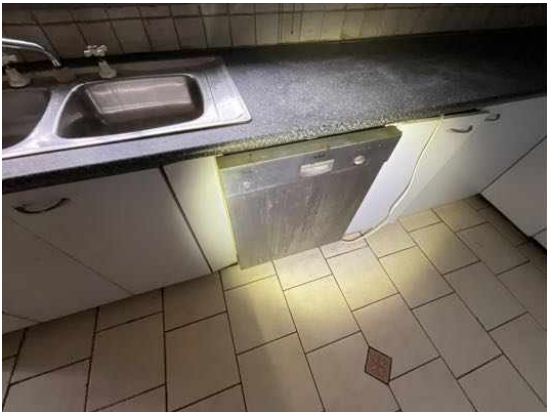
Building:	Main Building
Location:	All Areas
Finding:	Plumbing, Electrical & Gas Installations – Scope and Recommendations.
Information:	Plumbing and electrical inspections fall outside the scope of this building inspection and must be carried out by appropriately licensed and registered tradespersons.

Additional photos have been supplied with this report for your general reference.

- Any gas appliances (if applicable) must be inspected by a licensed gas plumber to confirm they are operating safely and efficiently.
- We also recommend that all other plumbing and electrical installations be thoroughly checked by qualified professionals to ensure they are functioning correctly and meet current safety and compliance standards.
