# Building and Timber Pest Inspection Report

Inspection Date: Tue, 24 Feb 2026

Property Address: 4/4 Kelsby St, Reservoir VIC 3073, Australia

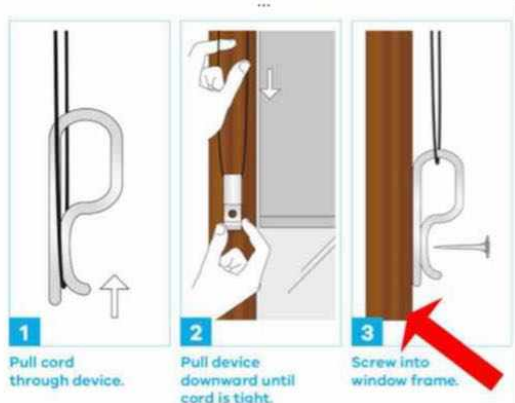
Building:	Main Building
Location:	Dining Room
Finding:	Curtain & Blind - Safety Cord
Information:	Looped curtain and blind cords pose a significant strangulation hazard for children as they can place the loop over their head and/or get tangled in the loose cords.

Check all the rooms in your house for any blinds or curtains with long cords that are either loose or looped. This includes any cords that are within children's reach at floor level or near furniture they can climb on.

Secure any loose or looped cords with cleats or tension devices – these can be purchased from your local curtain and blind retailer or hardware store. Do not put furniture such as cots, beds, highchairs, playpens, couches, chairs, tables or bookshelves near a window where children can reach the blind or curtain cord.

It is recommended that this defect be resolved immediately to avoid harm to occupants.

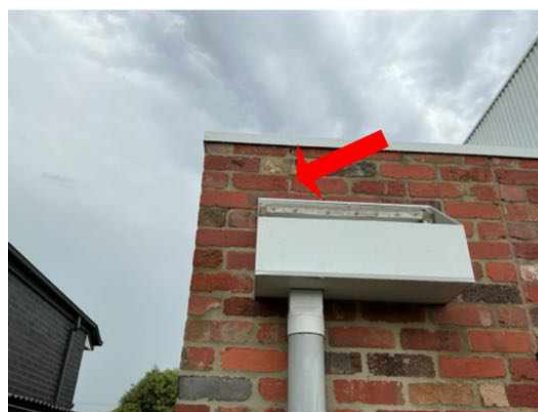
Building:	Main Building
Location:	Kitchen External wall
Finding:	Brickwork- Step cracking
Information:	Step cracking was identified to the brickwork in this area at the time of inspection. Step cracking, which is similar to other forms of cracking, has a variety of possible causes. However, the most common is the subsidence of adjacent footings.

Step cracking is a relatively common defect, and is most likely to occur adjacent to windows, doors and other openings. Mortar failure in the gaps between affected bricks indicates the stresses and tensions affecting the wall.

Where step cracking is extensive or severe, the client is advised to consult a Structural Engineer. Minor step cracking can be used as a warning sign to address factors causing stress to the wall, which can include the effect of surrounding trees, water leaks, soil erosion, or even the presence of reactive soils in the surrounding area.

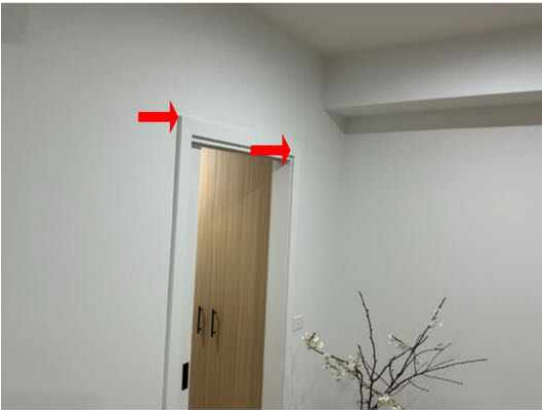
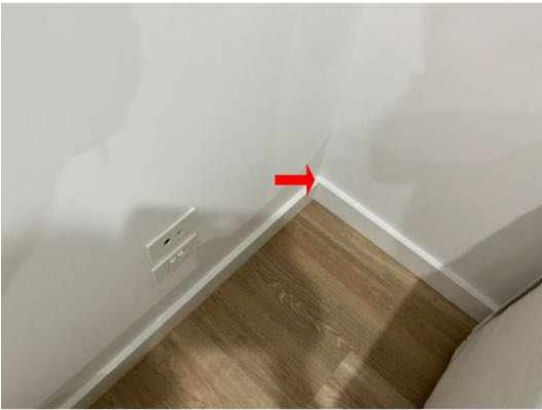
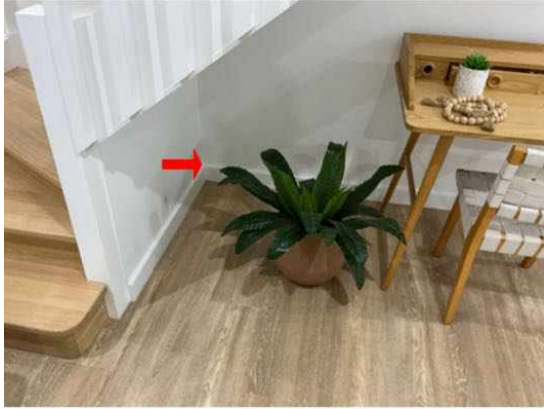
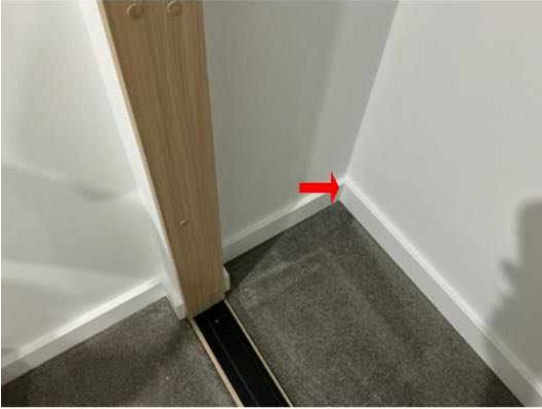
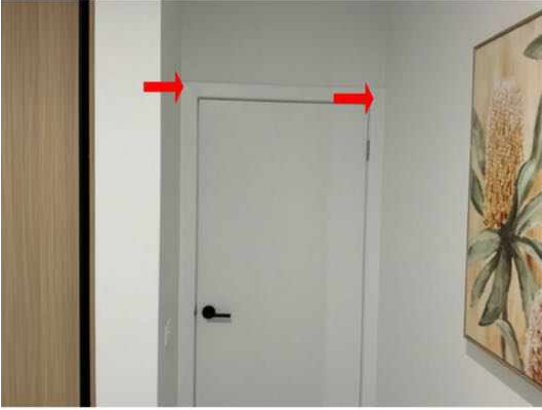
### Finding 3.03

Building:	Main Building
Location:	All Areas
Finding:	Cracking - Damage Category 1 - Fine (up to 1mm)
Information:	Although fine cracks are quite noticeable, they are often only considered to be an appearance defect, and usually do not indicate any structural damage. Generally, the cause of a fine crack is indicative of a separation between building materials and finishes (e.g. paint, plaster, etc.) along joins.

In this instance client have indicate that these cracks become visible after roof leaks. However the leaks have been repaired, and hence no change in terms of sizes.

Cracking of this nature can generally be repaired with minor sanding, filling and/or repainting. Such works should be performed by a qualified Painter or a general Handyman.

Monitoring of all cracking should be conducted frequently. Always contact a Building

Inspector should cracks widen, lengthen, or become more numerous.

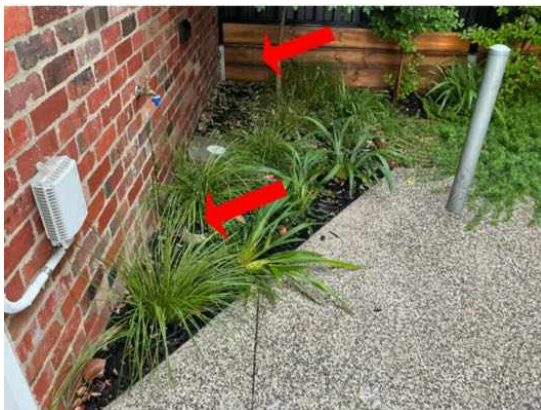
Building: Out Building  
 Location: Yard  
 Finding: Garden Beds - Conditions Conducive to Termite Attack  
 Information: Garden beds were found to be evident in close proximity to the building. Garden beds immediately adjacent to the perimeter of the building block the visual inspection of these areas, providing a concealed termite entry point.

Garden beds can include untreated timber and a combination of moisture from watering, which produce conditions conducive to termite activity and ingress.

Further advice from a Timber Pest Technician is required to ensure appropriate Termite Management systems are implemented.

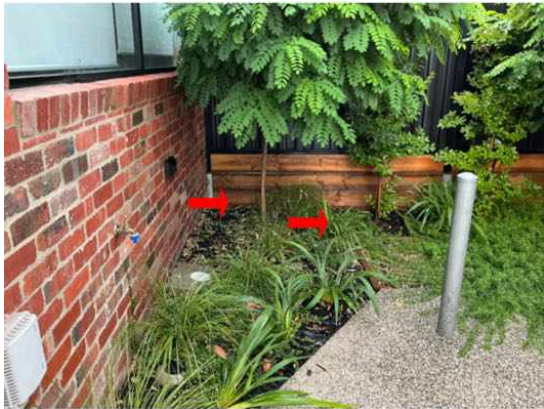
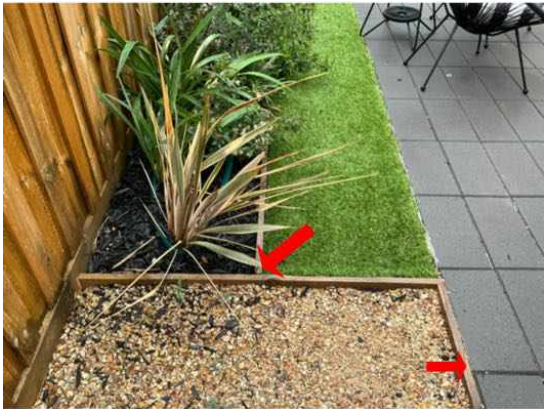
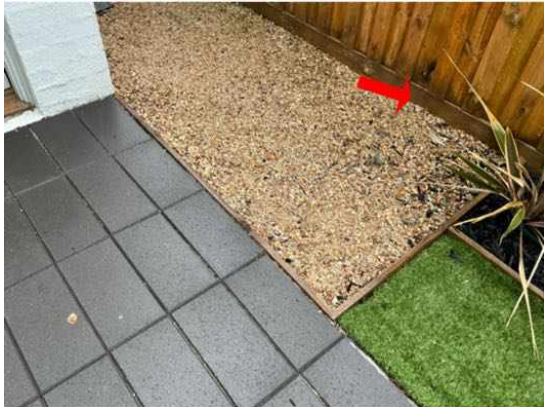
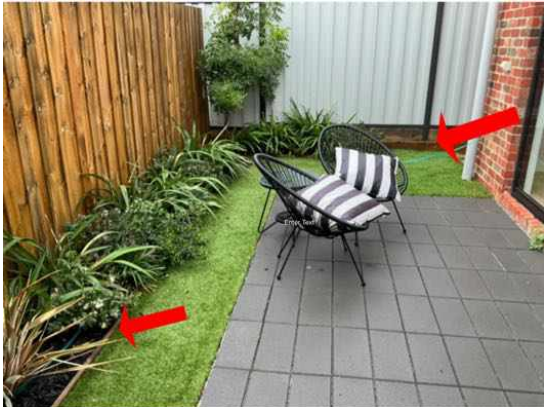
### Finding 6.02

Building:	Out Building
Location:	Yard
Finding:	In ground contact
Information:	Any timbers in direct ground contact provide opportunity for concealed termite entry and are likely to be subject to premature rot and decay as the soil retains moisture or damp conditions against the timbers.

Remove untreated timber that is in direct contact with external grounds. Consider replacement with more durable materials i.e. treated timber or non timber elements. Frequent pest inspections are advised to readily identify any termite activity in these areas.

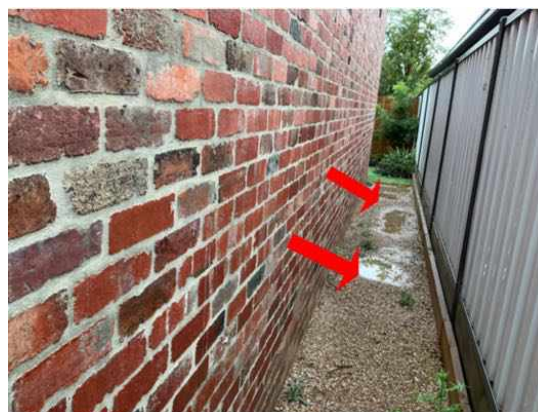
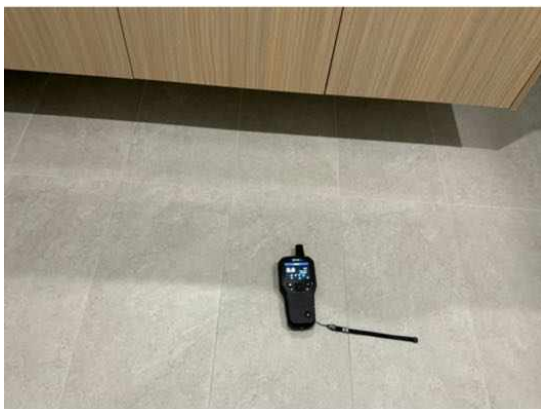
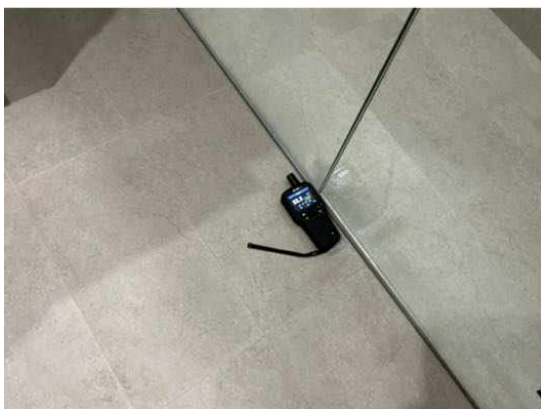
Building:	Main Building
Location:	Bathroom/main
Finding:	Evidence of excessive moisture was present at the time of inspection
Information:	A moisture meter was positioned at distance from the shower area to obtain a reference reading at the commencement of the measurements of the outside shower area. However, when I set the moisture meter to zero against the tiles next to the door, I observed elevated moisture readings.

Therefore, it is strongly recommended that all plumbing and drainage fixtures, fittings, tiles (grout and sealant), and other associated components be maintained regularly to prevent excessive moisture from accumulating within the internal property.

The shower was constructed prior to mandatory waterproofing to all wet areas. Therefore, we highly recommended that the shower be regouted with epoxy grout to prevent water penetration.

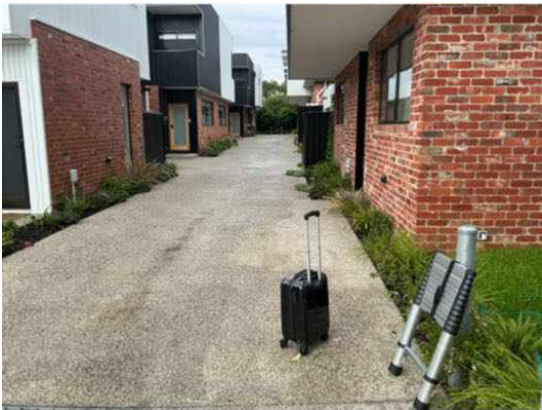
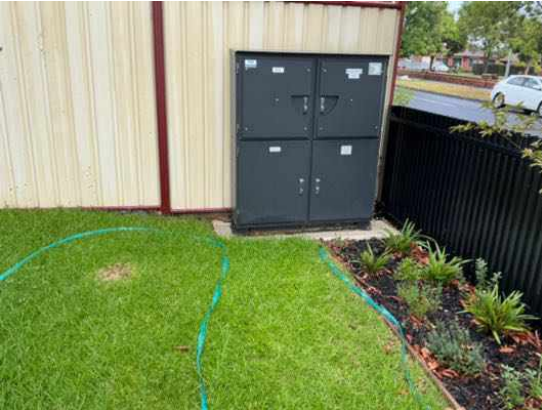
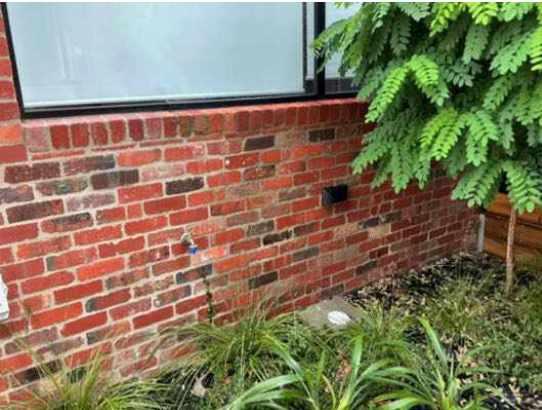
Building:	Main Building
Location:	All Areas
Finding:	Additional Photos - Obstructions and Limitations
Information:	These photographs are an indication of the obstructions and limitations which

impeded full inspection of the property at the time of inspection. These obstructions can hide an array of defects and should be removed to allow full inspection to be carried out. A re-inspection is recommended once the areas are made accessible.

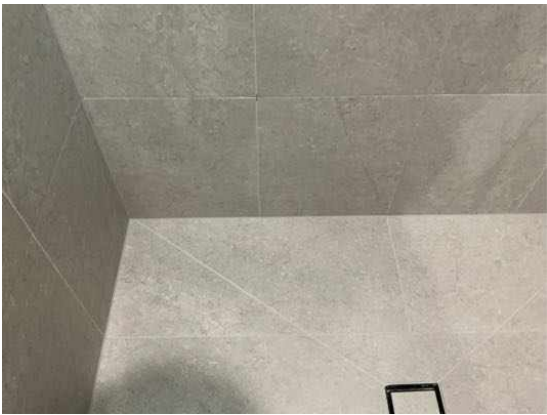
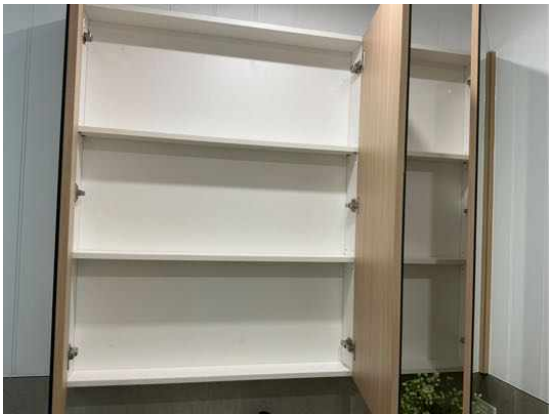
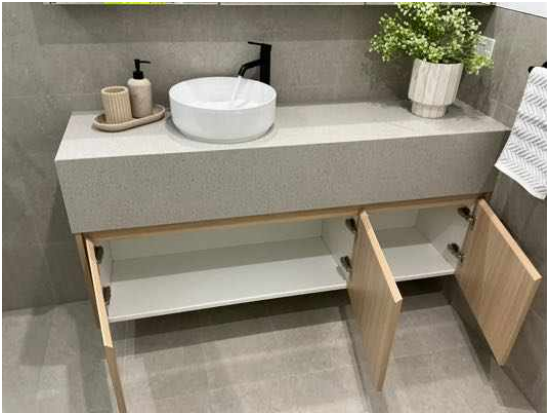
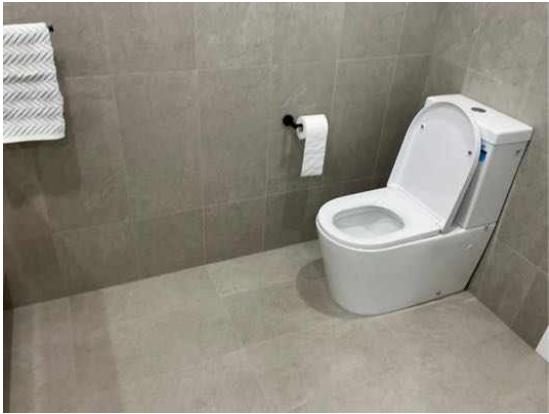
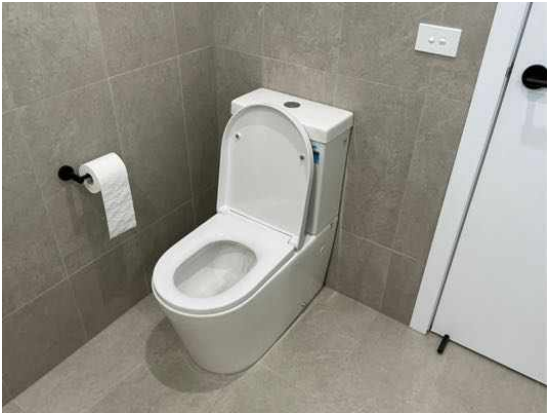
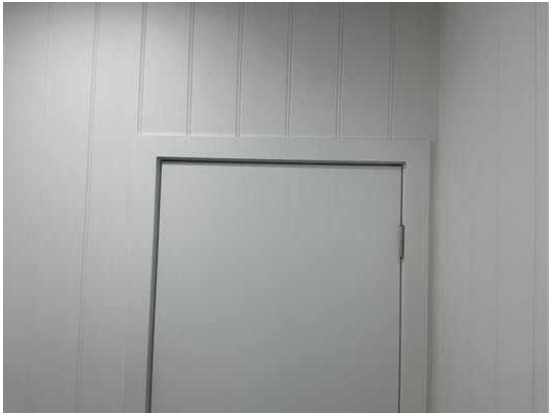
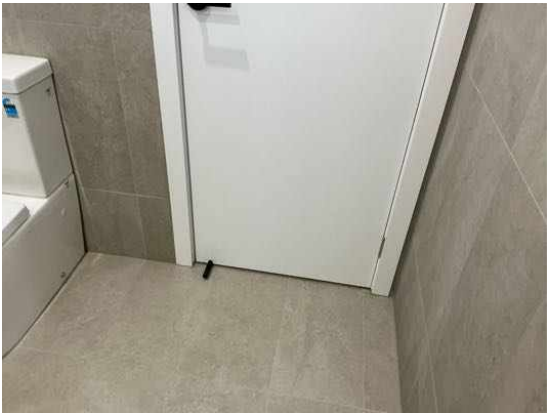
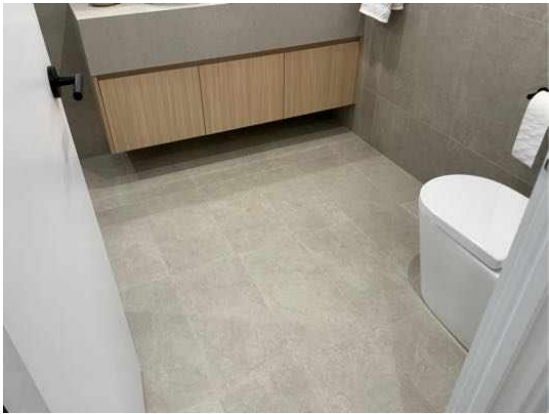
Building: Main Building

Information: These photographs are an indication of the obstructions and limitations which impeded full inspection of the property at the time of inspection. These obstructions can hide an array of defects and should be removed to allow full inspection to be carried out. A re-inspection is recommended once the areas are made accessible.
