# Building and Timber Pest Inspection Report

Inspection Date: Mon, 23 Mar 2026

Property Address: 5/2 Patricia St, Mays Hill NSW 2145,  
Australia

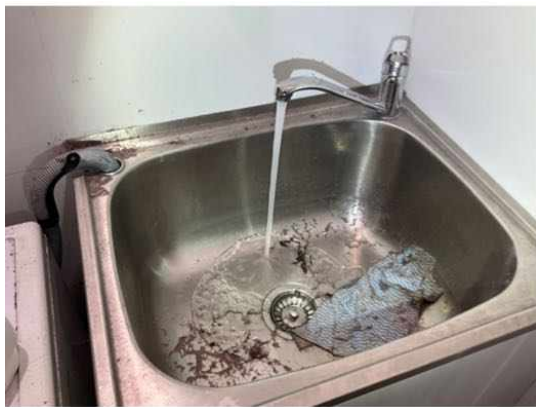
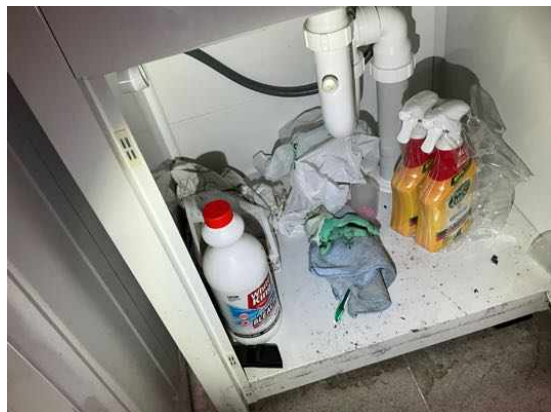
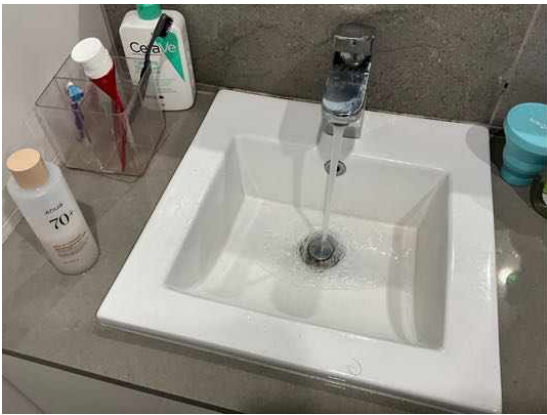
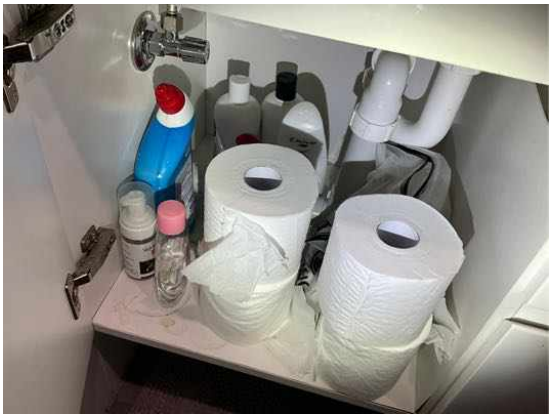
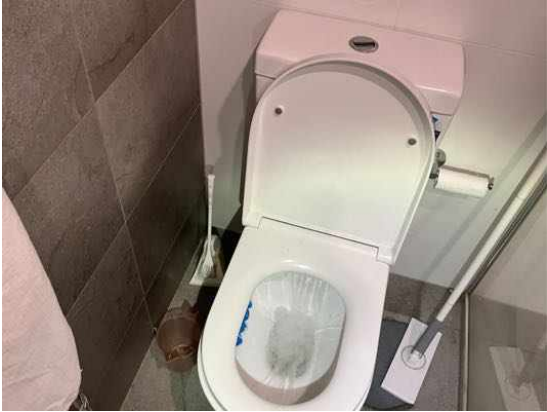
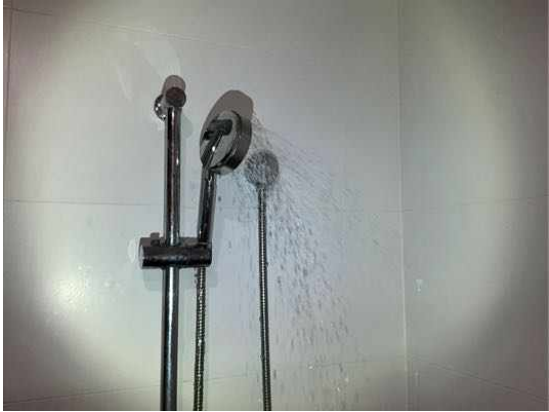
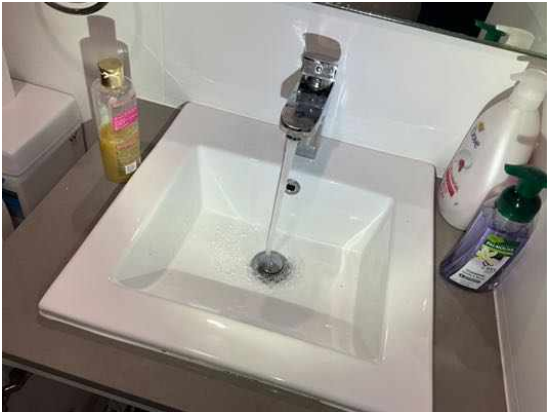
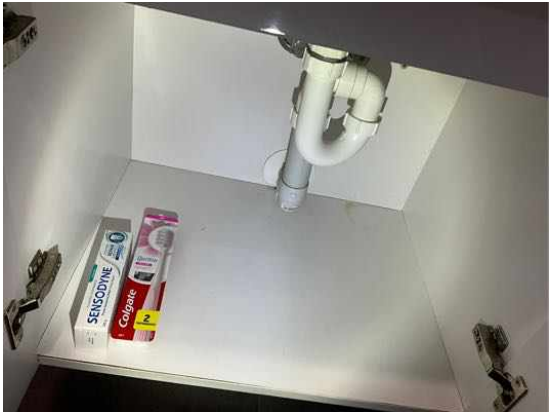
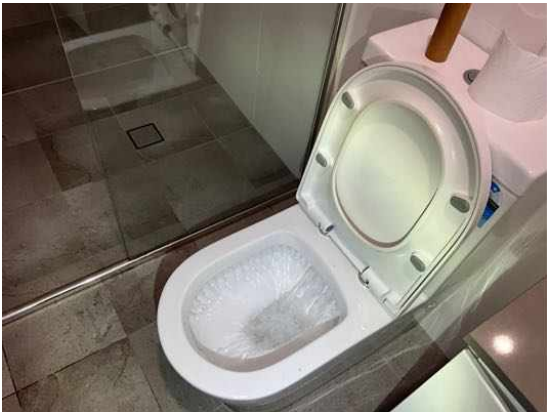
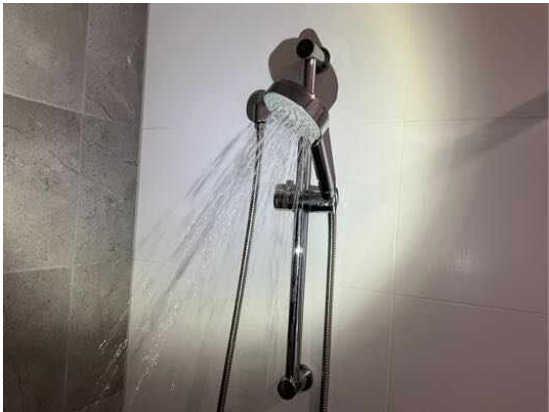
Building: Main Building  
Location: All Wet Areas  
Finding: Additional Photos  
Information:

Additional photos are provided for your general reference.

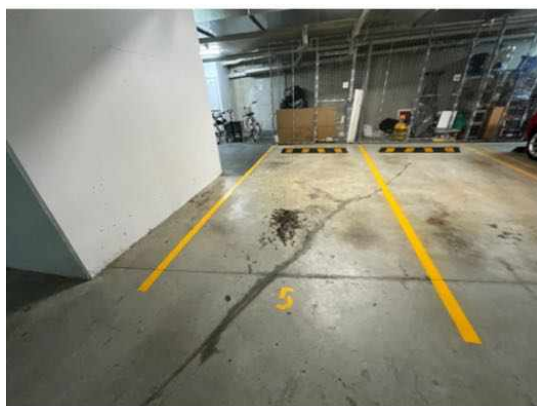
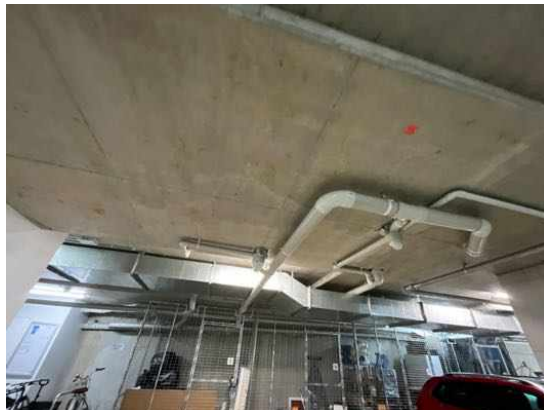
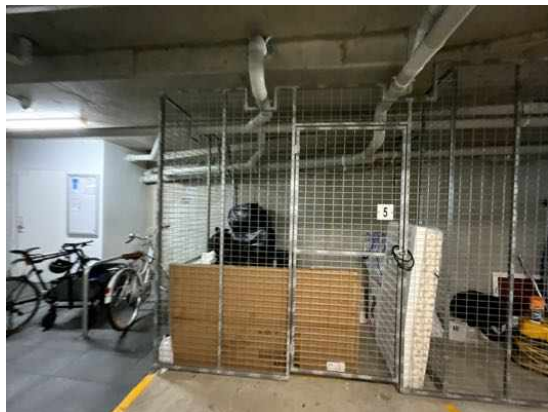
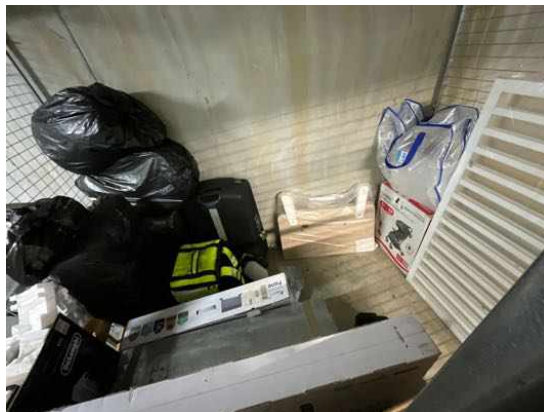
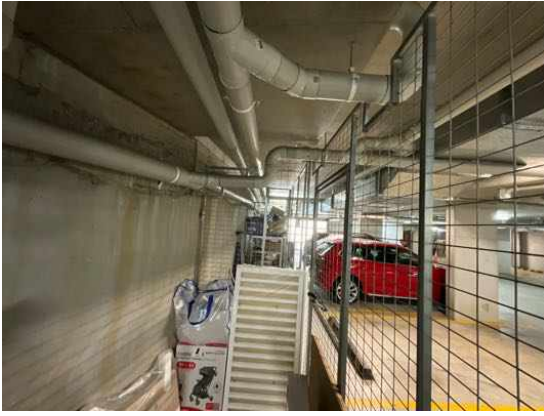
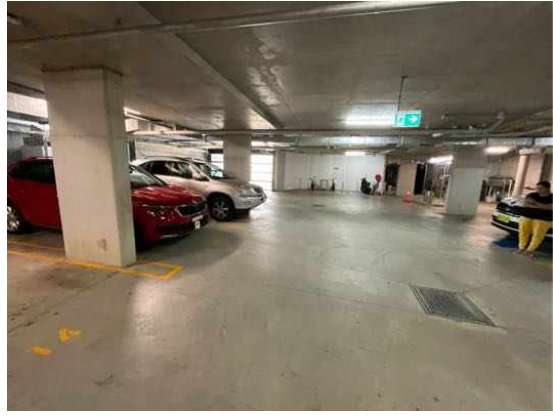
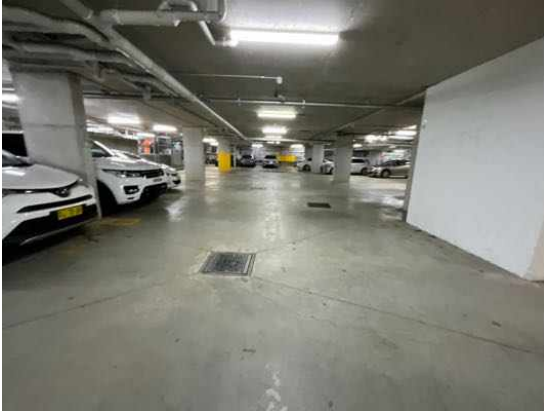
Building: Main Building  
Location: Garage  
Finding: Additional Photos- Garage  
Information: Additional photos are provided for your general reference. Arrows may have been included to highlight areas of importance. Please discuss these photos with your building consultant for clarification.

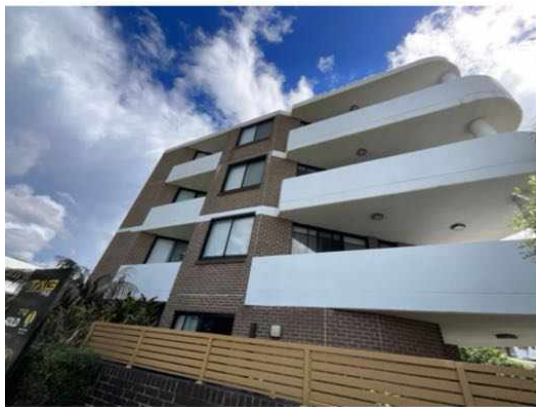
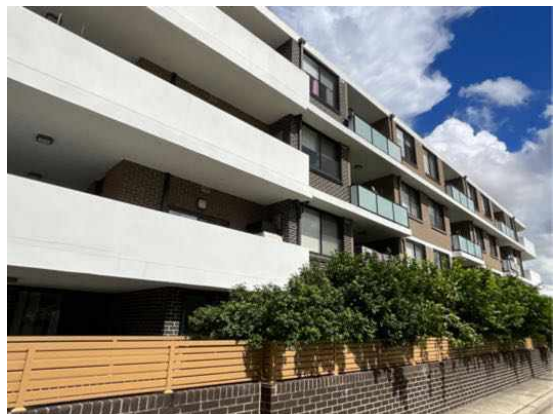
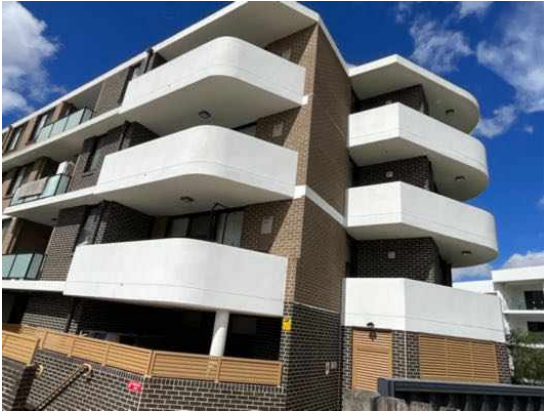
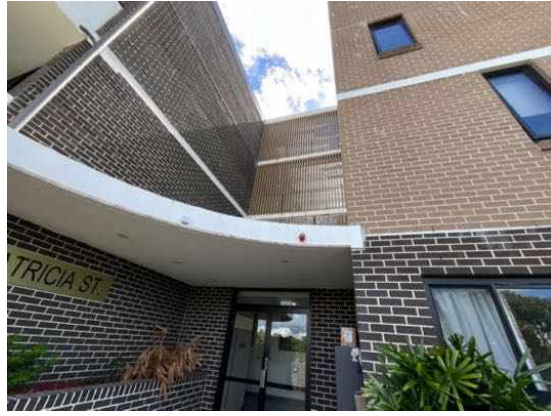
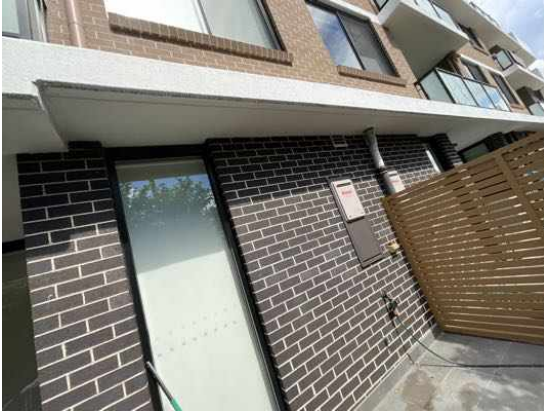
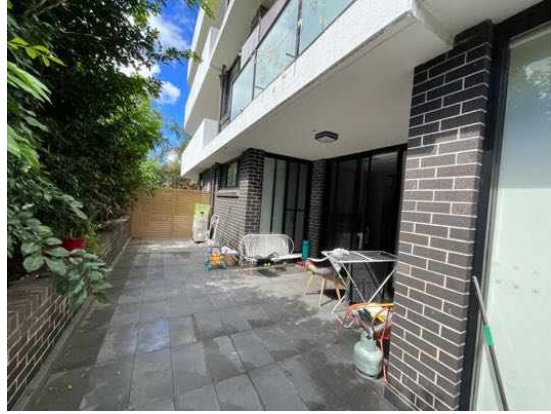
Finding: Additional Photos

Information: Additional photos are provided for your general reference.
