Building and Timber Pest Inspection Report

Inspection Date: Mon, 23 Feb 2026

Property Address: 7 Lexington Ave, Wadalba NSW 2259,
Australia

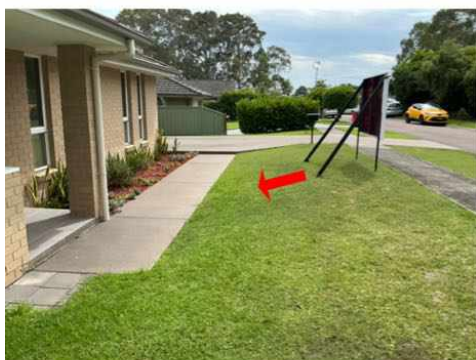
Building:	Main Building
Location:	Yard - Front
Finding:	Inadequate Site Drainage - Exterior Areas
Information:	At the time of inspection, inadequate site drainage was observed around the perimeter of the building, which can lead to water pooling and insufficient runoff management.

This condition may result in moisture being absorbed by the foundation or lower walls, potentially leading to rising damp, cracks in brickwork, erosion of the soil around the building, or structural issues over time. Water pooling can also create ideal conditions for mould growth, contribute to the deterioration of exterior materials, and act as conducive conditions for termite activity, as termites are attracted to areas with elevated and persistent moisture levels.

It is recommended that proper site drainage be installed, such as redirecting water flow away from the building or incorporating drainage systems, to prevent further damage and ensure the long-term stability of the structure.

To address the inadequate site drainage, a qualified landscaper or drainage specialist should be engaged to design and install appropriate drainage solutions, such as grading the ground away from the building or installing French drains, surface drains, or downspout extensions. If more complex issues are present, such as damage to the foundation or moisture entering the walls, a structural engineer may need to assess the situation, and a builder may be required for repairs.

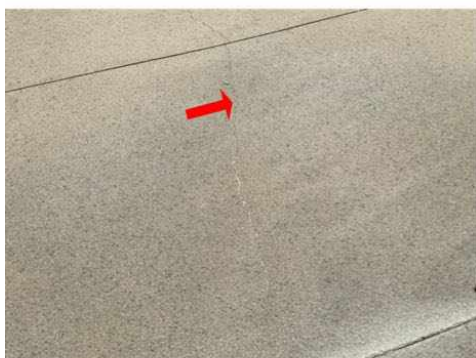
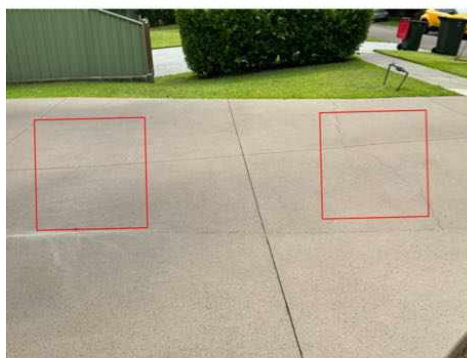
Finding 3.02

Building: Main Building
 Location: Driveway, Garage
 Finding: Crack in concrete slab - Category 2
 Information: A crack coded as Category 2 was identified in the slab. A Category 2 crack is described as a distinct crack, with the slab being noticeably curved or changed in level.

To be considered Category 2, the approximate width of the crack is less than 2.0mm, or a change in offset of less than 15mm when a 3m straight edge is placed over the defect.

Category 2 cracks to slabs should be monitored for a period of 12 months. At the end of the monitoring period, cracks rated greater than Category 2 are considered defects that require rectification.

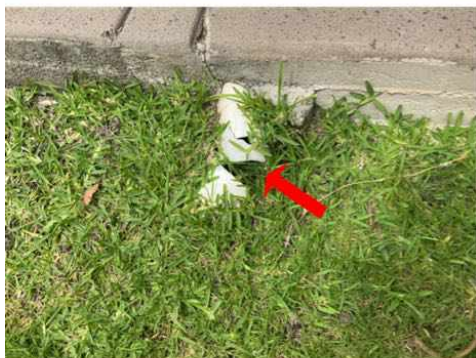
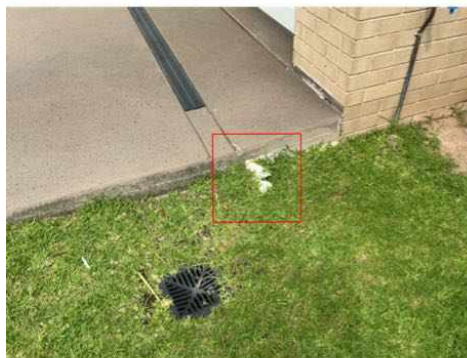
Finding 3.03

Building: Main Building
 Location: Near Driveway
 Finding: Plumbing Pipe - Damaged
 Information: At the time of inspection, the drain outlet pipe servicing the strip drain installed in front

of the garage was observed to be damaged and partially exposed at ground level. The pipe appears cracked/broken, which may impair the effective discharge of stormwater and could result in water pooling near the slab or foundation area. Prolonged water accumulation in this location may contribute to moisture ingress or undermining of adjacent ground surfaces.

It is recommended that a licensed plumber be engaged to assess the condition of the drainage connection and install a new compliant pipe to ensure proper stormwater discharge

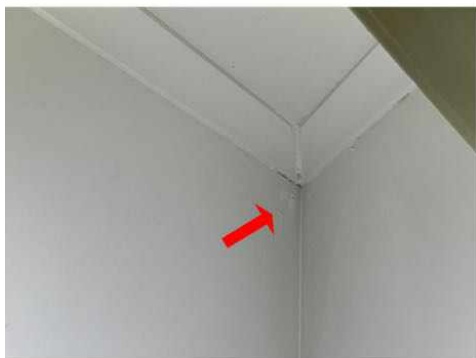
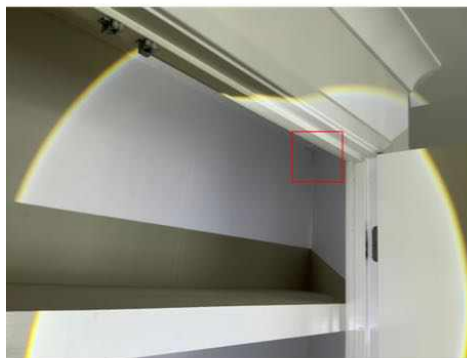
Finding 3.04

Building:	Main Building
Location:	Bedroom 4 Closet
Finding:	Paint Surface Irregularity
Information:	At the time of inspection, bubbling and uneven paint texture was noted to the upper corner area within the built-in robe of Bedroom Four. The affected area presented with a slightly raised and irregular finish; however, it was dry at the time of inspection. Inspection of the accessible roof space directly above did not reveal any active leaks or obvious moisture ingress.

While no immediate cause for concern was identified, such paint irregularities can sometimes be associated with past moisture exposure or minor condensation. The client is advised to monitor this area over the next 12 months for any signs of further deterioration, staining, peeling, or moisture development. Should the condition worsen or reappear, further assessment by a licensed builder or relevant tradesperson would be recommended.

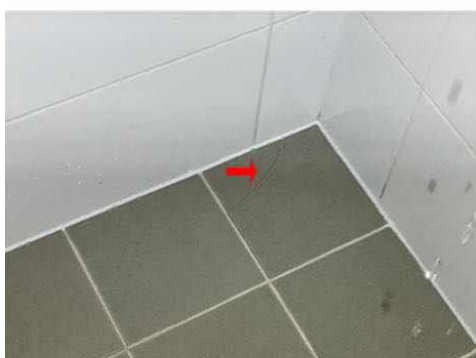
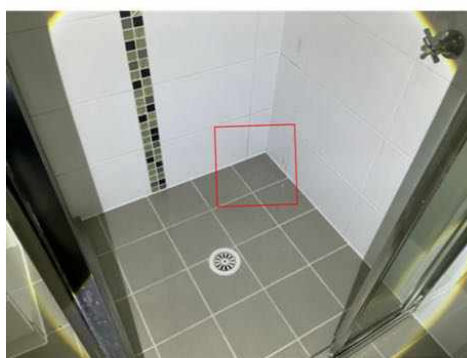
Finding 3.05

Building:	Main Building
Location:	Ensuite - Master
Finding:	Tiles - Cracked and/or Damaged
Information:	At the time of inspection, cracking in the tiles was evident in this area. It is suspected that this cracking has occurred as a result of minor settlement or material shrinkage.

While the cracking appears to be minor, this area may be exposed to water, allowing potential for water penetration into adjoining sections of walls or flooring. In wet areas particularly, cracked or compromised tiles can allow moisture to bypass the surface finish and place additional stress on the underlying waterproofing membrane. Over time, this may contribute to deterioration of the waterproofing system and shorten its effective service life.

While not considered a matter of urgency, replacement of cracked floor tiles is recommended at the client's discretion, particularly in wet areas to preserve the integrity and longevity of the waterproofing system. A licensed tiling contractor may be appointed to perform these works.

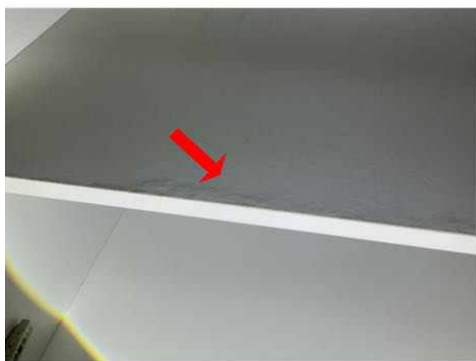
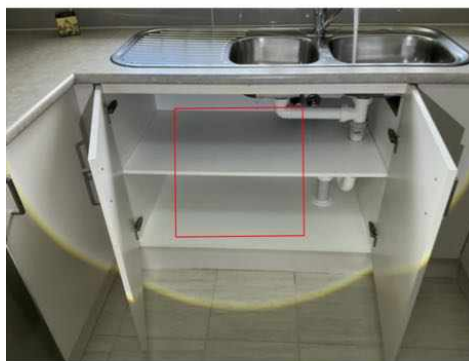
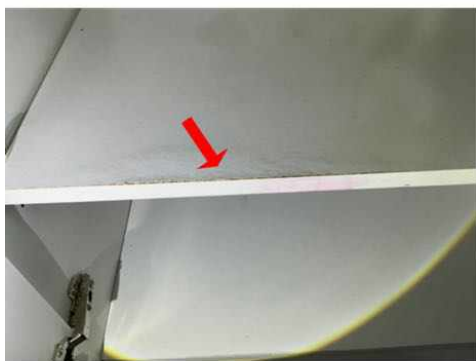
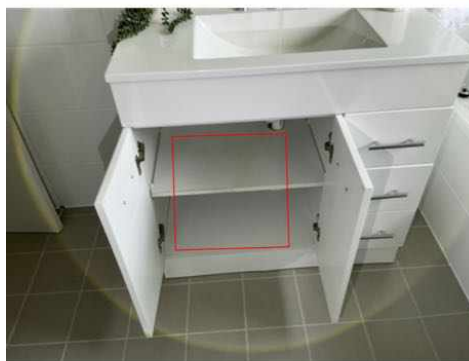
Finding 3.06

Building:	Main Building
Location:	Kitchen, Bathroom

Finding: Cabinetry - Water Damage
 Information: At the time of inspection, water-damaged cabinetry was observed, indicating previous or ongoing exposure to moisture. The affected sections show swelling, discolouration, and material deterioration, which may reduce the cabinetry's structural integrity and appearance over time. It is recommended that the client engage a cabinet maker to repair or replace the damaged sections and inspect for any underlying leaks or moisture sources to prevent recurrence.

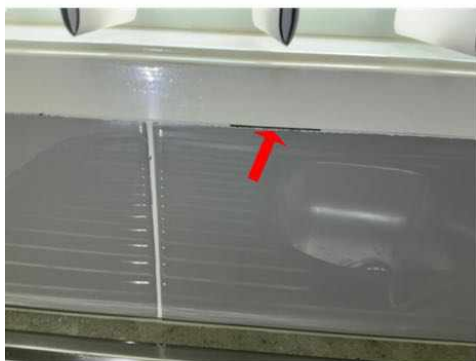
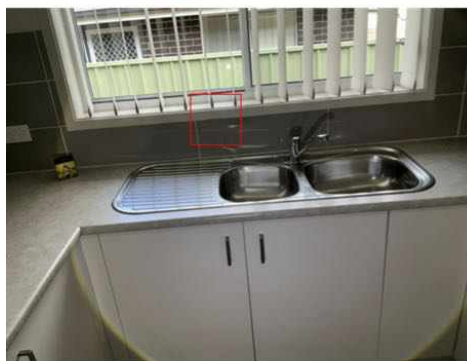
Finding 3.07

Building: Main Building
 Location: Kitchen
 Finding: Sealant/Grouting - Missing or Damaged
 Information: At the time of inspection, areas of missing and/or deteriorated sealant and grout were noted in this area. This condition can allow water to penetrate behind finishes, which may lead to moisture ingress, deterioration of waterproofing membranes, mould growth, and potential leaks into adjoining areas over time. If left unaddressed, this may result in costly repairs and hidden water damage.

It is recommended that a licensed plumber (or suitably qualified tradesperson experienced in wet area sealing) be engaged to assess the affected areas and reinstate compliant waterproof sealant and grout as required, ensuring all junctions are properly sealed to prevent further water ingress.

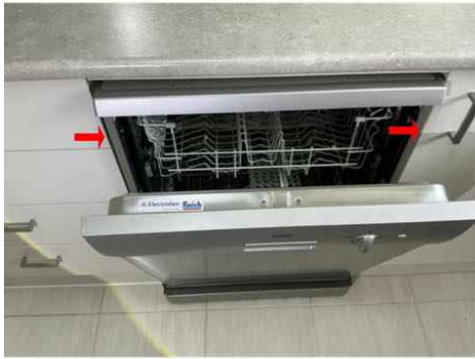
Finding 3.08

Information: At the time of the inspection, it was noted that the dishwasher in this area was not securely installed and appeared to be loose. This improper installation requires prompt attention to ensure the appliance is correctly fitted and stable. If left unmanaged, the condition of the fitting may worsen over time, potentially leading to further deterioration and the development of additional minor defects. These secondary issues could affect both the dishwasher itself and the surrounding cabinetry or flooring.

A loose dishwasher may produce excessive noise and vibration during operation, which can be both disruptive and uncomfortable for occupants. The lack of secure installation may also place strain on the dishwasher's components, potentially reducing the lifespan of the appliance and leading to more significant repairs or maintenance needs in the future.

It is strongly recommended that a qualified plumber be appointed to carry out the necessary rectification work. Ensuring the dishwasher is securely installed will improve its performance, reduce noise and vibration, and prevent further damage to the surrounding area. The client should engage a professional plumber to complete these repairs, ensuring the appliance operates efficiently and safely.

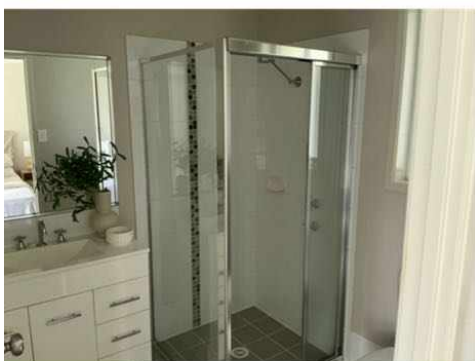
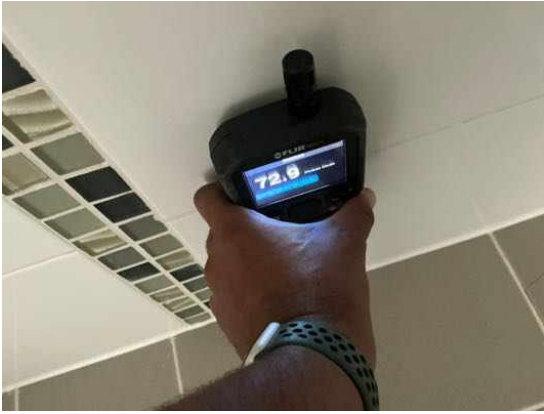
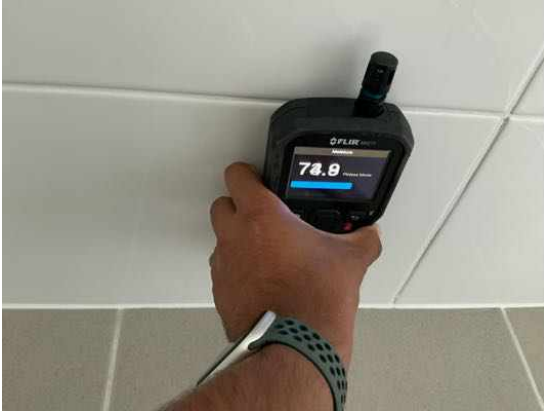
Finding 3.09

Building:	Main Building
Location:	Both Bathrooms
Finding:	Excessive Moisture - Shower Damp
Information:	At the time of inspection, excessive moisture was noted within the shower area, which is a common issue in wet areas due to the continual exposure to water. This condition is typically caused by moisture seeping through grout lines and settling behind tiles, resulting in localised high-moisture zones. Provided there is no evidence of water staining or elevated moisture readings on the opposite side of the wall, this is considered a minor defect.

However, persistently damp conditions may act as conducive conditions for termite activity, as termites are strongly attracted to moisture-rich environments. It is recommended that the client ensures regular use of the exhaust fan and maintains adequate ventilation after shower use to promote drying and reduce long-term moisture build-up, thereby also reducing the risk of attracting termites.

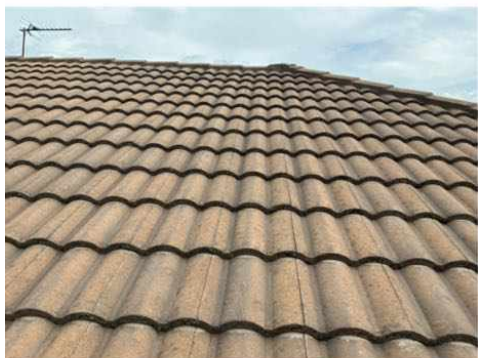
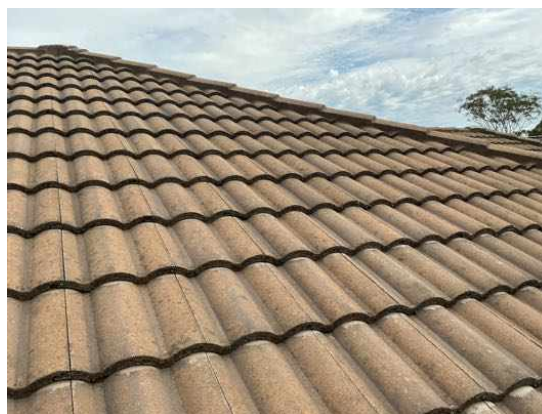
Finding 3.10

Information: It was noted at the time of inspection, the roof shows signs of weathering, with visible wear on the tiles and accumulated debris, such as leaves and branches. The tiles appear aged, which could lead to reduced durability if left unaddressed. Regular maintenance is advised to preserve the roof's integrity and prevent further deterioration.

Although no further action is required at the moment, the client is advised to get recommendation from Roofer for resurfacing in future.

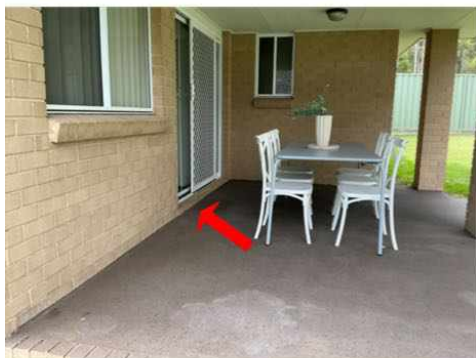
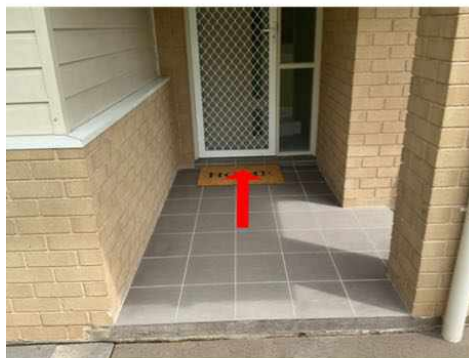
pooling and subsequent internal flooding is likely to occur which may attract termite activity to the internal area.

It is highly advised that a landscaper or relevant tradesperson be appointed to lower external grounds that are raised above or same as adjacent internal flooring. Alternatively if external grounds and internal flooring is level installation of a raised door sill may be appropriate in preventing any water pooling in the area. If the client wishes not to make any changes, then a qualified pest controller is recommended for termite treatment around the perimeter of the house and subfloor (if any) as soon as possible.

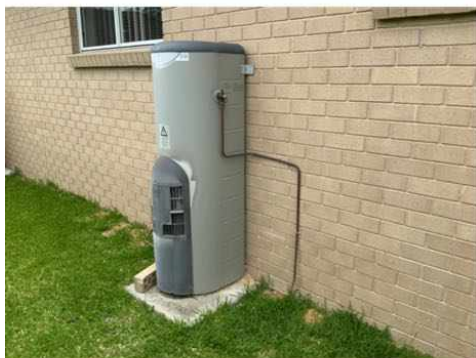
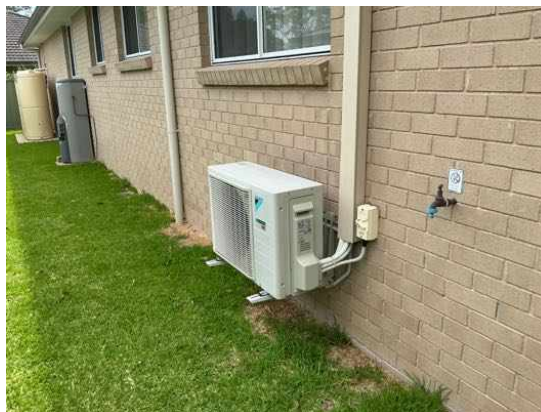
Finding 6.02

Building:	Main Building
Location:	Exterior walls - rear
Finding:	Bridging Appliances - Attachment to Buildings
Information:	Bridging occurs when items against a building provide a concealed entry point for termites into the building or by passing around a termite management system.

Where any part of an attachment to a building is not isolated and is not provided with a clear gap of not less than 25mm from the building, bridging occurs. Attachments to buildings such as hot water services, downpipes, verandahs, decks, steps, fences, service conduits and the like provide the opportunity for concealed entry.

Building attachments of this nature need to be frequently inspected for termite activity by a qualified inspector.

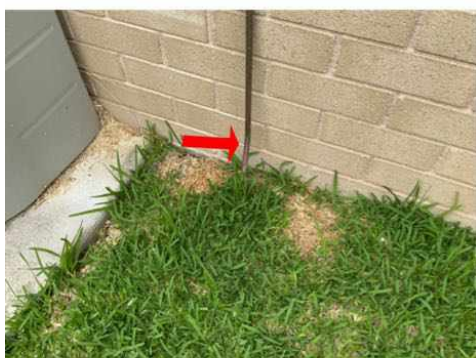
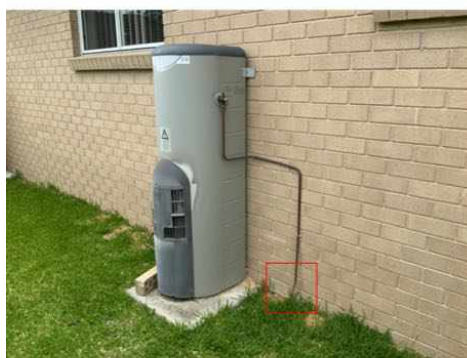
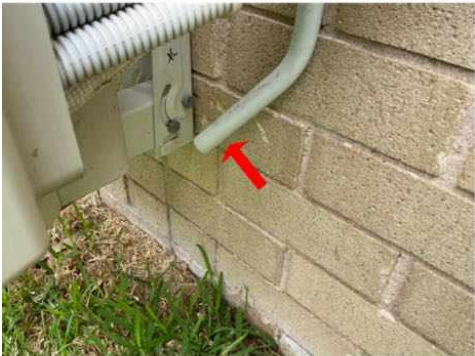
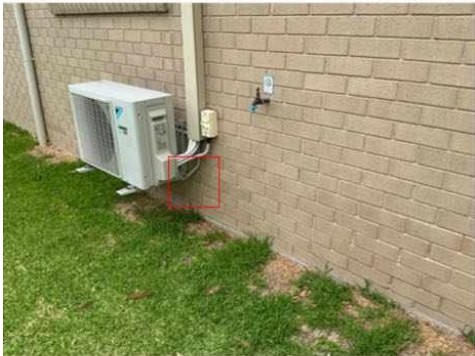
Finding 6.03

Building: Main Building
 Location: All Areas
 Finding: Overflow Disconnected - HWS/AC/Gas - Conducive Conditions to Termites
 Information: The overflow to this service was found to be disconnected from stormwater drainage and is creating excessive moisture in the surrounding area.

Such leaking creates an environment that is conducive to an array of defects, including water damage to associated building elements and the attraction of termite or timber pest infestation. These damp conditions can lead to secondary defects such as rot, rust, or corrosion of associated building elements, the formation of fungal decay, or even the creation of potential slip hazards. When coupled with poor site drainage, pooling of water may also attract termite activity to this area.

It is highly recommended that a licensed plumber be appointed to connect the overflow in order to prevent such an environment from being created. These minor works should be carried out as soon as possible.

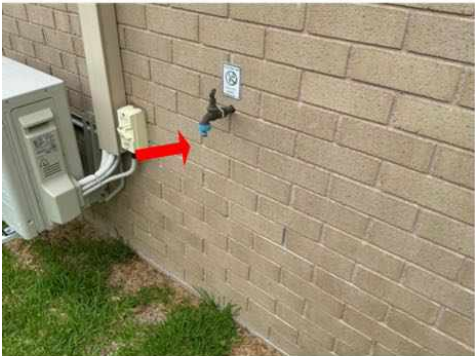
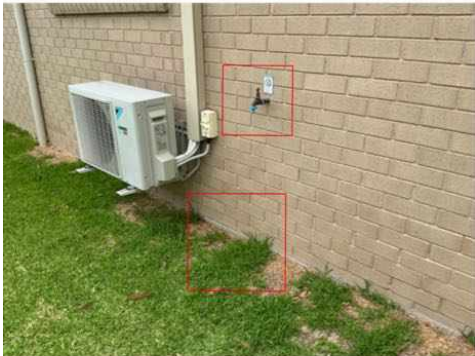
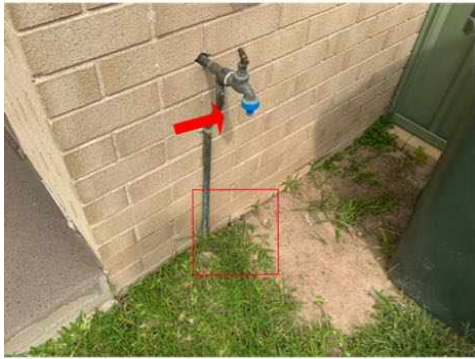
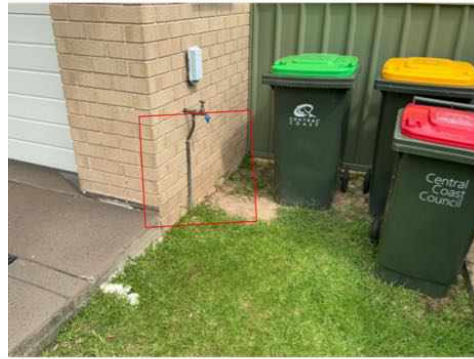
Finding 6.04

Information: The inspection identified that the exterior tap is not connected to a stormwater drainage system, allowing water to pool around the base. This can lead to moisture-related issues such as deterioration of nearby building materials, mould growth, and increased risk of termite activity—each of which may compromise the property’s structural integrity and create health or safety concerns.

To prevent these risks, it is strongly recommended that a licensed plumber be engaged to assess the area and install appropriate drainage, such as a stormwater connection or splash block, to redirect water away from the property. Ongoing maintenance and monitoring of external water sources are also advised to ensure long-term protection.

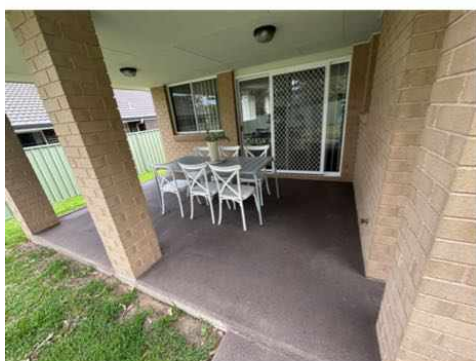
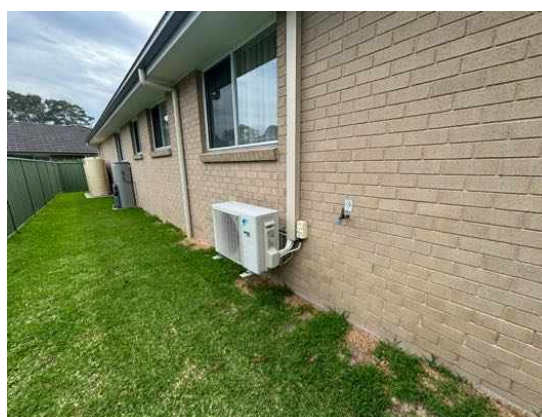
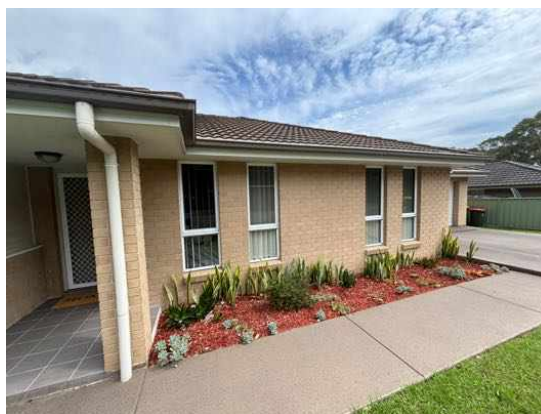
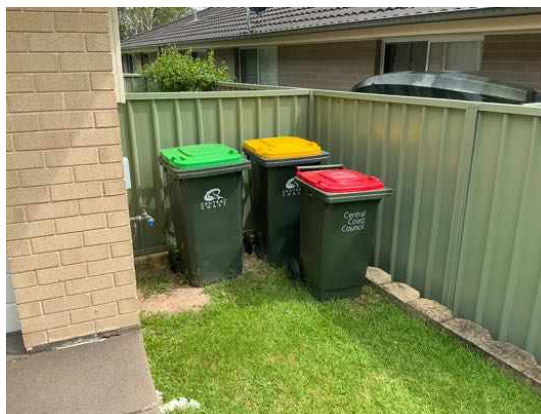
Building: Main Building
Location: All External Areas
Finding: Obstructions and Limitations - External Areas
Information: The attached photographs provide a visual representation of the obstructions and limitations that impeded a full inspection of the external areas of the property at the time of assessment. These obstructions, which may include vegetation, stored items, debris, or other physical barriers, can obscure potential defects and prevent a thorough evaluation of the property's condition. Obstructions of this nature can conceal a wide range of issues, such as structural damage, water ingress, pest infestations, or deteriorating building materials, which may not be visible during the initial inspection.

It is essential that these obstructions be cleared to allow for a comprehensive inspection of the external areas. Removing these barriers will enable a more accurate assessment of the property's condition and allow any hidden defects to be identified and addressed promptly. Failure to do so could result in undetected issues worsening over time, potentially leading to more costly repairs in the future.

Therefore, it is strongly recommended that the obstructions be removed and a re-inspection be scheduled once the affected areas are made fully accessible. This will ensure a complete evaluation of the property's exterior and provide the client with a clear understanding of any potential issues that may have been concealed during the initial inspection.

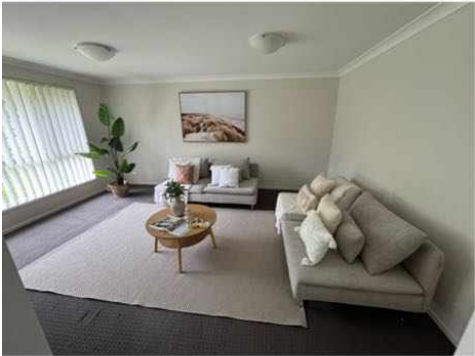
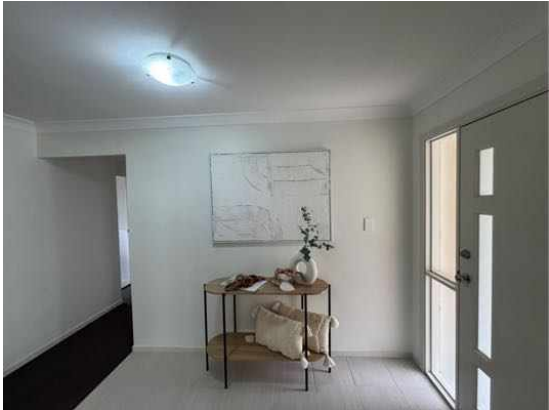
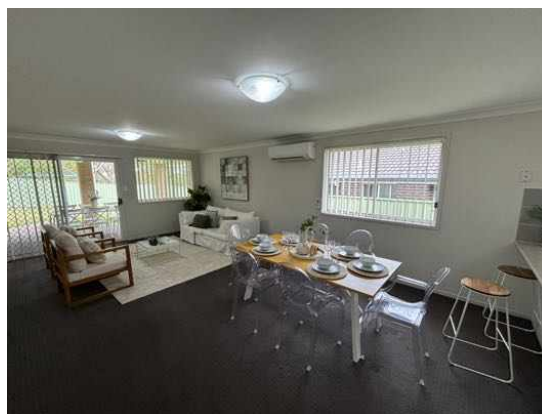
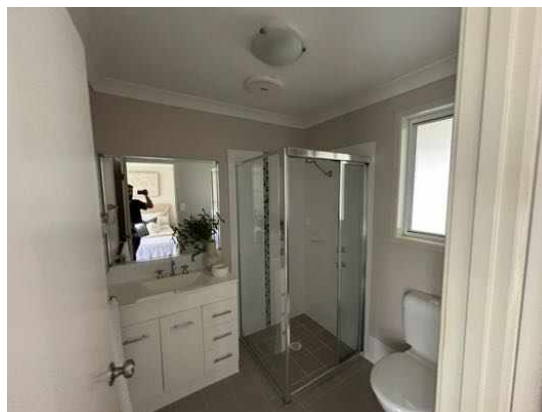
The presence of these impediments means that critical areas of the property were not accessible, and therefore, any underlying defects that may affect the integrity and safety of the property could remain undetected. These hidden defects, if left unaddressed, could worsen over time and may result in costly repairs or pose potential safety hazards to the occupants.

It is highly recommended that all obstructions be cleared to facilitate a complete and thorough inspection of the internal areas. Once the obstructions have been removed and full access is available, a re-inspection should be carried out to ensure that any

previously concealed issues can be properly identified and rectified. This follow-up inspection will provide a more accurate assessment of the property's internal condition and help the client make informed decisions about any necessary repairs or maintenance.

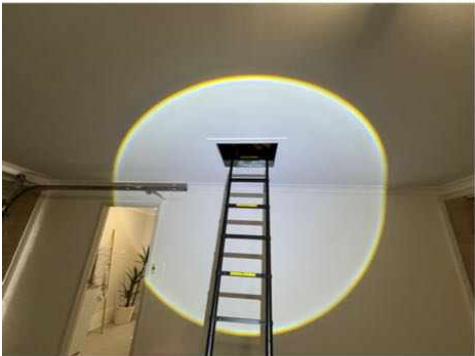
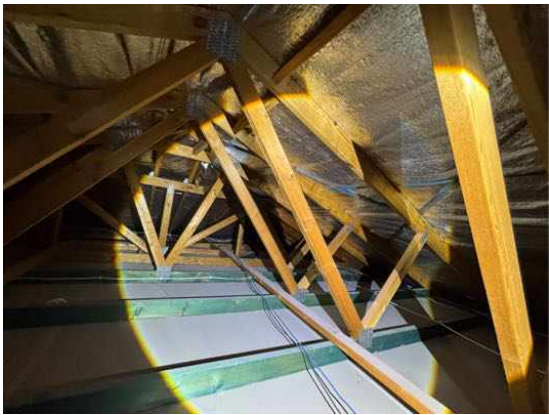
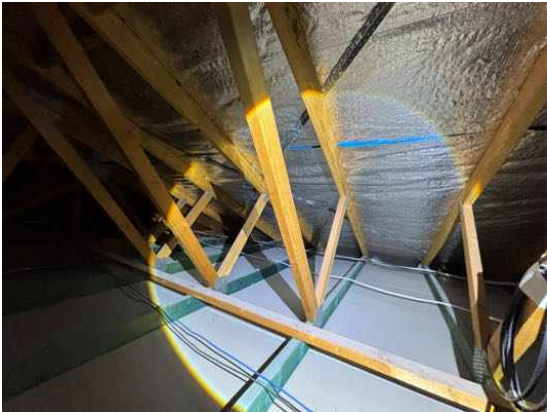
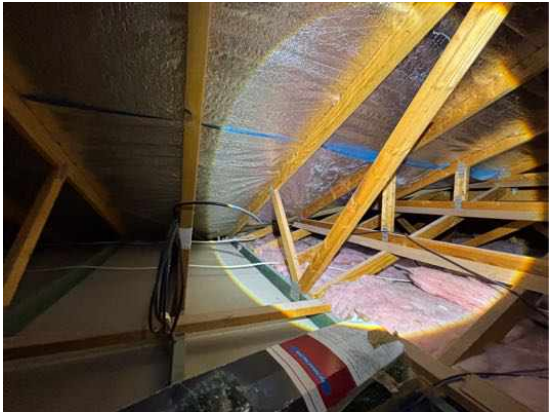
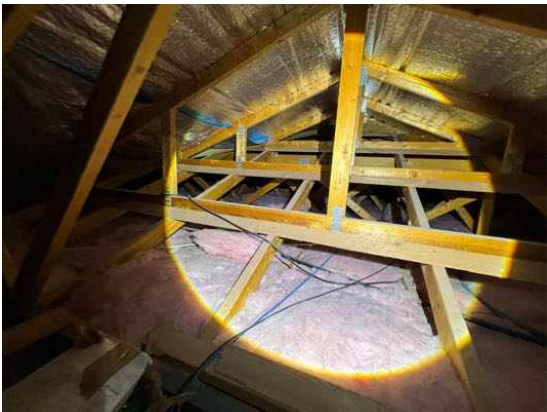
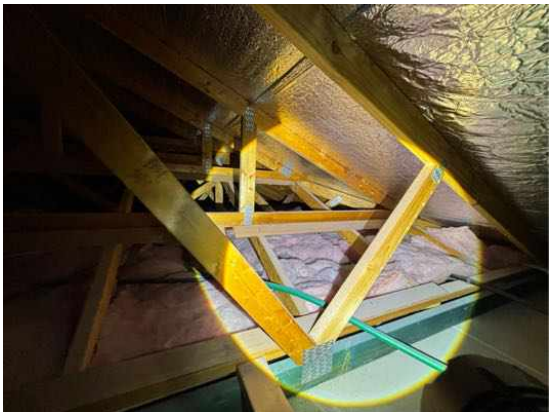
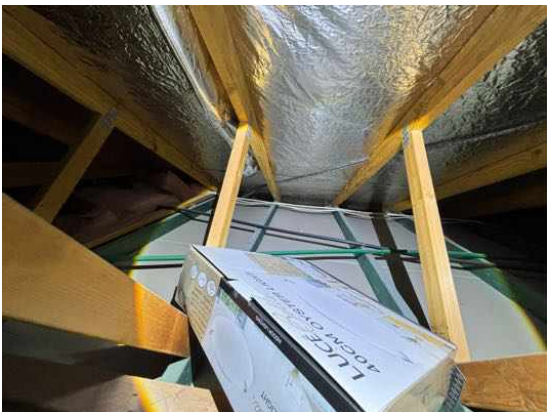
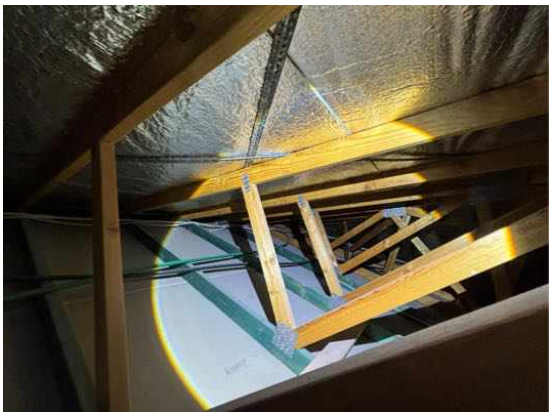
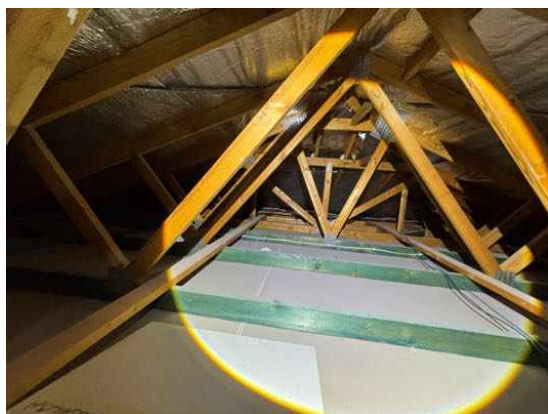
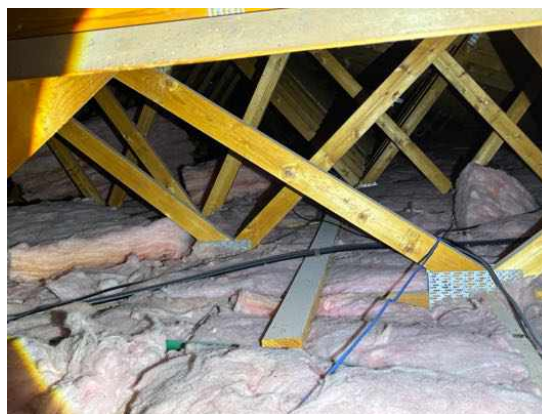
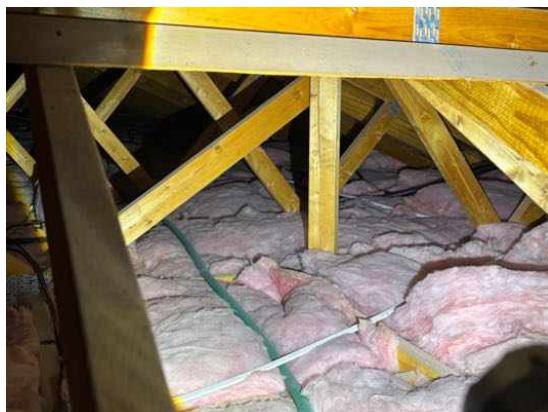
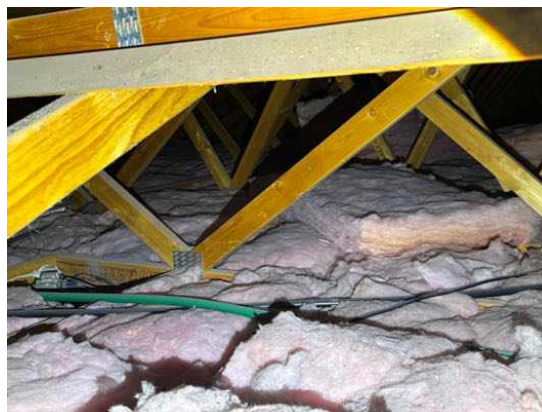
Building: Main Building
 Location: Roof Void
 Finding: Obstructions, Limitations, and General Roof Space Condition
 Information: The photographs provided document both the general condition and the obstructions and limitations that were present in the roof cavity of the main building at the time of inspection. These obstructions—such as insulation materials, stored items, structural elements, or electrical wiring—restricted safe and adequate access to key areas within the roof space. As a result, a comprehensive inspection of all components could not be completed.

Obstructions of this nature may conceal a variety of potential defects, including damaged framing, compromised insulation, evidence of moisture ingress, pest activity, or electrical hazards. While no major issues were observed in the visible areas, the presence of these limitations means that some defects may remain undetected.

It is recommended that these barriers be removed or repositioned to facilitate full and safe access to the roof space. Once clear, a follow-up inspection should be conducted to allow for a thorough assessment of all concealed areas. This will help ensure that the condition of the roof cavity is accurately evaluated and any hidden issues are appropriately identified and addressed.

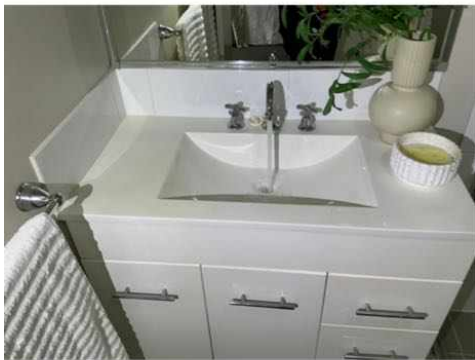
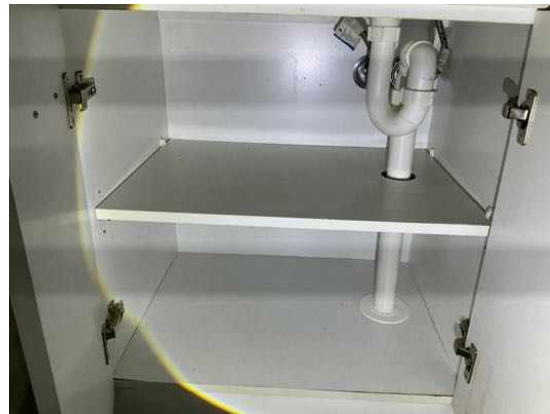
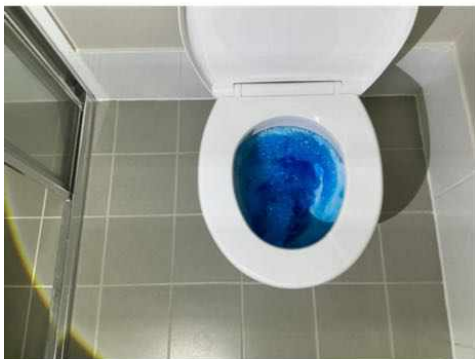
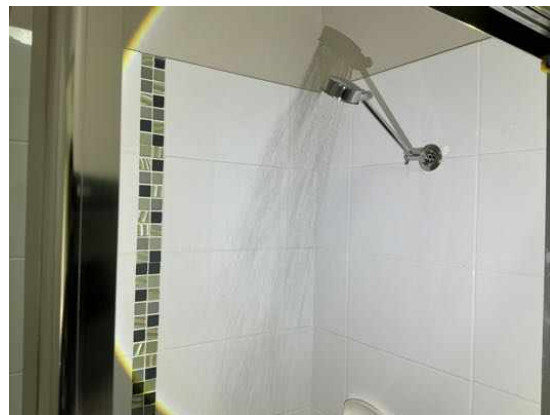
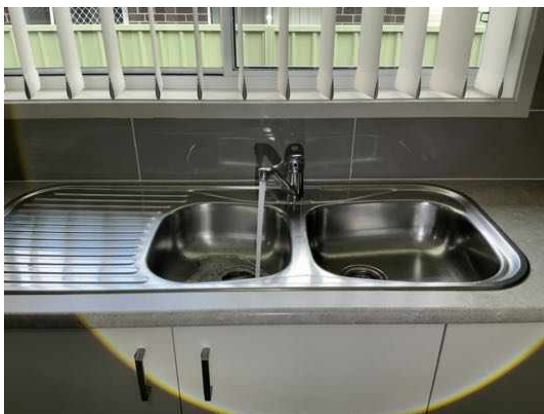
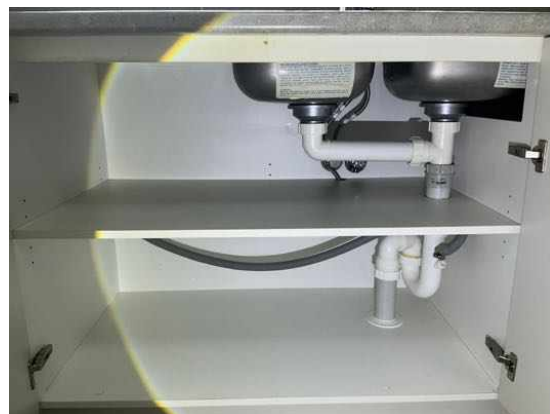
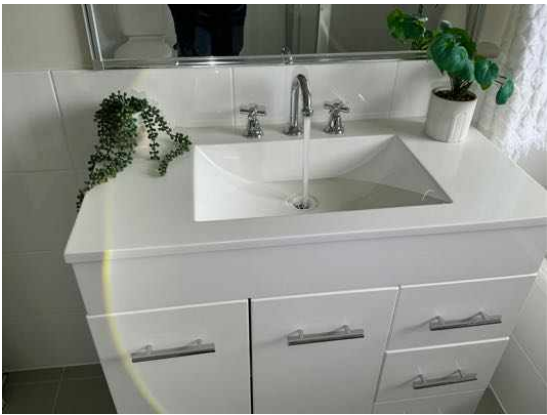
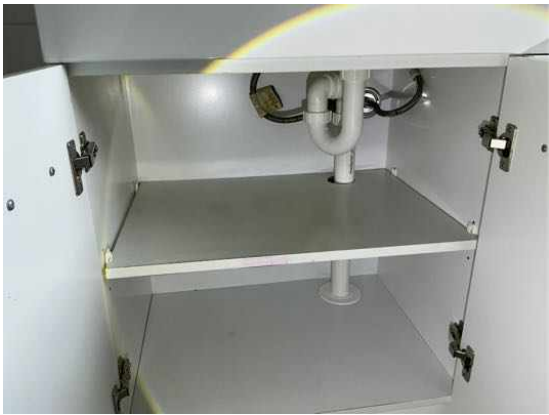
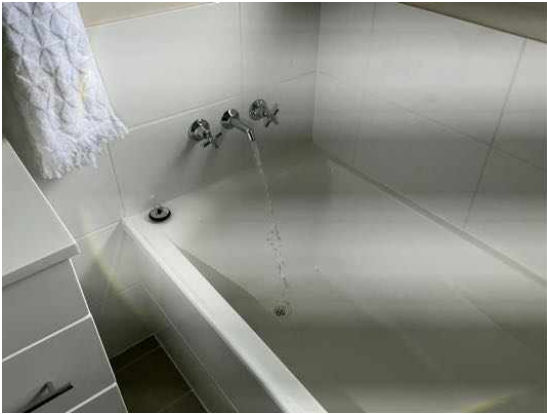
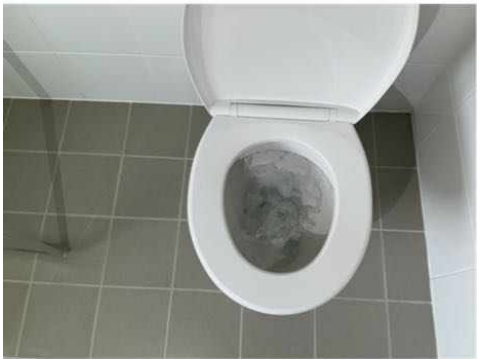
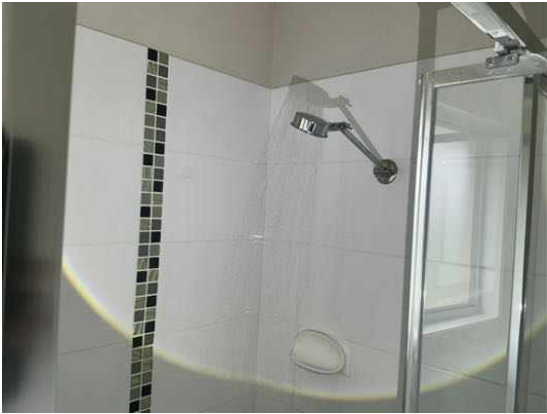
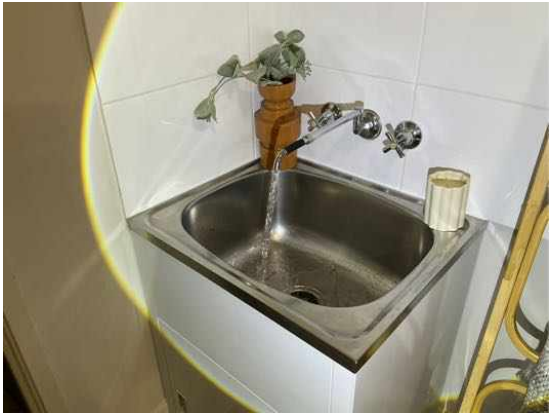
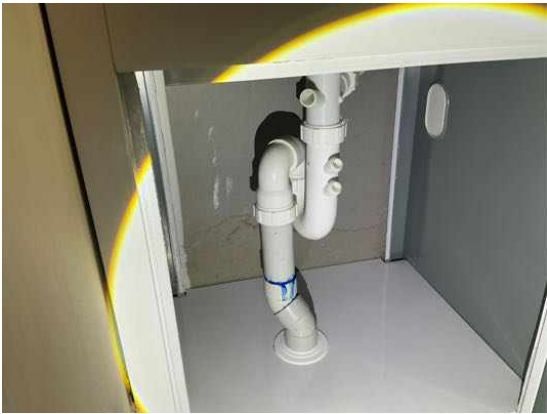
Building: Main Building
Location: All Areas
Finding: FYI - Taps, Drainage & Toilets Tested and Cabinetry Obstructions
Information: During the inspection, all accessible taps, drainage systems, and toilets were tested for water flow and drainage efficiency, and checked for any visible signs of leakage. At the time of the inspection, no issues were noted in these areas. Unless highlighted in a separate defect statement, no immediate remedial work appears necessary. Supporting images may be found in the additional photos section for reference.

beneath sinks and vanities was undertaken, stored personal items and fixtures presented obstructions that limited full visibility of the internal areas. As per standard inspection practices, inspectors are not permitted to move or disturb personal belongings during the inspection process. Therefore, only visible and accessible sections were inspected, and concealed water damage or plumbing defects may not have been detected.

Given this, a re-inspection is recommended after all obstructions have been cleared to allow for a comprehensive assessment of these areas. Regular maintenance and monitoring of plumbing and drainage systems is also advised to ensure ongoing functionality and early detection of potential issues.

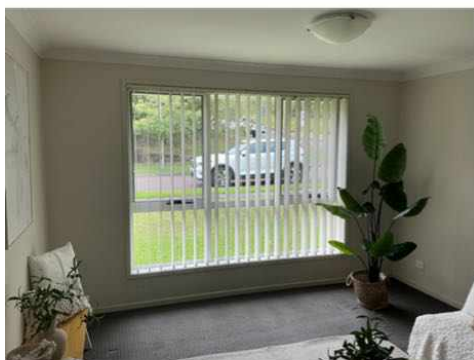
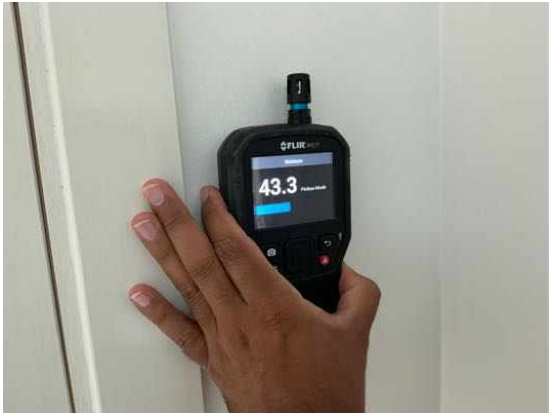
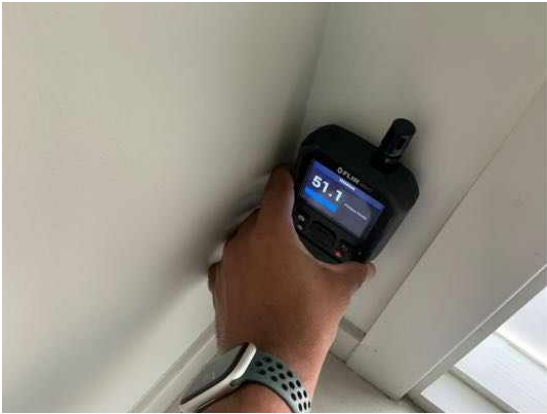
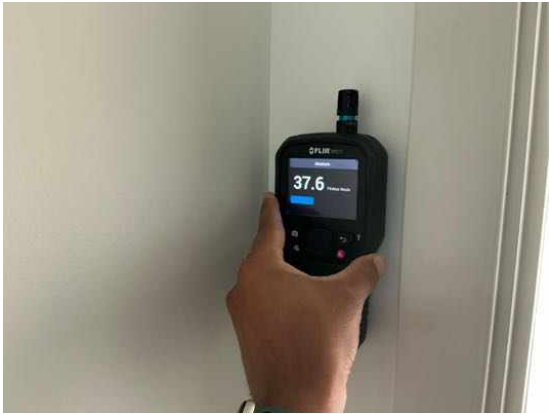
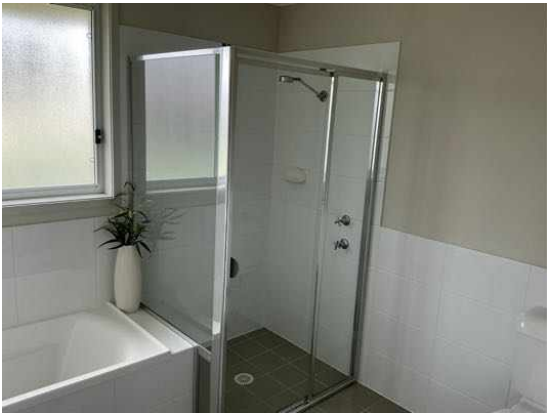
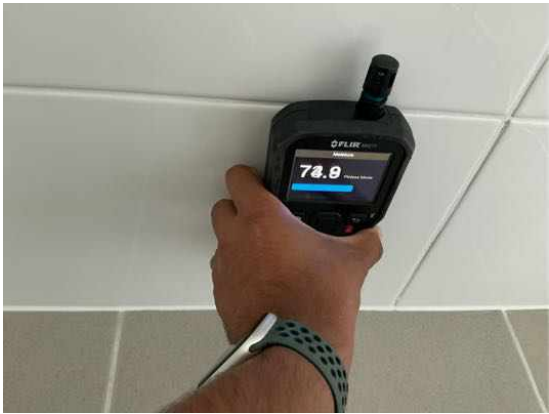
Building: Main Building
Location: All Areas
Finding: Additional Photos - Moisture Meter Readings
Information: Additional moisture meter reading photos have been provided for the property to offer further clarity on areas tested during the inspection. These photos are intended to give a visual reference for the specific locations where moisture levels were measured. These readings were taken at the time of the inspection to assess any potential moisture-related issues within the property. Any defects related to moisture that were identified during the inspection have been separately mentioned in the defect statements within the report.

For further clarification or additional information regarding the moisture readings, the client is encouraged to contact the building inspector directly. Regular monitoring of moisture-prone areas is recommended to ensure any emerging concerns are addressed promptly, particularly during wetter seasons or in high-humidity conditions.
