Building and Timber Pest Inspection Report

Inspection Date: Mon, 23 Feb 2026

Property Address: 7 Lexington Ave, Wadalba NSW 2259,
Australia

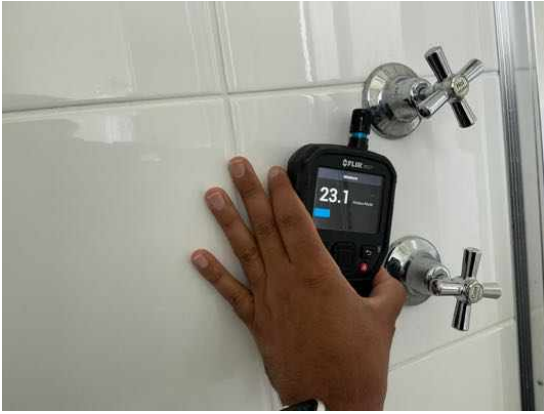
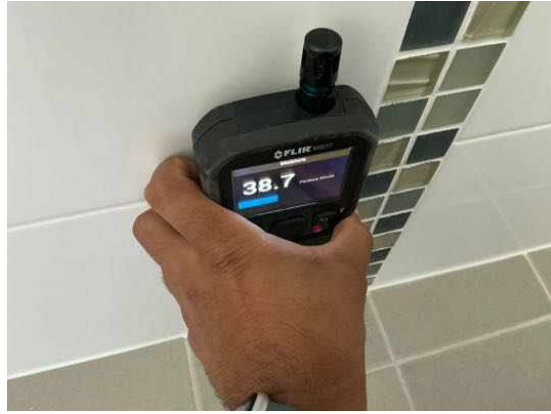
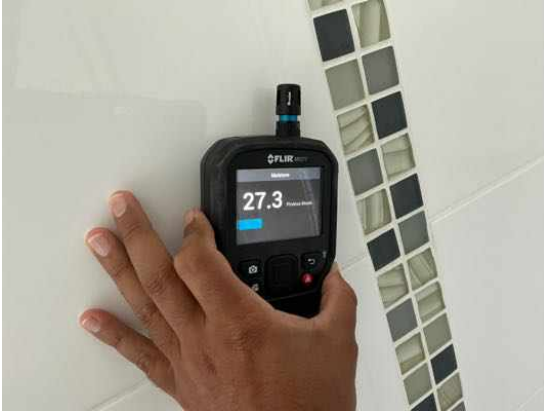
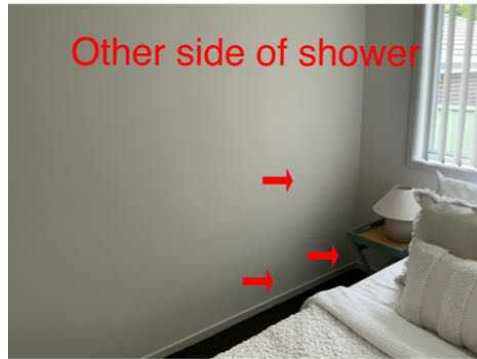
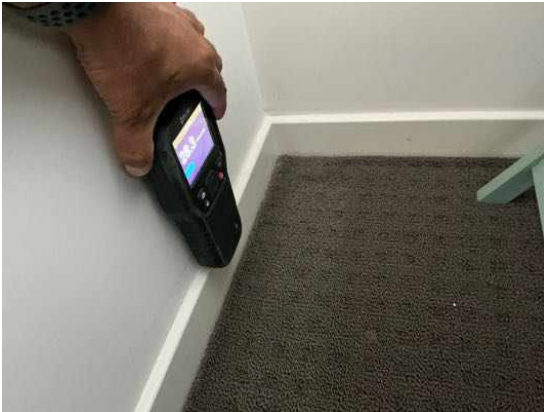
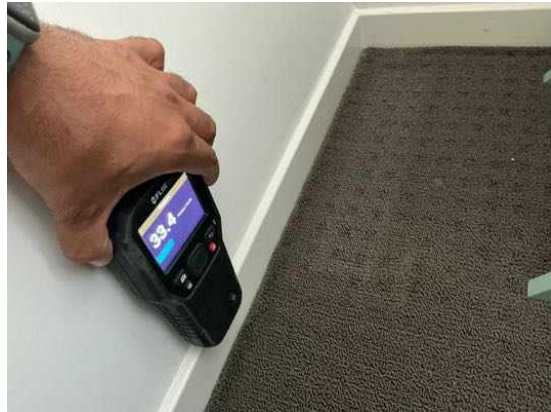
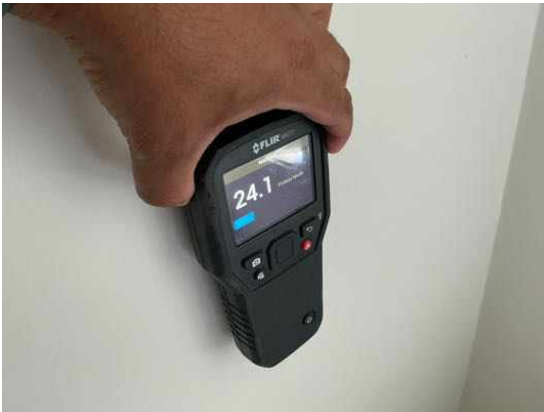
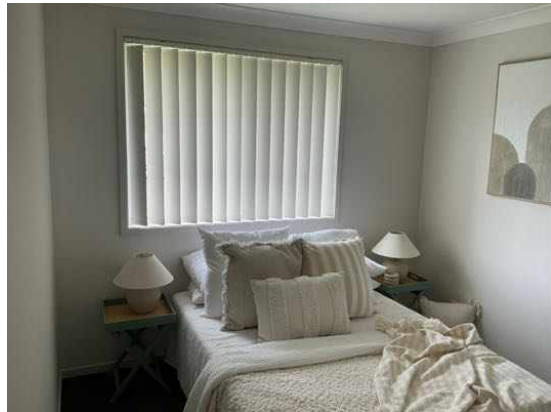
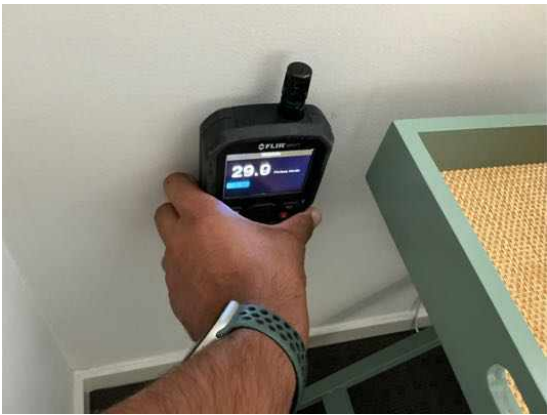
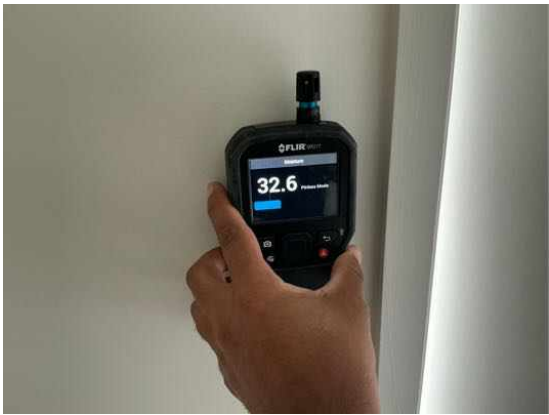
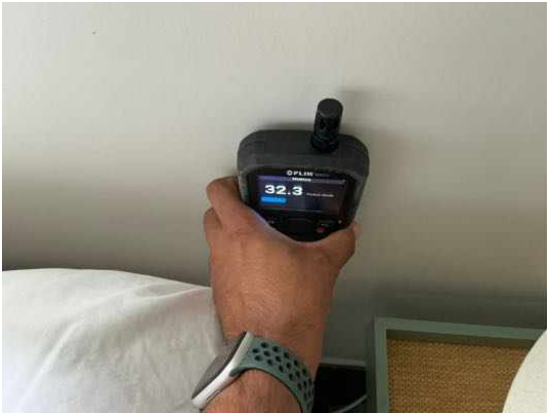
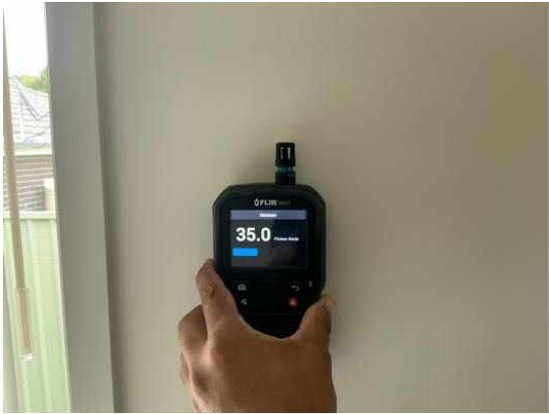
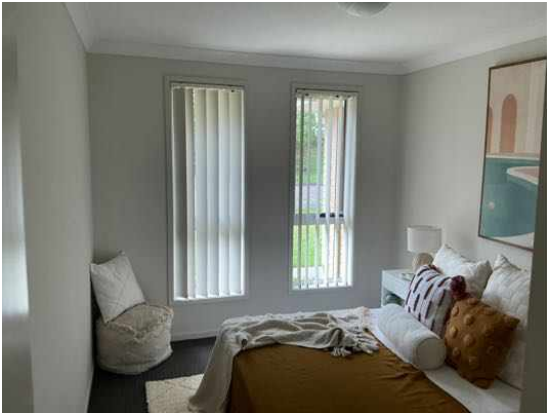
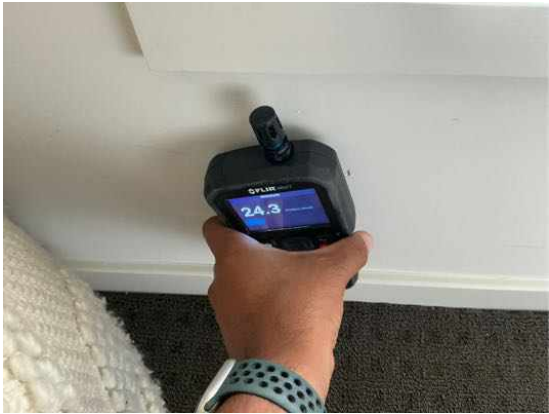
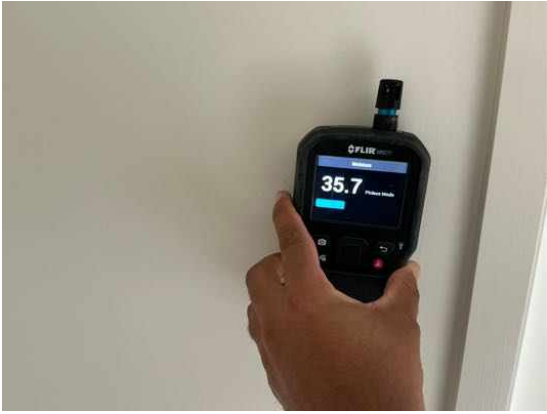
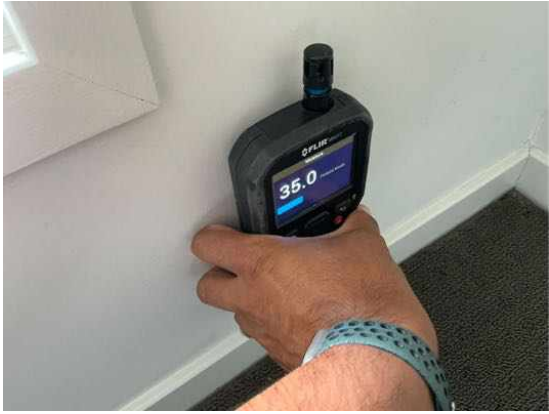
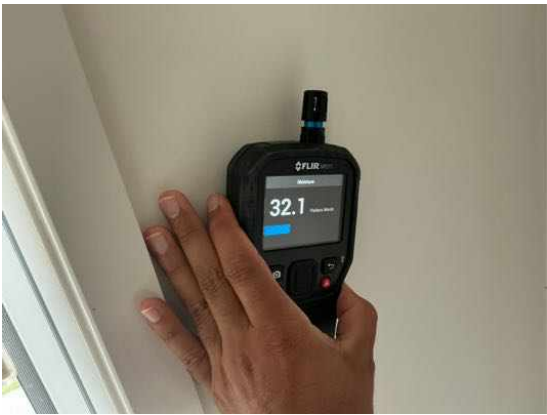
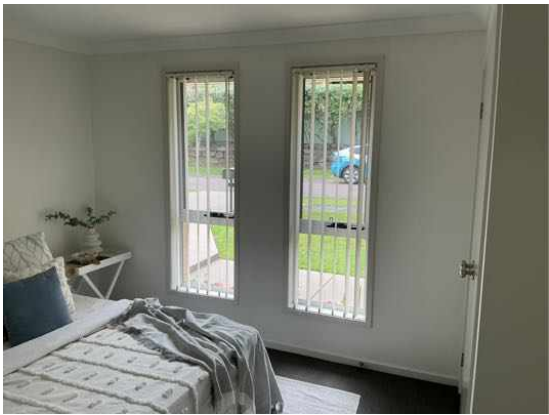
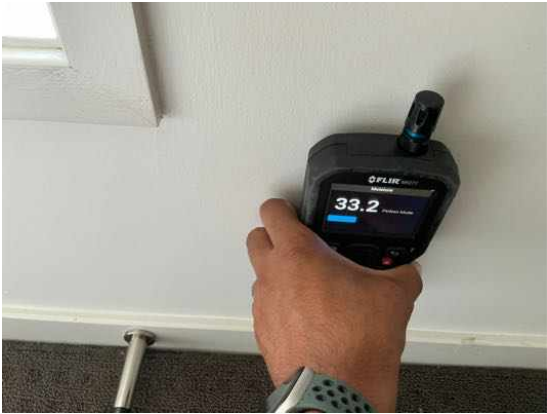
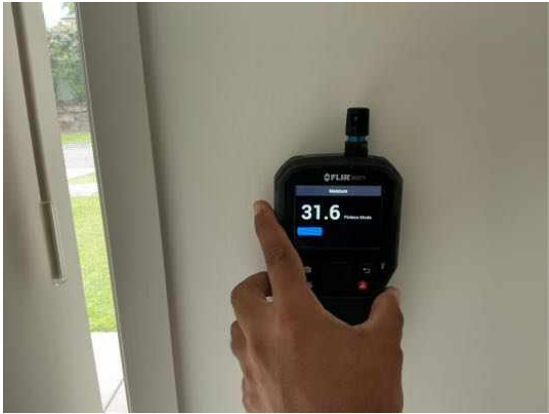
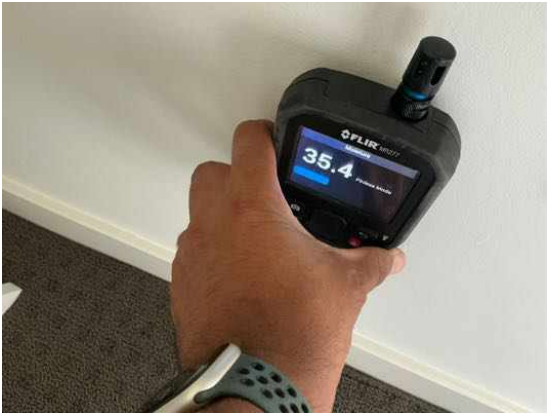
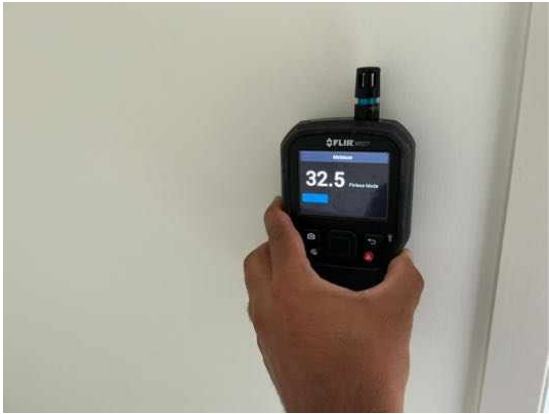
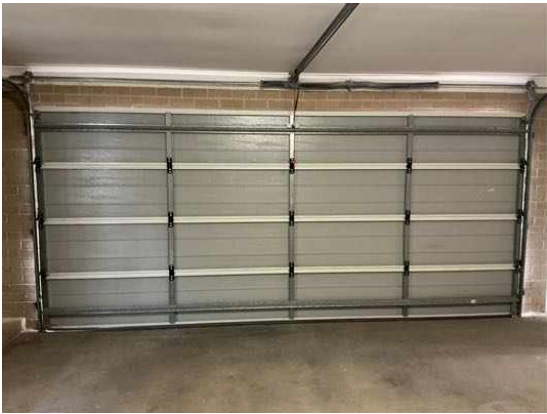
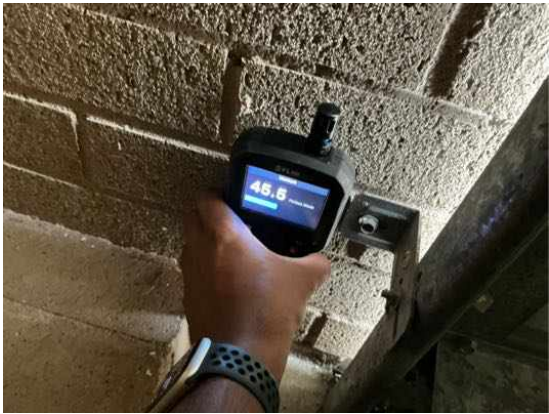
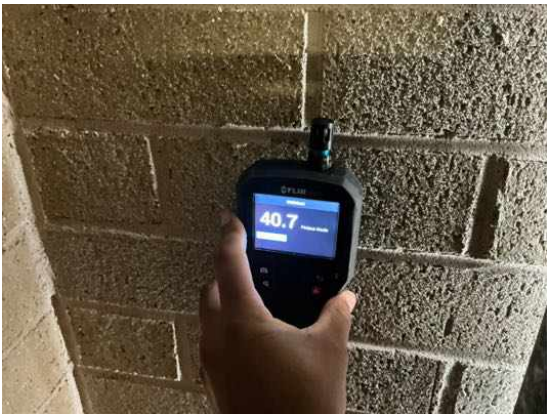
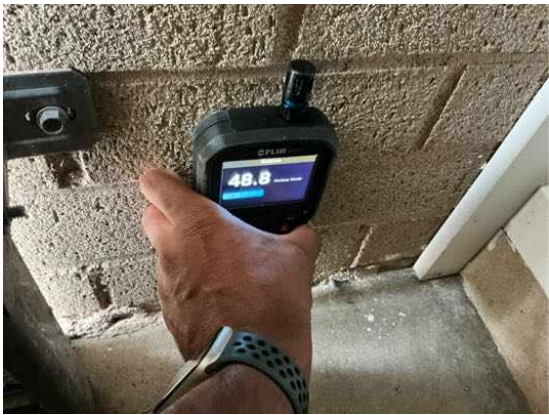
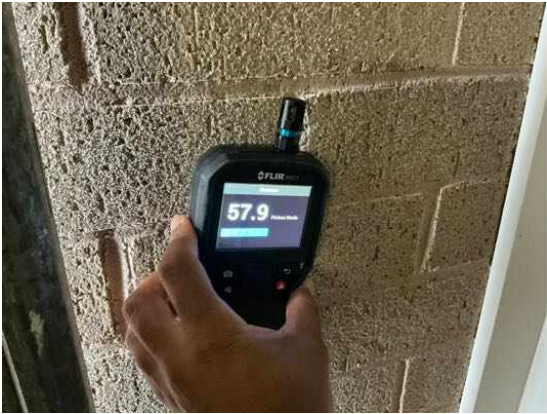
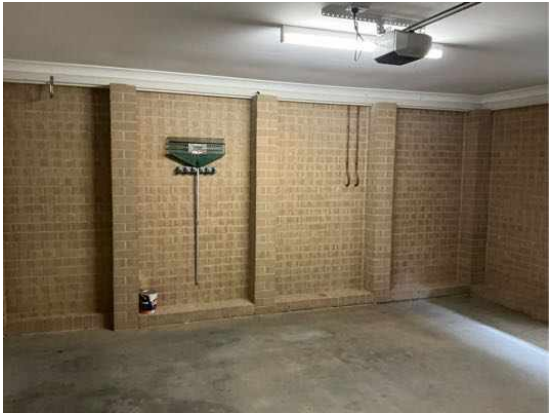
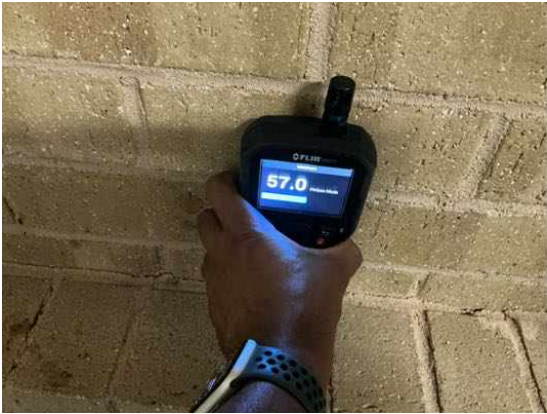
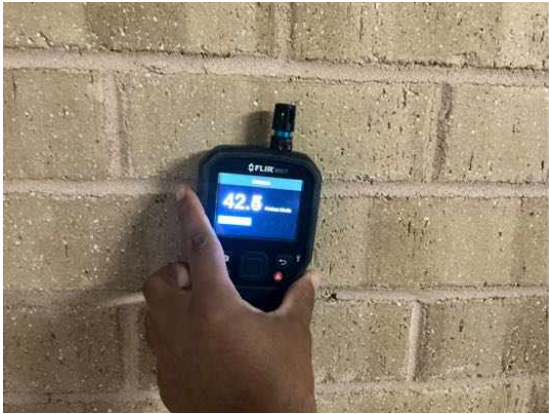
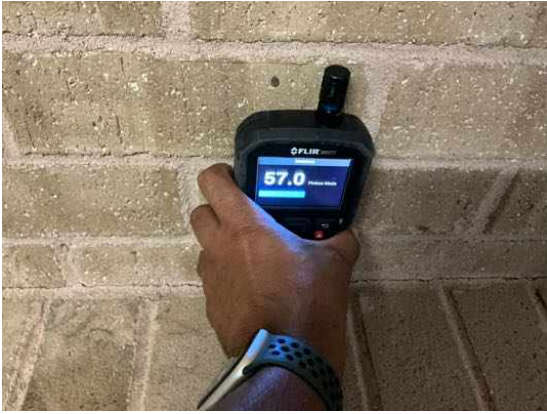
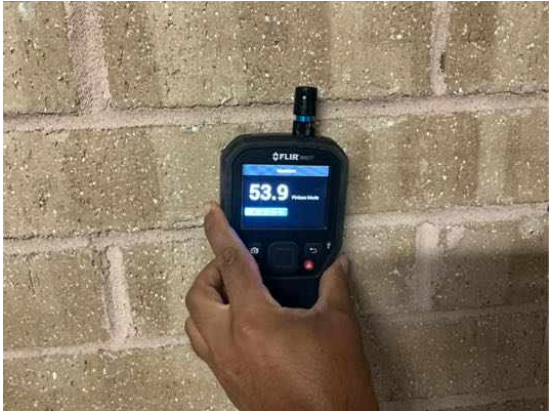
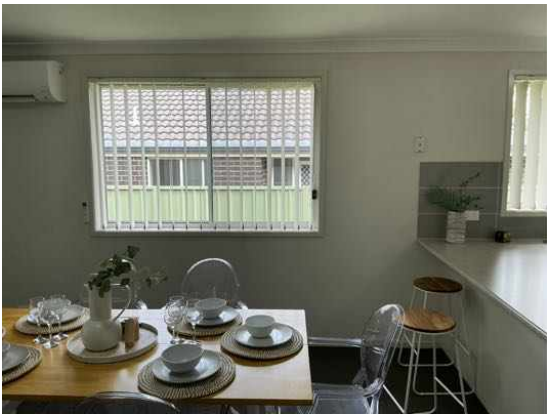
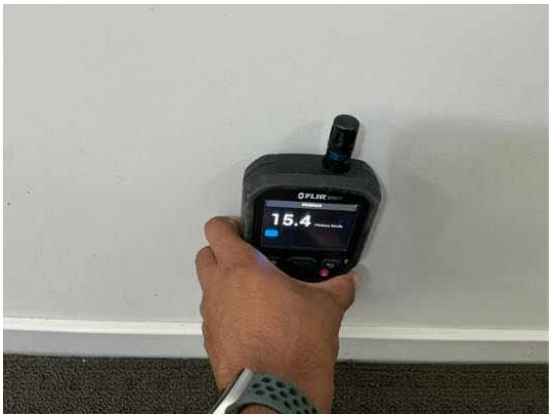
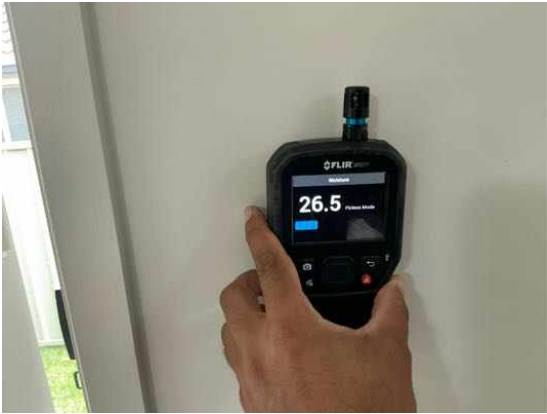
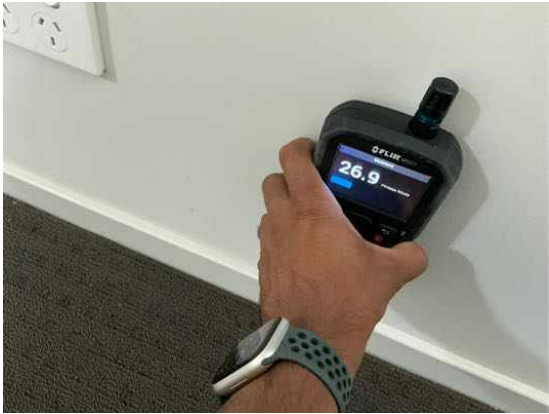
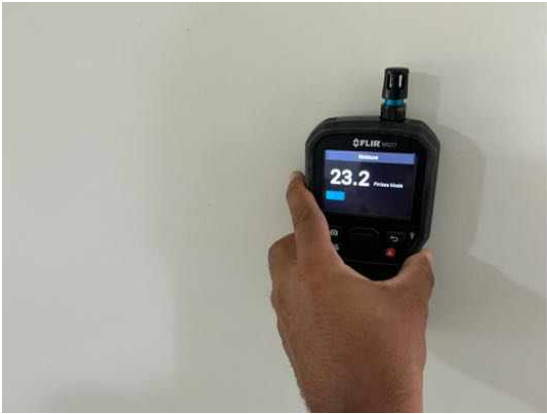
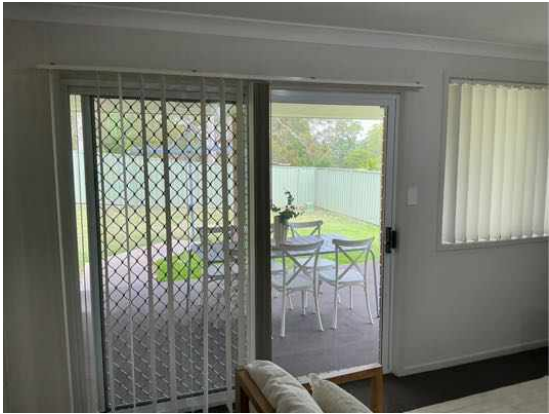
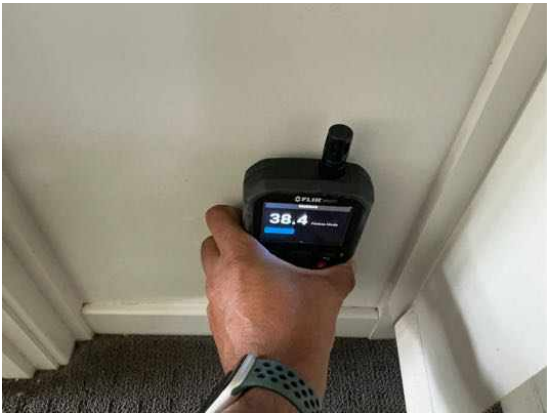
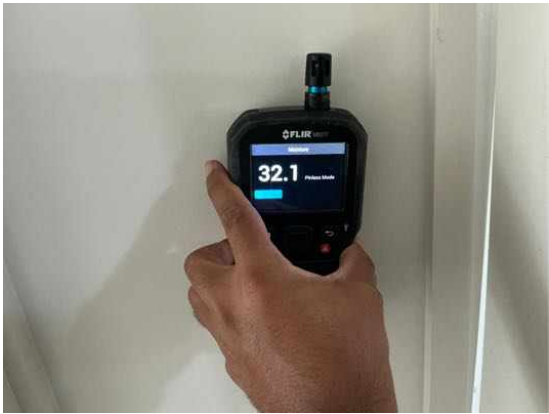
Noted Item

Building: Main Building
Location: All Areas
Finding: Additional Photos - Moisture Meter Readings
Information: Additional moisture meter reading photos have been provided for the property to offer further clarity on areas tested during the inspection. These photos are intended to give a visual reference for the specific locations where moisture levels were measured. These readings were taken at the time of the inspection to assess any potential moisture-related issues within the property. Any defects related to moisture that were identified during the inspection have been separately mentioned in the defect statements within the report.

It is important for the client to understand that moisture levels can fluctuate over time due to various factors, including changes in weather, humidity, and environmental conditions. While the readings reflect the property's moisture levels during the inspection, they may not represent future conditions, and increased moisture could lead to issues such as dampness, mould growth, or deterioration of building materials if left unmonitored.

For further clarification or additional information regarding the moisture readings, the client is encouraged to contact the building inspector directly. Regular monitoring of moisture-prone areas is recommended to ensure any emerging concerns are addressed promptly, particularly during wetter seasons or in high-humidity conditions.

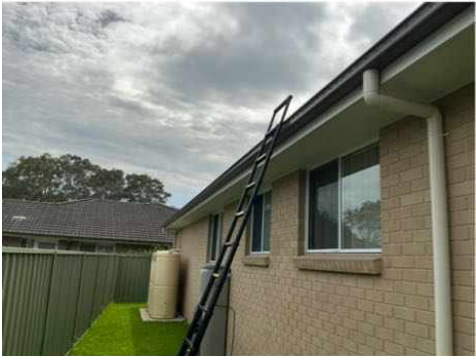
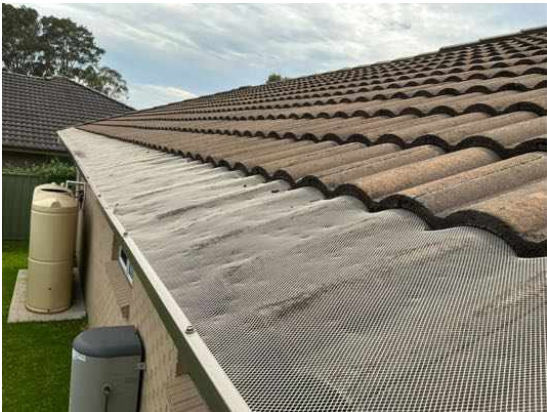
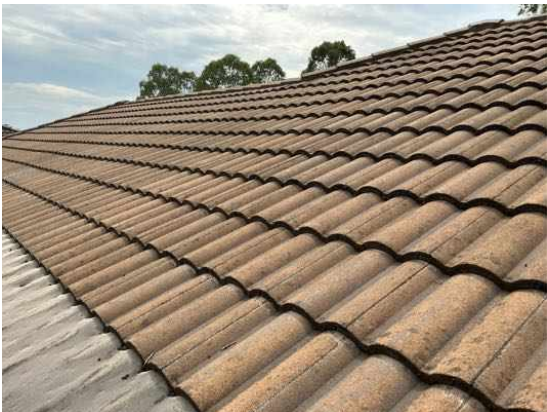
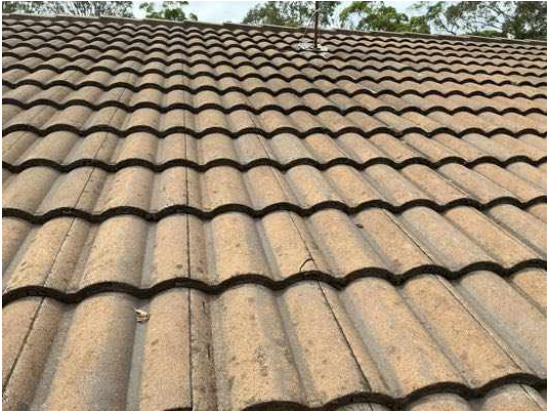
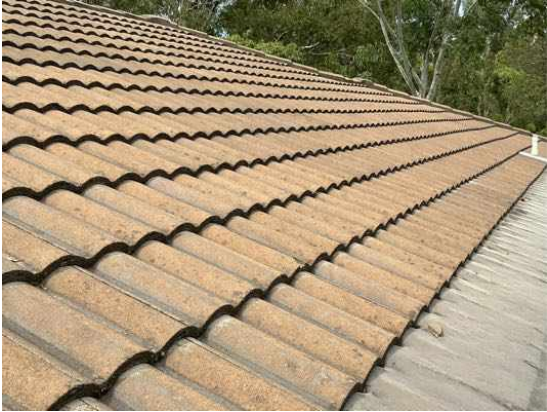
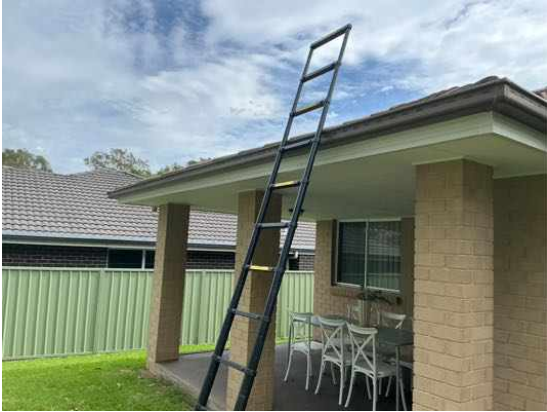
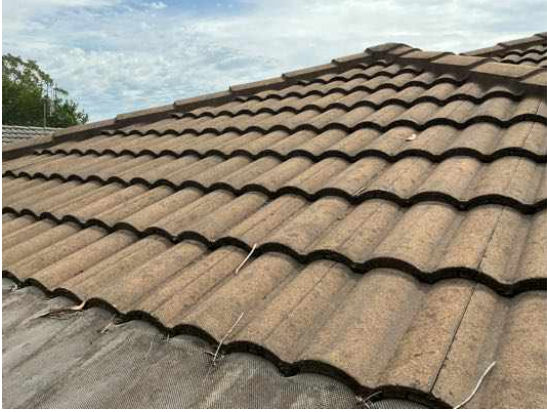
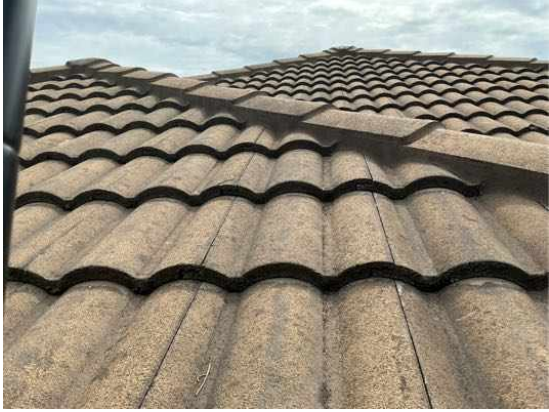
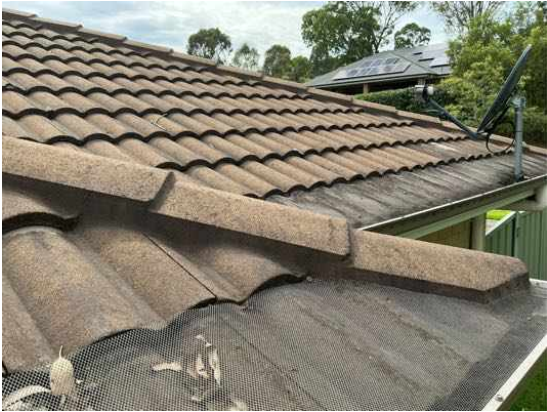
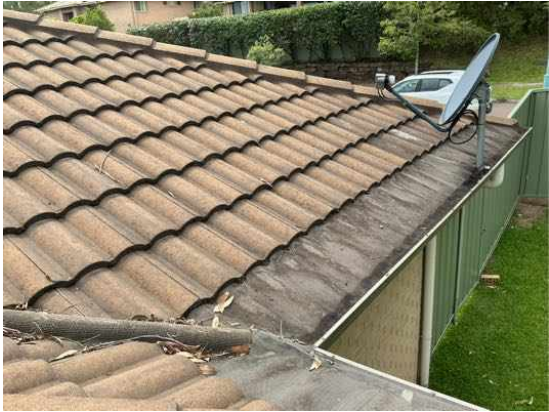
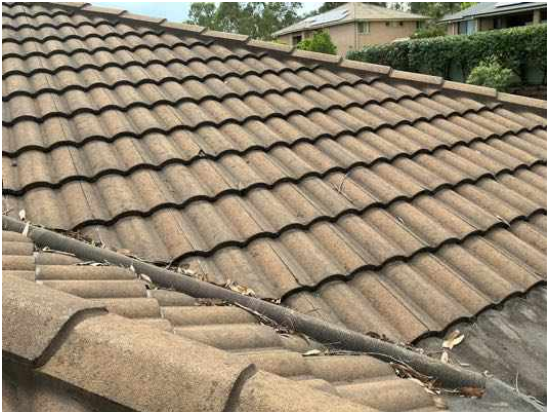
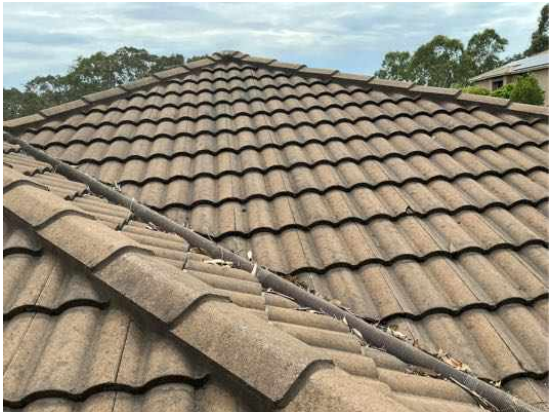
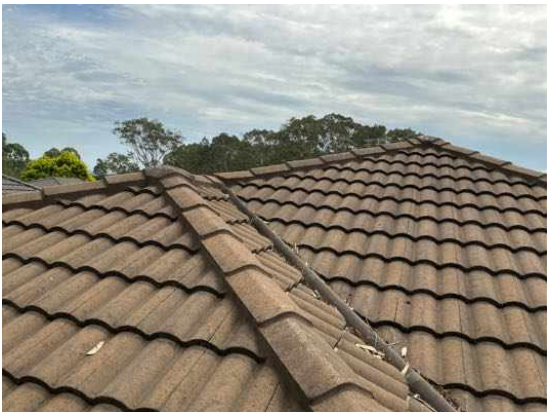
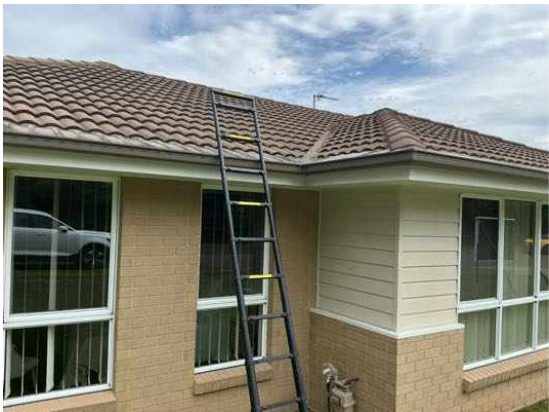
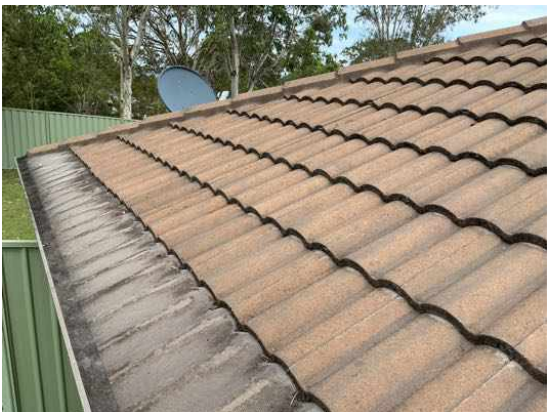
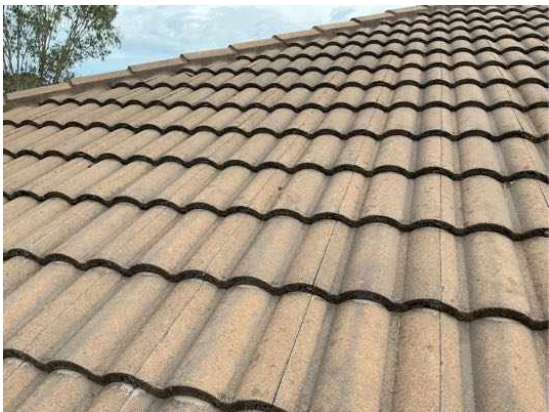
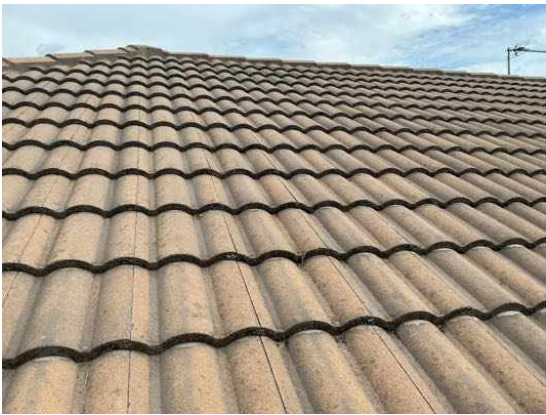
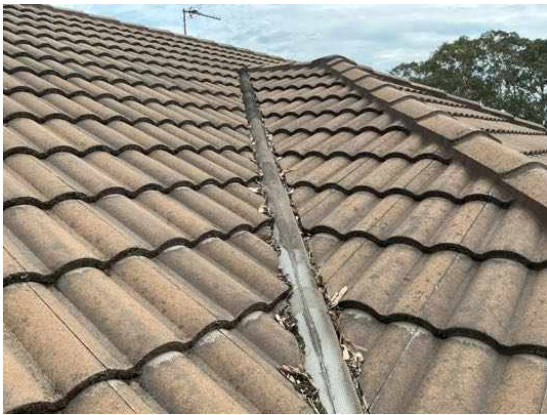
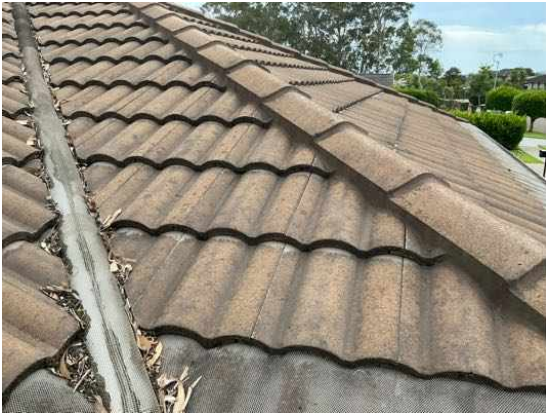
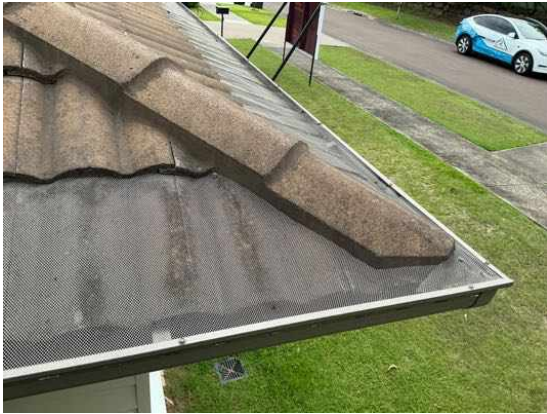
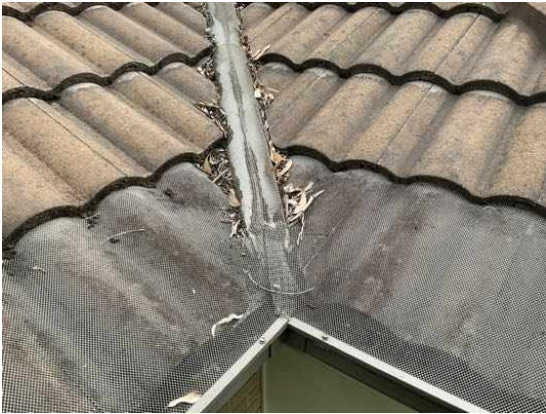
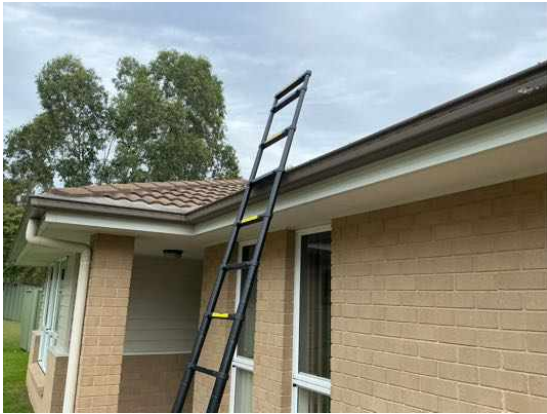
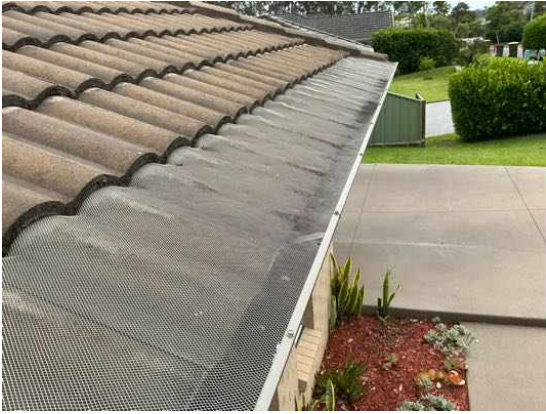
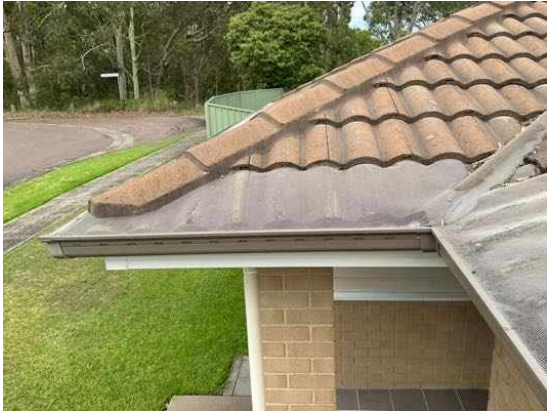
Building: Main Building
Location: Roof Exterior
Finding: Additional Roof Photos

Information: As part of the information provided, please note that the attached roof photos represent the condition of the roof at the time of inspection. These photos are for visual reference only and do not constitute a detailed roofing assessment. Any defects or issues identified with the roof are mentioned separately in the defect statements. It is strongly recommended that the client engage a qualified roofer to conduct a thorough inspection of the roof, ensuring that any potential issues, such as leaks, structural integrity, or wear and tear, are properly identified and addressed.

Additionally, the condition of the roof may change over time due to weather, natural wear, or other unforeseen factors. Regular maintenance and inspections by a licensed professional are advised to ensure the roof remains in good condition and to avoid costly repairs in the future. The information provided in these photos should be considered a snapshot of the roof's condition during the time of inspection and not a guarantee of its future performance.

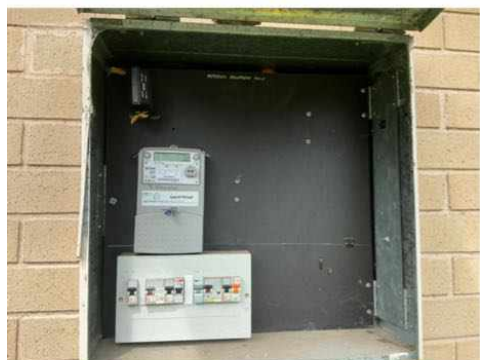
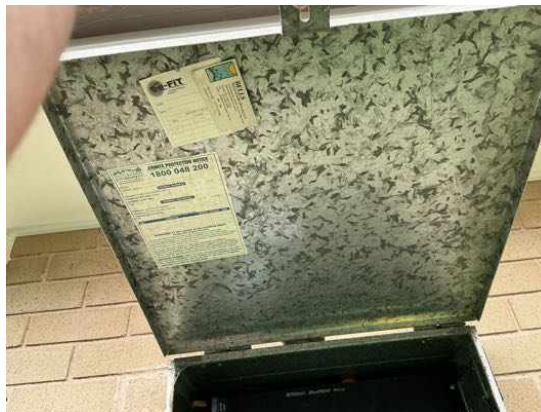
Building: Main Building
 Location: Meter Box
 Finding: Termite Management Recommendation – No Evidence of Chemical Installation
 Information: At the time of inspection, there was no visible evidence of a chemical termite management system installed around the property. Chemical barriers are a key component of termite protection and are particularly important in preventing concealed termite entry into timber elements of the structure.

In accordance with standard requirements, a durable notice should be located within the electrical switchboard to detail any termite protection systems applied, including chemical treatments. No such notice was observed during the inspection.

It is recommended that the client engage a licensed pest controller to assess the suitability of installing a chemical barrier, and to provide advice on associated costs and procedures. This should be considered a short-term priority, particularly if the property has any history of termite activity or is located in a high-risk area.

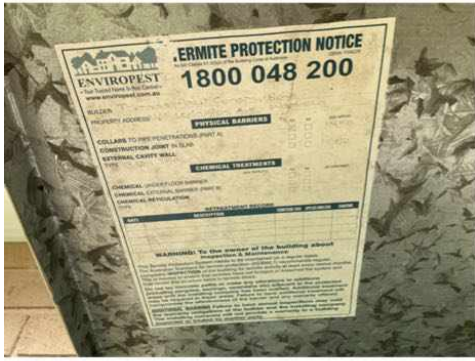
The following items were noted as - Evidence of a previous termite management program

Where a Termite Management System has been identified you should refer to the type of barrier date of installation warranty conditions and any documentation provided by a builder or past owner. Consult the company who installed the barrier to confirm whether the system is still under warranty.

Most chemical termite management systems expire and require replenishment and all physical systems are primarily designed to prevent concealed entry.
