Building and Timber Pest Inspection Report

Inspection Date: Tue, 31 Mar 2026

Property Address: 213 The River Rd, Revesby NSW 2212,
Australia

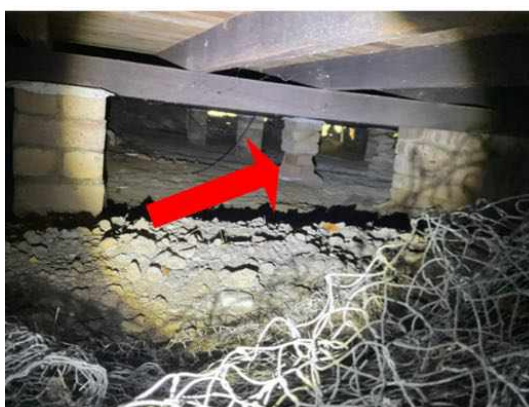
Location: Subfloor
 Finding: Brick Pier (Subfloor) - Deteriorated
 Information: The subfloor brick piers have significantly deteriorated, with visible cracking, displacement and loss of material integrity. The pier appears to have reduced load-bearing capacity and may no longer adequately support the structure above.

This condition is considered structural and major, as failure of the pier may lead to uneven settlement, floor sagging and potential structural instability.

Recommendation:

A structural engineer should be engaged to assess the extent of damage and design appropriate rectification, which may include replacement or underpinning of the pier. Urgent repair is recommended.

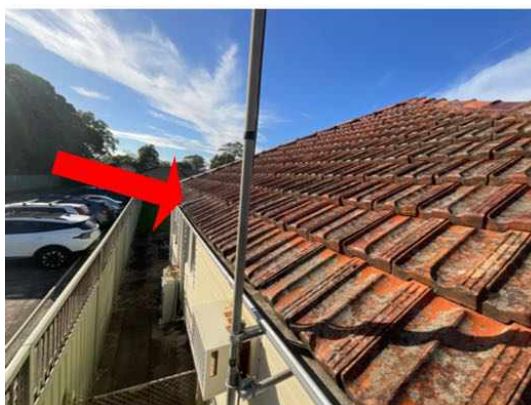
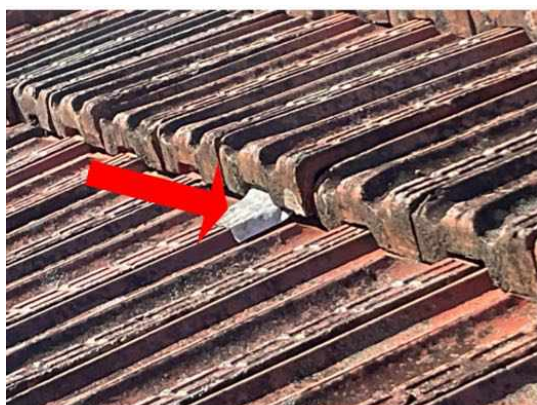
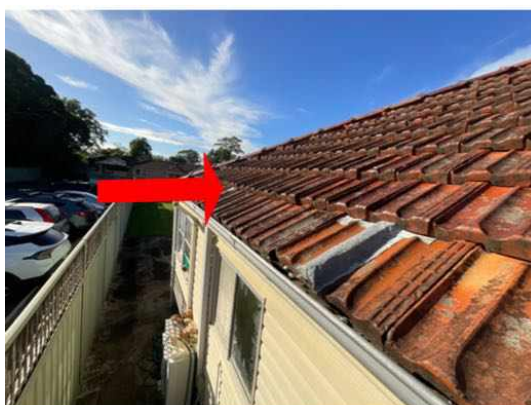
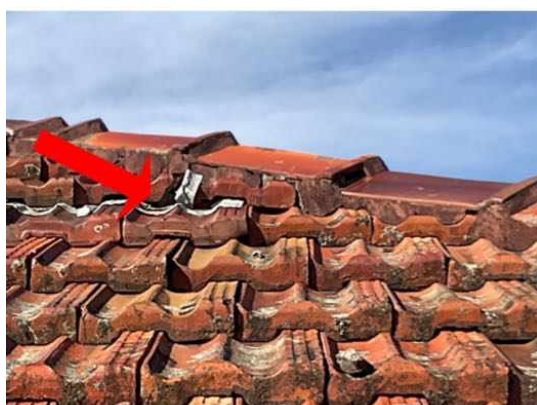
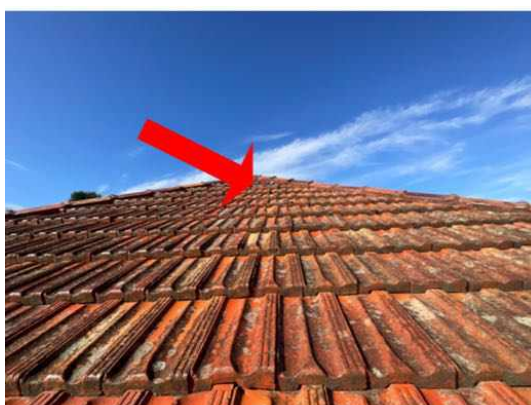
Finding 2.02

Building: Main Building
 Location: Roof Exterior
 Finding: Exterior roof - Leaking
 Information: Active roof leaks were evident at the time of inspection. Roof leaks can have a number of causes, including damage to roof coverings, deterioration of roof fixtures and fittings, or loosely associated materials (fascias etc.).

Where water leaks are active, rain penetration is likely to cause water damage to associated structures and building elements in this area, which can have a range of implications. If left unmanaged, the development of major structural damage to the roofing and associated structures may occur.

A roof plumber should be appointed as soon as possible to primarily identify the cause of the leak, and to provide subsequent repair works as necessary. Depending on the extent of the damage, replacement of sections of the roof covering and/or roofing structures may be required, and may be performed by a registered builder or qualified carpenter.

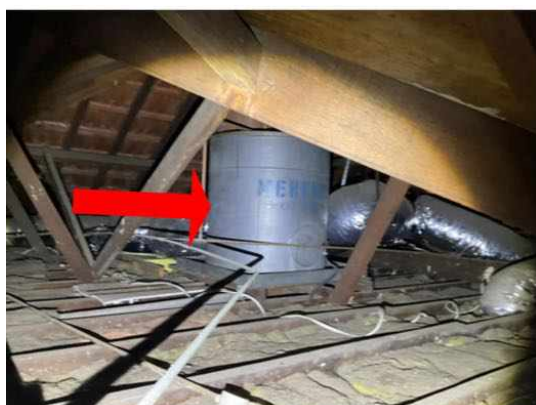
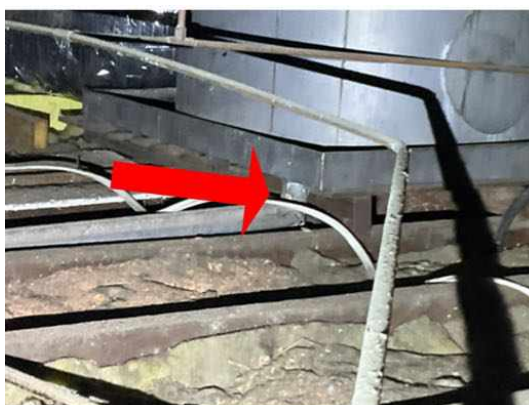
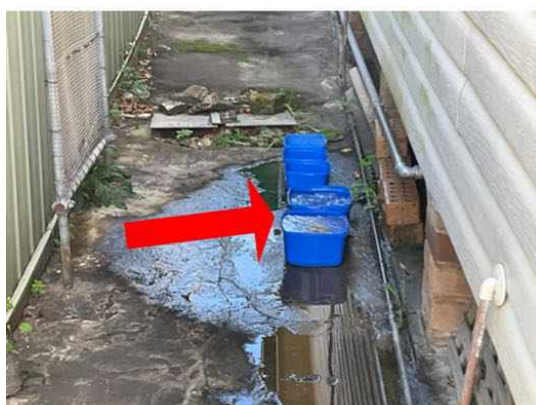
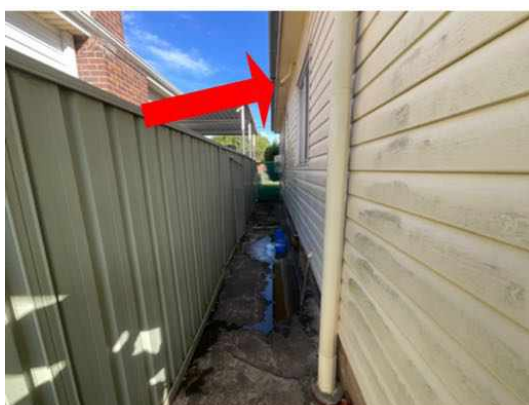
Finding 2.03

Building: Main Building
 Location: Roof Void
 Finding: Gravity-Fed HWS - Still in Use
 Information: An out-dated gravity-fed HWS is installed and still in use. While the HWS may still be working, it is highly likely that it produces very low water pressure during operation, detracting from the functionality of plumbing services throughout the property.

A gravity-fed HWS is also likely to reduce water efficiency, as it is not compatible with water-saving shower heads and other tapware. Failure to replace the system is therefore likely to result in poor water efficiency throughout the household.

While it is a costly exercise, replacement of the gravity-fed HWS is advisable in the short to medium term. Further consultation with a licensed plumber is advised to gain further advice on replacement options.

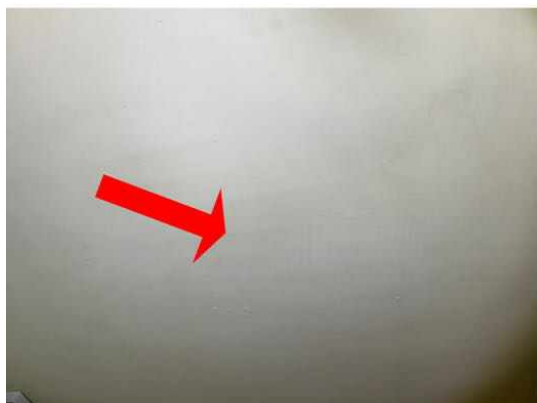
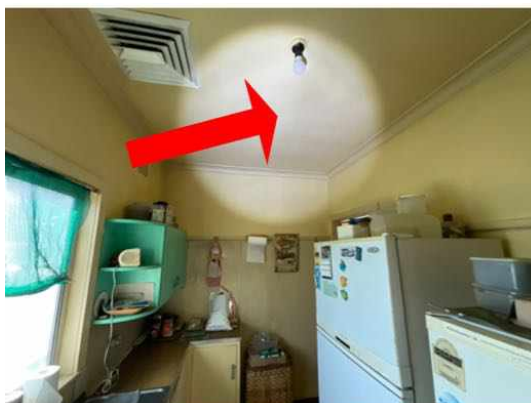
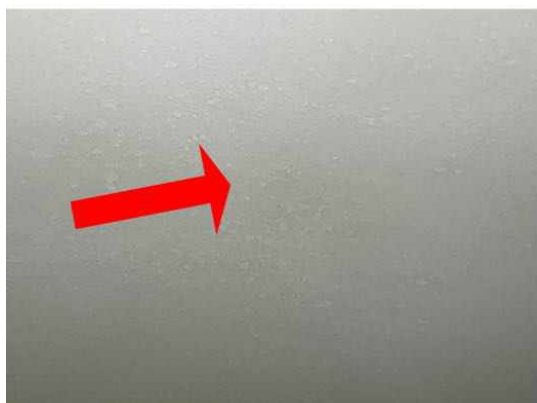
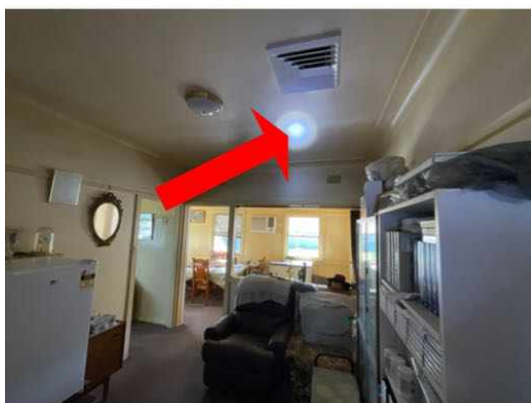
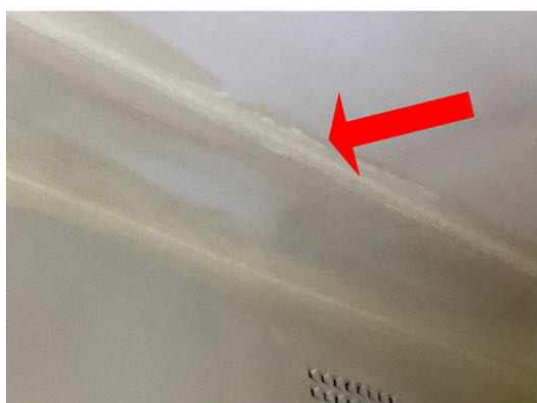
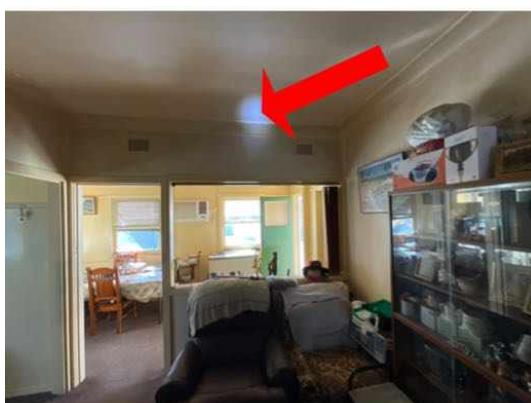
Finding 2.04

Building: Main Building
 Location: All Internal Areas
 Finding: Ceiling - suspected water damage
 Information: Suspected water damage to the ceiling lining is generally an indication of excessive moisture being present in the roof void, usually via a leak to the roof covering.

Where water damage is evident to the ceiling, the primary requirement is to identify and rectify the source of the leak. A roofing plumber should be appointed as soon as possible to identify the leak and perform rectification works as necessary, ensuring the water damage is restricted.

Once the leak is repaired, consultation with relevant tradespeople, including plasterers and painters, is advised. Rectification works may include replacement of ceiling lining or minor repainting, depending on the extent of the damage.

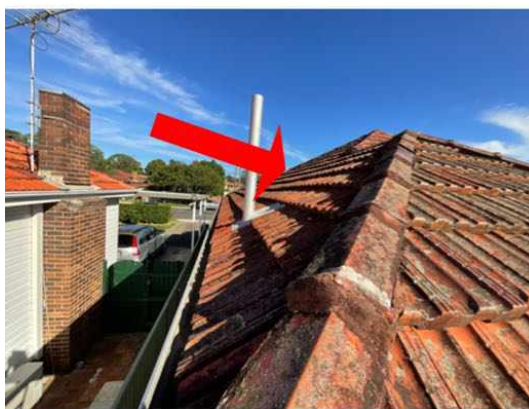
Finding 3.01

Building:	Main Building
Location:	Roof Exterior
Finding:	Roof structure - Connections (Sagging)
Information:	The roofing structure was found to be sagging in certain sections at the time of inspection. Upon closer inspection within the ceiling void and the roof exterior, it is suspected that the sagging is a direct result of inadequate connections, which appear to have deteriorated over a prolonged period of time.

Sagging roof structures are likely to create strain on associated building elements, creating potential for secondary damage. The roof is also unlikely to have sufficient support, which will lead to further sagging if left unmanaged.

It is critical to ensure that the fastenings holding important roof elements together remain structurally sound (i.e. not corroded) and tightly fastened. Any failure in fastenings can lead to movement of roof members, which is likely to result in an uneven or sagged appearance of the roof exterior. Improper nailing at the point where the ceiling joist connects to the bottom of the rafter may also cause sagging.

Remedial works are highly advised and should be performed by a registered builder or roofing contractor as soon as possible.

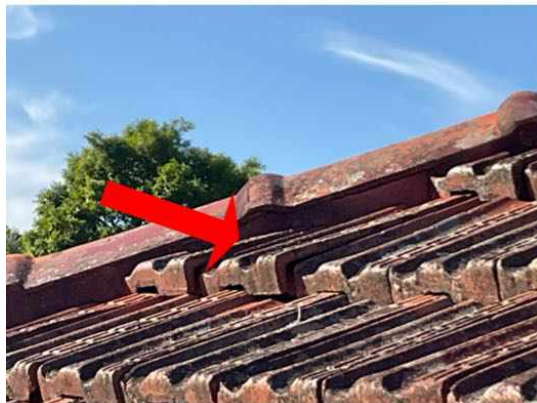
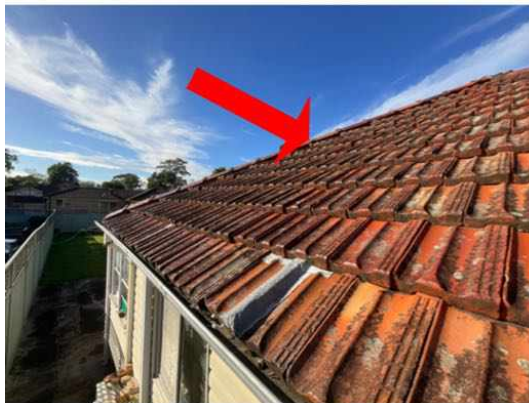
Finding 3.02

Building:	Main Building
Location:	Roof Exterior
Finding:	Roof tiles - Slippage
Information:	Upon inspection of the exterior roof covering, it was noted that numerous tiles have slipped from their original fixing. Tiles may slip over time due to a number of minor causes, including breakage of tiles, failings in the adjoining battens, or fixings that may have failed.

penetration into the roof void, exposing roofing structures to excessive moisture. This creates an environment that is conducive to water damage and accelerated deterioration of all associated building elements.

Replacement of loose or missing roofing tiles is recommended immediately to prevent the development of any secondary defects. A roofing restoration specialist should be appointed to complete such works as necessary.

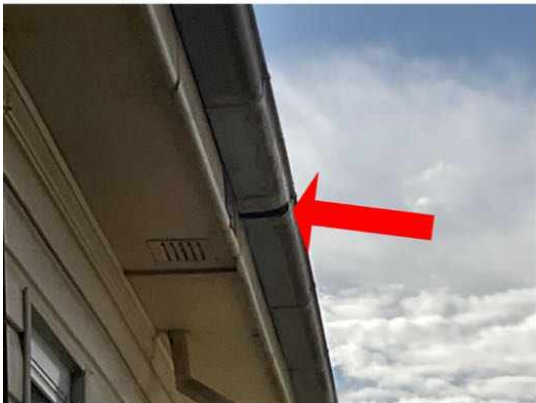
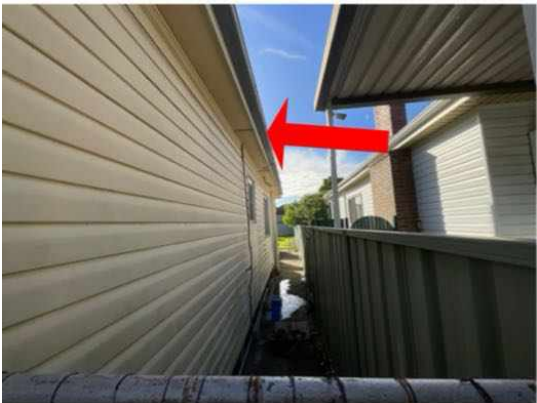
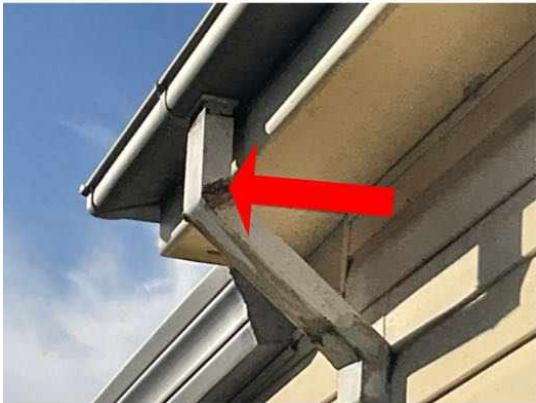
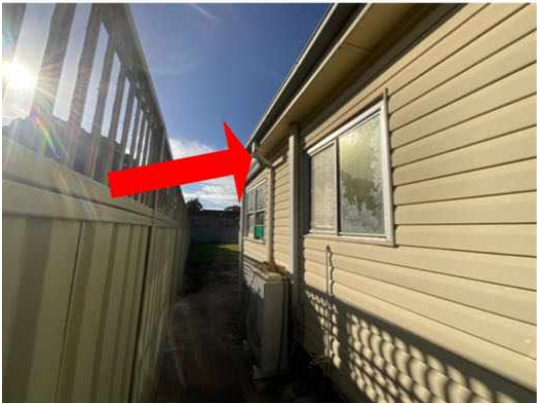
Finding 3.03

Building:	Main Building
Location:	Roof Exterior
Finding:	Water Leak - Gutters
Information:	Water leaks were found to be present to exterior plumbing work. Leaks are generally caused by deterioration of the plumbing elements over time, due to exposure to weather conditions, but may have also been caused by minor impact damage.

Such leaking creates damp conditions in the affected area, causing potential for water pooling and subsequent water damage if left unattended. These conditions may also attract termite attack, particularly if the area is subject to minimal levels of sun throughout daylight hours.

It is highly advised that a licensed plumber be appointed to rectify any water leaks that may be present. Areas of repair and replacement of plumbing fittings and fixtures may be required and, as such, a quotation should be sought.

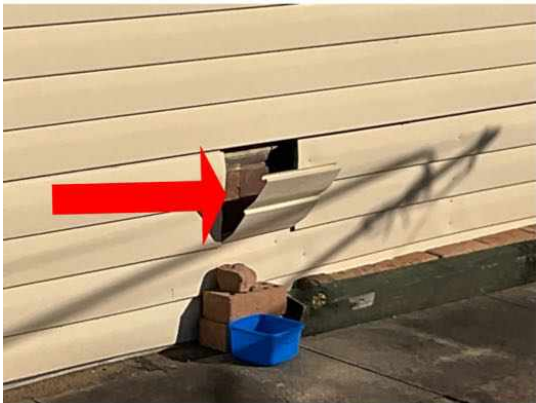
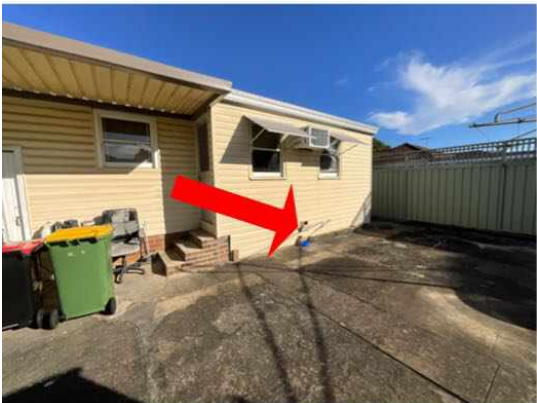
Finding 3.04

Building: Main Building
Location: All External Areas
Finding: External Cladding - Damaged
Information: At the time of inspection, the external cladding at the front elevation was found to be damaged. Further inspection by Licensed Building or Qualified Carpenter is highly recommended to ensure its safety and structural integrity of the area. If left unmanaged, the area is likely to deteriorate further, potentially creating not weather tight.

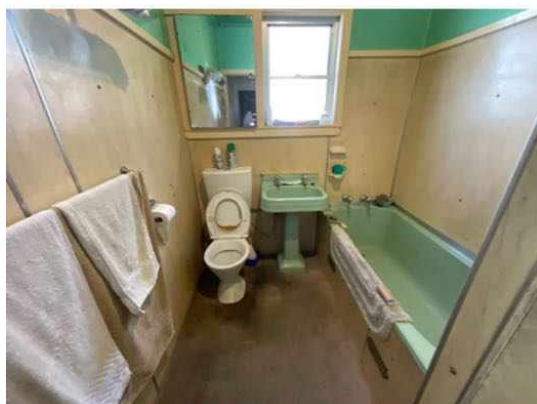
Building:	Main Building
Location:	Bathroom
Finding:	Bathroom - Below Current Standards
Information:	The bathroom is dated and constructed to an older standard. The floor and wall finishes, including junctions at wall/floor and shower area, do not appear to incorporate compliant waterproofing systems in accordance with current standards. Evidence of wear, staining and deterioration is present.

The shower area has inadequate water containment and may allow water ingress to surrounding areas and subfloor over time.

moisture ingress and deterioration.

Upgrade and renovation of the bathroom is recommended, including installation of compliant waterproofing system to AS 3740 by a licensed contractor.

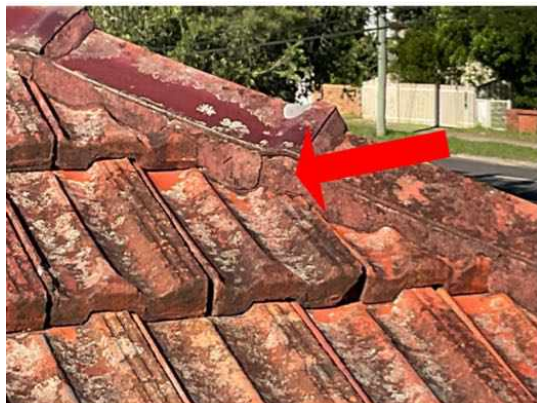
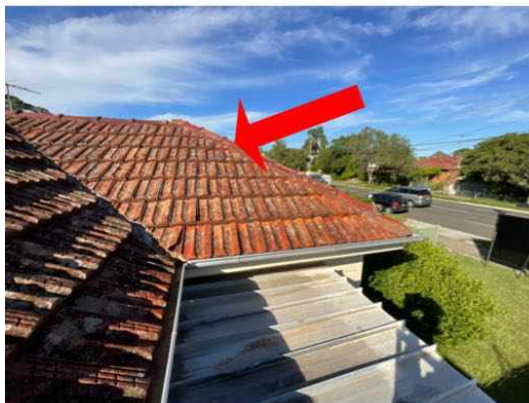
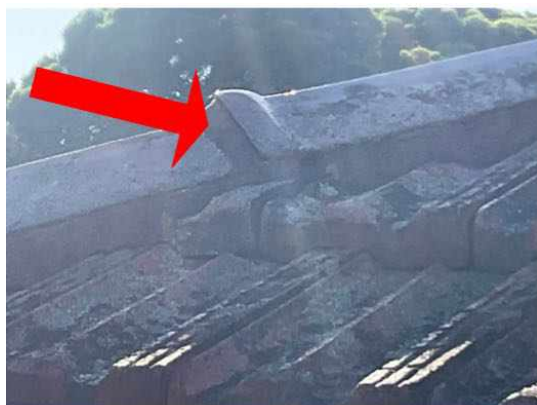
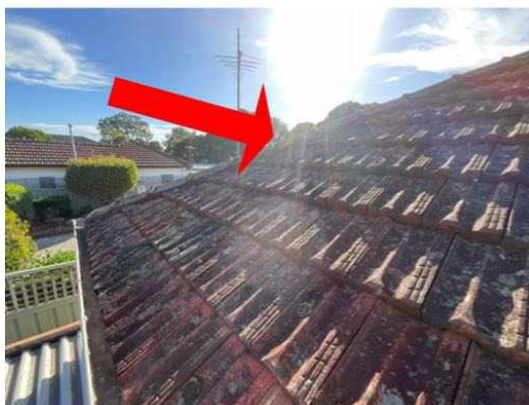
Finding 3.07

Building:	Main Building
Location:	Roof Exterior
Finding:	Mortar - Deterioration
Information:	Mortar, or 'bedding', is the material which fills joins and intersections between tiles and other building elements on the exterior roof covering, such as gable ends, hip capping and valleys. Upon inspection of the exterior roof, it was noted that sections of the mortar show varying levels of deterioration.

Mortar generally deteriorates as a result of frequent exposure to weather conditions over a prolonged period of time. Mortar that is deteriorating may allow water ingress into the roof void, putting associated building elements and roofing structures at risk of water damage. Deteriorated mortar also detracts from the functionality of roof tiles and other roofing elements, potentially decreasing weather tightness and roof drainage.

Mortar deterioration can be attended to by a handyman where areas of deterioration are localised and easily accessible. Otherwise, consultation with a roofing contractor is advised where greater works are required.

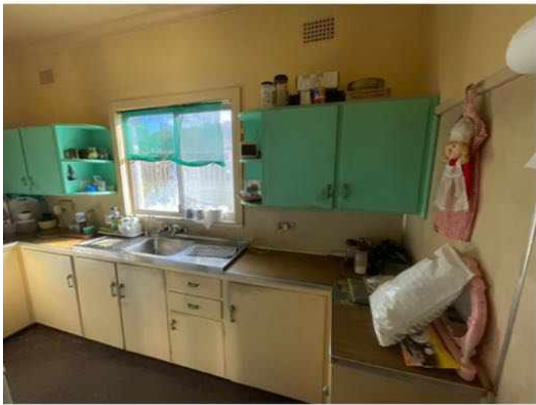
Finding 3.08

Building:	Main Building
Location:	Kitchen
Finding:	Kitchen - Outdated and Below Current Standards
Information:	The kitchen is dated and constructed to an older standard. Cabinetry, benchtops and wall linings show signs of wear, deterioration and ageing. The sink area and surrounding joinery show evidence of moisture exposure and potential long-term water ingress.

The electrical outlets and general layout appear outdated and may not comply with current safety and functional requirements. No visible waterproofing or moisture-resistant detailing is evident to wet areas around the sink.

While functional, the kitchen is obsolete and below current standards, with increased risk of moisture damage and serviceability issues.

Upgrade and renovation of the kitchen is recommended, including replacement of cabinetry, benchtop, and verification/upgrade of plumbing and electrical installations by licensed trades.

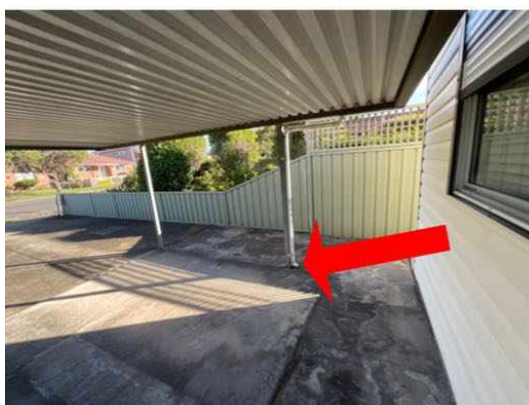
Building: Main Building
 Location: All External Areas
 Finding: Overflow (Downpipe) - Not plumbed for drainage
 Information: The overflow is not plumbed or connected to suitable drainage, which has resulted in the surrounding area becoming excessively damp. These damp conditions can lead to secondary defects such as rot, rust or corrosion of associated building elements, the formation of fungal decay, or even the creation of potential slip hazards. When coupled with poor site drainage, pooling of water may also attract termite activity to this area. It is highly recommended that a qualified plumber be appointed to install adequate drainage to the overflow. These works will ensure that the area remains dry and free of any secondary defects.

not connecting downpipes to the stormwater system can lead to various problems, including structural damage, safety hazards, and regulatory issues. It's essential to address this issue promptly by ensuring that downpipes are properly connected and directing water away from the building to mitigate these risks.

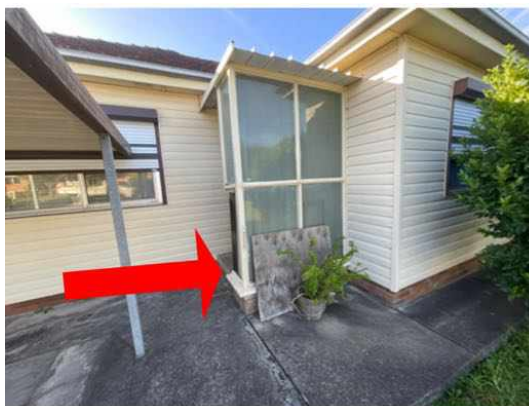
Finding 7.01

Building:	Main Building
Location:	All Areas
Finding:	Wood rot
Information:	This building element shows evidence of wood rot. Wood rot, also known as Fungal Decay, occurs when timbers and other cellulose building materials are exposed to damp conditions on an ongoing basis. This could be the result of exposure to weathering over a prolonged period of time, or the attraction of excessive moisture from other abutting building materials. Contributing factors also include poor air ventilation in the area.

Wood rot is often associated with general damp problems and is evidenced by a 'musty' smell or mould and mildew occurring on surfaces. If left unmanaged, damp conditions can lead to further health problems and the decay of timbers will continue.

Early intervention and regular maintenance, particularly of exterior timbers, will prolong the useful life of these building elements. Prior to any works being performed, the cause of the moisture that has created the visible wood rot should be identified and addressed in a suitable manner. Replacement of affected timbers may then be a necessary step in protecting surrounding building elements from such deterioration.

A qualified plumber may be appointed to assess the cause of excessive moisture and to provide advice on any remedial works as required. A qualified carpenter or registered builder may also be required to replace affected building materials.

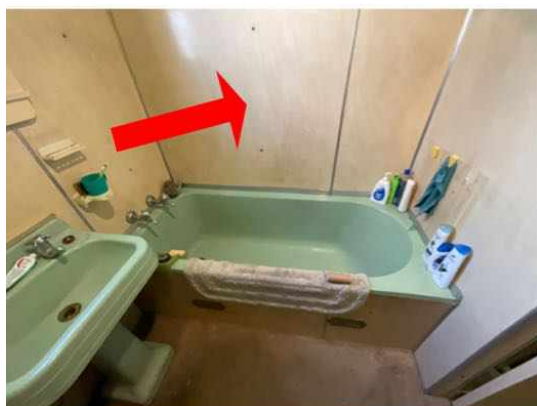
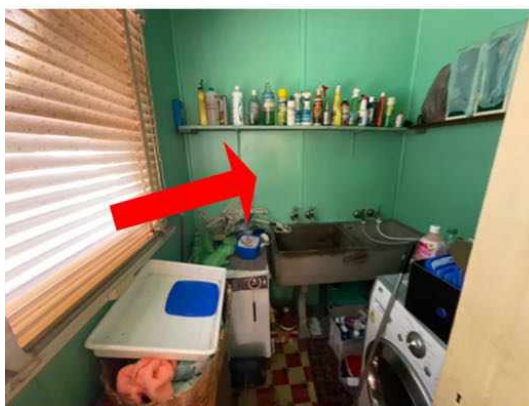
Building:	Main Building
Location:	All Areas
Finding:	Additional structure (Enclosed room)
Information:	The additional structure (room) that has been affixed to this area of the dwelling does not appear to comply with original design and approval. The structure does not currently appear to be unsafe, compliance with such standards ensures the structural integrity of the main dwelling and abutting addition.

As building standards have not been followed, this area provides a heightened risk of the development of building defects. The structural integrity of the area may have been compromised, which creates potential for the development or presence of fire safety issues.

It is highly recommended that the Client to request the document such as building permit, product specifications, designs, scope of work....

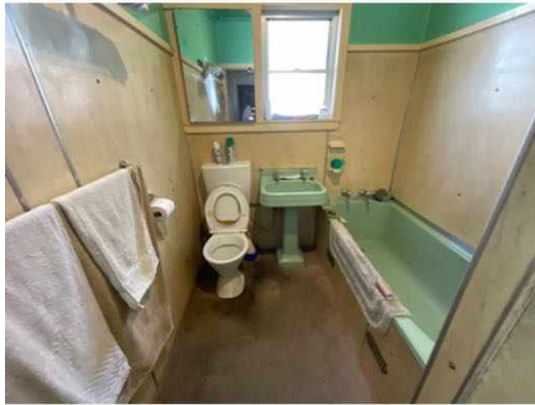
Building:	Main Building
Location:	All Areas
Finding:	Water Proofing Membranes - Information Only
Information:	Internal Water Proofing Membranes, are crucial in preventing water ingress into the property is important to know that the Membrane System used is to Australian Standards and has been installed correctly. Please refer to the original Building Documents or Maintenance Schedule for the relevant information including; - Membrane used and Manufacturers Specifications. - The Installer and Installation Certification. Especially with older property's where this information is unavailable, all wet areas should be monitored. Generally new waterproofing with a certificate may only have a guarantee of 8yrs. If any leaks, water staining, peeling or bubbling of the paint become evident to any adjacent walls or ceilings below a licensed builder or

waterproofing specialist is recommended to investigate further.

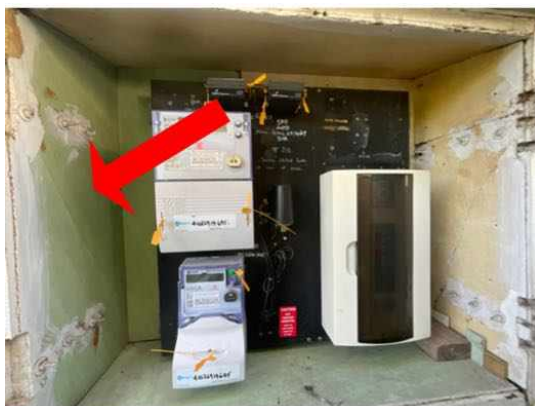
Building: Main Building
 Location: All Areas
 Finding: Termite Management System - no evidence of a chemical installation
 Information: The application of a post-construction chemical termite barrier is highly recommended for all properties, particularly if live termite activity has been found on the site previously. Such barriers are highly effective in preventing termite attack on any timber building elements throughout the property.

A durable notice should be placed in the switchboard unit to indicate current termite barriers. At the time of inspection, it appeared as though no termite management system has been installed, with no evidence to suggest preventative works taking place.

The client may consider gaining further advice from a pest controller as to the costs and procedures involved with this application. It is recommended that obtaining such advice be a short-term priority.

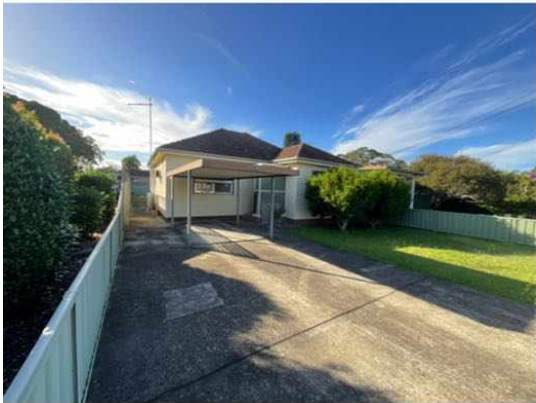
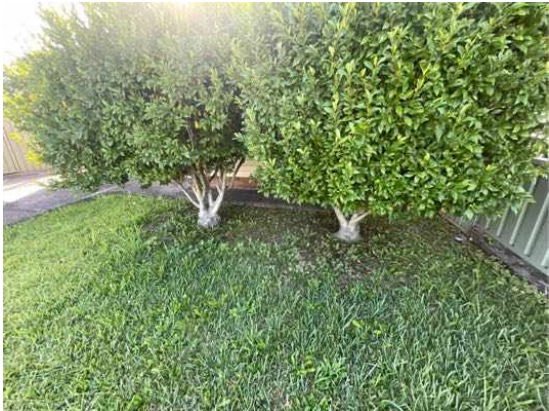
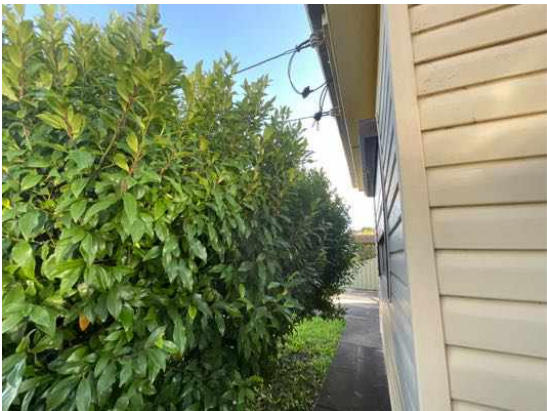
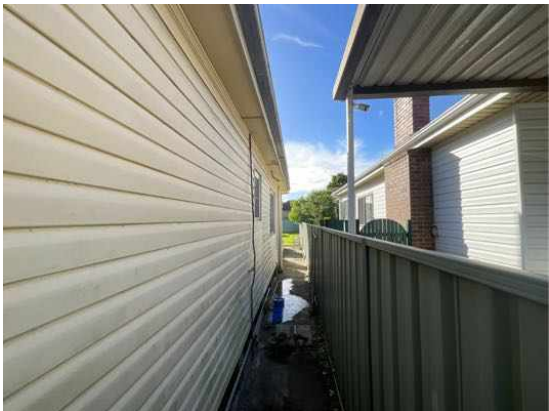
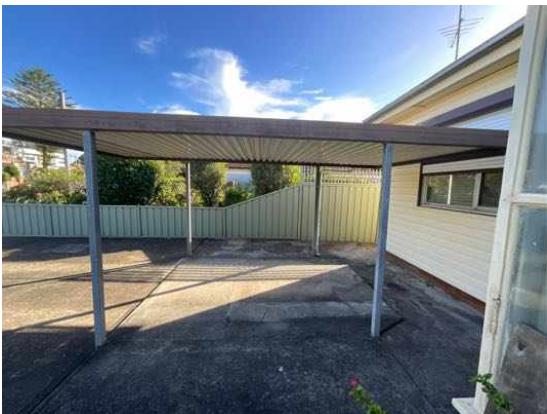
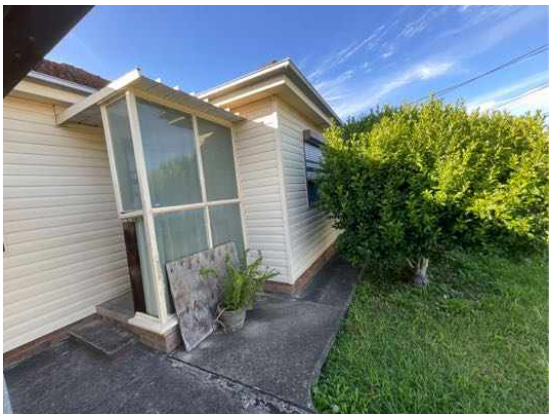
Building: Main Building
Location: All Areas
Finding: Additional Photos - Obstructions and Limitations
Information: These photographs are an indication of the obstructions and limitations which impeded full inspection of the property at the time of inspection. These obstructions can hide an array of defects and should be removed to allow full inspection to be carried out. A re-inspection is recommended once the areas are made accessible.
