Building and Timber Pest Inspection Report

Inspection Date: Wed, 21 Jan 2026

Property Address: 90 Harold St, Blacktown NSW 2148,
Australia

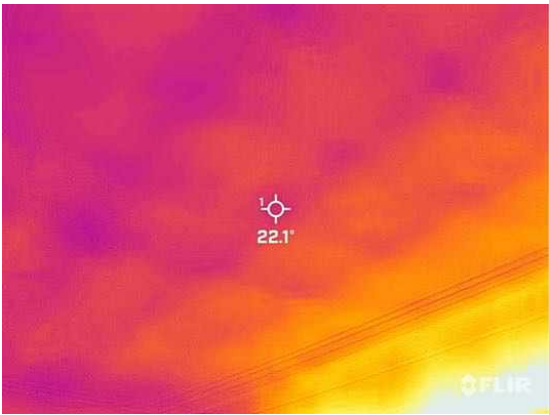
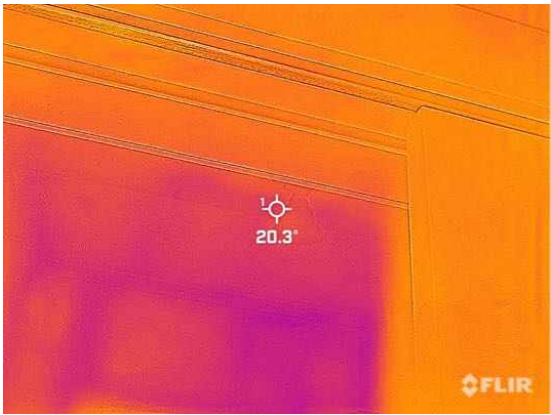
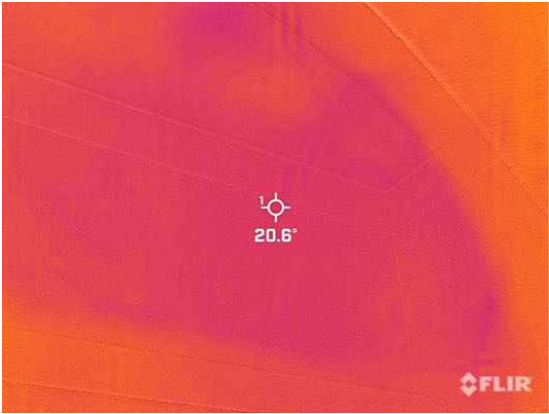
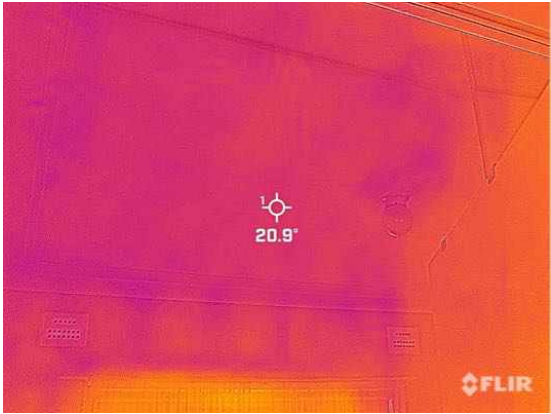
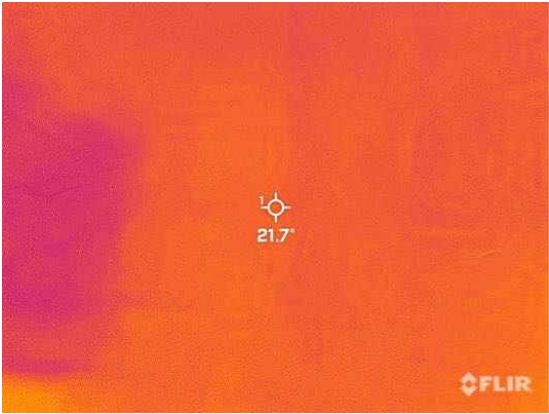
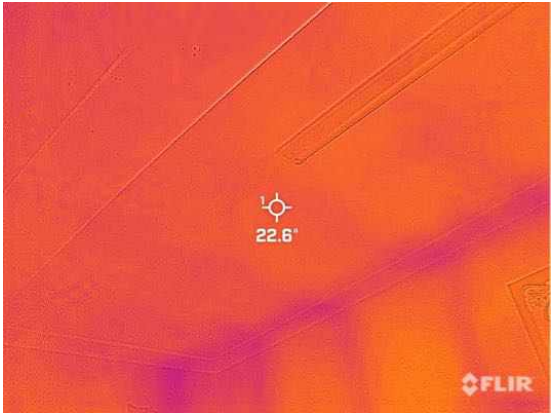
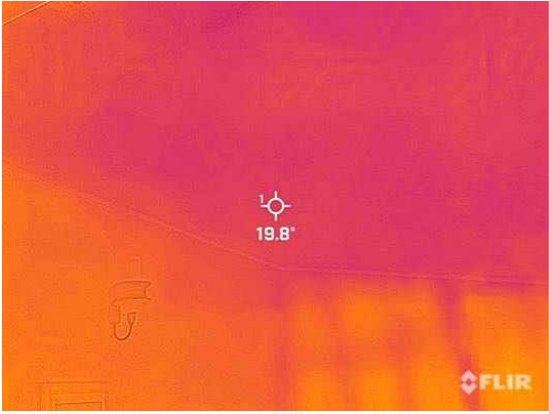
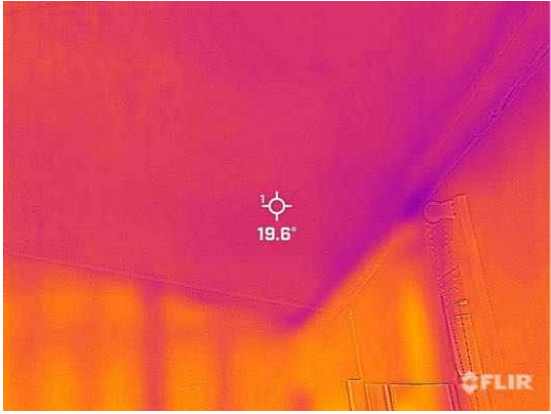
Building: Main Building
Location: All Areas
Finding: Additional Photos
Information: Thermal imaging camera was used to detect any active water leaks or/ and termite activities in the property. No water leaks or termite activities were found from inspection by thermal imaging camera. Additional photos are attached for general reference.
