Building Inspection Report

Inspection Date: Sun, 4 Jan 2026

Property Address: 62 Victoria Rd, Loch VIC 3945, Australia

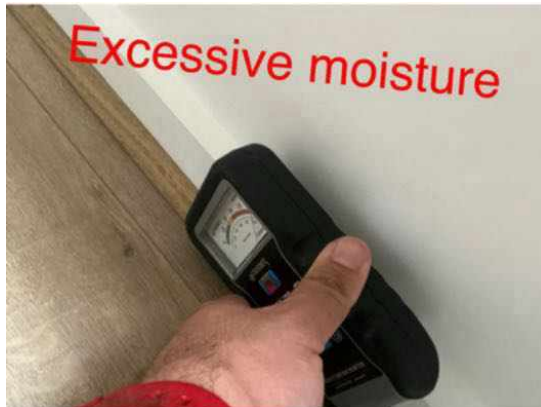
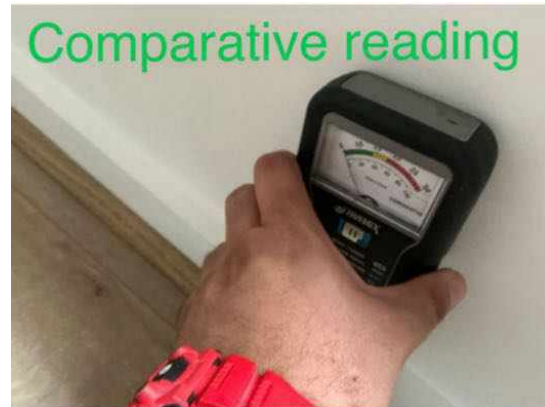
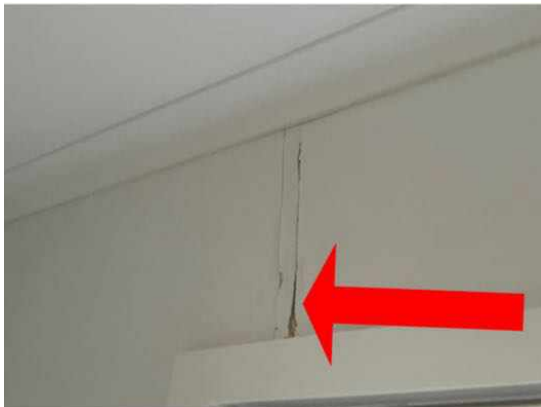
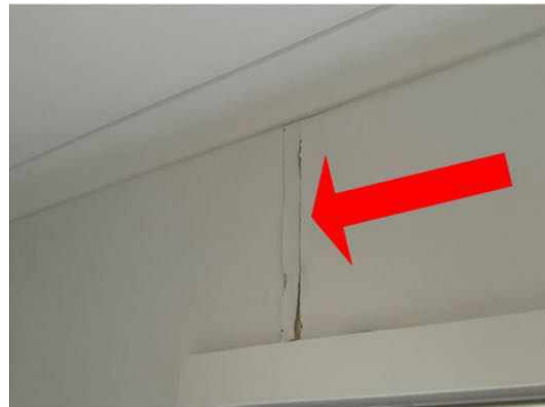
Defects 2.01

Building: Main Building
Location: Hallway
Finding: Major Defect – Suspected Water Ingress Affecting Hallway Wall and Finishes Adjacent to Window

At the time of inspection, excessive moisture readings were detected to the skirting boards beneath the hallway window. In addition, visible deterioration was observed to the internal plasterboard above the same window, including paint peeling, cracking along the plaster joint, and surface damage. Non-invasive moisture testing and thermal imaging identified abnormal moisture presence in this area. The combined findings are consistent with moisture ingress occurring at or around the window opening, allowing water to enter the wall cavity and affect both lower and upper internal finishes.

As this dwelling has been recently completed and handed over by the builder, the presence of moisture-related damage within internal wall linings is of significant concern. If left unrectified, ongoing water ingress may continue to penetrate the wall cavity, potentially resulting in deterioration of concealed timber framing, swelling or decay of skirting boards, degradation of plasterboard linings, and an increased risk of mould growth. Continued exposure to moisture may also lead to more extensive damage and increased rectification costs over time.

It is strongly recommended that a registered builder and/or licensed plumber be engaged immediately to undertake an invasive investigation to determine the exact source and pathway of water ingress, including removal of internal linings where necessary. Any defects identified to the window installation, flashing, sealing, or integration with the external cladding system must be rectified without delay. Prompt action is essential to prevent further moisture penetration and consequential damage, particularly given the recent completion of the dwelling.

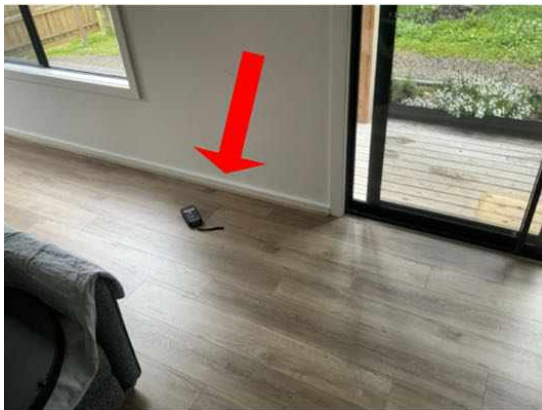
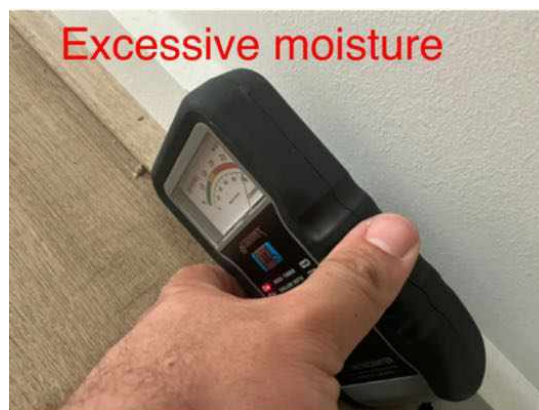
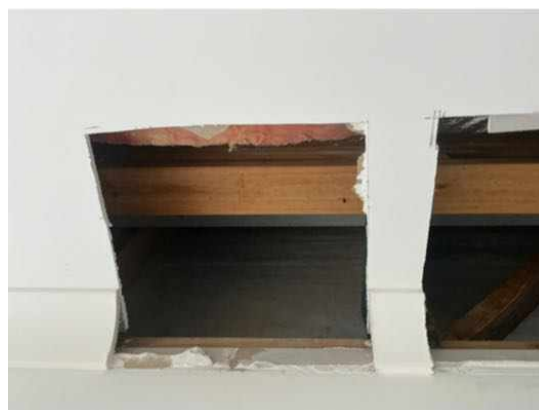
Defects 2.02

Building: Main Building
 Location: Entry
 Finding: Major Defect – Unrectified Ceiling Damage and Suspected Ongoing Moisture Ingress Adjacent to Entrance Sliding Door

Information: At the time of inspection, evidence of a previous water leak was observed at the entrance area adjacent to the sliding door. Sections of the internal ceiling plasterboard in this location had been cut to allow access to the roof space for repair works. However, at the time of inspection, these ceiling areas had not been reinstated, with exposed and unfinished plaster edges remaining visible. In addition, thermal imaging of the wall adjacent to the affected ceiling area identified abnormal moisture

concentration. Further non-invasive moisture testing to the skirting boards in this area recorded excessive moisture readings, indicating retained moisture within the wall cavity.

As this dwelling has been recently completed and handed over by the builder, the presence of unrectified ceiling damage and ongoing moisture within internal wall elements is of significant concern. If this condition remains unresolved, trapped moisture within the wall cavity may lead to deterioration of timber framing, damage to internal linings, and an increased risk of mould growth. The incomplete reinstatement of ceiling linings also represents poor finish and workmanship and may allow further moisture ingress if the original source has not been fully addressed.

It is strongly recommended that a registered builder and/or licensed plumber be engaged immediately to undertake an invasive investigation to determine the exact source and pathway of the moisture ingress, including inspection within the wall cavity and roof space as required. Any identified defects must be rectified without delay. Following confirmation that the moisture source has been rectified, all affected ceiling and wall linings are to be properly reinstated, including filling, sanding, and repainting to a smooth, consistent finish. Prompt rectification is essential given the recent completion of the dwelling and to prevent further moisture-related damage.

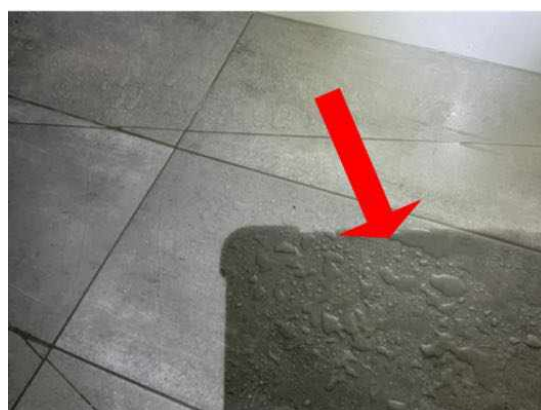
Defects 2.03

Building:	Main Building
Location:	Bathroom
Finding:	Major Defect – Non-Compliant Shower Floor Falls and Inadequate Drainage Performance
Information:

At the time of inspection, the shower floor was assessed using a 600 mm spirit level placed at multiple locations within the shower area. Several sections of the shower floor were found to have insufficient falls toward the floor waste, with some areas recording no measurable fall (flat). In accordance with AS 3740, shower floors are required to be graded to the waste with a minimum fall of 1:60, which equates to approximately 10 mm fall over every 600 mm. This minimum required fall was not achieved in the areas inspected.

To assess functional performance, the shower was operated continuously for approximately 20 minutes. During this period, water was observed to pool and remain scattered across multiple areas of the shower floor, rather than draining efficiently to the floor waste. The ponding visible in the shower area following operation confirms that the shower floor grading is ineffective and non-compliant.

Inadequate shower floor falls increase the risk of persistent water ponding, accelerated deterioration of grout and waterproofing systems, and potential moisture penetration to adjoining wall and floor junctions. This condition does not comply with

the minimum requirements of AS 3740 and is considered a significant defect in a recently completed dwelling.

It is strongly recommended that a registered builder and/or qualified tiler be engaged to carry out rectification works. Rectification is likely to require removal of floor tiles, inspection of the substrate and waterproofing membrane, regrading of the shower base to achieve compliant falls (minimum 10 mm fall over 600 mm toward the waste), and reinstatement of finishes. Rectification should be undertaken without delay.

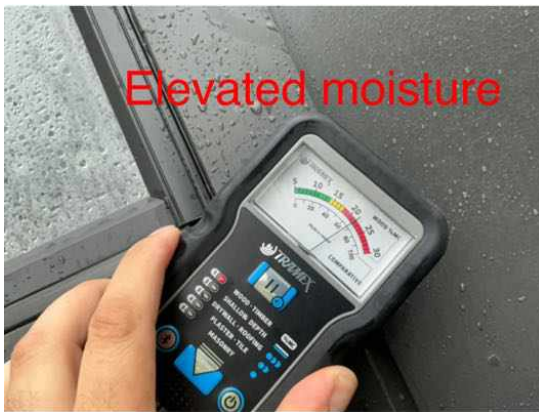
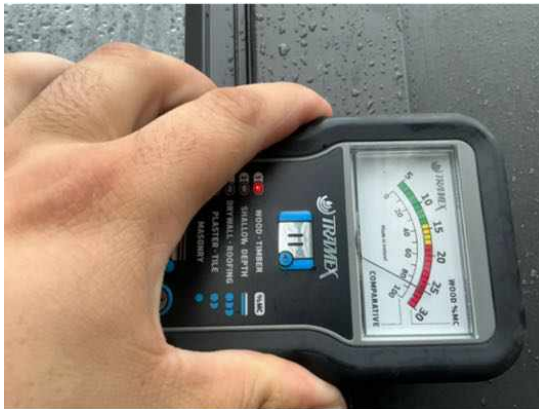
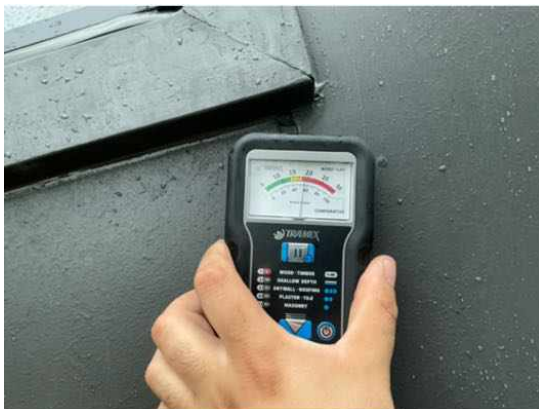
Defects 2.04

Building: Main Building
 Location: Bathroom
 Finding: Major Defect – Cracked Shower Tile and Suspected Water Ingress Through Wall Assembly

Information: At the time of inspection, a cracked floor tile was observed within the shower area. Given the dwelling is newly constructed, the presence of a cracked tile in a wet area is abnormal and of concern. A targeted water test was conducted by directing water toward the cracked tile for approximately 15 minutes. Subsequent inspection to the opposite side of the affected wall, including moisture testing to the external wall/cladding directly behind the crack location, identified elevated to excessive moisture readings in multiple areas.

The findings indicate that water may be penetrating past the tiled surface and waterproofing system at the location of the cracked tile, allowing moisture to enter the wall cavity. If left unaddressed, this condition may result in deterioration of the waterproofing membrane, damage to concealed wall framing, and an increased risk of mould growth and long-term moisture-related damage. This is a significant concern in a newly completed dwelling and suggests a failure in either the tile installation, substrate preparation, or waterproofing system.

It is strongly recommended that a licensed plumber and/or registered builder be engaged immediately to undertake an invasive investigation. This should include removal of the cracked tile, inspection of the underlying waterproofing membrane, and assessment of the wall cavity to confirm whether moisture is present or trapped behind the lining. Any defective waterproofing or tiling works must be rectified in full before reinstating finishes. Prompt action is required to prevent further moisture ingress and consequential damage.

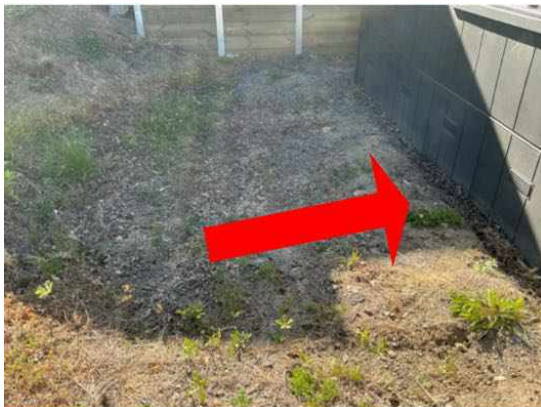
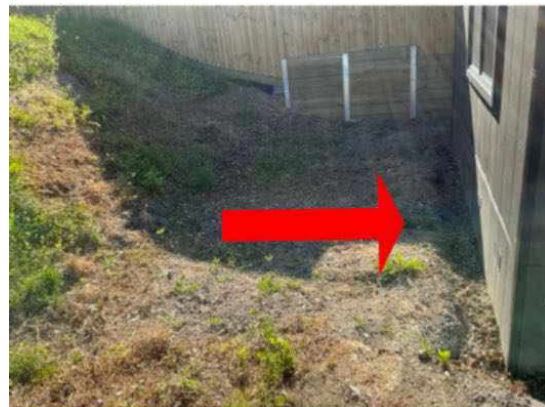
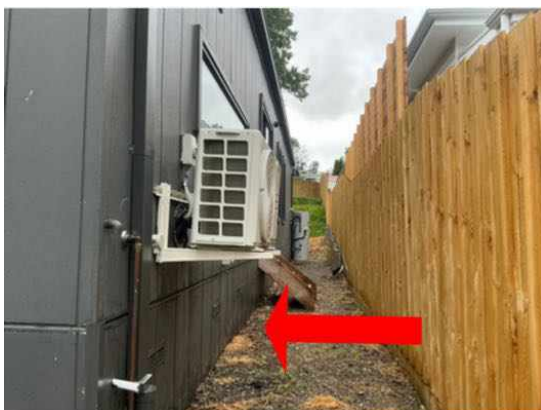
Defects 2.05

Building:	Main Building
Location:	All External Areas
Finding:	Inadequate Surface Drainage Resulting in Water Ponding and Subfloor Moisture Risk
Information:

At the time of inspection, the site was observed to have inadequate surface drainage around the dwelling, with ground levels sloping toward the building in multiple locations. Water is likely to pool against the external cladding and enter the subfloor area during rainfall events. This condition was particularly evident at the southern and eastern elevations, with the southern (rear) elevation being of heightened concern due to the significant natural slope behind the dwelling, which is likely to direct substantial volumes of surface water toward the building.

The current ground conditions indicate that, during periods of rainfall, water is likely to accumulate adjacent to the building perimeter and migrate into the subfloor area. Evidence of prior ground disturbance, including excavation or trenching works around the southern and eastern elevations, was noted; however, no visible evidence of subsoil (agi) drainage pipes or an effective perimeter drainage system was identified at the time of inspection.

If left unaddressed, ongoing water ingress into the subfloor may lead to persistent damp conditions, deterioration of building materials, increased moisture levels within the structure, and the creation of conditions conducive to termite activity. Prolonged exposure to subfloor moisture can also result in long-term durability and health concerns.

It is strongly recommended that the builder and/or a qualified drainage contractor be engaged as a matter of urgency to design and install an appropriate site drainage solution. This should include regrading of surface levels to direct water away from the building and the installation of a perimeter subsoil drainage system (agi drains) where required, connected to a lawful point of discharge. These measures are necessary to protect the dwelling from moisture ingress, particularly during heavy rainfall events.

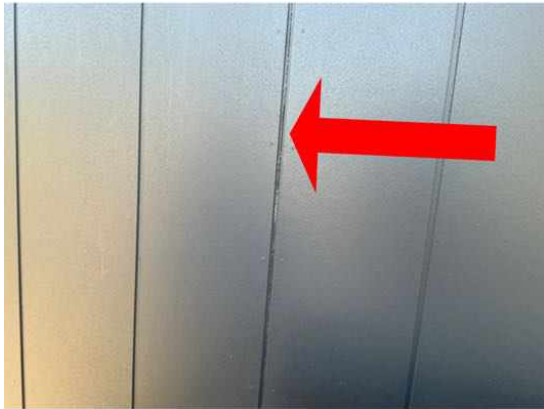
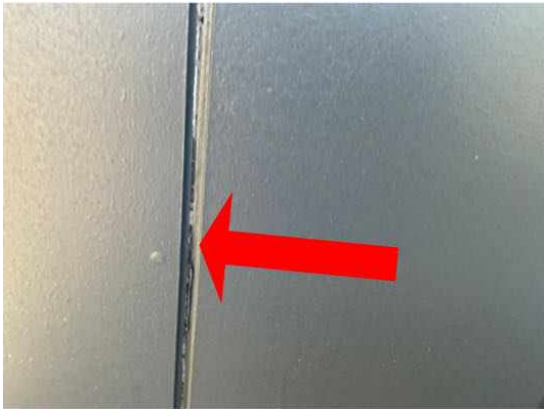
Defects 2.06

At the time of inspection, the external Weathertex cladding was observed to have open gaps and separation at sheet joints, with sections of the joint line appearing unsealed and inconsistent. In multiple locations, the joint opening appears large enough to expose the backing/interface behind the cladding, indicating the joint has not been finished or has separated since installation.

Open or poorly sealed cladding joints can compromise the weatherproofing performance of the external wall system. If left unrectified, wind-driven rain and moisture may enter behind the cladding, potentially wetting the wall wrap, battens/cavity components and framing, leading to moisture damage, deterioration of materials, and an increased risk of mould growth. This is of particular concern on a newly completed dwelling and is not consistent with acceptable workmanship for an external building envelope.

It is strongly recommended that the builder and/or qualified cladding installer be engaged to investigate and rectify the cladding joint detailing without delay. Rectification should include confirming the correct jointing method has been used for this Weathertex system (e.g., appropriate jointer/trim/backing strip and sealing method), reinstating the joints in accordance with the manufacturer's installation requirements, and confirming the wall wrap and cavity behind the affected joints have not been compromised by moisture. Any defective sheets, trims, or sealants should be replaced and the joint finish made good to achieve a consistent, weather-resistant outcome.

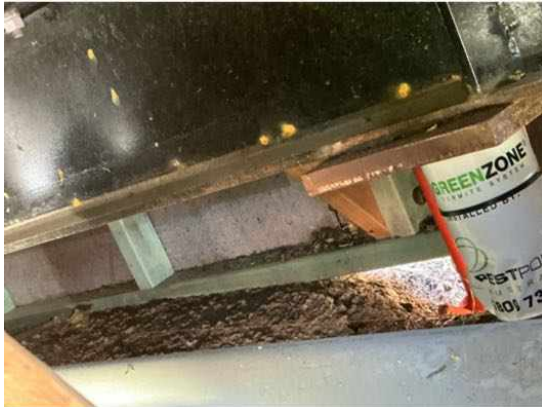
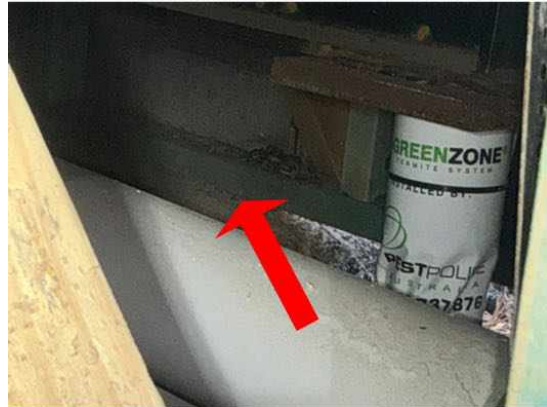
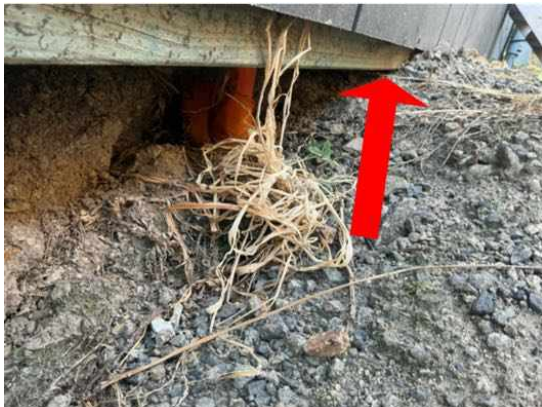
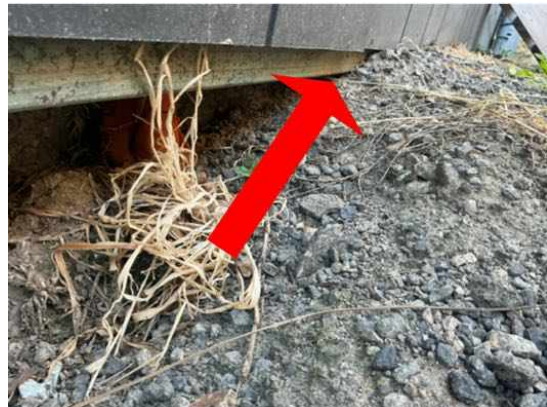
Defects 2.08

Building: Main Building
 Location: All External Areas
 Finding: Major Defect – External Weathertex Cladding Installed with Inadequate Ground Clearance

Information: At the time of inspection, the external Weathertex wall cladding was observed to be installed with insufficient clearance to the surrounding unprotected ground in multiple locations around the entire perimeter of the dwelling. In many areas, the cladding terminates at or very near ground level, with soil, gravel, leaf debris, and natural ground buildup in close proximity or direct contact with the bottom edge of the cladding.

This installation does not comply with the Weathertex installation manual, which requires a minimum clearance of 225 mm between the bottom edge of the cladding and unprotected ground (such as soil, garden beds, or natural ground). Inadequate ground clearance significantly increases the risk of moisture ingress through capillary action and splash-back, leading to persistently damp conditions at the base of the wall system. If left unrectified, this may result in deterioration of cladding materials, moisture penetration into the wall cavity, internal moisture damage, and the creation of conditions conducive to termite activity, particularly given the reduced ability to visually inspect the subfloor perimeter.

It is strongly recommended that the builder be engaged to urgently rectify this condition by regrading and lowering ground levels around the entire dwelling perimeter to reinstate a minimum 225 mm clearance to unprotected ground, in strict accordance with the Weathertex installation requirements. Where site conditions result in water collecting or flowing toward the building, appropriate surface and/or subsoil drainage measures should also be installed to ensure water is directed away from the structure and does not accumulate against the cladding or subfloor area.

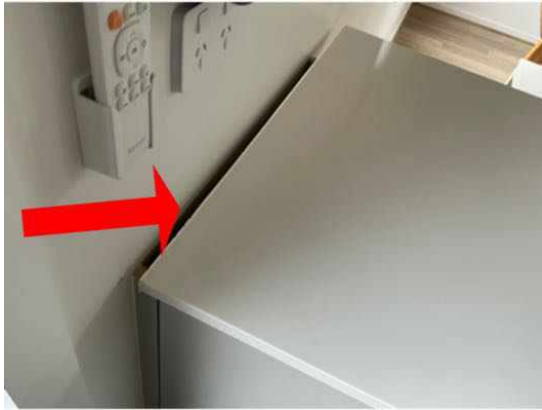
Defects 3.01

At the time of inspection, the kitchen benchtop was found to be inadequately secured to the underlying cabinetry. The benchtop was loose and moved when light pressure was applied, indicating that it has not been fixed correctly to the joinery.

If left unrectified, continued movement may result in damage to the benchtop or cabinetry and reflects poor workmanship for a recently completed dwelling.

It is recommended that a qualified cabinetmaker or kitchen installation specialist be engaged to properly secure the benchtop to the joinery in accordance with standard installation practices.

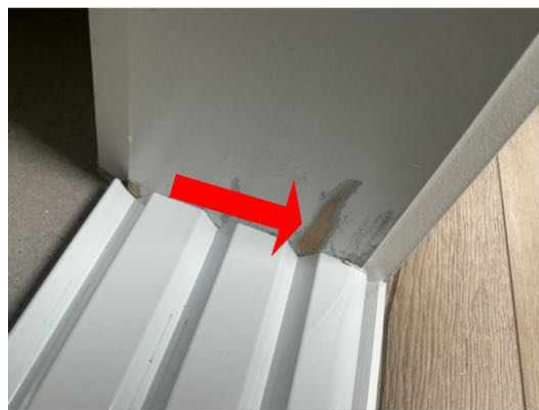
Defects 3.02

Building: Main Building
 Location: Laundry
 Finding: Damaged Paint Finish to Timber Sliding Door Frame (Laundry)
 Information:

At the time of inspection, damage to the paint finish was observed to the lower section of the timber frame to the sliding door in the laundry. The paint appears to have been removed or damaged, likely due to impact.

If left unrectified, the damaged finish may detract from the appearance of the door frame and reduce the durability of the painted surface.

It is recommended that the affected area be lightly sanded, prepared, and repainted to achieve a consistent and satisfactory finish.

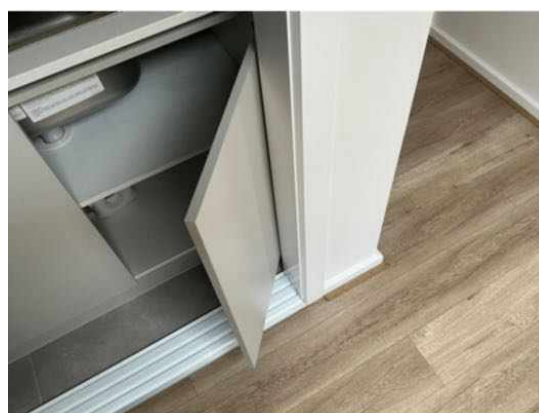
Defects 3.03

Building: Main Building
 Location: Laundry
 Finding: Laundry Cabinetry Doors Obstructed by Sliding Door and Frame
 Information:

At the time of inspection, the laundry cabinetry doors were found to be unable to open fully due to obstruction from the adjacent sliding door tracks and sliding door frame. This condition prevents proper access to the cabinetry and significantly restricts the functionality of the laundry space. It was noted that some internal cabinetry doors have been removed by the occupant to allow access, which is not an acceptable outcome for a completed dwelling.

The current configuration represents a poor design outcome given the limited size of the laundry, as the hinged cabinetry doors require clearance that is not available within the space.

It is recommended that the builder and/or cabinetmaker review the laundry cabinetry design and modify it to a more suitable solution, such as installing sliding or alternative low-clearance cabinetry doors, to allow practical and unobstructed use of the laundry without interference.

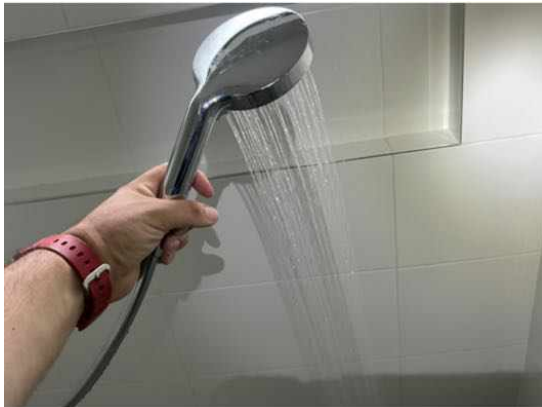
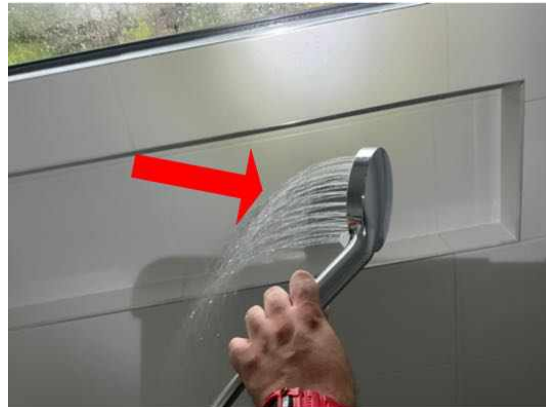
Defects 3.06

Building: Main Building
 Location: Bathroom
 Finding: Inadequate Water Flow at Shower Outlet
 Information:

At the time of inspection, the water flow at the shower outlet was observed to be weak and below what would be reasonably expected for normal use.

If left unaddressed, inadequate water flow may affect the functionality and user experience of the shower.

It is recommended that a licensed plumber inspect the shower installation to confirm correct water pressure, flow rate, and fixture performance, and rectify as required.

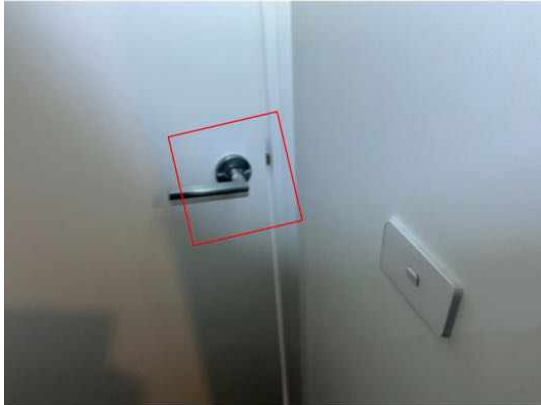
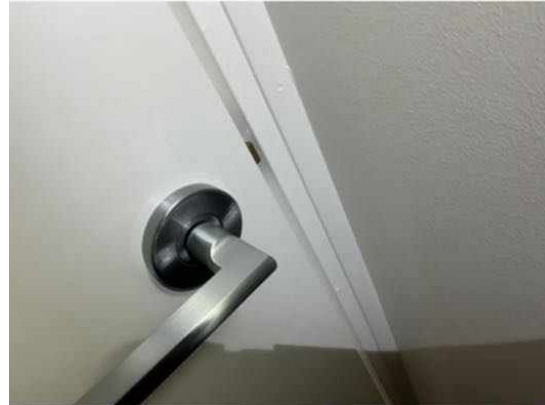
Defects 3.07

Building: Main Building
 Location: Bedroom 1
 Finding: Door handle - Not latching
 Information:

It was noted that the door in Bedroom 1 was not latching during operation at the time of inspection. Whilst detracting from the functionality of this building element, this minor defect may also be a security risk, and may therefore have serious implications if

left unattended.

A qualified carpenter or general handyperson may be appointed to perform rectification works as necessary, at client discretion. If left unattended, further functional impairment is likely to occur.

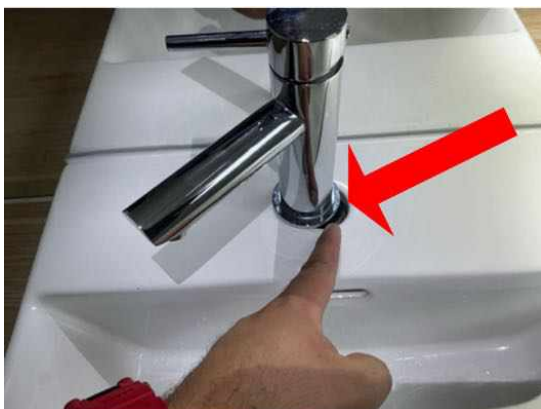
Defects 3.08

Building: Main Building
 Location: Bathroom
 Finding: Tap - Loose
 Information: The tap in the bathroom has not been installed correctly and is consequently loose. This tap being loose creates potential for water leaks and subsequent water damage to the surrounding area.

Where taps or spouts are loose, a qualified plumber should be appointed to re-fix the plumbing fitting.

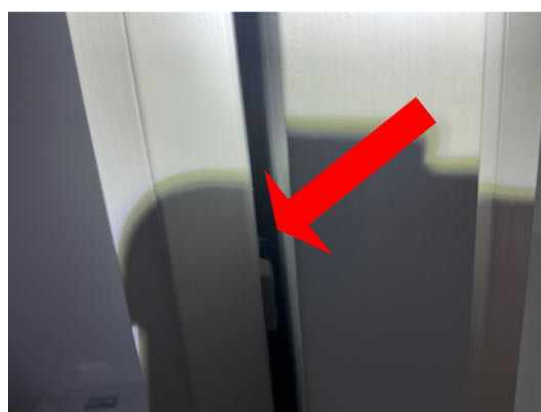
Defects 3.09

Building: Main Building
 Location: Toilet (WC)
 Finding: Sliding Door to WC Requires Realignment

Information: At the time of inspection, the sliding door to the WC was found to be misaligned and did not operate smoothly. The door showed signs of internal scratching, likely caused by contact with fixings or components within the wall cavity.

If left unrectified, continued operation in this condition may result in further damage to the door and affect its functionality.

It is recommended that a qualified carpenter or handyman realign the sliding door and adjust internal components as required to ensure smooth operation and prevent further damage.

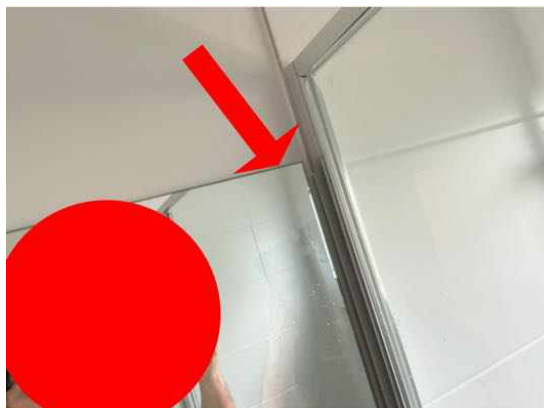
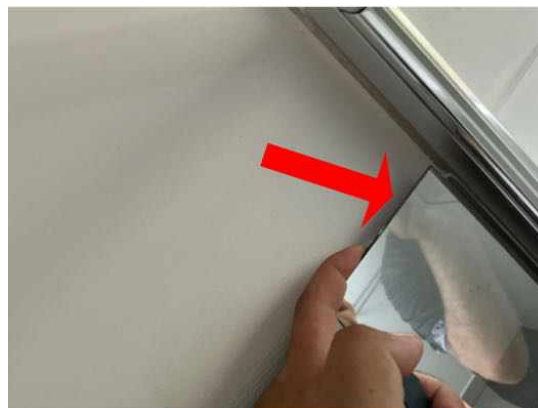
Defects 3.10

Building: Main Building
 Location: Bathroom
 Finding: Bathroom Mirror Not Securely Fixed
 Information:

At the time of inspection, the bathroom mirror was found to be inadequately fixed to the wall. The mirror was loose and exhibited noticeable movement when lightly touched.

If left unrectified, continued movement may lead to further loosening of fixings and potential damage to the mirror or wall surface.

It is recommended that a glazier or handyman securely refix the mirror to the wall in accordance with standard installation practices.

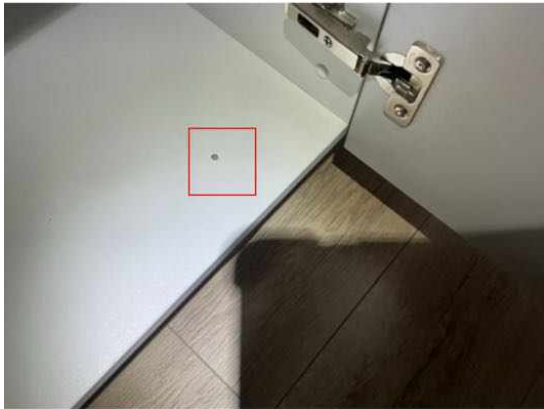
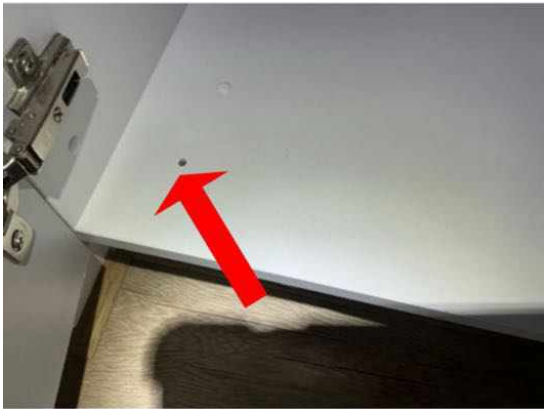
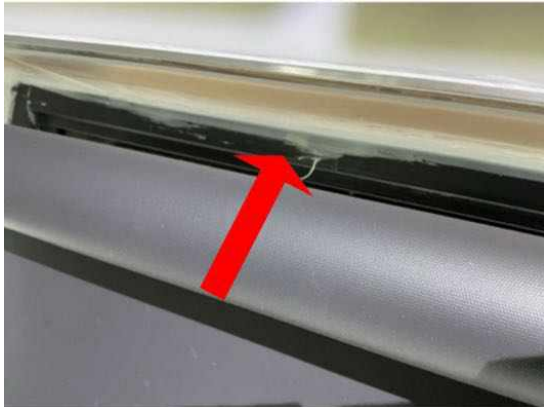
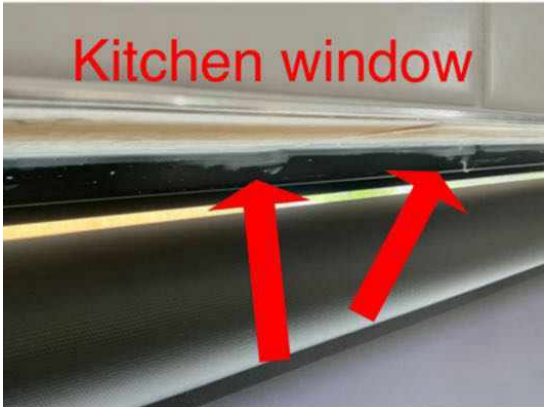
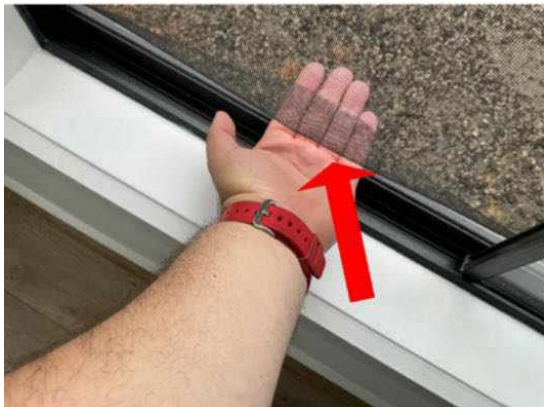
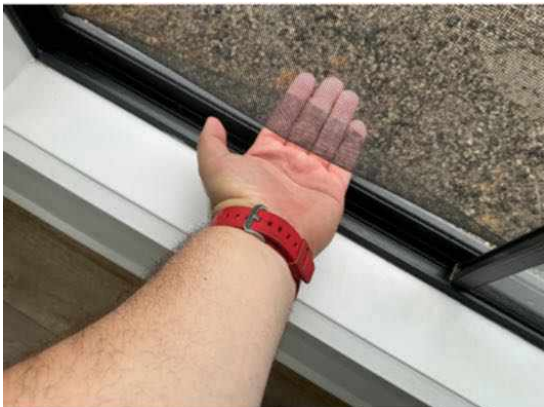
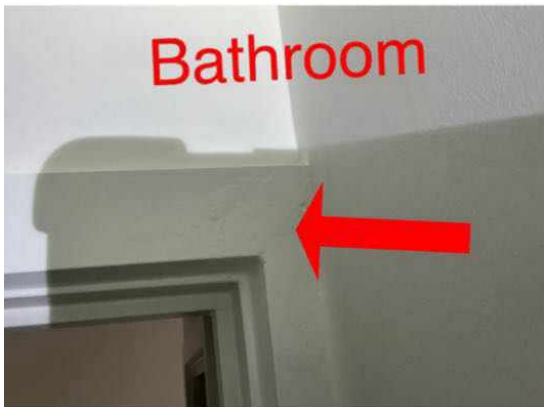
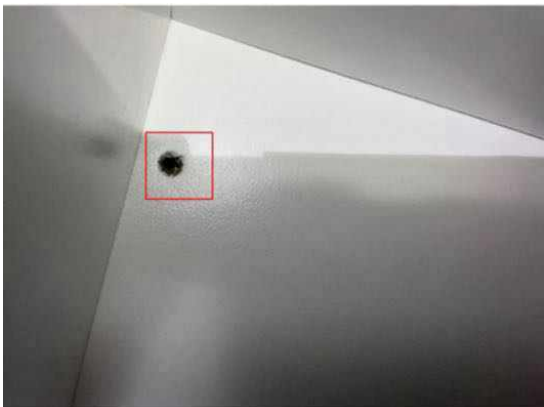
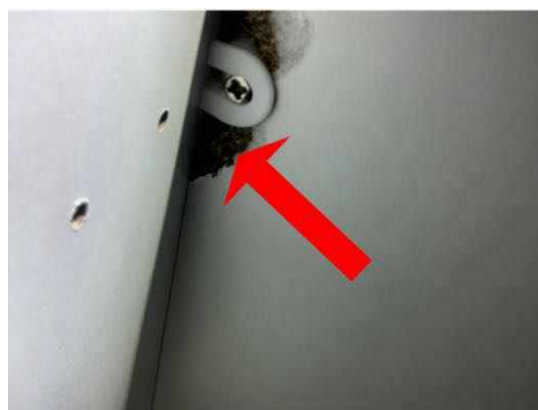
Defects 3.11

Building:	Main Building
Location:	All Internal Areas
Finding:	Substandard Workmanship to Joinery, Fixtures, and Finishes
Information:	The photographs provided show multiple instances of poor workmanship and incomplete finishes throughout the dwelling. These include cabinet modifications where screw and nail fixings have been left exposed without cover caps, damaged or inadequately installed flyscreens, bathroom door frames exhibiting an unsatisfactory finish requiring sanding and repainting, and poorly finished reworked cabinetry within the master bedroom walk-in robe. In addition, the silicone sealant applied around the kitchen window was found to be excessive and non-uniform, resulting in an untidy and visually unacceptable finish.

While these items are non-structural, they detract from the overall presentation and quality of the dwelling and are not consistent with reasonable workmanship standards expected of a newly completed home.

It is recommended that the builder and relevant trades, including cabinetmakers, painters, and glaziers, return to properly rectify all workmanship and finish issues. Rectification should include concealing fixings, repairing or replacing damaged components, re-finishing affected surfaces, and removing and reapplying silicone sealant neatly and evenly to achieve an acceptable standard of finish.

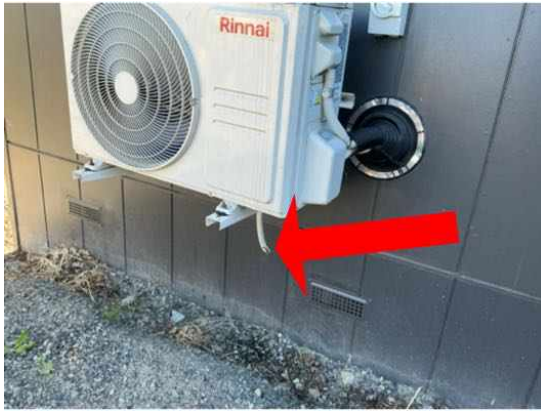
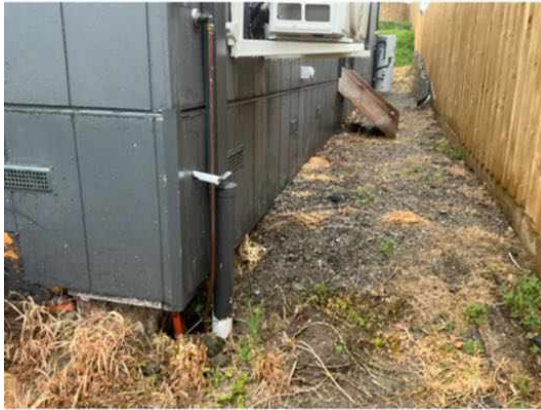
Defects 3.12

Building:	Main Building
Location:	All External Areas
Finding:	Air Conditioning Condensate Overflow Not Connected
Information:

At the time of inspection, the air-conditioning condensate overflow pipes were found to be loose and not connected to any approved drainage system. The current arrangement does not provide controlled disposal of condensate.

In accordance with the NCC (Plumbing Code of Australia) and AS/NZS 3500, condensate from mechanical plant is required to be discharged to an approved drainage system or lawful point of discharge. Uncontrolled discharge may result in water pooling, dampness, or moisture-related damage to adjacent building elements.

It is recommended that a licensed plumber or qualified HVAC installer connect the condensate overflow to an approved drainage system, such as the stormwater system, in accordance with NCC plumbing requirements.

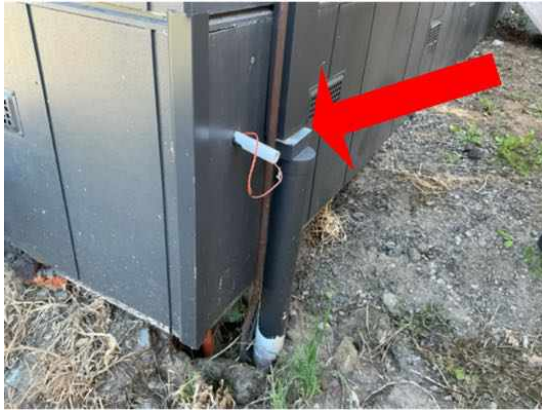
Defects 3.13

Building: Main Building
 Location: Western elevation
 Finding: Disconnected Downpipe at Western Elevation
 Information:

At the time of inspection, the downpipe at the western elevation was found to be disconnected from the stormwater drainage system, likely due to a drop in the surrounding ground level.

If left unrectified, uncontrolled roof water discharge may lead to water pooling, erosion, or moisture-related issues adjacent to the building.

It is recommended that the builder or licensed plumber reconnect the downpipe to the stormwater system and make good the surrounding ground levels as required to ensure effective drainage.

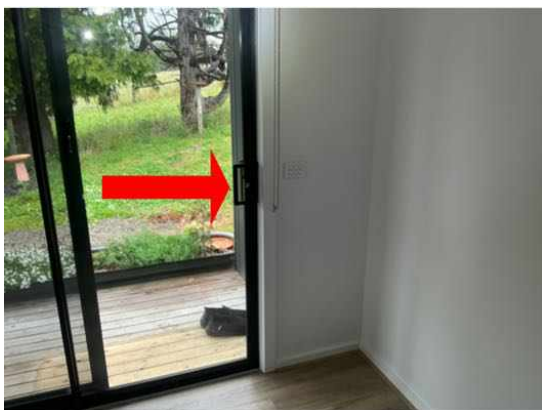
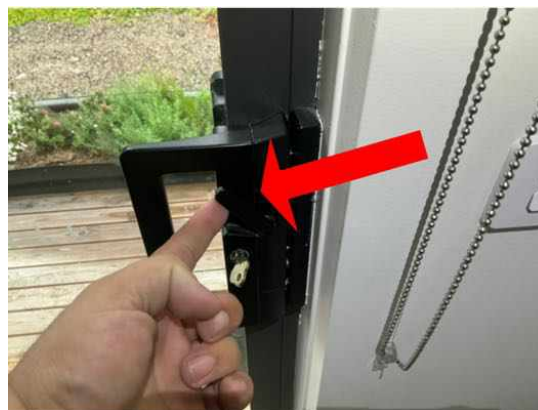
Defects 3.14

Information: It was noted that the entry sliding door's lock was not latching during operation at the time of inspection. Whilst detracting from the functionality of this building element, this minor defect may also be a security risk, and may therefore have serious implications if left unattended.

A qualified carpenter or general handyperson may be appointed to perform rectification works as necessary, at client discretion. If left unattended, further functional impairment is likely to occur.

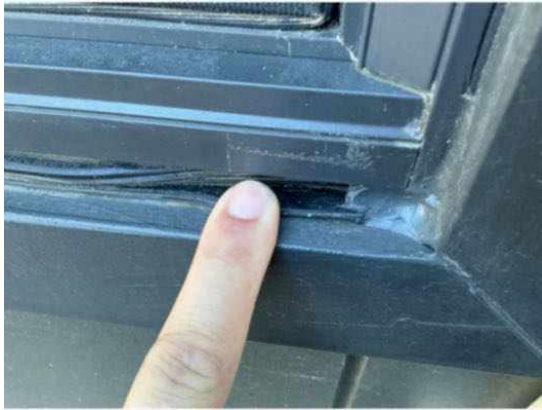
Defects 3.15

Building:	Main Building
Location:	All External Areas
Finding:	Inadequate Weatherproofing at Window-to-Cladding Interface
Information:

At the time of inspection, gaps, poor sealing, and incomplete detailing were observed at the junction between the window frame/sill and the external Weathertex cladding. The sealant application was inconsistent, with visible openings and separation at the lower window sill and corner junctions, indicating that the window-to-cladding interface has not been adequately weatherproofed.

This condition creates a high risk of water ingress, particularly during wind-driven rain events. Moisture entering at this location may bypass the external cladding system and penetrate the wall cavity, potentially wetting the wall wrap, battens, insulation, and timber framing. If left unrectified, this may lead to elevated moisture levels, material deterioration, mould growth, internal water damage, and the creation of conditions conducive to termite activity.

It is strongly recommended that the builder and/or a qualified window installer or cladding contractor be engaged immediately to carry out an invasive inspection of the affected window opening. Rectification works should include reinstating compliant window flashing and sealing details in accordance with the NCC weatherproofing intent and the relevant manufacturer's installation requirements, ensuring all gaps are properly sealed and the wall system is restored to a weather-resistant condition.

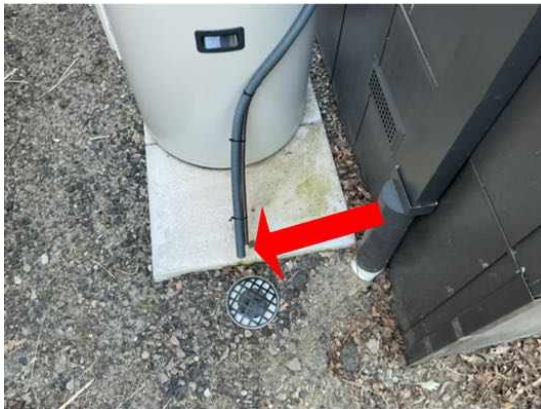
Defects 3.16

Building:	Main Building
Location:	Western elevation
Finding:	HWS Overflow - Not Connected
Information:	The Hot Water System (HWS) overflow was found to be disconnected from storm water drainage and is creating excessive moisture in the surrounding area.

These damp conditions can lead to secondary defects such as rot, rust or corrosion of associated building elements, the formation of fungal decay, or even the creation of potential slip hazards. When coupled with poor site drainage, pooling of water may also attract termite activity to this area.

It is highly recommended that a licensed plumber be appointed to connect the HWS overflow in order to prevent such an environment from being created. These minor works should be carried out as soon as possible.

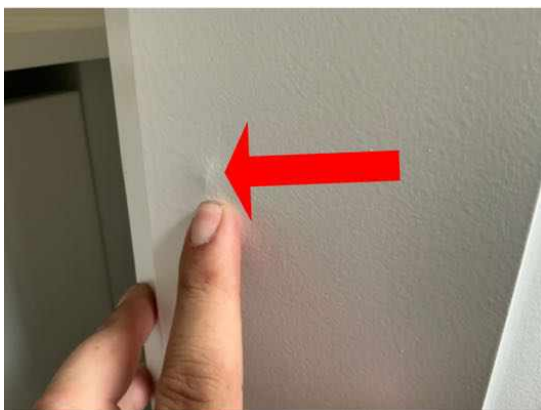
Defects 3.17

At the time of inspection, a popped nail was observed in the timber frame of the sliding door within the laundry. This condition is indicative of poor workmanship and an incomplete finish.

If left unrectified, the protruding nail may continue to work loose and affect the appearance and durability of the door frame.

It is recommended that a qualified carpenter or handyman re-fix the affected area, set the nail correctly, and make good the surface to achieve a neat finish.

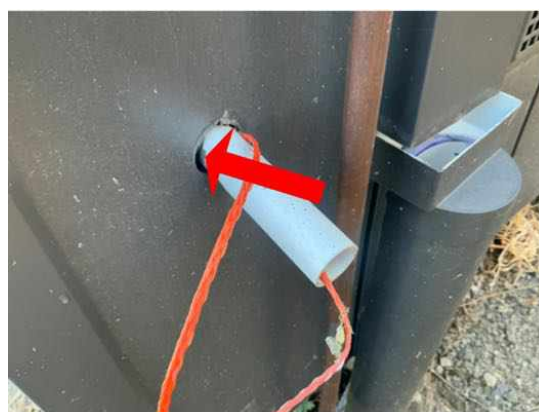
Defects 3.18

Location: Western elevation
 Finding: Unsealed Electrical Conduit Penetration to External Cladding
 Information: An external electrical conduit penetration was identified where a PVC conduit, containing a draw wire for future services, protrudes through the external cladding and is left open-ended. The penetration is inadequately finished, with no appropriate sealing, grommet, or weatherproof flashing provided at the cladding interface. This condition was observed externally and presents as poor workmanship rather than an incomplete service installation.

The lack of proper sealing compromises the weatherproofing of the external wall system and may allow water, moisture, insects, and vermin to enter the wall cavity. Over time, this can contribute to moisture-related deterioration of building elements, reduced durability of the cladding system, and increased risk of concealed damage within the wall assembly.

It is recommended that a licensed electrician or suitably qualified tradesperson properly terminate the conduit by installing an appropriate cap or gland and sealing the penetration in accordance with good building practice and the intent of NCC weatherproofing provisions, ensuring the external wall envelope is adequately protected.

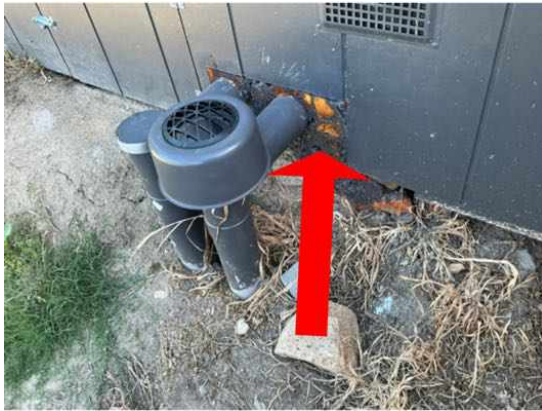
Defects 3.19

Building: Main Building
 Location: Northern elevation
 Finding: Northern Elevation: Use of Expanding Foam at Subfloor Penetrations
 Information:

At the northern elevation, the external wall cladding around the subfloor penetrations has been infilled using expanding polyurethane foam rather than a properly detailed flashing and sealing system. The foam filler is visibly exposed, uneven, and deteriorating, and it has been used as the primary method of closing gaps between the cladding and the pipe penetrations.

penetrations and is susceptible to UV degradation, moisture absorption, and breakdown over time. Its use in this location does not provide a reliable weather-tight seal and increases the risk of water ingress behind the cladding, moisture accumulation within the subfloor, and subsequent deterioration of adjacent building elements.

It is recommended that the foam filler be removed and the penetrations be rectified by a suitably qualified contractor using appropriate flashing, sleeves, and sealants in accordance with good building practice and the cladding manufacturer's installation requirements, to ensure a durable and weather-tight outcome.

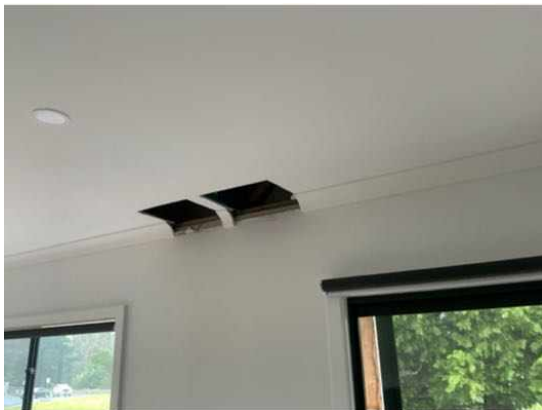
Building:	Main Building
Location:	Roof Void
Finding:	Obstructions and Limitations - Roof Cavity No access Hole
Information:	The roof cavity was inaccessible at the time of the inspection due to no access hole which impeded the inspection of the roof cavity of the main building at the time of inspection. These obstructions can hide an array of defects and should be removed to allow full inspection to be carried out. A re-inspection is recommended once the areas are made accessible.

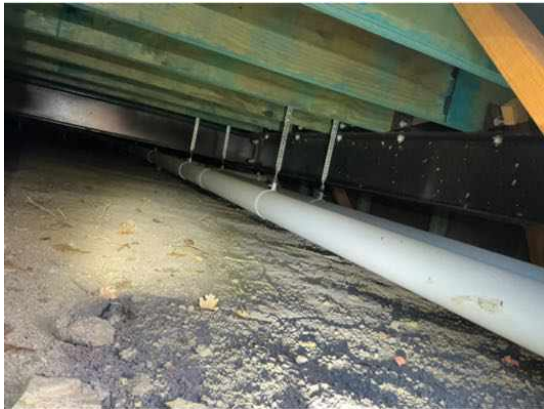
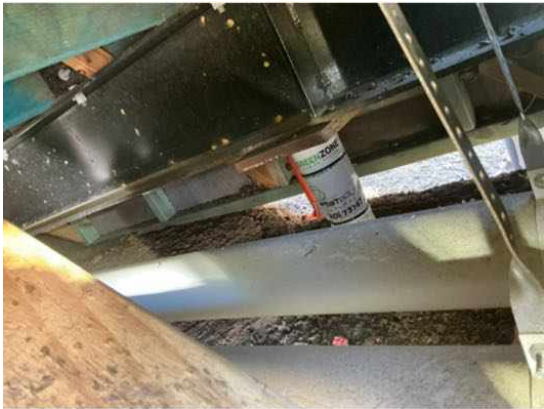
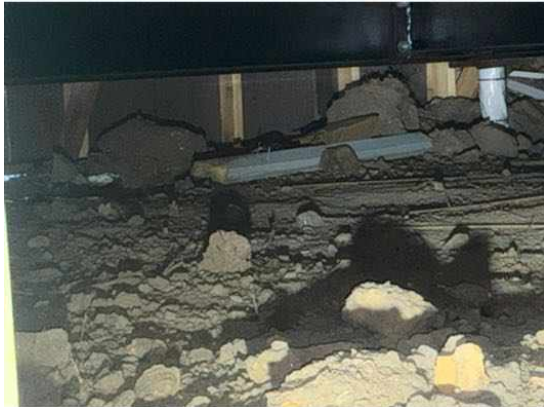
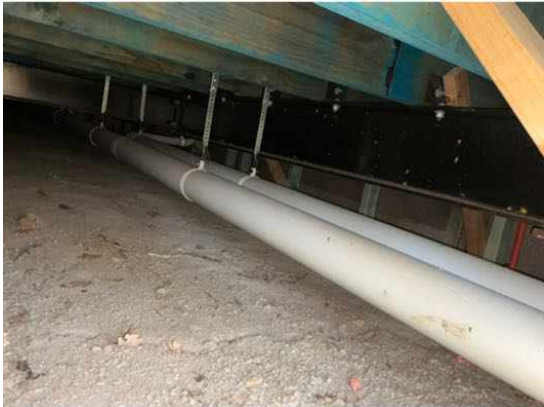
Building:	Main Building
Location:	Subfloor
Finding:	Obstructions and Limitations - subfloor
Information:	These photographs are an indication of the obstructions and limitations which impeded the inspection of the subfloor area of the property at the time of inspection. These obstructions can hide an array of defects and should be removed to allow full inspection to be carried out. A re-inspection is recommended once the areas are made accessible.
