# Building and Timber Pest Inspection Report

Inspection Date: Thu, 26 Mar 2026

Property Address: 6 River St, Springfield NSW 2250, Australia

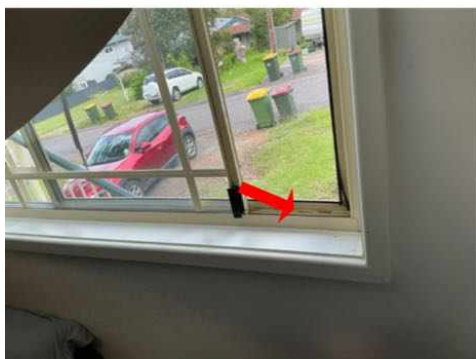
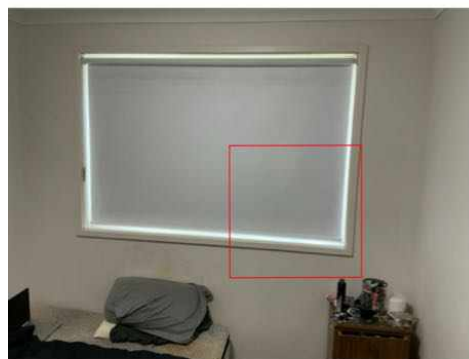
Building:	Main Building
Location:	All Areas
Finding:	Window Restrictors - Recommended
Information:	Upstairs windows did not have window restrictors installed. Although not a requirement at the time of construction, it is advisable to install window opening restrictors on all second storey windows with sill heights below 1.7 meter and potential fall of 2 meters or more.

If you live in a strata scheme, window safety devices must be installed on all applicable windows by 13 March 2018. Residents with safety devices installed can still fully open their windows but it's recommended that devices be engaged whenever children are present, to prevent falls.

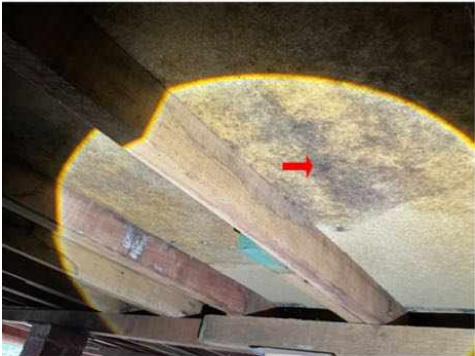
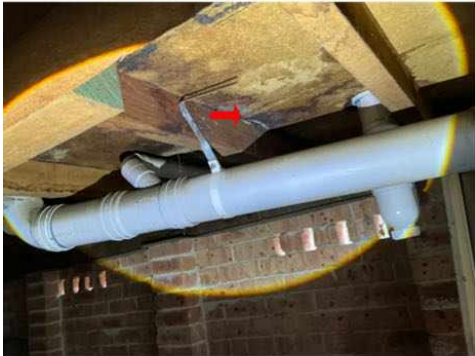
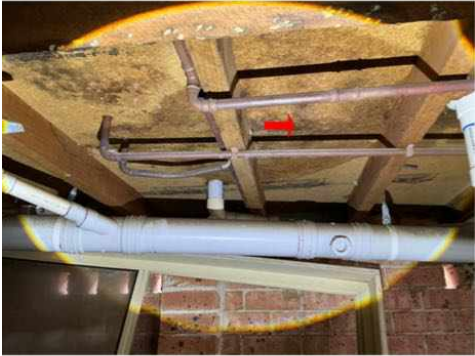
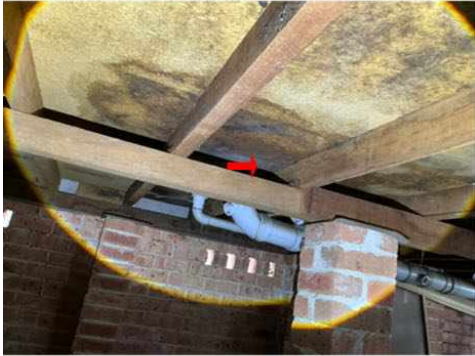
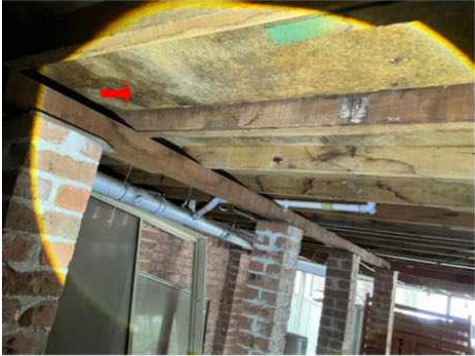
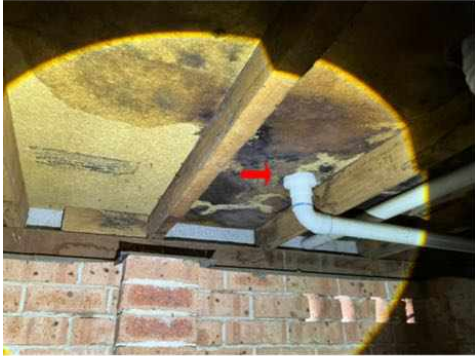
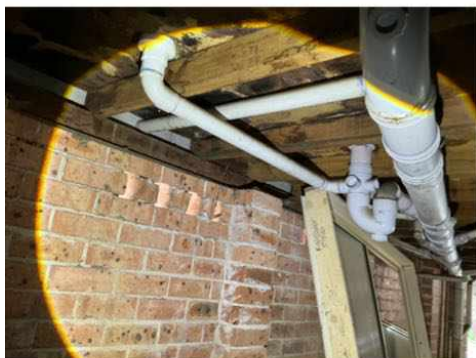
#### Finding 2.01

Building:	Main Building
Location:	All Areas
Finding:	Stains - Floorboards (Subfloor)
Information:	At the time of inspection, staining was observed on the underside of the yellow tongue in the subfloor area. The staining pattern suggests past or ongoing water leaks, likely caused by plumbing issues and/or failed waterproofing above the affected area. Continued moisture exposure may lead to timber decay, mould growth, and attract termite activity if left unrectified. The client should engage a licensed plumber to identify and repair any active leaks and replace any damaged plumbing components. A qualified waterproofing specialist and builder should also assess the wet areas

above and in subfloor to determine the extent of waterproofing failure and undertake necessary rectification to prevent further water ingress. All affected yellow tongue should be replaced.

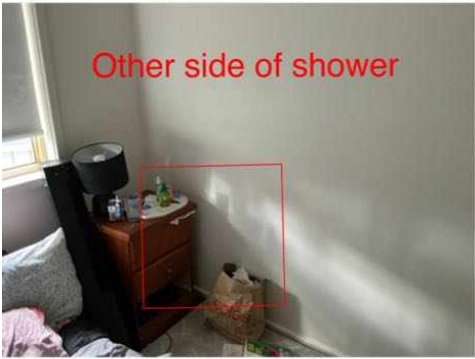
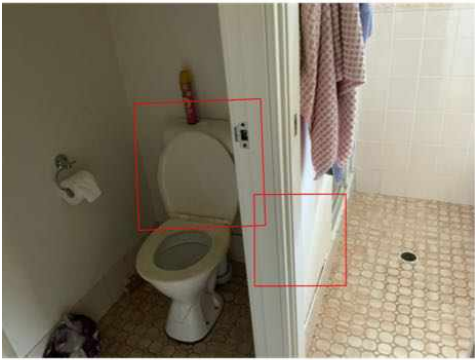
## Finding 2.02

Building:	Main Building
Location:	Bathroom
Finding:	Excessive Moisture on Walls (Adjacent Bathroom) - Major Defect
Information:	A major defect was identified during the inspection, with evidence of moisture penetration noted on the walls adjoining the bathroom and shower area. These walls are shared with the bedrooms on either side of the bathroom. The presence of moisture raises serious concerns about the integrity of the waterproofing system, which is a critical component in preventing water ingress into adjoining structures.

The moisture penetration is likely due to a failure or inadequacy in the waterproofing membrane beneath the tiled surfaces in the bathroom and shower area. Waterproofing systems are designed to act as a barrier, and any breach can result in water escaping into adjacent walls. This could also be exacerbated by inadequate sealing around fixtures, joints, or tiles, which are common entry points for water. Additionally, the defect may be attributed to substandard installation practices or the natural wear and tear of waterproofing materials over time, both of which can compromise the membrane's effectiveness.

If left unaddressed, this issue could lead to significant consequences. Persistent moisture can weaken the structural integrity of the walls, resulting in costly repairs or replacement. Damp conditions also create an ideal environment for mould growth, which poses health risks and further compromises the interior condition of the property. Moreover, unresolved waterproofing issues can adversely impact the property's value and marketability.

The client is advised to use services of a professional waterproofing specialist as soon as possible.

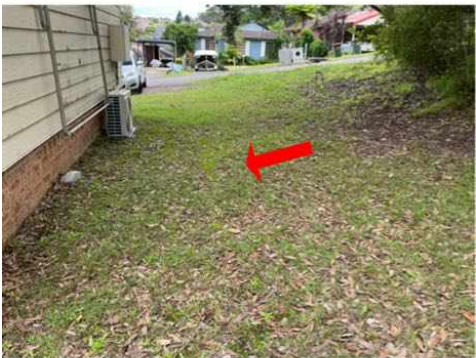
Building:	Main Building
Location:	All Areas
Finding:	Inadequate Site Drainage - Exterior Areas
Information:	At the time of inspection, inadequate site drainage was observed around the perimeter of the building, which can lead to water pooling and insufficient runoff management.

This condition may result in moisture being absorbed by the foundation or lower walls, potentially leading to rising damp, cracks in brickwork, erosion of the soil around the building, or structural issues over time. Water pooling can also create ideal conditions for mould growth, contribute to the deterioration of exterior materials, and act as conducive conditions for termite activity, as termites are attracted to areas with elevated and persistent moisture levels.

It is recommended that proper site drainage be installed, such as redirecting water flow away from the building or incorporating drainage systems, to prevent further damage and ensure the long-term stability of the structure.

To address the inadequate site drainage, a qualified landscaper or drainage specialist should be engaged to design and install appropriate drainage solutions, such as grading the ground away from the building or installing French drains, surface drains, or downspout extensions. If more complex issues are present, such as damage to the foundation or moisture entering the walls, a structural engineer may need to assess the situation, and a builder may be required for repairs.

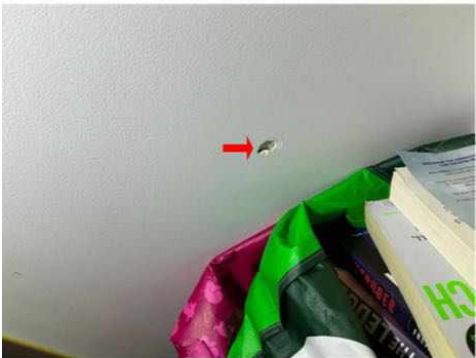
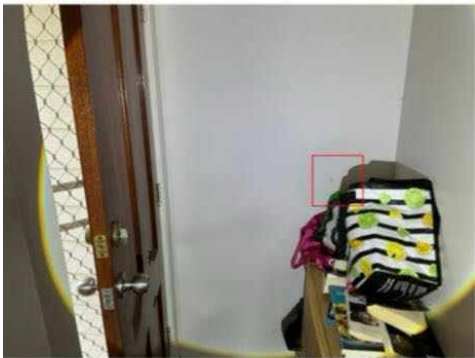
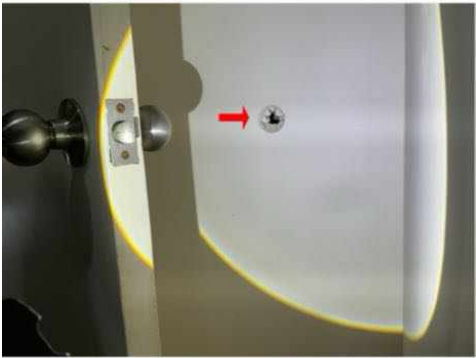
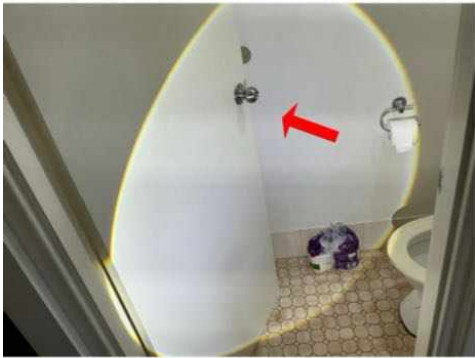
**Finding 3.02**

Building: Main Building  
Location: Entry, WC  
Finding: Plasterboard - Holes  
Information: A hole has been observed in the plasterboard at the time of inspection.

It is essential to repair the plasterboard promptly to prevent further deterioration and maintain the overall safety and appearance of the property.

The client is advised to hire services of a handyman or plasterer to fix the issue.

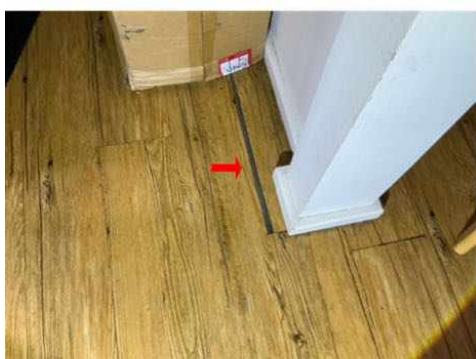
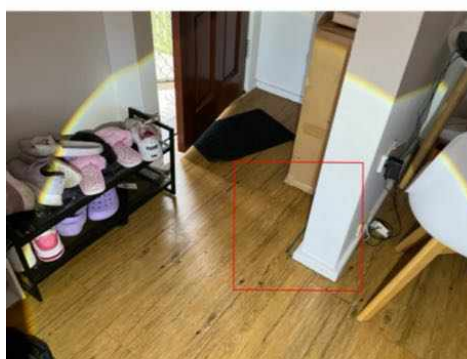
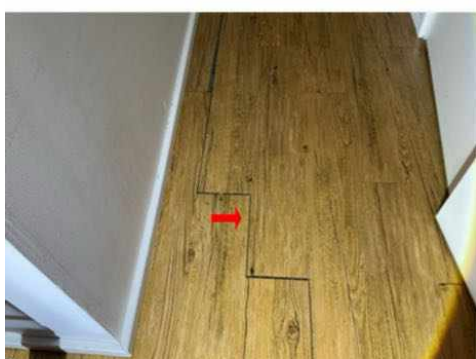
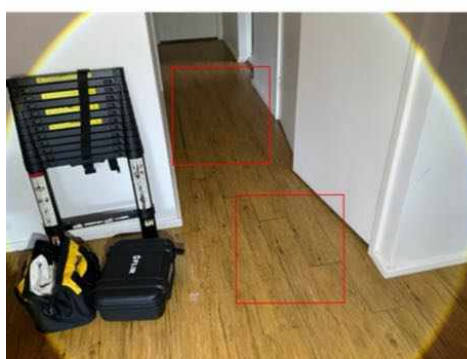
### Finding 3.03

Building:	Main Building
Location:	All Areas
Finding:	Flooring - Gaps
Information:	It was noted at the time of inspection, gaps were noted in the flooring.

These gaps could be attributed to several factors. One common reason is natural expansion and contraction of the wood due to fluctuations in temperature and humidity, which can cause the wood to shrink, leading to visible gaps. Poor installation practices, such as not leaving enough expansion space around the edges, can also contribute to this issue. Additionally, the age and wear of the flooring may lead to loosening of the boards over time. It's essential to address these gaps to prevent further movement and potential damage to the flooring structure.

Proper evaluation by a flooring professional is recommended to determine the best course of action for repair or maintenance.

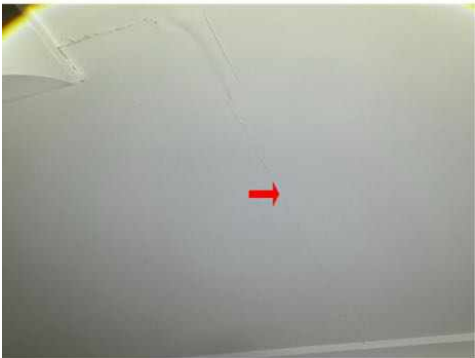
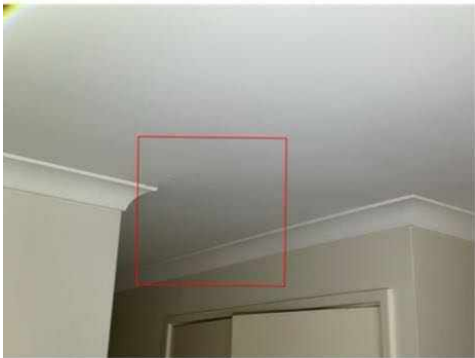
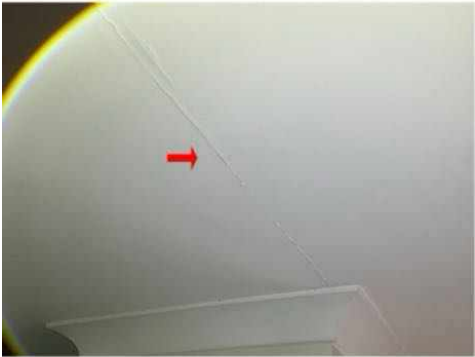
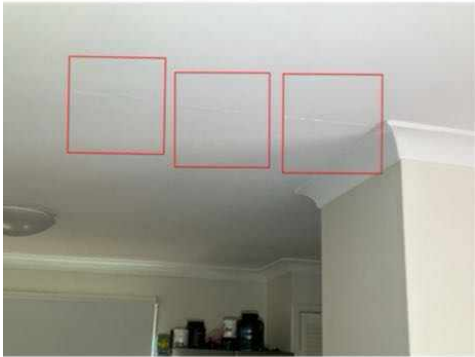
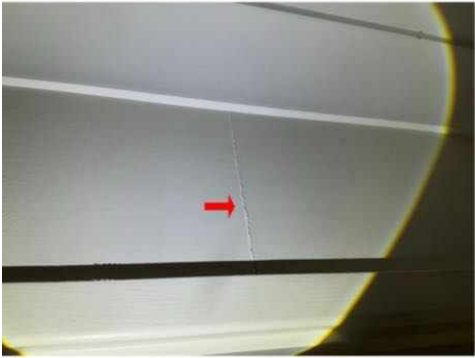
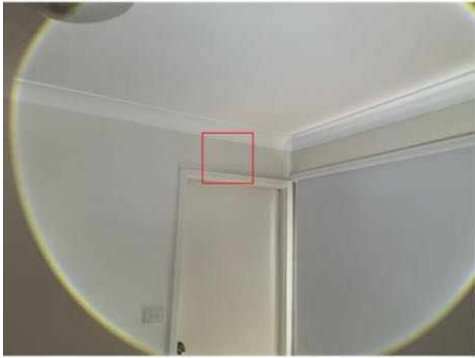
### Finding 3.04

Building:	Main Building
Location:	Living Room, Hallway
Finding:	Cracking - Damage Category 1 - Fine (up to 1mm)

Although fine cracks are quite noticeable, they are often only considered to be an appearance defect, and usually do not indicate any structural damage. Generally, the cause of a fine crack is indicative of a separation between building materials and finishes (e.g. paint, plaster, etc.) along joints.

Cracking of this nature can generally be repaired with minor sanding, filling and/or repainting. Such works should be performed by a qualified painter or a general handyman.

Monitoring of all cracking should be conducted frequently. Always contact a building inspector should cracks widen, lengthen, or become more numerous.

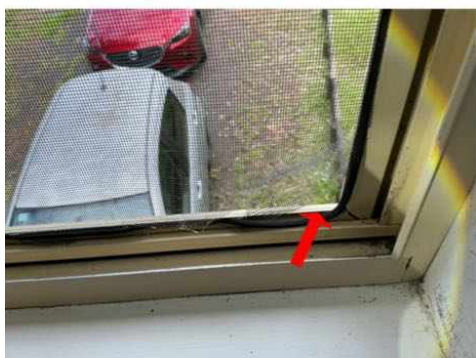
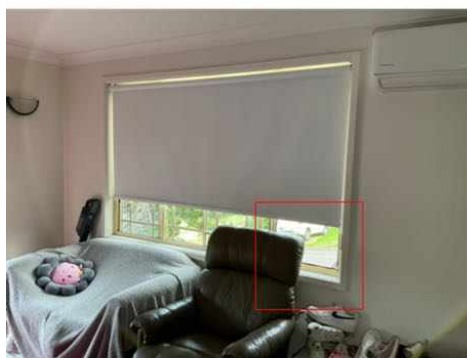
### Finding 3.05

Building:	Main Building
Location:	Living Room
Finding:	Fly Screen Damaged
Information:	It was noted at the time of inspection, the fly screen was damaged.

Window fly screens can sustain damage due to a variety of reasons, including exposure to harsh weather conditions like storms or strong winds, accidental tears or punctures, wear and tear over time, pets scratching or clawing at the screens, poor installation leading to misalignment or weak attachment points, and the use of low-quality materials that may deteriorate faster. Regular maintenance and addressing these factors can help prevent or minimize damage to window fly screens.

A general handyman should be appointed to rectify the issue at owners discretion.

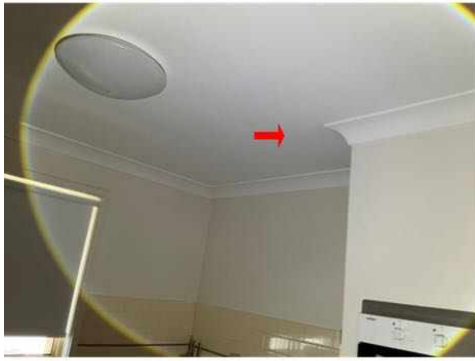
### Finding 3.06

Building:	Main Building
Location:	Kitchen
Finding:	Kitchen Exhaust Fan - Missing
Information:	It was noted at the time of inspection, the kitchen is missing an exhaust fan, which is essential for proper ventilation.

Without adequate extraction, cooking fumes, steam, and grease particles can accumulate, leading to poor indoor air quality, excess moisture, and potential mould growth over time. Additionally, inadequate ventilation can cause lingering odours and contribute to the deterioration of cabinetry and wall finishes. To mitigate these risks and ensure compliance with ventilation standards, we recommend engaging a licensed electrician to install an appropriate exhaust fan that effectively removes airborne contaminants and improves overall air circulation.

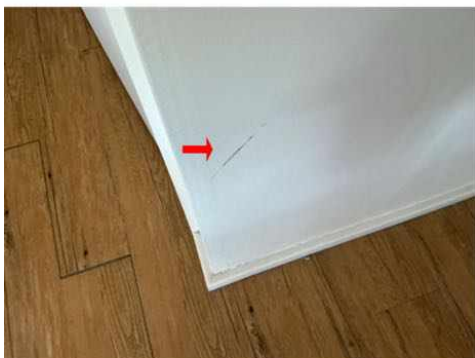
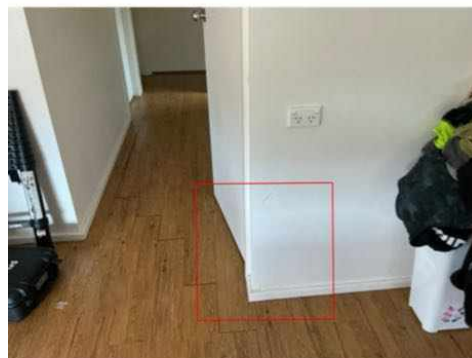
### Finding 3.07

Finding: Maintenance and/or Wear and tear on building elements

Information: It was observed at the time of inspection that some building elements and areas around the property require general maintenance, wear and tear on cabinets and/or exhibit signs of wear and tear. These typically include minor imperfections such as paint scuff marks, scratches on surfaces, small chips, nails or hooks left in walls from previous picture hanging, and other superficial blemishes.

These are generally considered minor items that are common in established homes. While they may be noticeable on visual inspection, they do not affect the structural integrity or functionality of the property. In most cases, these issues can be easily addressed by a qualified handyman as part of routine maintenance.

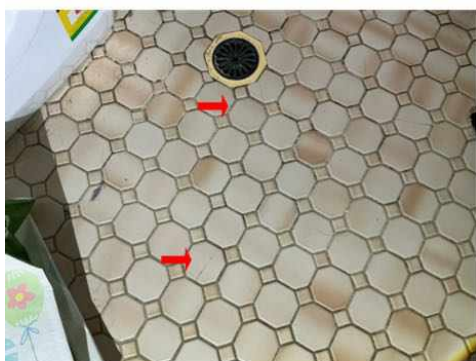
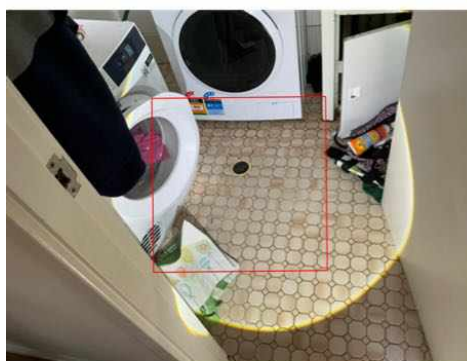
### Finding 3.09

Building:	Main Building
Location:	All Areas
Finding:	Tiles Coming off & Deteriorating Sealant/Grout
Information:	At the time of inspection, sections of tile were noted to be coming loose, with missing or deteriorated grout and sealant in the affected area. This condition may allow water to penetrate beneath the tiles, leading to potential moisture damage, mould growth, or further tile displacement. Rectification by a qualified tiler is recommended to resecure the loose tiles and reapply grout and waterproof sealant to restore the integrity of the surface.

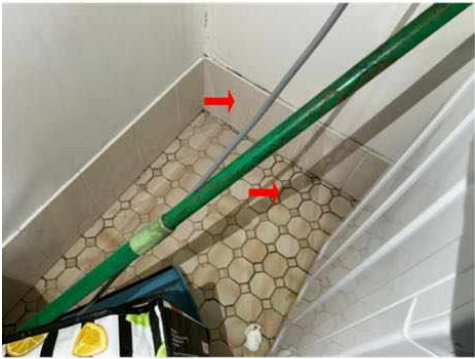
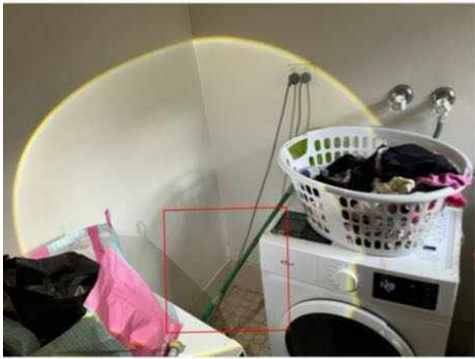
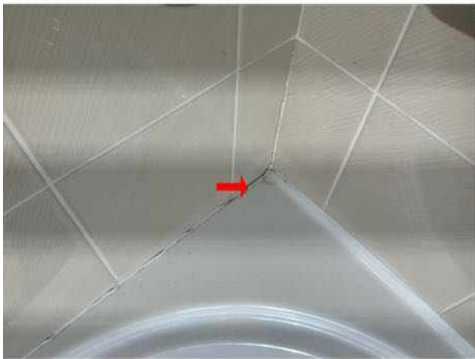
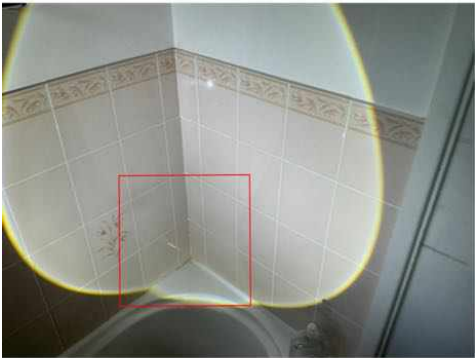
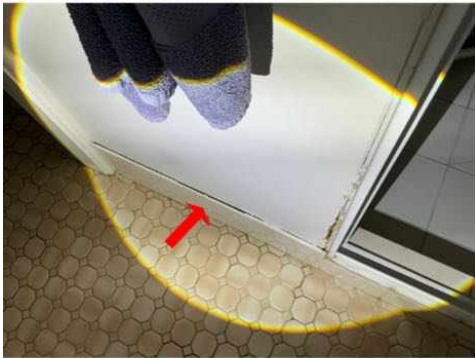
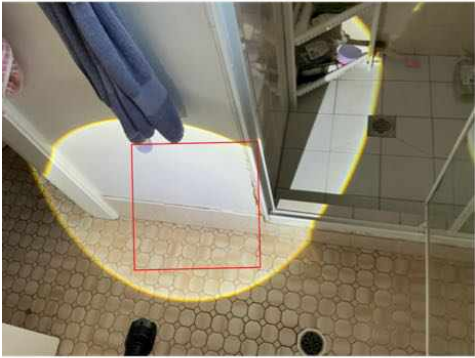
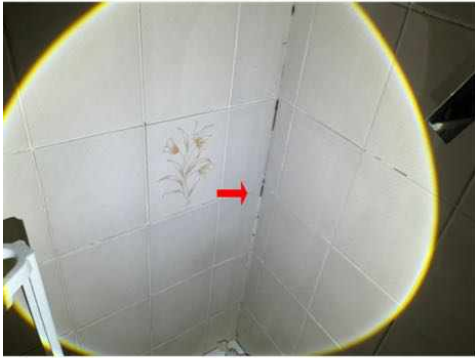
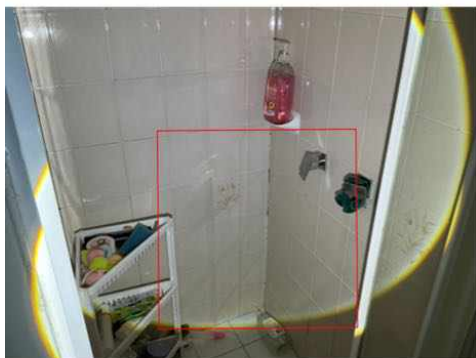
### Finding 3.10

Building:	Main Building
Location:	Laundry
Finding:	Building element - Rusted or corroded
Information:	This building element shows evidence of rusting and corrosion, which is likely to have developed as a result of excessive exposure to moisture and or inadequate coatings.

As surface rust provides no protection to the underlying iron, the deteriorating condition is likely to worsen if not addressed in the short-term future.

Where possible, the use of galvanized (treated) metals or aluminium coated metals aid in rust prevention, as does regular general maintenance. Rust formation can be controlled with coatings, such as paint, that isolate the iron from the environment.

Rusting and corrosion should be managed by ideally removing or limiting the affected surface from exposure to moisture. A registered builder may be appointed to replace any building elements that have been severely affected by rust or water damage.

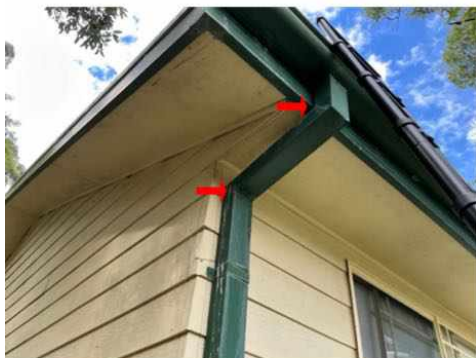
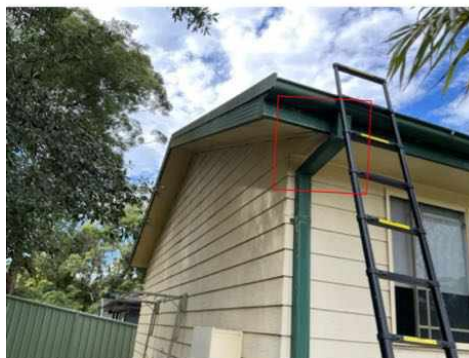
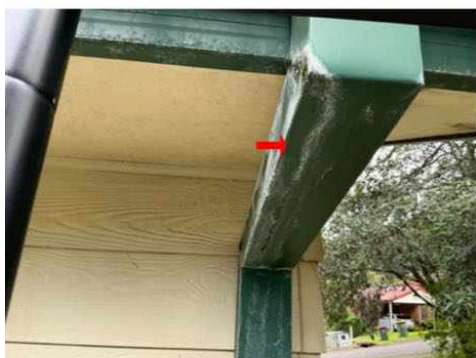
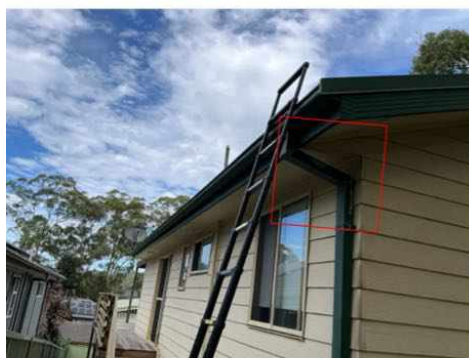
### Finding 3.21

Building:	Main Building
Location:	All Areas
Finding:	Downpipe - Rusted/Corroded
Information:	<p>At the time of inspection, sections of the downpipe were observed to be rusted and showing signs of corrosion. This deterioration is likely due to prolonged exposure to moisture, standing water within the pipe, or insufficient drainage maintenance. Over time, corrosion can weaken the pipe, leading to leaks, blockages, or complete failure of the downpipe, reducing the effectiveness of the stormwater drainage system.</p>

It is recommended that a licensed roof plumber be engaged to replace the rusted or corroded sections and ensure the downpipe is securely fitted and functioning correctly. Regular cleaning and inspection are advised to prevent further corrosion and maintain effective water flow.

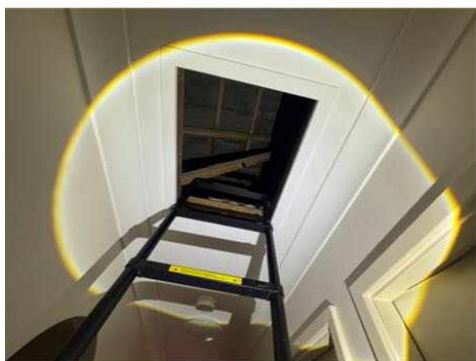
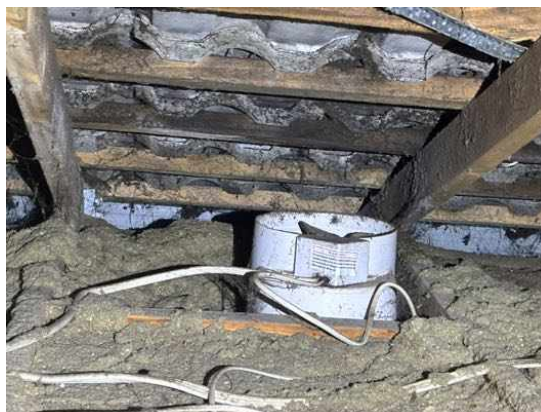
### Finding 3.22

Building:	Main Building
Location:	Roof Void
Finding:	Vent - Extracted into Roof Space
Information:	During the inspection, it was noted that the exhaust vent has been improperly terminated into the roof space instead of being ducted to the exterior of the property.

This configuration is a defect as it allows moist air to accumulate within the roof cavity, increasing the risk of condensation, mould growth, and deterioration of insulation or timber framing. Proper ventilation is essential to maintain a healthy indoor environment and protect the structural integrity of the building. It is recommended that the vent be appropriately re-routed to discharge externally in compliance with relevant building standards.

A licensed mechanical ventilation contractor/electrician should be appointed as soon as possible to provide further consultation on the scope of these works and to provide quotations for any necessary works.

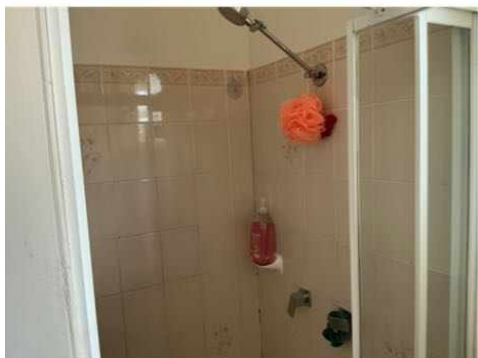
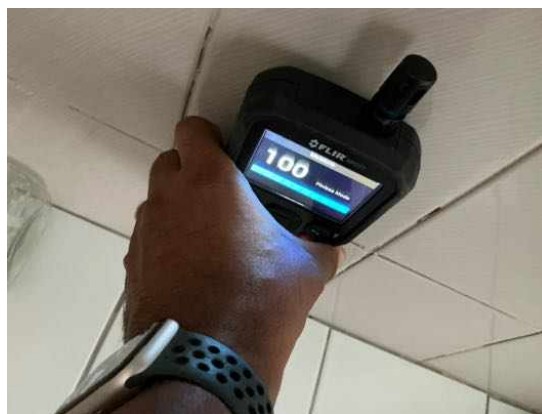
### Finding 3.23

Building:	Main Building
Location:	Bathroom
Finding:	Excessive Moisture - Shower Damp
Information:	At the time of inspection, excessive moisture was noted within the shower area, which is a common issue in wet areas due to the continual exposure to water. This condition is typically caused by moisture seeping through grout lines and settling behind tiles, resulting in localised high-moisture zones. Provided there is no evidence of water staining or elevated moisture readings on the opposite side of the wall, this is considered a minor defect.

However, persistently damp conditions may act as conducive conditions for termite activity, as termites are strongly attracted to moisture-rich environments. It is recommended that the client ensures regular use of the exhaust fan and maintains adequate ventilation after shower use to promote drying and reduce long-term moisture build-up, thereby also reducing the risk of attracting termites.

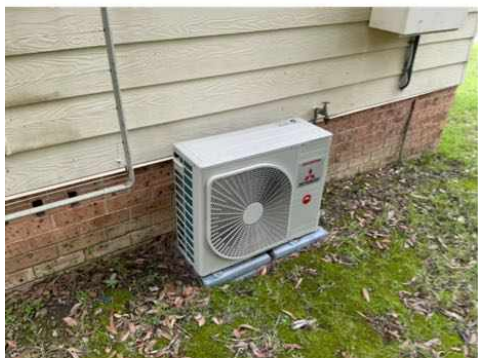
Where any part of an attachment to a building is not isolated and is not provided with a clear gap of not less than 25mm from the building, bridging occurs. Attachments to buildings such as hot water services, downpipes, verandahs, decks, steps, fences, service conduits and the like provide the opportunity for concealed entry.

Building attachments of this nature need to be frequently inspected for termite activity by a qualified inspector.

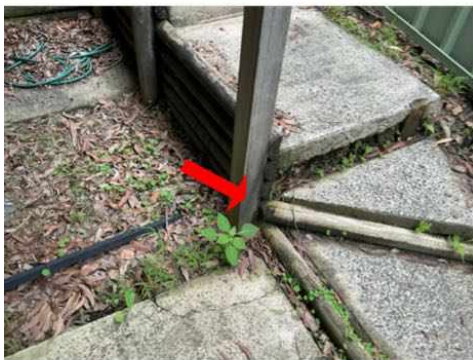
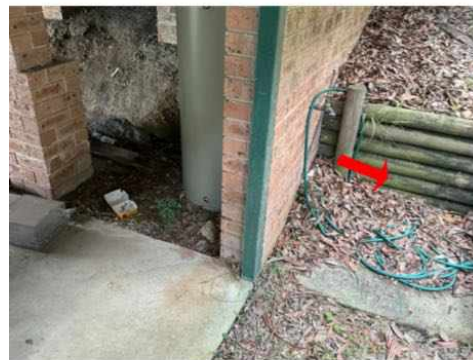
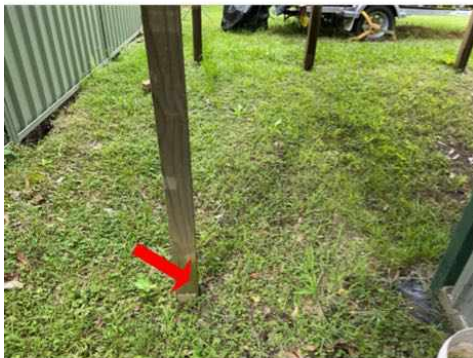
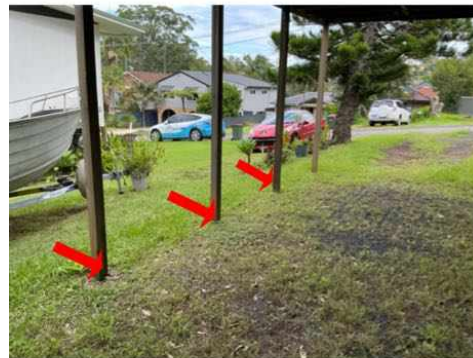
## Finding 6.02

Building:	Yard
Location:	All Areas
Finding:	Building Materials in Direct Ground Contact - Conducive to Termites
Information:	Timber elements that are in direct contact with the ground and exposed to moisture or damp conditions are highly conducive to termite activity. This susceptibility arises because timber, when in contact with soil and dampness, creates an environment that is particularly attractive to termites, encouraging infestation and potential structural compromise. Whether the timber is used as a part of the building's construction or incorporated into fencing, its presence near or on the ground can become a pathway for termites to access and damage the property.

When exposed to excessive moisture, timber begins to deteriorate, developing conditions such as wood decay and rot. These compromised areas of timber are even more appealing to termites, as they are easier to infest and consume. This is especially true for untreated or non-durable timber, which lacks the protective treatments that can deter or withstand termite attacks. Termites can use these weakened, moisture-laden elements as a bridge into other parts of the structure, creating an entry point for potential infestations that can spread and cause extensive damage if left unchecked.

For any timber in direct contact with the external ground, special attention is required. The combination of moisture, untreated wood, and direct ground contact not only accelerates the decay process but also provides subterranean termites with a straightforward means of ingress into the structure. This entry can lead to termites moving undetected into other vulnerable areas, resulting in potentially significant structural issues and costly repairs.

necessary for use should be made durable through appropriate treatments and maintained to ensure they do not create conditions conducive to termites. Additionally, the client is advised to schedule regular termite treatments to maintain an effective barrier against infestations and ensure ongoing protection.

The client is strongly advised to assess the property for any timber elements that may be in direct contact with the ground and ensure prompt action is taken to remove or treat them effectively. Regular inspections, proactive maintenance, and consistent termite treatment are essential steps in minimising the risk of termite attack and protecting the structural integrity of the property. Taking these preventive measures is crucial for maintaining a termite-free environment and avoiding potentially costly damage and future repairs.

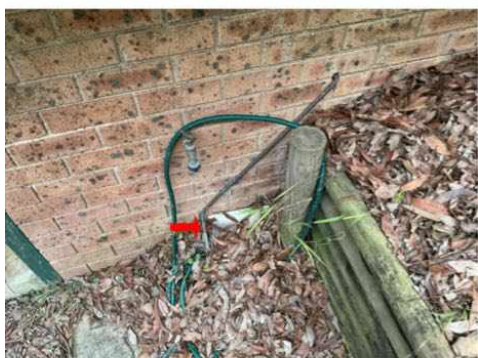
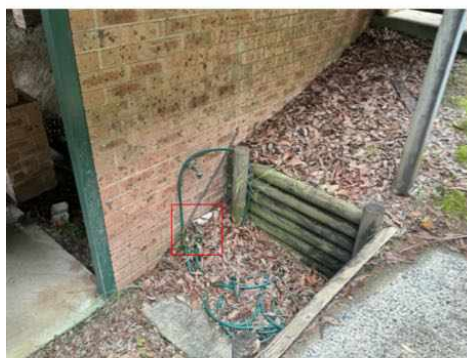
### Finding 6.03

Building:	Main Building
Location:	All Areas
Finding:	Overflow Disconnected - HWS/AC/Gas - Conducive Conditions to Termites
Information:	The overflow to this service was found to be disconnected from stormwater drainage and is creating excessive moisture in the surrounding area.

Such leaking creates an environment that is conducive to an array of defects, including water damage to associated building elements and the attraction of termite or timber

pest infestation. These damp conditions can lead to secondary defects such as rot, rust, or corrosion of associated building elements, the formation of fungal decay, or even the creation of potential slip hazards. When coupled with poor site drainage, pooling of water may also attract termite activity to this area.

It is highly recommended that a licensed plumber be appointed to connect the overflow in order to prevent such an environment from being created. These minor works should be carried out as soon as possible.

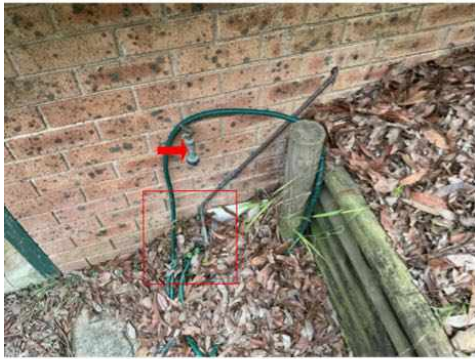
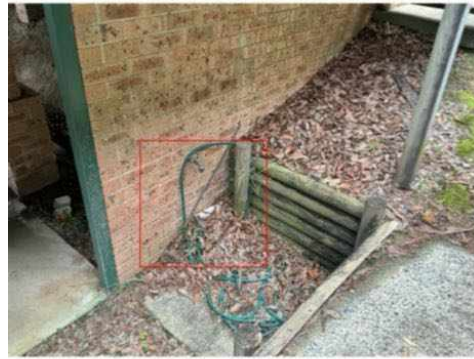
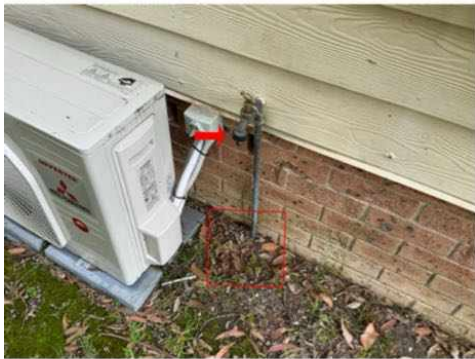
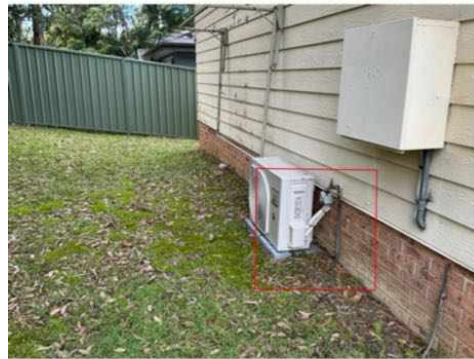
#### Finding 6.04

Building:	Main Building
Location:	All Areas
Finding:	No Stormwater Drain - Under Exterior Tap
Information:	The inspection identified that the exterior tap is not connected to a stormwater drainage system, allowing water to pool around the base. This can lead to moisture-related issues such as deterioration of nearby building materials, mould growth, and increased risk of termite activity—each of which may compromise the property's structural integrity and create health or safety concerns.

To prevent these risks, it is strongly recommended that a licensed plumber be engaged to assess the area and install appropriate drainage, such as a stormwater connection or splash block, to redirect water away from the property. Ongoing maintenance and monitoring of external water sources are also advised to ensure long-term protection.

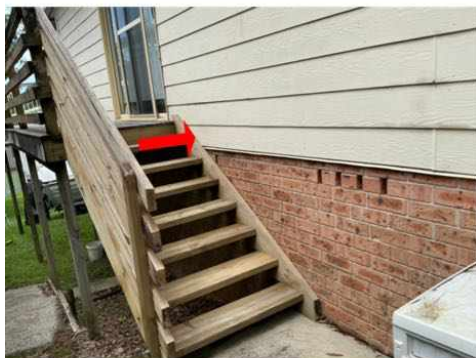
### Finding 6.05

Building:	Main Building
Location:	Stairs
Finding:	Timber Directly Attached to Building
Information:	At the time of inspection, timber materials were noted to be directly attached to the external wall of the dwelling. This practice is considered a conducive condition for termite activity, as it provides both a potential food source and concealed entry point for termites into the structure.

It is recommended that the timber be removed, isolated, or appropriately treated to reduce the risk of termite infestation. A licensed pest management specialist should be consulted for further assessment and advice in line with AS 3660.2 (Termite Management).

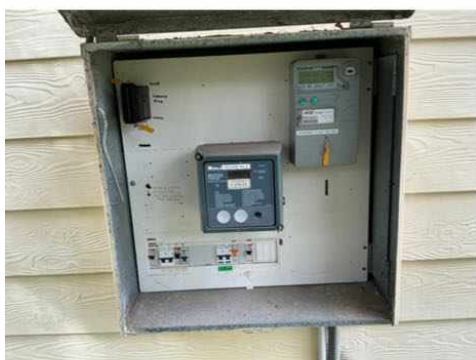
### Finding 6.06

Building:	Main Building
Location:	Meter Box
Finding:	Termite Management System - No Evidence of Installation
Information:	The application of a post-construction chemical termite barrier is strongly recommended for all properties, especially if there has been any history of live termite activity on-site. These barriers are highly effective in protecting timber building elements throughout the property by preventing termite attacks. It is also advisable to install a durable notice within the switchboard unit, indicating the presence of any termite barriers for future reference.

During the inspection, there was no indication that a termite management system had been installed, nor was there any evidence to suggest that preventative measures had previously been undertaken. The client is encouraged to seek further advice from a licensed pest controller regarding the costs and procedures involved in the application of a termite barrier. Prioritizing this step in the short term is strongly advised to ensure long-term protection.

Additionally, the client may want to consult with the vendor to determine whether regular Timber Pest inspections, as per AS4349.3 or AS 3660.2, have been conducted in the past. This will provide further insights into any past termite management practices and help inform the appropriate course of action.

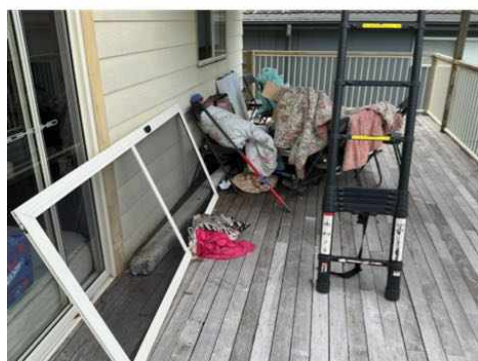
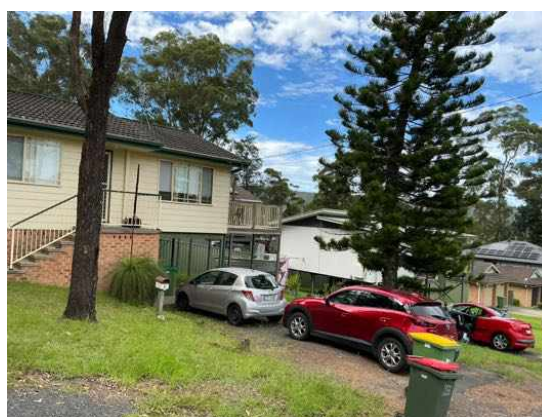
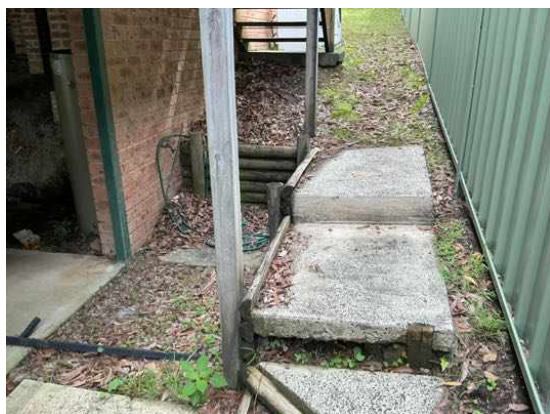
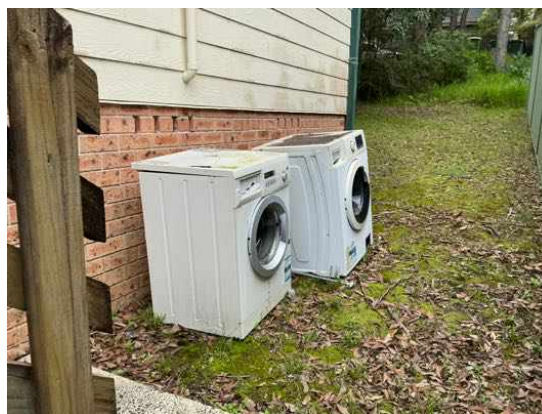
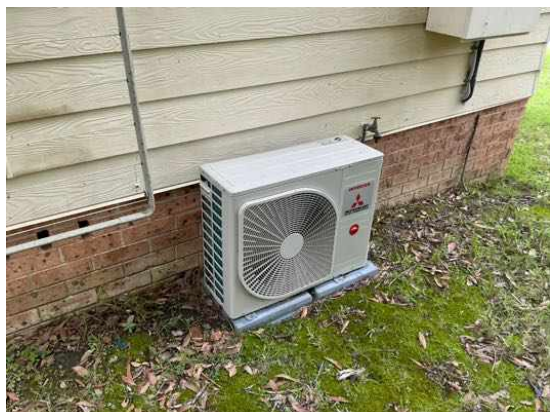
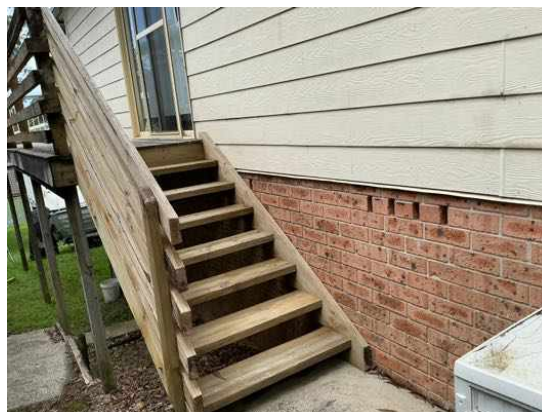
Building: Main Building  
Location: All External Areas  
Finding: Obstructions and Limitations - External Areas  
Information: The attached photographs provide a visual representation of the obstructions and limitations that impeded a full inspection of the external areas of the property at the time of assessment. These obstructions, which may include vegetation, stored items, debris, or other physical barriers, can obscure potential defects and prevent a thorough evaluation of the property's condition. Obstructions of this nature can conceal a wide range of issues, such as structural damage, water ingress, pest infestations, or deteriorating building materials, which may not be visible during the initial inspection.

It is essential that these obstructions be cleared to allow for a comprehensive inspection of the external areas. Removing these barriers will enable a more accurate assessment of the property's condition and allow any hidden defects to be identified and addressed promptly. Failure to do so could result in undetected issues worsening over time, potentially leading to more costly repairs in the future.

Therefore, it is strongly recommended that the obstructions be removed and a re-inspection be scheduled once the affected areas are made fully accessible. This will ensure a complete evaluation of the property's exterior and provide the client with a clear understanding of any potential issues that may have been concealed during the initial inspection.

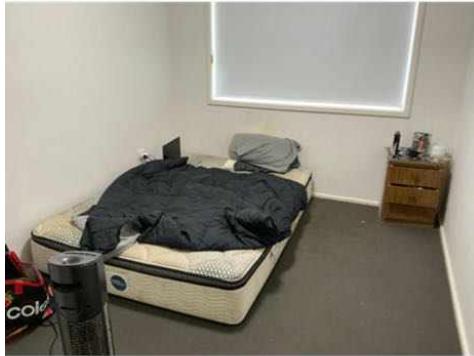
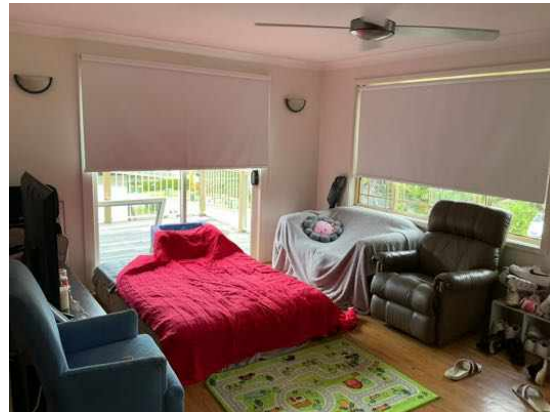
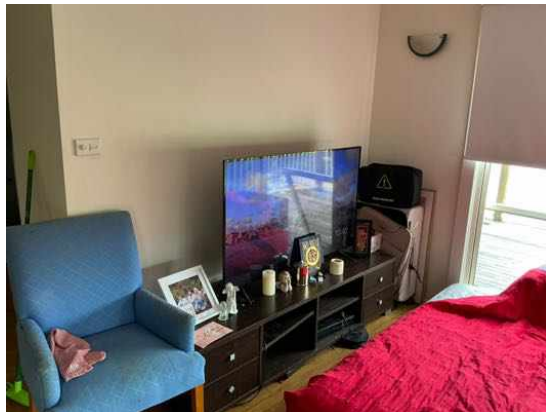
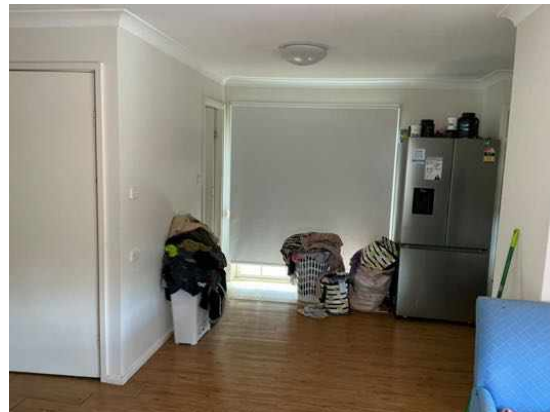
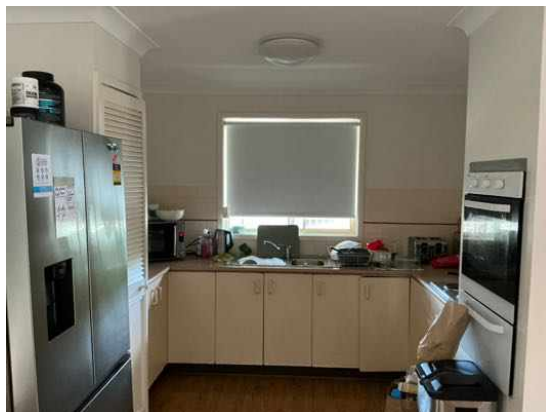
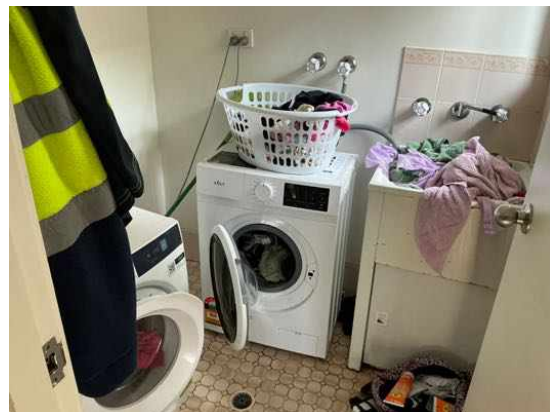
Information: The accompanying photographs provide clear evidence of the obstructions and limitations that restricted a comprehensive inspection of the internal areas of the property at the time of assessment. These obstructions, which may include furniture, personal belongings, stored items, or structural elements such as wall coverings and built-ins, significantly hindered the ability to thoroughly evaluate these areas. It is important to note that such obstructions can potentially conceal a wide array of defects, ranging from hidden structural damage, water leaks, pest infestations, or electrical issues, to deteriorating materials that may not be visible during the initial inspection.

The presence of these impediments means that critical areas of the property were not accessible, and therefore, any underlying defects that may affect the integrity and safety of the property could remain undetected. These hidden defects, if left unaddressed, could worsen over time and may result in costly repairs or pose potential safety hazards to the occupants.

It is highly recommended that all obstructions be cleared to facilitate a complete and thorough inspection of the internal areas. Once the obstructions have been removed and full access is available, a re-inspection should be carried out to ensure that any

previously concealed issues can be properly identified and rectified. This follow-up inspection will provide a more accurate assessment of the property's internal condition and help the client make informed decisions about any necessary repairs or maintenance.

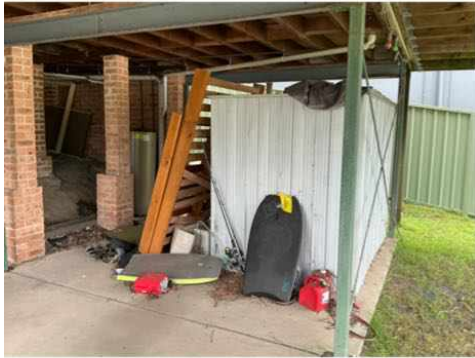
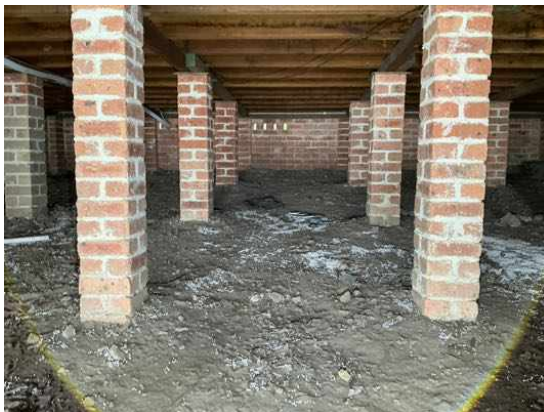
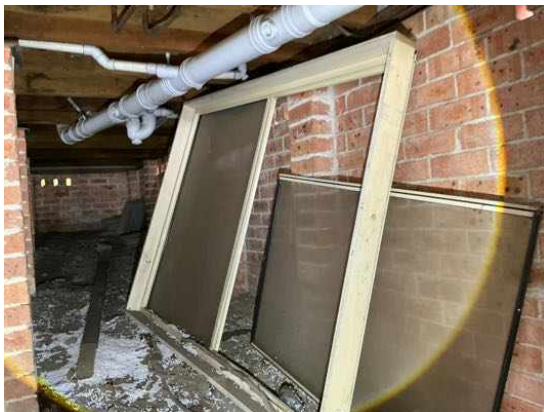
Building: Main Building  
 Location: Subfloor  
 Finding: Obstructions, Limitations, and General Subfloor Condition  
 Information: The attached photographs illustrate the obstructions and access limitations that restricted a full inspection of the subfloor area of the main property at the time of assessment. Items such as stored materials, construction debris, low-hanging services, and insulation impeded movement and visibility within key sections of the subfloor. In addition, the limited crawl height further restricted safe access to inspect critical structural components.

Restricted access and confined spaces can significantly hinder the ability to evaluate important elements such as floor joists, bearers, stumps, drainage, subfloor ventilation, and signs of moisture or pest activity. These obstructions may also conceal defects such as timber decay, water ingress, termite damage, inadequate support, or ventilation issues that are not immediately visible during a limited inspection.

While no major concerns were identified in the accessible areas, a full and unobstructed inspection is necessary to properly assess the overall condition of the subfloor. It is recommended that obstructions be removed and access improved where possible. Once adequate clearance is provided, a re-inspection should be arranged to ensure that any concealed defects can be identified and addressed accordingly. This will assist in providing a more comprehensive understanding of the

subfloor's condition and reduce the risk of unforeseen issues.

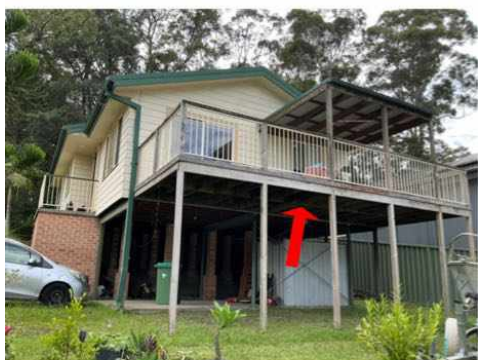
You should also arrange annual inspections of the structure by an engineer or other suitably qualified person to ensure any maintenance, that may become necessary, is identified. Care must be taken not to overload the structure.

Nothing contained in this report should be taken as an indicator that an assessment has been made, on any elevated structure, as suitable for any specific number of people or purpose. This can only be done by a qualified engineer. For the purpose of this report, the Structure includes elevated decks, verandah, pergolas, balconies, handrails, stairs and children's play areas.
