# Building and Timber Pest Inspection Report

Inspection Date: Thu, 26 Mar 2026

Property Address: 6 River St, Springfield NSW 2250, Australia

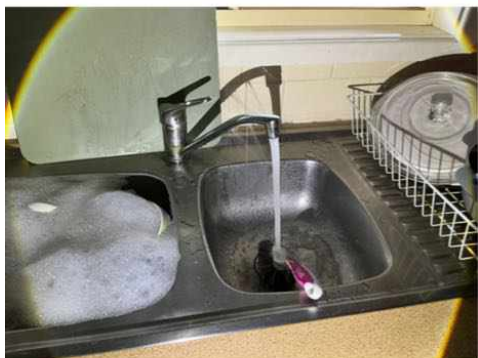
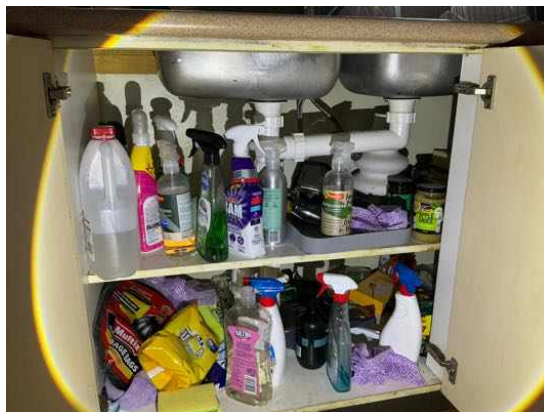
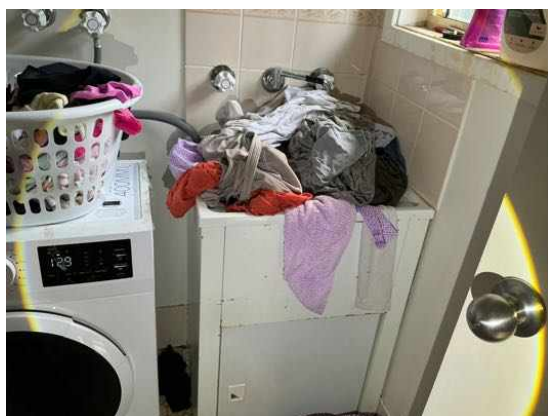
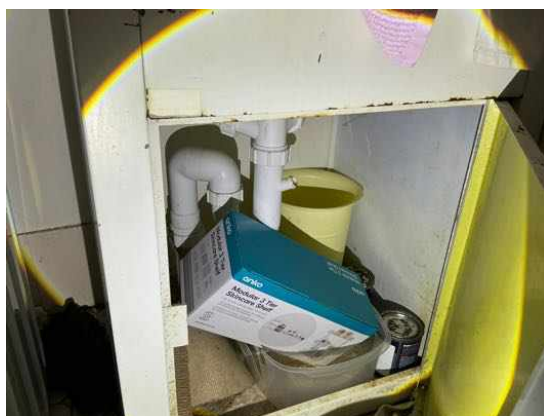
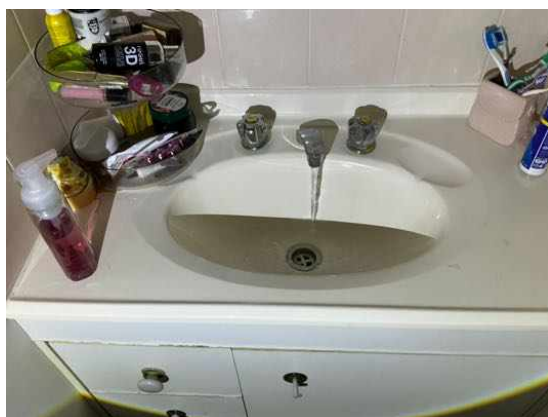
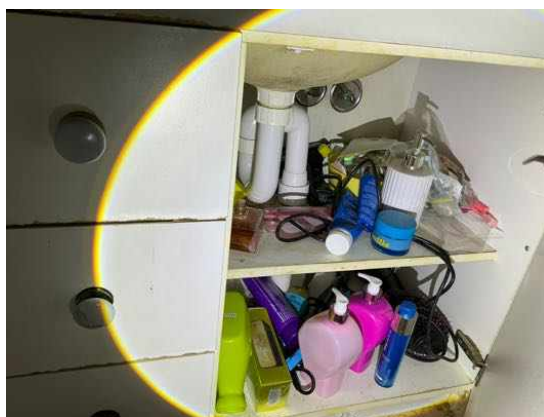
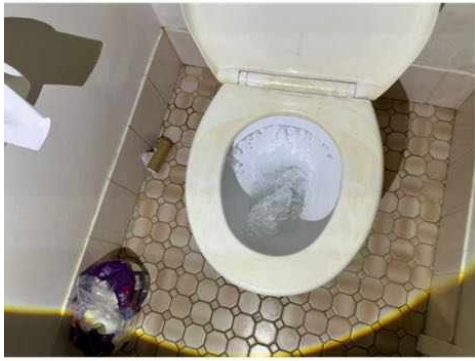
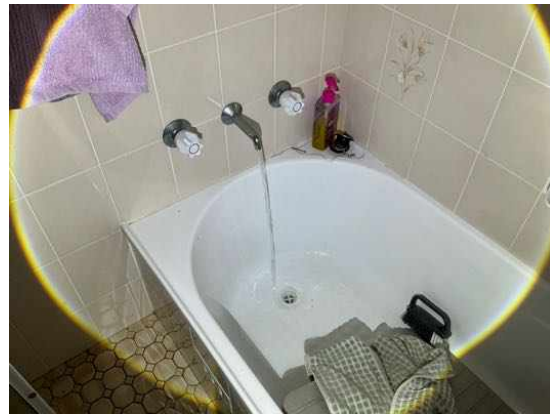
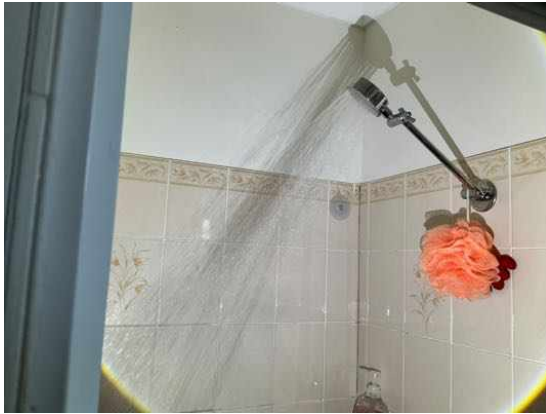
Building:	Main Building
Location:	All Areas
Finding:	FYI - Taps, Drainage & Toilets Tested and Cabinetry Obstructions
Information:	During the inspection, all accessible taps, drainage systems, and toilets were tested for water flow and drainage efficiency, and checked for any visible signs of leakage. At the time of the inspection, no issues were noted in these areas. Unless highlighted in a separate defect statement, no immediate remedial work appears necessary. Supporting images may be found in the additional photos section for reference.

inspection practices, inspectors are not permitted to move or disturb personal belongings during the inspection process. Therefore, only visible and accessible sections were inspected, and concealed water damage or plumbing defects may not have been detected.

Given this, a re-inspection is recommended after all obstructions have been cleared to allow for a comprehensive assessment of these areas. Regular maintenance and monitoring of plumbing and drainage systems is also advised to ensure ongoing functionality and early detection of potential issues.

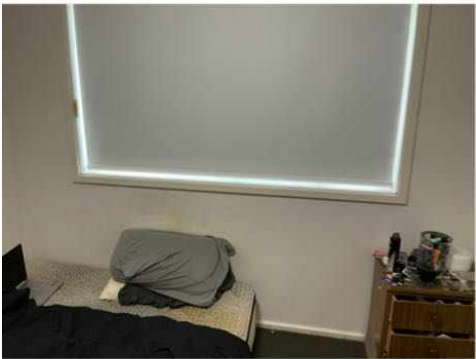
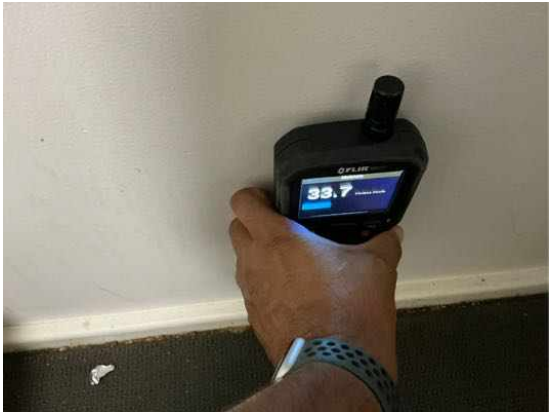
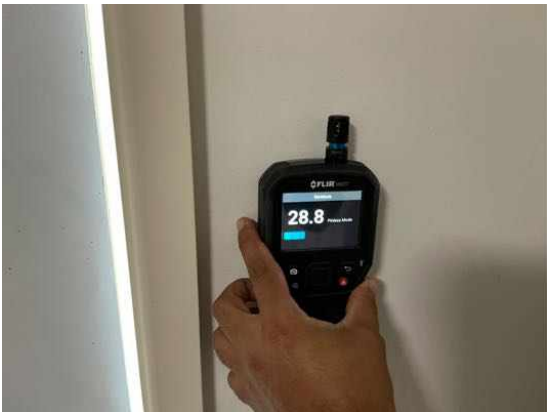
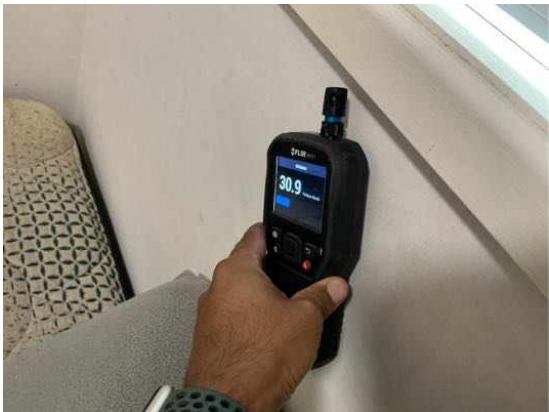
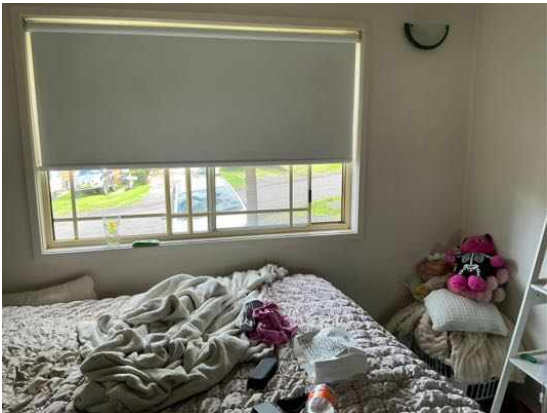
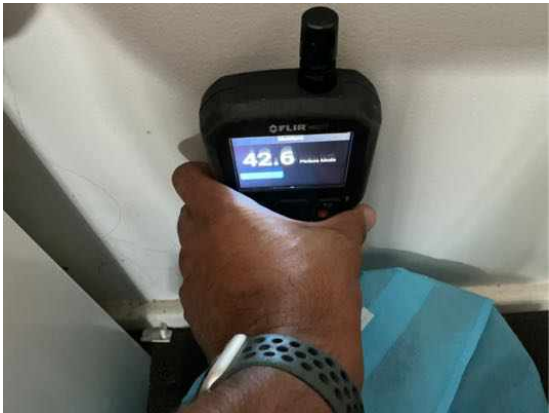
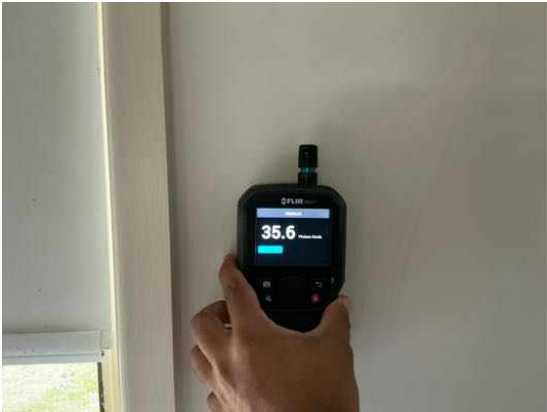
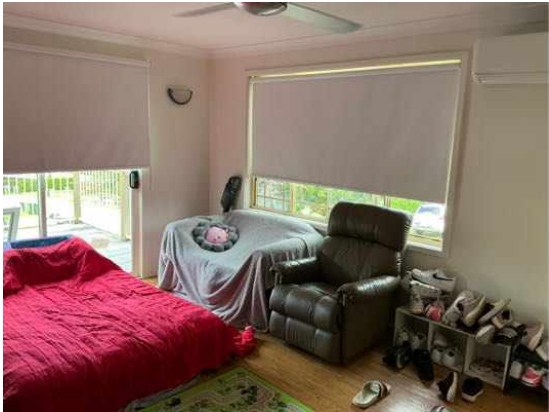
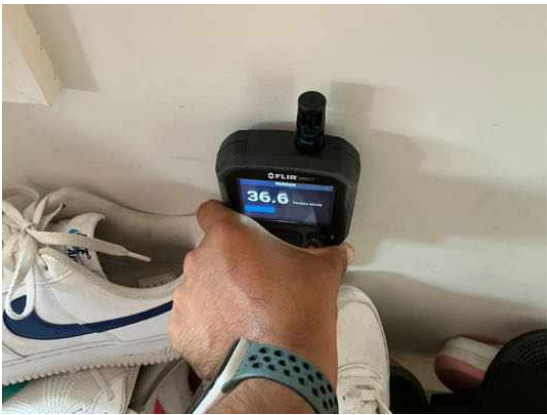
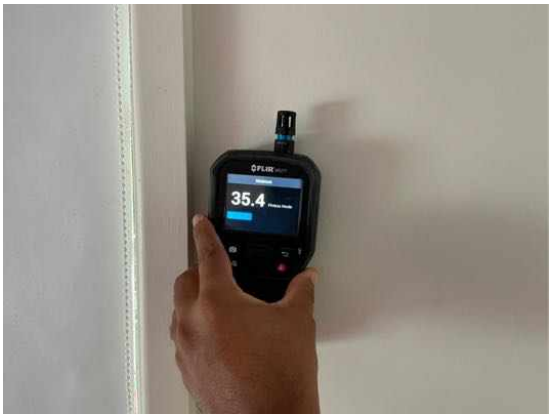
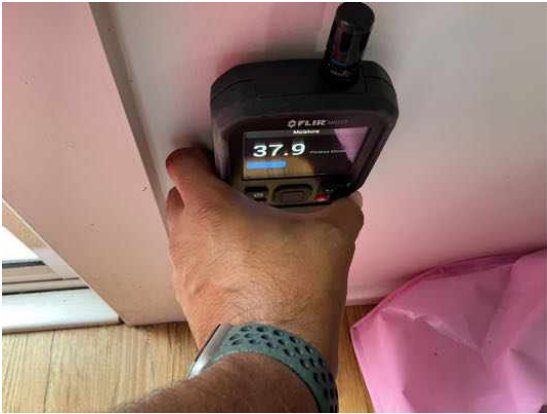
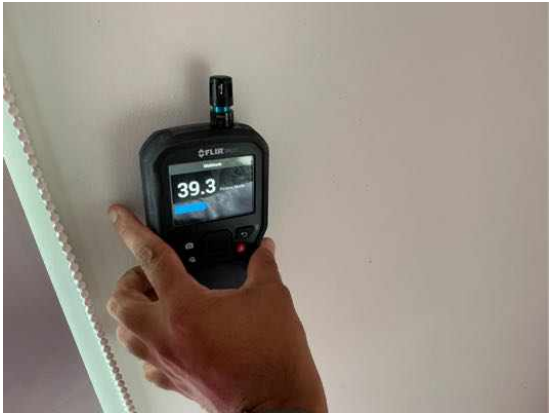
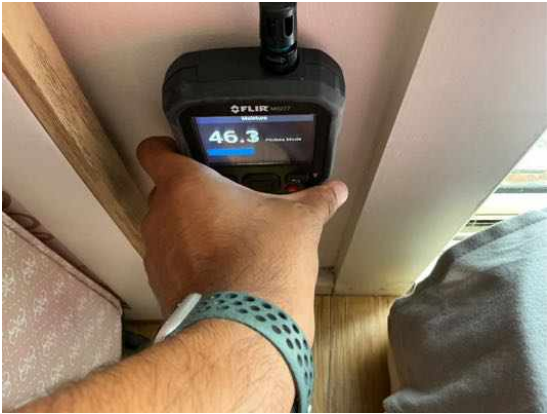
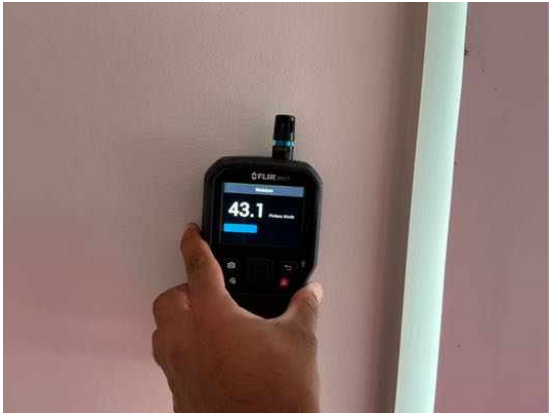
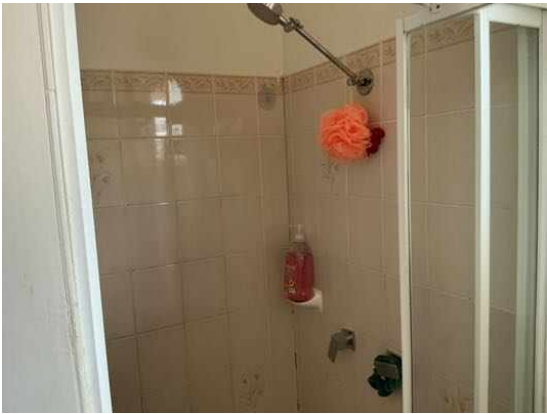
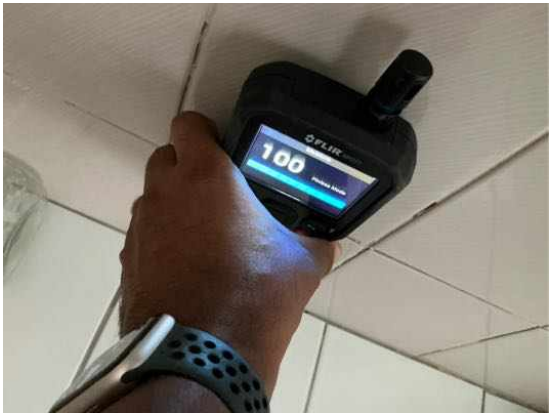
Building:	Main Building
Location:	All Areas
Finding:	Additional Photos - Moisture Meter Readings
Information:	Additional moisture meter reading photos have been provided for the property to offer further clarity on areas tested during the inspection. These photos are intended to give a visual reference for the specific locations where moisture levels were measured. These readings were taken at the time of the inspection to assess any potential moisture-related issues within the property. Any defects related to moisture that were identified during the inspection have been separately mentioned in the defect statements within the report.

It is important for the client to understand that moisture levels can fluctuate over time due to various factors, including changes in weather, humidity, and environmental conditions. While the readings reflect the property's moisture levels during the inspection, they may not represent future conditions, and increased moisture could lead to issues such as dampness, mould growth, or deterioration of building materials if left unmonitored.

For further clarification or additional information regarding the moisture readings, the client is encouraged to contact the building inspector directly. Regular monitoring of moisture-prone areas is recommended to ensure any emerging concerns are addressed promptly, particularly during wetter seasons or in high-humidity conditions.

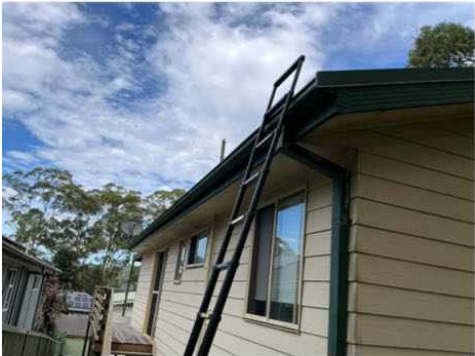
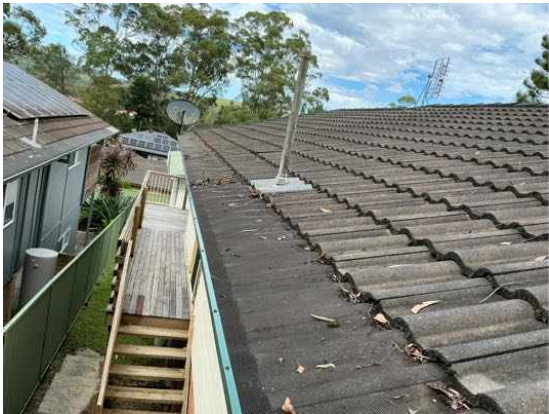
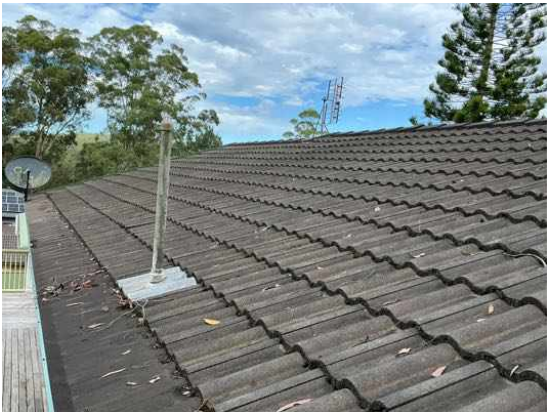
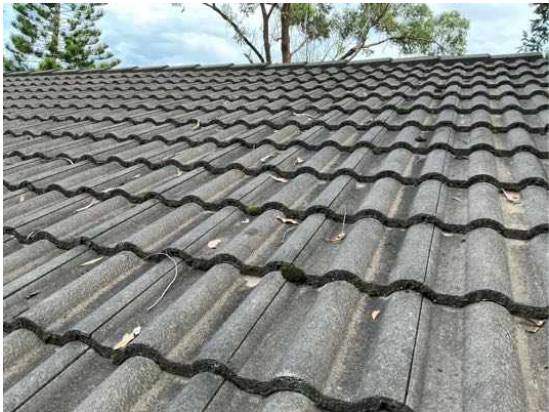
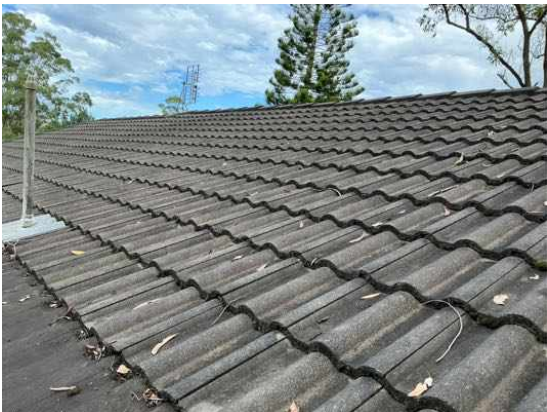
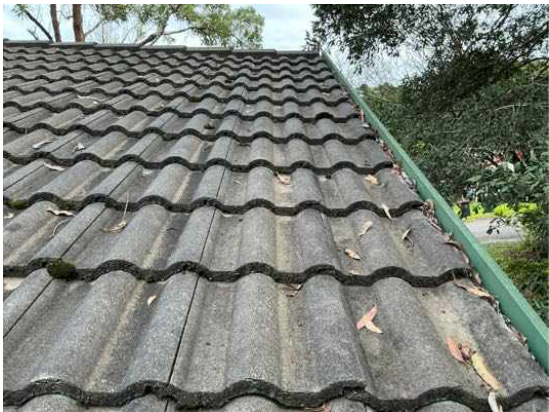
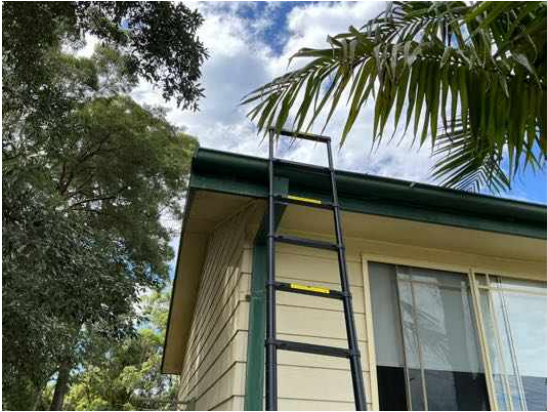
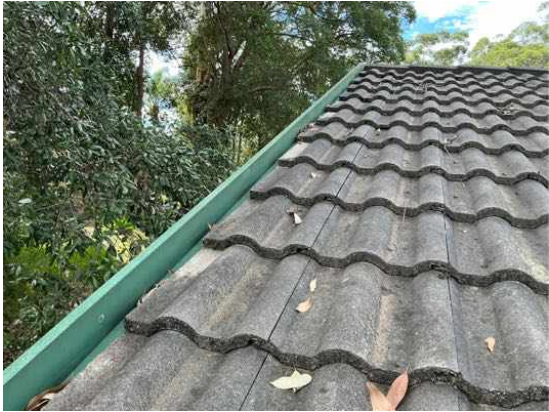
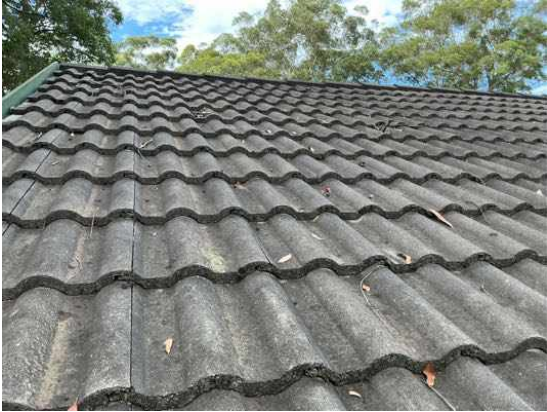
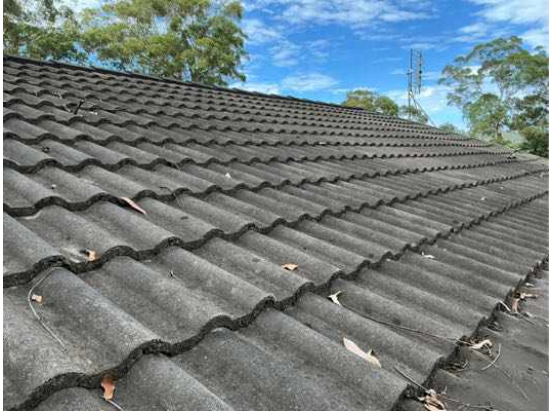
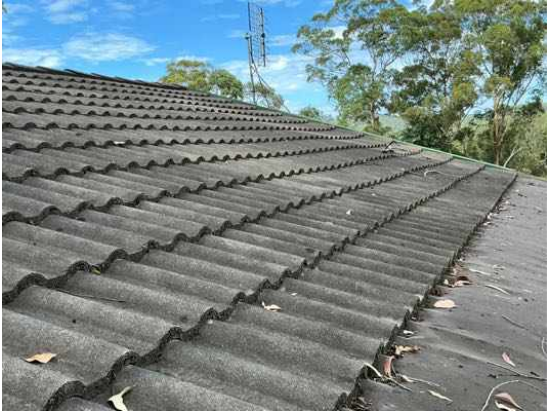
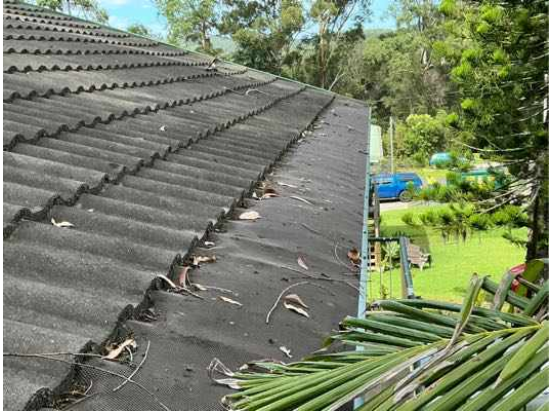
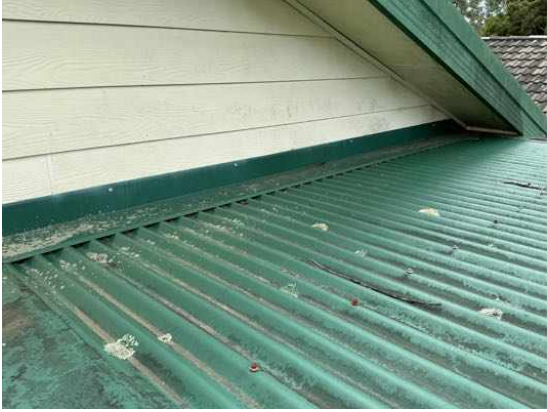
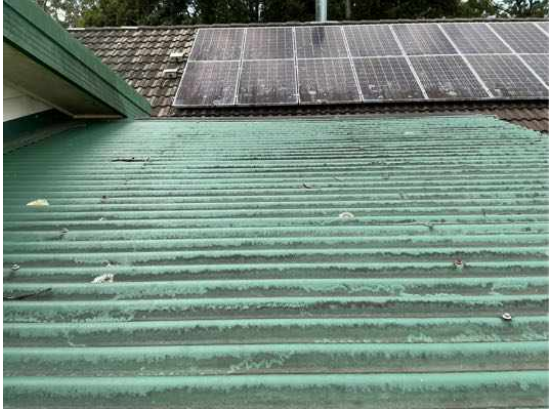
**Noted Item**

Building: Main Building  
Location: Roof Exterior  
Finding: Additional Roof Photos

Information: As part of the information provided, please note that the attached roof photos represent the condition of the roof at the time of inspection. These photos are for visual reference only and do not constitute a detailed roofing assessment. Any defects or issues identified with the roof are mentioned separately in the defect statements. It is strongly recommended that the client engage a qualified roofer to conduct a thorough inspection of the roof, ensuring that any potential issues, such as leaks, structural integrity, or wear and tear, are properly identified and addressed.

Additionally, the condition of the roof may change over time due to weather, natural wear, or other unforeseen factors. Regular maintenance and inspections by a licensed professional are advised to ensure the roof remains in good condition and to avoid costly repairs in the future. The information provided in these photos should be considered a snapshot of the roof's condition during the time of inspection and not a guarantee of its future performance.

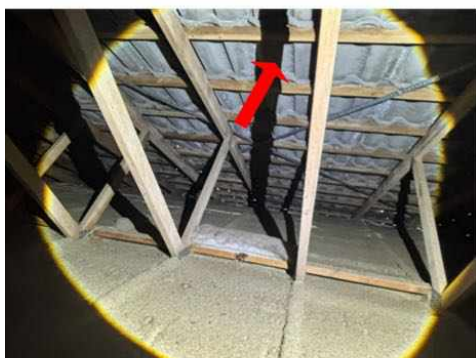
Building: Main Building  
Location: Roof Void  
Finding: Sarking - Missing  
Information: Sarking is missing under the roof sheeting. Sarking acts as an insulator that helps with noise reduction and protects against water penetration. Sarking plays a key role in the operation and function of the overall roofing structure and its performance.

Although not a requirement at the time of construction, replacement of any missing building element is advisable (although this can be quite expensive to do after the time of construction). Where sarking is missing, regular inspections of the roof tiles for cracking and potential moisture penetration is required.

Sarking may be retrospectively fitted by a registered builder at the discretion of the client.
